Growth behavior of surface cracks in pipeline steels exposed to near-neutral pH environments

AFOLABI TAIWO EGBEWANDE

Doctor of Philosophy

Materials Engineering

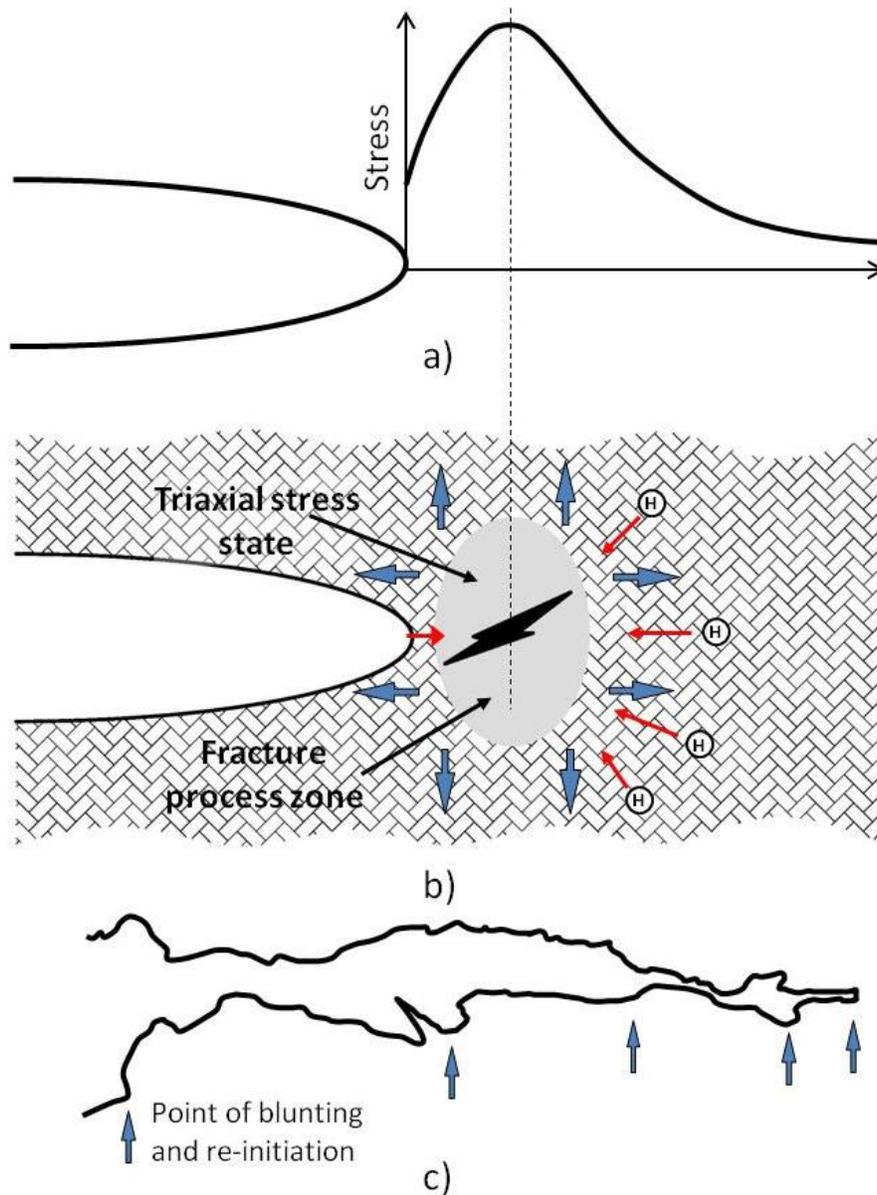
Figure 4-21: (a) Stress distribution ahead of a crack tip (b) triaxial stress state in the hydrogen process zone (c) profile of a crack that experienced periodic dormancy during crack propagation

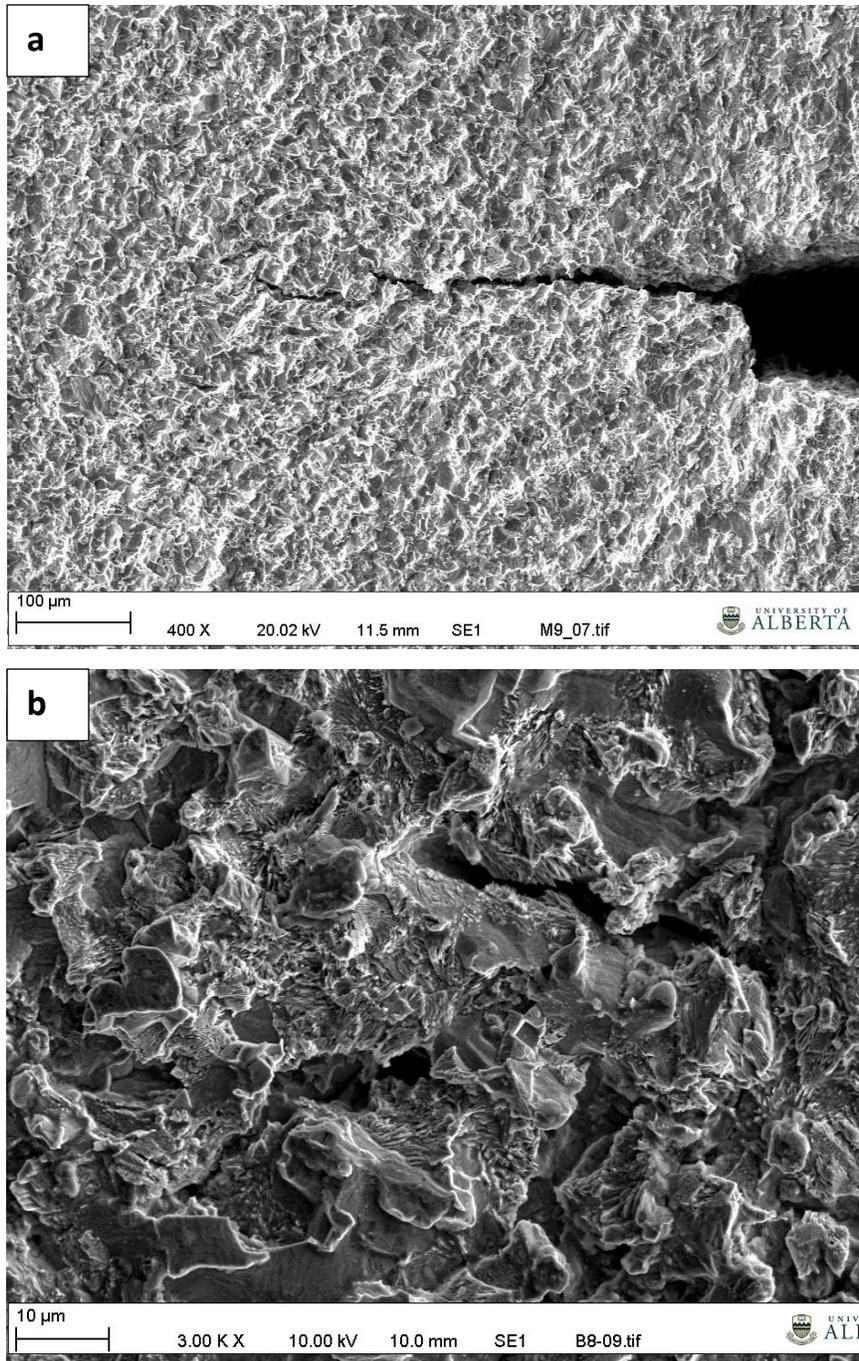
Figure 5-7: Secondary cracks at the pre-fatigue crack tip in test I (a) at low magnification, (b) high magnification

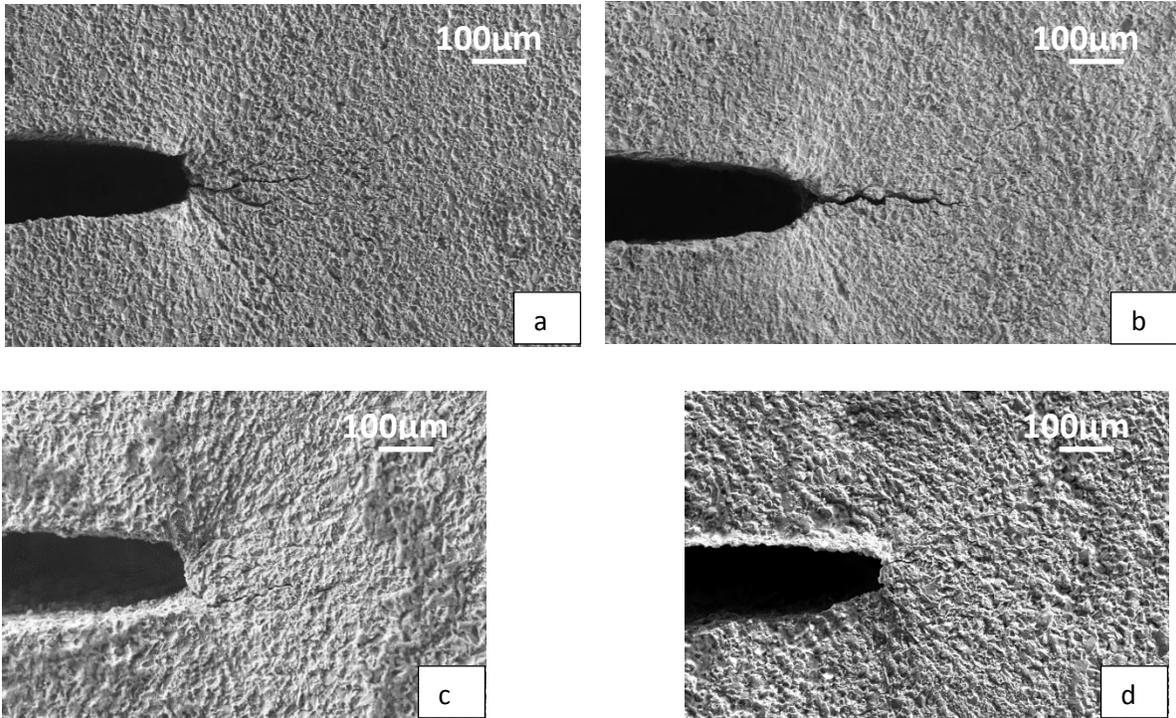
Figure 5-12: Post-test pre-fatigue crack tip morphology (a) 75 mm from OM in test II, (b) 150 mm from OM in test II, (c) 75 mm from OM in test III, (d) 150 mm from OM in test III

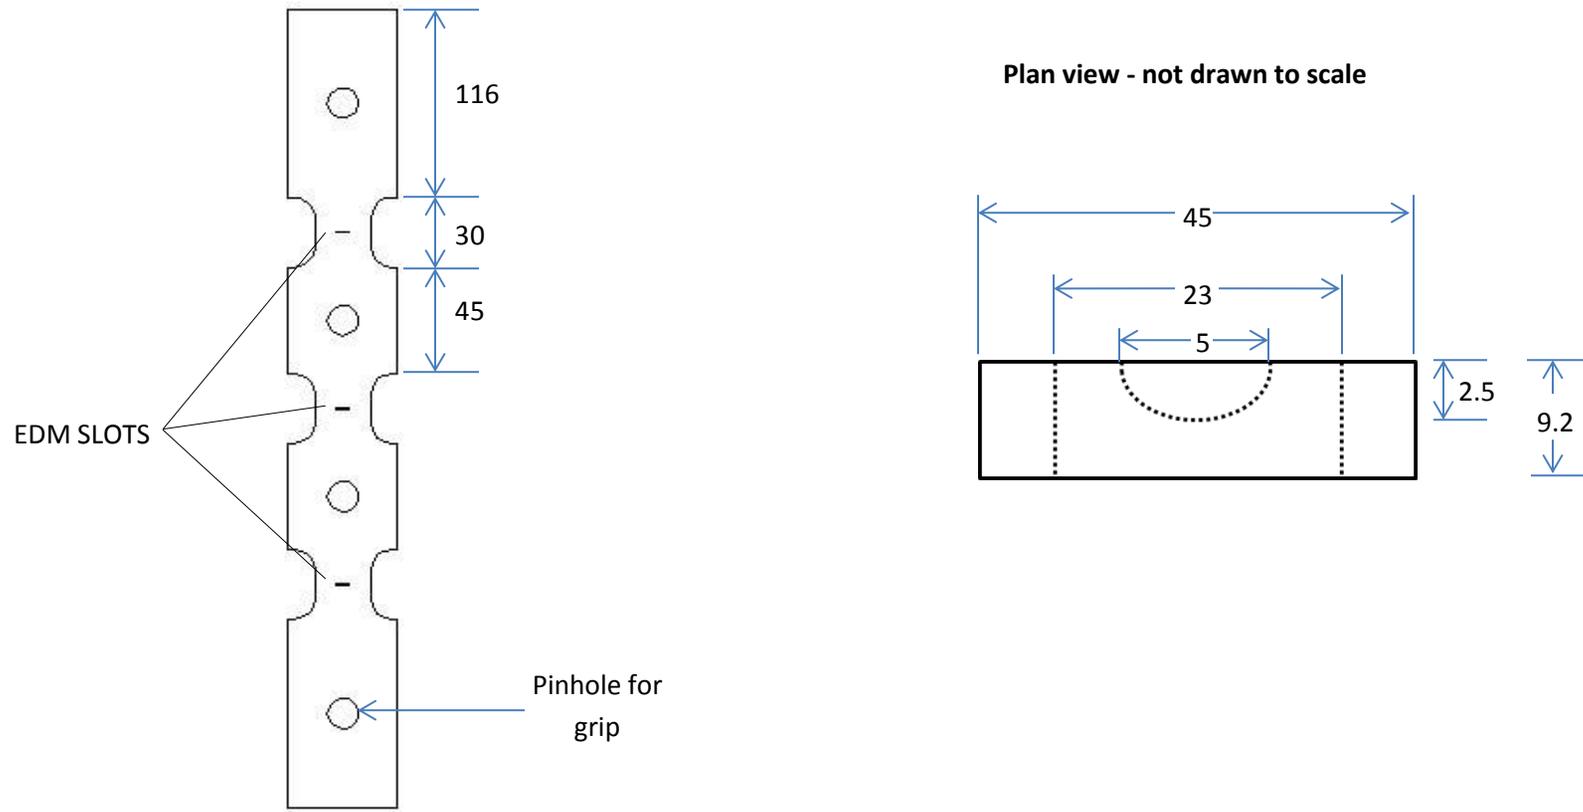
FIGURE 6-1: Test sample designed for this study. All units in mm.

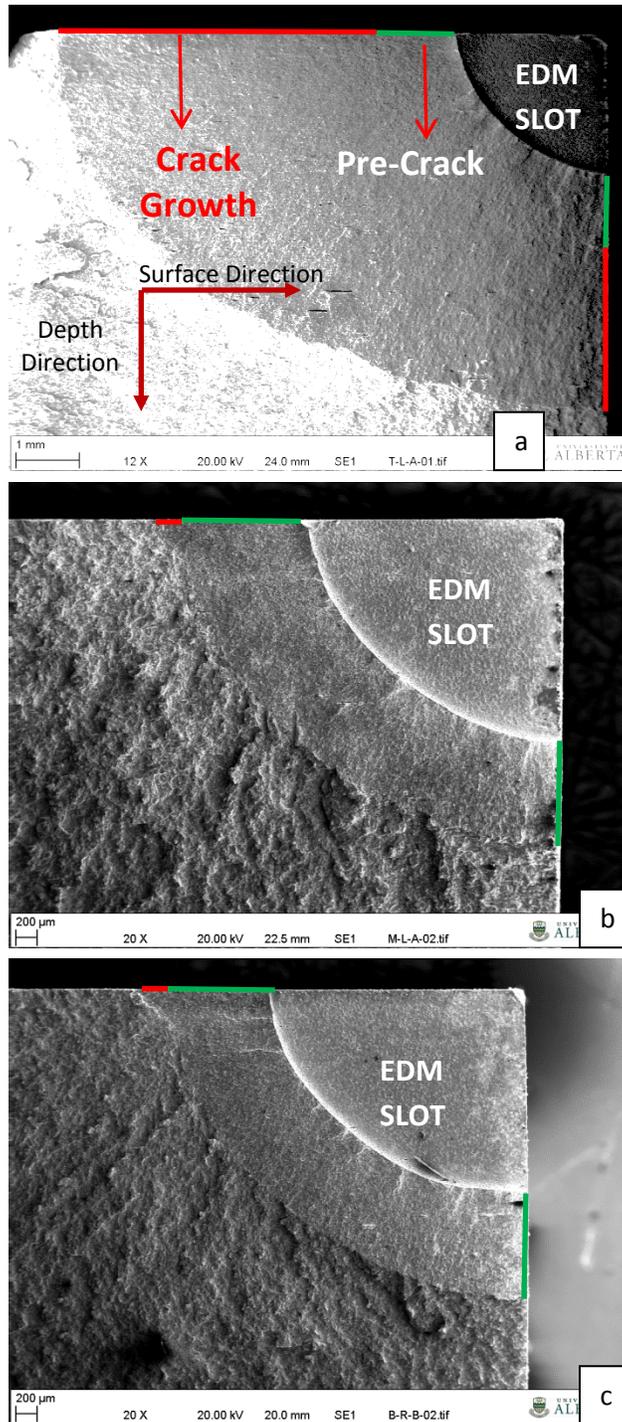
Figure 6-11: Fracture surface morphology of the test sample in test III at the (a) OM, (b) 75 mm from OM and (c) 150 mm from OM. The images clearly show that while there was significant growth at the open mouth in both the surface and depth directions, there was very little growth at 75 mm from the OM and no growth at 150 mm from the OM.

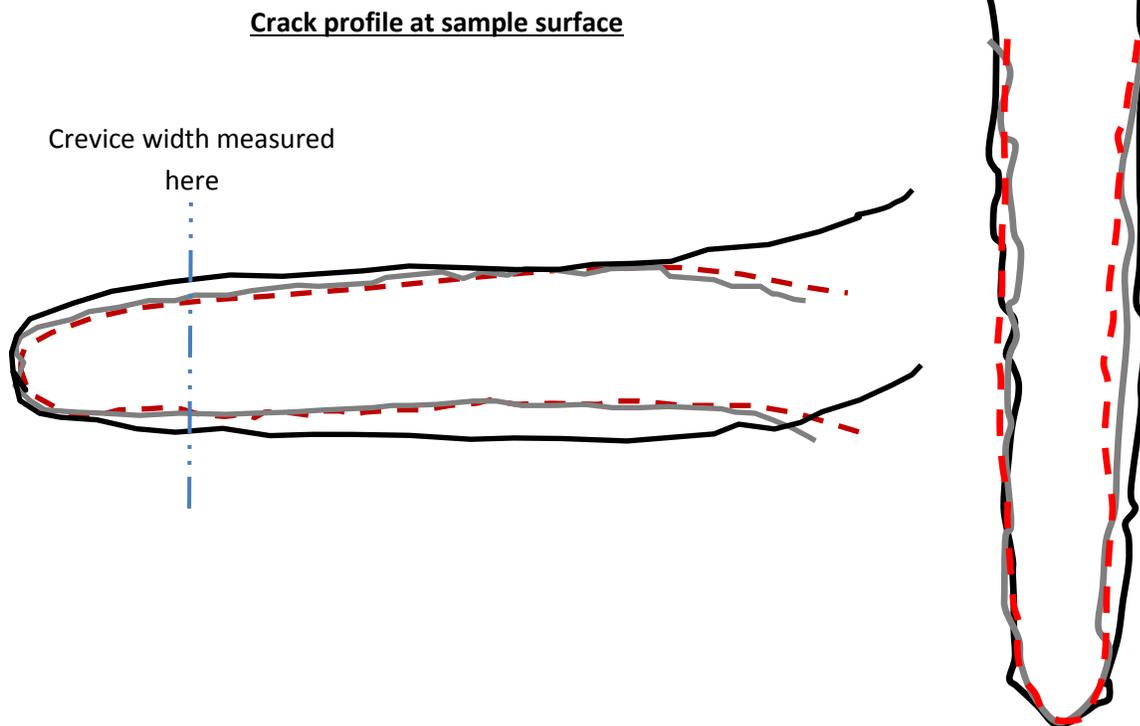
Figure 6-17: Crack outlines: in air, indirect contact with solution, direct contact with solution. Crack outline at sample surface (horizontal), crack outline in depth direction (vertical)

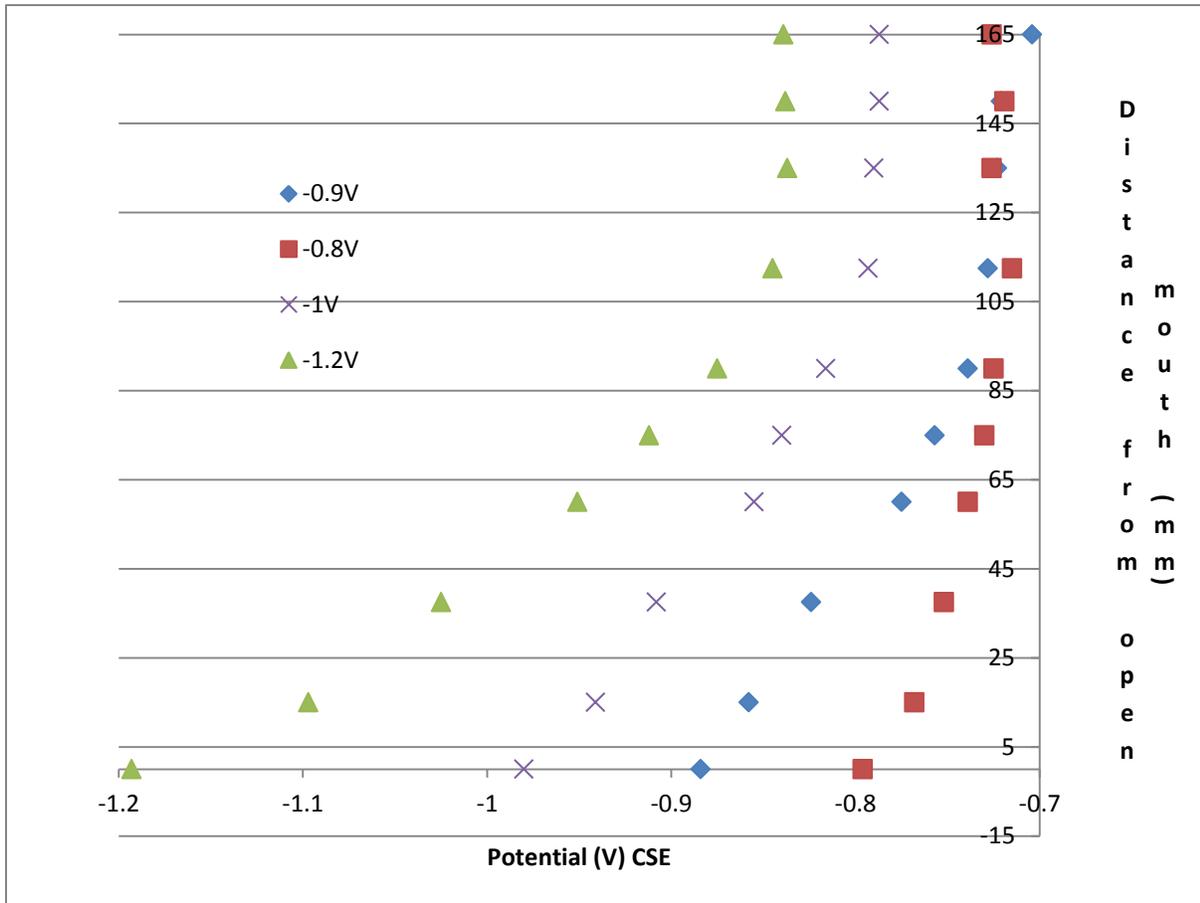
Figure 6-18: Variation of cathodic potential with distance from the open mouth, at different applied potentials. Legend shows the cathodic potential applied at the open mouth of the disbondment

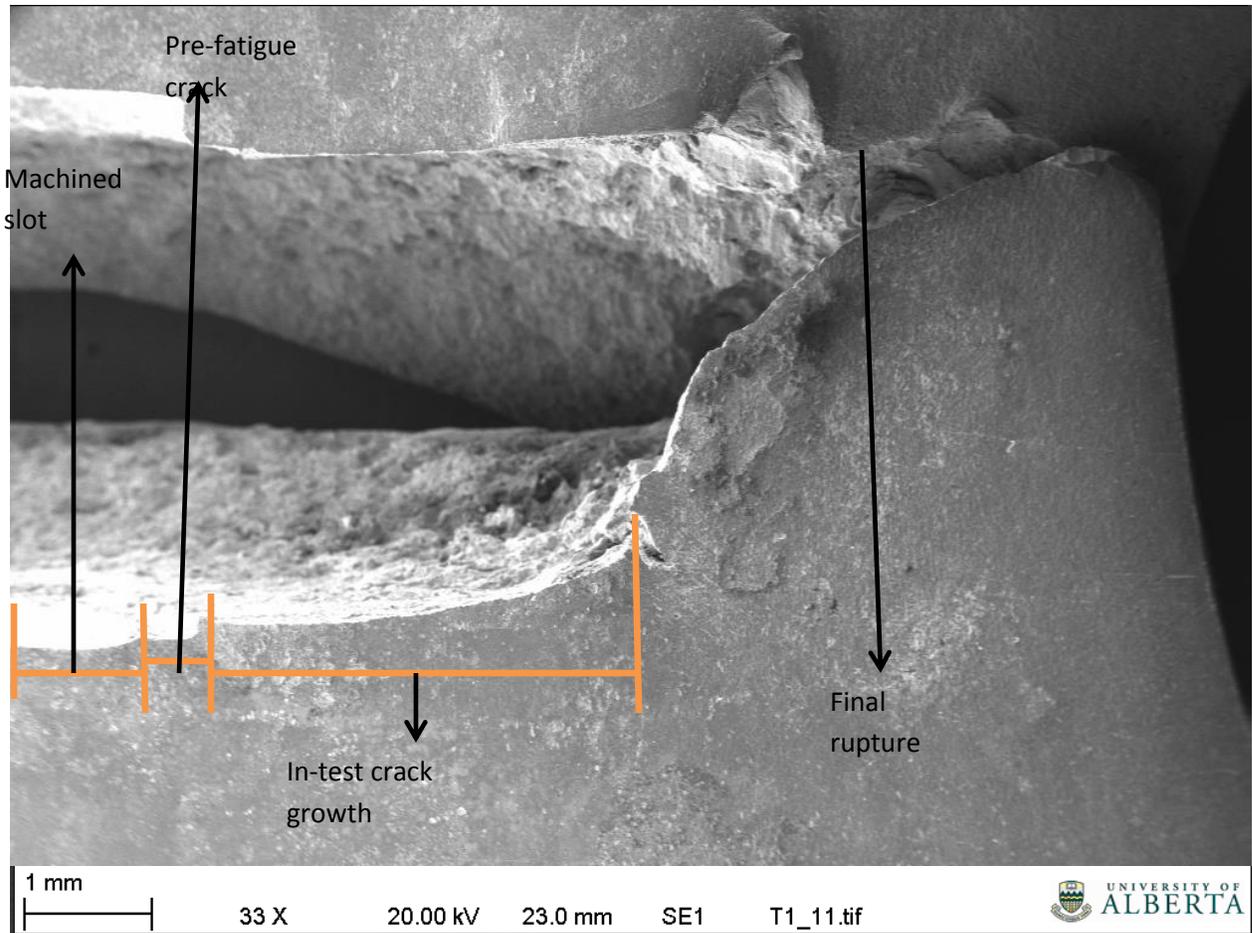
Figure 7-12: Half section of ruptured sample. Sample ruptured during test and was manually held together for photo. Micro-crack colony was found oriented along a 45° line from shear lip.

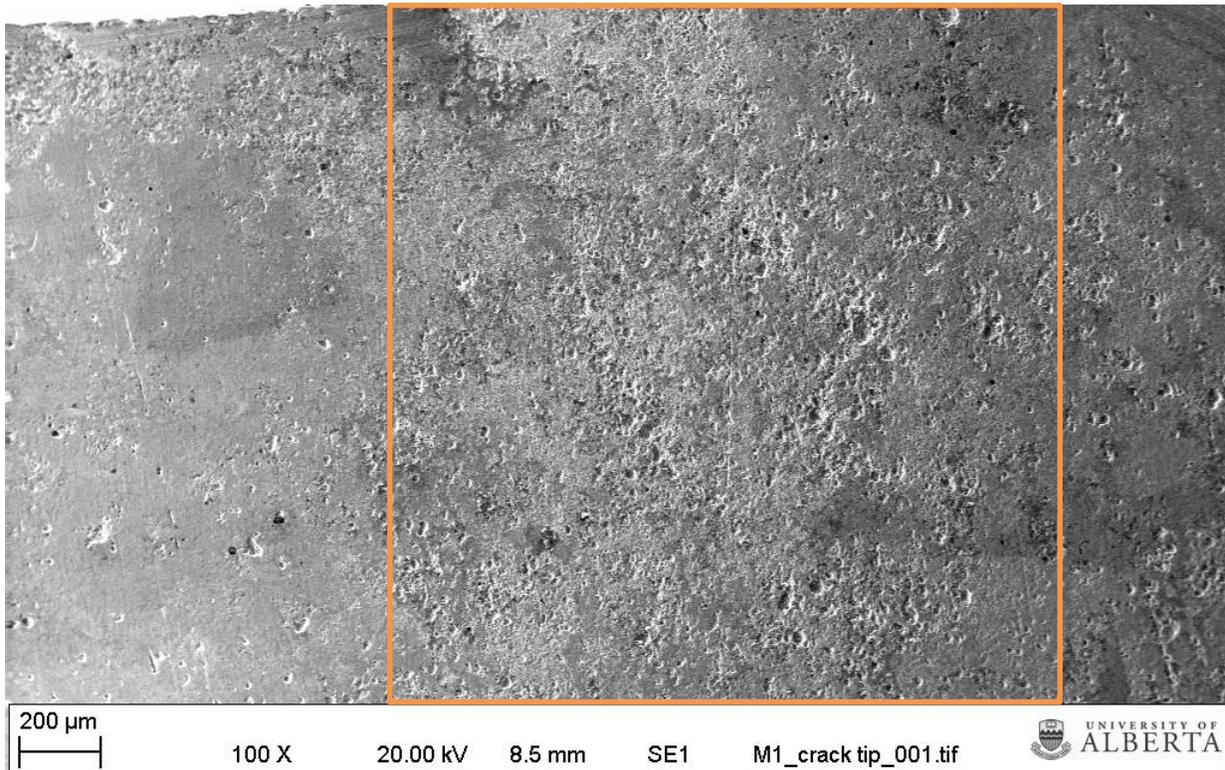
Figure 7-14: Cluster of pits at crack tip (75 mm from open mouth). Highlighted area shows dense pit clusters around the final crack tip

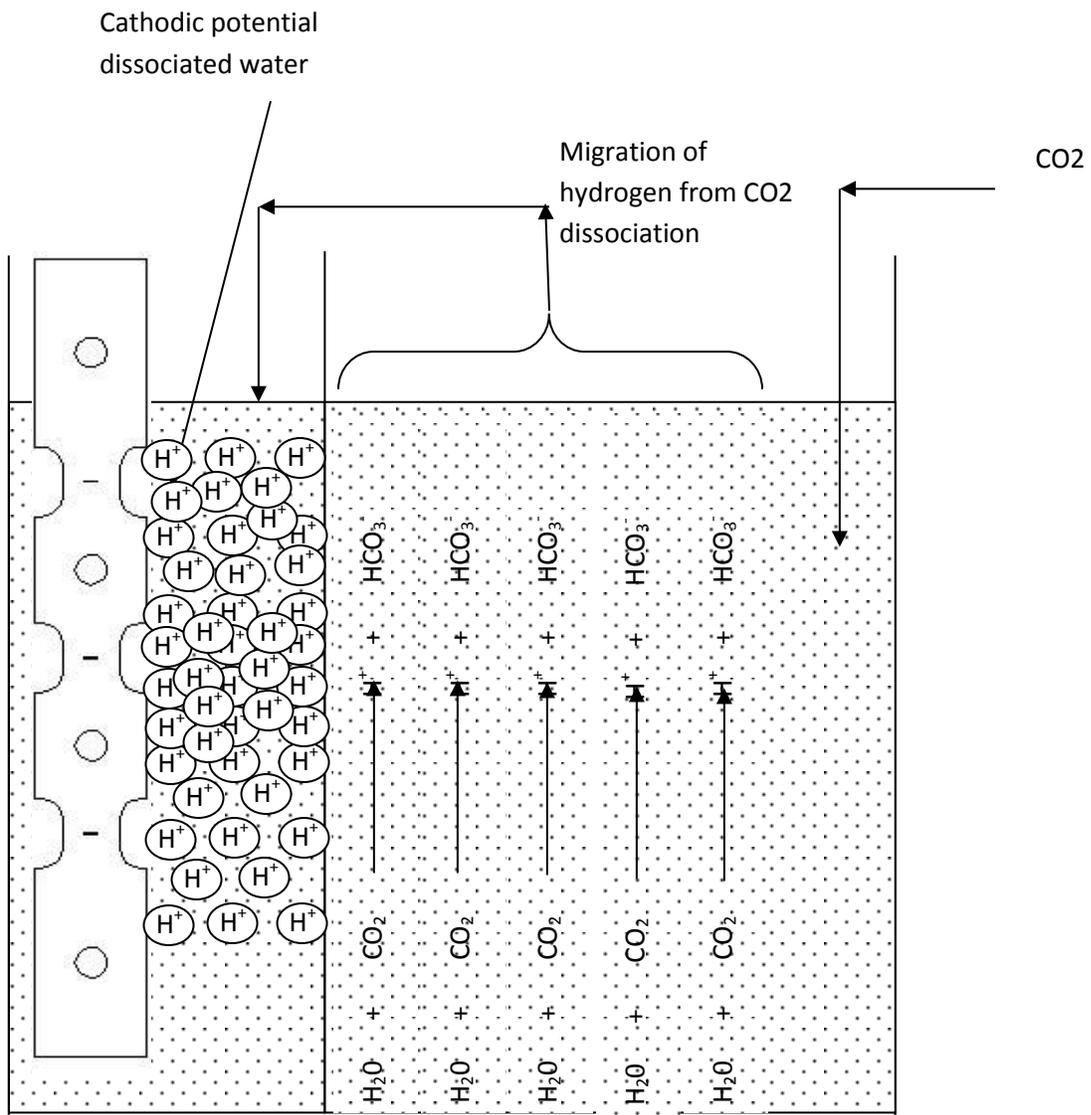
Figure 7-17: Schematic depiction of hydrogen ion distribution inside a disbondment at an applied potential of -0.9V

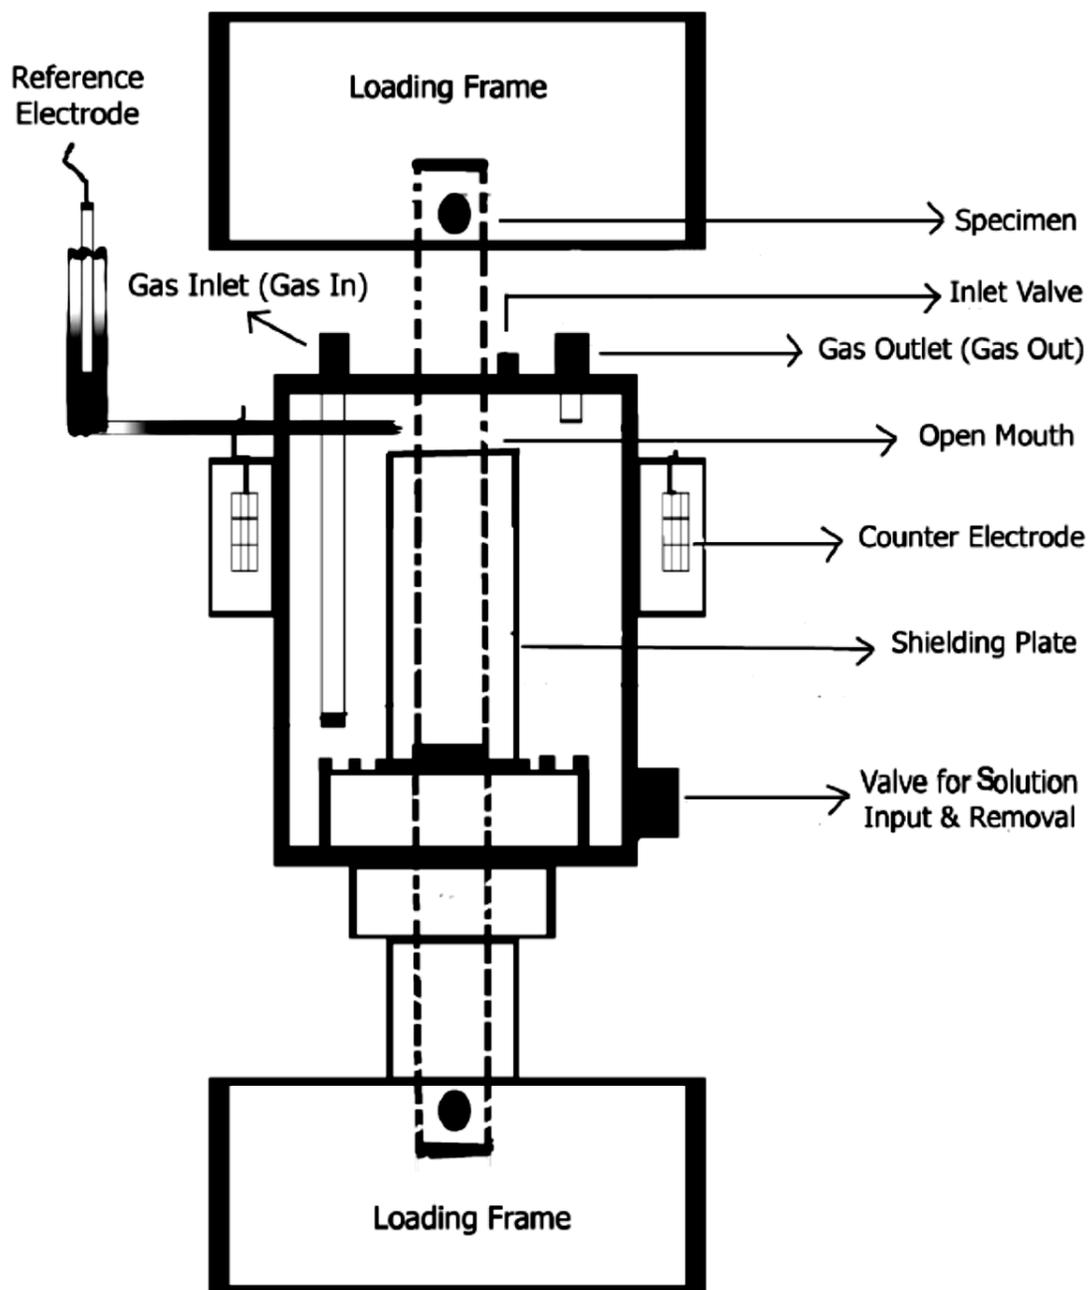
Figure B-5: Corrosion test cell used for this study

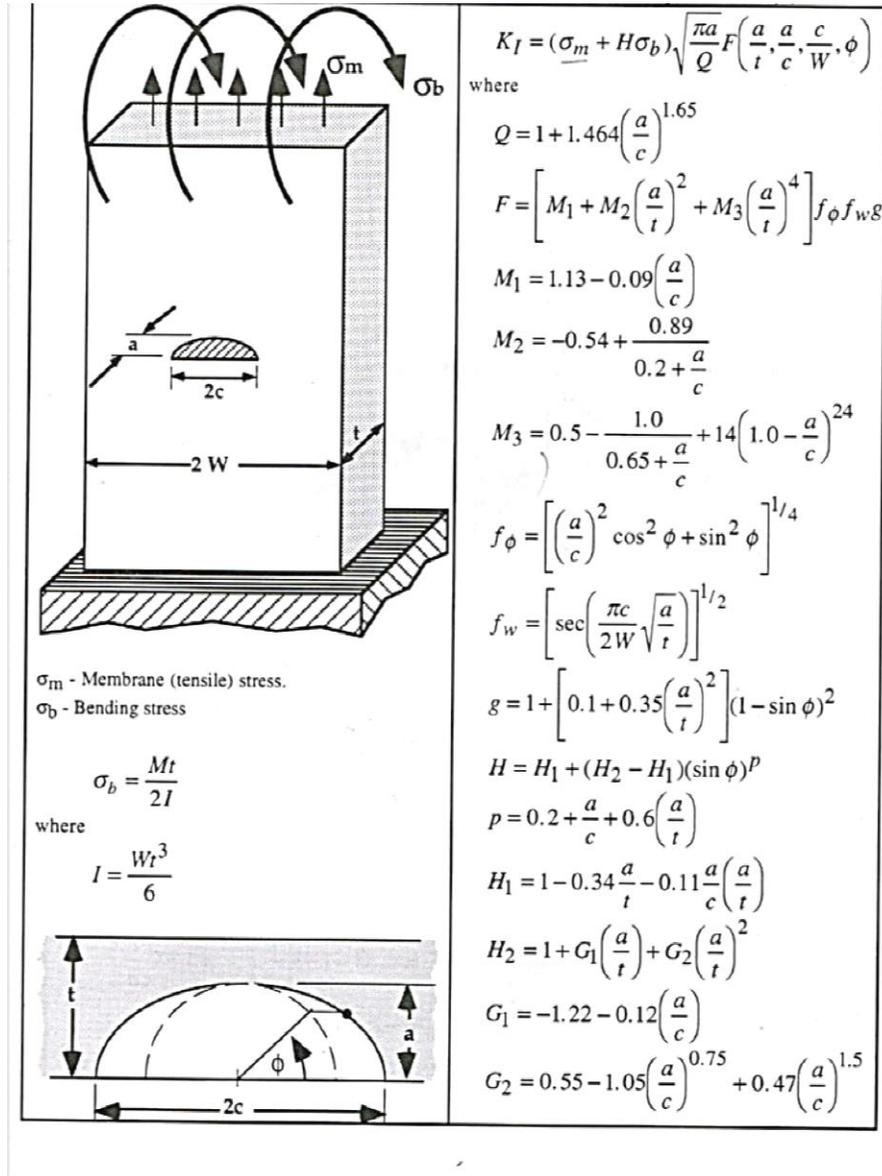
Figure B-7: Stress intensity factor equation for a semi-elliptical crack

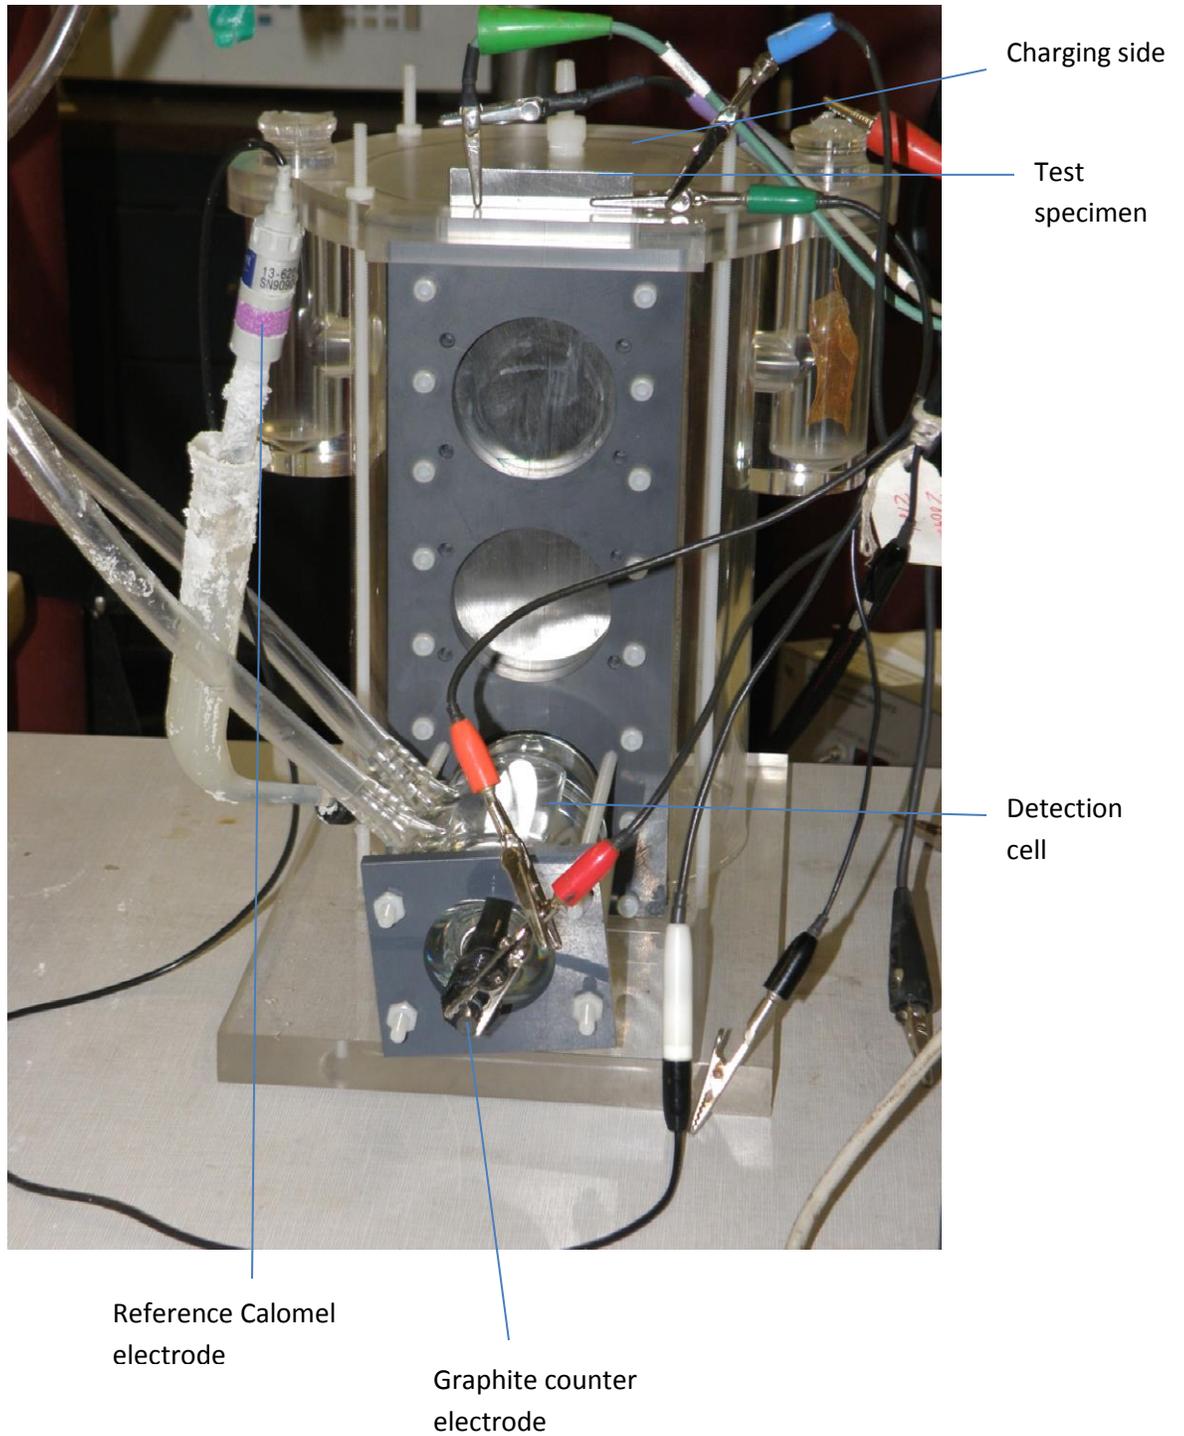
Figure B- 8: Test setup
