A STUDY OF DELAYED FAILURE OF
A CUT SLOPE IN STIFF CLAY

UNIVERSITY OF ALBERTA

MASTER OF SCIENCE

1978

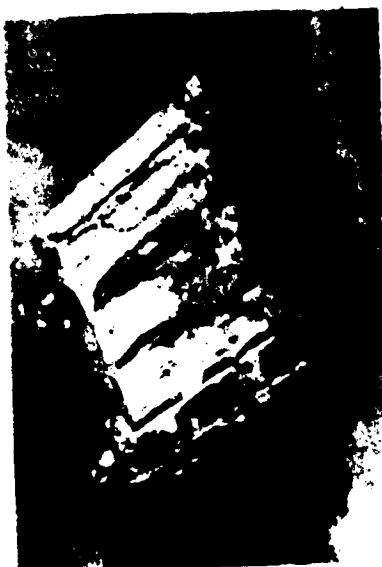
6c Failure plane of
direct shear sample
T-34(A); Test #5.
