SUPPLYING THE ROMAN EMPIRE

LIMES XXV VOLUME 4

The newly excavated brick and tile kiln in the *Vindolanda* North Field

Craig A. Harvey and Elizabeth M. Greene

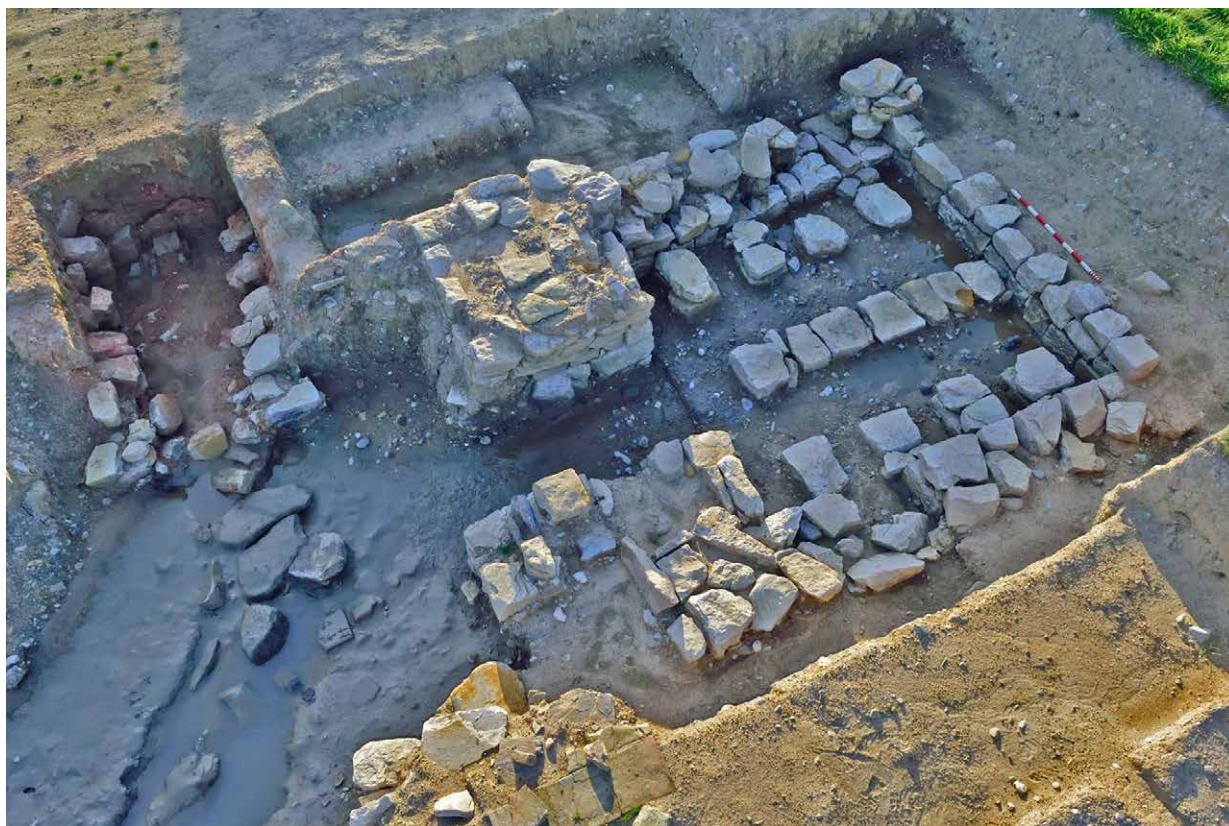
Figure 4. Oblique aerial view of the kiln complex looking west/northwest with the large kiln on the right and the smaller kiln at a ninety-degree angle on the left with the shared stokehole on the bottom left (The Vindolanda Trust/Adam Stanford).

(figs. 3-4). Immediately south of the large rectangular kiln (the aperture of which faces roughly southeast), a smaller kiln was found in the area of the heavily oxidized clay. This smaller kiln sits at a ninety-degree angle to the larger kiln, with its aperture facing roughly northeast. The apertures (or flues) of both these kilns face the large concentration of ash, which was eventually revealed to be a large stokehole shared by the two kilns. By the end of the season, excavation had exposed the entirety of the large kiln, the interior of the smaller kiln, and their shared stokehole. The trench was subsequently backfilled to preserve the uncovered remains, but enough of both kilns was excavated to conduct a detailed study of their construction and place them into their typological context.

The larger of the two kilns uncovered in the North Field is rectilinear in shape and has exterior dimensions of roughly 3.75 m (northeast-southwest) and 4.0 m (northwest-southeast) (fig. 4; for plan fig. 3). Nothing of this kiln's superstructure was found preserved, but the extant remains of its firing chamber, fire box (or flue), and support system were constructed of roughly cut blocks of local sandstone. Notably, the back (or northwest) wall of the kiln does not have an exterior face, suggesting that this kiln was constructed into the side of a low-lying hill, which was a common building practice for such kilns (McWhirr 1979, 99). Within the firing chamber, excavation uncovered the remains of the support system comprising four stone-built cross walls and a central tongue-support. These supports once held the oven floor, of which nothing survives intact, but the discovery of large amounts of 'crushed brick' during excavation of this

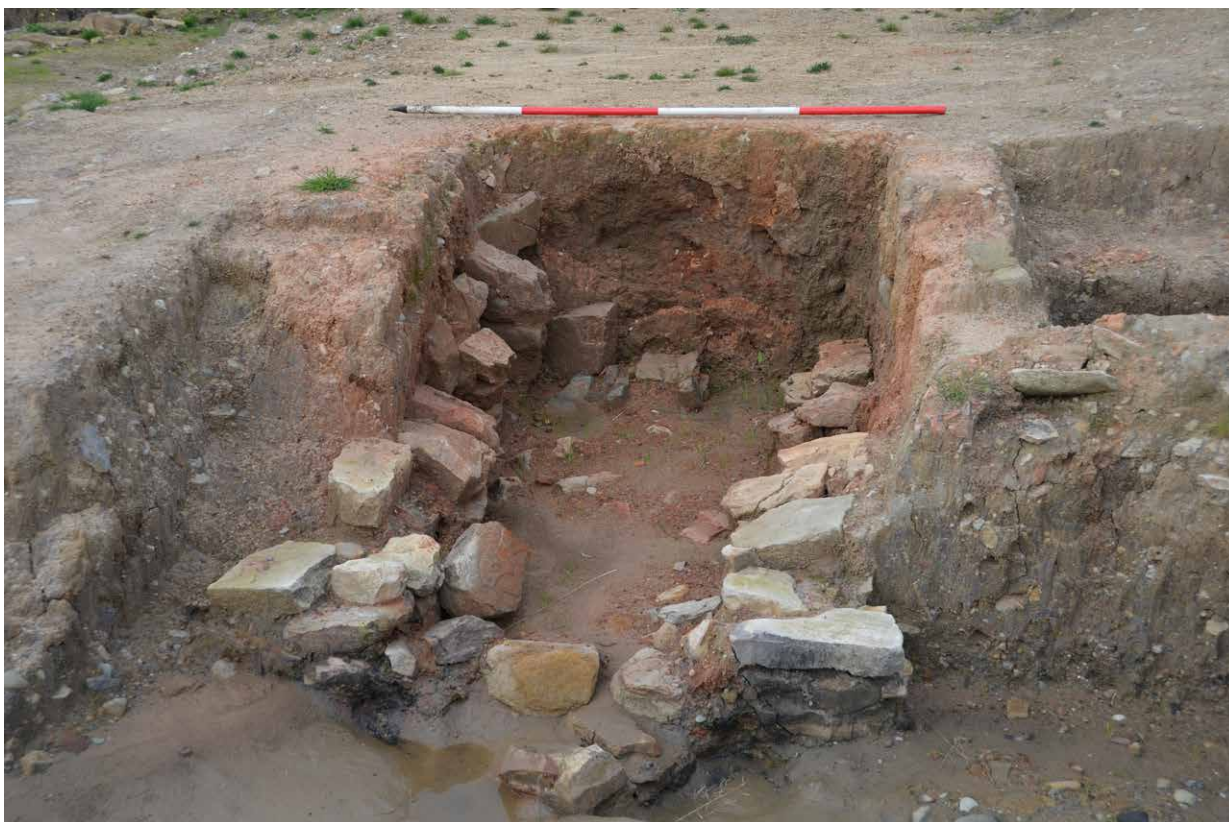
Figure 5. View of the smaller kiln excavated, facing west.

Directly to the south of the large rectangular kiln is a much smaller kiln measuring roughly 1.5 by 2 m (fig. 5; for plan fig. 3). This kiln is also rectangular in shape, but rather than having stone walls, its firing chamber appears to have been built using the more typical technique of digging a hole in a natural hill slope and plastering its sides with clay (Swan 1984, 32). The heavy use of this smaller kiln is attested by the large quantity of ash that was found within its firing chamber and the striking appearance of the surrounding clay into which it was dug, which was baked to an orangey-red colour. Although this kiln may also have produced bricks and tiles, its small size and the kiln waste recovered suggest that it primarily produced ceramic vessels.
