Landslide Hazard Assessment, Town of Peace River, Alberta

Doctor of Philosophy
in
Geotechnical Engineering

Department of Civil and Environmental Engineering

©Tai-Hoon Kim
Spring 2012
Edmonton, Alberta

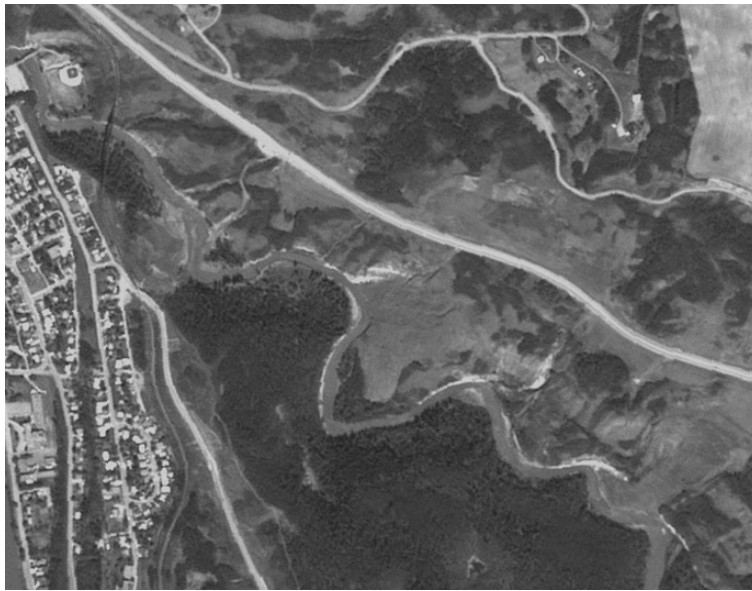
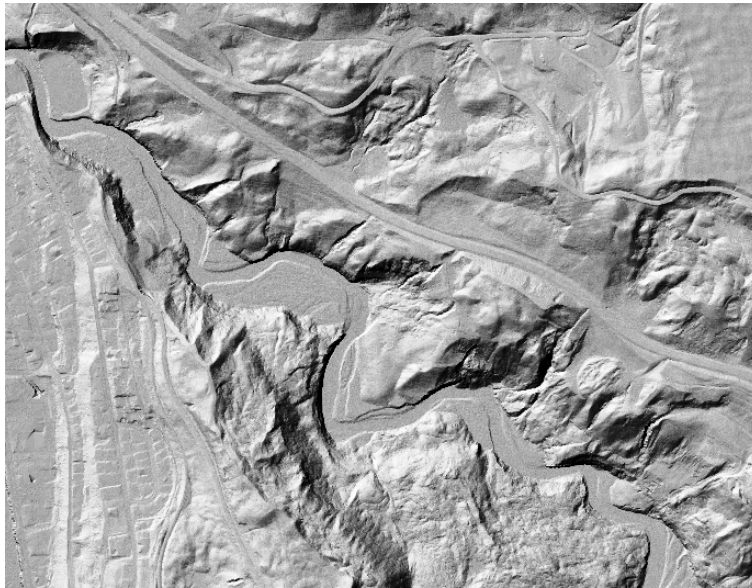
Figure 2.2 Comparison of LiDAR and conventional optical images. a. SRTM (NASA Shuttle Radar Topography Mission) satellite image along the Heart River flowing northwest, near Town of Peace River, Alberta. b. LiDAR bare earth image which has the same extent of a. Scale 1:15,000

By selecting pulses of light reflected from the objects the generated DEM does contain the ground surface beneath vegetation and other obstacles (Figure 2.2). The bare earth DEM derived from LiDAR is the most promising functionality for the landslide inventory mapping dealing with remnants of previous landslides degraded by the weathering process or ongoing features of current landslides covered by dense vegetation (Schulz 2007; van Den Eeckhaut et al. 2007). Schulz (2007) pointed out the landslide identification augmented by LiDAR technique has increased its capability by detecting four times more landslides observed in Seattle than those using conventional methodologies such as aerial photo interpretation. The terrestrial LiDAR technique, an alternative application of the airborne laser altimetry, would allow an objective and detailed topographic modeling with fast data processing and least efforts of operators (Rowlands et al. 2003). Norheim et al. (2002) evaluated a suburban terrain in eastern Seattle by using LiDAR and InSAR derived DEMs and found LiDAR derived DEM gave more suitable results with less bias and variance than those obtained from InSAR DEM. They also noted both tech-

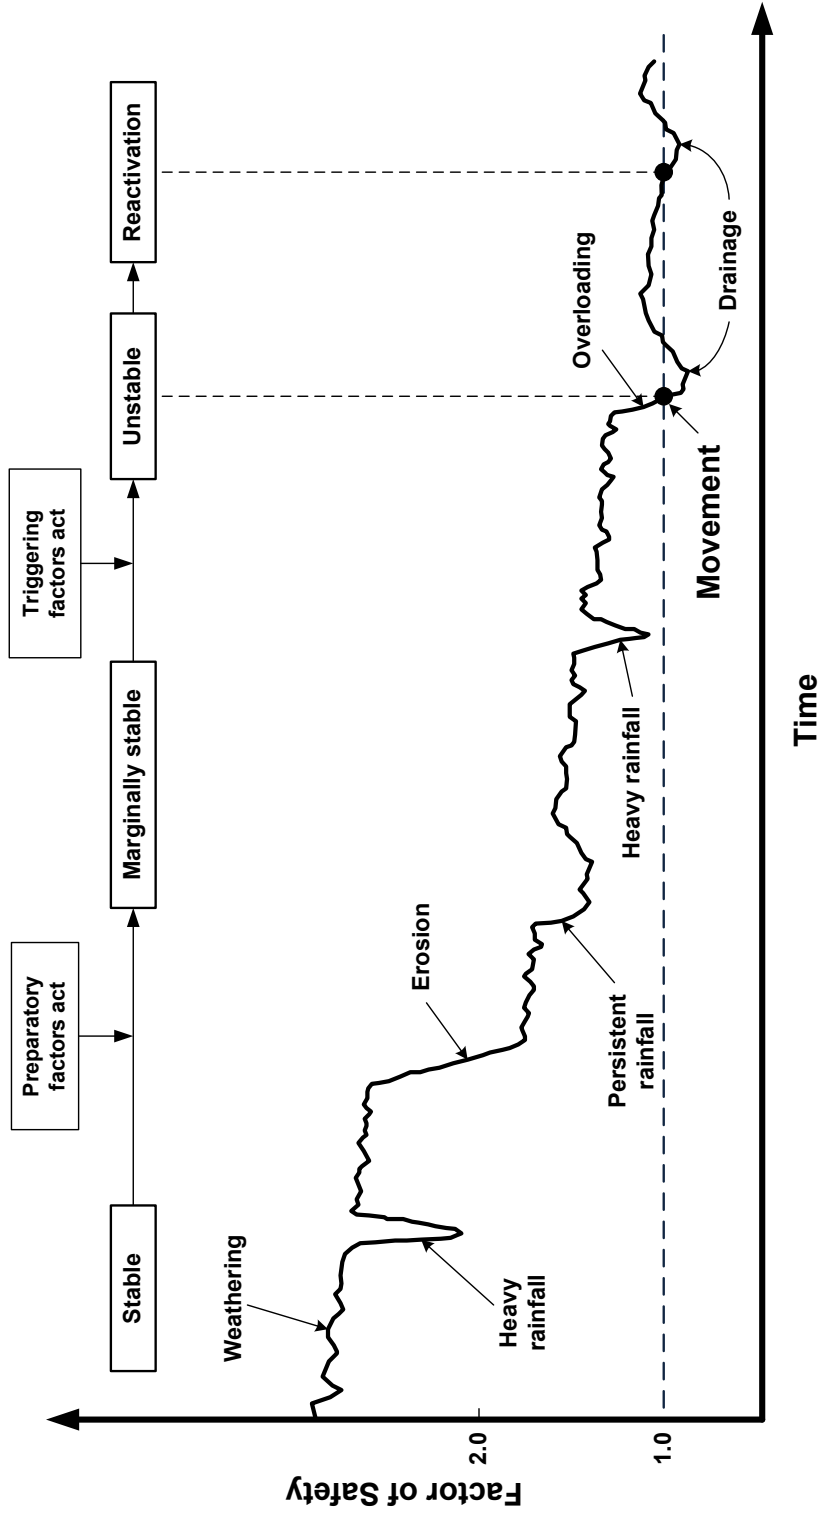
Figure 2.3 Changes in the factor of safety by causal factors. Examples of preparatory and triggering causal factors are also described. *Source:* Popescu 1994, Fig. 1

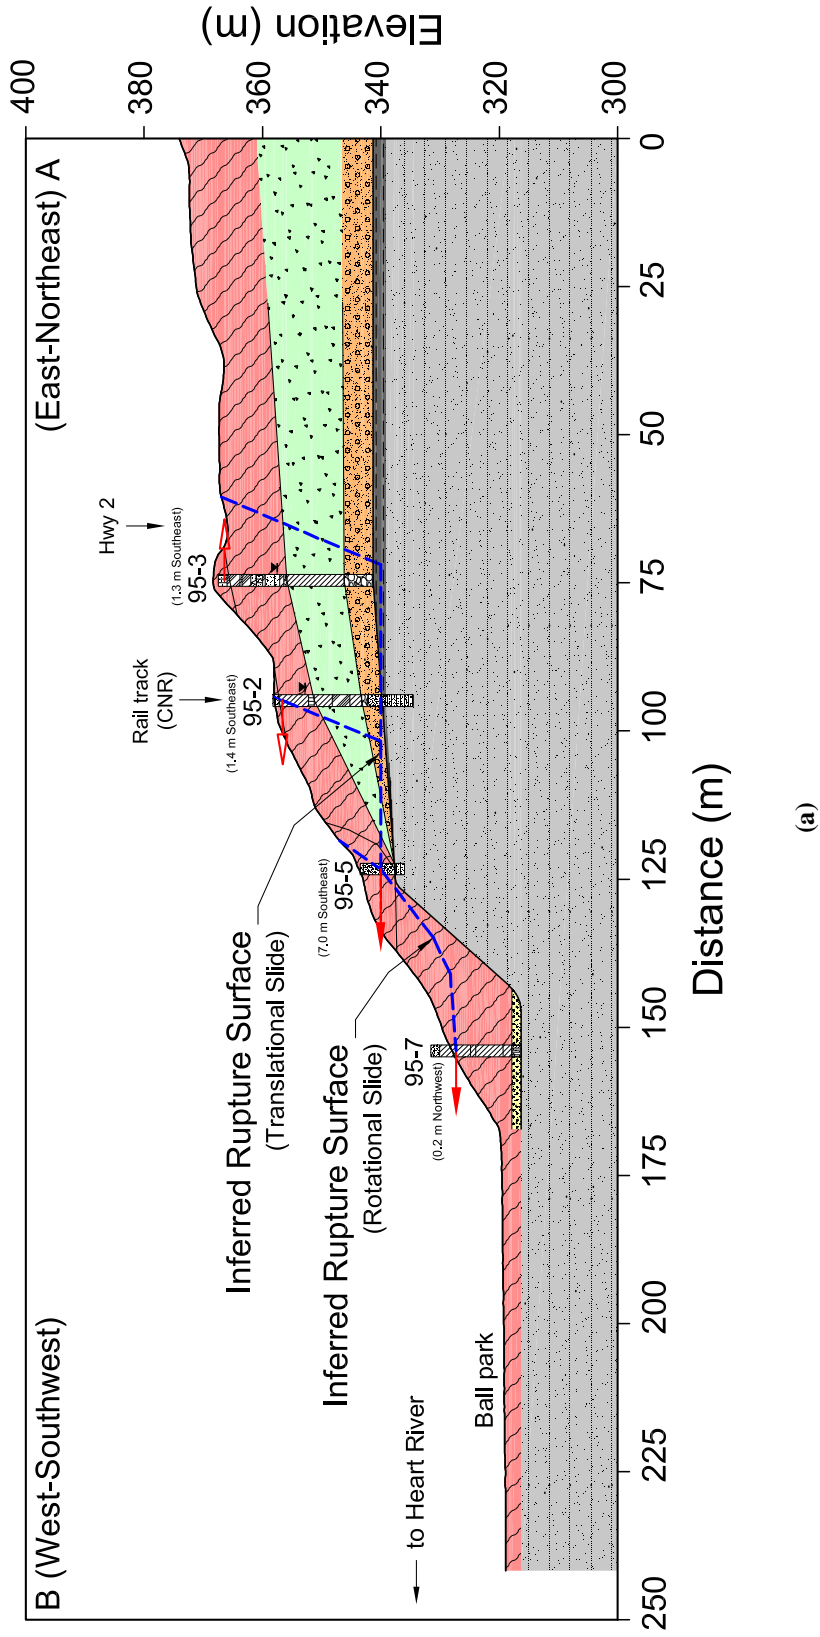
Figure 4.3 Cross section of the Mile 47.8 Slide. a. Cross section of the slide. Boreholes and their proximity to the cross line are indicated. Lithological and genetic stratigraphies are also shown. Observed locations for ground movements are illustrated by red arrows. Ground movement delineated by a red open arrow in borehole 95-3 was imported from borehole 95-4 in which the slope inclinometer was originally installed (Figure 4.2). Inferred rupture surfaces are delineated by thick blue dashed lines. Detail borehole data are also noted in Appendix A. b. Representative symbols for a. Lithological and genetic units are illustrated with their unique symbols and colors. Unit numbers in genetic stratigraphy are equivalent to those shown in Figure 3.9. Other features such as groundwater level and observed locations for ground movements are also presented

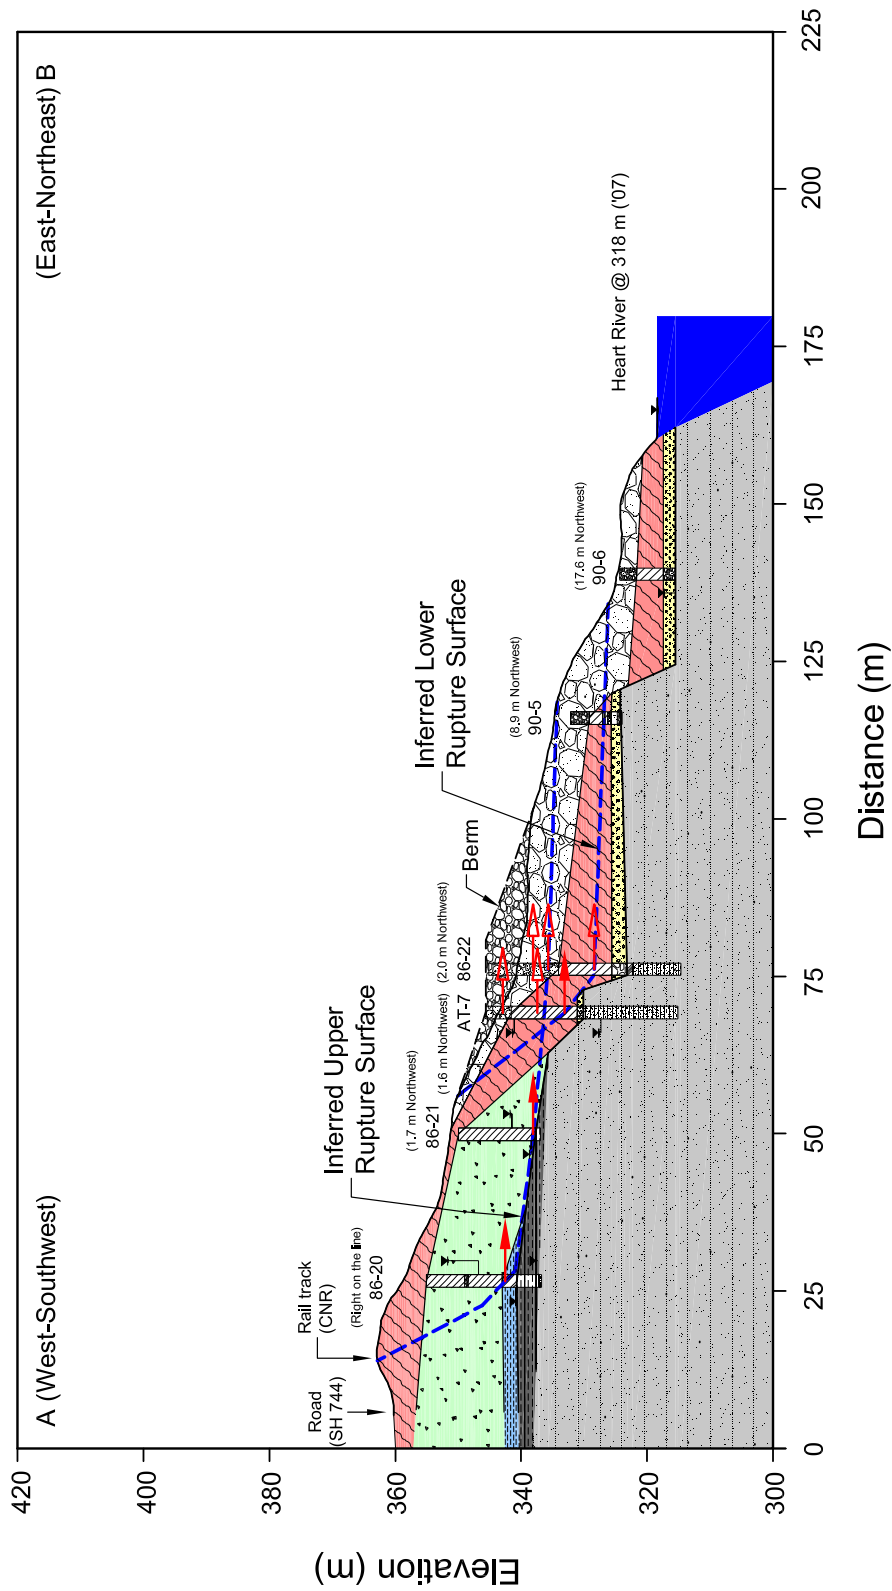
Figure 4.8 Cross section of the Mile 47.6 Slide. Boreholes and their proximity to the section plane are indicated. Lithological and genetic stratigraphies are also shown. Observed locations for ground movements are illustrated by red arrows. Inferred rupture surfaces are delineated by thick blue dashed lines. Representative symbols for lithological and genetic units are also presented in Figure 4.3. Detail borehole data are also noted in Appendix A

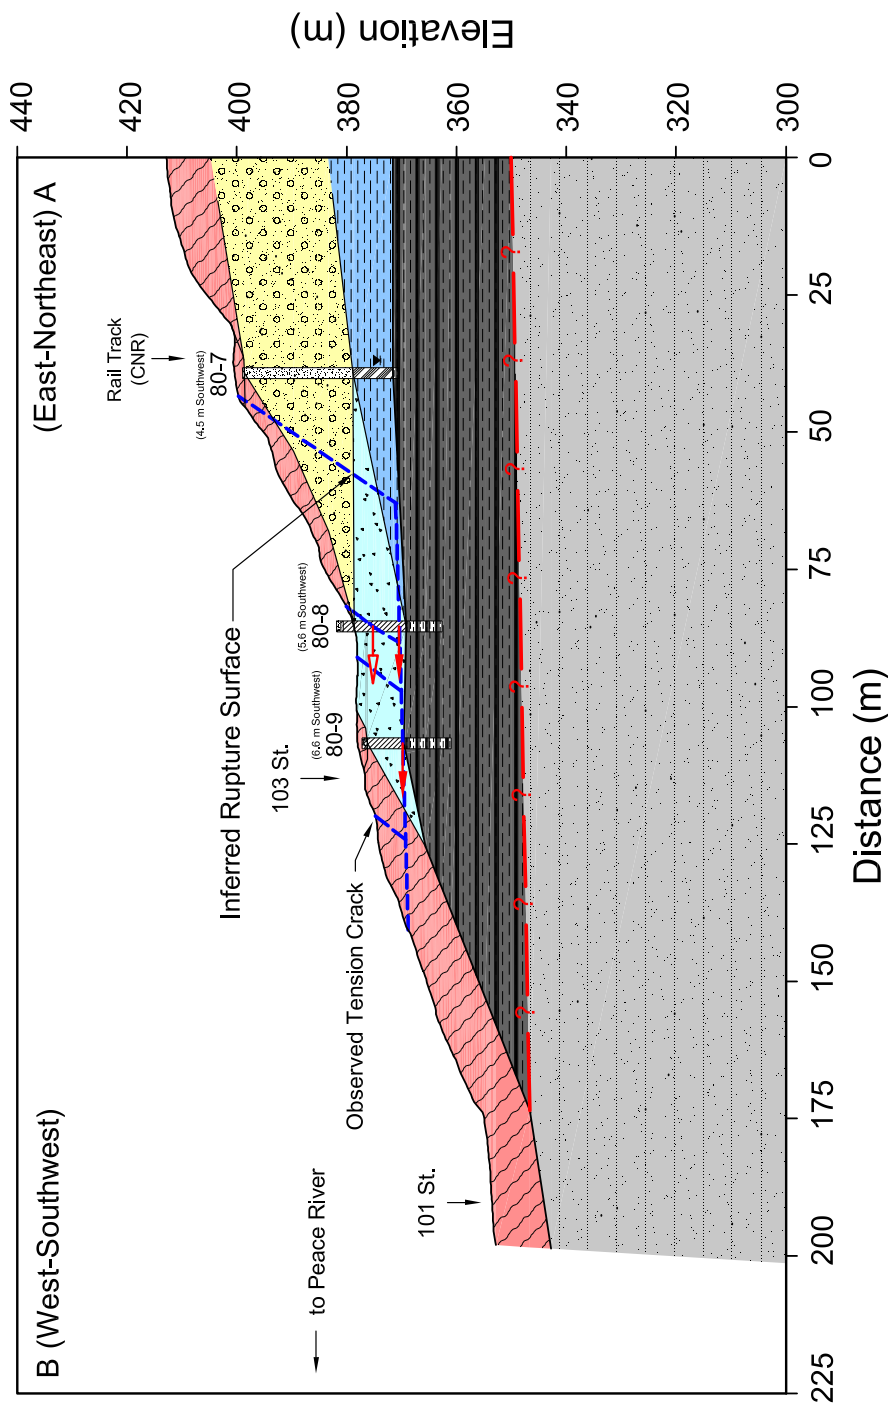
Figure 4.13 Cross section of the Mile 46.5 Slide. Boreholes and their proximity to the section plane are indicated. Lithological and genetic stratigraphies are also shown. Observed locations for ground movements are illustrated by red arrows. Inferred rupture surfaces are delineated by thick blue dashed lines. Representative symbols for lithological and genetic units are also presented in Figure 4.3. Detail borehole data are also noted in Appendix A

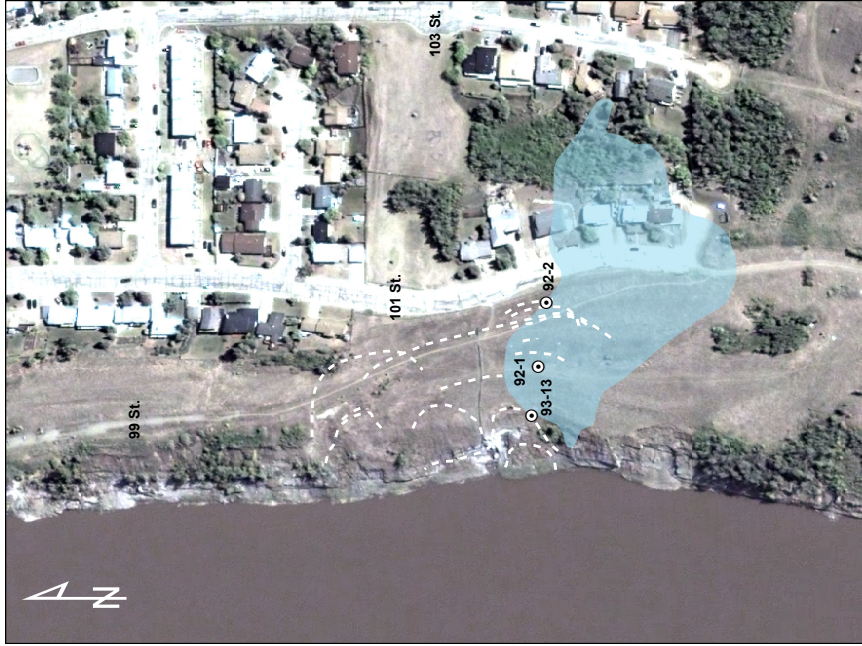
Figure 4.16 Anthropogenic effects on the End of 101 Street Slide. a. 1958 air photo (Alberta Photo: AS26-162) b. 2007 Quickbird imagery. Scale 1:2,000. Approximate boundary of gully is delineated by a blue shade. Symbols of air photo interpretation in a are consistent with Dearman et al. (1972) and Federal Geographic Data Committee (2006). Landslide scarps and tension cracks are shown in b by white dashed line. Detail borehole data are also noted in Appendix A

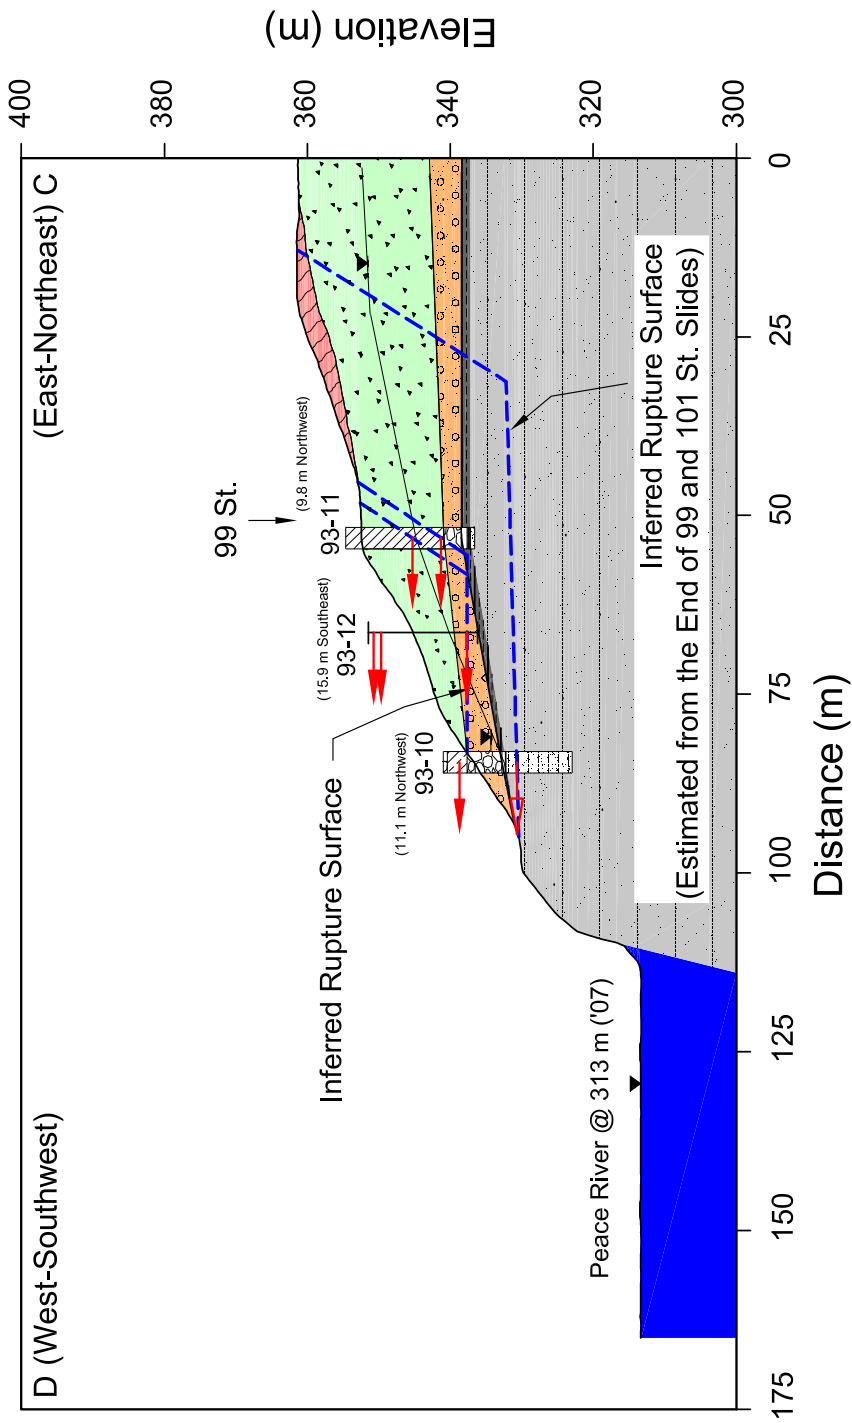
Figure 4.18 Cross section of the Transition Zone Slide (C-D). Boreholes and their proximity to the section plane are indicated. Lithological and genetic stratigraphies are also shown. Observed locations for ground movements are illustrated by red arrows. Inferred rupture surfaces are delineated by thick blue dashed lines. Representative symbols for lithological and genetic units are also presented in Figure 4.3. Detail borehole data are also noted in Appendix A

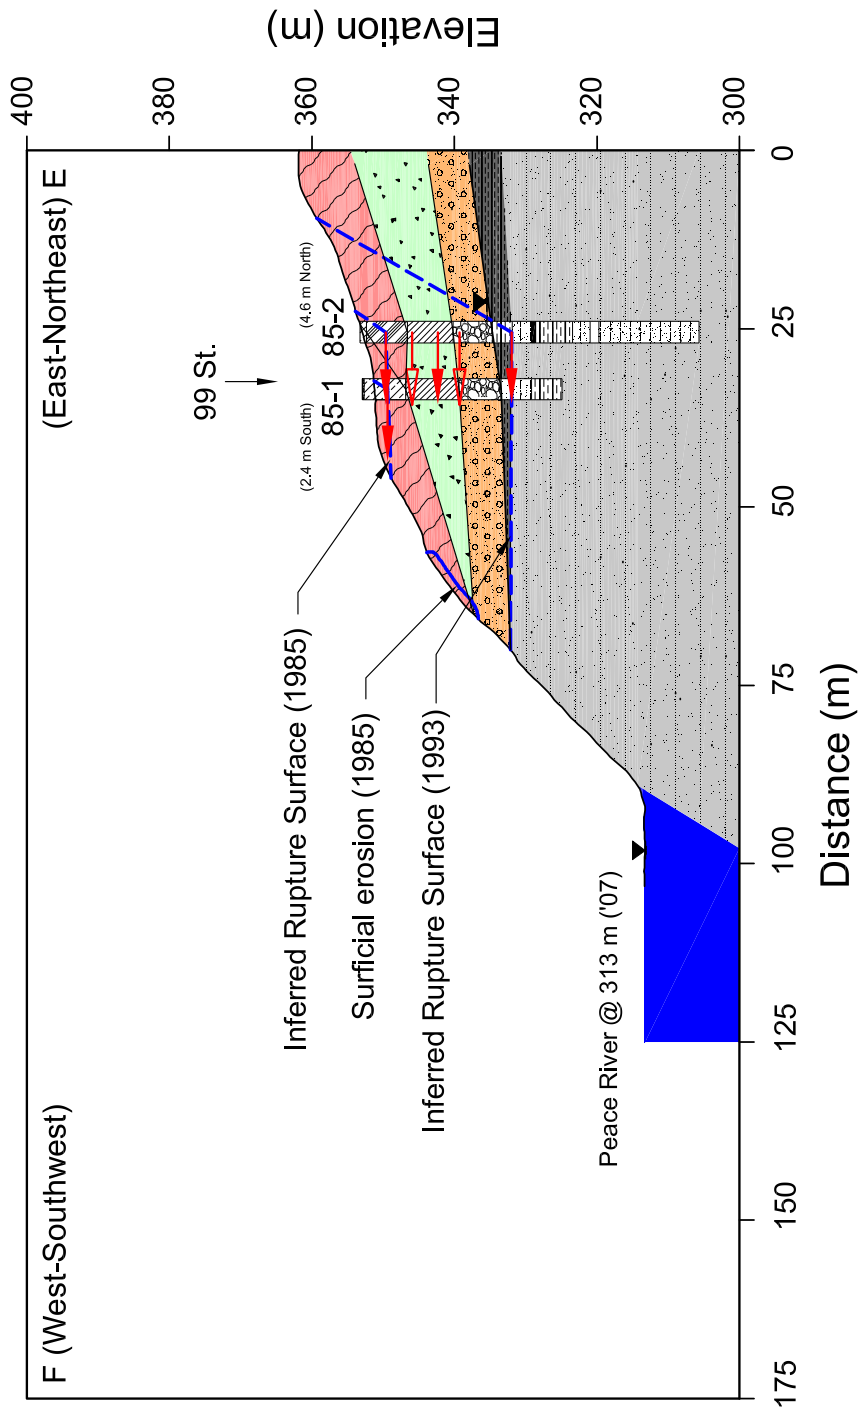
Figure 4.19 Cross section of the End of 99 Street Slide (E-F). Boreholes and their proximity to the section plane are indicated. Lithological and genetic stratigraphies are also shown. Observed locations for ground movements are illustrated by red arrows. Inferred rupture surfaces are delineated by thick blue dashed lines. Representative symbols for lithological and genetic units are also presented in Figure 4.3. Detail borehole data are also noted in Appendix A

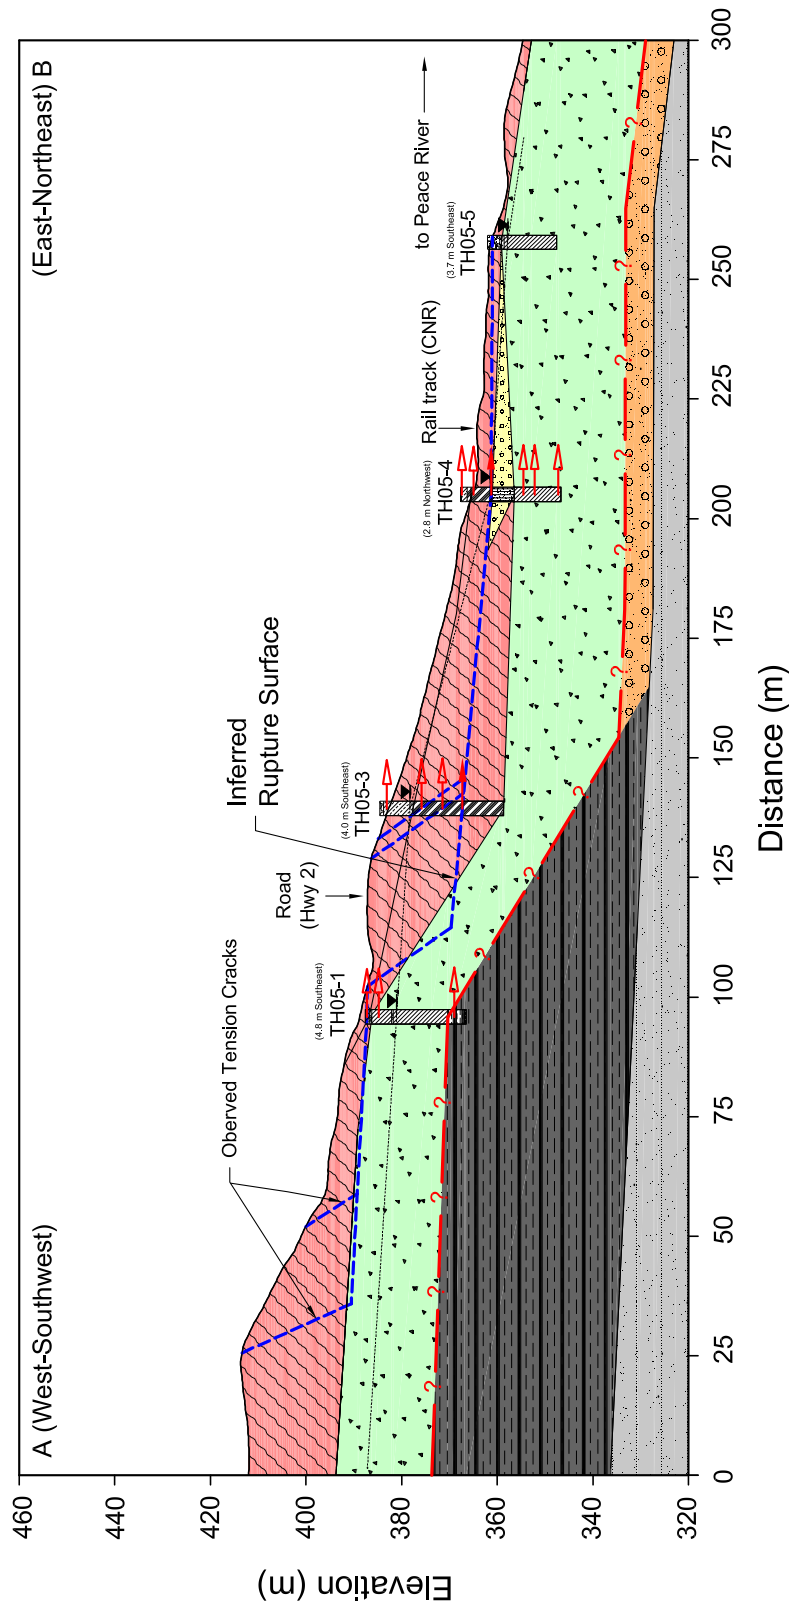
Figure 4.29 Cross section of the Shop Slide. Boreholes and their proximity to the section plane are indicated. Lithological and genetic stratigraphies are also shown. Observed locations for ground movements are illustrated by red arrows. Inferred rupture surfaces are delineated by thick blue dashed lines. Representative symbols for lithological and genetic units are also presented in Figure 4.3. Detail borehole data are also noted in Appendix A

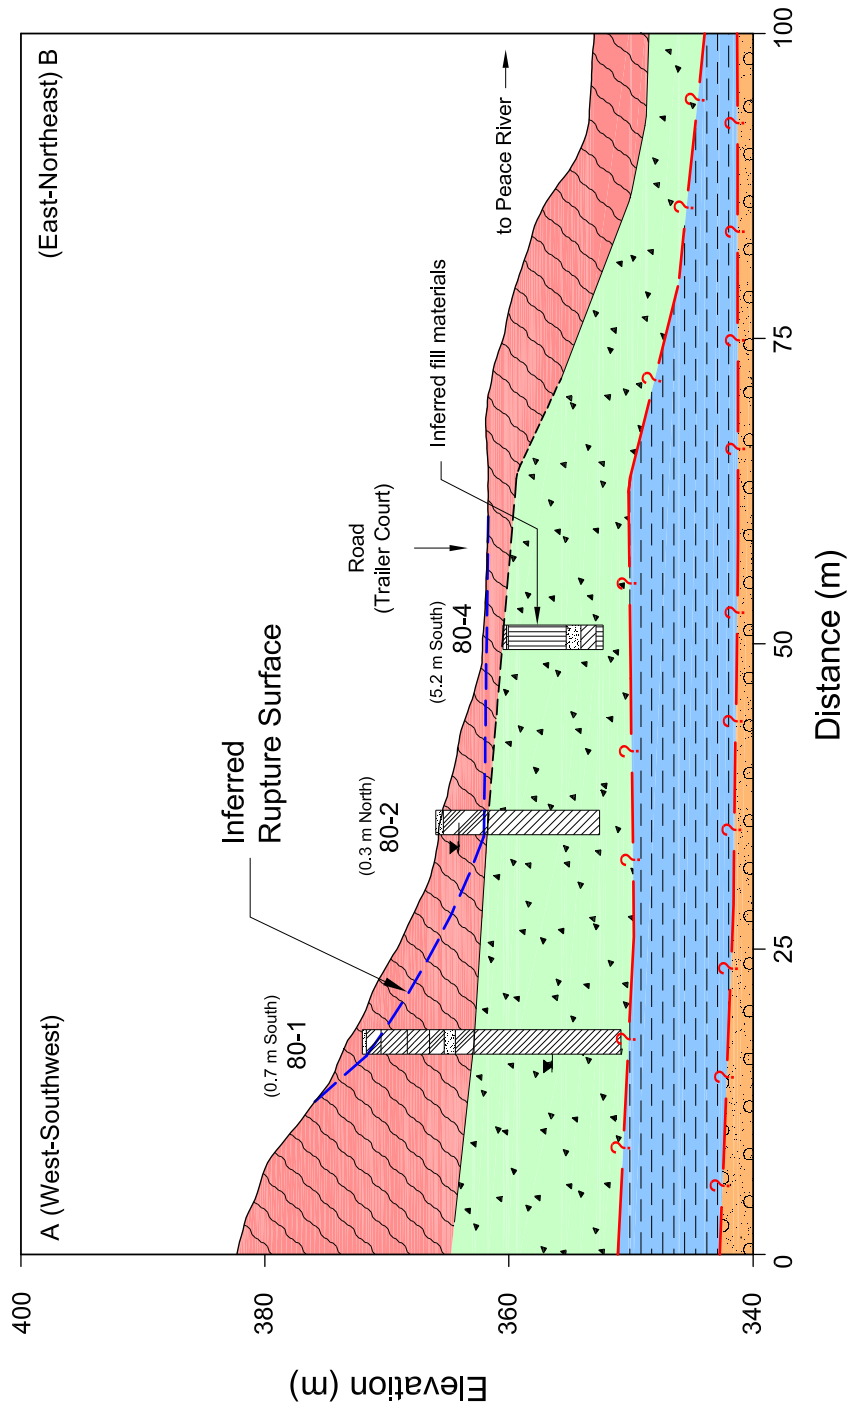
Figure 4.34 Cross section of the Mile 50.9 Slide. Boreholes and their proximity to the section plane are indicated. Lithological and genetic stratigraphies are also shown. Observed locations for ground movements are illustrated by red arrows. Inferred rupture surfaces are delineated by thick blue dashed lines. Representative symbols for lithological and genetic units are also presented in Figure 4.3. Detail borehole data are also noted in Appendix A

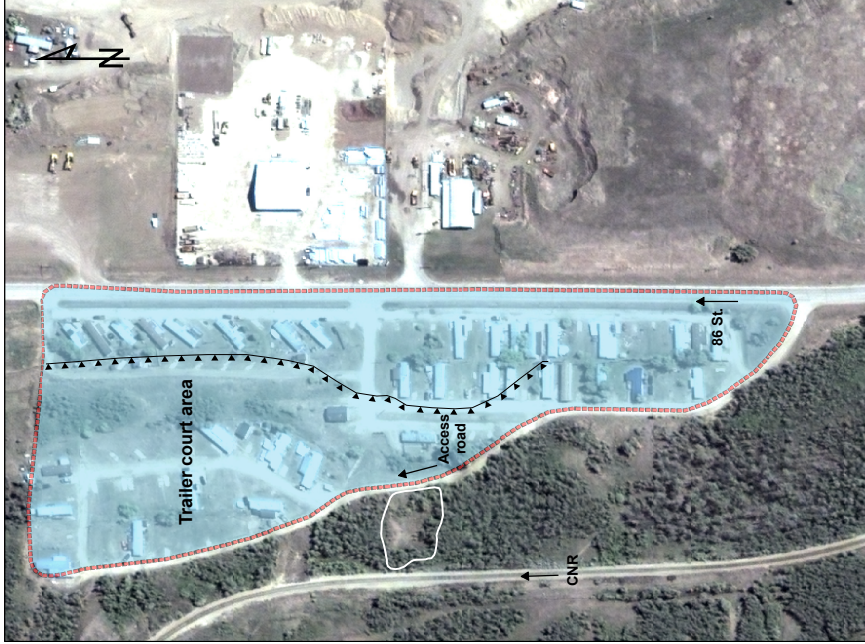
Figure 4.37 Anthropogenic effects on the Mile 50.9 Slide. a. 1958 aerial photograph (Alberta Photo: AS26-100) b. 2007 Quickbird imagery. Scale 1:2,000. The Mile 50.9 Slide is delineated by white line. The boundary of the trailer court is shown by a blue shade and red dashed line. Symbols of air photo interpretation are consistent with Dearman et al. (1972) and Federal Geographic Data Committee (2006)

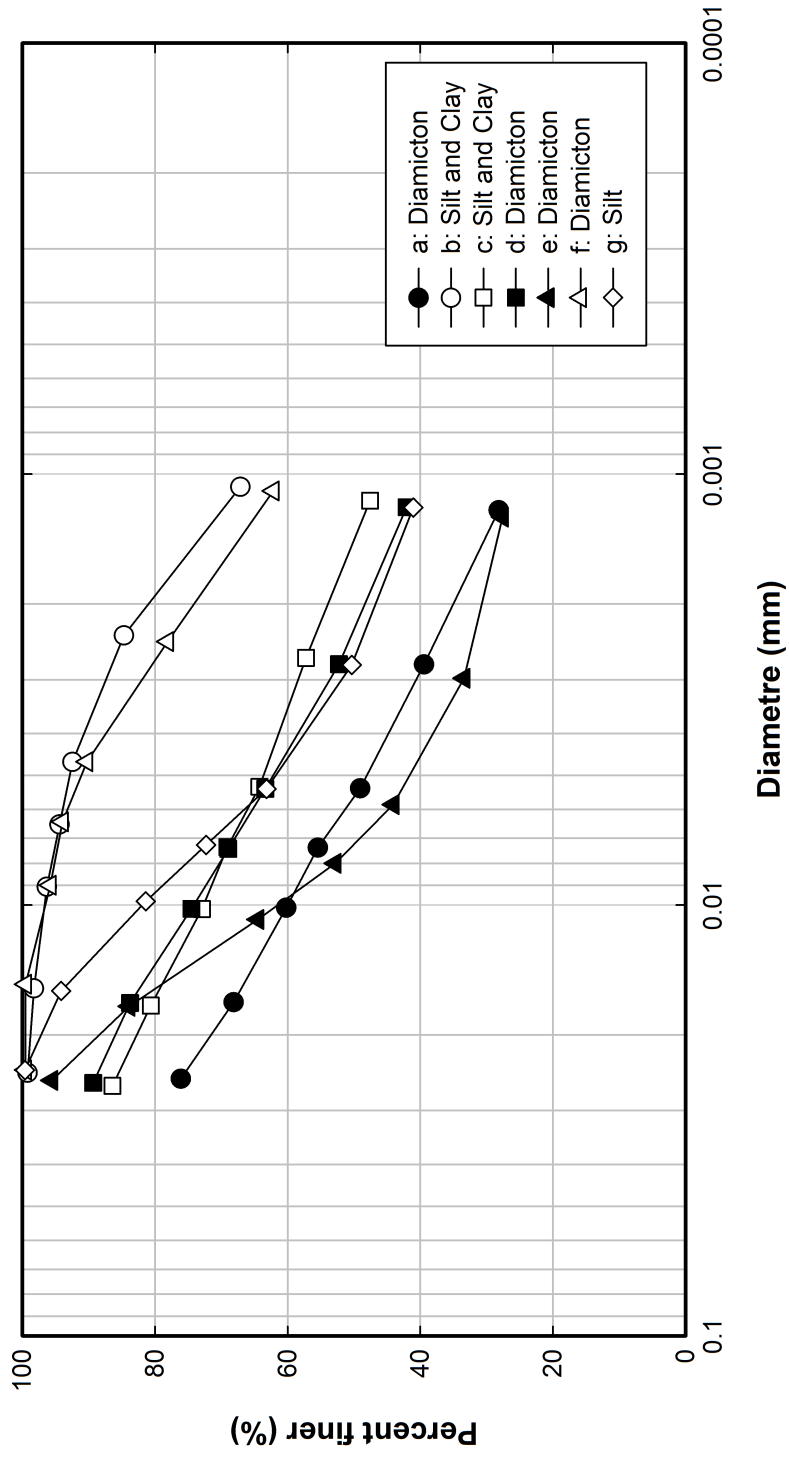
Figure 4.38 Hydrometer test results for soil samples. The general description of each sample is described in Table 4.1.1. Soil samples are differentiated based on their representative types (diamicton type soil: black solid symbol; silt or silt and clay: white solid symbols)

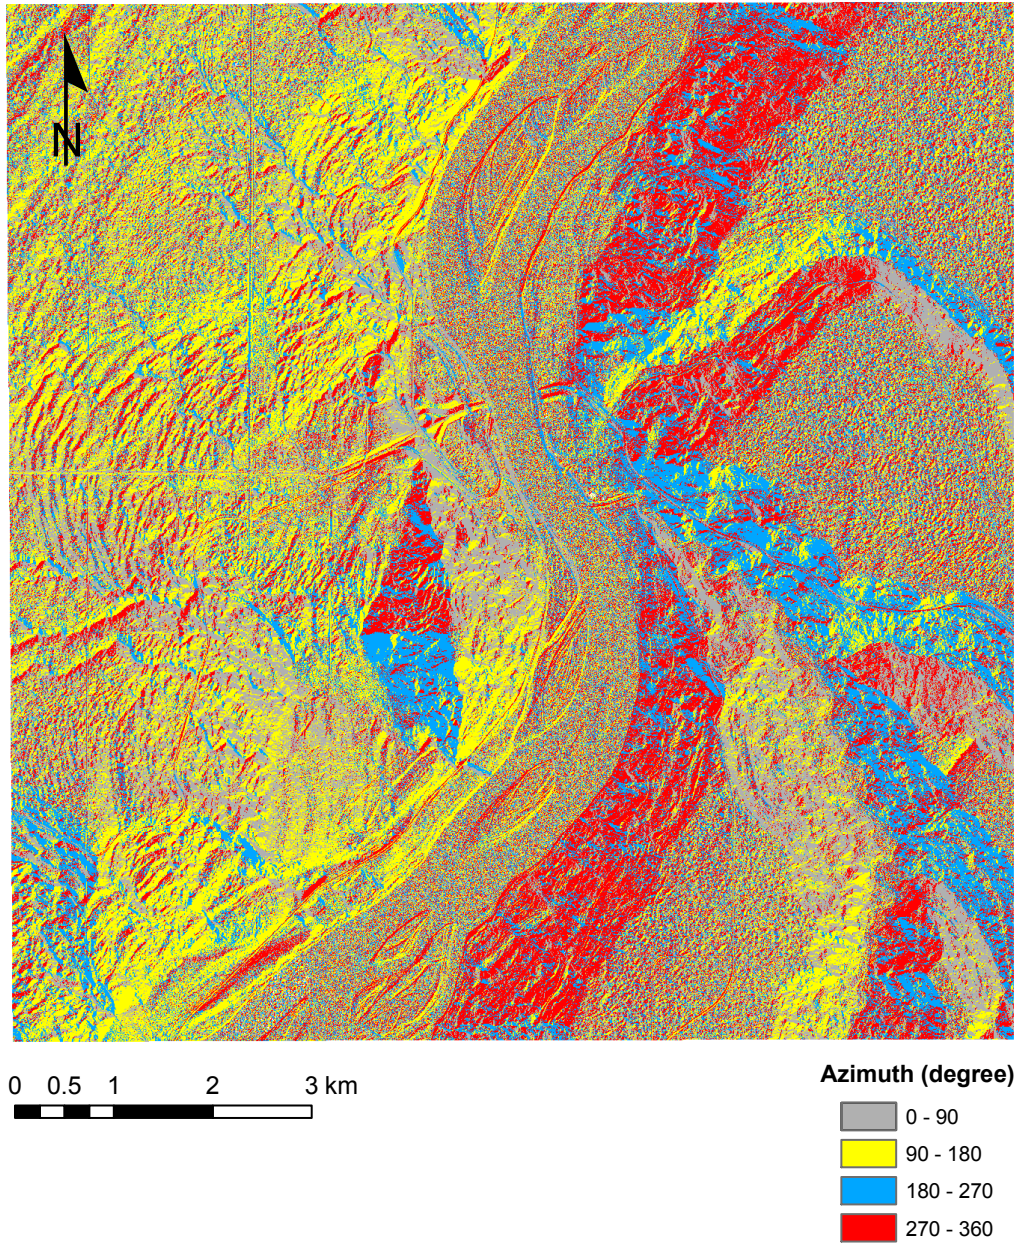
Figure 5.6 Spatial distribution of aspect values. The cell size is 0.5 by 0.5 metres. It is generated from the digital elevation model (Figure 5.4)

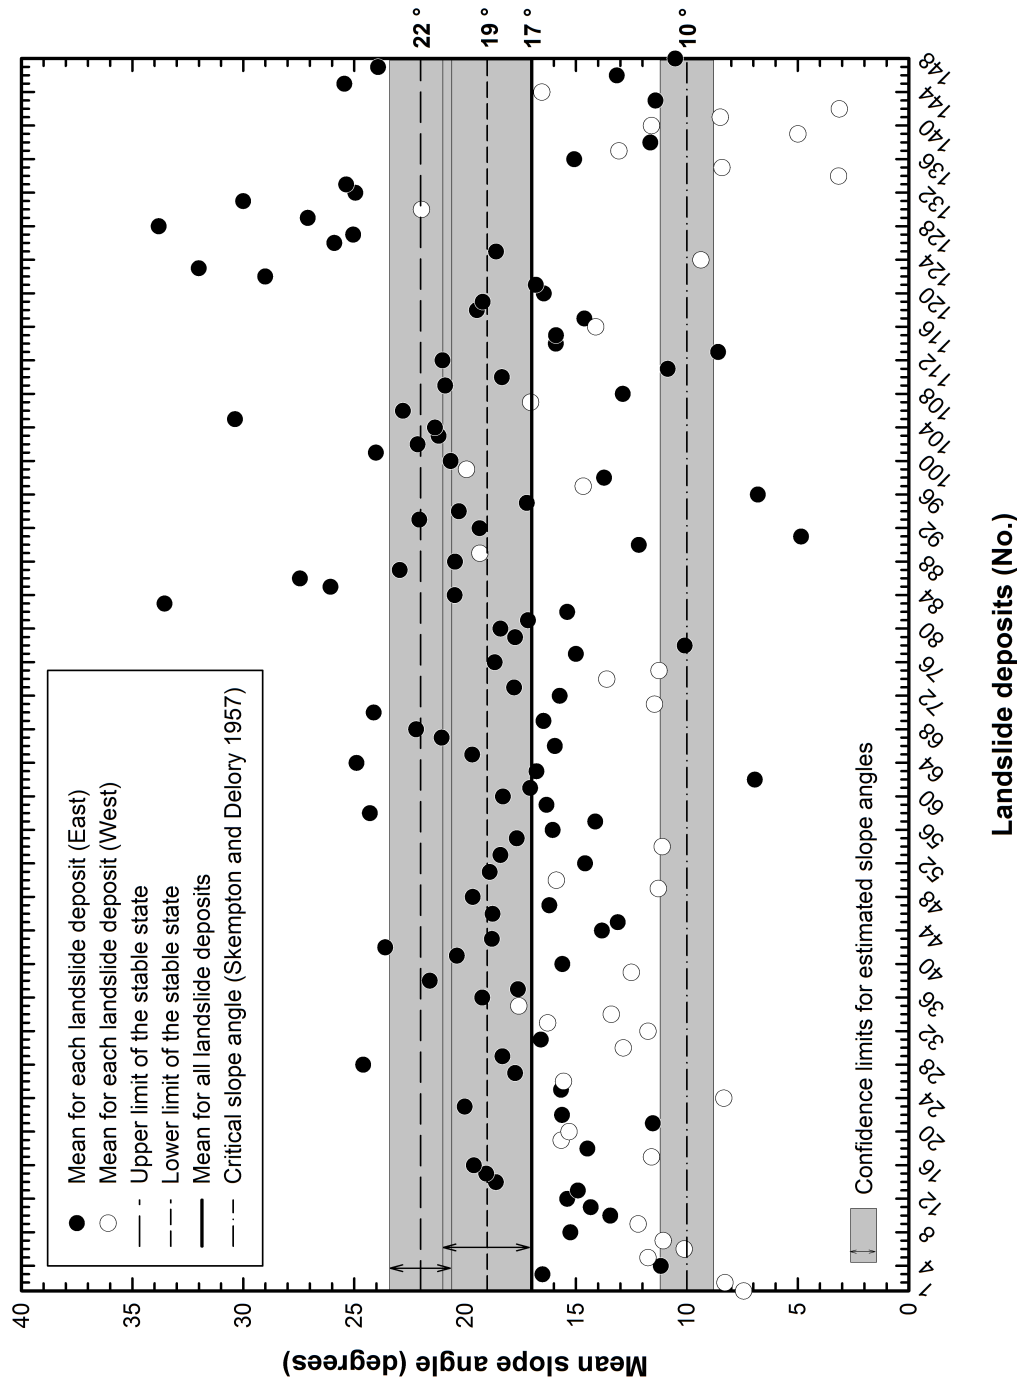
Figure 5.13 Mean slope values of landslide deposits observed in the study area. Landslide deposits denoted by the unique number are presented in the abscissa while corresponding average slope angles are shown in the ordinate. Landslide deposits are grouped, either the west or east, based on the location where they were identified. Horizontal lines represent the critical slope angle, average slope angle for all landslide deposits, and lower and upper limits of the stable state, respectively. Gray shaded areas also illustrate the 95 percent confidence intervals with respect to friction angles and the uncertainty of the unit weight of colluvial sediments, which described in the text. Detailed information for landslide deposits are also presented in Appendix E

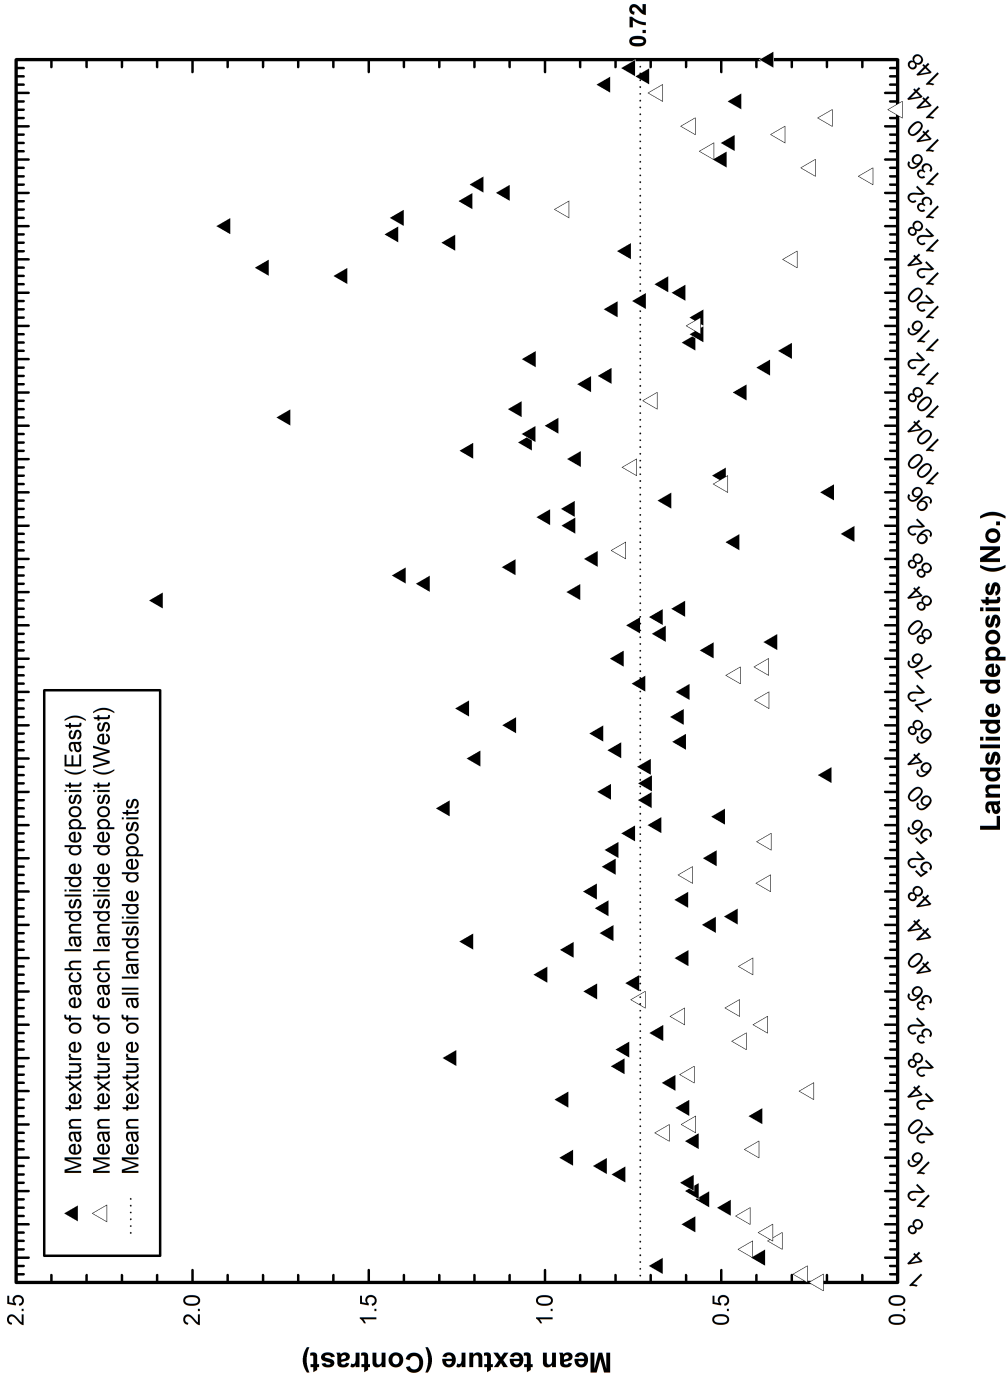
Figure 5.25 Mean texture values of previous landslide deposits observed in the study area. Landslide deposits denoted by the unique number are presented in the abscissa while corresponding average texture values are shown in the ordinate. Landslide deposits are grouped, either the west or east, based on the location where they were identified. The horizontal line represents the average texture value for all landslide deposits. Detailed information for landslide deposits are also presented in Appendix E

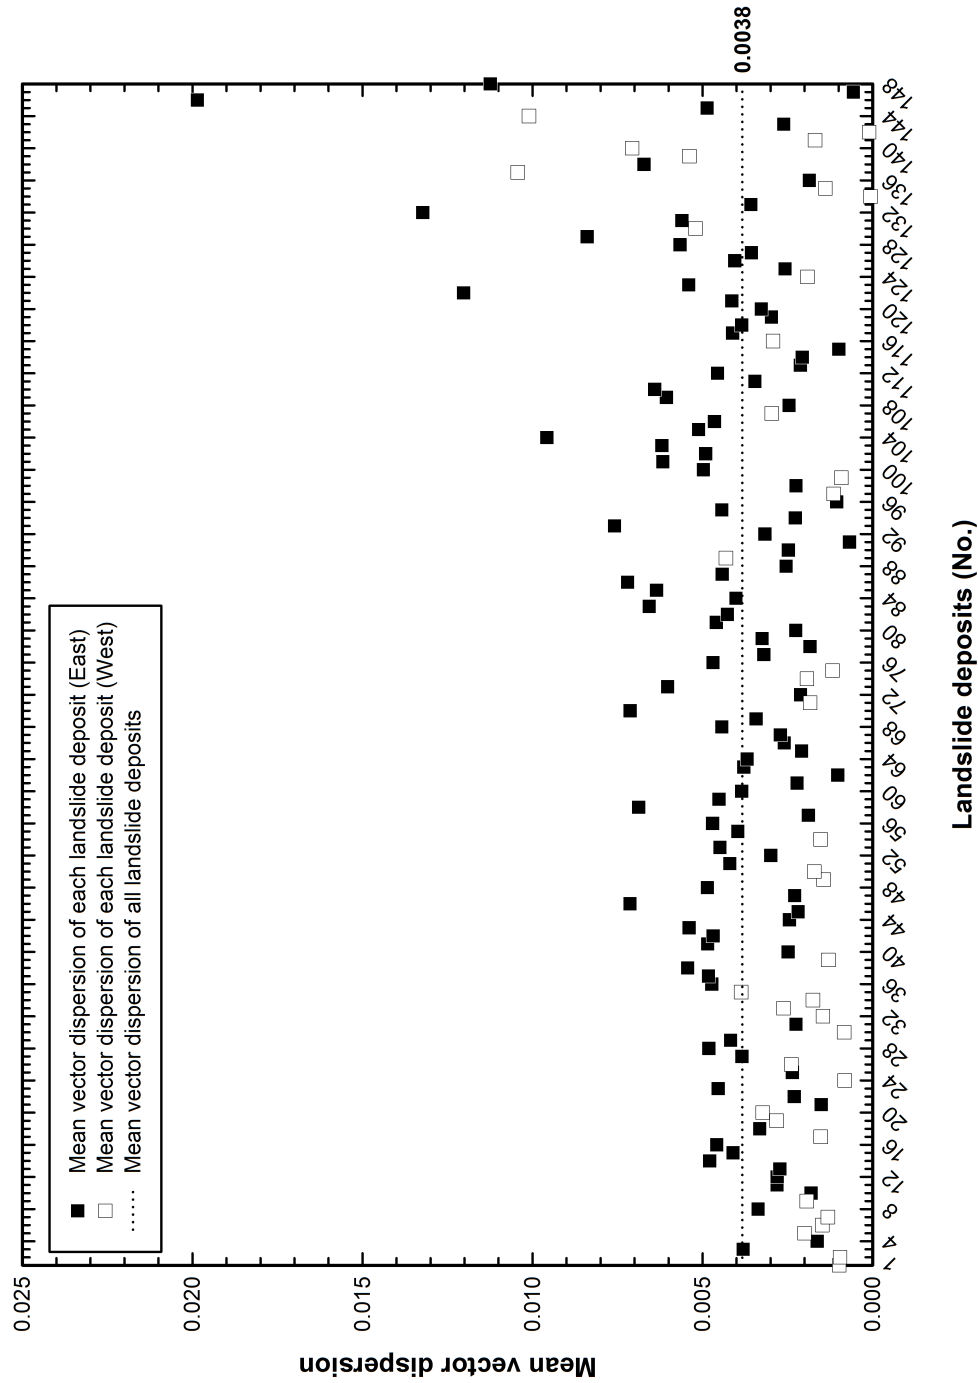
Figure 5.35 Mean vector dispersion values of previous landslide deposits observed in the study area. Landslide deposits denoted by the unique number are presented in the abscissa while corresponding average vector dispersion values are shown in the ordinate. Landslide deposits are grouped, either the west or east, based on the location where they were identified. The horizontal line represents the average vector dispersion value for all landslide deposits. Detailed information for landslide deposits are also presented in Appendix E

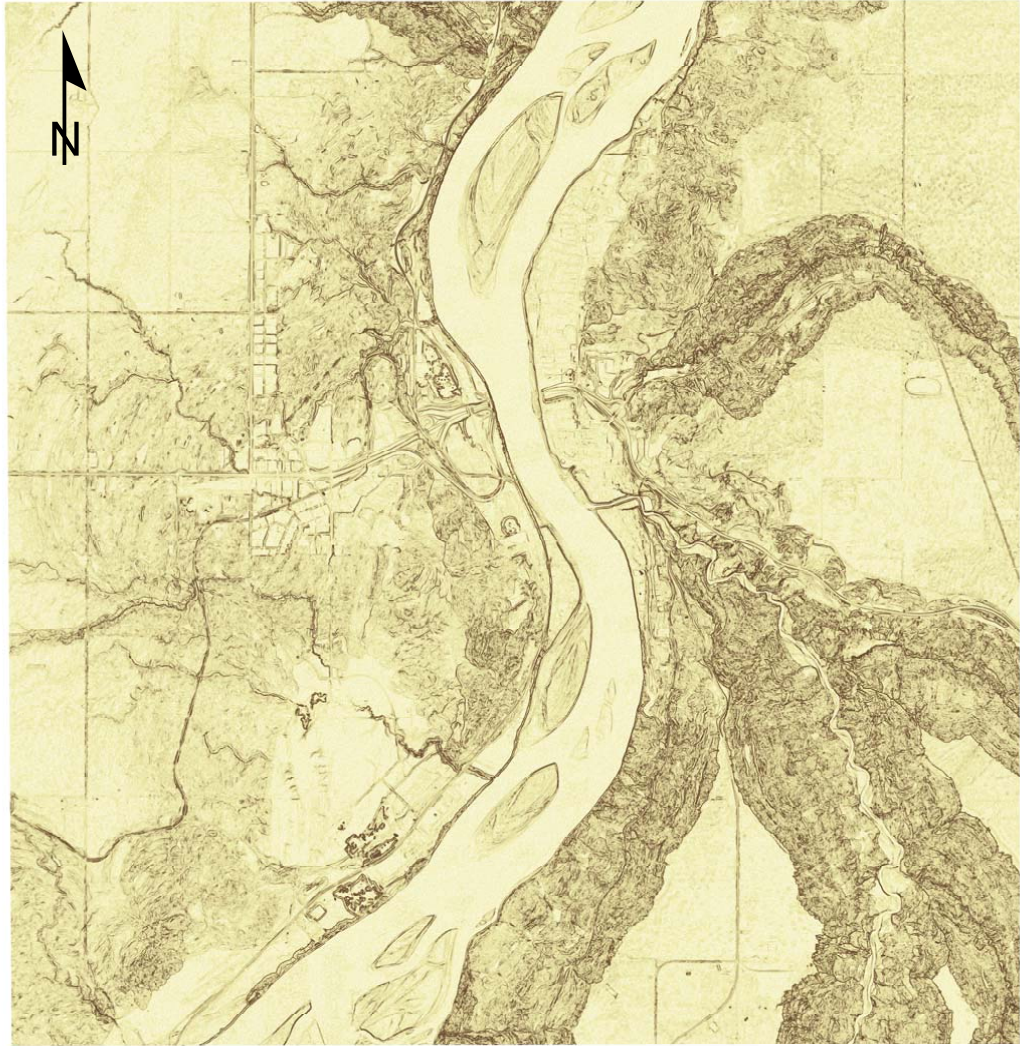
Figure 5.41 Spatial distribution of eigenvalues for the study area. a. S_1 . b. S_2 . c. S_3 . The cell size is 2.5 by 2.5 metres. Variations of each eigenvalue are illustrated in the legend. Eigenvalues are calculated from the orientation matrix which shown in Equations (5.19) and (5.20), then normalized by the total grids of N (Equation (5.21)). The orientation data of each cell is generated from the digital elevation model shown in Figure 5.4, which is modified to a 2.5 by 2.5 metre resolution for the analysis
