Landslide Hazard Assessment, Town of Peace River, Alberta

Doctor of Philosophy
in
Geotechnical Engineering

Department of Civil and Environmental Engineering

©Tai-Hoon Kim
Spring 2012
Edmonton, Alberta

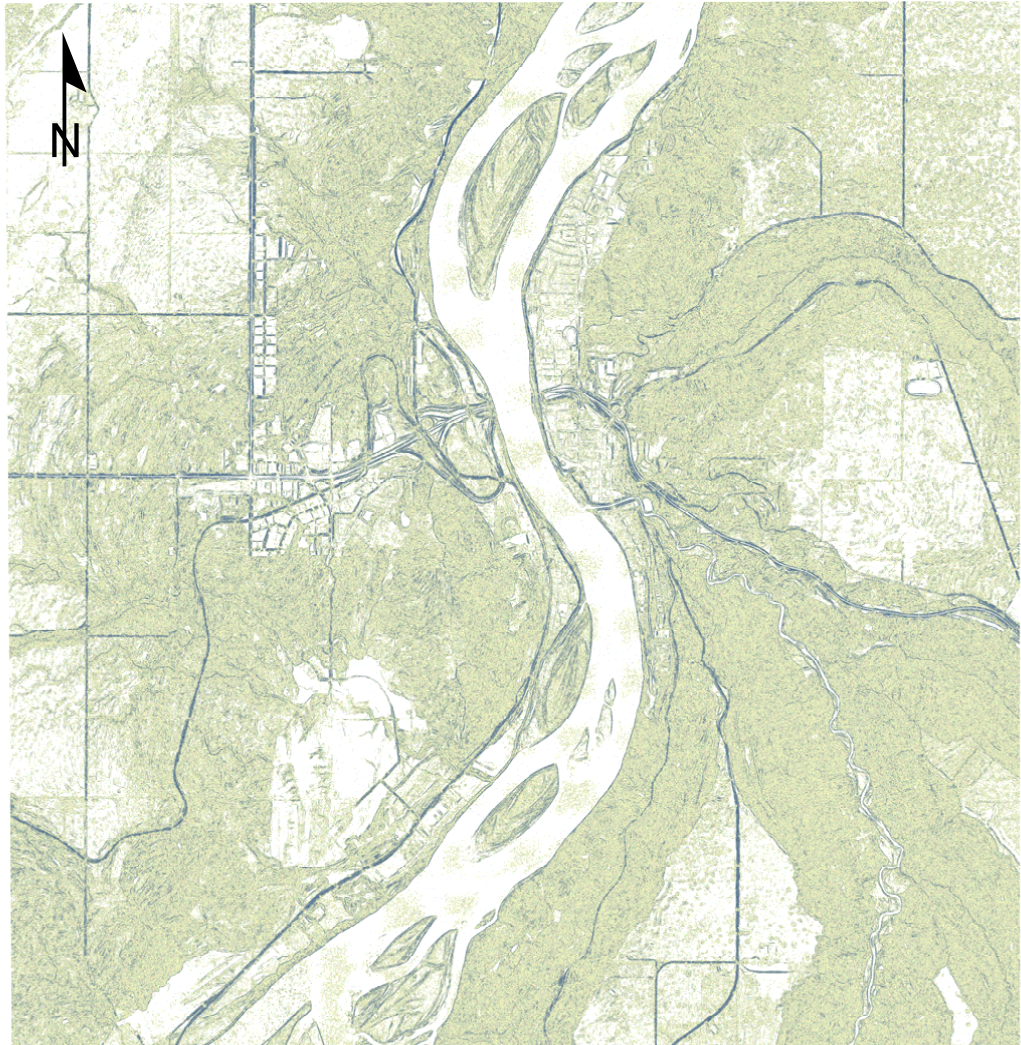
Figure 5.42 Spatial distribution of the eigenvalue ratio of $\ln(S_1/S_2)$ in the study area. The cell size is 2.5 by 2.5 metres. Variations of the eigenvalue ratio are shown in the legend. The eigenvalue ratio is generated among three individual values illustrated in Figure 5.41. Obtained ratios can be represented by the natural logarithmic scale. The area outlined by the black rectangle is also shown in Figure 5.45

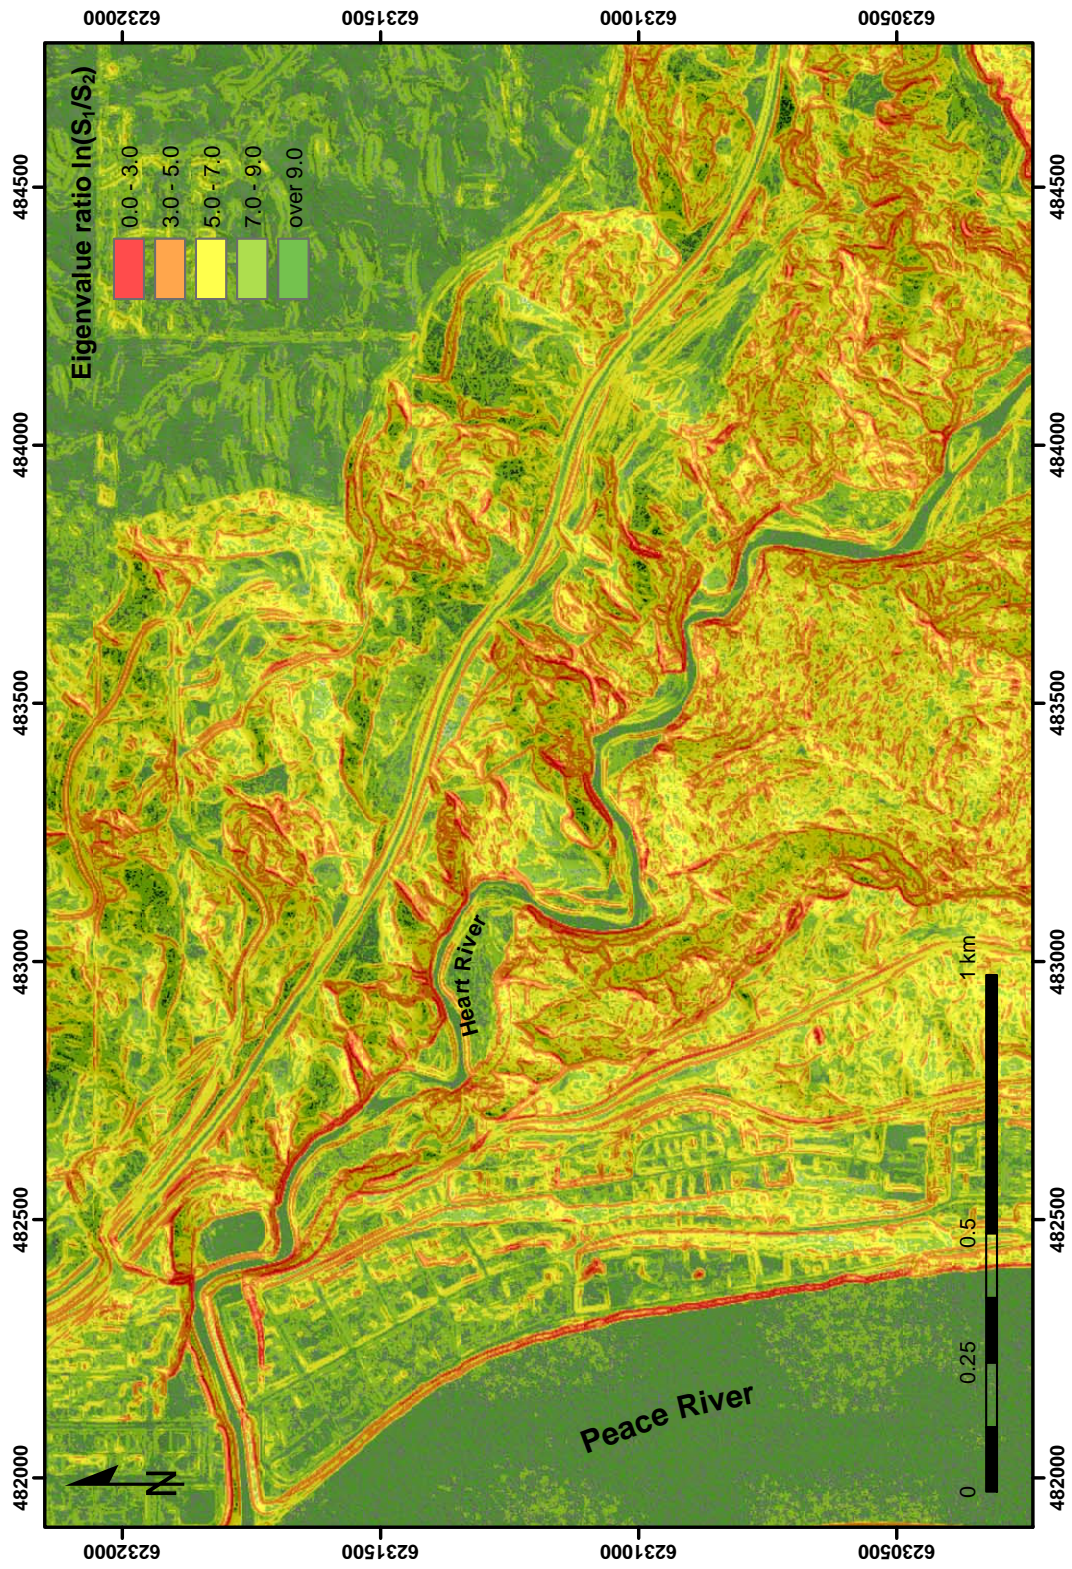
Figure 5.45 A closer look at the part of study area draped by the eigenvalue ratio of $\ln(S_1/S_2)$. The location is illustrated in Figure 5.42. The same variation of the eigenvalue ratio shown in Figure 5.42 is also presented in the legend. Peace and Heart Rivers flow northward, respectively. A hillshade imagery presented in the background is obtained from the digital elevation model (Figure 5.4) with the spatial resolution of 0.5 by 0.5 metres

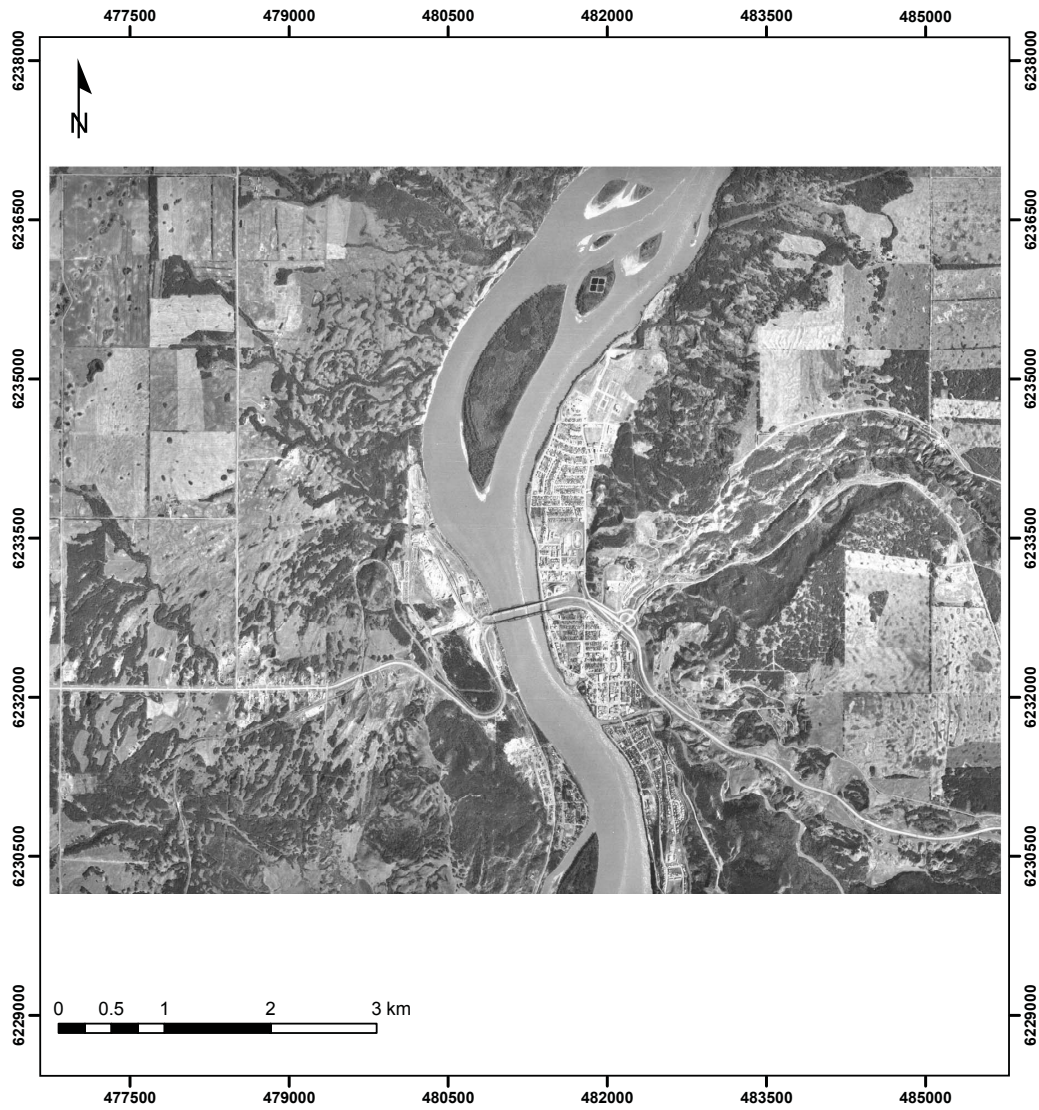
Figure 5.54 1977 aerial photographs of the Peace River area, scale 1:51,000 (Alberta photo: AS 1575 240 to 242)

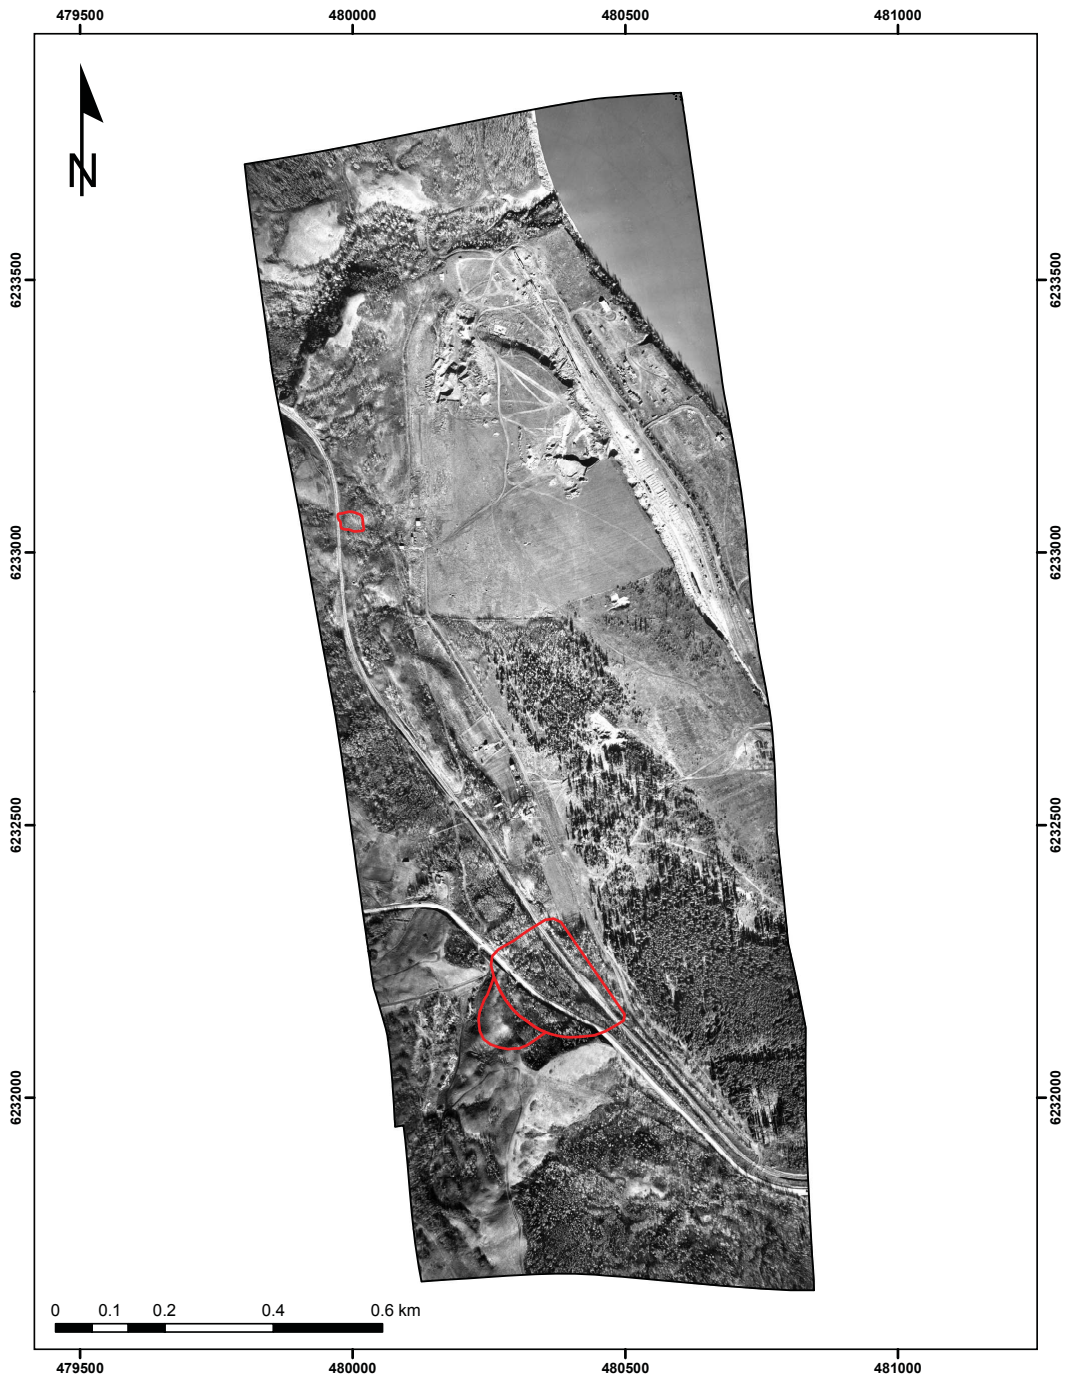
Figure 5.58 1958 aerial photographs of the west bank of the Peace River, scale 1:9,000 (Alberta photo: AS 26-99 to 103). Areas enclosed by red solid lines represent recent landslides occurred in the west bank of the Peace River, which are Mile 50.9 and Shop Slides (Figure 4.1)

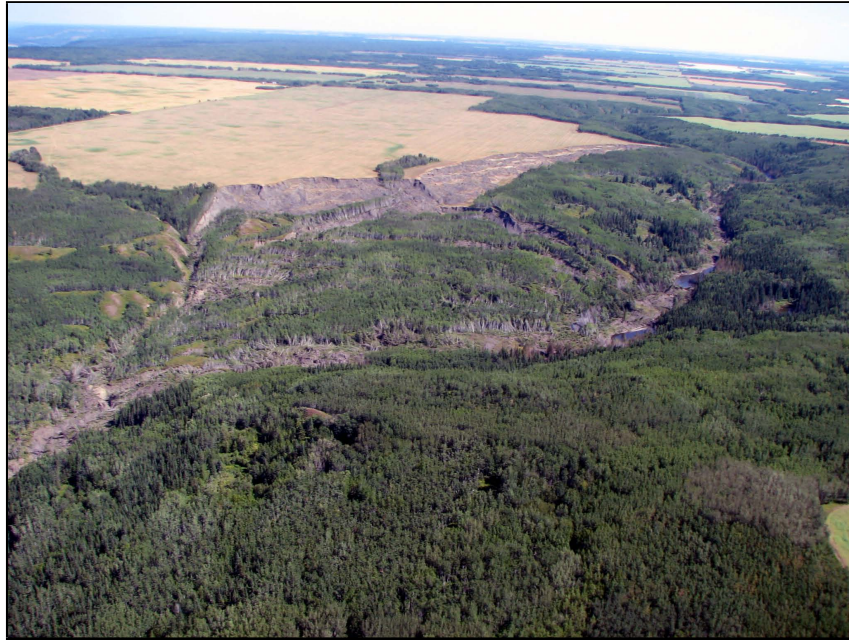
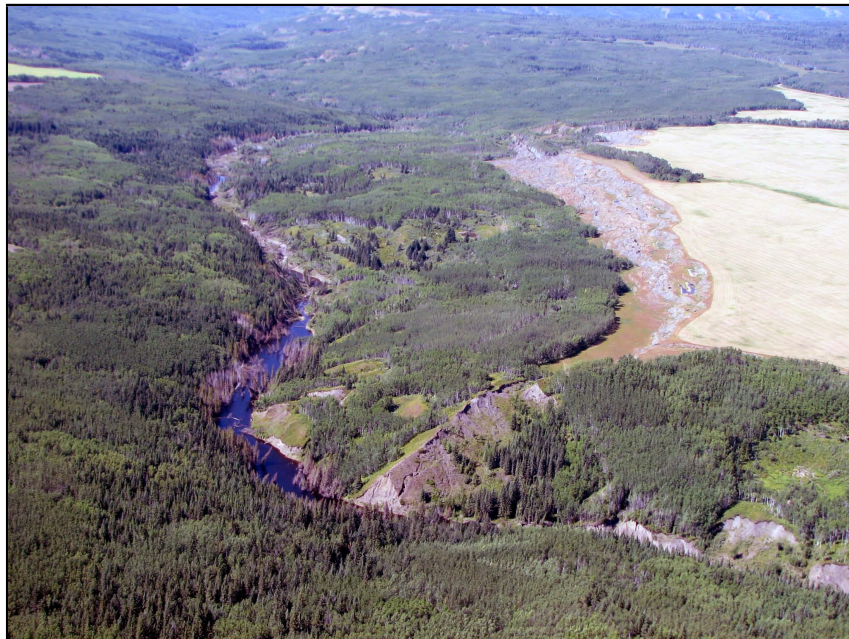
Figure D.2 Aerial overview of the 2007 Fox Creek landslide. a. High oblique view of the affected area (looking northeast). b. Landslide lake located at the toe of the east sliding block (looking west)

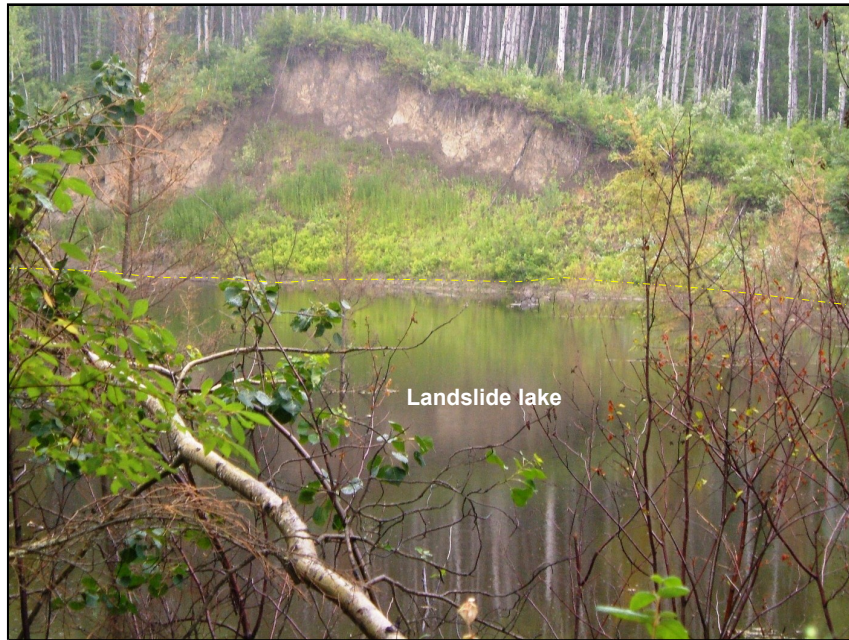
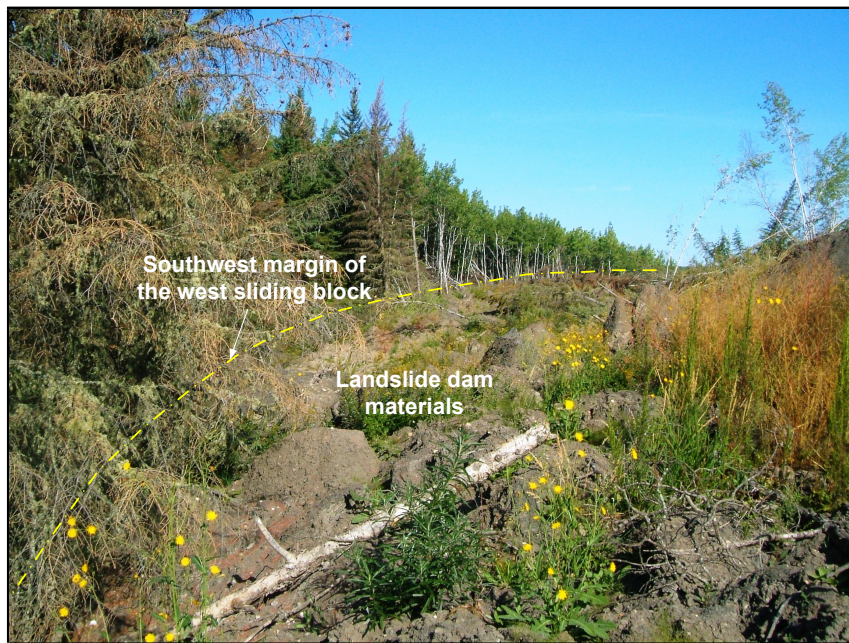
Figure D.8 Landslide features on the lower part of the sliding blocks and landslide dam. a. Close view of a landslide lake at the toe of the east sliding block. b. Landslide dam materials displaced on the toe of the west sliding block. c. Close view of a typical advance phase glaciolacustrine sediments in the west sliding block showing rhythmic nature. Pebbles are visible in tills and majorities are less than 5 cm. d. Preslide riverbed consisting of sand and gravel underlying the toe of the west sliding block
