UNIVERSITY OF ALBERTA

Landslides and Geotechnical Properties of Volcanic
Tuff on Mount Cayley, British Columbia

A thesis submitted to the Faculty of Graduate Studies and
Research in partial fulfillment of the requirements for the
degree of Doctor of Philosophy

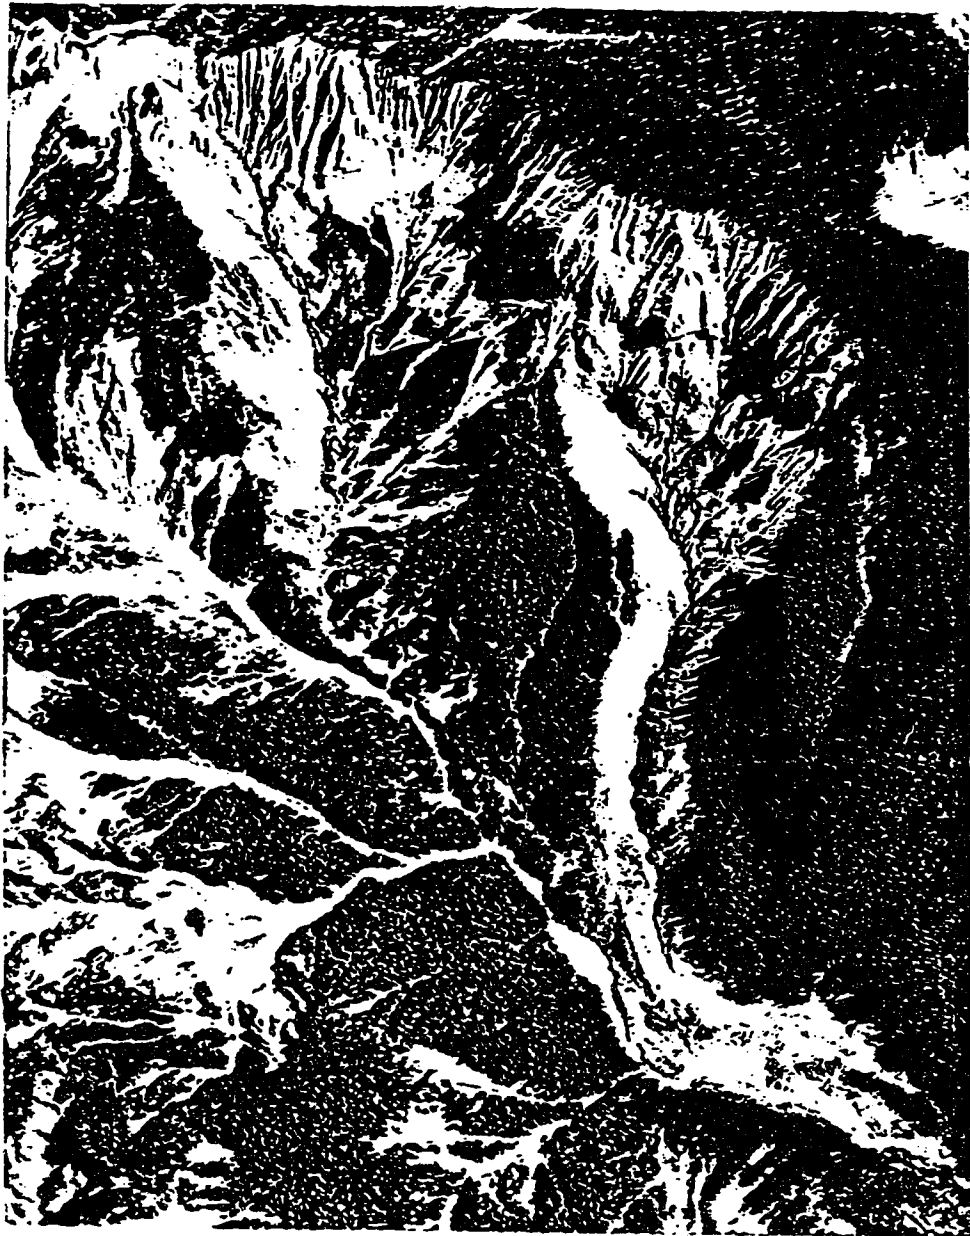
Figure 2.3 Air photo of the study area on August 8, 1973
(Province of British Columbia photos BC7520-259).

A scarp at the head of Avalanche Creek at elevation of 1600 m and new deposits in the valleys of Avalanche and Turbid Creeks are clearly shown on the air photo taken in 1986 (Fig. 2.2). Comparing the air photo with the air photos taken in 1982 and 1973 (Fig. 2.3), significant changes can be recognized (Fig. 2.2).

Interpretation of air photos (Figs. 2.3, 3.1, 3.2 and 3.3) shows that after the deposition of the volcanic rocks, Mount Cayley was probably extensively glaciated. Cirques developed on the volcanic slopes. Cirque glaciers eroded steep, straight, U-shaped valleys (Fig. 6.8). This process might cause the upper weak tuff layer at the bottom of unit 4 of the volcanic rocks to daylight on the steep slopes. As the rock block's lateral connection with the slope was not totally destroyed, the rock mass above the upper weak tuff layer would not fail. As the ice decayed, tributary drainage would develop presumably at high angle to the radial drainage (Fig. 6.8). So prehistoric inactive episodes of slope movement are correspond to glaciations and active episodes of slope movement are correspond to glacier recessions. In some cases, rock slopes would be cut into isolated blocks. At that time the rock block would fail and slide downstream along the upper weak tuff layer rapidly forming a rock slide similar to the 1984 rock slide, a Tuff Type rock slide. Sometimes even when the upper weak tuff layer at the bottom of unit 4 is daylighting on the slope resulting from erosion, if the lateral connections still exist, the slope won't fail immediately. On the other hand, if erosion is still developing after some slopes consisting of units 4 and 5 failed, and reaches

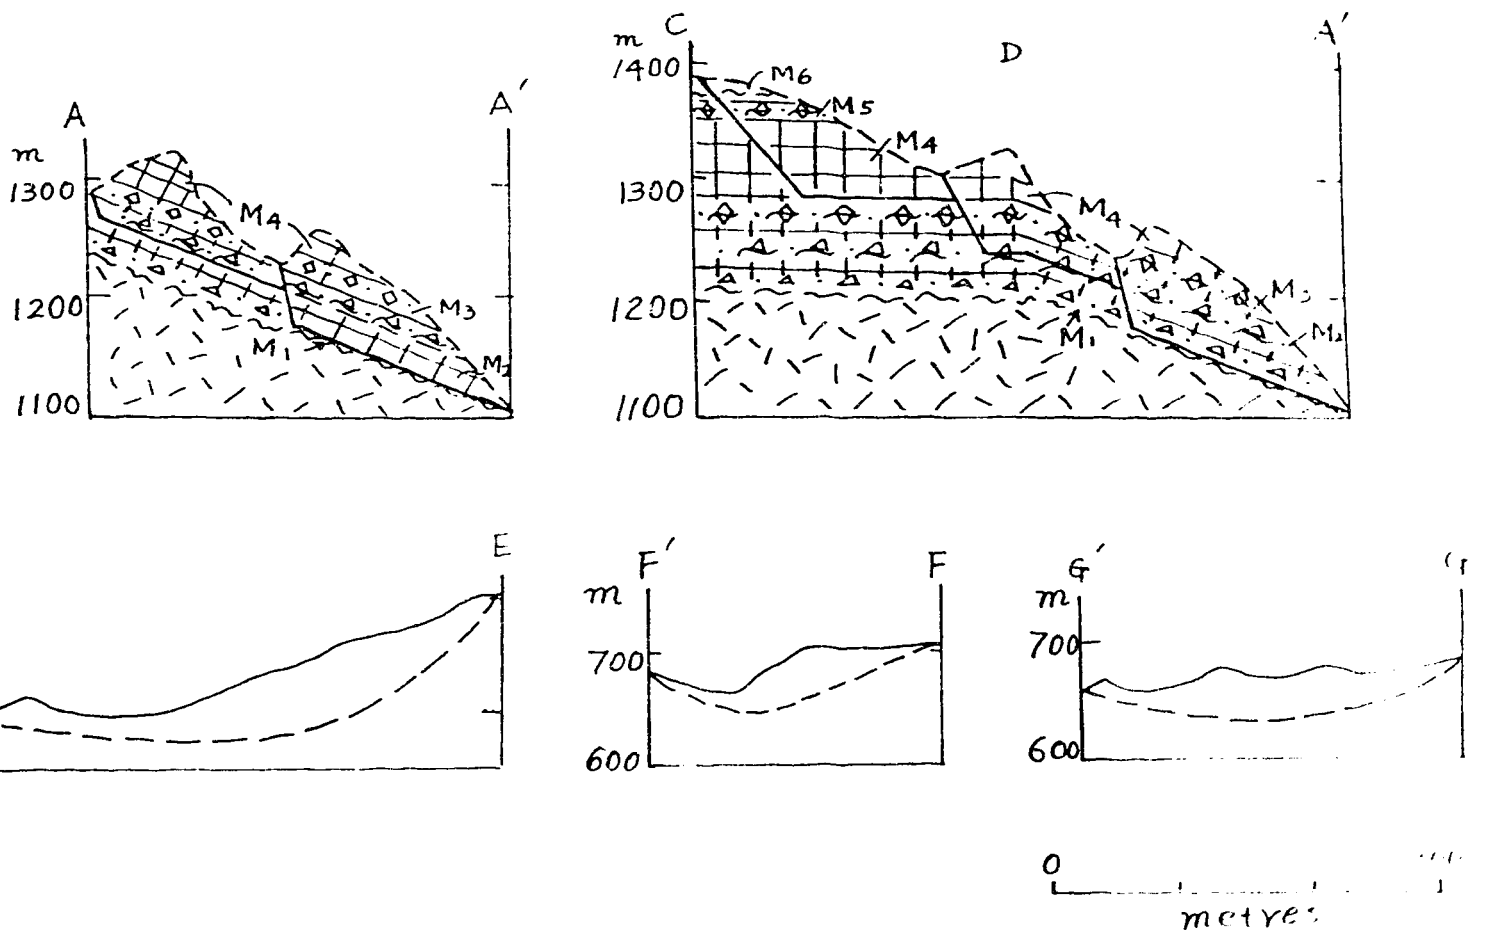
Figure 3.5 Cross-sections of the depletion and accumulation zones, lines of cross sections on Figure 3.4.

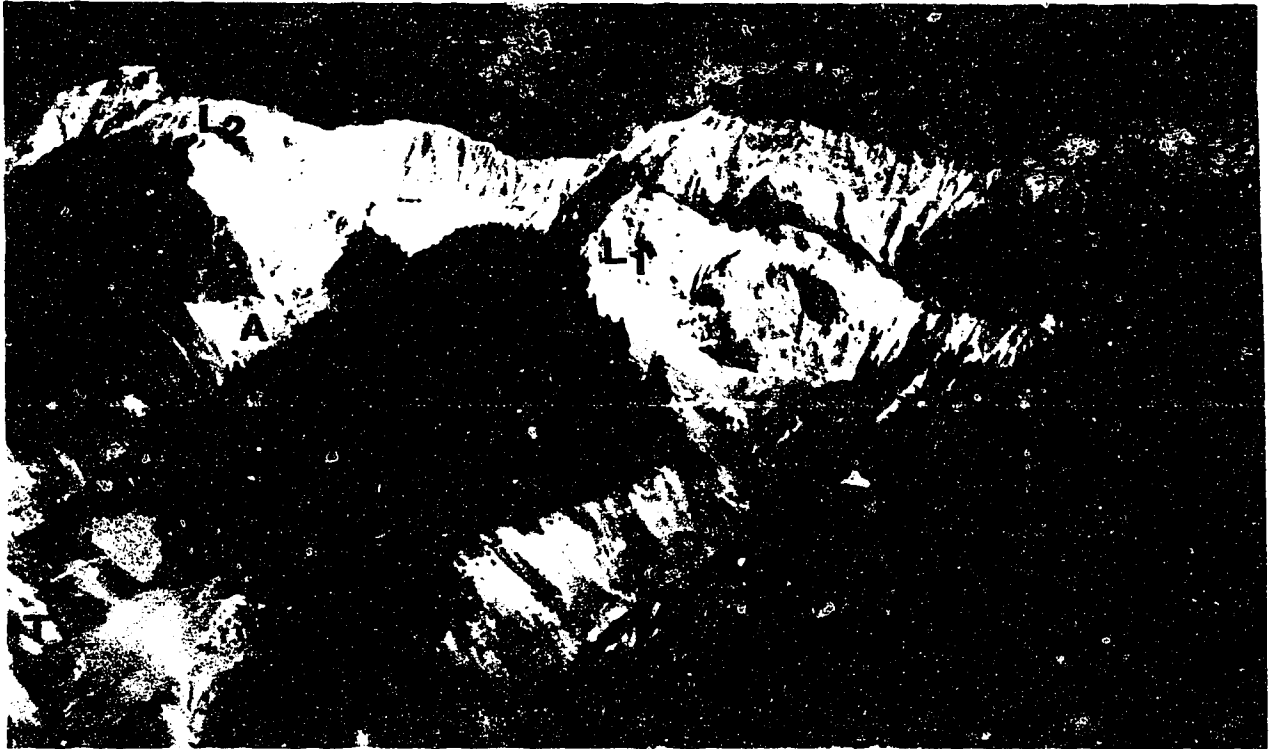
Figure 5.1 Depletion zones of the 1963 and the 1984 events, taken from a helicopter in the summer of 1985 looking NE. Note that Avalanche Creek, Dusty Creek and Turbid Creek are represented by A, D and T respectively, and L₁ and L₂ indicate the depletion zones of the 1963 rock slide and the 1984 rock slide respectively.

The depletion zones of two major historic slope movement events, the 1963 rock slide, and the 1984 rock slide and debris flow, from Mount Cayley are closely located in a small area. Figure 5.1 shows the depletion zones of these two events. The horizontal distance between these depletion zones is about 0.8 km. The 1963 rock slide, and the 1984 rock slide and debris flow started from the heads of two small tributaries, Dusty and Avalanche Creeks, of
