University of Alberta

**Process Analysis of Rockfalls with Stationary Terrestrial LiDAR and RockFall
Analyst**

A thesis submitted to the Faculty of Graduate Studies and Research
in partial fulfillment of the requirements for the degree of

Geotechnical Engineering

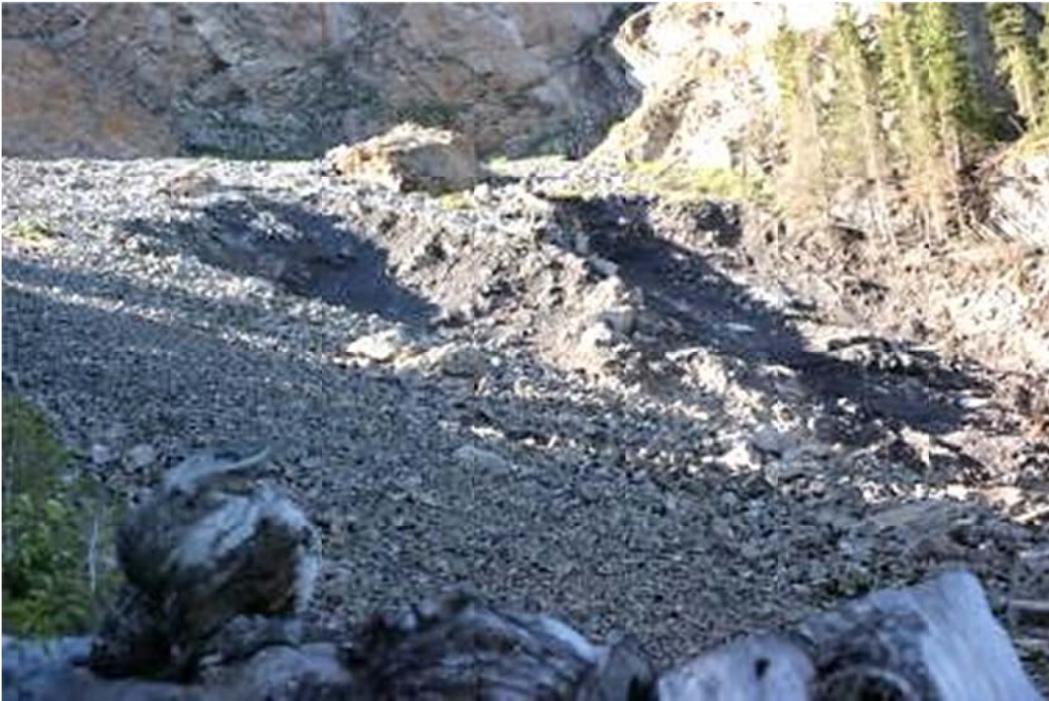
Figure 2.1: Rockfall Source at Crowsnest Lake Site (photo by James Russell)

The main area of concern for the rockfall hazard at this site would be the head of the gully formed in the talus slope (as seen in Figures 2.1 and 3.3). Groundwater springs have been noted on both the talus slope and rock cut slope behind the barrier, which is consistent with the seasonal groundwater discharge. It would appear that this seasonal water discharge, coupled with precipitation, and perhaps even freeze/thaw cycles, has led to a heavy amount of erosion in the talus slope. This can be clearly observed at site, and gravel to cobble-sized rockfalls can be noted quite frequently. It can also be noted that the clearing of the talus has revealed several larger boulders, that when fully exposed could be at risk of falling.

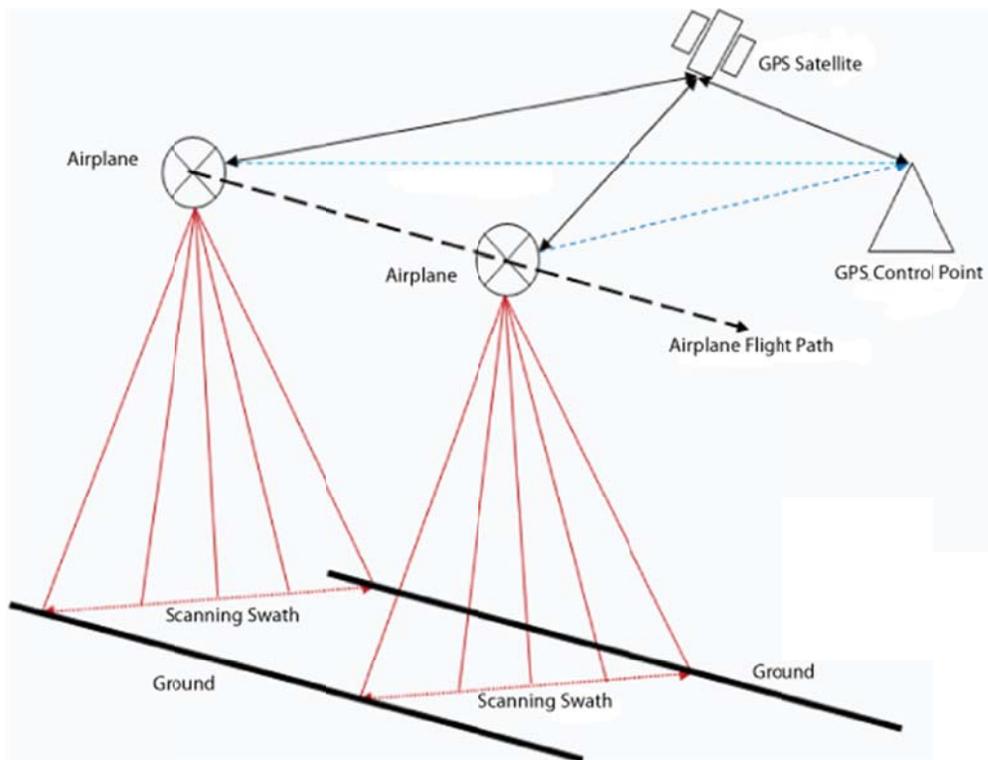
Figure 2.2: Schematic of Aerial LiDAR Process

interpolated into a surface grid that forms the DEM. Since the DEM is formed by interpolation, it should be noted that it will be subject to error between each of the points, and therefore the most accurate representation from the surface is actually in the form of the XYZ point cloud. Having made this observation, Glenn et al (2006) note that the LiDAR device has a 16cm absolute vertical accuracy, with up to a 5cm discrepancy from point-to-point, which is a very small level of error. Sato et al (2007) found an accuracy of 15cm on bare earth, with errors of up to 0.42m in defoliated deciduous vegetation, and 1.02m in coniferous vegetation. The 15cm accuracy can be given as a saturation level of approximately 36pts/m². Other sources would label point saturation more conservatively at 10pts/m² (Lato et al 2009, p938), which is within the same order of magnitude as the previous saturation. A DEM is best formed when points are taken directly from the bare ground surface, but LiDAR can obtain bare earth images even with vegetation present, noting potential error as pointed out previously. The light pulses are classified as received as first pulse, last pulse, and any in between being noted as other pulses (Sato et al 2007). By ignoring the first and other pulses obtained within a given pulse area and only taking the last pulses, the bare earth image DEM is obtained. This bare earth DEM is very useful in noting surface roughness and sloping due to its high spatial resolution, and can be used to define a great many geomorphologic features. Sato et al (2007) found that, since LiDAR images directly measure the 3-dimensional ground coordinates, LiDAR-DEMs illustrate these geomorphologic features in better detail than when using the photogrammetric technique.

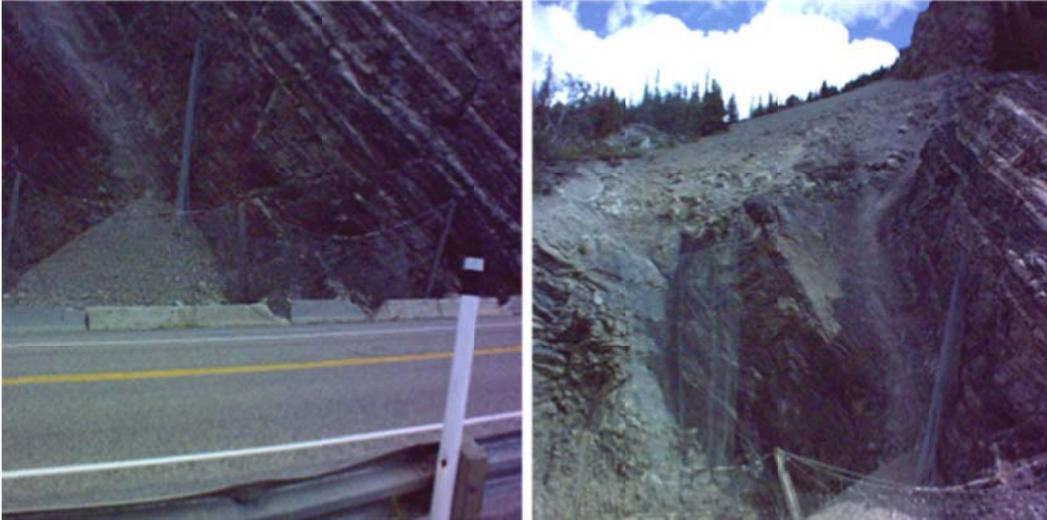
Figure 3.1: Crowsnest Lake Rockfall Site (Taken From ILRIS-3D Camera)

A persistent rockfall hazard has existed along the Crowsnest Pass, or Highway 3, for some time. Previous investigations in 1999 have led to construction of a concrete lock-block wall downslope of the outlet gully that is the point of concern for the rockfall hazard. Scaling of adjacent cut slopes was also performed. In 2003, an increase in both volume and frequency of rockfalls was noted, and an AMEC inspection led to the replacement of the wall with a rockfall barrier net in 2005. Figure 3.1 shows the site as seen from the LiDAR station on site.

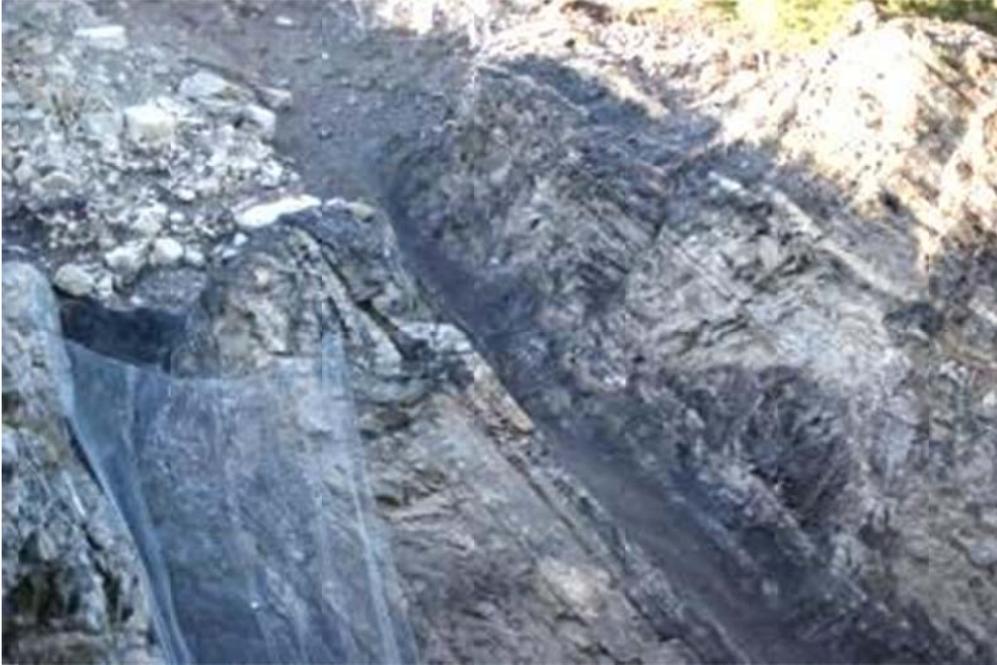
Figure 3.3: Gully/Erosion Path at Crowsnest Lake Site (photo by James Russell)

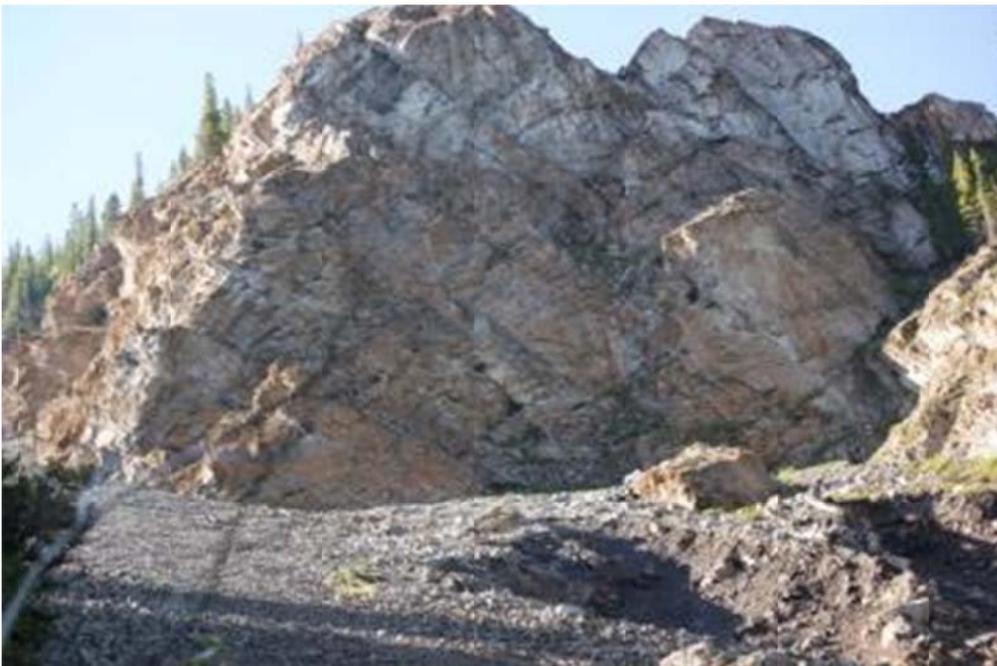
A higher rock face has been noted, as seen in Figure 3.4, and may be a concern for rockfalls in the future. At this time, it is unclear as to whether this face is contributing to the rockfall, but if it were, it would certainly present a present danger to the site, and increase the risk level.

Figure 3.4: High Rock Face at Crowsnest Lake Site (photo by James Russell)

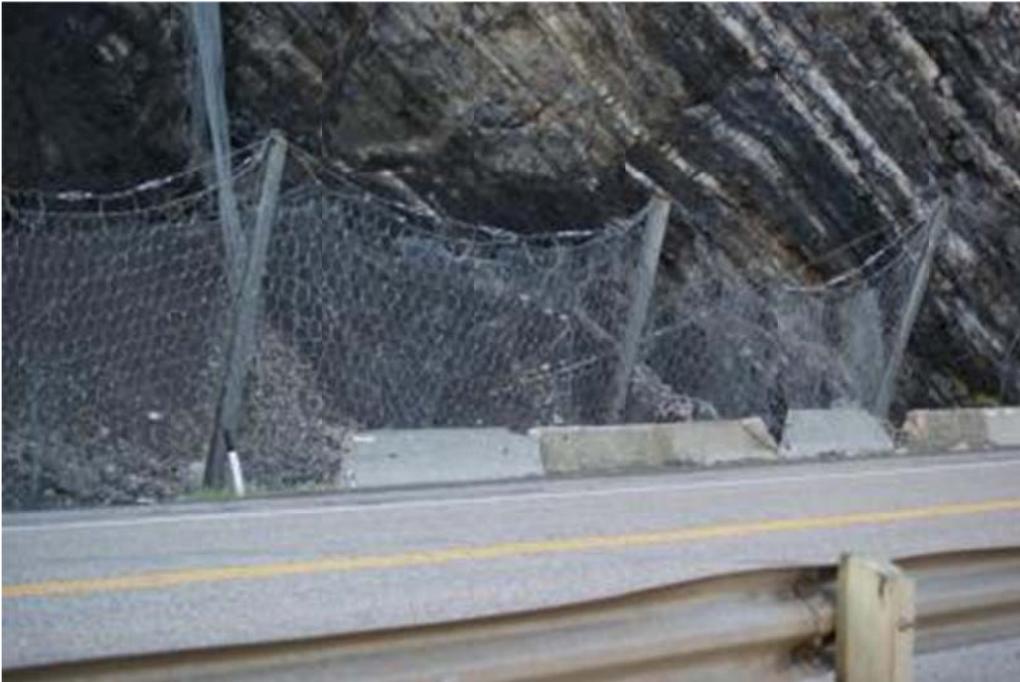
The barrier net that was installed in 2005 would seem to have been functioning properly as of 2006 (See Figure 3.5). Recommendations there were to maintain proper maintenance of the net to maintain capacity and ensure that it remains up to standards. As of the 2007 AMEC report, the east anchor ropes of the net had been disconnected to allow access behind the barrier for the clearing of rockfall debris. Unfortunately, removing these anchors and leaving them as such has reduced the capacity of the barrier net by a large amount, thereby reducing the protection it offers to the highway. The anchors can be disconnected for maintenance under the assumption that they will be reconnected thereafter, which has not been done. As of the 2008 report, the barrier net design is still considered to be sufficient, but maintenance has not been properly conducted as per the 2007 report, thus the net is not performing to the intended design standards. It is to be noted that cleaning the debris behind the net is a necessity to maintain the design standards; therefore the concerns of the maintenance contractors should be noted for both safety and ease of access. However, the design standards are still to be maintained if the highway is to be kept at the lowest possible risk level.

Figure 3.5: Barrier Net at Crowsnest Lake Site (photo by James Russell)

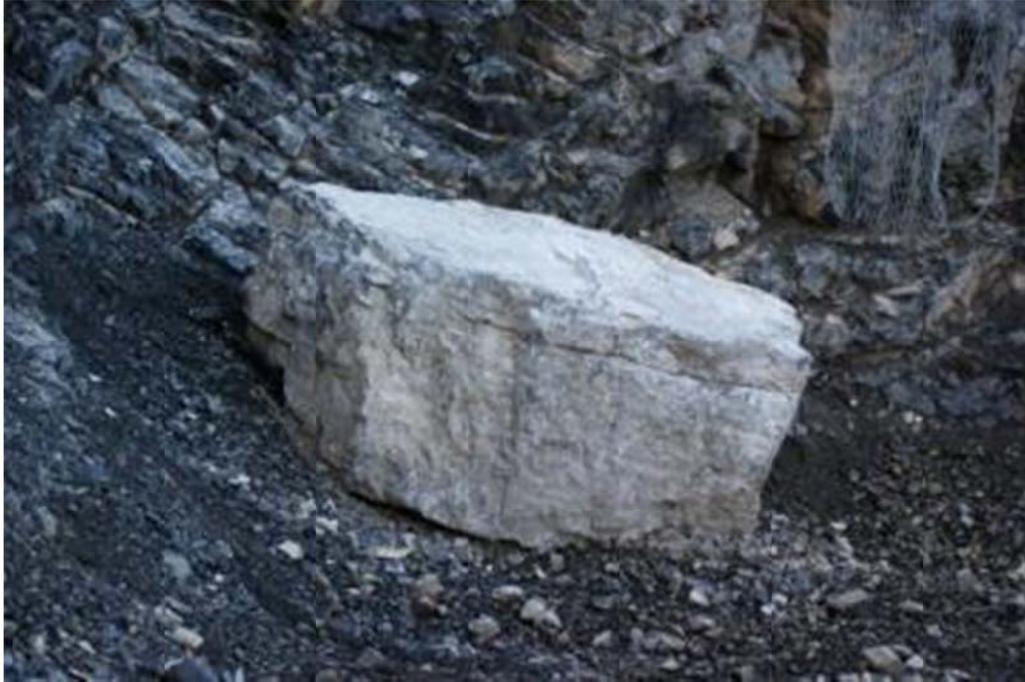
Large boulders have struck the barrier net. One, measuring 2m x 1.8m x 1.1m struck and was retained by the net on April 4, 2006. There was damage to the supports and net, but the boulder was retained. Other rocks of size have been noted in the talus slope, as mentioned previously, and several have been removed pre-emptively with the intent to prevent any risk of their falling. One such boulder can be seen in Figure 3.6. Ensuring that the net is maintained properly is of paramount concern for a rockfall of this size.

Figure 3.6: Large Boulder Behind Barrier Net at Crowsnest Lake Site (photo by James Russell)

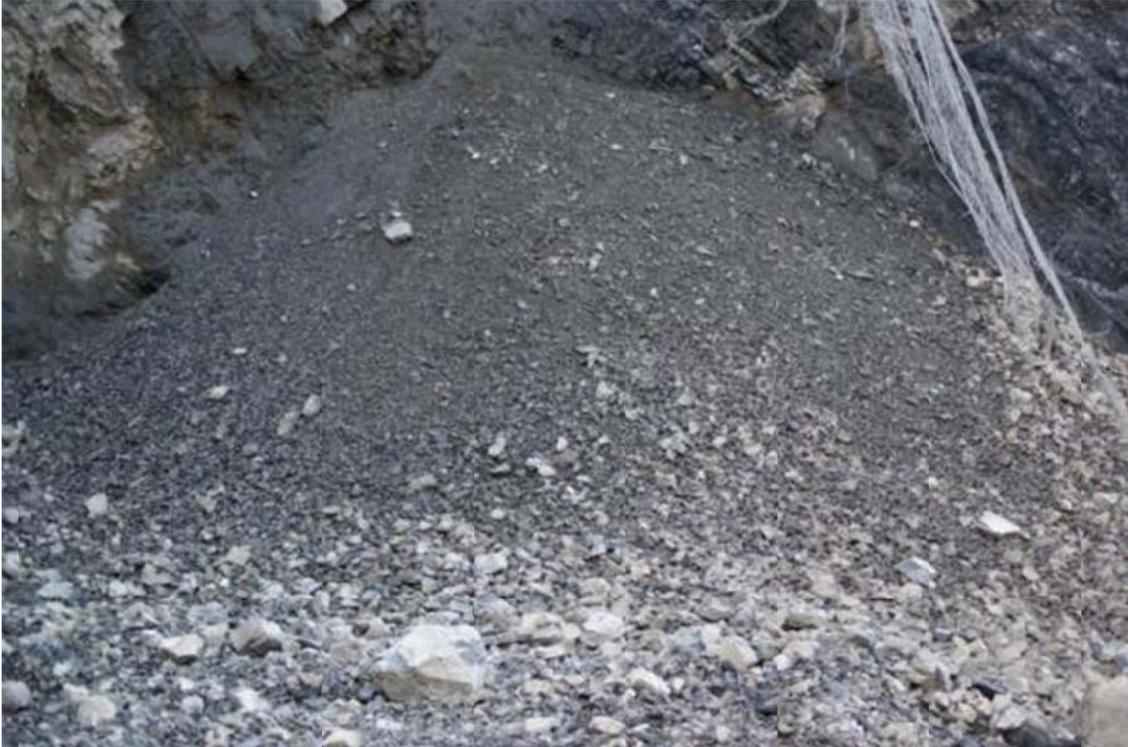
As already noted, the primary remedial measure for this site has already been implemented; the rockfall barrier net. Inspection, maintenance, and repairs of the net are to be completed regularly to ensure that it maintains capacity, and reduces the level of risk on site. Assuming that this is done on a regular basis, the requirements for annual inspections may no longer be needed. Clearing the talus slope that builds up behind the barrier net is a key maintenance requirement (talus can be seen in Figure 3.7).

Figure 3.7: Talus Pile to be Cleared at Crowsnest Lake Site (photo by James Russell)

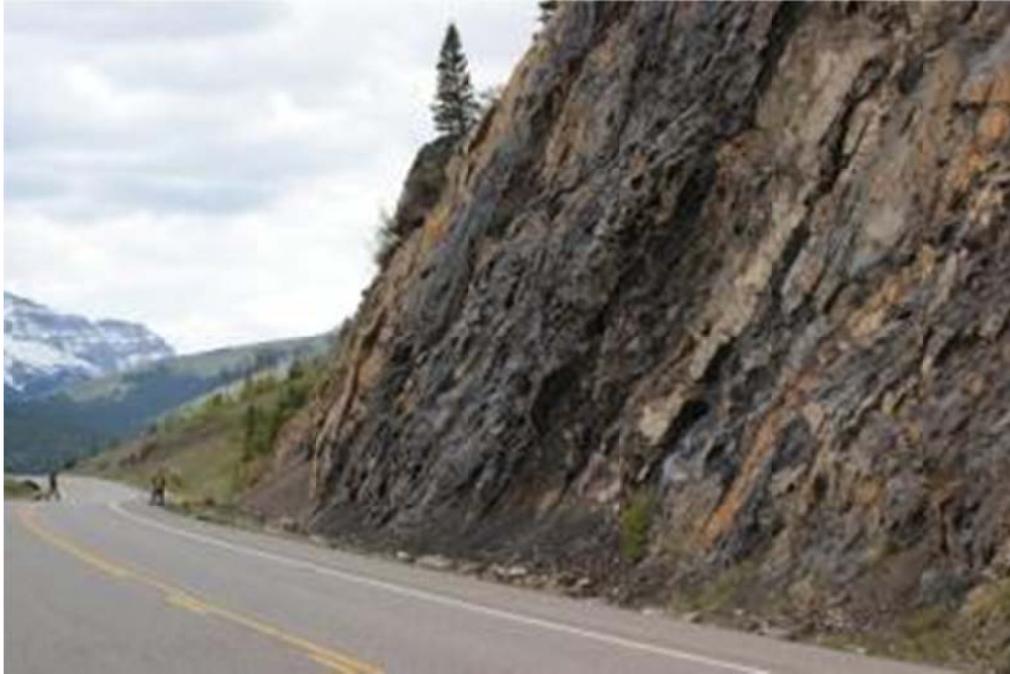
Maximum vertical height is estimated to exceed 20m, with a slope of near-vertical to legitimately vertical along the length of the cut. The highway strikes at approximately 80° , while the rock strikes at 30° with a bedding angle of 55° . The opposite side of the highway drops off into a valley after several meters; therefore the hazard source for the rockfalls is only from the southward facing cut slope. Highway 541 and the rock-cut can be seen in Figure 3.10.

Figure 3.10: Highwood House Rock-Cut (photo by James Russell)

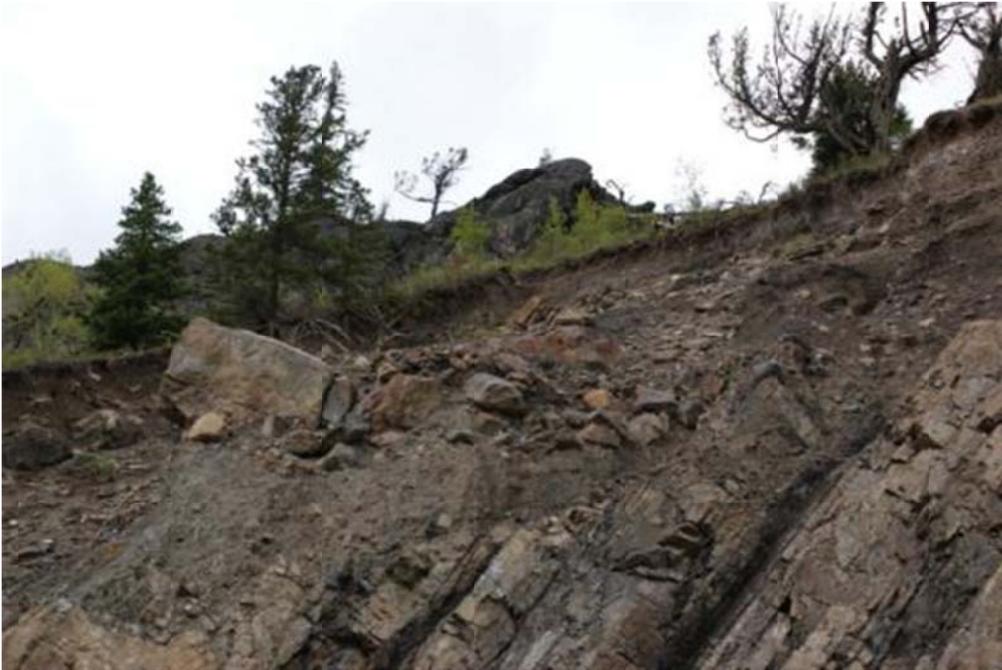
The rockfall hazards at this site seem to be mostly erosion based. Debris was typically found accumulated in talus cones beneath erosion gullies passing through the more easily erodable layers of the exposed bedrock. It should be noted that larger rocks have fallen from exposures in the rock slope, which are more likely from a freeze thaw cycle or failure along weak planes in the bedding. Additional rock is eroded from the rocky soil located at the crest of the slope, releasing larger sized rock masses that pose a greater threat than those released and deposited into the talus cones. These hazards can be seen in Figure 3.11.

Figure 3.11: Hazard Zone at Head of Highwood House Rock-Cut (photo by James Russell)

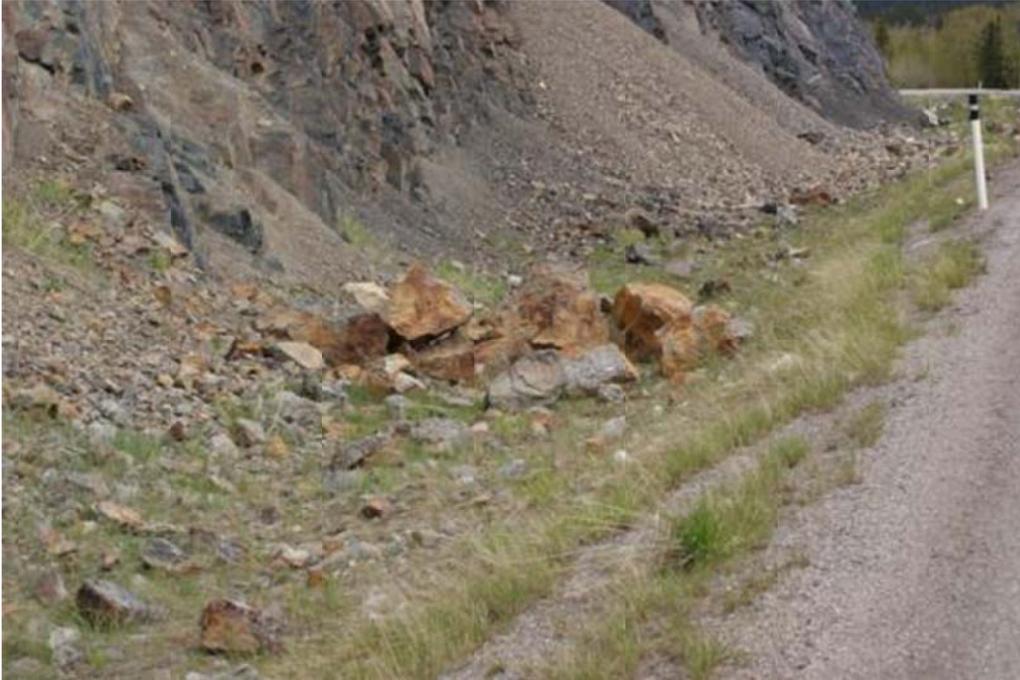
maximum dimension have been noted to have fallen into the ditch. These have fallen from exposures in the cut rock slope and/or have been eroded from the rocky soil face at the crest of the slope. However, these rocks were contained within the ditch at the west end of the site, and did not impact the road.

Figure 3.12: Ditch of Highwood House Rock-Cut (photo by James Russell)

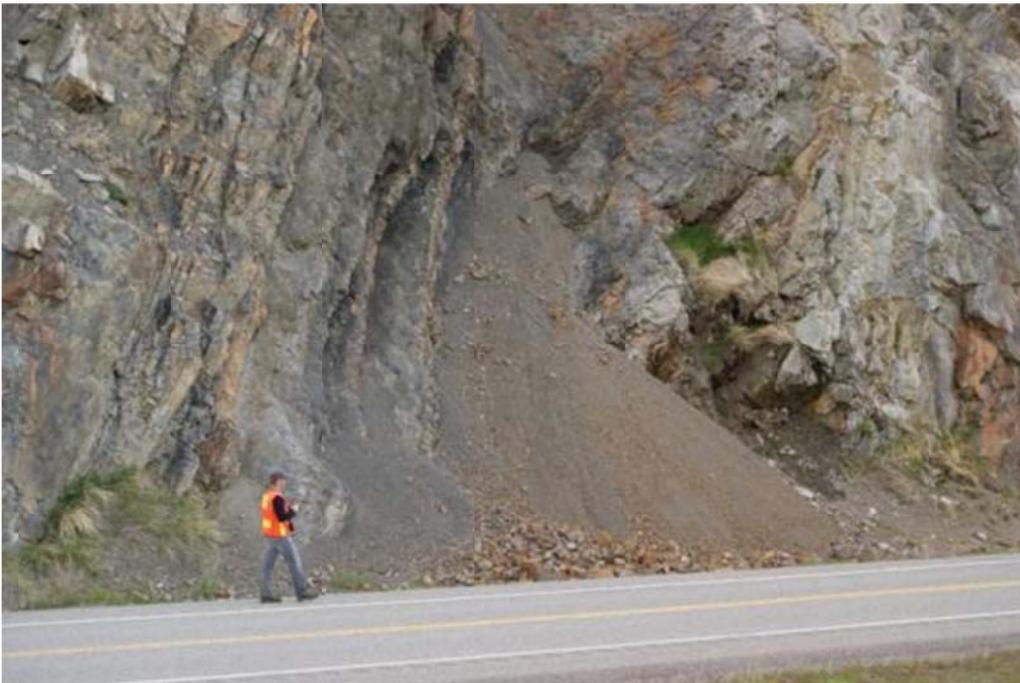
A talus cone has built up beneath a notable erosional gully, which appears to be the largest source of debris at this site. However, damage to the road indicates that previous rockfalls have impacted the road. Cobble to boulder size debris in the ditch indicates that there may be additional erosion at the crest of the slope, or failure along the bedding planes. Freeze/thaw action cannot be ruled out as a factor.

Figure 3.14: Talus Cone Formed Under Erosion Gully at Fir Creek Site (photo by James Russell)

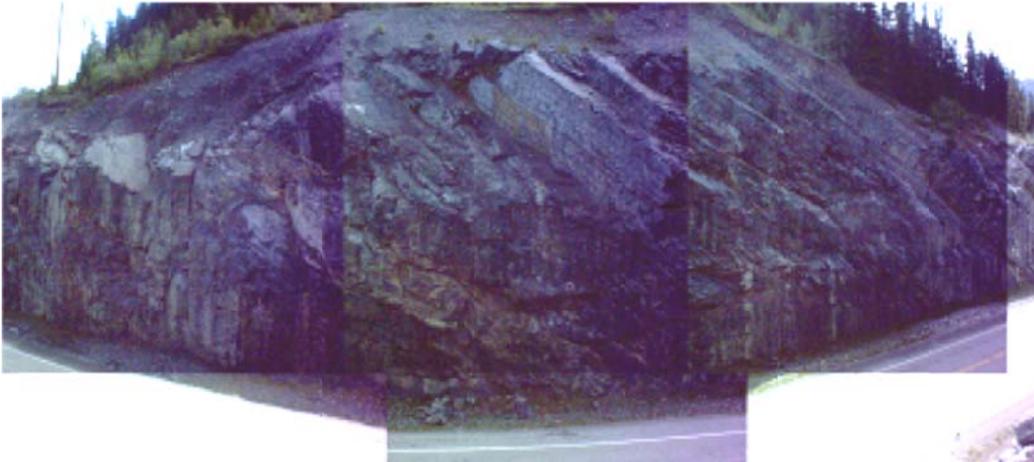
The Galatea Creek Through-Cut is composed of both an east and west cut slope flanking Highway 40 as it passes in the north/south direction. Studies by AMEC have been conducted on this site, and it is still currently under review and inspection. The study has found that it is the East Cut slope that presents the greater hazard level, and therefore the East Cut slope is the point of study hereafter. Figure 3.15 shows a composite image of the entirety of the East Cut slope.

Figure 3.15: Composite Image of Galatea Creek Through-Cut Stitched Together from ILRIS-3D Camera Images

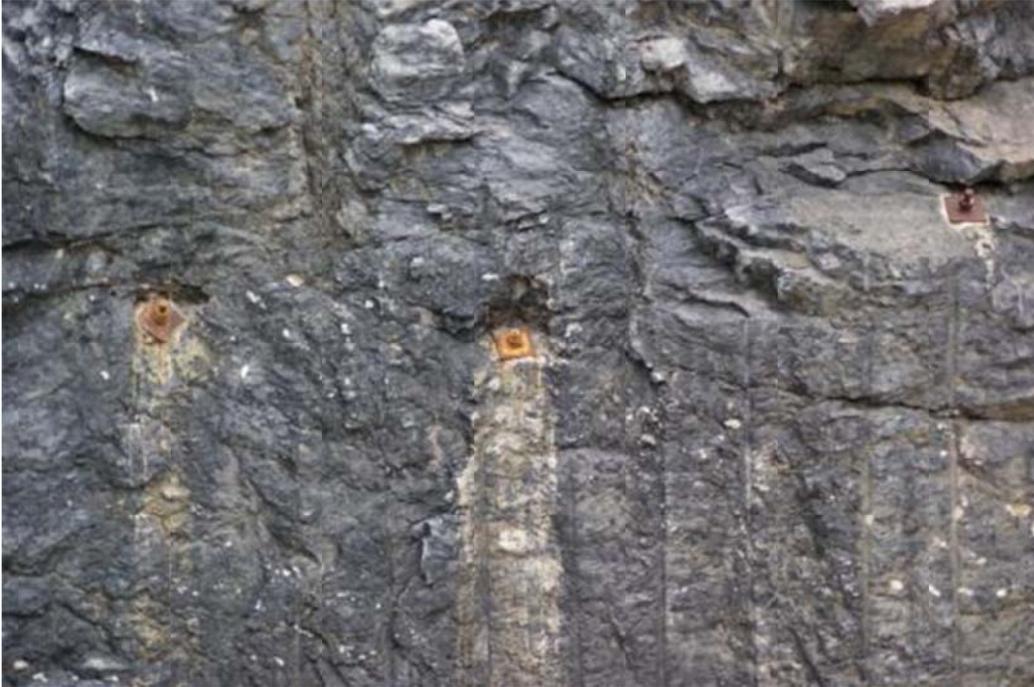
Figure 3.17: Rock Bolts in Galatea Through-Cut East Rock Face (photo by James Russell)

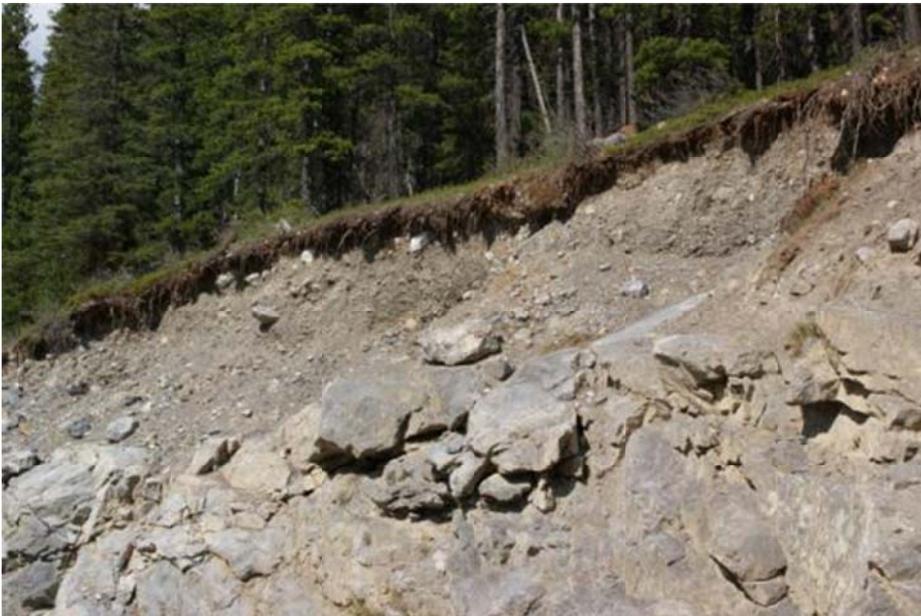
It would seem that the greatest hazard at this site exist with the exposed rock in the soil at the crest of the slope, rather than from the slope itself. Therefore erosional cycles are the primary source of concern, and freeze/thaw effects would also contribute to the loosening of rock within the exposed soil layer. Indications do not suggest that the face itself poses a major threat to the site, but it is a near vertical layer exposed to the elements, and will as a result contribute to the rockfall numbers.

Figure 3.20: Crest of Rock Slope at Mt. Baldy Rock-Cut (photo by James Russell)

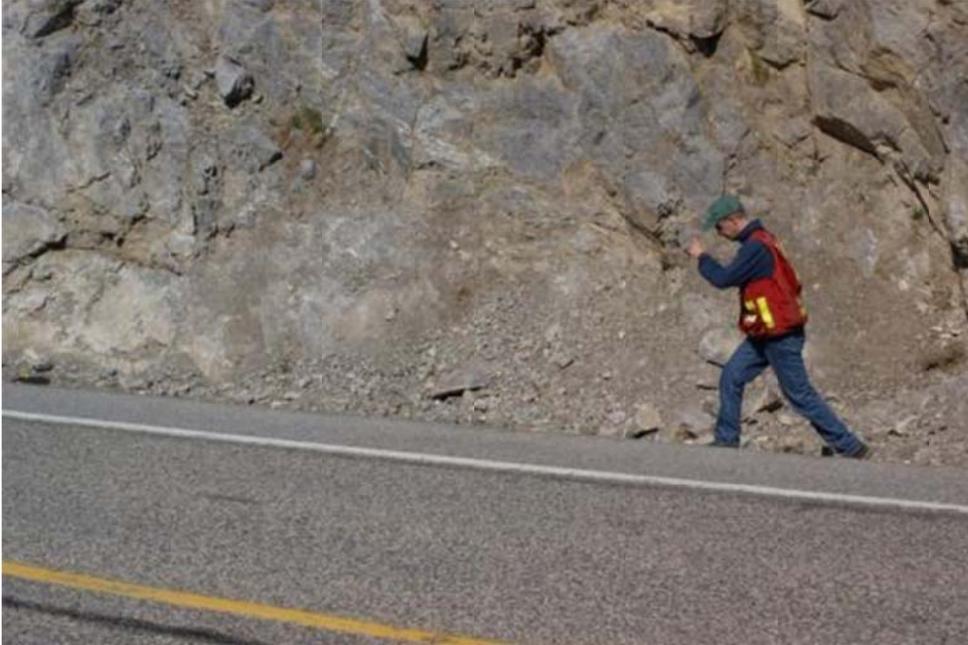
The Mt. Baldy ditch is approximately 4m wide and 0.75m deep. For the maximum height of the site, the rockfall ditch sizing criteria indicates that a minimum width of 4.3-4.7m with a minimum depth of 1.15-1.3m is necessary. This means that the ditch is not to standards for the segments of the cut that range at the maximum height levels.

Figure 3.20: Material in Ditch at Mt. Baldy Rock-Cut (photo by James Russell)

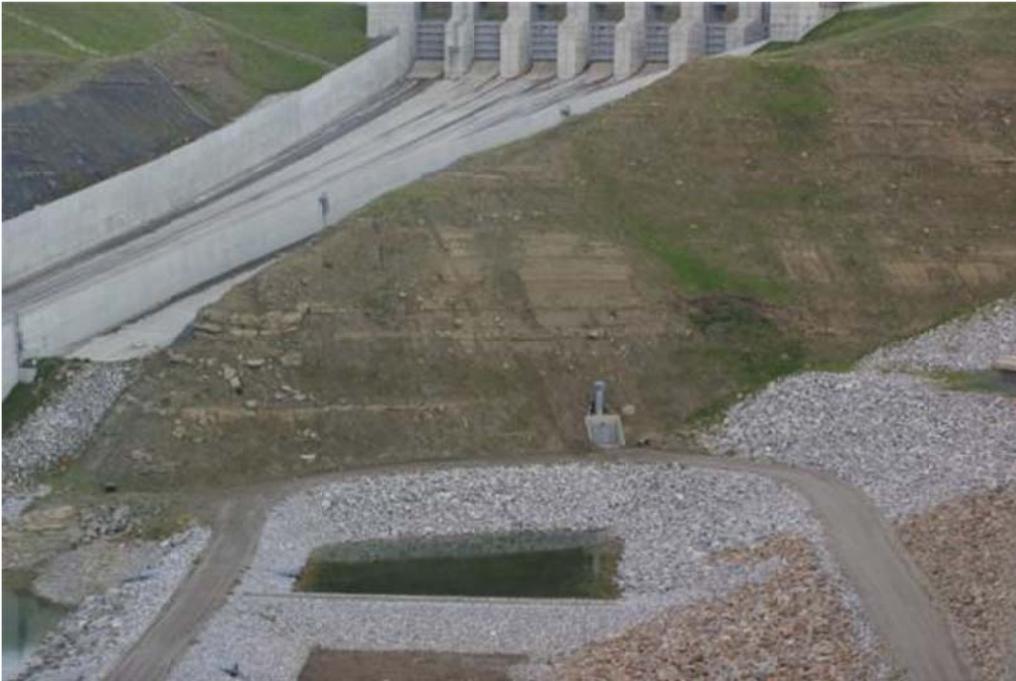
The Old Man Dam falls under the jurisdiction of Alberta Infrastructure and Transportation (AIT) for investigation and maintenance. As a result, when erosion along one of the embankments caused rockfall concerns, with a particular focus on down slope equipment damage, AIT launched an investigation. Areas of concern for the rockfalls are clearly evidenced upon observation, and it was deemed that an analysis of the site would be beneficial for determining remedial measures and potential future risks. The zone of interest on the dam can be seen in Figure 3.21.

Figure 3.21: Old Man Dam Rockfall Hazard Area (Taken from ILRIS-3D Camera)

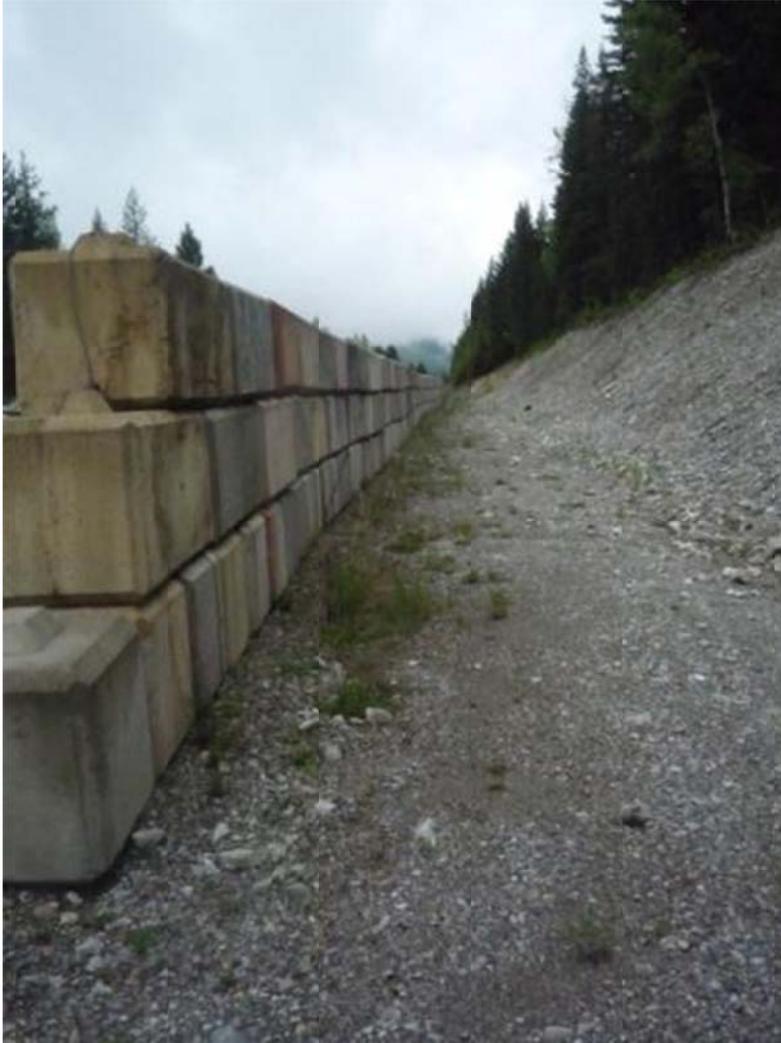
Figure 3.26: Barrier Wall and Catchment Area at Tornado Mt. (photo by James Russell)

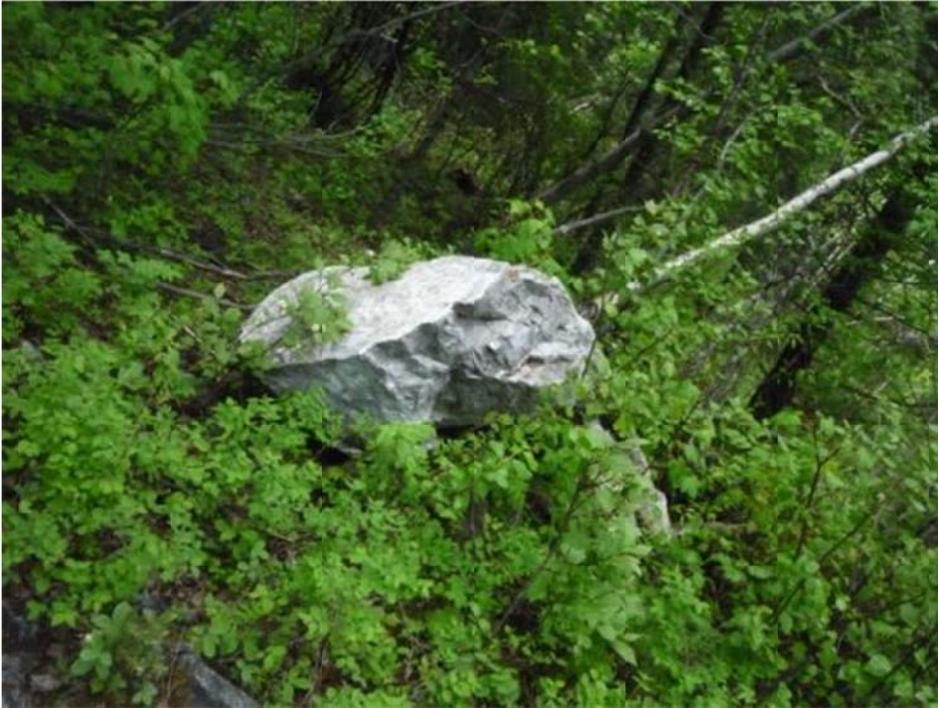
Figure 3.28: Large Past Rockfall Event on Slope at Tornado Mt. (photo by Renato Macciotta)

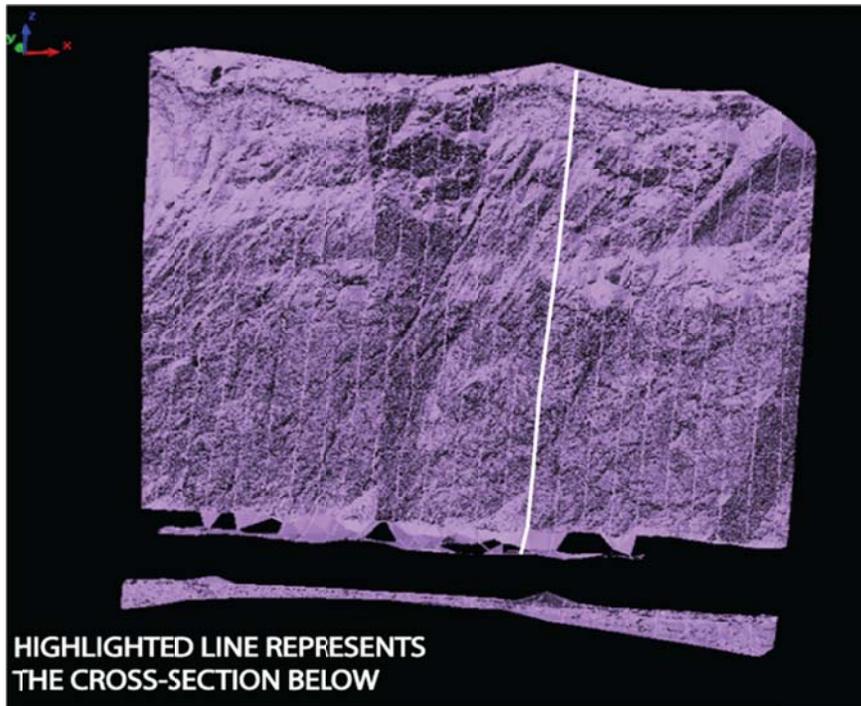
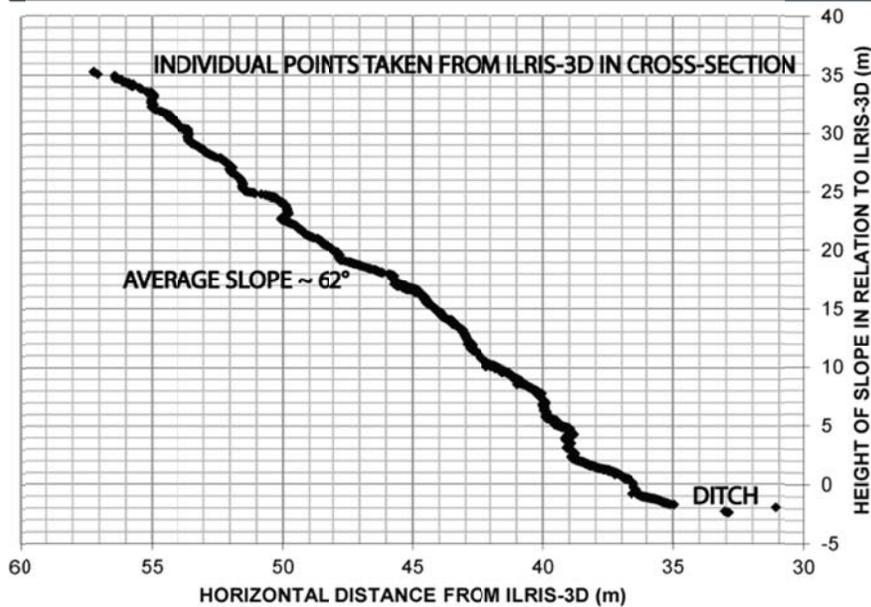
Figure 4.5: Surface Map and Cross-Section of Highwood House Rock-Cut

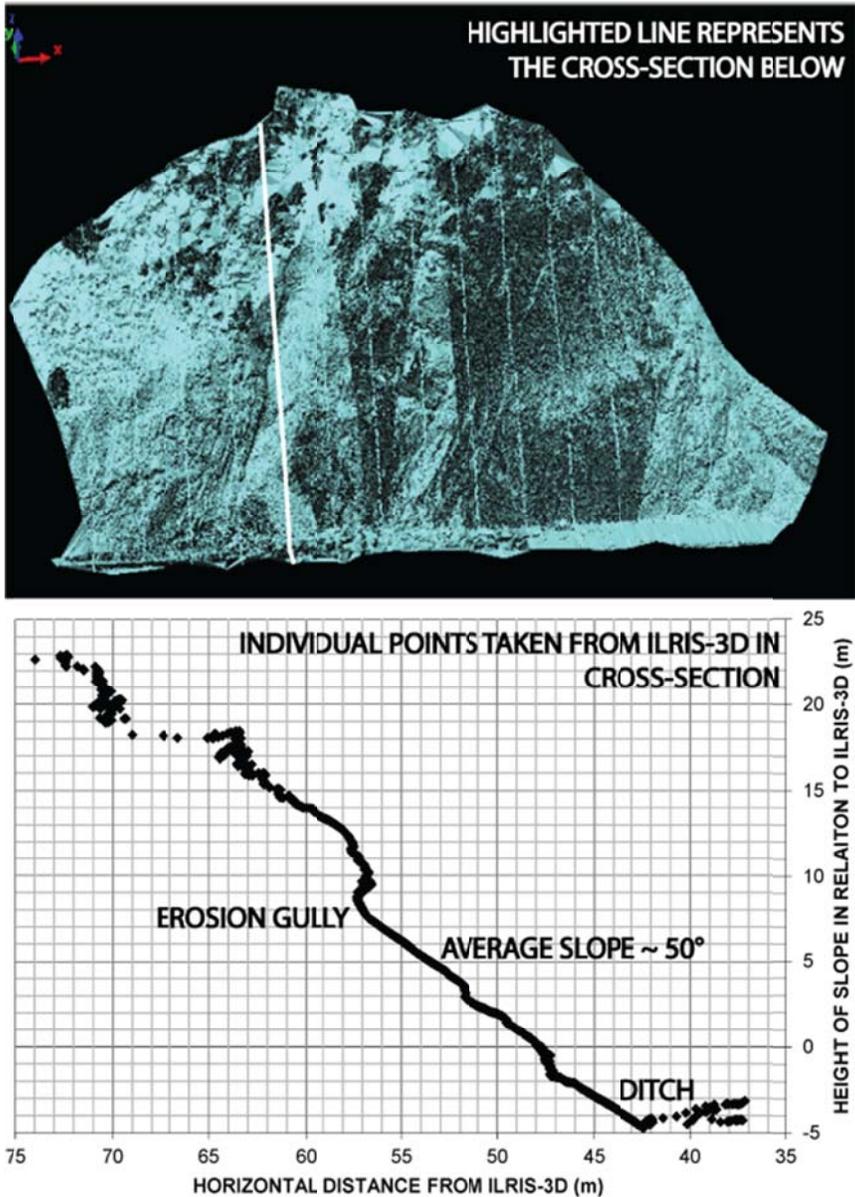
Figure 4.6: Surface Map and Cross-Section of Fir Creek Rock-Cut

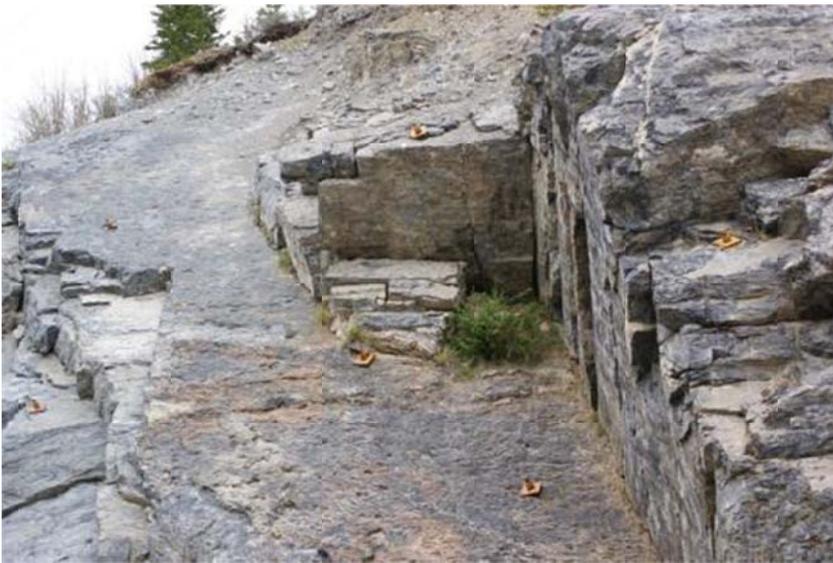
Figure 4.7: Rock Bolts Holding Rocks in Galatea Through-Cut (photo by James Russell)

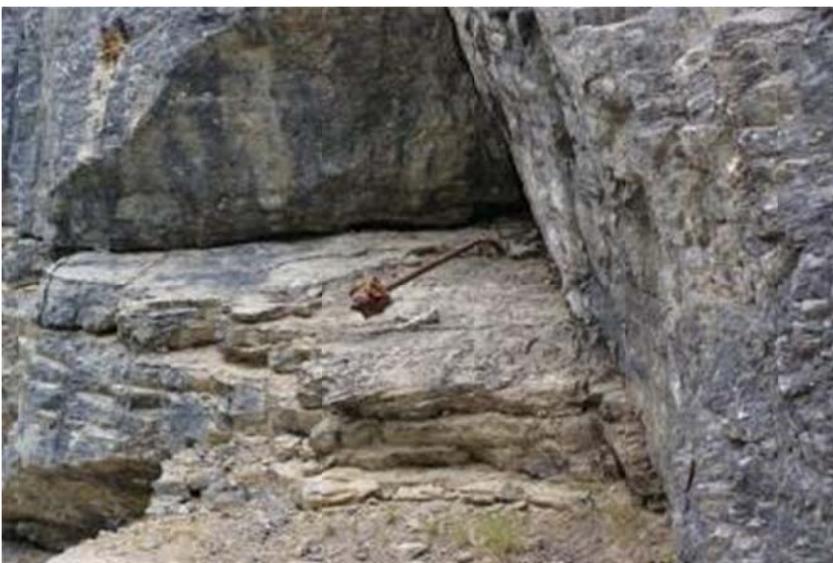
Figure 4.8: Loose Rock Bolt in Galatea Through-Cut (photo by James Russell)

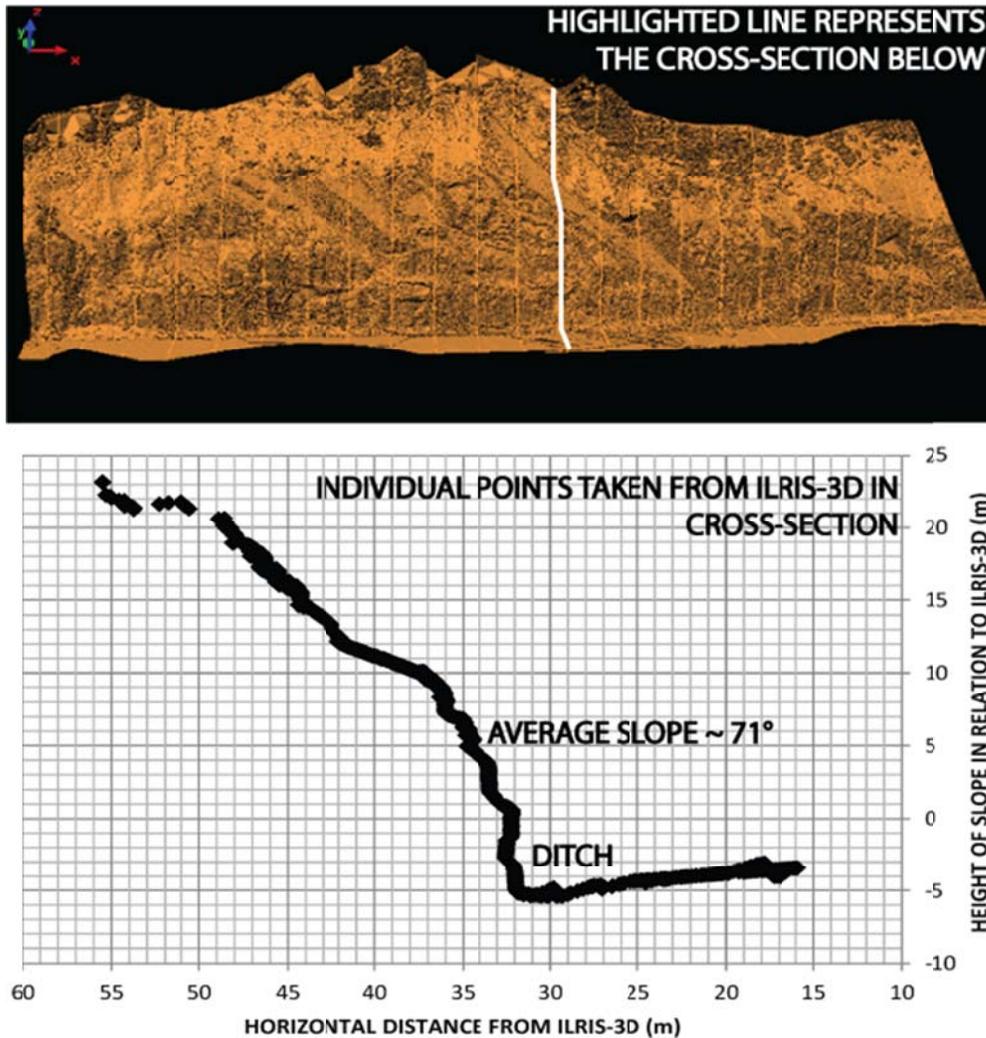
Figure 4.9: Surface Map and Cross-Section of Galatea Through-Cut

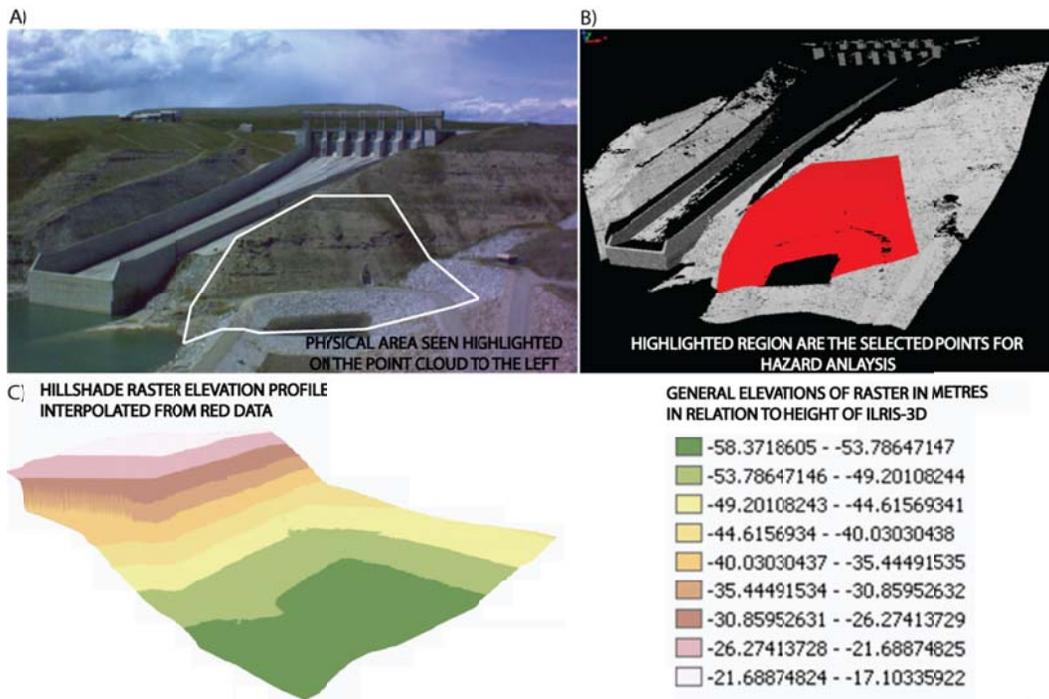
Figure 4.11: A) Old Man Dam (Taken from ILRIS-3D Camera). B) Point Cloud of Old Man Dam. C) Raster Hillshade Elevation Profile in ArcGIS from Selected Points in Point Cloud

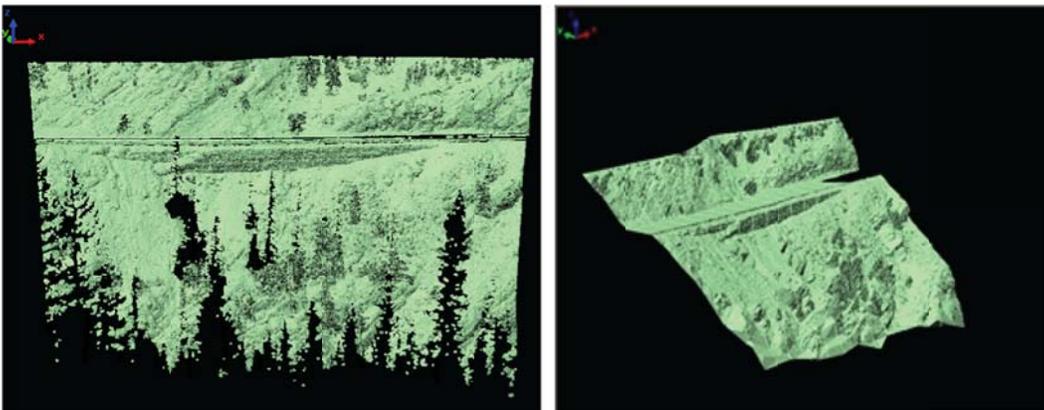
Figure 4.12: Point Cloud of Spray Lake Site Demonstrating Shadowed Areas Due to Line-Of-Site Obstruction from Vegetation and Resulting Interpolated Surface Map

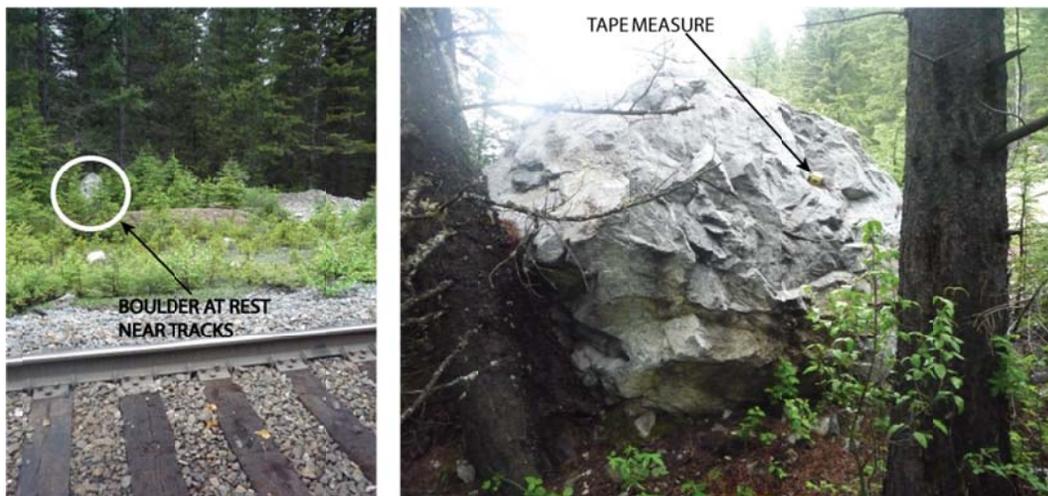
Figure 5.1: Rockfall Boulder Found Near CP Railway Tracks (Photos by Renato Macciotta)

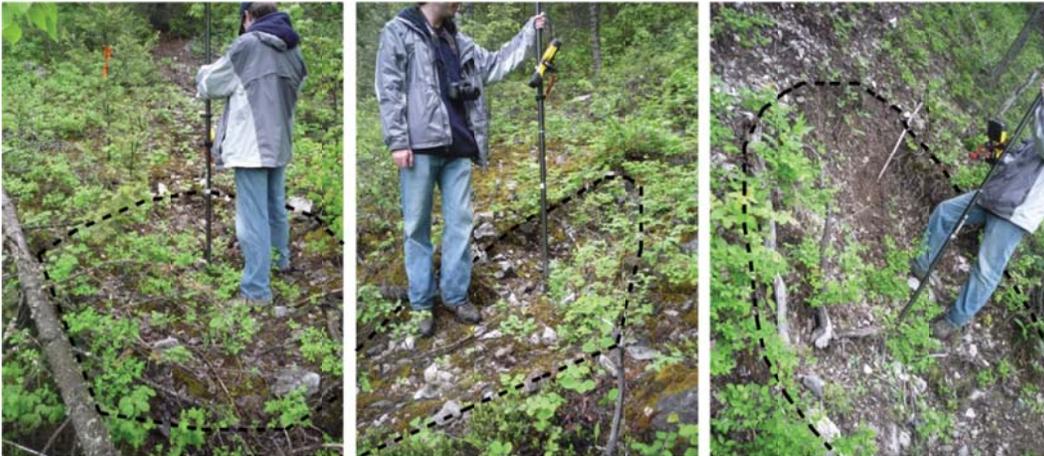
Figure 5.2: Rockfall Impact Points (Photos by Renato Macciotta)
