University of Alberta

**Process Analysis of Rockfalls with Stationary Terrestrial LiDAR and RockFall
Analyst**

A thesis submitted to the Faculty of Graduate Studies and Research
in partial fulfillment of the requirements for the degree of

Geotechnical Engineering

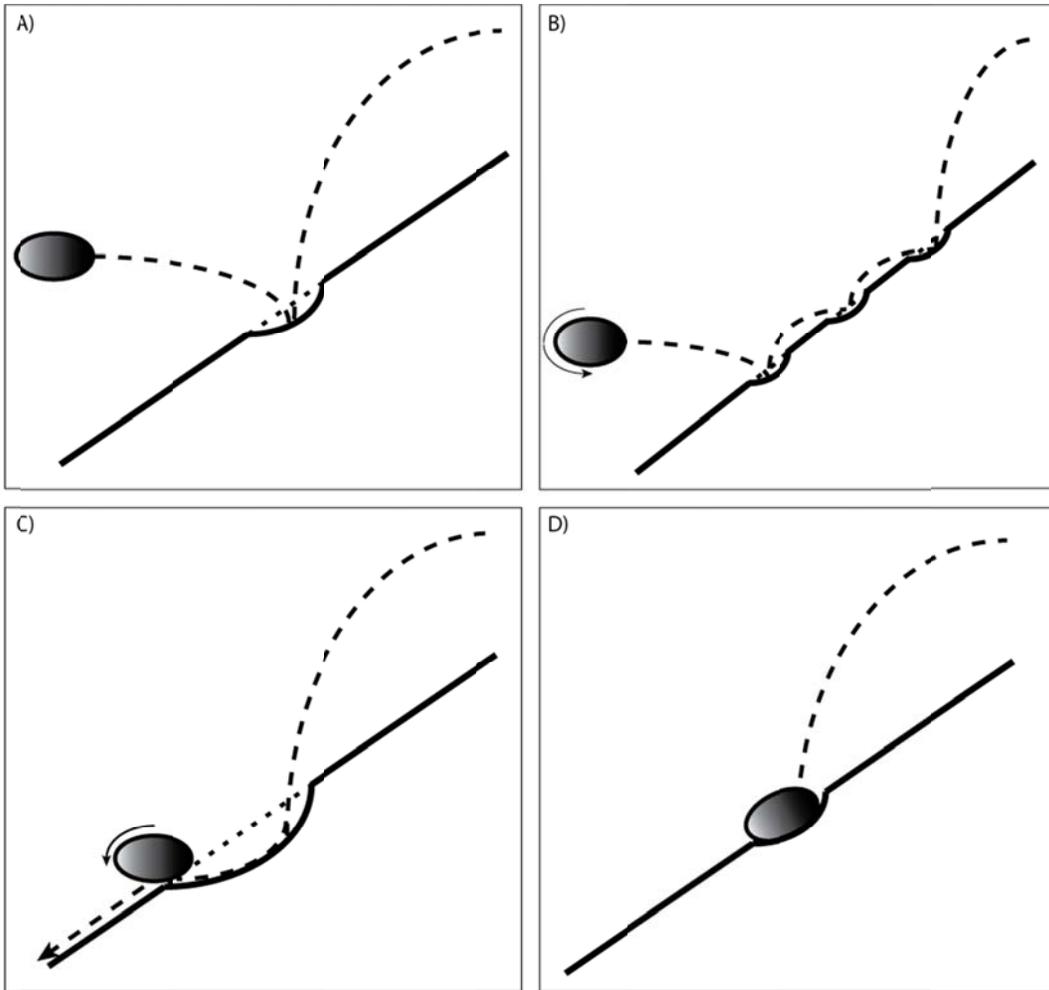
Figure 5.3: Rockfall Impact Craters A) General Bounce Profile, B) Tumbling Bounce Profile, C) Impact Causes Enough Loss in Energy to Result in Roll/Slide, and D) Boulder Comes to Rest

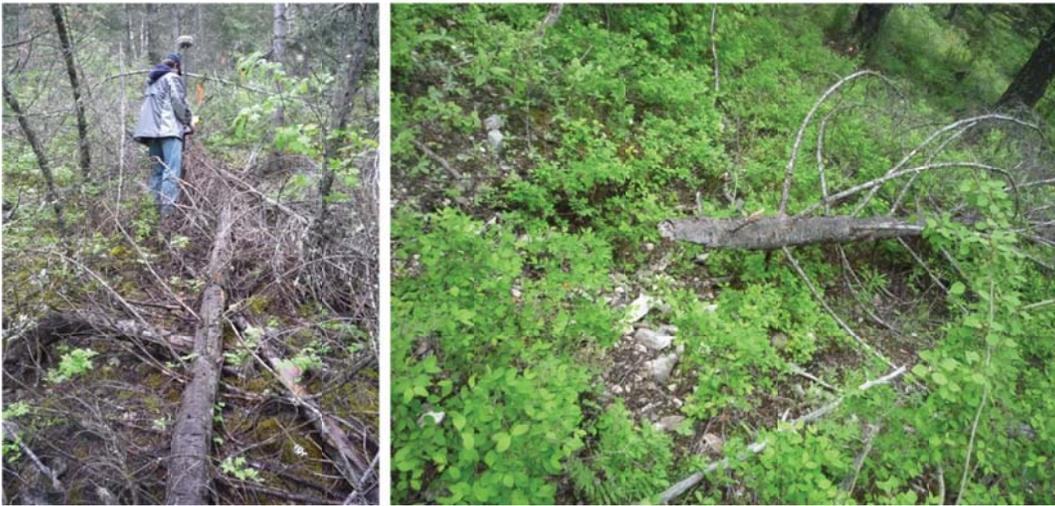
Figure 5.4: Trees Broken Along Rockfall Paths (Photos of Renato Macciotta and James Russell)

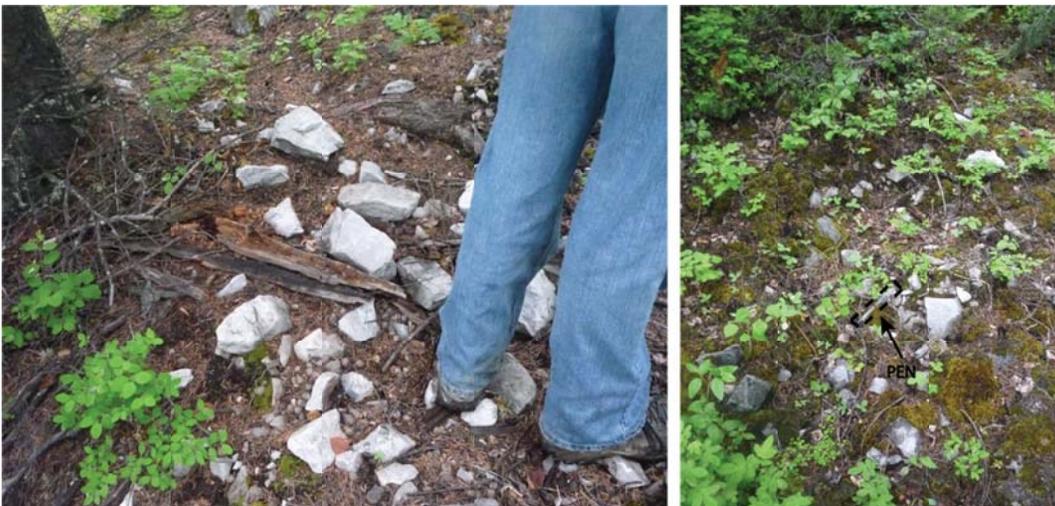
Figure 5.5: Fragments from Boulder at Impact Points Along Rockfall Path (Photos by Renato Macciotta)

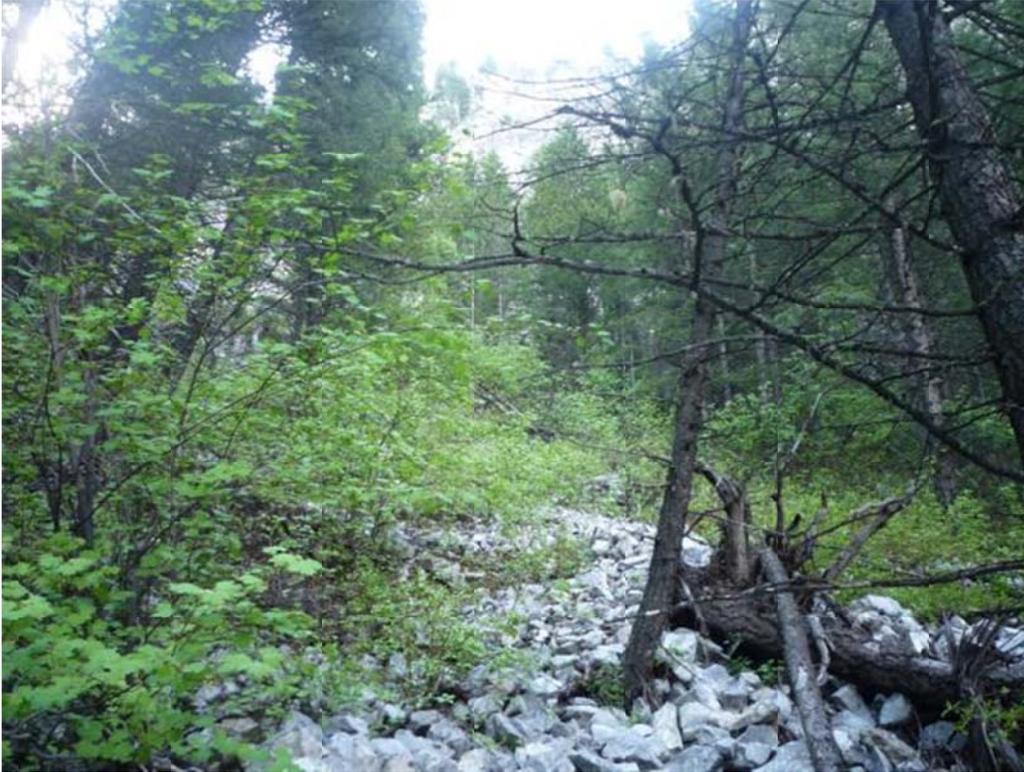
Figure 5.6: Increasing Talus Material Looking up Rockfall Path to Source Area (Photo by Renato Macciotta)

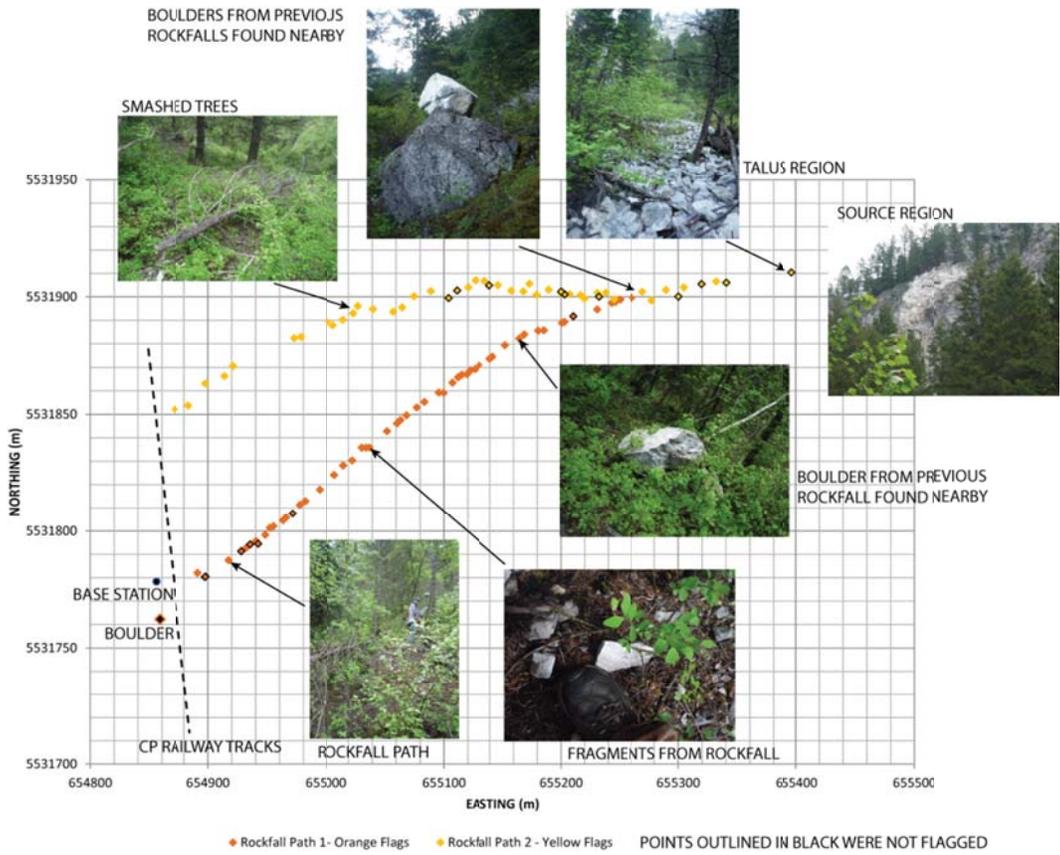
Figure 5.7: Plan View of RTK GPS Survey of Tornado Mountain Rockfall Path

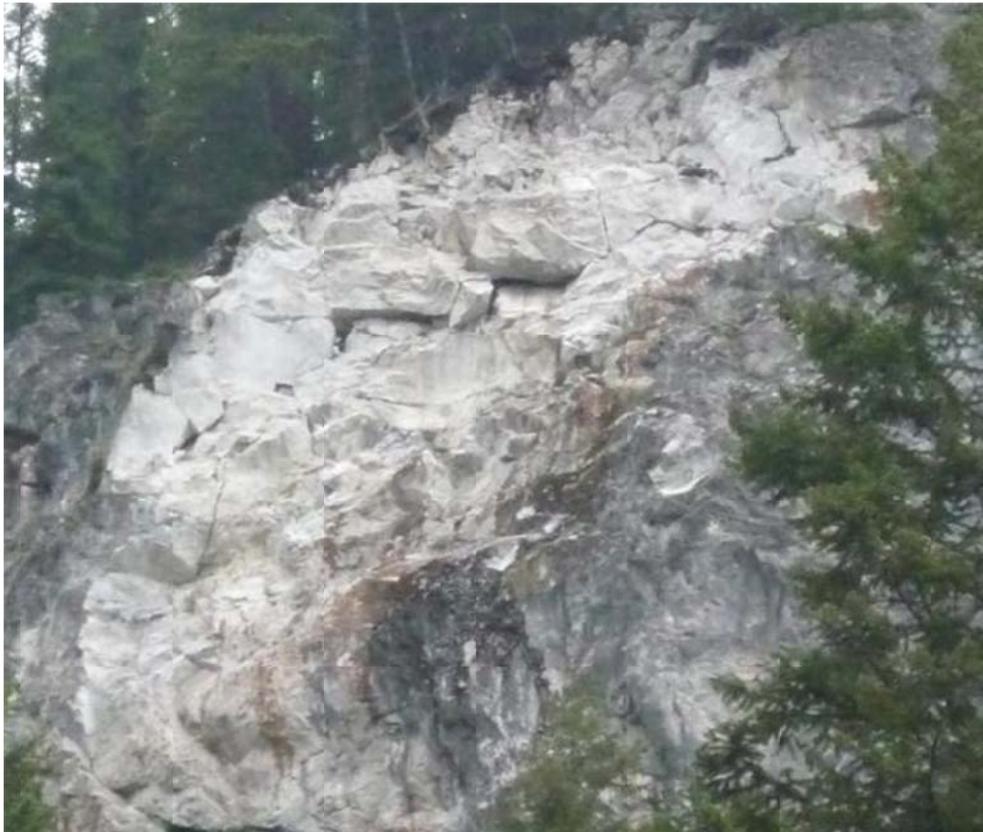
Figure 5.12: Rockfall Source in Fractured Limestone Cliff Face at Tornado Mountain (Photo by Renato Macciotta)

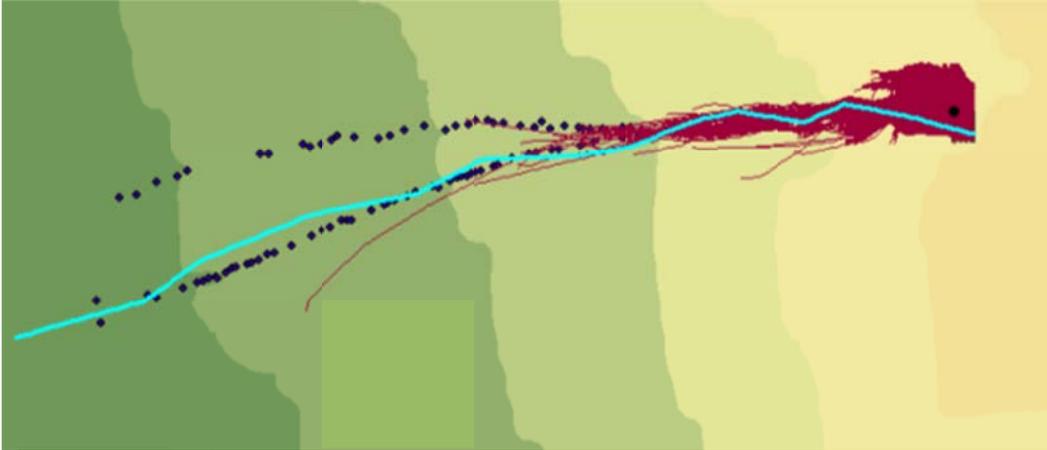
Figure 5.15: Initial Calibration of Rockfall Simulation with 15m/s Horizontal Velocity, 10m/s Vertical Velocity, 5m Drop Height, and Initial COR Values

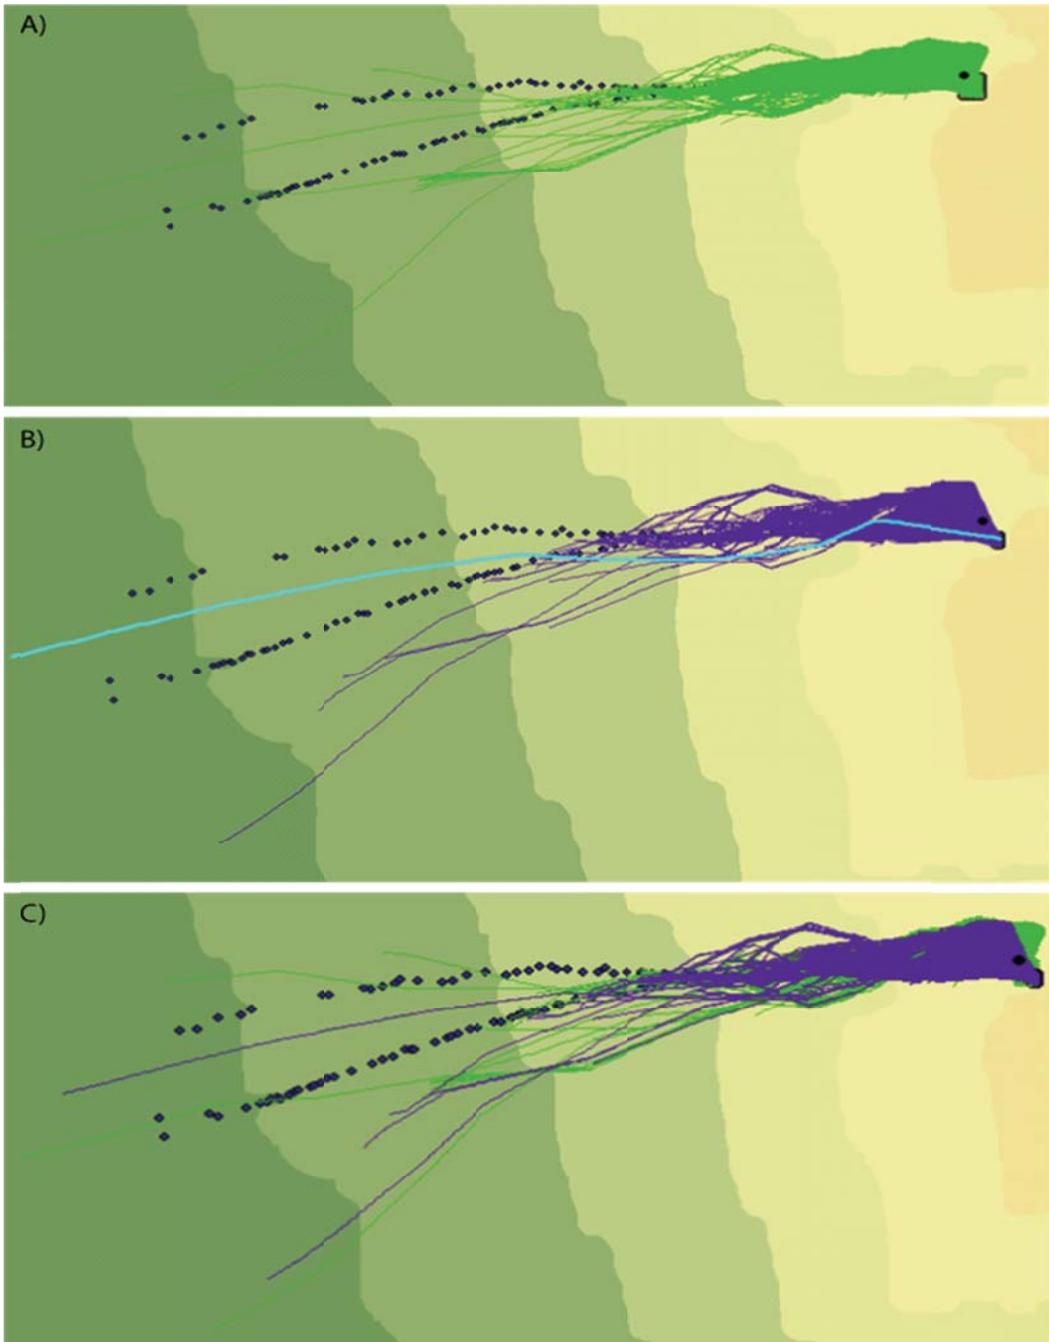
Figure 5.17: Rockfall Simulation Calibration Tests with Initial Calibration Parameters and A) Redefined Polyline Seeder, B) Further Redefined Polyline Seeder, and C) Comparison of Rockfall Trajectories from Both Seeders

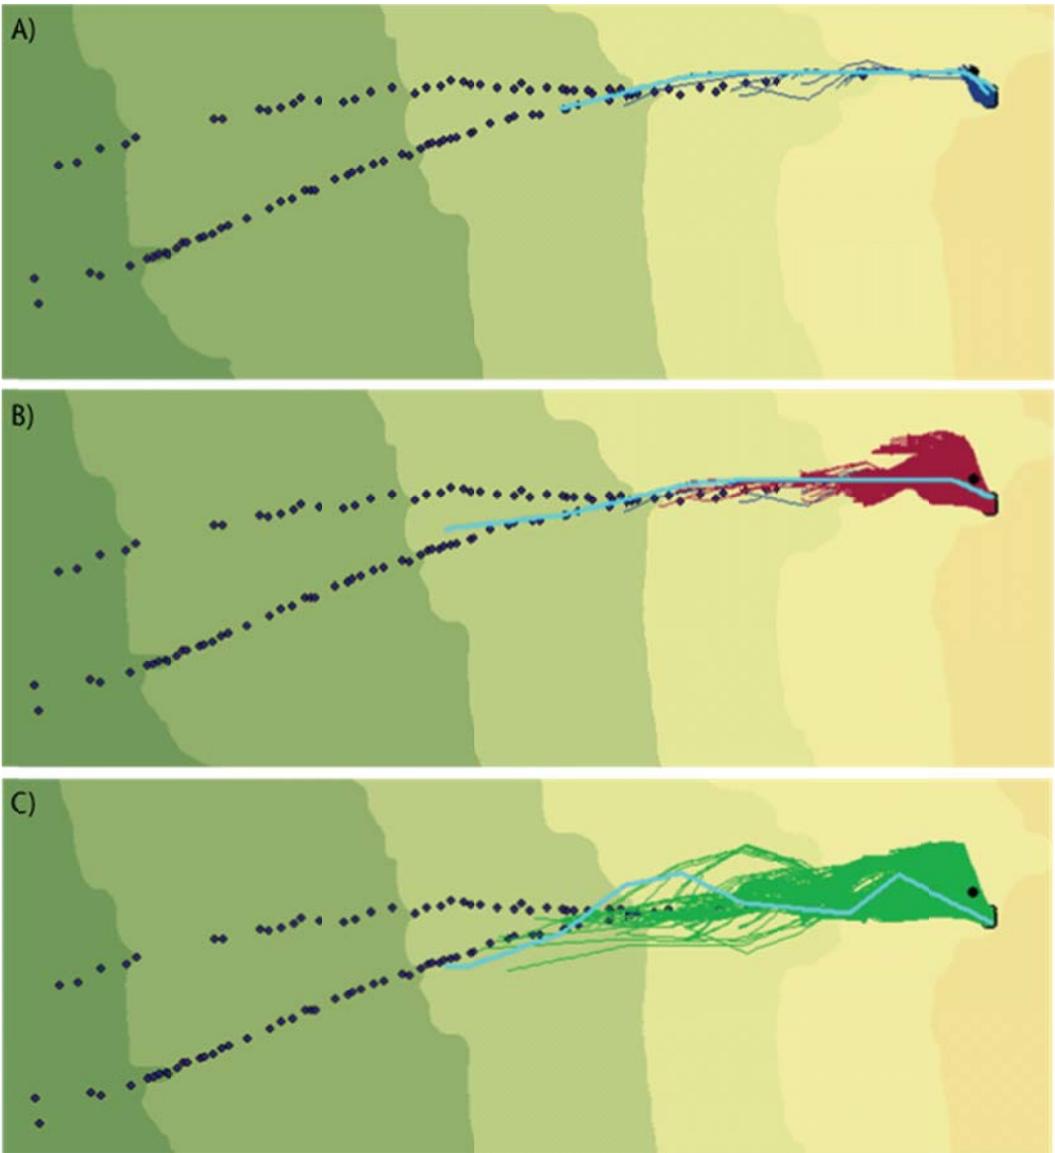
Figure 5.18: Rockfall Simulation Velocity Sensitivity with Initial Calibration Parameters and 5m Drop Height at A) 5m/s Horizontal and 0m/s Vertical, B) 10m/s Horizontal and 5m/s Vertical, and C) 15m/s Horizontal and 10m/s Vertical

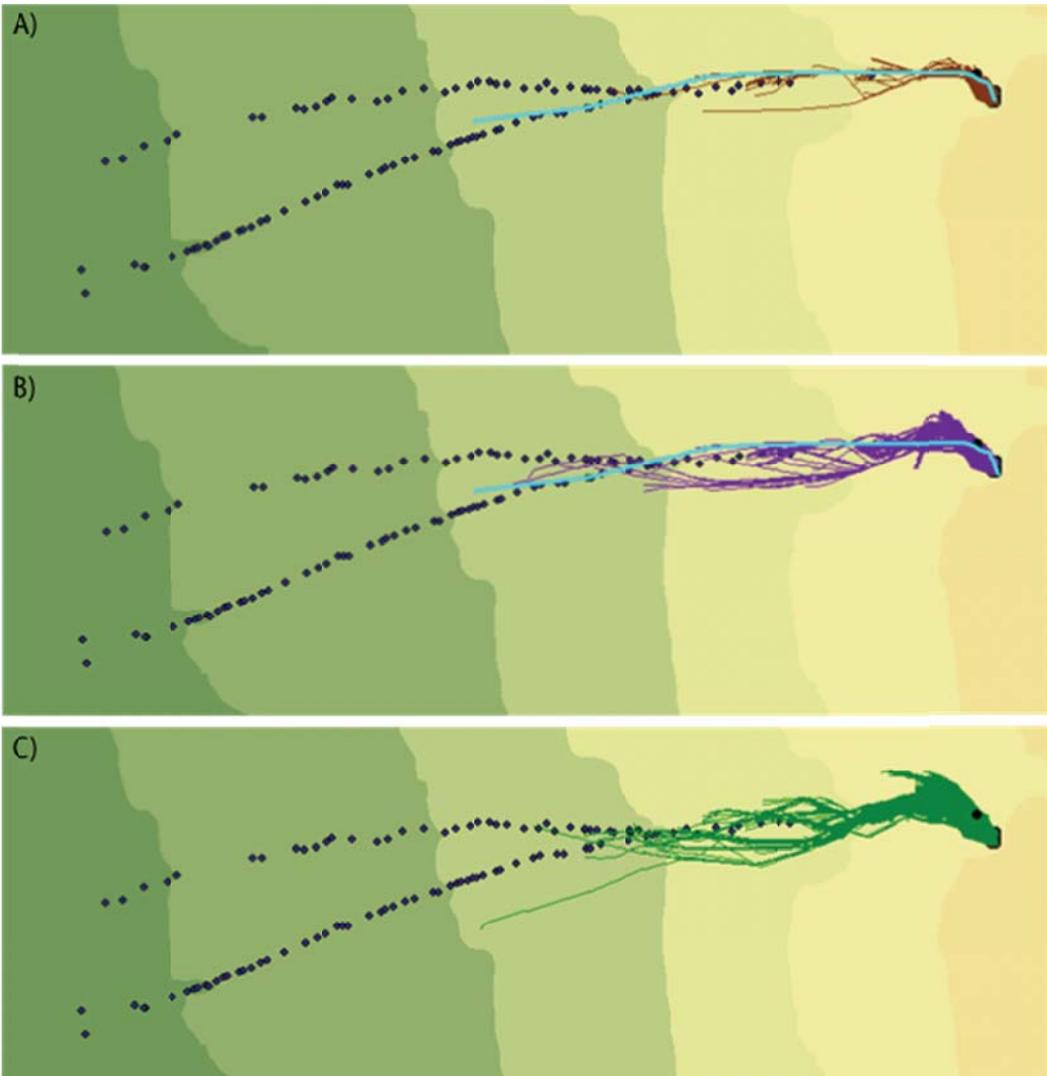
Figure 5.19: Rockfall Simulation Drop Height Sensitivity with Initial Calibration Parameters and 5m/s Horizontal Velocity and 0m/s Vertical Velocity at A) 10m Drop Height, B) 25m Drop Height, and C) 50m Drop Height

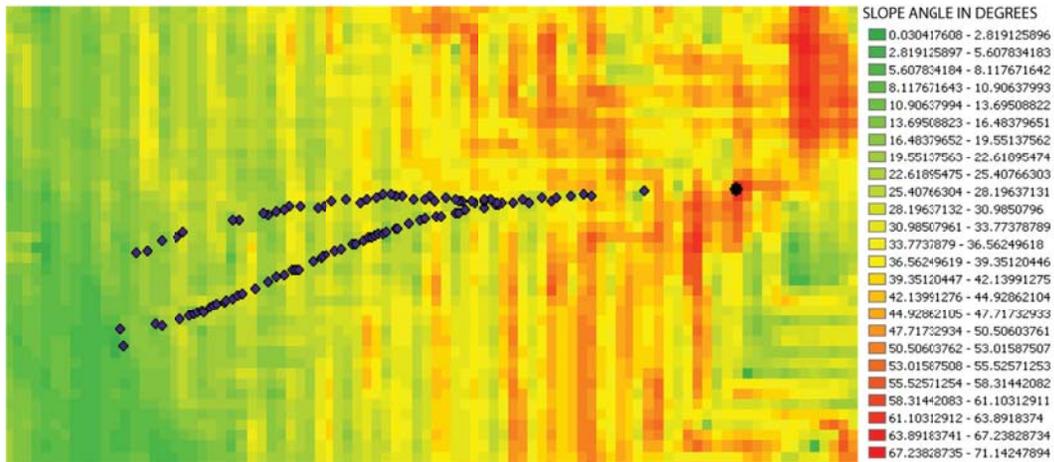
Figure 5.20: Raster Image of Slope Angles for Tornado Mountain DEM

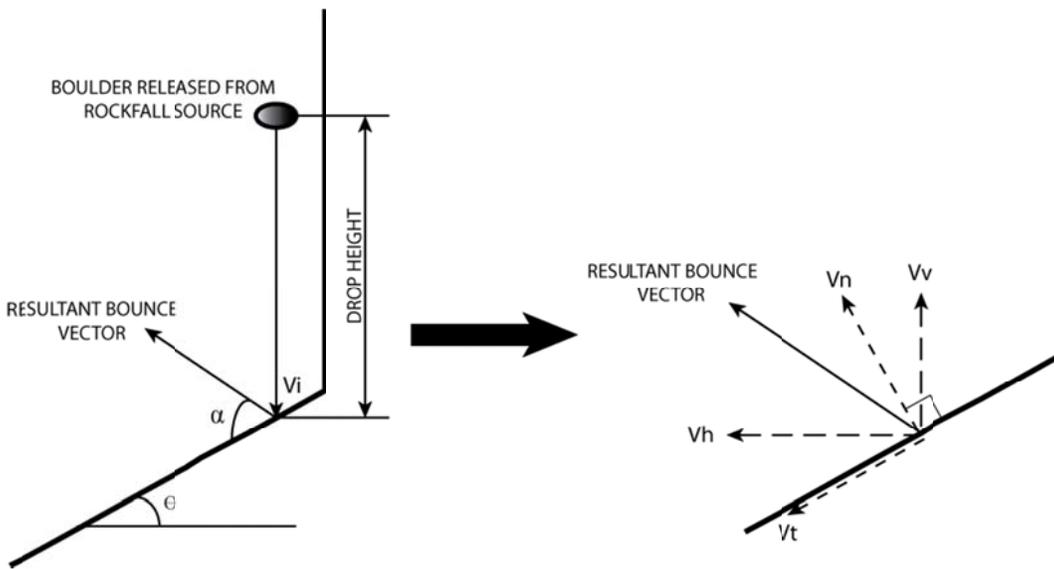
Figure 5.21: Rockfall Energy Calibration Visual Model

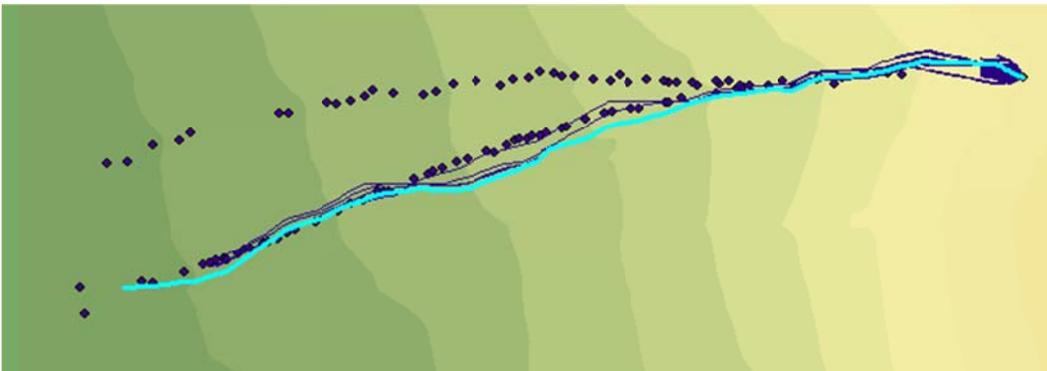
Figure 5.26: Typical COR Value Simulation (65° Slope Angle and 70m Drop Height)

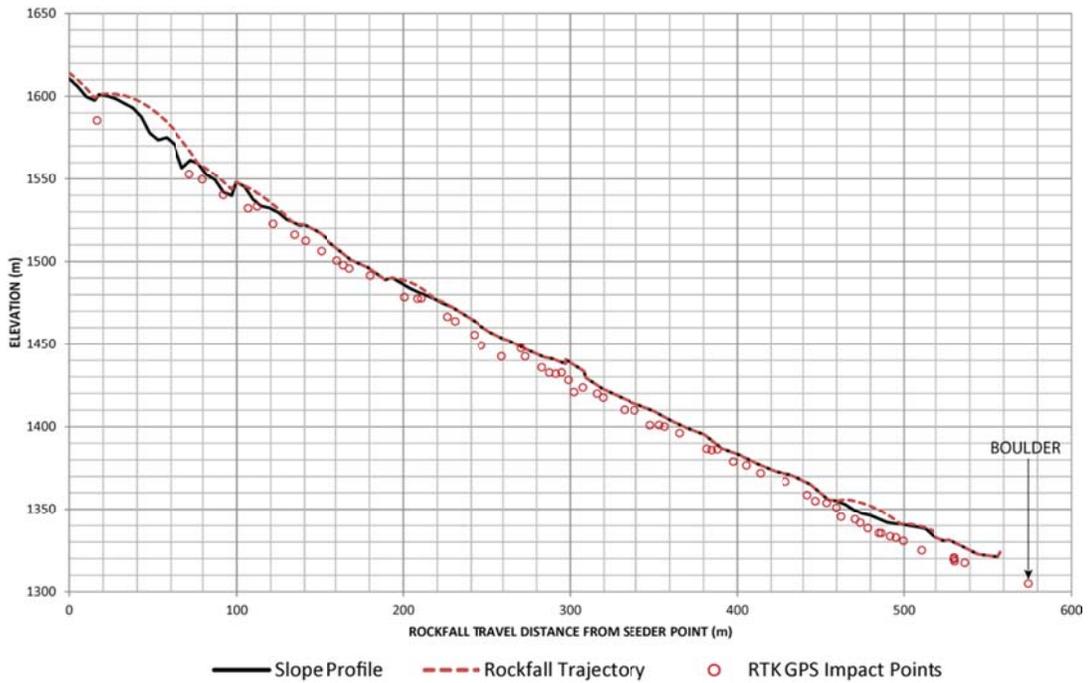
Figure 5.27: 2-Dimensional Rockfall Simulation Profile and RTK GPS Impact Point Comparison (Typical COR: $R_n=0.3$ $R_t=0.8$; Slope Angle 55° ; Drop Height 70m)

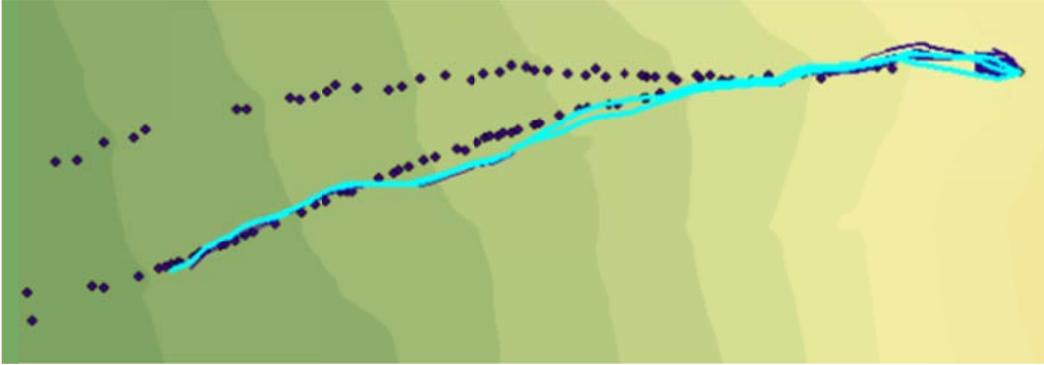
Figure 5.40: Typical Normal Greatly Reduced Tangential COR Value Simulation (65° Slope Angle and 70m Drop Height)

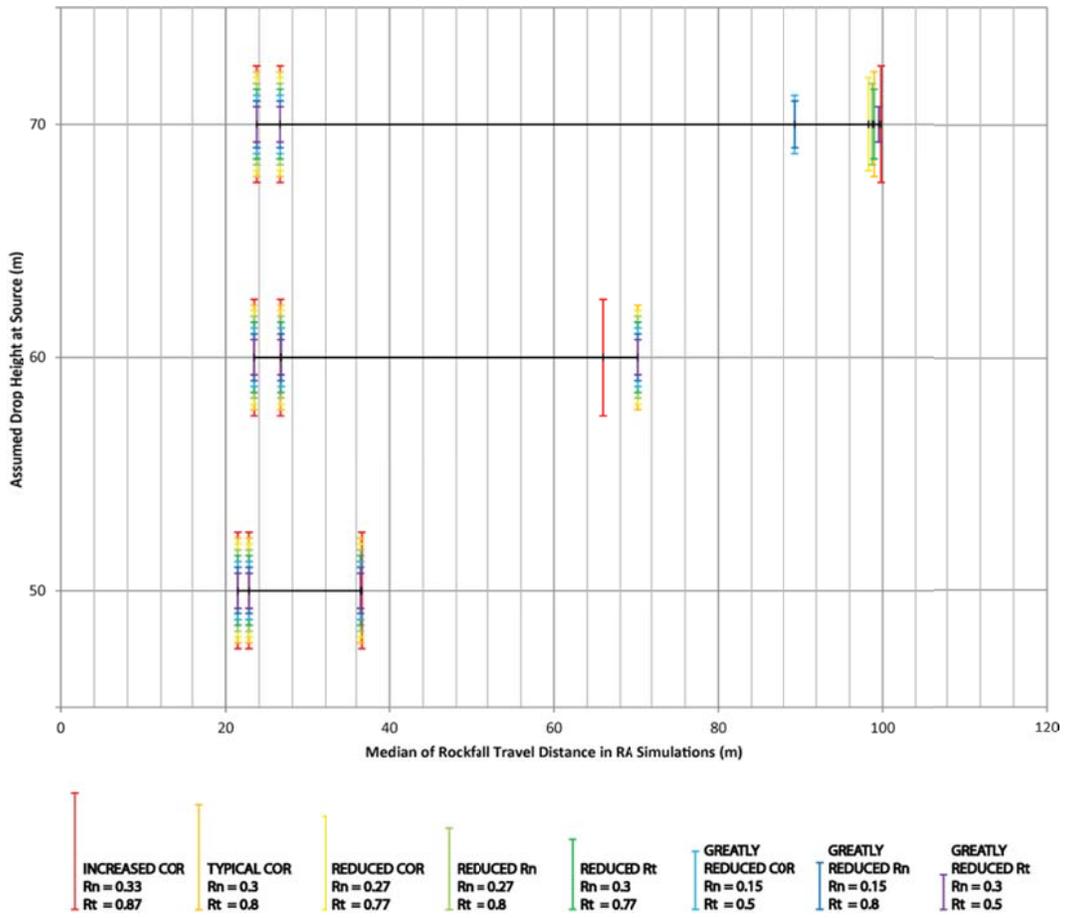
Figure 5.41: Median Rockfall Travel Distance in RA vs. the Assumed Drop Height at Source

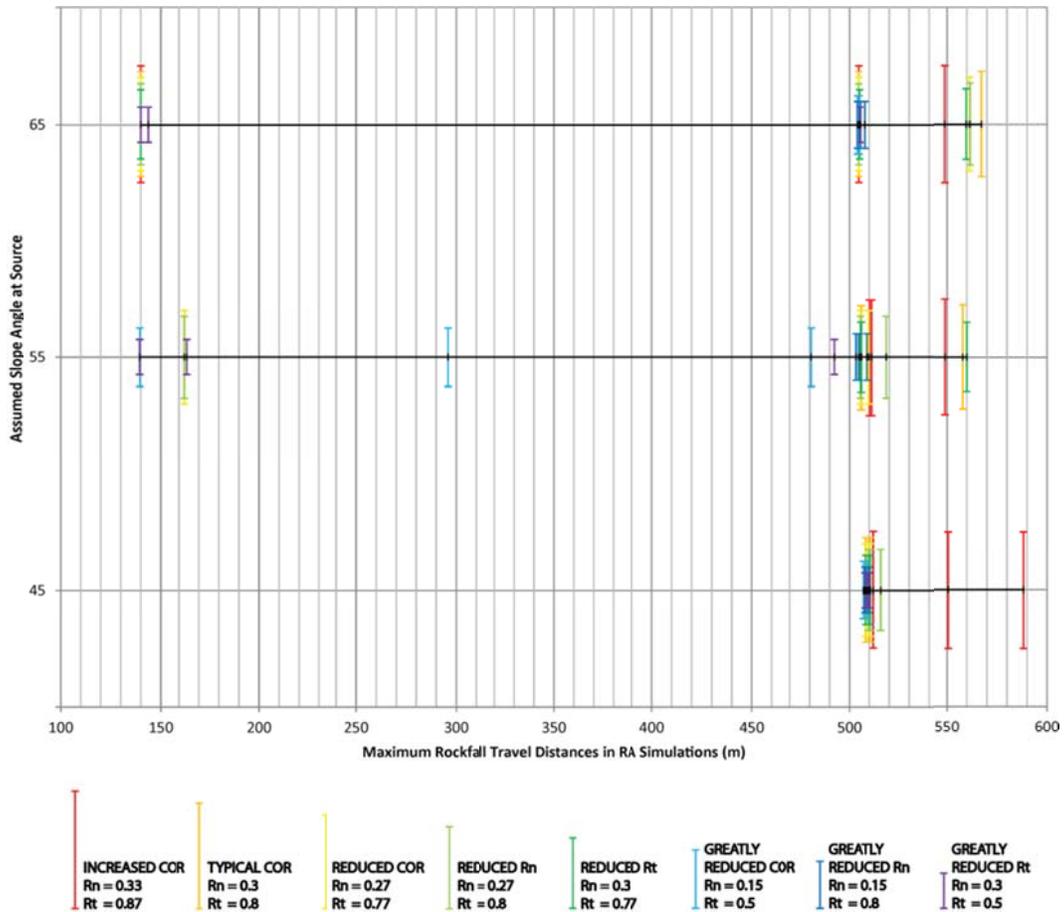
Figure 5.44: Maximum Rockfall Travel Distance in RA vs. the Assumed Slope Angle at Source

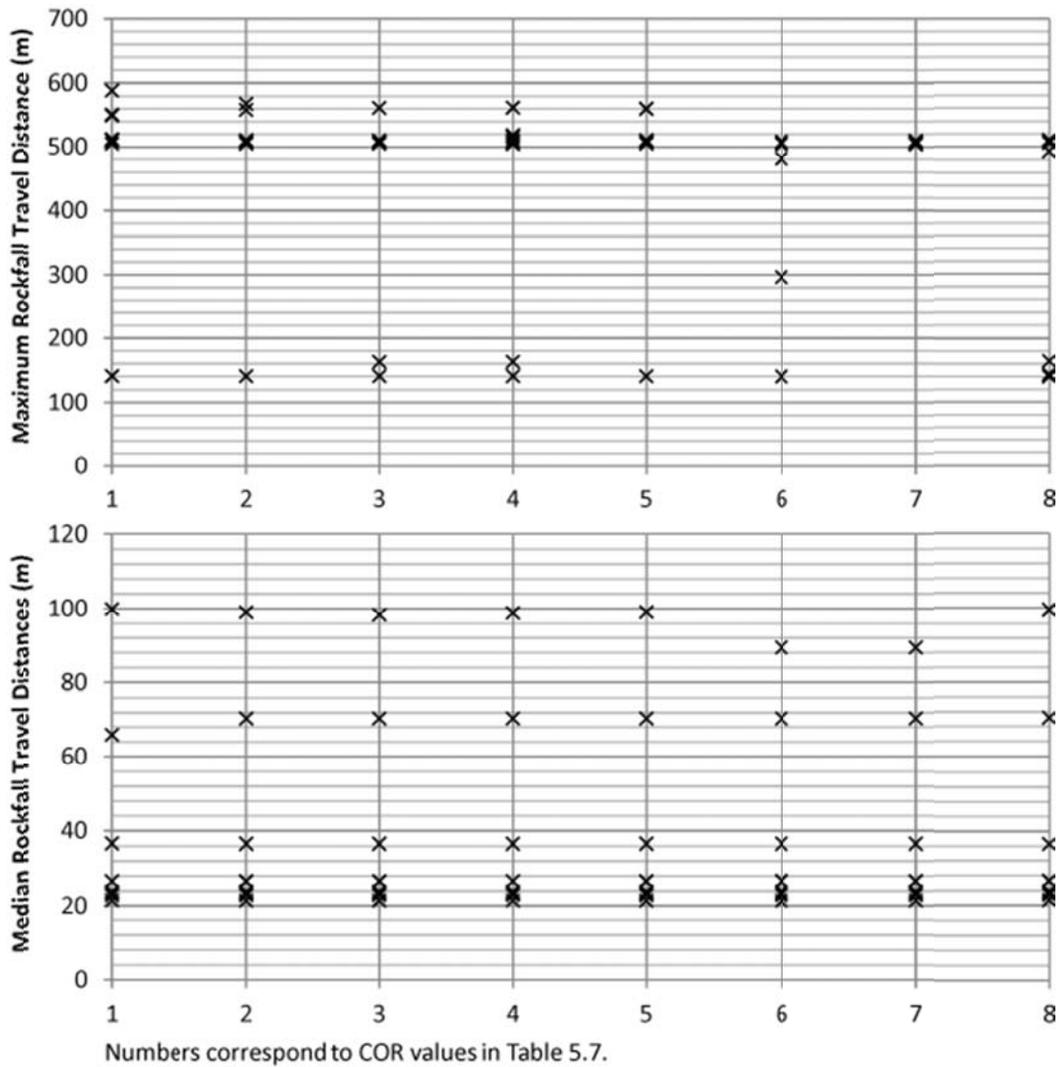
Figure 5.45: Maximum and Median Rockfall Travel Distance by COR Value

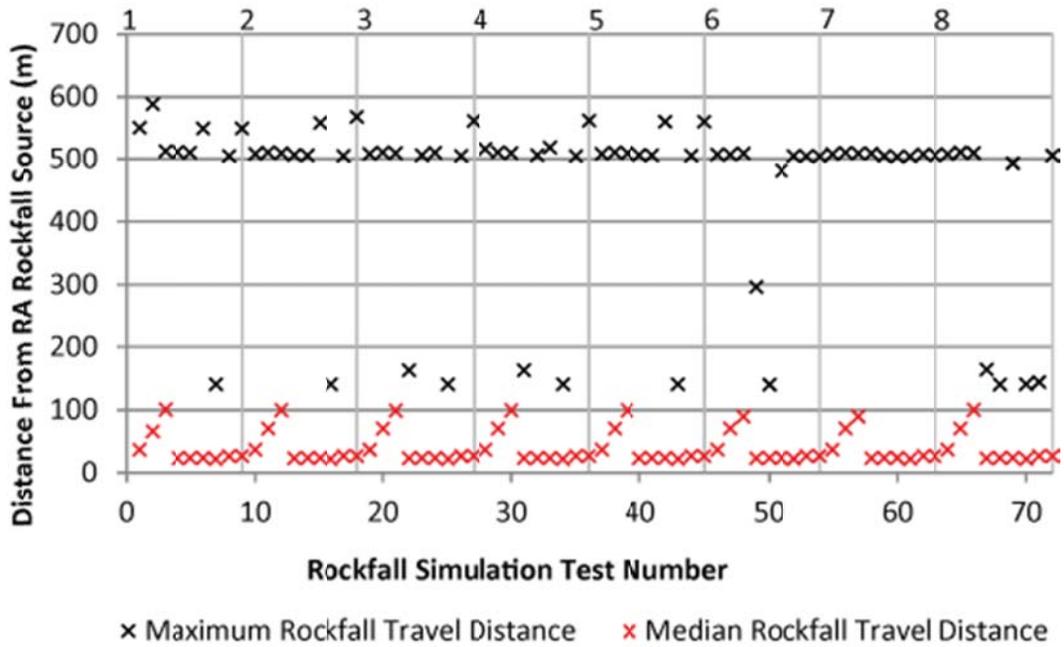
Figure 5.46: Maximum and Median Rockfall Travel Distance by Test Number

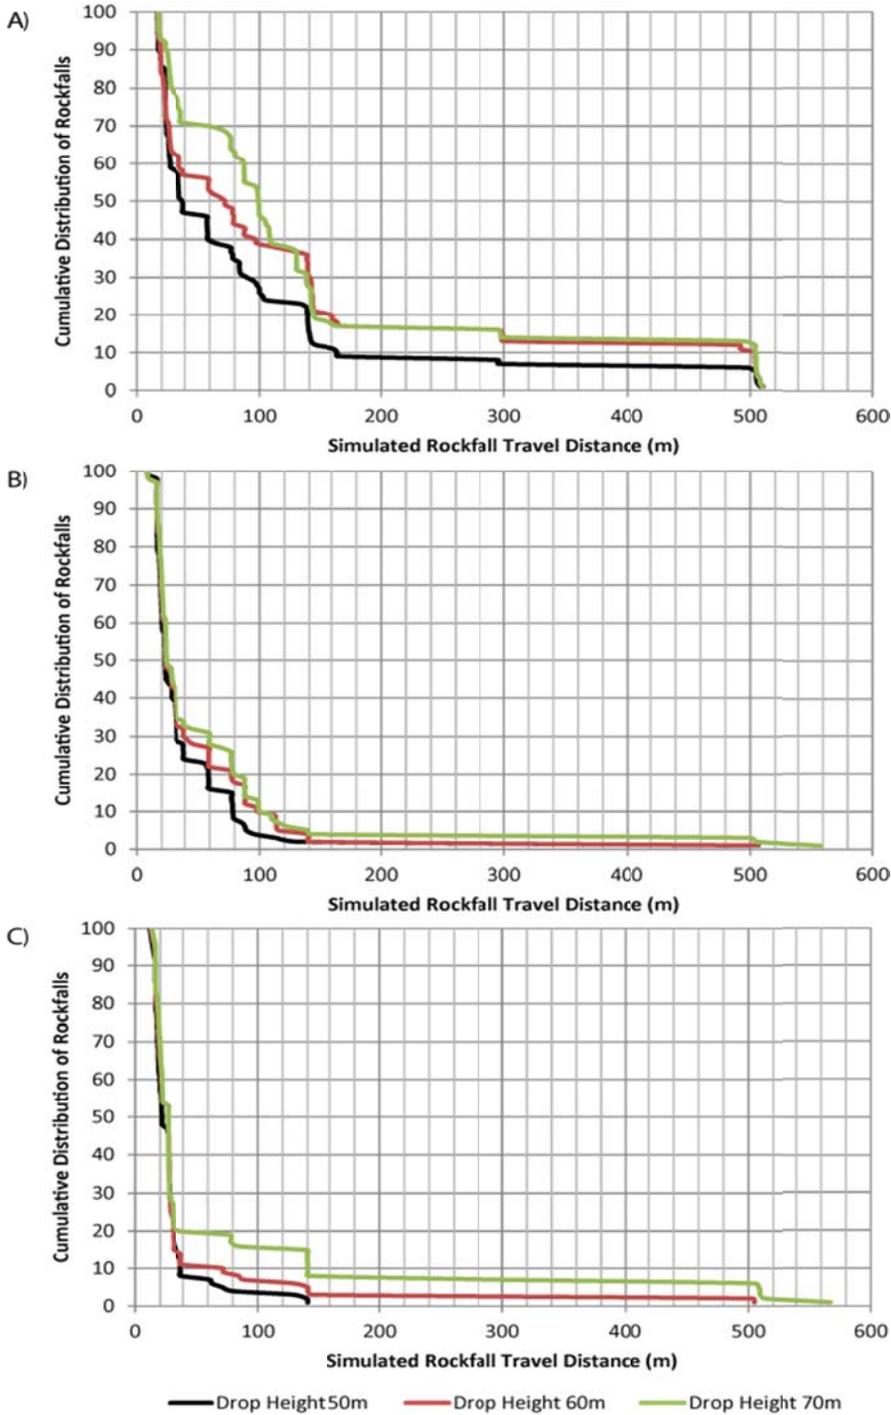
Figure 5.47: Cumulative Distribution of Typical COR Rockfalls for A) 45° Slope Angle, B) 55° Slope Angle, and C) 65° Slope Angle

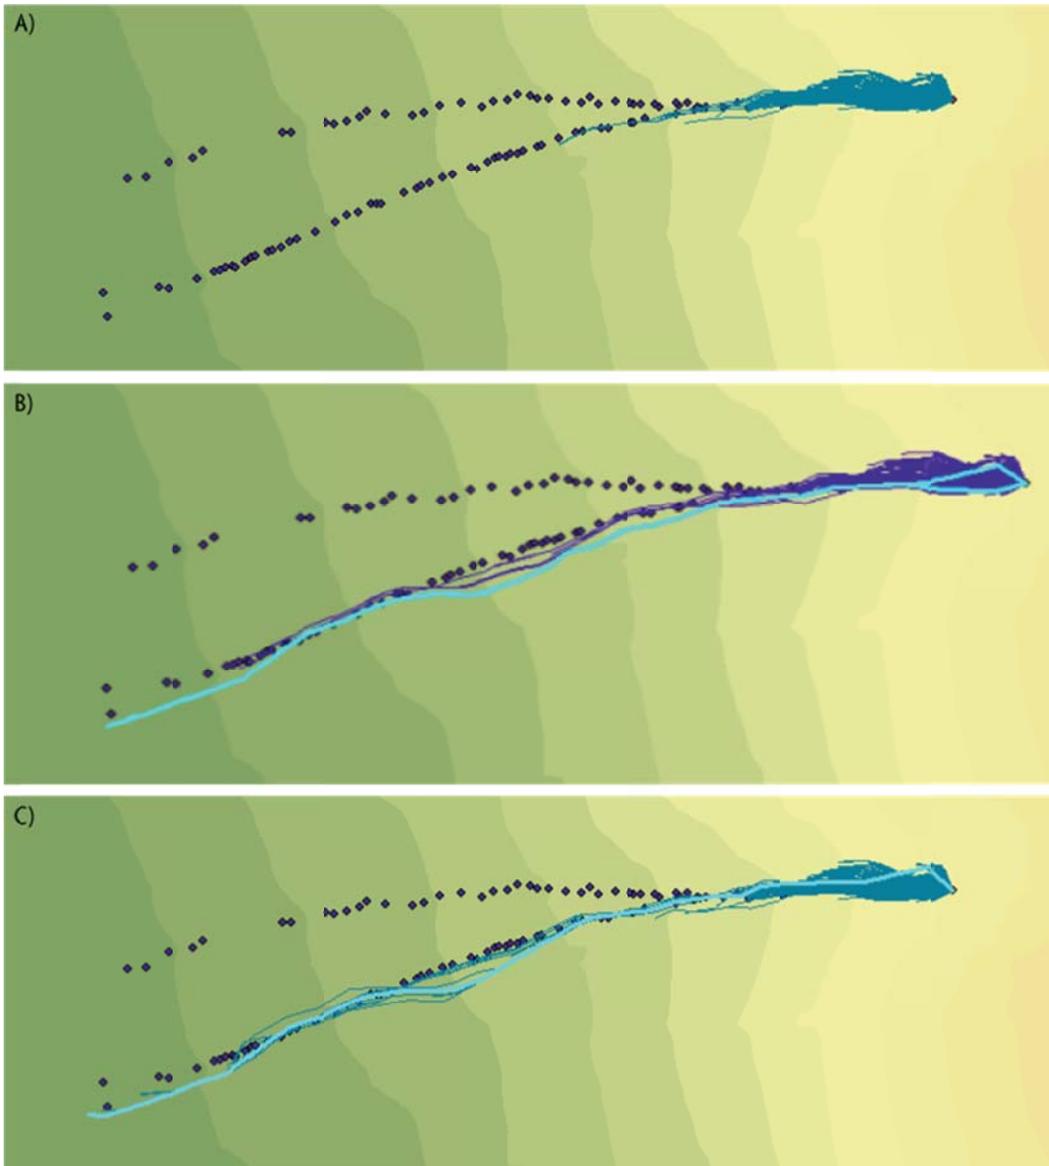
Figure 5.48: Rockfall Simulation Friction Sensitivity Test with Increased COR for 45° Slope Angle, 60m Drop Height, and Friction of A) 25°, B) 20°, and C) 15°

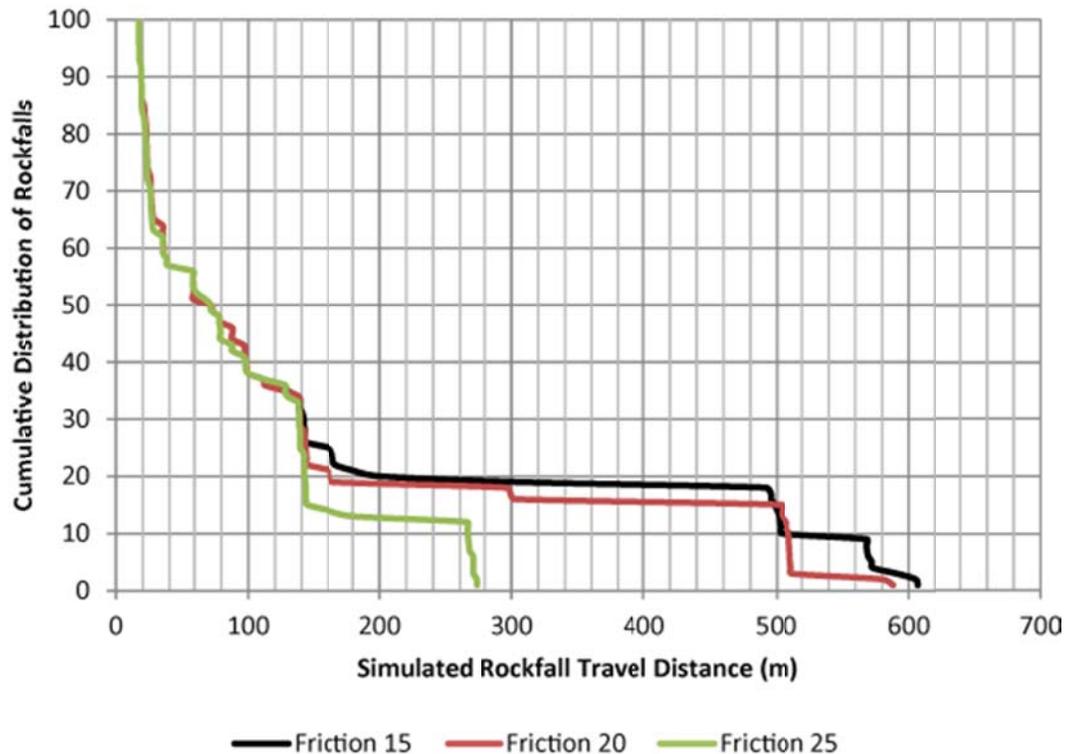
Figure 5.49: Cumulative Distribution Curve of Rockfall Travel Distance for Friction Angle of Slope

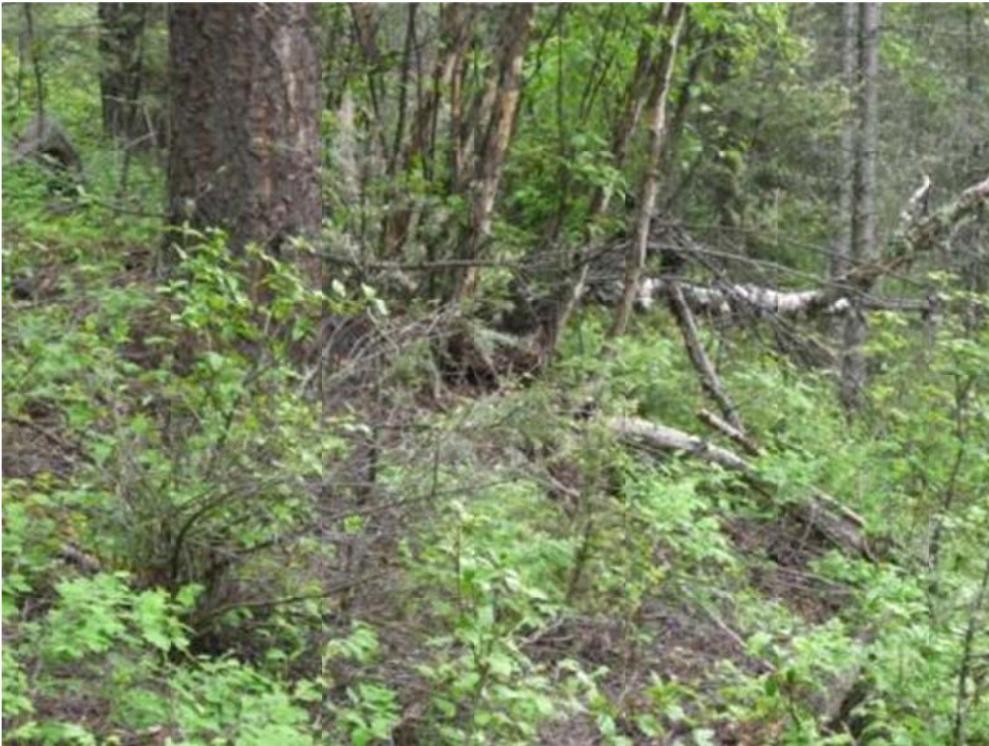
Figure 5.50: Smashed and Scarred Trees (photo by Renato Macciotta)

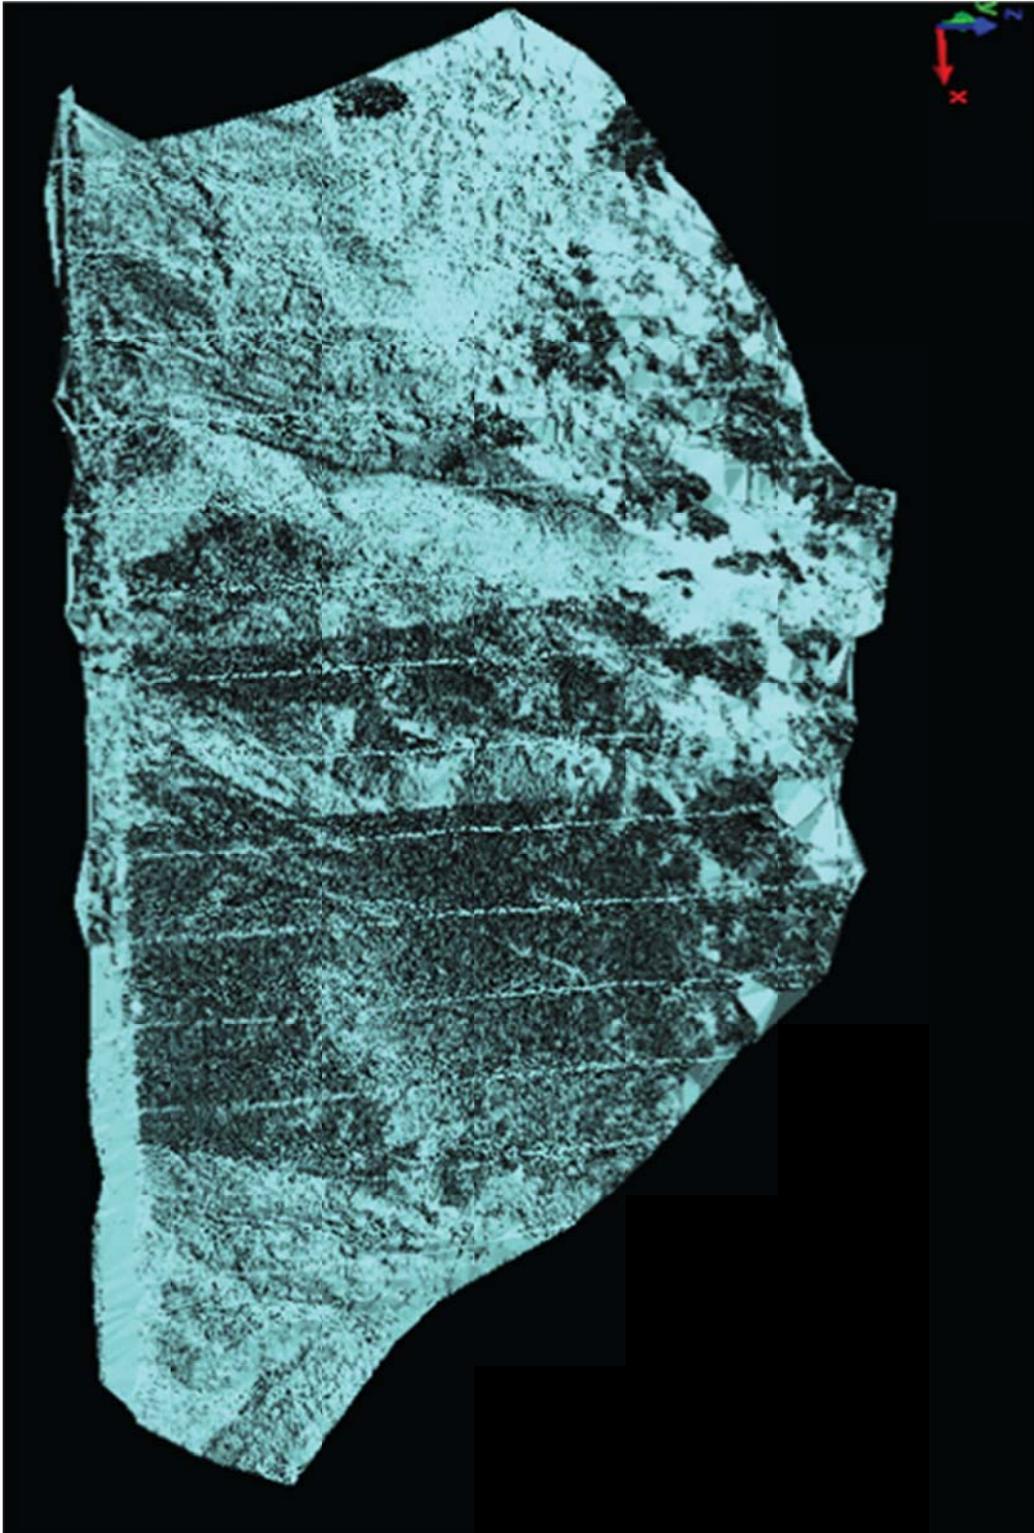
Figure B.4: Surface Map of Fir Creek Rock-Cut (Rotated)

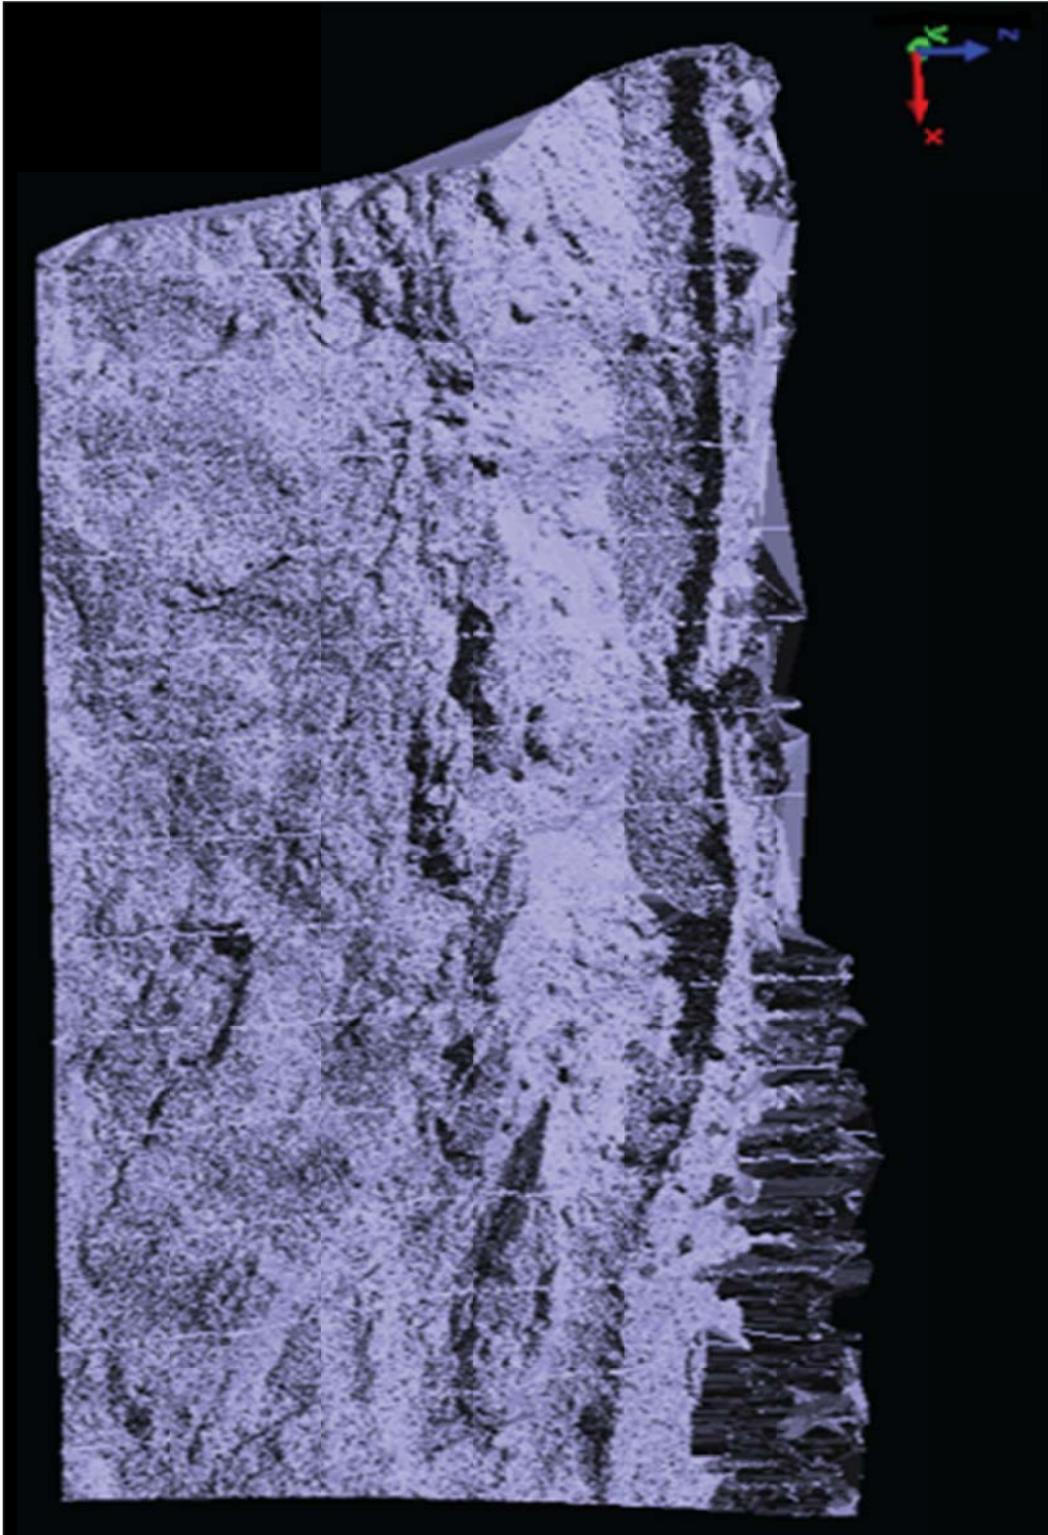
Figure B.6: Surface Map of Mt. Baldy Rock-Cut (Rotated)
