University of Alberta

**Process Analysis of Rockfalls with Stationary Terrestrial LiDAR and RockFall
Analyst**

A thesis submitted to the Faculty of Graduate Studies and Research
in partial fulfillment of the requirements for the degree of

Geotechnical Engineering

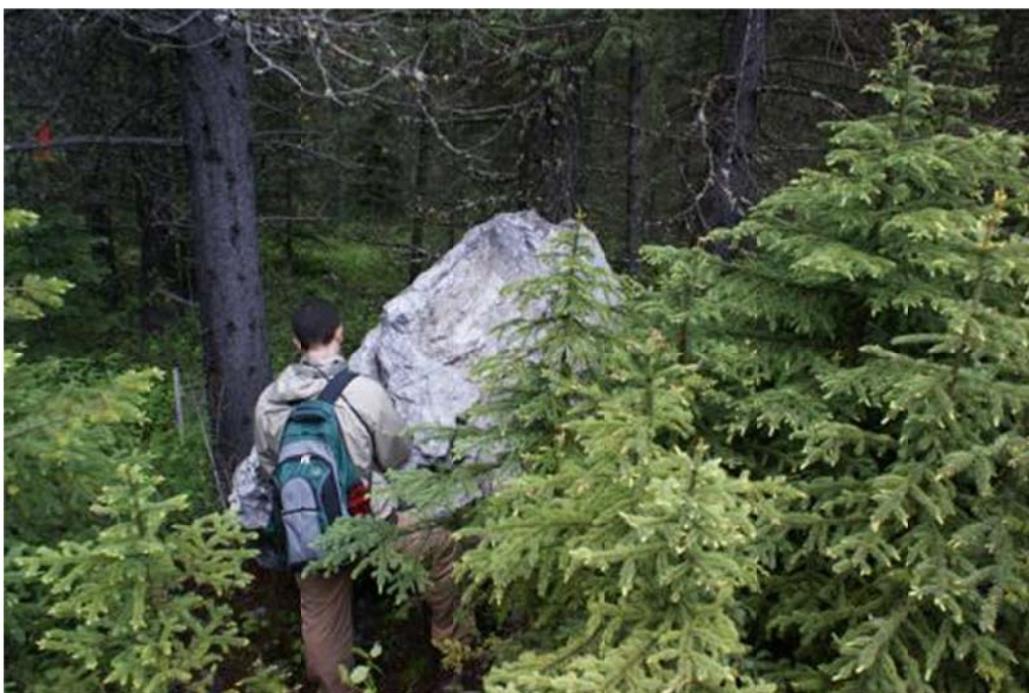
Figure C.1: Rock Block from Orange Flagged Path

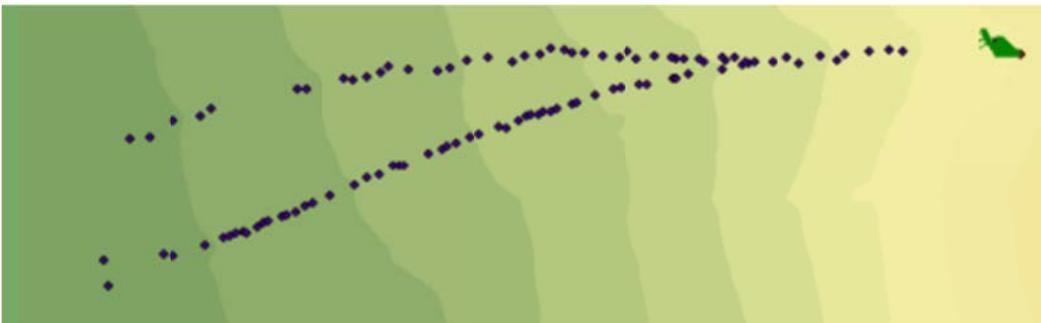
Figure C.29: Rockfall Simulation: $R_n = 0.33$ $R_t = 0.87$; Slope Angle 75° ; Drop Height 70m

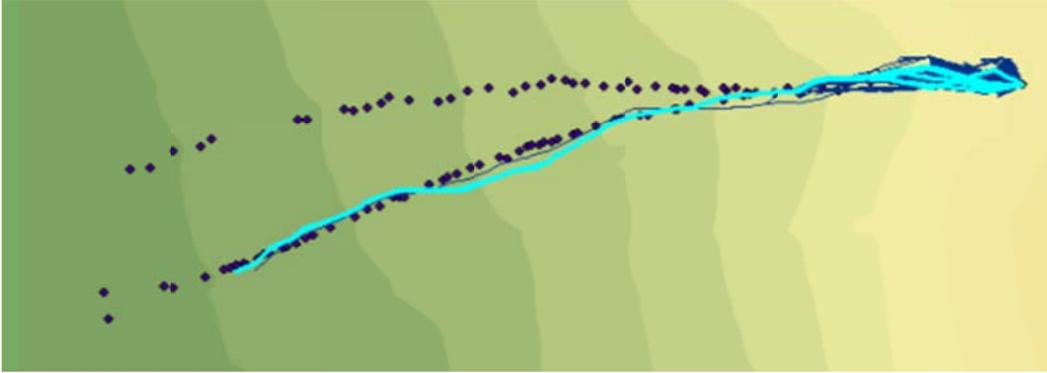
Figure C.30: Rockfall Simulation: $R_n = 0.3$ $R_t = 0.8$; Slope Angle 45° ; Drop Height 50m

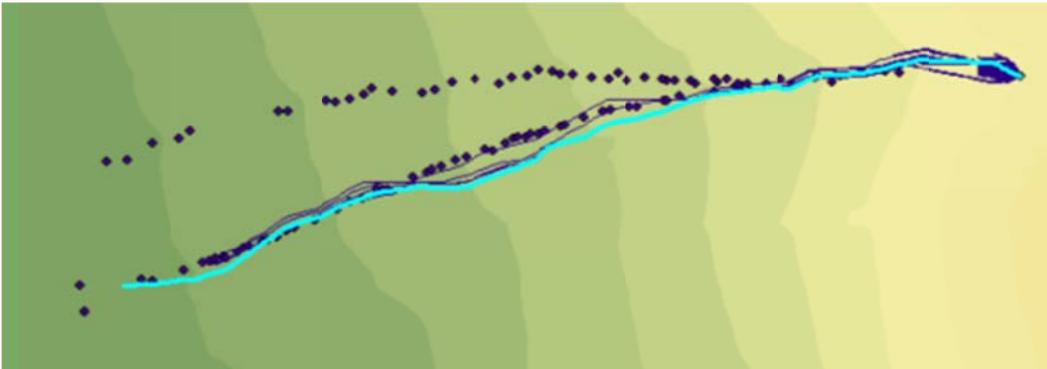
Figure C.38: Rockfall Simulation: $R_n = 0.3$ $R_t = 0.8$; Slope Angle 65° ; Drop Height 70m

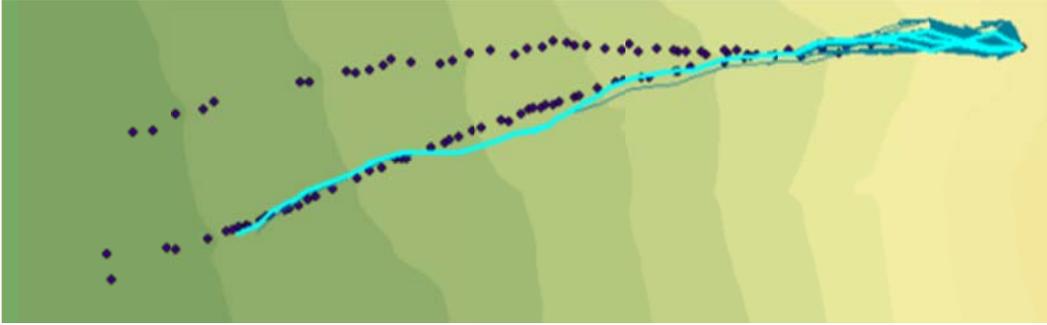
Figure C.39: Rockfall Simulation: $R_n = 0.27$ $R_t = 0.77$; Slope Angle 45° ; Drop Height 50m

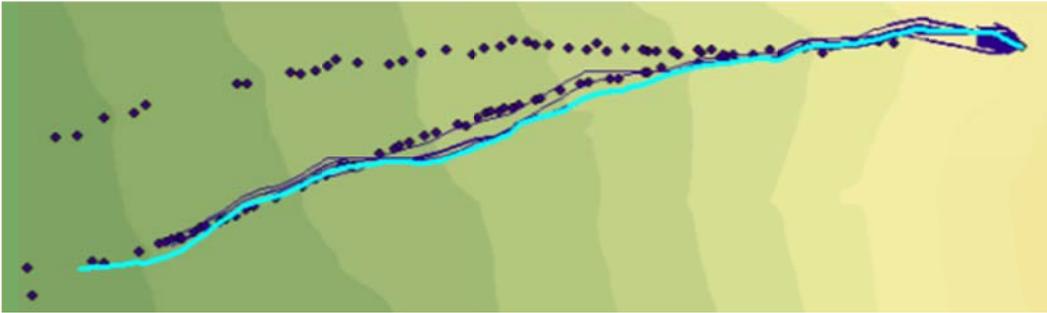
Figure C.65: Rockfall Simulation: $R_n = 0.3$ $R_t = 0.77$; Slope Angle 65° ; Drop Height 70m

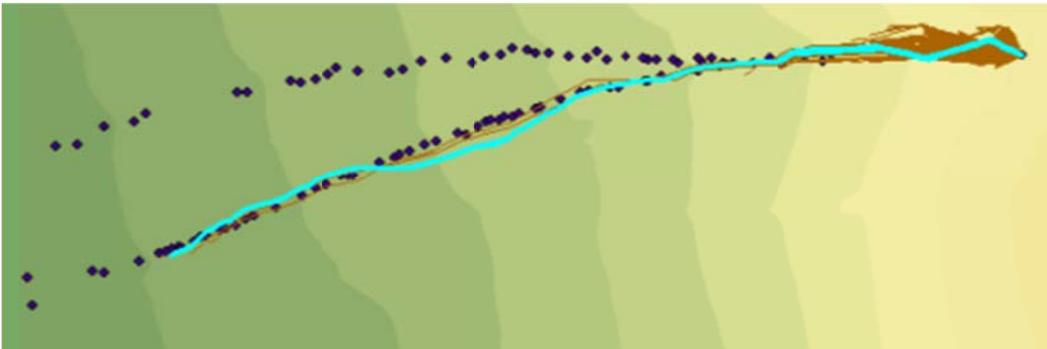
Figure C.66: Rockfall Simulation: $R_n = 0.15$ $R_t = 0.5$; Slope Angle 45° ; Drop Height 50m

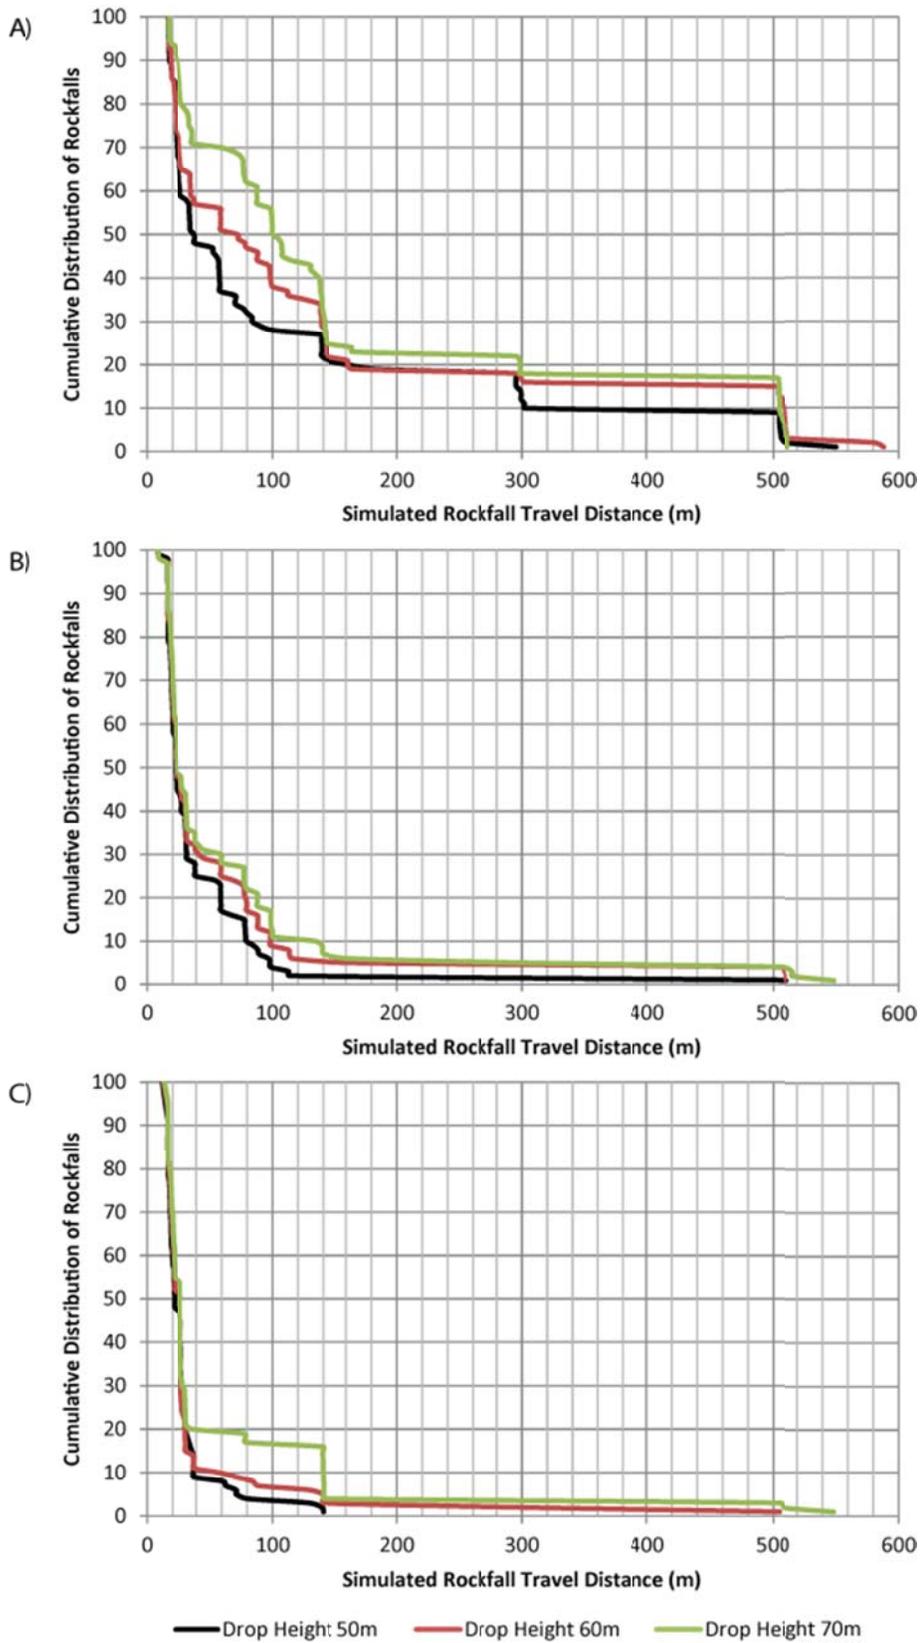
Figure C.105: Cumulative Distribution Curves for Increased COR at Assumed Slope Angles of A) 45°, B) 55°, and C) 65°

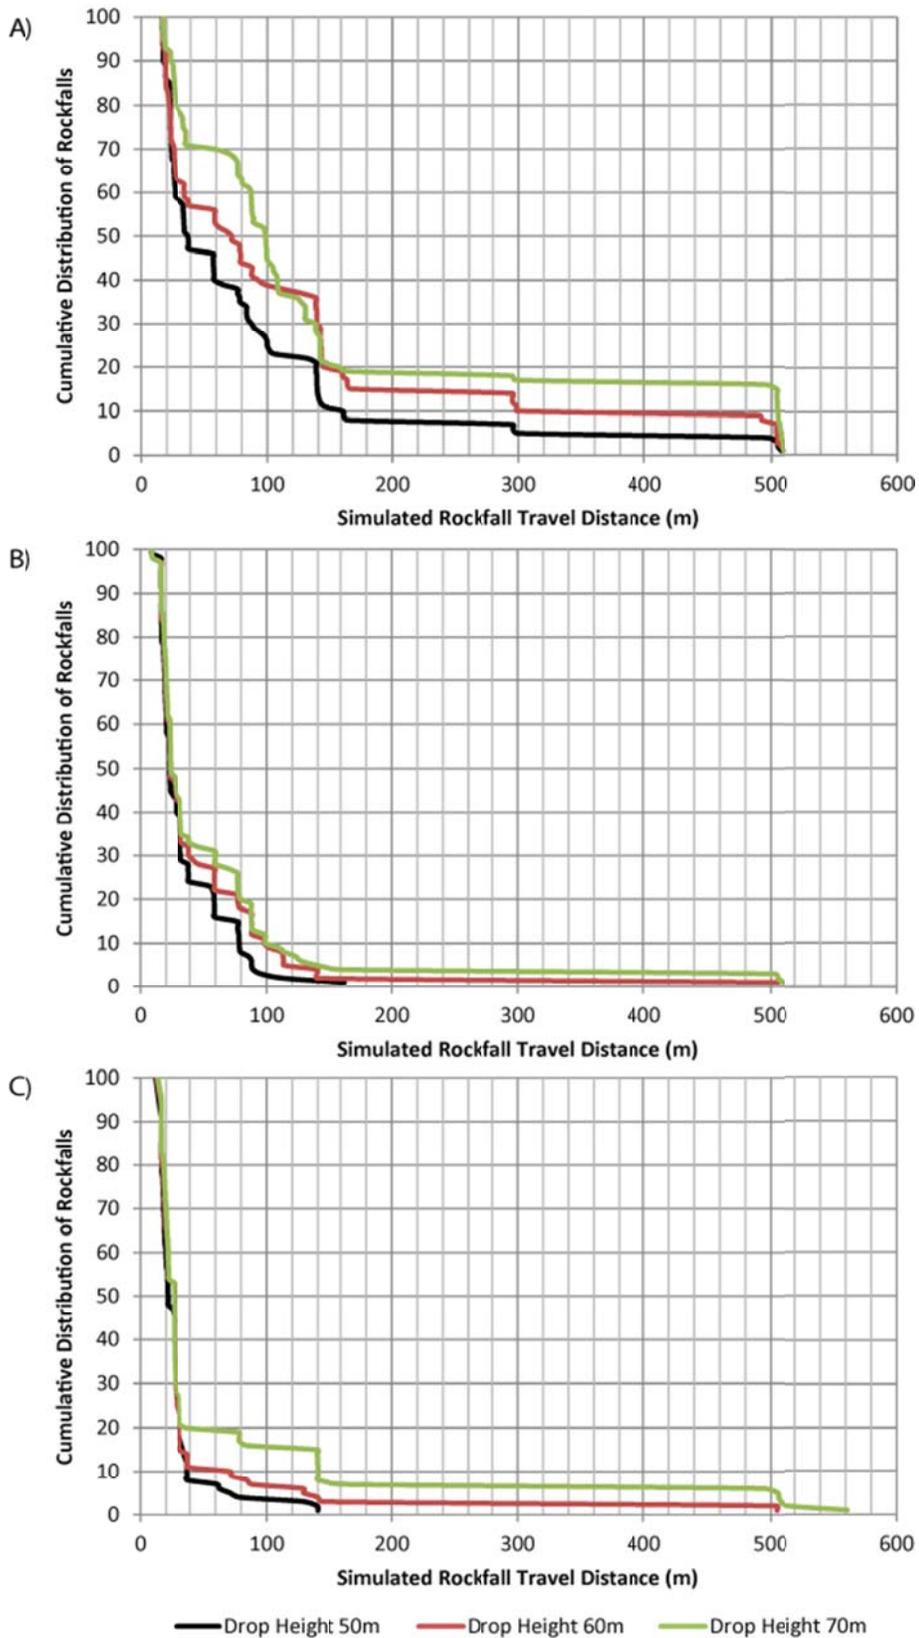
Figure C.106: Cumulative Distribution Curves for Reduced COR at Assumed Slope Angles of A) 45°, B) 55°, and C) 65°

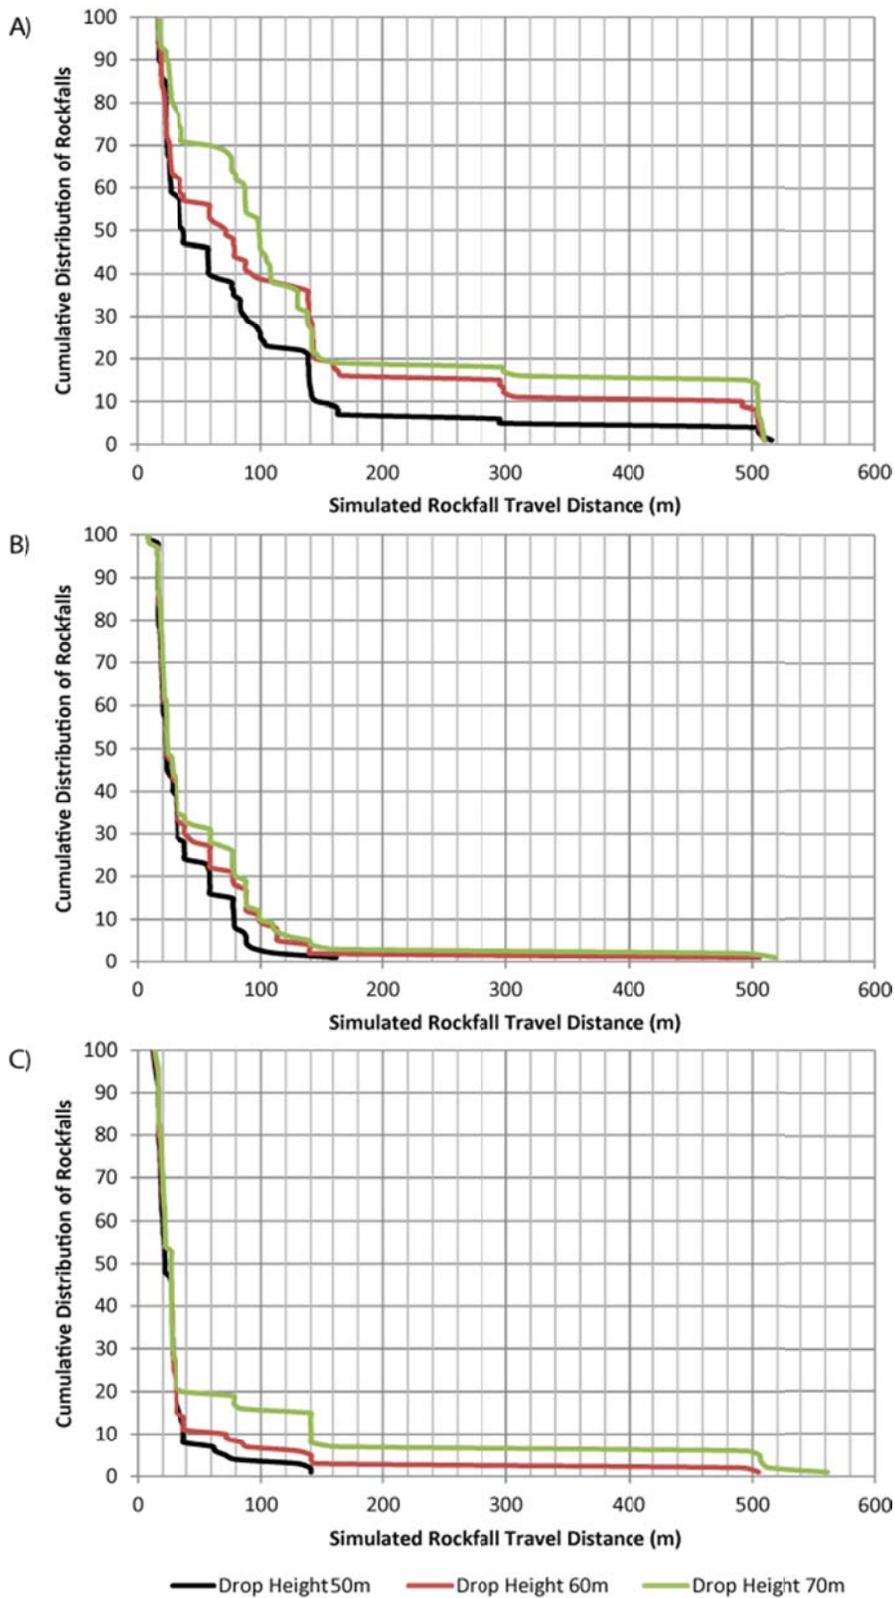
Figure C.107: Cumulative Distribution Curves for Reduced R_n at Assumed Slope Angles of A) 45° , B) 55° , and C) 65°

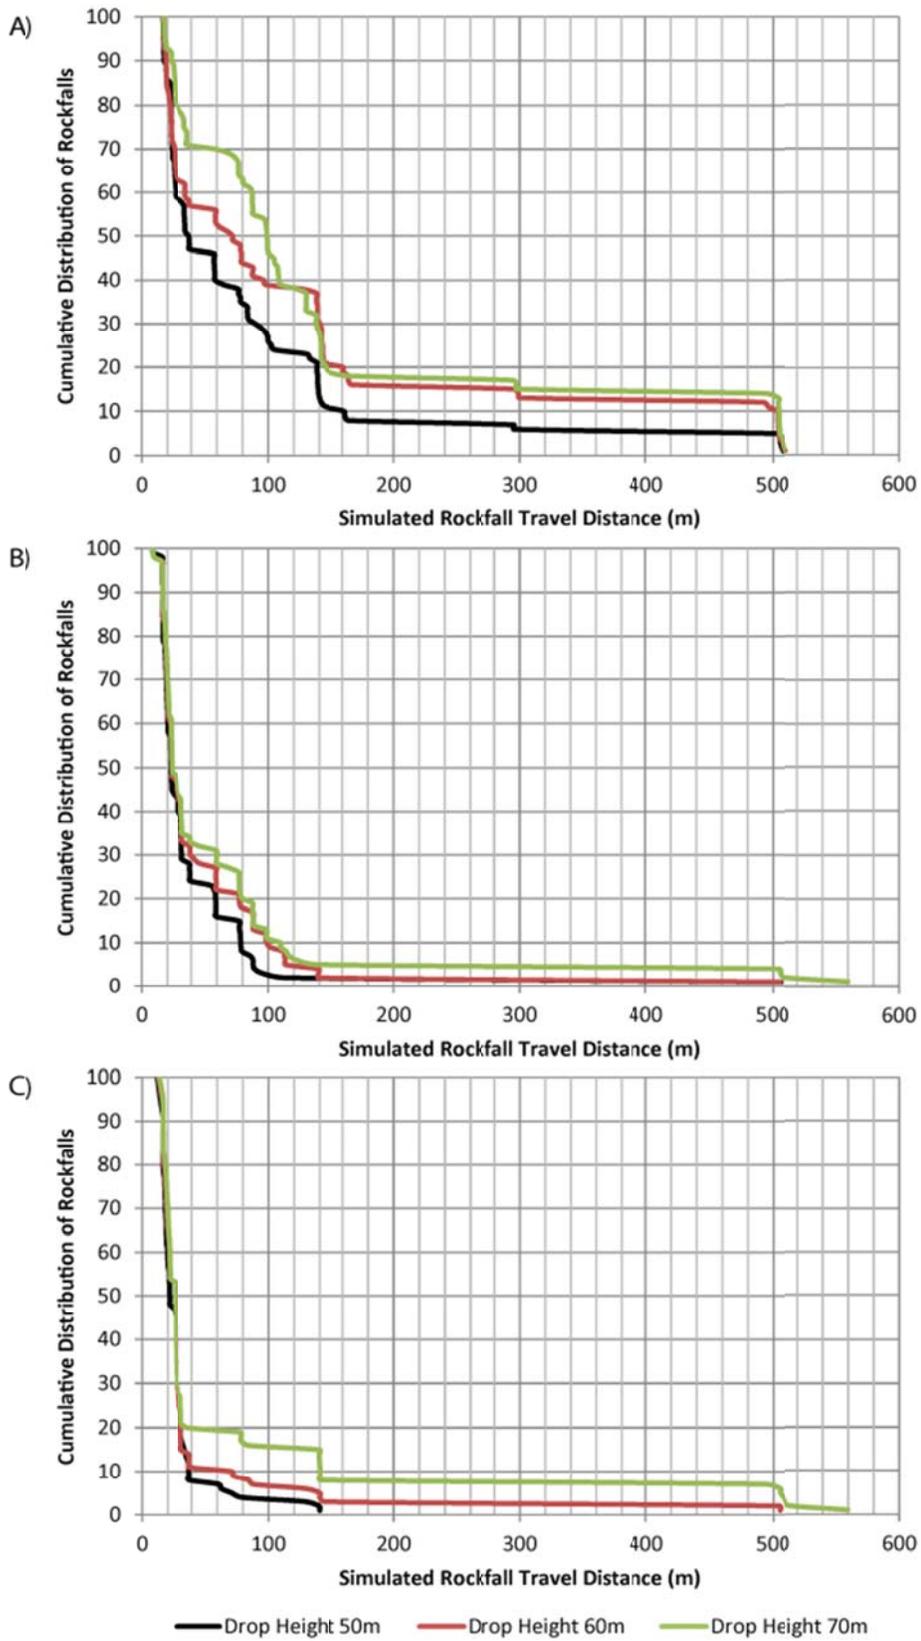
Figure C.108: Cumulative Distribution Curves for Reduced R_t at Assumed Slope Angles of A) 45°, B) 55°, and C) 65°

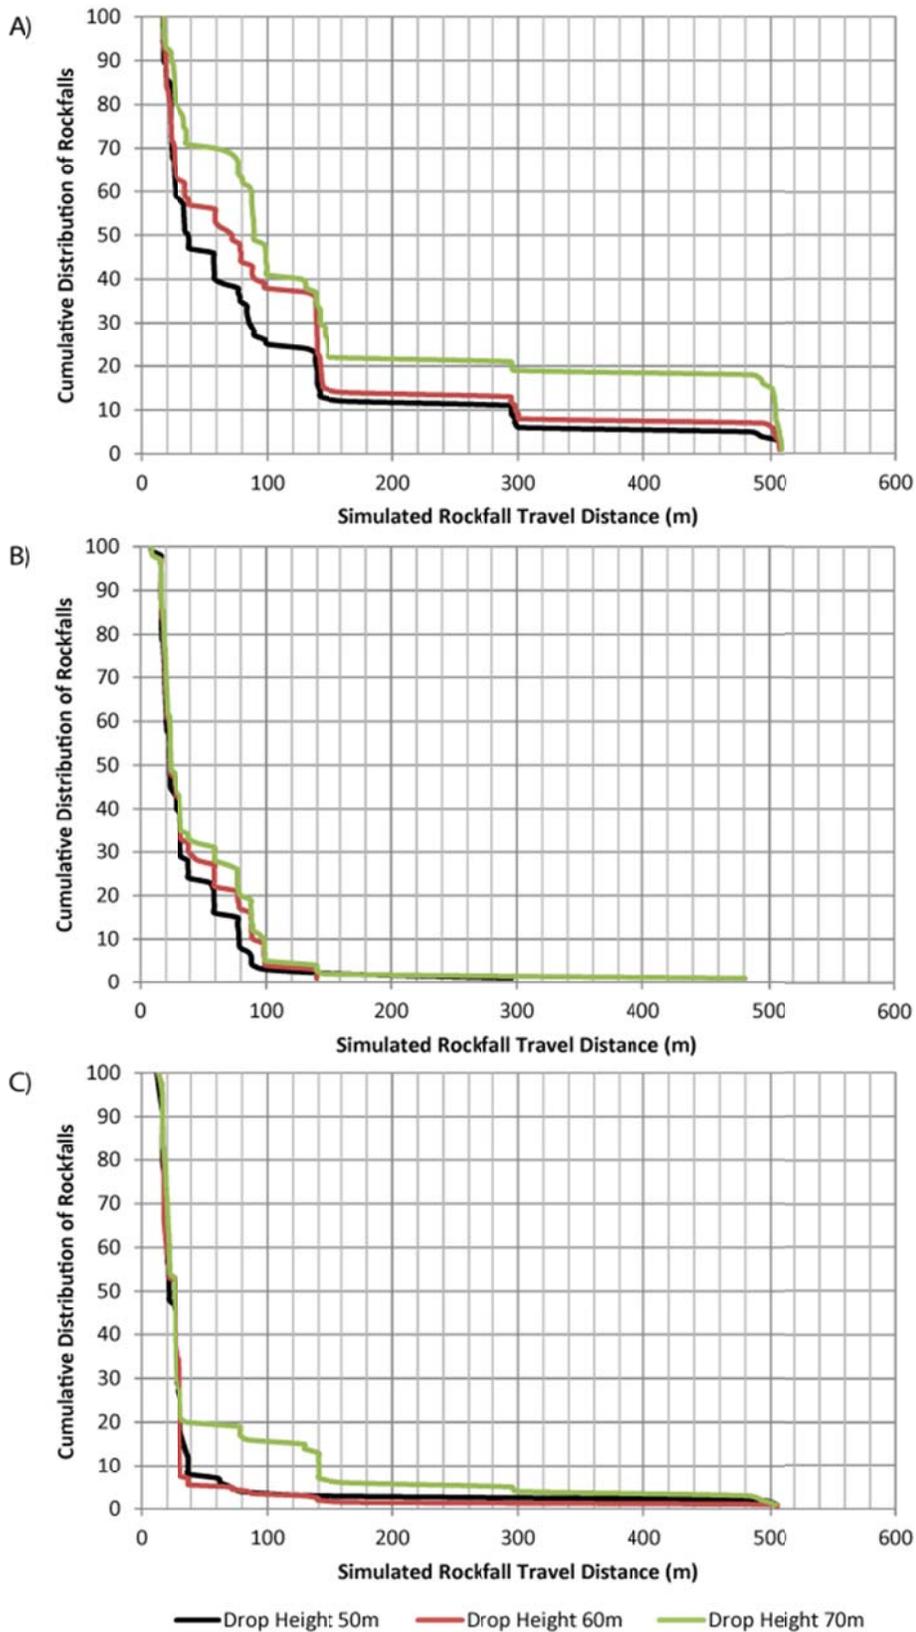
Figure C.109: Cumulative Distribution Curves for Greatly Reduced COR at Assumed Slope Angles of A) 45°, B) 55°, and C) 65°

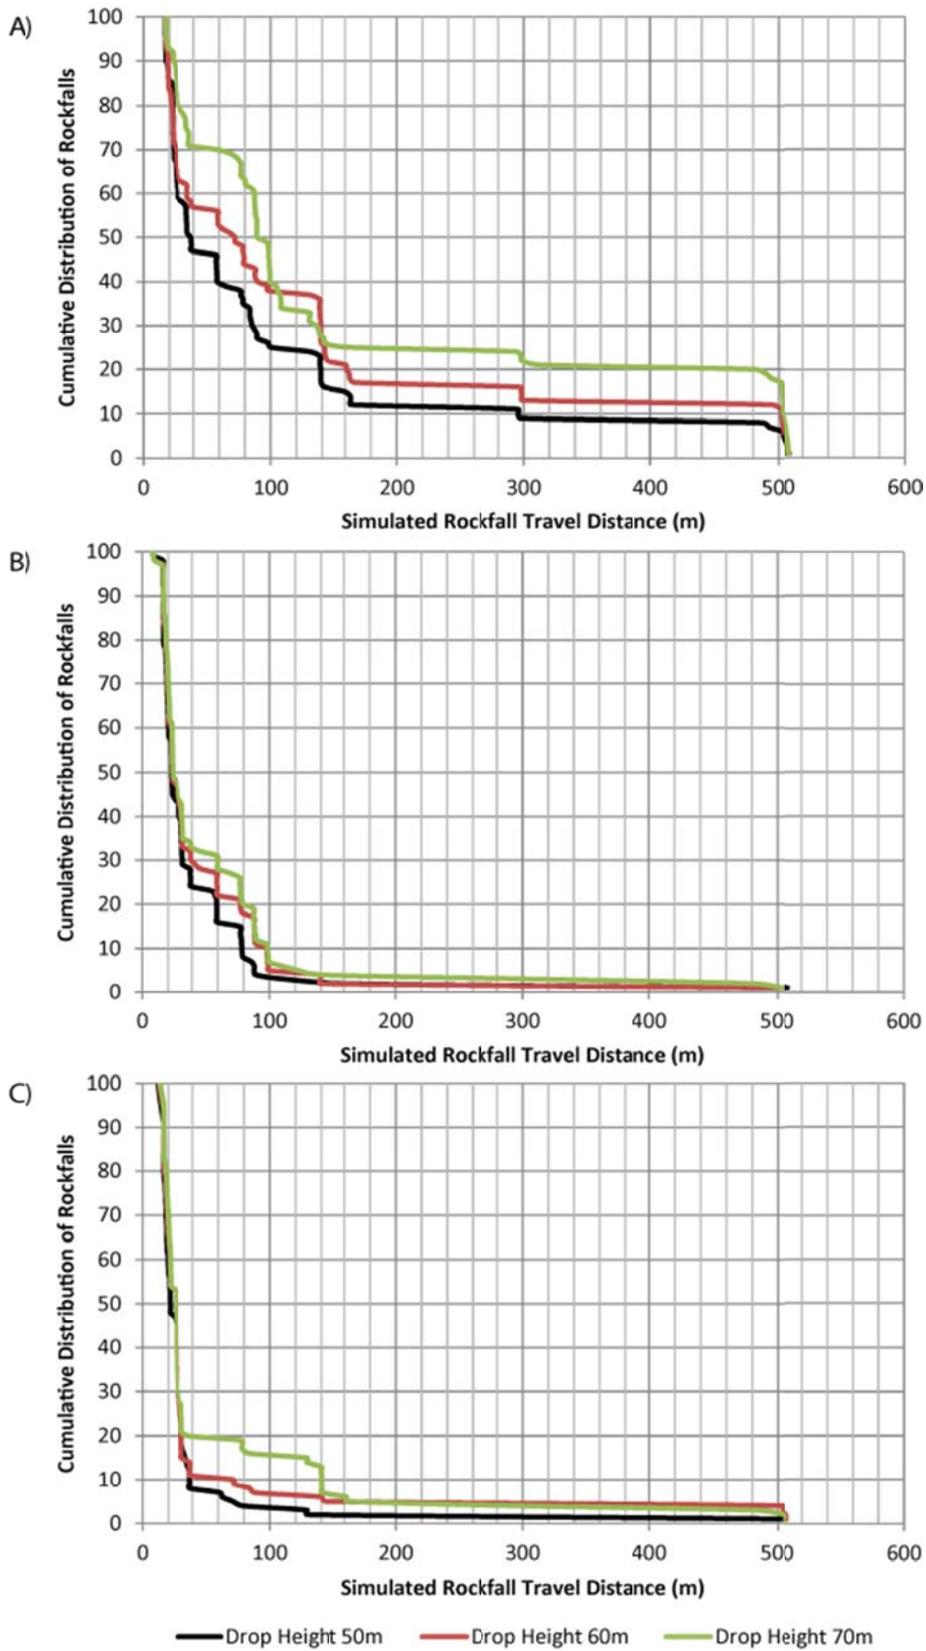
Figure C.110: Cumulative Distribution Curves for Greatly Reduced R_n at Assumed Slope Angles of A) 45°, B) 55°, and C) 65°
