Title of Thesis: A Slide in the Harrowby Hills

A thesis submitted to the Faculty of Graduate Studies and Research in partial fulfillment of
the requirements for the degree of Master of Science

Geotechnical Engineering

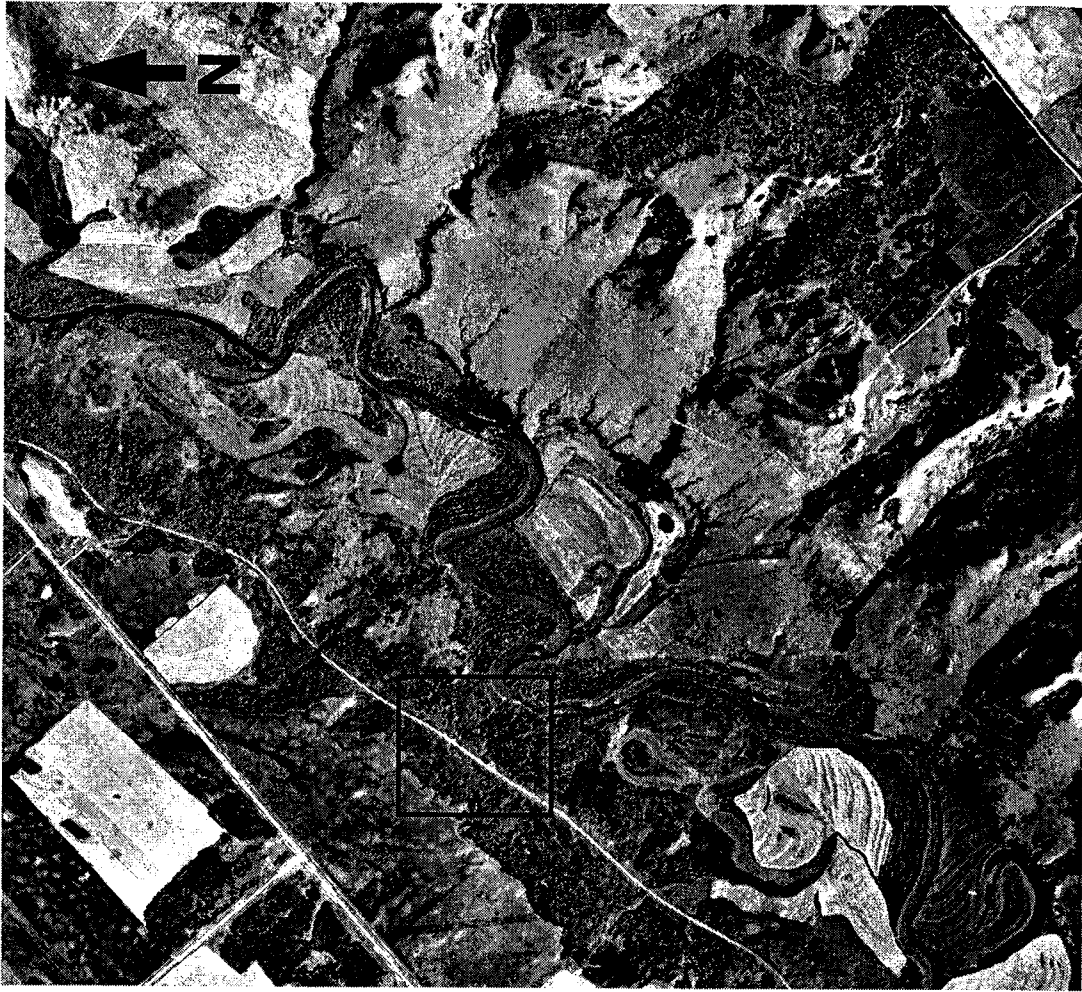
Figure 1-2: Aerial photo of the study area, outlined by the box. Scale 1:267000. (modified from Machair Surveys, 1971)

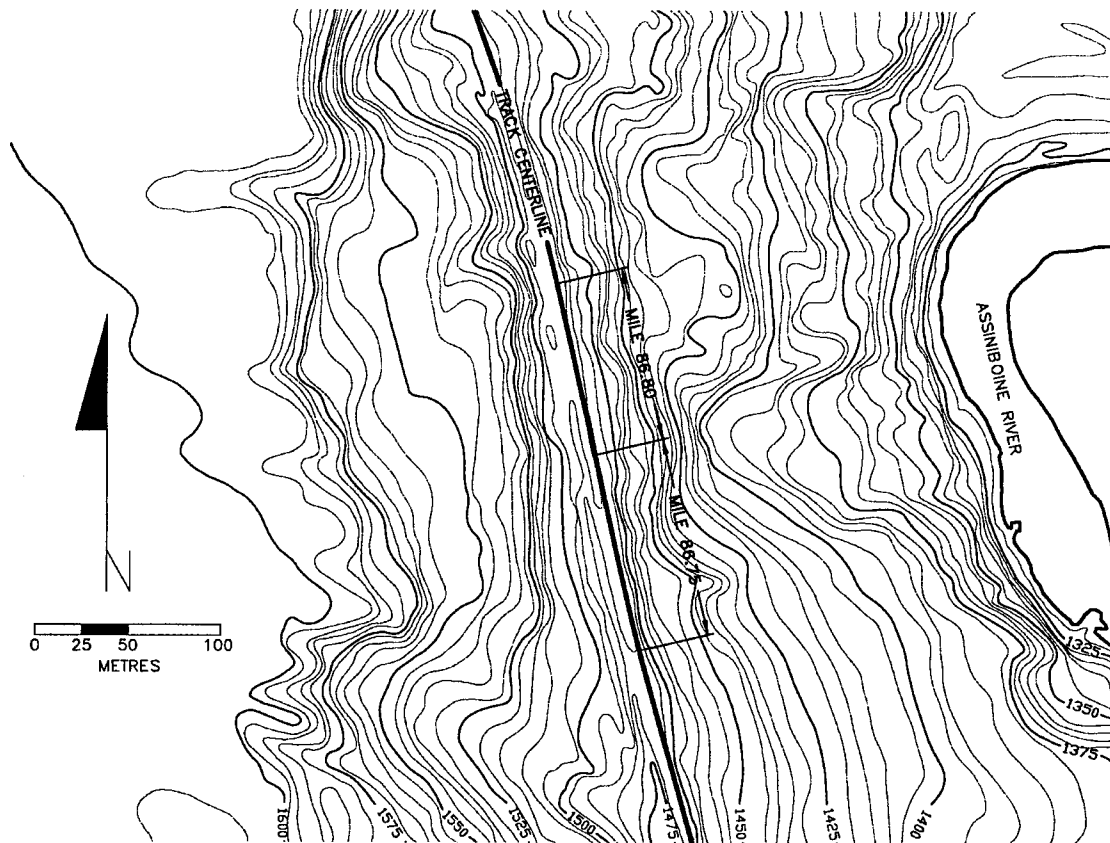
Figure 1-3: Location of Miles 86.8 and 86.75 in the study site (contours are in feet).

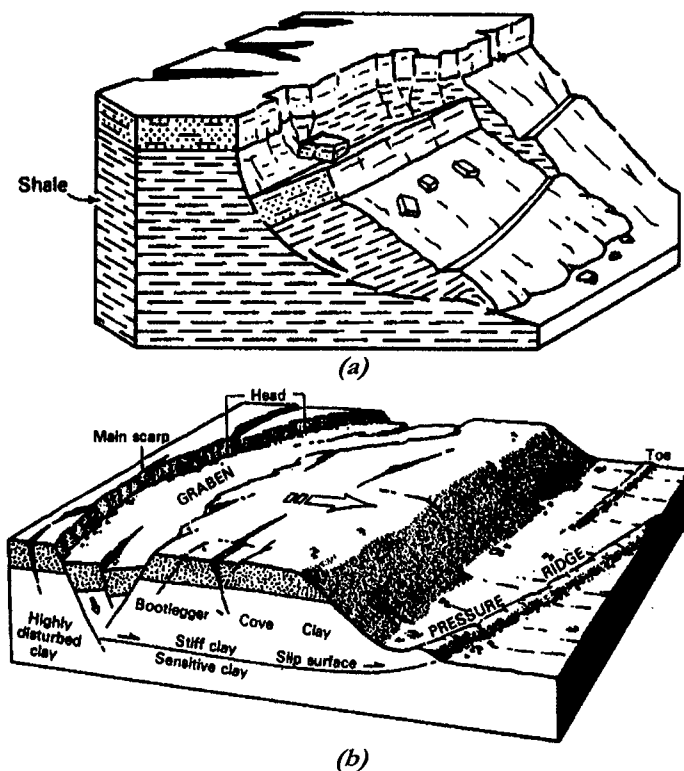
Figure 2-2: Modes of sliding: (a) rotational rock slide (b) translational earth block slide. (modified from Cruden and Varnes, 1996)

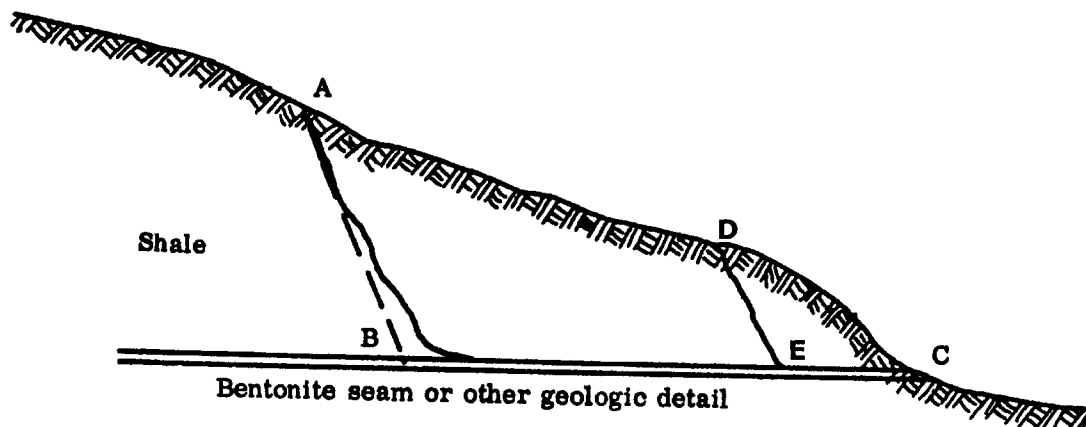
Figure 2-4: Mode of retrogressive sliding along a discrete geological feature. (modified from Scott and Brooker, 1966)

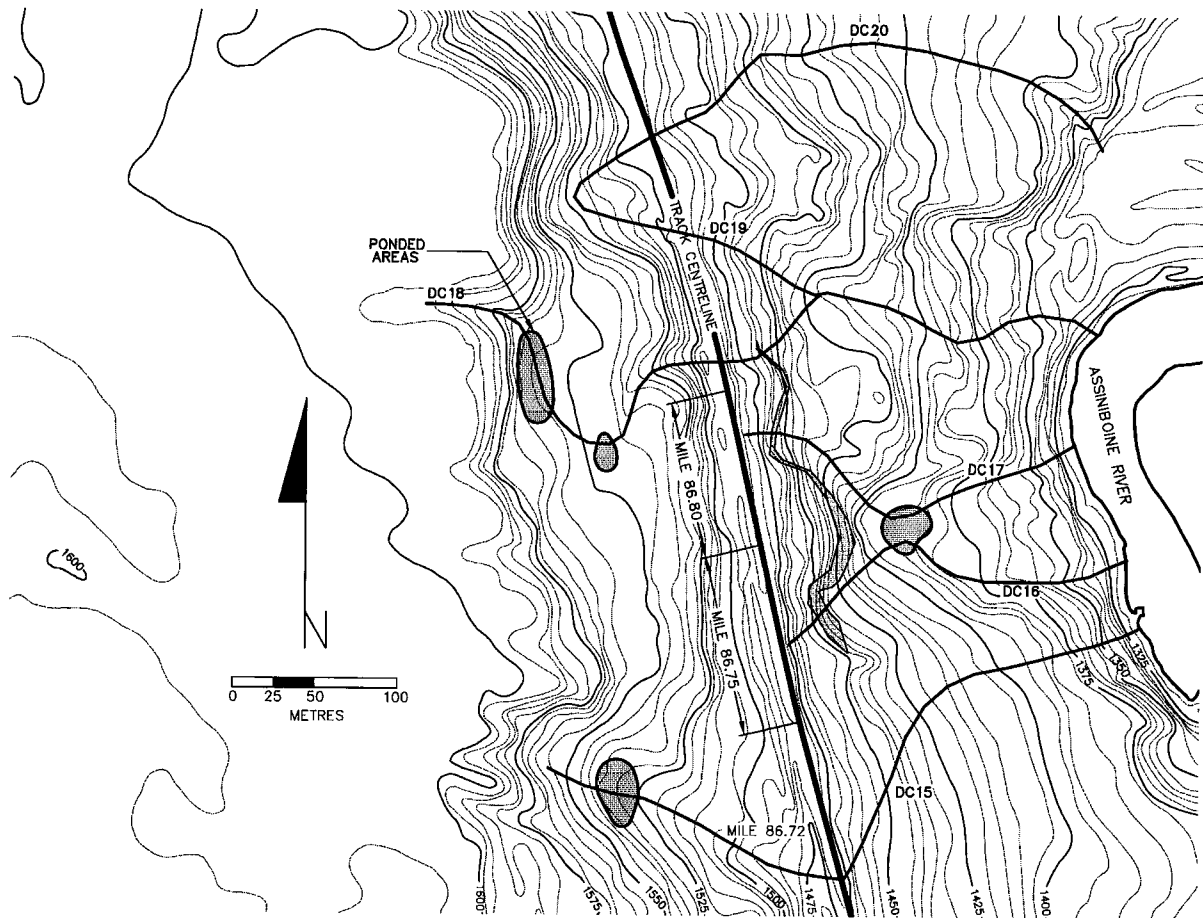
Within the study area, six drainage courses (DC15 to DC20) and four ponded areas (hatched areas) were identified, as shown below in Figure 4-6.

Figure 4-6: Surface drainage conditions, contours are in feet (Clifton Associates Ltd., 1986).

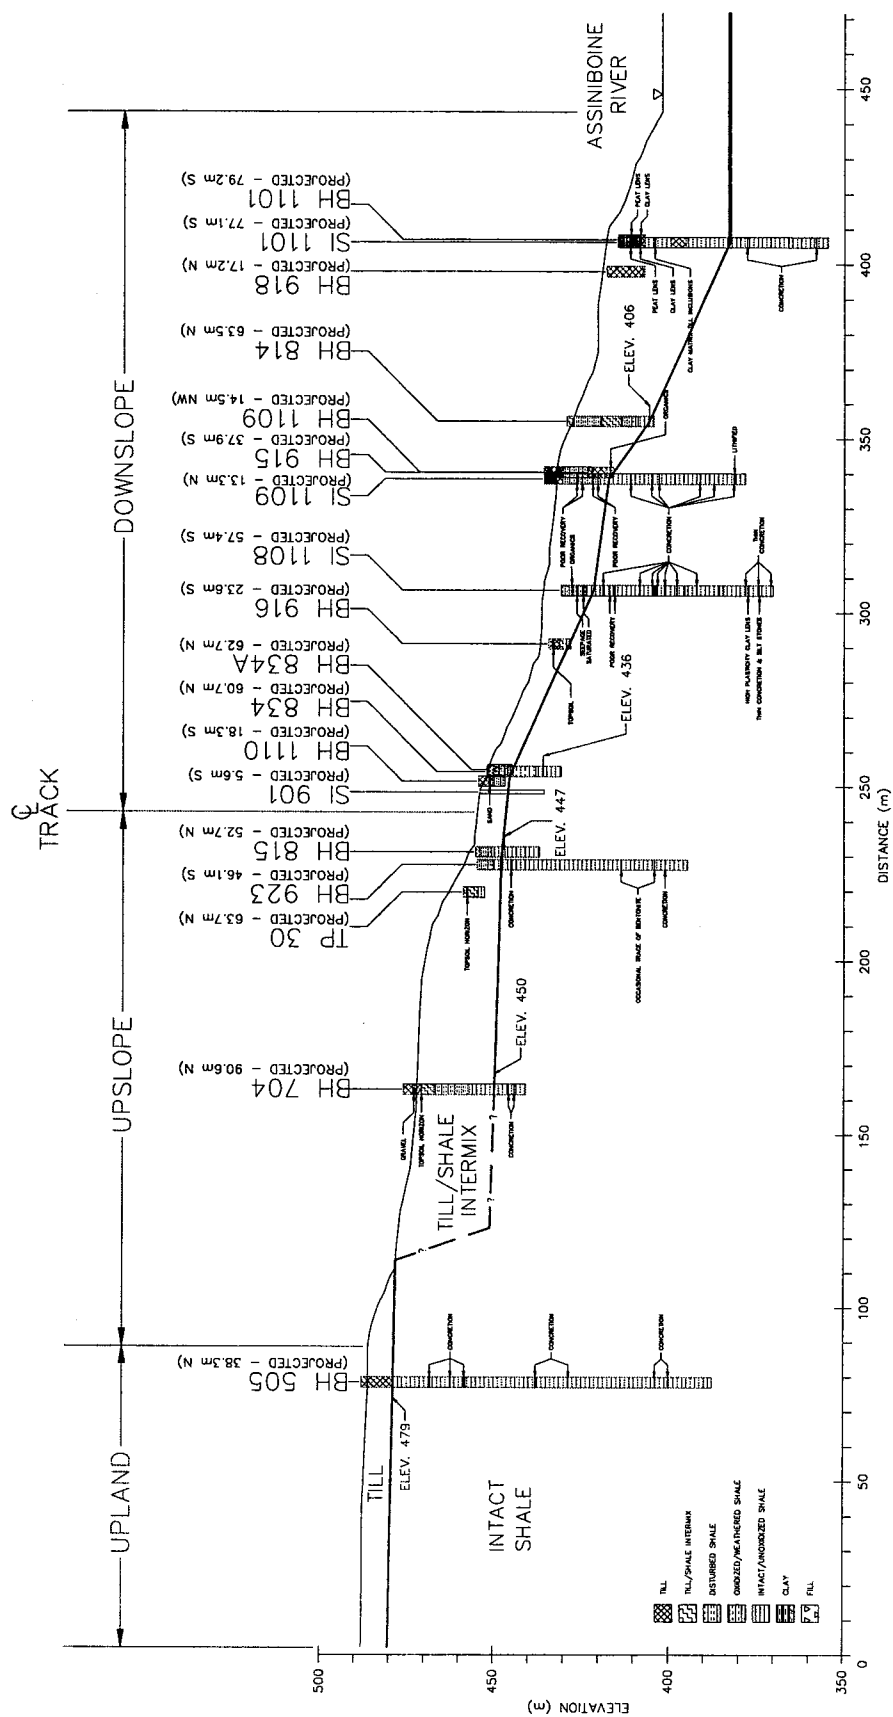
Figure 4-11: Stratigraphy of section Z3 with enlarged figure (Figure A-21) in Appendix A. (See Figure 4-8 for location of section)

The mid-upslope condition (Figure 4-11) was determined from BH 704, while TP 30, BH 923, and BH 815 were used to establish the near-track portion of the upslope. Again, only two strata were identified, intermix and the intact shale bedrock. Till, directly overlying the clay shale stratum, was also found at the top of BH 704 with a thickness of 8.8 m. The clay shale stratum was weathered with shear zones and disturbed regions in the top 17.2 m, and was underlain by intact shale at an elevation of 450 m (this was the only hole in the study area which reported the occurrence of an “intact shale” stratum that was differentiated from the “clay shale” stratum). In the upslope and near the track, the occurrence of any till layer was absent. Instead, the clay shale stratum was directly overlain by either topsoil or fill. In TP 30, the bottom of the weathered/oxidized shale, as evidenced by iron and manganese staining (Crandell, 1958; Schaefer and Lohnes, 2001), and disturbed shale zone was reached at a depth of 4.2 m when the shale became unoxidized and hard. No interpreted intact shale elevation was observed in BH 923 and no mention of it was made in the borehole log. In this case, both the water content and dry density profiles (Figure 4-13) were used in determining its location. The water content at elevation 448.9 m was consistently near 20%; below this elevation, the water contents ranged from a low of 18.2% to a high of 22.3% (average of 20%), while those above this point ranged from 22.2% to 31.5% (average of

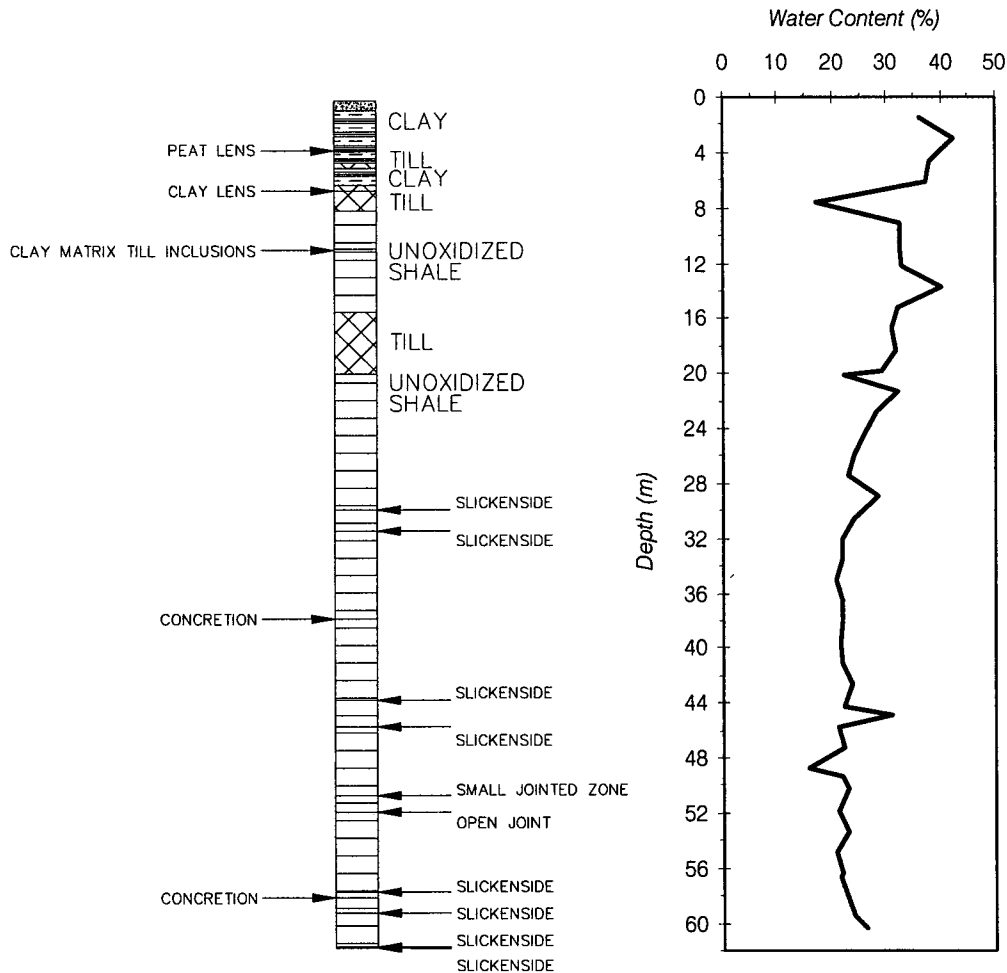
Figure 4-12: Water content profile of SI 1101.

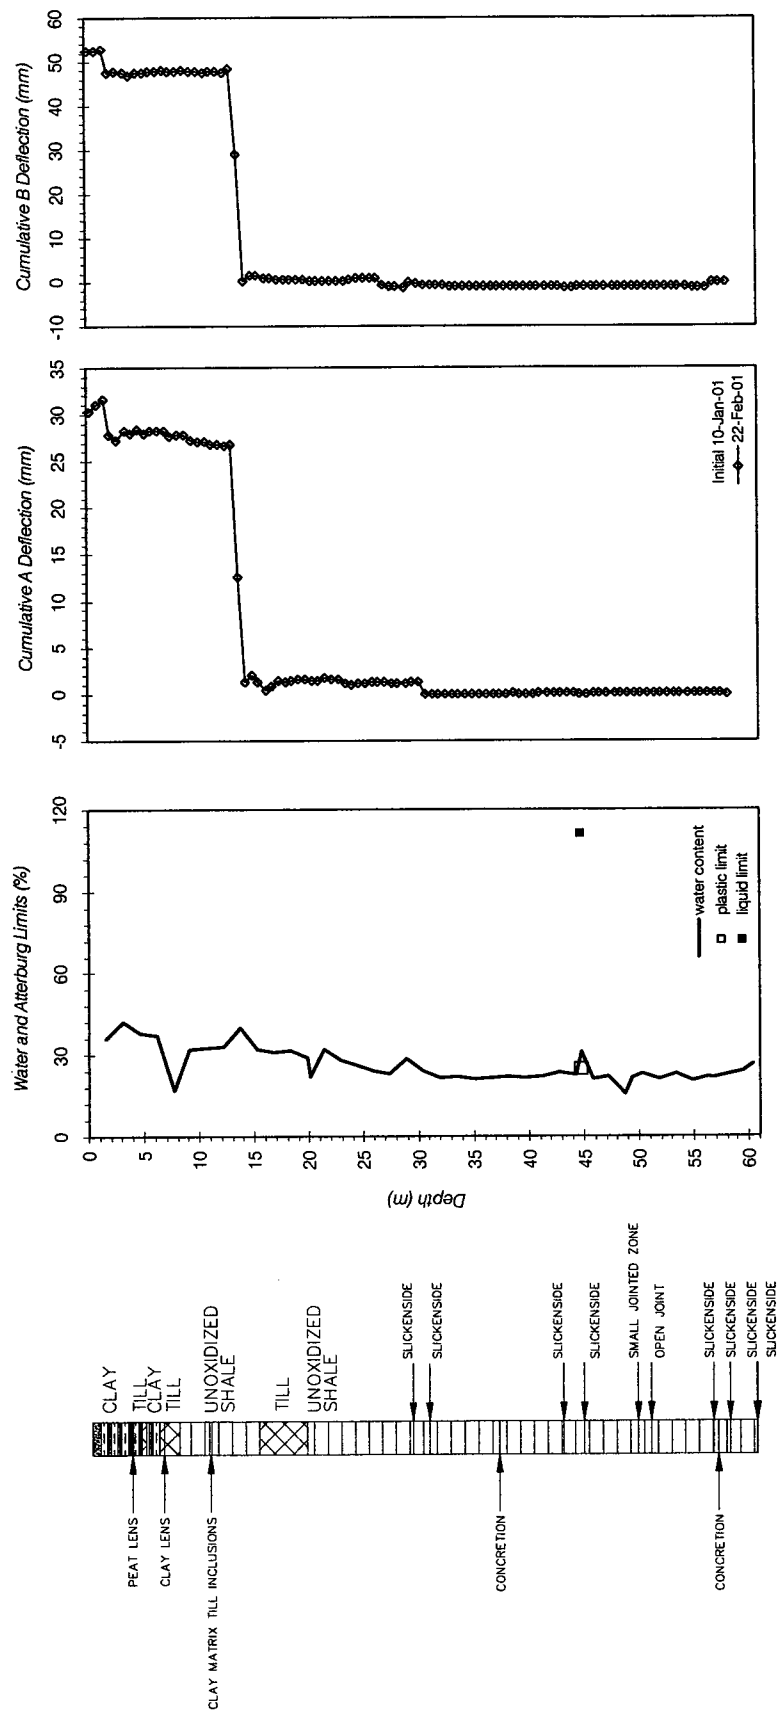
Figure 4-18: Borehole log of SI 1101 compared with cumulative slope inclinometer data.

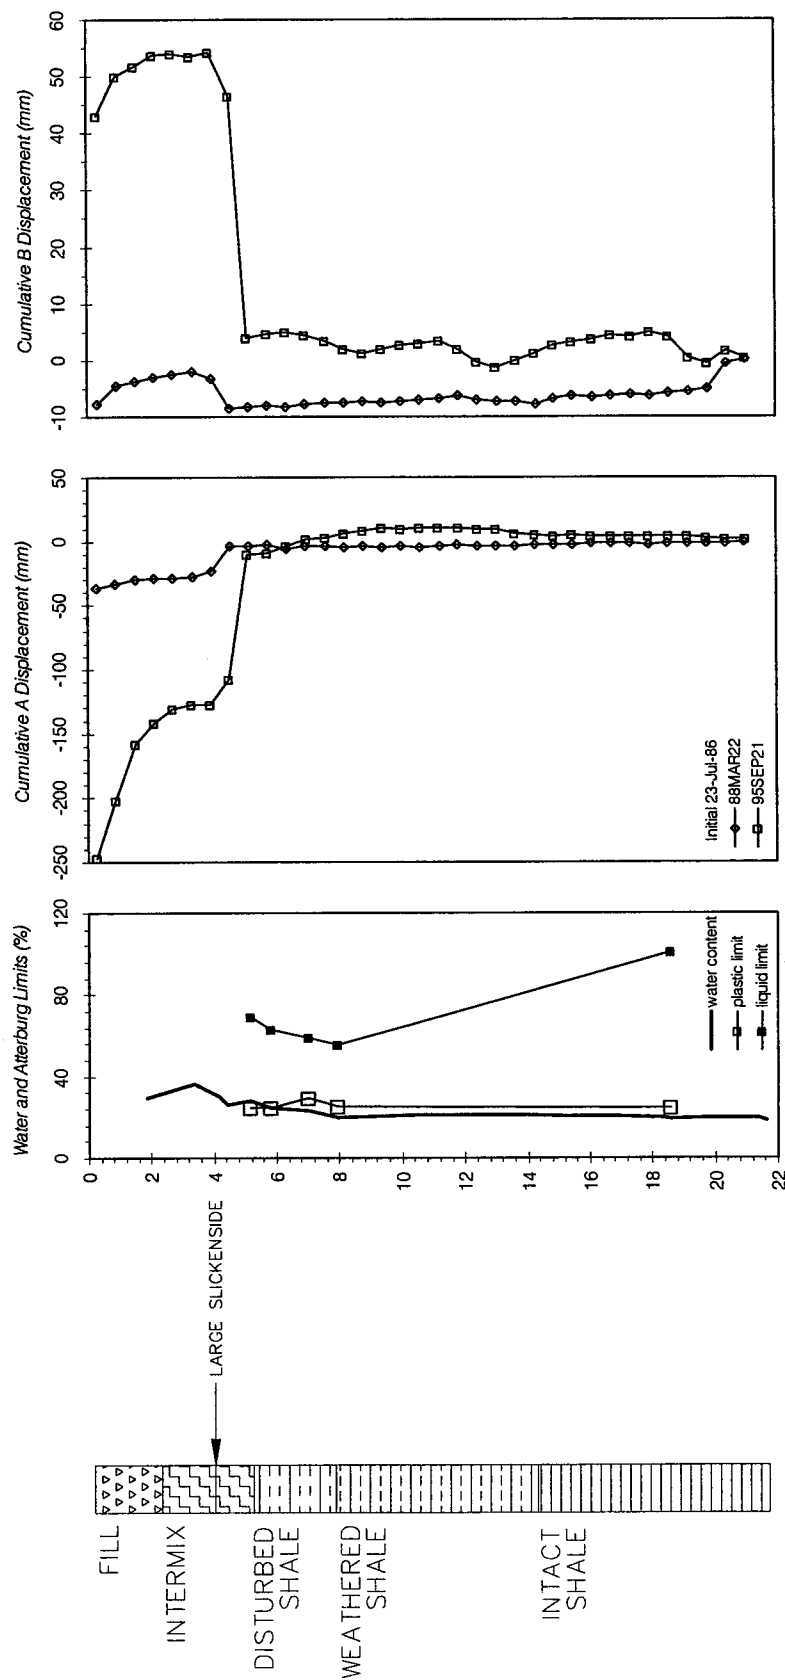
Figure 4-19: Borehole log of SI 834 compared with cumulative slope inclinometer data.

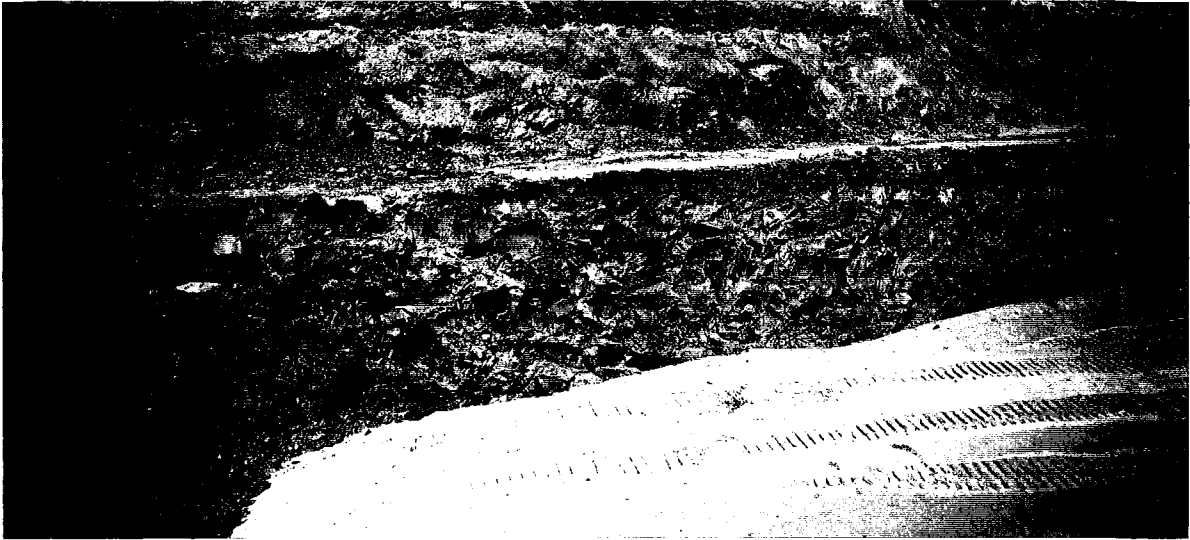
Another observation of interest was the rather steep, nearly vertical inclination of the walls excavated into the shale bedrock, which was maintained throughout the duration of the trip without the assistance of any external support. The only indications of instability were the small, local orthogonal wedge failures evidenced by the rubble piles along the base.

Figure 4-26: Indication of a number of parallel continuous joints (2002 site visit).

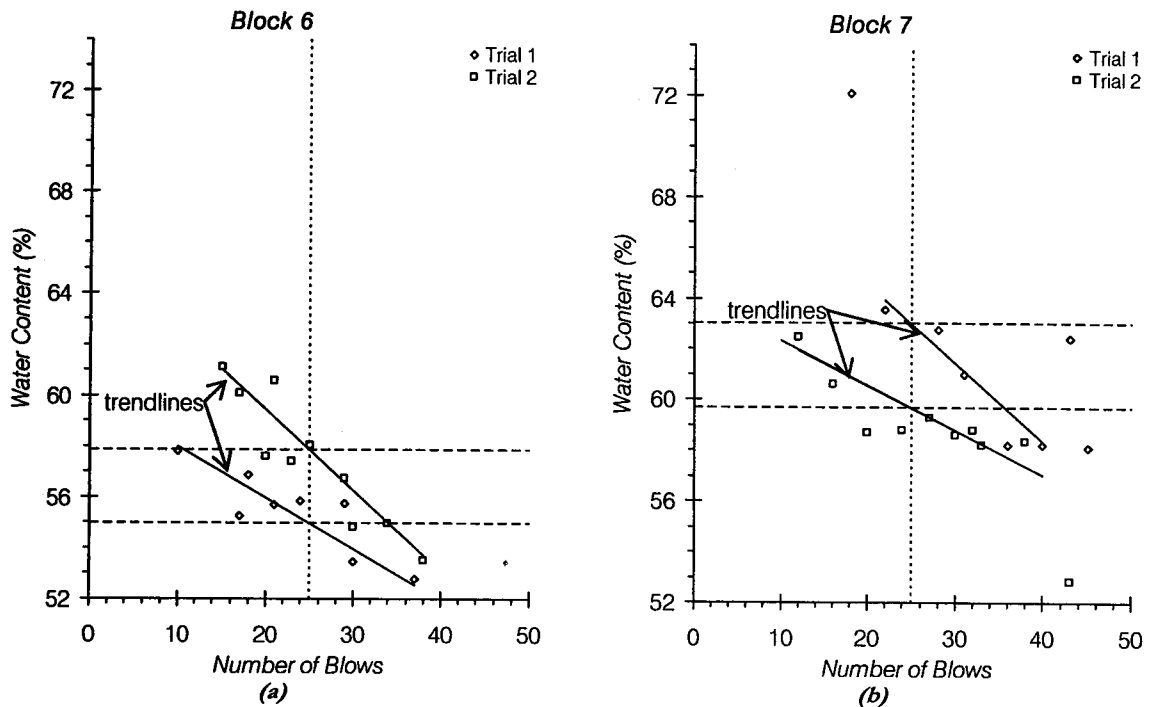
Figure 5-2: Summary of liquid limit tests.

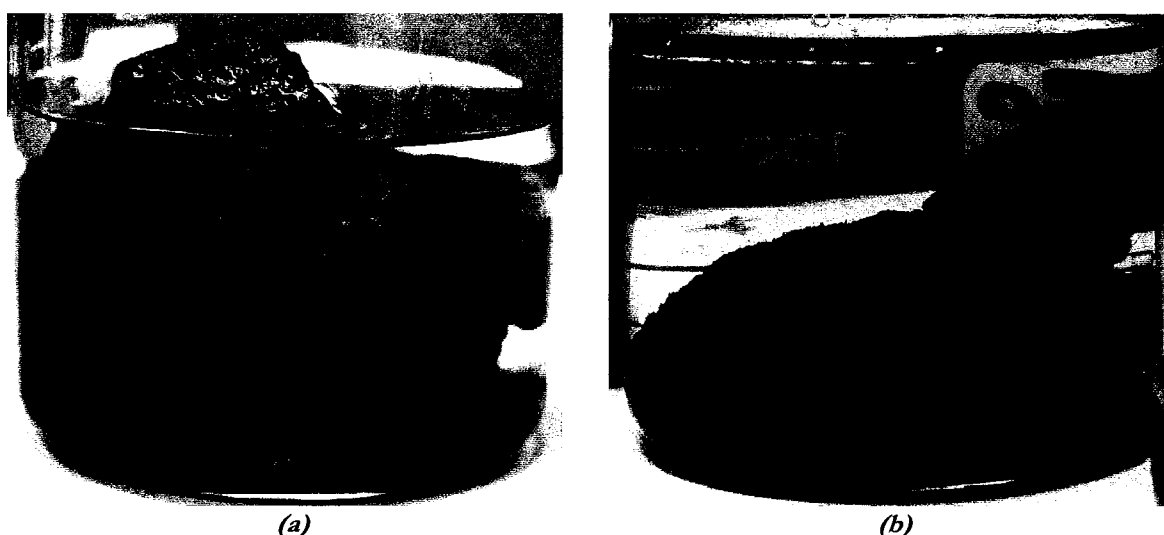
Figure 5-3: Equilibrated state of Samples 7-A (a) and 7-B (b) during the water deterioration test.

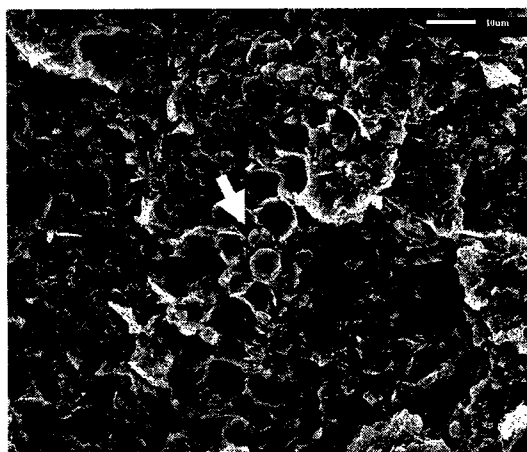
Figure 5-7: Pyrite nodules.

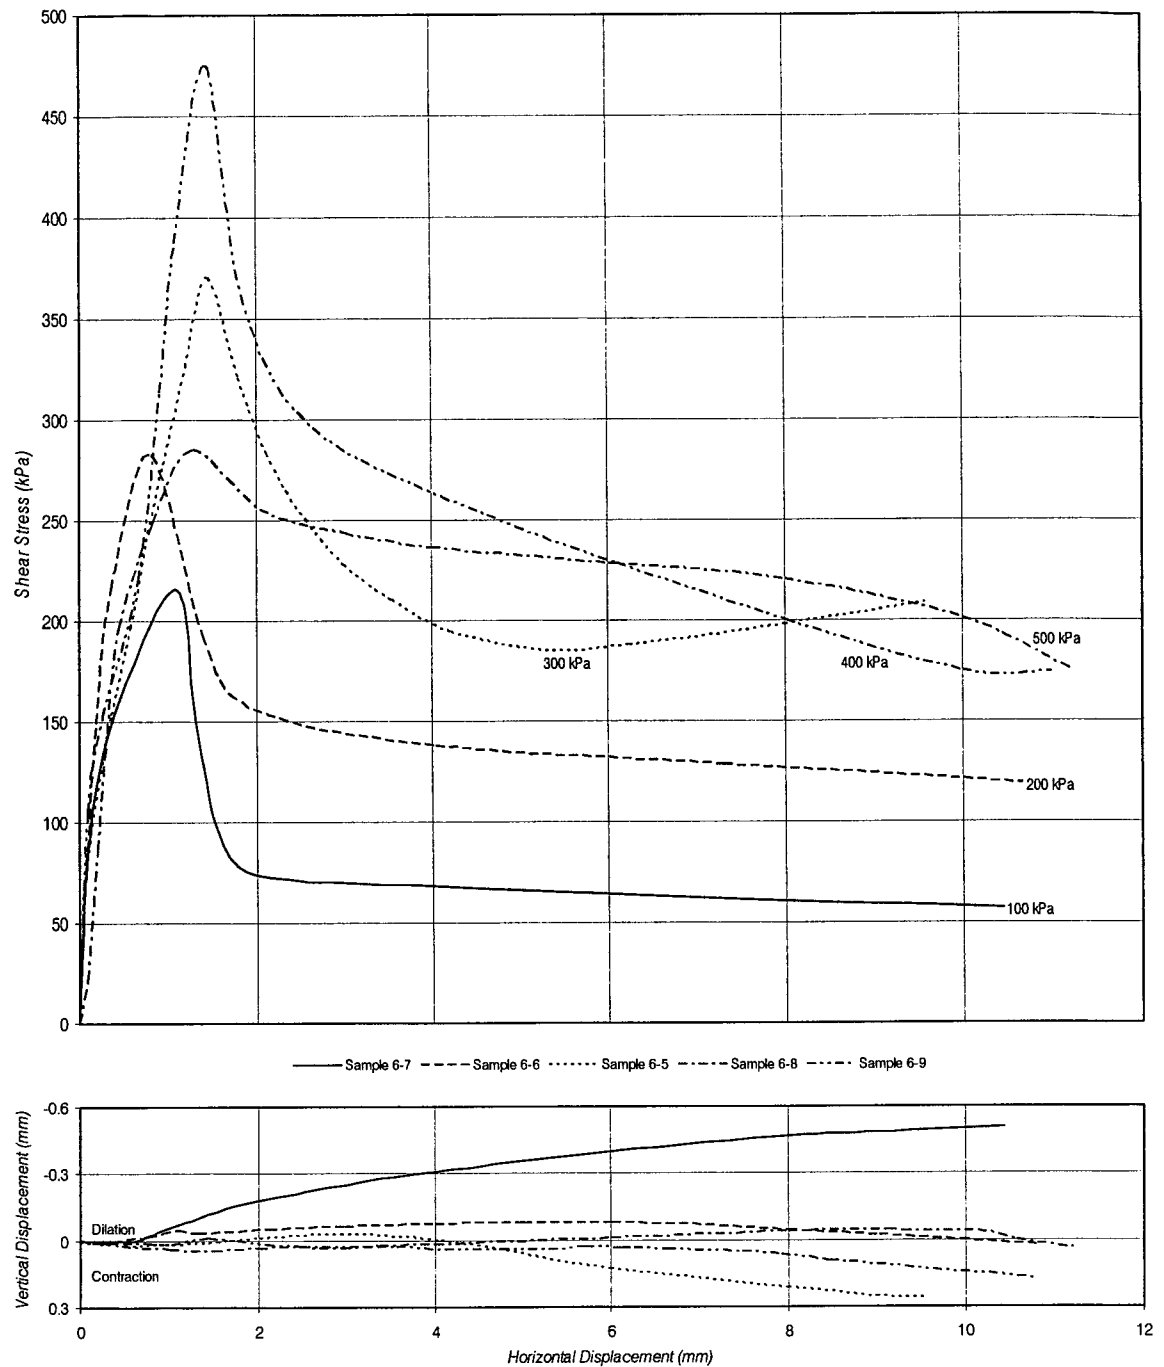
Figure 5-9: Summary of direct shear tests on in-situ samples (peak travel).

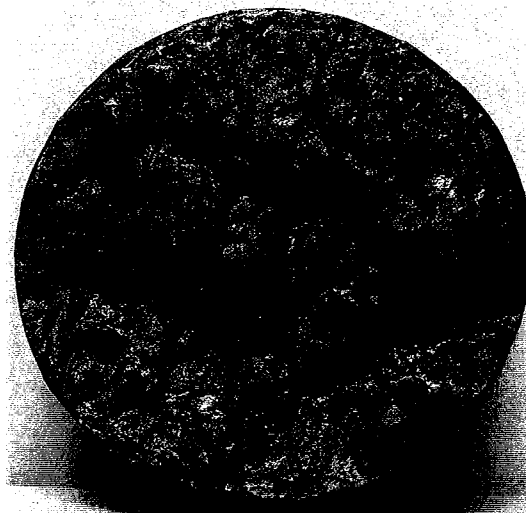
Figure 5-10: Shear surface after peak travel (Sample 6-7).

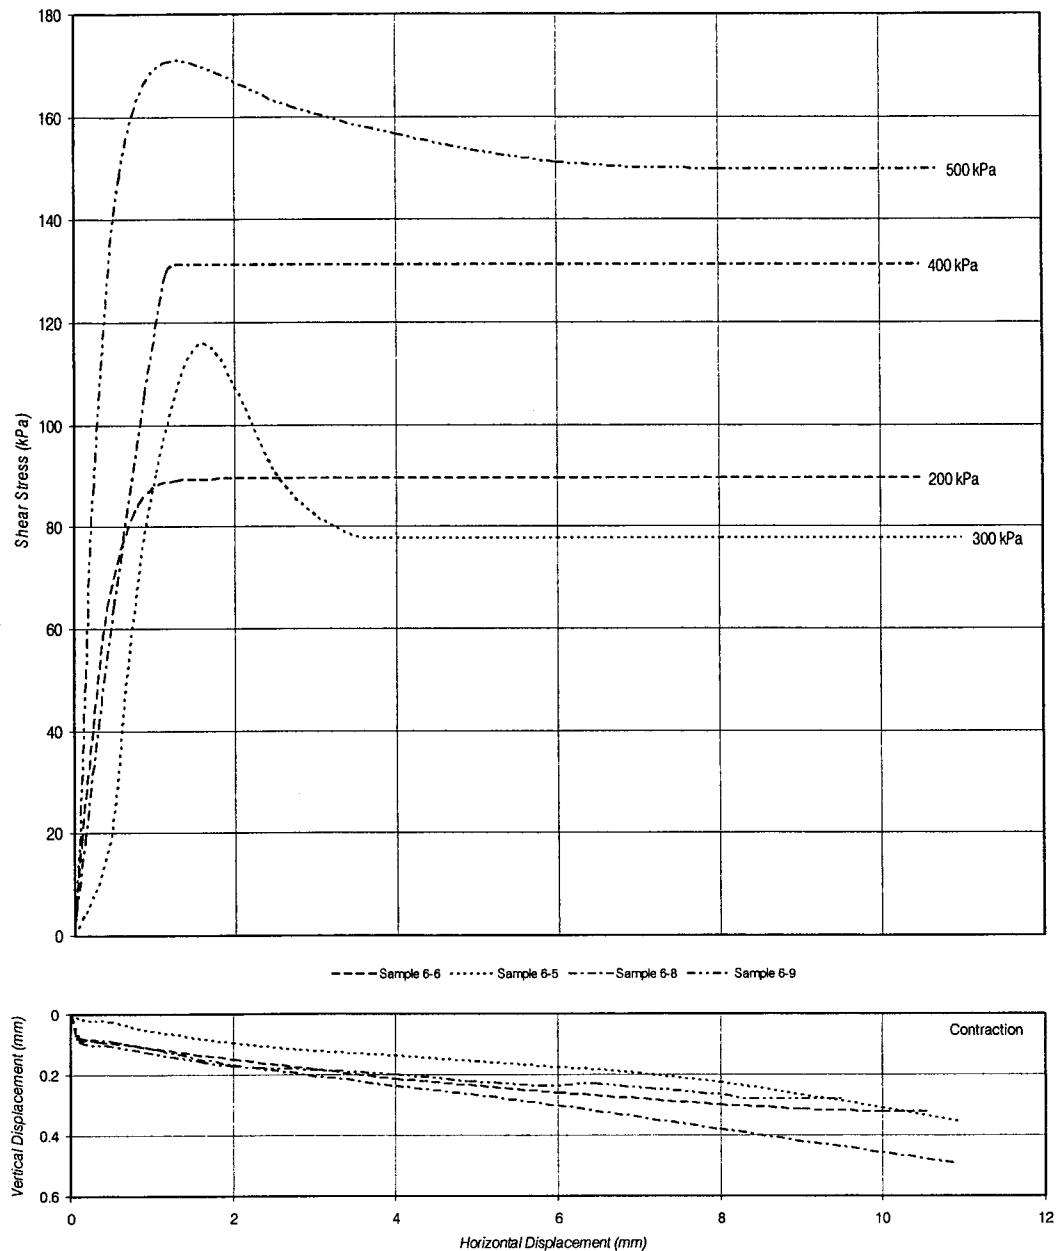
Figure 5-11: Summary of direct shear tests on a cut surface following peak shear (residual travel).

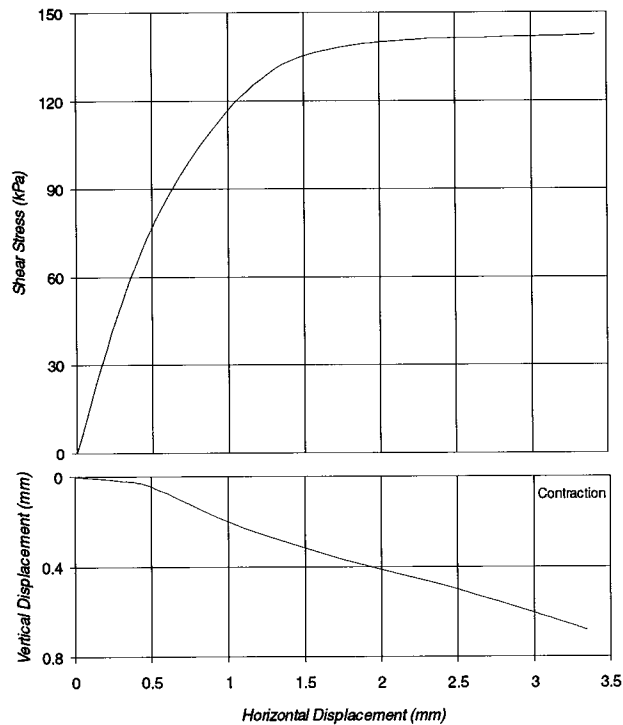
Figure 5-13: Summary of direct shear test on a remoulded sample.

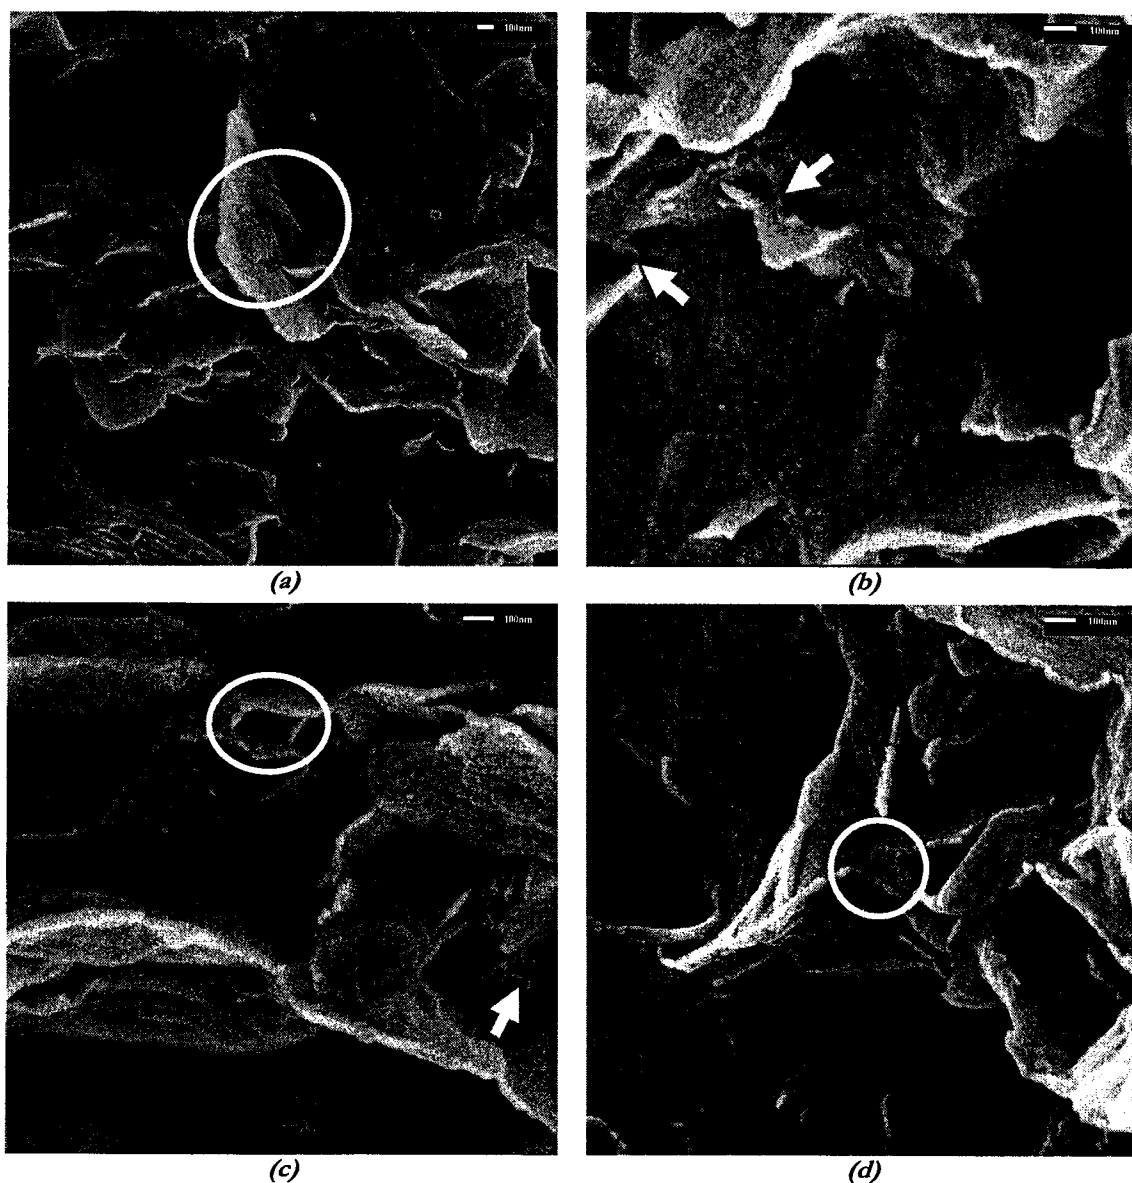
Figure 5-19: *Shale fabric from the dry SEM analysis, illustrating the possibility of cementation.*

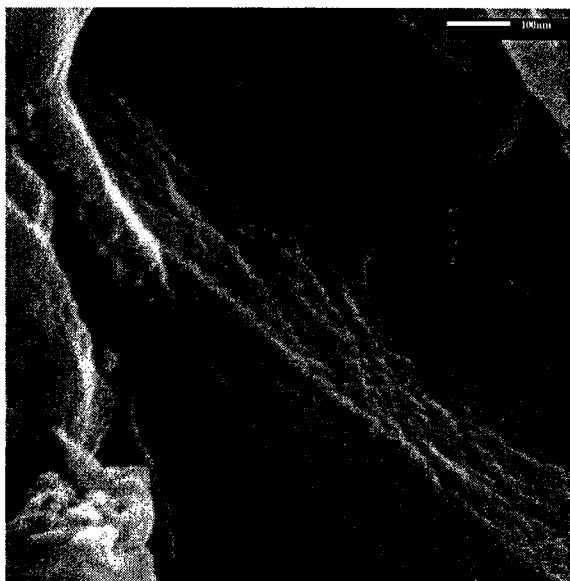
Figure 5-20: Possible cementation between clay platelets.

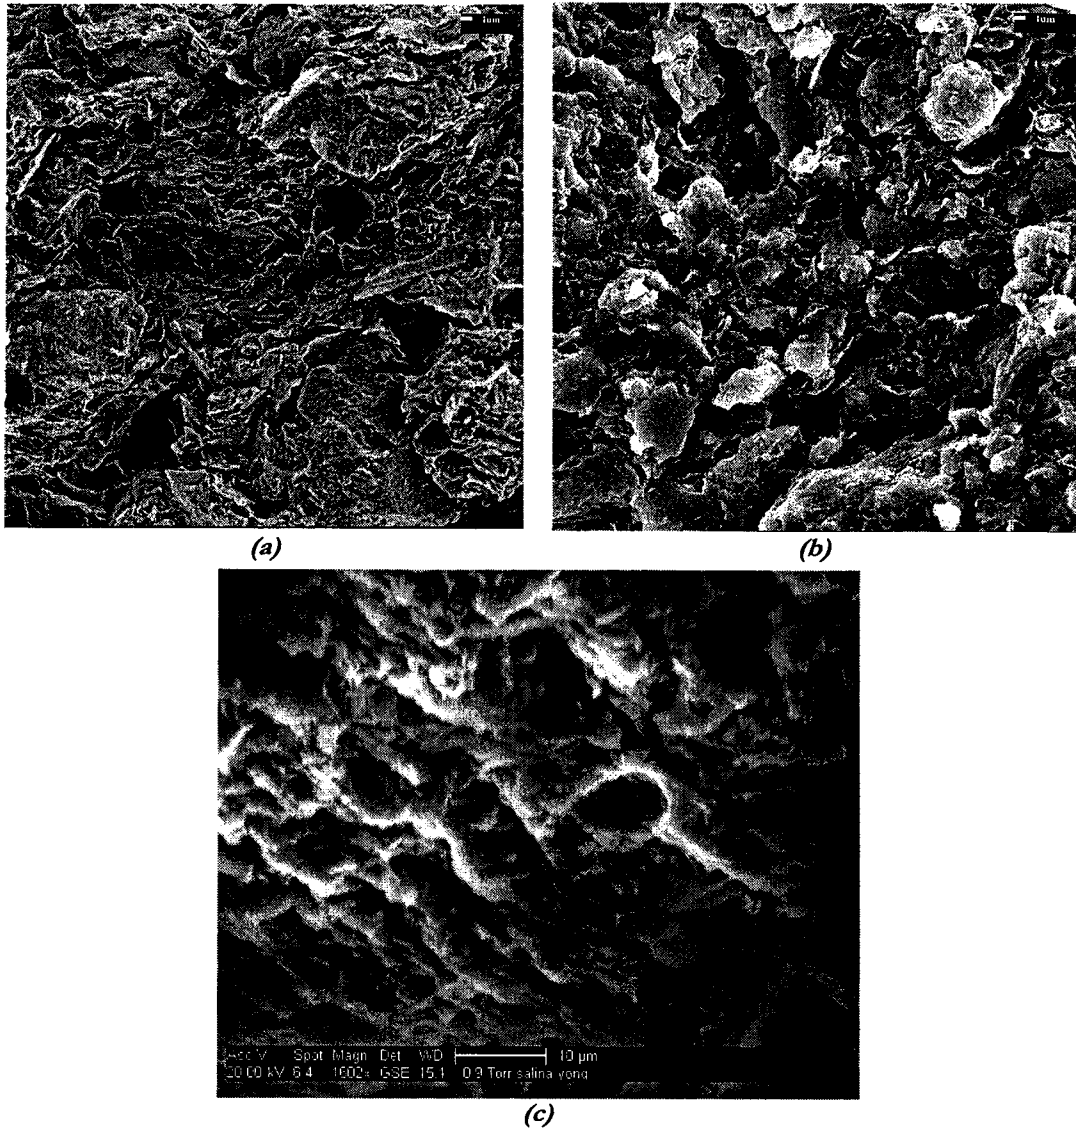
Figure 5-21: Comparison of dry and wet SEM results (a) dry SEM at cross-bedding, 2000X magnification (b) dry SEM at parallel-bedding, 2000X magnification (c) wet SEM, bedding orientation unknown, 1602X magnification.

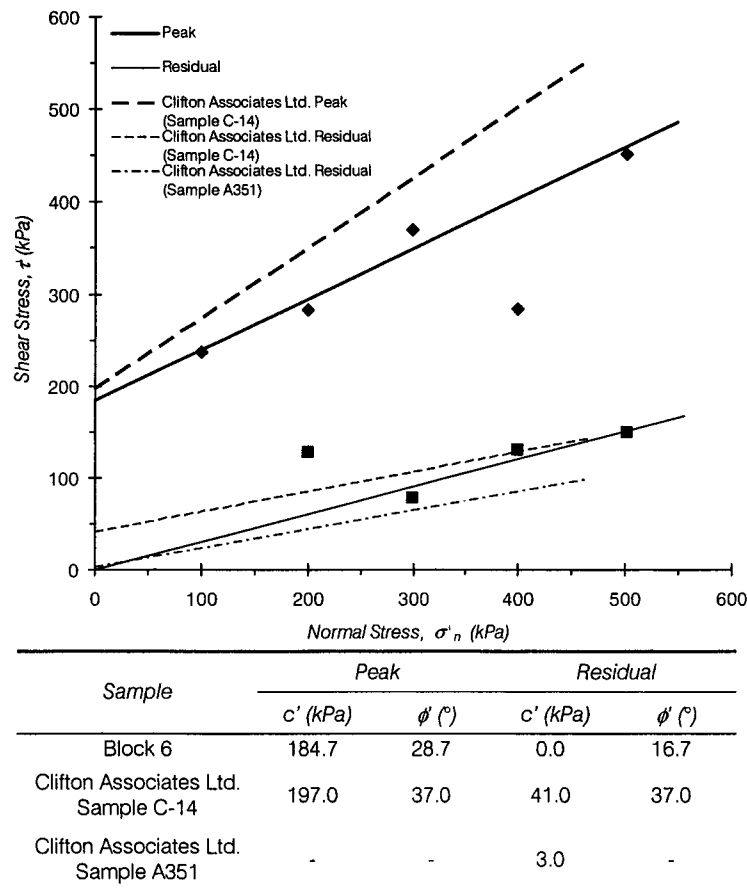
Figure 5-22: Mohr-Coulomb failure envelopes from direct shear tests.

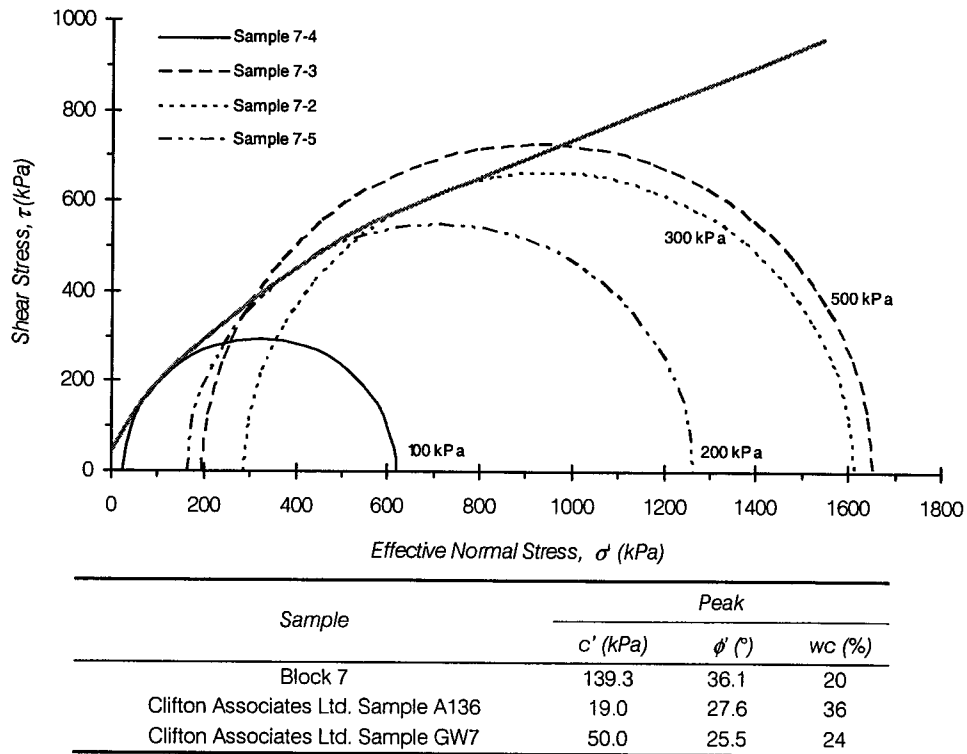
Figure 5-24: Mohr-Coulomb failure envelopes from triaxial tests.

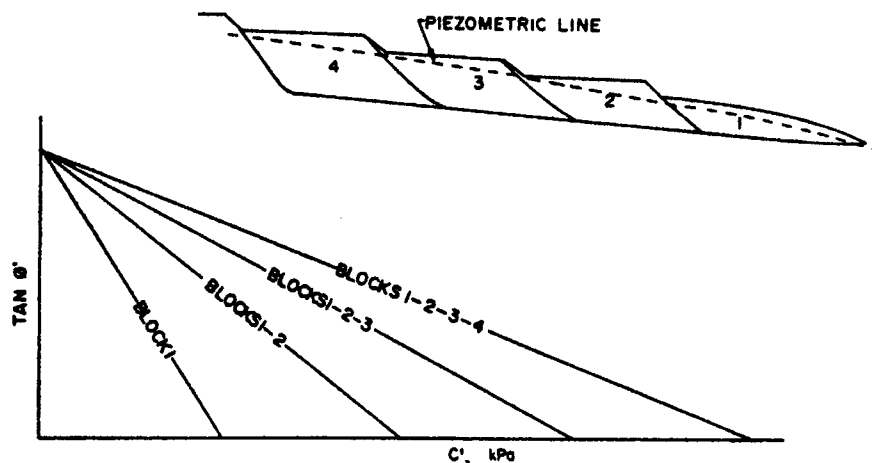
Figure 6-2: An idealized retrogressive failure (modified from Sauer, 1983).

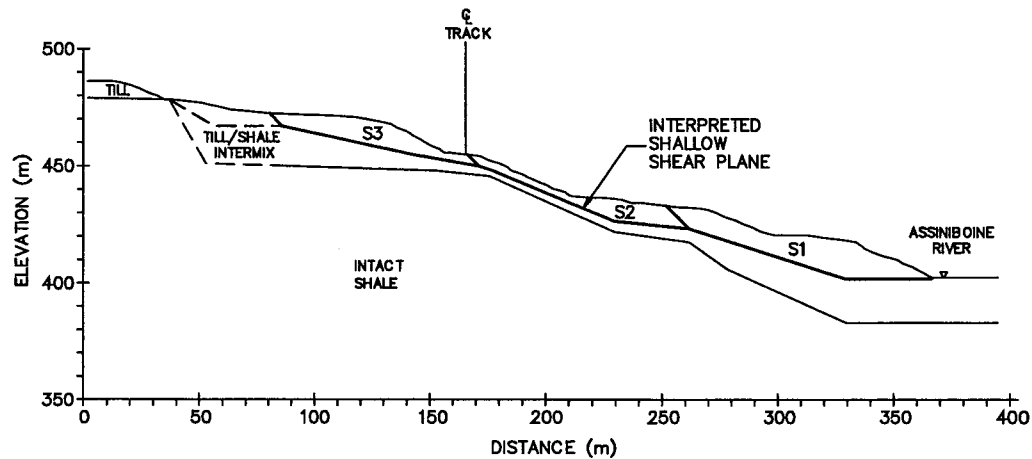
Figure 6-3: Limit equilibrium model of the shallow-seated failure.

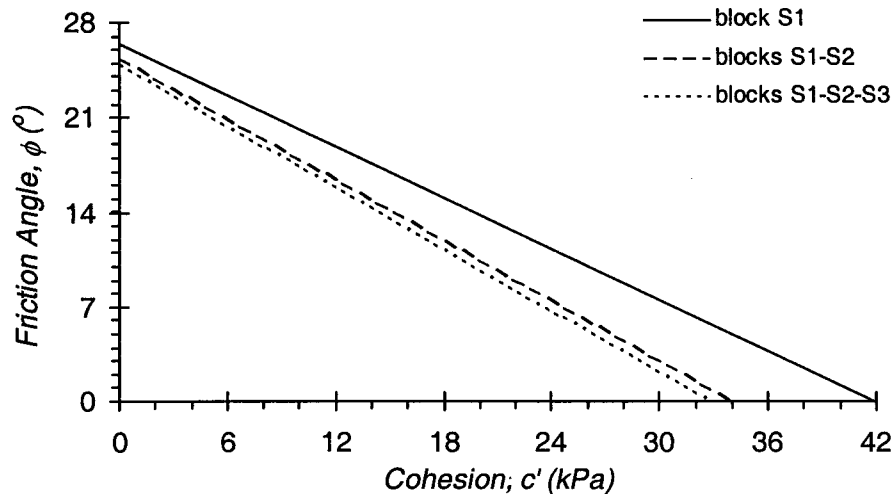
Figure 6-5: Analysis for a retrogressive mechanism in the shallow-seated failure.

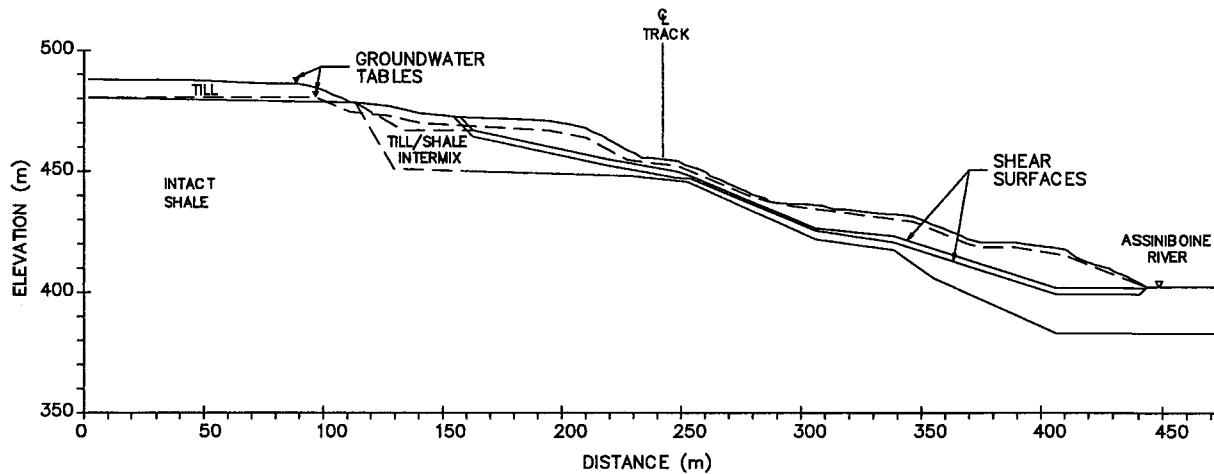
Figure 6-6: Location of the shear surfaces and groundwater conditions used in the sensitivity analysis.

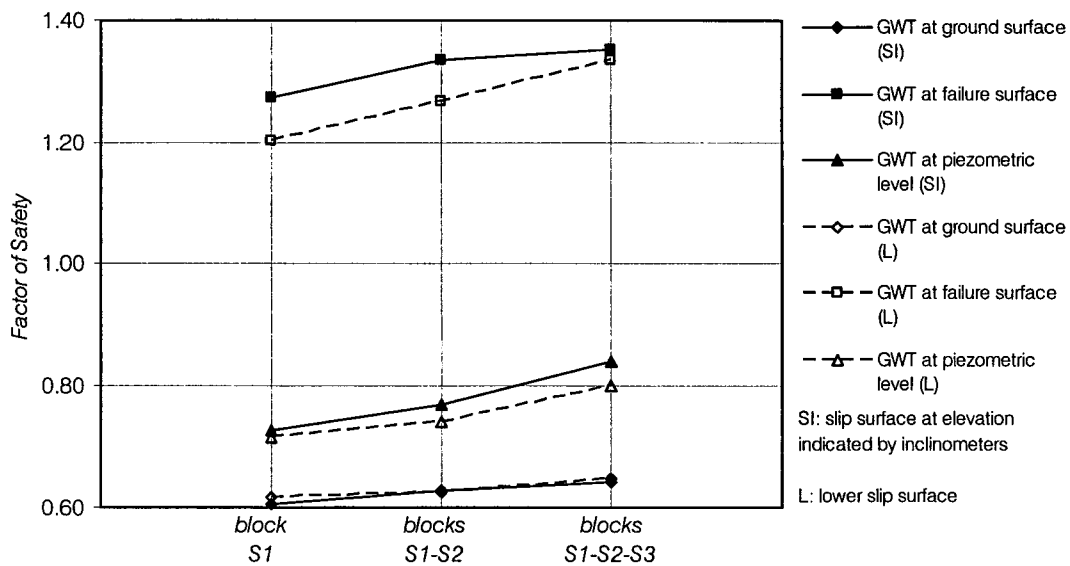
Figure 6-7: Sensitivity analysis of the location of the shear surfaces and groundwater conditions.
