Title of Thesis: A Slide in the Harrowby Hills

A thesis submitted to the Faculty of Graduate Studies and Research in partial fulfillment of
the requirements for the degree of Master of Science

Geotechnical Engineering

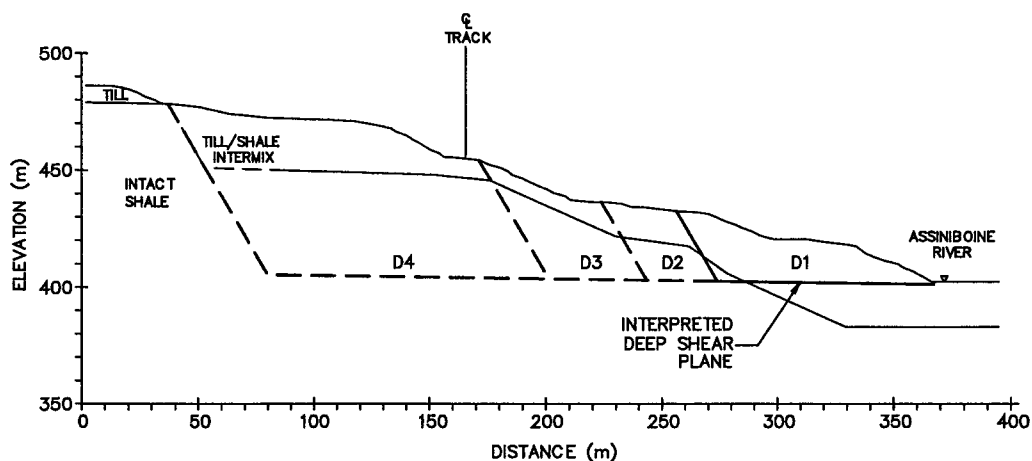
Figure 6-9: Geometry of the possible retrogressive nature of the deep-seated slope movement.

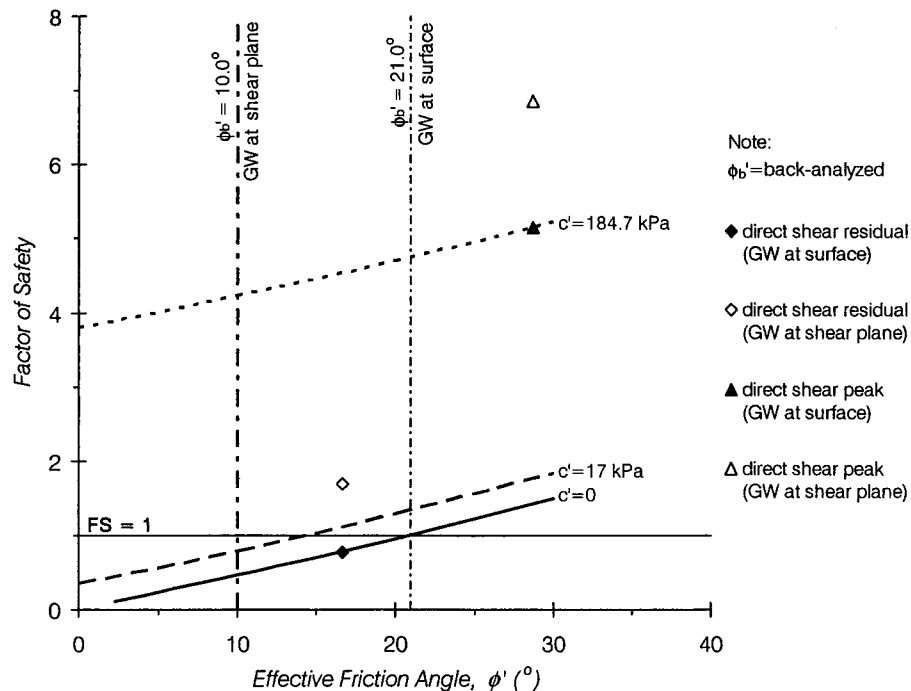
Figure 6-10: Shear strength parameters for the deep-seated failure of the lower block (groundwater at surface).

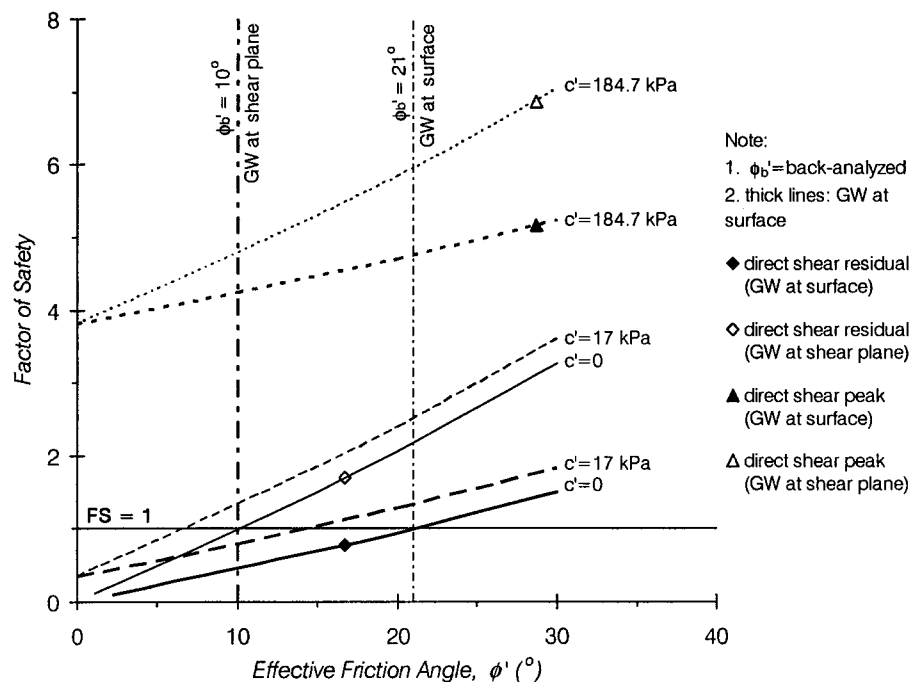
Figure 6-12: Sensitivity analysis of the groundwater conditions in the deep-seated failure.

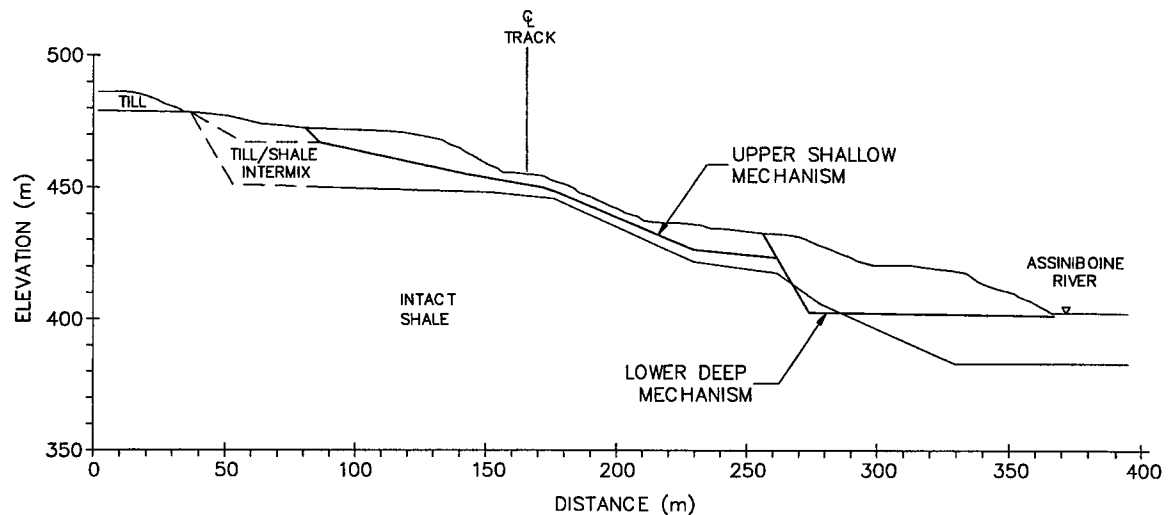
Figure 6-13: Proposed failure mechanism.

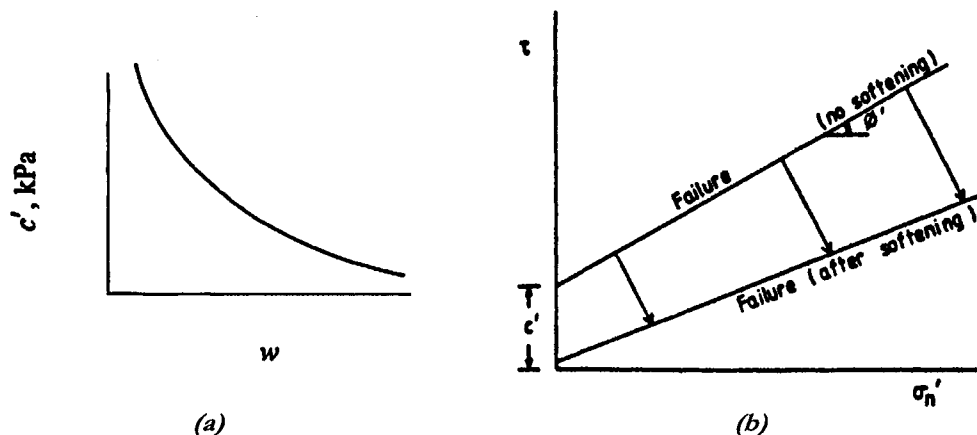
Figure 6-14: Reduction in cohesion: (a) relationship between effective cohesion and water content (modified from Wood, 1990) and (b) reduction of the cohesion component (modified from Chandler, 1984b).

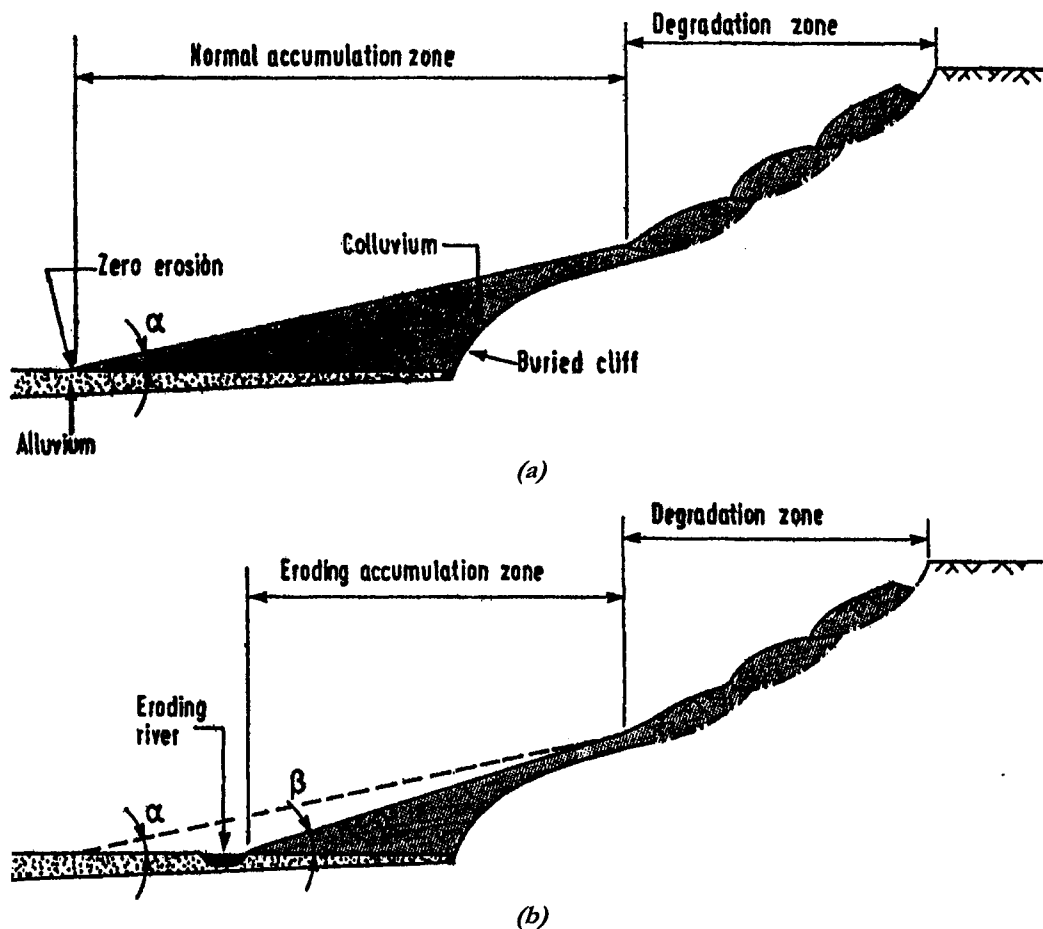
Figure 6-15: Abandoned cliff concept: (a) Hadleigh type with zero erosion and a normal accumulation zone (b) degrading cliff with an eroding accumulation zone (modified from Hutchinson, 1995).

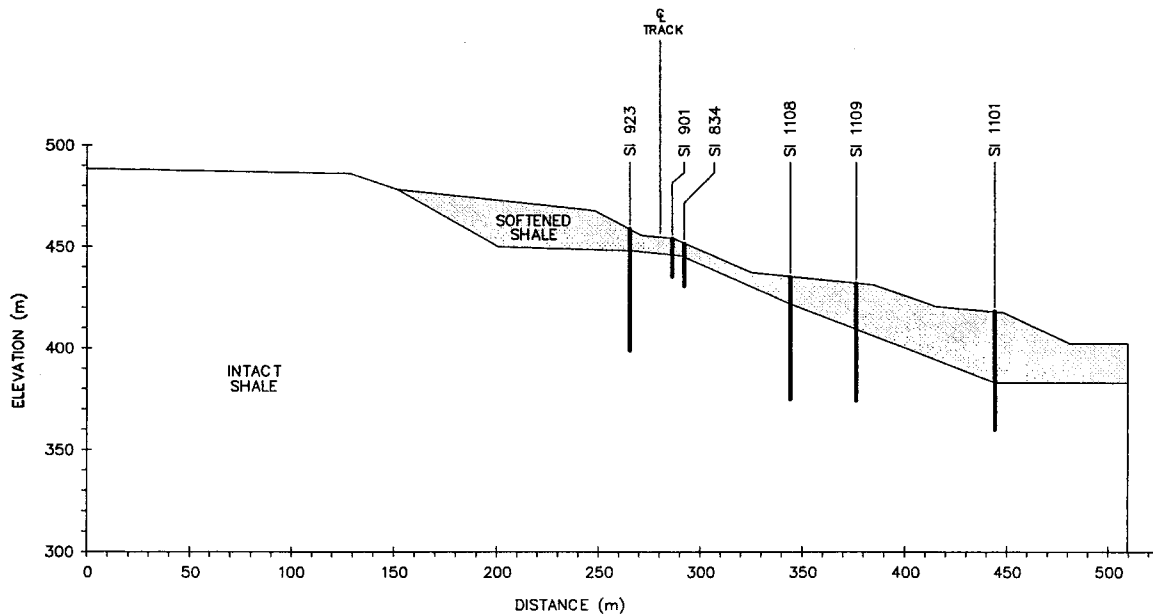
Figure 6-17: Location and depth of the SI data extraction from the FLAC analysis.

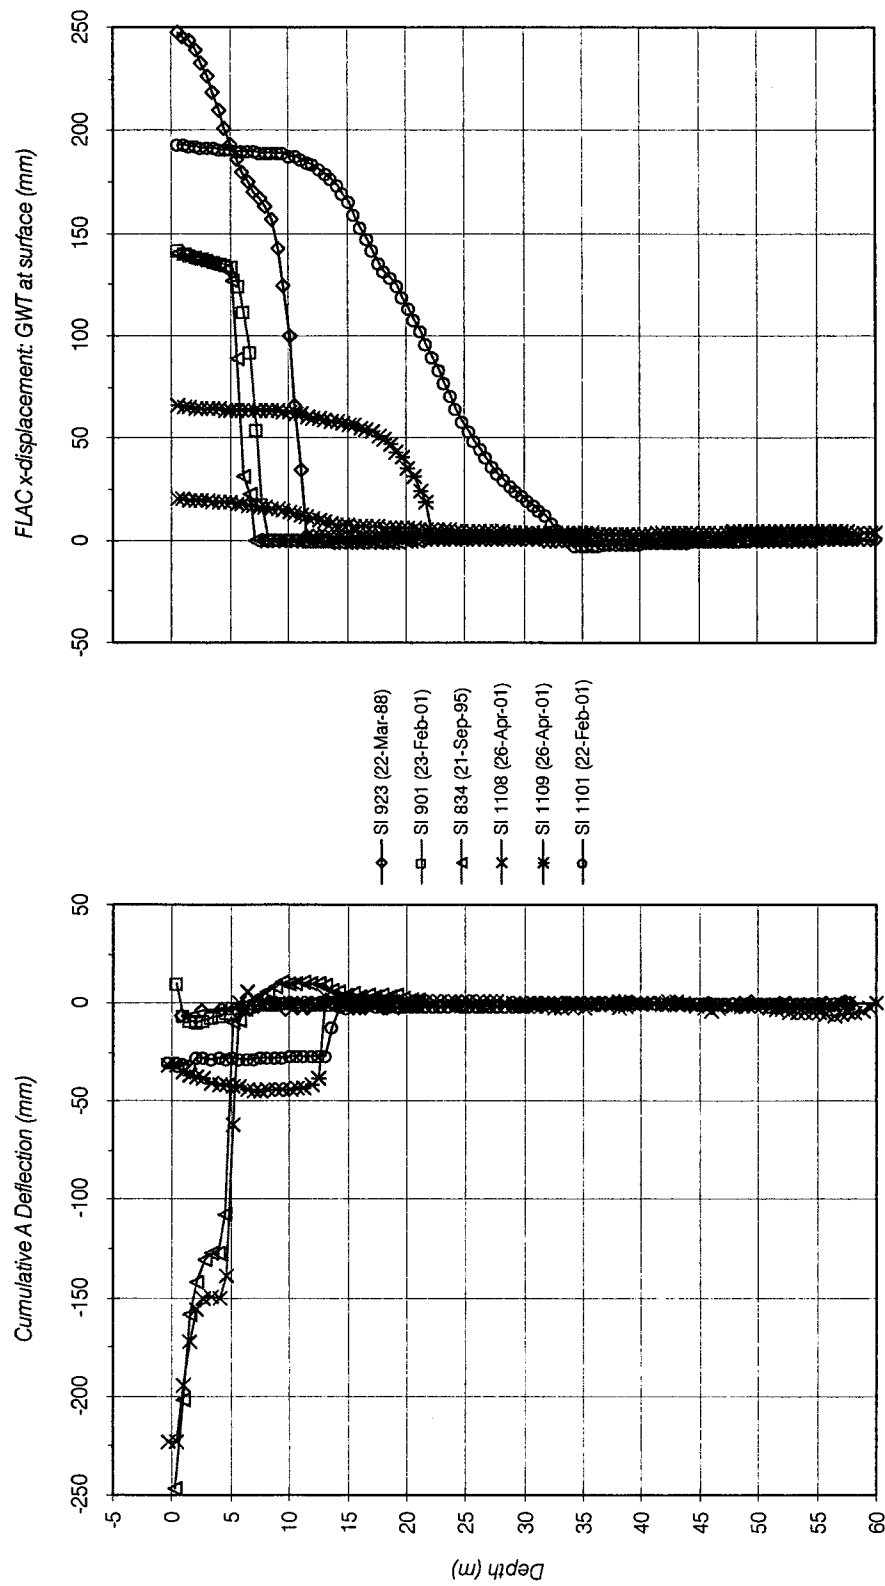
Figure 6-18: Comparison of slope movements between field installations and FLAC trends (inclinometer data assumed negative values for downslope movement, but the opposite was true for the FLAC results).

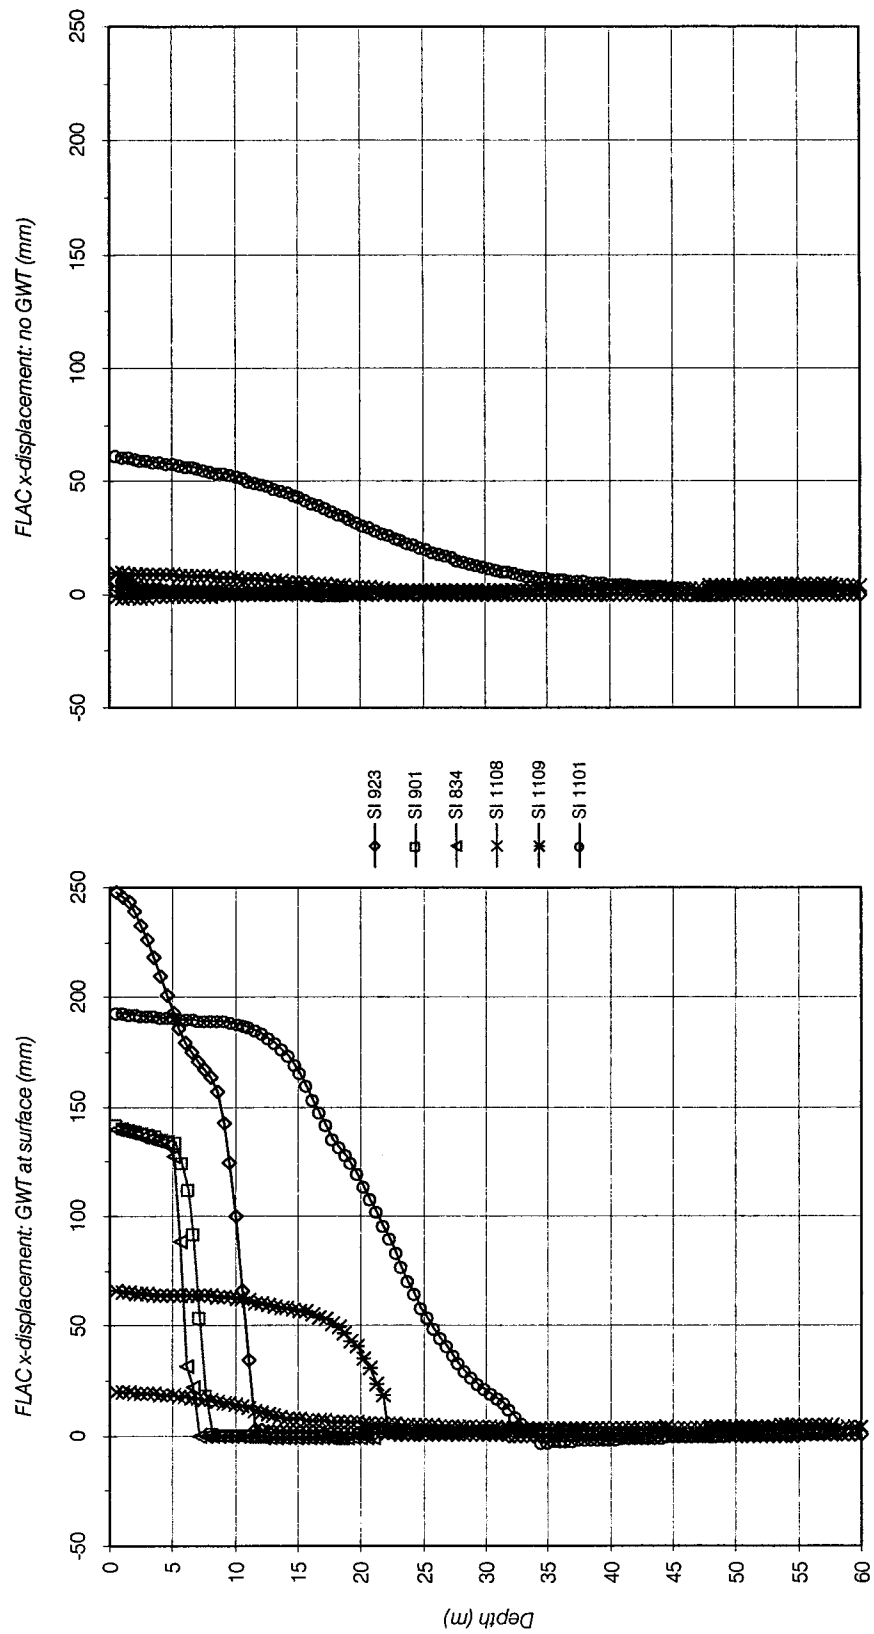
Figure 6-19: Slope movement trends from FLAC at different groundwater conditions.

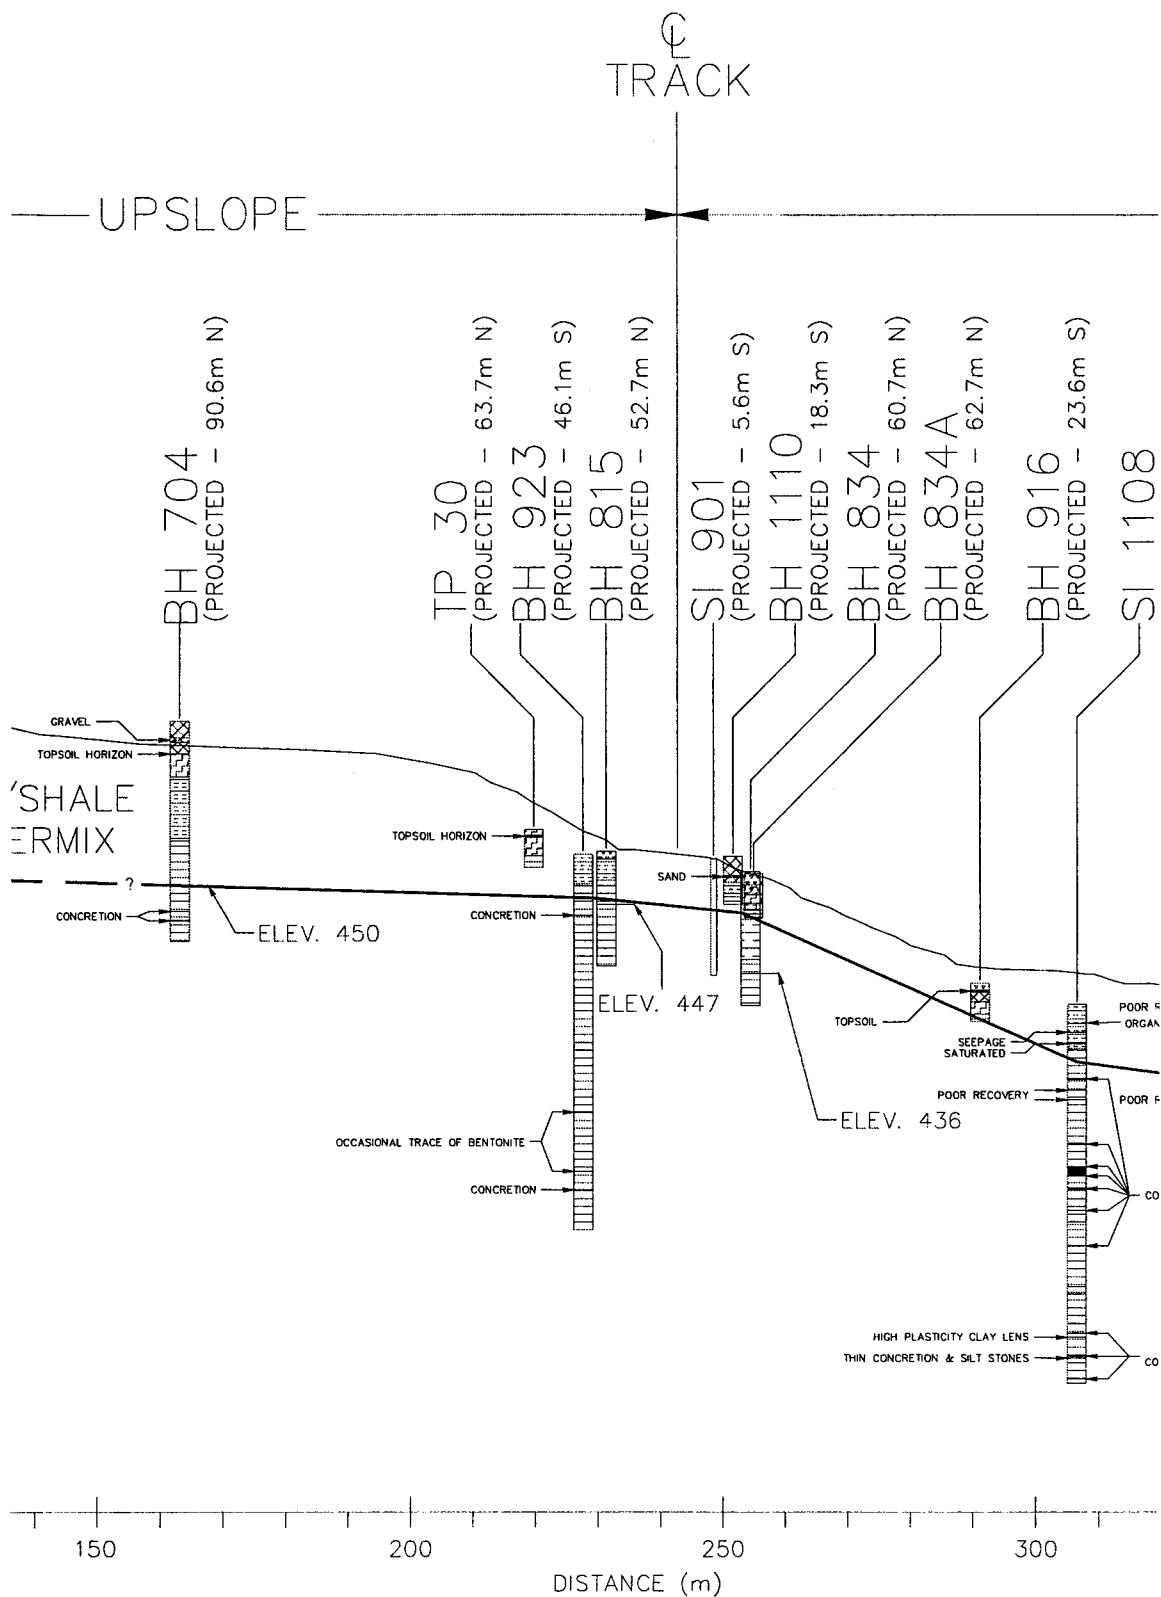
Figure A-21b: Enlarged section of the stratigraphic interpretation Figure 4-11 (cont.).

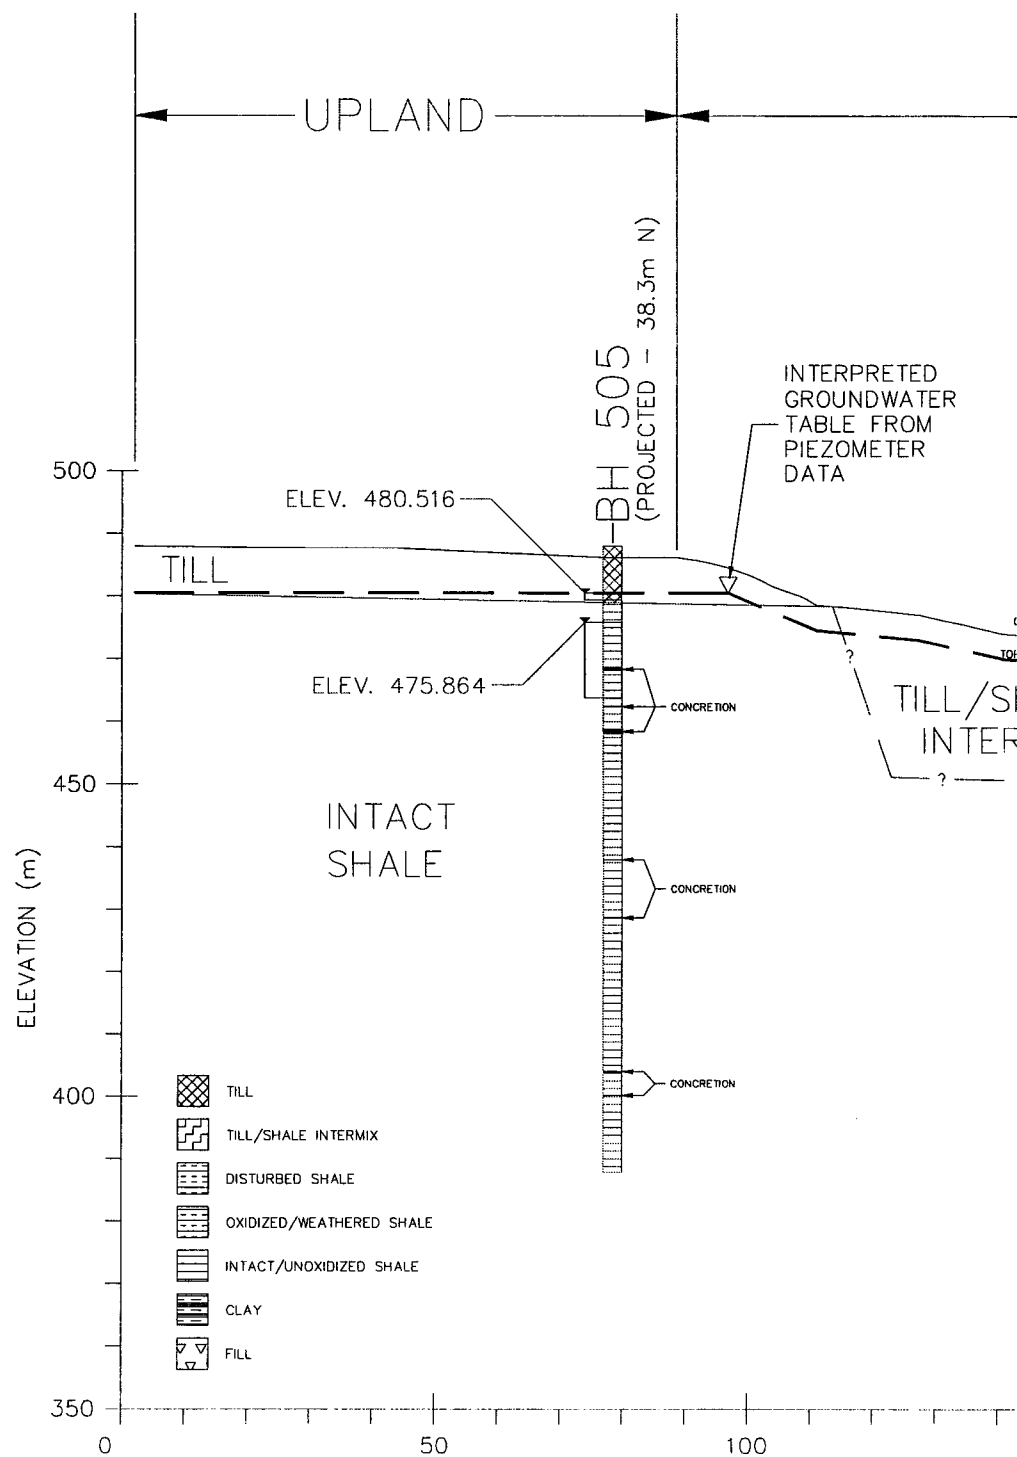
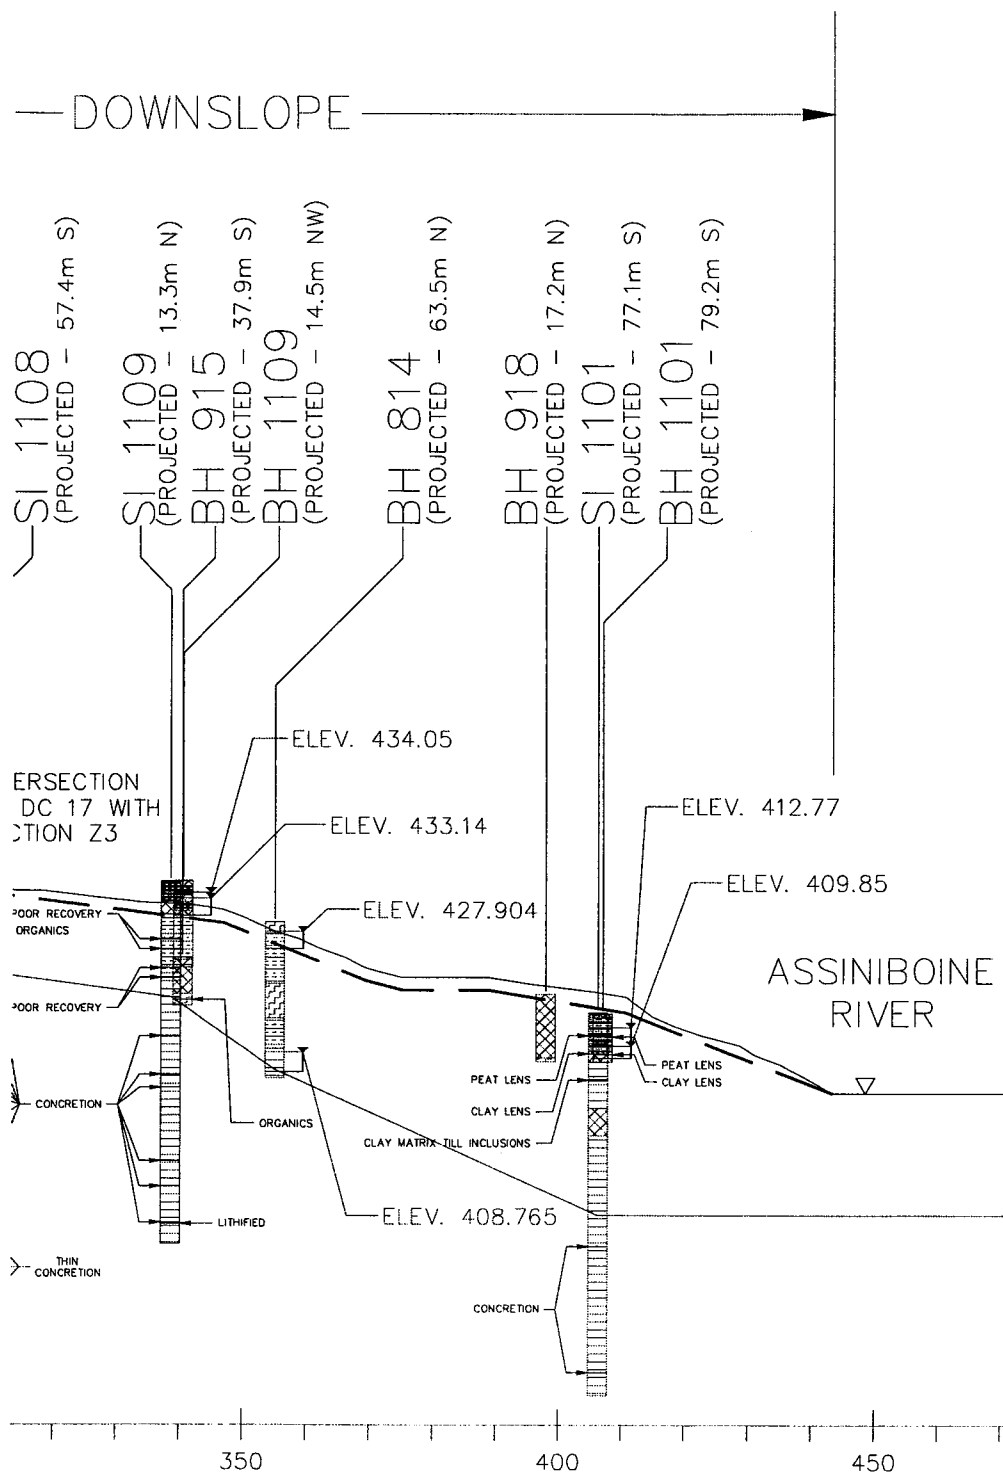
Figure A-22a: Enlarged section of the groundwater conditions of Figure 4-15.

Figure A-22b: Enlarged section of the groundwater conditions of Figure 4-15 (cont.).

Figure A-22c: Enlarged section of the groundwater conditions of Figure 4-15 (cont.).

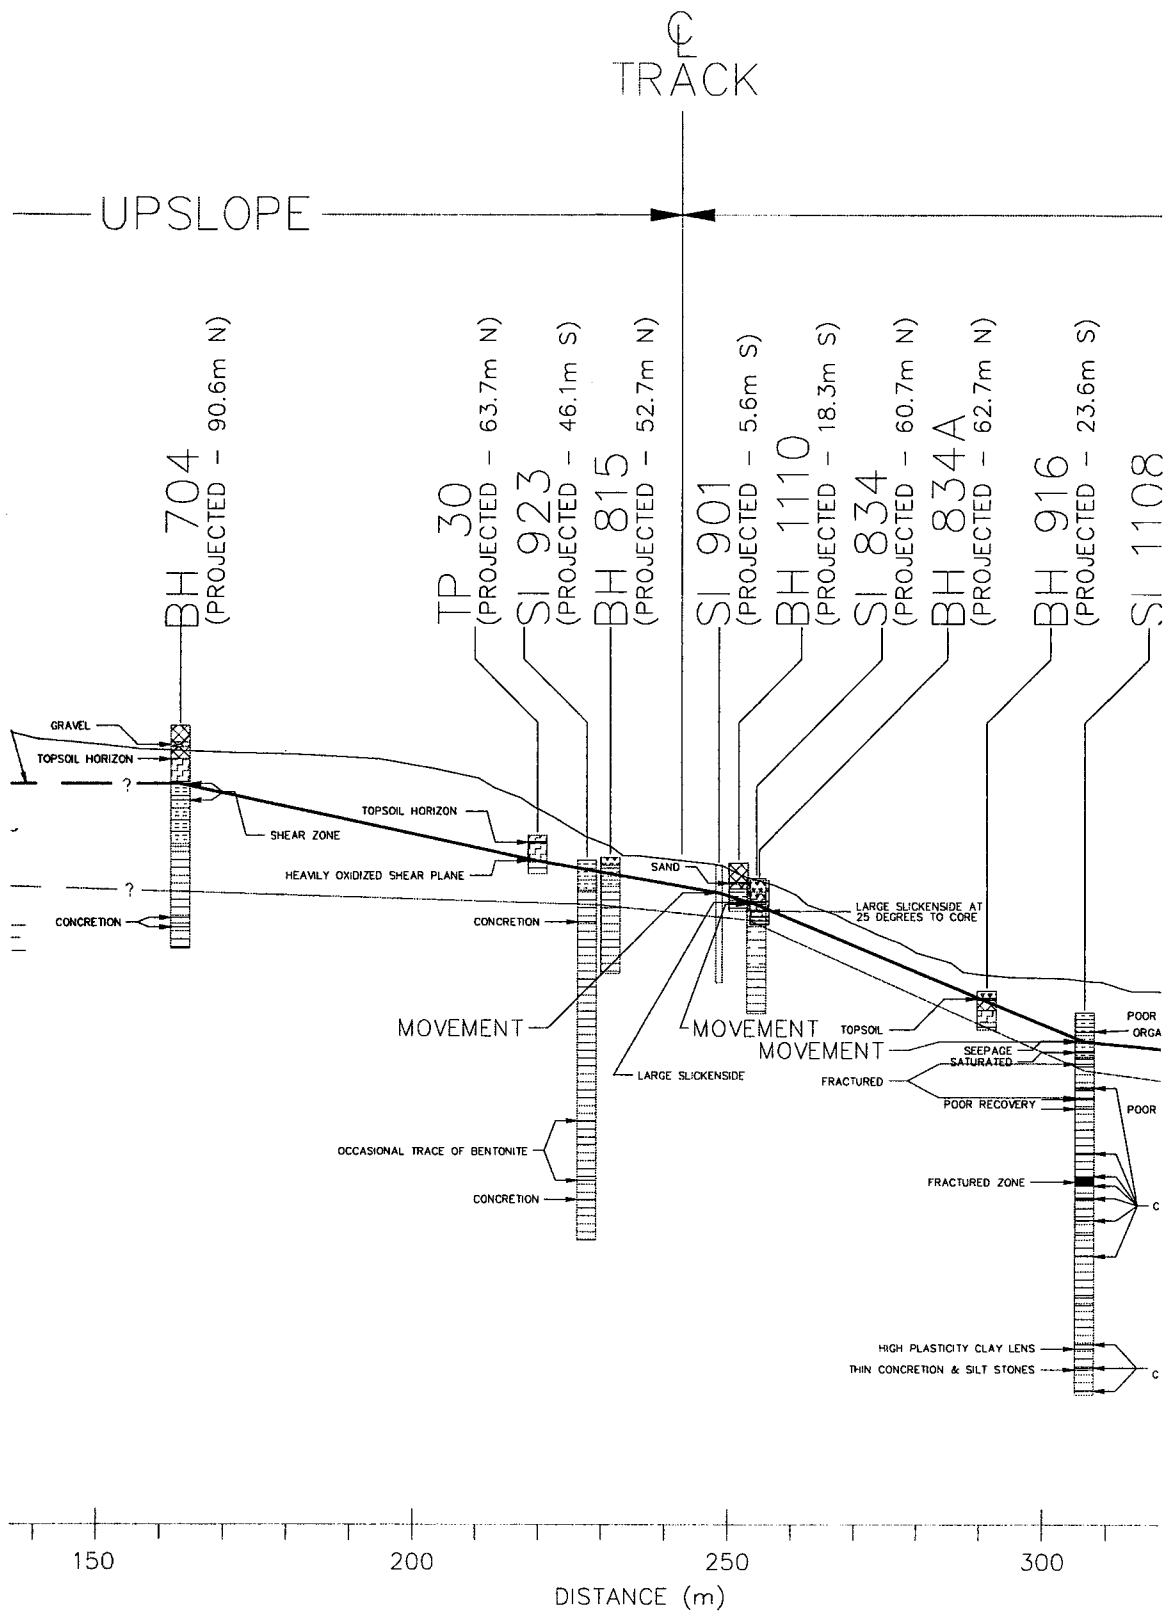
Figure 4-16: Location of the shear plane with enlarged figure (Figure A-23) in Appendix A.

Figure A-23a: Enlarged section of the shear plane location of Figure 4-16.

Figure A-23b: Enlarged section of the shear plane location of Figure 4-16 (cont.).

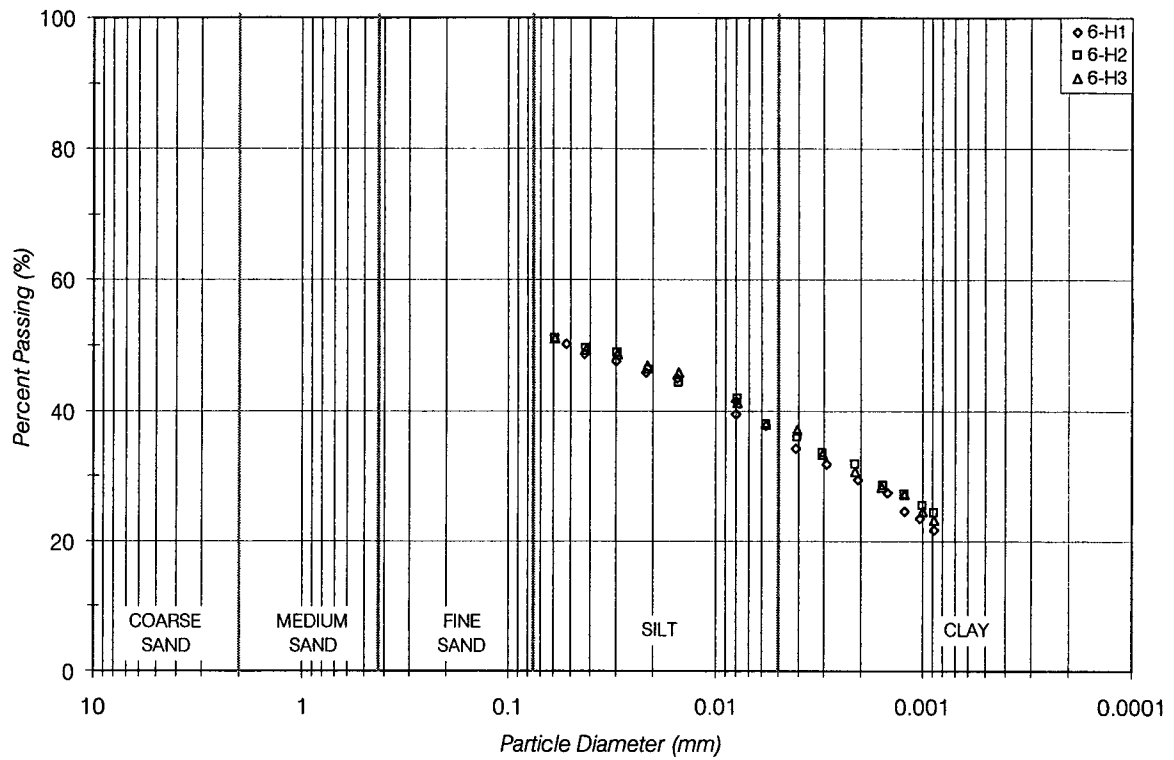
Figure B-1: Grain size distribution of Block 6.
