Masonry Chair Report No. 103–2011

**PROCEEDINGS OF THE
3rd MASONRY MINI SYMPOSIUM
EDMONTON, ALBERTA**

The Art Gallery of Alberta – The Challenges of the Building Envelope Design

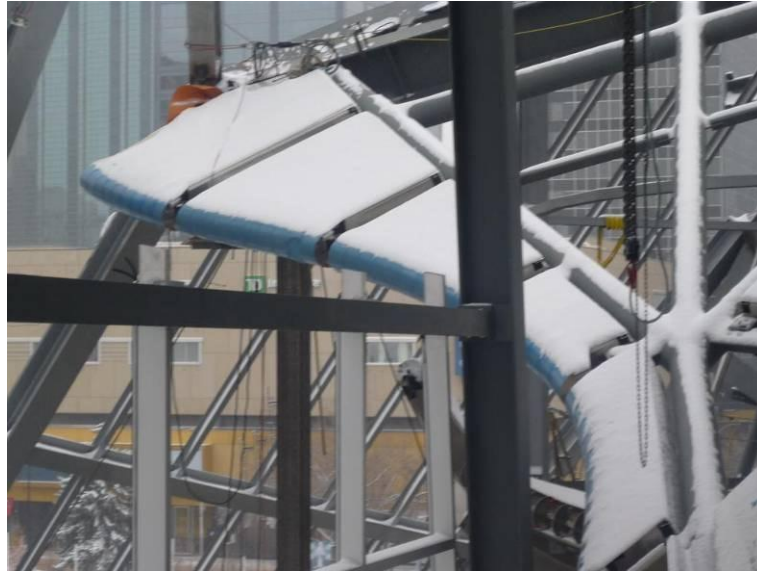
The unique shapes of the exterior portion of the Borealis lead to concerns with the accumulation of snow and ice on the members (Figure 6). As the Borealis is located over the main entrance to the building, it was crucial that water, snow and ice not be allowed to fall onto the entrance space below.

Figure 6: Snow accumulation on Borealis during construction.

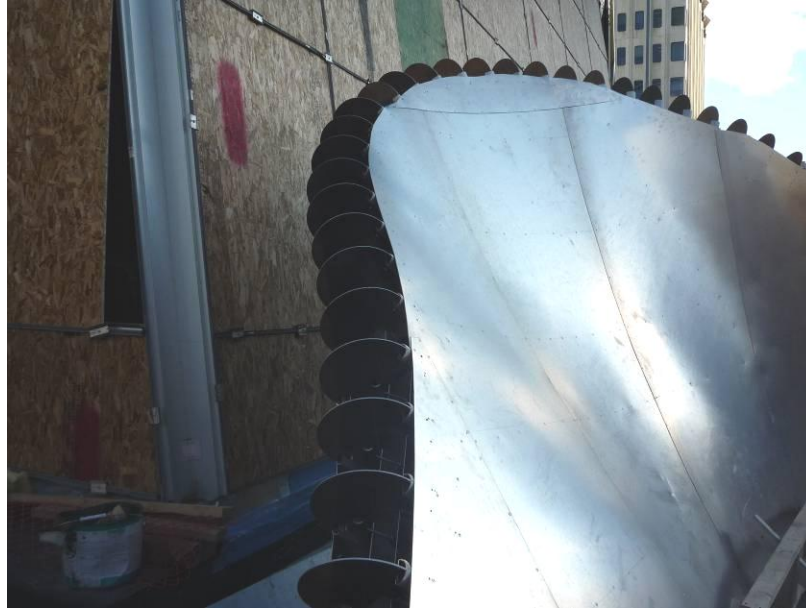
The Borealis is cantilevered from the building and is formed using strips of stainless steel wrapped around prefabricated metal panels that span between the structural steel support members (Figure 8). The Borealis is not critical to the performance of the building envelope (with regard to the interior environment of the building) however, there was concern that water could penetrate the framing of the Borealis, resulting in accumulation of moisture inside the panels. Although drainage paths were provided to allow water inside the panels to exit, should water enter the Borealis cavity, this water could freeze in colder temperatures, resulting in the risk of overloading the members and/or the formation of icicles over the main entrances to the building. In order to reduce the risk of water penetration, the panels will be waterproofed prior to application of the finished steel cladding. The self-adhering sheet membrane will be sandwiched tightly between the metal liner and the exterior stainless steel cladding as the construction method of the metal skins did not permit a vented drainage plane.

Figure 8 Prefabricated Borealis panel prior to installation on building.

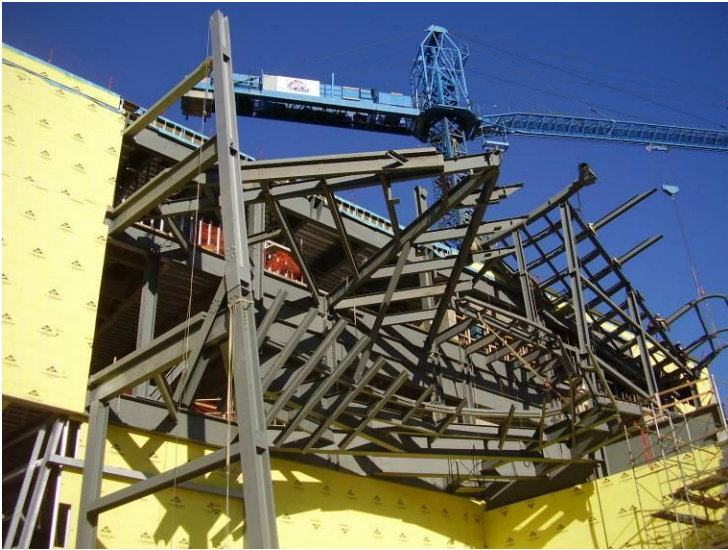
However, the cantilevered design of the Borealis creates areas where the structural steel framing pierces the building envelope (Figure 10). This creates thermal bridges where the steel passes from a warm conditioned space to the exterior of the building. In cold weather, this can cause the interior steel temperature to drop, increasing the risk of condensation on the interior spaces. As it was not reasonable to support the Borealis totally from the exterior, two measures were taken to reduce the thermal bridges.

Figure 10: Structural steel framing for Borealis.

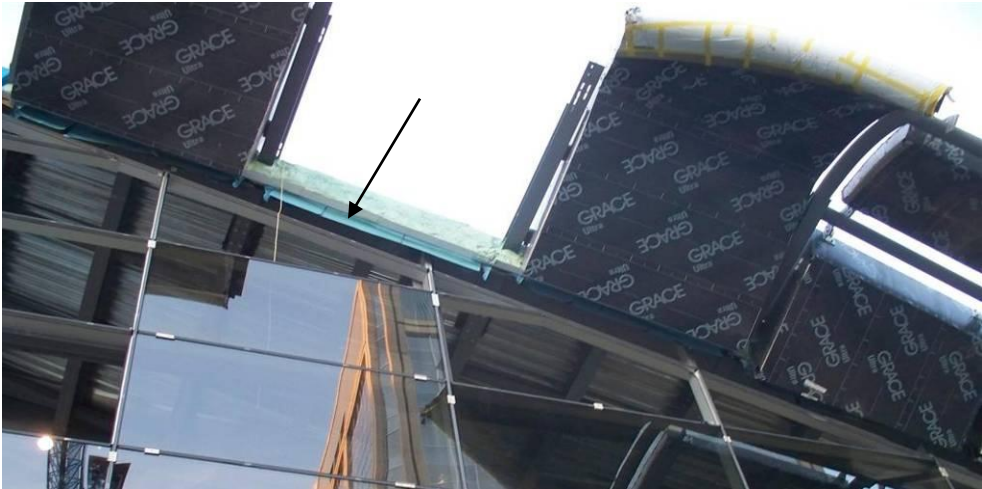
Secondly, since there were still small thermal bridges created by the bolts used to fasten the sections together, there was a small risk that condensation could still form on the interior surfaces of the steel. To reduce this risk, the interior section of steel was sprayed with an air barrier, vapour retarder insulating foam for the first 400 mm to 600 mm of section adjacent to the exterior wall (Figure 12). The intent of the foam was to prevent the cooler steel in this area from coming in contact with the warm, humid interior air, thereby reducing the risk of condensation forming on the steel. A fire retardant coating will be applied to the foam to address fire code concerns.

Figure 12: Foam applied to exterior steel prior to panel erection.

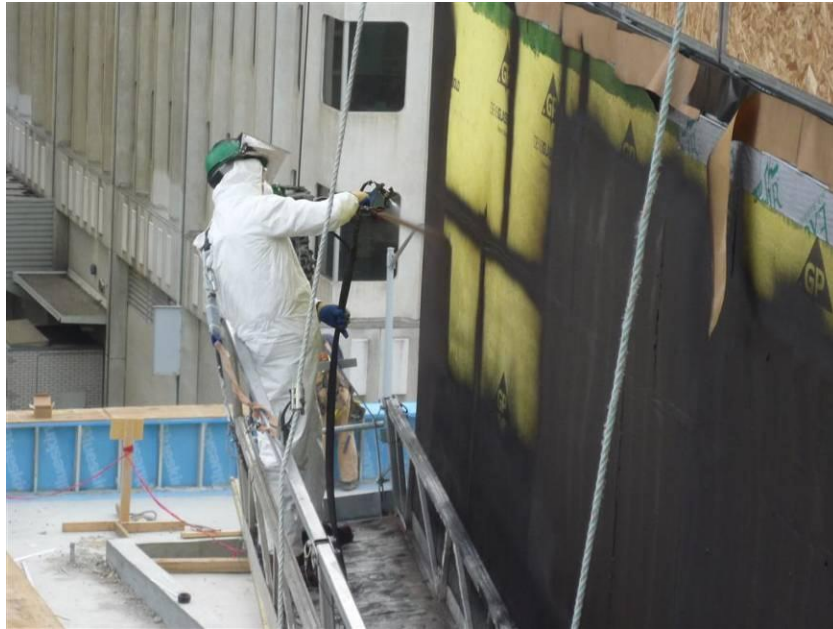
Visual inspection was also performed to examine the uniformity and coverage of the coating. The membrane could also easily be repaired or additional material added as required.

Figure 13: Application of sprayed membrane.

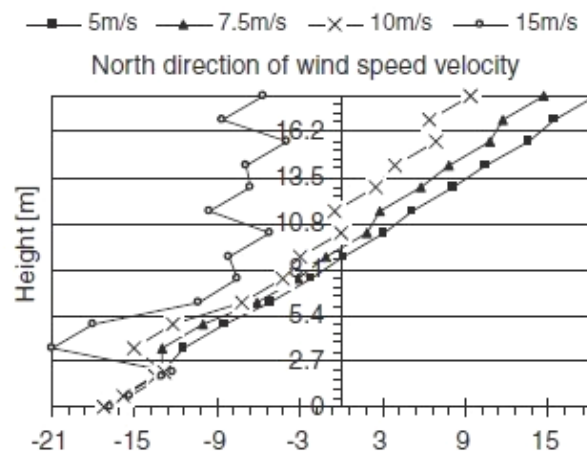
Total air infiltration increases with the rising of the wind speed (Khoukhi et al., 2007). The effect of the wind speed on the pressure difference between the stairwell and outside is insignificant for a small value of the wind speed velocity. At high wind speed, the effect is very strong and the pressure difference curves are not linear in shape. Figure 2 shows the research result.

Figure 2—Pressure difference caused by stack effect (Khoukhi et al., 2007)

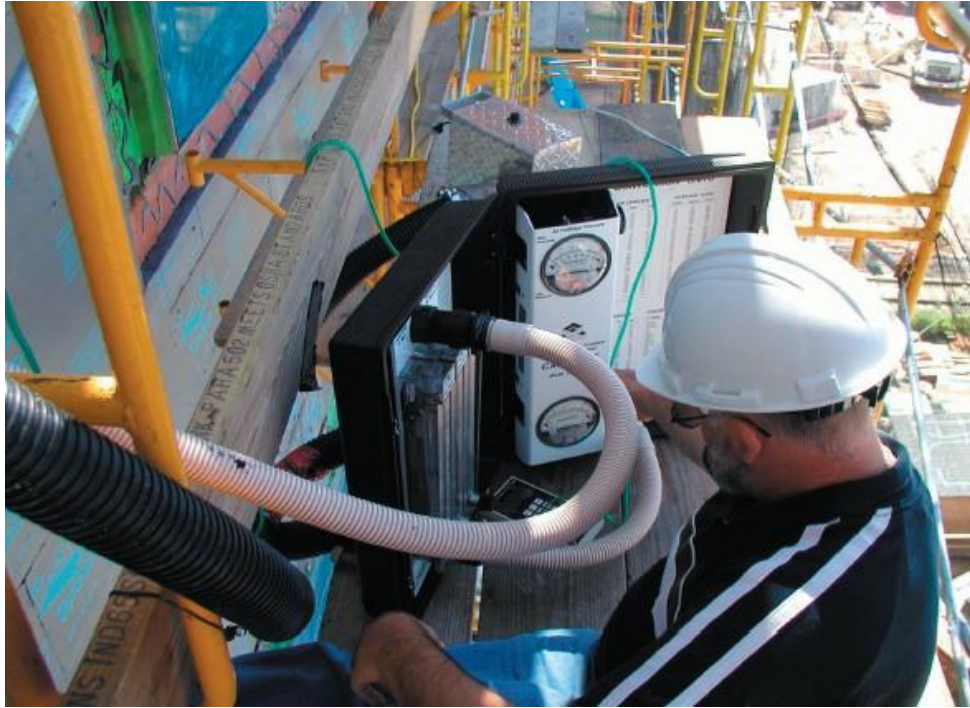
An air leakage test is carried out by installing a test chamber to the masonry wall and attaching a fan into the chamber. Flow readings are taken during the testing. While applying a certain fan speed, the air flow rate and the pressure difference across the building envelope are read. Typical pressure differential is in the range of 75 to 150Pa. The test results are affected by site conditions, therefore, all heating, ventilation and air conditioning systems must be turned off during the test. All openings including waste pipes to the outside must be sealed. In addition, when calculating the air leakage rate, a correction should be done with different site conditions. The major standards related to air leakage test are ASTM E 2357, ASTM E 2178, ASTM E 1186, ASTM E783 and ASTM E 779. Figures 6 to 8 are field test photos displaying a typical air leakage test.

Figure 6—Airtightness test conducted by ASTM E 783(Knight and Boyle, 2010)

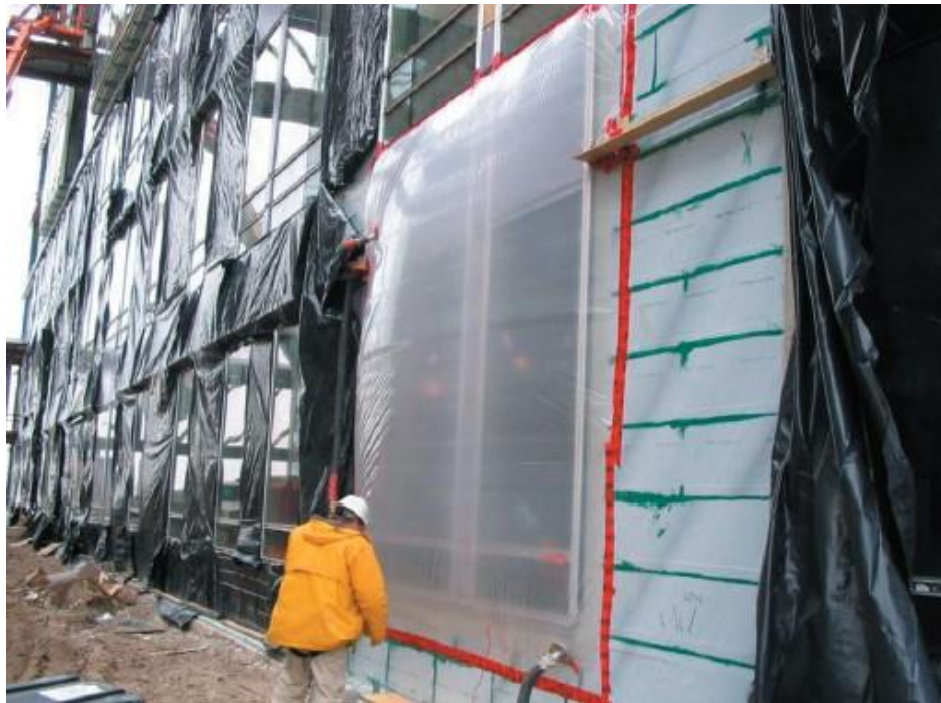
Figure 7—Airtightness test conducted by ASTM E 1186 (Knight and Boyle, 2010)

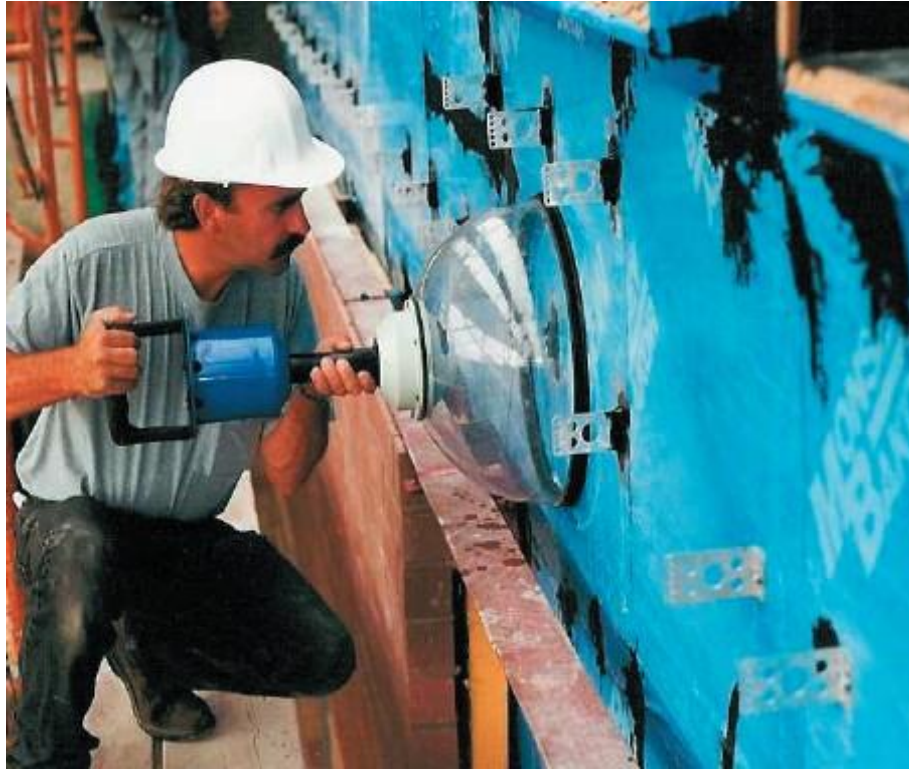
Figure 8—Airtightness test conducted per ASTM E 1186(Knight and Boyle, 2010)

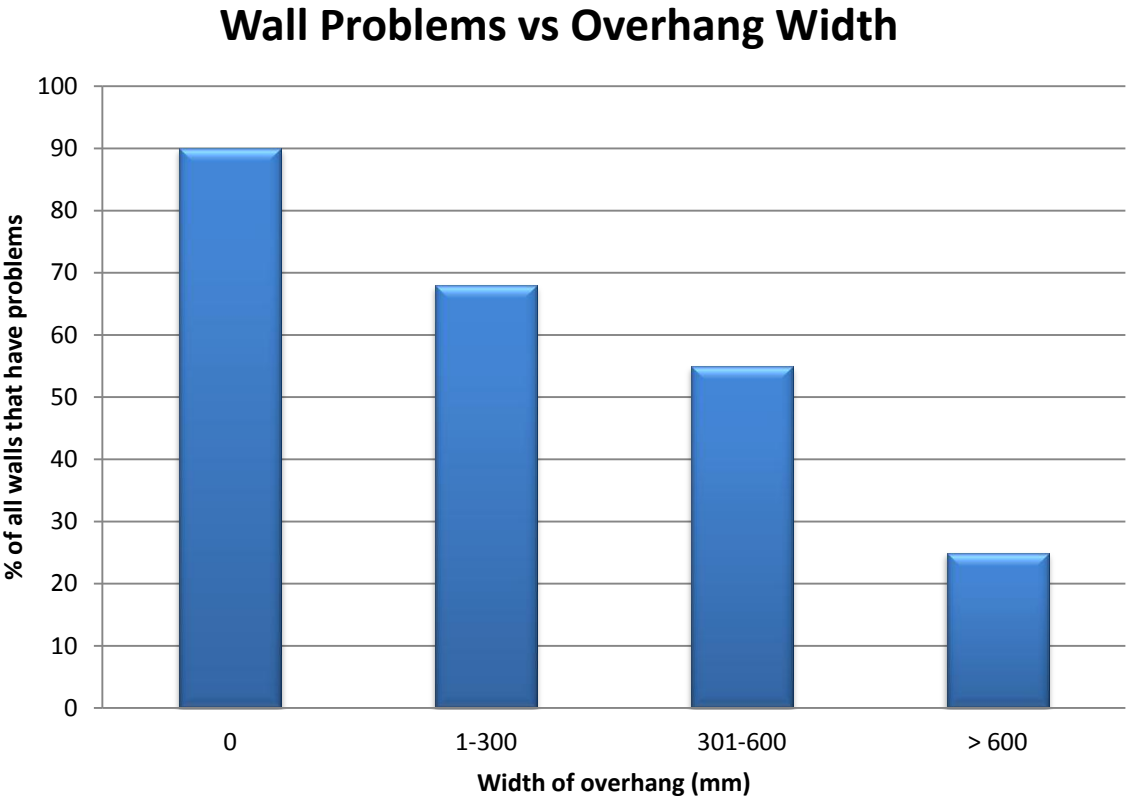
Sloped roofs and overhangs can have a huge impact on reducing the risks of having walls with problems due to rain as shown in Figure 9. Overhangs help shelter portions of the wall from direct impact of the rain.

Figure 9: Wall problems with respect to overhang size (Straube, 2006)

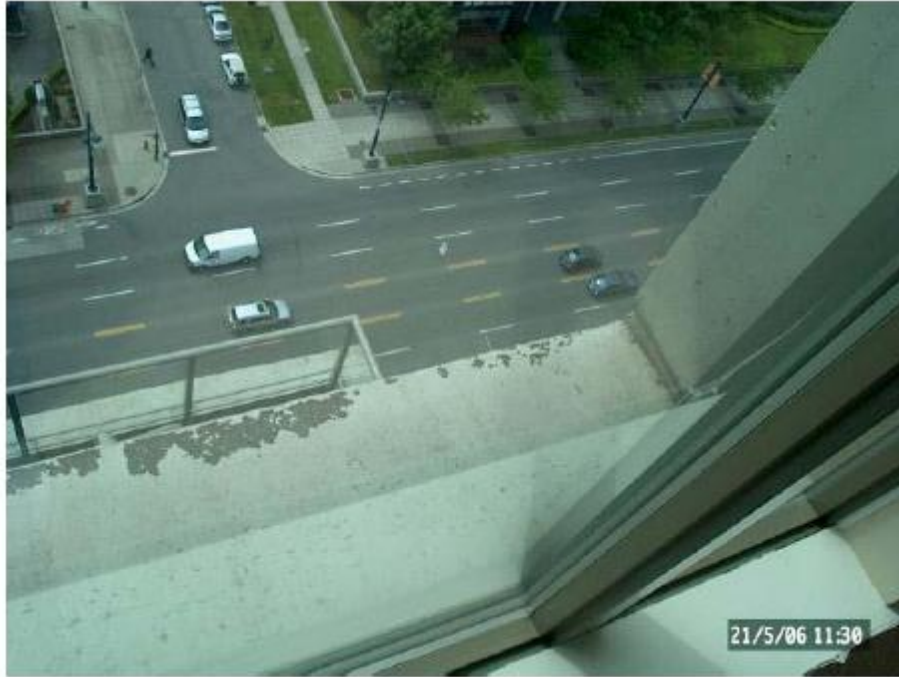
Figure 15 - Slab Projection past Glazing System showing loss of coating from the concrete (Busque, 2010)

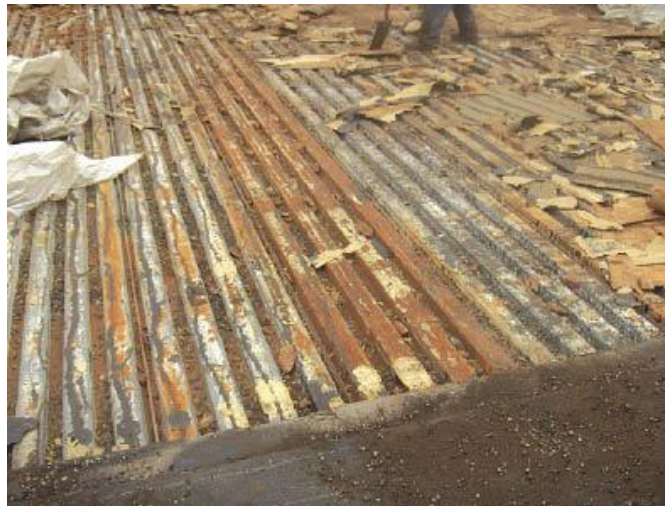
Figure 16 - Corrosion of a metal roof deck caused by water ingress. If left unrepaired, corrosion can cause structural failure in structural metal components such as the roof deck (O'Reilly, 2006)

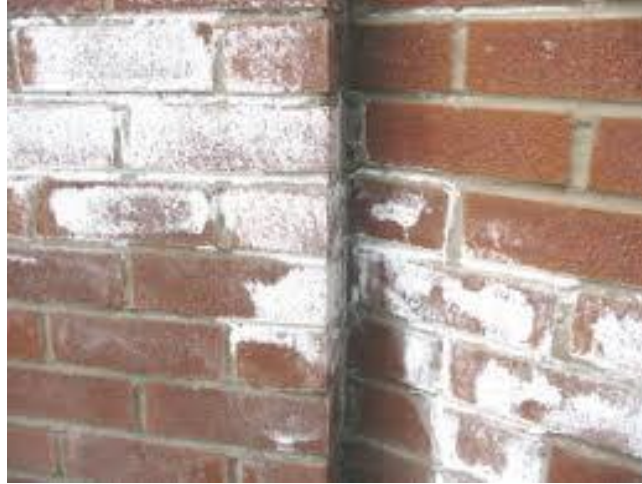
Figure 17 – Efflorescence staining on a building’s brick façade indicates moisture issues within the wall cavity (photo courtesy of Read Jones Christoffersen)

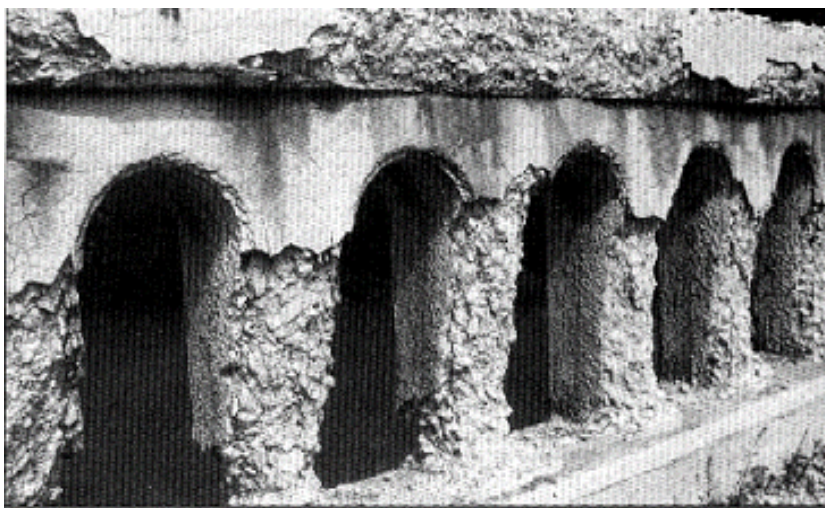
The phenomenon of freeze-thaw damage only occurs in the presence of moisture. When moisture is allowed to penetrate a porous material, such as concrete or masonry, and there is a decline in temperature below freezing, the moisture will freeze and in turn expand causing stresses on the material. As this cycle repeats itself, the material is weakened and visible damage can occur, see Figure 6.

Figure 18 – The effects of freeze-thaw on an older structure (Portland Cement Association, 1998)

The rate of cooling and the temperature has a significant affect (Straube and Burnett, 2005). If allowed to continue, freeze-thaw cycles can lead to significant deterioration of a structure.

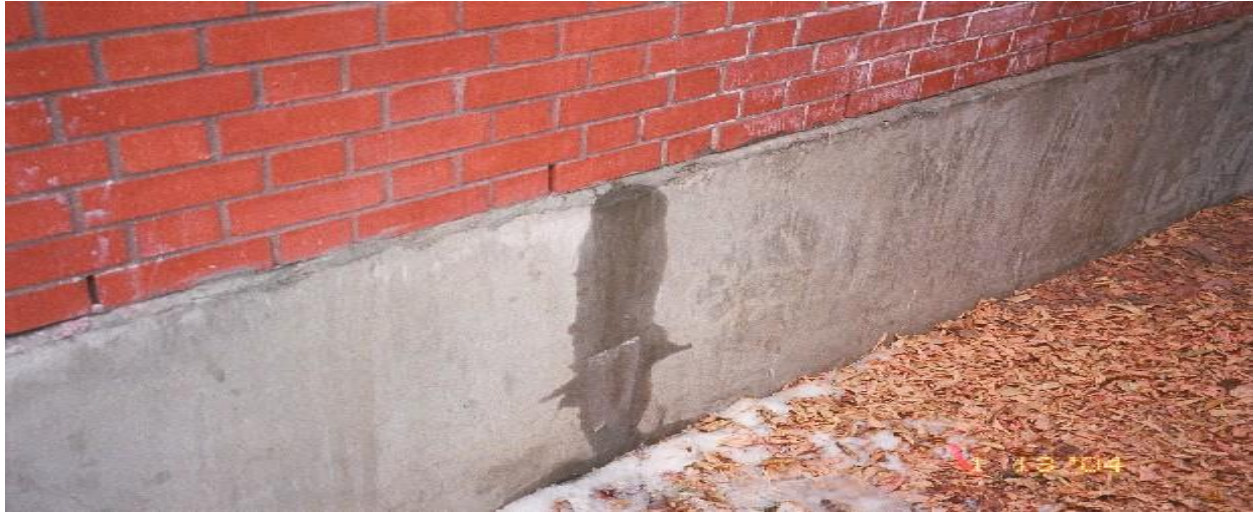
Figure 19 – Horizontal shrinkage cracks of a concrete foundation wall allow for water to seep through the crack (photo courtesy of Read Jones Christoffersen)

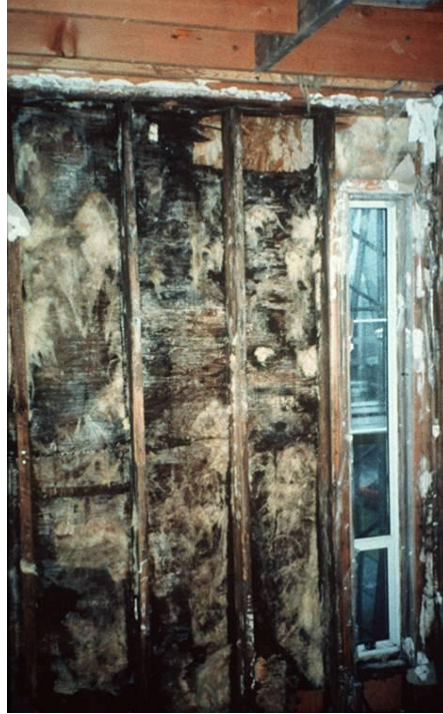
Figure 20- Mouldy insulation in a wood stud wall caused by water entering the wall cavity (photo courtesy of Read Jones Christoffersen)

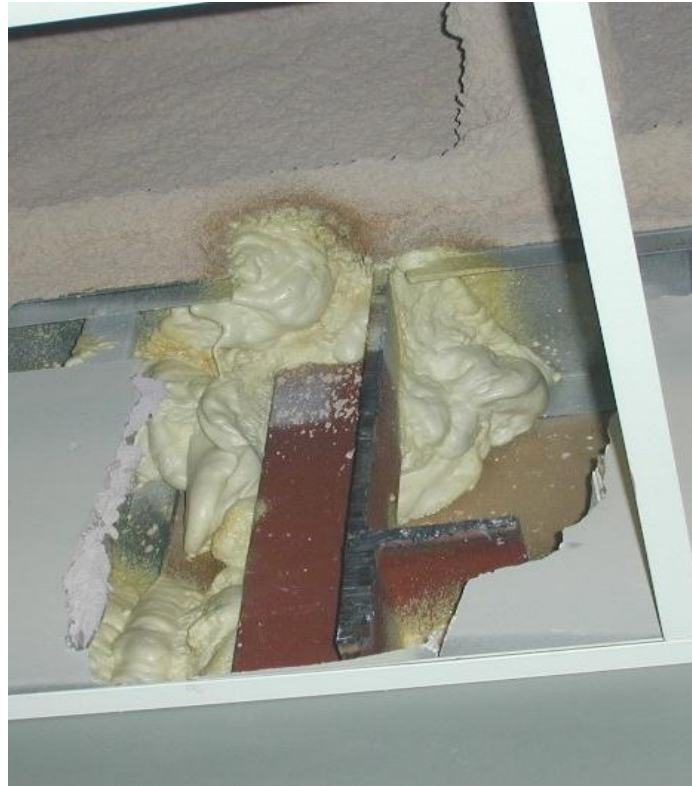
Figure 23 - Wall penetration repair had been completed after building envelope failure was first expected in hopes of solving the building envelope issues

The first building envelope issues noticed were condensation problems. These were first observed in November of 2000. Condensation was observed on the interior surfaces of many windows and water leakage and staining became evident at locations on the exterior walls. Due to these issues, the Contractor performed selected repairs in the fall of the following year. These repairs entailed sealing certain wall penetrations with air barrier foam at the interior (seen in Figure 11), repair of discontinuities of the air vapour barrier AVB at the entrance canopies, skylight, roof parapet and brick curtain wall joints as well as repair of the curtain wall itself. A short two weeks after these repairs were completed; leakage was still present throughout the

building including the areas that were repaired. Humidity in the building was lowered in the hopes that the condensation related problems would cease; however, they did not. Thermo-graphic scans showed that there was air leaking in a number of locations throughout the building. In 2003 a full investigation of Building X's building envelope was carried out.

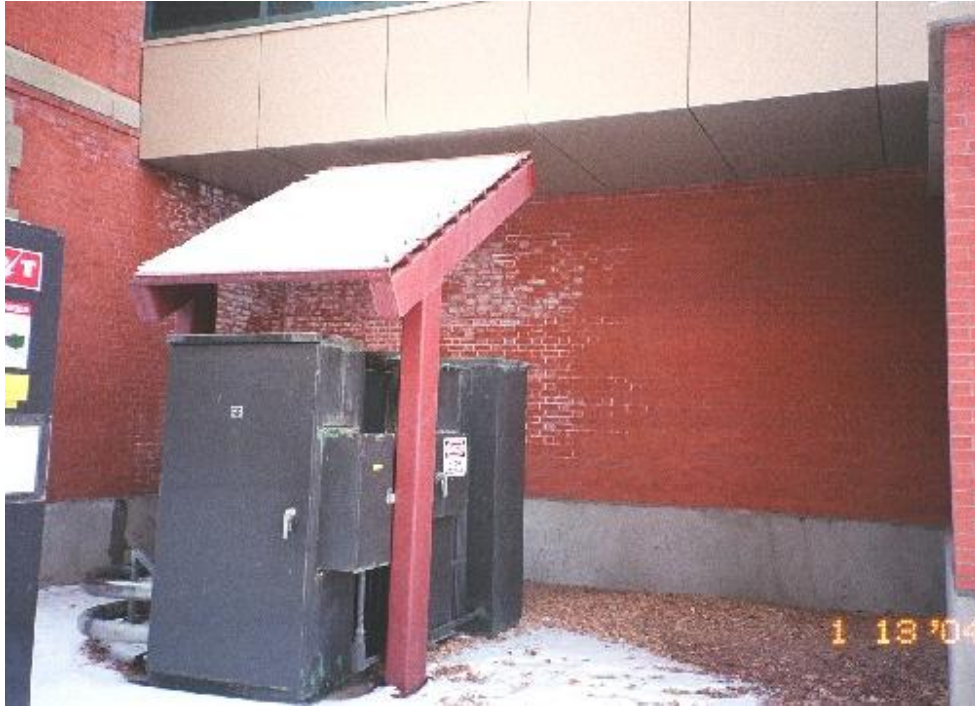
Figure 24 - Efflorescence stained brick façade on the exterior of Building X. This indicated condensation issues occurring behind the façade

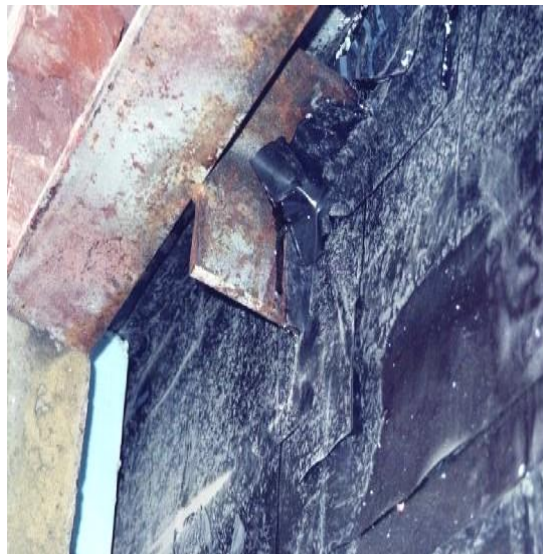
**Figure 25 - Knife edge support at brick angle location where heat loss was present.
Membrane appeared to be haphazardly applied**

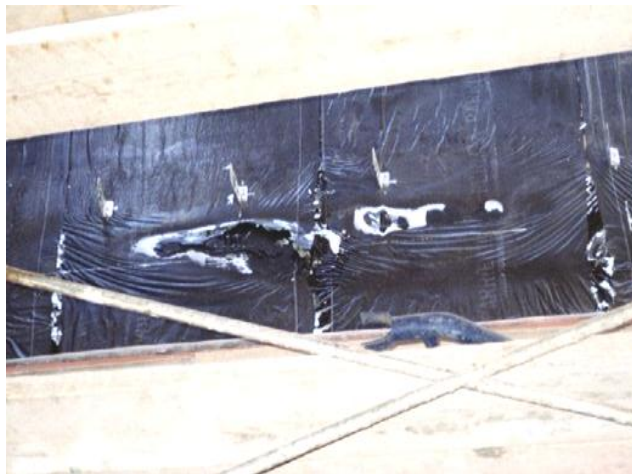
Figure 26 - Melted membrane caused by the fire during initial construction
