TITLE OF THESIS/TITRE DE LA THÈSE Prestressed Concrete Tee Beams
Containing Large Circular Web
Openings

UNIVERSITY/UNIVERSITÉ Univ. of Alberta

The present test series consisted of twelve Prestressed Concrete tee beams with large circular web openings, loaded to failure with two symmetrically placed point loads. All beams were 20 inches deep with a 20-inch flange and were prestressed with five prestressing strands of 3/8-inch diameter.

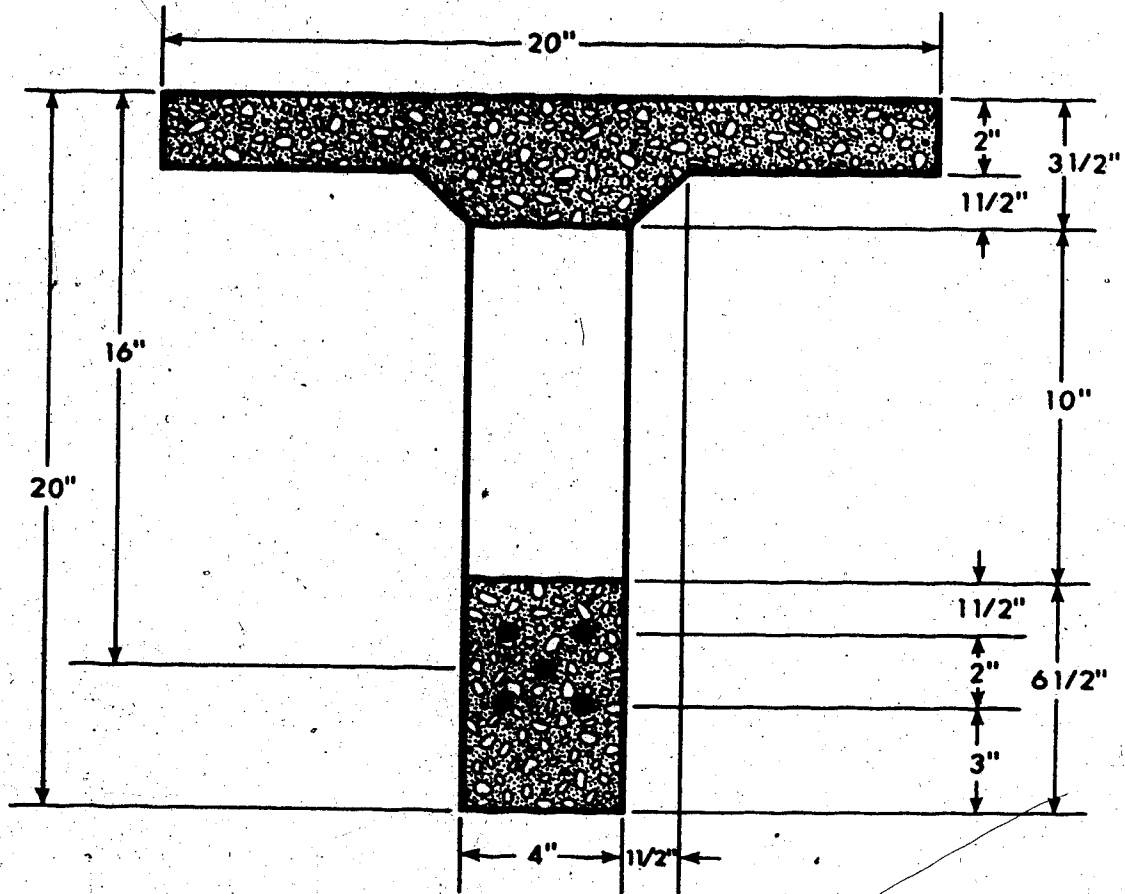
FIGURE 3.1

TYPICAL CONCRETE CROSS-SECTION

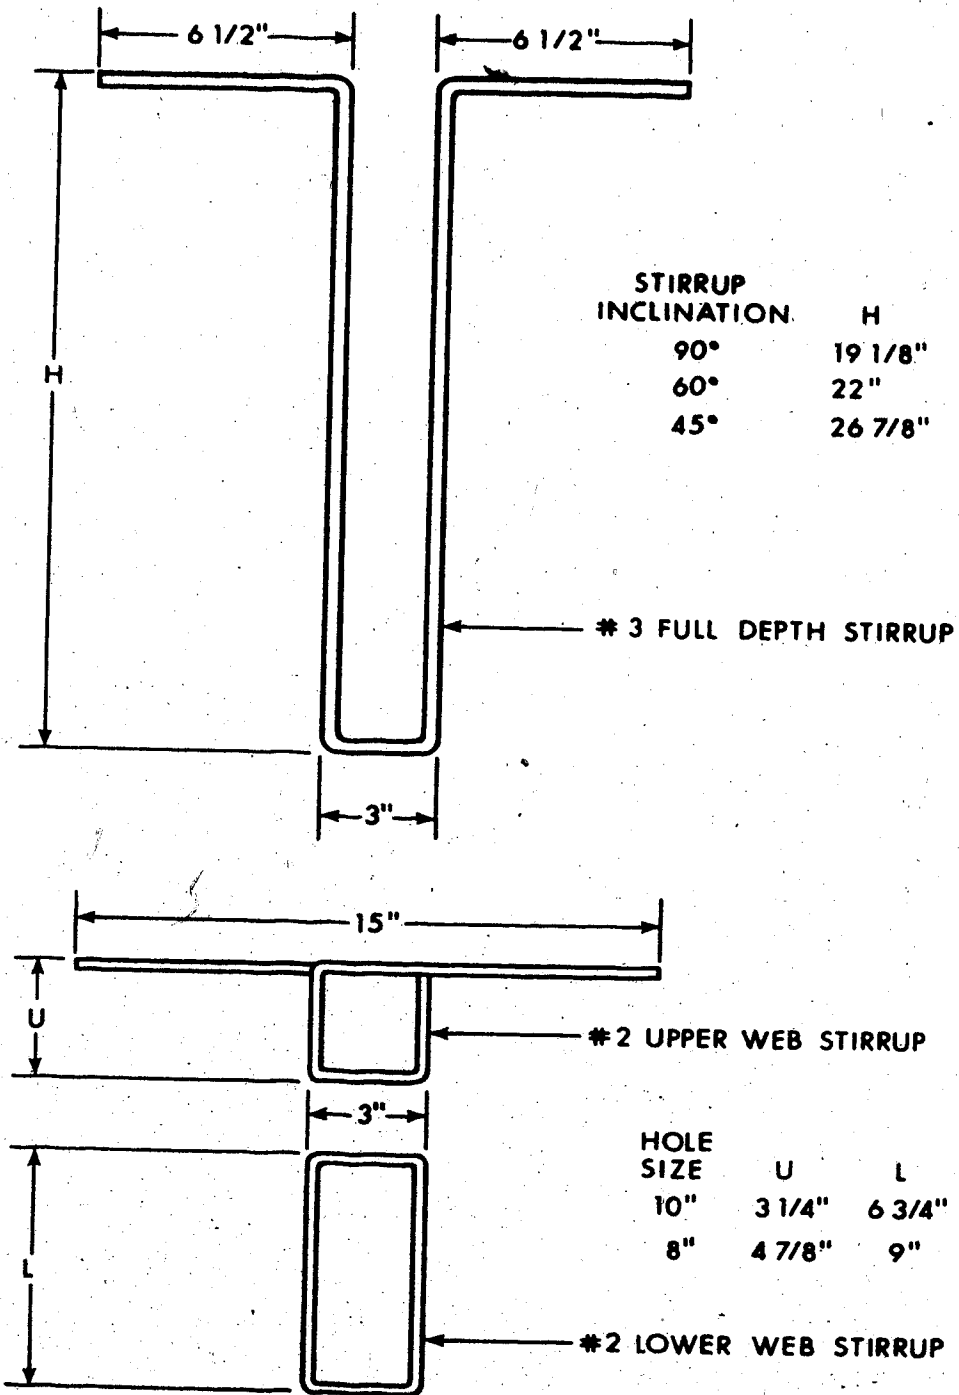
FIGURE 3.3
STIRRUP DETAILS

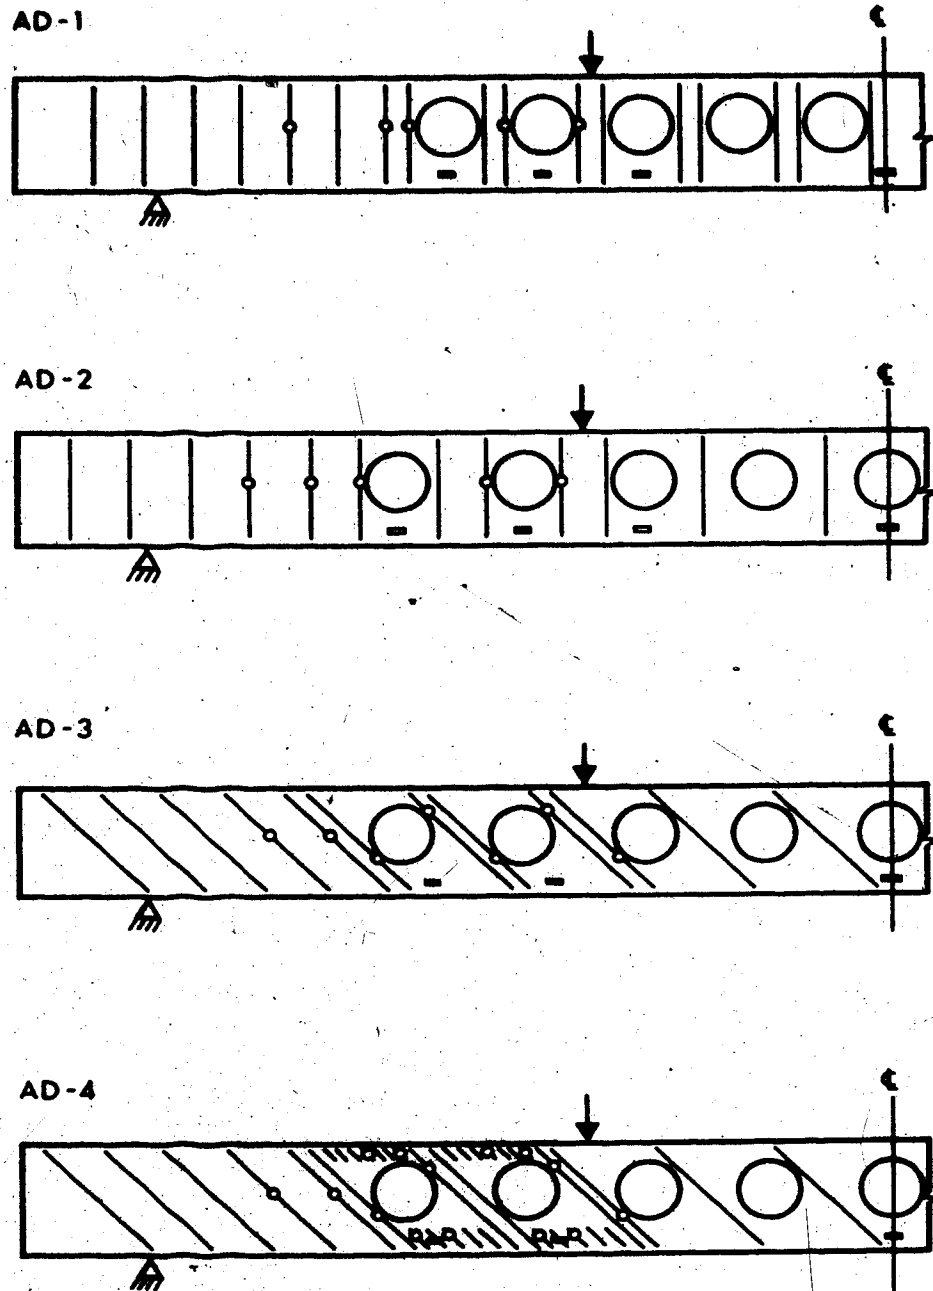
FIGURE 3.5.1

SHEAR REINFORCEMENT DETAILS CASTING GROUP ONE

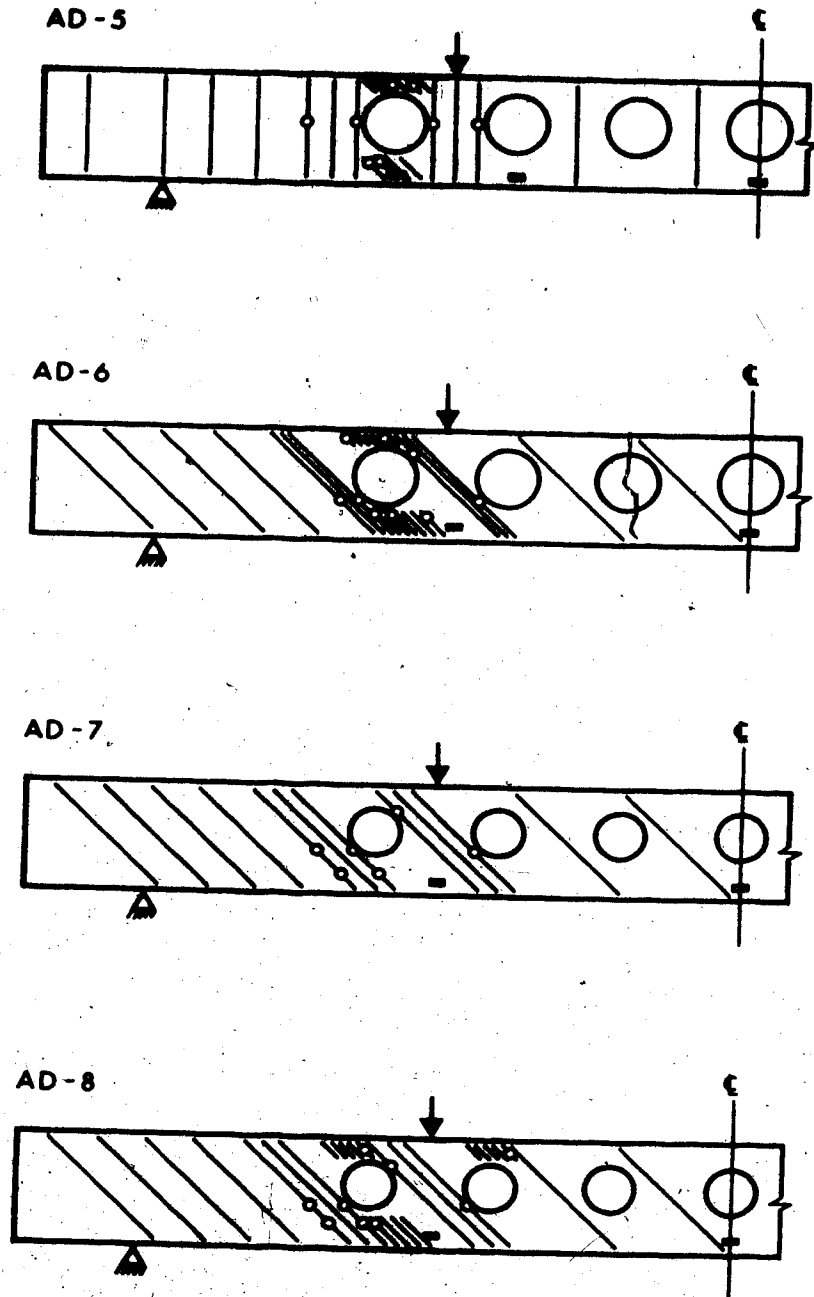
FIGURE 3.5.2
SHEAR REINFORCEMENT DETAILS CASTING GROUP TWO

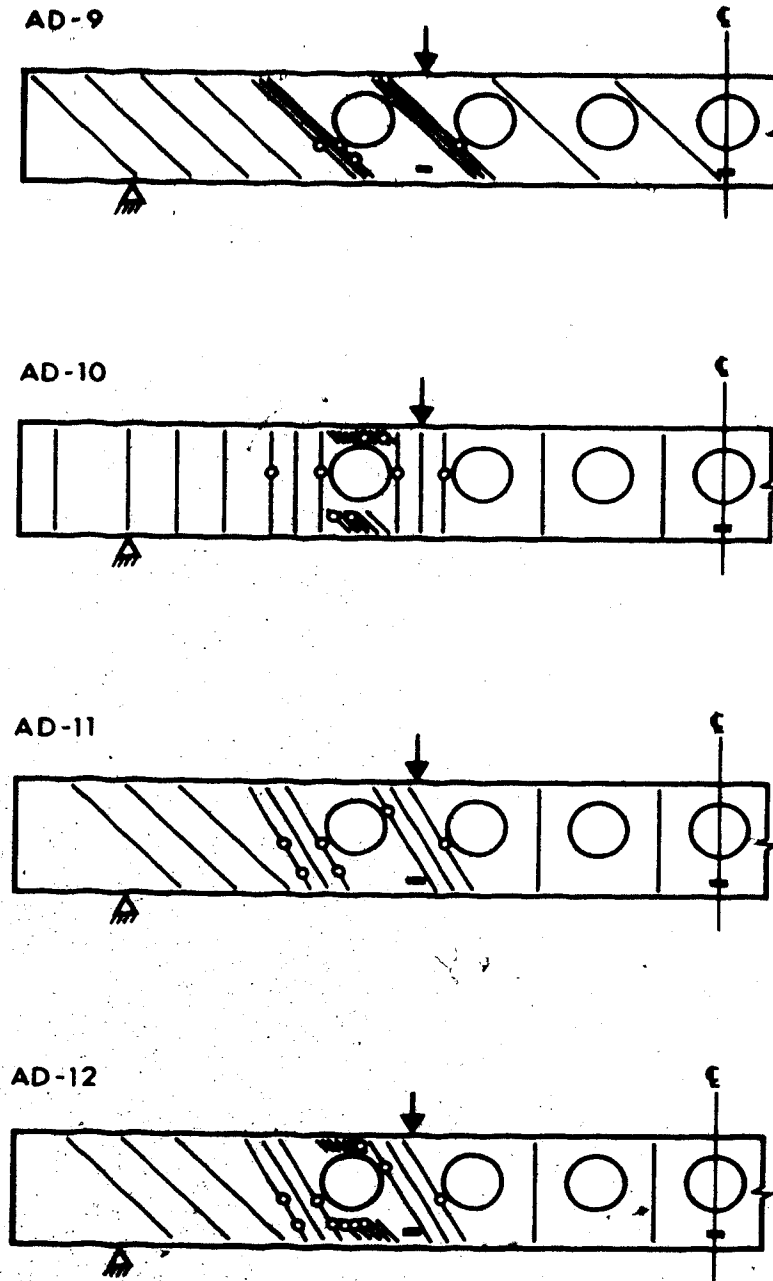
FIGURE 3.5.3

SHEAR REINFORCEMENT DETAILS CASTING GROUP THREE

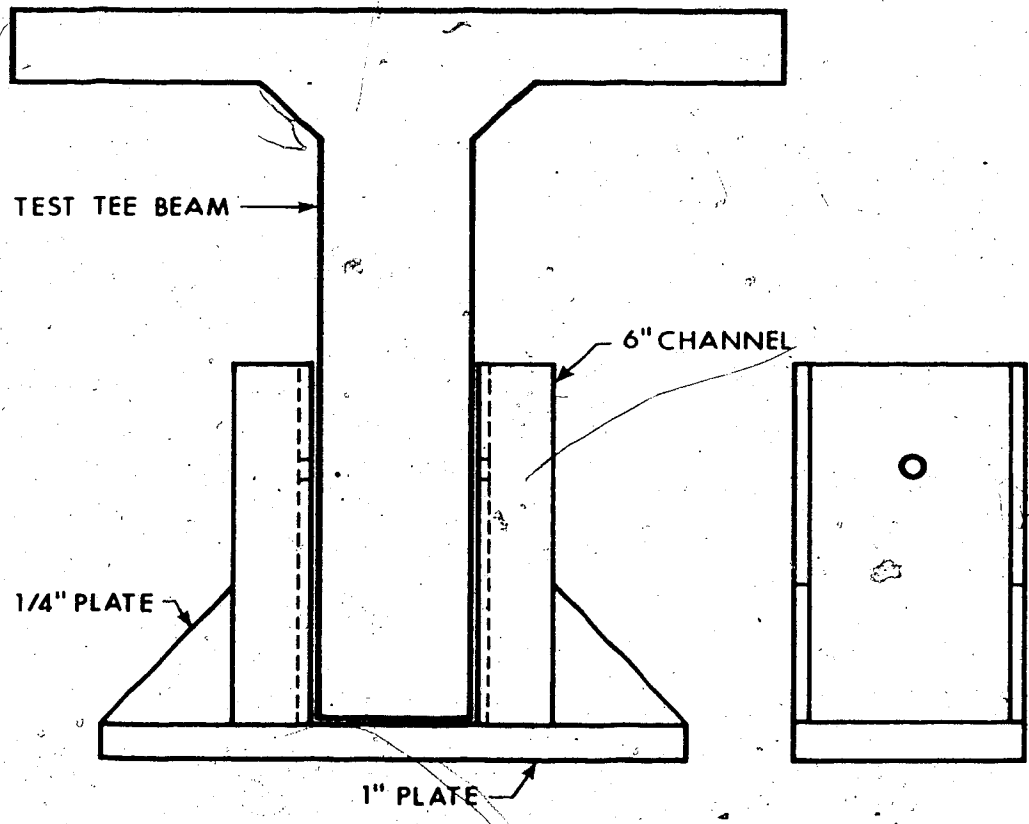
FIGURE 3.6
BEAM SEAT DETAIL

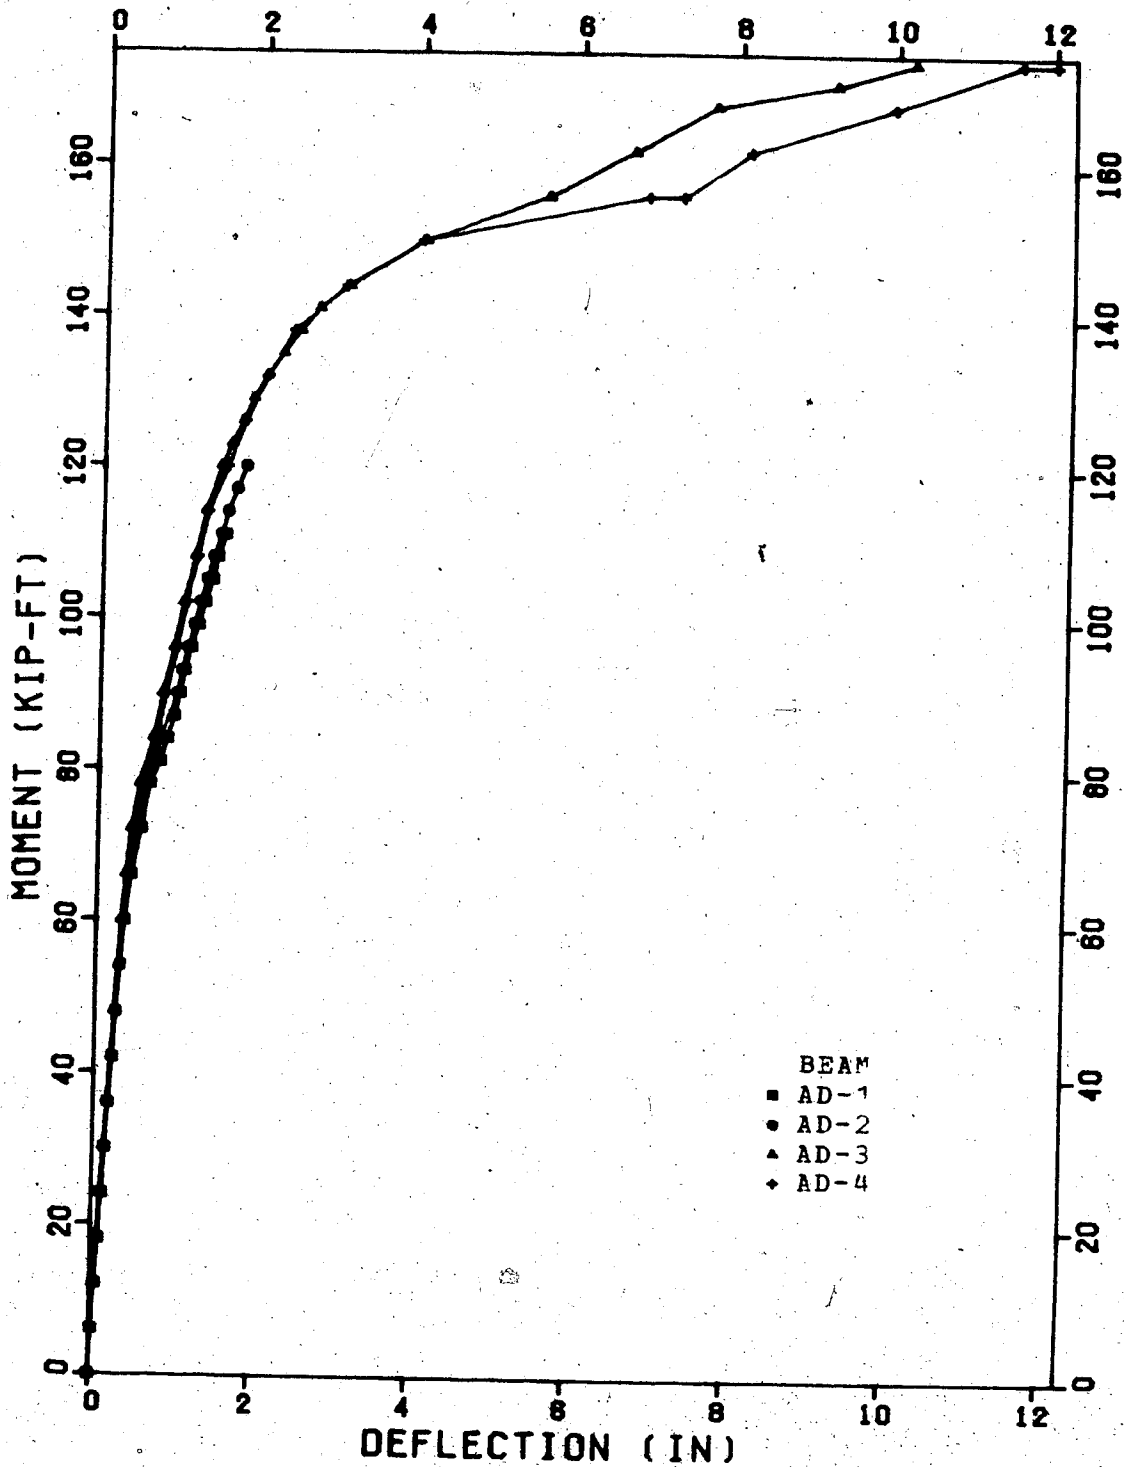
FIGURE 4.1.1 CASTING GROUP ONE
APPLIED MOMENT VS. CENTERLINE DEFLECTION

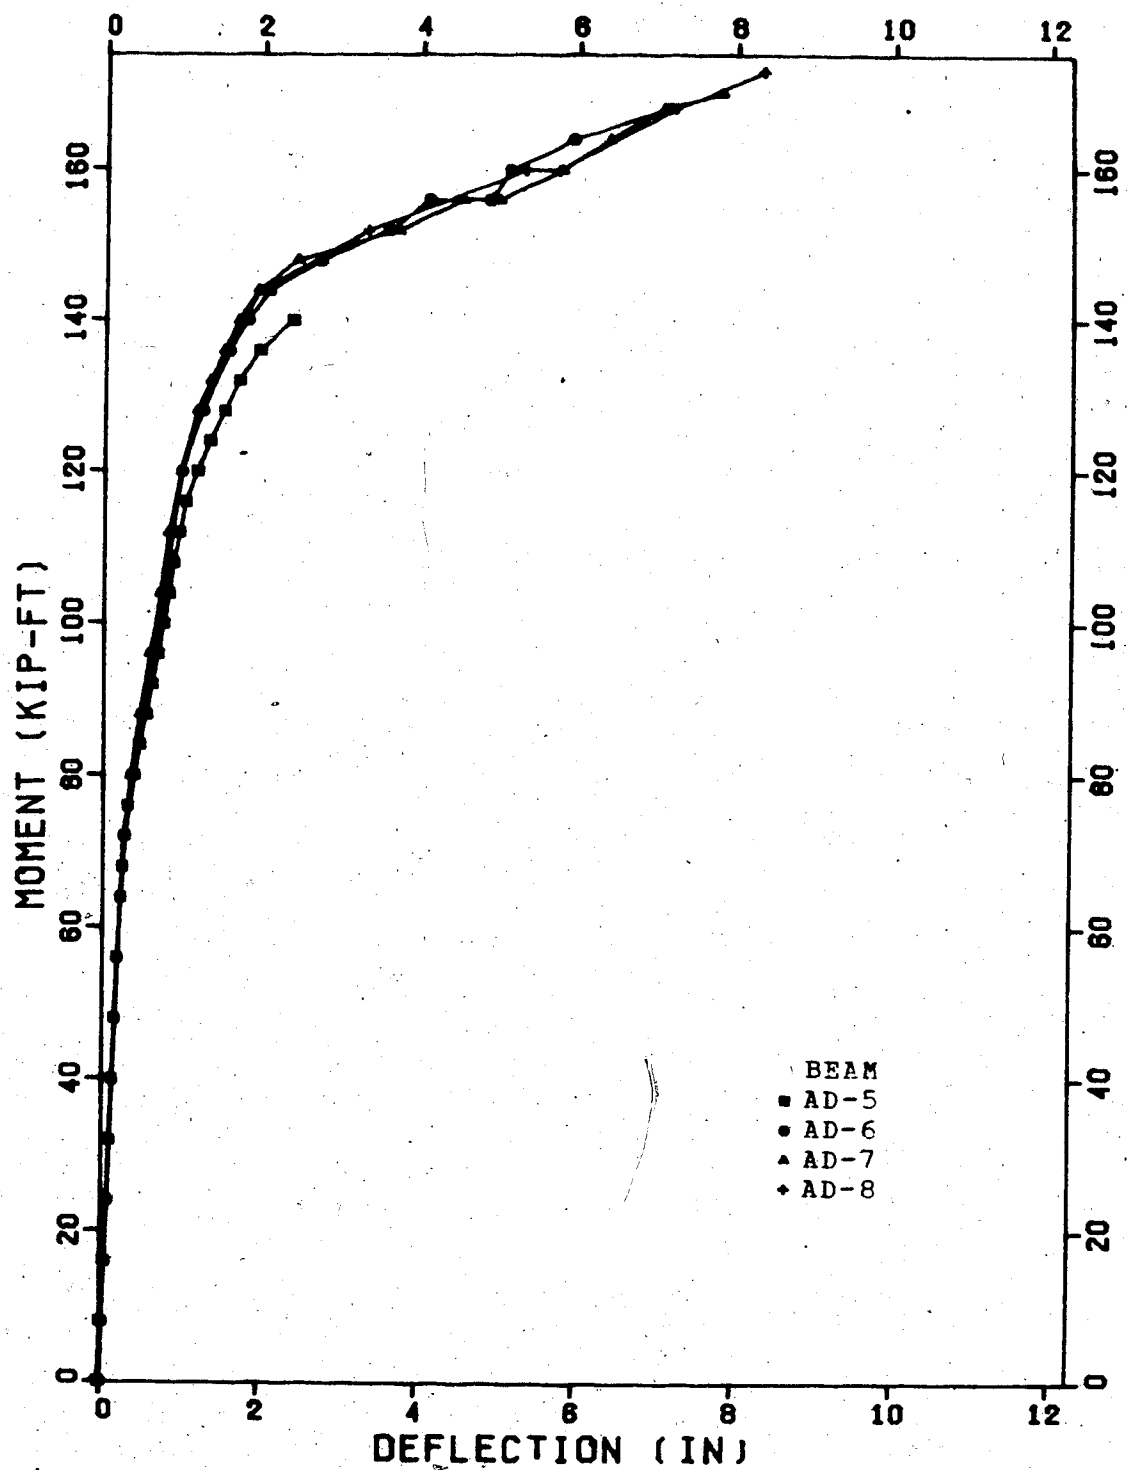
FIGURE 4.1.2 CASTING GROUP TWO
APPLIED MOMENT VS. CENTERLINE DEFLECTION

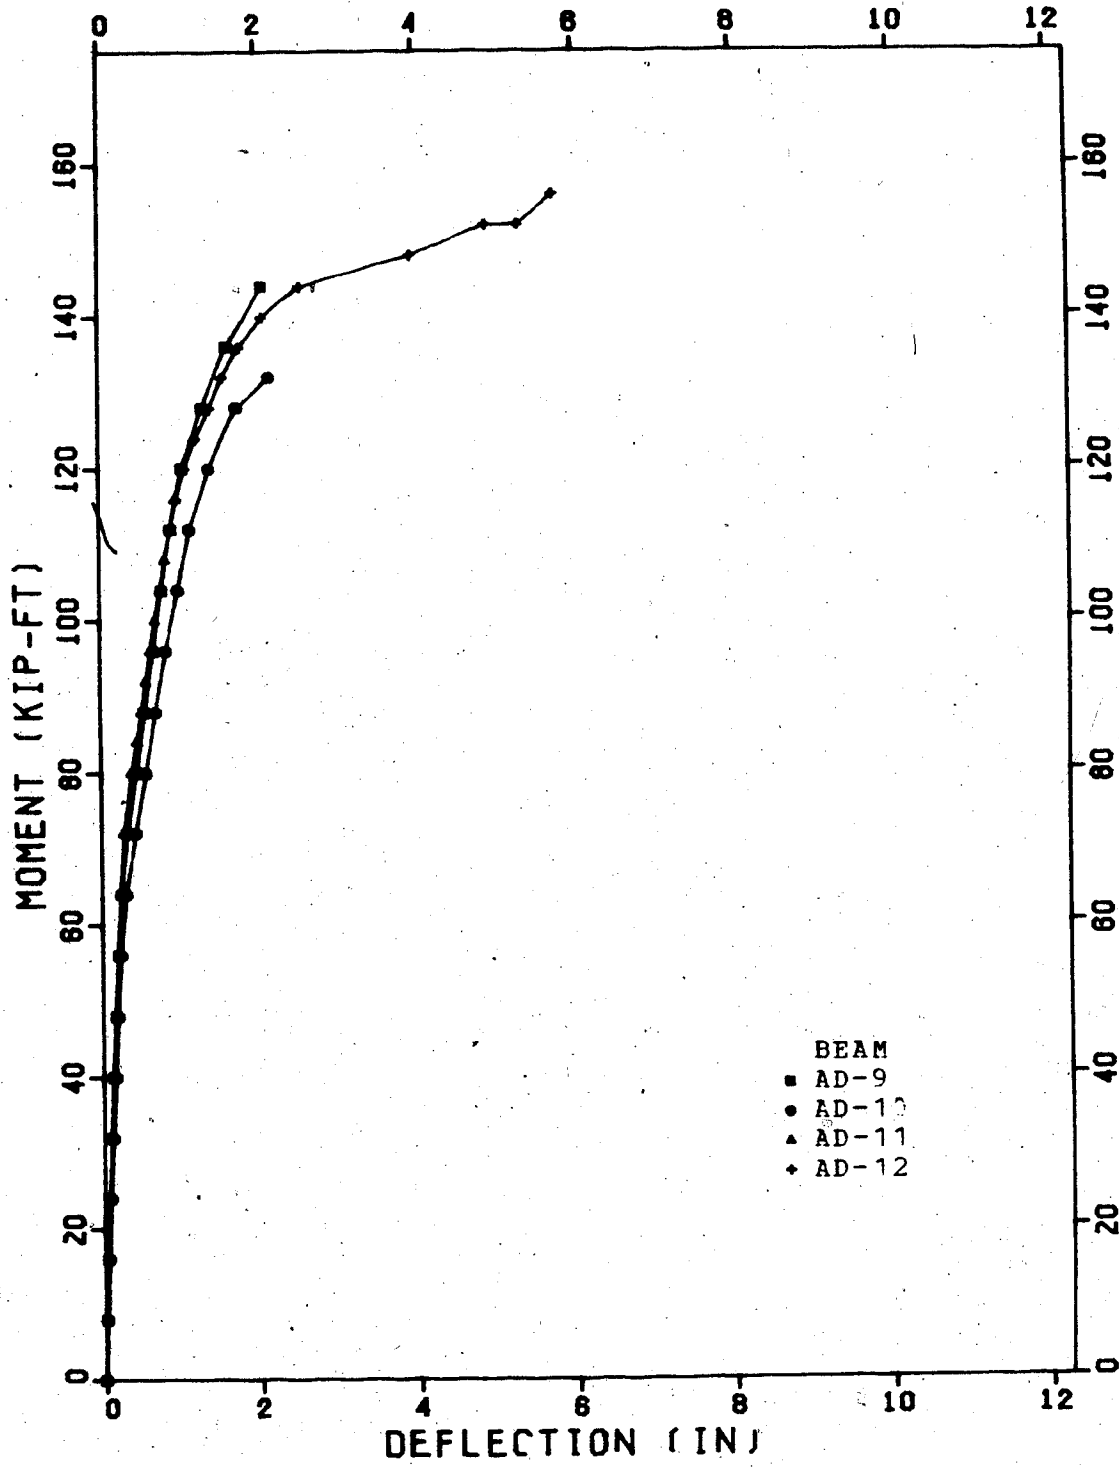
FIGURE 4.1.3 CASTING GROUP THREE
APPLIED MOMENT VS. CENTERLINE DEFLECTION

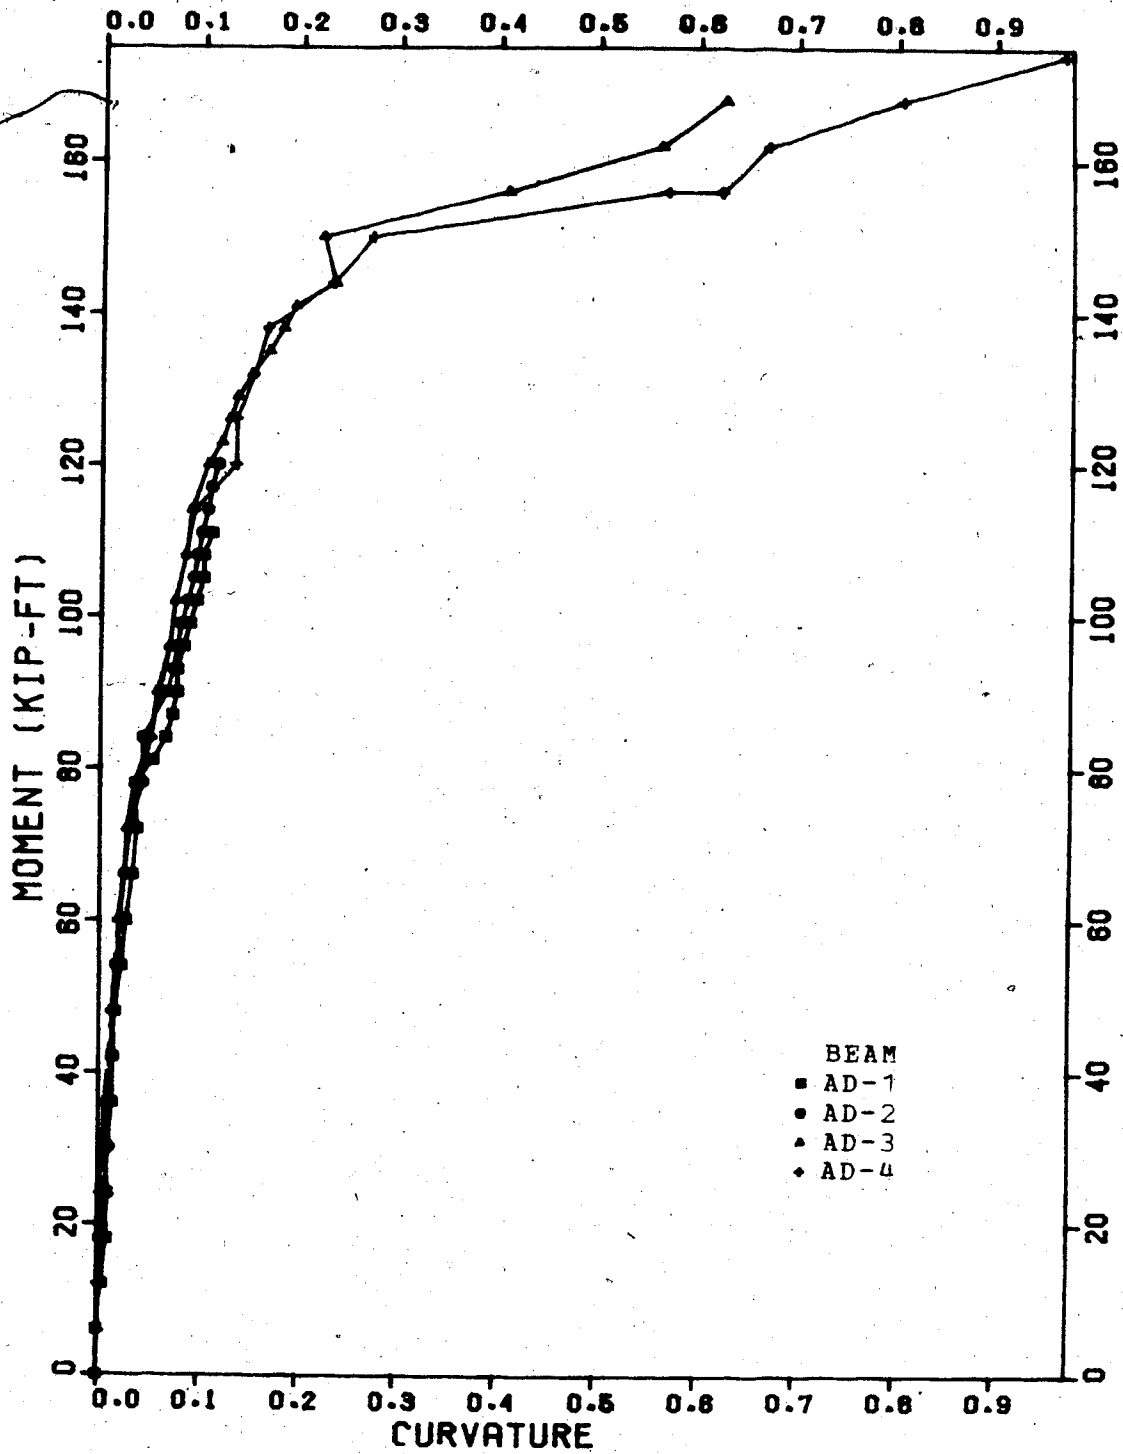
FIGURE 4.2.1 CASTING GROUP ONE

APPLIED MOMENT VS. AVERAGE CURVATURE ($\text{in}^{-1} \cdot 10^{-3}$)

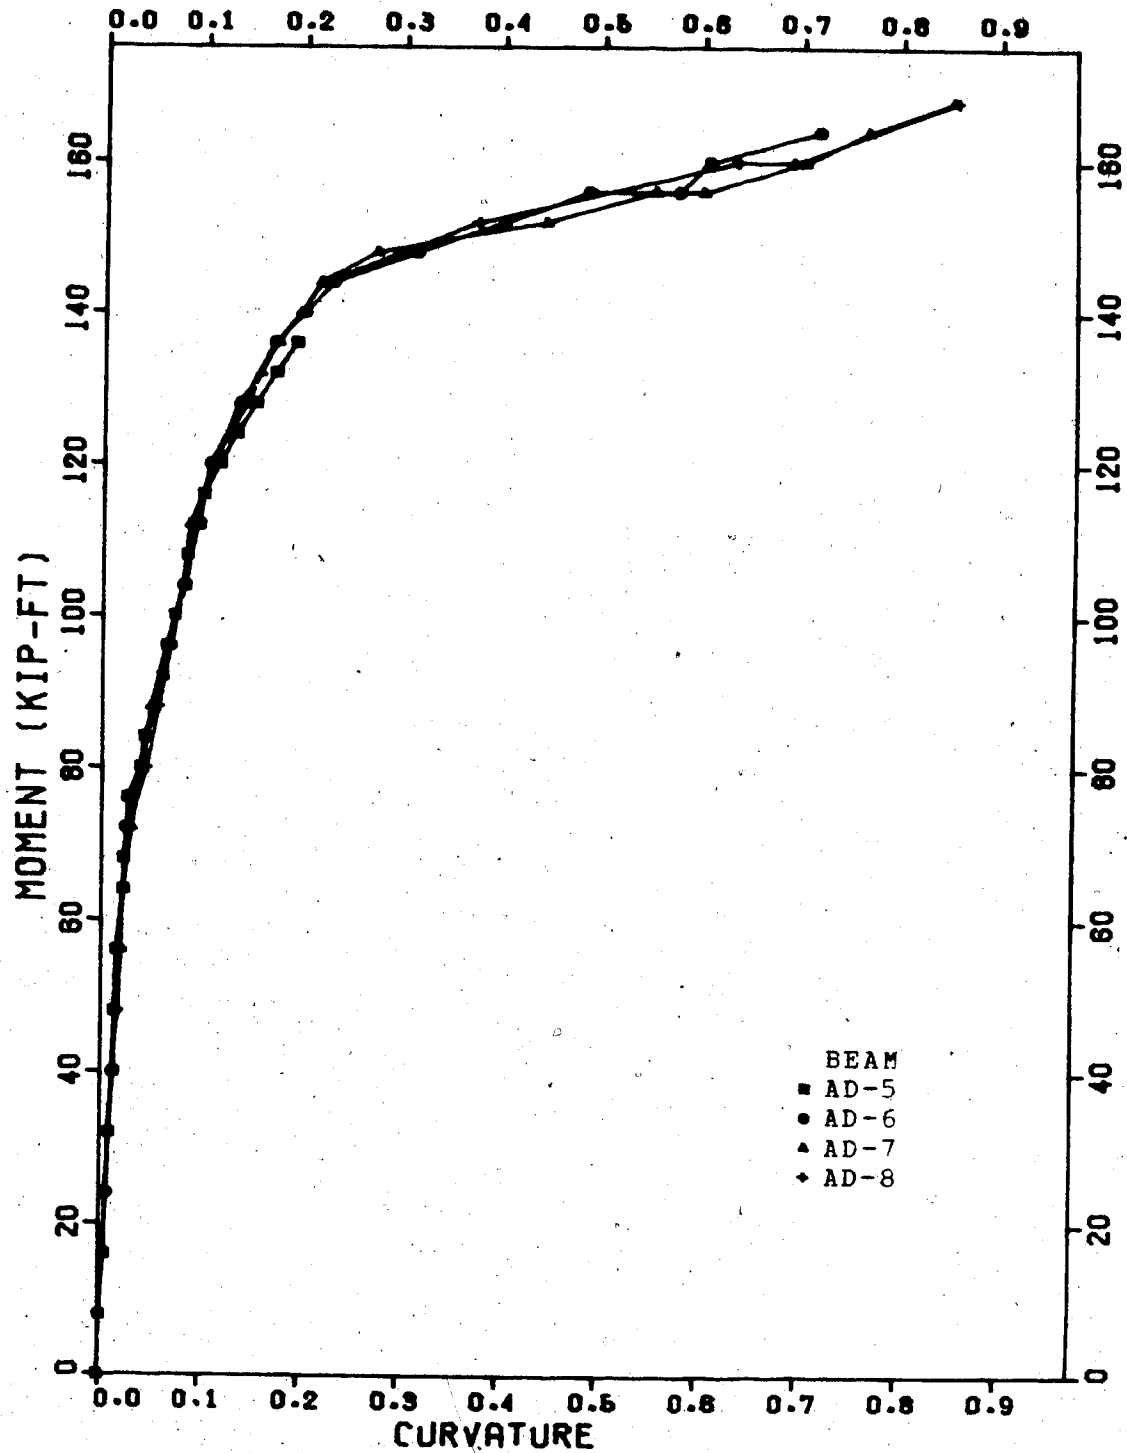
FIGURE 4.2.2 CASTING GROUP TWO

APPLIED MOMENT VS. AVERAGE CURVATURE (in⁻¹*10⁻³)

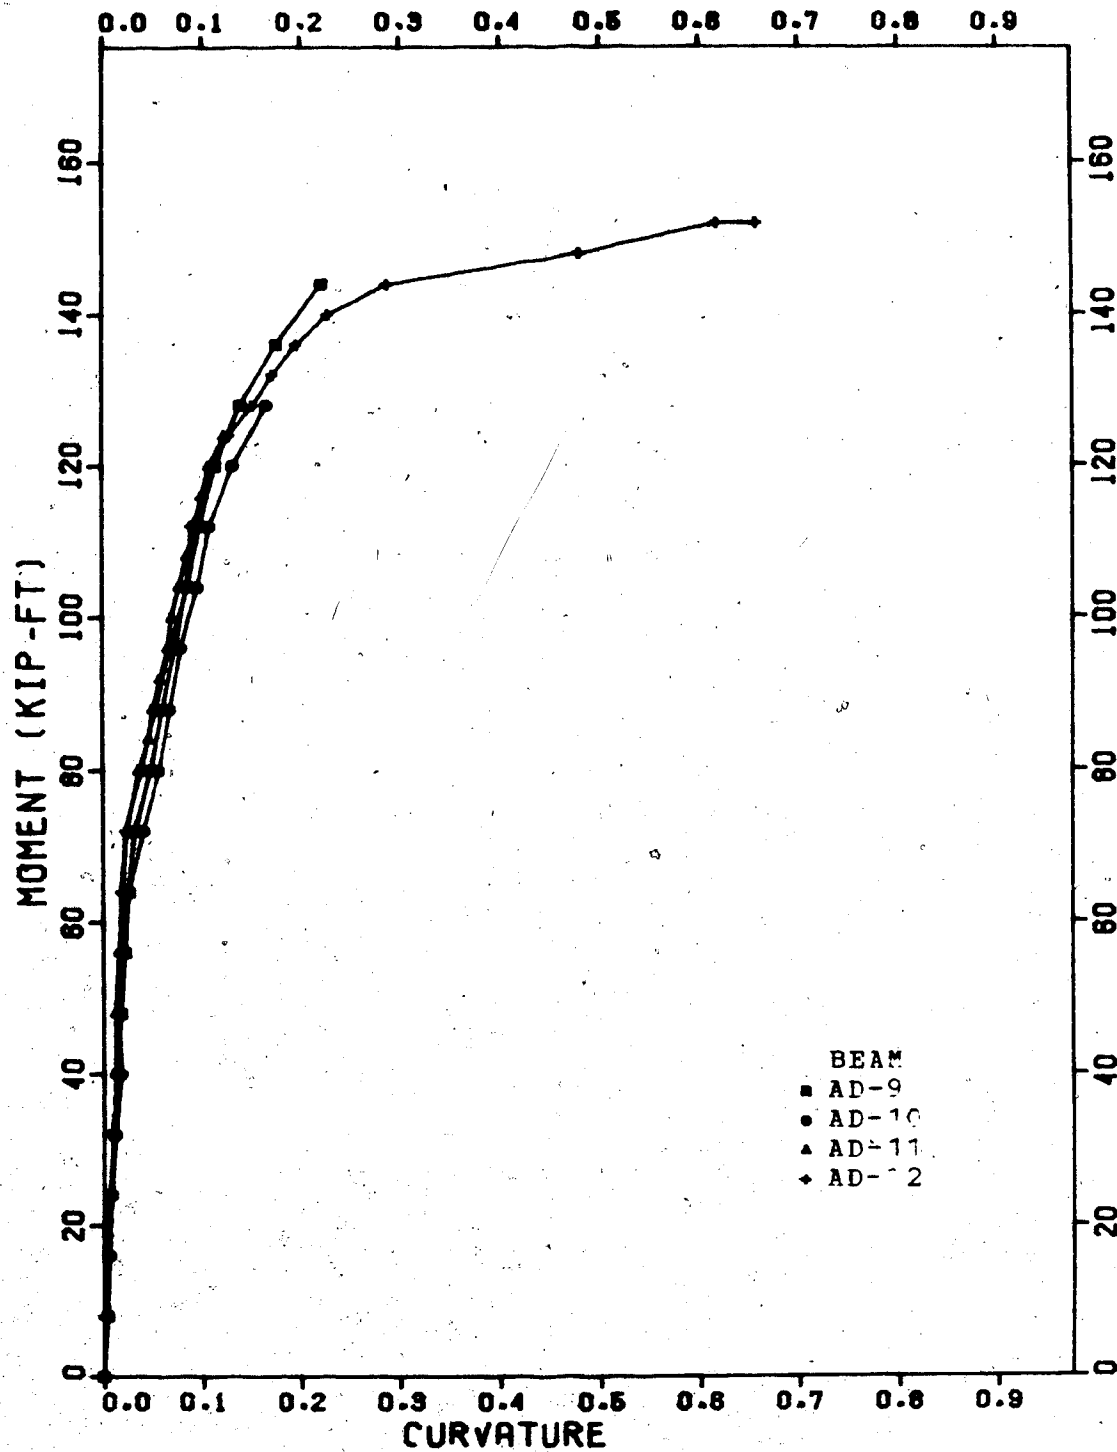
FIGURE 4.2.3 CASTING GROUP THREE
 APPLIED MOMENT VS. AVERAGE CURVATURE ($\text{in}^{-1} \cdot 10^{-3}$)

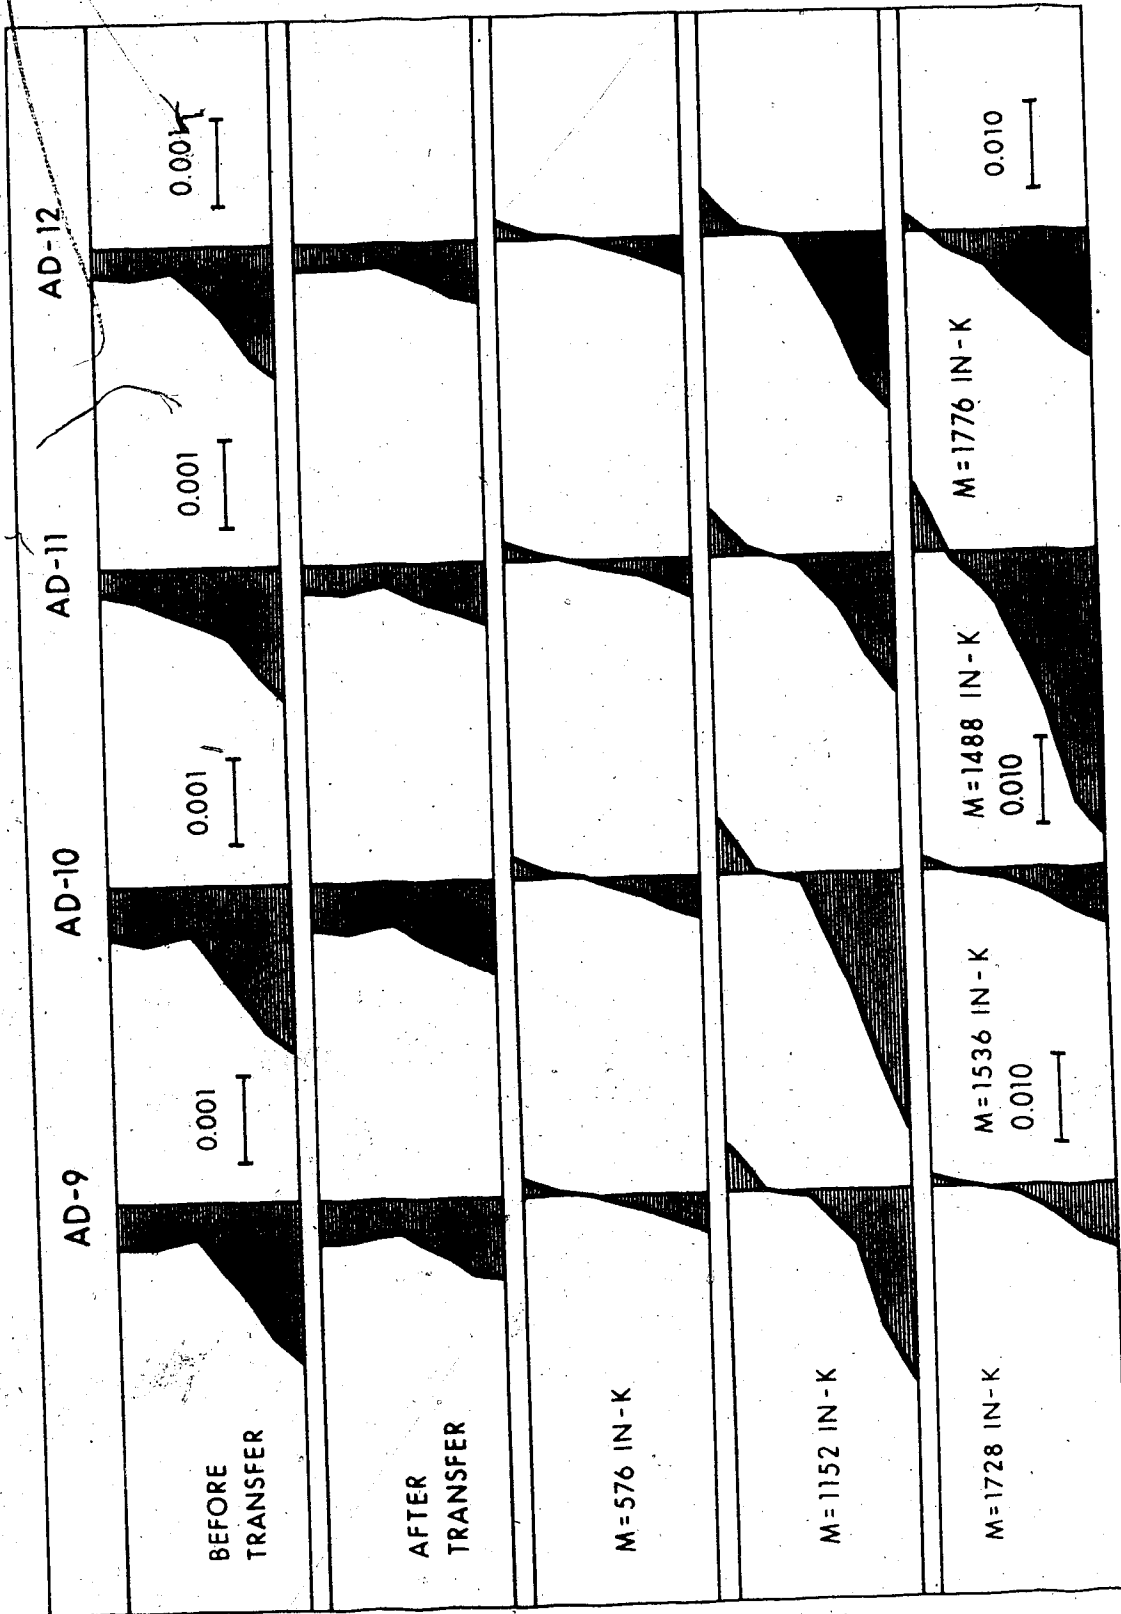
FIGURE 4.3.3 CASTING GROUP THREE STRAIN DISTRIBUTION

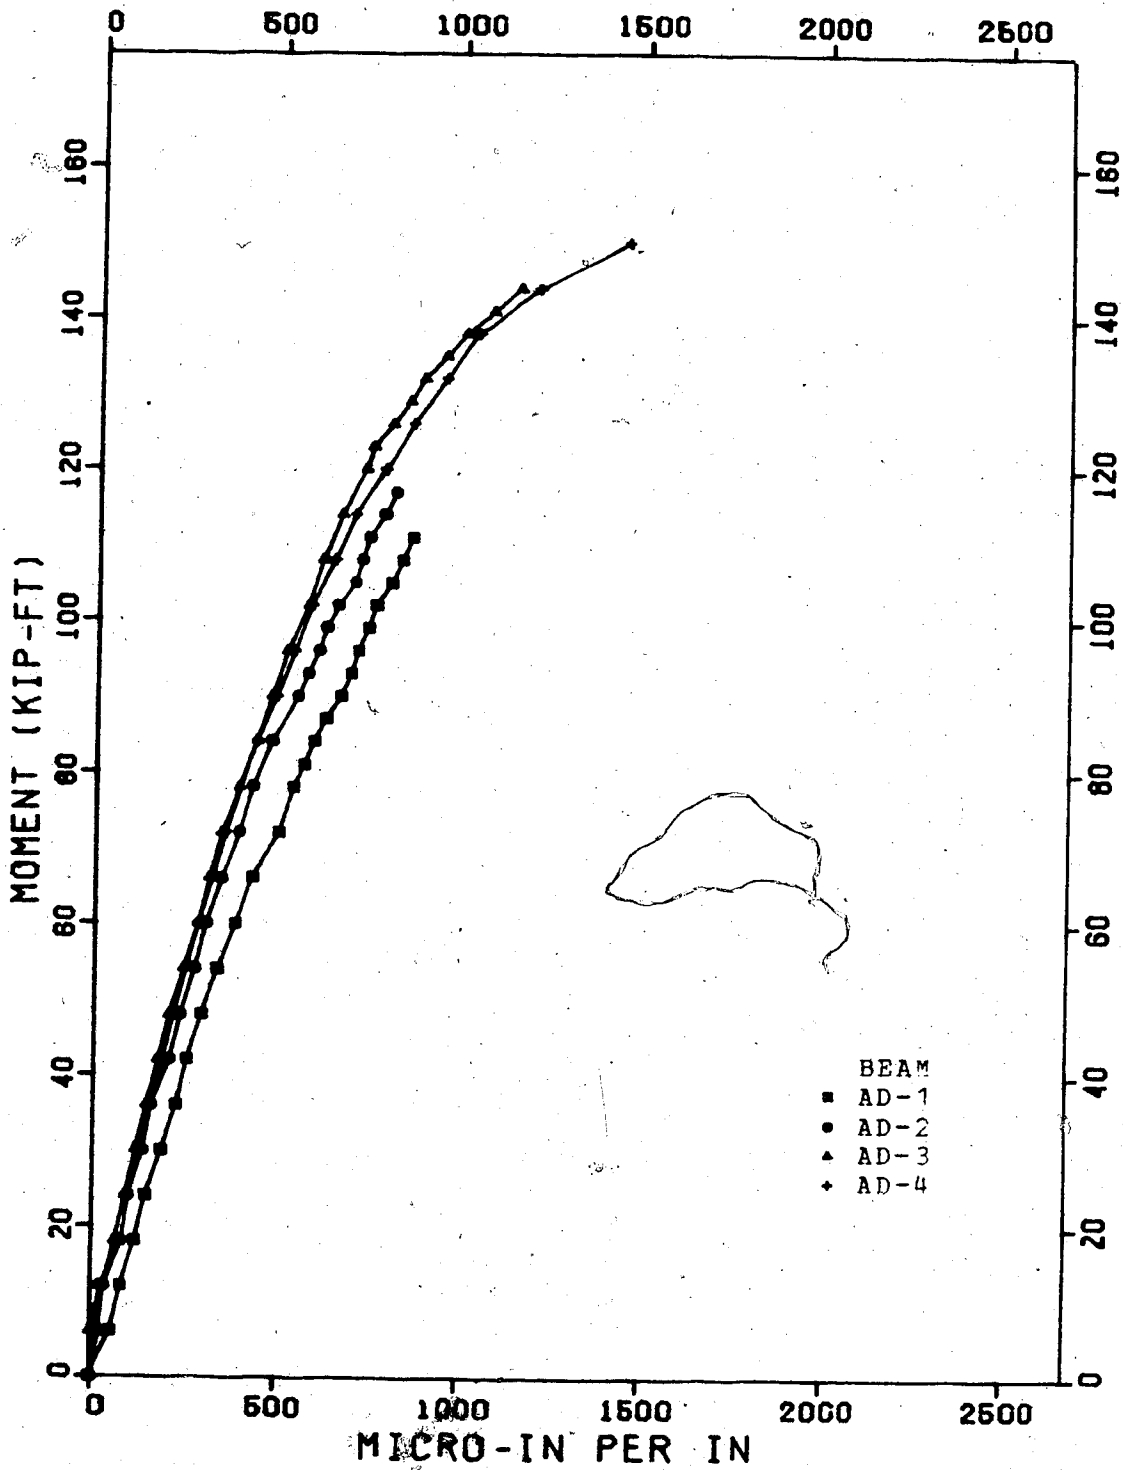
FIGURE 4.4.1 CASTING GROUP ONE

APPLIED MOMENT VS. STRAIN ON TOP SURFACE OF FLANGE

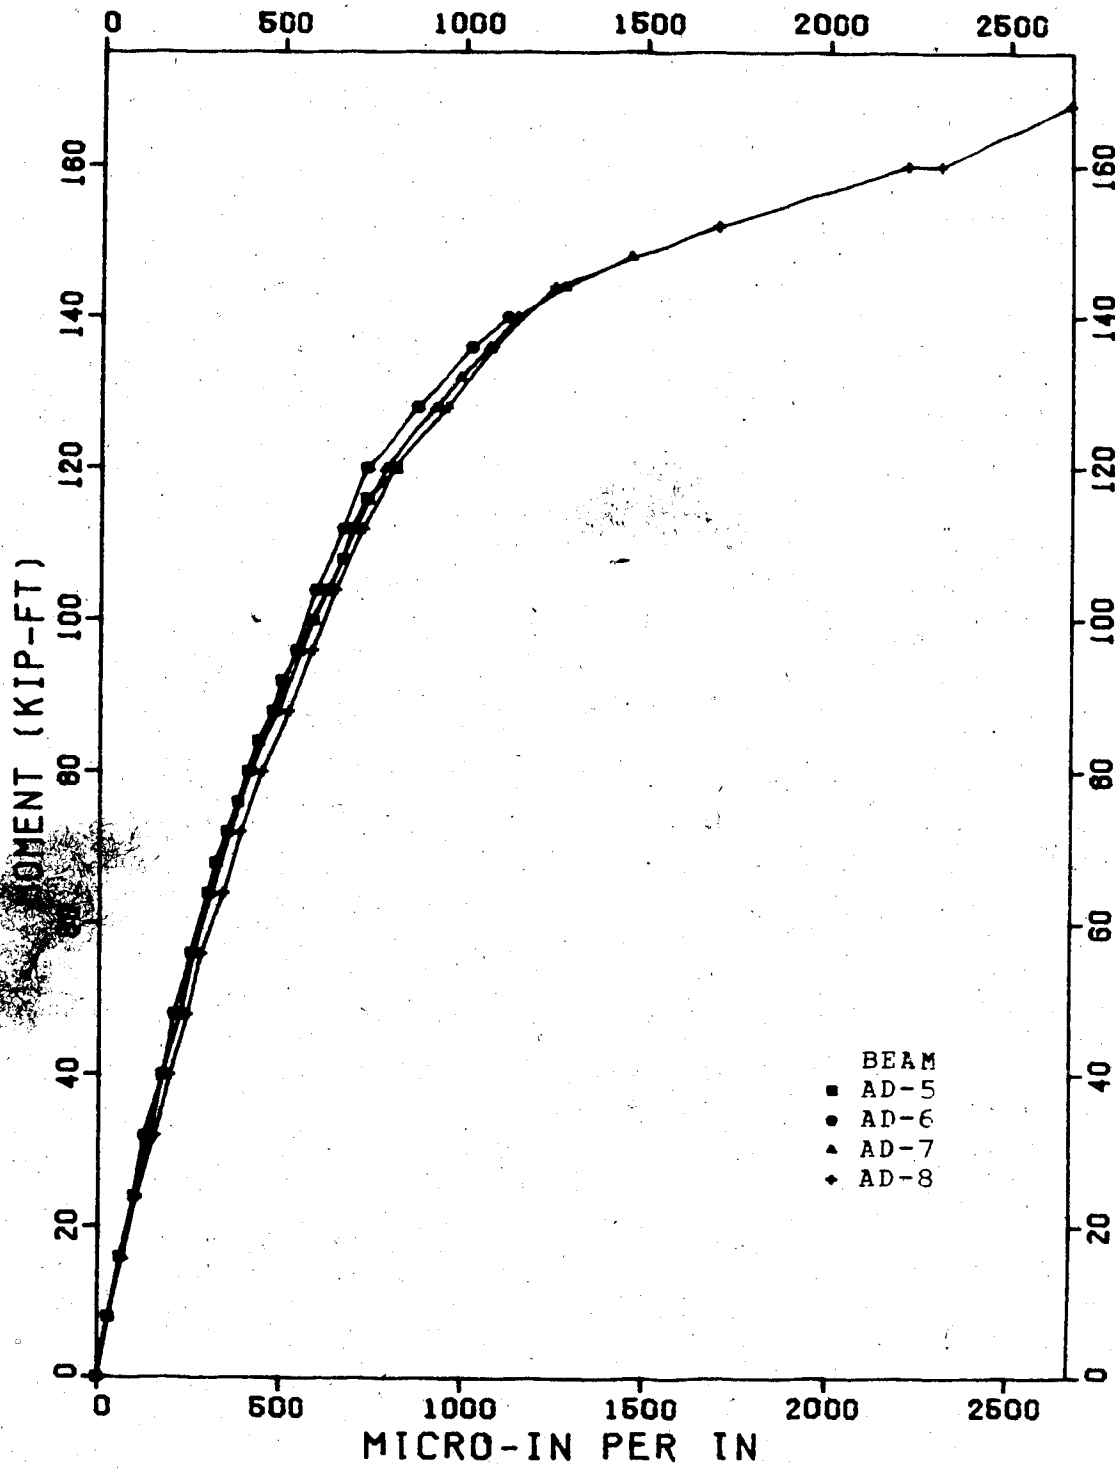
FIGURE 4.4.2 CASTING GROUP TWO

APPLIED MOMENT VS. STRAIN ON TOP SURFACE OF FLANGE
