TITLE OF THESIS/TITRE DE LA THÈSE Prestressed Concrete Tee Beams
Containing Large Circular Web
Openings

UNIVERSITY/UNIVERSITÉ Univ. of Alberta

The present test series consisted of twelve Prestressed Concrete tee beams with large circular web openings, loaded to failure with two symmetrically placed point loads. All beams were 20 inches deep with a 20-inch flange and were prestressed with five prestressing strands of 3/8-inch diameter.

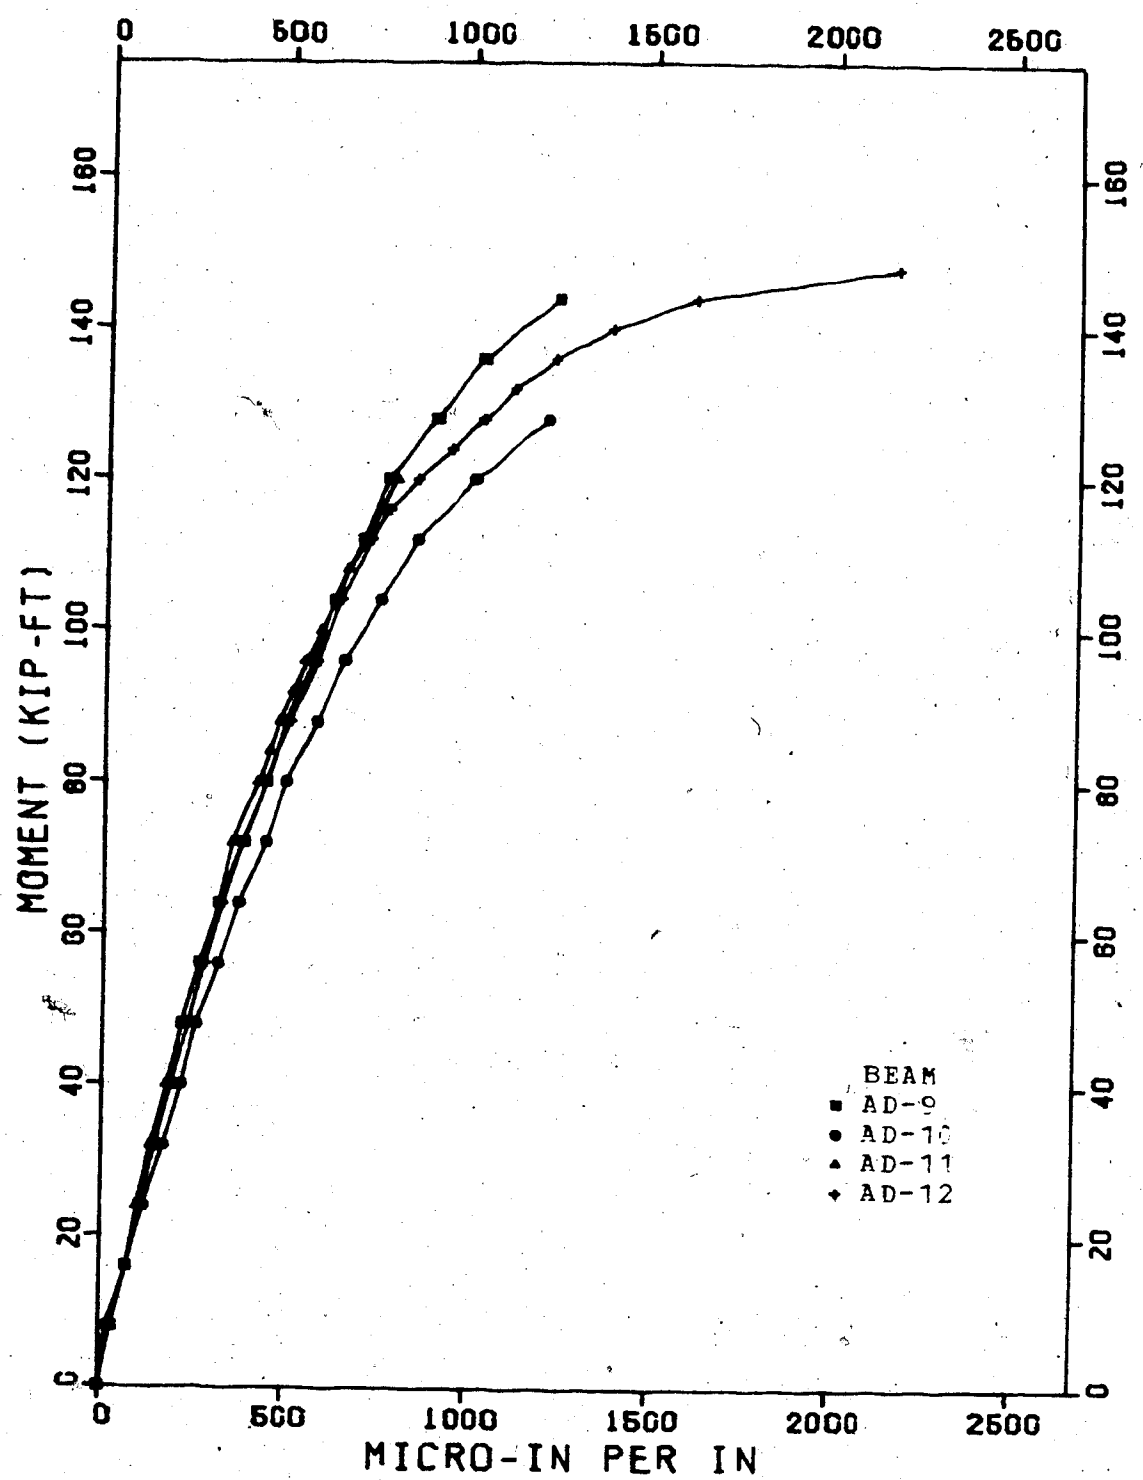
FIGURE 4.4.3 CASTING GROUP THREE

APPLIED MOMENT VS. STRAIN ON TOP SURFACE OF FLANGE

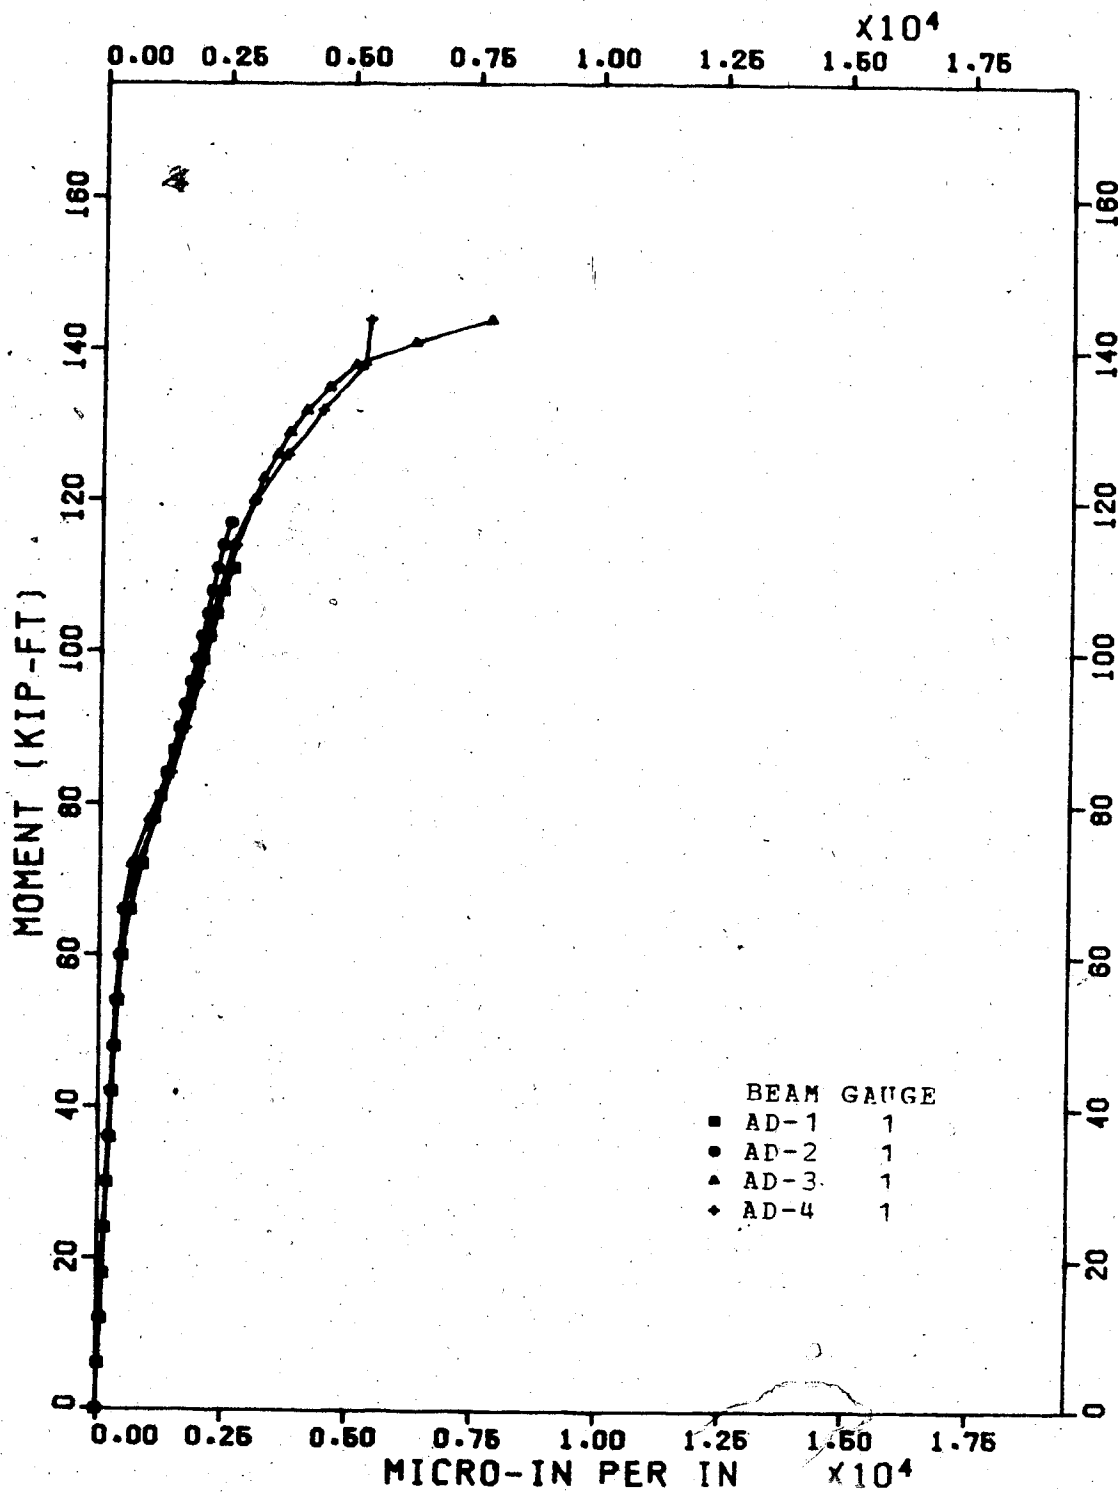
FIGURE 4.6.1 CASTING GROUP C

APPLIED MOMENT VS. STRAND STRAIN AT CENTERLINE

The remaining figures show the relationships between applied moment and strain in the reinforcement obtained from readings of the strain gauges mounted on the prestressing strand and shear reinforcement. General locations of these gauges are shown in Figure 4.5. Individual curves are referenced with beam number and gauge number in order that the exact location of any gauge can be found in Appendix B.

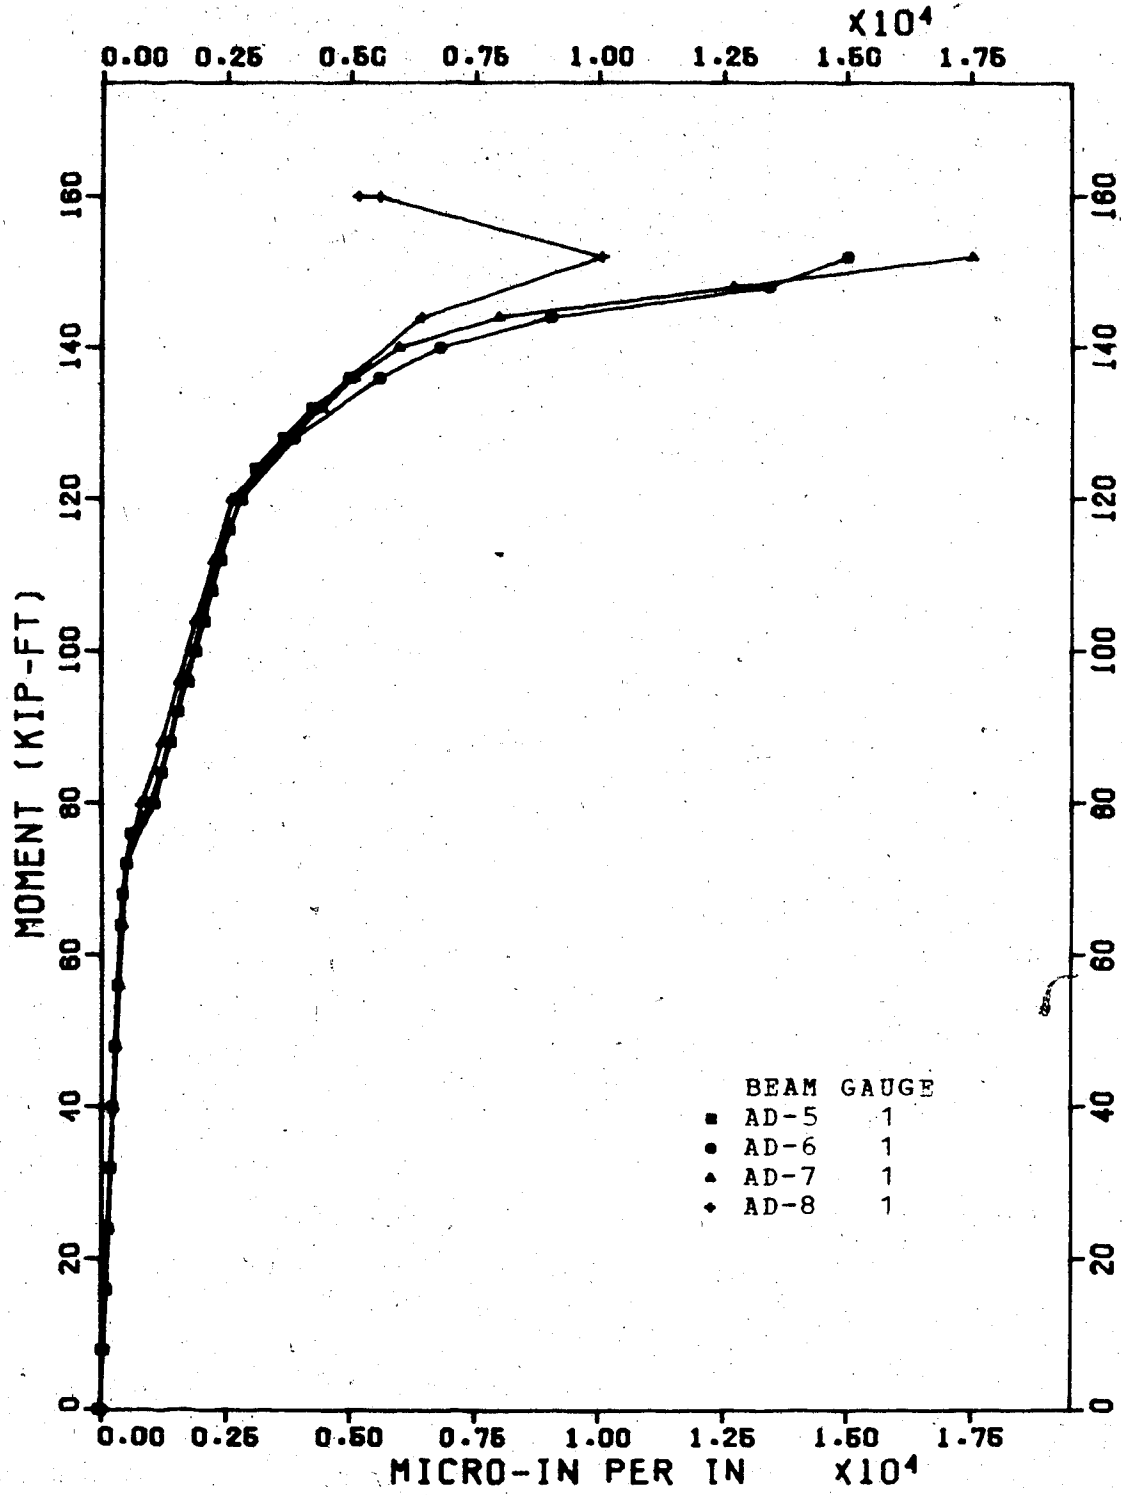
FIGURE 4.6.2 CASTING GROUP TWO
APPLIED MOMENT VS. STRAND STRAIN AT CENTERLINE

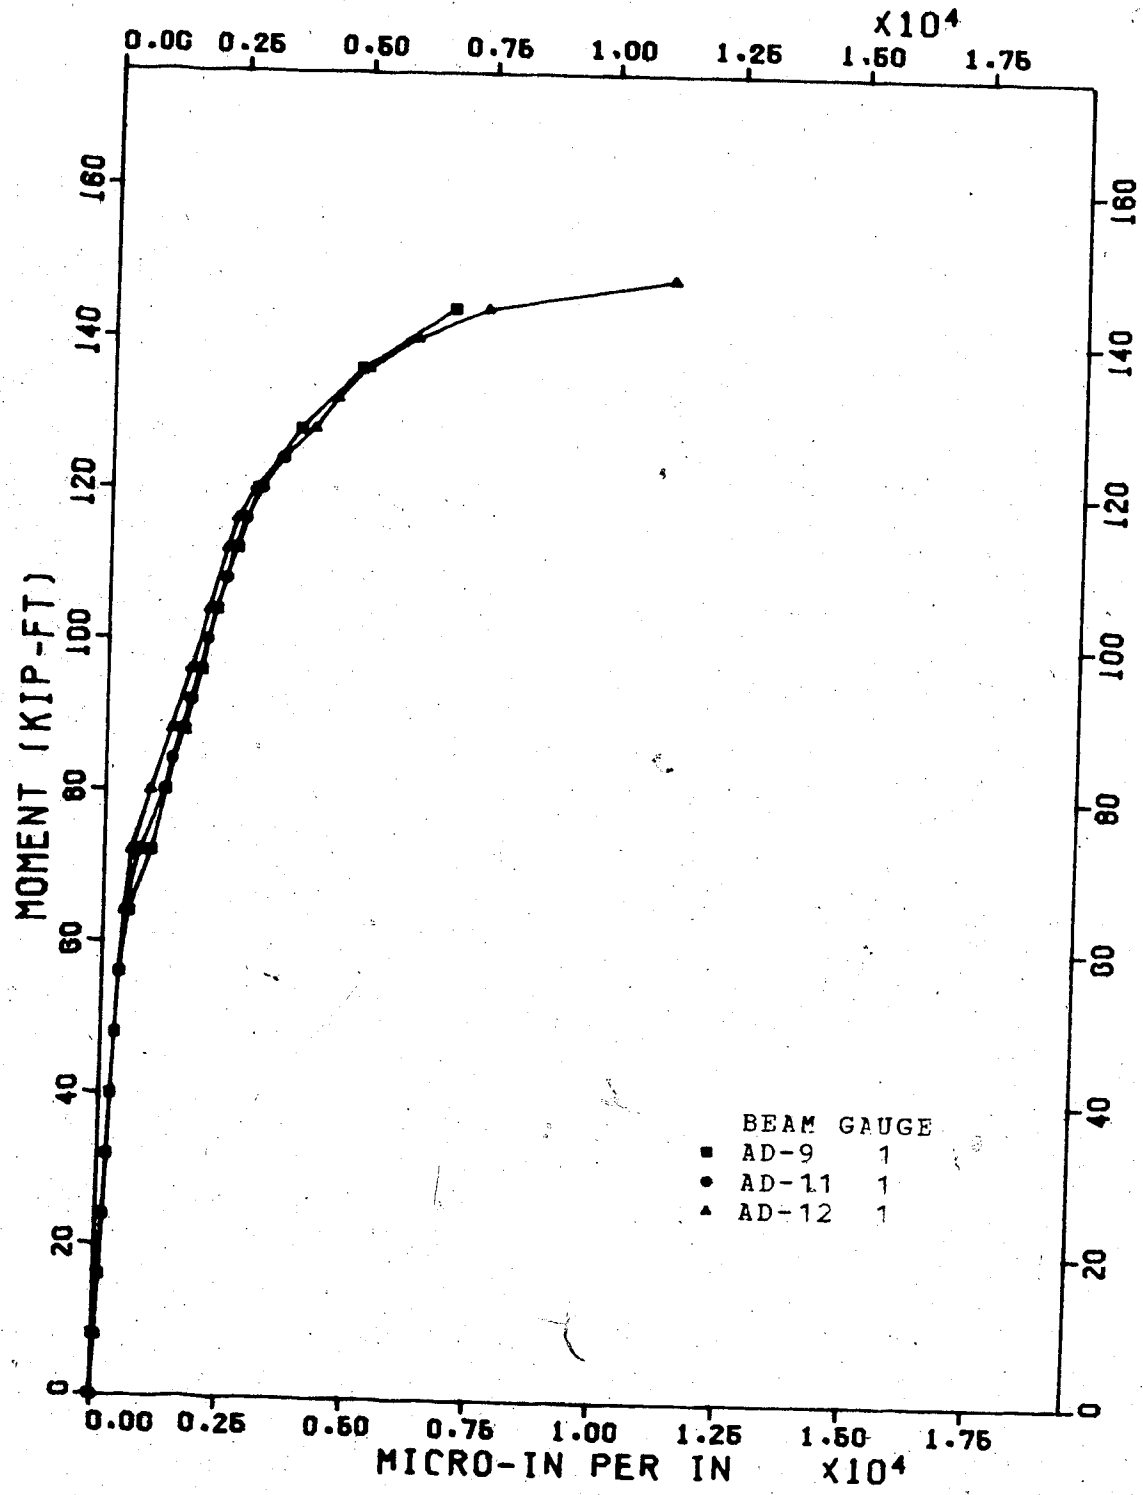
FIGURE 4.6.3 CASTING GROUP THREE
APPLIED MOMENT VS. STRAND STRAIN AT CENTERLINE

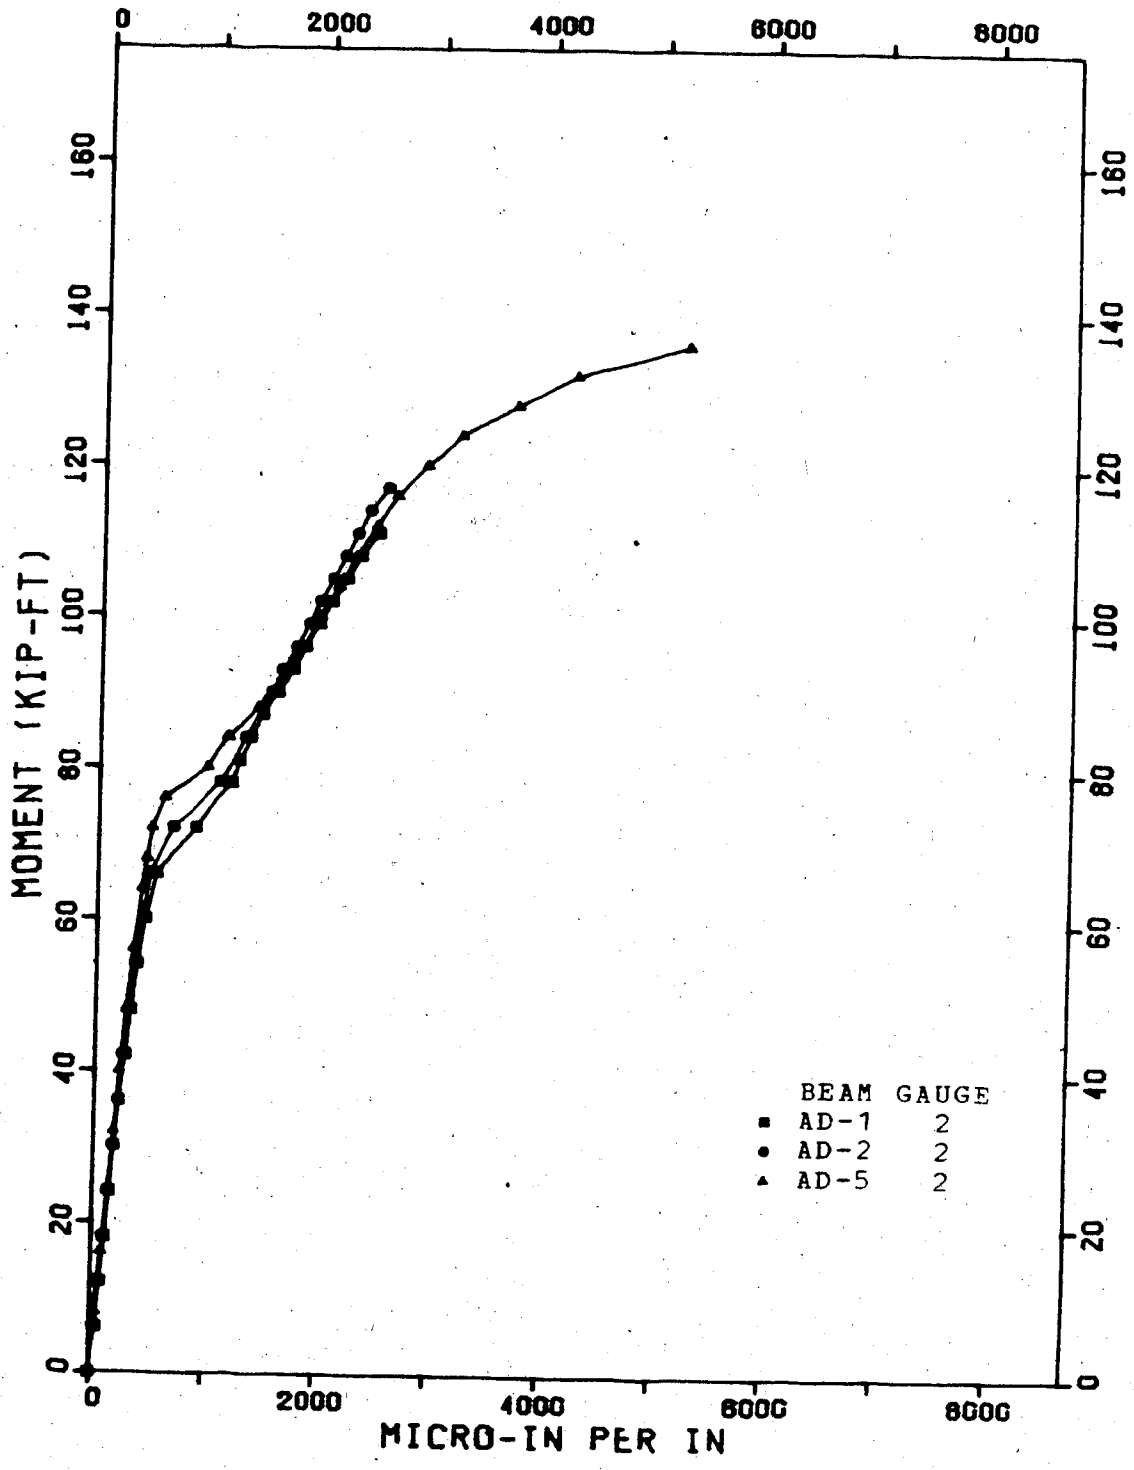
FIGURE 4.7.1

APPLIED MOMENT VS. STRAND STRAIN AT LOCATION 'S1'

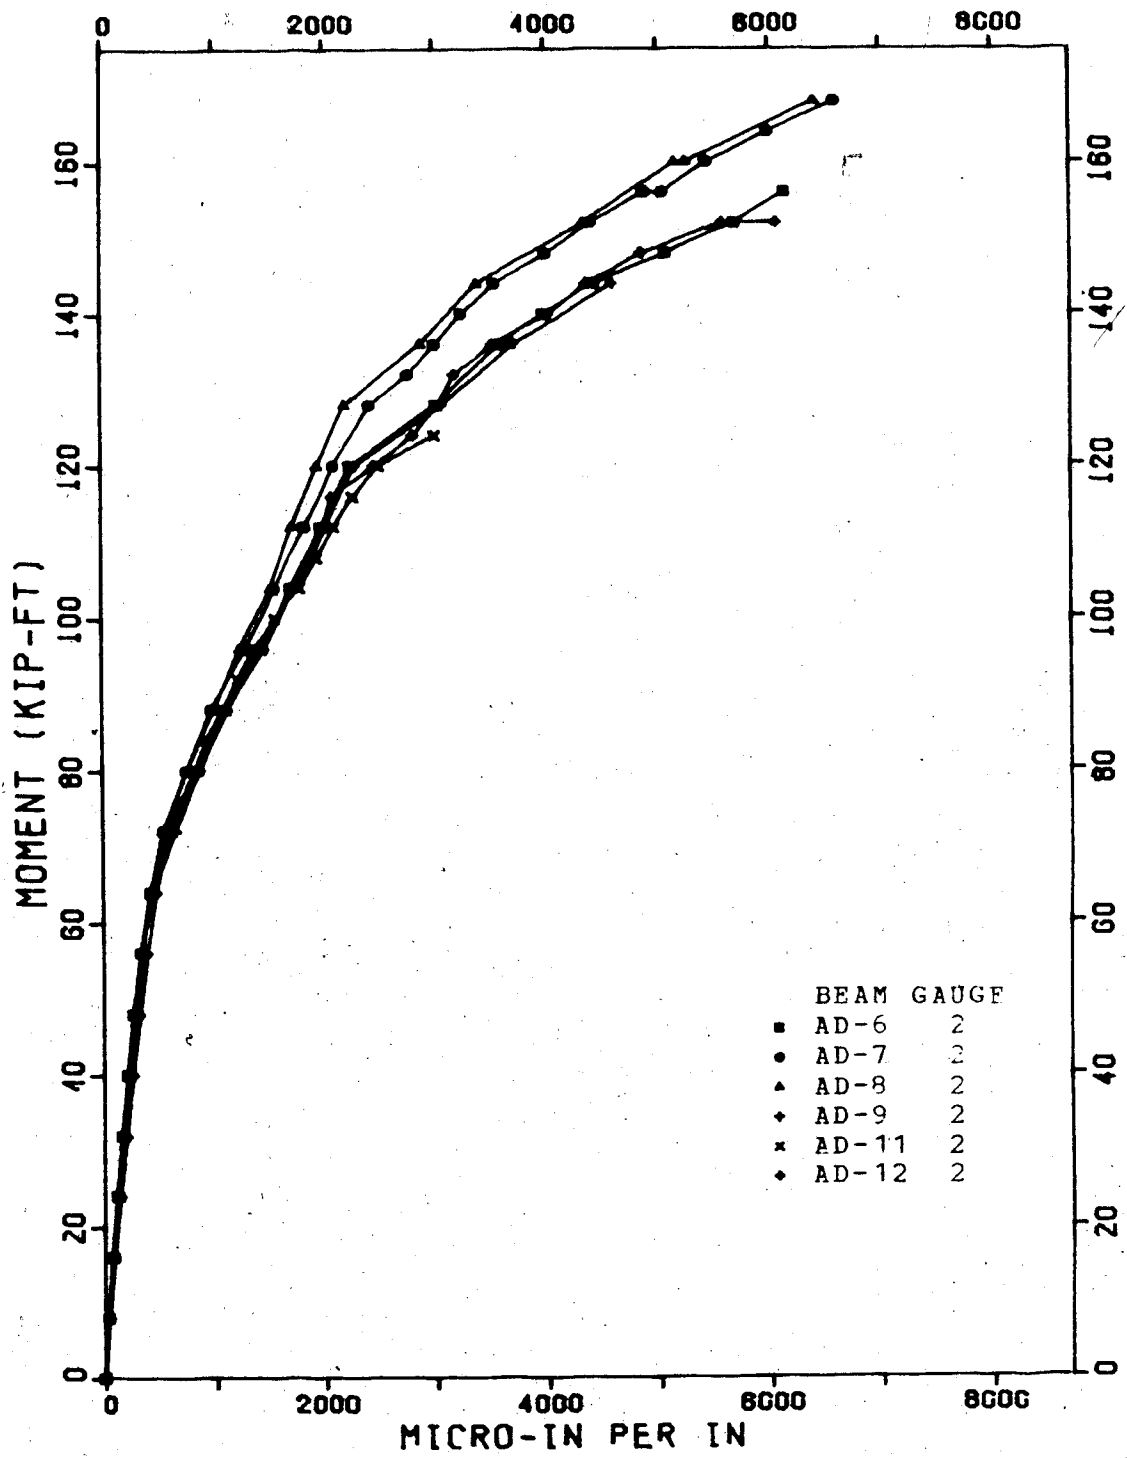
FIGURE 4.7.2

APPLIED MOMENT VS. STRAND STRAIN AT LOCATION 'S2'

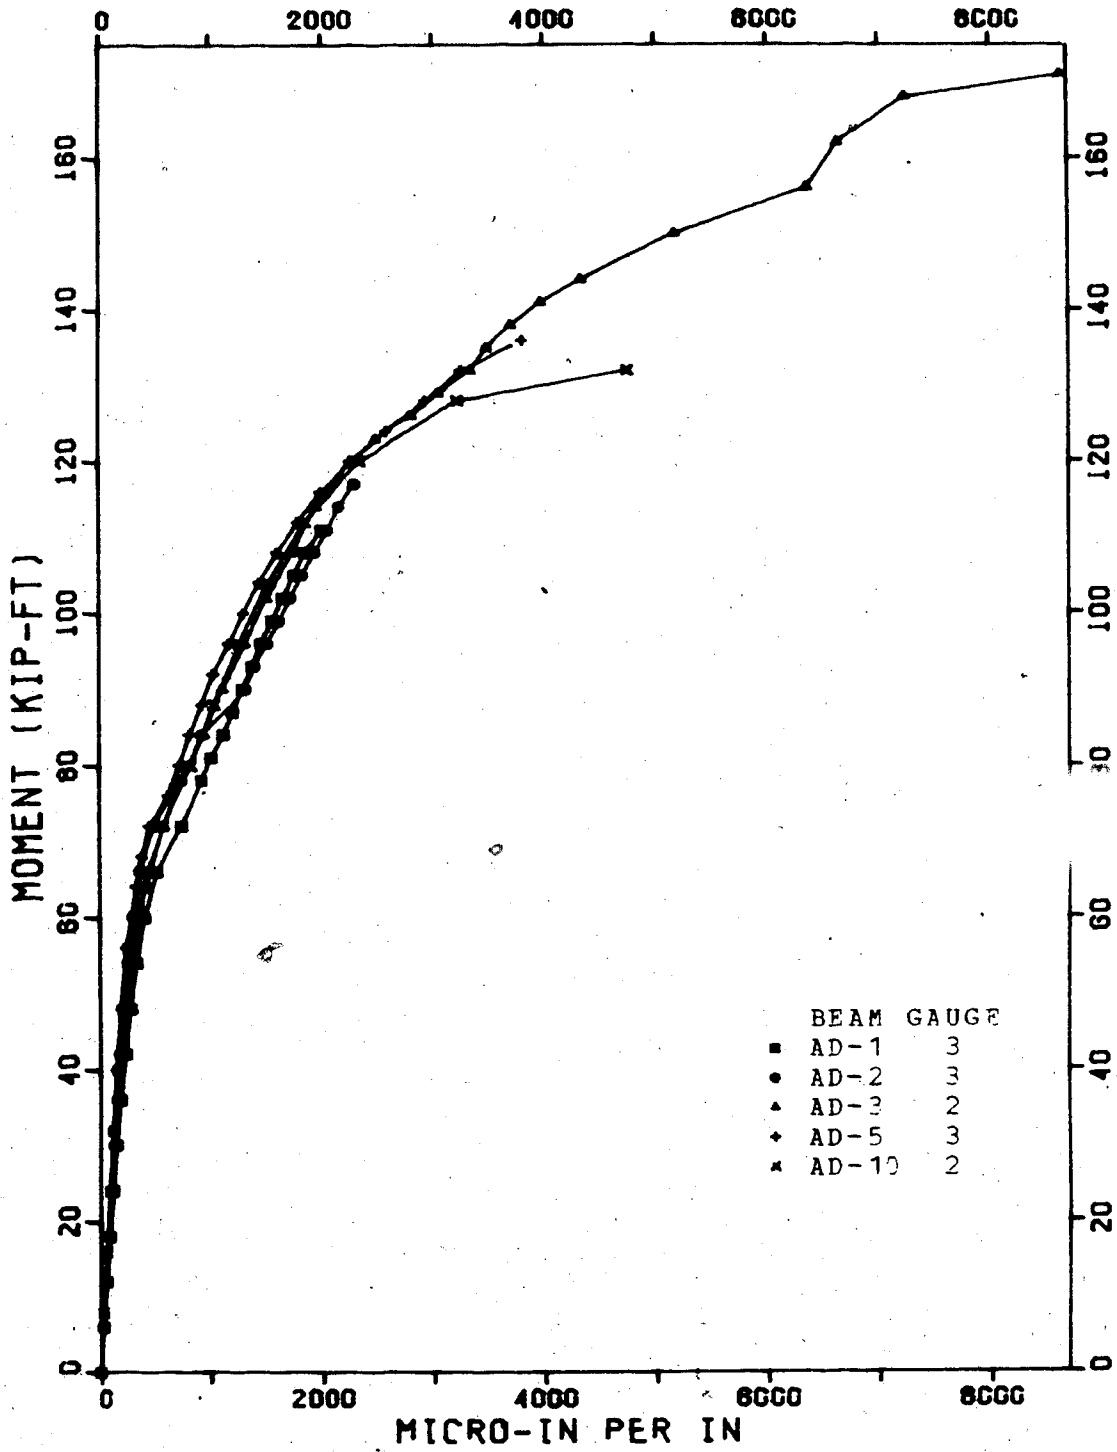
FIGURE 4.7.3

APPLIED MOMENT VS. STRAND STRAIN AT LOCATION 'S3'

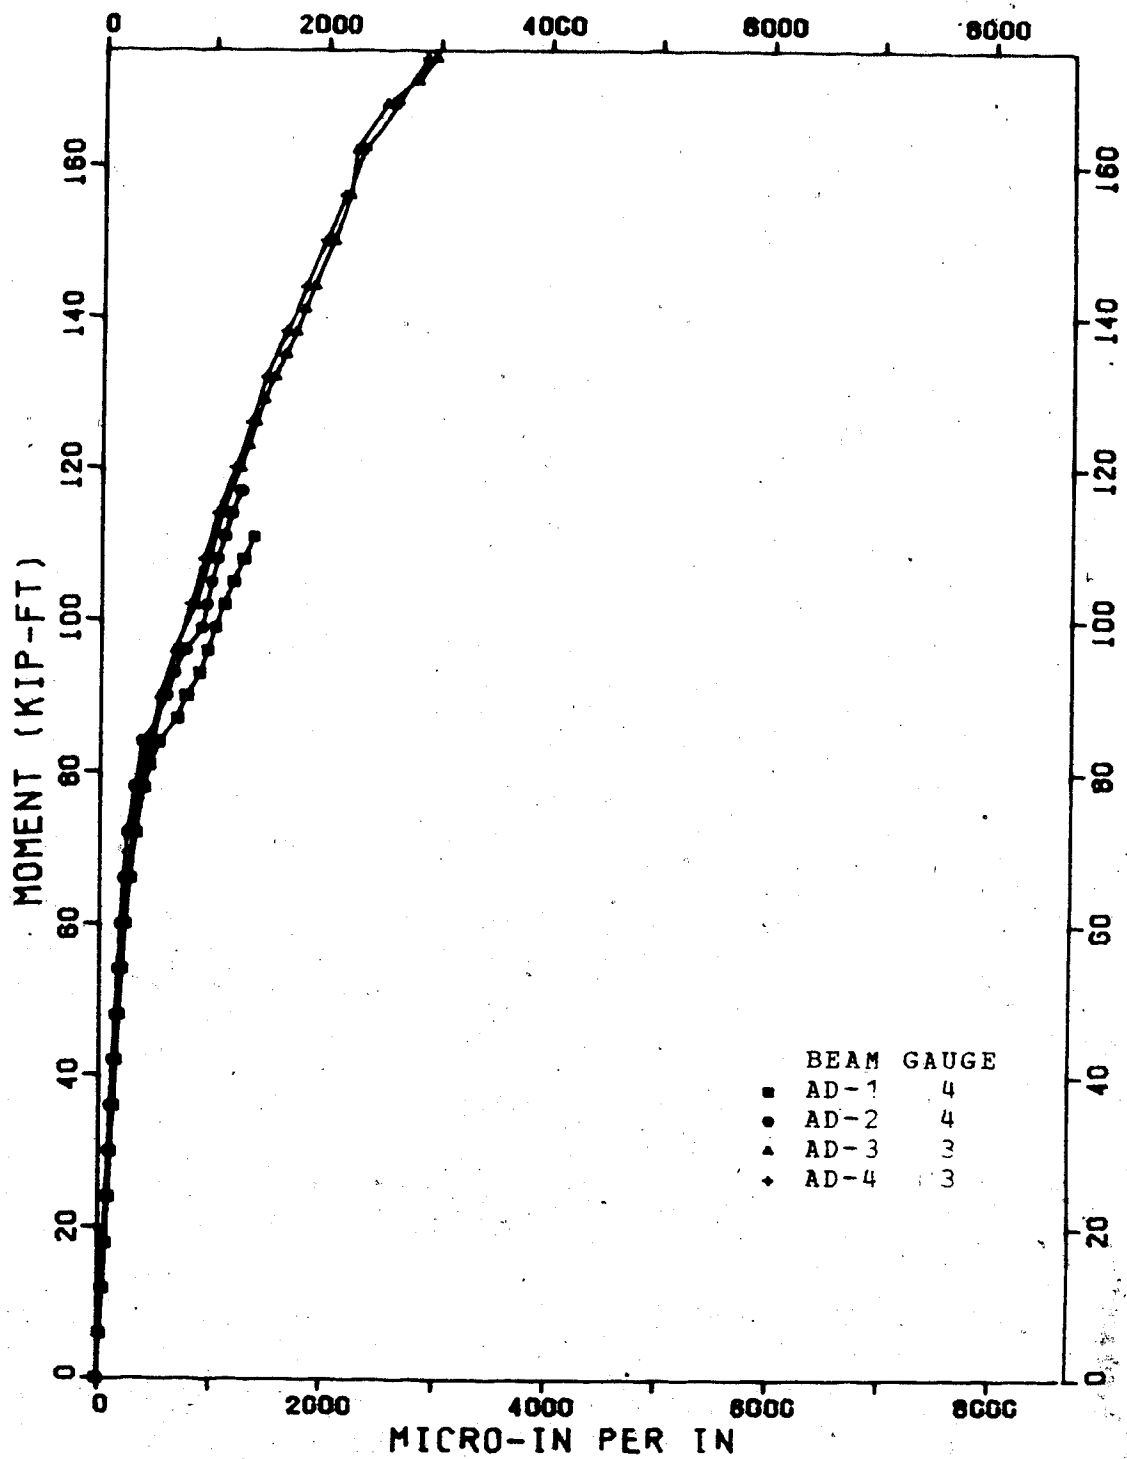
FIGURE 4.7.4

APPLIED MOMENT VS. STRAND STRAIN AT LOCATION 'S4'

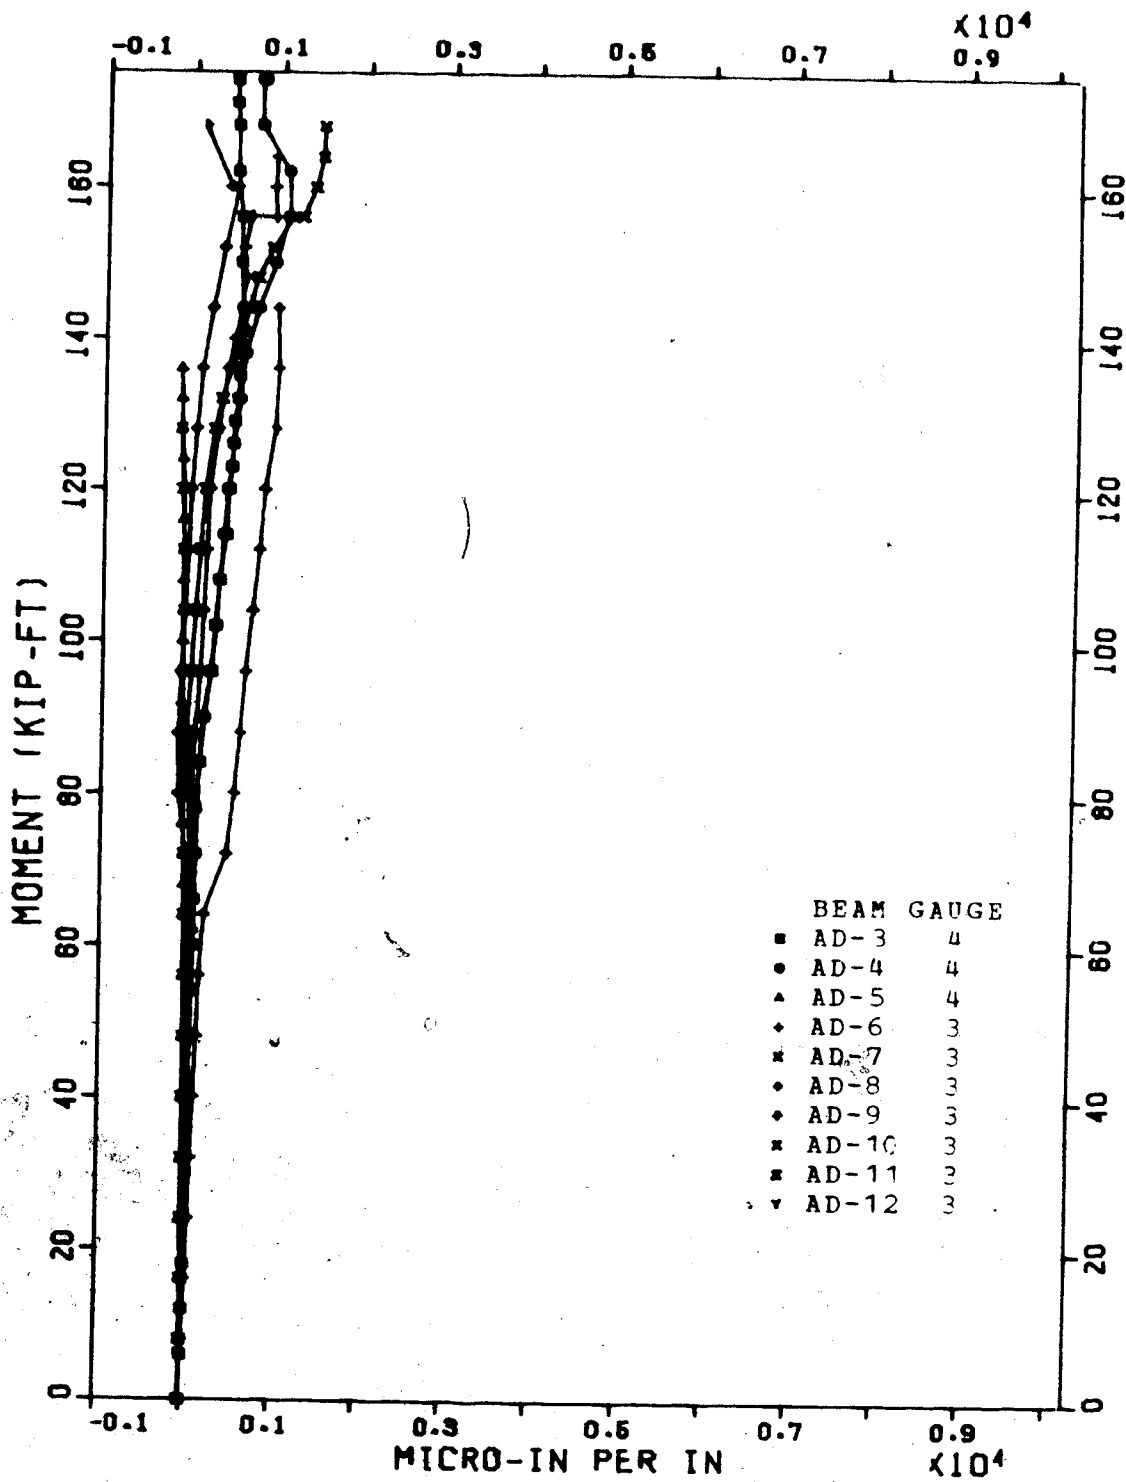
FIGURE 4.8.1

APPLIED MOMENT VS. STIRRUP STRAIN AT LOCATION 'F1'

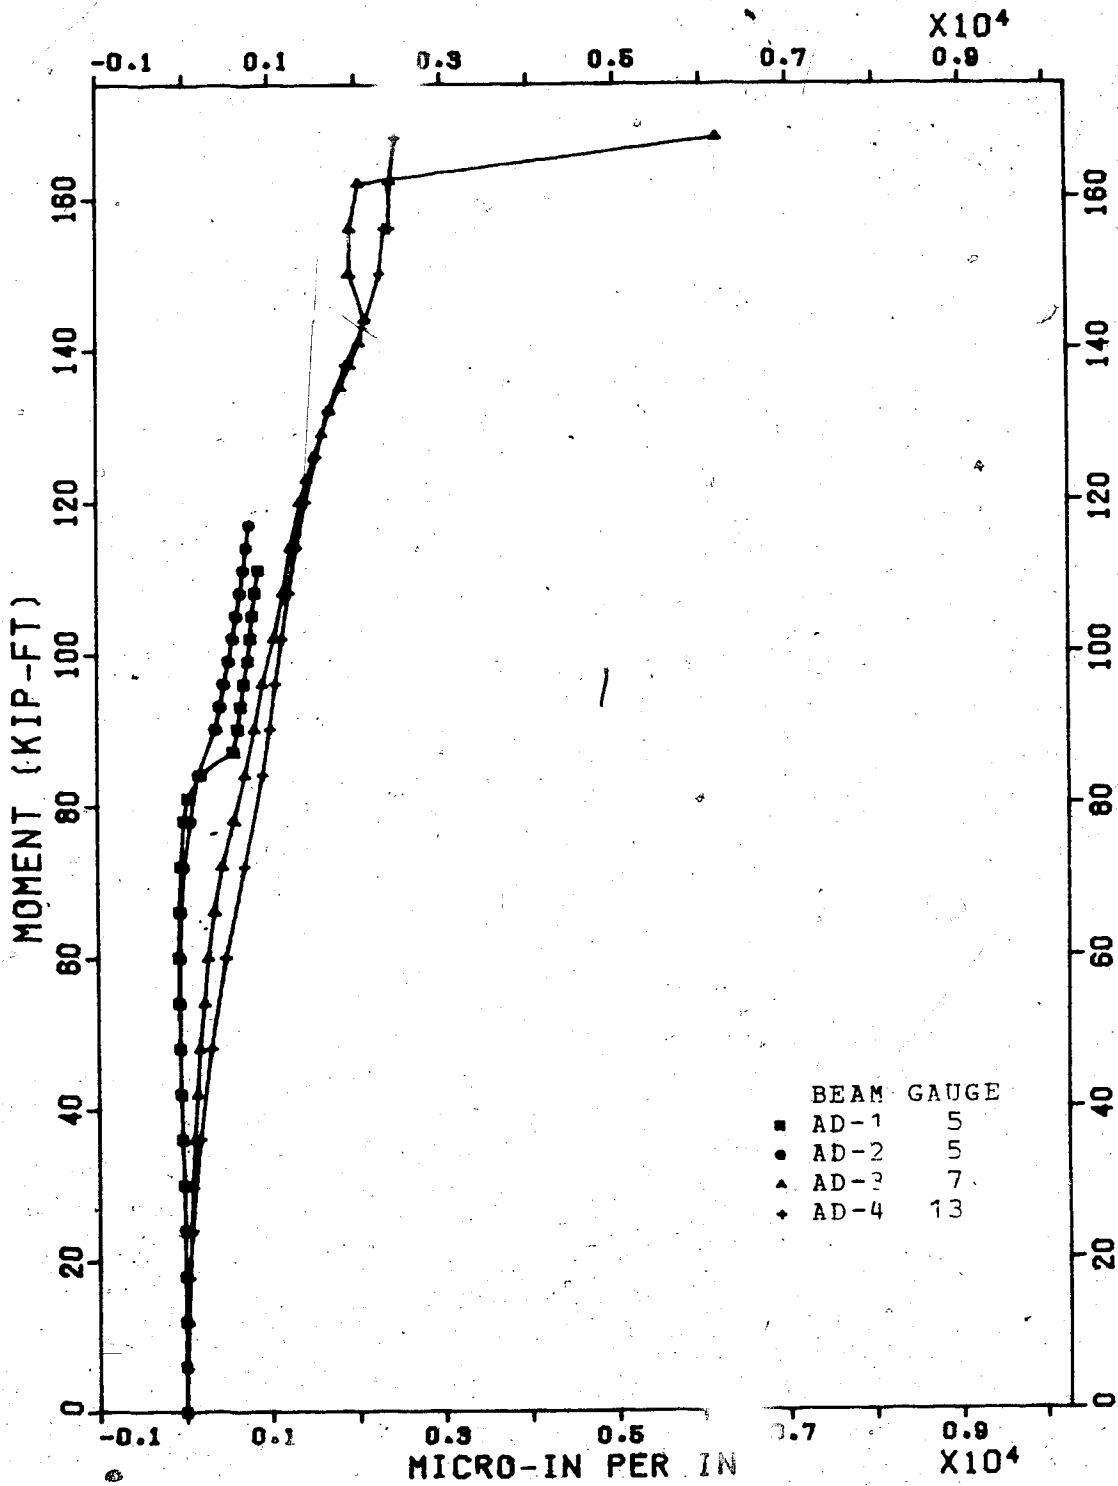
FIGURE 4.8.2

APPLIED MOMENT VS. STIRRUP STRAIN AT LOCATION 'F2'

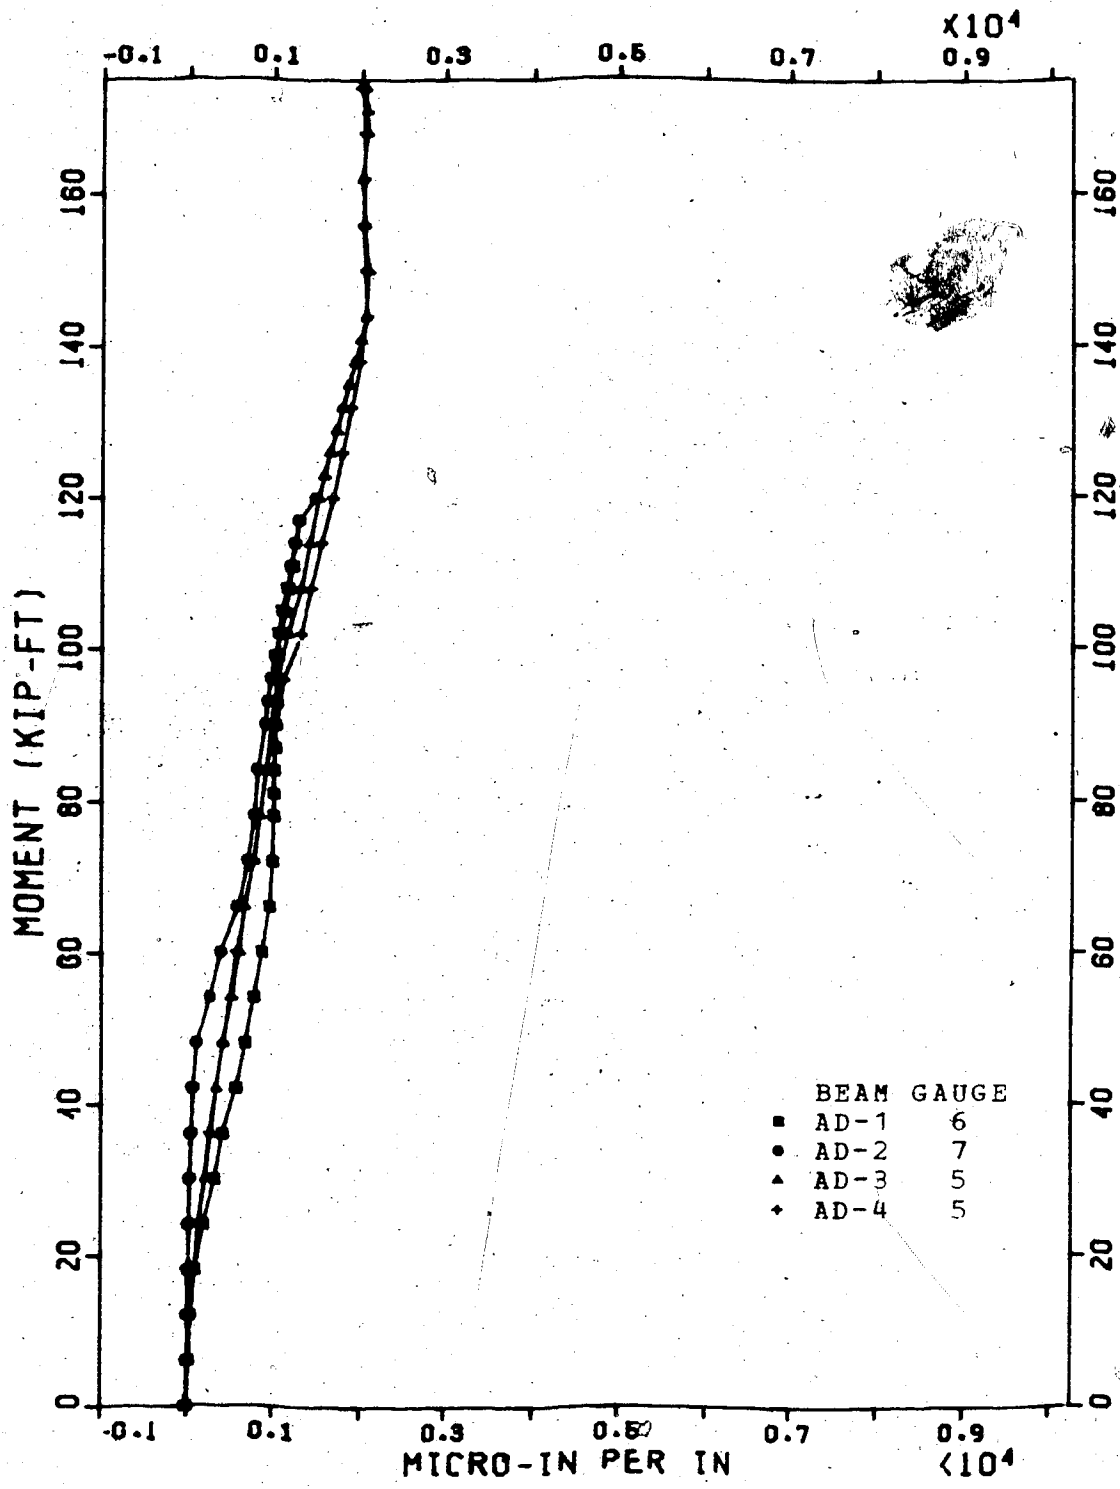
FIGURE 4.8.3

APPLIED MOMENT VS. STIRRUP STRAIN AT LOCATION 'F3'

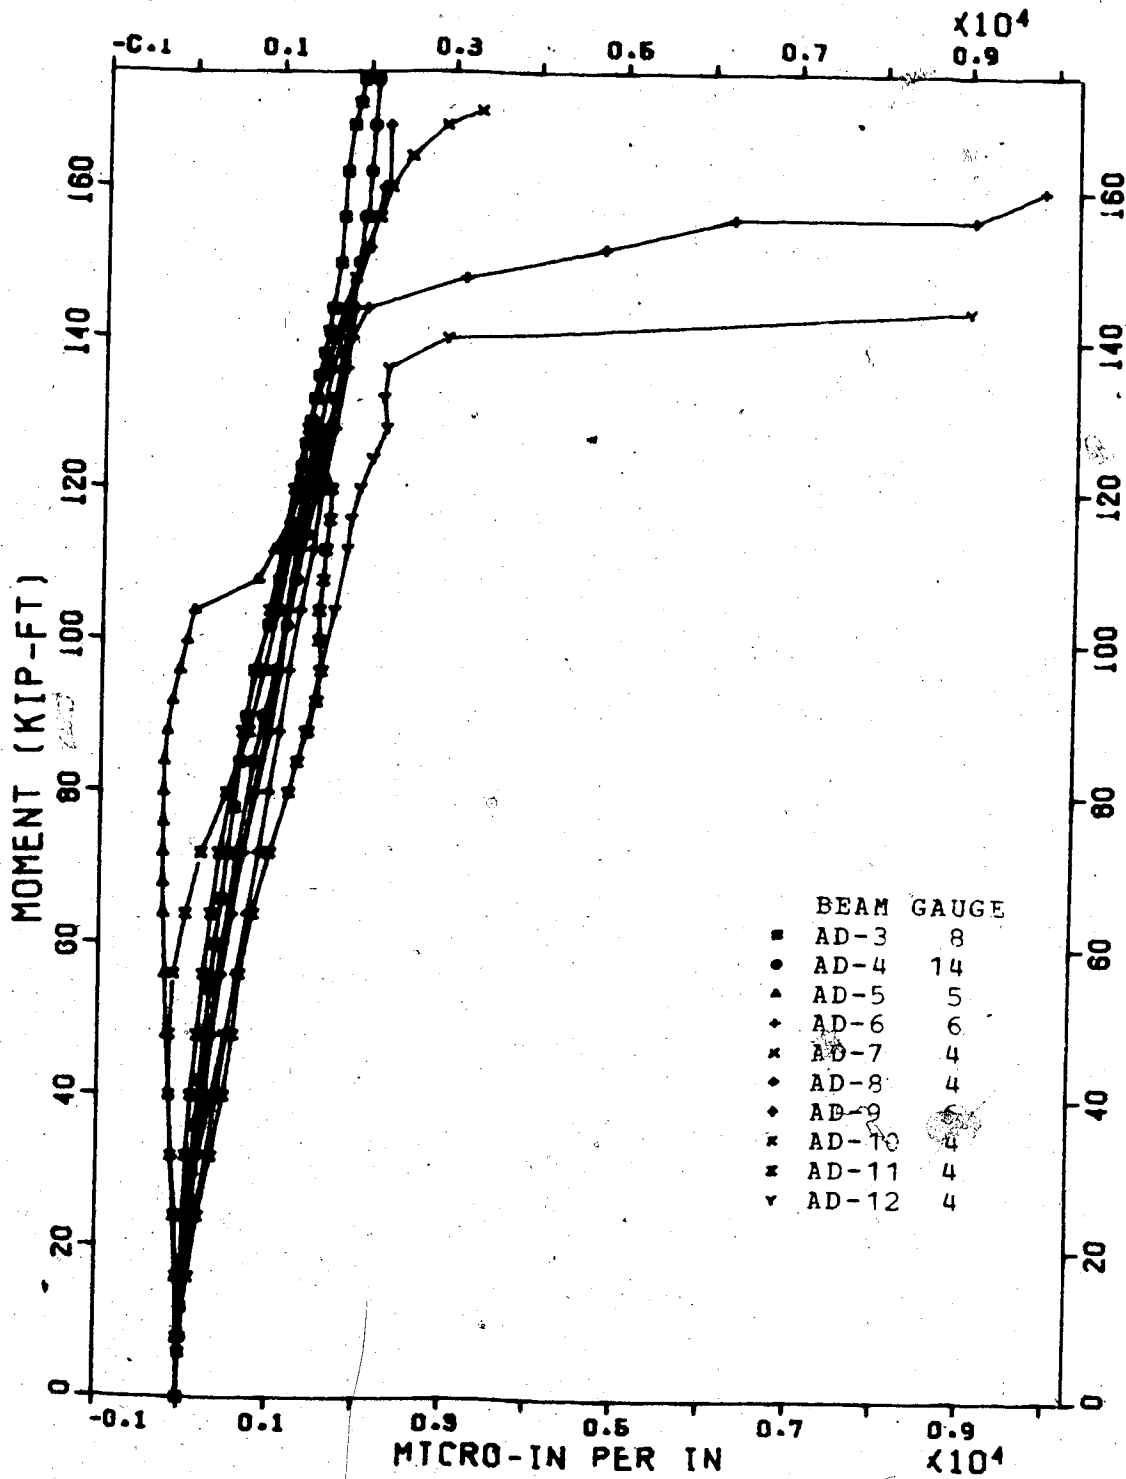
FIGURE 4.8.4

APPLIED MOMENT VS. STIRRUP STRAIN AT LOCATION 'F4'

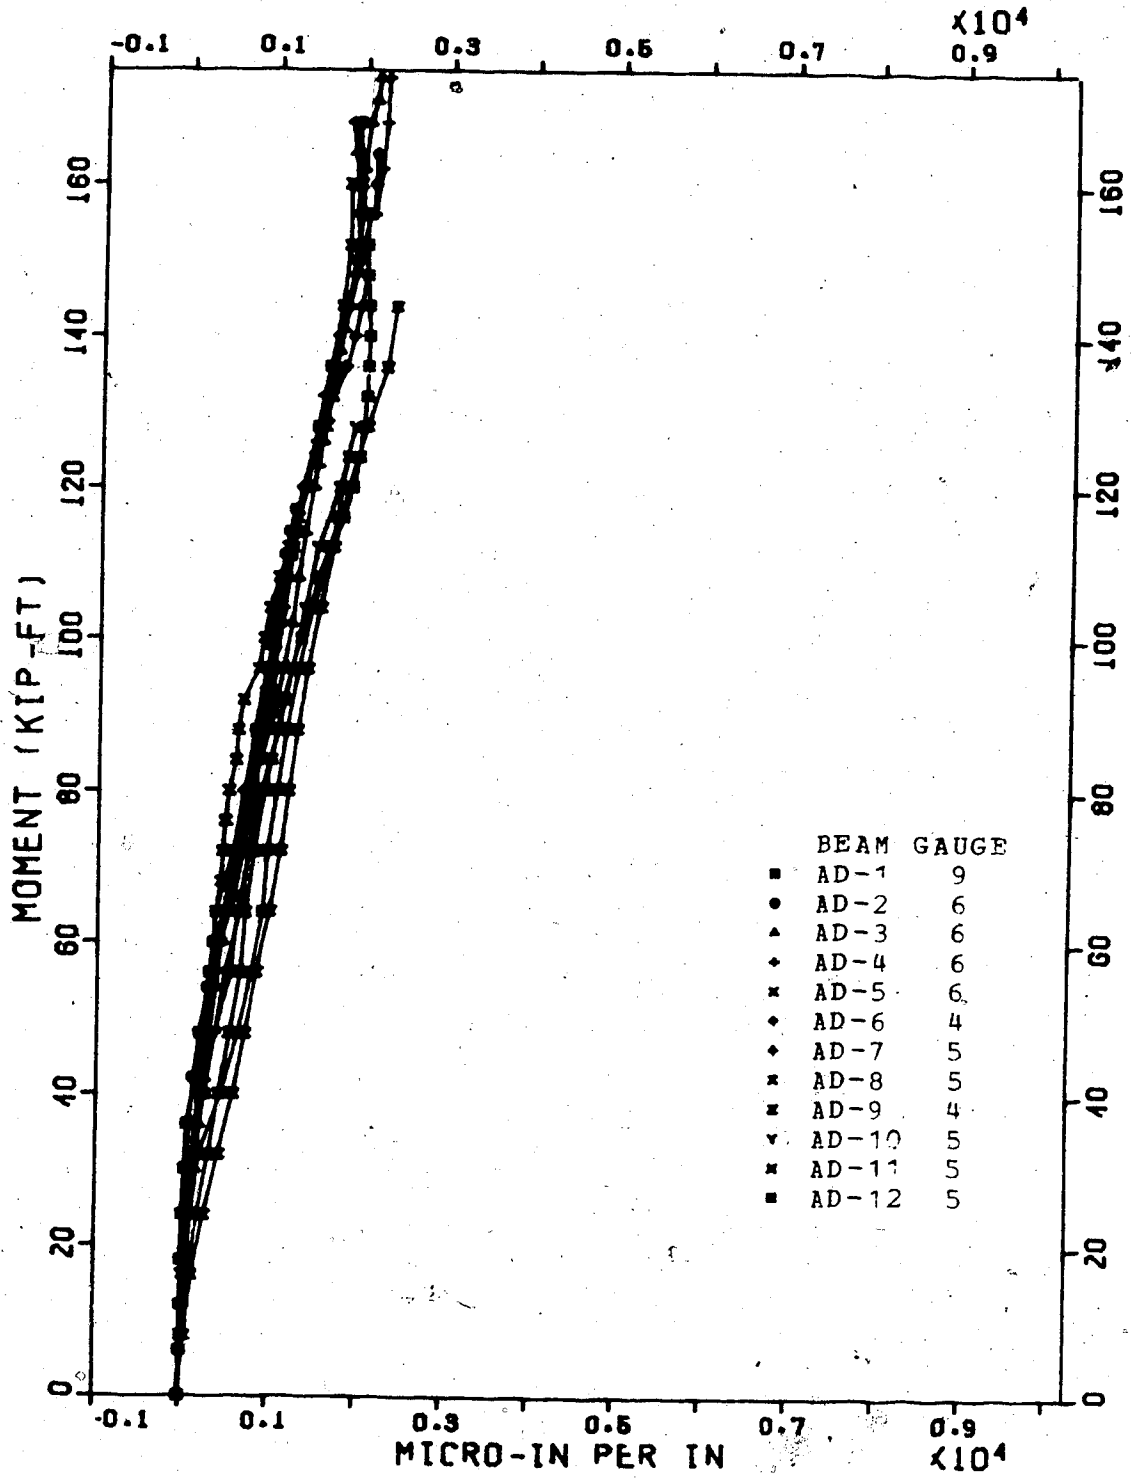
FIGURE 4.8.5

APPLIED MOMENT VS. STIRRUP STRAIN AT LOCATION 'F5'
