TITLE OF THESIS/TITRE DE LA THÈSE Prestressed Concrete Tee Beams
Containing Large Circular Web
Openings

UNIVERSITY/UNIVERSITÉ Univ. of Alberta

The present test series consisted of twelve Prestressed Concrete tee beams with large circular web openings, loaded to failure with two symmetrically placed point loads. All beams were 20 inches deep with a 20-inch flange and were prestressed with five prestressing strands of 3/8-inch diameter.

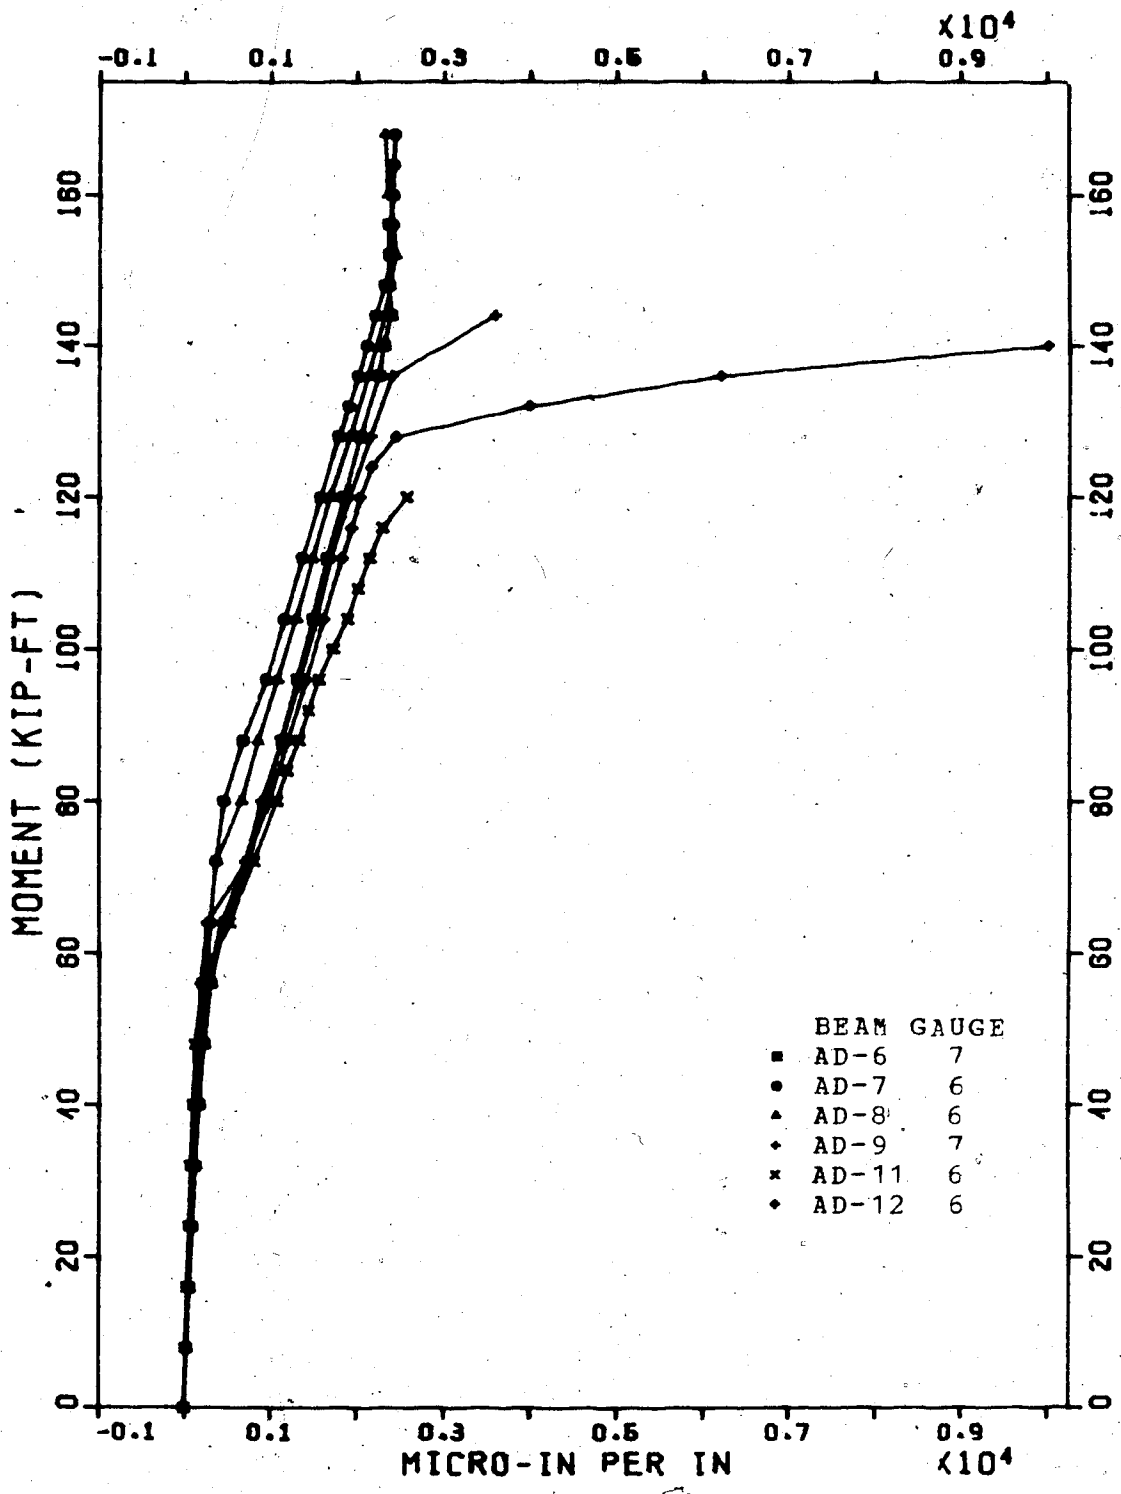
FIGURE 4.8.6

APPLIED MOMENT VS. STIRRUP TRAIN AT LOCATION 'F6'

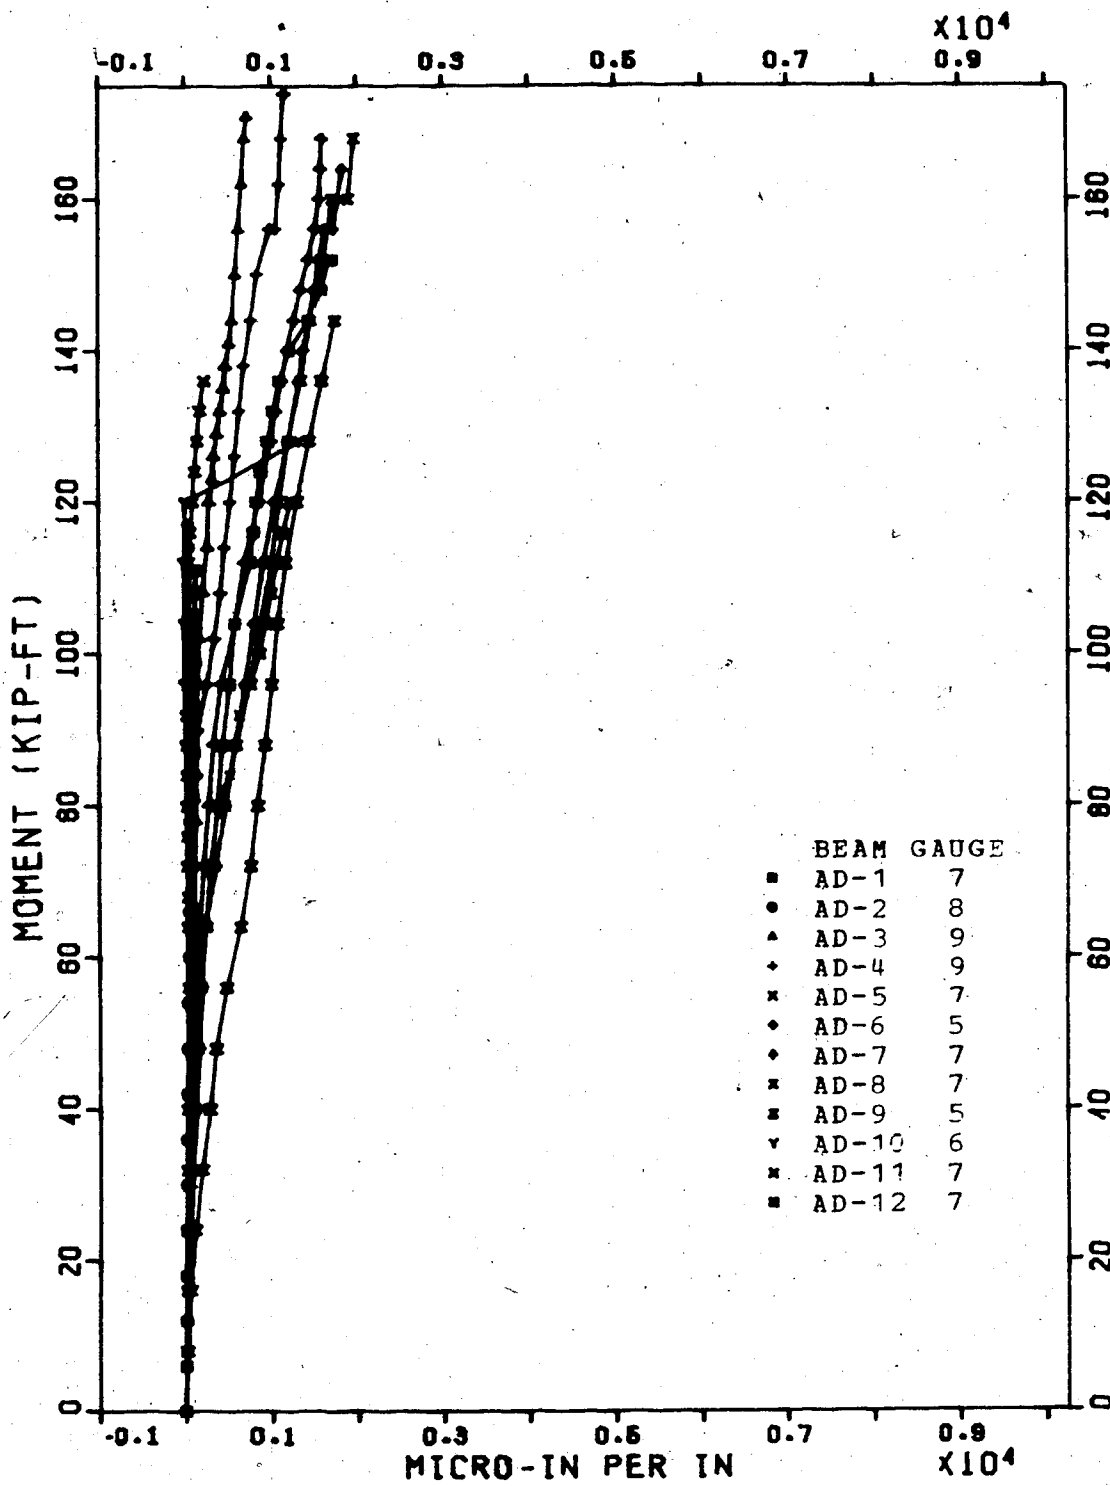
FIGURE 4.8.7

APPLIED MOMENT VS. STIRRUP STRAIN AT LOCATION 'F7'

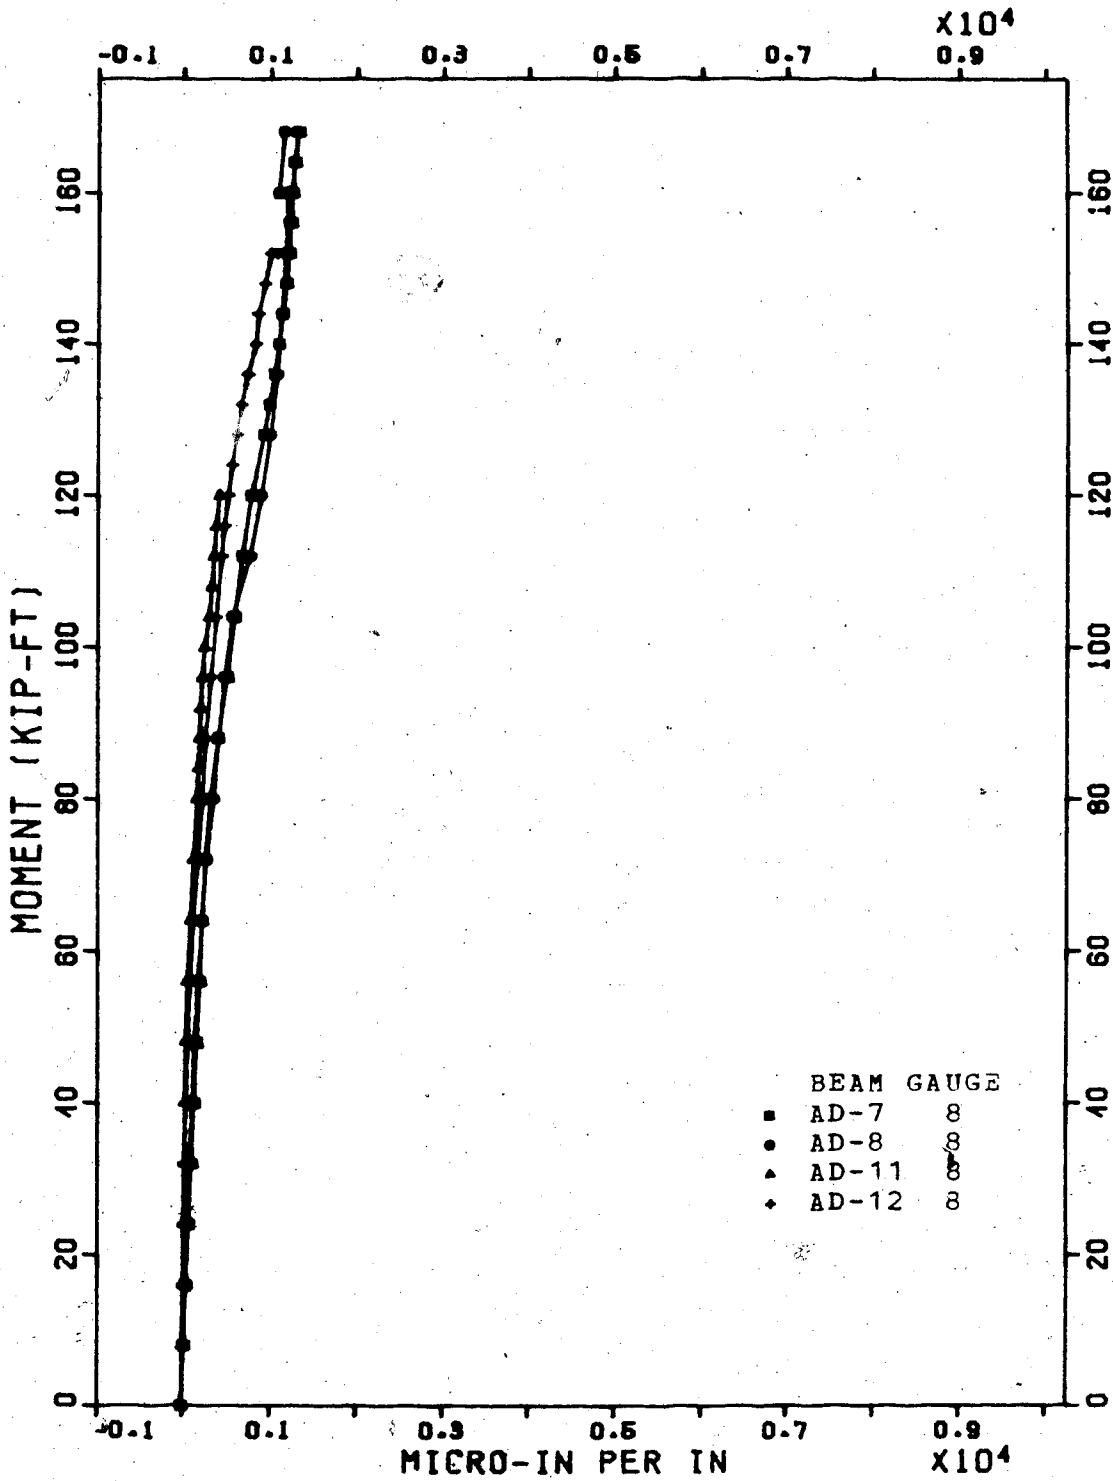
FIGURE 4.8.8

APPLIED MOMENT VS. STIRUP STRAIN AT LOCATION 'F8'

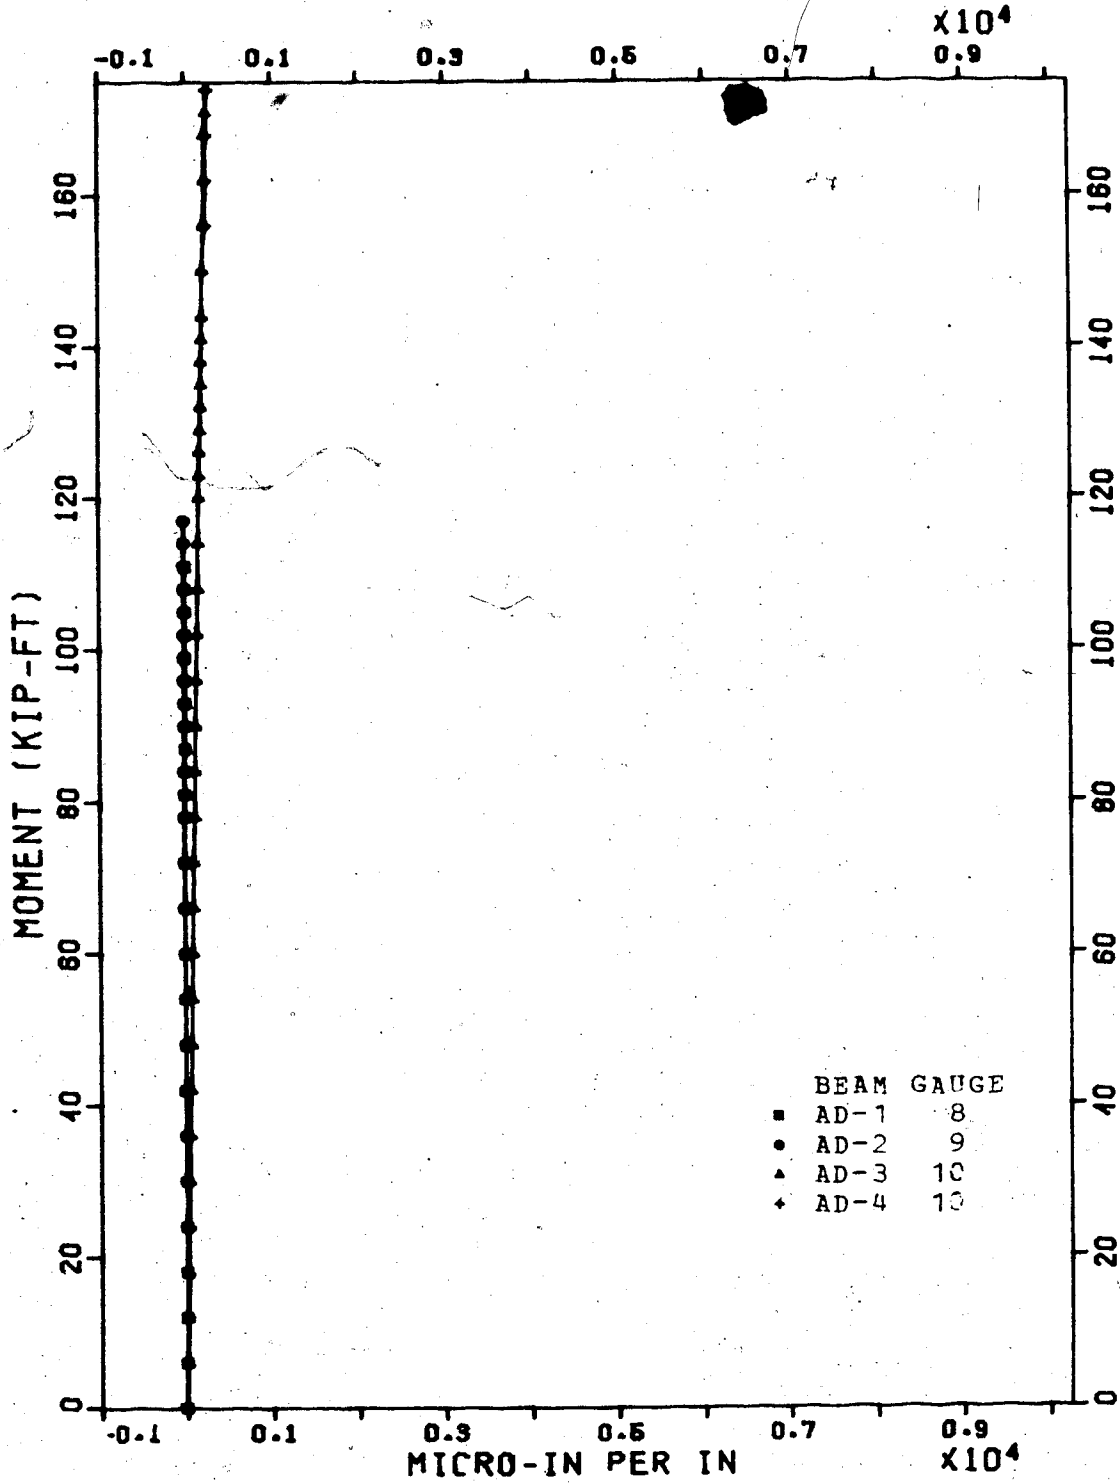
FIGURE 4.8.9

APPLIED MOMENT VS. STIRRUP STRAIN AT LOCATION 'F9'

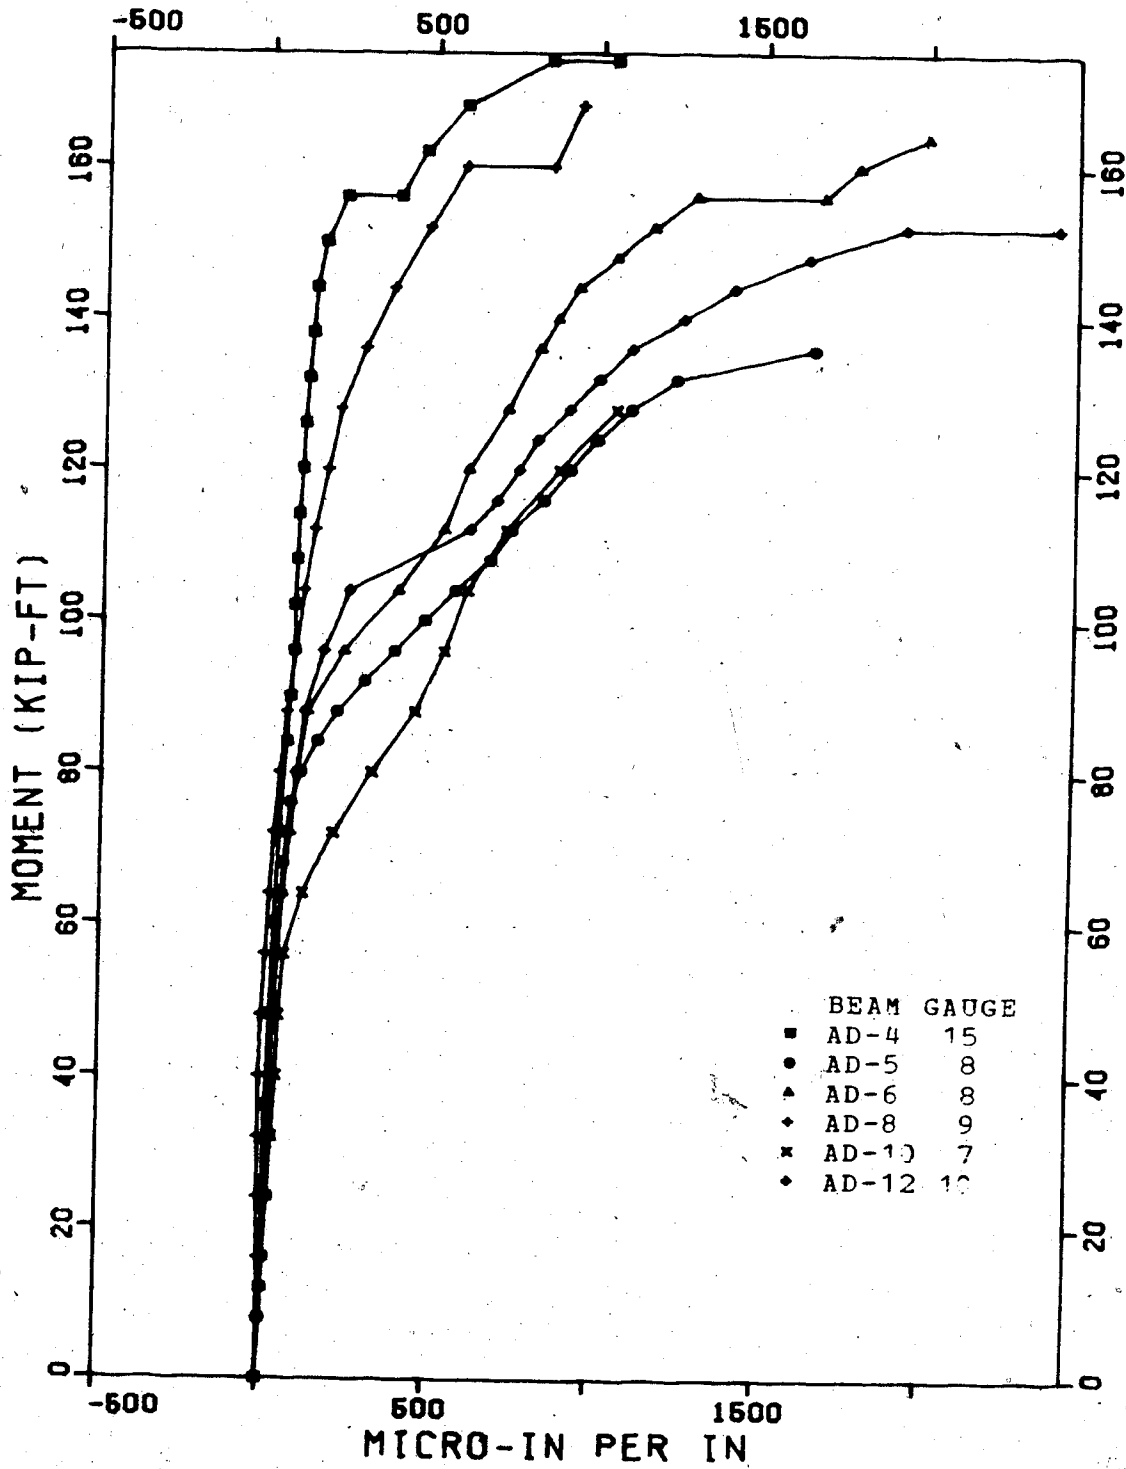
FIGURE 4.9.1 UPPER WEB STIRRUPS
APPLIED MOMENT VS. MOST CRITICAL STRAINS

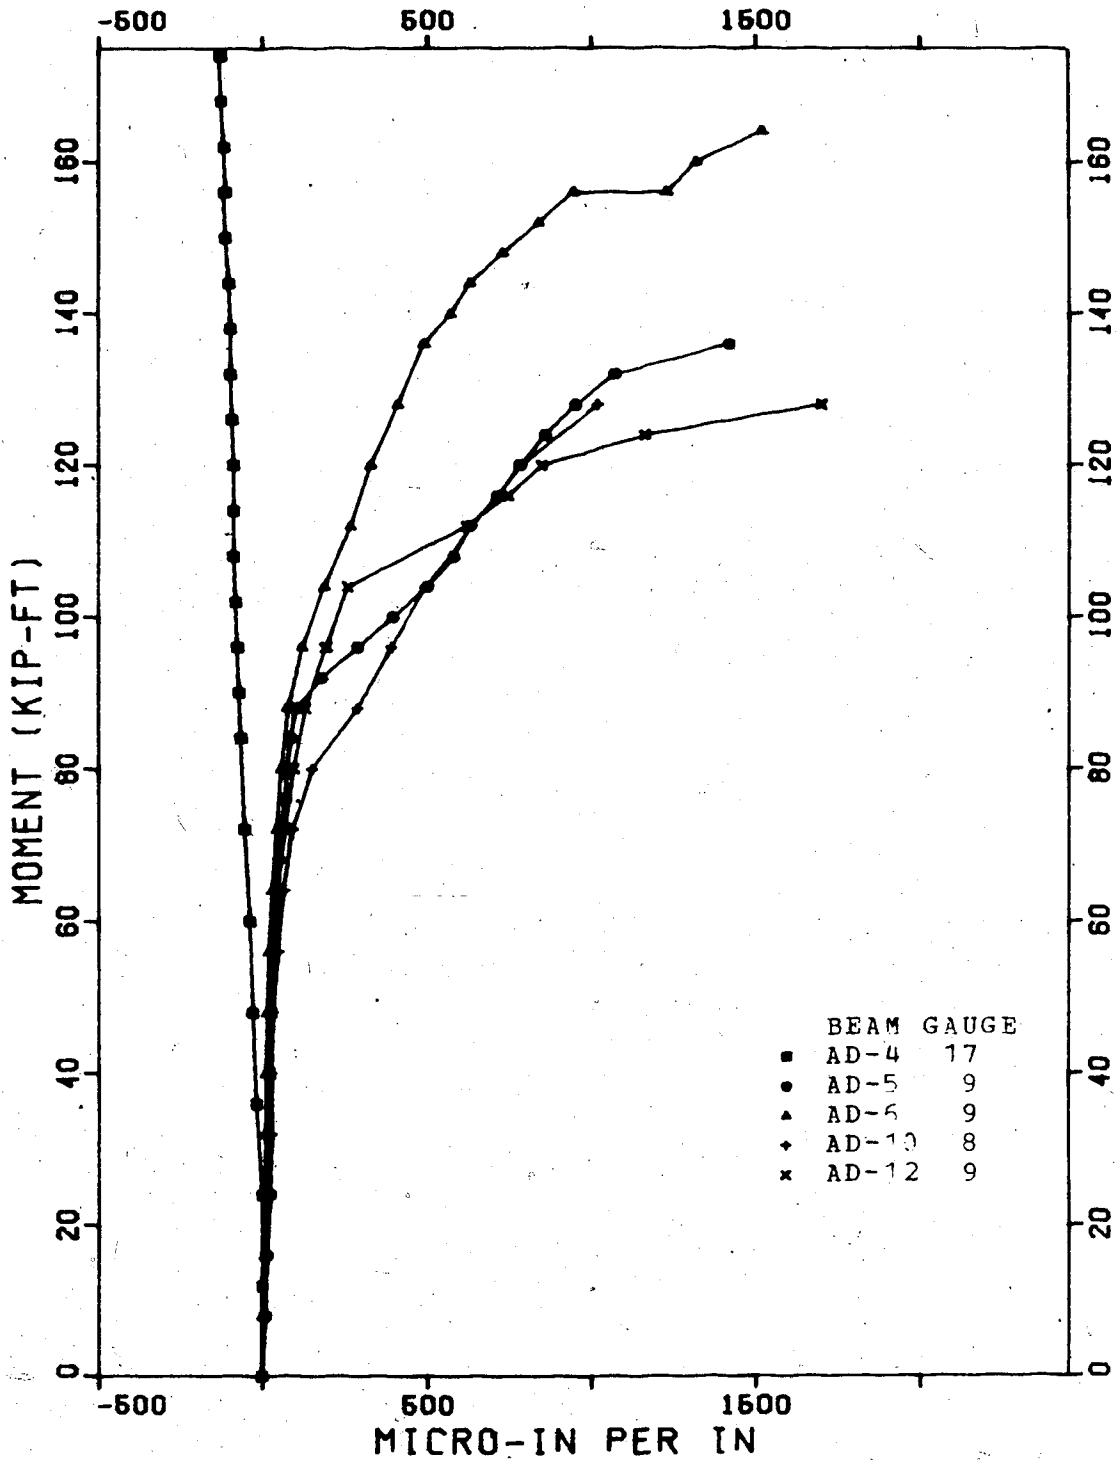
FIGURE 4.9.2 UPPER WEB STIRRUPS
APPLIED MOMENT VS. INTERMEDIATE STRAINS

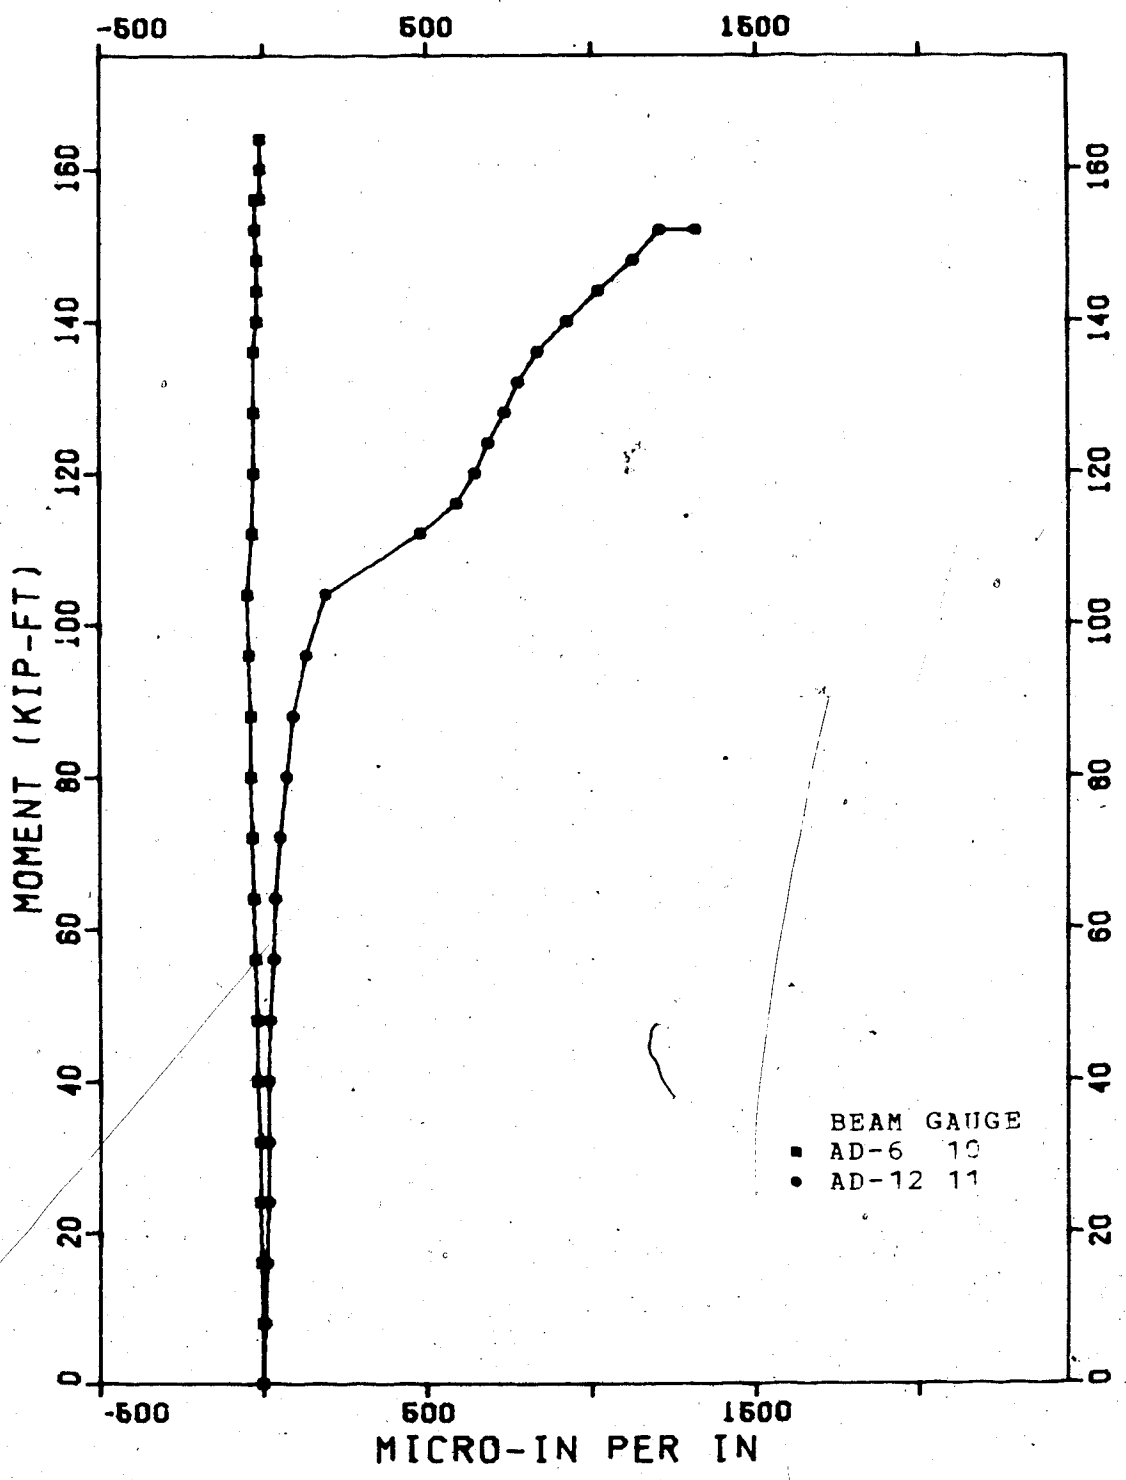
FIGURE 4.9.3 UPPER WEB STIRRUPS
APPLIED MOMENT VS. LEAST CRITICAL STRAINS

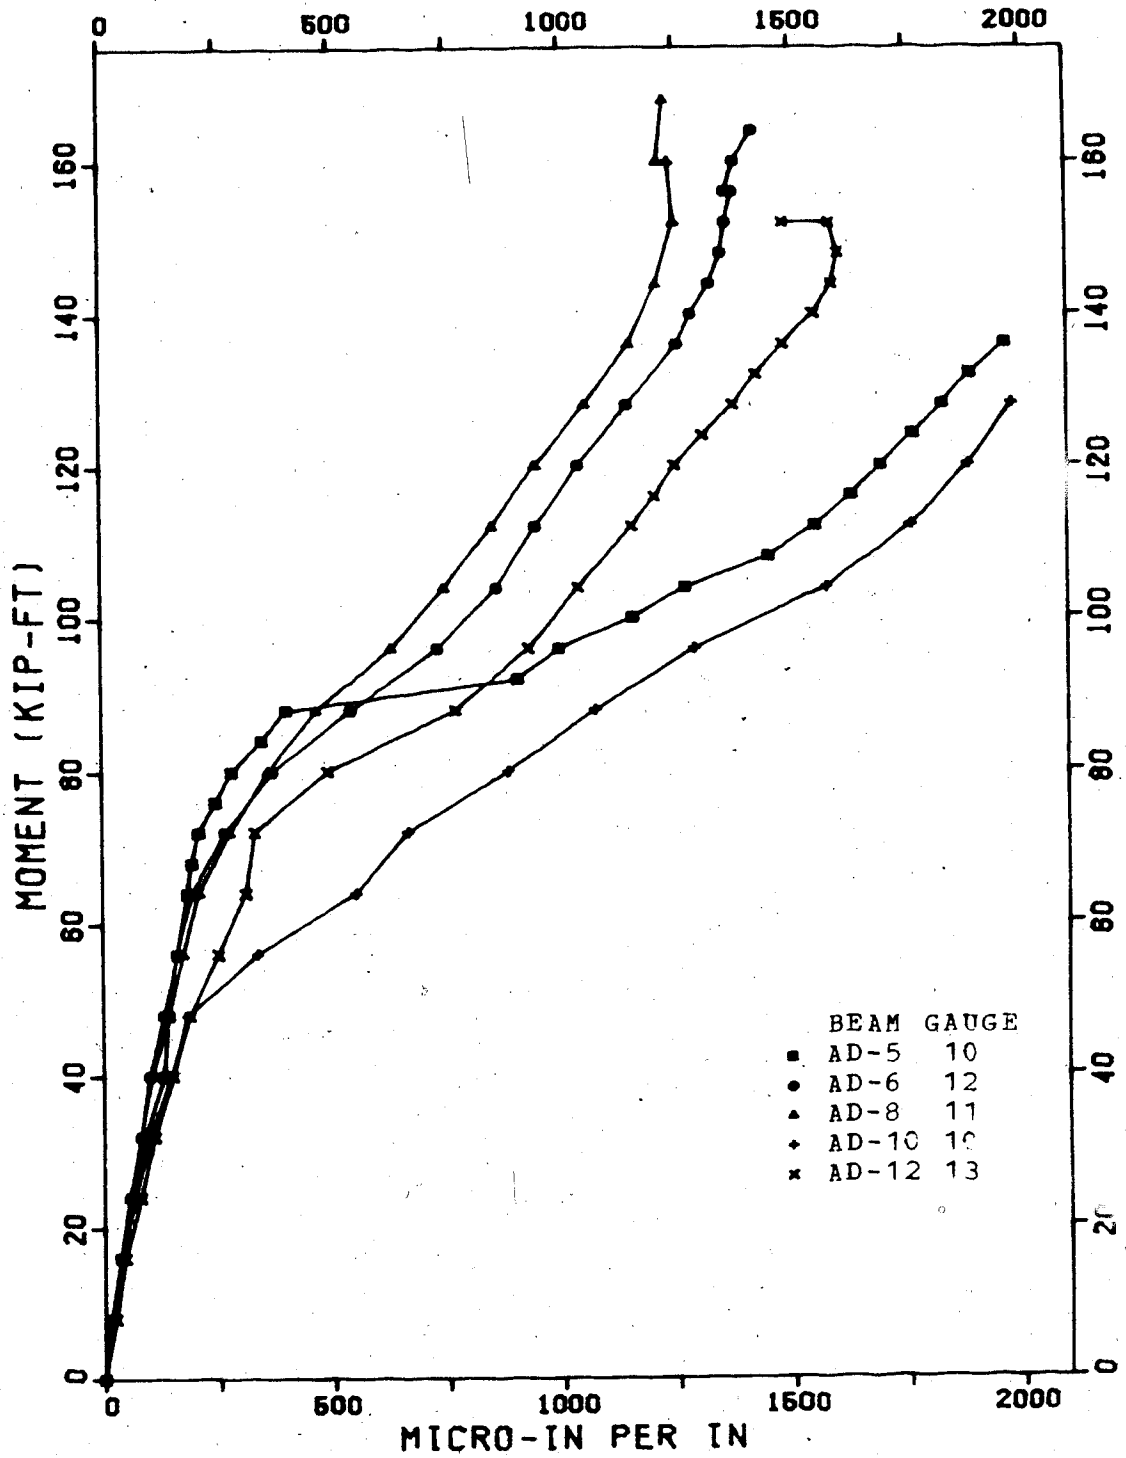
FIGURE 4.10.1 LOWER WEB STIRRUPS
APPLIED MOMENT VS. MOST CRITICAL STRAINS

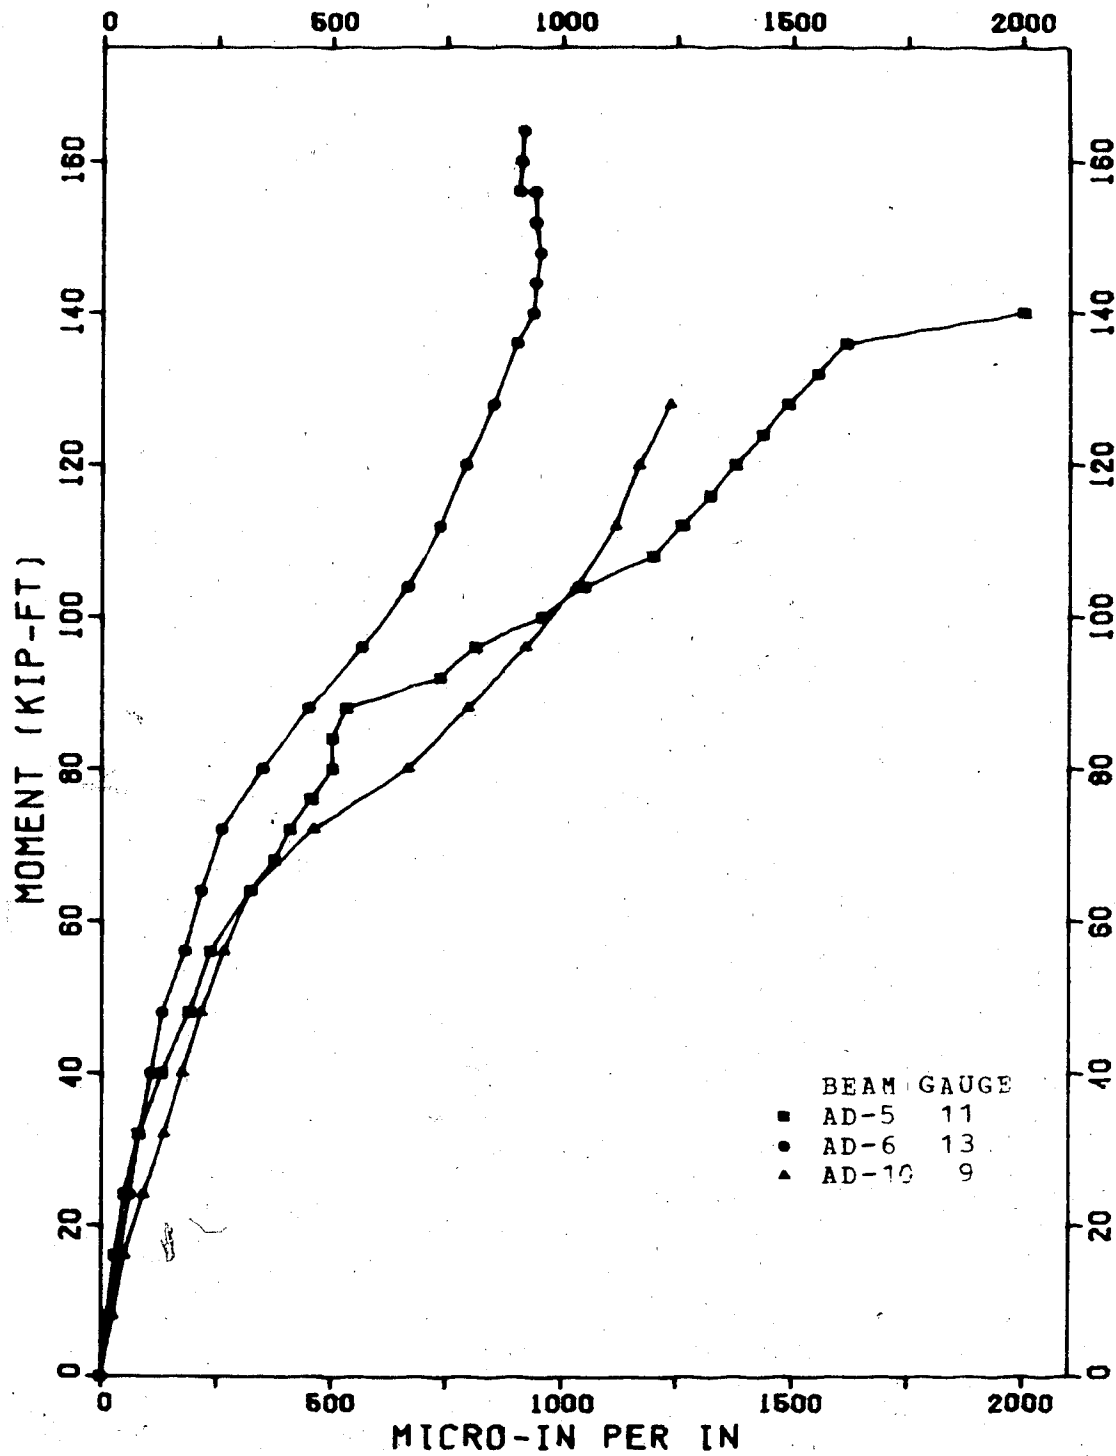
FIGURE 4.10.2 LOWER WEB STIRRUPS
APPLIED MOMENT VS. INTERMEDIATE STRAINS

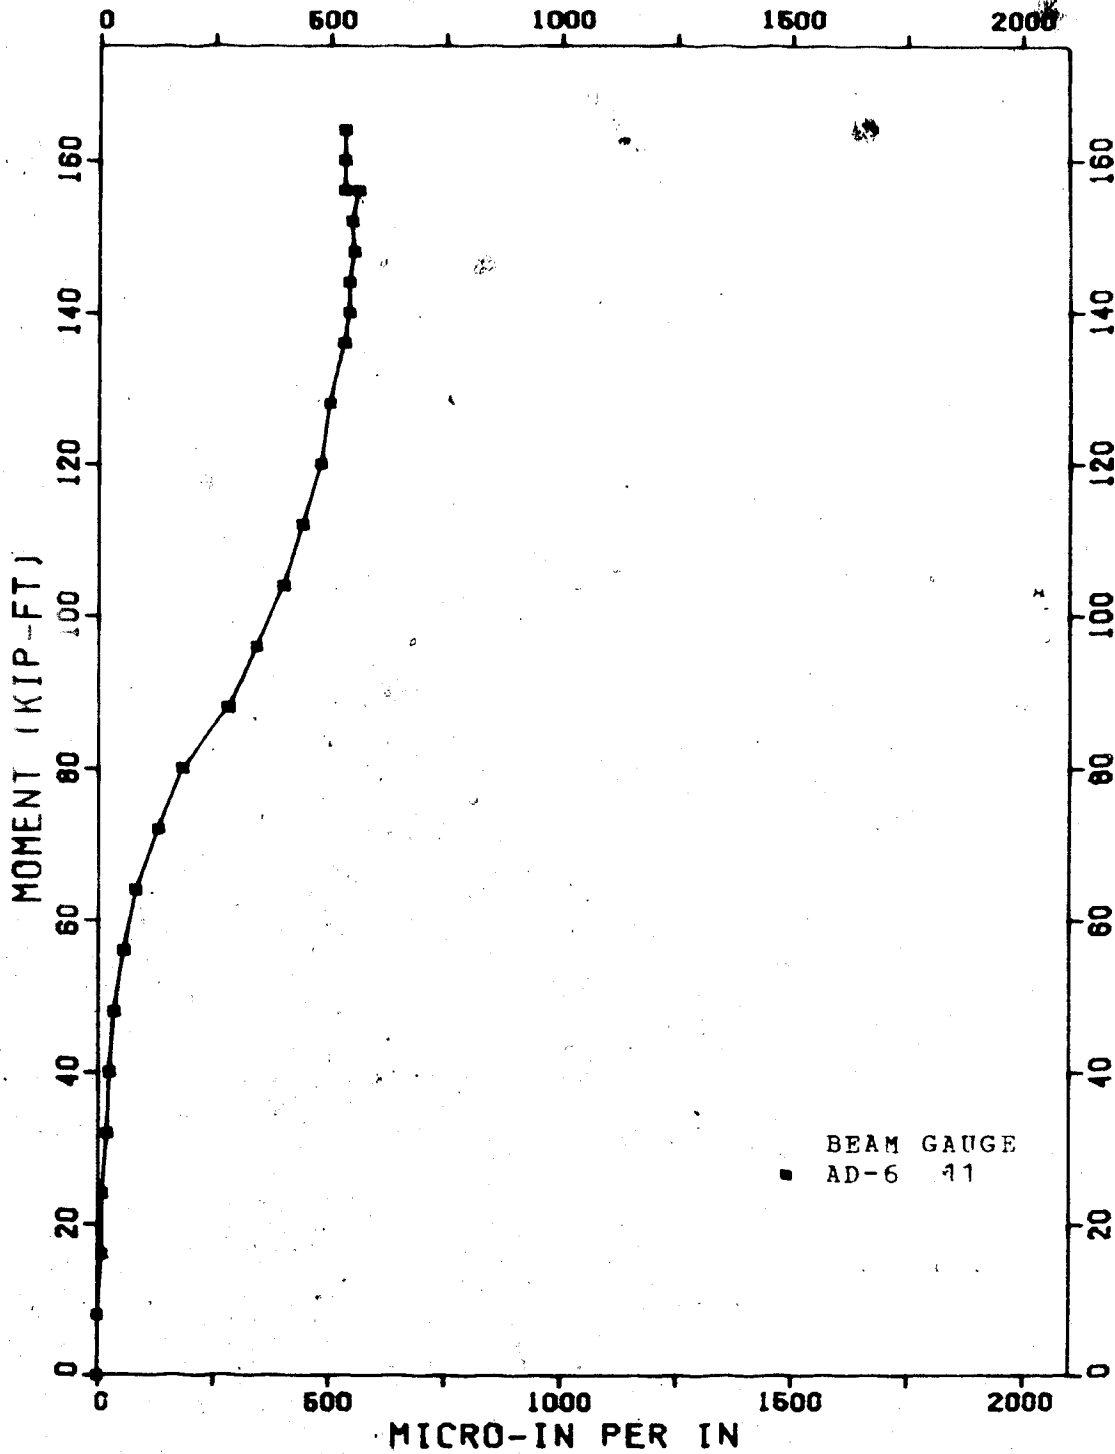
FIGURE 4.10.3 LOWER WEB STIRRUPS
APPLIED MOMENT^o VS. LEAST CRITICAL STRAINS

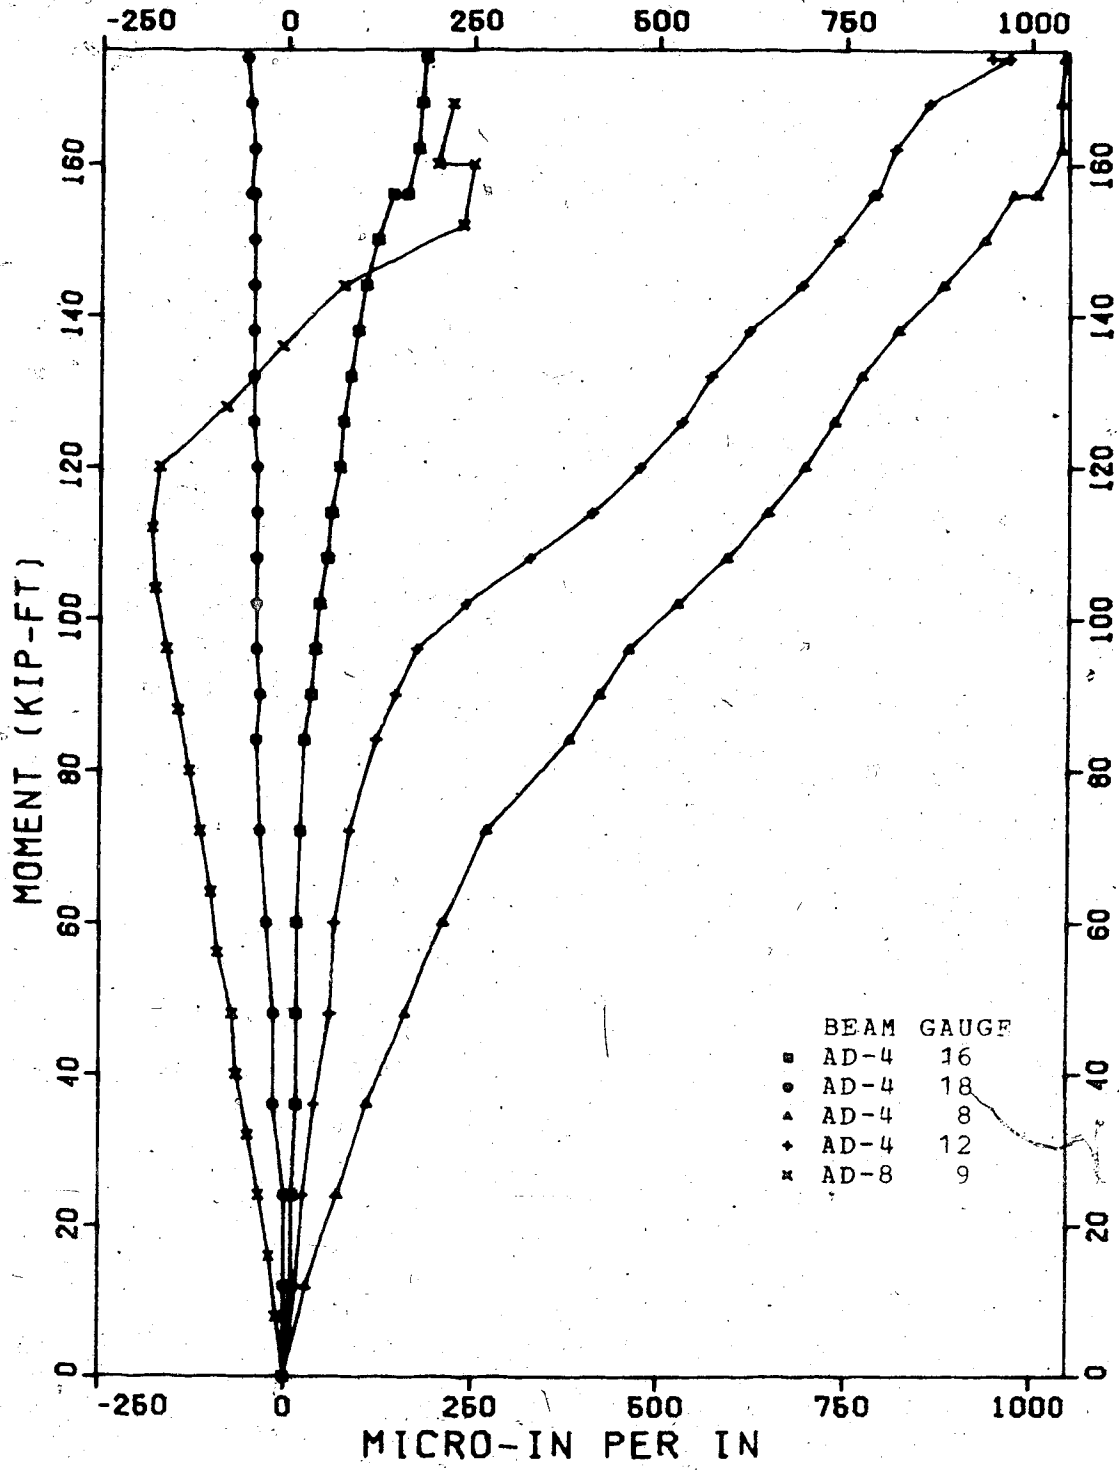
FIGURE 4.11

APPLIED MOMENT VS. MISCELLANEOUS #2 STIRRUP STRAINS

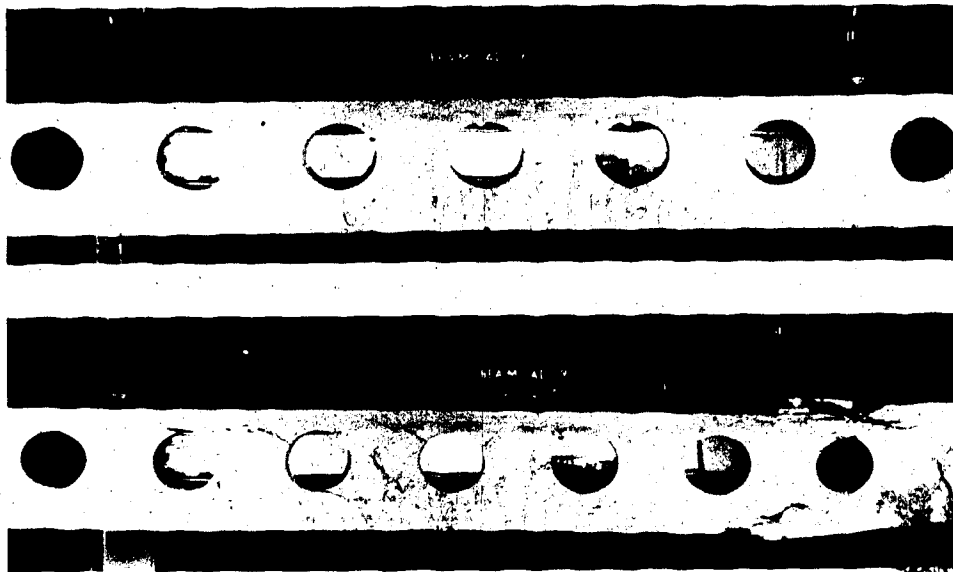
PLATE 4.9 BEAM AD-9 CRACKING AND FAILURE PATTERNS

Plates 4.1 to 4.12 consist of photographs of each of the beams at two stages of loading. The first load is one at which the general cracking pattern has developed, and the second is the failure load. Close-up views of the failure regions of beams AD-1, AD-7, and AD-8 are shown in Plates 4.13 to 4.15 to illustrate the three modes of failure by which the beams are classified.

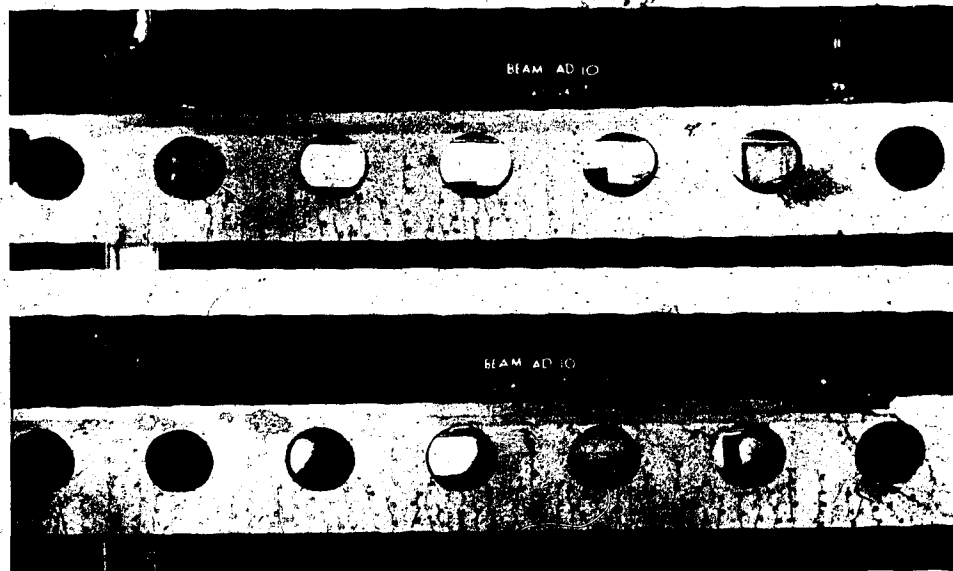
PLATE 4.10 BEAM AD-10 CRACKING AND FAILURE PATTERNS

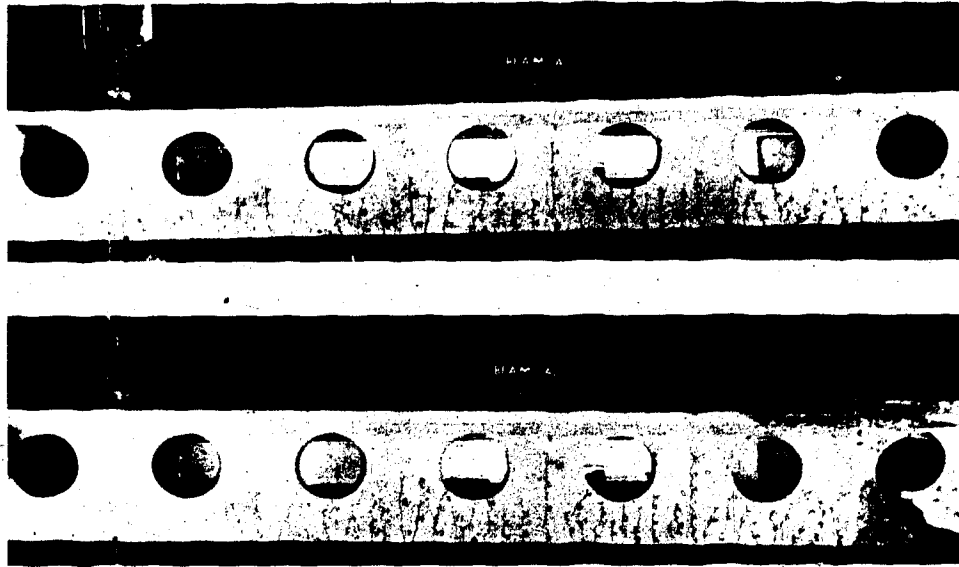
PLATE 4.11 BEAM AD-11 CRACKING AND FAILURE PATTERNS

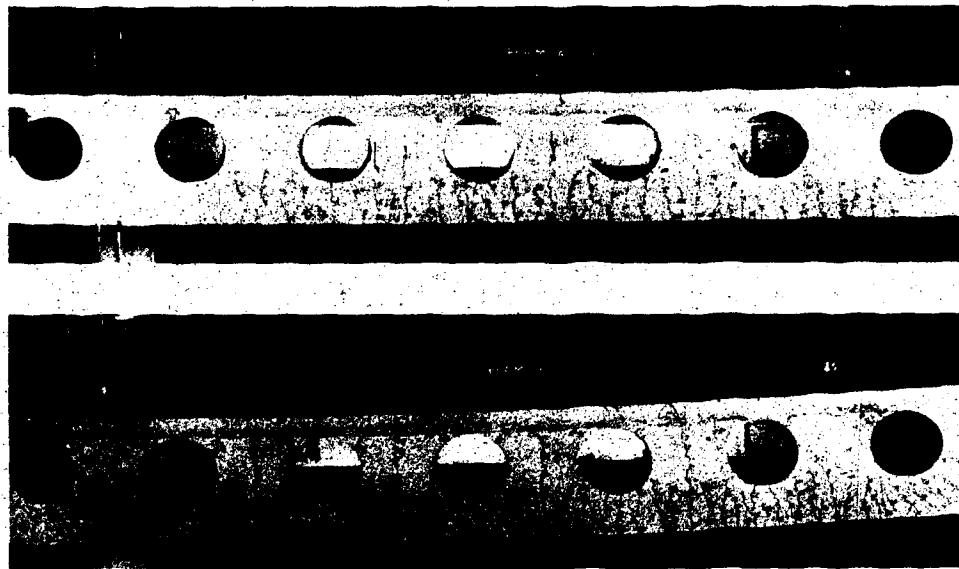
PLATE 4.12 BEAM AD-12 CRACKING AND FAILURE PATTERNS

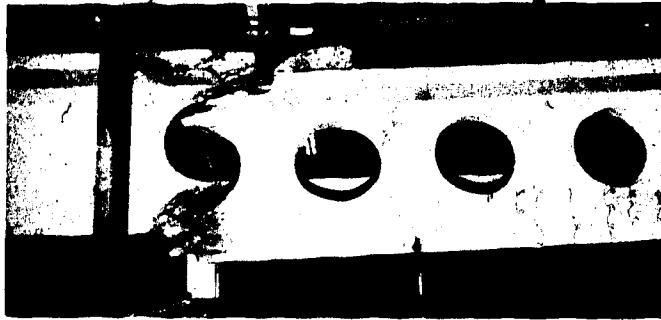
PLATE 4.13 BEAM AD-1
TYPICAL SHEAR FAILURE DETAIL

The beams were divided into three categories depending on their mode of failure. The flexural group contains all the beams that failed in the desirable flexural manner, indicating that their shear reinforcement was sufficient for them to attain their ultimate capacity. The shear group consists of those beams that failed at loads considerably below the expected flexural capacities, due to insufficient shear strength. The shear-compression group includes the beams that failed at relatively high loads, but in a manner similar to the shear failures. Failures typical of these three types can be seen in Plates 4.13, 4.14, and 4.15.

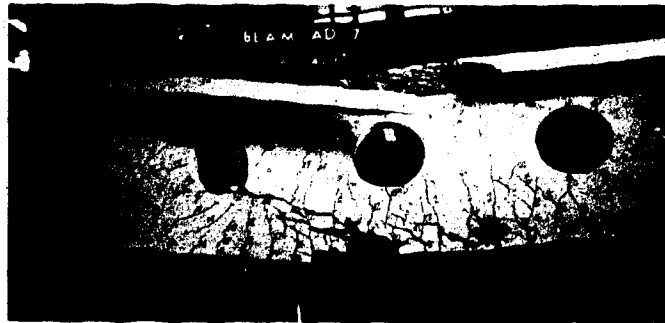
PLATE 4.14 BEAM AD-7
TYPICAL SHEAR-COMPRESSION FAILURE DETAIL

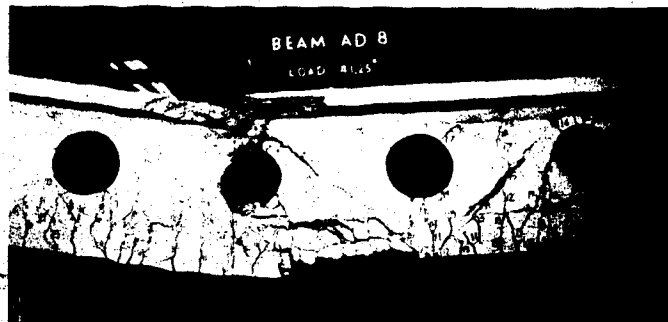
PLATE 4.15 BEAM AD-8
TYPICAL FLEXURAL FAILURE DETAIL

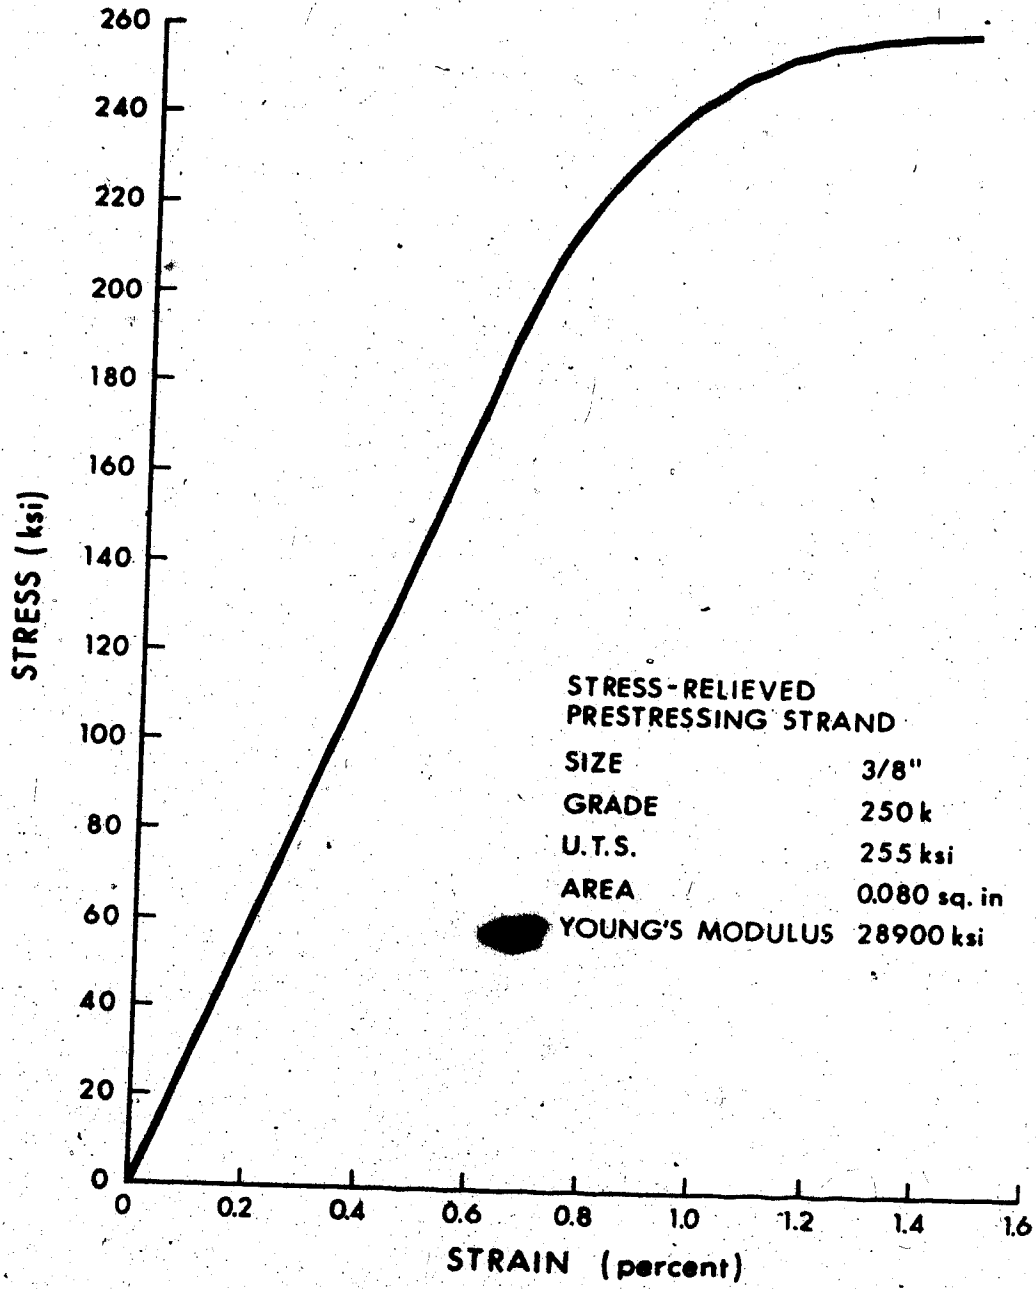
FIGURE A.1
STRAND STRESS-STRAIN CURVE
