TITLE OF THESIS/TITRE DE LA THÈSE Prestressed Concrete Tee Beams
Containing Large Circular Web
Openings

UNIVERSITY/UNIVERSITÉ Univ. of Alberta

The present test series consisted of twelve Prestressed Concrete tee beams with large circular web openings, loaded to failure with two symmetrically placed point loads. All beams were 20 inches deep with a 20-inch flange and were prestressed with five prestressing strands of 3/8-inch diameter.

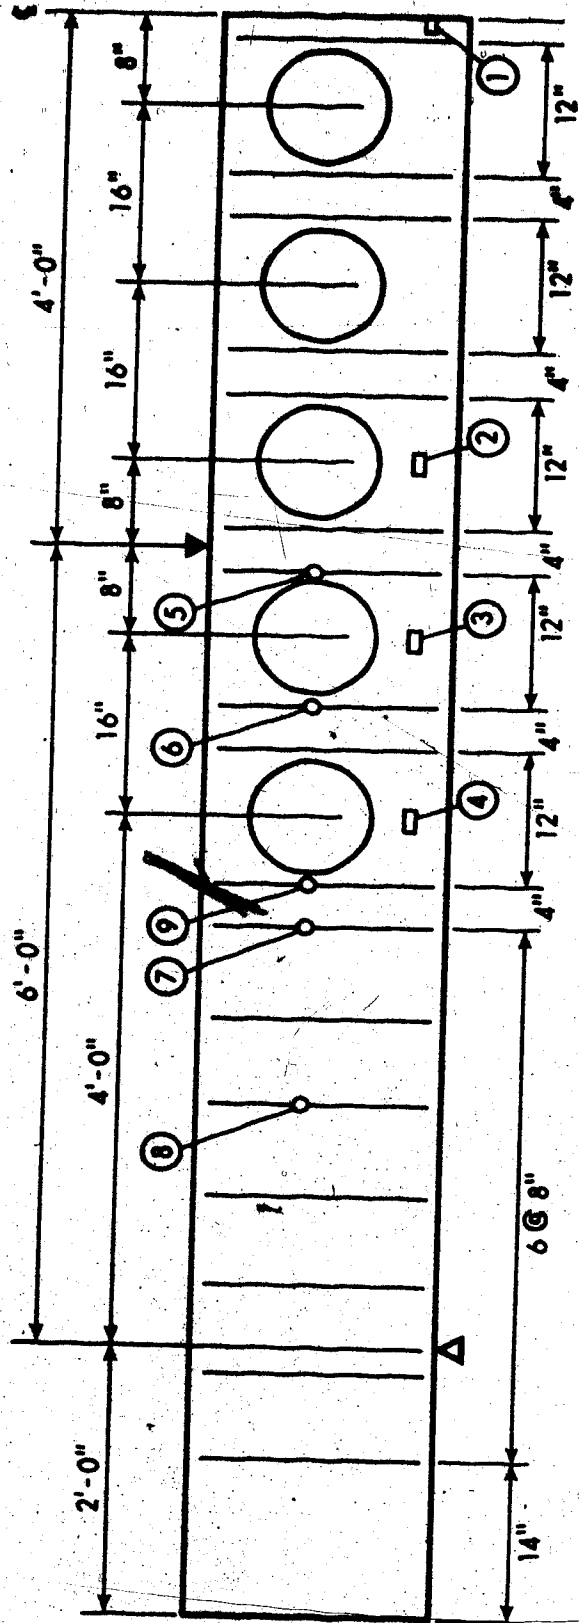
FIGURE B.1 BEAM AD-1 REINFORCEMENT AND GAUGE DETAILS

This appendix contains a drawing of each beam showing the locations of the shear reinforcement and strain gauges, as well as tables of data recorded during the tests. For clarity the readings are referenced to zero applied load, and are given in the basic units of inches for deflection and microinches per inch for strain. Tensile strains and downward deflections are noted as positive.

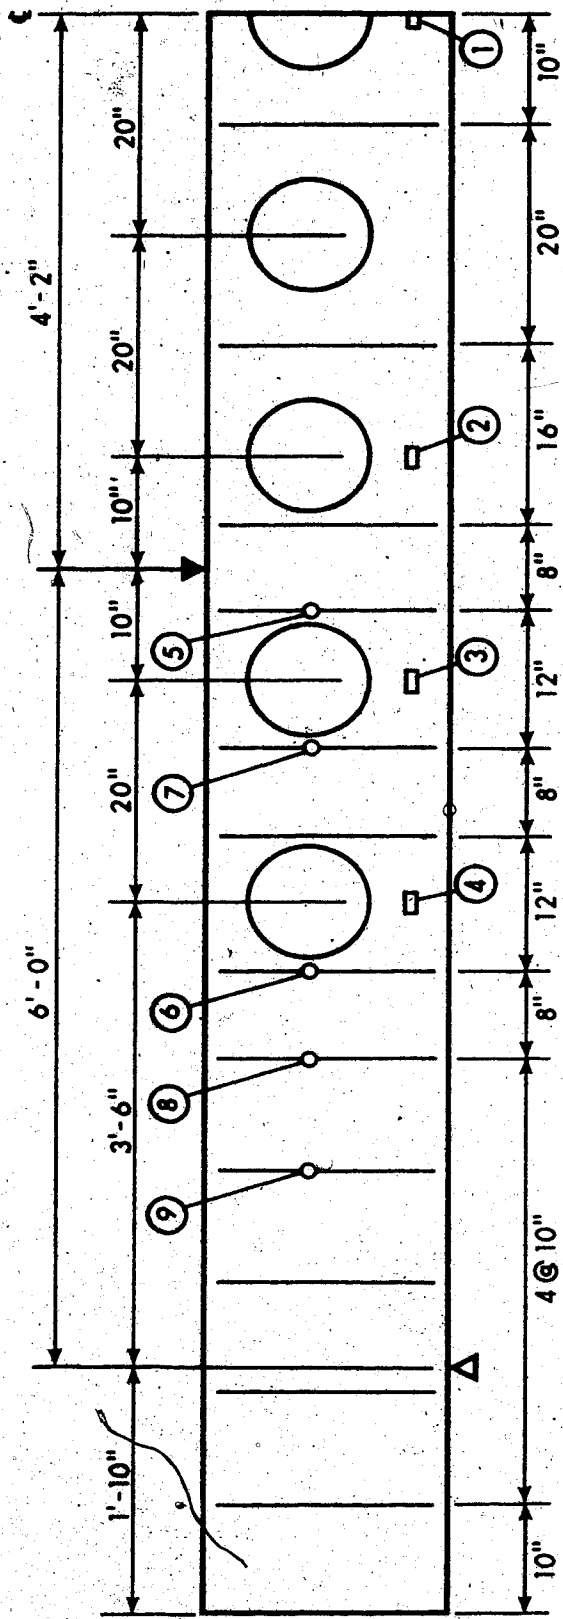
FIGURE B.2 BEAM AD-2 REINFORCEMENT AND GAUGE DETAILS

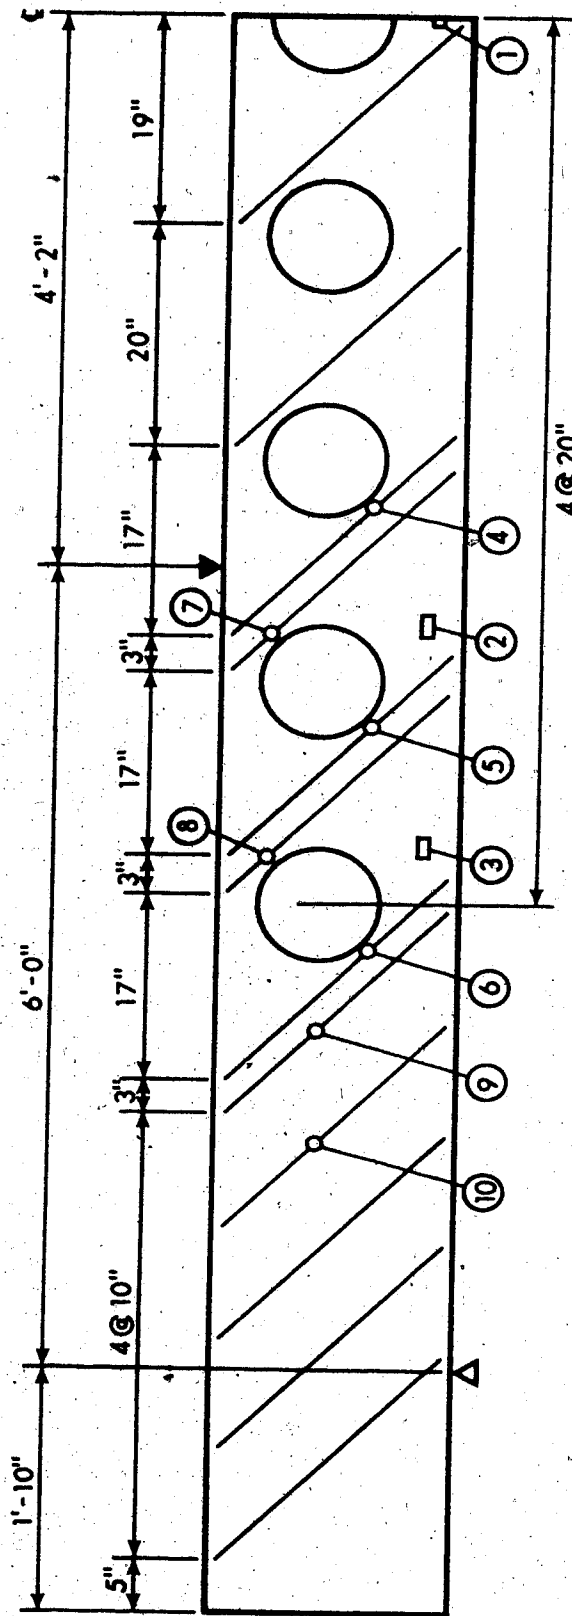
FIGURE B.3 BEAM AD-3 REINFORCEMENT AND GAUGE DETAILS

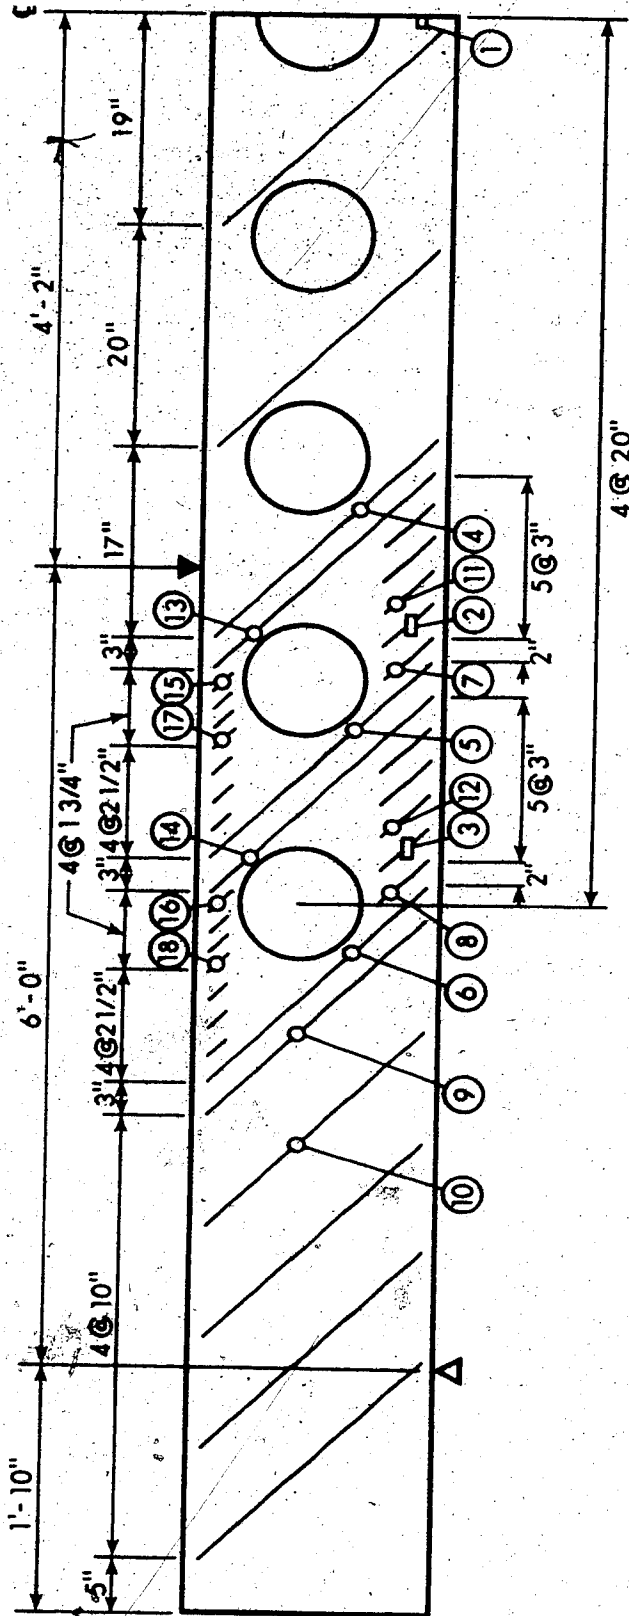
FIGURE B.4 BEAM AD-4 REINFORCEMENT AND GAUGE DETAILS

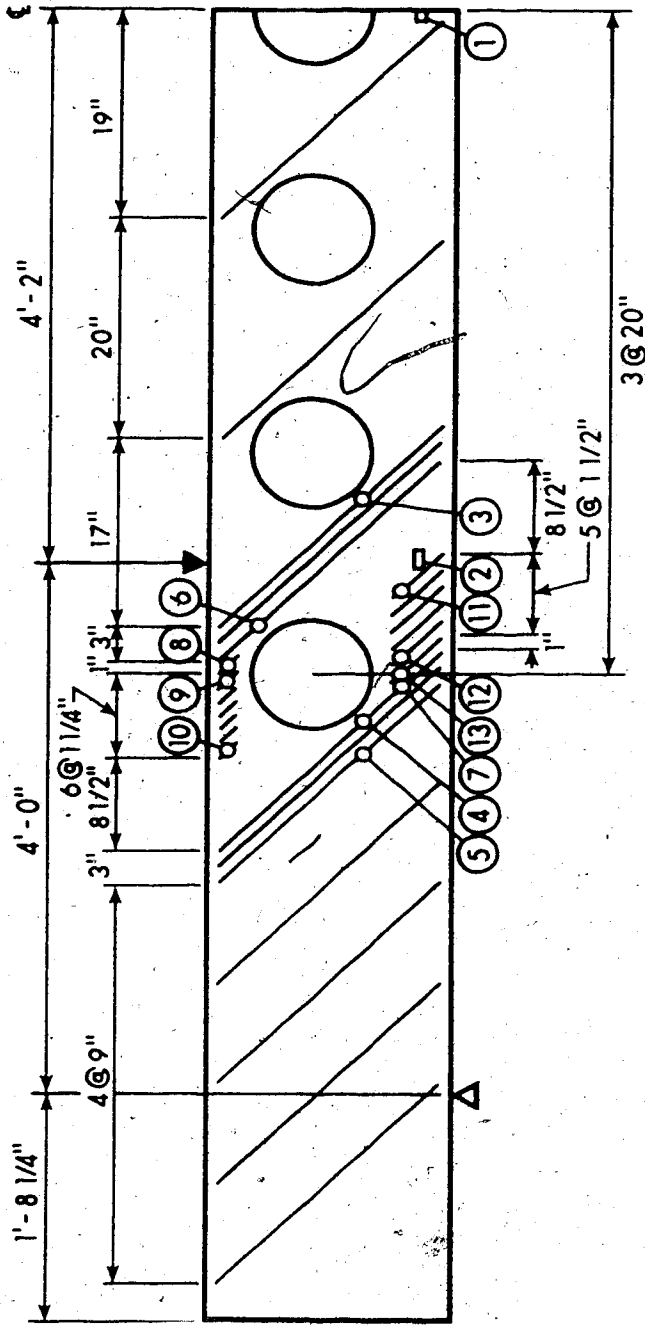
FIGURE B.6 BEAM AD-6 REINFORCEMENT AND GAUGE DETAILS

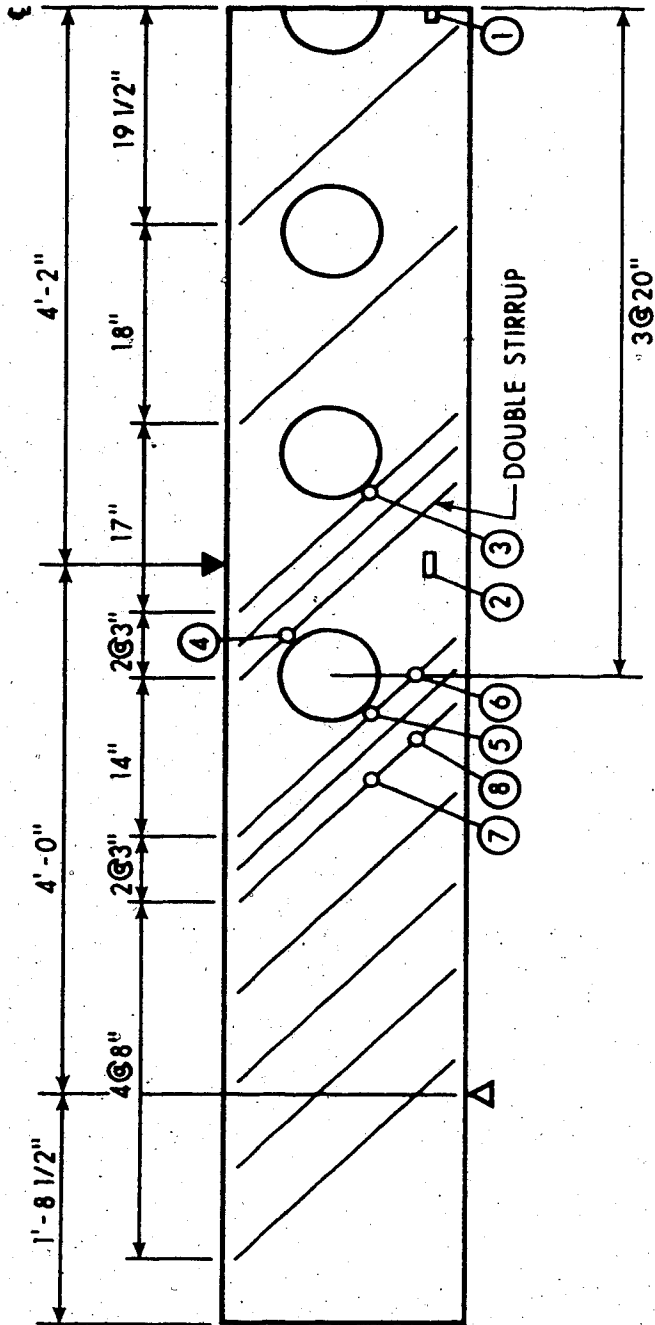
FIGURE B.7 BEAM AD-7 REINFORCEMENT AND GAUGE DETAILS

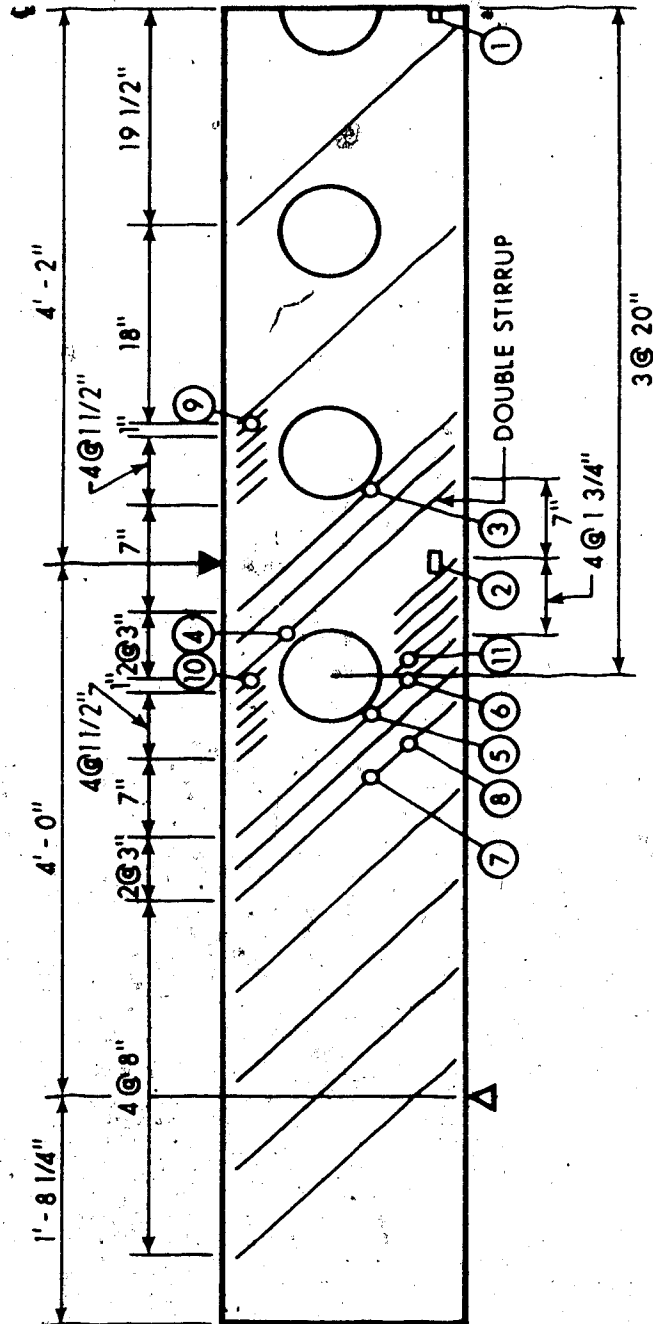
FIGURE B.8 BEAM AD-8 REINFORCEMENT AND GAUGE DETAILS

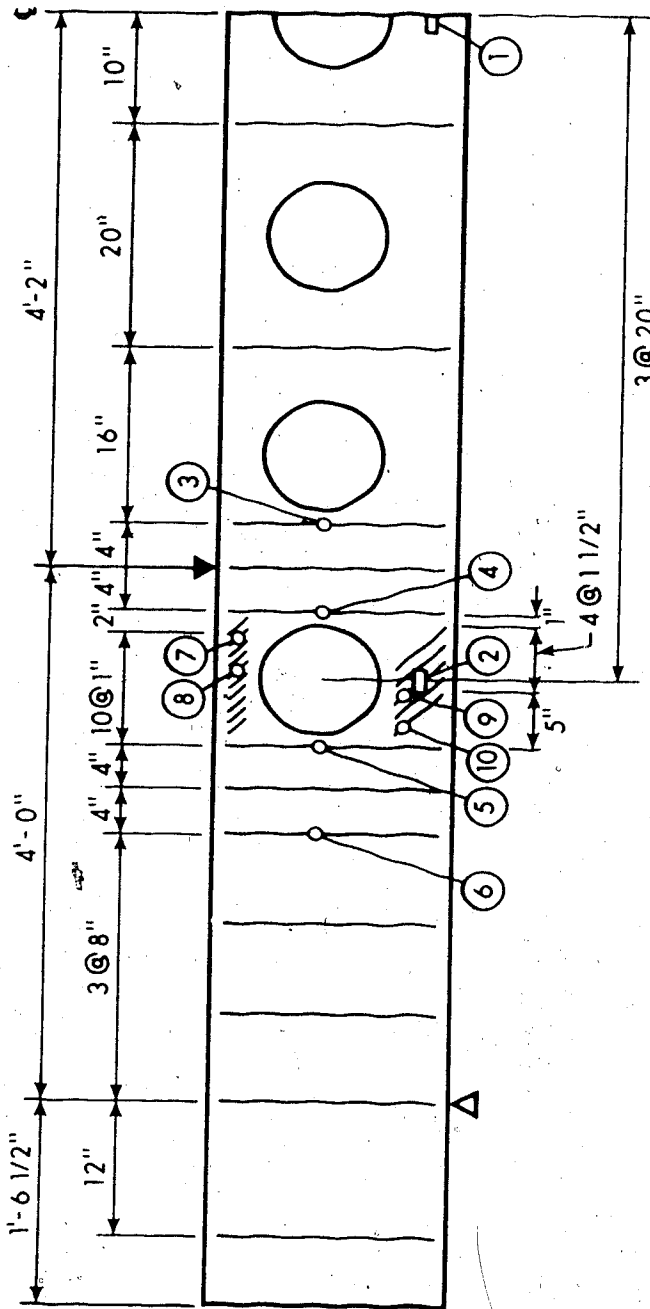
FIGURE B.10 BEAM AD-10 REINFORCEMENT AND GAUGE DETAILS

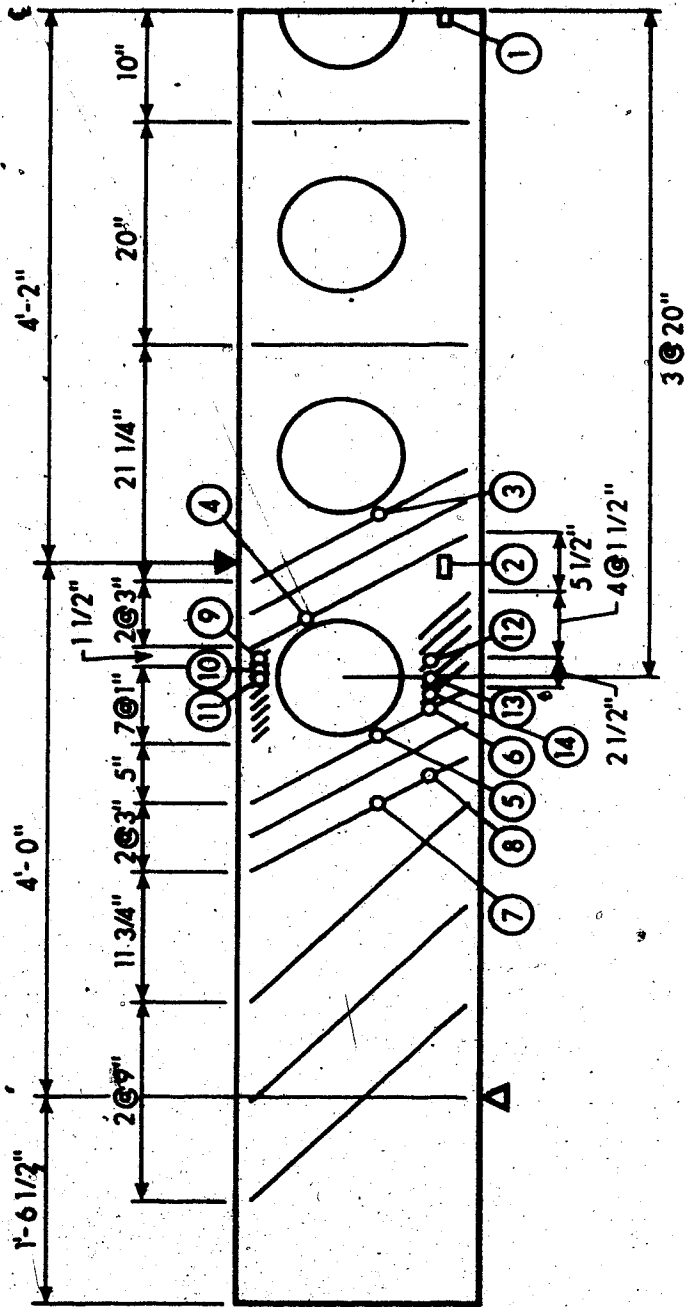
FIGURE B.12 BEAM AD-12 REINFORCEMENT AND GAUGE DETAILS
