The undersigned certify that they have read, and recommend to the Faculty of Graduate Studies and Research, for acceptance, a thesis entitled Behaviour of Concrete T-Beams with Welded Wire Fabric Reinforcement, submitted by Kevin L. Baskin, in partial fulfillment of the requirements for the degree of Master of Science in Civil Engineering.

All beams tested had diagonal tension type failures. The test results indicated that the ACI and CSA Code equations for predicting beam shear strength were conservative for the welded wire fabric sheets used, provided that there was proper anchorage. The Code equations were less conservative as the web reinforcement ratio decreased. The best anchorage was provided with two horizontal cross-wires at the top and bottom of the reinforcement sheets as proposed by the PCI/WRI Ad Hoc Committee for the case of single leg welded wire fabric shear reinforcement sheets with smooth vertical wires. In the case of welded deformed wire fabric, anchorage with only one horizontal cross-wire top and bottom was also satisfactory, provided the bottom cross-wire was not above the lowest main reinforcement and the upper cross-wire was close to the top face of the be

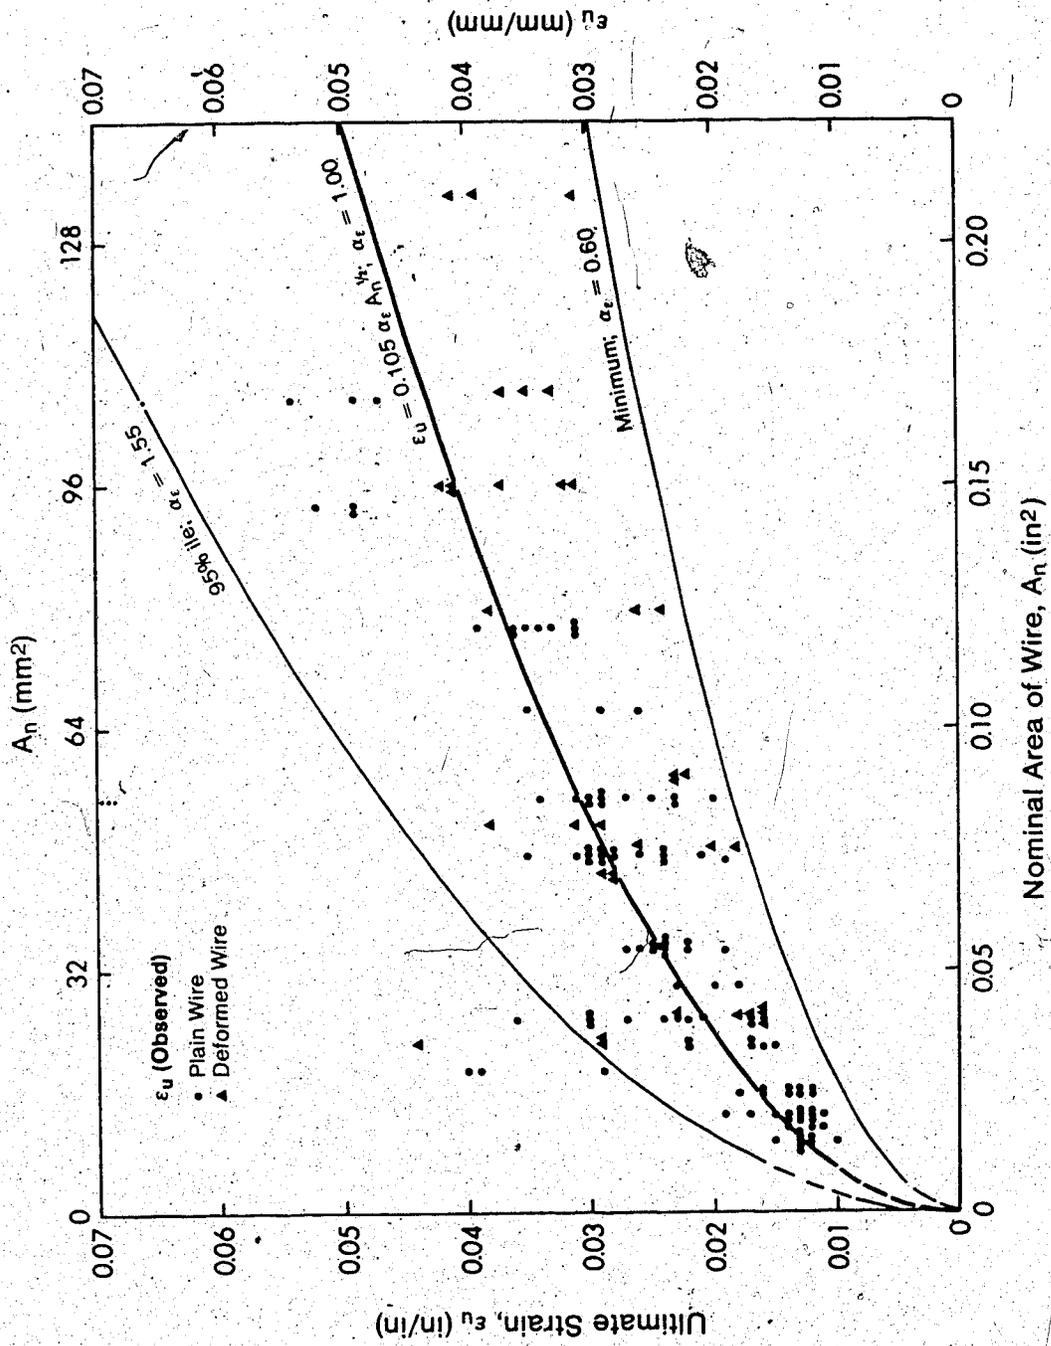
FIGURE 2.1 - Effect of Wire Size on Ultimate Strain

The value of ultimate strain for wires obtained from tension tests has been shown to be substantially lower than that of conventional bars for the tests conducted by Wiss, Janney, Elstner and Associates (1969). Mirza and MacGregor (1981) have plotted the WJE data as a function of bar area as shown in Figure 2.1. Although the wires had yield strengths of approximately 515 to 585 MPa (75 to 85 ksi), the reduced ultimate elongation could be of concern for reinforced concrete members where, at ultimate load, the wire would be subjected to tensions similar to those resulting from direct tension tests. The reduced ultimate strain could result in a less ductile member. A large reduction in ductility would be undesirable, as the design of reinforced concrete members is based on achieving ductile failures to allow advance warning of failure and to allow moment redistribution in structures designed to resist earthquake loadings. This concern was analytically investigated by Mirza and MacGregor (1981) who indicated that while slabs reinforced with welded wire fabric develop the anticipated ultimate flexural

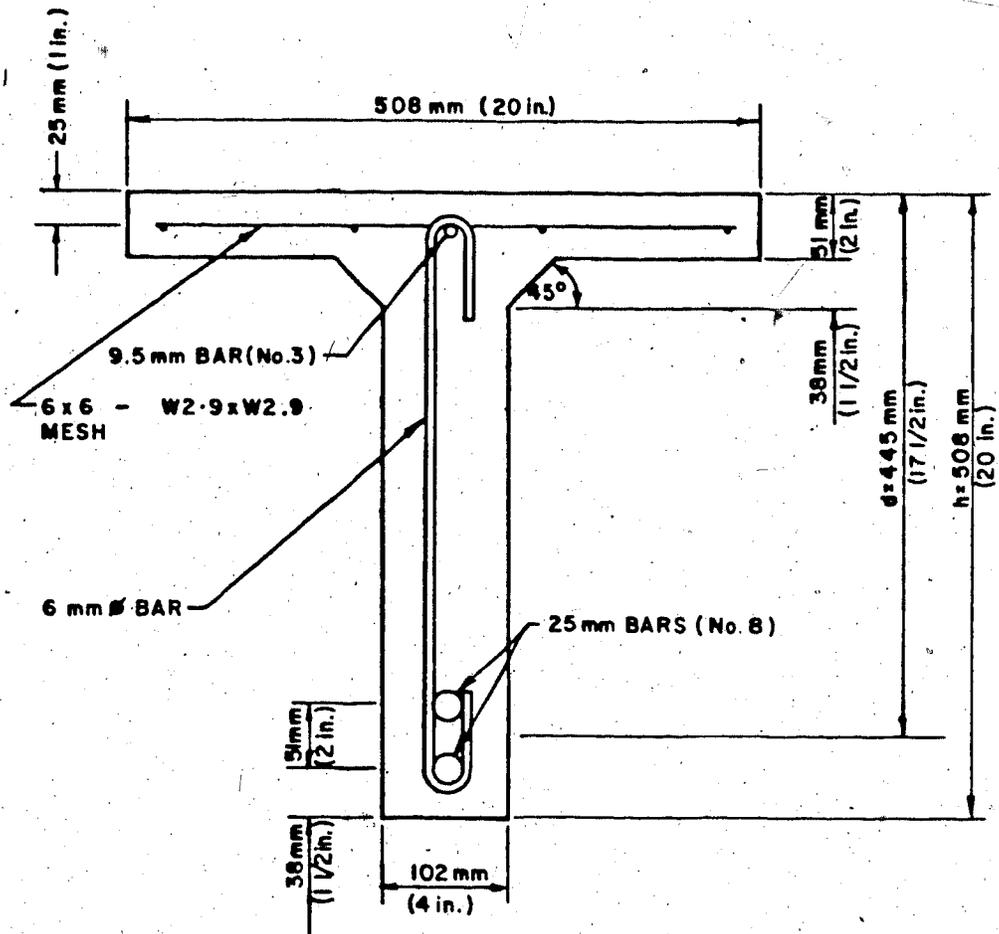
FIGURE 3.5 - Typical Cross-Section of Beam in Testing Program with Conventional 6 mm Diameter Stirrups

The center of gravity of the 25 mm bars was at the vertical centerline of the web for all of the beams. One bar was placed on each side of the web reinforcement in the beams that had the WWF located at the web centerline (beams TB 1 to TB 7). For the other beams, the two bars were placed at the centerline, one above the other. This is illustrated in Figures 3.4 and 3.5.

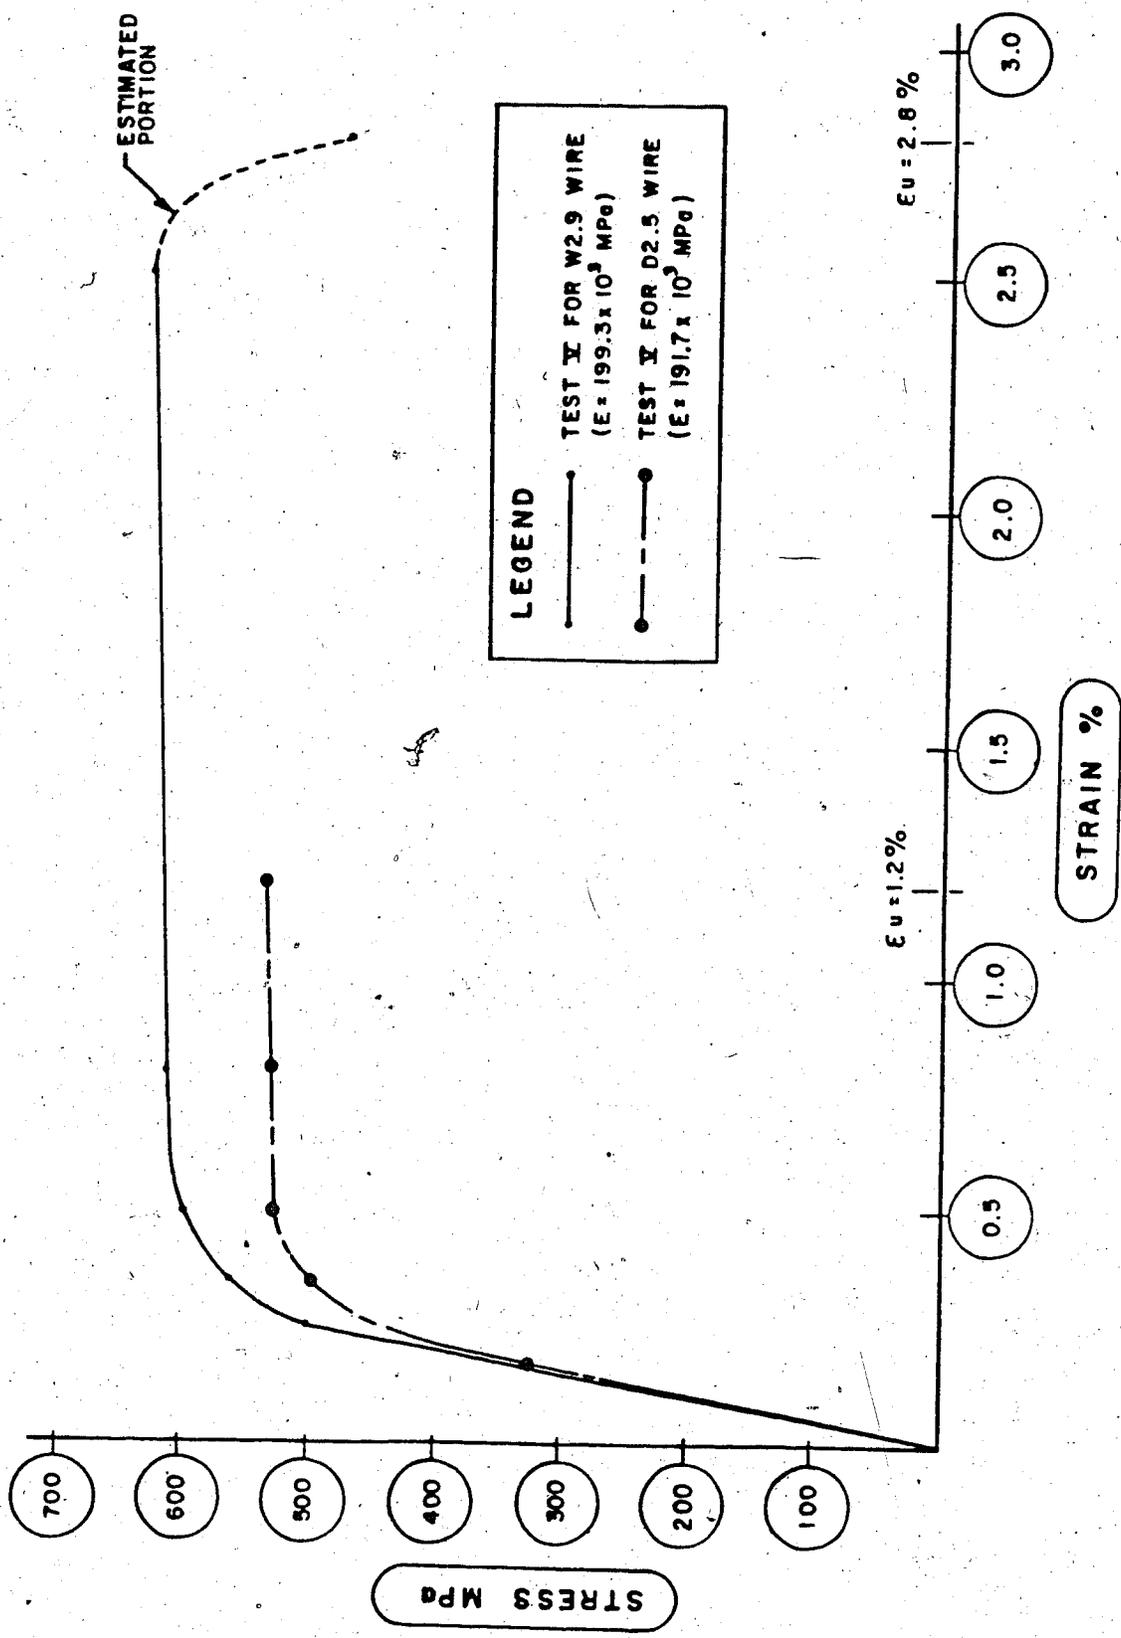
FIGURE 4.1 - Typical Stress-Strain Curves for Wires

the value of ultimate strain was unchanged whether failure occurred at or away from the cross-wires. The ultimate strain of the W2.5 wire was higher when failure occurred away from the cross-wires than when failure occurred at the cross-wires. In the case of the W2.9 wire, no failures occurred at the cross-wires within the gauge length.

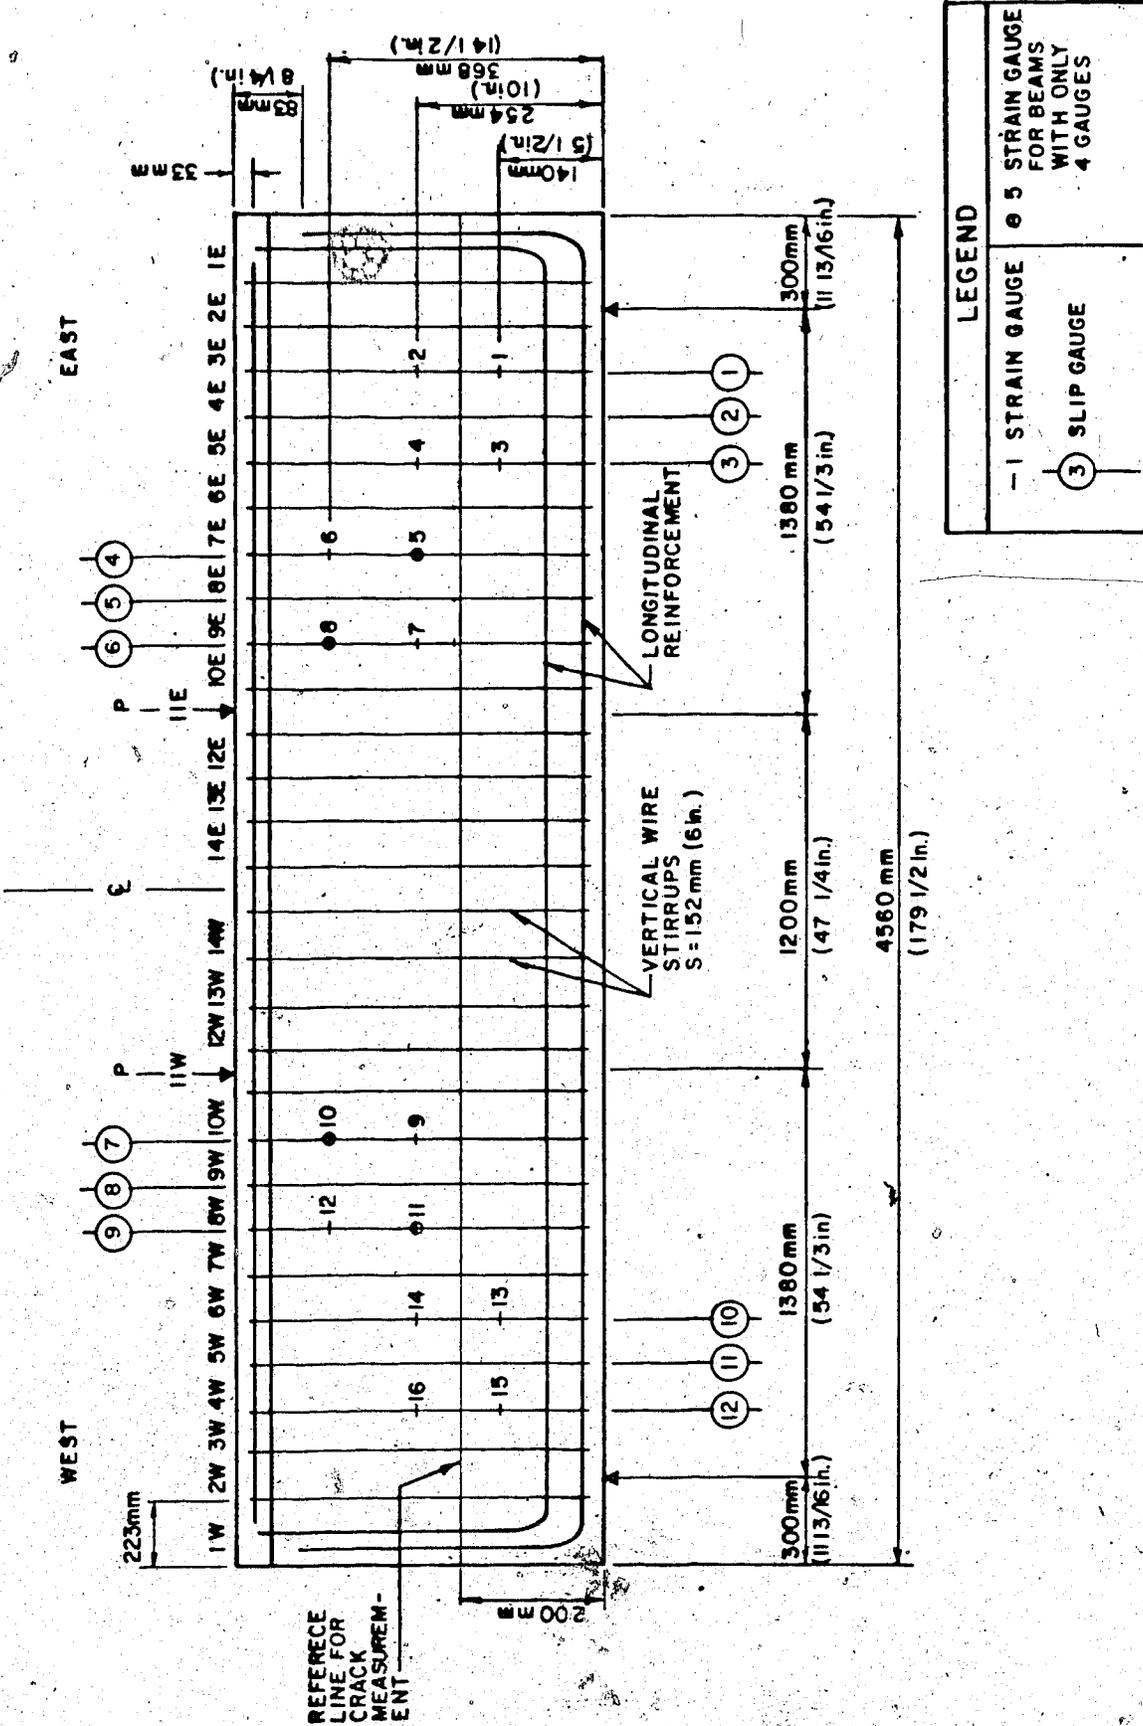
FIGURE 5.3 - Locations for Instrumentation for Beams with WWF Web Reinforcement (Not to Scale)

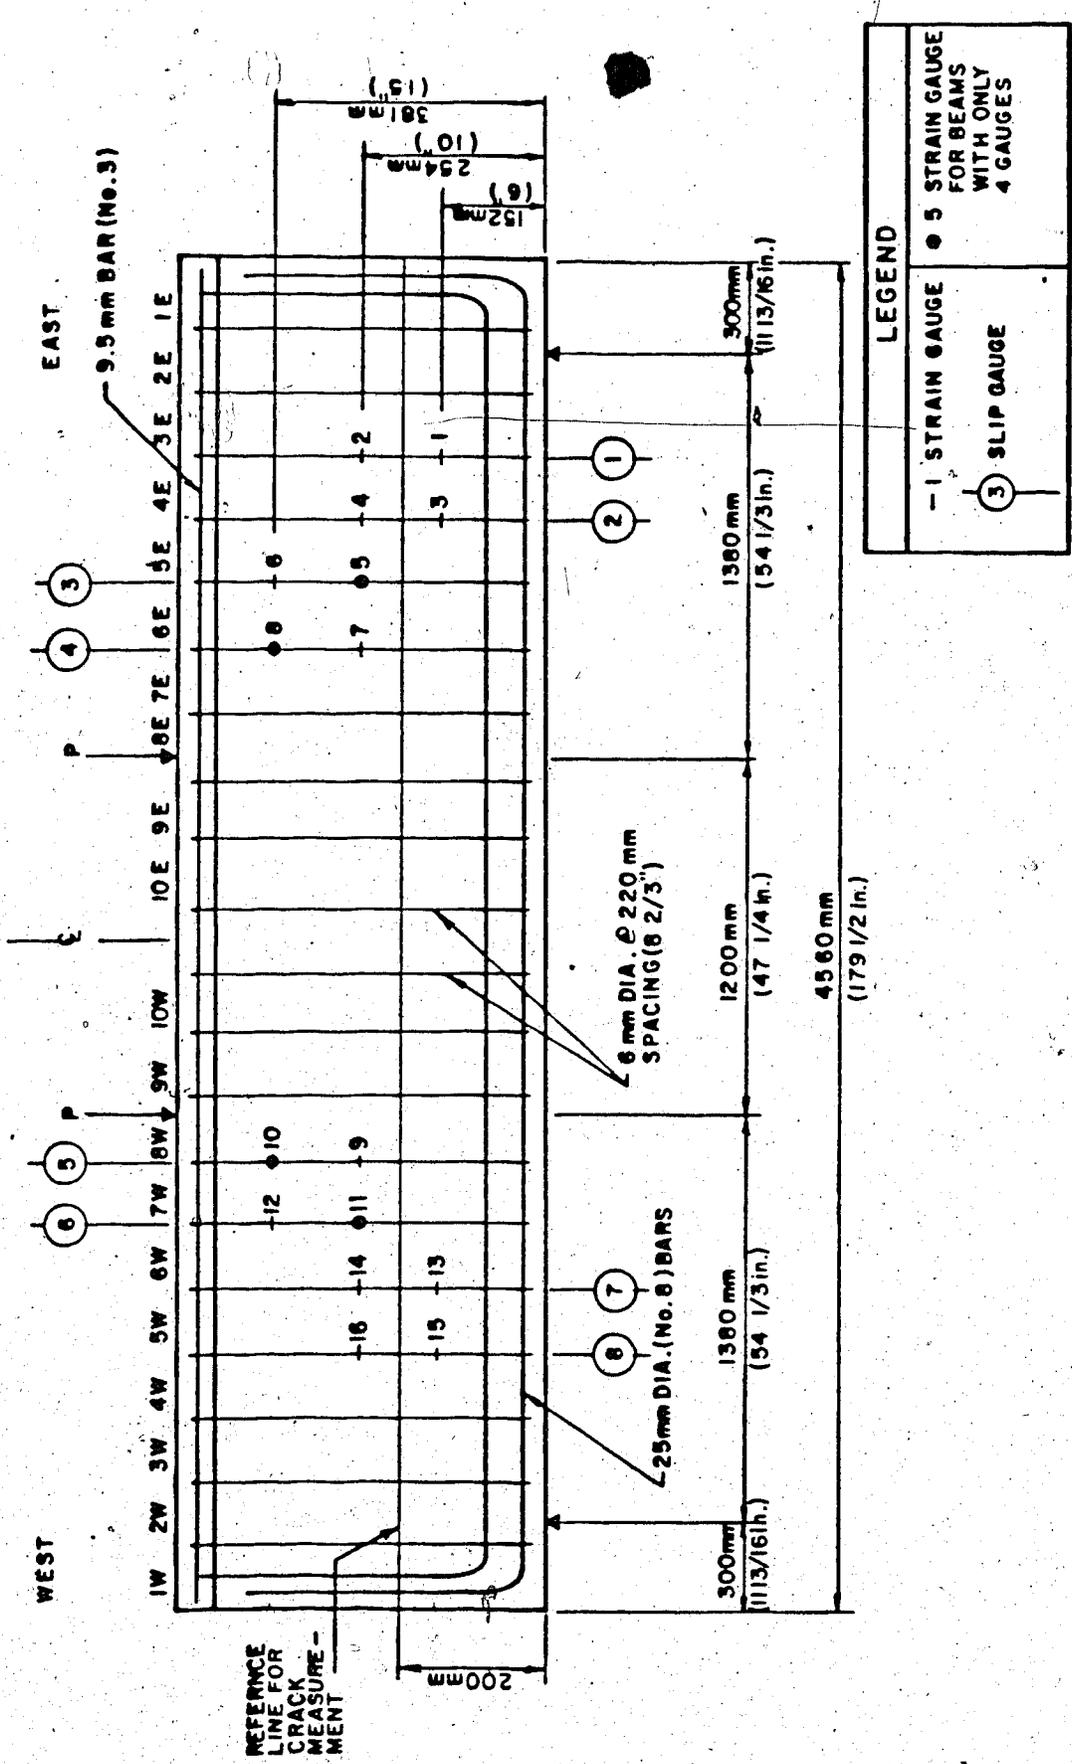
FIGURE 5.4 - Locations for Instrumentation for Beams with Conventional 6 mm Diameter Stirrups (Not to Scale)

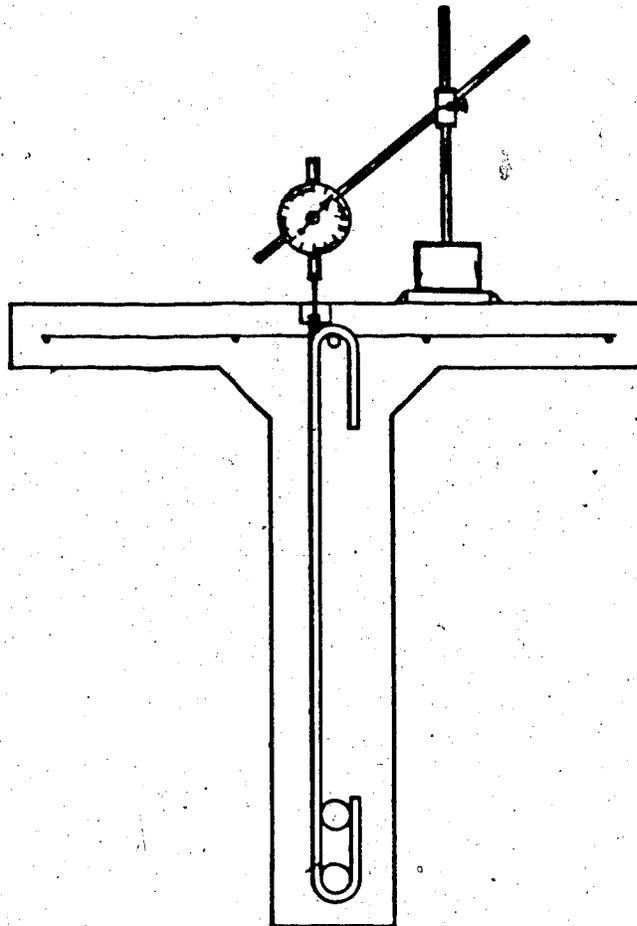
FIGURE 5.9 - Mounting of Dial Gauge Apparatus for Measuring Stirrup Slip

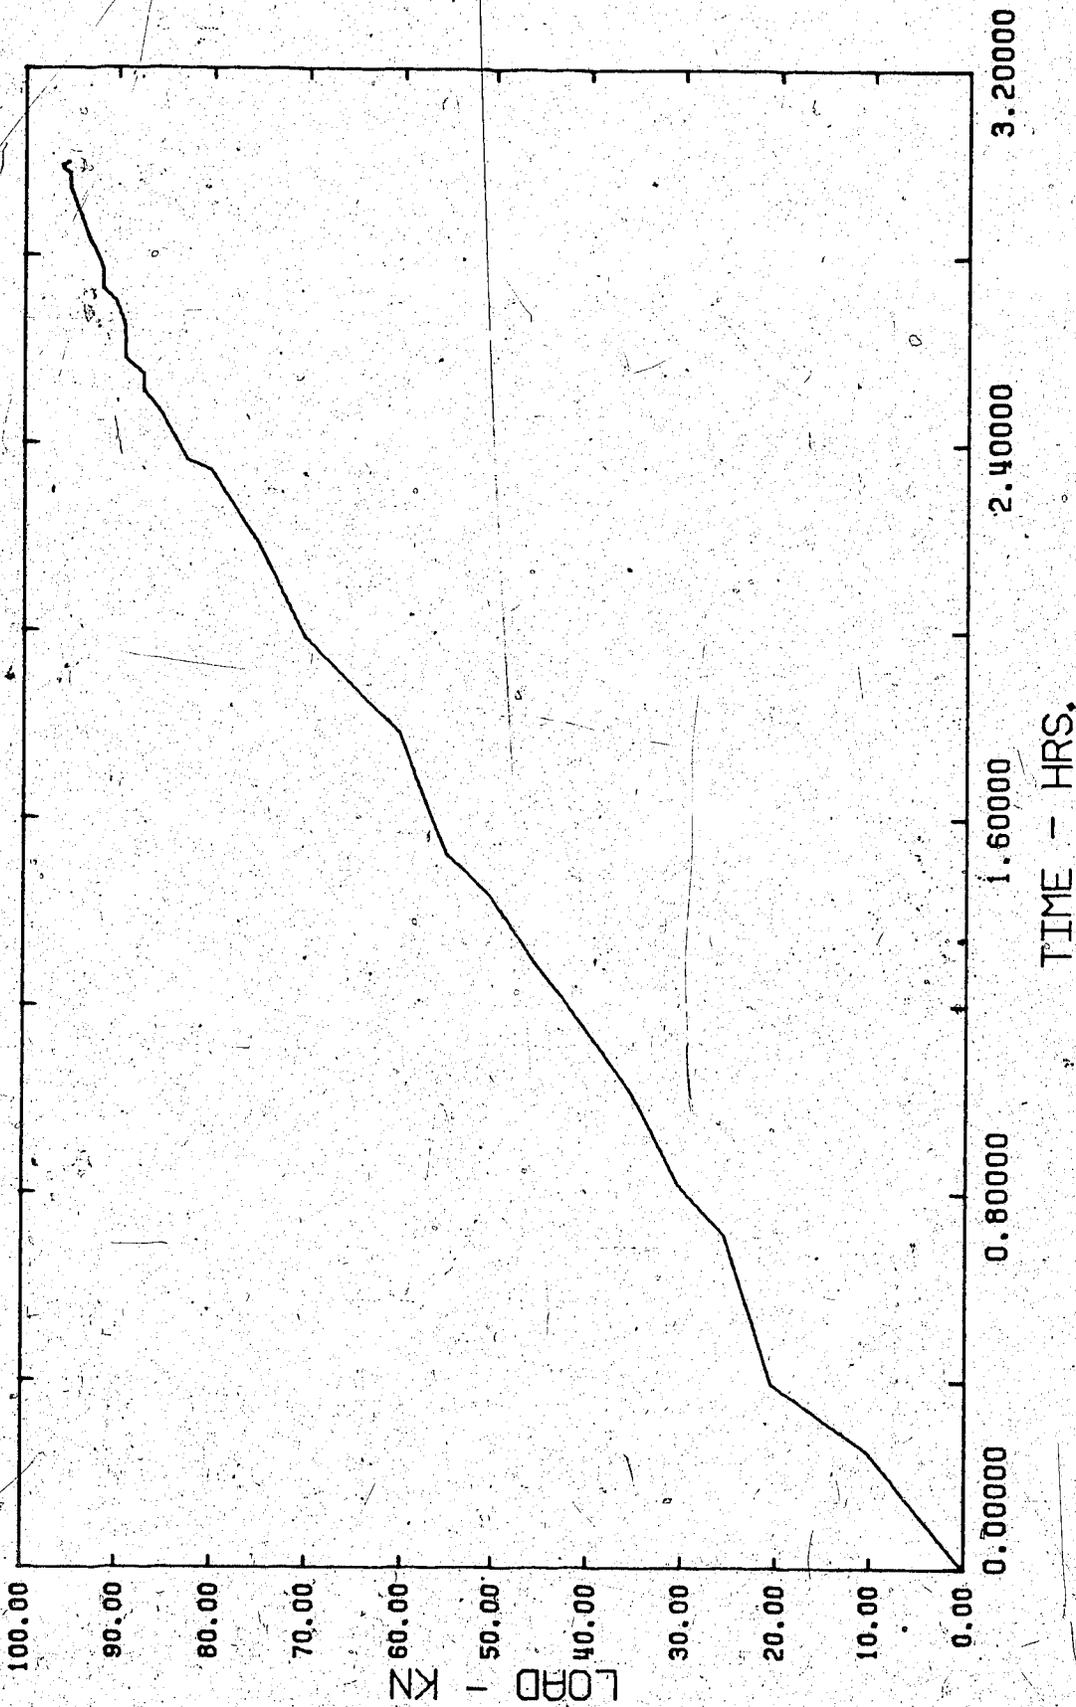
FIGURE 5.10 - Typical Load versus Time Graph for Beam Test (TB 10)

It should be noted that TB 3 was initially loaded up to 45 kN (10 kips) in the first load step. The load was removed and the test was re-started but inclined cracks had already formed.

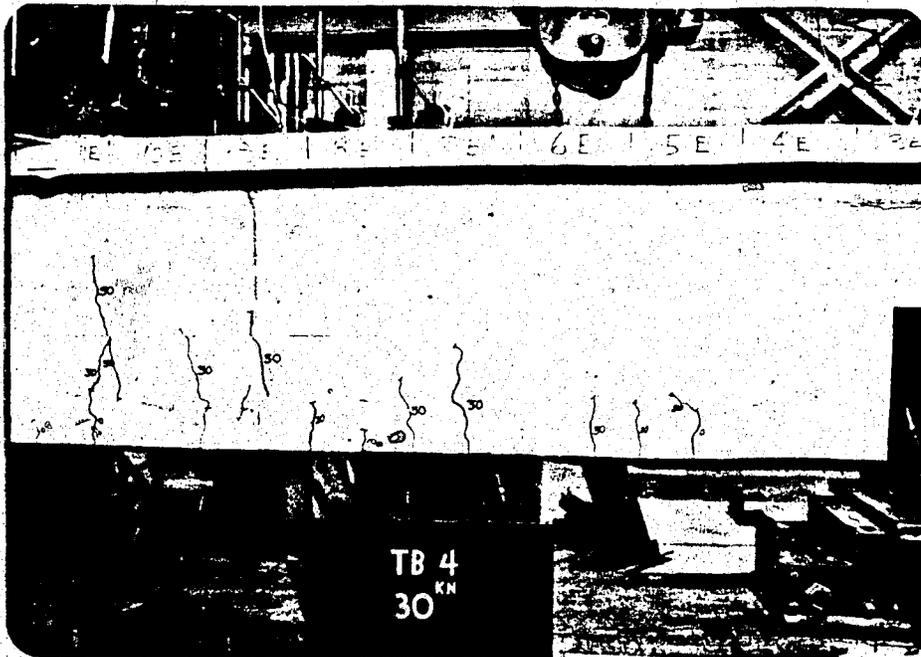
FIGURE 6.1 - Cracking in east shear span of TB 4
at $P = 30 \text{ kN}$

Photographs of TB 2 and TB 4 during loading and after failure are shown in Figures 6.1 to 6.18. Beam TB 2 failed at 70 kN (15.7 kips) and TB 4 failed at a load of 80 kN (18.0 kips). The WWF web reinforcement in TB 2 had D2.5 vertical wires at 152 mm (6 inch) spacing while TB 4 had D2.9 vertical wires with the same spacing. In both cases, the WWF mats had two horizontal cross-wires top and bottom. It should be noted that TB 4 failed immediately after all measurements were taken at the 80 kN load level while TB 2 failed as measurements were being taken at the 70 kN load level.

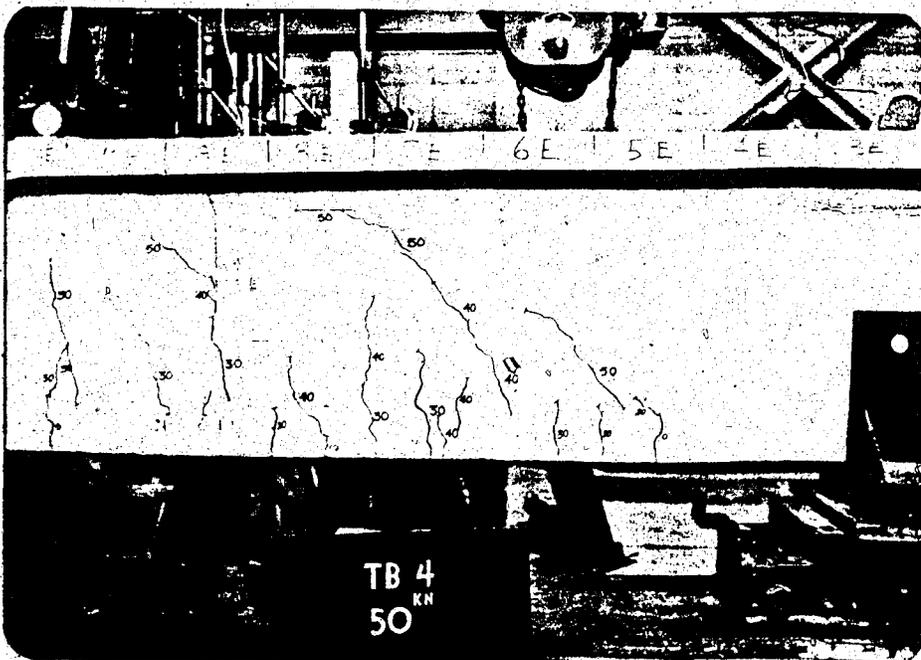
FIGURE 6.2 - Cracking in east shear span of TB 4
at $P = 50 \text{ kN}$

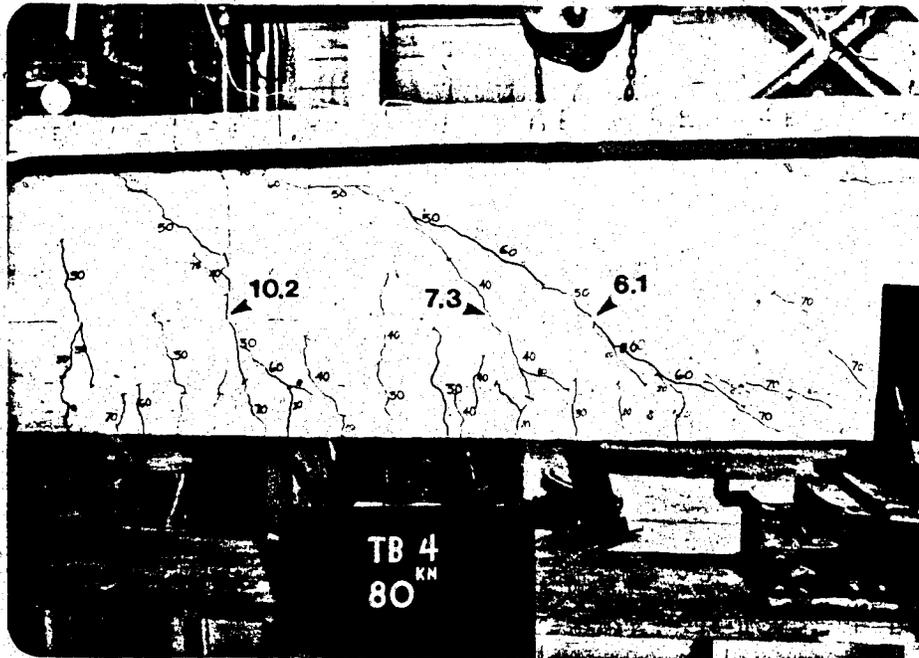
FIGURE 6.3 - Cracking in east shear span of TB 4 at ultimate load ($P_{ult} = 80 \text{ kN}$) with crack numbers shown

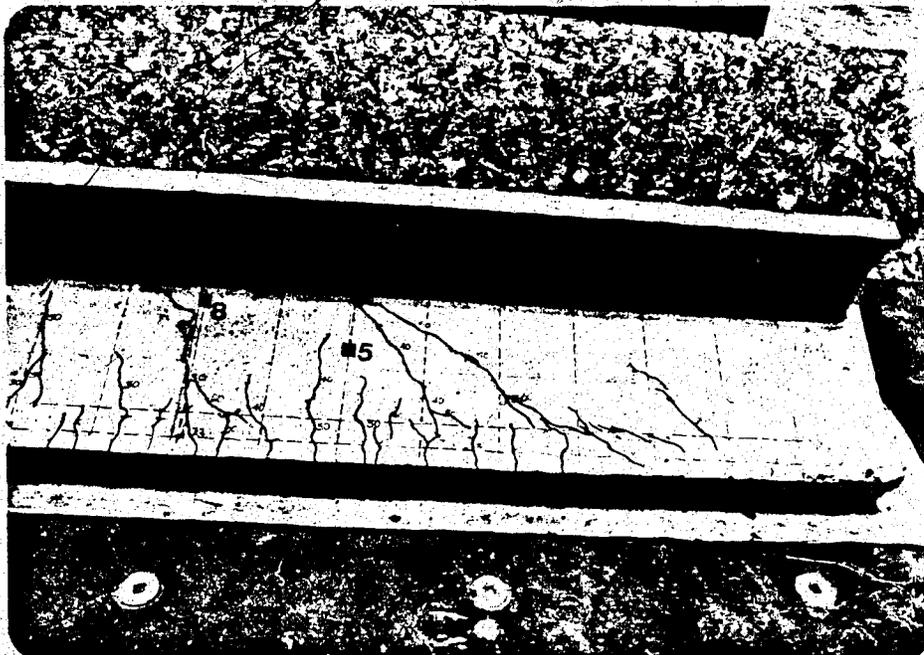
FIGURE 6.4 - Cracking in east shear span of TB 4 after testing with strain gauge locations shown

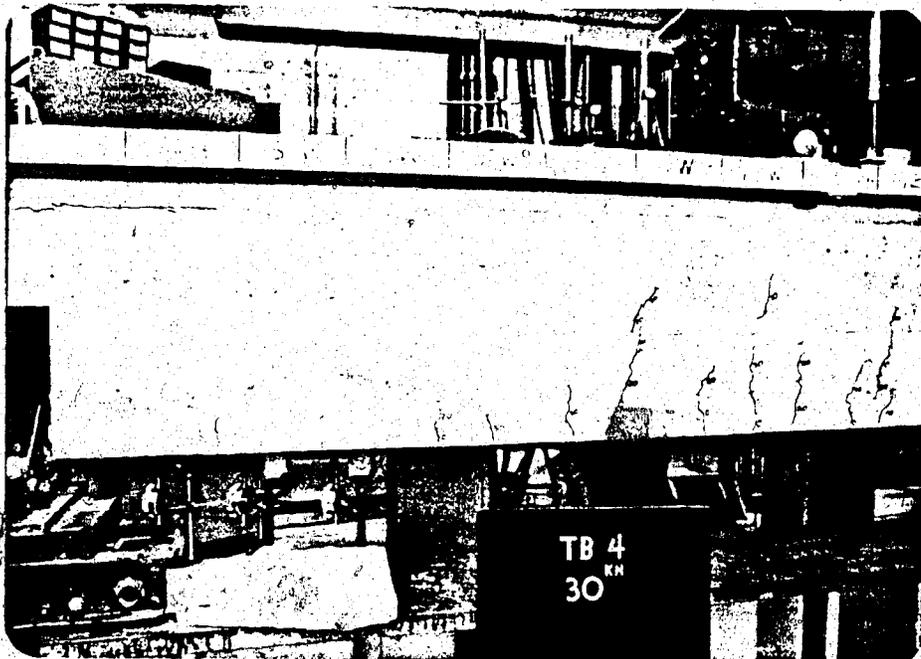
FIGURE 6.5 - Cracking in west shear span of TB 4
at $P = 30$ kN

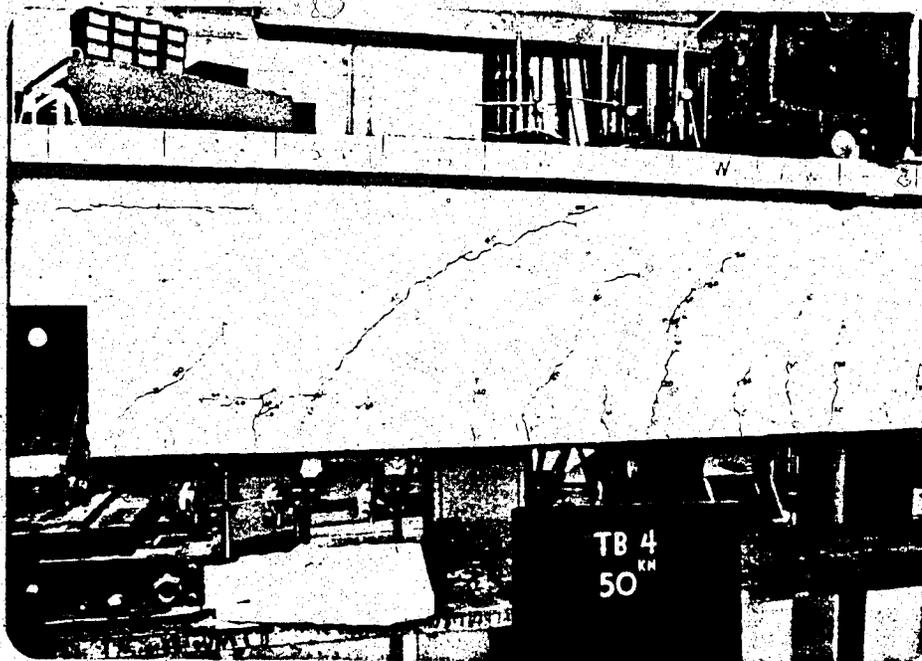
FIGURE 6.6 - Cracking in west shear span of TB 4
at $P = 50$ kN

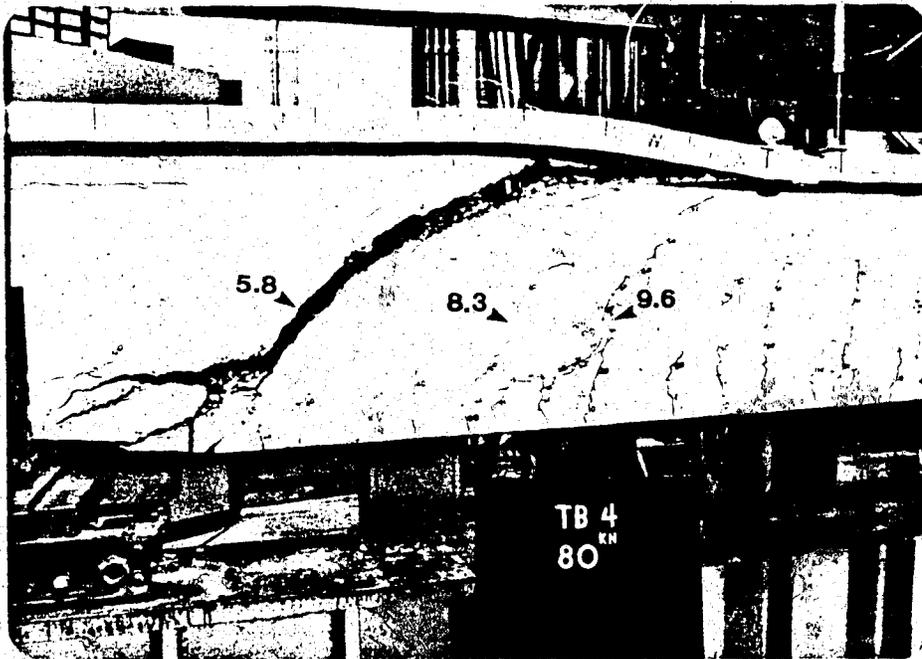
FIGURE 6.7 - Cracking in west shear span of TB 4 at ultimate load ($P_{ult} = 80 \text{ kN}$) with crack numbers shown

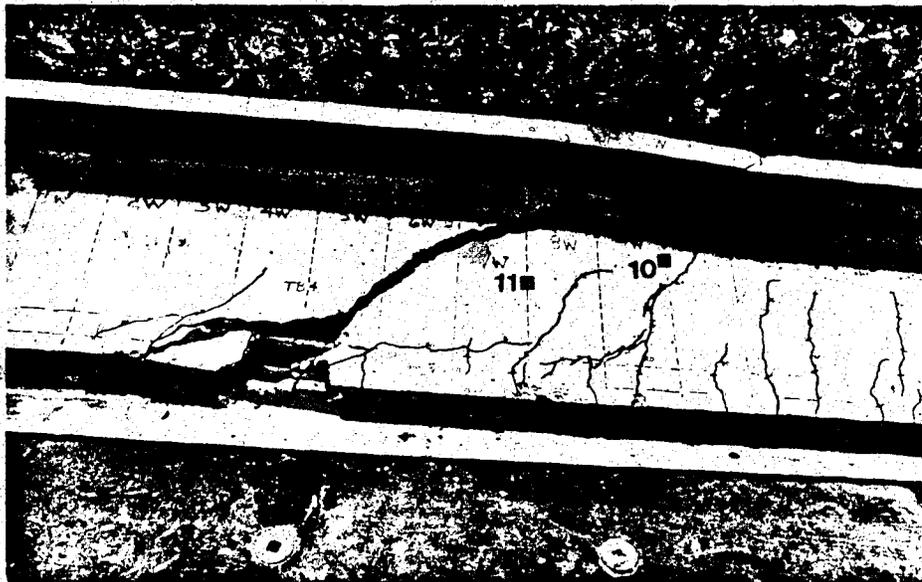
FIGURE 6.8 - Cracking in west shear span of TB 4 after testing with strain gauge locations shown

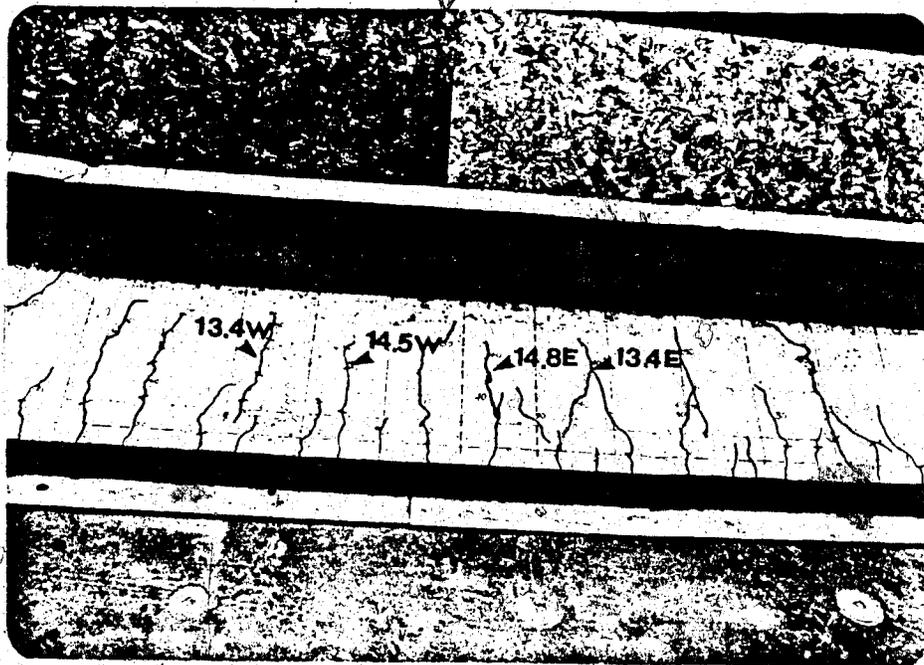
FIGURE 6.9 - Cracking in pure moment region of TB 4 after testing with crack numbers shown

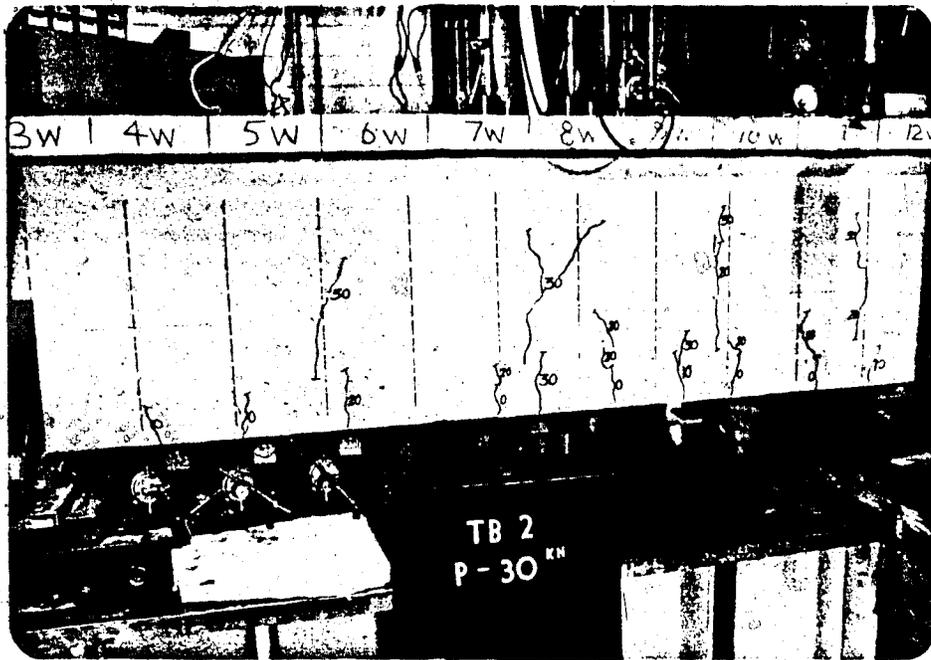
FIGURE 6.10 - Cracking in west shear span of TB 2 at $P = 30$ kN

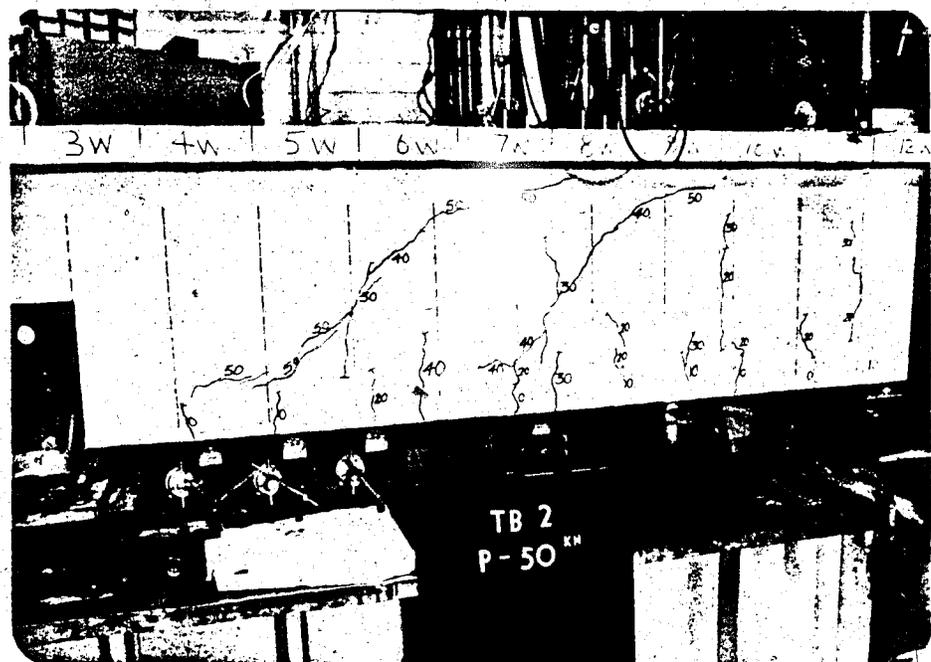
FIGURE 6.11 - Cracking in west shear span of TB 2 at $P = 50$ kN

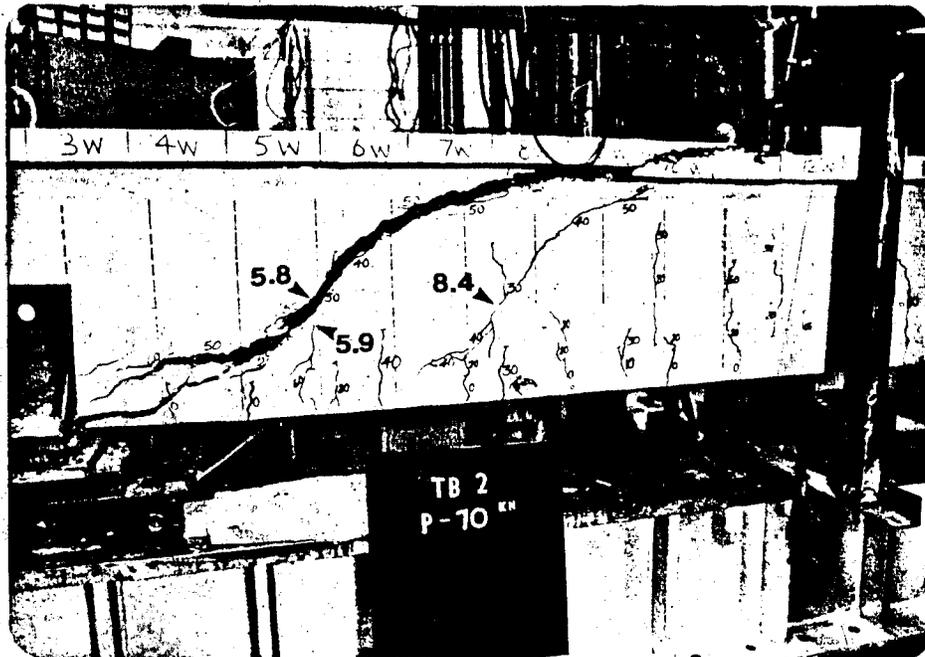
FIGURE 6.12 - Cracking in west shear span of TB 2 at ultimate load ($P_{ult} = 70$ kN) with crack numbers shown

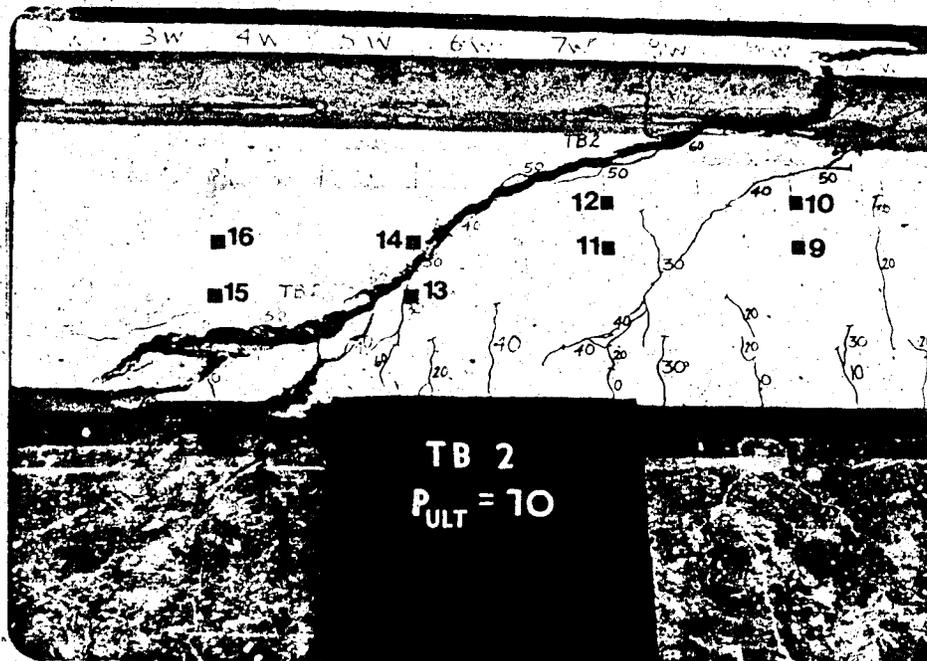
FIGURE 6.13 - Cracking in west shear span of TB 2 after testing with strain gauge locations shown

In TB 2, 16 strain gauges were installed but only 11 gave reliable readings. Four of these were in the east shear span (gauges 2, 5, 6 and 7) and seven in the west span (gauges 9, 10, 12, 13, 14, 15 and 16). Two gauges were mounted on each stirrup that was monitored. These gauges were located as shown in Figures 6.13 and 6.17. Figures 6.20 and 6.21 plot stirrup strain versus load using the strain gauges that gave the highest readings for each stirrup monitored. Strain gauges 14 in the west span and 5 in the east span recorded the largest strains. These gauges were installed on well anchored stirrups that were crossed by the widest inclined cracks in the region between the top of the main reinforcement and the web-to-flange transition. Because these stirrups were well anchored on each side of the cracks, they were able to develop larger loads, as was borne out by the measured strains. The gauges that gave lower readings were located on stirrups that were either crossed by narrow inclined cracks (gauge 10 in Figure 6.13) or they were crossed by the wider inclined cracks in the regions near the web-to-flange transition (gauge 7 in Figure 6.17) or near the main reinforcement (gauge 15 in Figure 6.13).

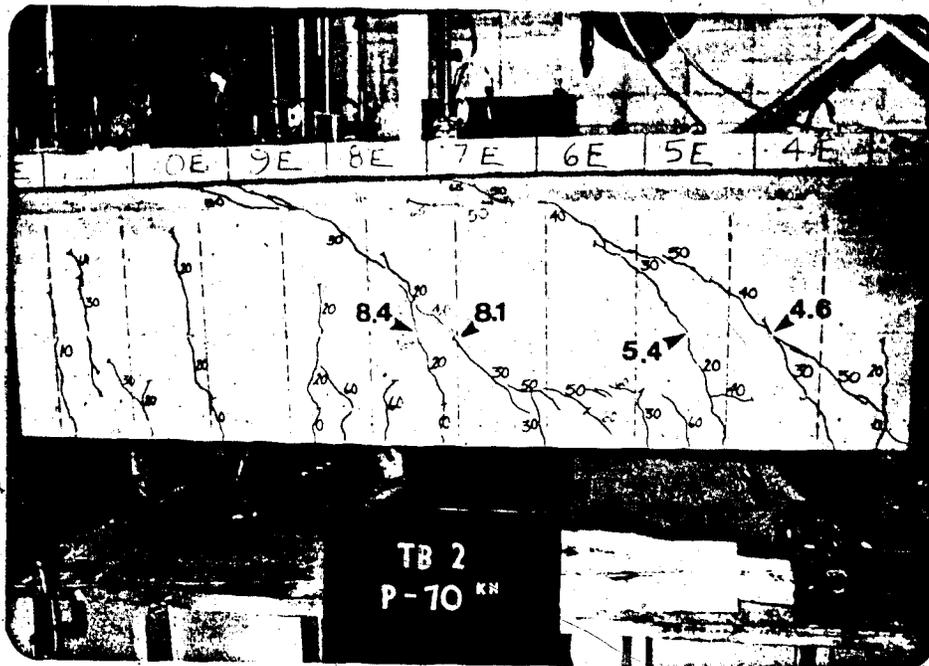
FIGURE 6.16 - Cracking in east shear span of TB 2 at ultimate load ($P_{ult} = 70$ KN) with crack numbers shown

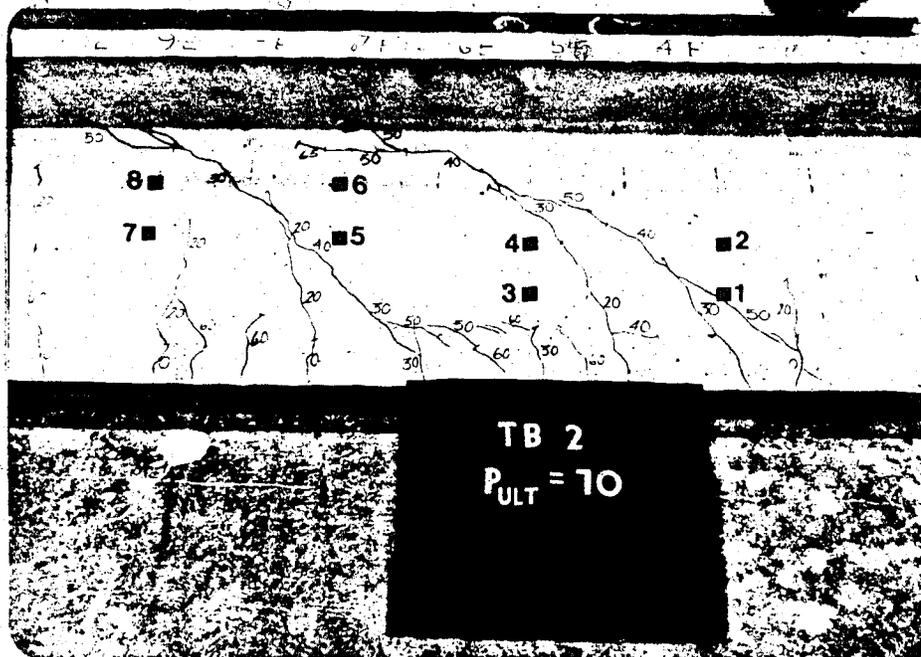
FIGURE 6.17 - Cracking in east shear span of TB 2 after testing with strain gauge locations shown

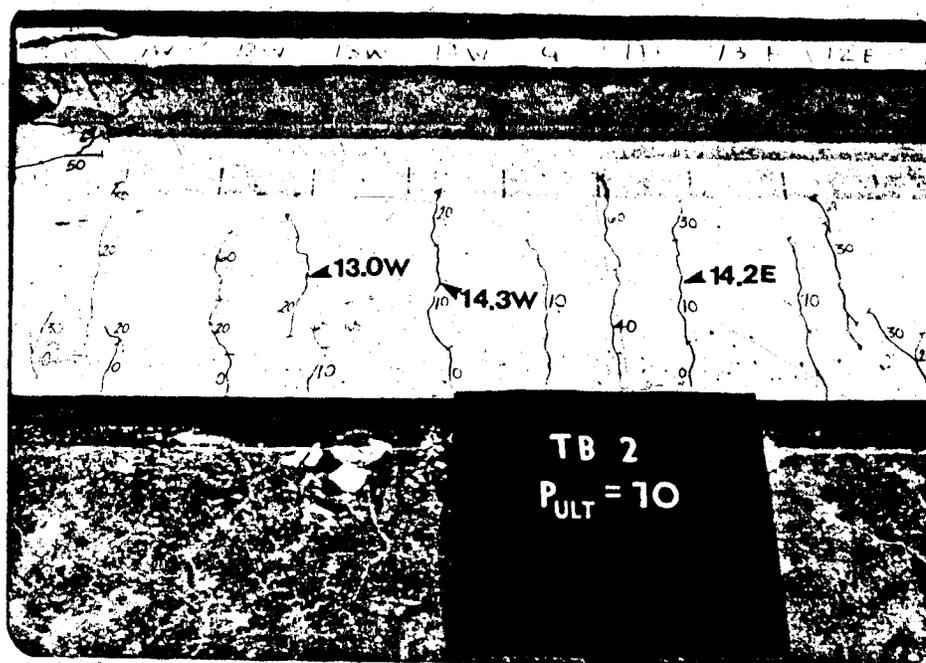
FIGURE 6.18 - Cracking in pure moment region of TB 2 after testing with crack numbers shown

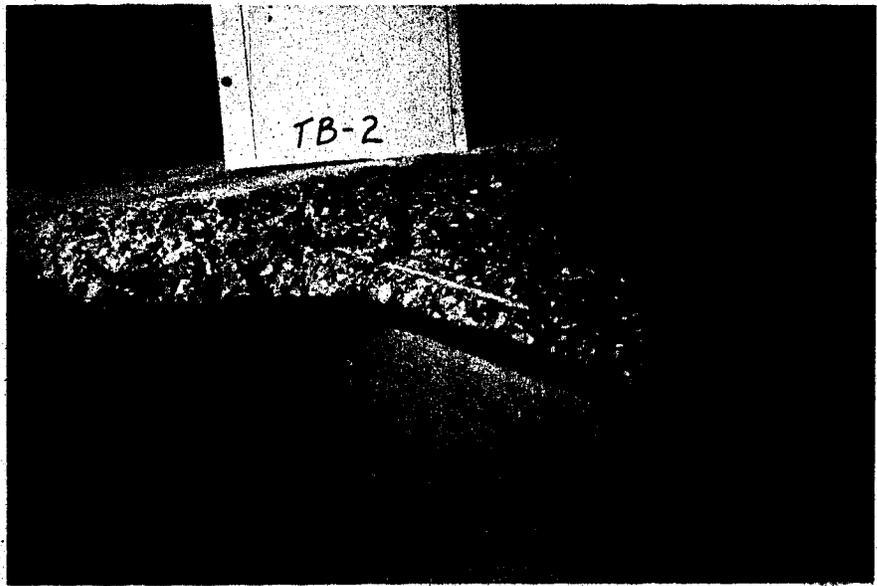
FIGURE 6.19 - Failure crack above exterior anchorage wire at top of TB 2
