The undersigned certify that they have read, and recommend to the Faculty of Graduate Studies and Research, for acceptance, a thesis entitled Behaviour of Concrete T-Beams with Welded Wire Fabric Reinforcement, submitted by Kevin L. Baskin, in partial fulfillment of the requirements for the degree of Master of Science in Civil Engineering.

All beams tested had diagonal tension type failures. The test results indicated that the ACI and CSA Code equations for predicting beam shear strength were conservative for the welded wire fabric sheets used, provided that there was proper anchorage. The Code equations were less conservative as the web reinforcement ratio decreased. The best anchorage was provided with two horizontal cross-wires at the top and bottom of the reinforcement sheets as proposed by the PCI/WRI Ad Hoc Committee for the case of single leg welded wire fabric shear reinforcement sheets with smooth vertical wires. In the case of welded deformed wire fabric, anchorage with only one horizontal cross-wire top and bottom was also satisfactory, provided the bottom cross-wire was not above the lowest main reinforcement and the upper cross-wire was close to the top face of the be

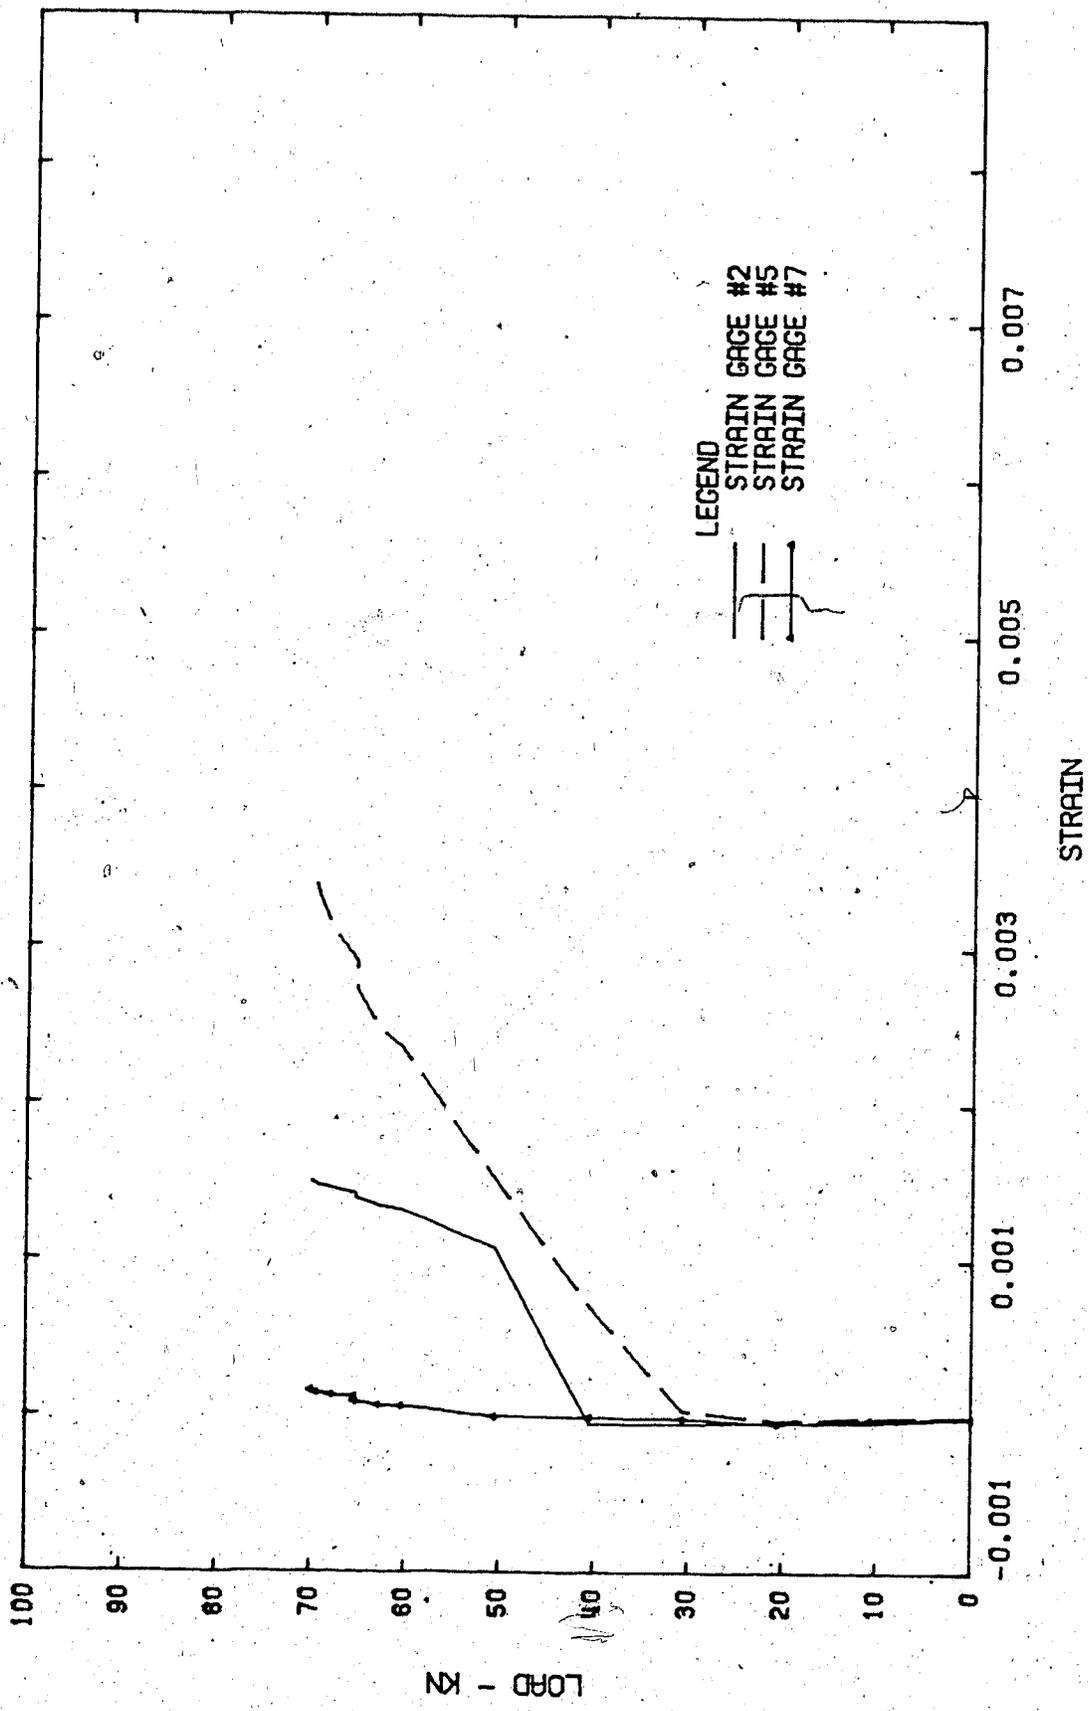
FIGURE 6.20 - Point Load Versus Stirrup Strain for East Shear Span of TB 2

In TB 2, 16 strain gauges were installed but only 11 gave reliable readings. Four of these were in the east shear span (gauges 2, 5, 6 and 7) and seven in the west span (gauges 9, 10, 12, 13, 14, 15 and 16). Two gauges were mounted on each stirrup that was monitored. These gauges were located as shown in Figures 6.13 and 6.17. Figures 6.20 and 6.21 plot stirrup strain versus load using the strain gauges that gave the highest readings for each stirrup monitored. Strain gauges 14 in the west span and 5 in the east span recorded the largest strains. These gauges were installed on well anchored stirrups that were crossed by the widest inclined cracks in the region between the top of the main reinforcement and the web-to-flange transition. Because these stirrups were well anchored on each side of the cracks, they were able to develop larger loads, as was borne out by the measured strains. The gauges that gave lower readings were located on stirrups that were either crossed by narrow inclined cracks (gauge 10 in Figure 6.13) or they were crossed by the wider inclined cracks in the regions near the web-to-flange transition (gauge 7 in Figure 6.17) or near the main reinforcement (gauge 15 in Figure 6.13).

If the yield strain of the vertical wires is taken as 0.0035 as given in the ACI and CSA Codes, then the only gauge that measured a strain larger than yield prior to failure of the beam was gauge 14. Strain gauge 5 gave a reading that was very close to yield.

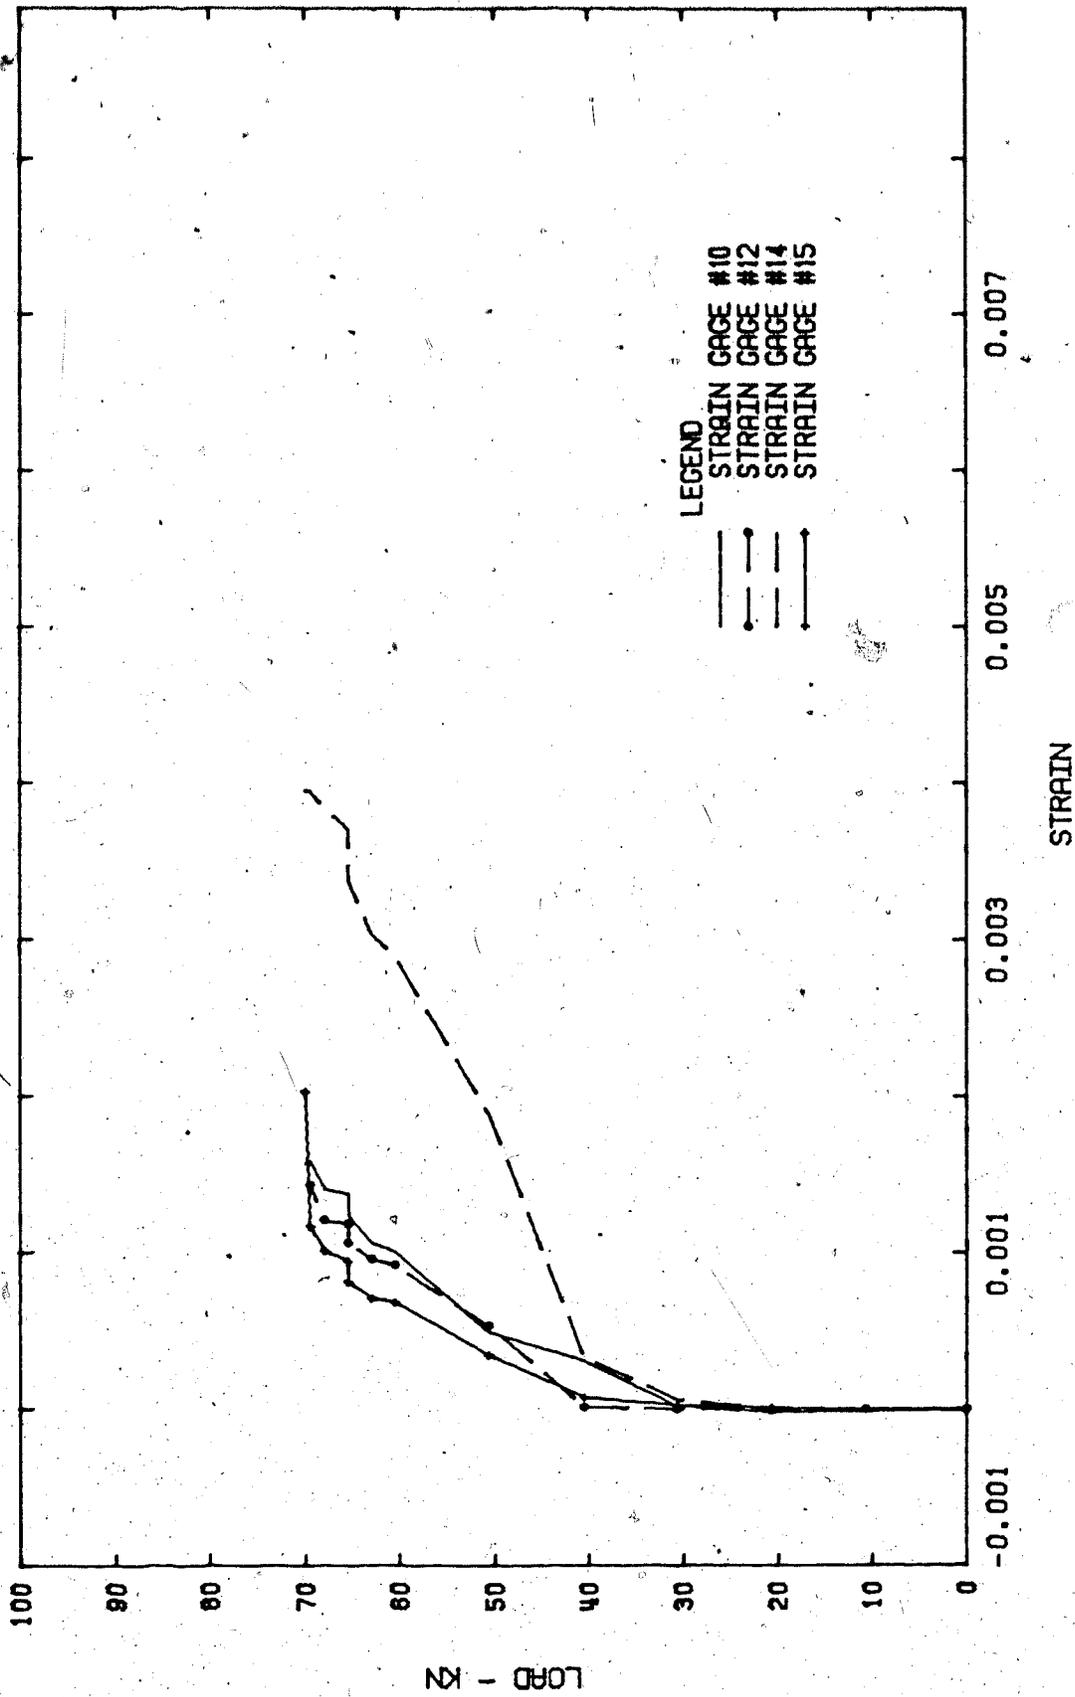
FIGURE 6.21 - Point Load Versus Stirrup Strain for West Shear Span of TB 2

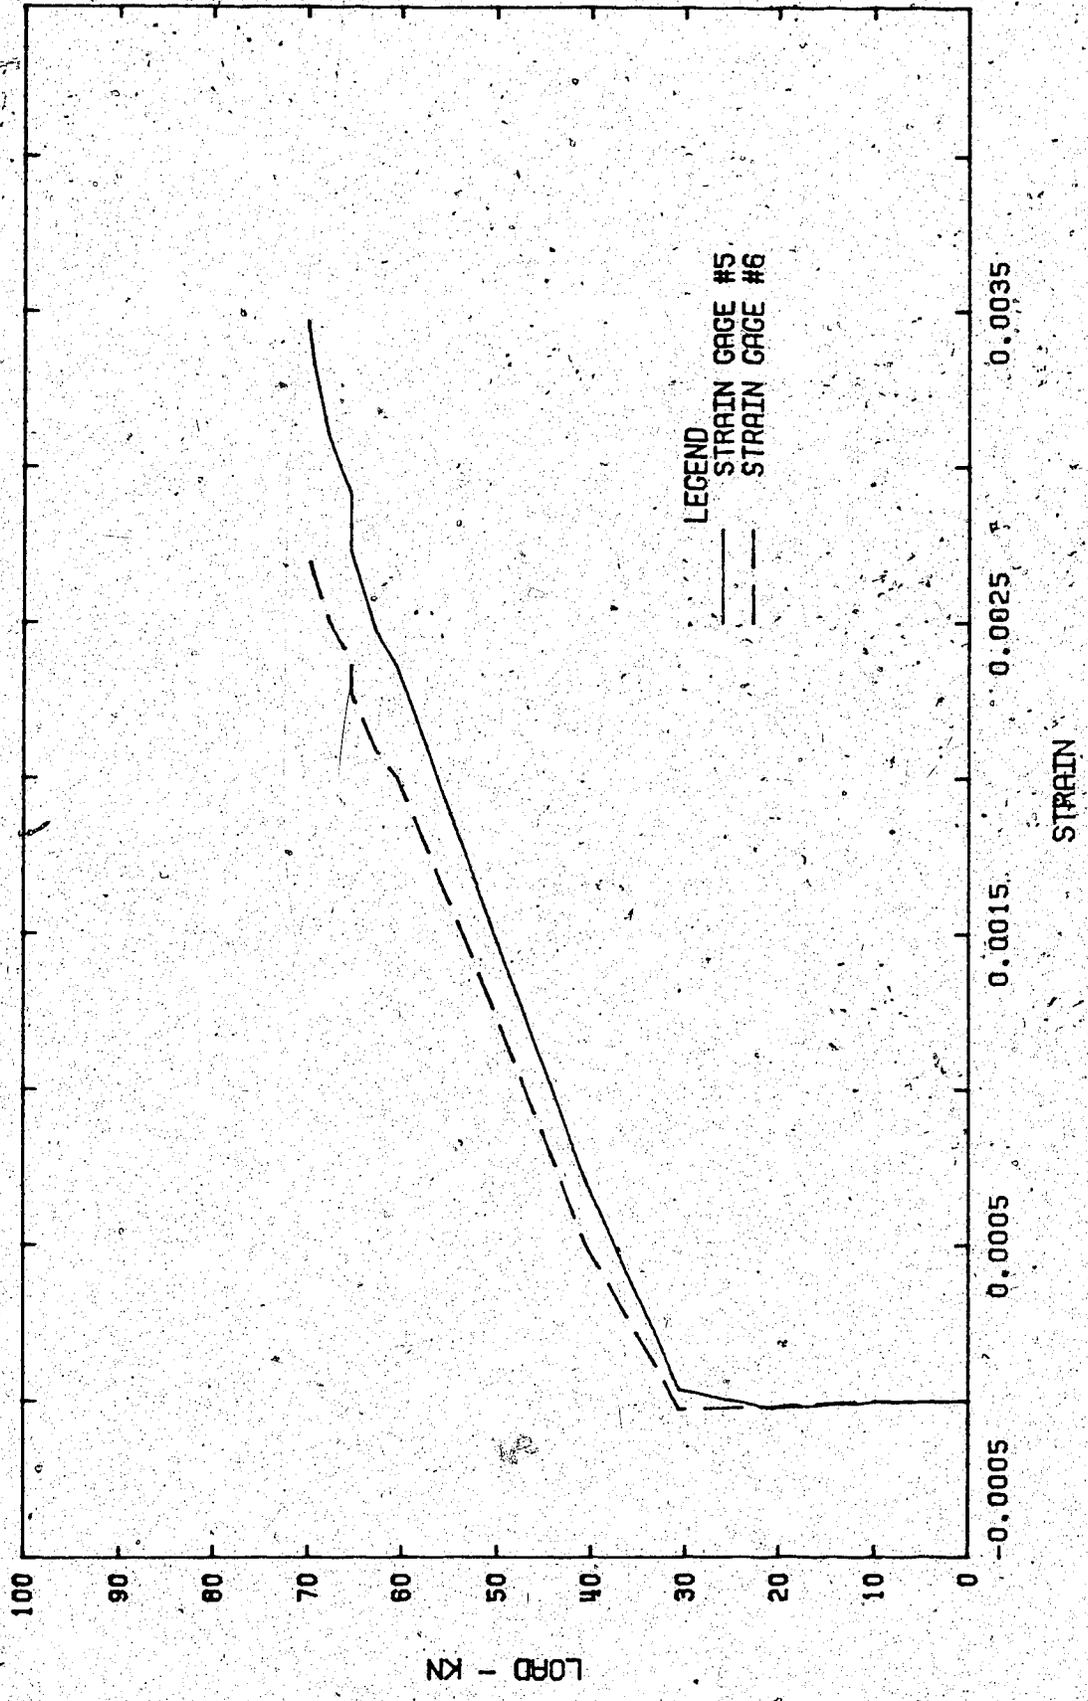
FIGURE 6.22 - Graphs of Load Versus Strain for Strain Gauges 5 and 6 from TB 2 Showing the Difference in Strain Due to Bond

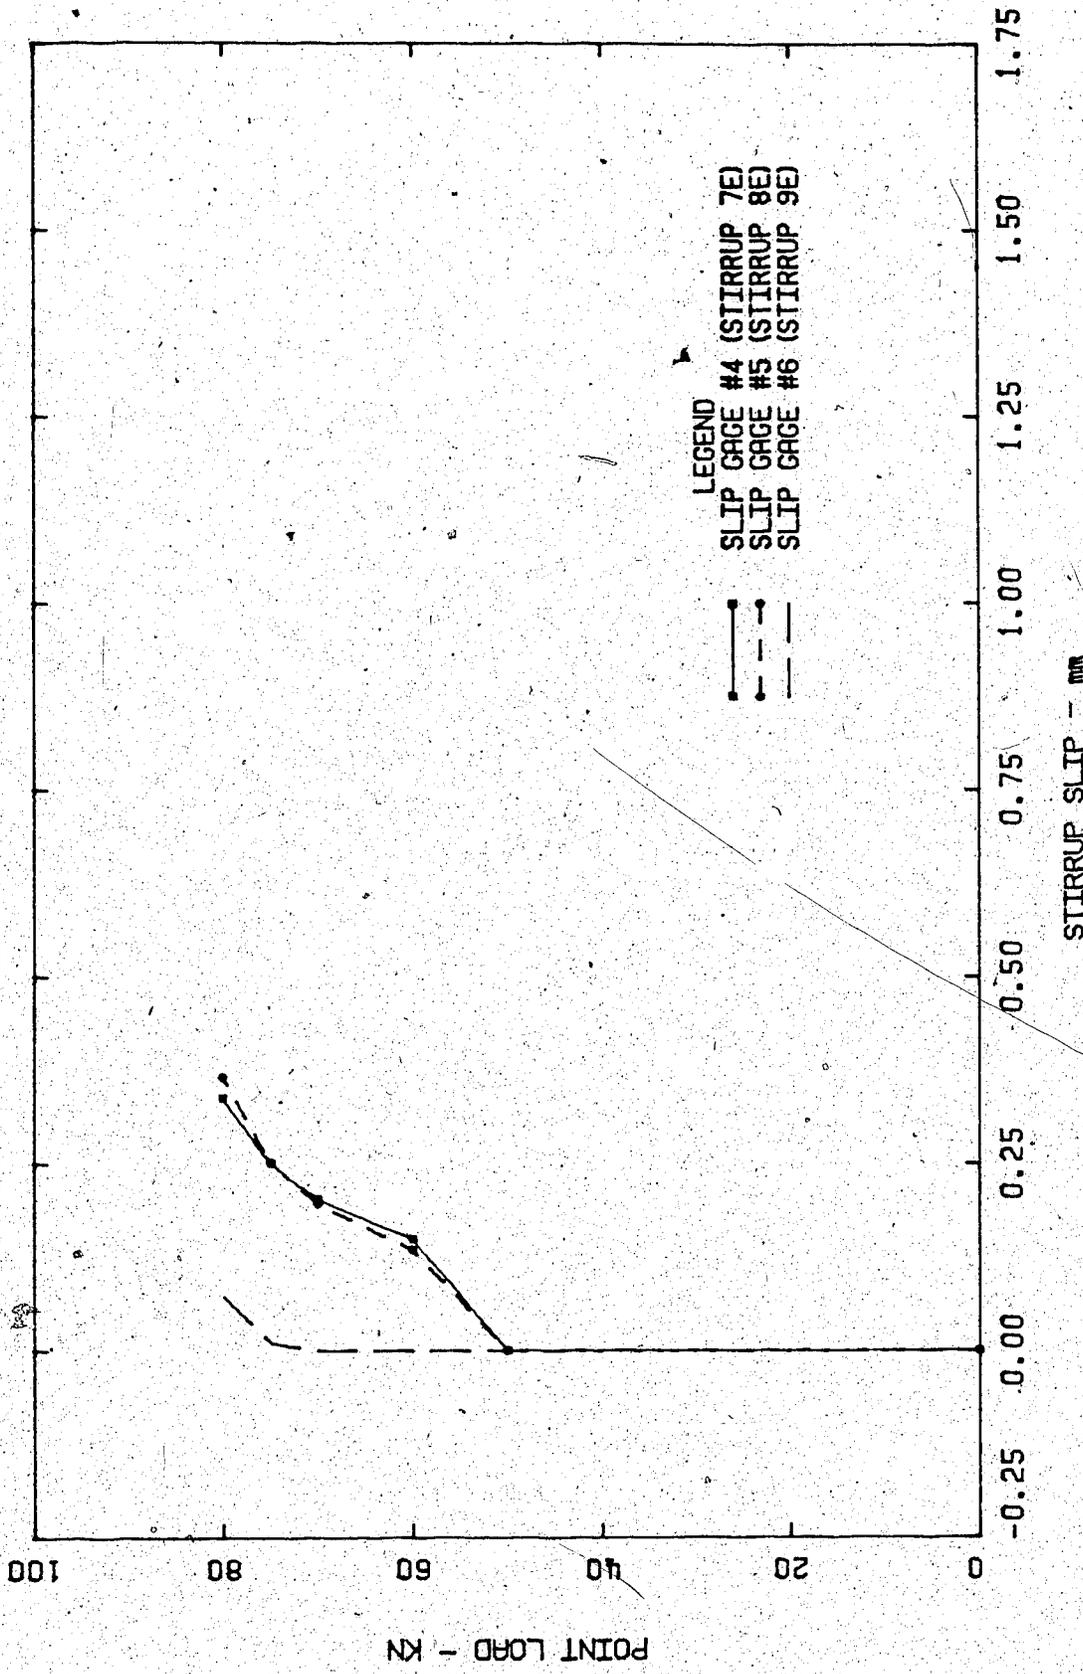
FIGURE 6.24 - Graph of Load Versus Stirrup Slip as Measured from the Top Gauges of TB 4 in the East Shear Span

The largest slip measurements occurred at the stirrups which were crossed by the inclined cracks either in the region of the top or bottom cross-wire anchorage. The readings in the failure span were generally larger than the readings in the

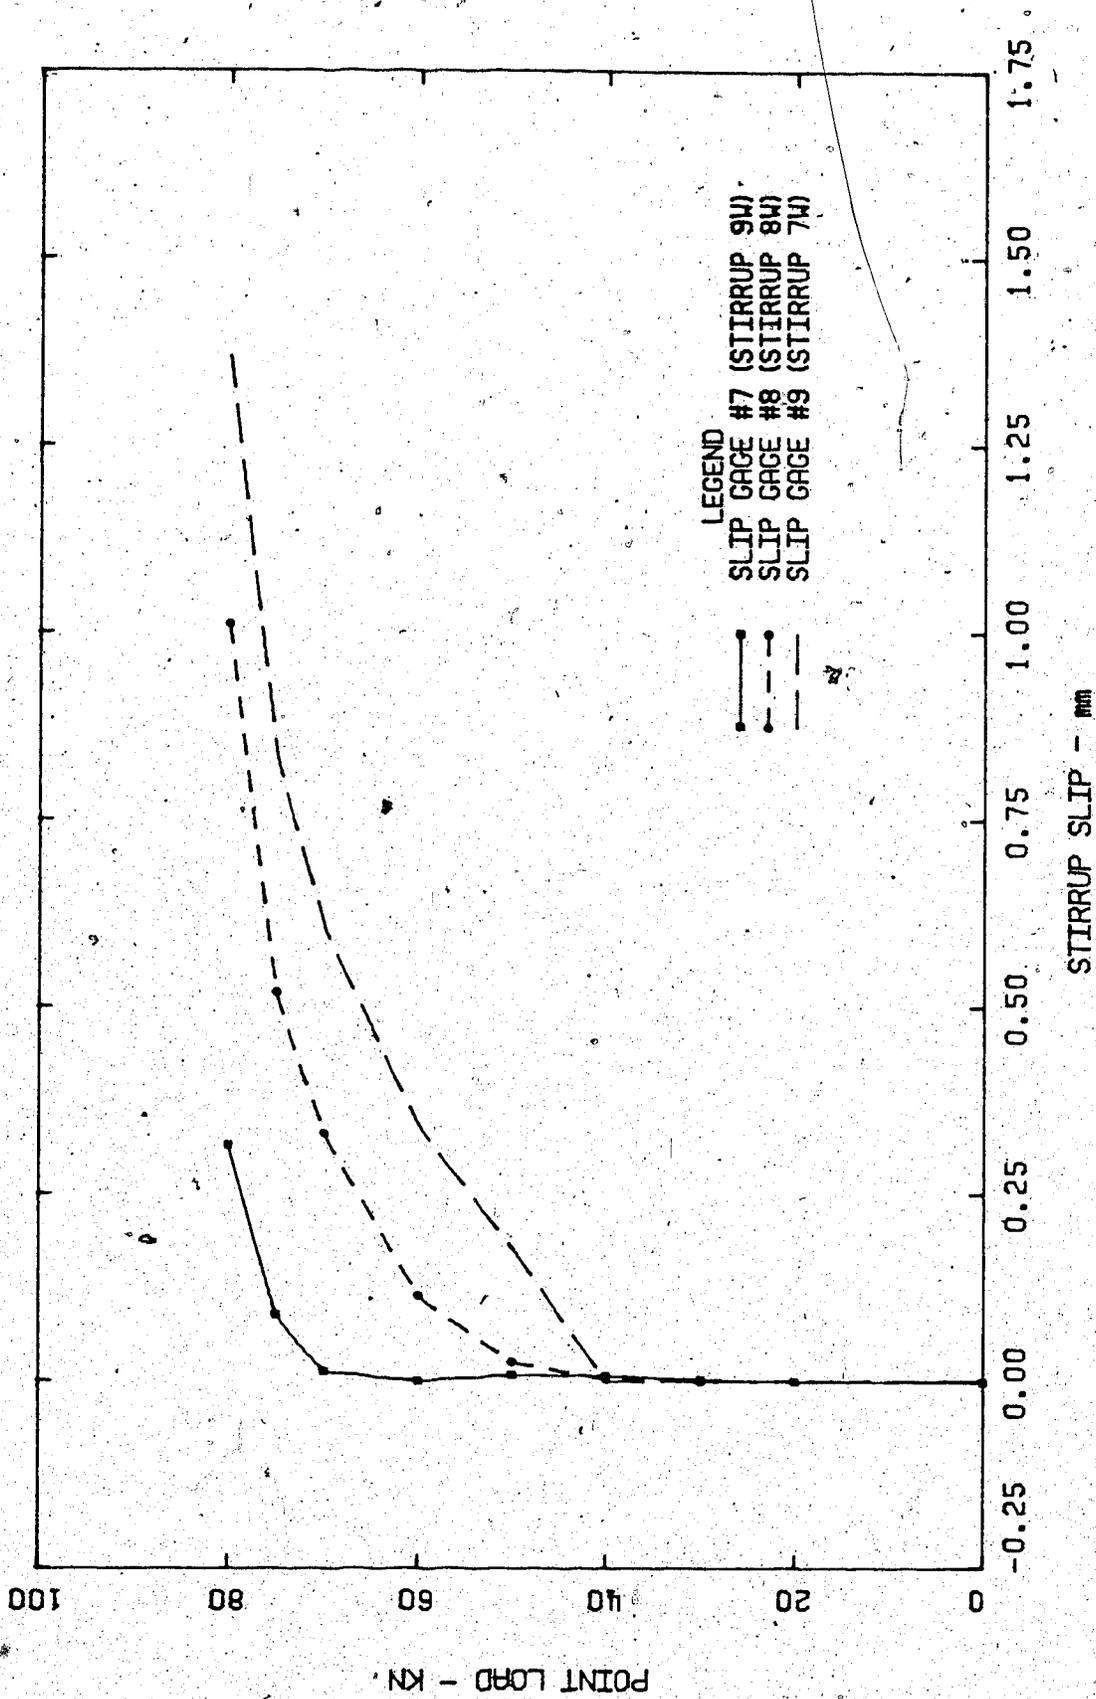
FIGURE 6.26 - Graph of Load Versus Stirrup Slip as Measured From the Top Gauges of TB 4 in the West Shear Span

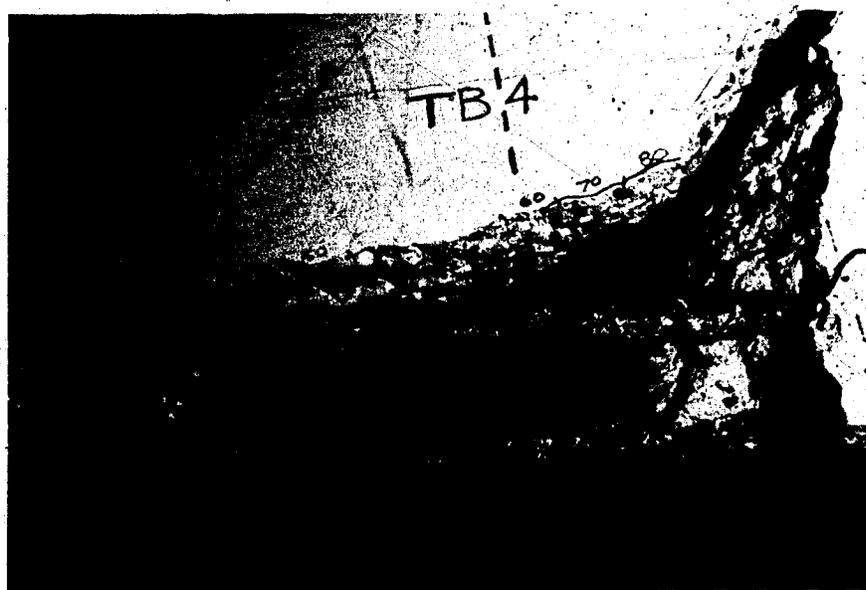
FIGURE 6.27 - Damage to anchorage at bottom of failure crack in TB 4.

other span. Damage to the anchorage was evident after the beam failed on the stirrups crossed by the failure crack in the region near the anchorage wires.

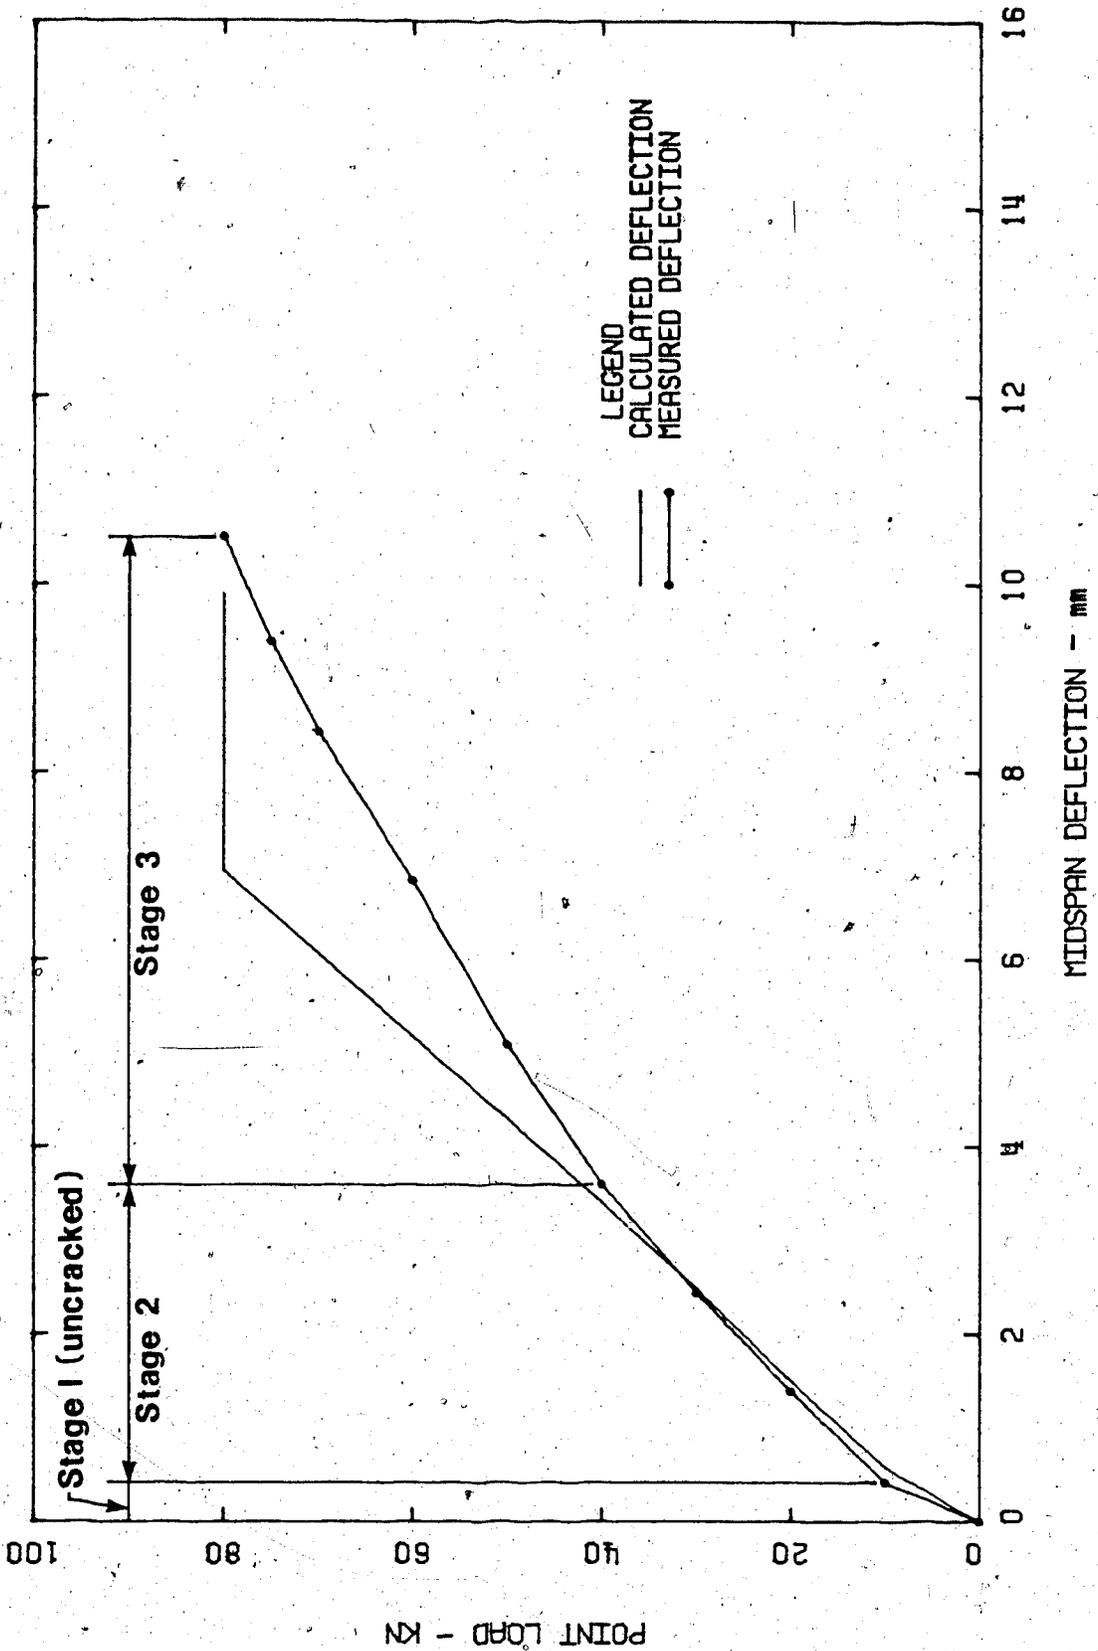
FIGURE 6.28 - Load Versus Midspan Deflection for TB 4

sections. The initial portion of the graph from 0 to 10 kN represents the uncracked region. The calculated cracking moment for this beam is approximately 19 kN/m (14 ft./kips) which corresponds to a load of 13.8 kN (3.1 kips). After the cracking load, the rate of deflection increases. The slope of the second portion of the graph between 10 and 40 kN is relatively constant. This corresponds to the load stage between the flexural cracking load and the inclined cracking load. In the final portion of the graphs from inclined cracking to failure, the rate of deflection increases again.

The load versus centerline deflection graph for TB 4 is shown in Figure 6.28. The graph can be broken into three

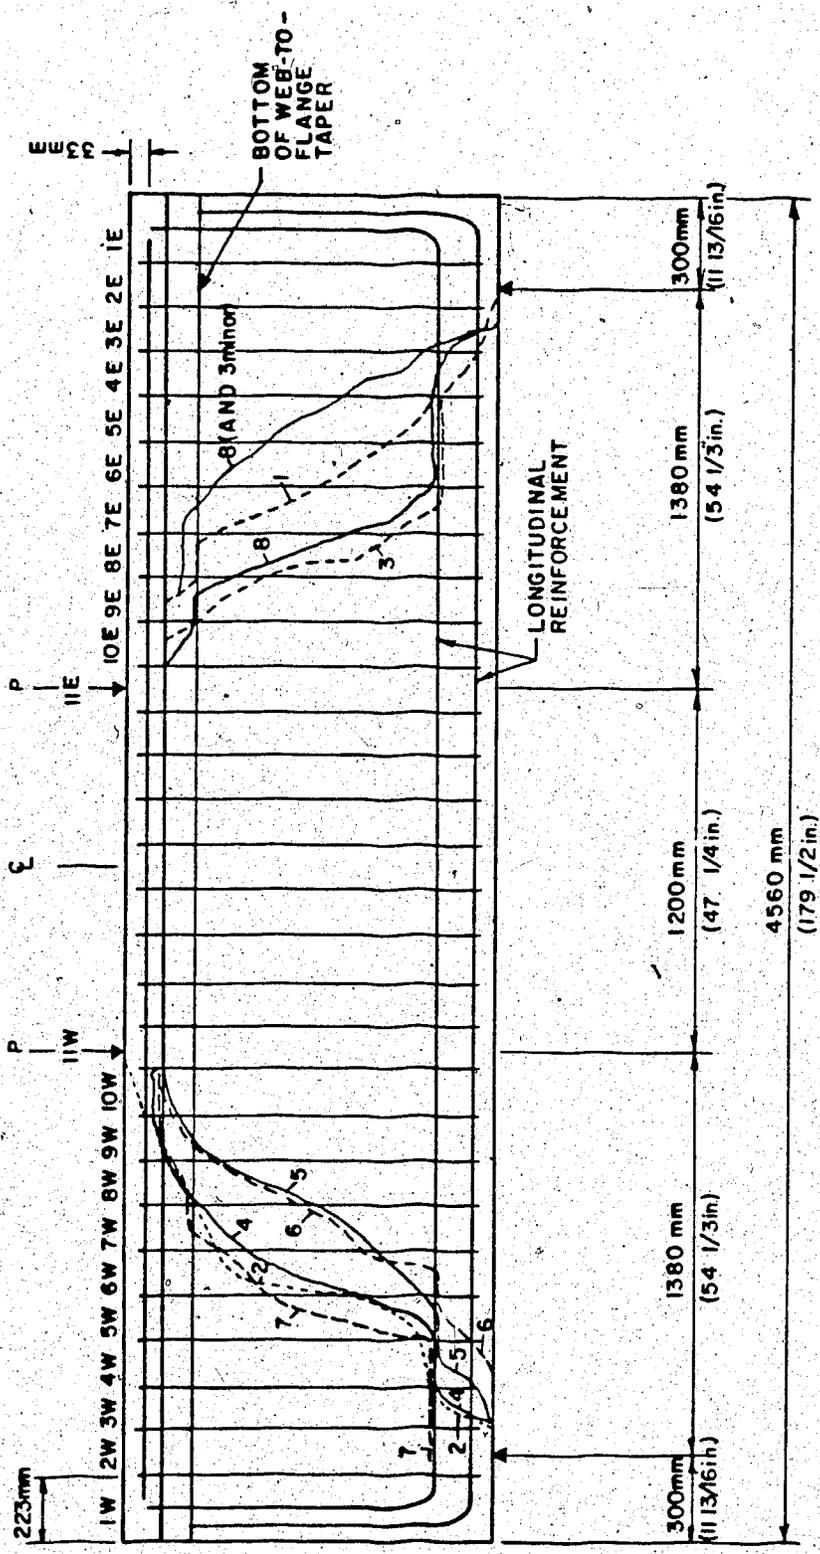
NOTE: THE THE NUMBER ON THE
CRACK INDICATES THE
BEAM NUMBER.

FIGURE 6.29 - Locations of Failure Cracks in TB 1 to TB 8 (Not to Scale)

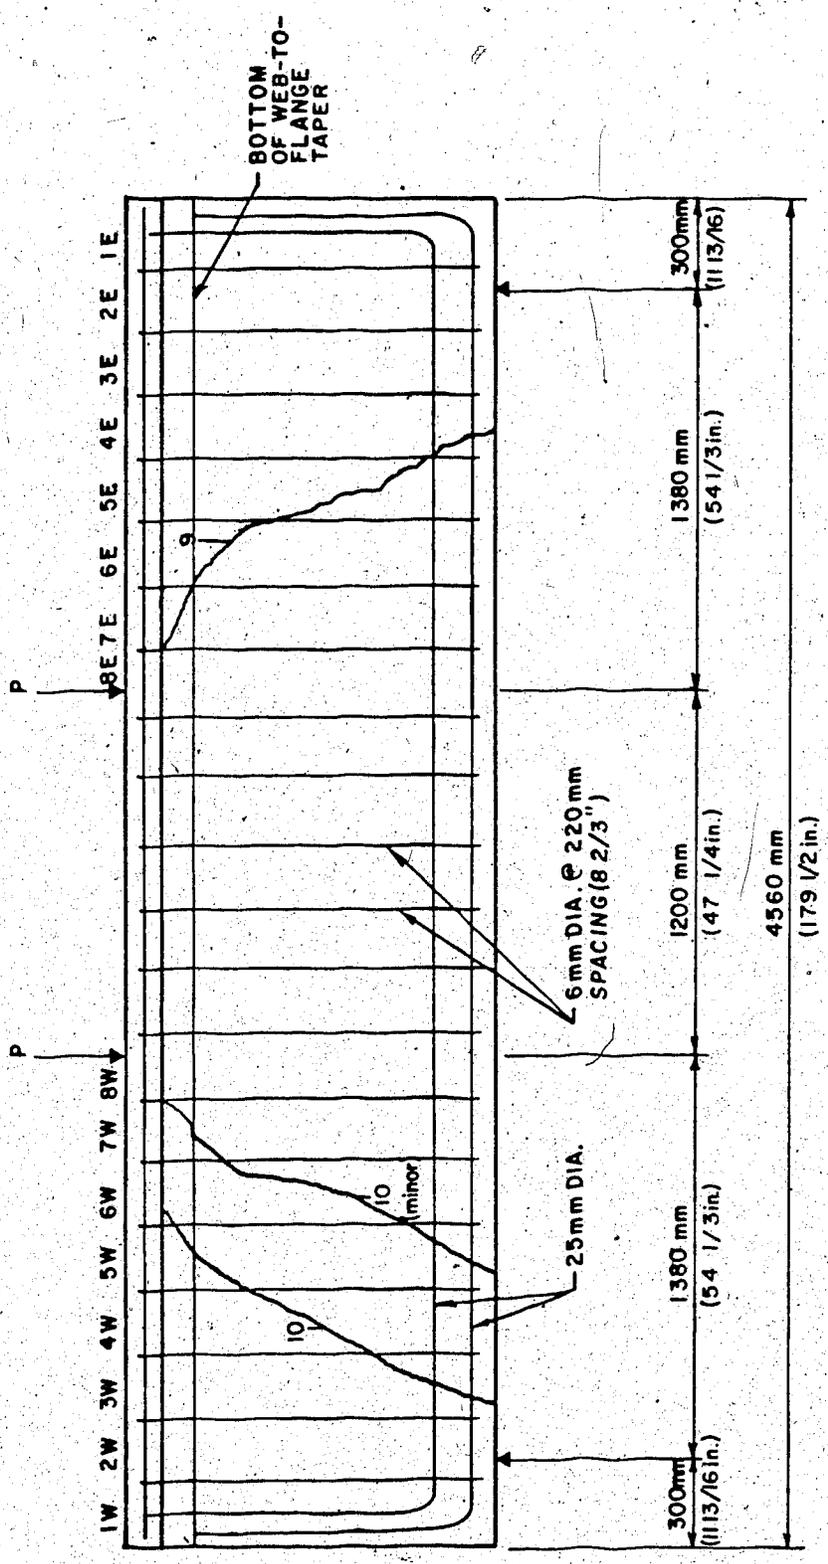
NOTE: THE NUMBER ON THE CRACK INDICATES THE BEAM NUMBER

FIGURE 6.30 - Locations of Failure Cracks in TB 9 and TB 10 (Not to Scale)

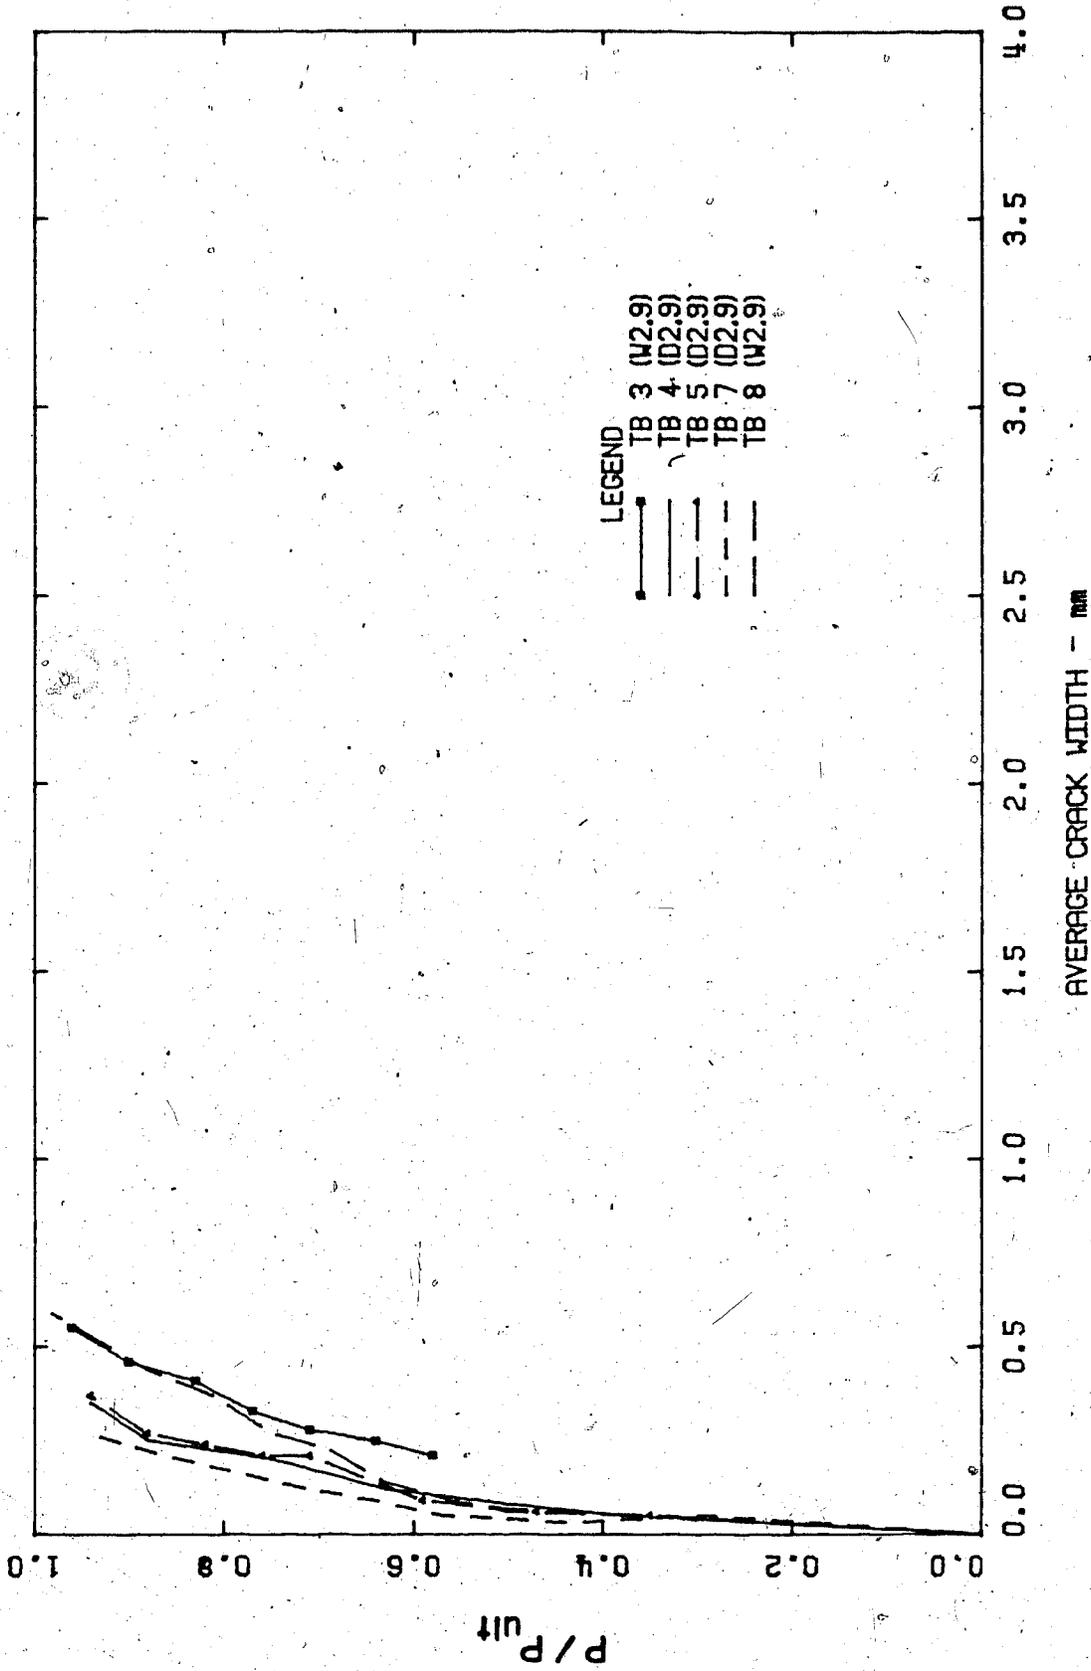
FIGURE 6.32 - Graphs of $\frac{P}{P_{ult}}$ Versus Average Crack Width for TB 3, TB 4, TB 5, TB 7 and TB 8

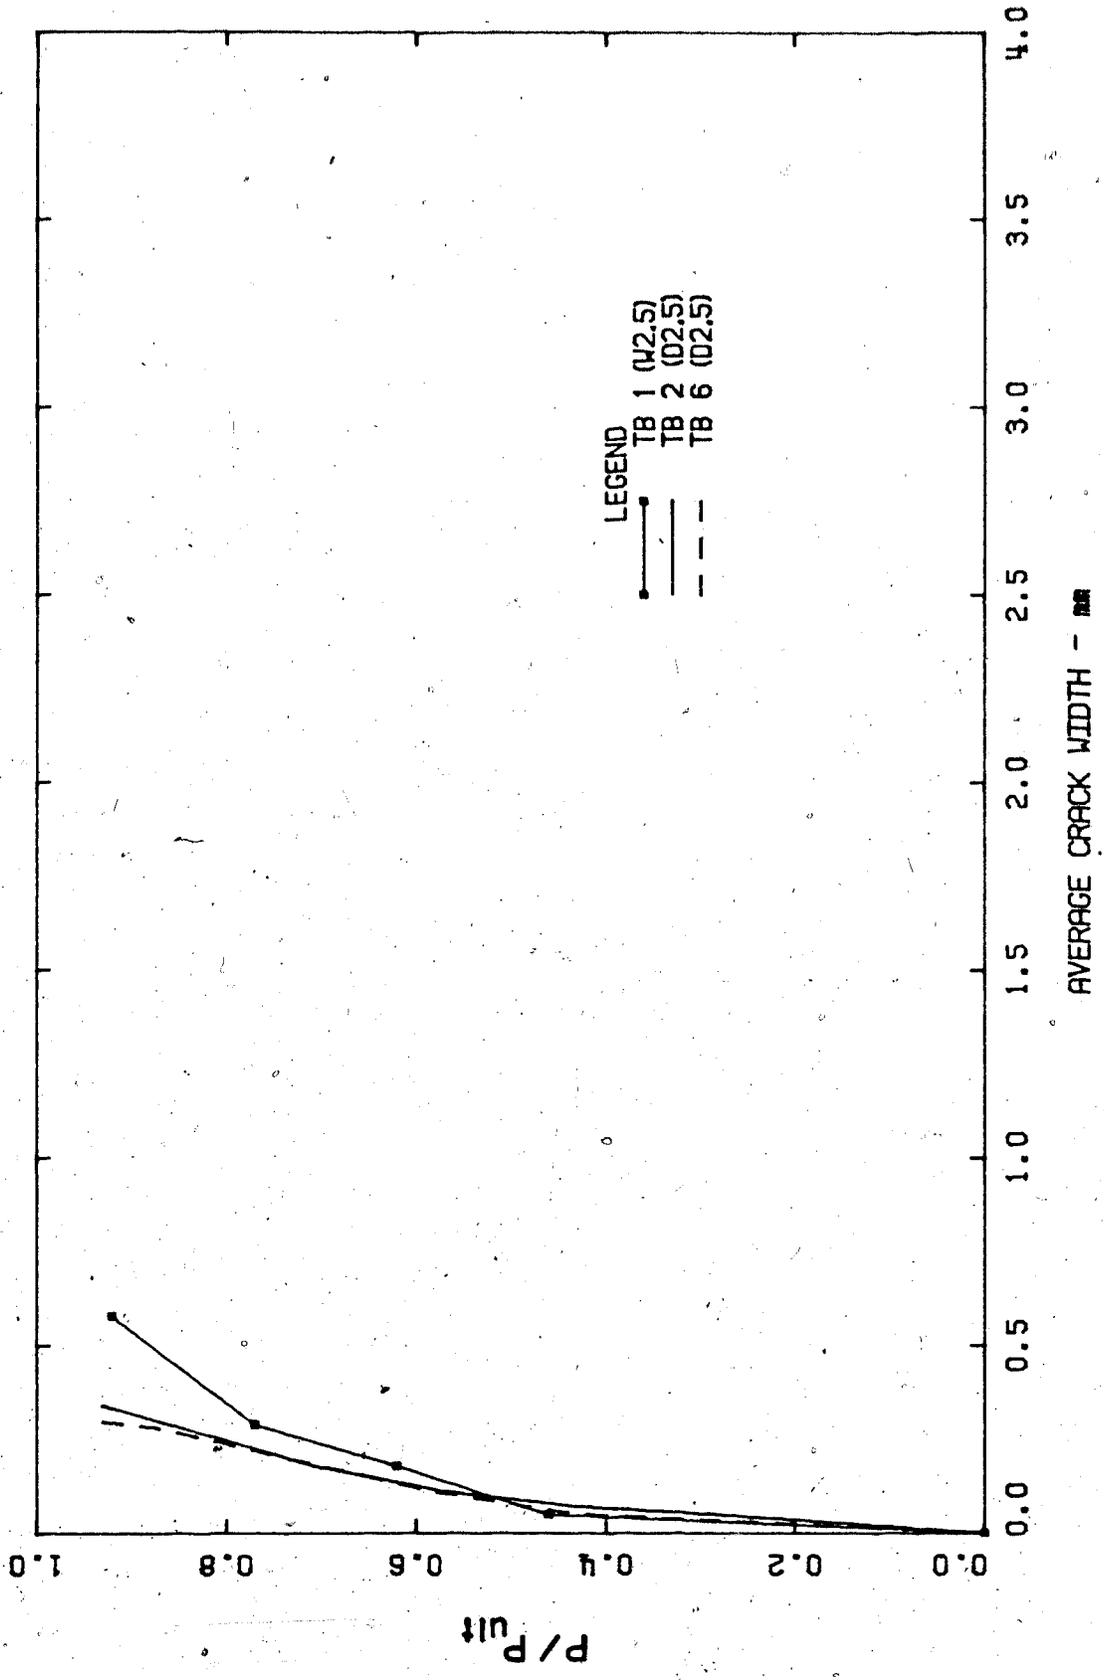
FIGURE 6.33 - Graphs of $\frac{P}{P_{ult}}$ Versus Average Crack Width for TB 1, TB 2 and TB 6

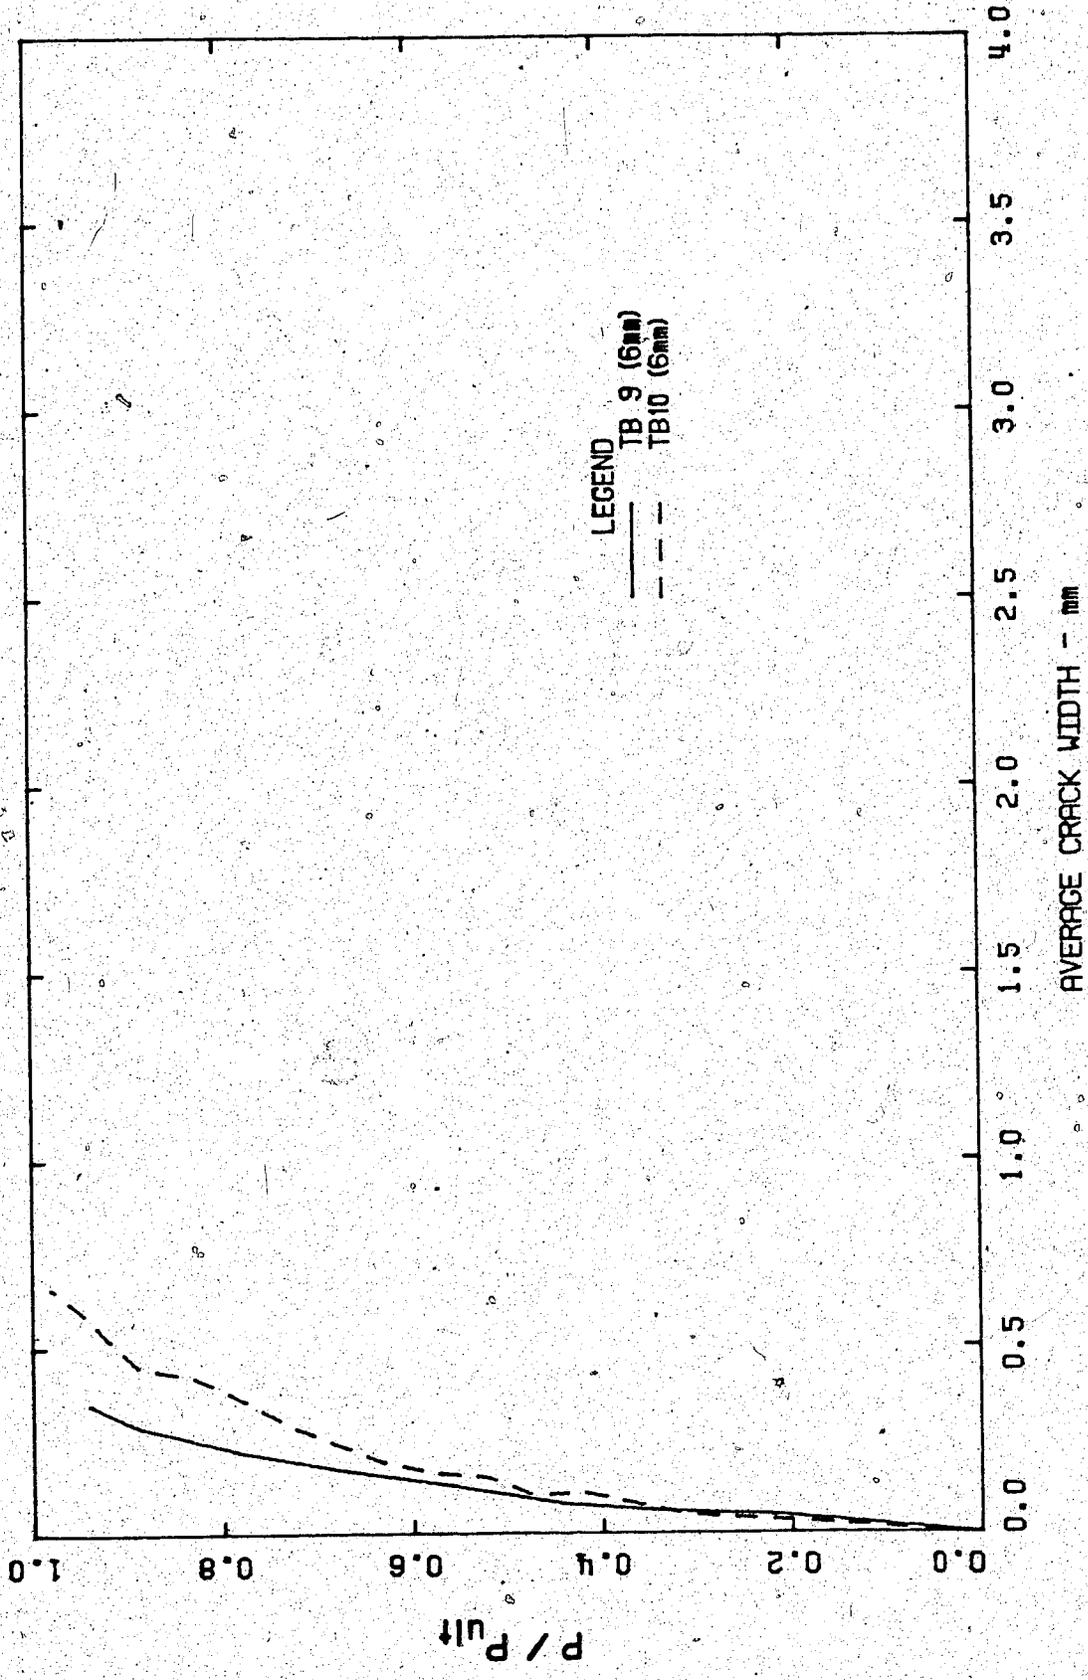
FIGURE 6.34 - Graphs of $\frac{P}{P_{ult}}$ Versus Average Crack Width for TB 9 and TB 10

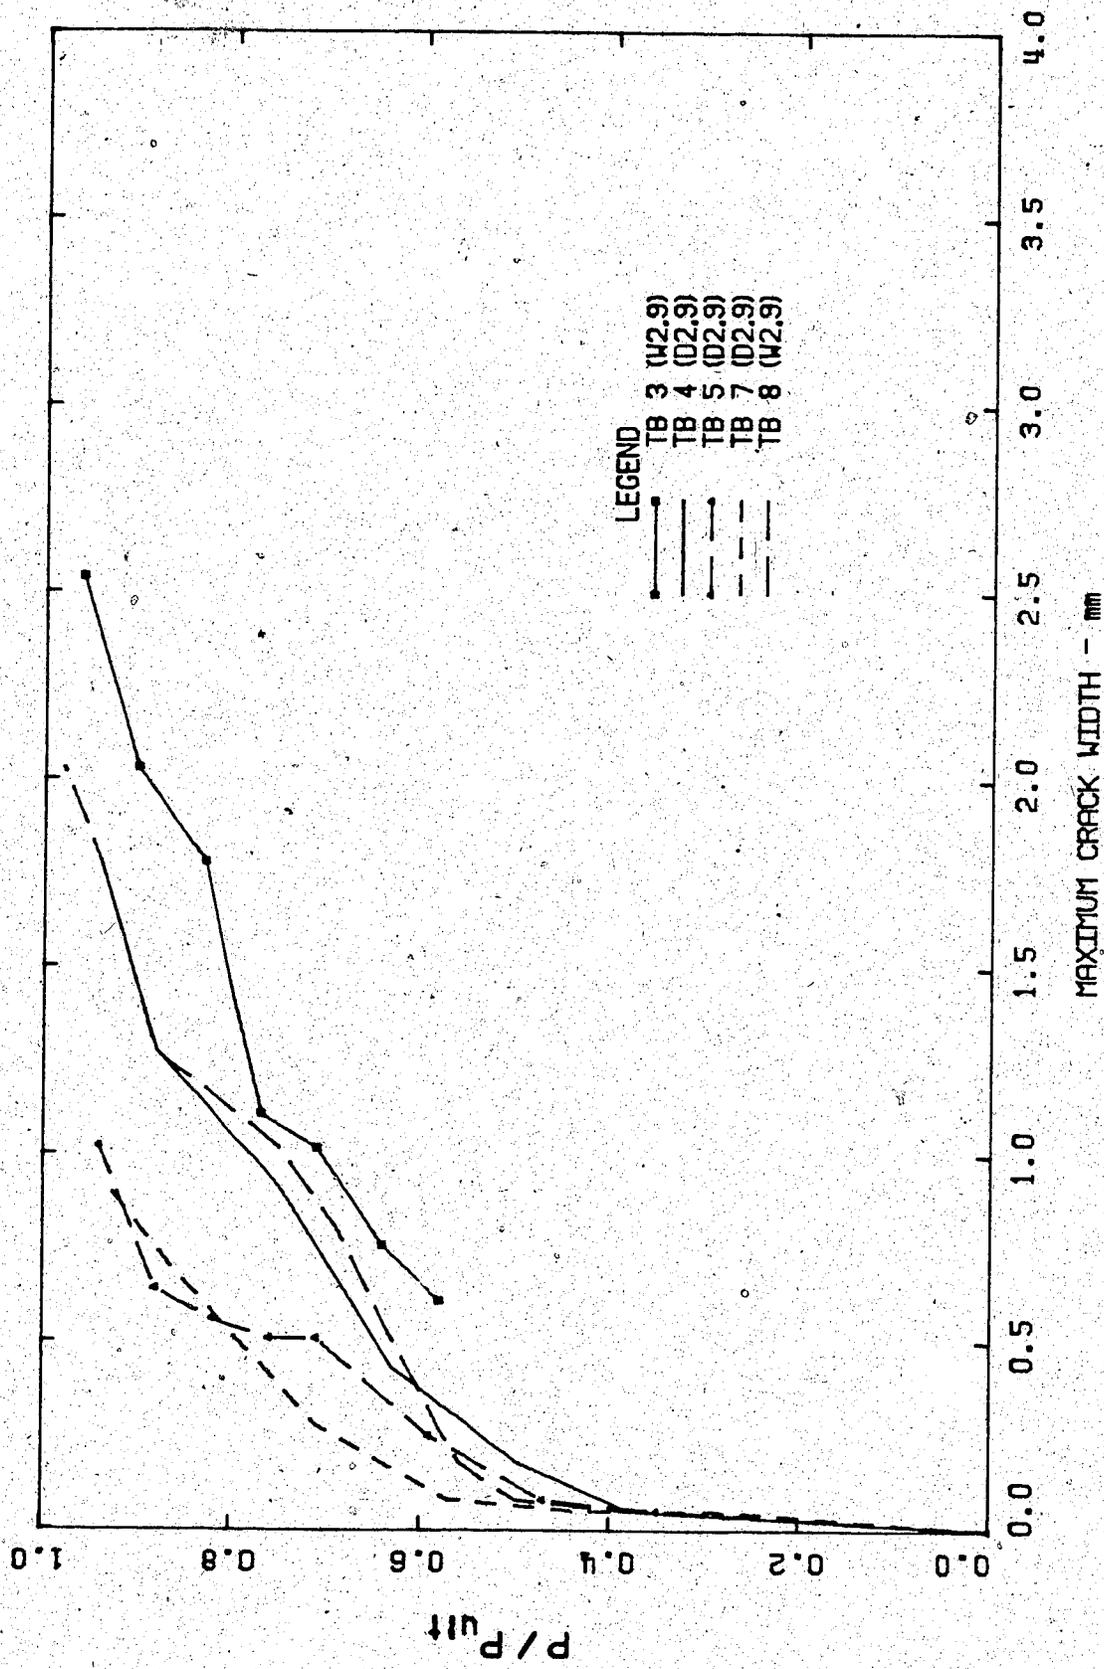
FIGURE 6.35 - Graphs of $\frac{P}{P_{ult}}$ Versus Maximum Crack Width for TB 3, TB 4, TB 5, TB 7 and TB 8
