The undersigned certify that they have read, and recommend to the Faculty of Graduate Studies and Research, for acceptance, a thesis entitled Behaviour of Concrete T-Beams with Welded Wire Fabric Reinforcement, submitted by Kevin L. Baskin, in partial fulfillment of the requirements for the degree of Master of Science in Civil Engineering.

All beams tested had diagonal tension type failures. The test results indicated that the ACI and CSA Code equations for predicting beam shear strength were conservative for the welded wire fabric sheets used, provided that there was proper anchorage. The Code equations were less conservative as the web reinforcement ratio decreased. The best anchorage was provided with two horizontal cross-wires at the top and bottom of the reinforcement sheets as proposed by the PCI/WRI Ad Hoc Committee for the case of single leg welded wire fabric shear reinforcement sheets with smooth vertical wires. In the case of welded deformed wire fabric, anchorage with only one horizontal cross-wire top and bottom was also satisfactory, provided the bottom cross-wire was not above the lowest main reinforcement and the upper cross-wire was close to the top face of the be

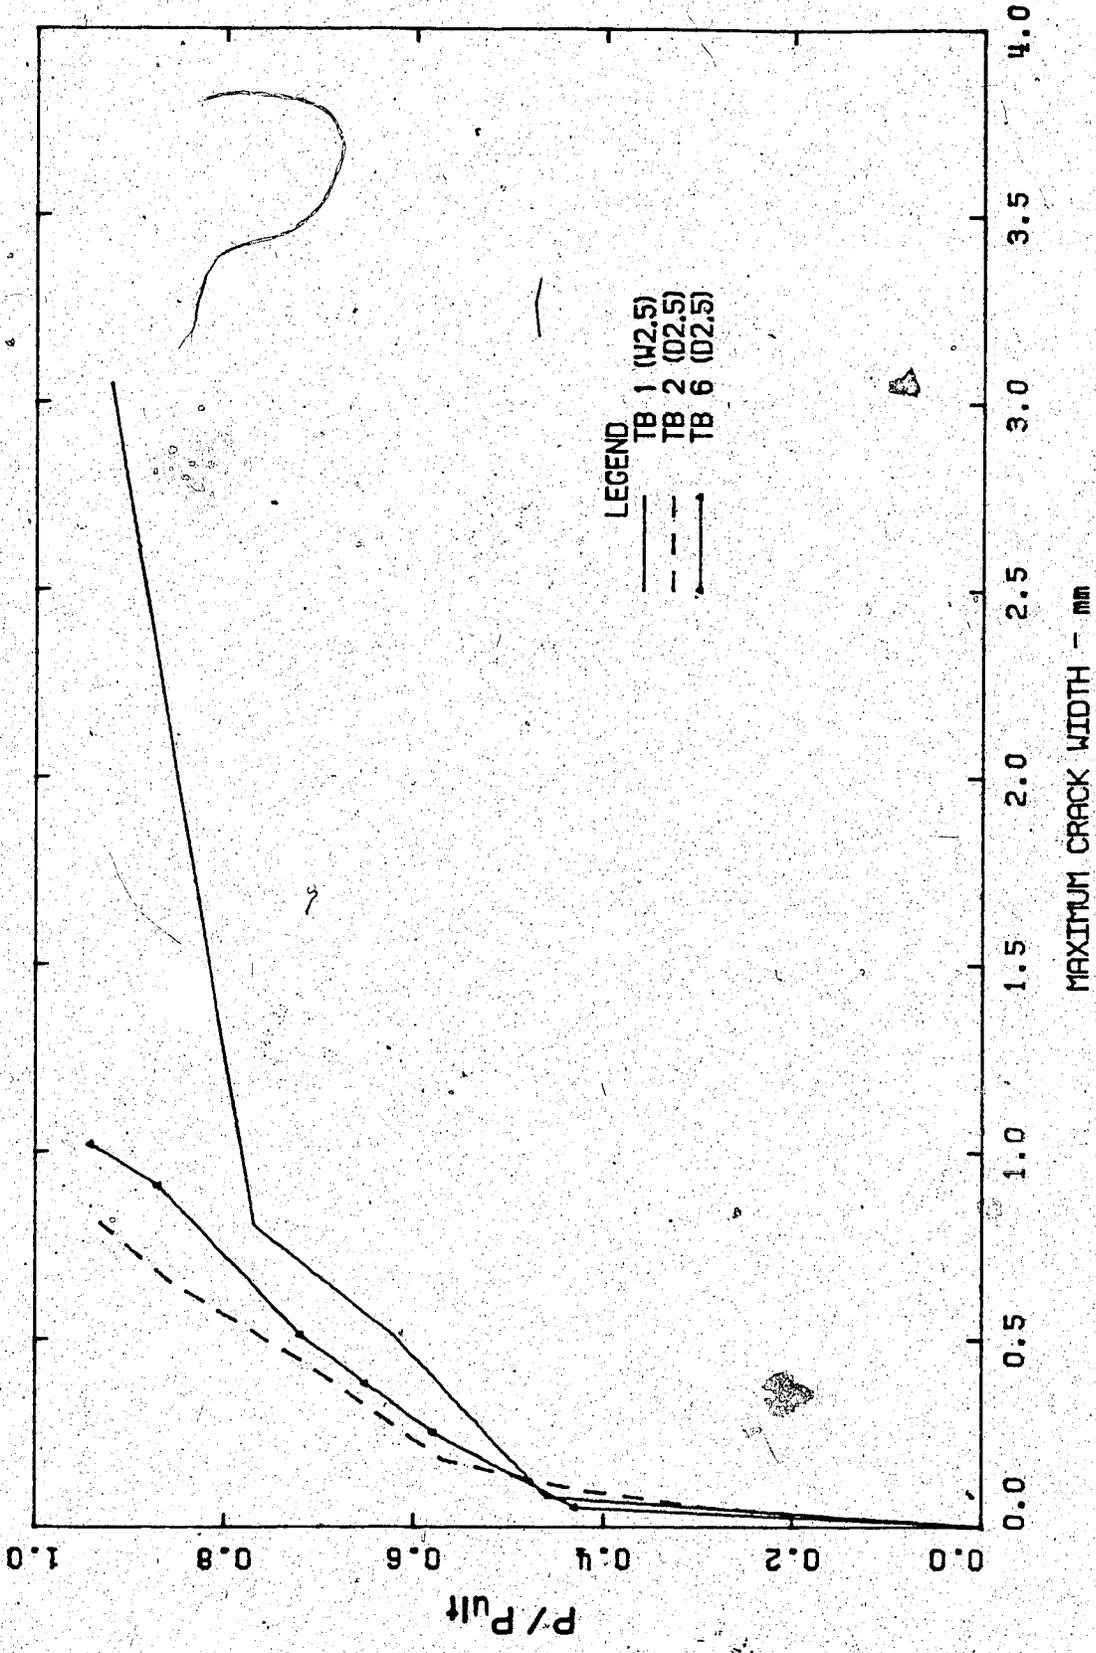
FIGURE 6.36 - Graphs of $\frac{P}{P_{ult}}$ Versus Maximum Crack Width for TB 1, TB 2 and TB 6

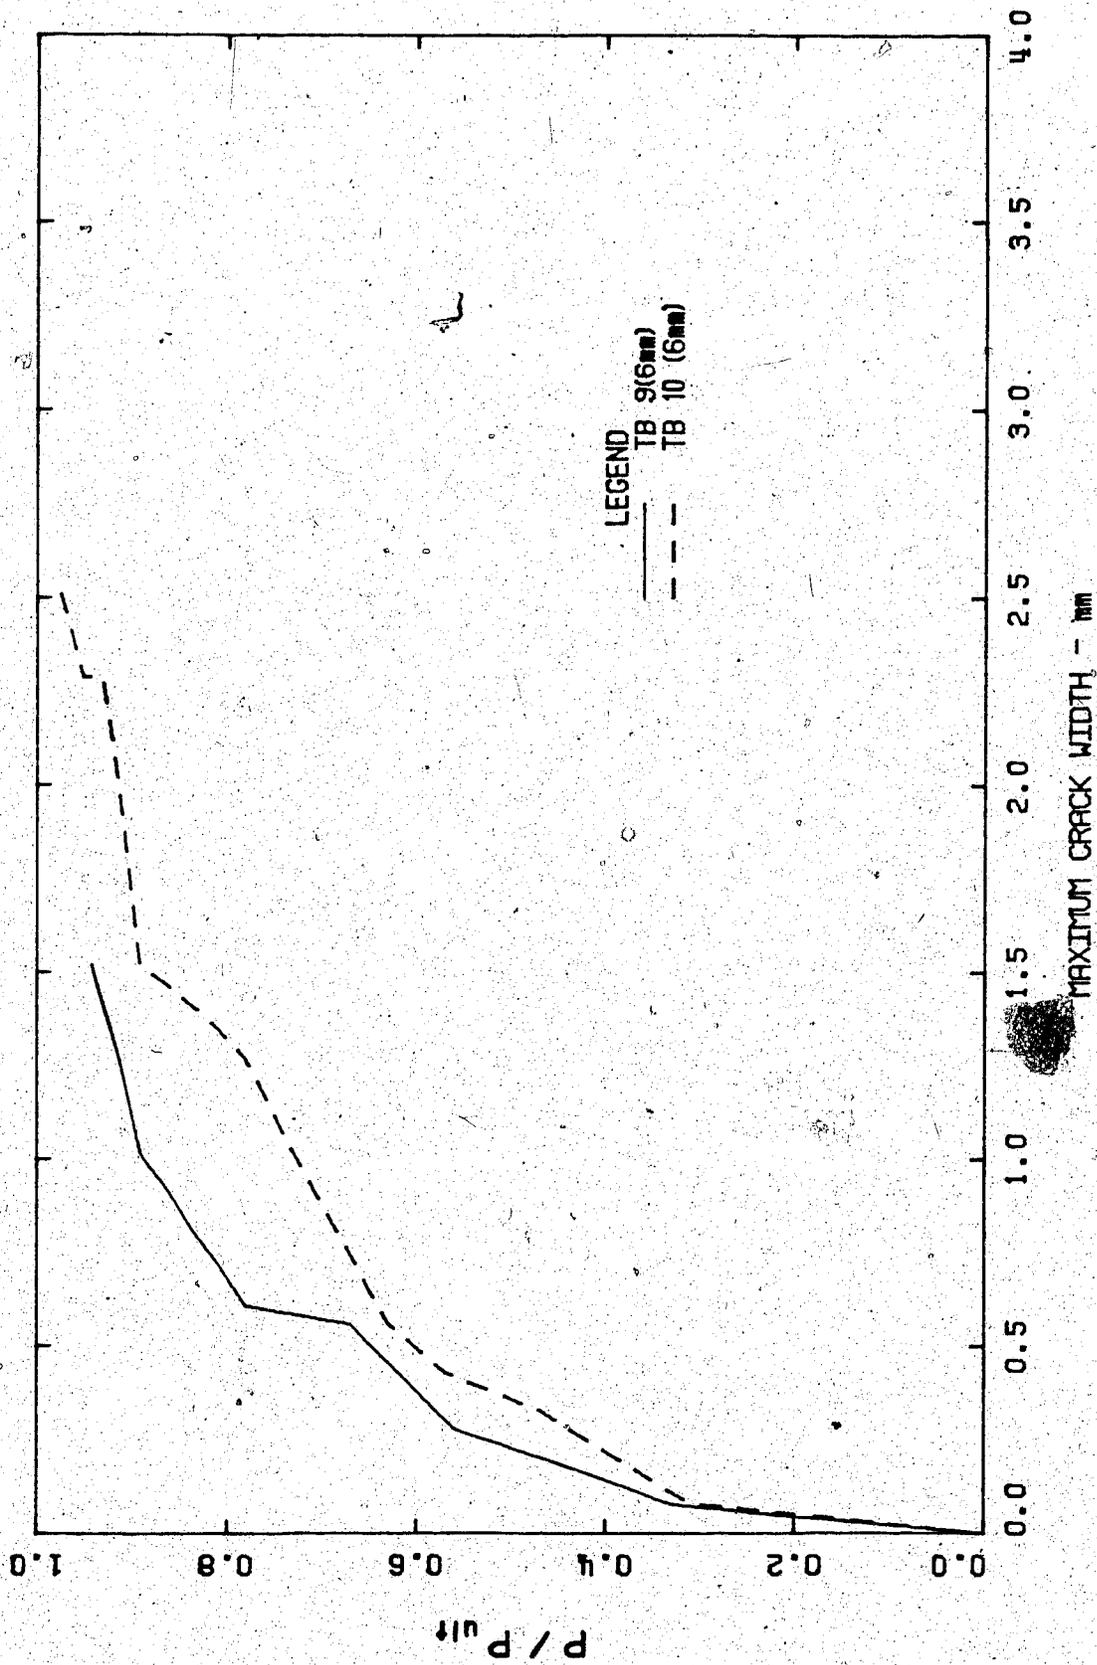
FIGURE 6.37 - Graphs of $\frac{P}{P_{ult}}$ Versus Maximum Crack Width for TB 9 and TB 10

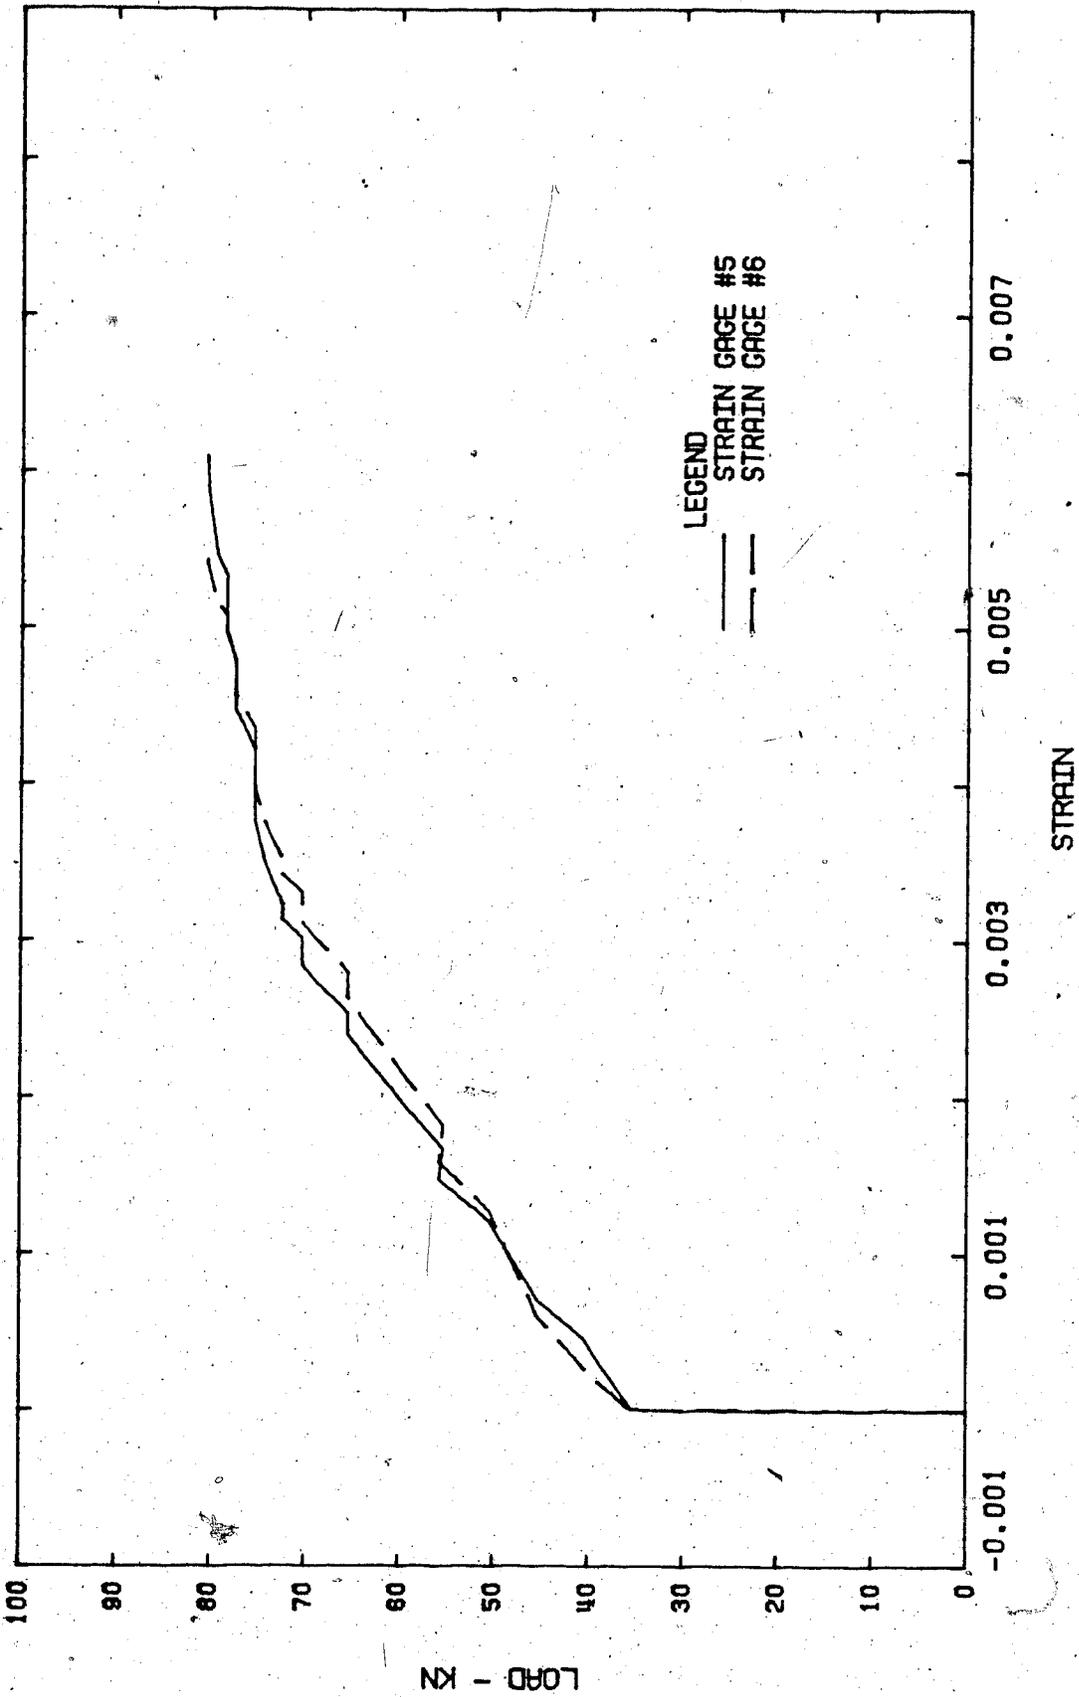
FIGURE 6.38 - Graph of Load Versus Strain for Strain Gauges 5 and 6 from TB 8 Showing Unbonding Between Concrete and Stirrup Wire

Some partial loss of bond was evident in the case of the deformed wire stirrups as discussed in Section 6.1.7. This was not observed in the case of the conventional stirrups. For the conventional stirrups, the strain gauge located closest to the crack generally had the highest reading. This indicated that there was some bond between the concrete and these stirrups.

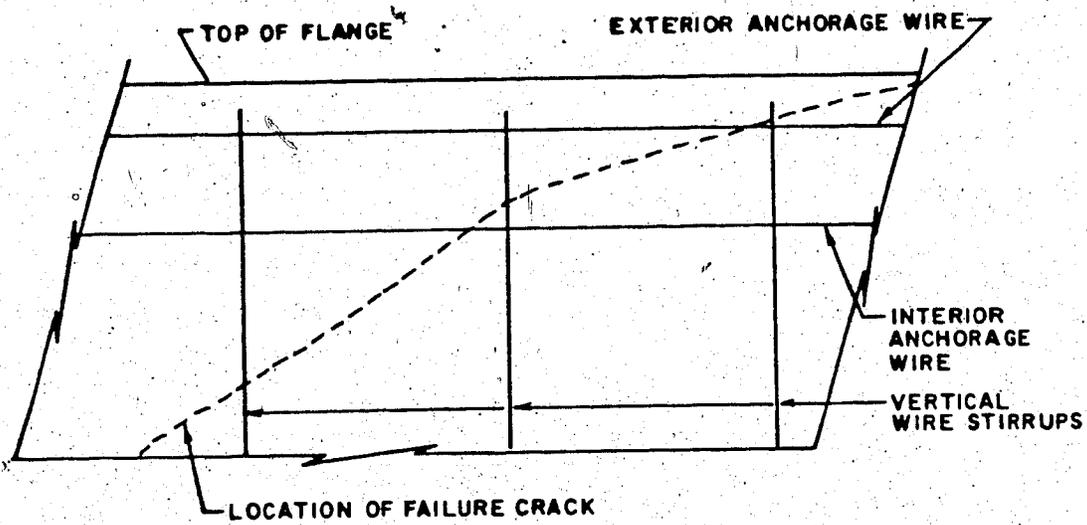
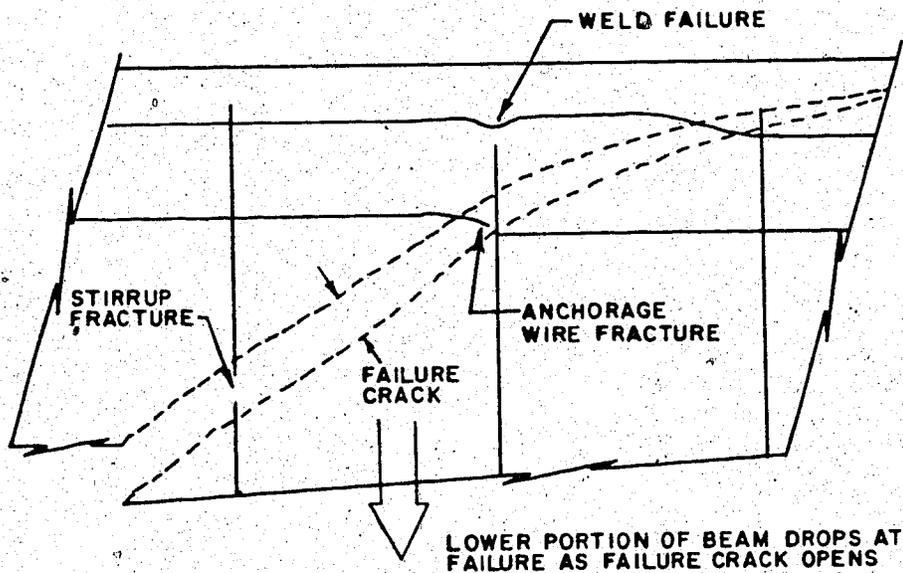
BEFORE BEAM FAILURE LOAD

AFTER BEAM FAILURE LOAD

FIGURE 6.40 - Illustration Showing How the Anchorage Wires at the Top of the Beams were Damaged at the Beam Failure Load

The damage to the anchorages of the wire stirrups resulted either when the weld between the stirrup and the anchorage wire failed, the anchorage wire fractured at the weld, or both of these occurred together. A typical failure case is illustrated in Figure 6.40. The exterior anchorage at the top of the beam was usually damaged when the failure crack crossed the stirrups below this anchorage in the web-to-flange transition. The stirrup remained well anchored below the failure crack so as the crack widened and the segment of the beam below the crack dropped, either the exterior weld or cross-wire or both failed and the stirrup was pulled out of the flange. The exterior anchorage at the bottom of the beam failed in a similar manner. Damage to the anchorage

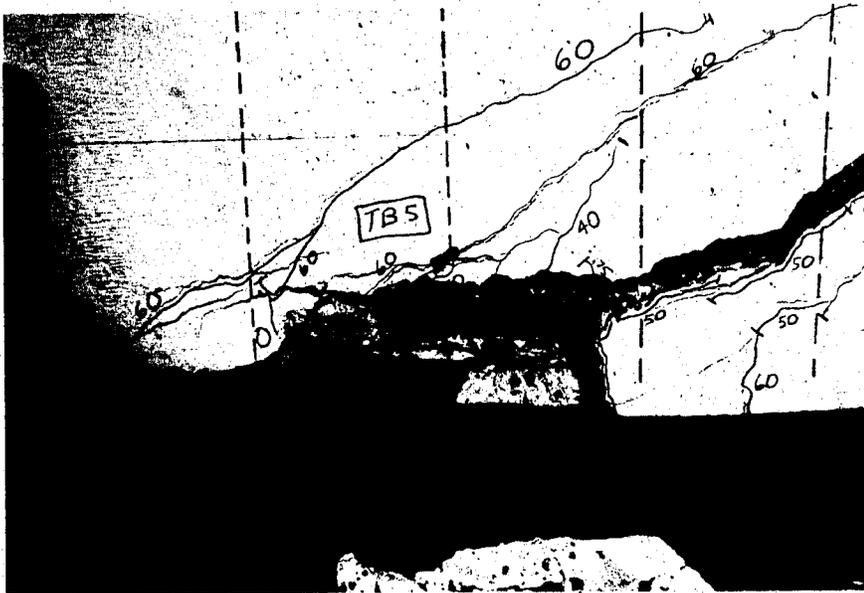
FIGURE 6.41 - Damage to anchorage at bottom of failure crack in TB 5

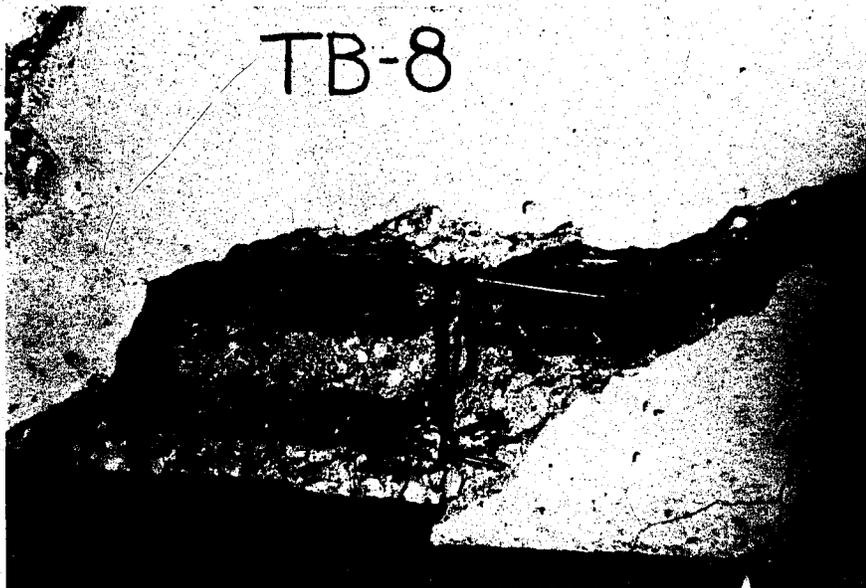
FIGURE 6.42 - Damage to anchorage at bottom of failure crack in TB 8
