**Nanostructured Environmental Barrier Coatings for Corrosion
Resistance in Recovery Boilers**

Shishir Rao

A thesis submitted to the Faculty of Graduate Studies and Research
in partial fulfillment of the requirements for the degree of

Department of Mechanical Engineering

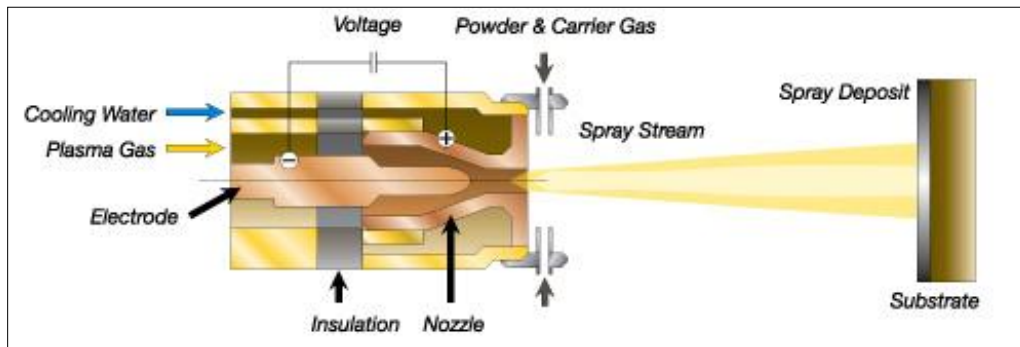
Figure 2: Atmospheric plasma spraying [4].

Plasma gases are used to generate the plasma jet. A primary gas (typically argon or nitrogen) and a secondary gas (helium and/or hydrogen) together constitute the plasma gas. The strong electric arc generated ionizes the process gases into a plasma state. Powder feedstock material is injected into the plasma jet by a carrier gas, melting the powder and accelerating it towards the substrate. The molten powder impacts and spreads on the substrate surface and forms a layer of coating. The spray gun (or torch) is usually mounted on a robot, which is

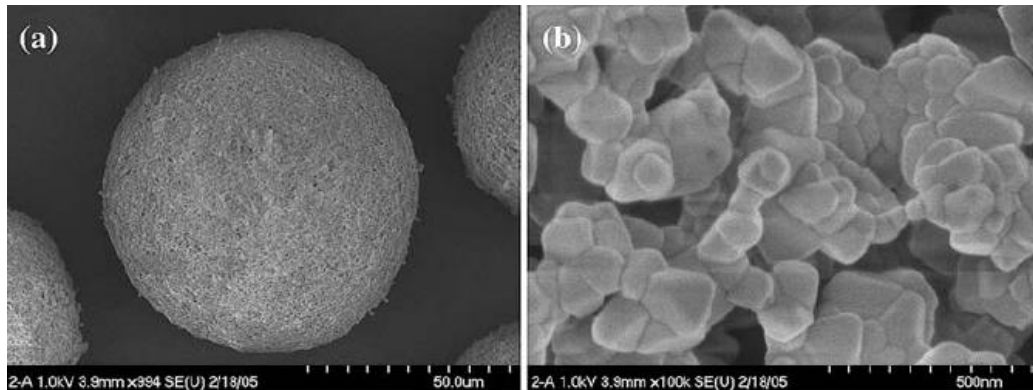
Figure 3: (a) YSZ feedstock particle formed by the agglomeration of individual nano-particles (b) Particle of (a) observed at higher magnification showing individual nano sized YSZ particles. [12]

particles shown in Fig. 3b. While air plasma spraying nanostructured YSZ powder, it is important to control carefully the spray parameters so as not to completely melt the powder and preserve part of the nanostructure of the agglomerates in the coating microstructure.

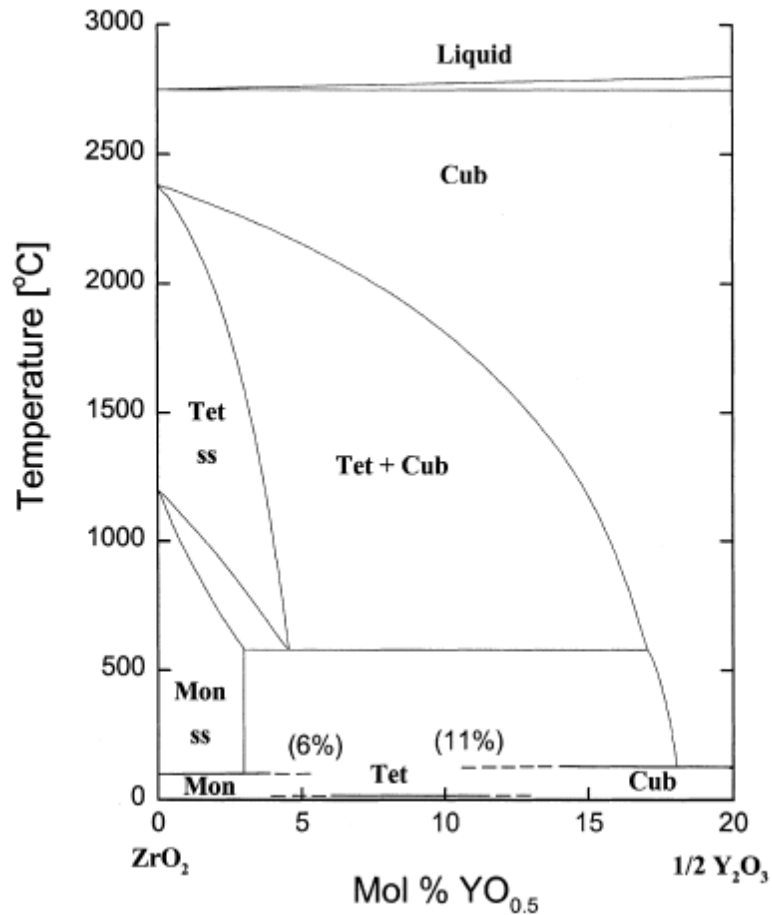
Figure 4: Phase diagram of YSZ [14]

The t' phase does not undergo the martensitic transformation to the monoclinic phase. The transformation between the tetragonal (t) and monoclinic (m) is accompanied by a volume change (approx 3~5 vol%) [17]. This change in volume is detrimental to the integrity of the coating as it causes cracking and may lead to failure of the coating due to the thermal expansion co-efficient mismatch with the substrate. Hence, the t' phase is the most desirable phase in YSZ coatings.

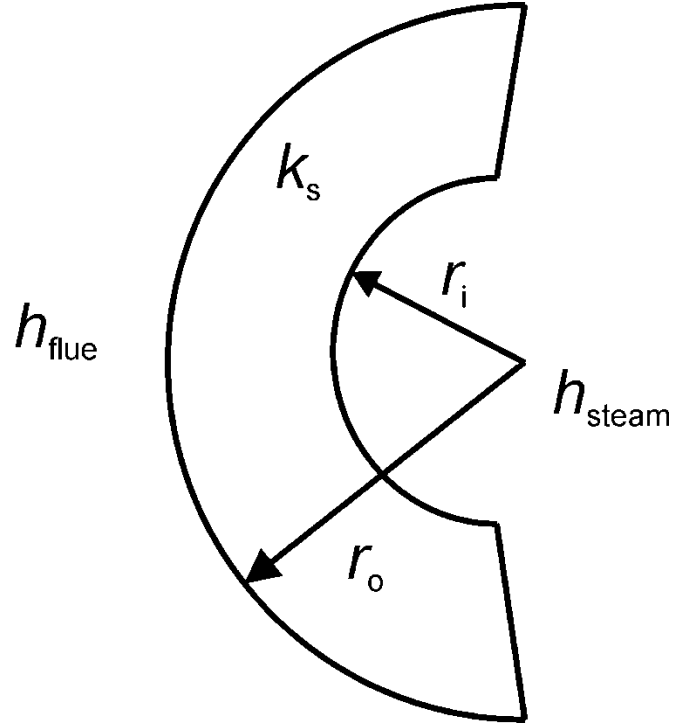
Figure 1: Section of a superheater tube.

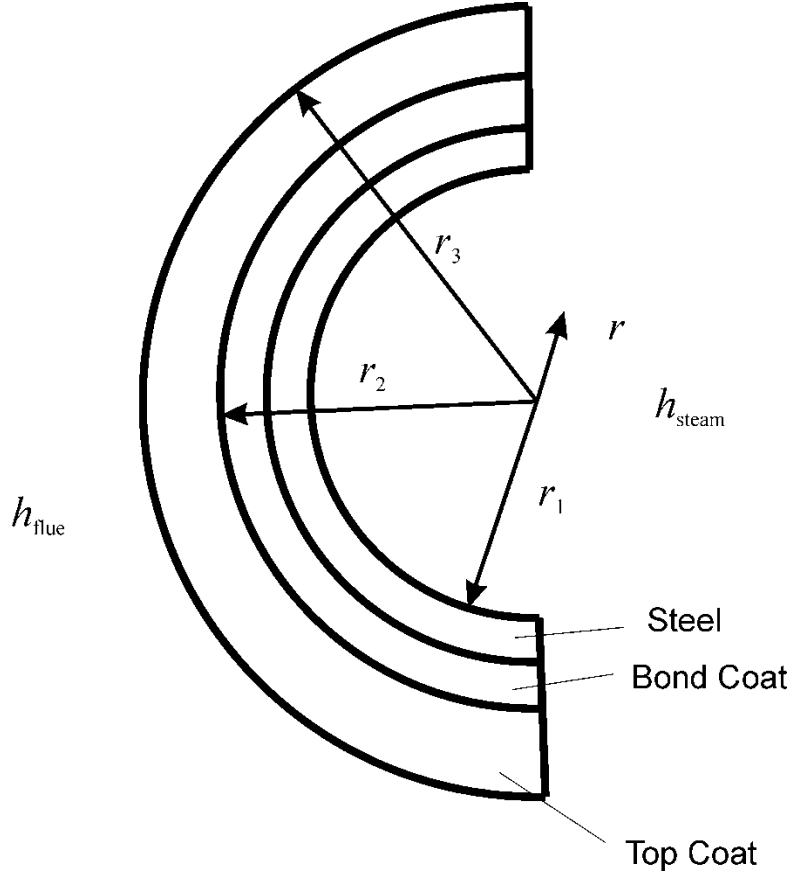
Figure 2: Section of the superheater tube with the thermal barrier coating.

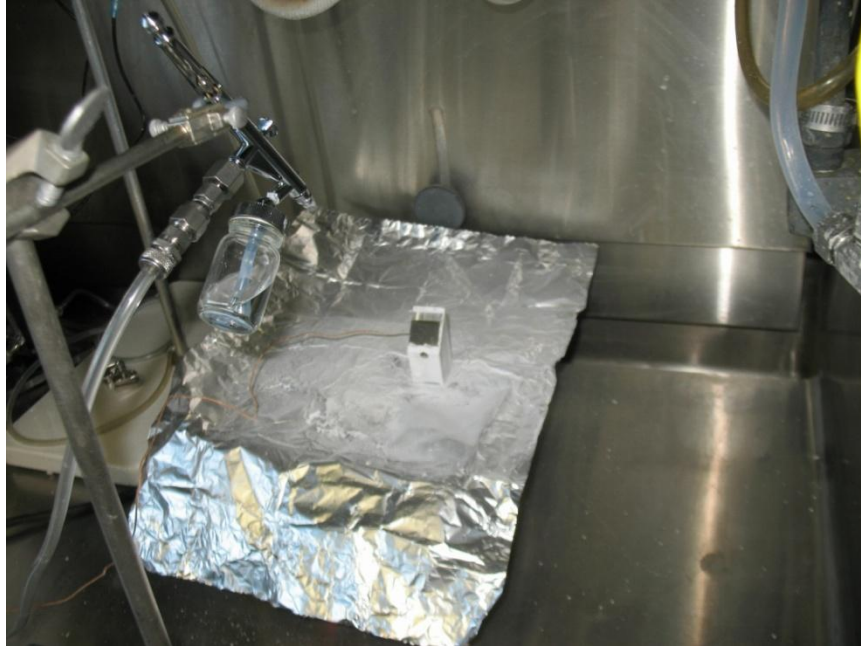
Figure 1: Salt spray apparatus

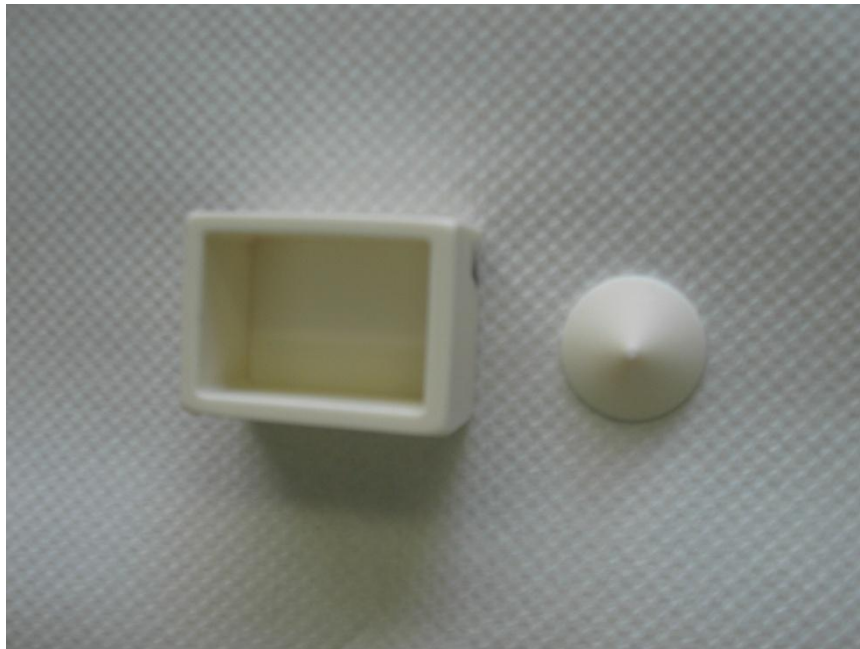
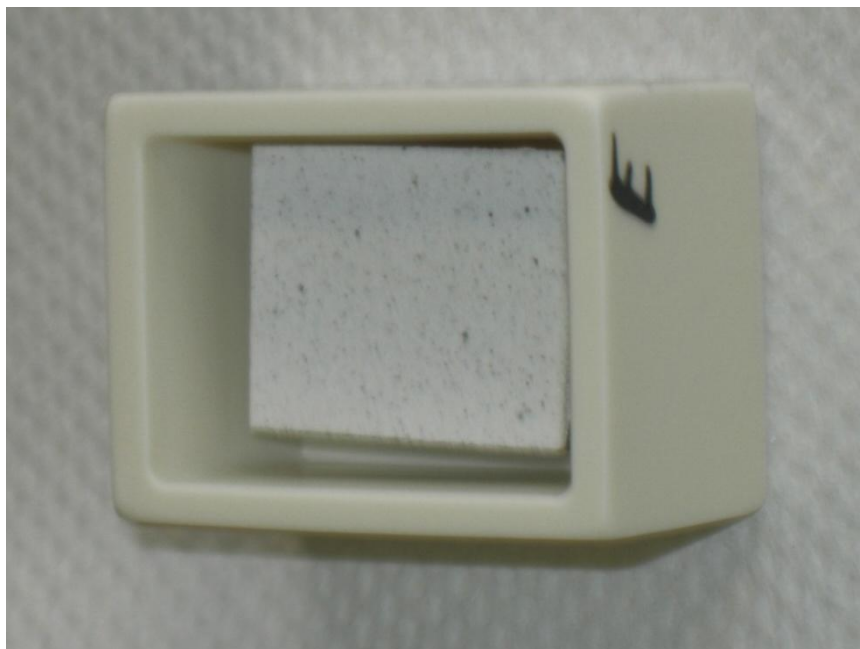
Figure 2: Alumina crucible and stub

Figure 3: Substrate sitting inside crucible

Once the samples were ready to be introduced into the furnace, they were arranged on a stub in an alumina crucible as shown in Figs. 2 and 3. These crucibles were placed on top of a D-shaped alumina support and then inserted into a mullite tube shown in Fig. 4. This mullite tube was then placed inside a 3-zone furnace. The furnace (Lindberg Model 55347, Lindberg/MPH, Riverside, MI, USA) was arranged horizontally as shown in Fig. 5. The samples were heated in the furnace for a continuous period of 76 hours in the presence of air (ISO Standard 85-73-1, Class 2), flowing at a rate of 200 standard cubic centimetres per minute (SCCM).

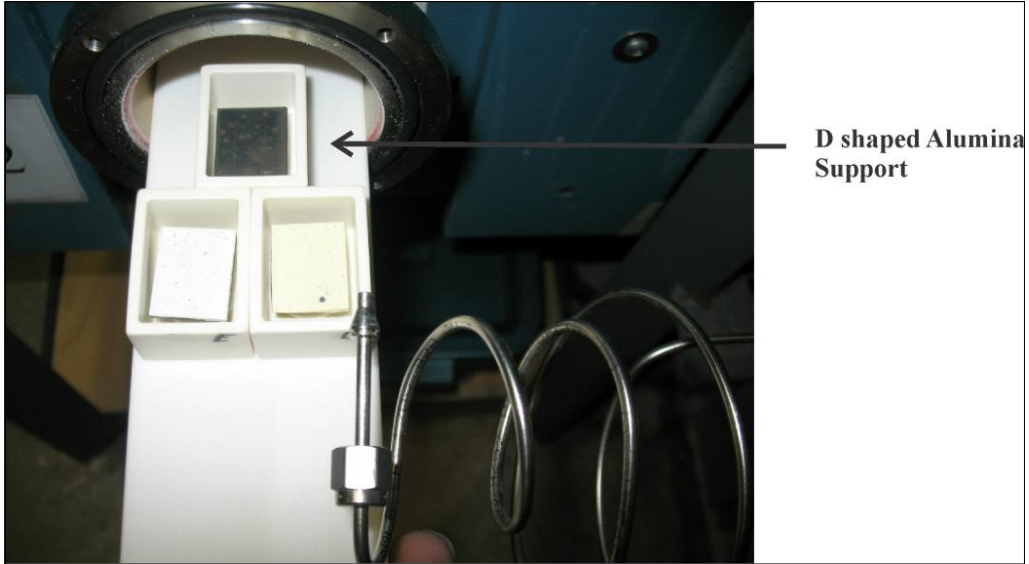
Figure 4: D-shaped alumina support

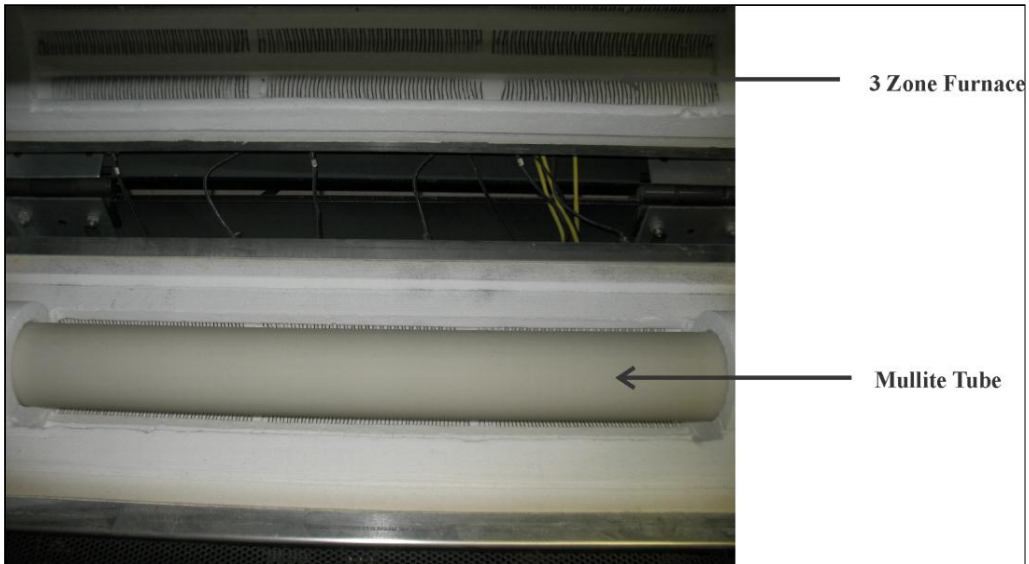
Figure 5: 3 Zone furnace and Mullite tube

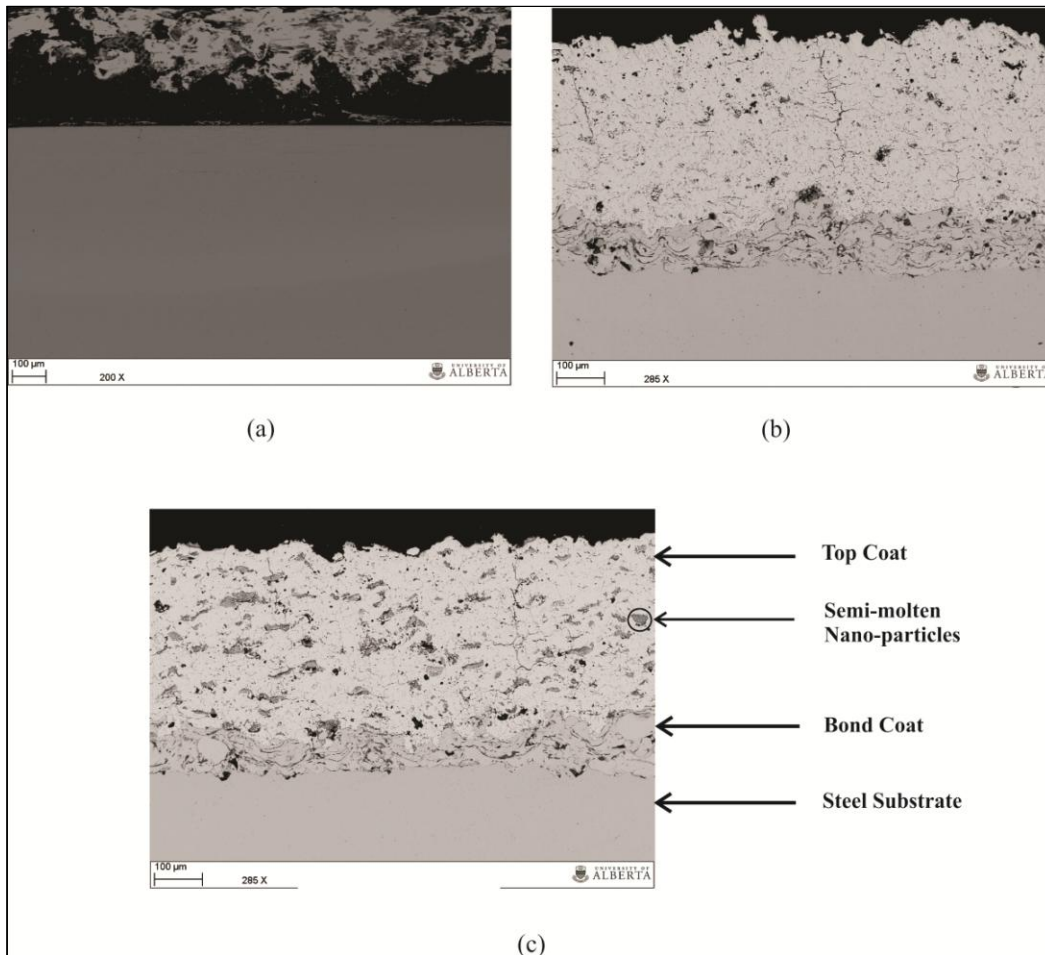
Figure 7: Cross sections of SEM BSE images for the (a) Bare steel (b) Conventional YSZ coating (c) Nanostructured YSZ coating samples from Test A (600°C, 76 hrs, air).

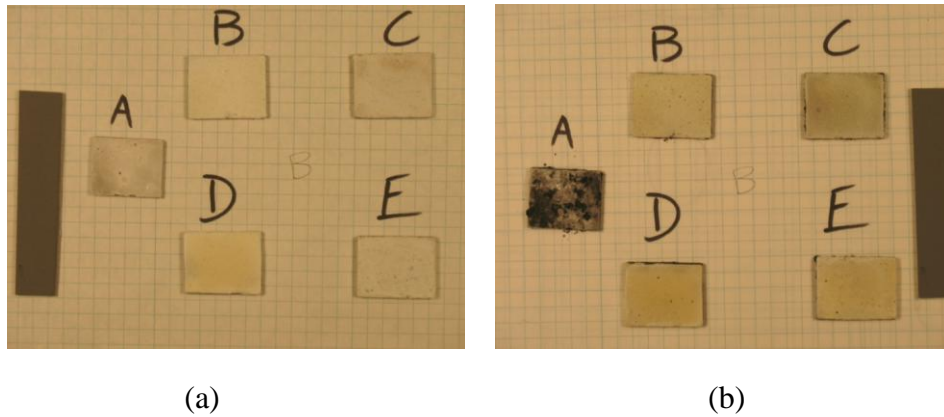
Figure 9: Images of samples from Test B (600°C, 76 hrs, air, NaCl salt) (a) before and (b) after corrosion testing

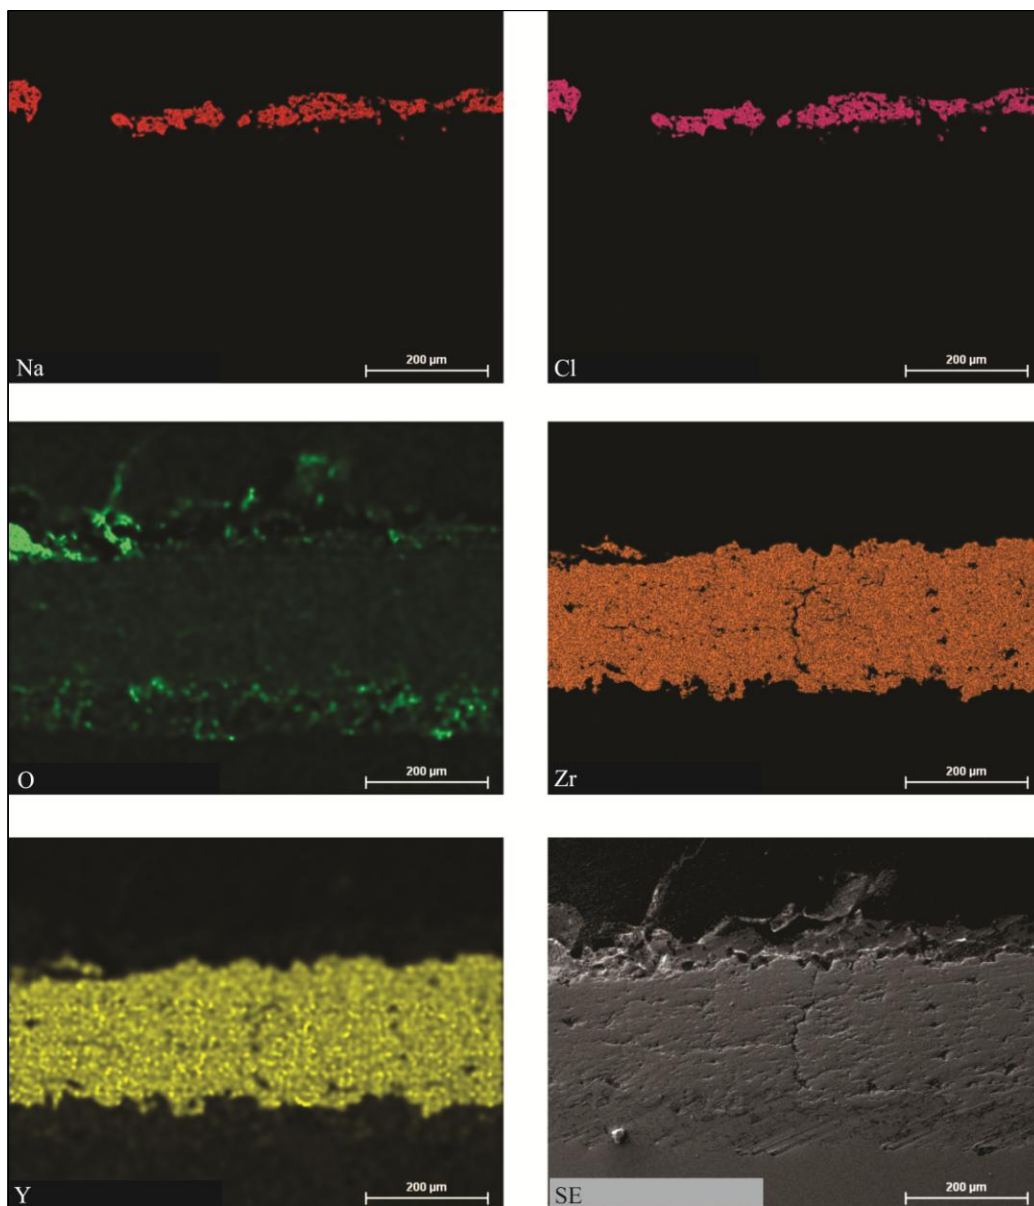
Figure 10: EDS images of conventional YSZ coating sample BD from Test B (600°C, 76 hrs, air, NaCl salt.)

In order to determine if NaCl salt penetrated the YSZ coatings, an elemental mapping was done on the SEM images. EDS (Energy Dispersive Spectroscopy) images of conventional YSZ coating and nanostructured YSZ coating samples are shown in Figs. 10 and 11, respectively. In both these figures, it can be seen that Na and Cl species are concentrated on top of the YSZ layer, indicating that there is no penetration of the salts into the coating. This is also confirmed by observing the line spectrum shown in Fig. 12, for the nanostructured YSZ coating sample BE.

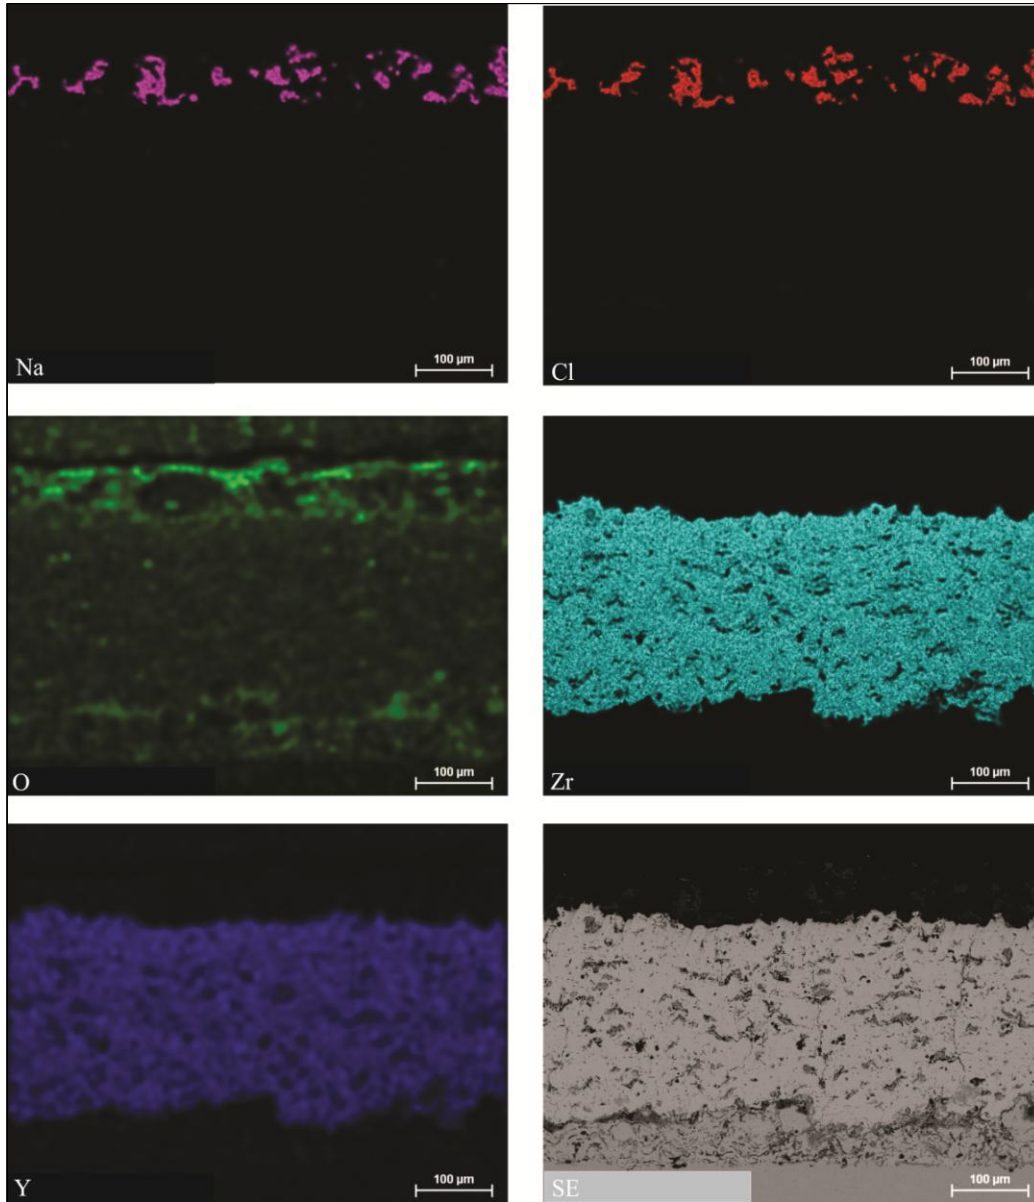
Figure 11: EDS images of nanostructured YSZ coating sample BE from Test B (600°C, 76 hrs, air, NaCl salt.)

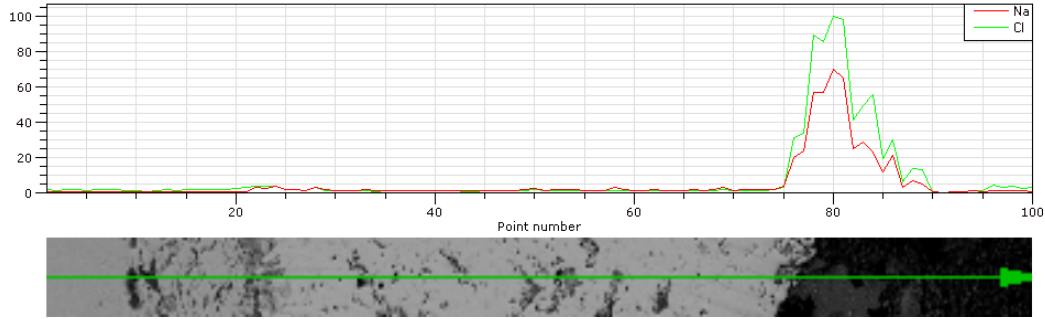
Figure 12: Line spectrum showing NaCl concentration on top of YSZ layer.

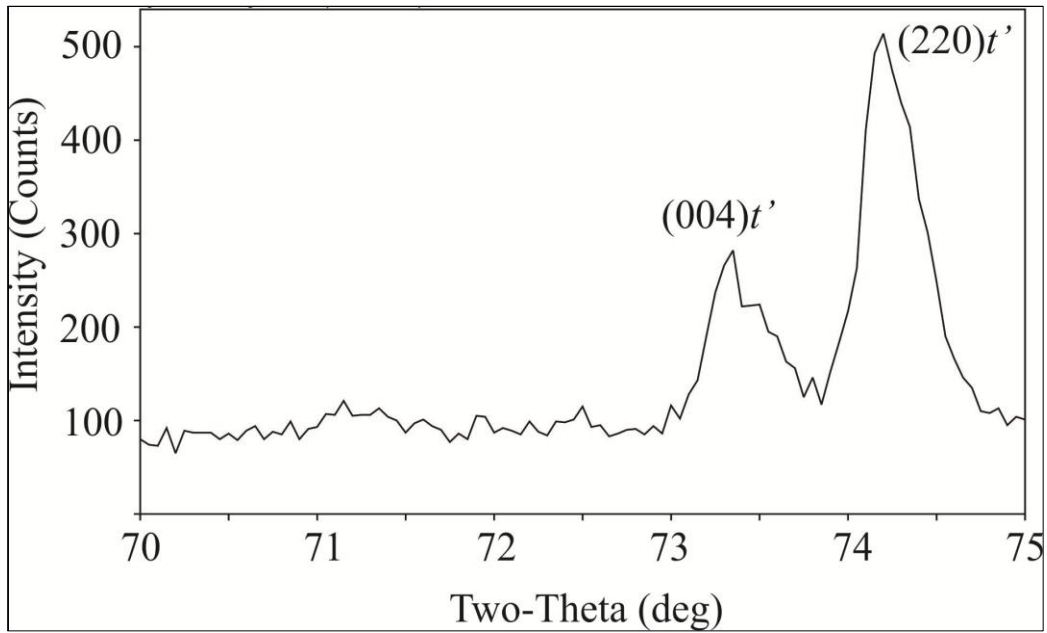
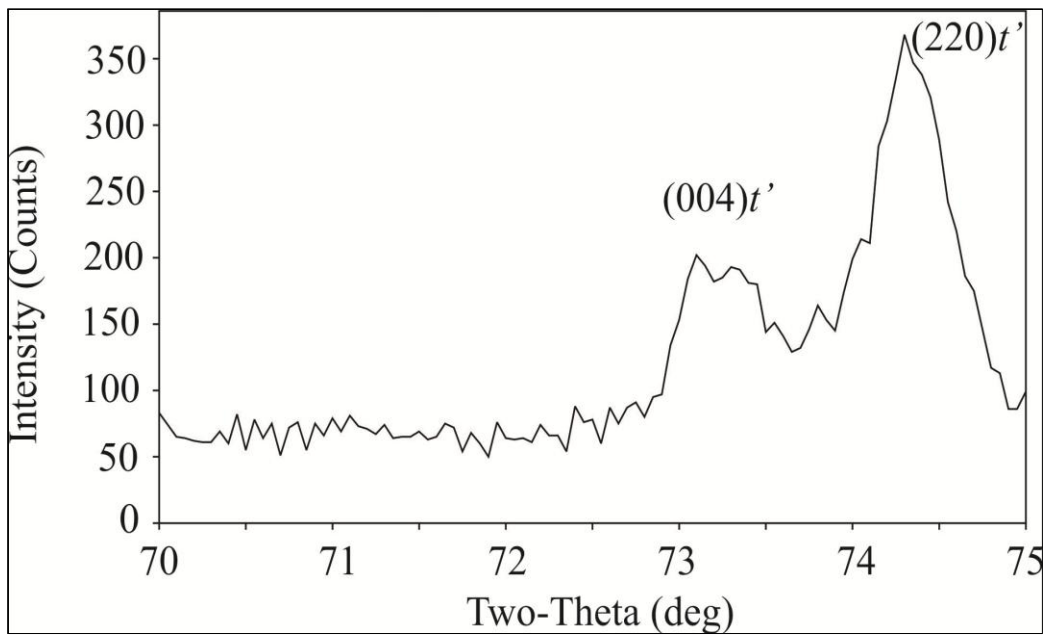
Figure 13: XRD pattern of (a) conventional (b) nano-structured YSZ powder

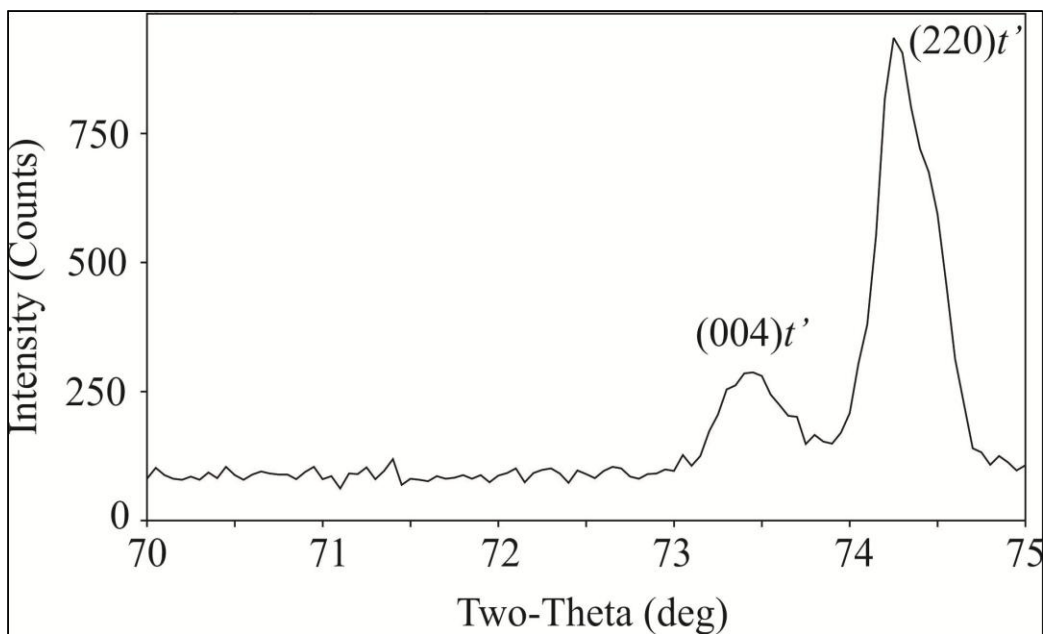
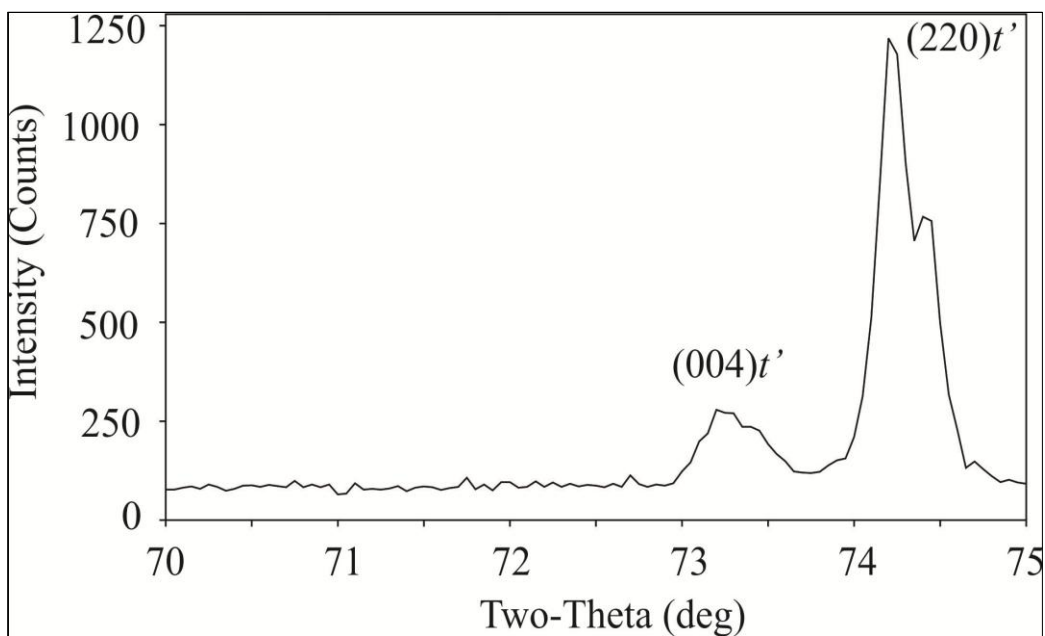
Figure 14: XRD pattern of as-sprayed (a) conventional (b) nano-structured YSZ coatings

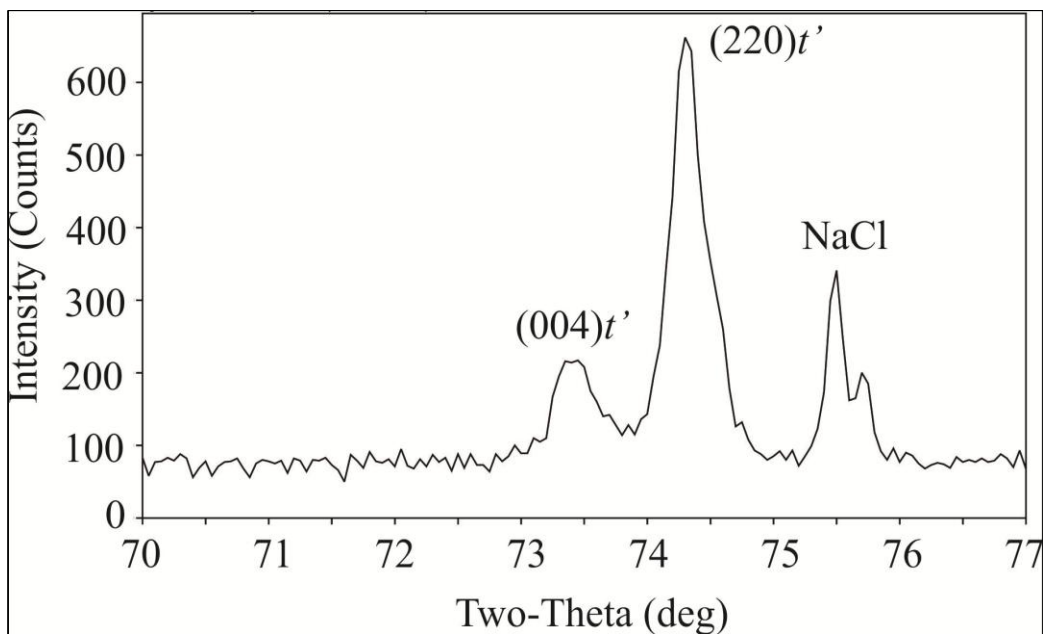
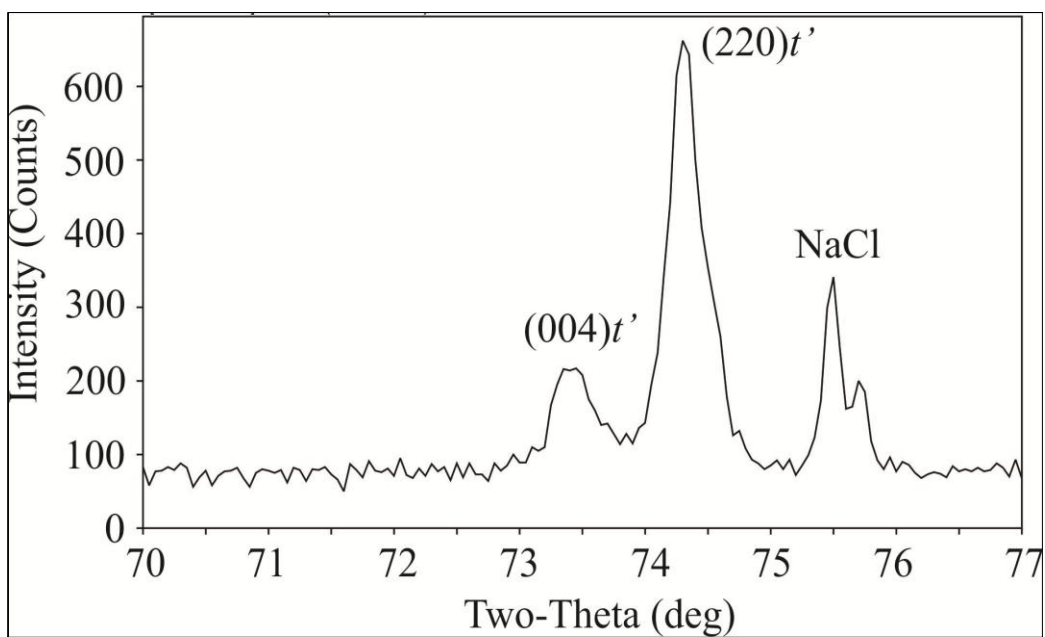
Figure 15: XRD pattern of samples (a) BB (conventional YSZ) (b) BE (nanostructured YSZ) from Test B (600°C, 76 hrs, air, NaCl salt).

Metastable tetragonal phase (t' -phase) is the most desirable phase for the integrity of YSZ plasma-sprayed coatings [3]. A detailed discussion about this non transformable tetragonal phase has been provided in Chapter 1. The metastable tetragonal phase is identified by analysing the 72° to 75° region of the 2θ coordinate on the XRD pattern of YSZ. Figure 13 shows this region of the XRD pattern for the conventional YSZ powder and nanostructured YSZ powder, while Fig. 14 shows the same for as sprayed conventional and nanostructured YSZ coatings. The two peaks in this region can be associated with the metastable t' phase [3,4]. It is possible to see that the t' phase, which is present in the powders, has been retained in the as-sprayed coatings. XRD patterns of the YSZ samples used in test B are shown in Fig. 15. These patterns also showed the same peaks, indicating that the metastable phase was retained. This was expected since the exposure temperature was not high enough for the decomposition of the t' phase to the equilibrium t and c phases. Figure 15 shows the diffraction pattern for sample BB (conventional YSZ coating) and sample BE (nano-structured YSZ coating). NaCl peak can be clearly seen in the XRD patterns.

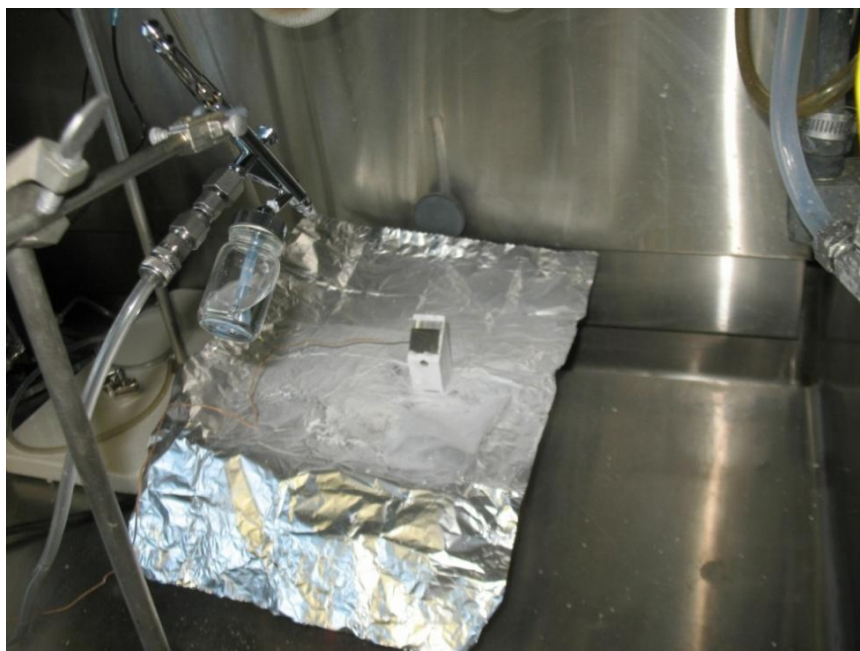
Figure 1: Salt spray apparatus

an artist's air brush (Iwata HP-BC 1 Plus, Iwata Medea, Inc., Portland, OR, USA). The air pressure used was 20 psig and the stand-off distance – the distance between the brush and the sample – was fixed at 190 mm. The apparatus is shown in Fig. 1. While the solution was being sprayed, the substrates were maintained at a temperature around 130°C. This allowed the water from the solution to evaporate immediately, leaving a layer of solid salt on the coated sample. A jig was manufactured in order to keep the substrate perpendicular to the axis of the air brush. The salt was scraped off from the test sample and sent for a differential thermal analysis (DTA). The DTA analysis confirmed that the salt had a single first melting point of around 520°C. The first melting point is the temperature at which the material first begins to melt and below which there is no liquid phase in the salt [5].

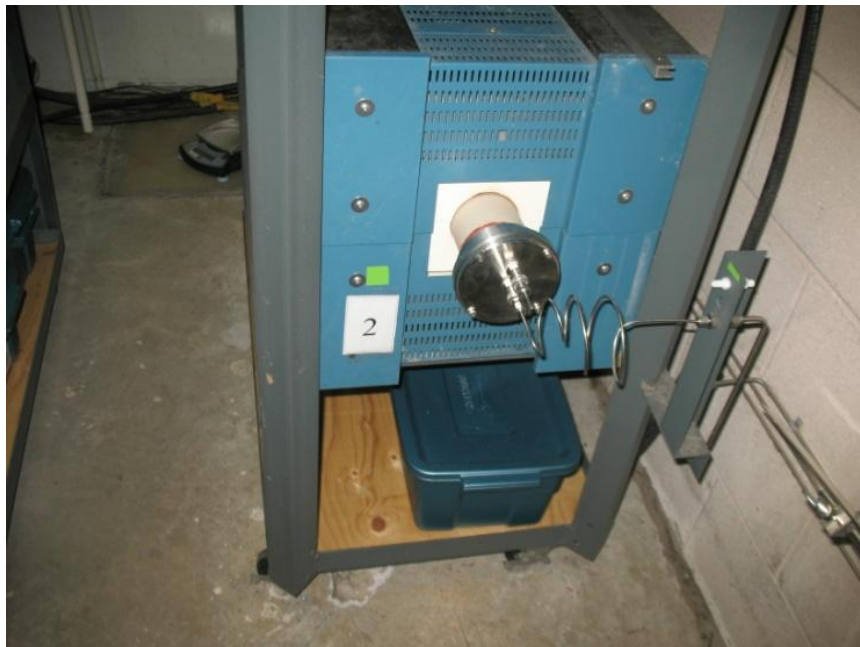
Figure 2: Front end of horizontal furnace.

All three tests were conducted simultaneously in three different horizontal furnaces (Lindberg Model 55347, Lindberg/MPH, Riverside, MI, USA) maintained at 600°C . Figure 2 shows one end of the horizontal furnace. All samples were arranged on a stub in an alumina crucible as shown in Figs. 3 and 4.

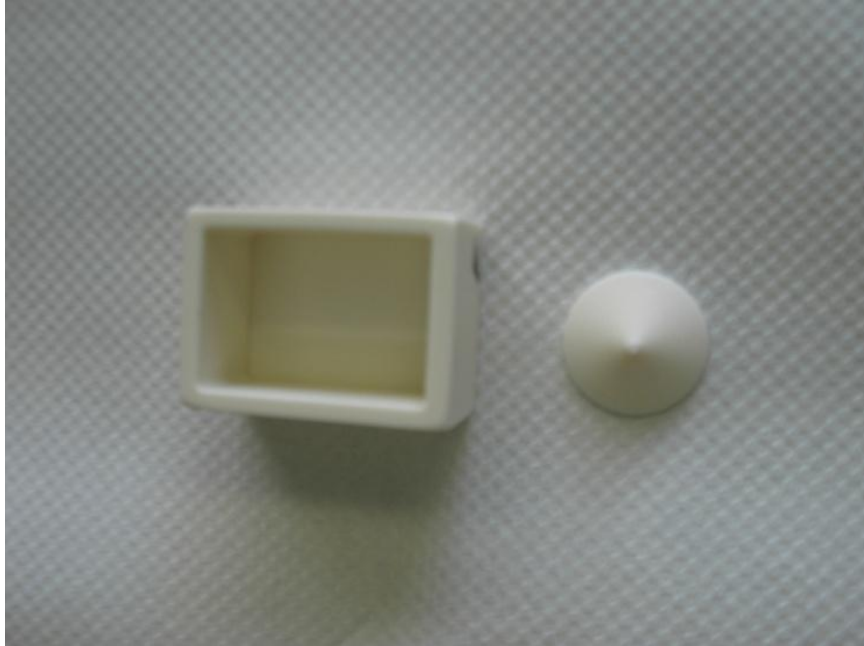
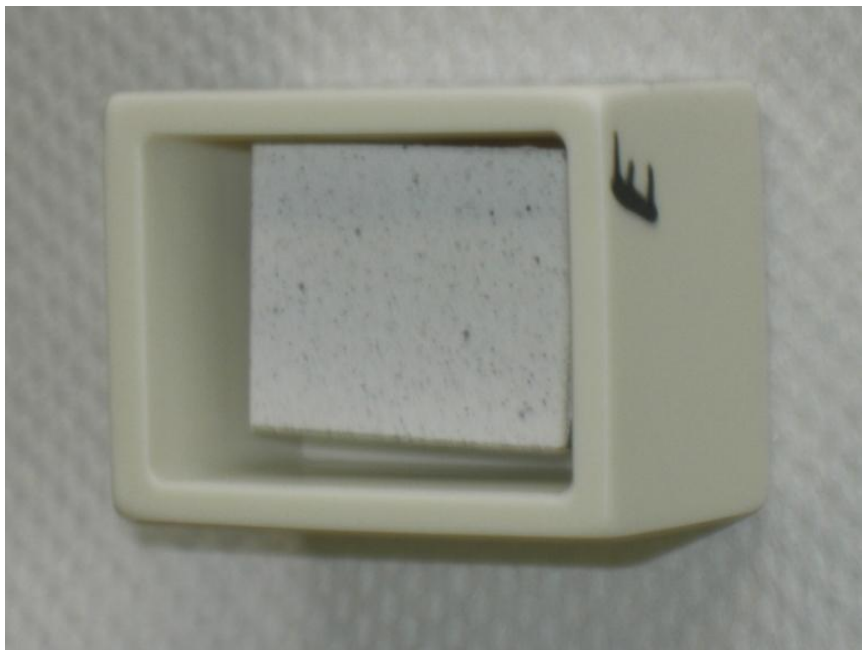
Figure 3: Alumina crucible and stub

Figure 4: Substrate sitting inside crucible

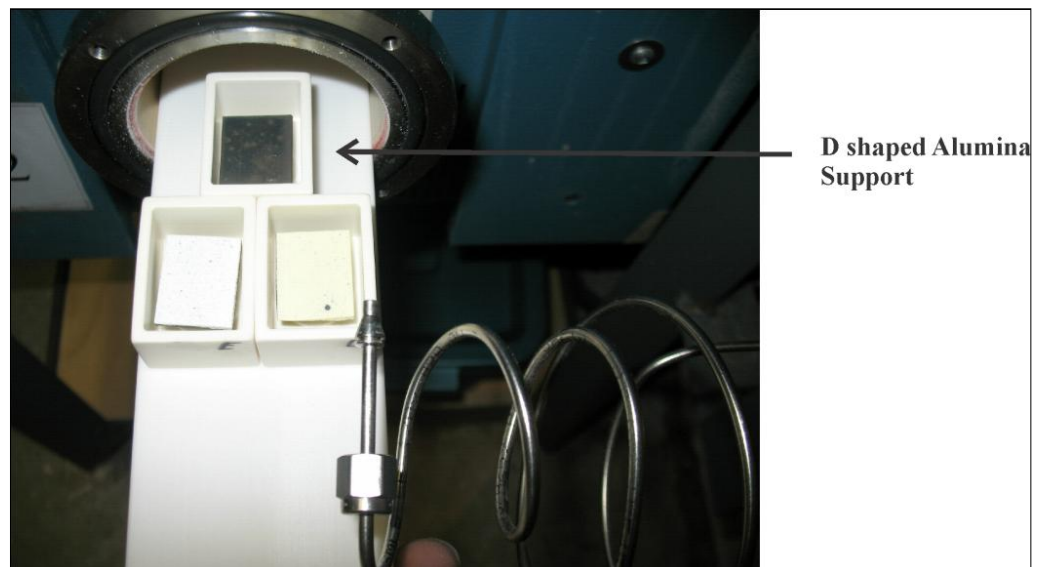
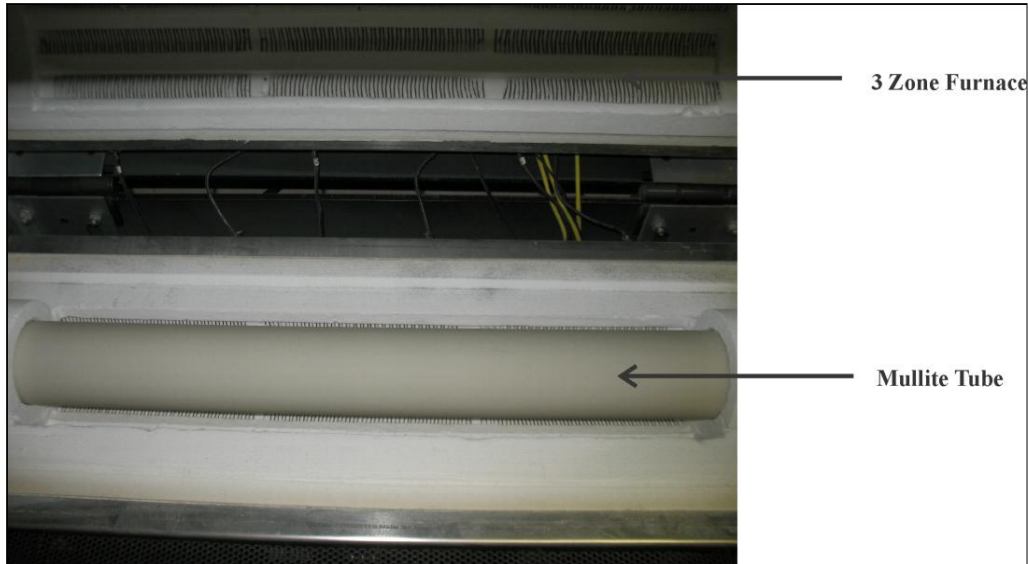
Figure 5: D-shaped alumina support

Figure 6: 3 Zone furnace and Mullite tube

These crucibles were placed on top of a D-shaped alumina support and then inserted into a 48 inch mullite tube shown in Fig. 5. This mullite tube was then placed in the 3-zone furnace as shown in Fig. 6. The ID of the mullite tube used was 72 mm. All furnaces were arranged horizontally. Figure 6 shows the 3 zones inside the furnace. At the furnace controller, the input was fed in such a way that a 12 inch section at the centre of the mullite tube was maintained at $600 \pm 3^{\circ}\text{C}$. The input to the furnace controller consisted of 3 different parameters corresponding to the 3 zones inside the furnace. These 3 parameters In, Centre and Out. The desired furnace temperature was specified to the central zone. Variation from this temperature was fed into the In and Out parameters. For example, suppose the input parameters to the furnace controller were as follows:

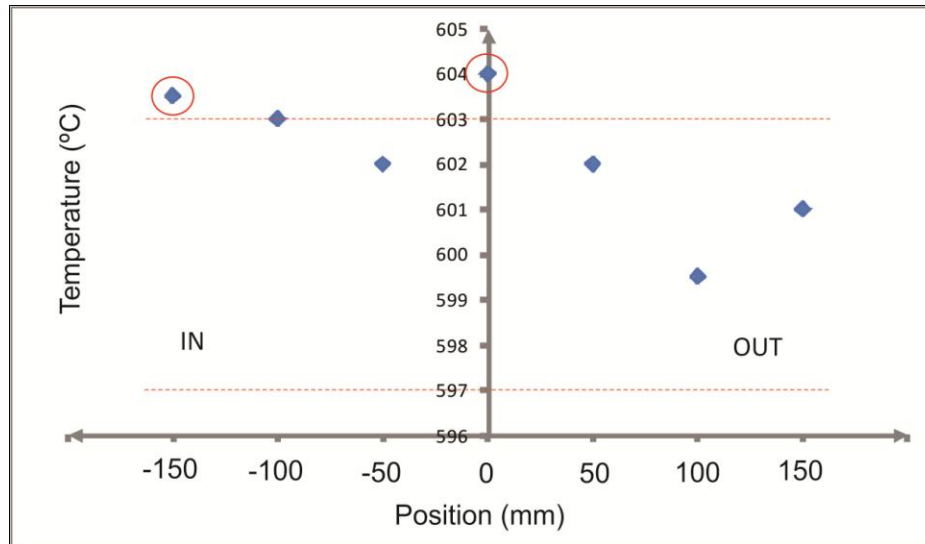
Figure 7: Furnace tuning data.

In: + 2.3 Centre: 598 Out: +2.3

By giving the above input, the central zone tried to maintain the temperature at 598 °C while the inner zone (gases entering) was maintained at $598 + 2.3 = 600.3^{\circ}\text{C}$ and the outer zone (gases leaving) was maintained at $598 + 2.3 = 600.3^{\circ}\text{C}$. With these settings, we measured the temperature every 2 inches (50.8mm) across the centre for the entire 12 inches (304.8 mm) of the furnace and documented it as shown in Fig. 7. From this figure, we found that the temperatures at the centre and at the -6 (152.4 mm) positions were greater than the targeted $\pm 3^{\circ}\text{C}$ variation from 600°C (data circled in red). Hence, we changed our input parameters until the targeted $600 \pm 3^{\circ}\text{C}$ temperature range was achieved.

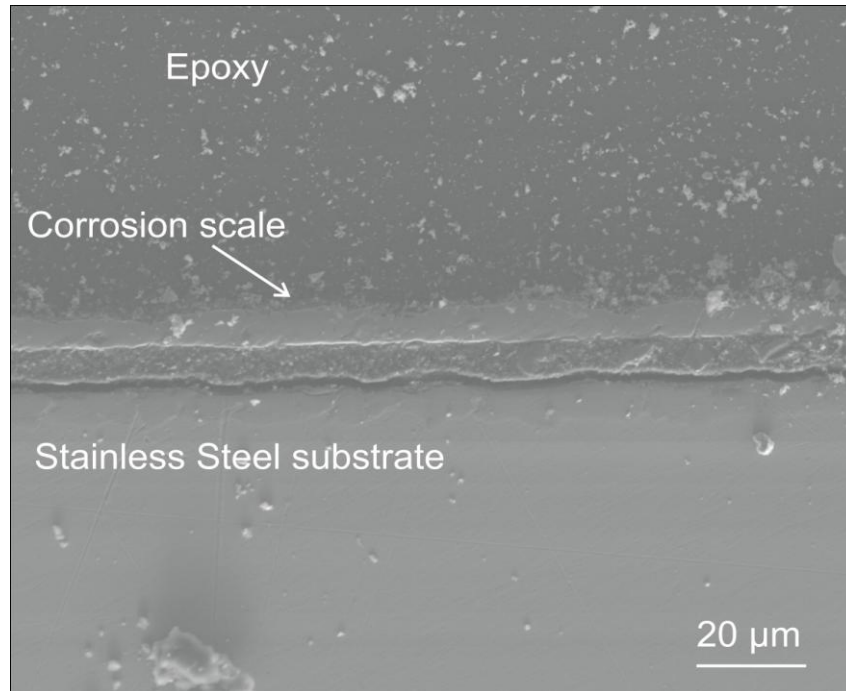
Figure 8: SEM image of cross section of Type 309 steel

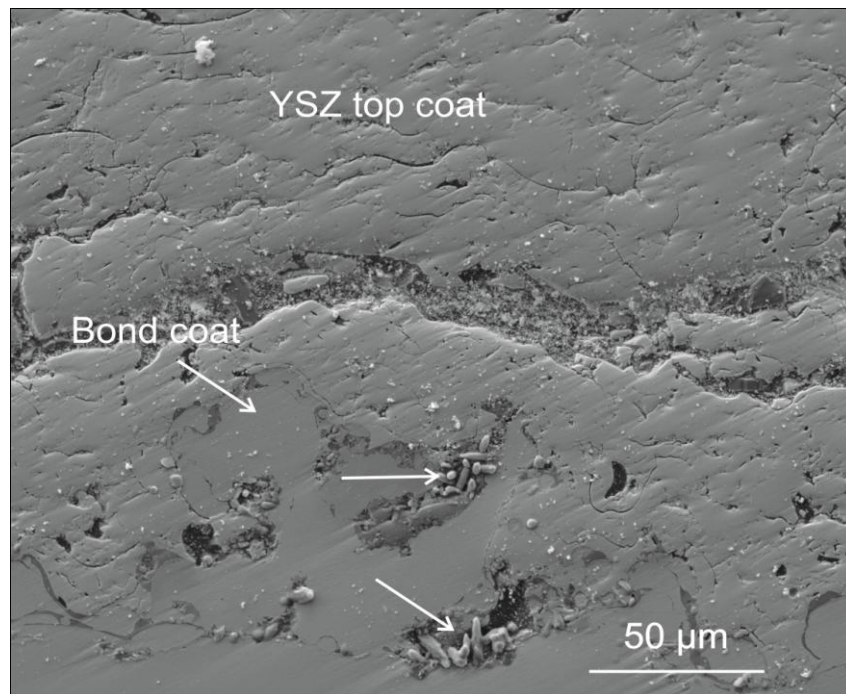
Figure 9(a): SEM image of cross section of conventional YSZ top coating. Arrows point to salt crystals.

This test involved exposing the coupons to flue gases and salt vapors, only. Hence, the coupons were not sprayed manually with a salt solution. Salt vapors in this case were contaminants originating from other test samples. Figure 8 shows an SEM image of the cross section of Type 309 steel used in this test. It can be clearly seen that the corrosion scale has spalled off the bare steel sample. Figure 9a shows an SEM image of the cross section of the conventional YSZ-based EBC. Salt crystals, shown by white arrows, can be seen in the bond coat of this coating. This is confirmed by the EDS spectrum presented in Fig. 9b. The EDS spectrum shows the presence of elements such as Na and K, which were present in the corroding salt. Cross-sectional images of the nano-based YSZ EBC coating used in this test are shown in Fig. 10. No salt crystals were found in the cross section of the nano-based EBC coatings.

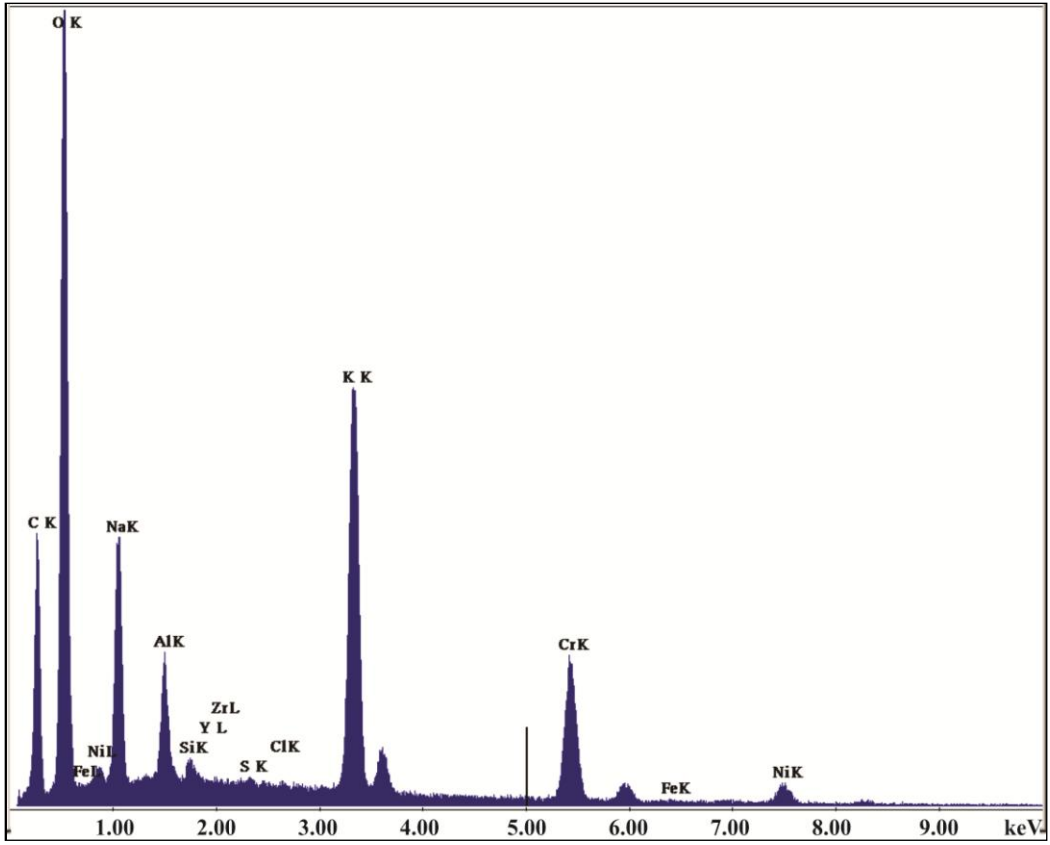
Figure 9(b): EDS spectrum of crystals in the conventional YSZ top coat
