**Nanostructured Environmental Barrier Coatings for Corrosion
Resistance in Recovery Boilers**

Shishir Rao

A thesis submitted to the Faculty of Graduate Studies and Research
in partial fulfillment of the requirements for the degree of

Department of Mechanical Engineering

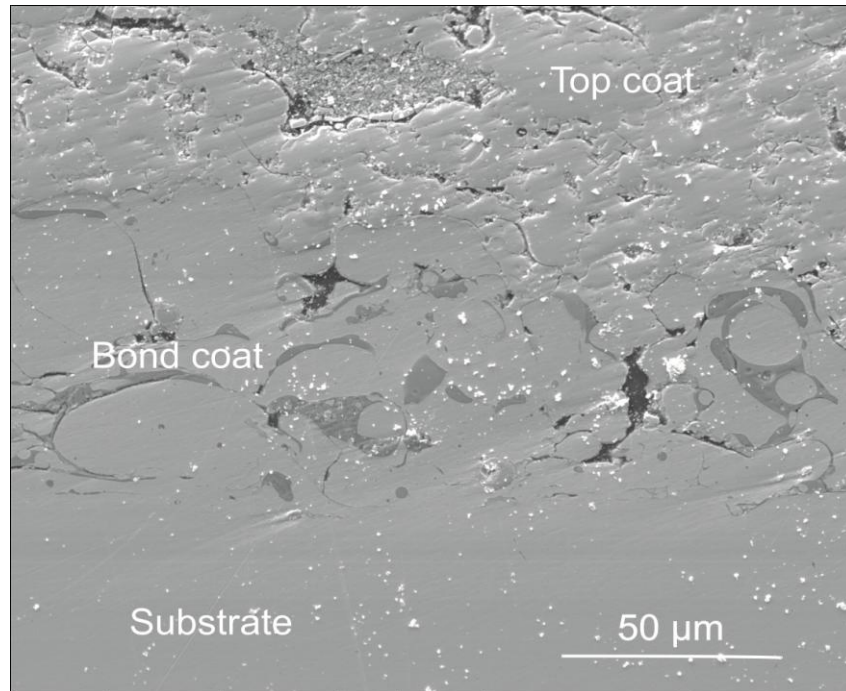
Figure 10: SEM image of cross section of nanostructured YSZ coating

This test involved exposing the coupons to flue gases and salt vapors, only. Hence, the coupons were not sprayed manually with a salt solution. Salt vapors in this case were contaminants originating from other test samples. Figure 8 shows an SEM image of the cross section of Type 309 steel used in this test. It can be clearly seen that the corrosion scale has spalled off the bare steel sample. Figure 9a shows an SEM image of the cross section of the conventional YSZ-based EBC. Salt crystals, shown by white arrows, can be seen in the bond coat of this coating. This is confirmed by the EDS spectrum presented in Fig. 9b. The EDS spectrum shows the presence of elements such as Na and K, which were present in the corroding salt. Cross-sectional images of the nano-based YSZ EBC coating used in this test are shown in Fig. 10. No salt crystals were found in the cross section of the nano-based EBC coatings.

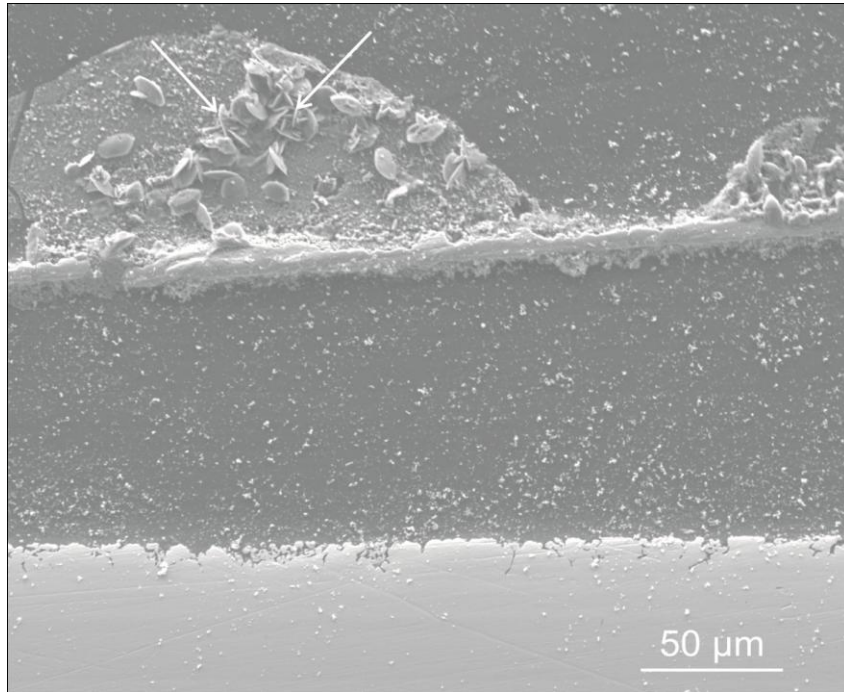
Figure 11: SEM image of cross section of Type 309 steel. Arrows point to salt crystals.

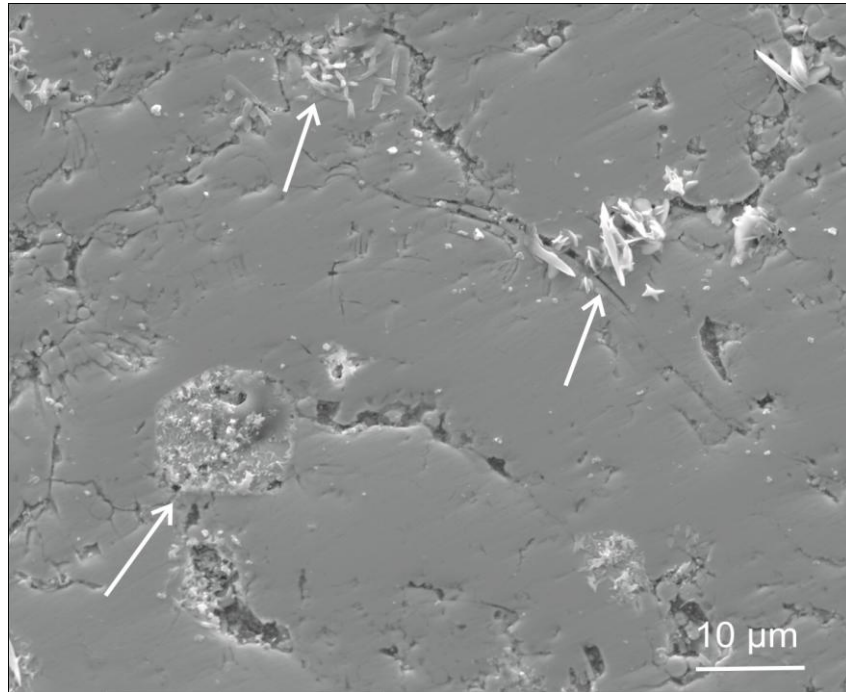
Figure 12(a): Salt crystals oozing out of cracks of conventional YSZ coating. Arrows point to salt crystals.

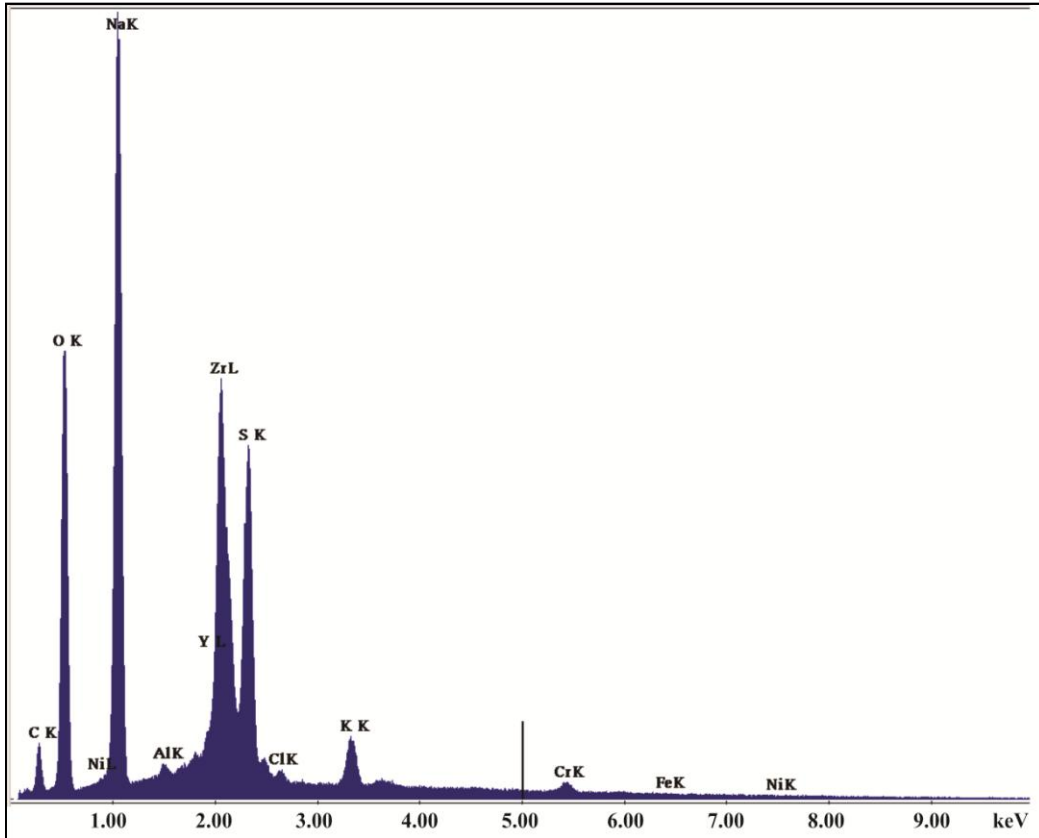
Figure 12(b): EDS spectrum of salt crystals in the conventional YSZ top coat

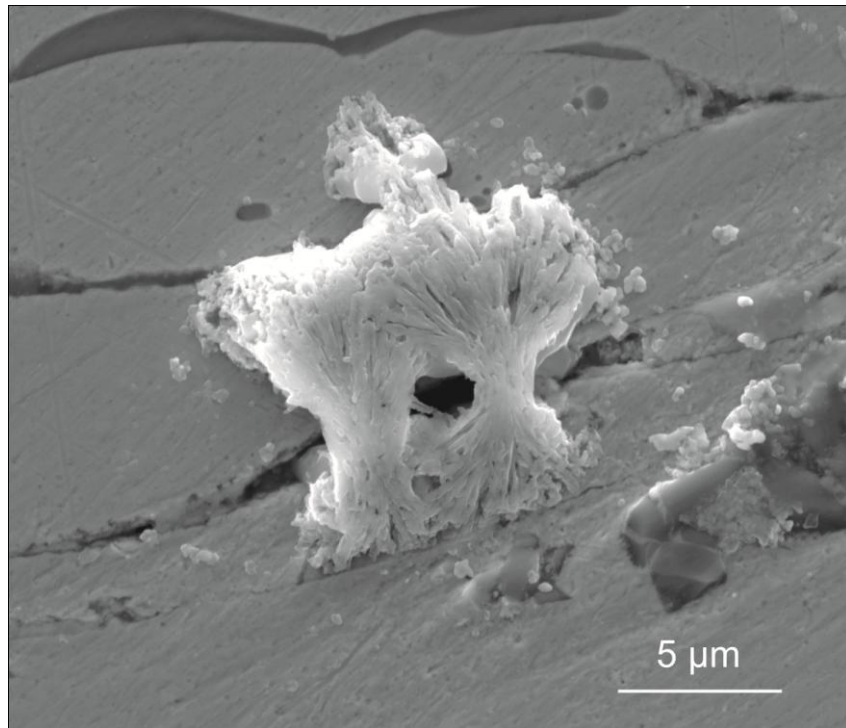
Figure 12(c): Salt crystal at the interface of bond coat and substrate of conventional YSZ coating

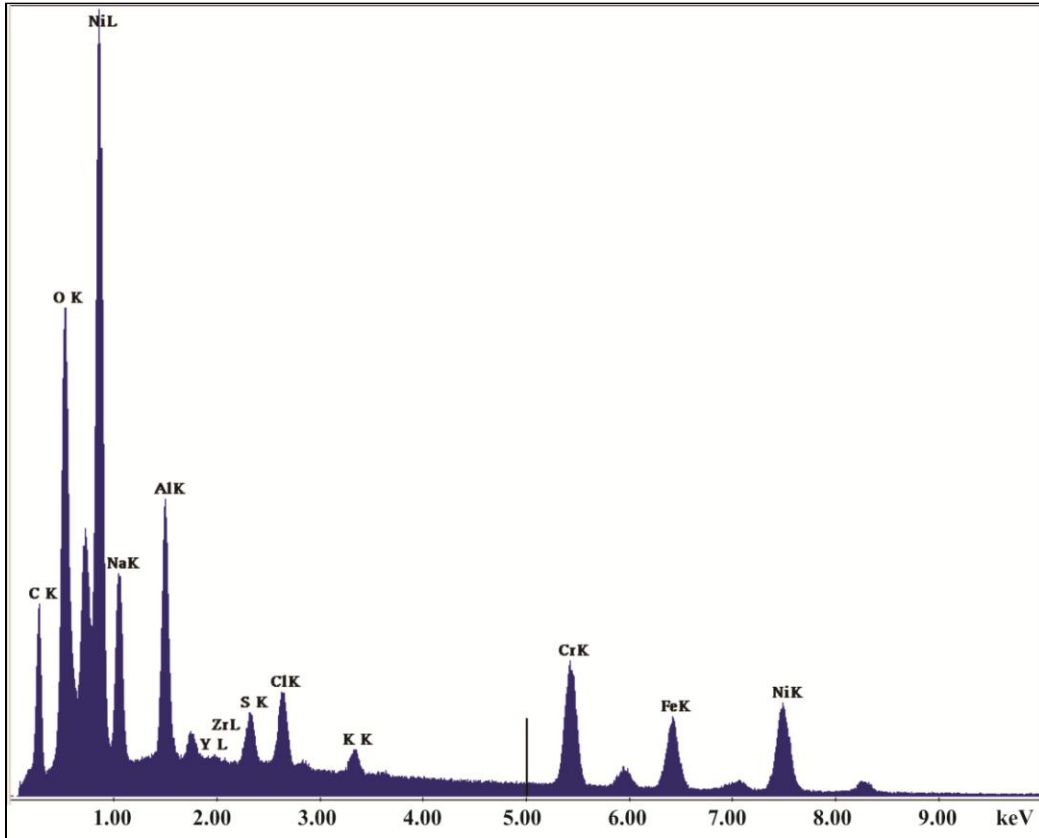
Figure 12(d): EDS spectrum of conventional YSZ top coat SEM image shown in Fig. 12c.

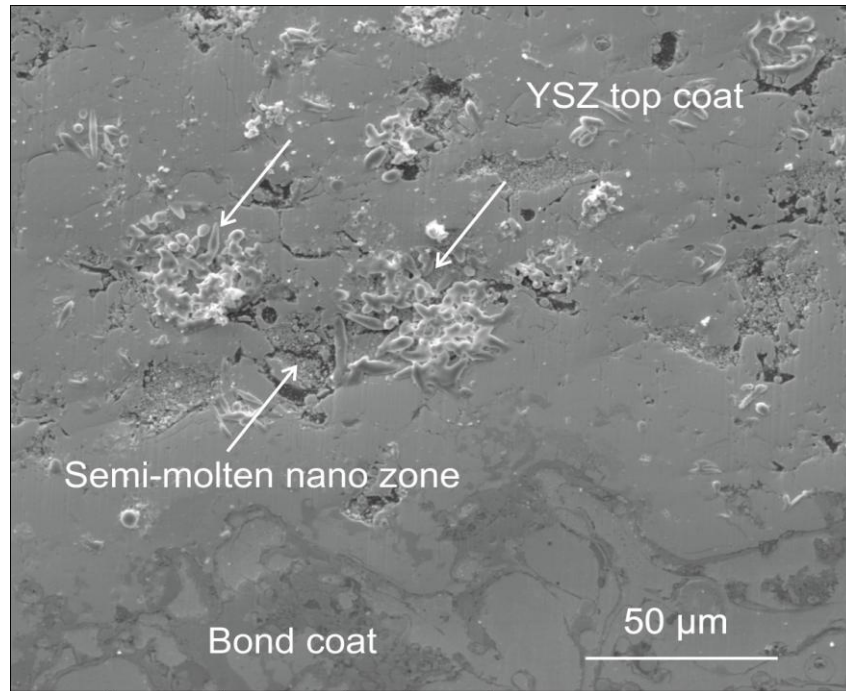
Figure 13(a): SEM image of cross section of nanostructured YSZ coating. Arrows point to salt crystals.

A typical cross section of the nanostructured YSZ-based EBC coating is shown in Fig. 13a. Although salt crystals were found in the YSZ top coat, none were found in the bond coat or near the steel substrate of this sample. The white arrow in the image points to the salt crystals. Unlike the conventional YSZ top coat, where salt was found in cracks in the coating (see Fig. 12a), it tended to crystallize in zones of semi-molten nanoparticles in the nano based YSZ top coat. This is evident from Fig. 13b, which is a high-magnification SEM image of the cross section of a nanostructured YSZ top coating. The presence of the semi-molten nanoparticles also confirm that the coating will have nanostructured characteristics and a bimodal microstructure. Figure 13c is an EDS spectrum of the crystal in Fig. 13b and it confirms the presence of elements like Na, S, K and some Cl, which were present in the corroding salt.

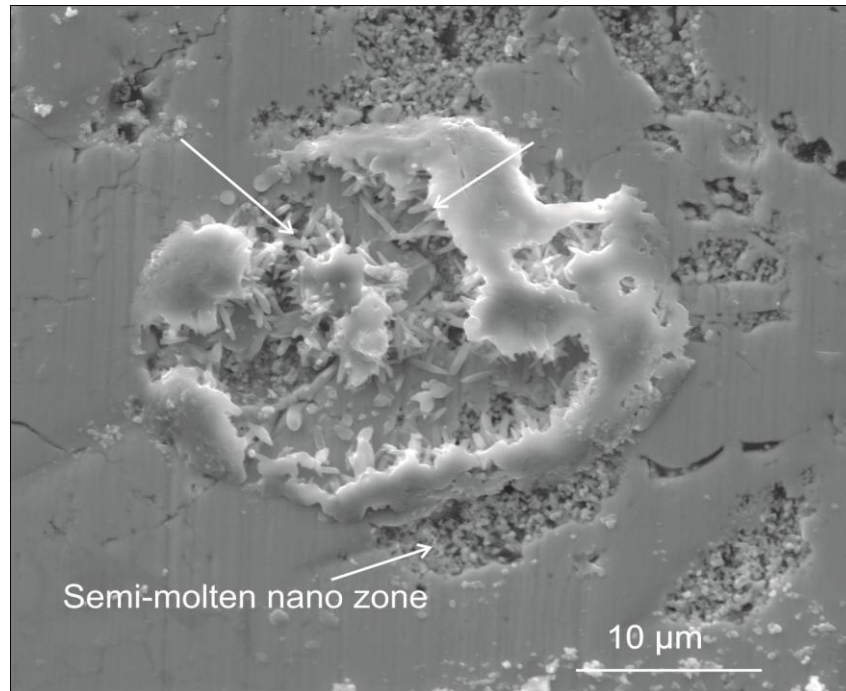
Figure 13(b): Salt crystal crystallizing in nano zones. Arrows point to salt crystals.

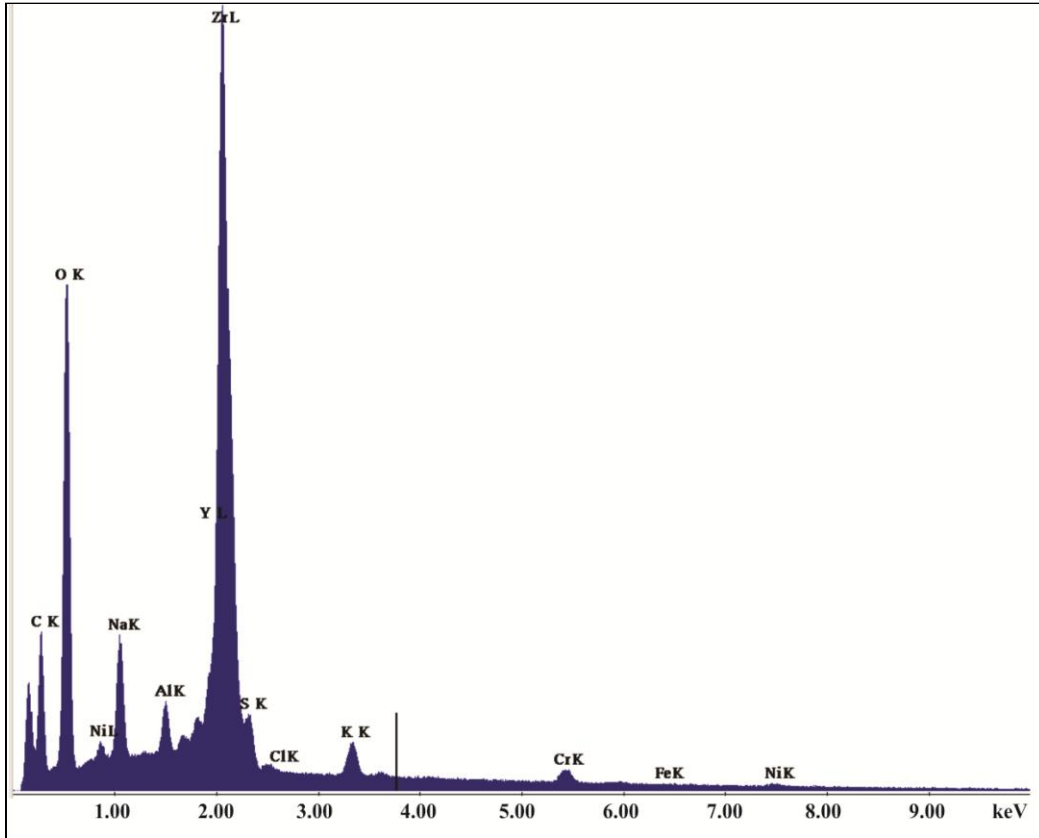
Figure 13(c): EDS spectrum of salt crystals in nano-YSZ top coat shown in Fig. 13(b)

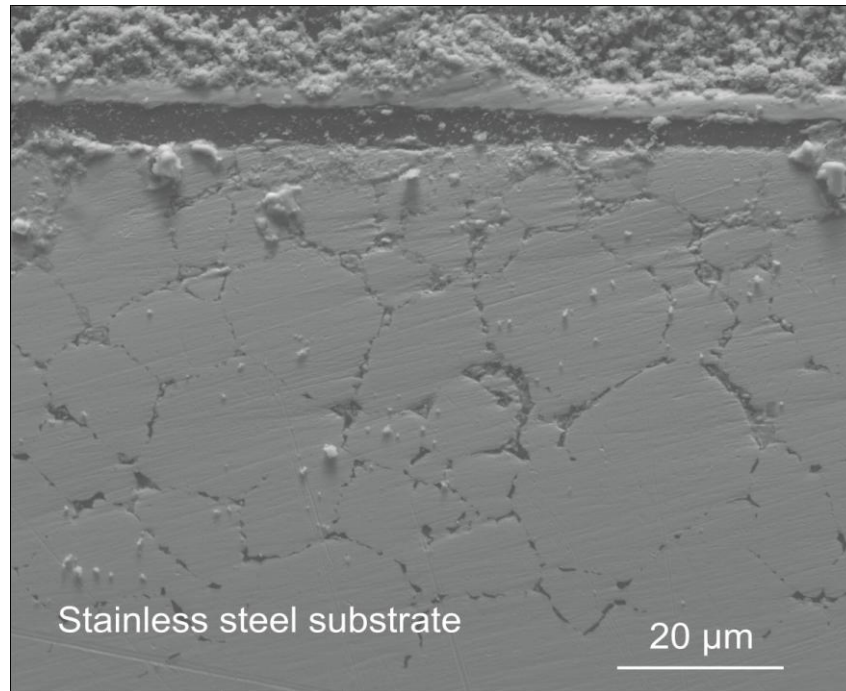
Figure 14: SEM image of cross section of Type 309 steel

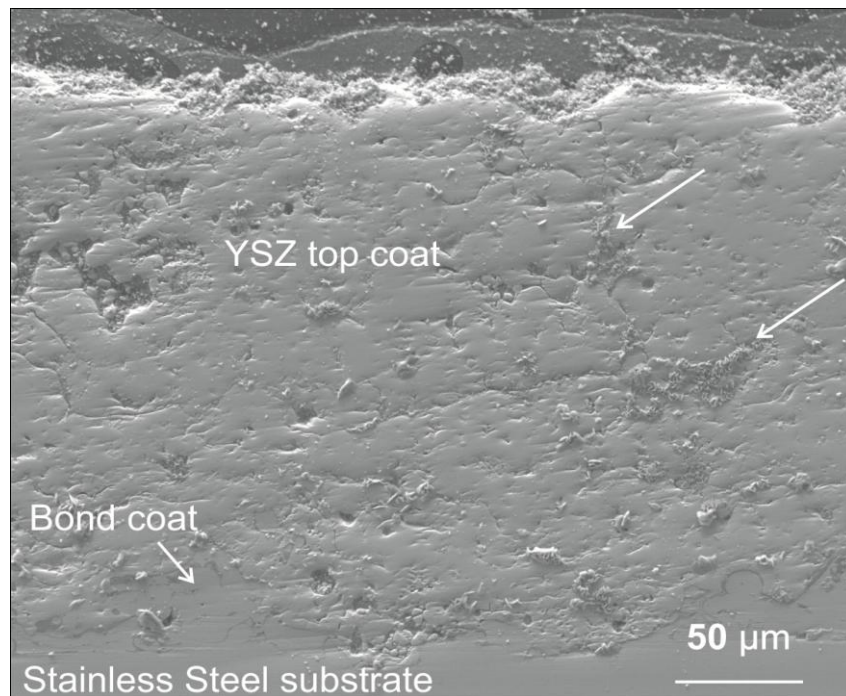
Figure 15(a): SEM image of cross section of conventional YSZ coating showing salt crystals in cracks. Arrows point to salt crystals.

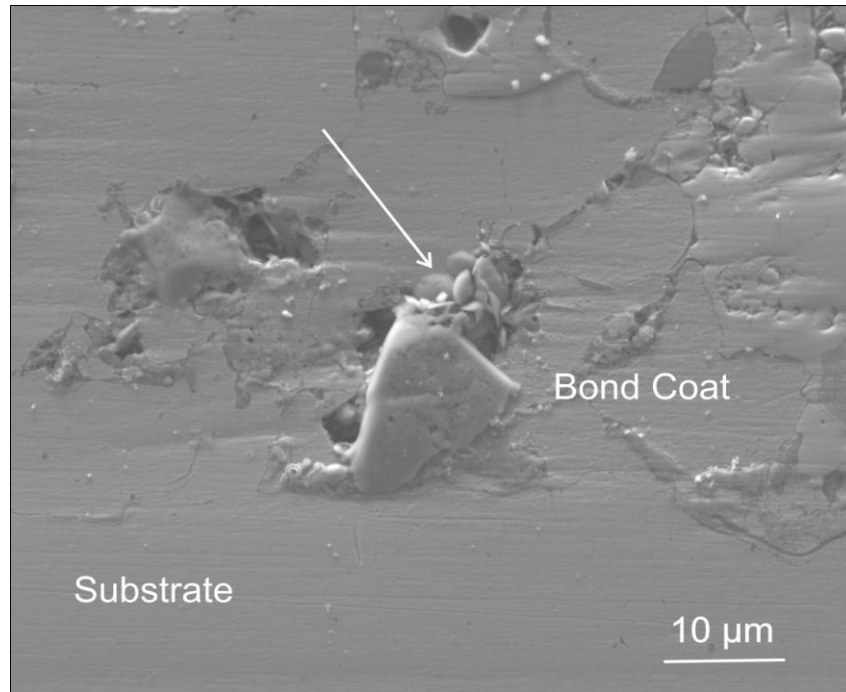
Figure 15(b): Salt crystal at the interface of bond coat and substrate of conventional YSZ coating. Arrow points to salt crystals.

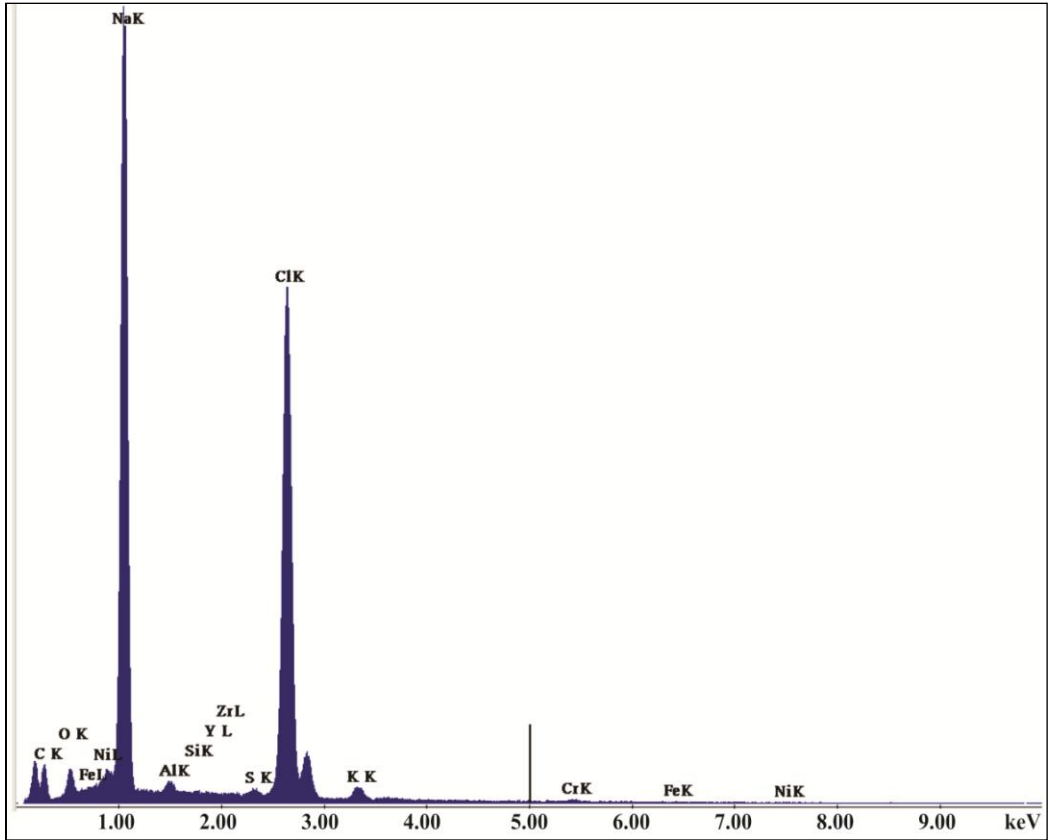
Figure 15(c): EDS spectrum of salt crystal at the interface of bond coat and substrate in conventional YSZ sample shown in Fig. 15(b).

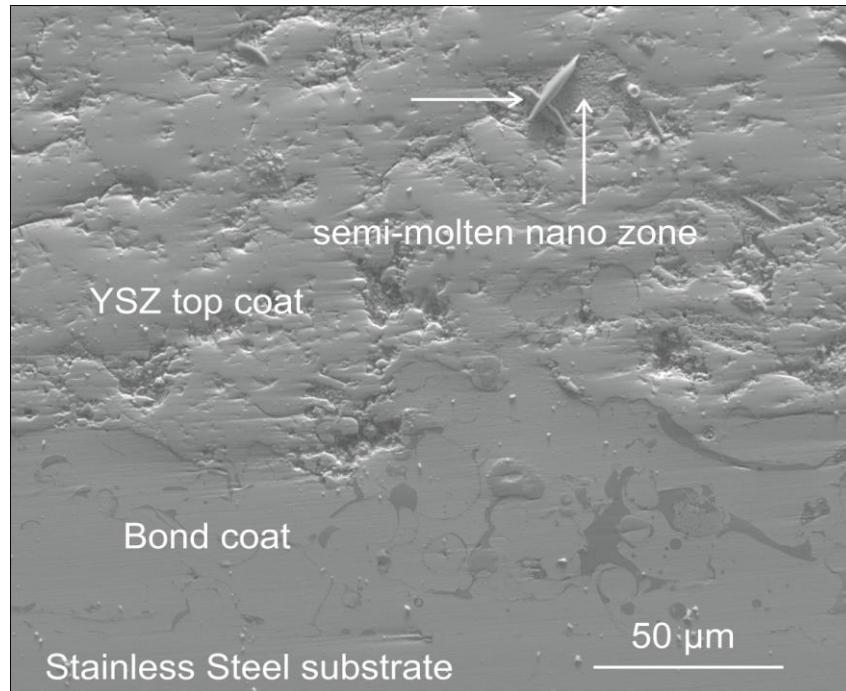
Figure 16(a):SEM image of cross section of nanostructured YSZ coating. Arrow points to a salt crystal.

The cross sectional image of the nanostructured-based YSZ EBC from this test is shown in Fig. 16a. Similar to the previous test, it can be clearly seen that the crystals tend to crystallize in the nano zone areas of the EBC. The same phenomenon can also be seen in Fig. 16b which shows salt crystallizing in the semi-molten nano particle area. A spot scan was performed on the crystal in Fig. 16b and the resulting EDS spectrum is shown in Fig. 16c. The spectrum confirms that the crystal shown is a Na_2SO_4 crystal

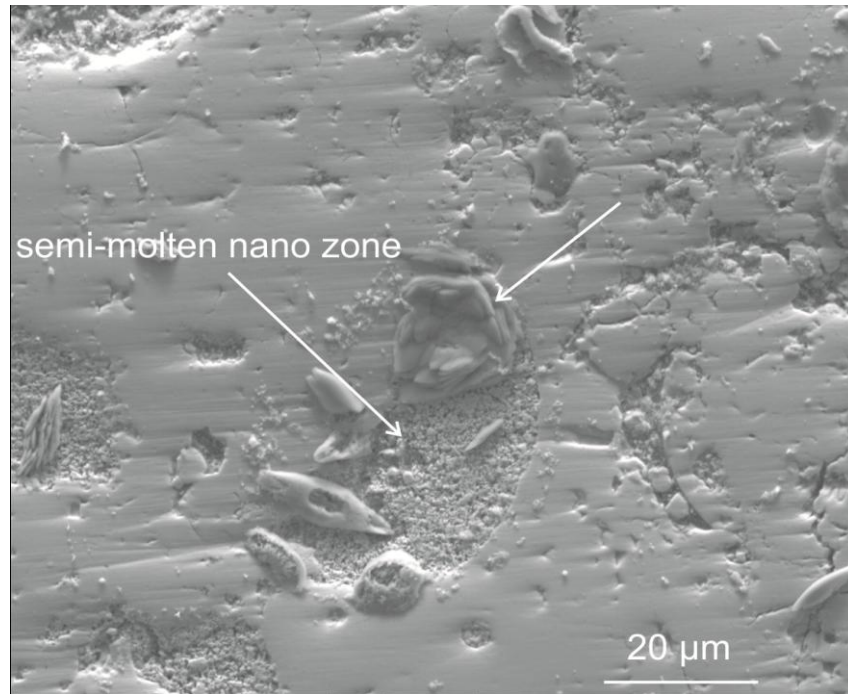
Figure 16(b): Salt crystal oozing out of nanozone of nanostructured YSZ coating. Arrow points to a salt crystal.

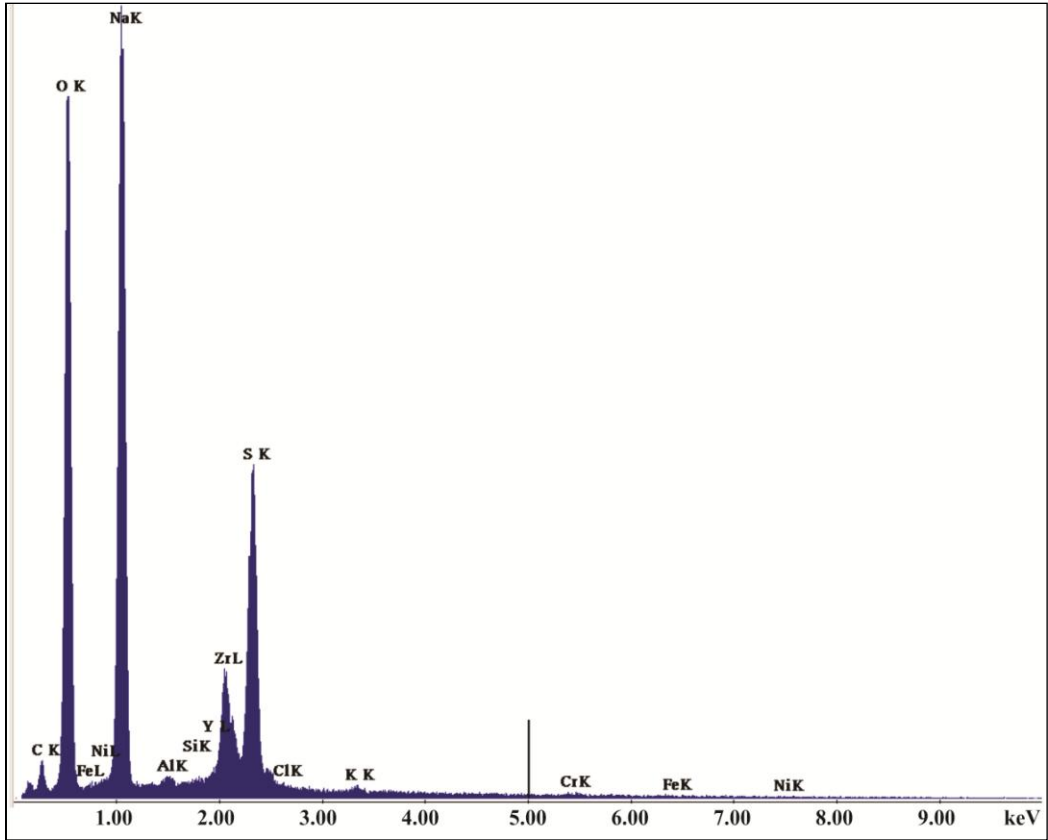
Figure 16(c): EDS image of salt crystal in nano YSZ top coat shown in Fig. 16(b).

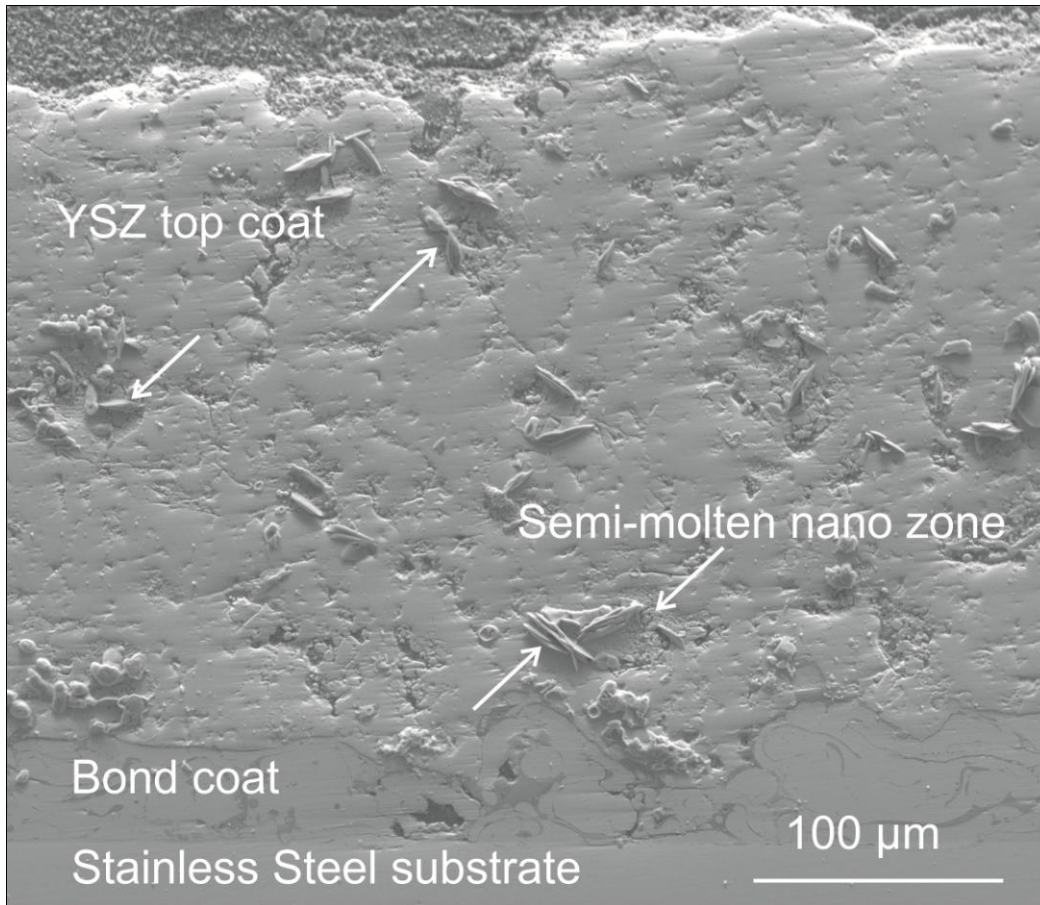
Figure 17: Nanostructured YSZ coating showing salt crystals in nano zone areas. Arrows point to salt crystals.

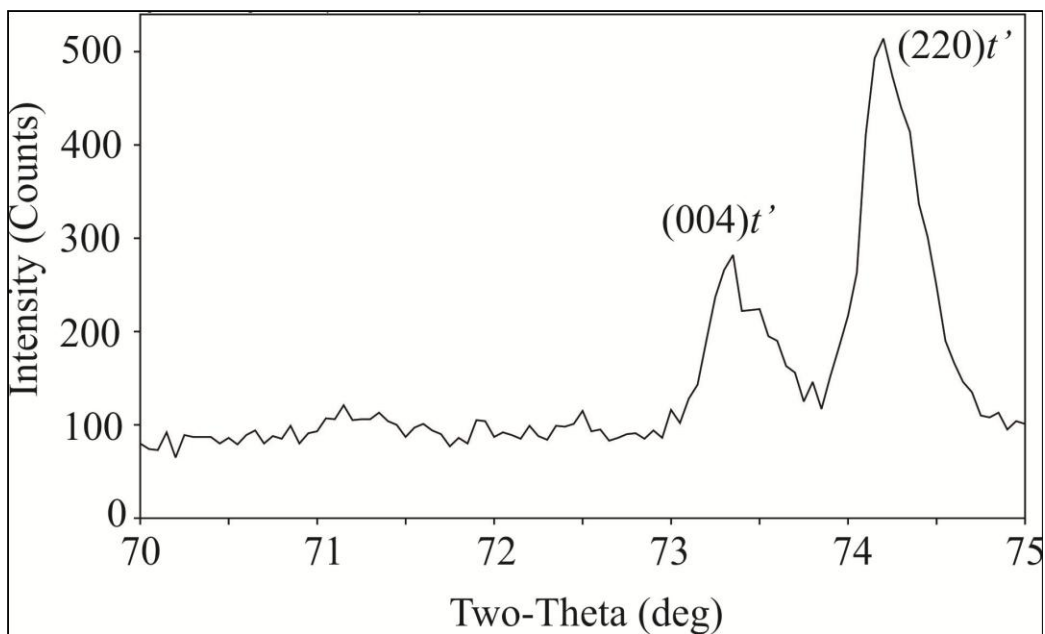
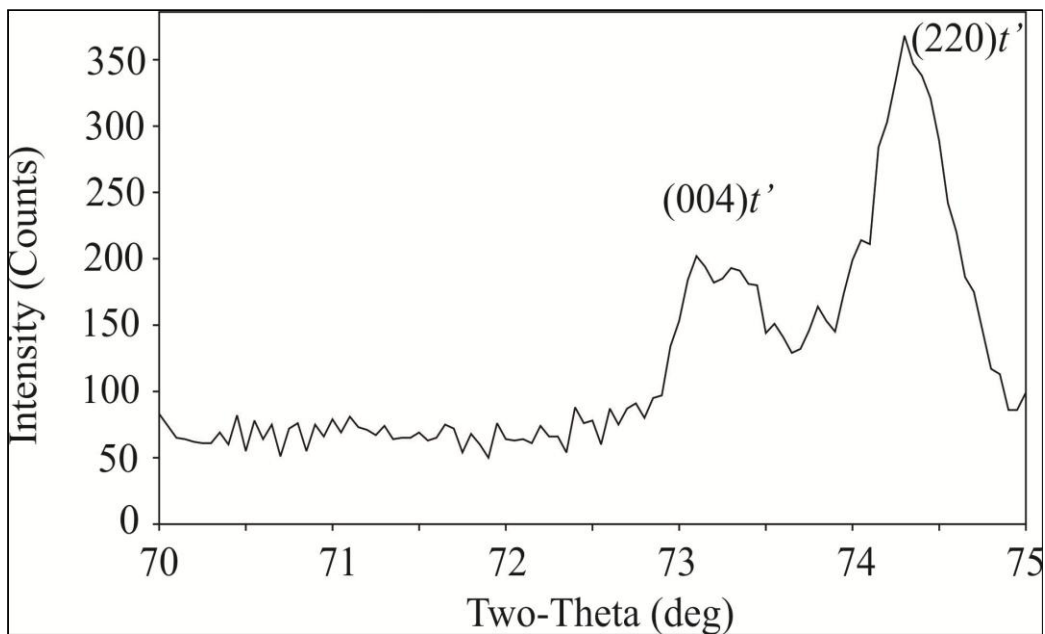
Figure 18: XRD pattern of (a) conventional (b) nano-structured YSZ powder

A slight difference in peak positions (peak shifts) is observed between the conventional YSZ coatings and nanostructures YSZ coatings. Shift in peak positions might be related to microstrains or different yttria contents [9]. The conventional YSZ feedstock powder (Metco 204NS-G, Sulzer Metco, Inc., Westbury, NY, USA) consisted of 8wt% yttria while the nanostructured YSZ feedstock powder (Nanox Powder S4007, Inframat Corporation, Farmington, CT, USA) consisted of 7wt% yttria. This could be a possible reason for the shift in peak positions.

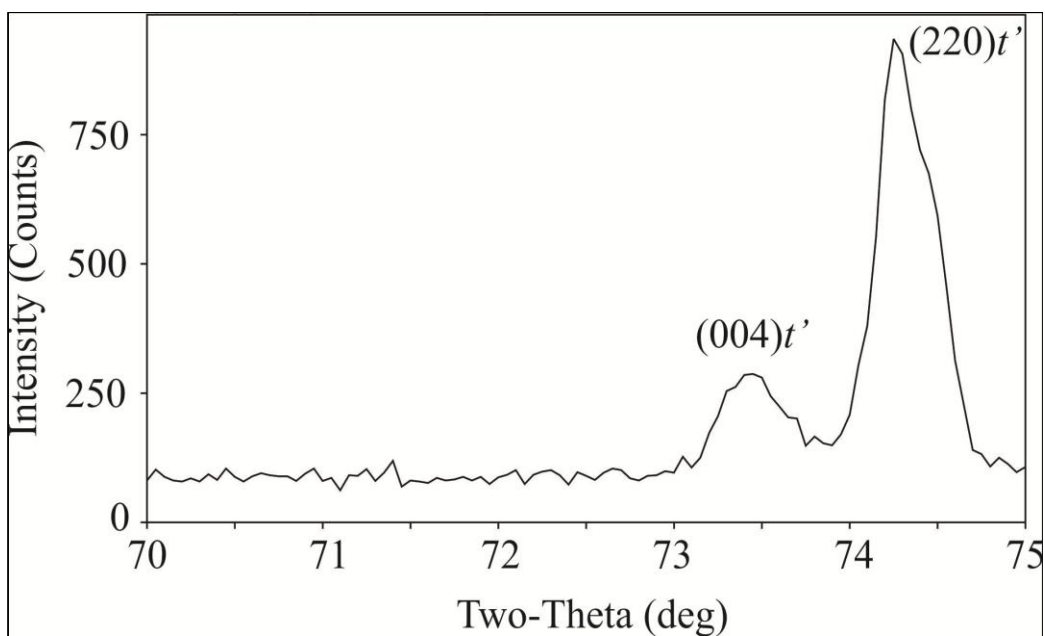
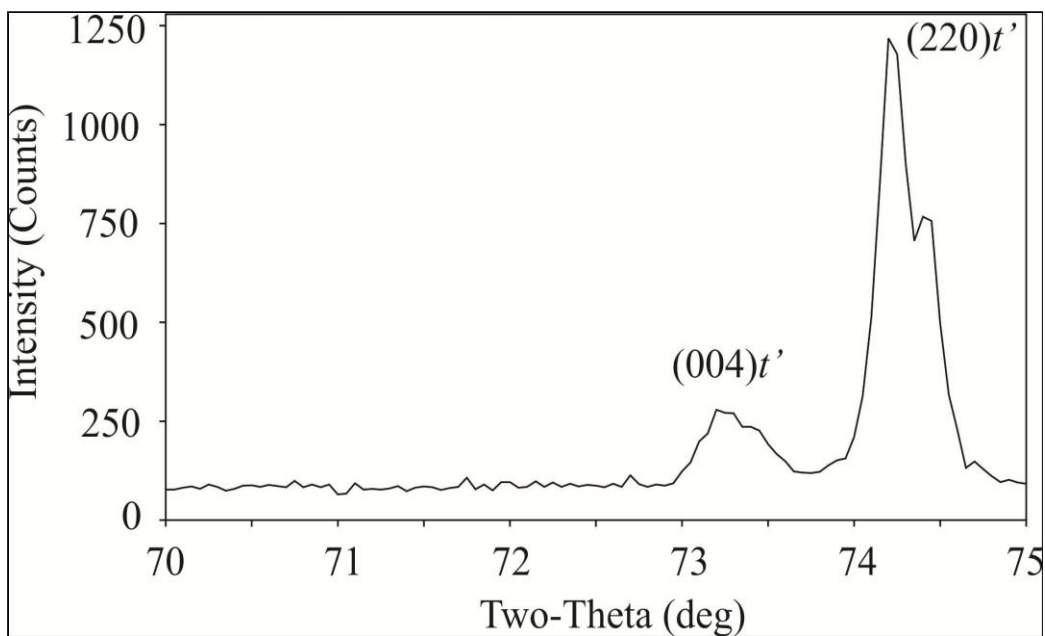
Figure 19: XRD pattern of as-sprayed (a) conventional (b) nano-structured YSZ coatings

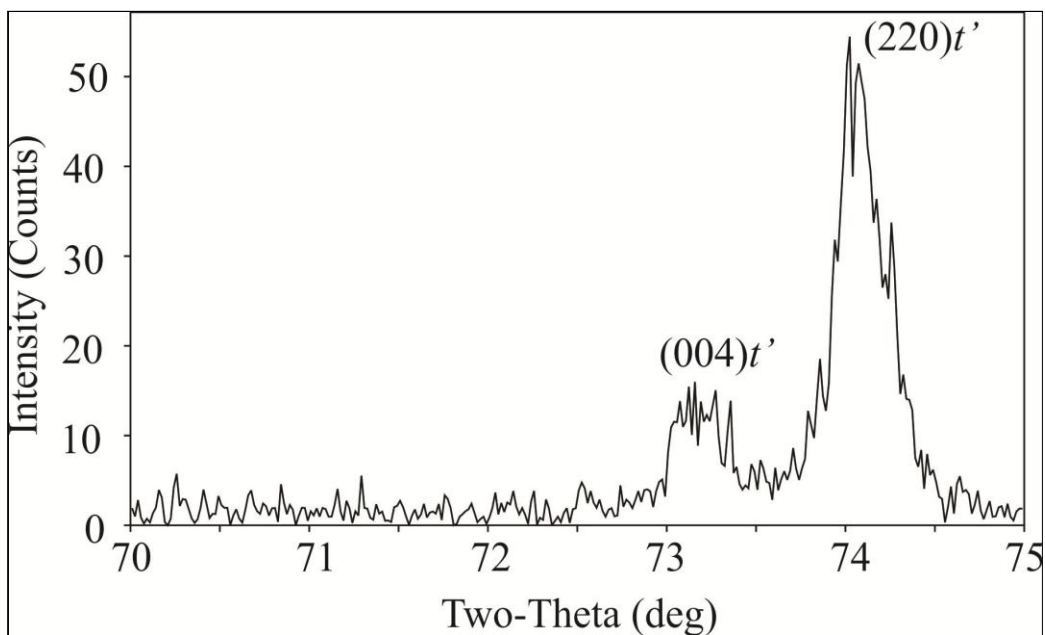
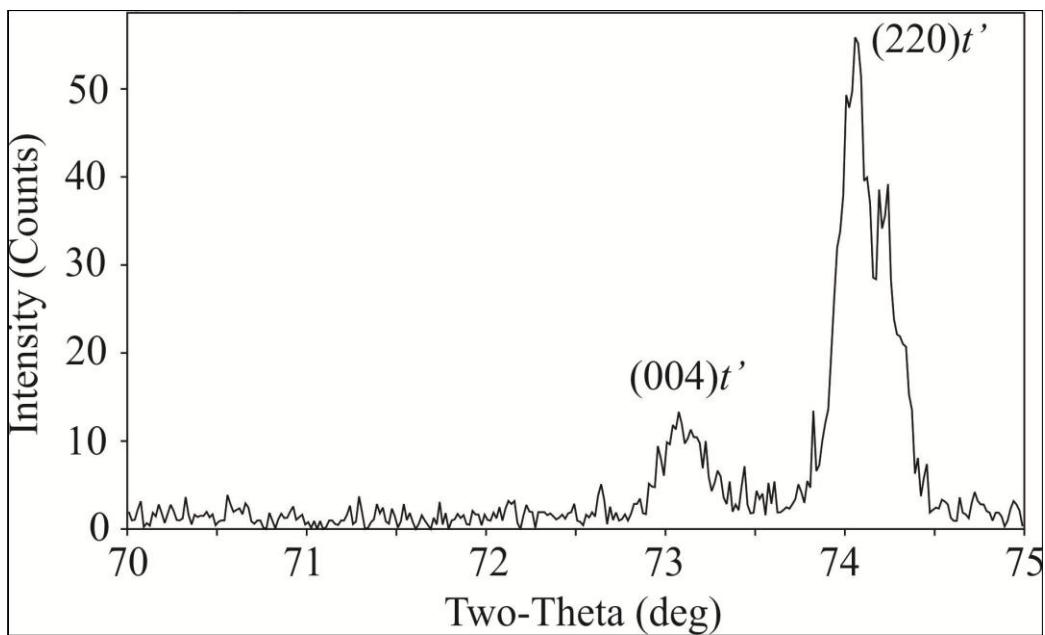
Figure 20: XRD pattern of (a) conventional YSZ coating and (b) nanostructured YSZ coating from test B (600°C, air, synthetic salt mixture)

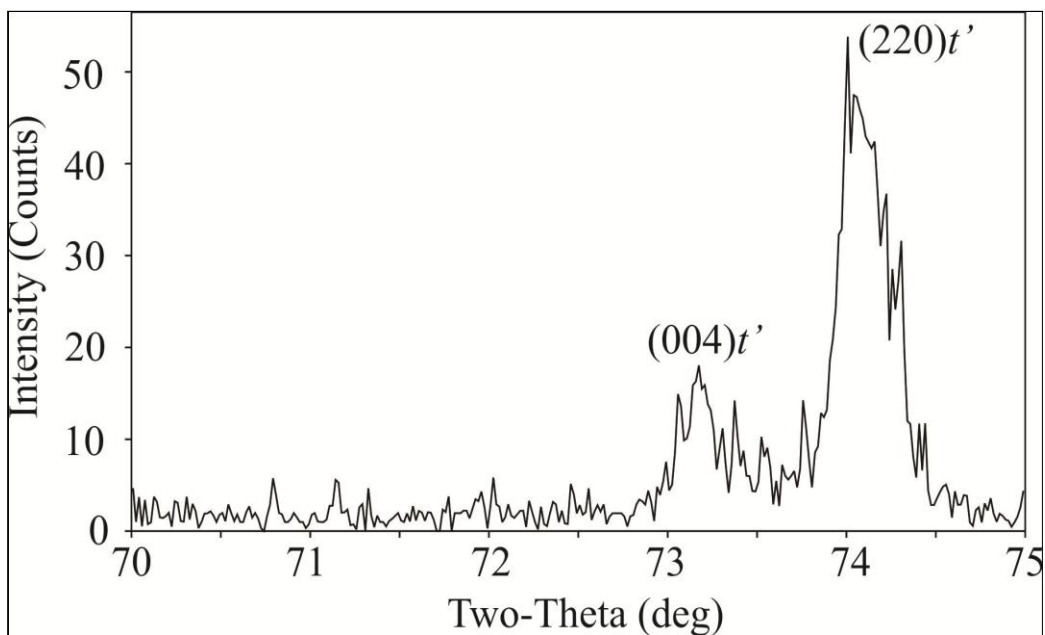
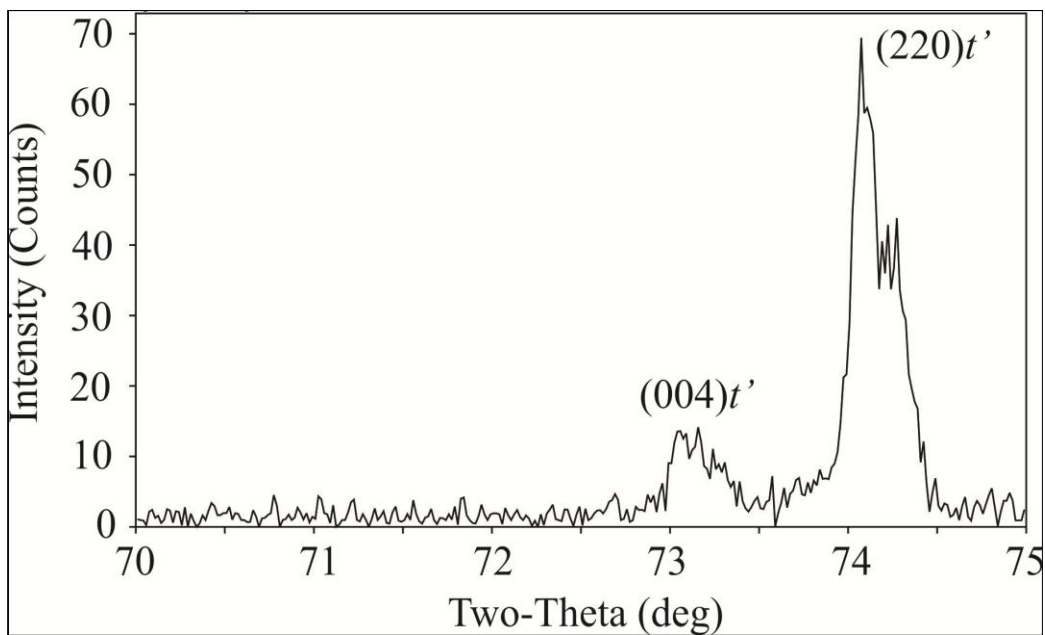
Figure 21: XRD pattern of (a) conventional YSZ coating and (b) nanostructured YSZ coating from test C (600°C, flue gas, synthetic salt mixture)
