# **The Application of Emerging Monitoring Technologies on Very Slow Vegetated Landslides**

A thesis submitted in partial fulfillment of the requirements for the degree of

Geotechnical Engineering

University of Alberta

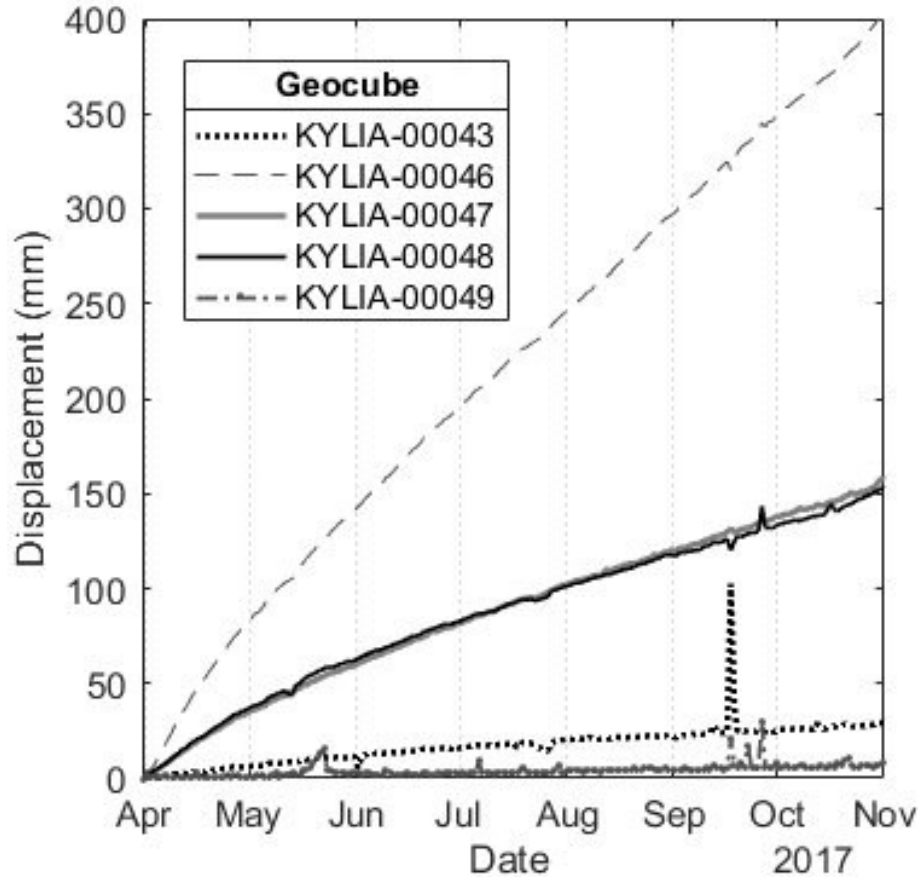
Figure 2-3: Cumulative displacement for various GPS units on 10-Mile slide (Rodriguez et al. 2018 – With permission)

Rodriguez et al. (2018) combined the use of a differential GPS system with LiDAR on the 10-Mile slide in British Columbia. Movement levels on 10-Mile slide are quite large, in excess of 400 mm/year in some locations (Figure 2-3). This led to very discernible and smooth trends in GPS data. Achievable GPS accuracy was 1 – 2 mm with a fixed point located less than 500 m from the remaining GPS units. With 24-hour readings GPS accuracy under ideal environmental conditions can range from 1 – 2 mm with a fixed point up to 1000 meters from the remaining GPS units and 2 – 4 mm at 3000 meters (Ophelia-Sensors 2019). These numbers are based on ideal conditions and accuracy levels should be expected to be lower than this in real world application.

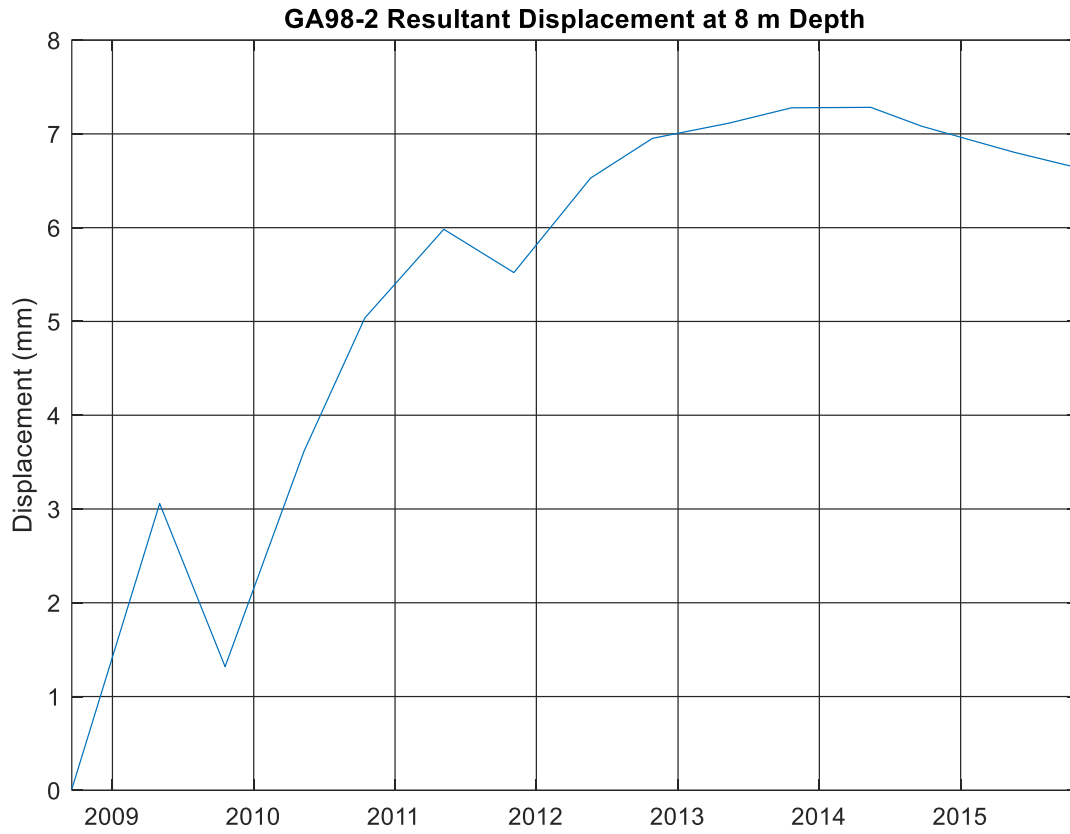
Figure 3-7: Cumulative displacement at 8 m depth in slope inclinometer GA98-2 (Modified from AMEC FW 2015)

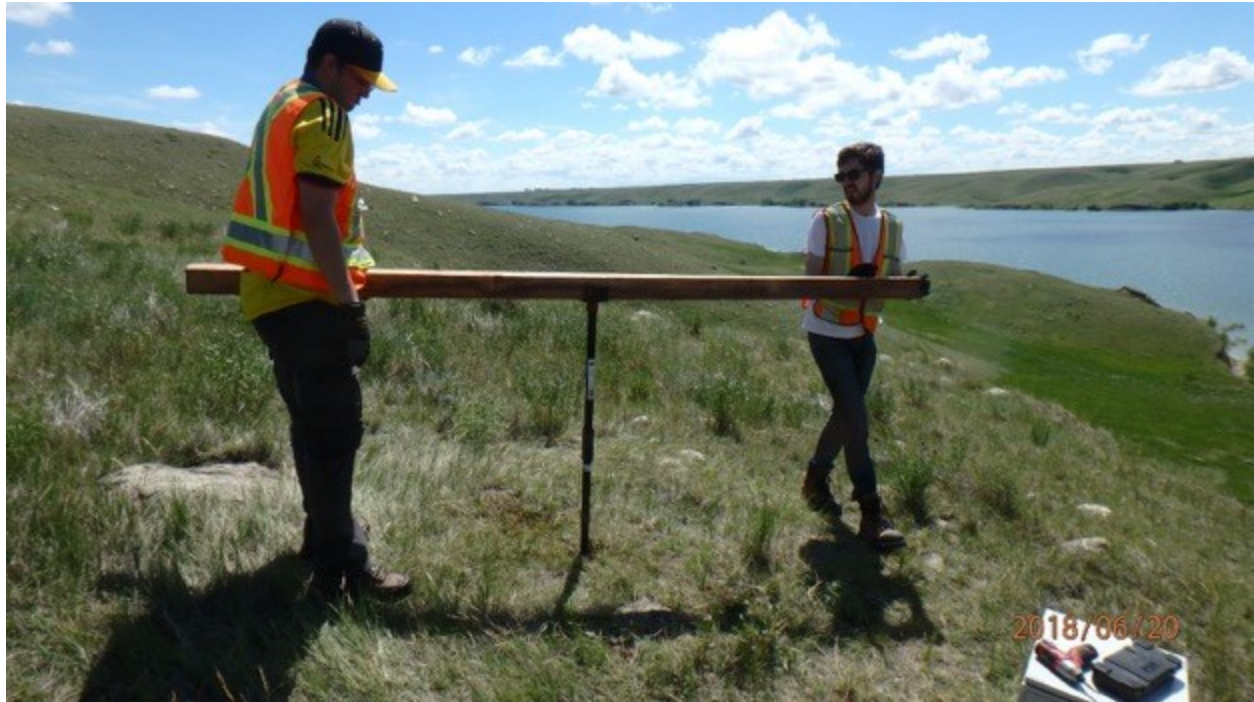
*Figure 4-2: Chin Coulee GPS deck screw pile installation (Hong 2018)*

GPS units were mounted on deck screw piles which were embedded by hand roughly 1 m into the ground. Figure 4-2 and Figure 4-4 shows the installation method of the deck screw piles and final setup employed on Chin Coulee. Figure 4-3 shows an installation on 10-Mile slide for comparison.

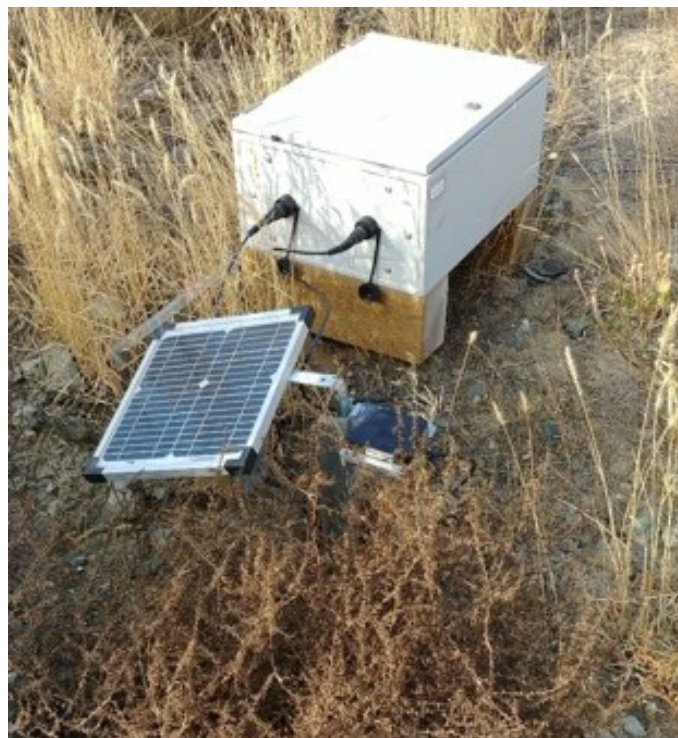
*Figure 4-3: 10-Mile Slide GPS unit final setup (Rodriguez 2017)*

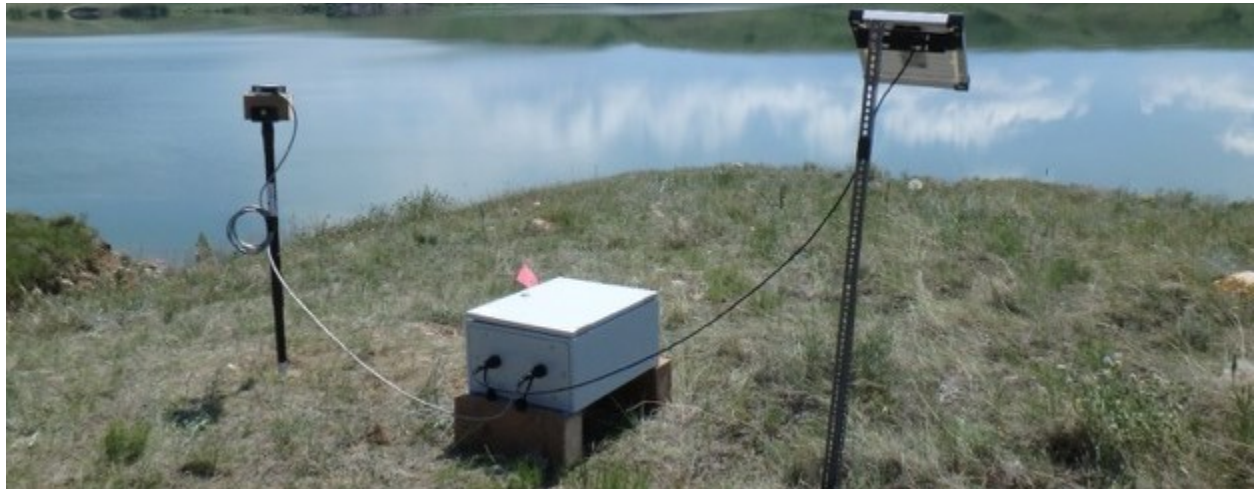
*Figure 4-4: Solar panel, GPS unit, and battery box setup on Chin Coulee (Hong 2018)*

Power for the GPS was provided by a 10-Watt solar panel (See Figure 4-4). Two 12-volt, 100 Ah batteries were also installed with each GPS unit to ensure continuous power to the GPS system overnight and during overcast days (See Figure 4-5).

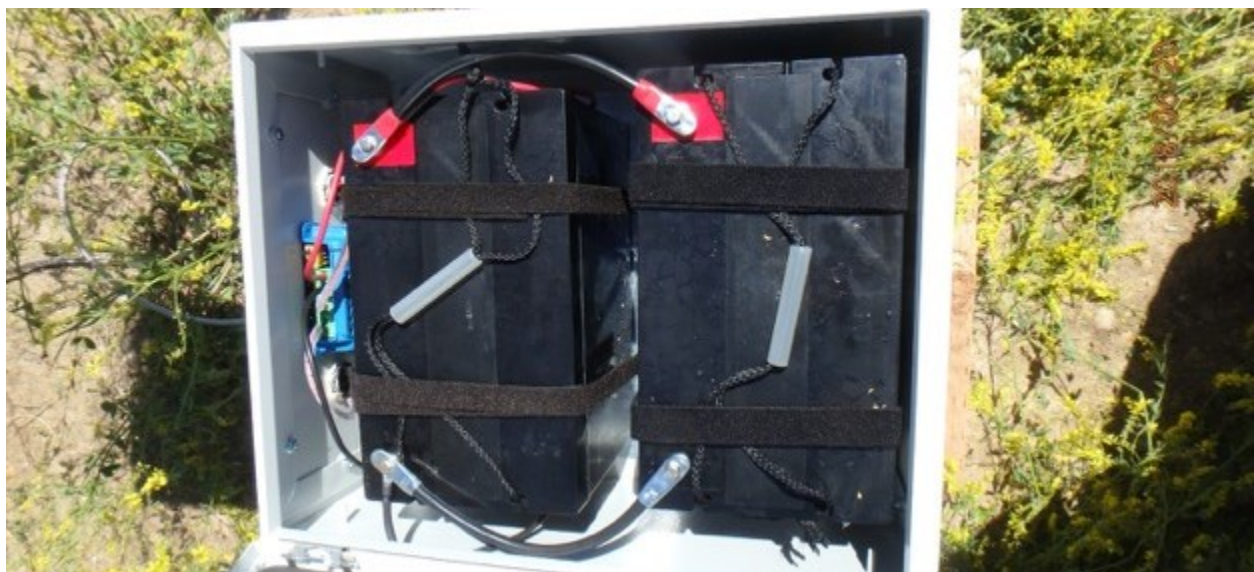
*Figure 4-5: GPS battery box and batteries on Chin Coulee (Hong 2018)*

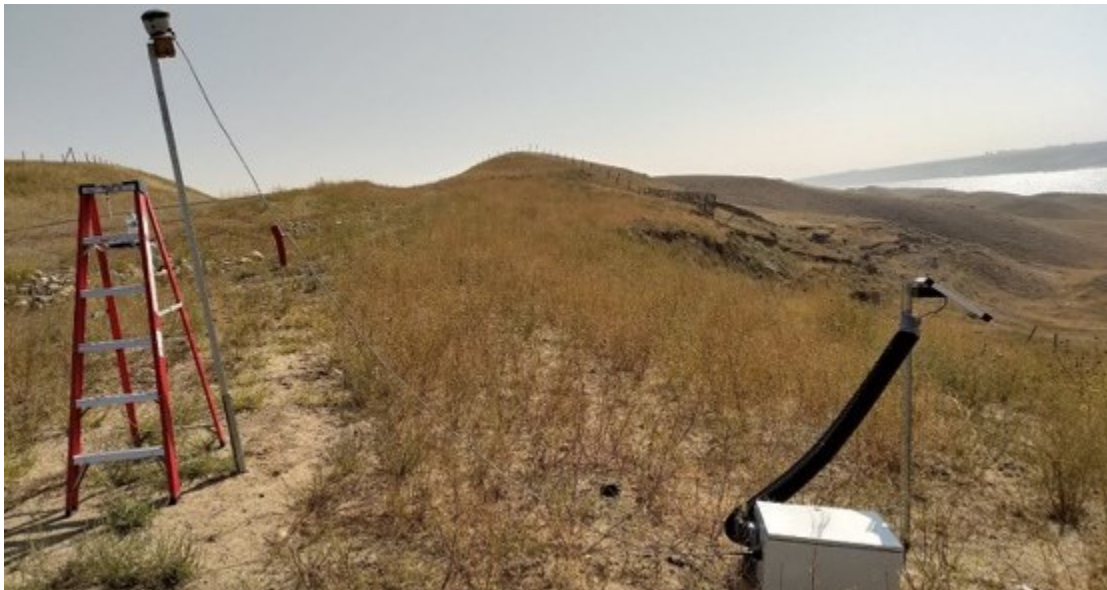
*Figure 4-6: Headscarp GPS unit at Chin Coulee after external antenna relocation and raised GPS unit*

GPS unit 152 at the headscarp repeatedly lost radio signal and failed to connect to the rest of the system. This was corrected by raising the GPS unit to a height of roughly 2 m. Figure 4-6 shows the GPS installation after relocation.

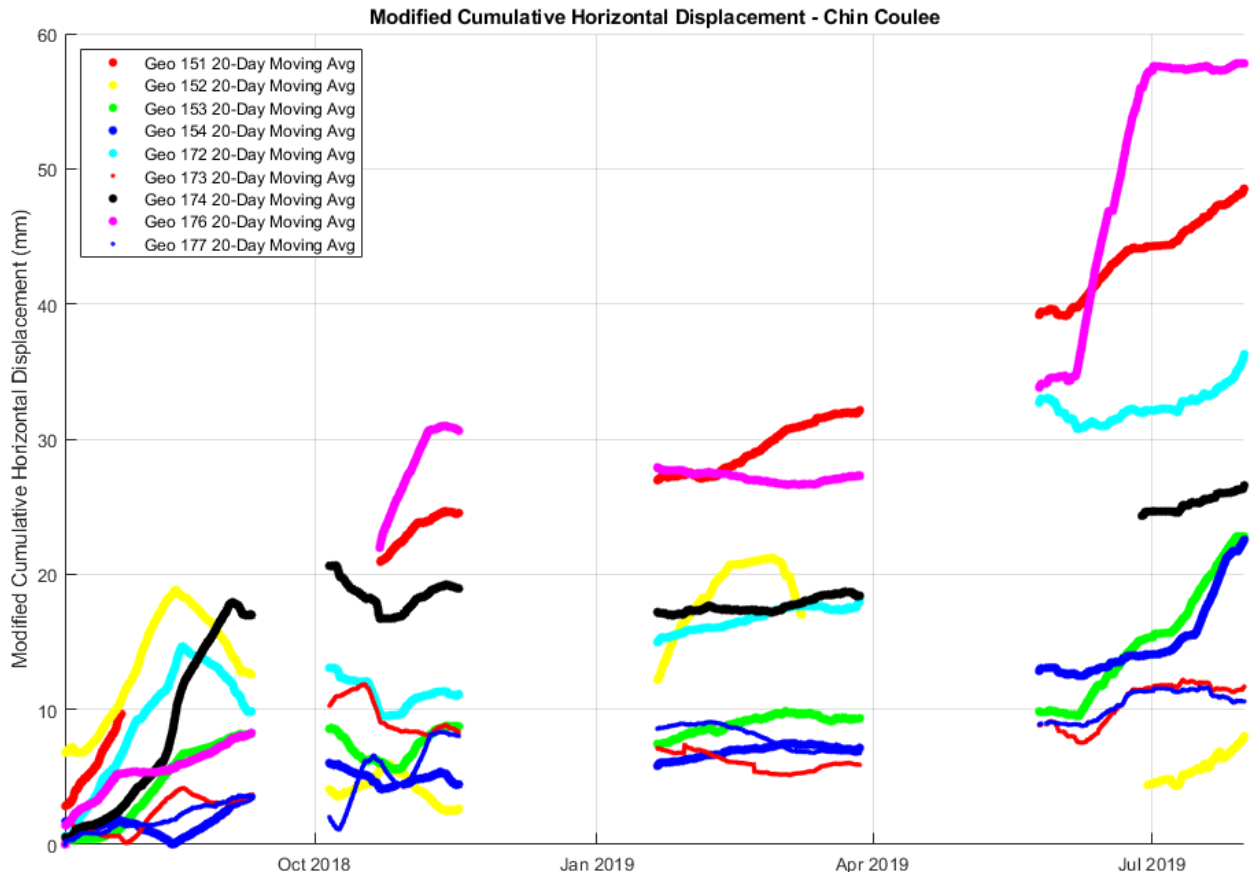
Figure 4-9: Modified cumulative horizontal displacement of Geocubes (July 11, 2018 - July 30, 2019)

Horizontal and vertical displacement vector plots from initiation of the Geocube system on July 11, 2018 to July 30, 2019 are shown in Figure 4-7 and Figure 4-8. Vector color signifies the perceived expectation for movement in that direction, with green being expected and red and yellow being less expected. Plots showing 20-day moving average horizontal and vertical displacement are shown in Figure 4-9 and Figure 4-10.

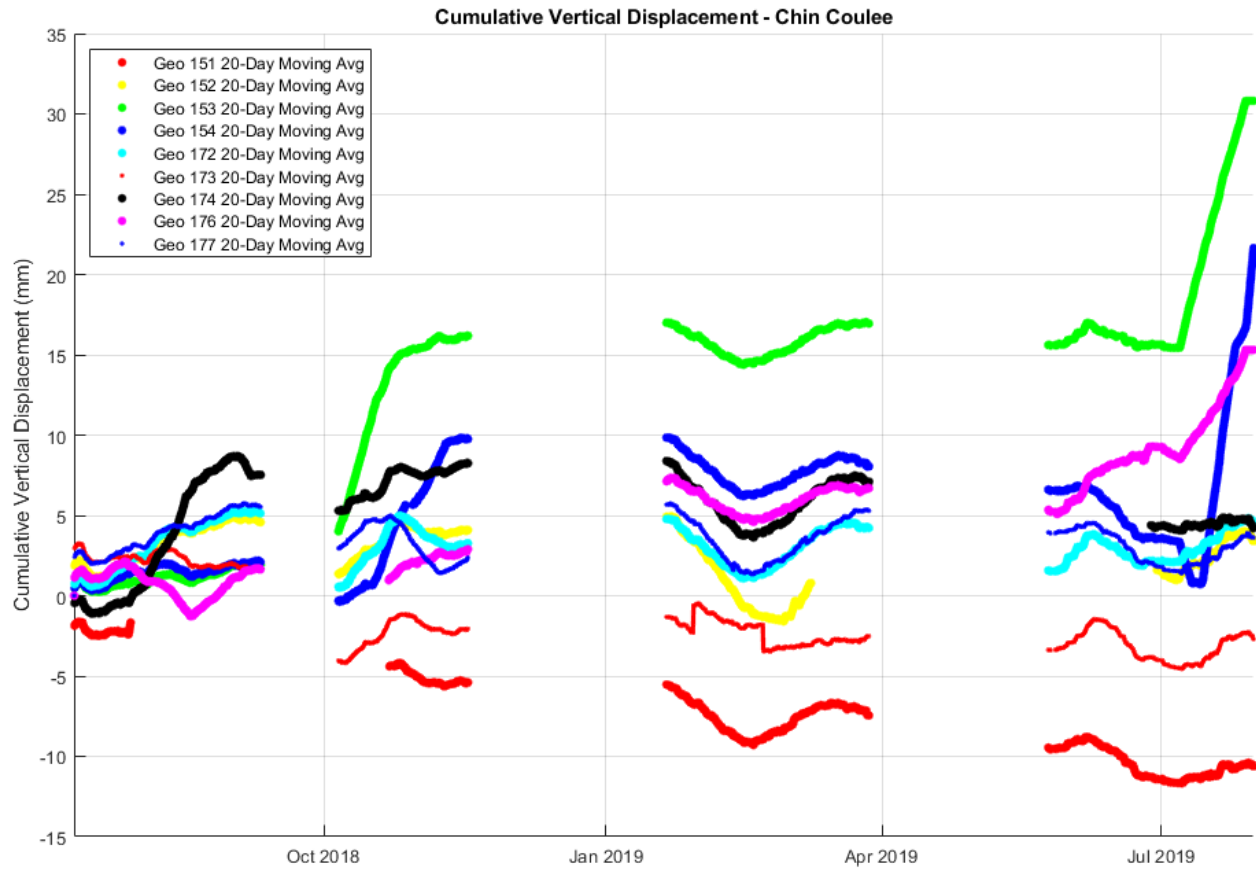
Figure 4-10: Modified cumulative vertical displacement of Geocubes (July 11, 2018 - July 30, 2019)

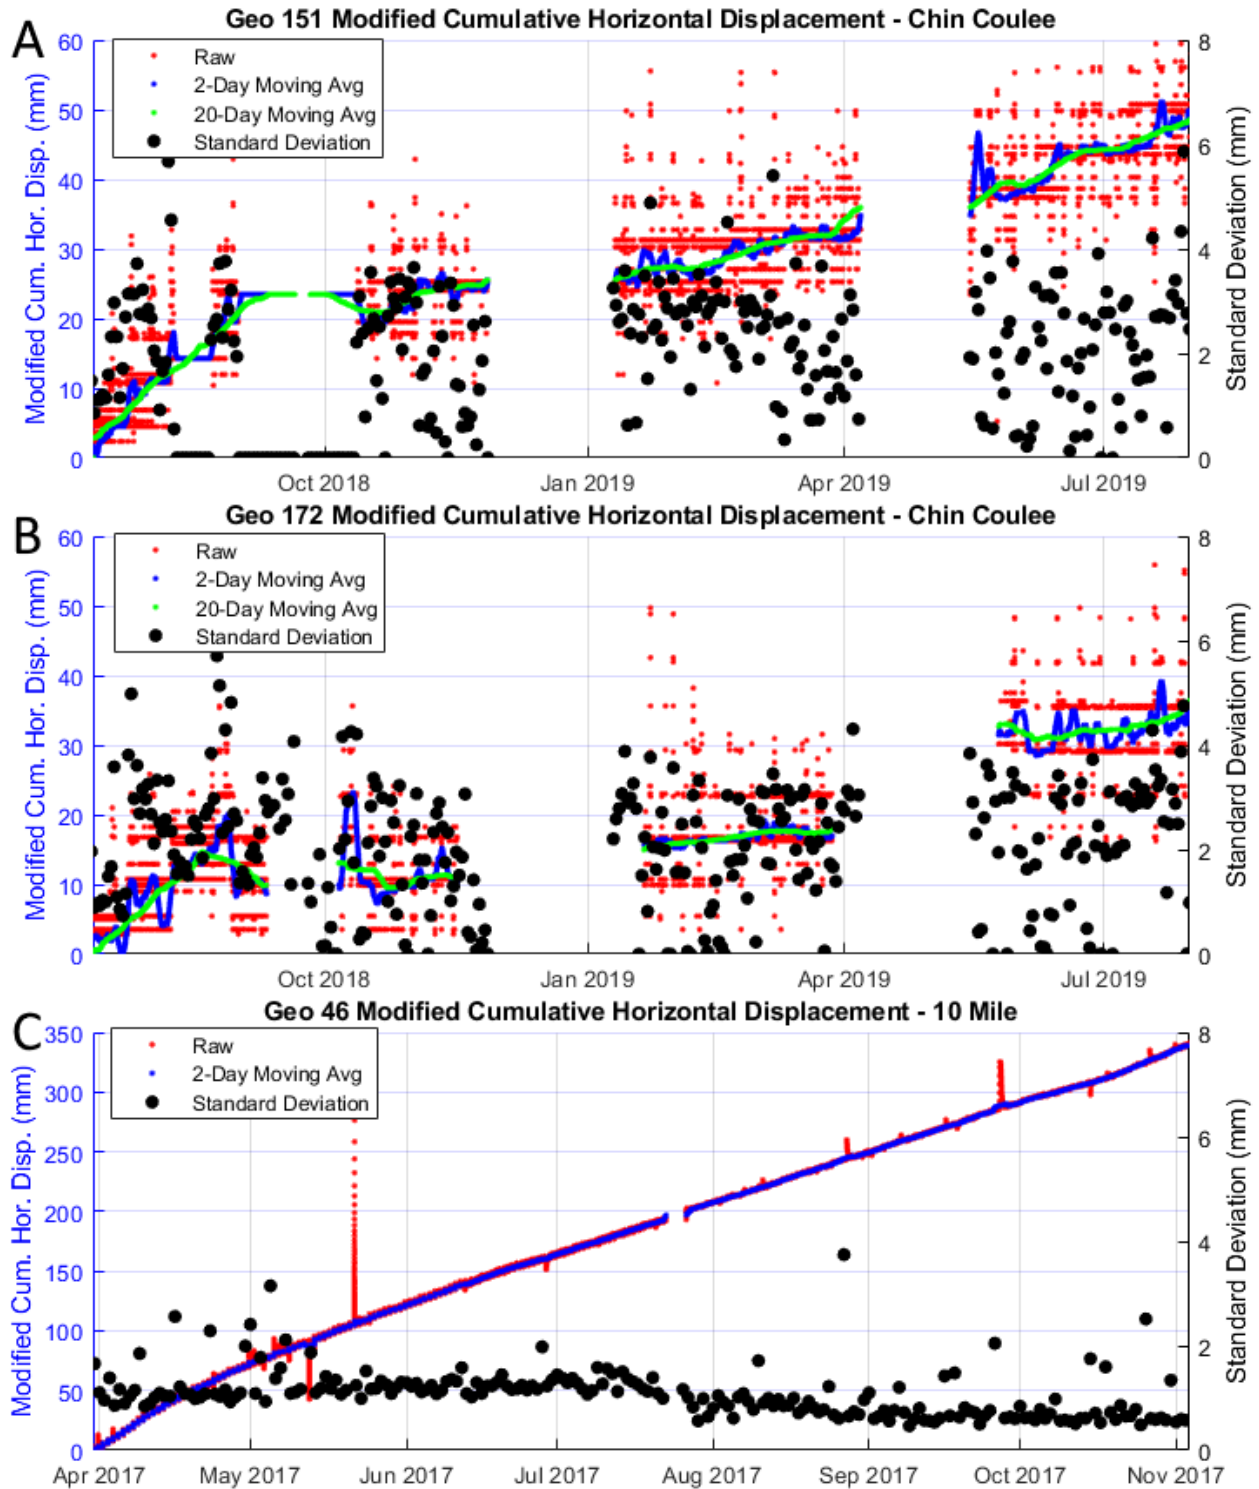
Figure 4-11: Geocube 151 (A) and 172 (B) on Chin Coulee and Geocube 46 (C) on 10-Mile

Data collected from 10-Mile GPS units consisted of multiple monitoring campaigns and had to be stitched together (See Figure 4-12 and Figure 4-11C). The exact position of the GPS unit at the end of one campaign and the beginning of the next did not align due to the error associated with determining the location of the fixed point. The Easting, Northing, and elevation from the end of one campaign was directly matched to the beginning of the following campaign to alleviate this issue.

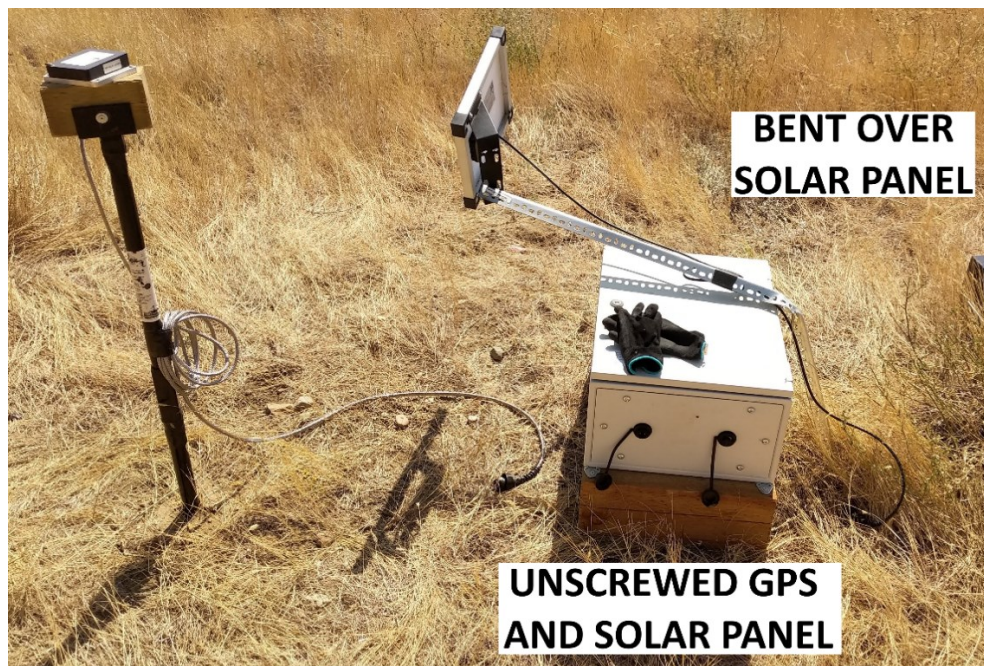
*Figure 4-13: Vandalism to Geocube on Chin Coulee. GPS and solar panel unscrewed and damaged*

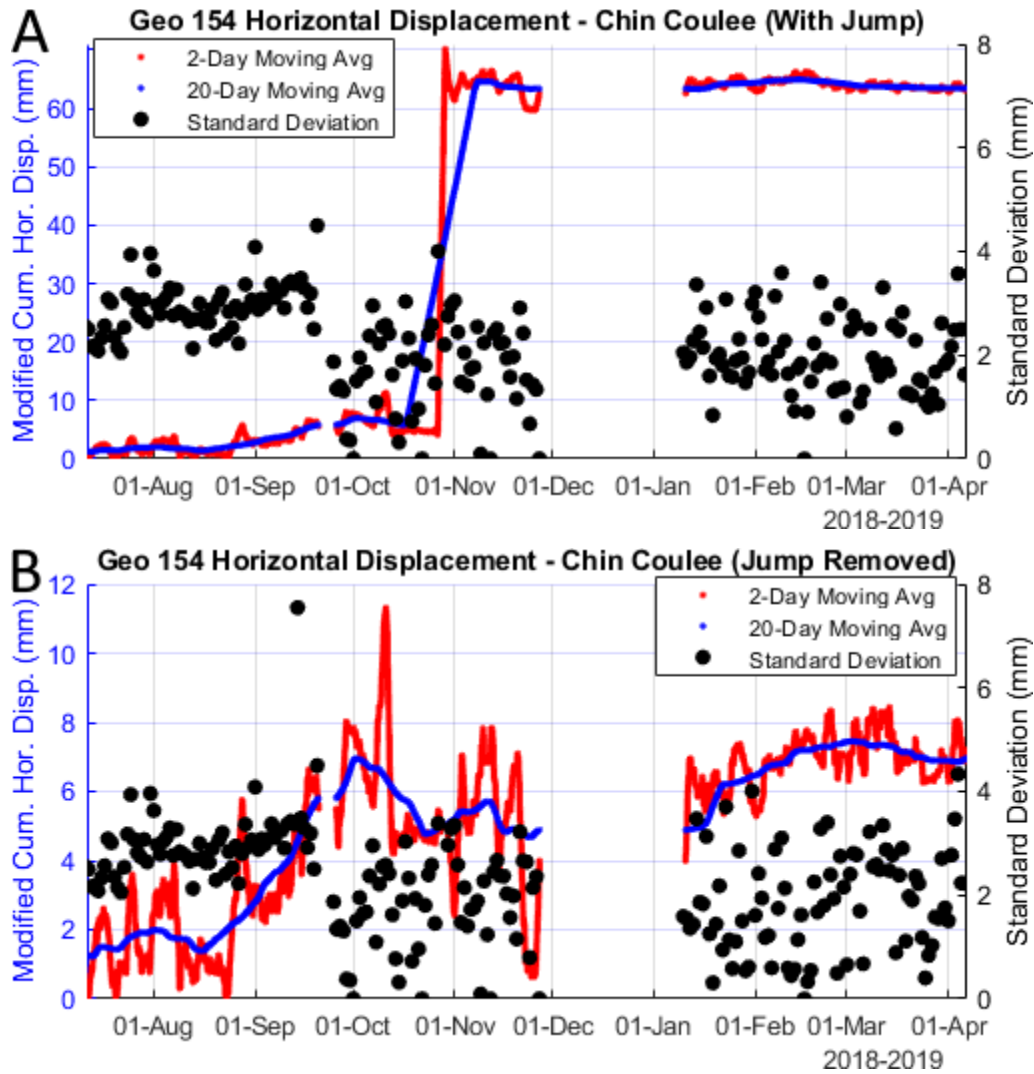
Figure 4-14: Geocube 154 on Chin Coulee before discontinuity removal (A) and after discontinuity removal (B)

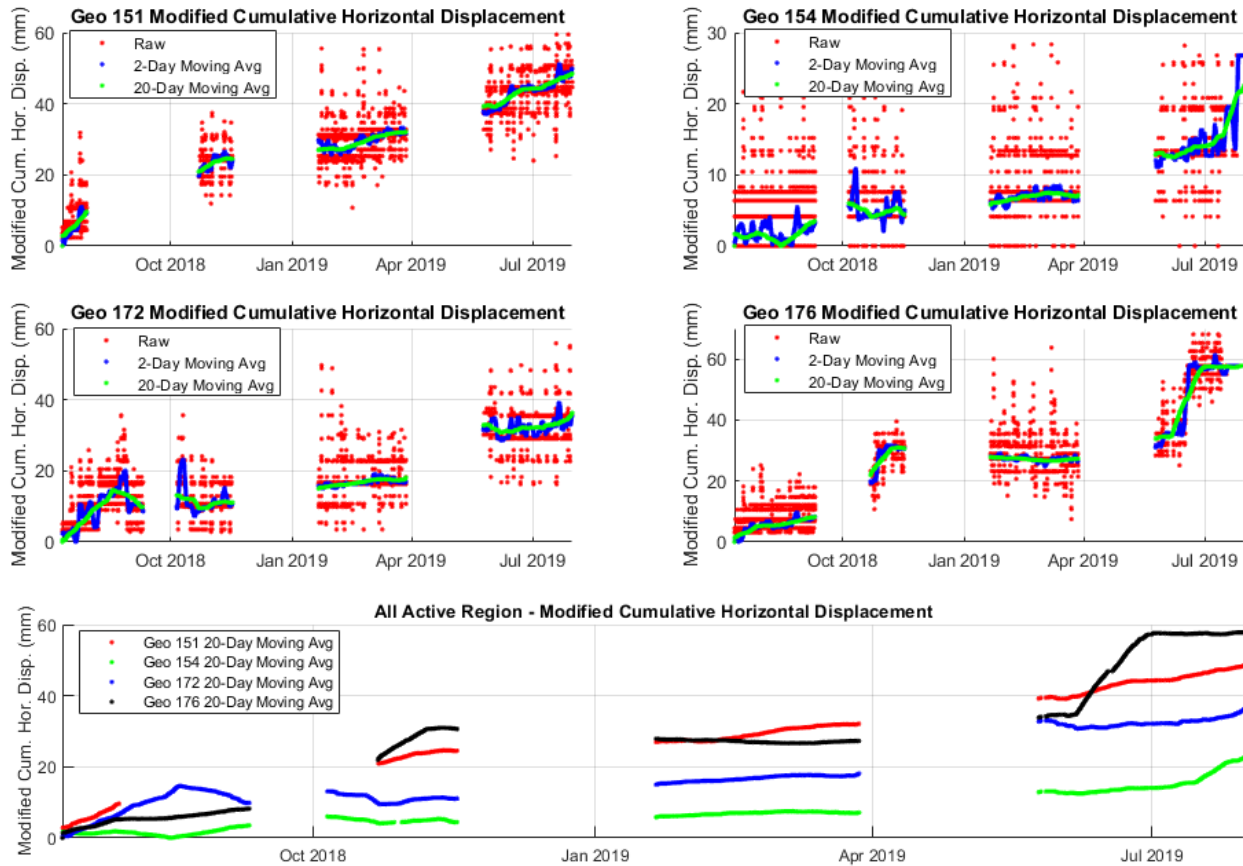
Figure 4-18: Horizontal movement of Geocubes within the active region

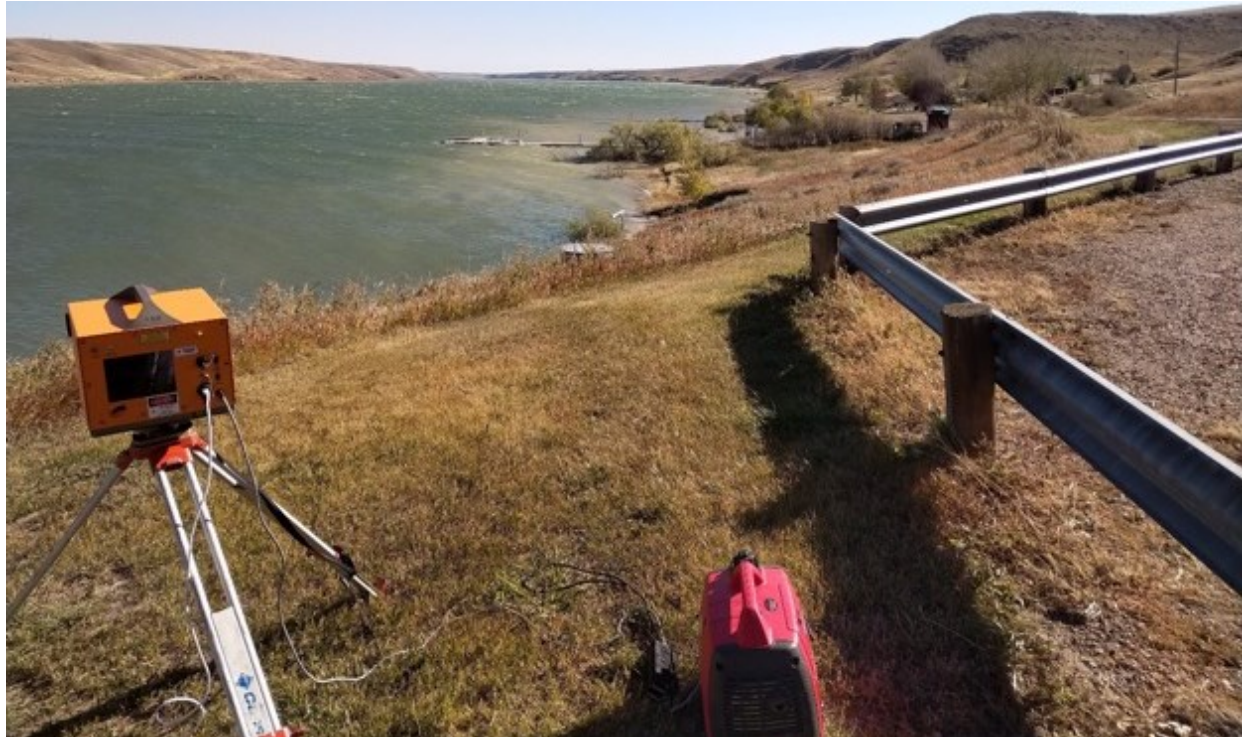
*Figure 5-1: ILRIS-LR LiDAR scanner used on Chin Coulee (Location 1)*

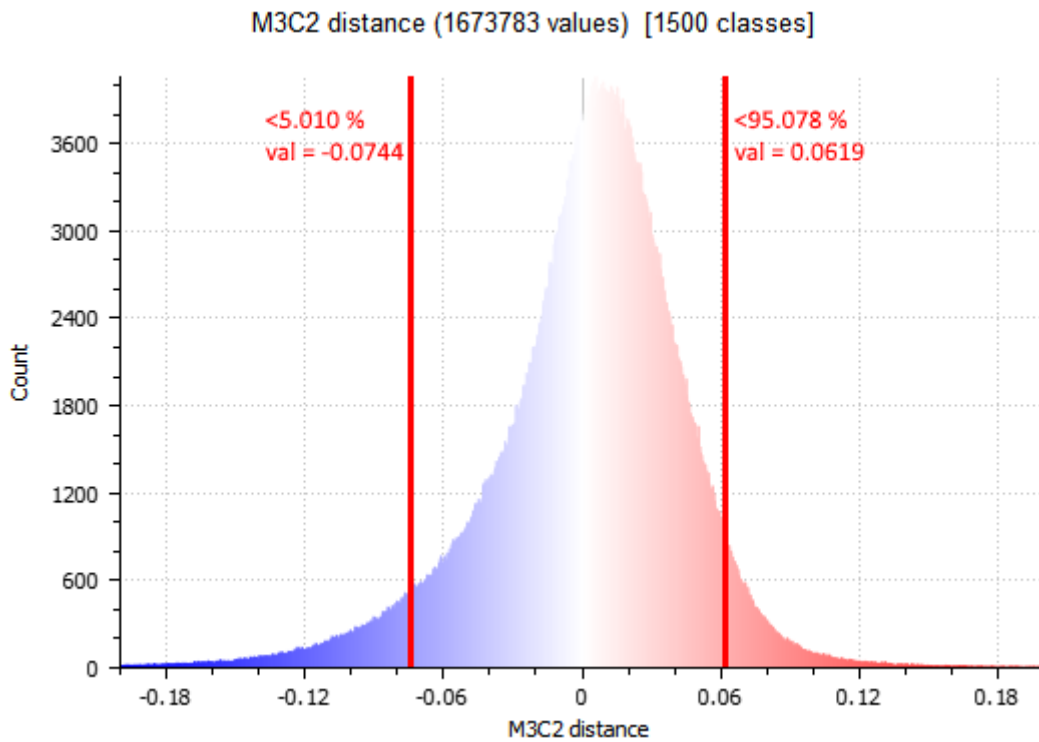
Figure 5-5: Level of detection on Chin Coulee LiDAR change detection between July 10, 2018 and August 23, 2018

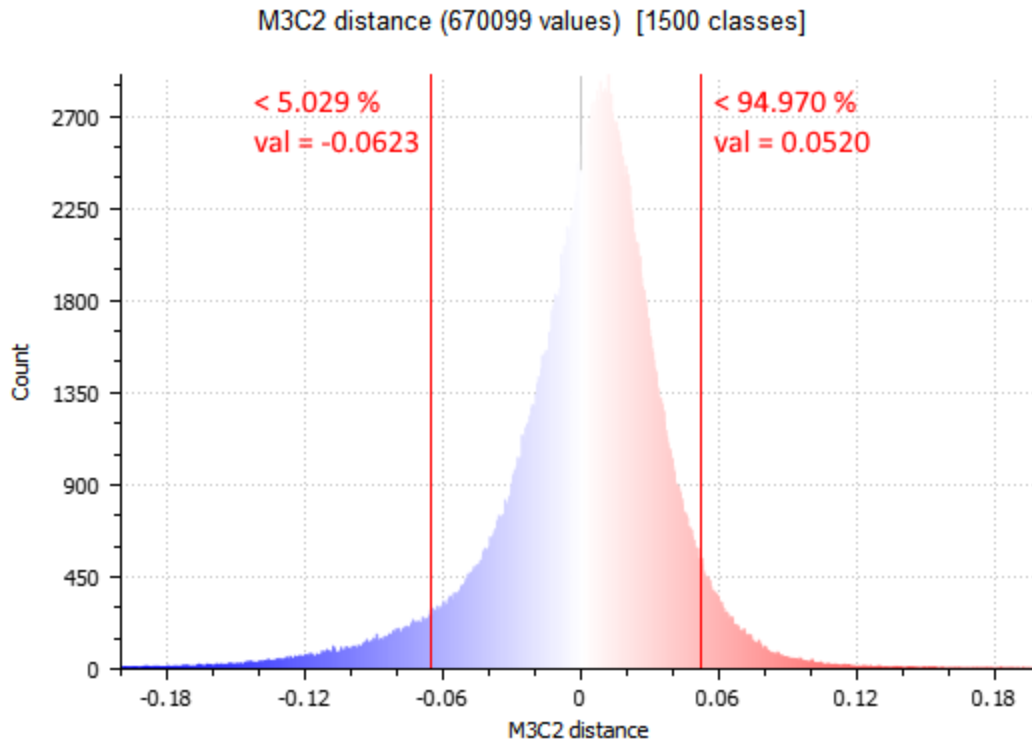
Figure 5-8: Level of detection on Chin Coulee LiDAR change detection between August 23, 2018 and July 29, 2019

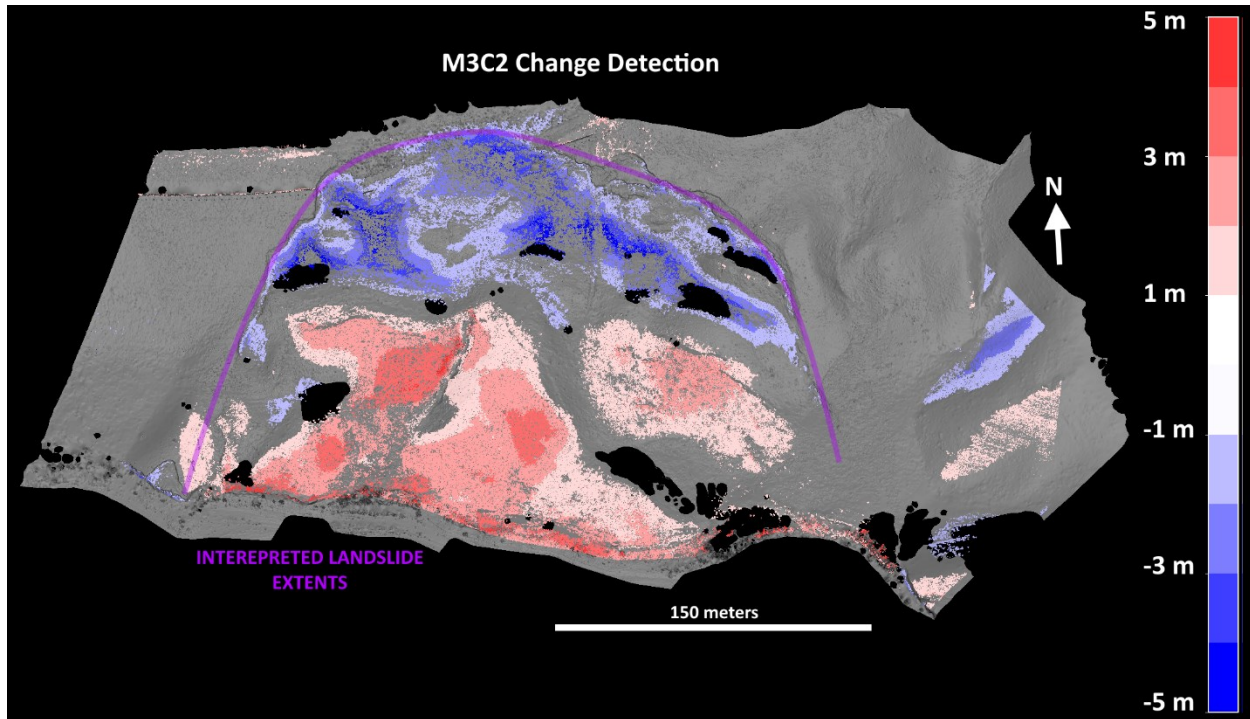
Figure 6-2: 1982 photogrammetry model – July 29, 2019 LiDAR scan M3C2 change detection

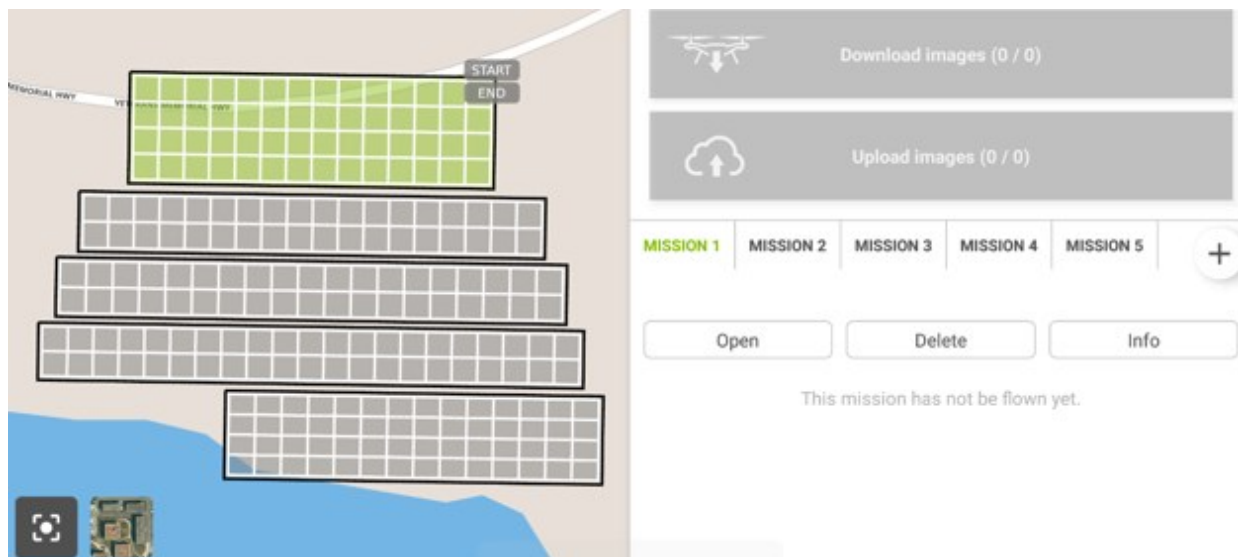
Figure 6-5: Pix4DCapture flight plan ui for Chin Coulee (Pix4D 2019)

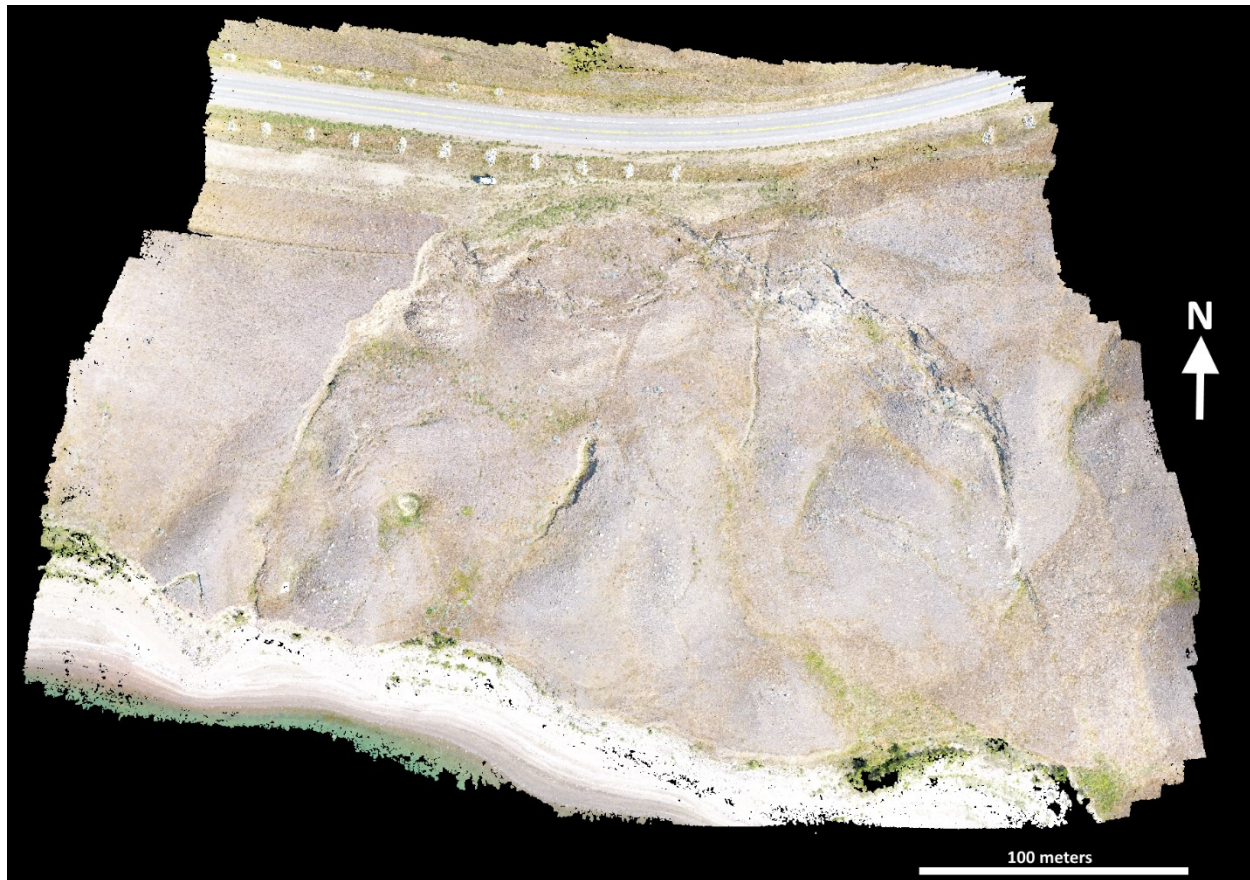
*Figure 6-9: UAV photogrammetry model from July 30, 2019 flight on Chin Coulee*

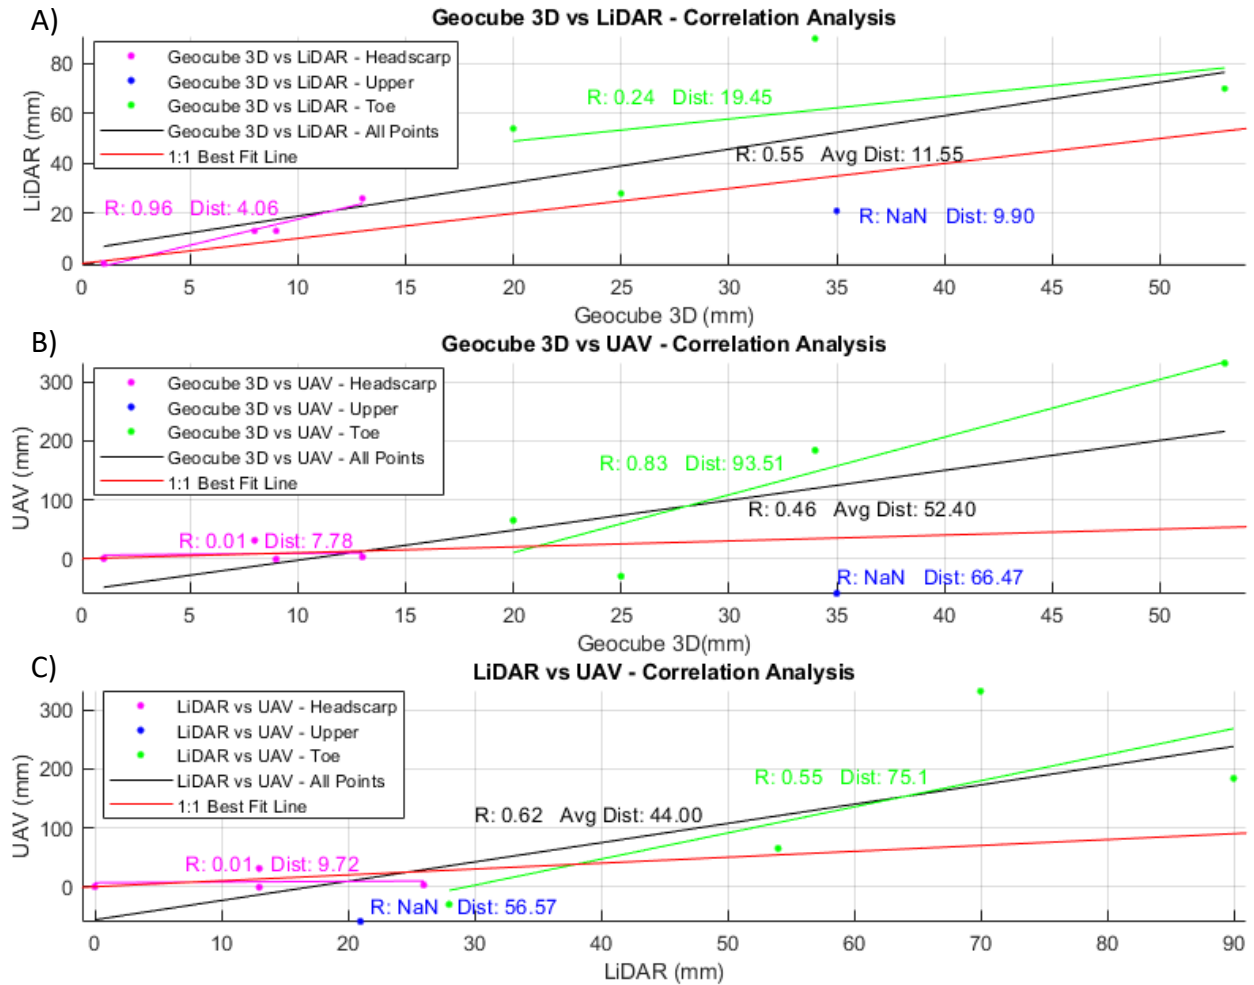
Figure 7-2: Technology results correlation and consistency analysis

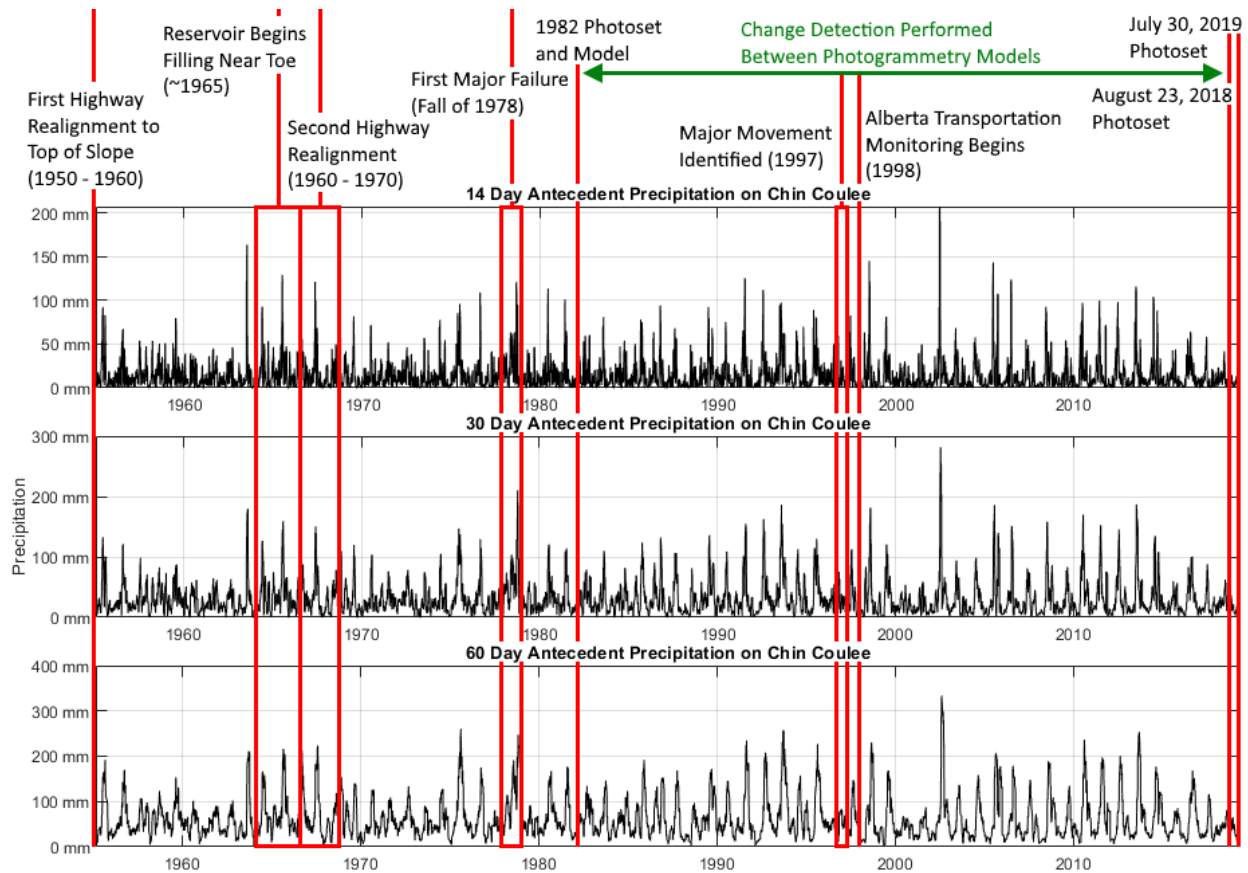
Figure 8-7: Chin Coulee site history and antecedent precipitation from 1955 through 2019

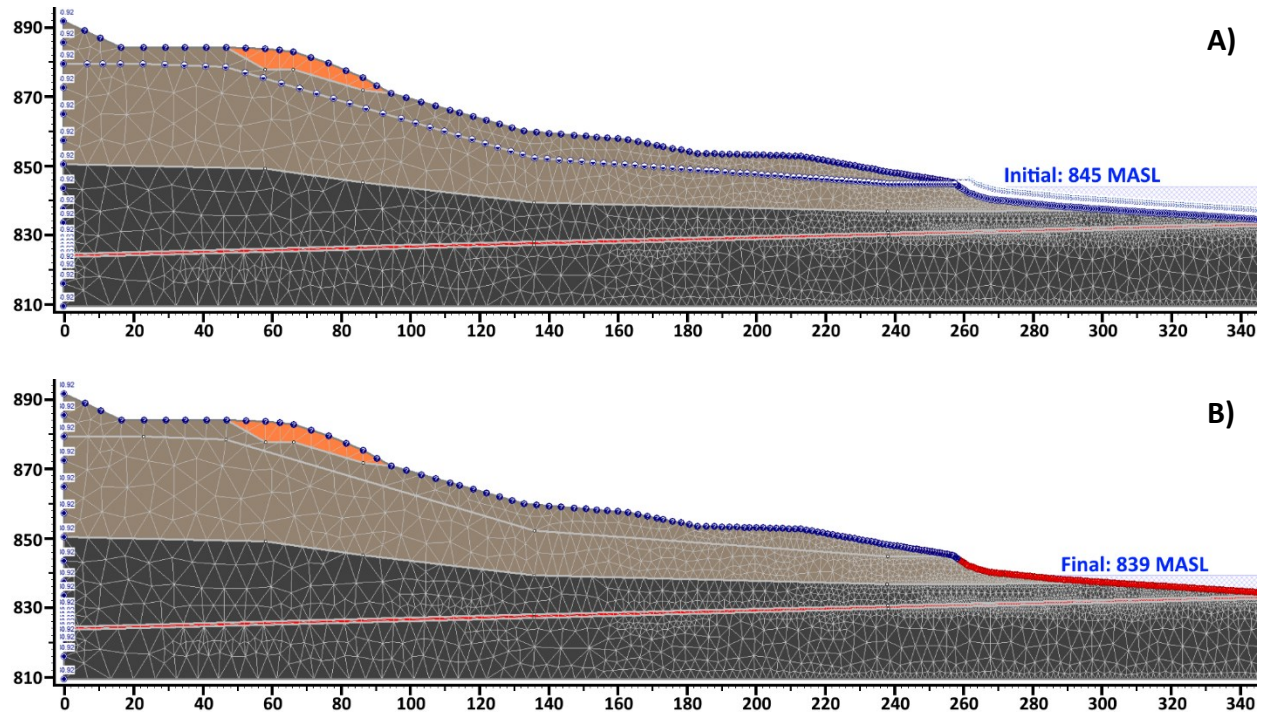
Figure 8-14: Initial (Steady State) (A) and final (Transient) (B) reservoir states for permeability sensitivity analysis

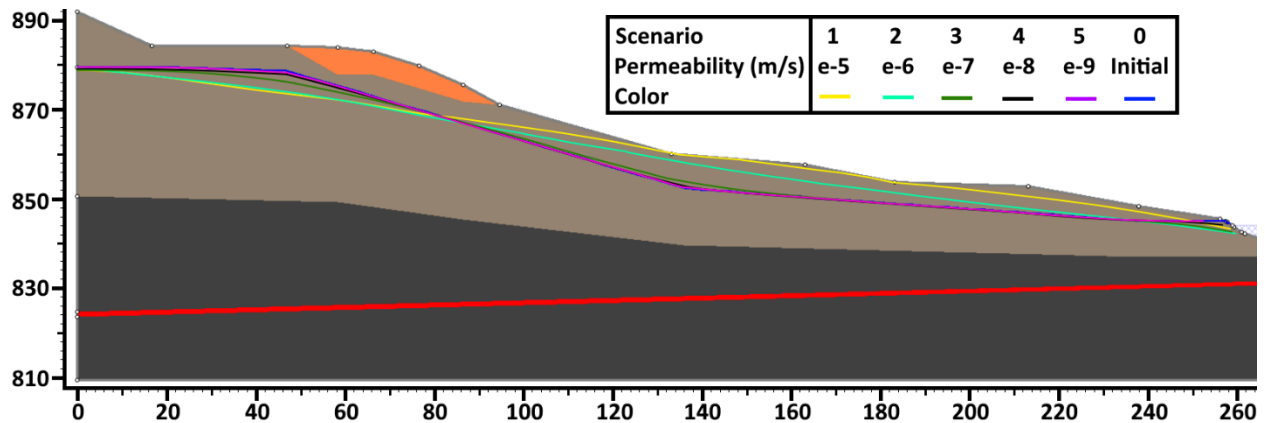
Figure 8-15: Chin Coulee Clay Till permeability sensitivity analysis (5 meter drawdown over 55 days)
