Modelling Repair Techniques for Reinforced Concrete Bridge Barriers using Glass Fibre  
Reinforced Polymer Bars

A thesis submitted in partial fulfillment of the requirements for the degree of

STRUCTURAL ENGINEERING

University of Alberta

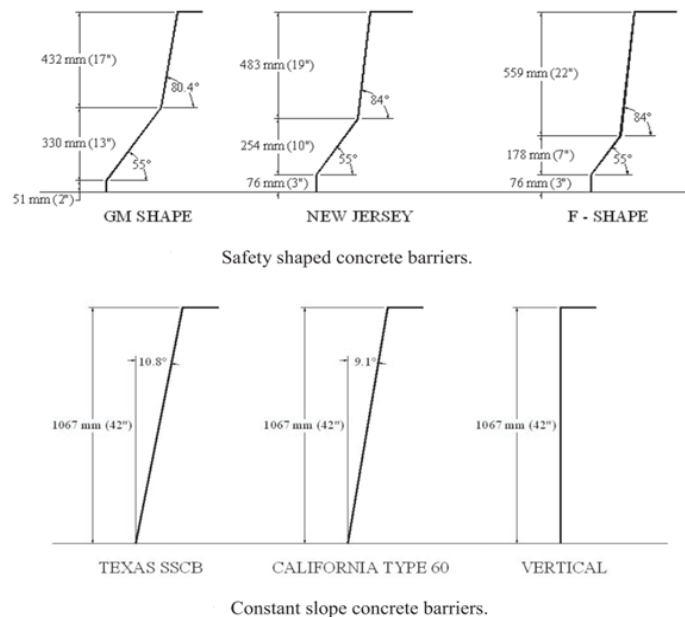
**Figure 2.3: Different shapes of concrete barriers (Rosenbaugh et al. 2007).**

The GM shape and its descendants, shown in Figure 2.3, are called safety shaped barriers. Through the late 1950's and early 1960's the New Jersey Department of Transportation developed the New Jersey barrier via crash testing (Hellriegel 1968). The lower slope of this barrier allows impact forces to act over the time the vehicle travels over the slope and transversely into the barrier. This extended time results in lower peak impact forces and reduced accelerations for the passengers as opposed to the shorter interval associated with a flat wall (Rosenbaugh et al. 2007). However, tire climb increases the possibility of vehicle rollover at higher impact angles. The F-shape barrier was designed to reduce vehicle climb and rollover as a result of a parametric study on the basic New Jersey shape. Single slope barriers were developed to further increase vehicle stability by eliminating the lower slope of the New Jersey and F-shape barriers. Vehicle stability is greatly improved for single slope barriers compared to two-slope shapes. Single-slope barriers include the California Type 60 barrier and the Texas SSCB. Due to the significant amount of wheel climb and risk of instability problems (i.e. rollover), barriers with vertical faces were developed to improve vehicle stability but these shapes reduce impact time duration leading to larger peak impact forces which lead to increased risk of injury and fatality during impacts (Rosenbaugh et al. 2007).

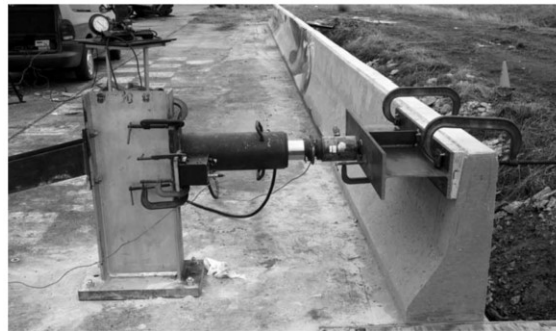
*Figure 2.9: Test setup for static load testing (Alberson et al. 2004).*

Crash tests by Alberson et al (2004) were followed by static tests replicating the most critical load used in design (i.e. the transverse load) to verify the analytical capacity of the barrier. As seen in Figure 2.9, a hydraulic ram attached to a braced load frame, pushing on a load cell, and placed against a spreader beam was utilized to apply the static load. It was concluded from static testing of the barrier that the actual capacity exceeded yield line analysis predictions by around 10%. Also, it was inferred that static analysis using yield line theory provides good estimates of failure loads.

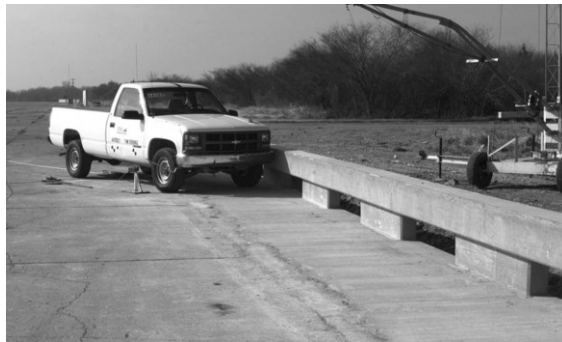
**Figure 2.13: Open post-railing reinforced with GFRP and test vehicle (Buth et al. 2003).**

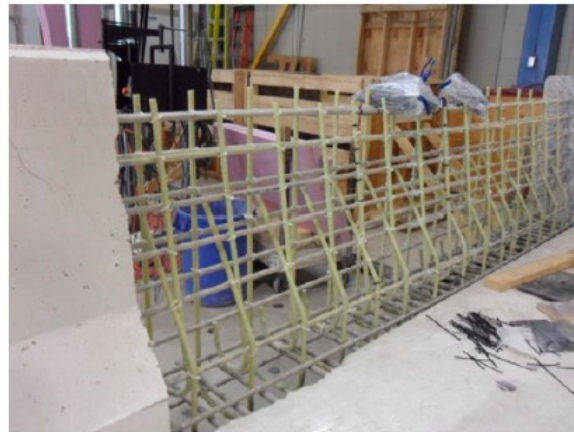
**Figure 2.14: Doweling technique showing hole layout and photograph of planted reinforcement (El-Salakawy et al. 2014).**

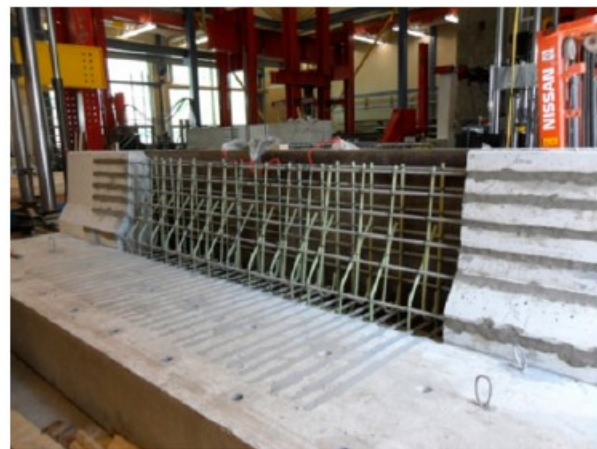
**Figure 2.15: NSM technique showing NSM groove layout and photograph of NSM reinforcement (El-Salakawy et al. 2014).**

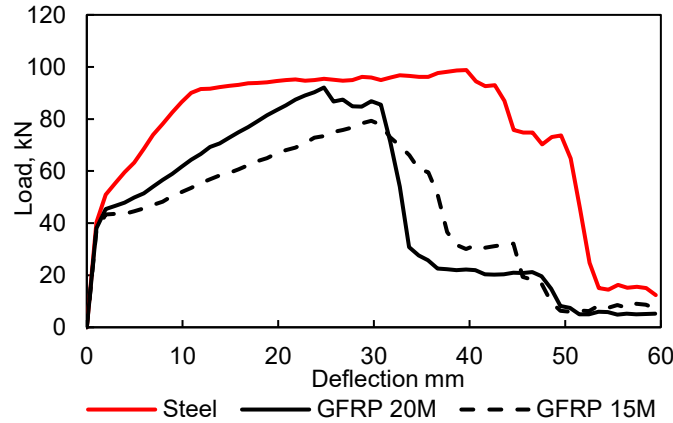
*Figure 3.3: Comparison between Steel and GFRP reinforced models.*

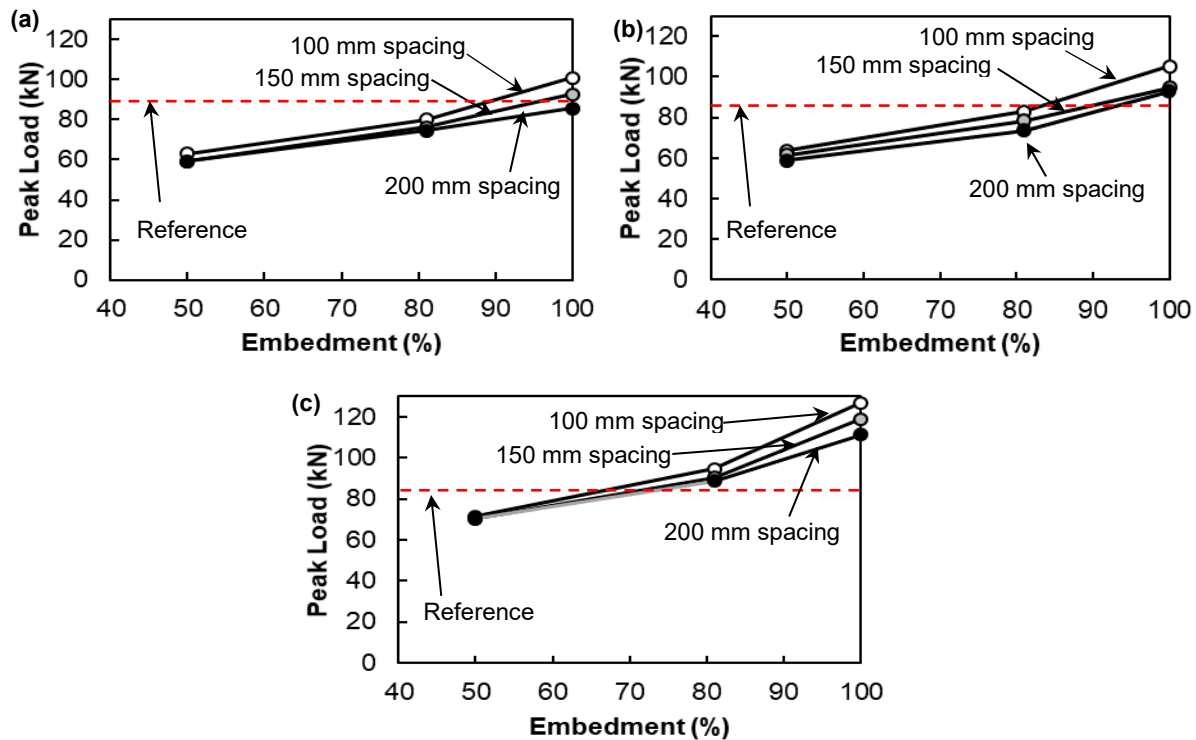
**Figure 3.6: Effect of embedment ratio on barrier peak load for (a) 15 mm GFRP retrofit on 15M reinforced barrier (b) 20 mm GFRP retrofit on 15M reinforced barrier (c) 20 mm GFRP retrofit on 20M reinforced barrier.**

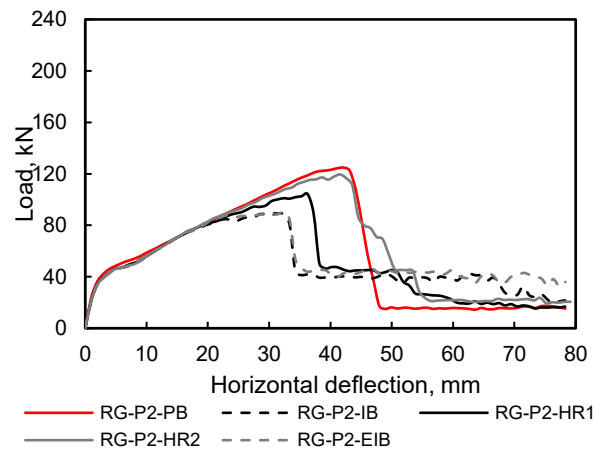
**Figure 5.4: Effect of bond action assumptions on the barrier parapet repair models.**
