Risk Analysis for Rock Fall on Highways

Christopher M. Bunce

A thesis submitted to the Faculty of Graduate Studies and Research in partial fulfillment of the requirements for the degree of Master of Science.

Geotechnical Engineering

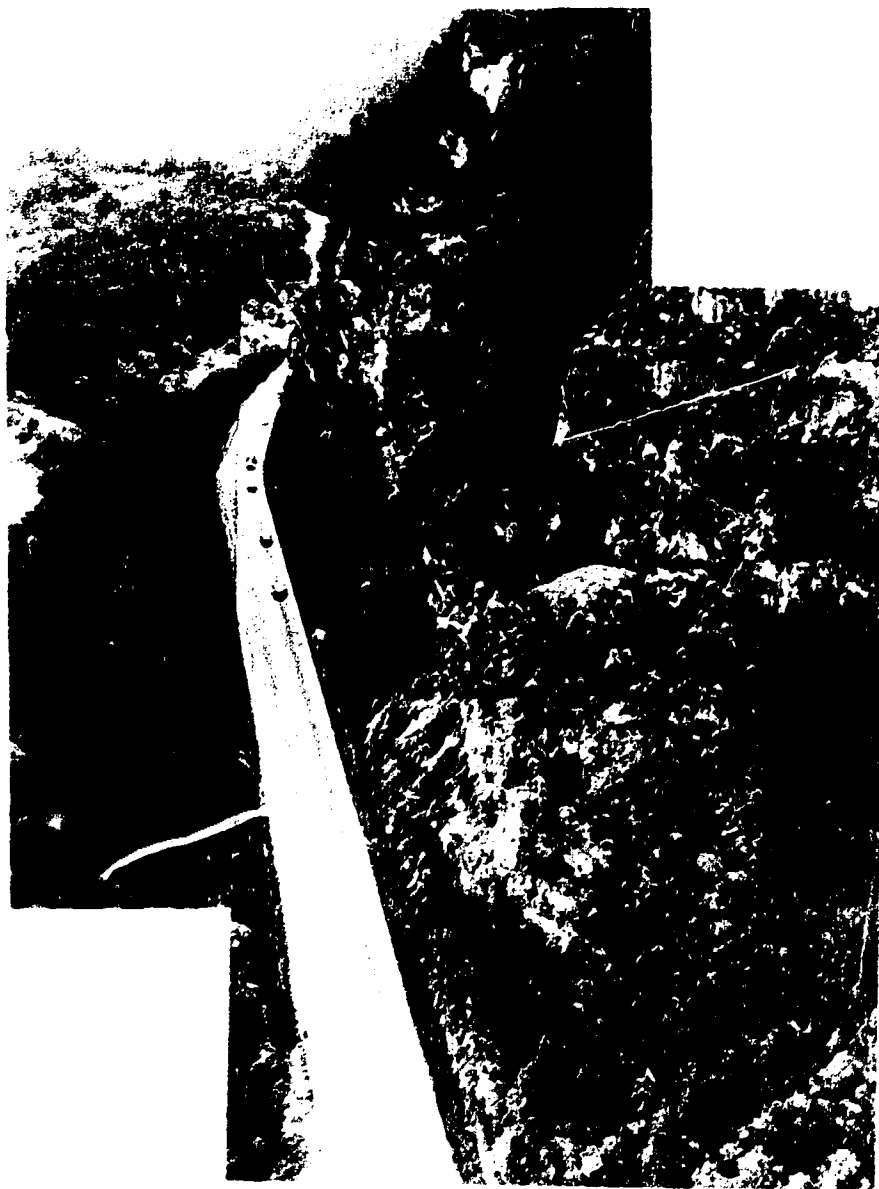
Figure 5.4 Oblique aerial photo collage parallel to Argillite Cut from the north.

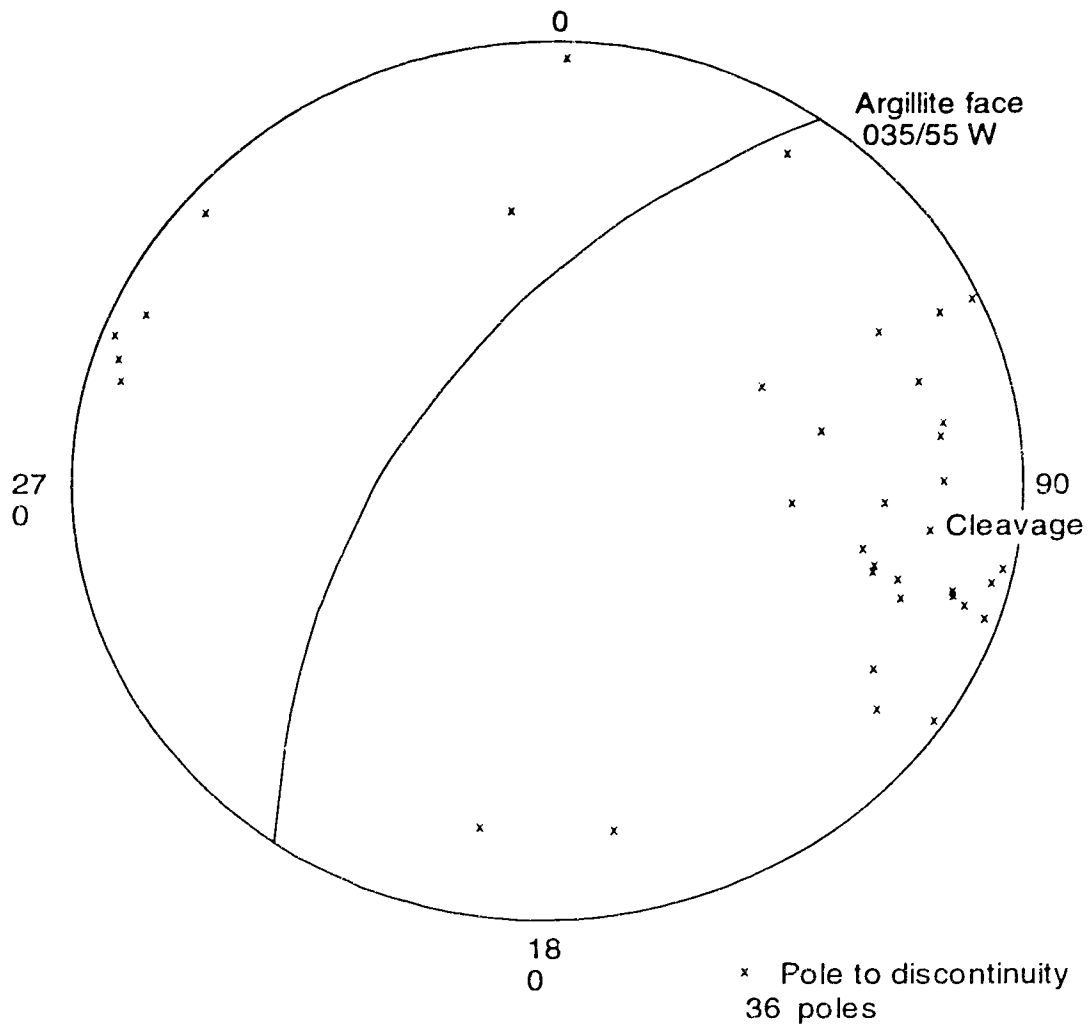
Figure 5.7 Equal area stereonet of discontinuities in the Argillite Cut argillite
