**University of Alberta**

The Effect of Microstructure on Near-Neutral-pH SCC

A thesis submitted to the Faculty of Graduate Studies and Research in partial  
fulfillment of the requirements for the degree of Master of Science

Materials Engineering

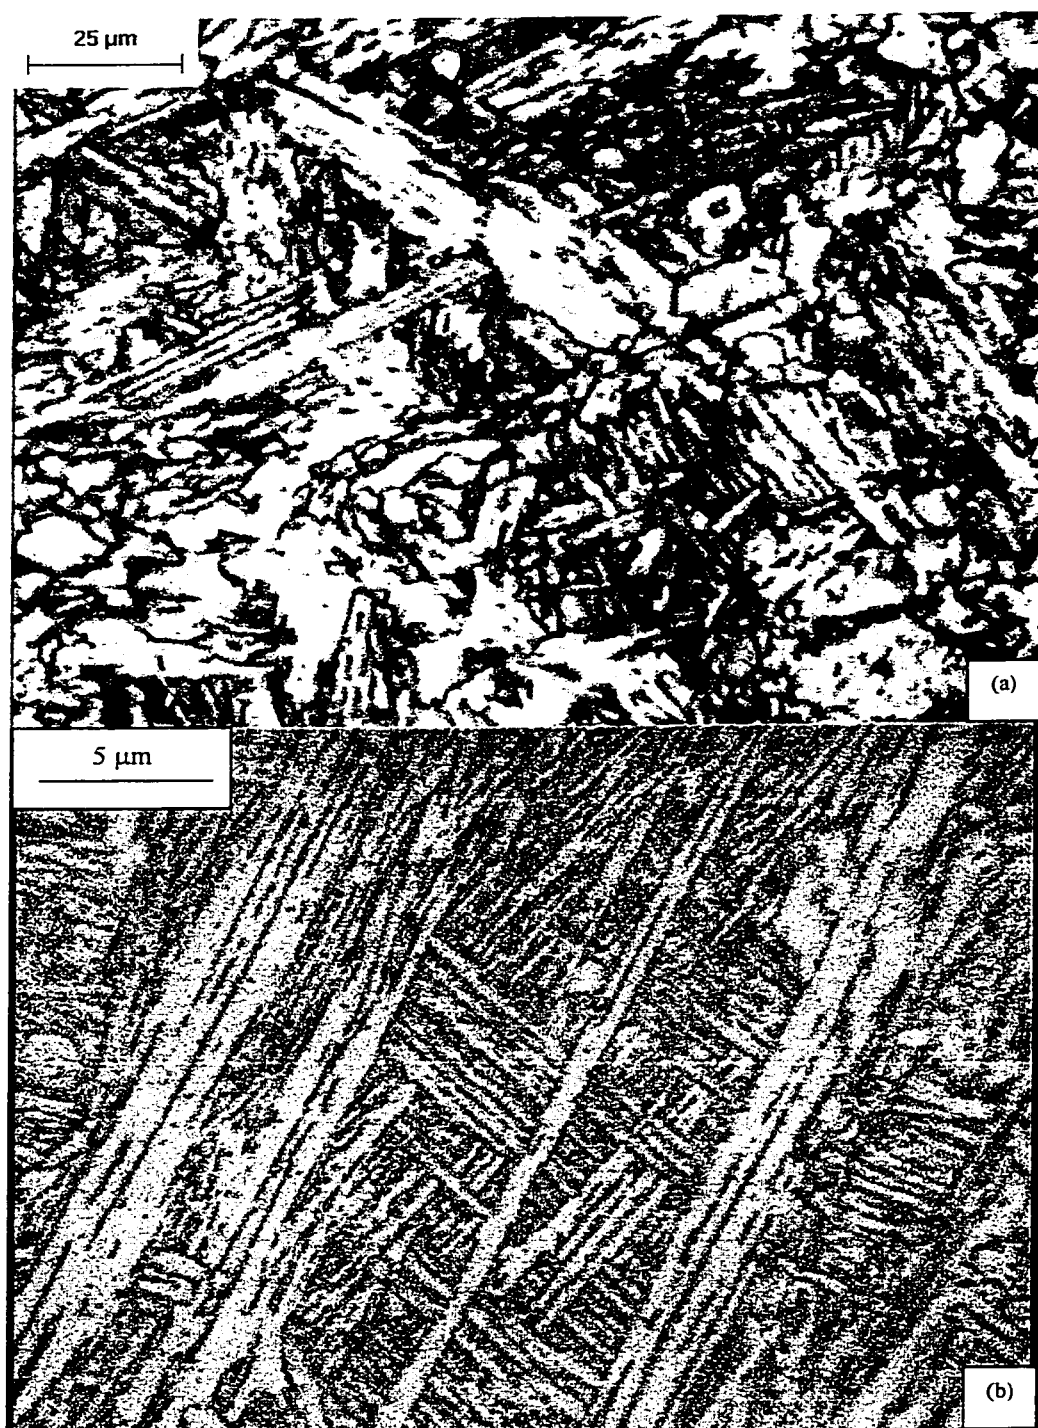
**Figure 4-15: Quenched X-70 microstructure, (a) a low magnification image showing the general microstructure, (b) a high magnification image showing mostly acicular ferrite**
