LARGE WEB OPENINGS IN PRESTRESSED CONCRETE T-BEAMS

RALPH A. LINDER

The undersigned certify that they have read, and recommend to the Faculty of Graduate Studies and Research, for acceptance, a thesis entitled LARGE WEB OPENINGS IN PRESTRESSED CONCRETE T-BEAMS submitted by RALPH A. LINDER in partial fulfilment of the requirements for the degree of Master of Science in Engineering.

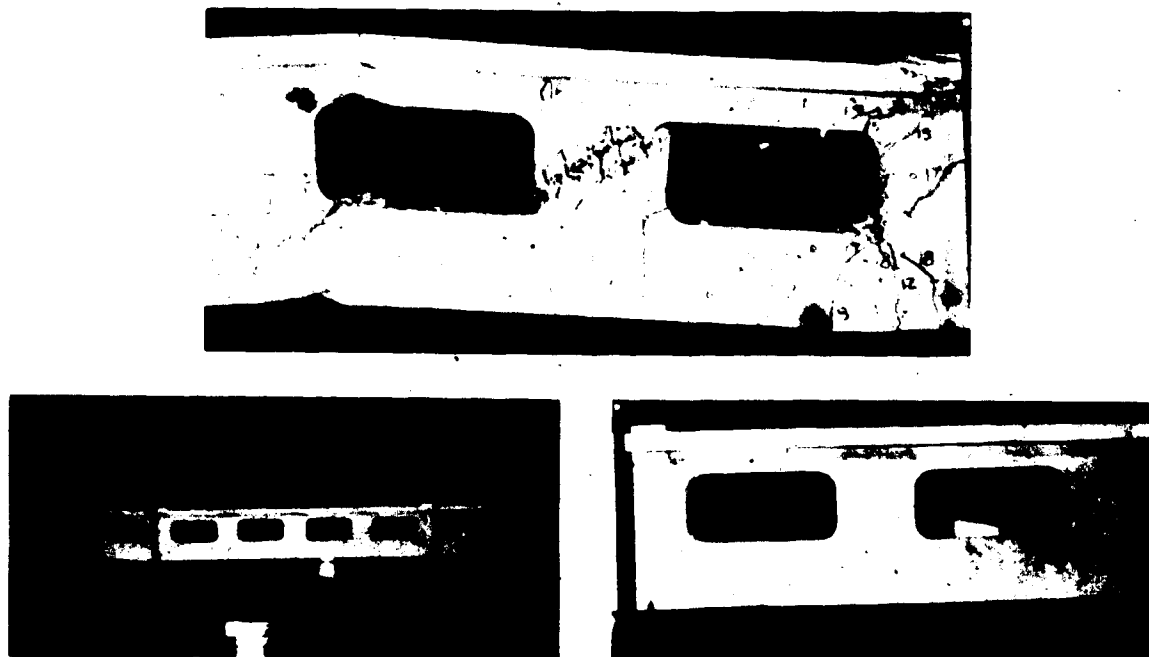
FIGURE 4.114 CRACKING AND FAILURE PATTERN OF BEAM 6-16-6

Figures 4.109 to 4.138 include photographic plates of the cracking and failure patterns of the thirty beams tested. They contain close-up photographs of the beam in the region of the failure and full-length photographs of the beam at failure. The cracks were traced on the beam surface and numbered with the corresponding load increments. The loads and increments are tabulated in Appendix B.

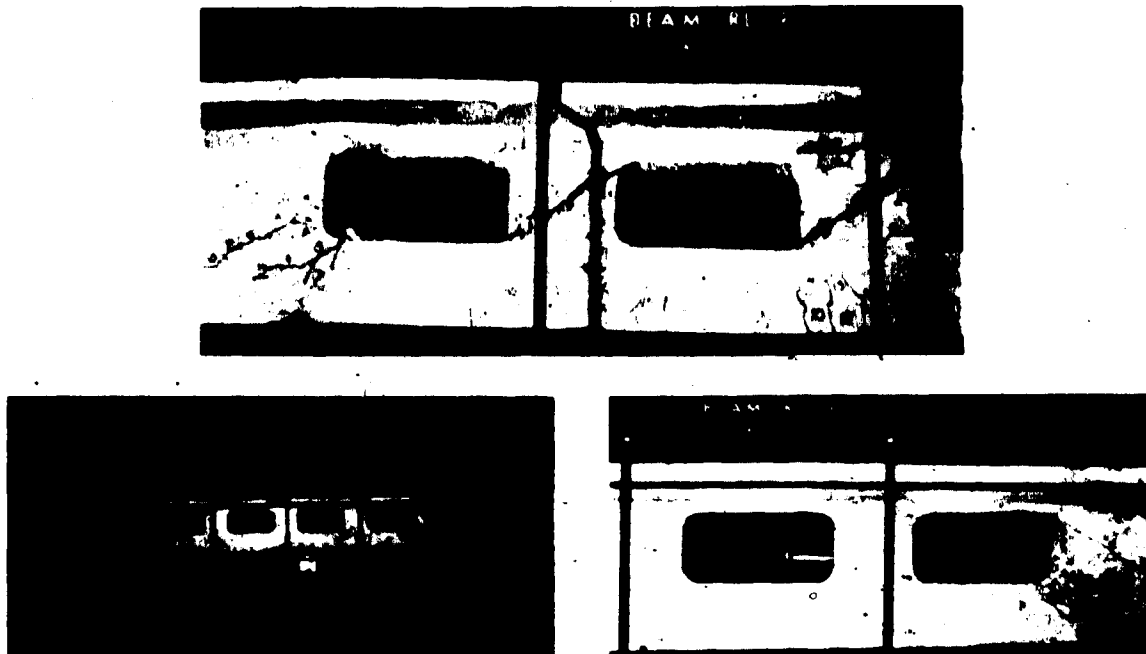
FIGURE 4.117 CRACKING AND FAILURE PATTERN OF BEAM 9-16-7L

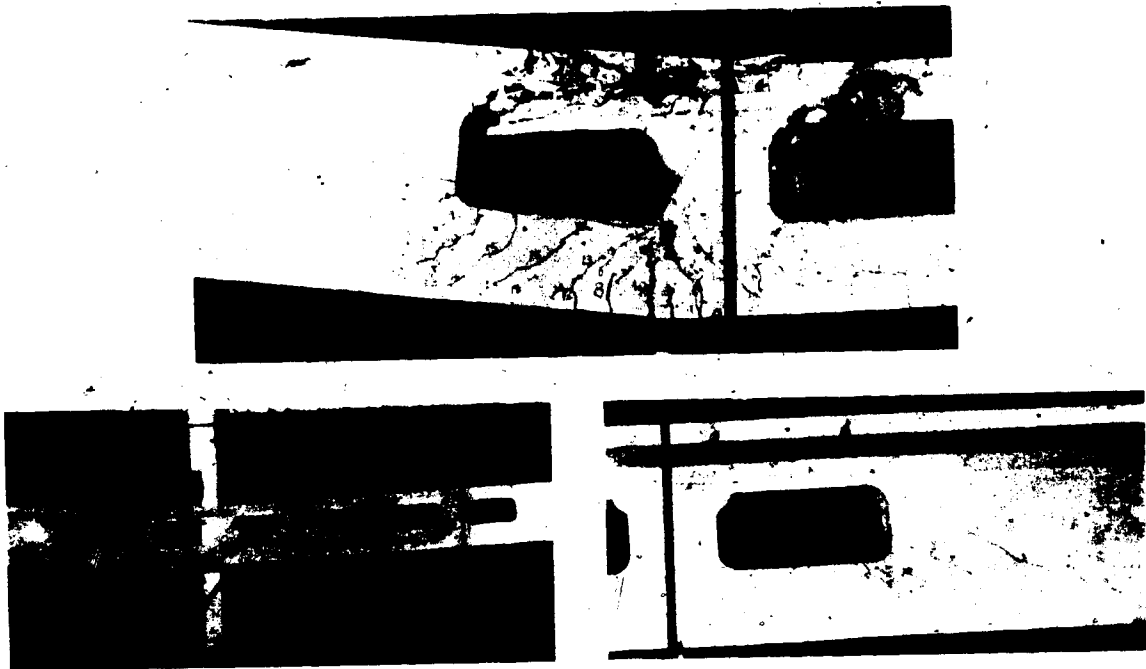
FIGURE 4.125 CRACKING AND FAILURE PATTERN OF BEAM 17-16-4

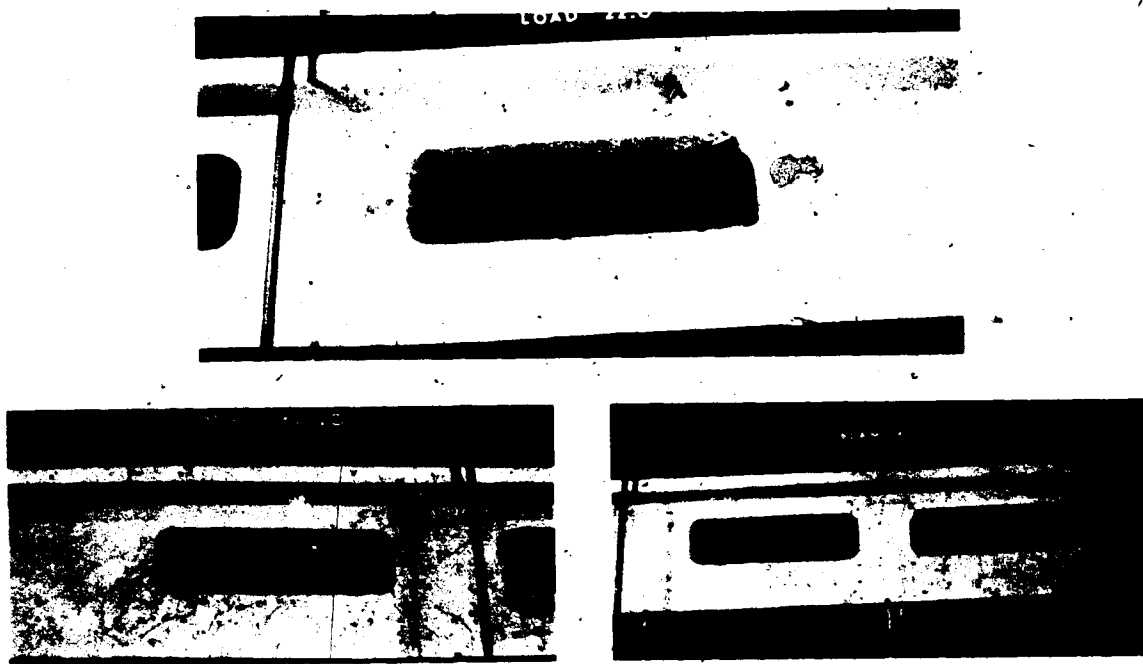
FIGURE 4.128 CRACKING AND FAILURE PATTERN OF BEAM 20-26-5

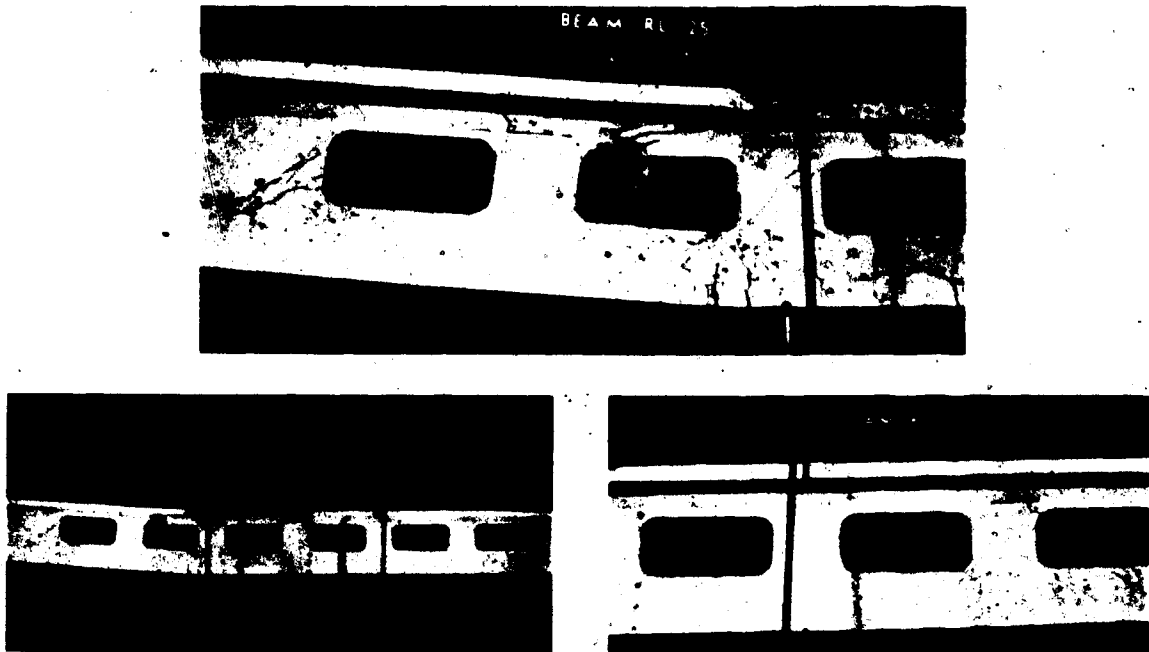
FIGURE 4.133 CRACKING AND FAILURE PATTERN OF BEAM 25-16-6

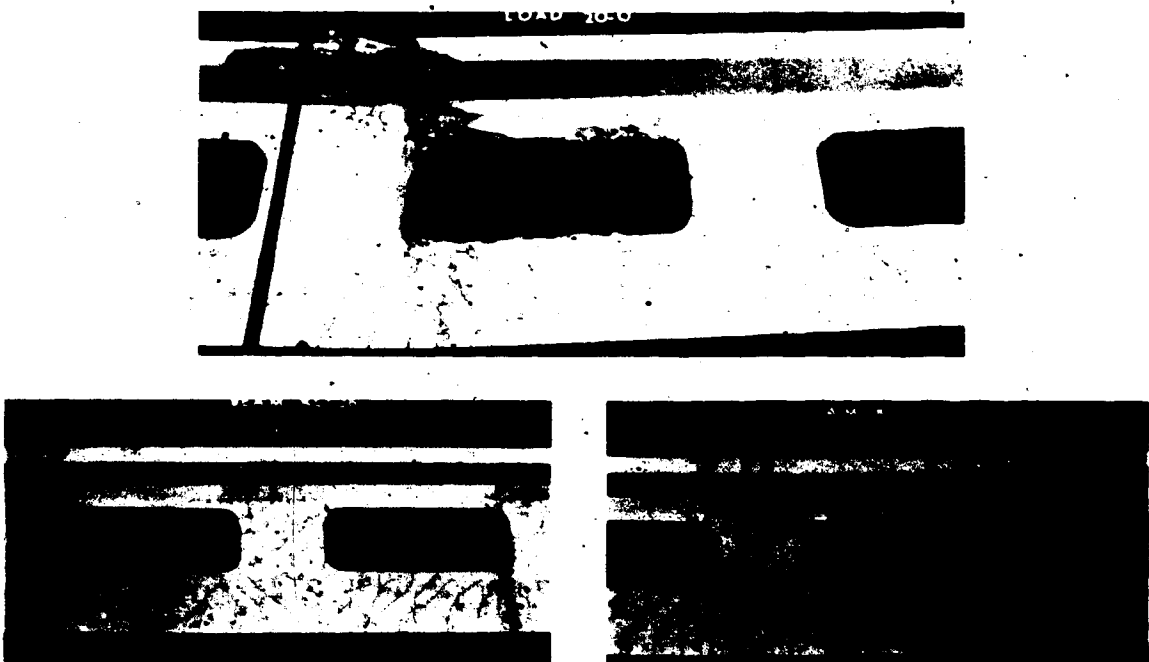
FIGURE 4.134 CRACKING AND FAILURE PATTERN OF BEAM 26-21-7

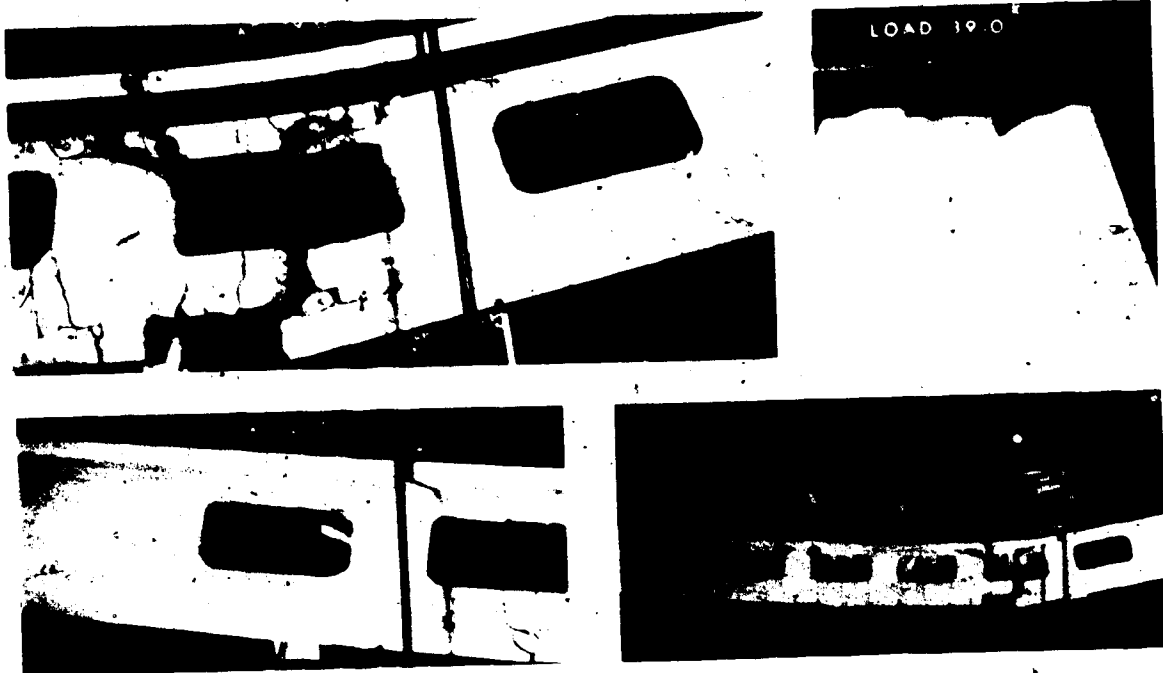
FIGURE 4.135 CRACKING AND FAILURE PATTERN OF BEAM 27-16-4
