DUCTILE STEEL PLATE SHEAR WALLS WITH PEC COLUMNS

Doctor of Philosophy

Structural Engineering

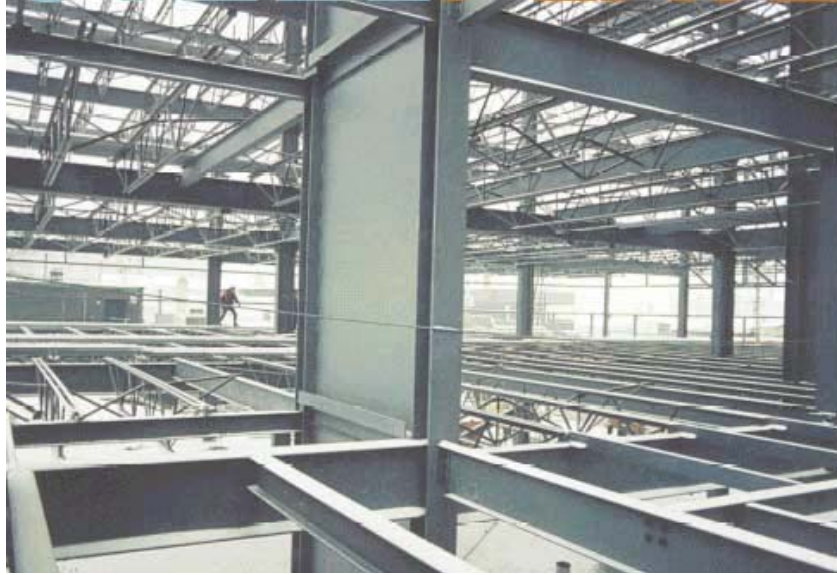
Figure 1.1: Typical steel plate shear wall (Photo courtesy of Canam Group)

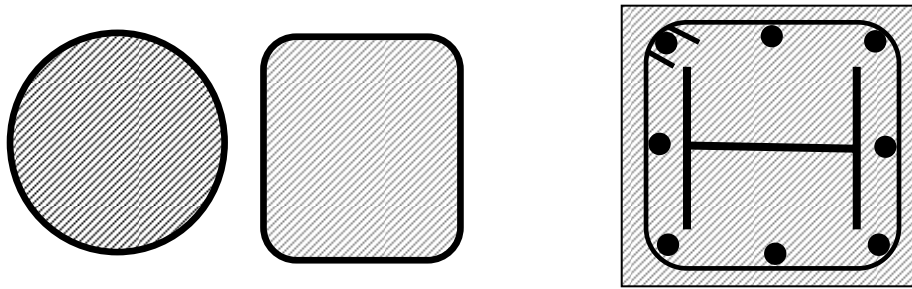
Figure 2.1: Concrete-filled tubes (left) and fully encased composite column (right)

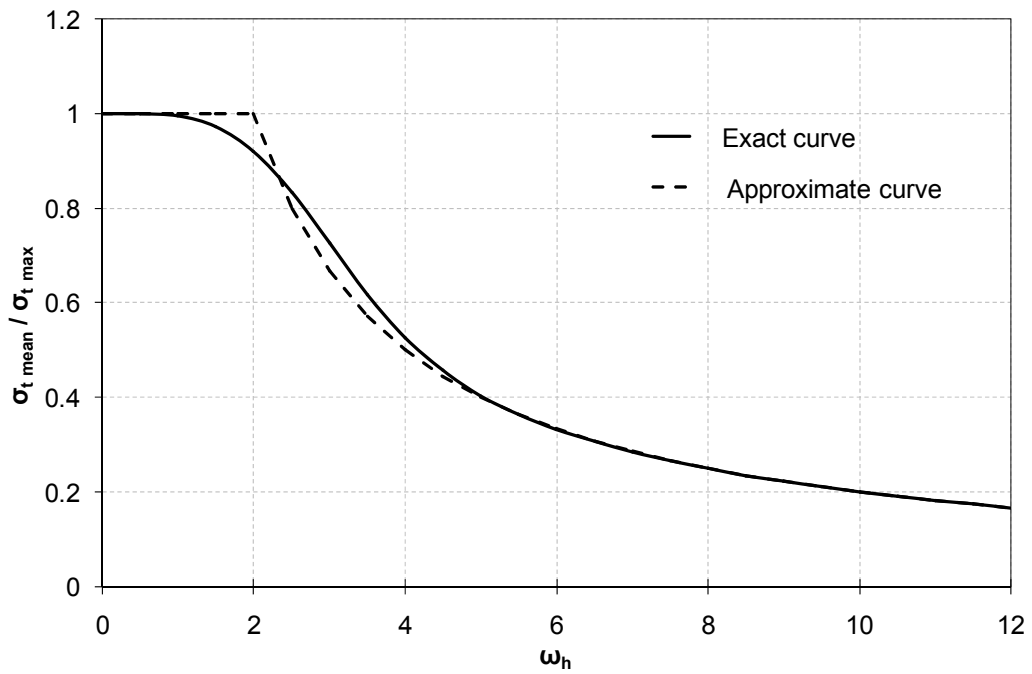
Figure 2.6: Exact and approximate curves to find the maximum stress in a non-uniform tension field (Wagner 1931)

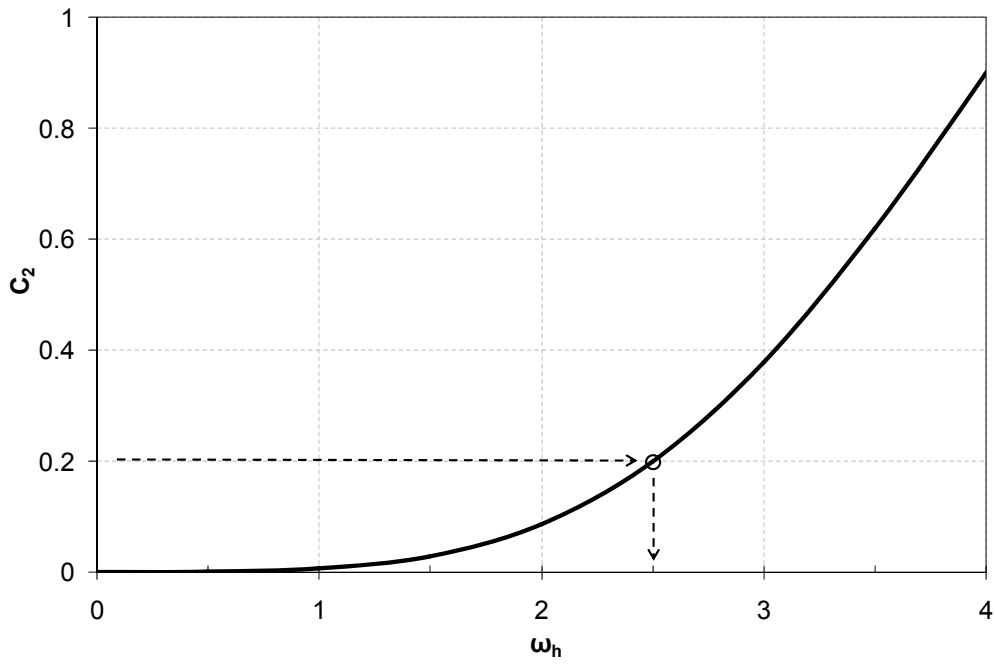
Figure 2.7: Parameter C_2 as a function of the parameter ω_h

Kuhn et al. (1952) made some more assumptions on the equation of ω_h to further simplify it. One of the assumptions was that the angle of inclination, α , is assumed slightly less than 45 degrees and thus $\sin \alpha = 0.7$. Also, the sum of the reciprocals could be replaced by four times the reciprocal of the sum. The simplified equation for calculation of the parameter ω_h was proposed as follows:

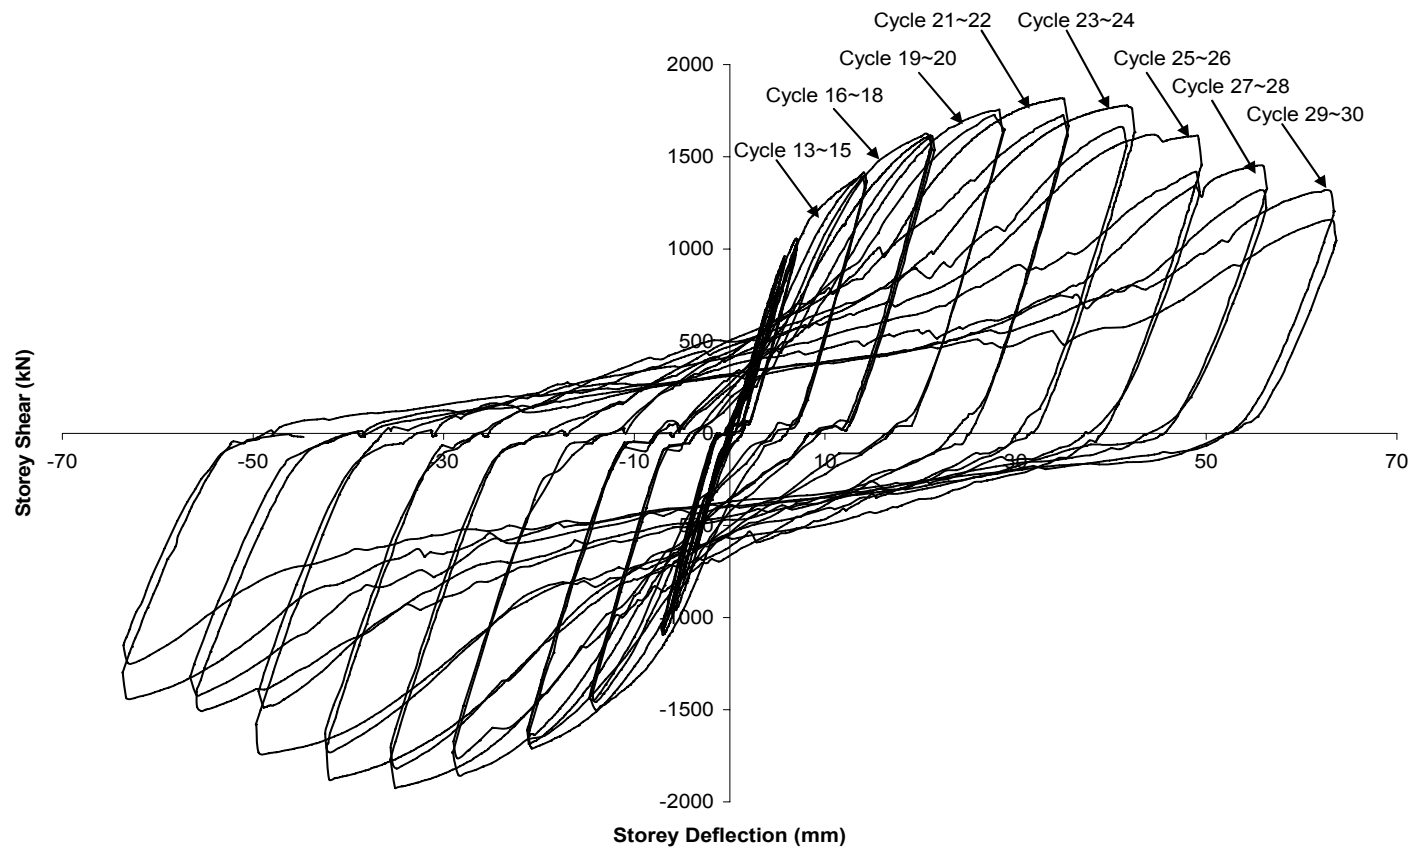
Figure 2.18: Hysteretic loops of story shear versus story deflection of first story (Deng et al. 2008)

The hysteretic loops of base shear versus the story deflection of panel 1 (i.e., first story) are shown in Figure 2.18. The first crack in the column concrete was detected in the first seven cycles and several cracks were detected in cycles 8 and 9, due to the frame

action. The stiffness of the specimen decreased considerably in cycle 13 of the test (cycle to reach first story deflection of 14 mm) due to the development of several horizontal and vertical cracks in the columns. The first sign of local buckling of the outer flanges of columns was detected in cycle 19. Tearing of the outer flanges of the columns started in cycle 21 (cycle to reach first story deflection of 35 mm) and the flanges of the columns tore completely in cycle 26, where the specimen experienced the first story deformation of 49 mm. The maximum base shear of 1817 kN was attained in cycle 21 at a first story deformation of 35 mm. The test was terminated due to significant propagation of the column flange tears into the webs of the columns. Severe concrete crushing was detected in the post-peak stage of this test, which indicates the presence of excessive compressive stress in the concrete at the bases of the columns. A few links failed at the bases of columns in the plastic hinge locations, which worsened the situation in that region as the confinement of concrete as well as the local buckling capacity of column flanges decreased.

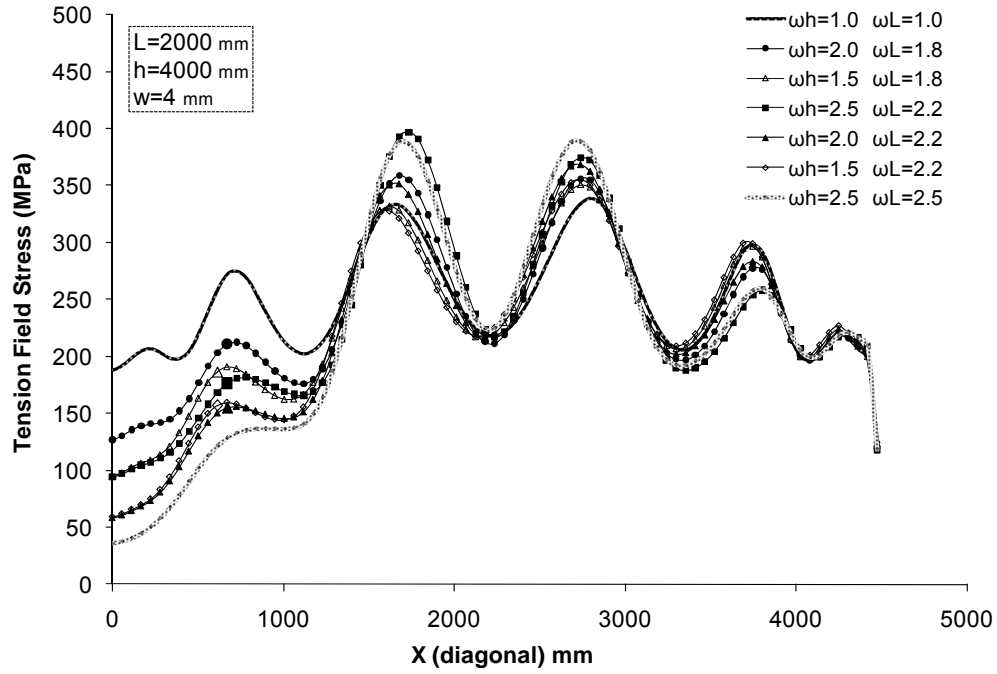
Figure 3.4: Stress distribution along the diagonal of the end panel with $L / h = 0.5$

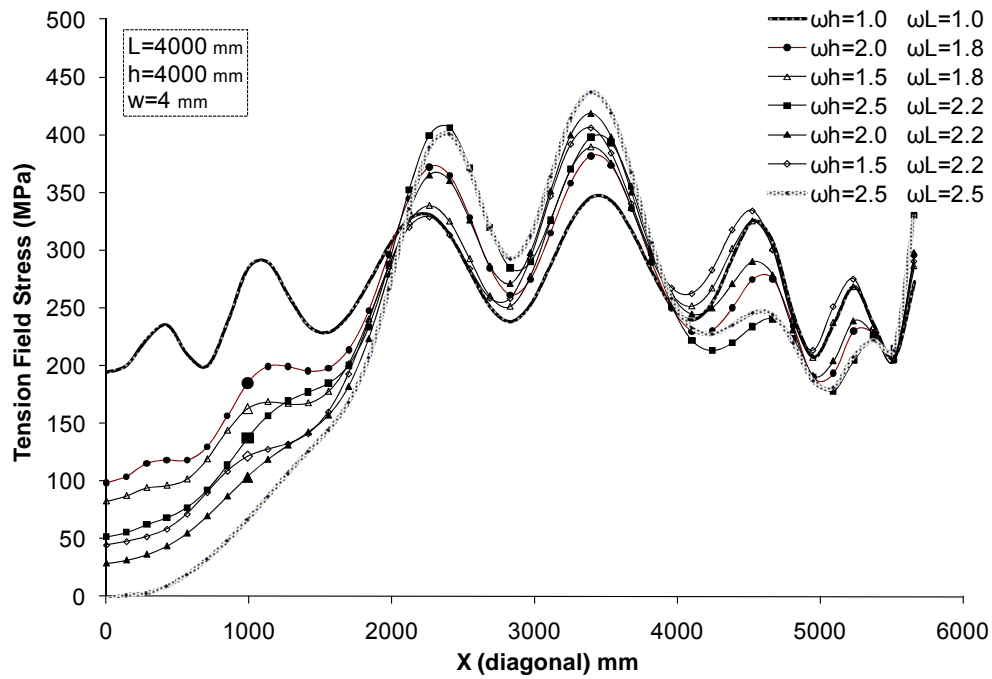
Figure 3.5: Stress distribution along the diagonal of the end panel with $L / h = 1.0$

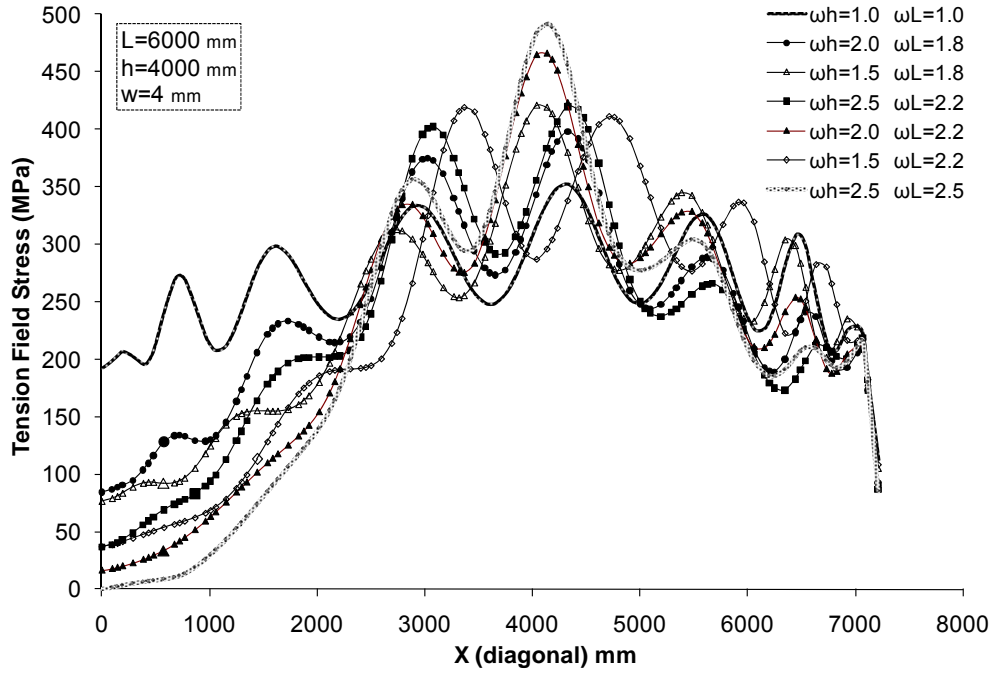
Figure 3.6: Stress distribution along the diagonal of the end panel with $L / h = 1.5$

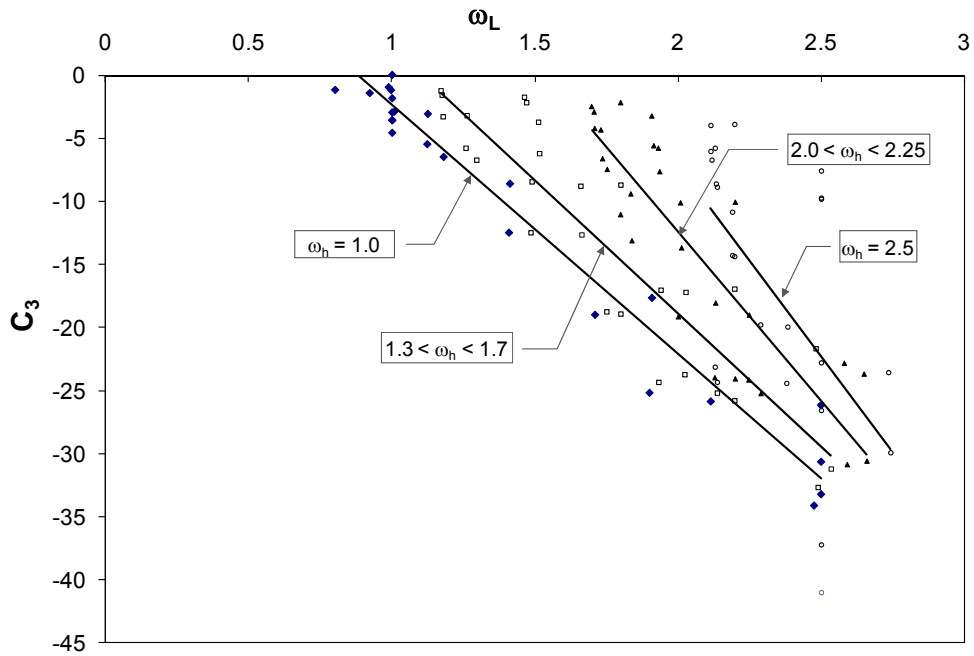
Figure 3.7: Non-uniformity of tension field stress as a function of ω_L and ω_h

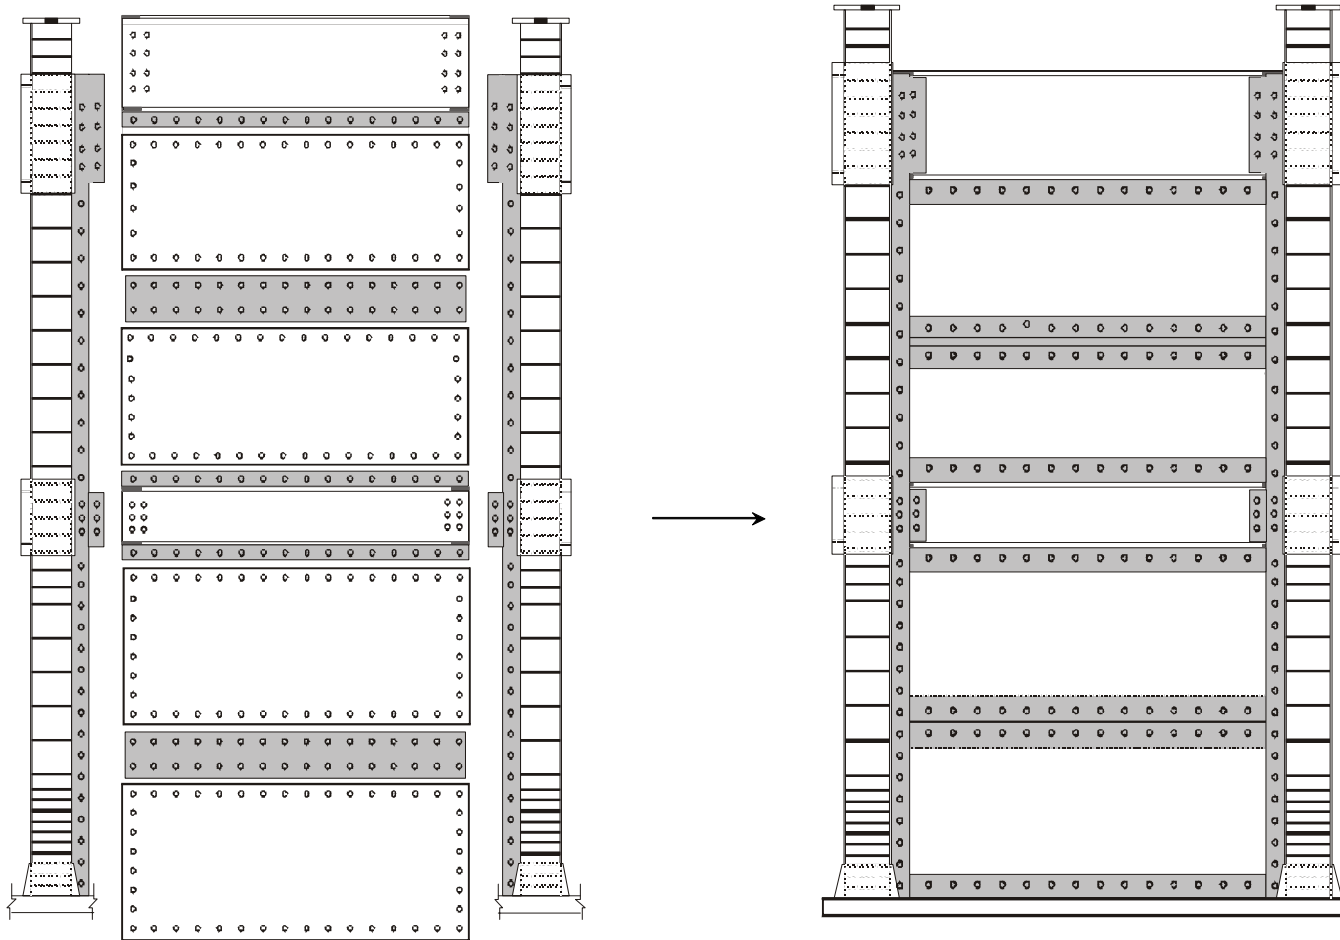
Figure 4.1: Exploded (left) and assembled (right) view of the modular test specimen

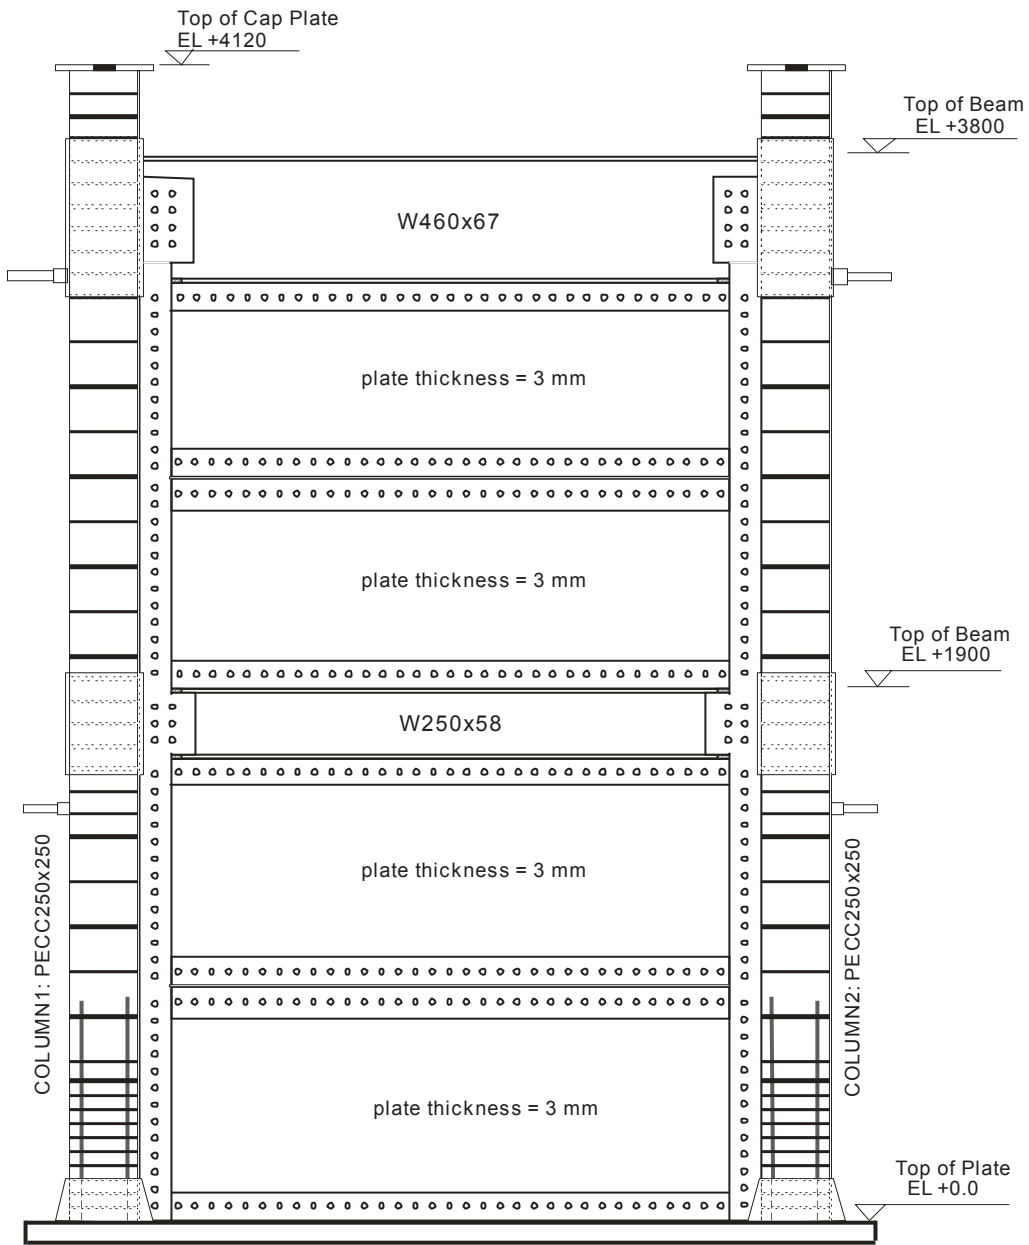
Figure 4.3: Modular steel plate shear wall test specimen

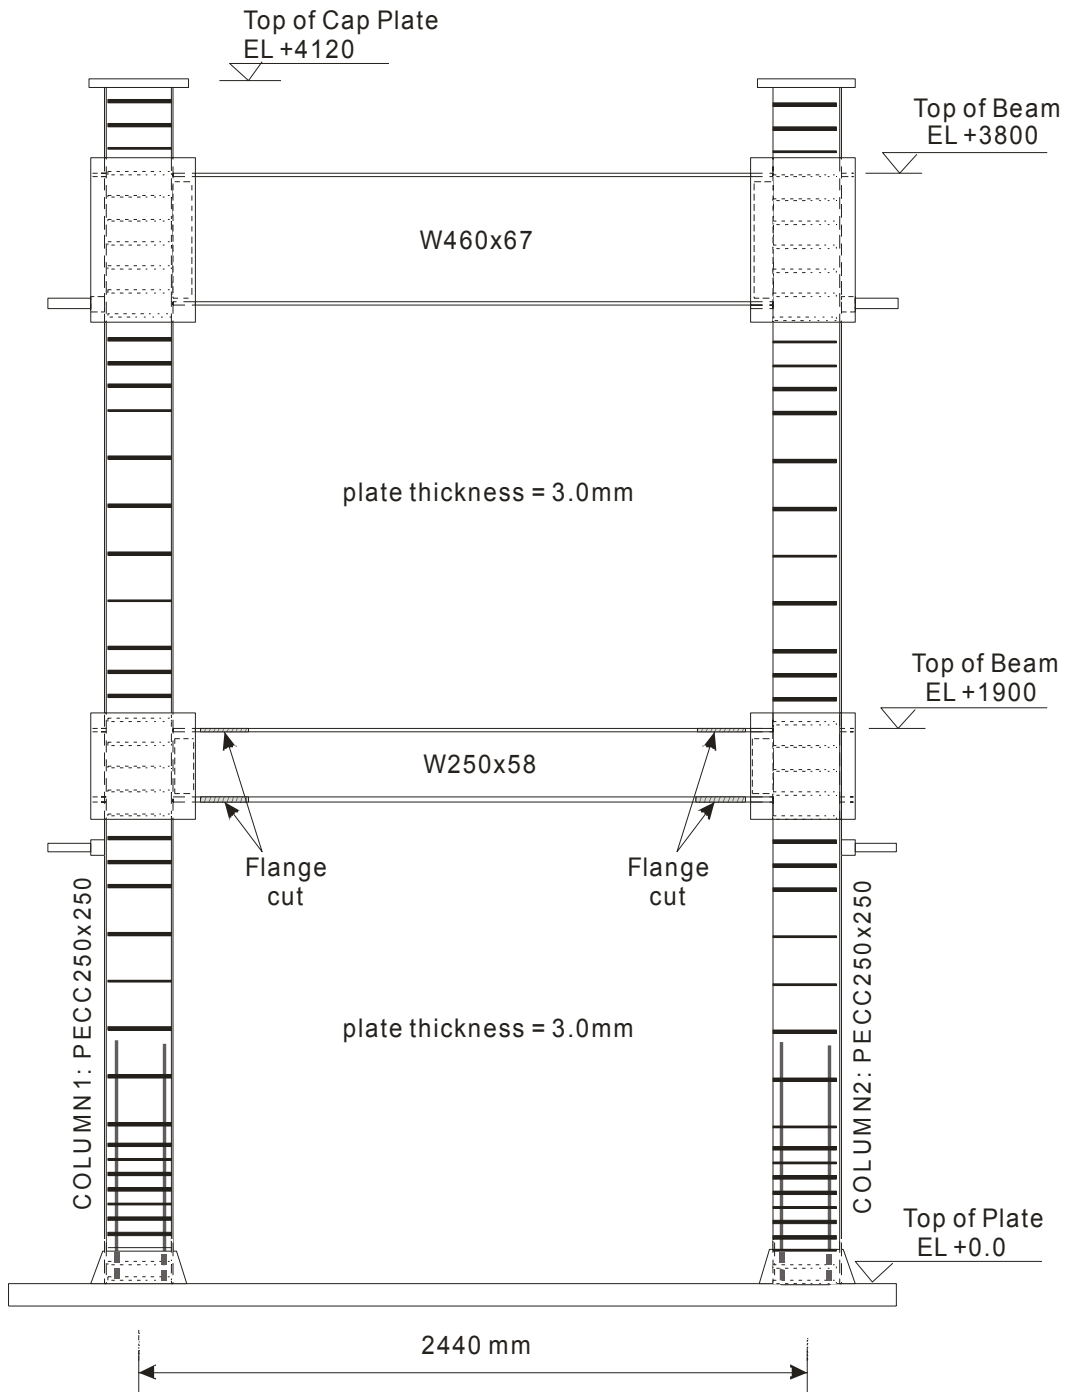
Figure 4.5: Steel plate shear wall test specimen with RBS connections in the first story

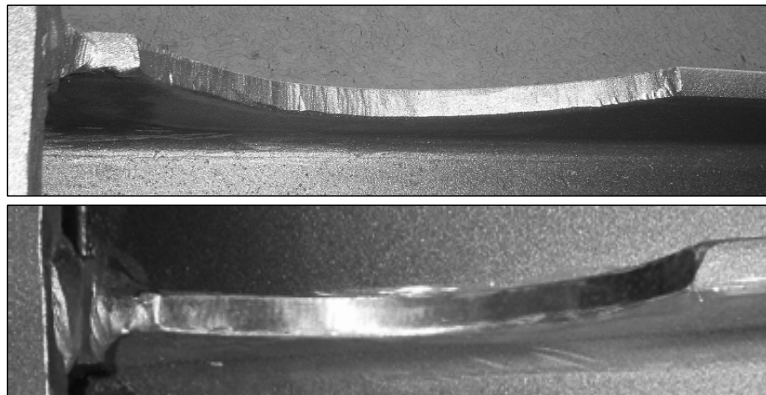
Figure 4.7: RBS cut surface condition; before grinding (top) and after grinding (bottom)

As the RBS cut is normally made by thermal cutting, the cut should be made to avoid nicks, gouges and other discontinuities. The surfaces should be ground smooth to remove any notches in order to avoid fracture or low cycle fatigue in the cut portion. All corners should be rounded to minimize notch effects and, in addition, cut edges have to be ground to a surface roughness of less than 500 micro-inches to meet the requirements of AWS C4.1-77 class 4 (1977).

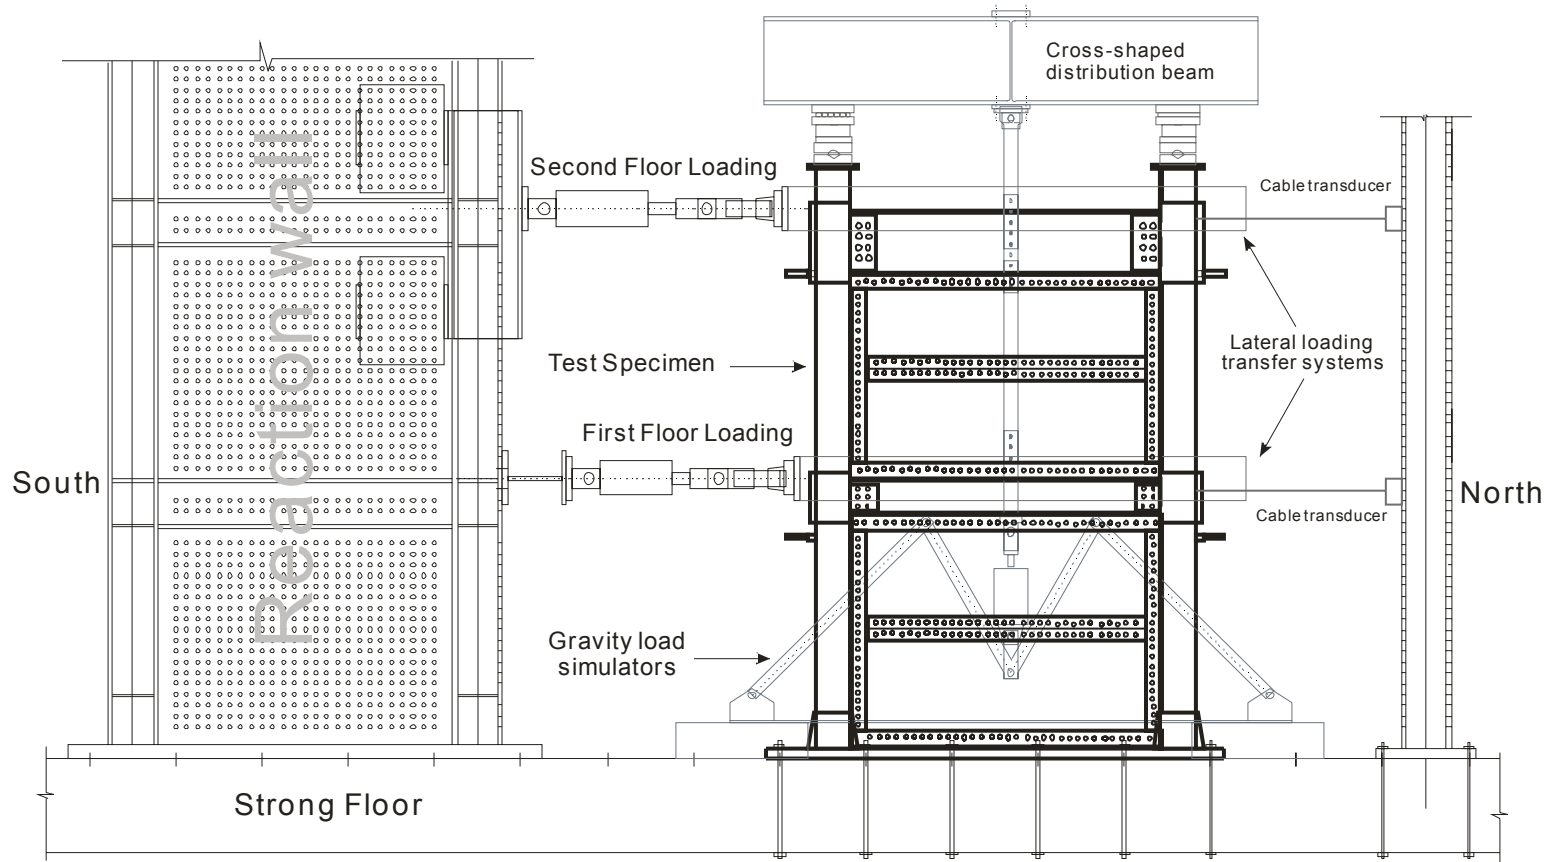
Figure 4.8: East elevation of the modular test set-up

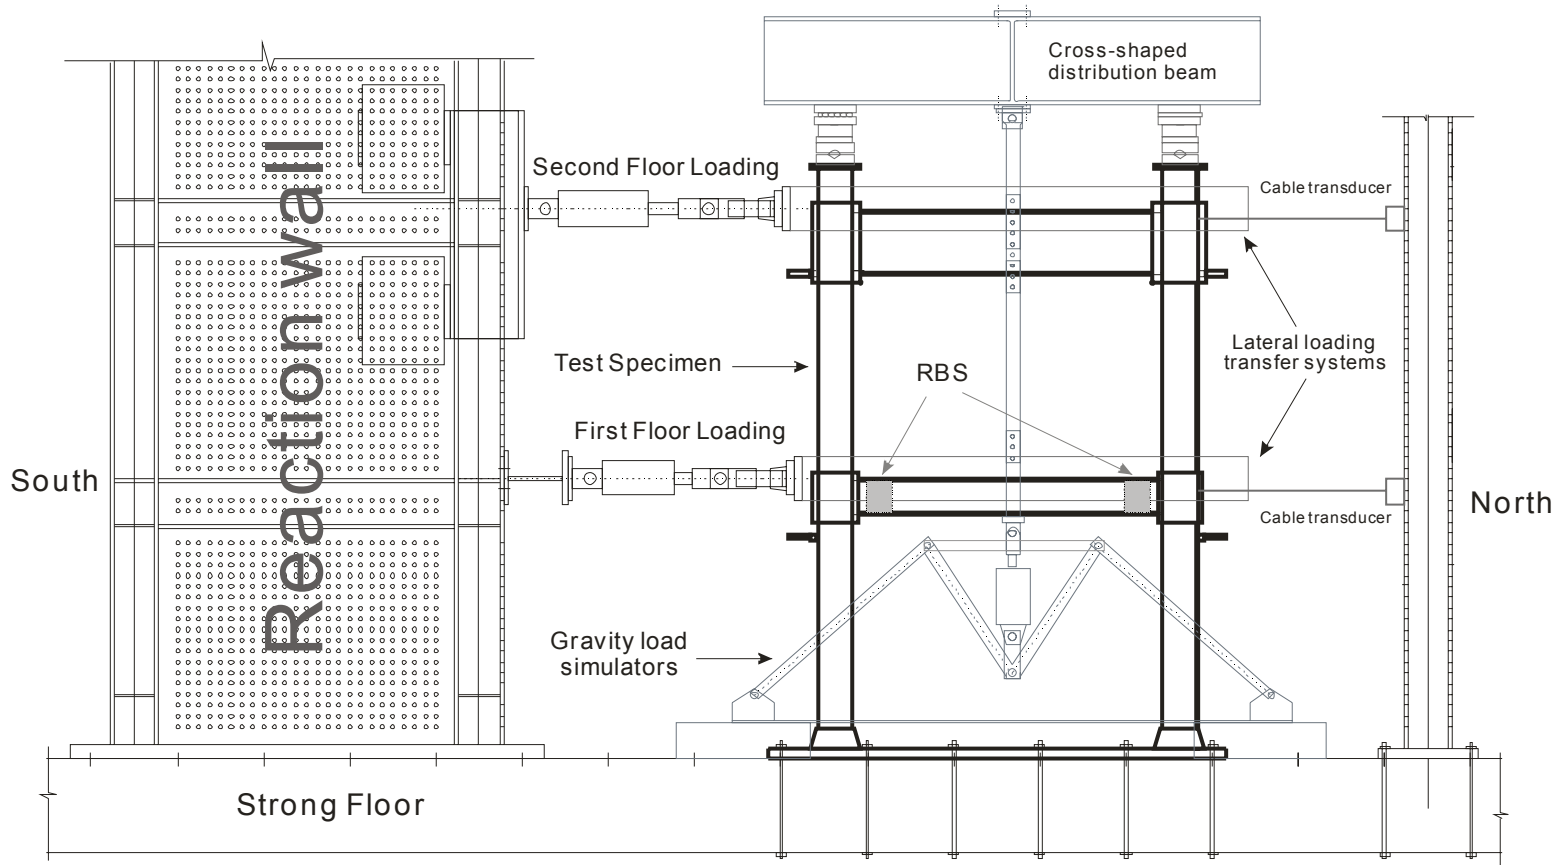
Figure 4.9: East elevation of the RBS test set-up

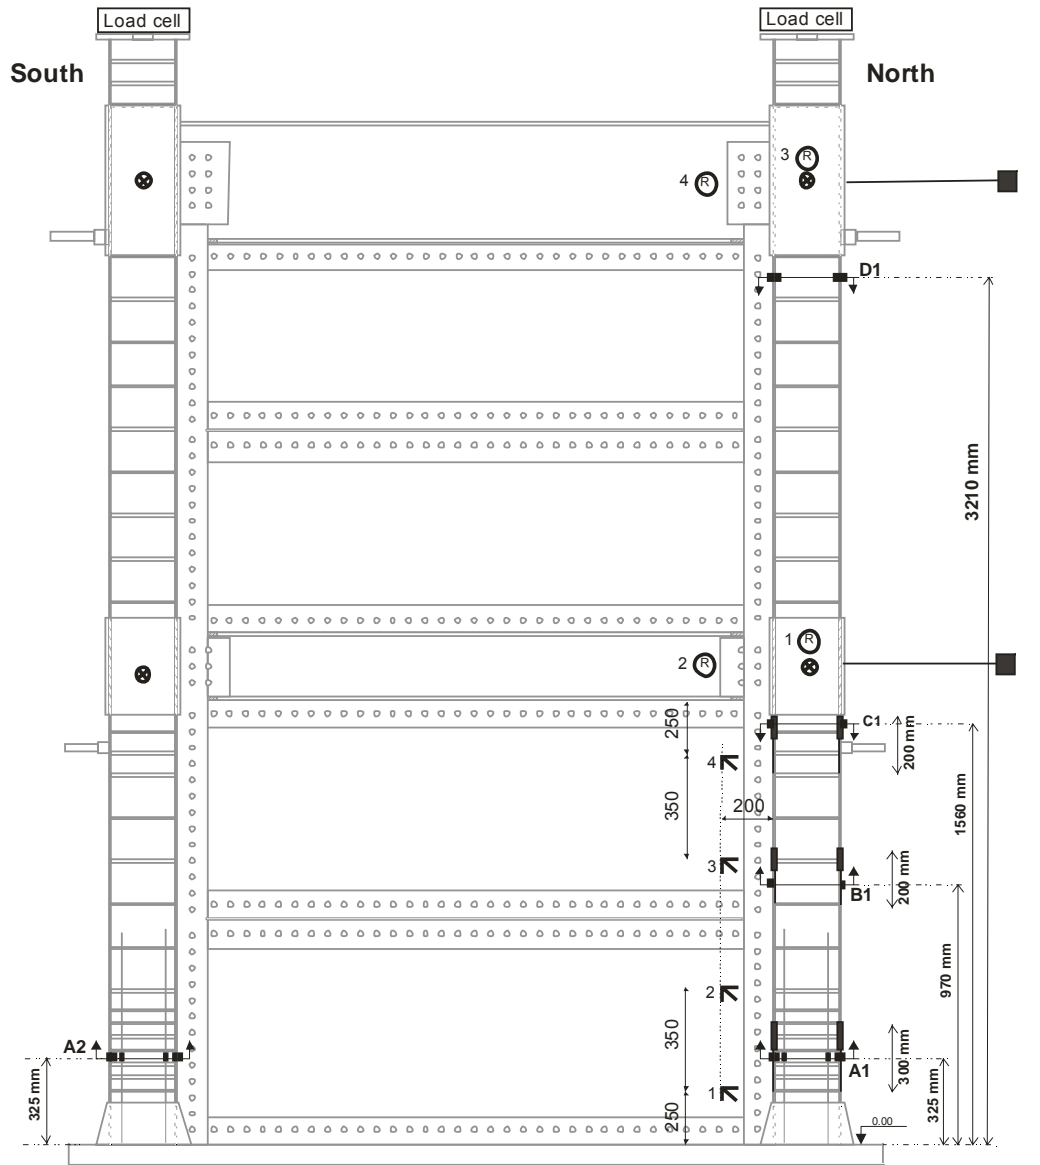
Notes:
 - Strain gauges, which are close to the tip of the flanges of columns in sections A1, A2, B1, C1 and D1, are 15 mm away from the flange tips.

Figure 4.12: Instrumentation layout for the modular test specimen

A total of eight strain gauge rosettes were used to monitor the strains in the infill plate of the first story at four elevations (as shown in Figure 4.12). Rosettes on both sides of the infill plate permit the state of strain to be determined at the mid-surface of the plate. The infill plate did not yield in the first three cycles. During cycle 4, the infill plate yielded at location 1, which was located 250 mm above the base plate. In cycle 7, in which the base shear was $Q = 900$ kN, the infill plate was still elastic at locations 2 to 4. The angle of inclination of the tension field from vertical was 45 degrees at locations 2 and 3, while it was 33 degrees at location 4. Location 4 was close to the frame connection and because of the very limited rotation of the frame connection at this point in the test, the infill plate was affected by the gravity load in the column. The maximum principal strain at location 4 was $580 \mu\epsilon$. The infill plate yielded at locations 2 and 3 during cycle 10, in which $\delta = \delta_y = 8.5$ mm, but at location 4 the infill plate remained elastic (with a maximum principal strain of $630 \mu\epsilon$) and the angle of inclination of the tension field did not change compared to cycle 7. In cycle 13, during which the frame connections started to rotate substantially, the infill plate of the first story yielded completely and the maximum principal strain in location 4 was over $2600 \mu\epsilon$, which shows a significant increase in the principal strains in location 4. In cycle 21, in which the specimen reached its maximum strength, the maximum principal strain in the infill plate of the first story reached $16,000 \mu\epsilon$ at location 1.

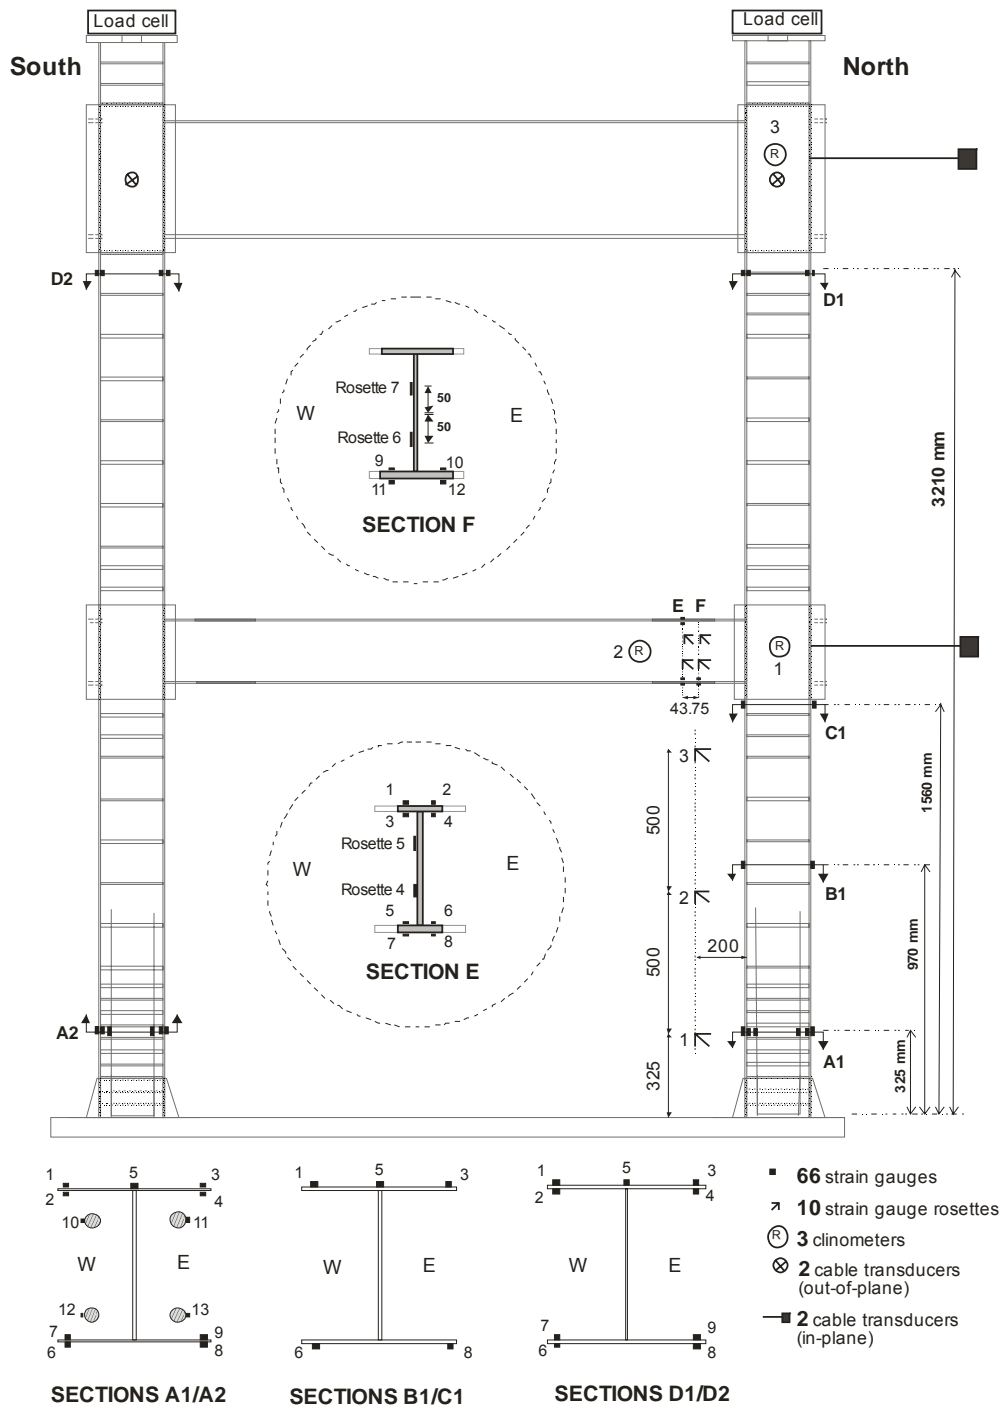
- Strain gauges, which are close to the tip of the flanges of columns in sections A1, A2, B1, C1, D1 and D2 are 15 mm away from the flange tips.
- Strain gauges, which are close to the tip of the flanges of the floor beam in sections E and F are 25 mm away from the flange tips.

Figure 4.13: Instrumentation layout for the RBS test specimen

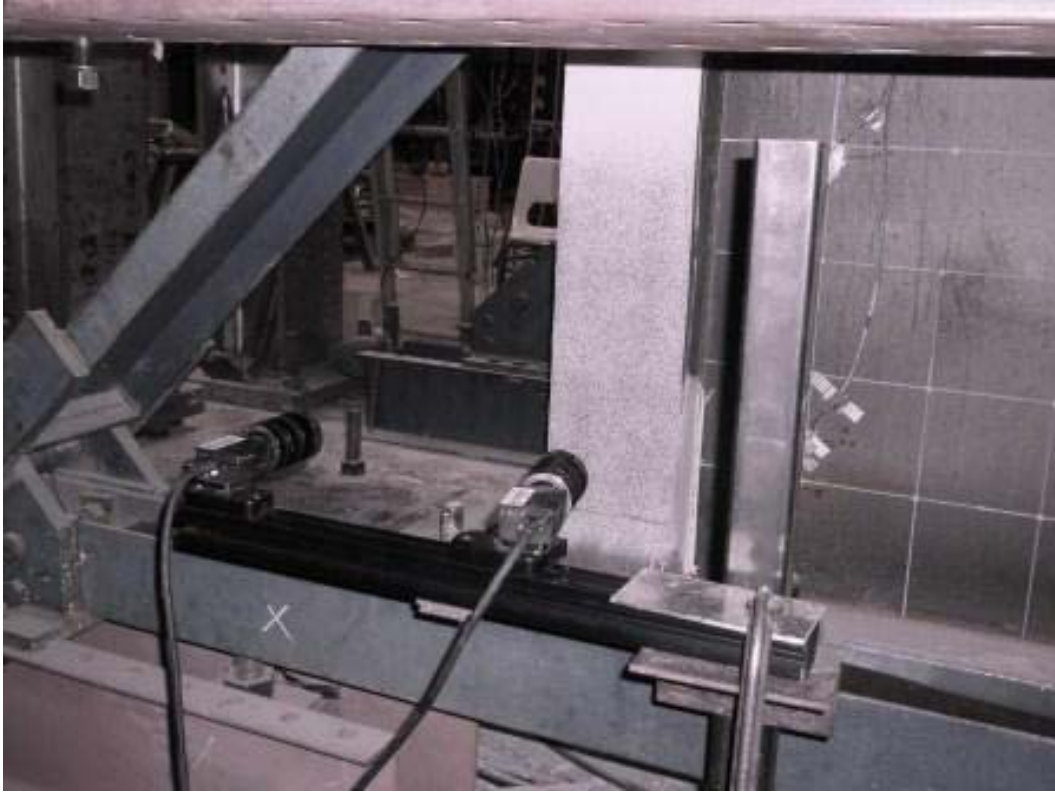
Figure 4.14: One set of cameras, monitoring the concrete face of PEC column at base

To study the behavior of the concrete in the columns at the expected hinge location close to the base, the west side of the north column was monitored by another set of cameras. Figure 6.29 shows the principal strain distribution in cycle 4⁻, showing the appearance of the first cracks. The pattern of the cracks from the 3D camera system is similar to the pattern of cracks shown in Figure 6.1. The concrete started to crack adjacent to the inner flange during cycle 13⁺, as can be seen in the maximum principal strain distribution in Figure 6.30. The crushing of the concrete in compression close to the base of the column can be seen in Figures 6.31 to 6.33, in which the maximum principal strain distribution in the concrete is shown in cycles 19⁺, 21⁺ and 23⁺, respectively.

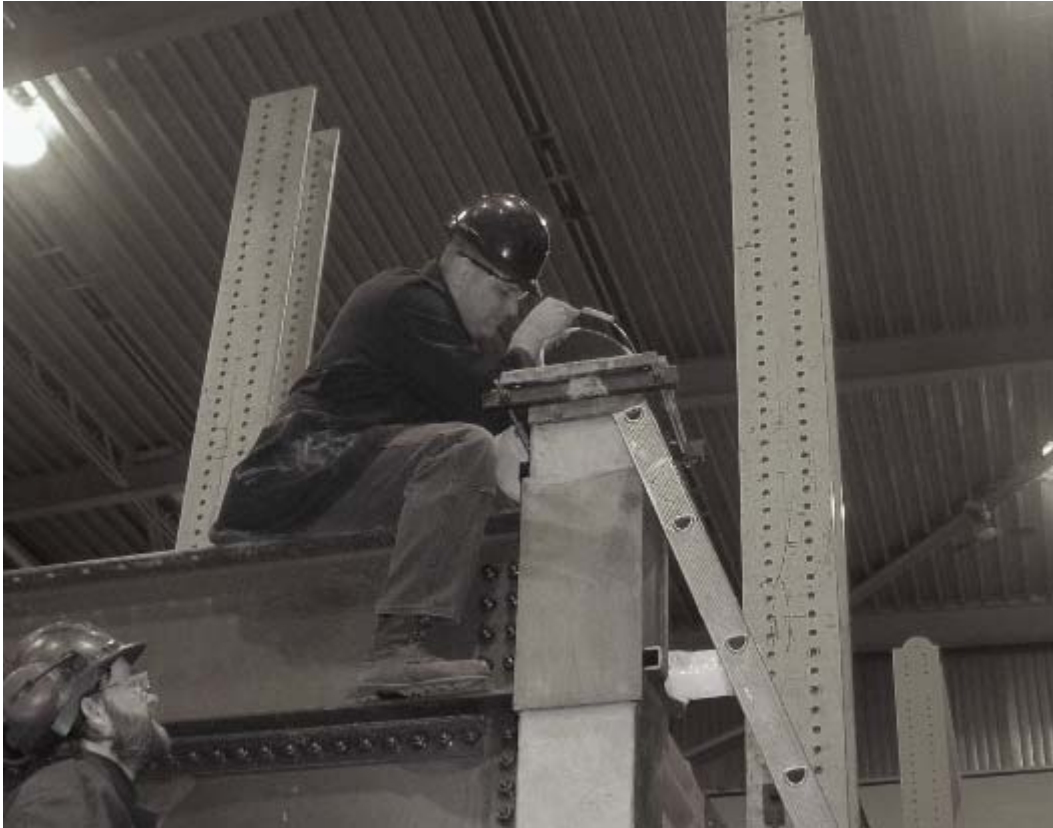
Figure 4.18: Grouting of the remaining gap under the cap plate

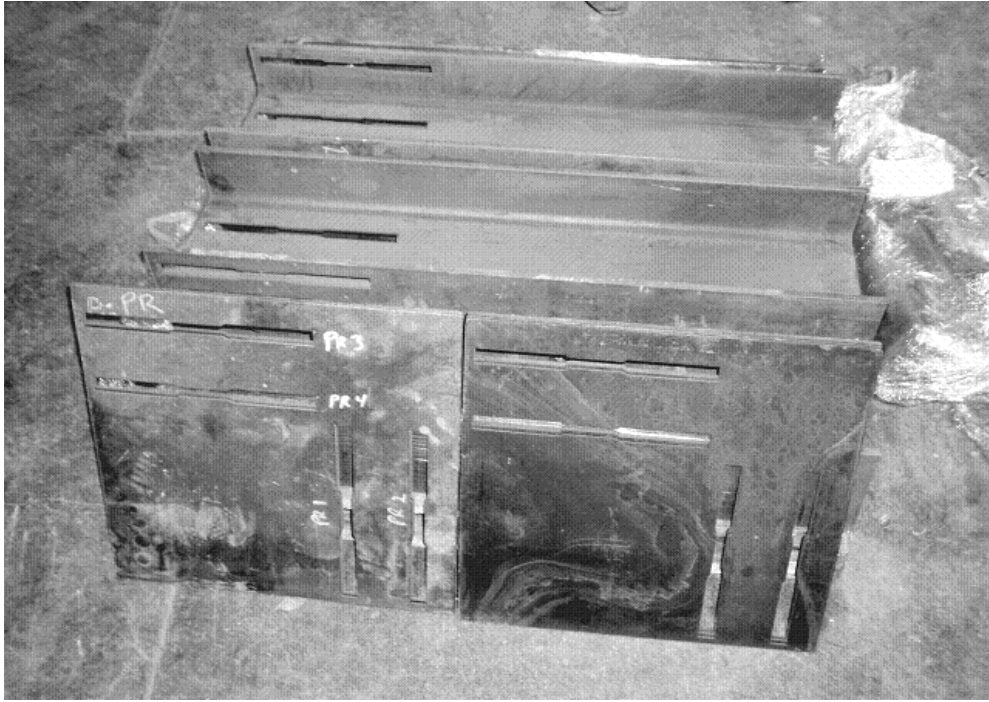
Figure 4.20: Remaining material after the coupons were removed

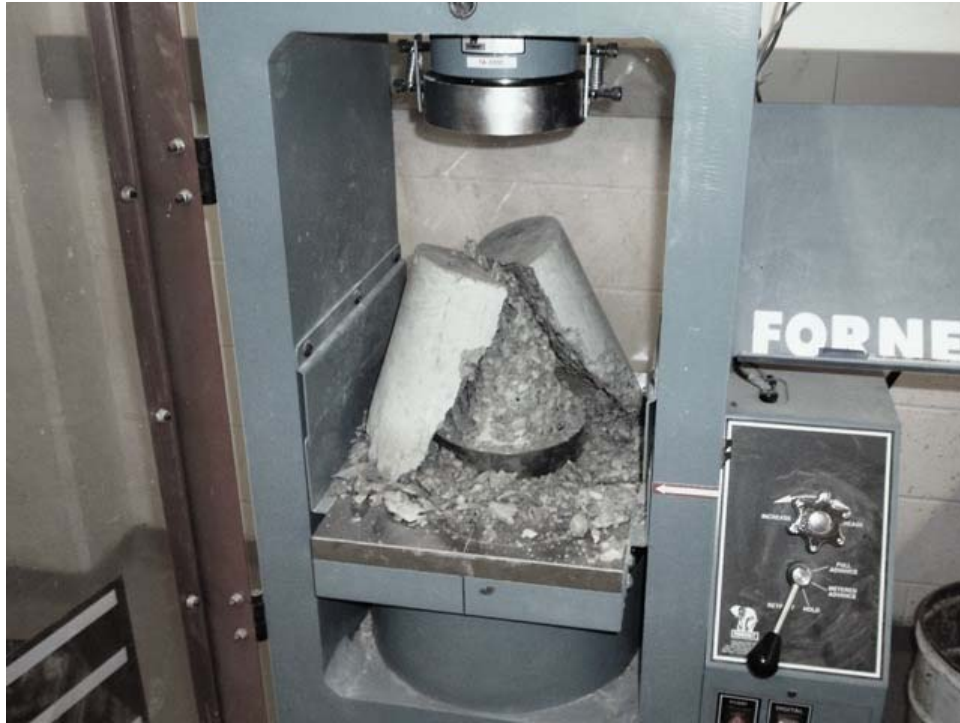
Figure 4.22: “Split and cone” type of failure of the concrete cylinder in compression test

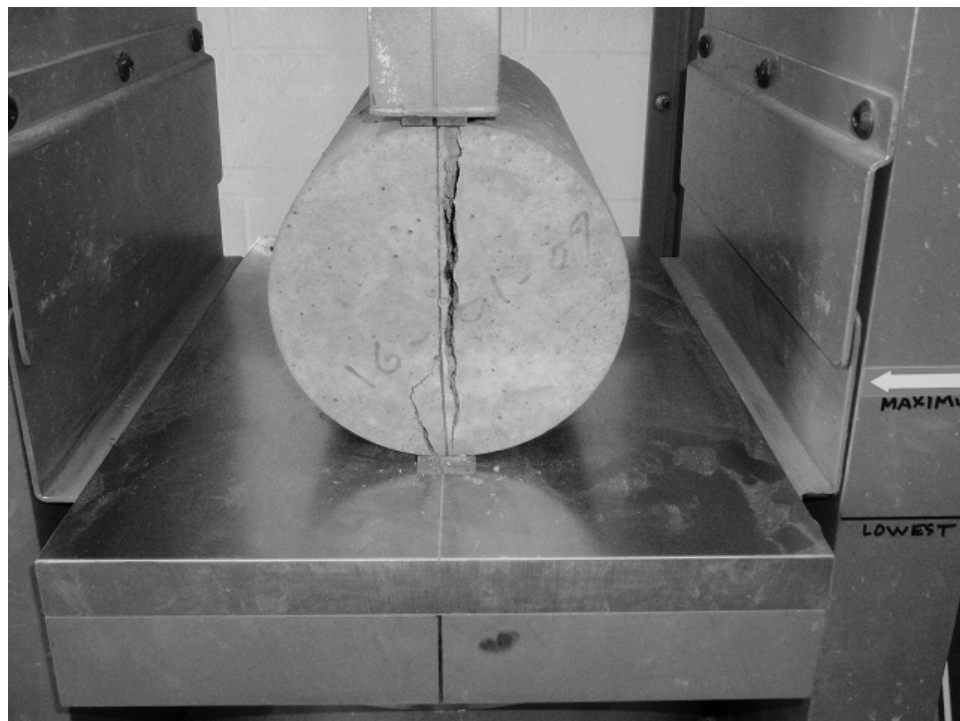
Figure 4.23: The concrete split cylinder test to determine the tensile strength of concrete

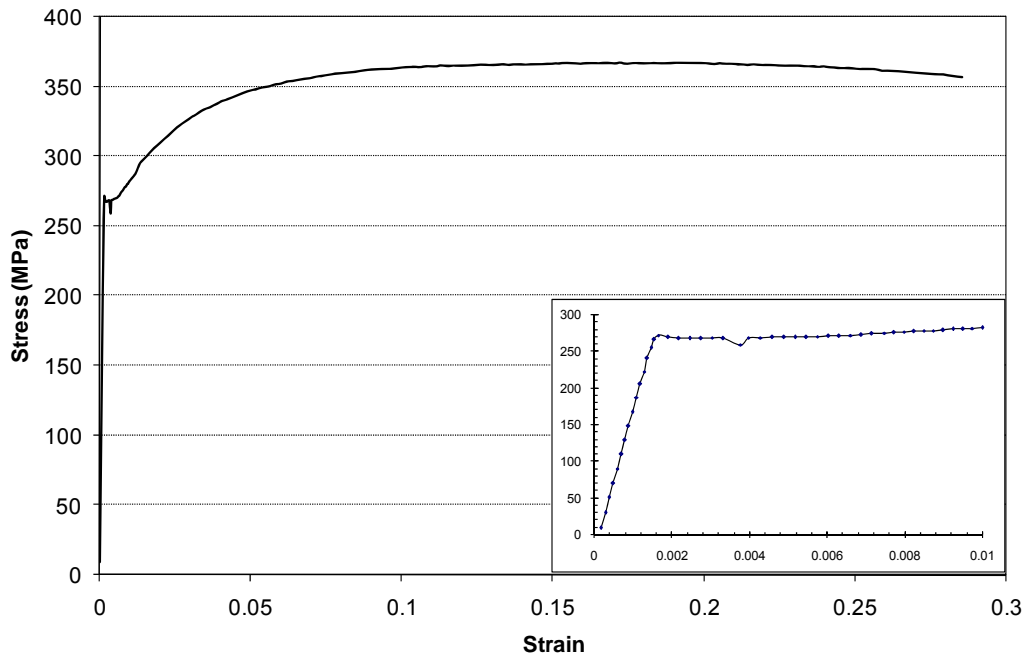
Figure 4.25: Typical stress vs. strain curve for the infill plates (coupon mark: PR1)

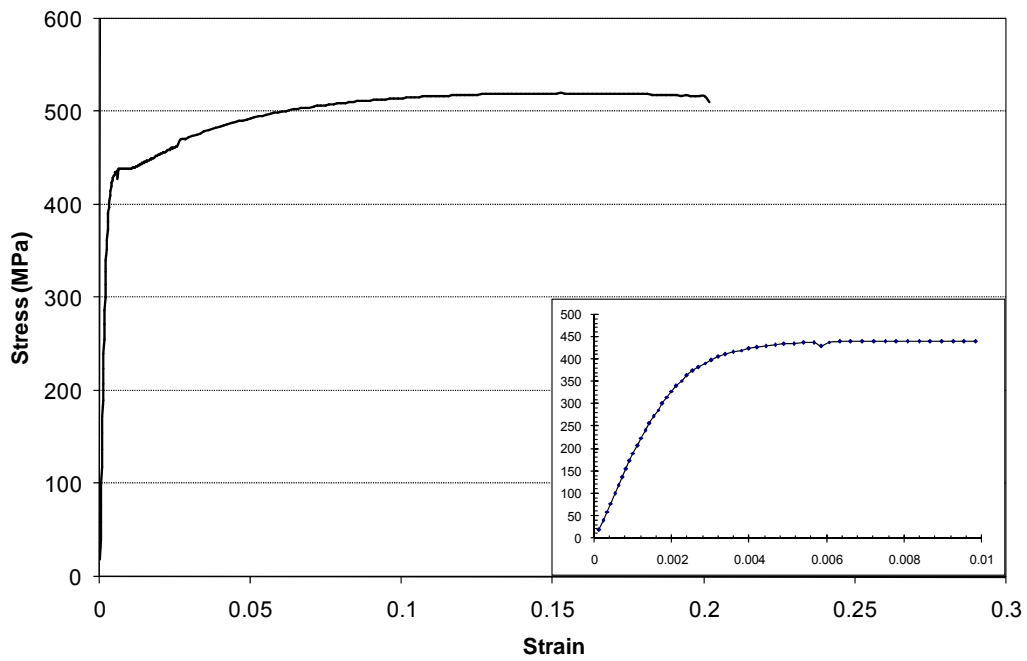
Figure 4.26: Typical stress vs. strain curve for the column plates (coupon mark: PAA1)

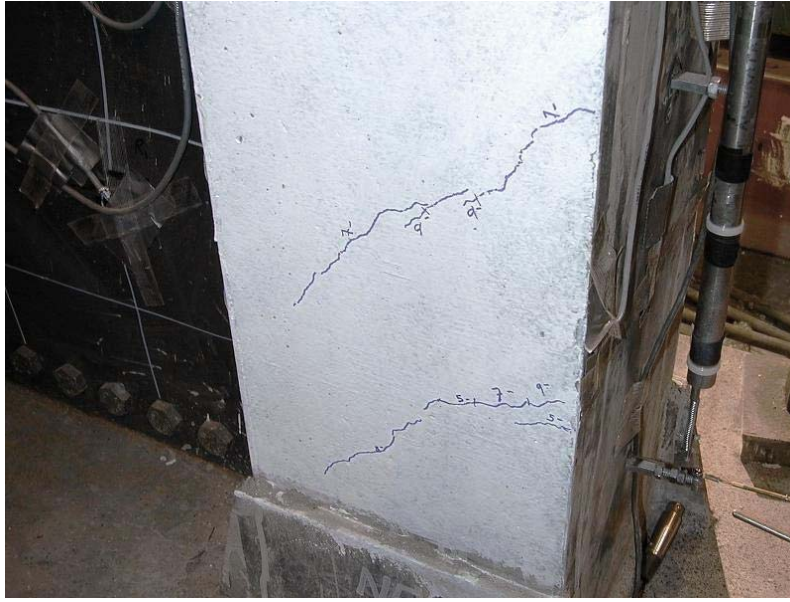
Figure 5.1: Cracks in concrete of the north PEC column in cycle 9
