DUCTILE STEEL PLATE SHEAR WALLS WITH PEC COLUMNS

Doctor of Philosophy

Structural Engineering

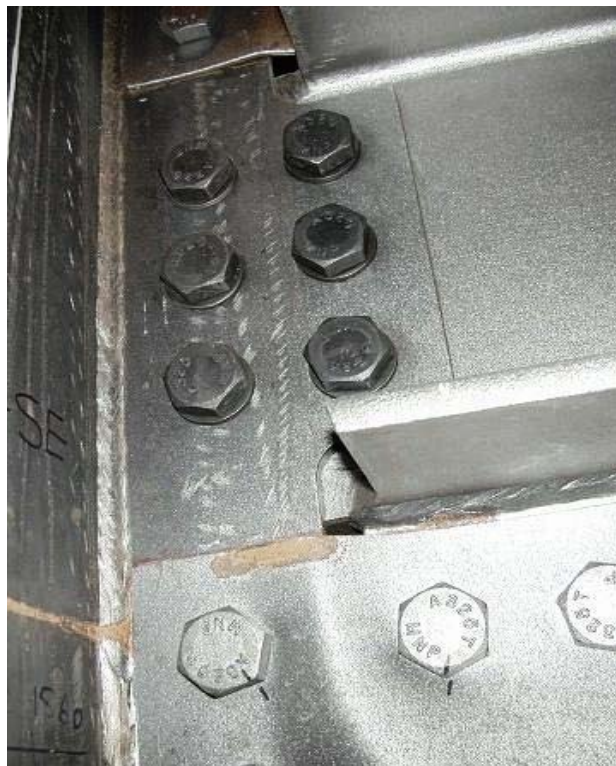
Figure 5.2: First story infill plate fold due to rotation of the frame connection

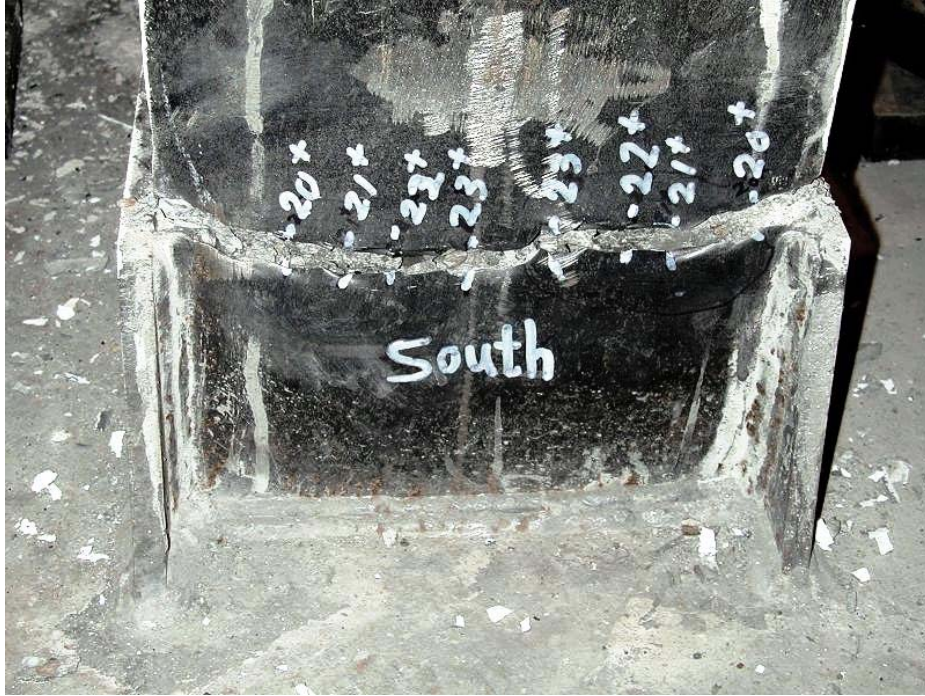
Figure 5.7: Outer flange of the south column at the base in cycle 24

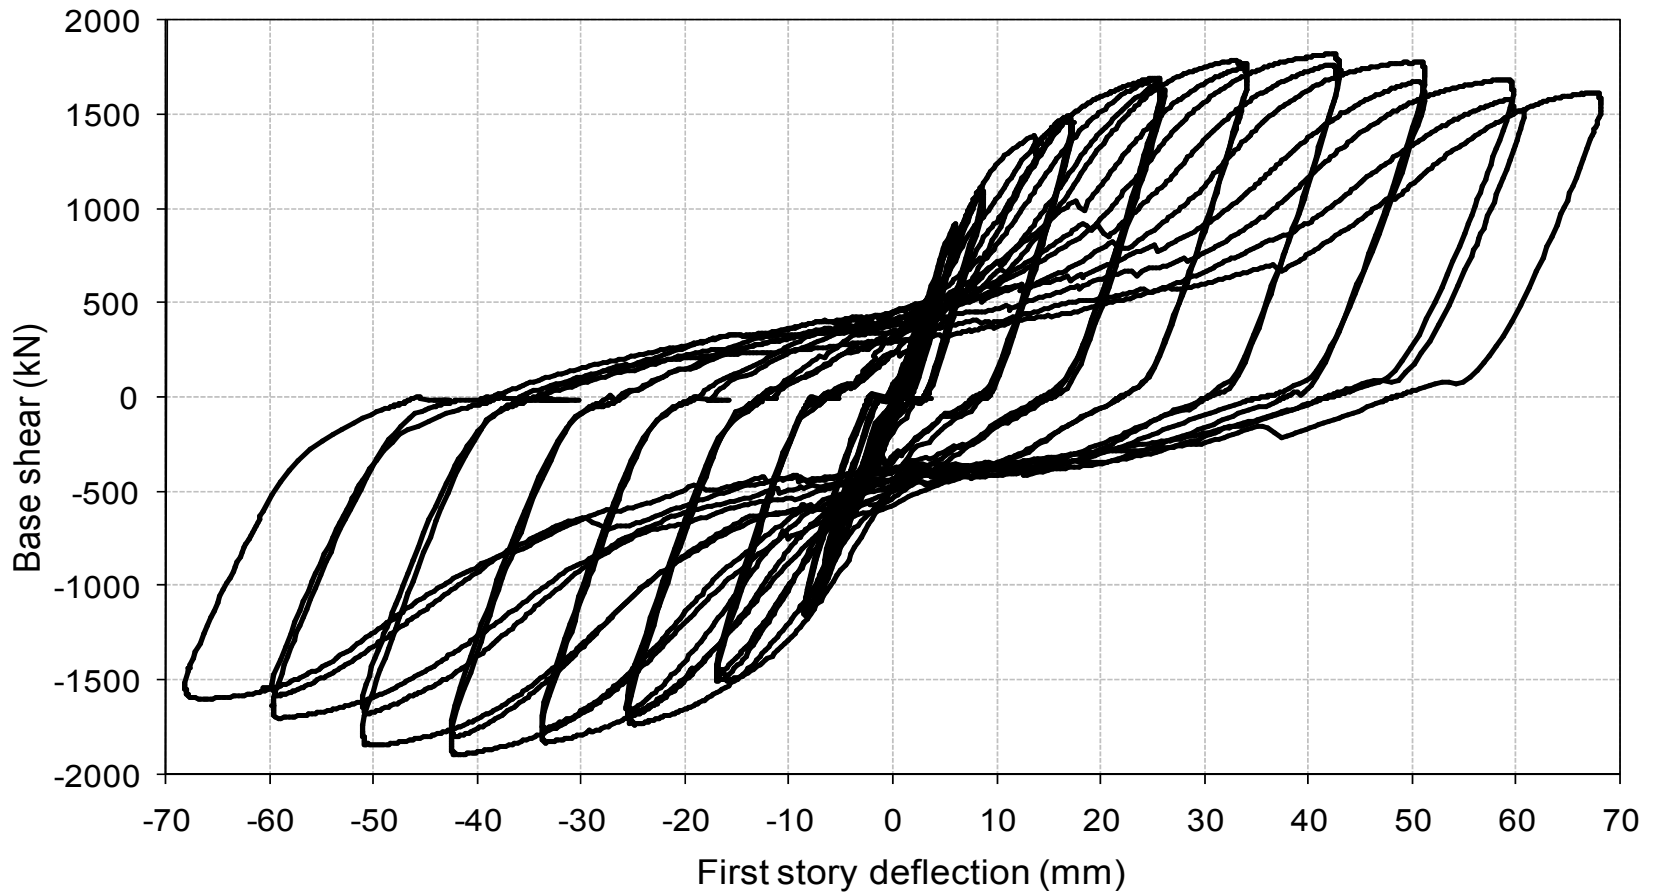
Figure 5.10: Base shear versus first story deflection in the modular test

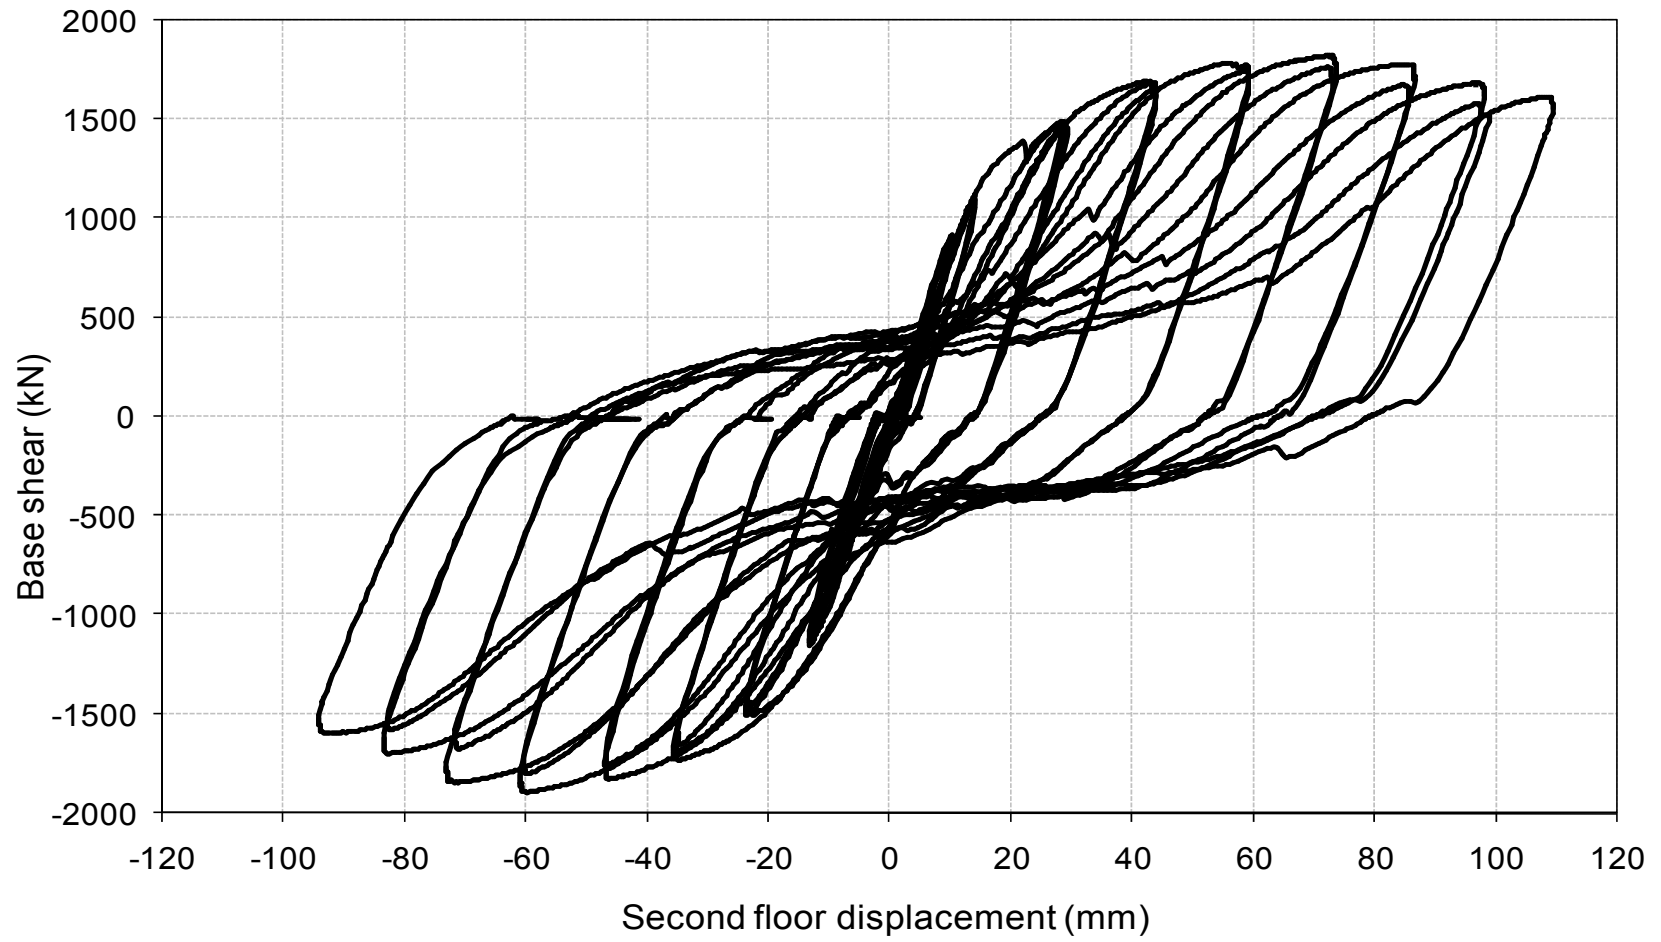
Figure 5.11: Base shear versus second floor displacement in the modular test

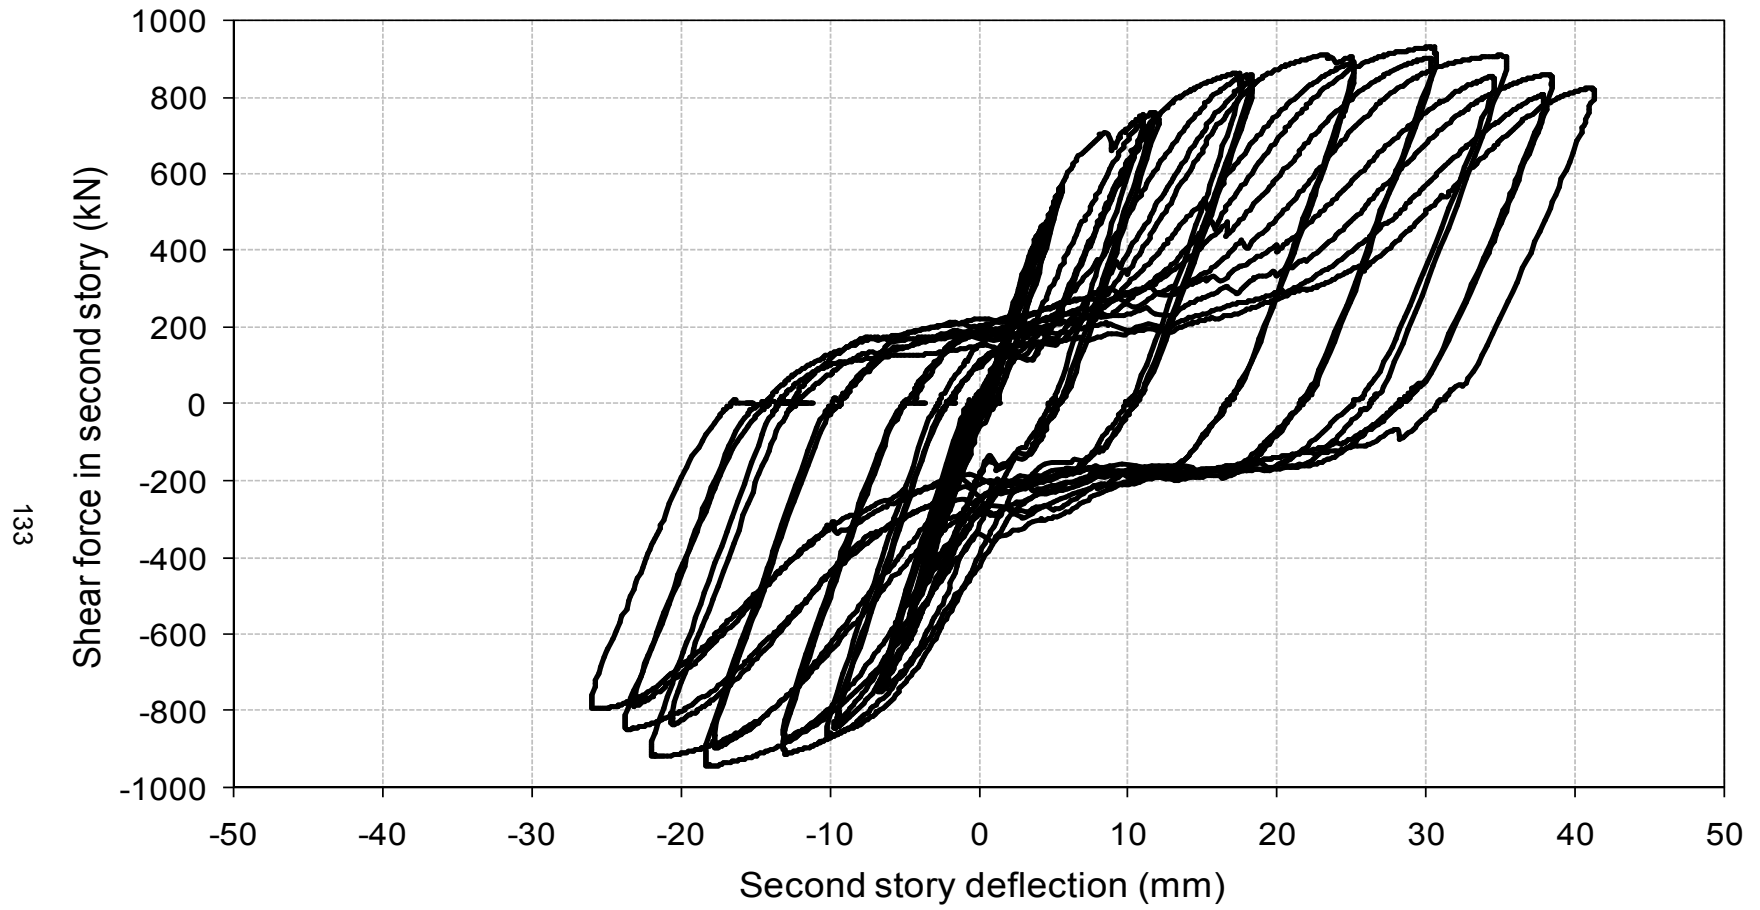
Figure 5.12: Shear force in the second story versus second story deflection in the modular test

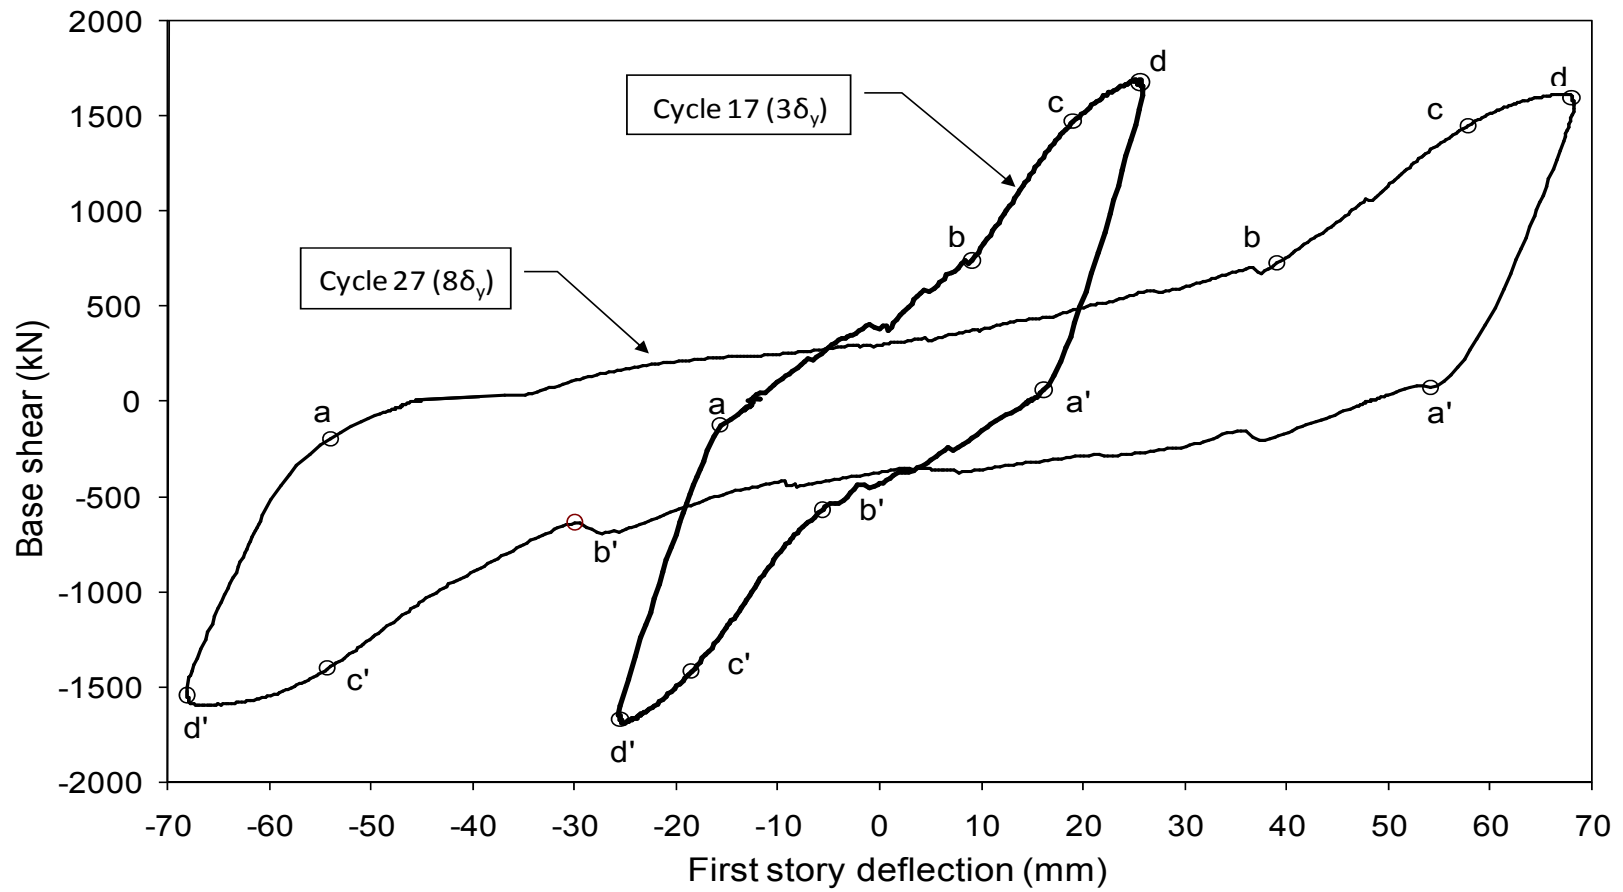
Figure 5.13: Hysteretic loops of cycles 17 and 27

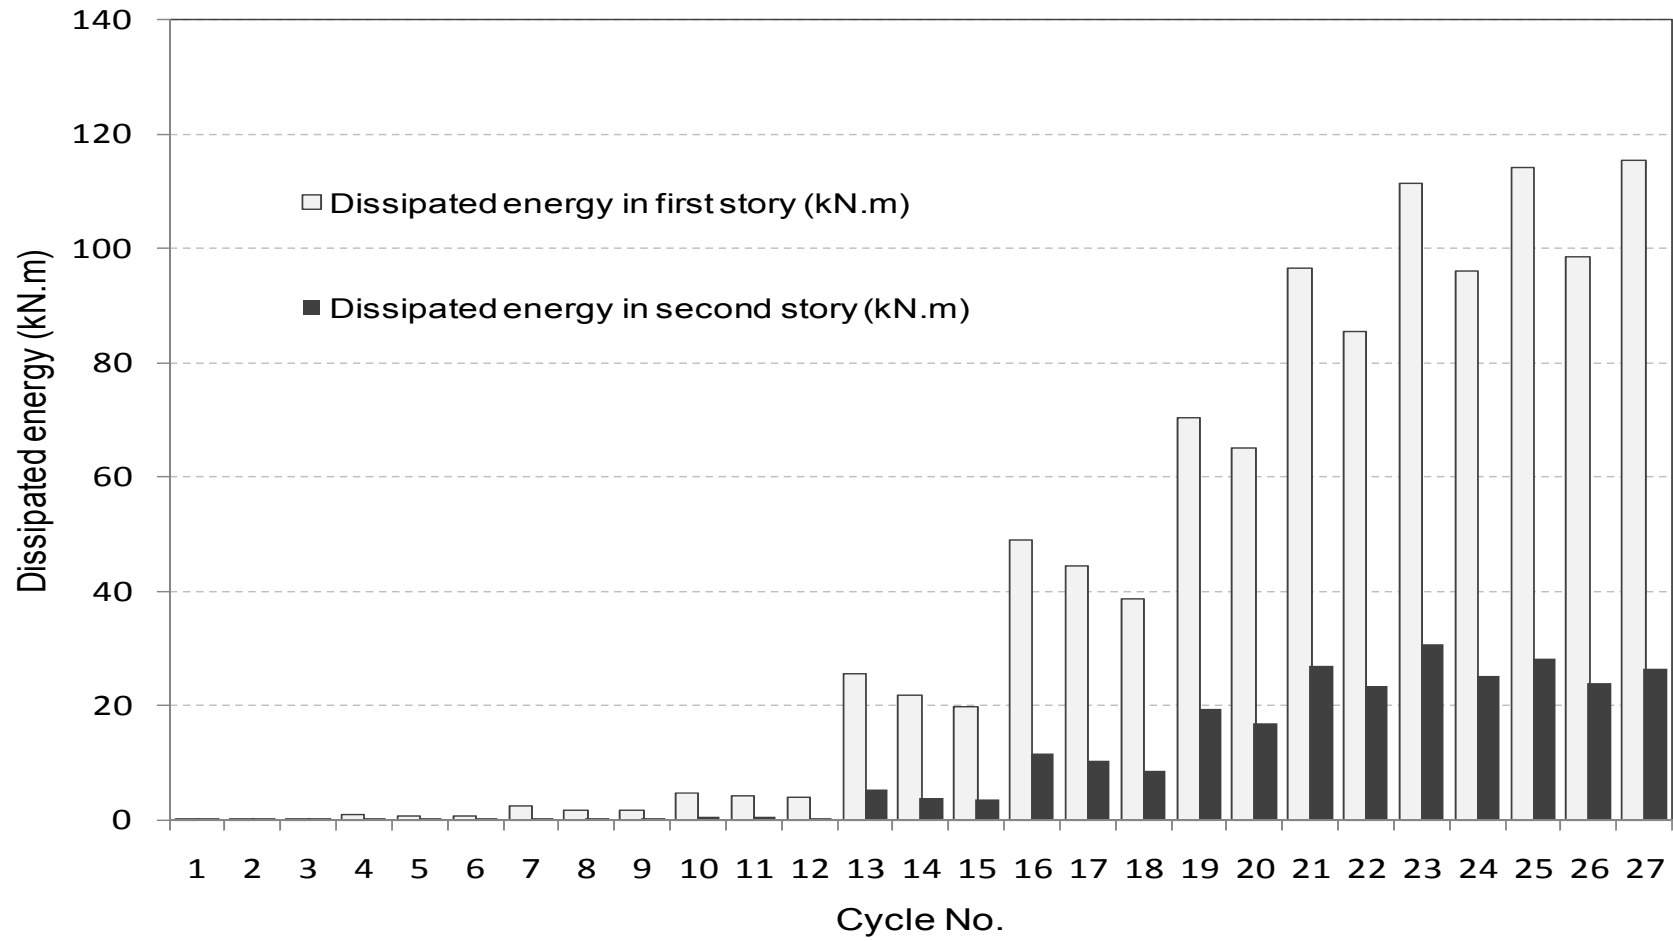
Figure 5.18: Dissipated energy in the first and second stories of the modular specimen in each cycle

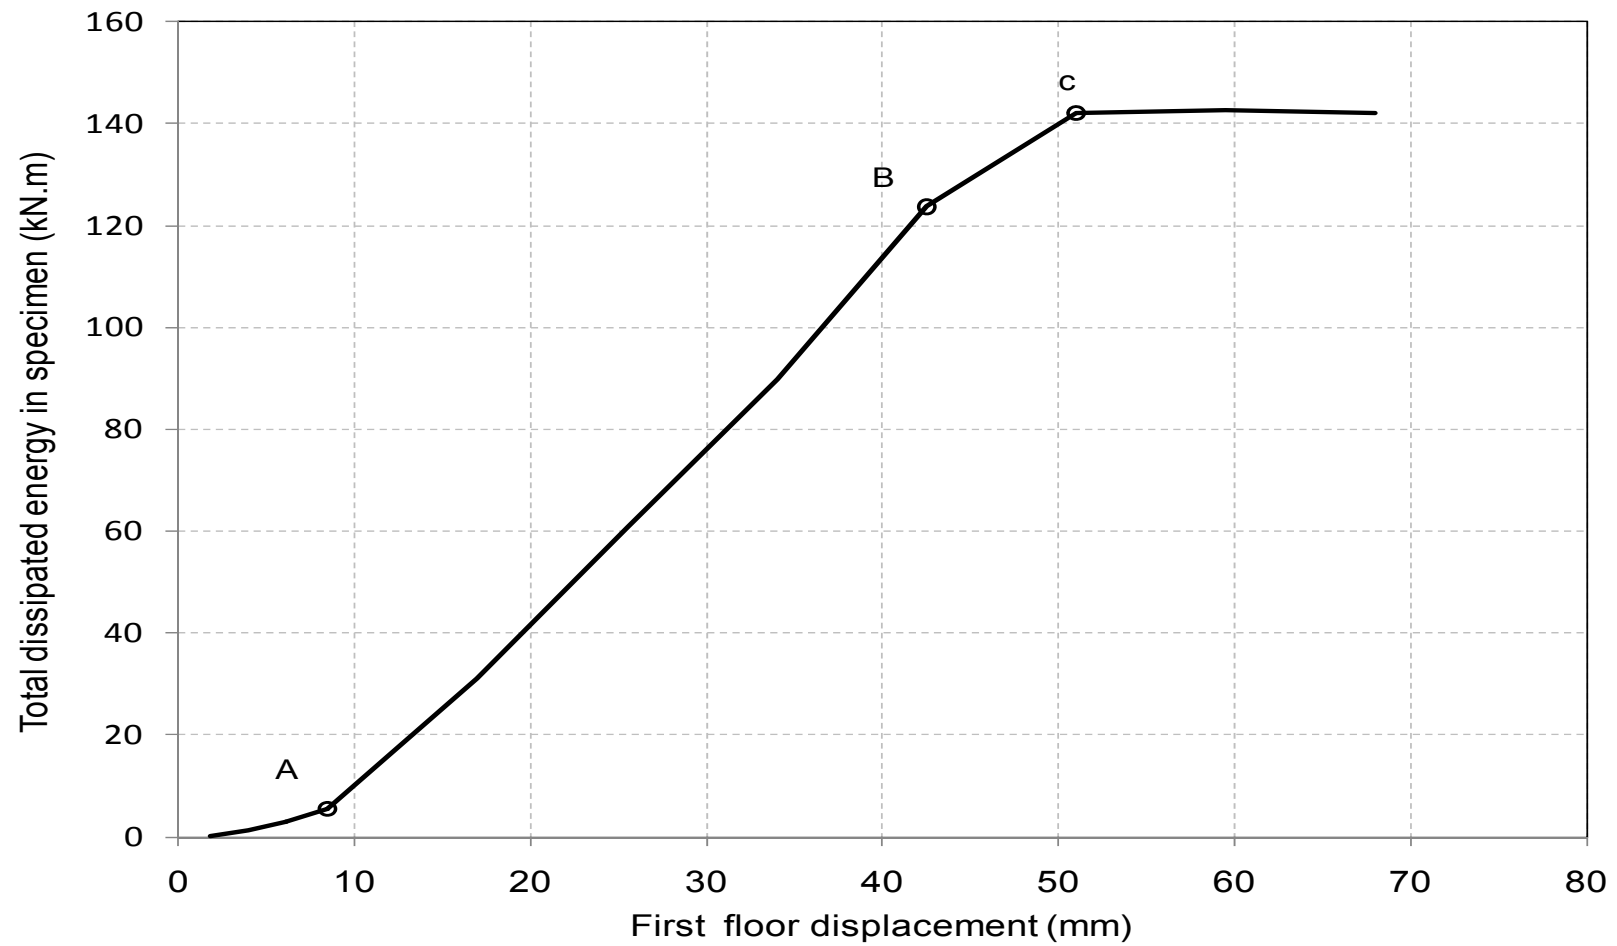
Figure 5.19: Total dissipated energy in the modular specimen versus first floor displacement

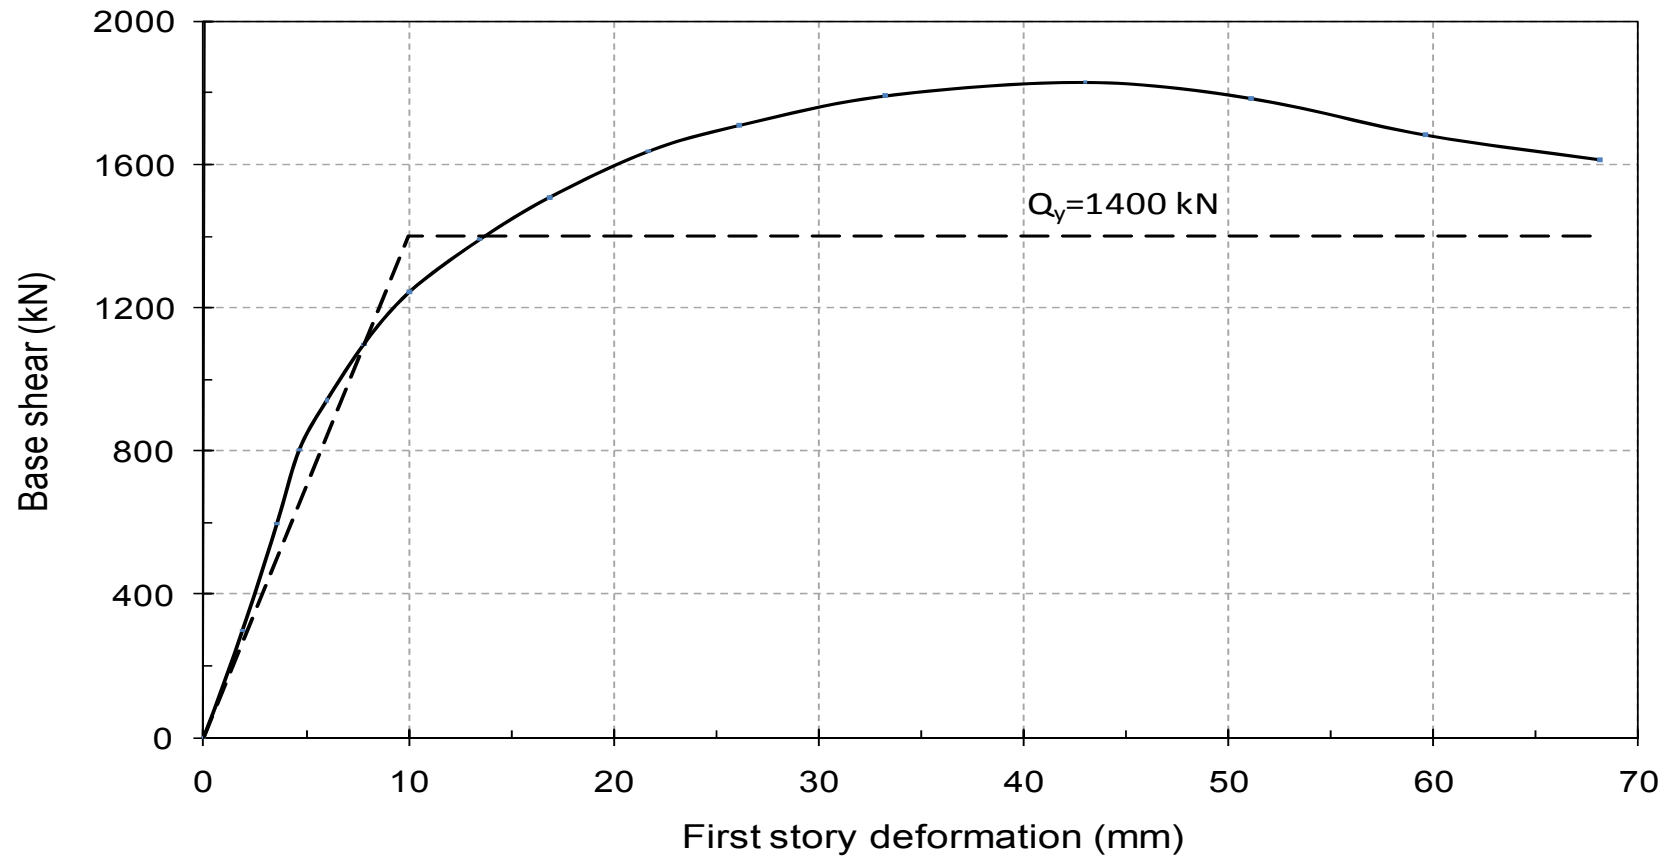
Figure 5.20: Envelope of the hysteretic loops of base shear versus first story deformation in the modular test

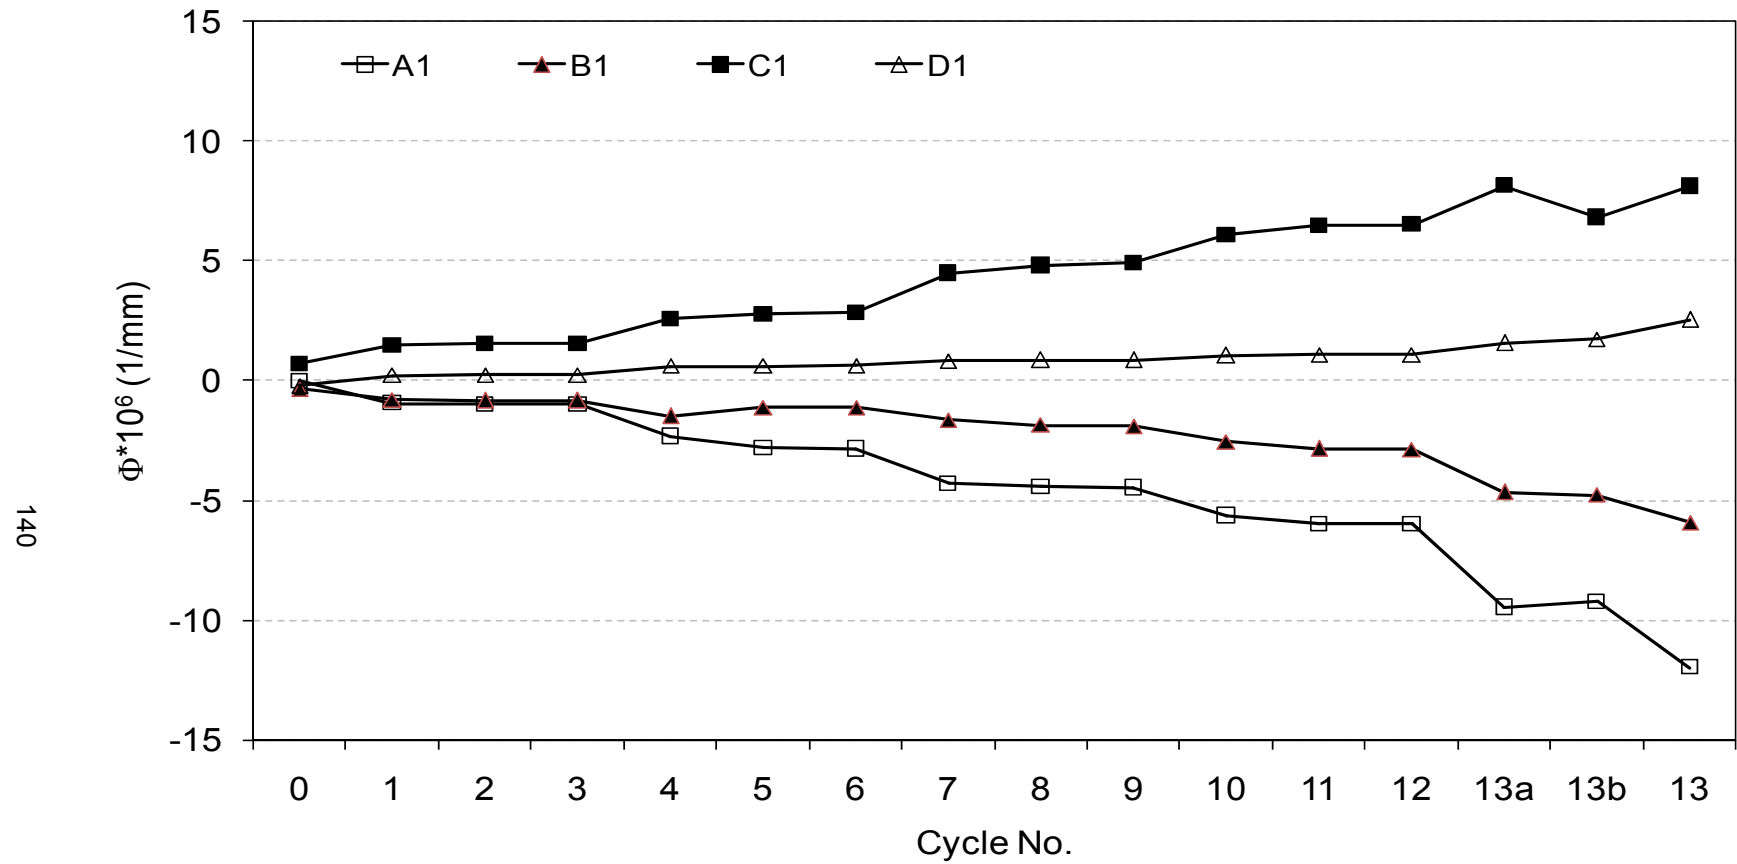
Figure 5.21: Curvature of the north column at four sections in cycles 1 to 13

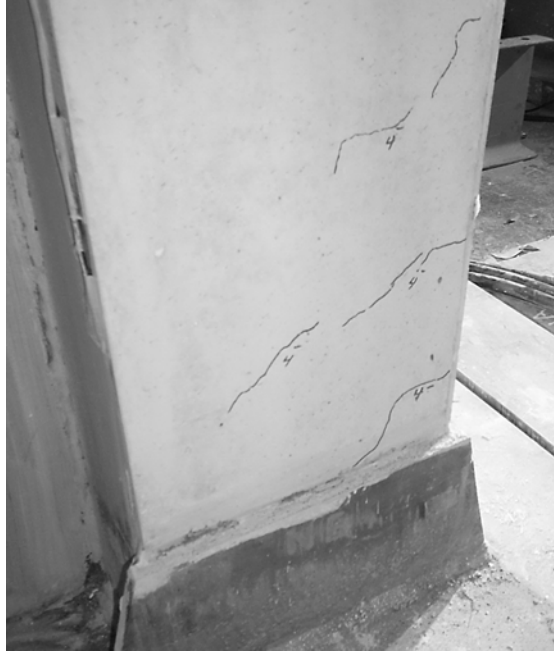
Figure 6.1: East face of north column in cycle 4

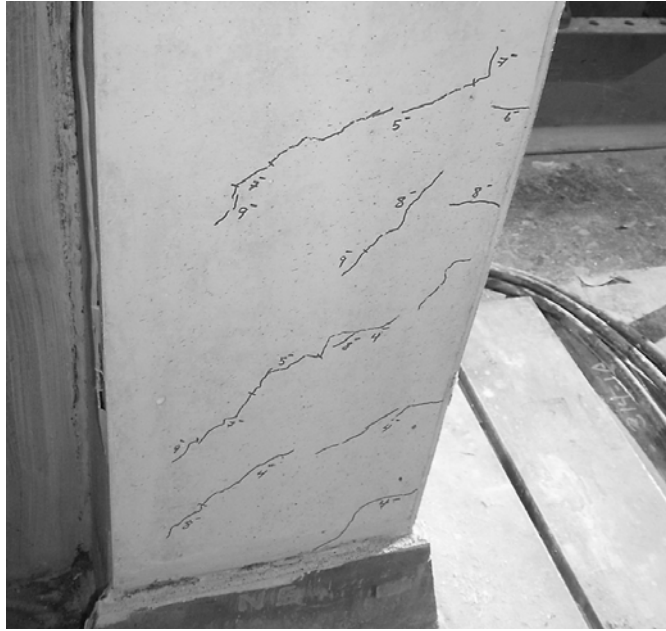
Figure 6.3: Cracks in concrete on the east face of north column in cycle 9

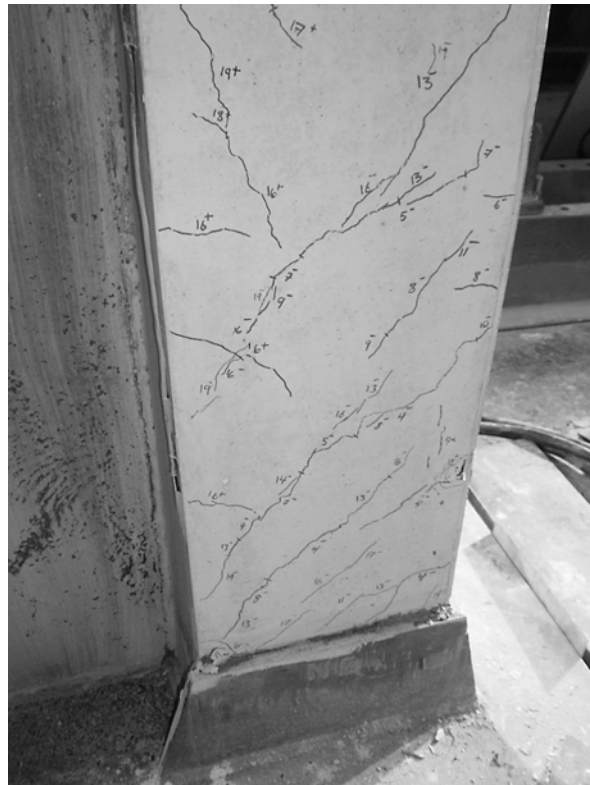
Figure 6.4: Bottom part of east face of the north column in cycle 19

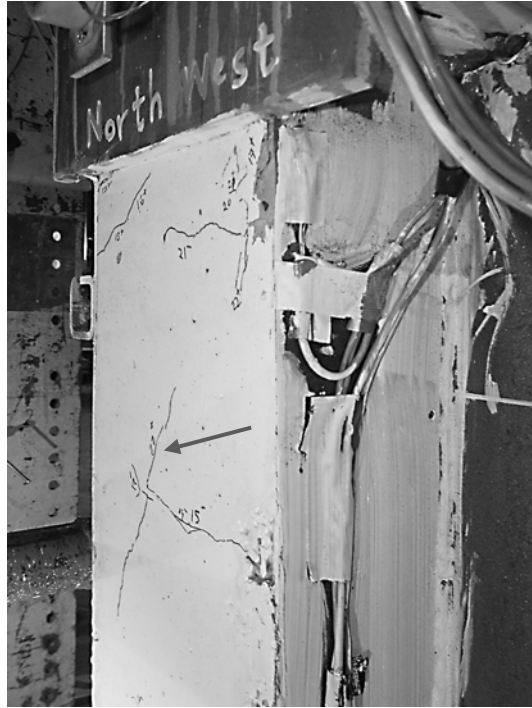
Figure 6.5: Diagonal crack close to top of the north column on west side in the first story during cycle 22

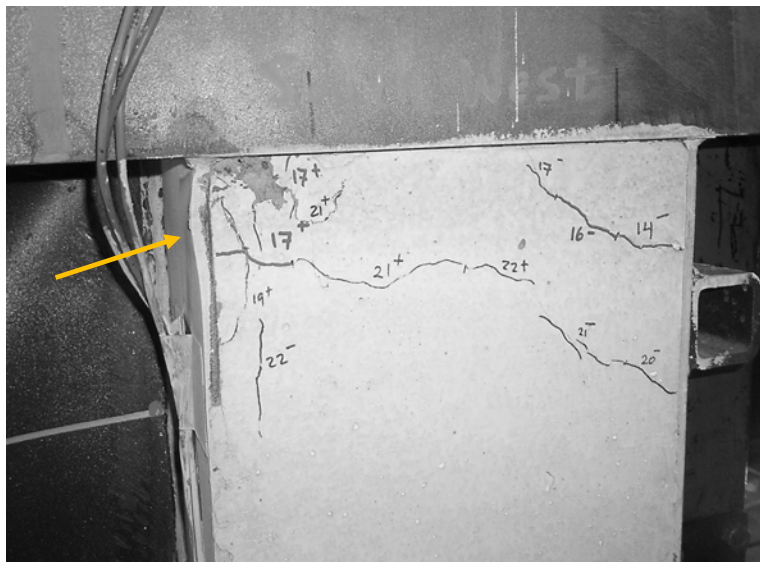
Figure 6.6: Buckling of inner flange and local crushing of the adjacent concrete under the side plate of first floor in cycle 22

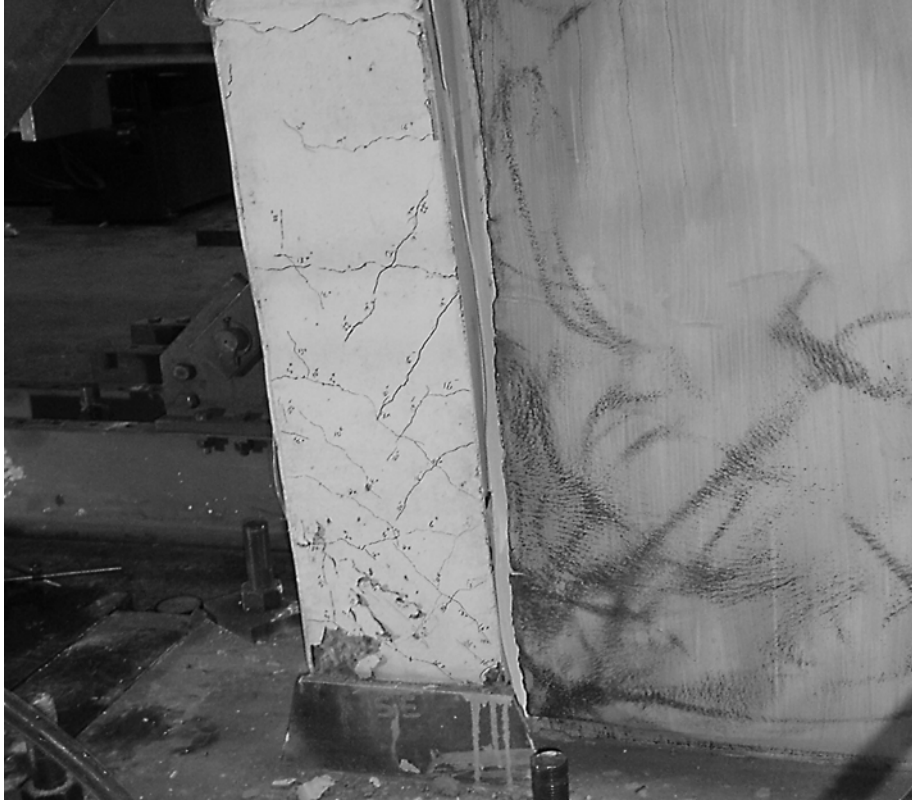
Figure 6.13: Base of the south column and adjacent infill plate, separated from the column, at the end of the test

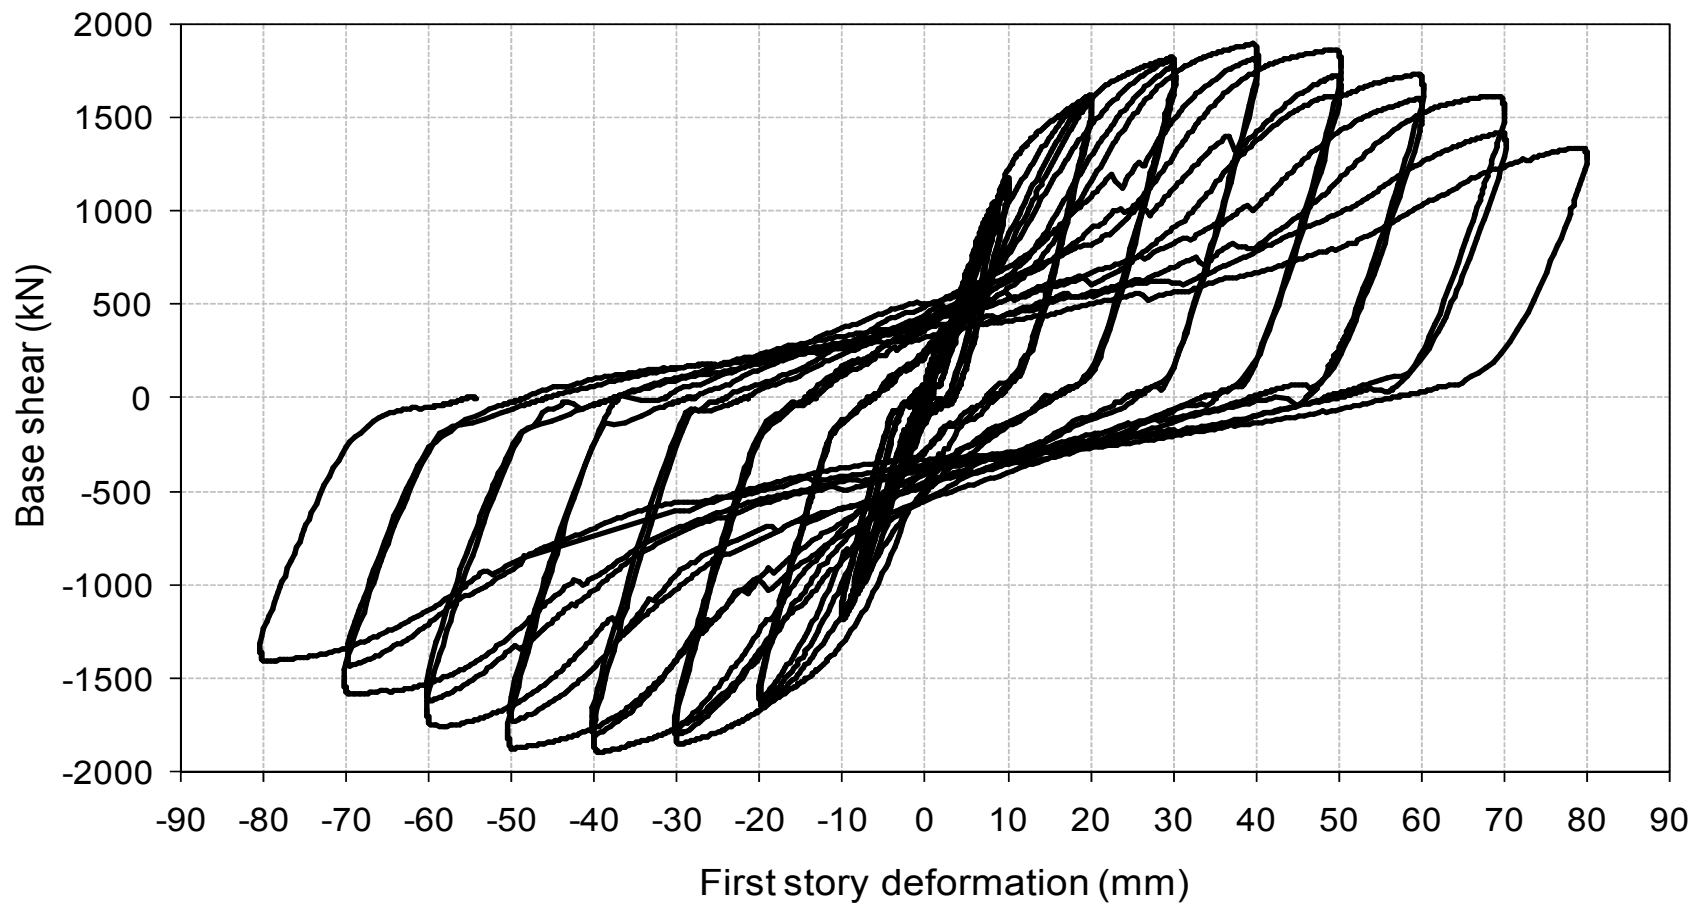
Figure 6.15: Base shear versus first story deflection in the RBS test

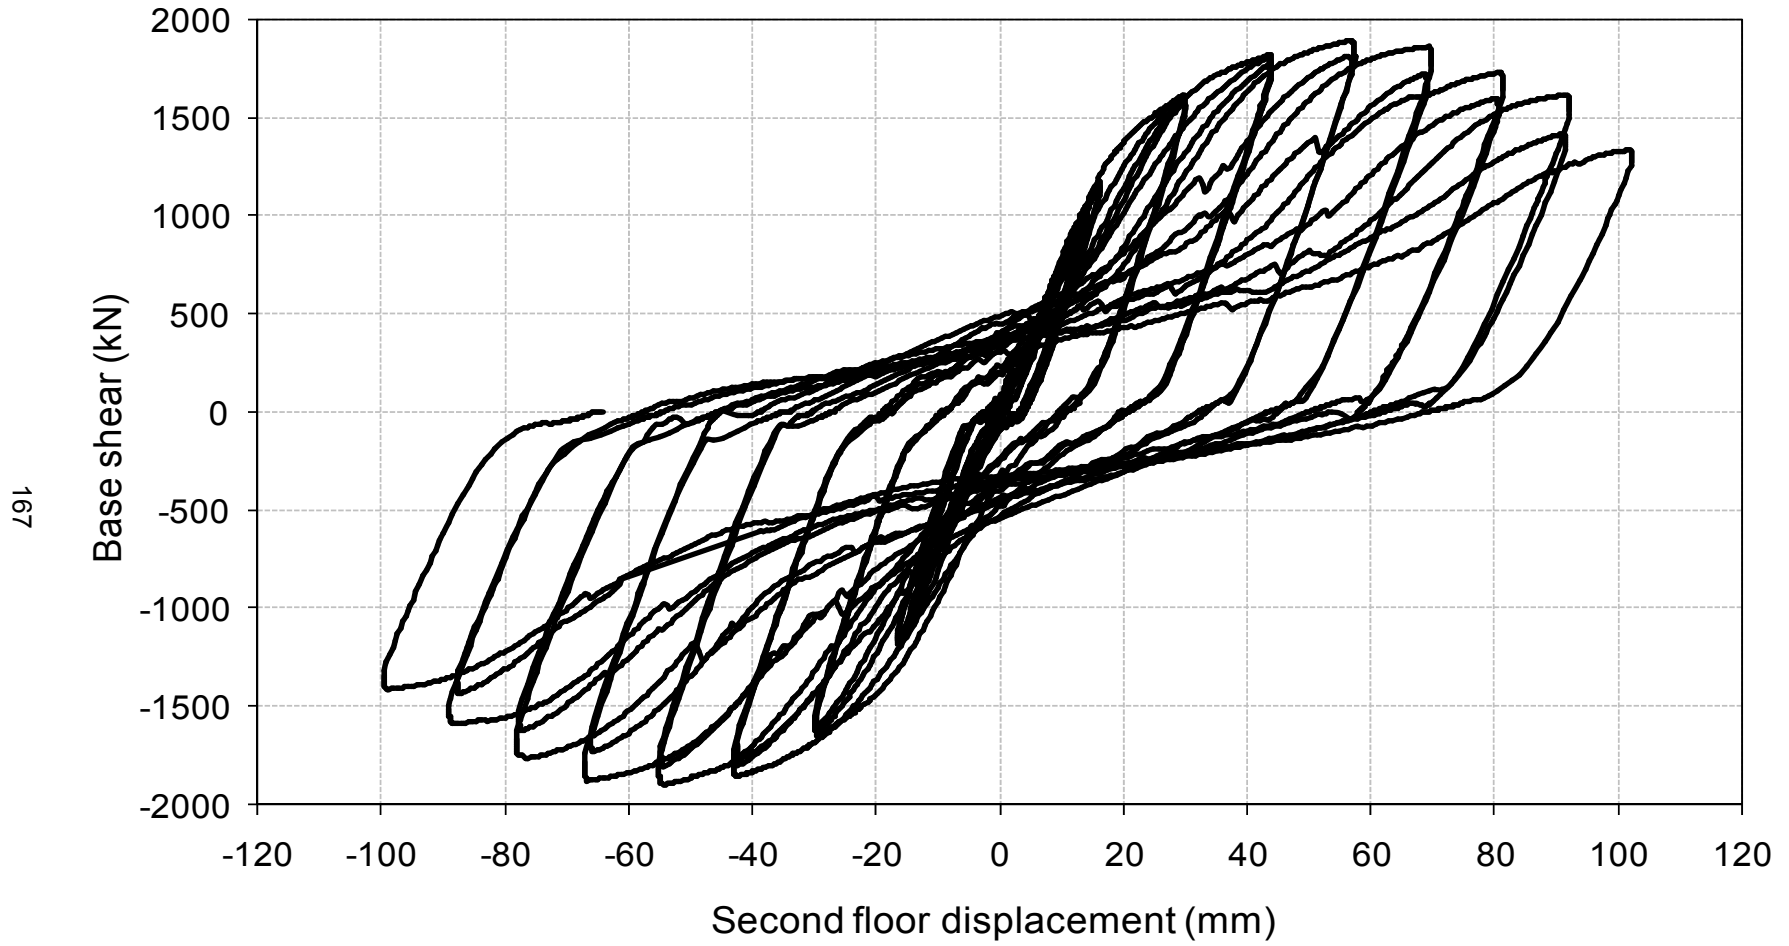
Figure 6.16: Base shear versus second floor displacement in the RBS test

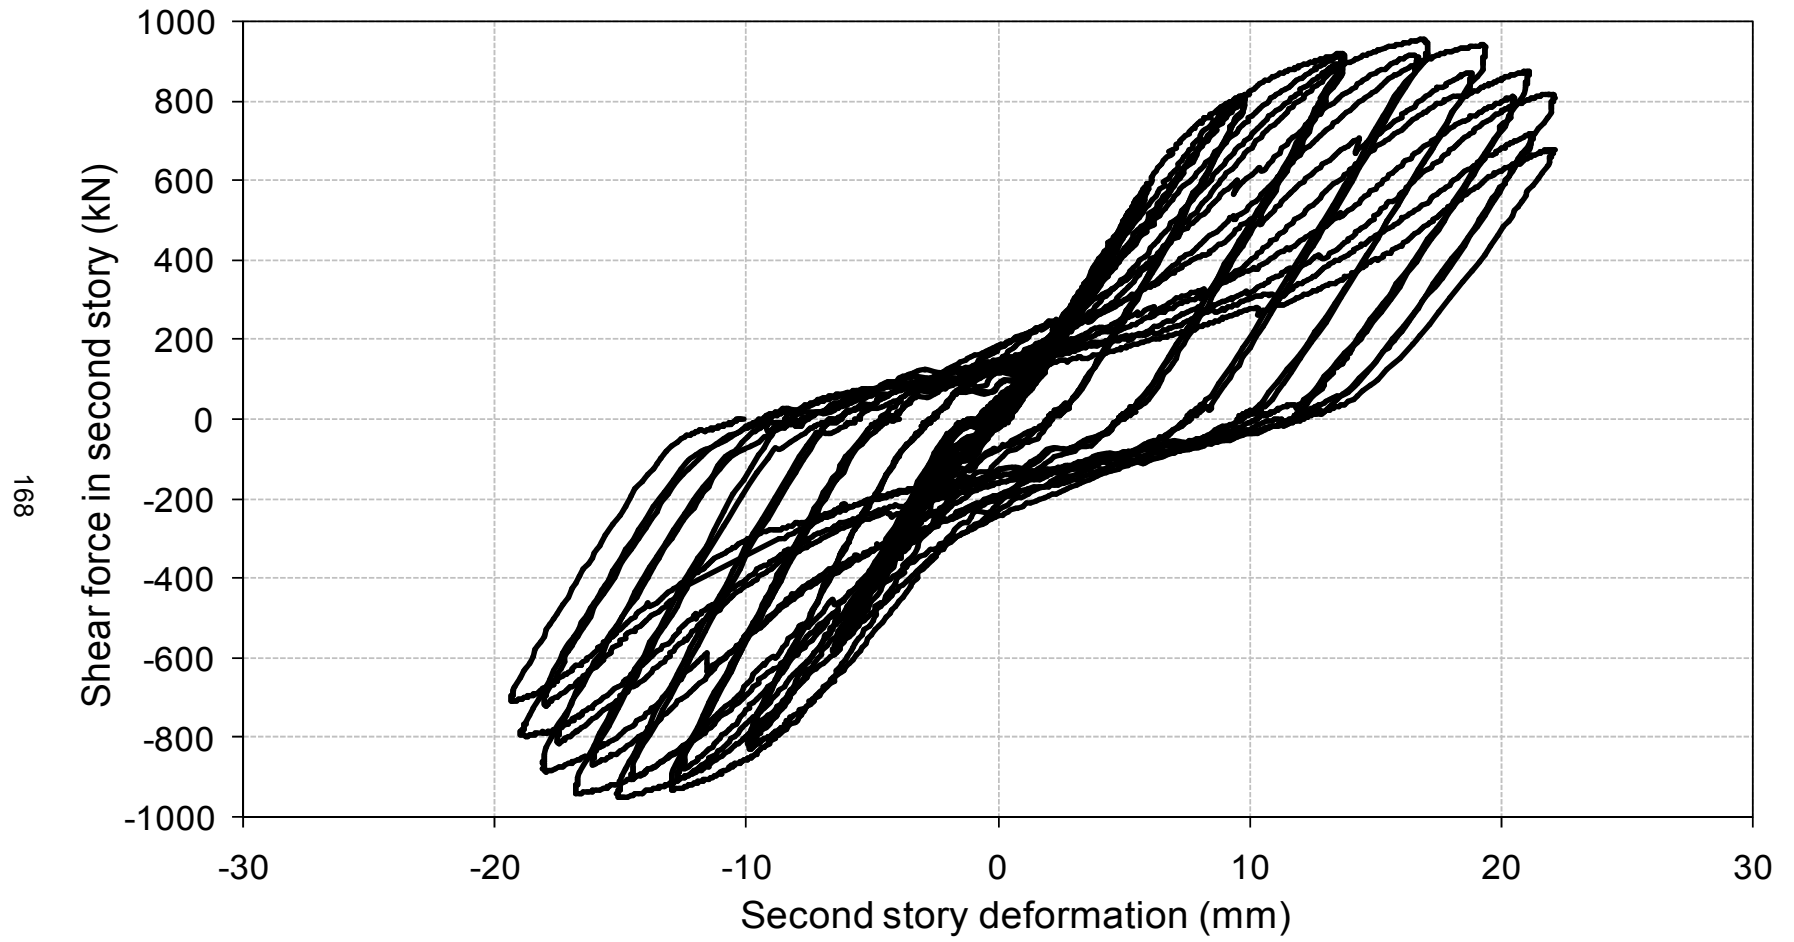
Figure 6.17: Shear force in the second story versus second story deflection in the RBS test

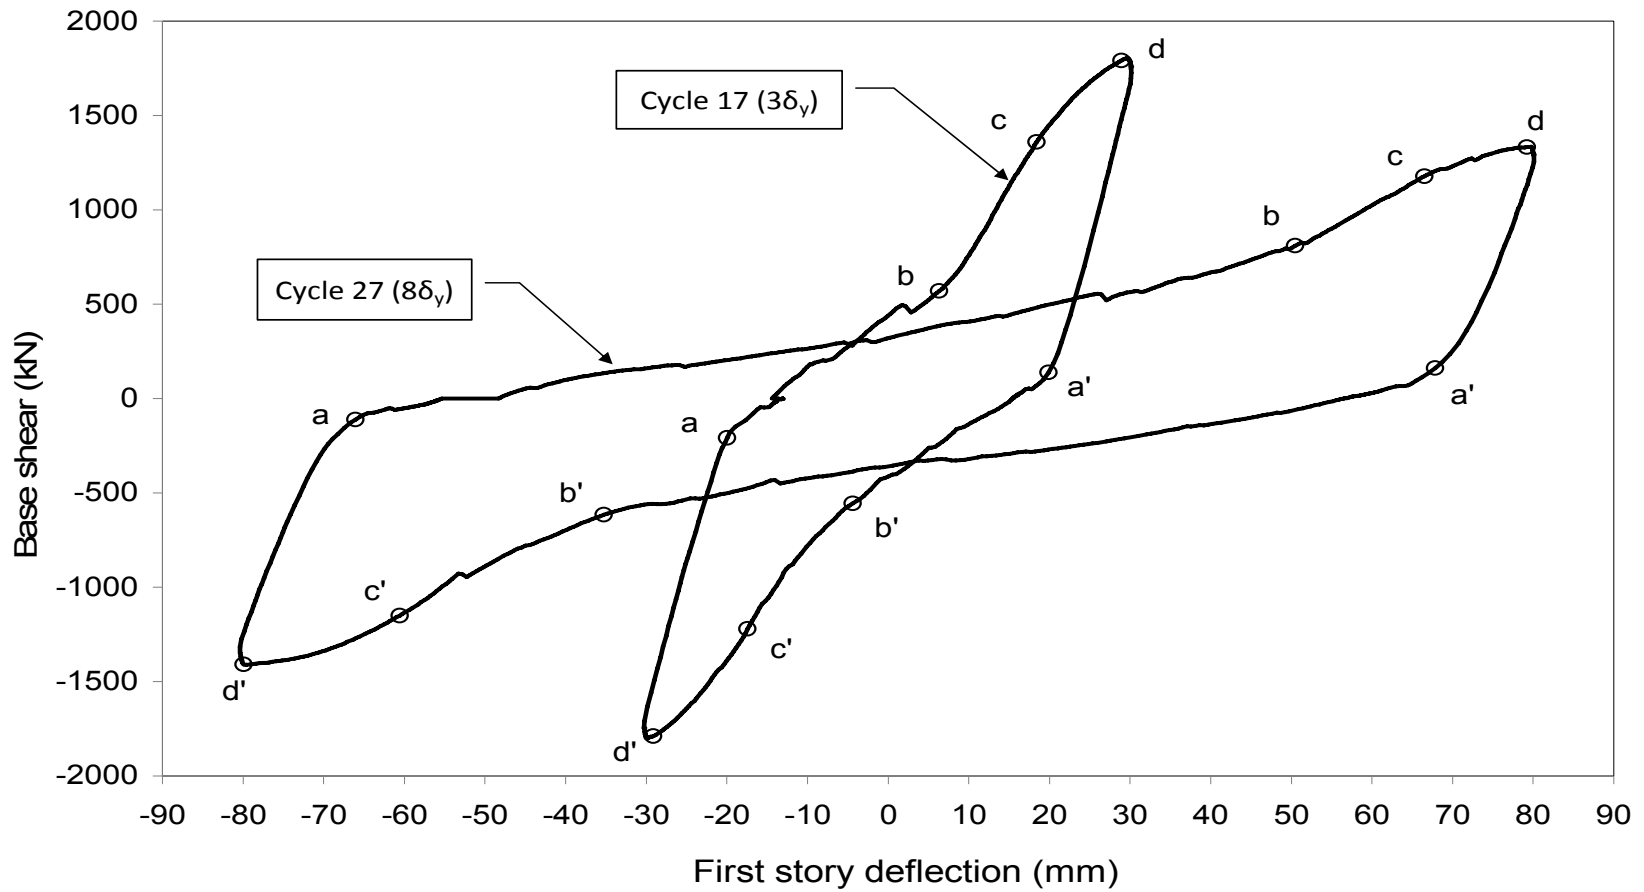
Figure 6.18: Hysteretic loops of cycles 17 and 27 of the RBS test
