DUCTILE STEEL PLATE SHEAR WALLS WITH PEC COLUMNS

Doctor of Philosophy

Structural Engineering

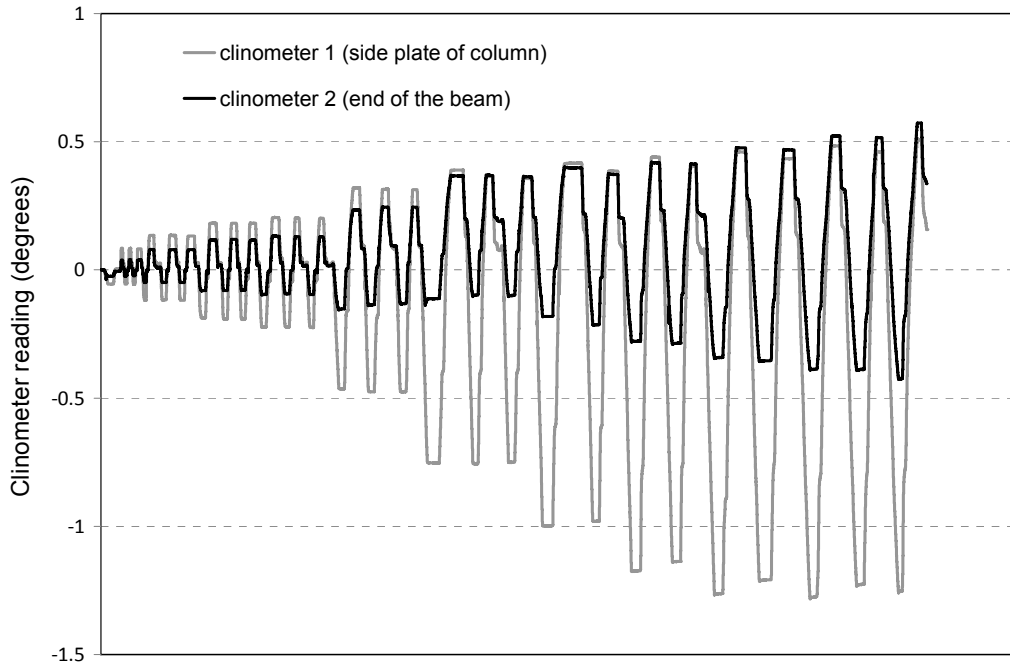
Figure 6.19: Rotation history of the side plate of column and end of the beam in the first floor of the RBS test specimen

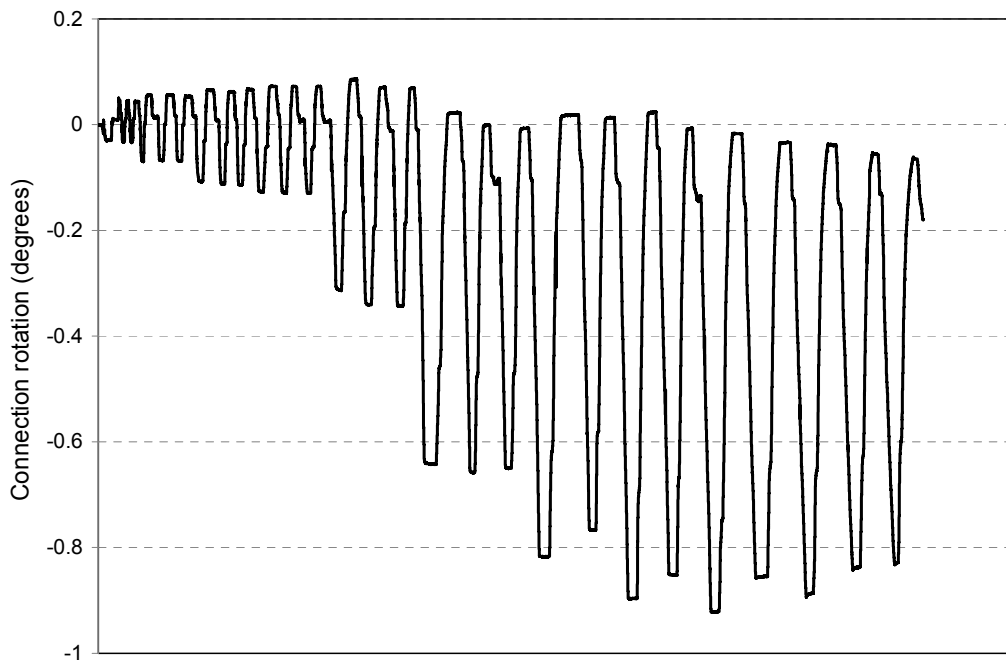
Figure 6.20: Rotation history of the frame connection in the first floor during the RBS test

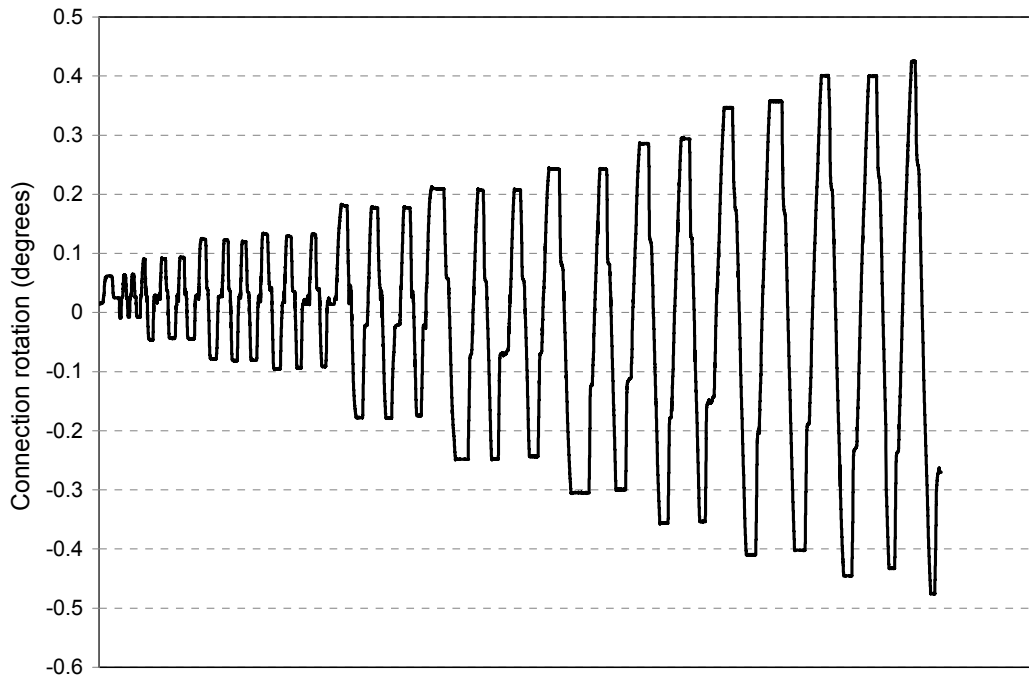
Figure 6.21: Rotation history of the side plate of column in the second floor of the RBS test specimen

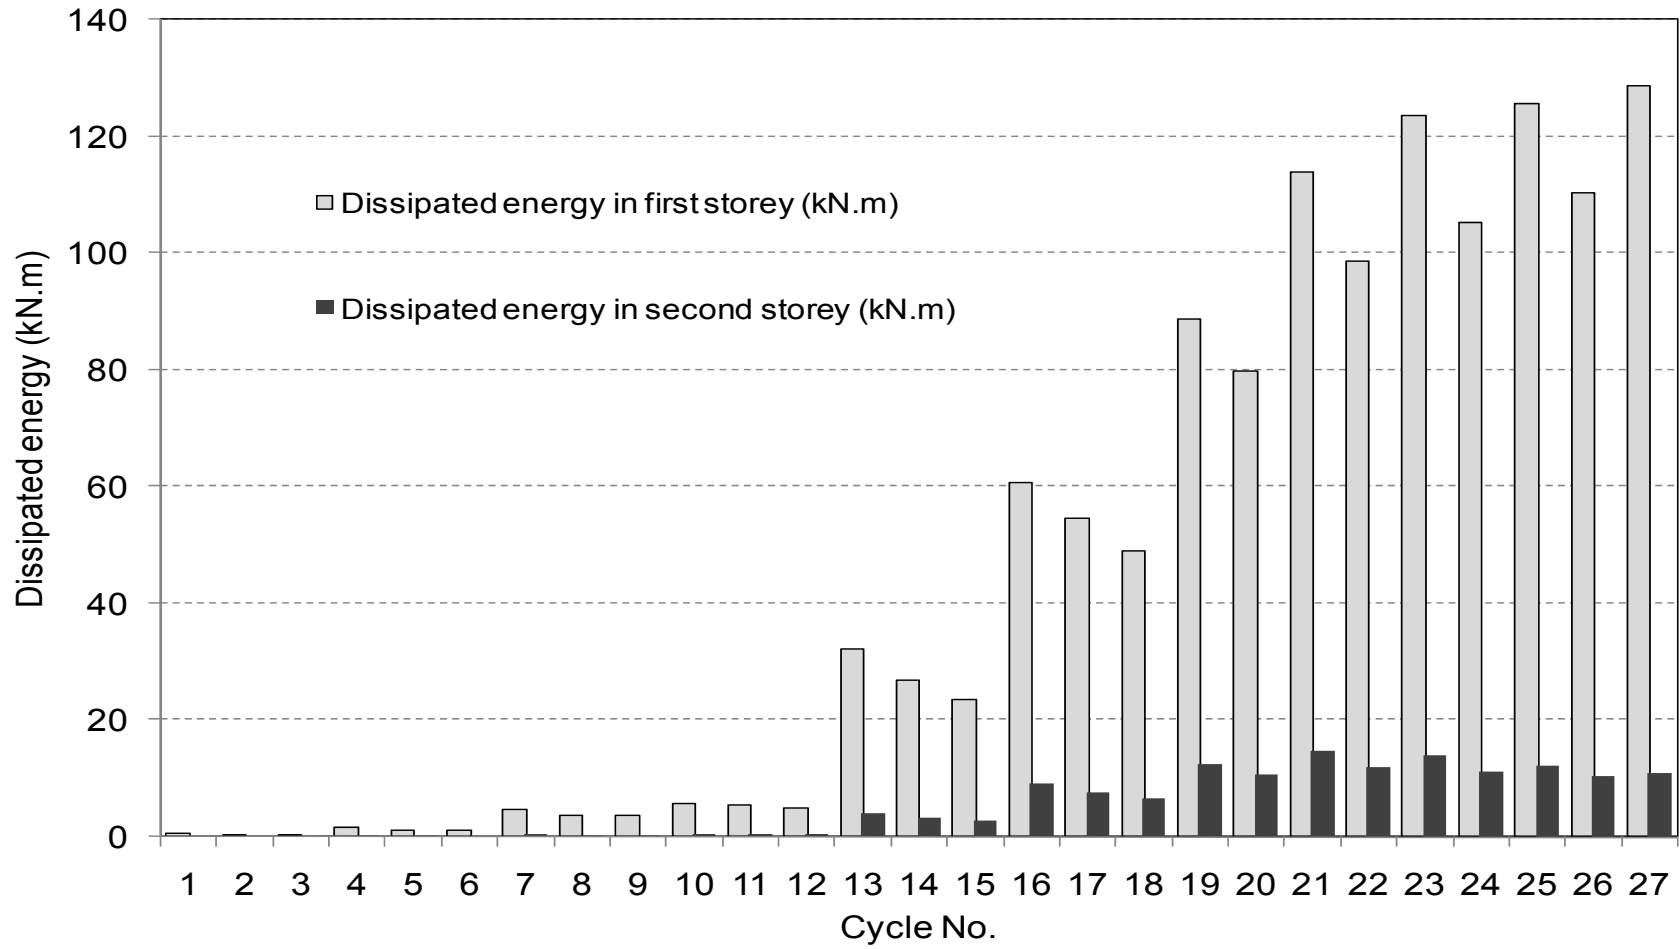
Figure 6.22: Amount of the dissipated energy in each cycle of the RBS test in the first and second storeys

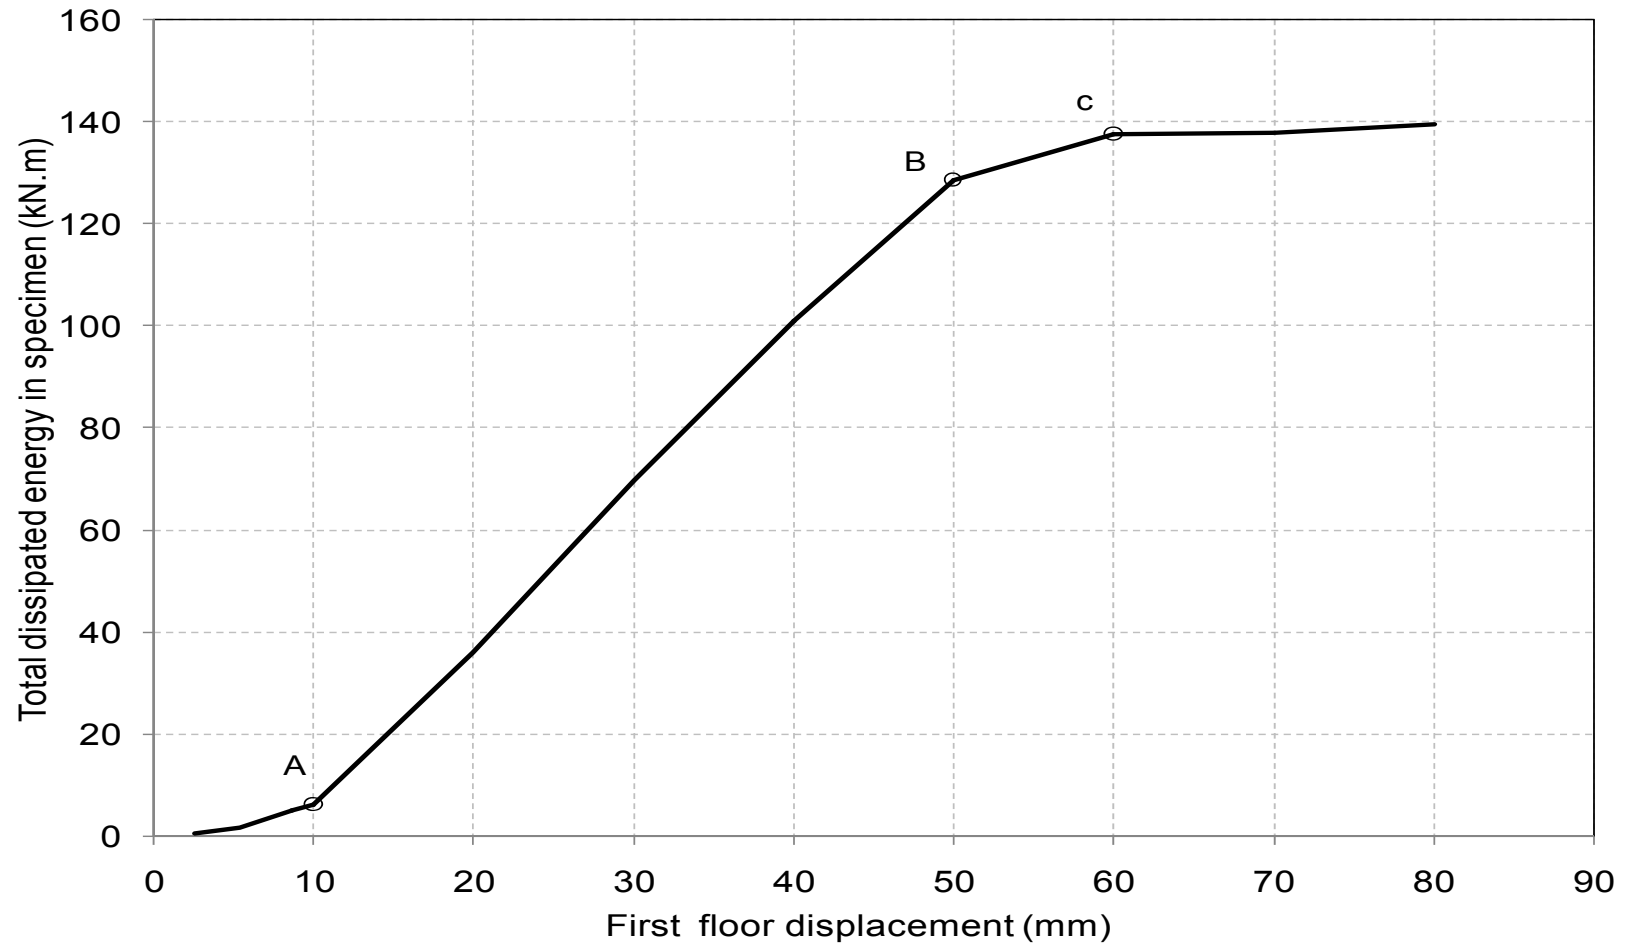
Figure 6.23: Total dissipated energy versus first floor displacement in the RBS test

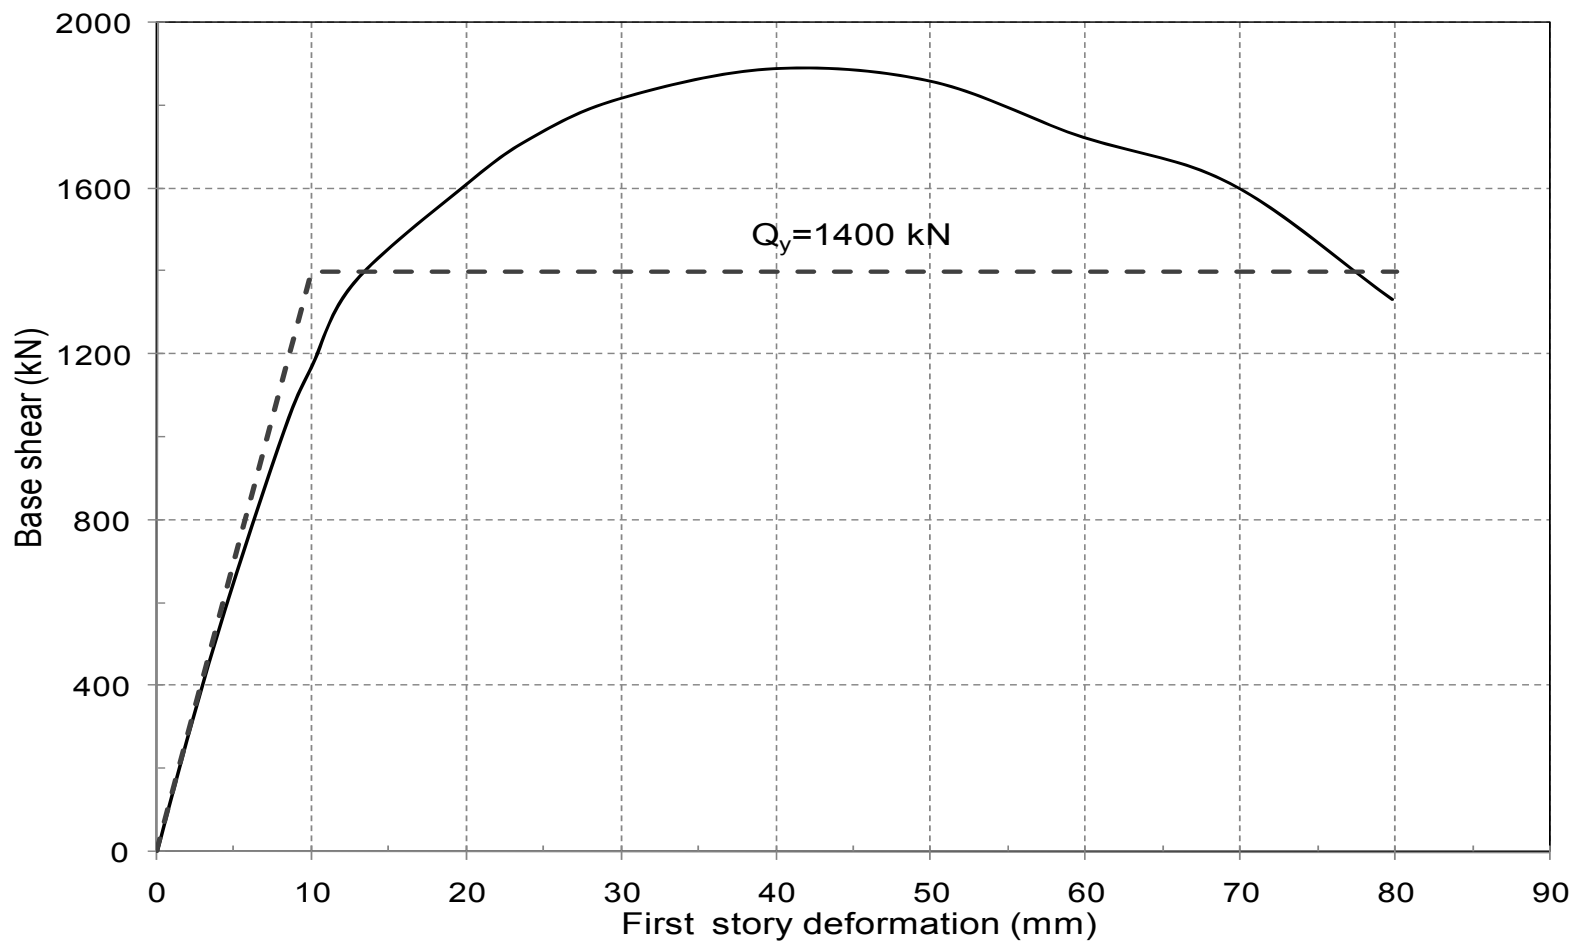
Figure 6.24: Envelope of the hysteretic loops of base shear versus first story deformation in the RBS test

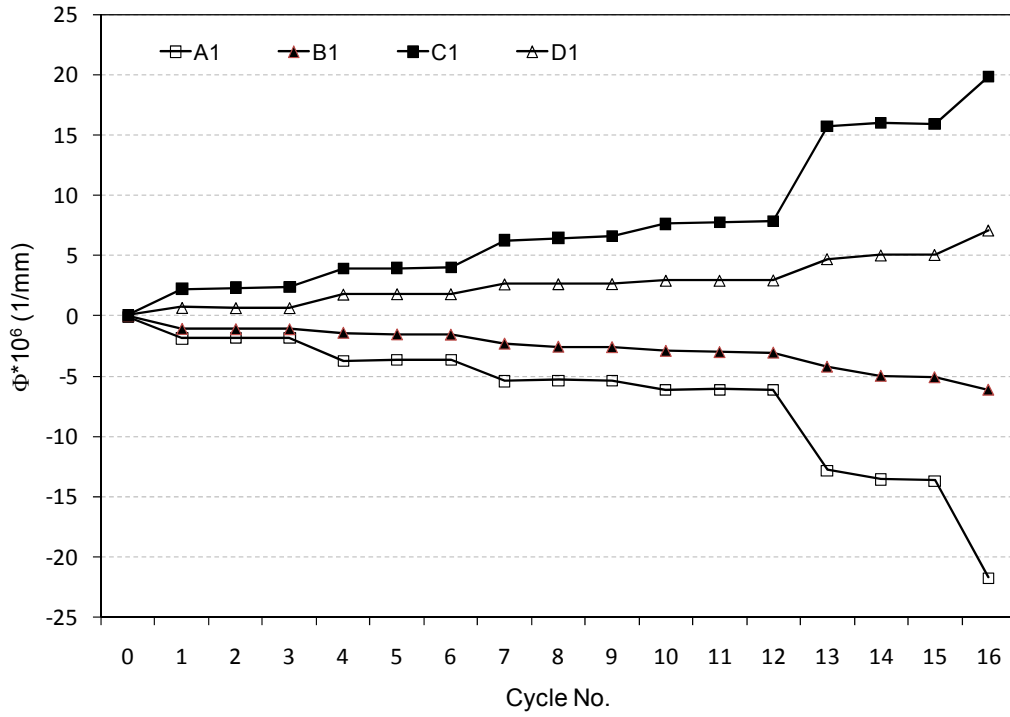
Figure 6.25: The curvature of the north column at four sections in cycles 1 to 16

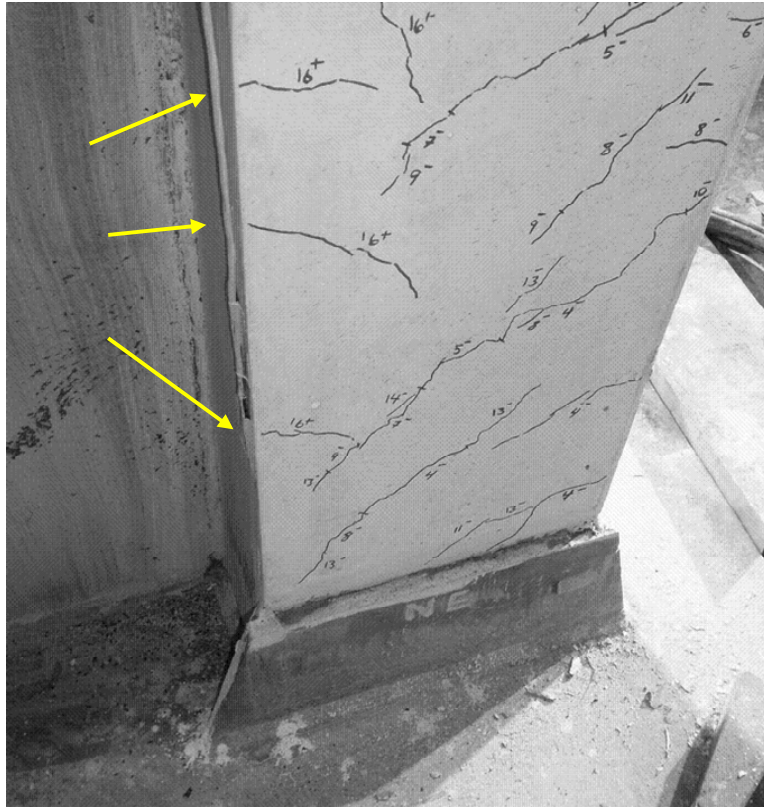
Figure 6.26: Base of north column in cycle 16⁺ and initiation of new cracks, adjacent to the inner flange of column

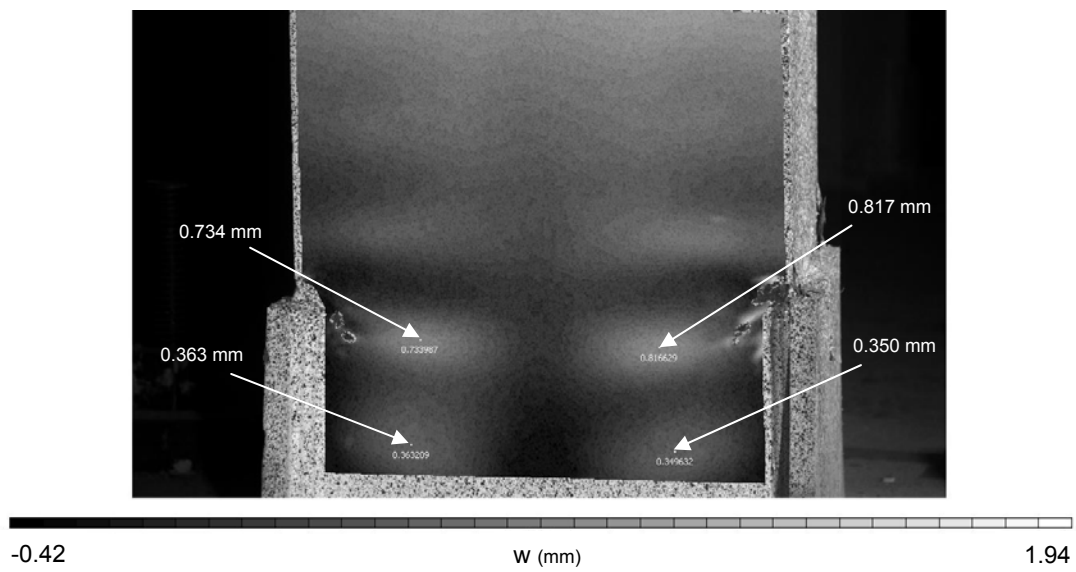
Figure 6.27: Out of flatness deformation of outer flange of north column in cycle 18⁺

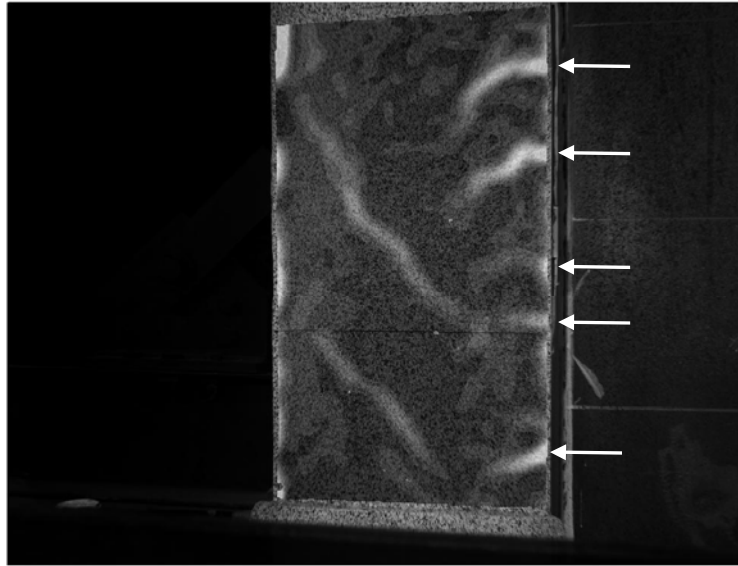
Figure 6.30: Maximum principal strain distribution in cycle 13⁺, showing the locations of the flexural cracks adjacent to the inner flange of column

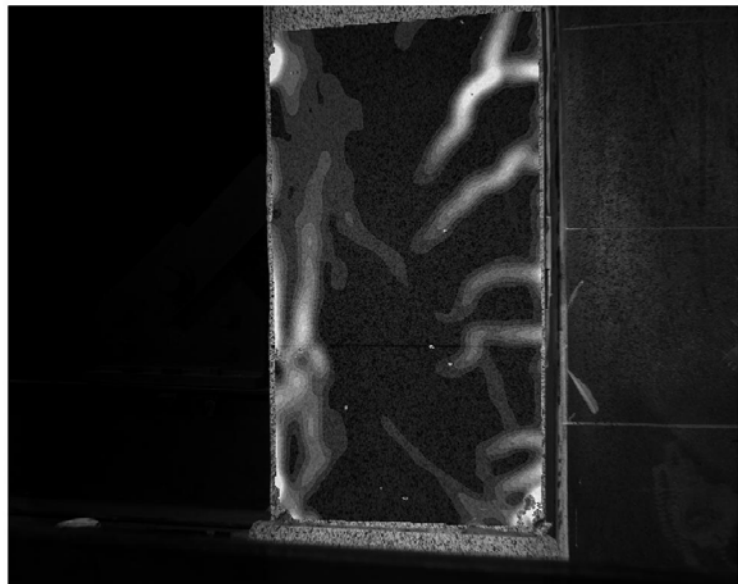
Figure 6.31: Maximum principal strain distribution in cycle 19⁺

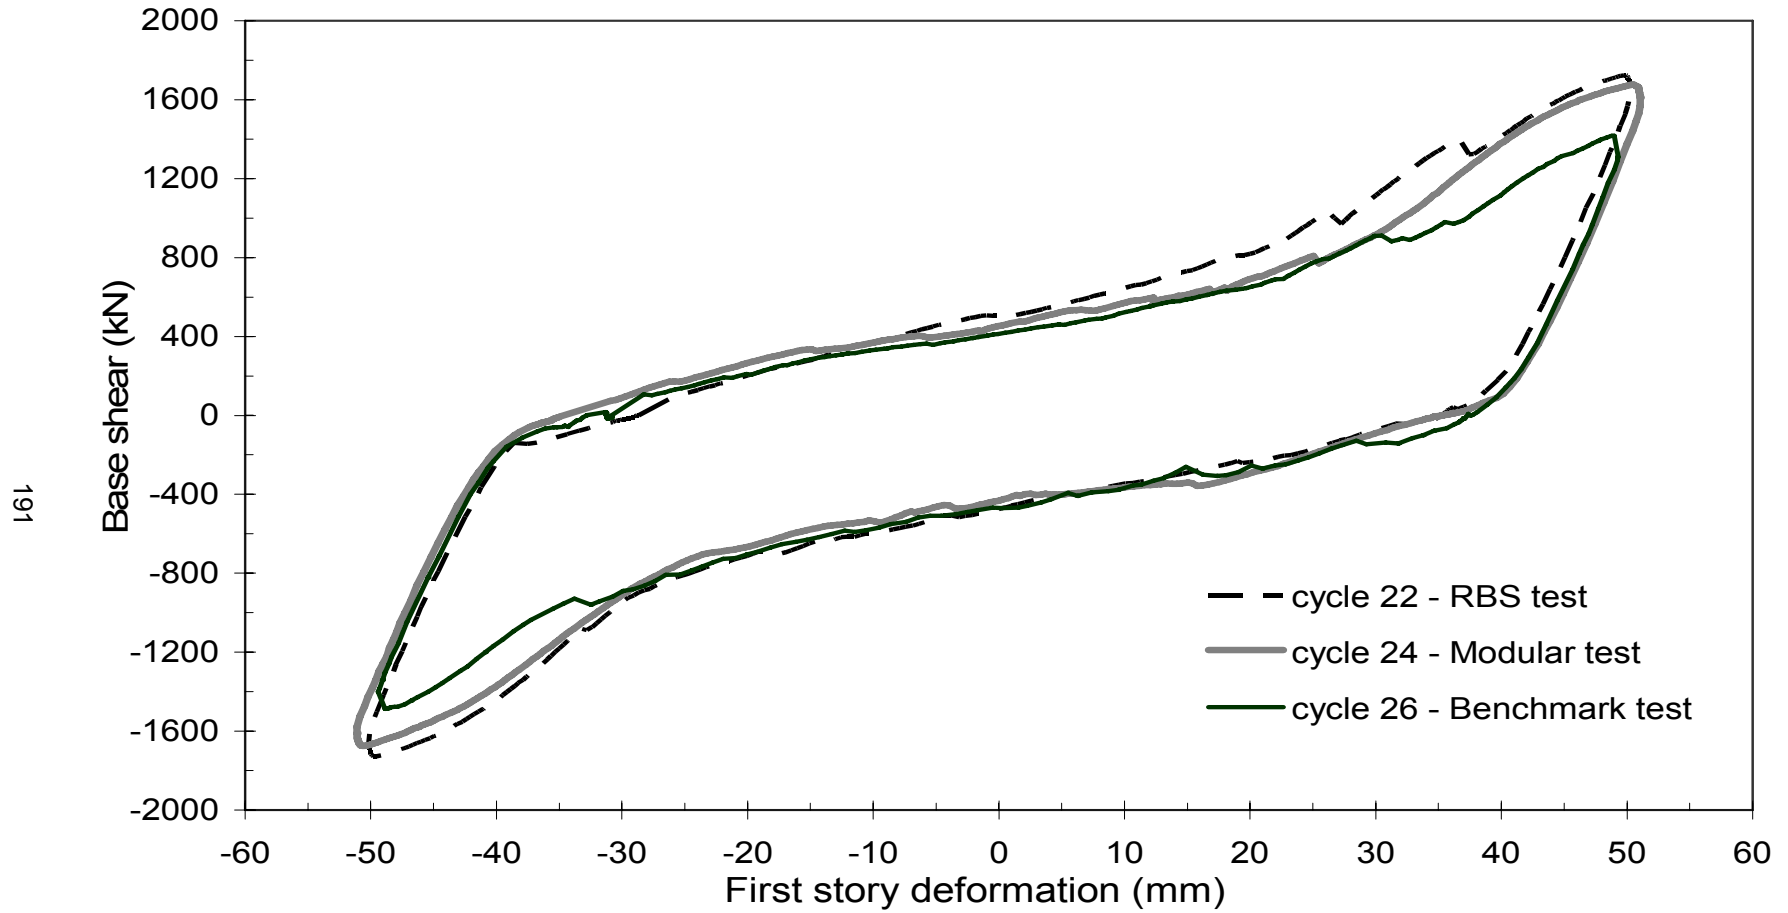
Figure 7.1: Hysteretic loops of cycles with story deformations of close to 50 mm

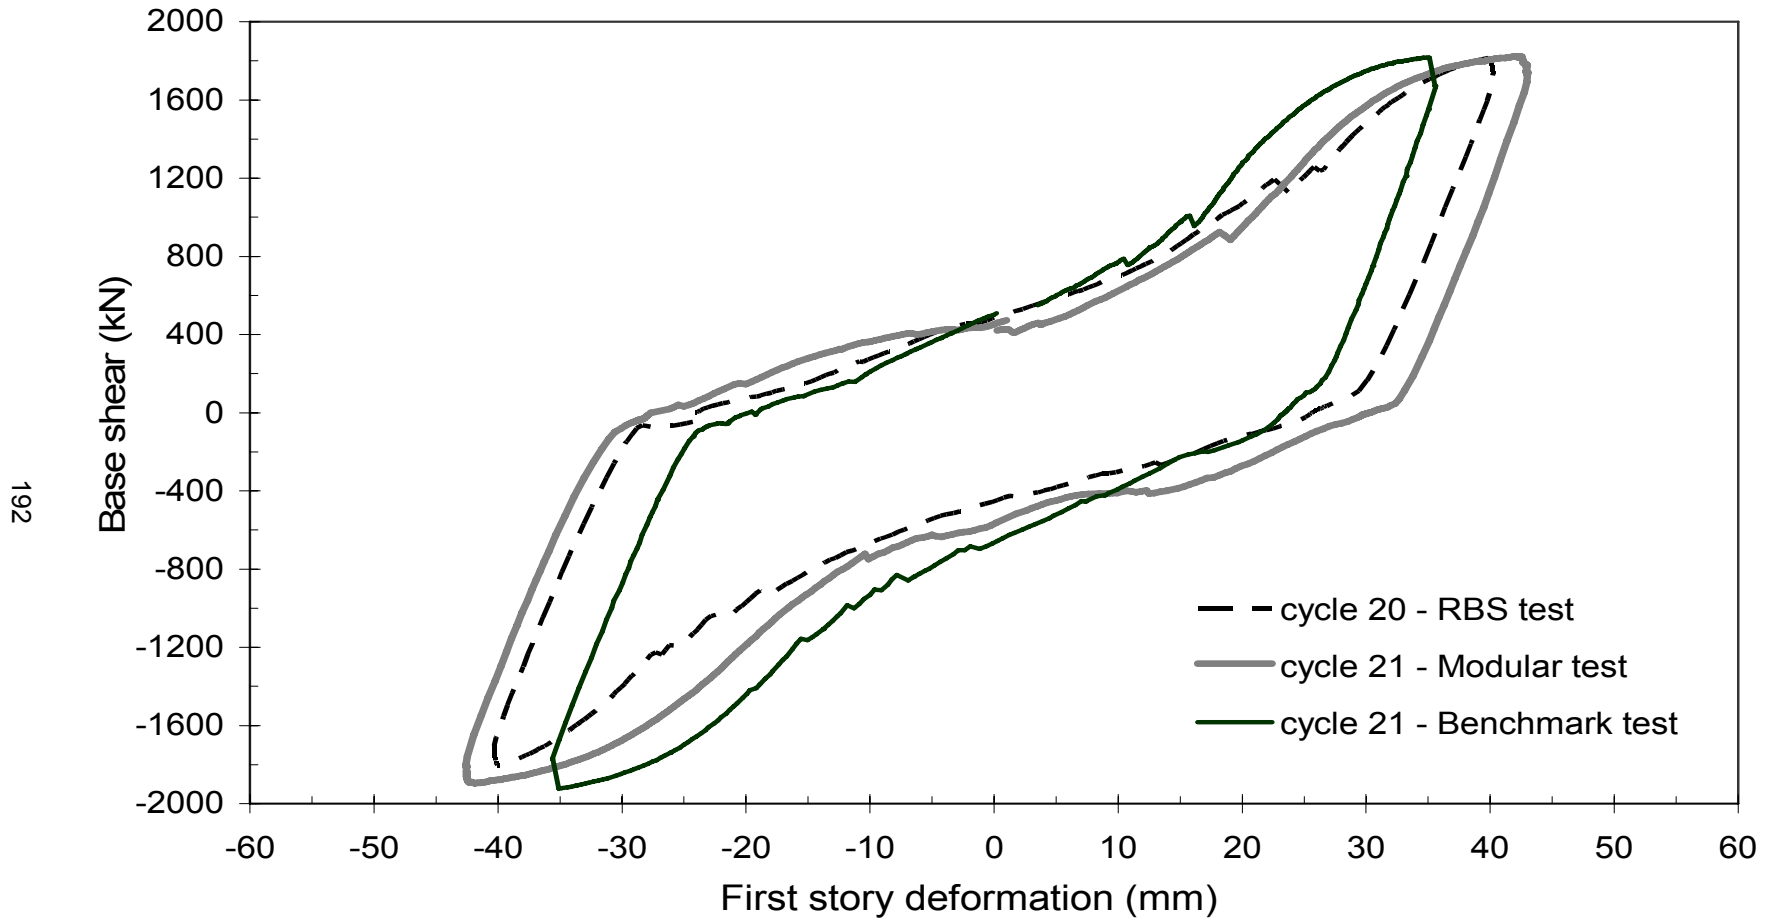
Figure 7.2: Hysteretic loops of cycles with the peak base shear

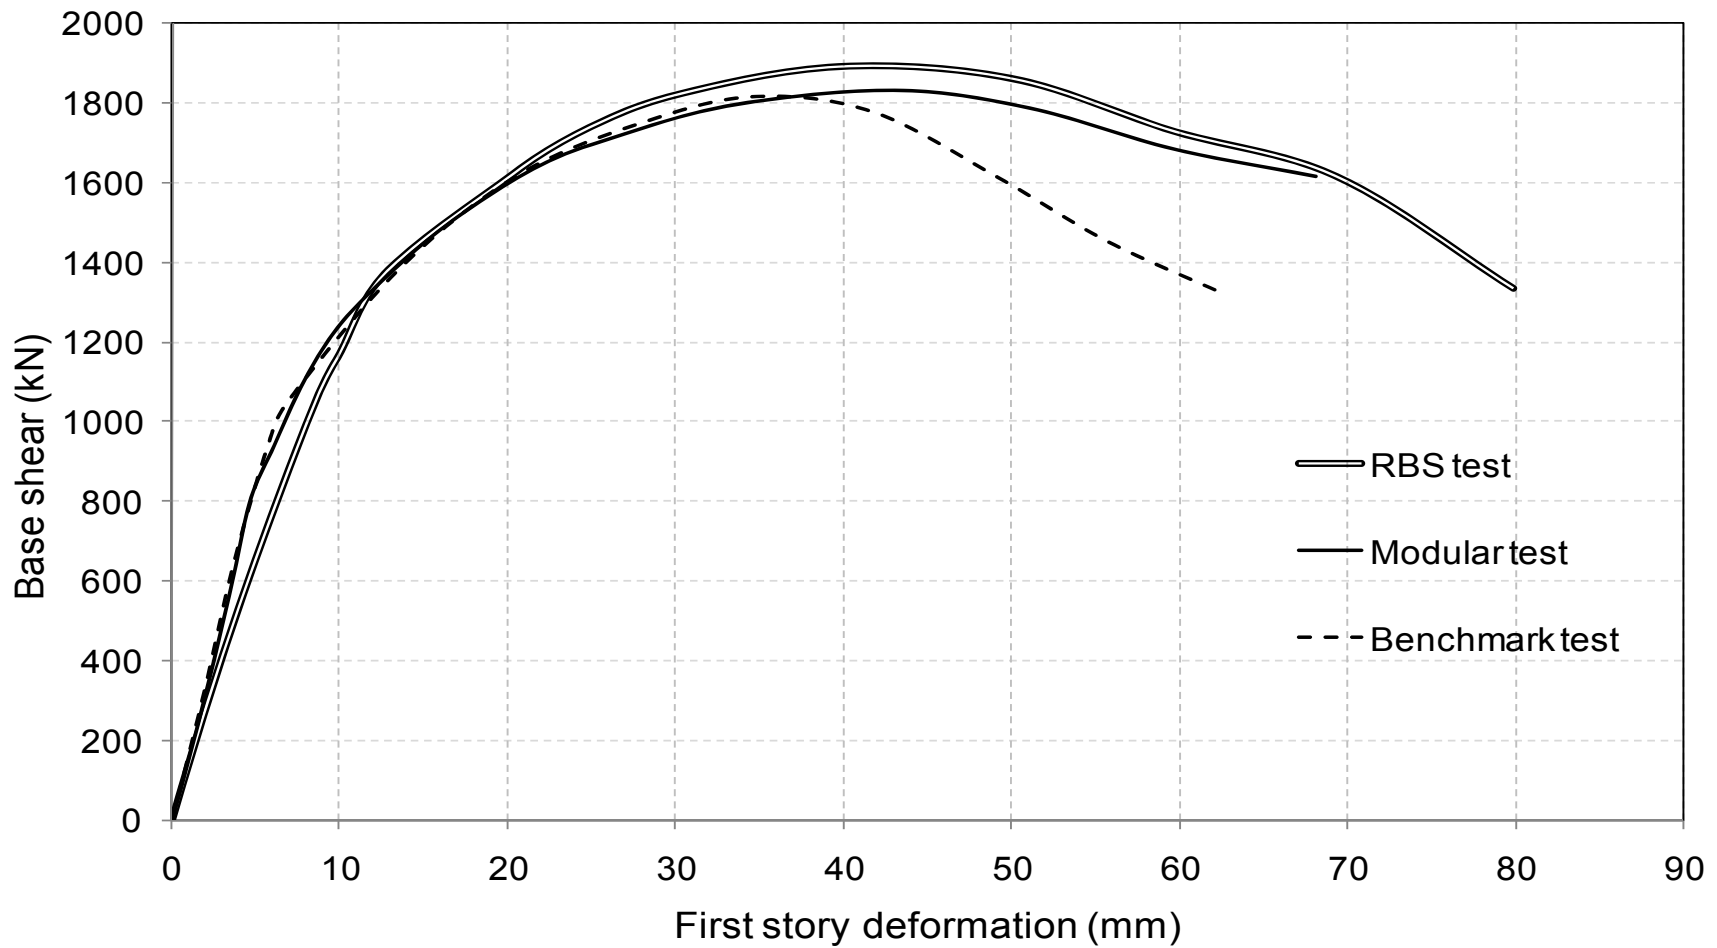
Figure 7.3: Envelope of hysteretic loops of first story of three test specimens

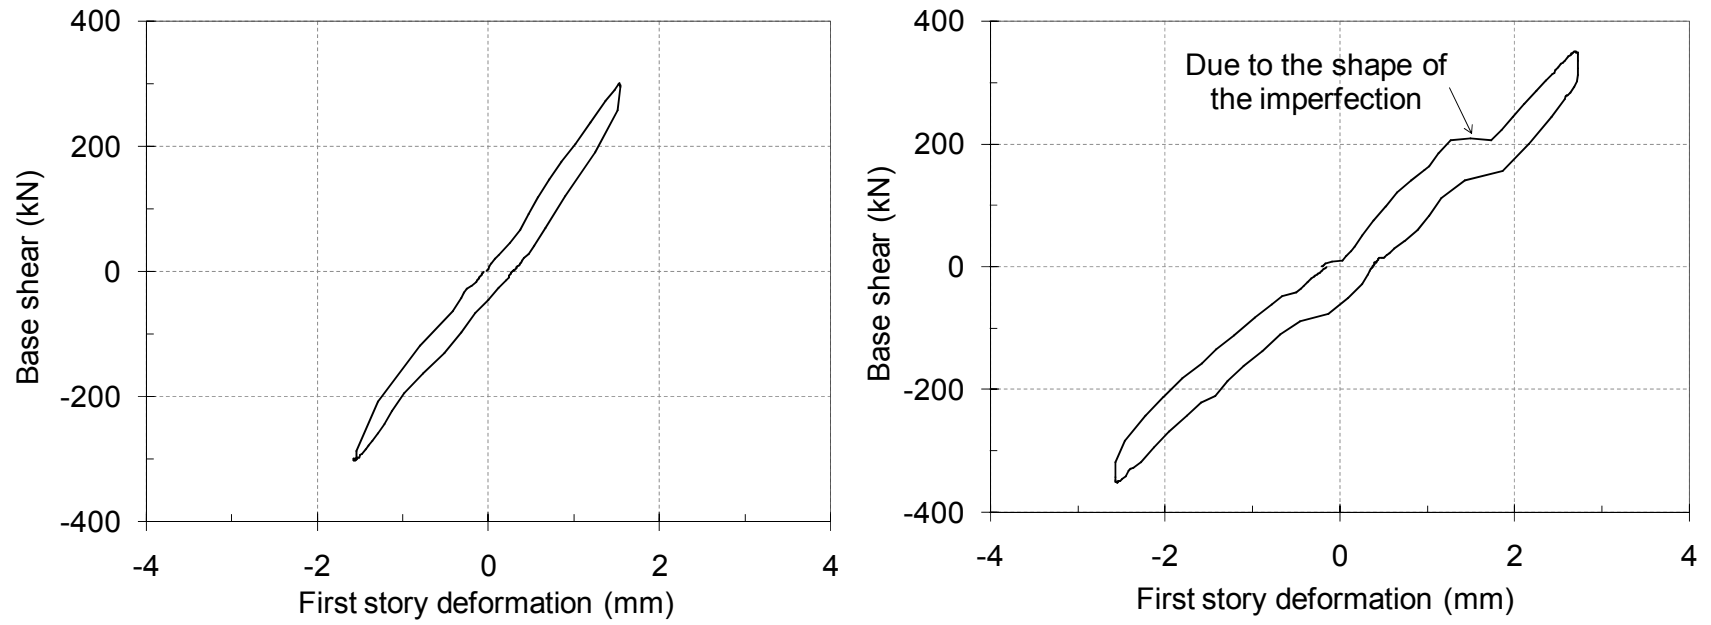
Figure 7.4: Hysteretic loop of cycle 3 of the modular test (left) and RBS test (right)

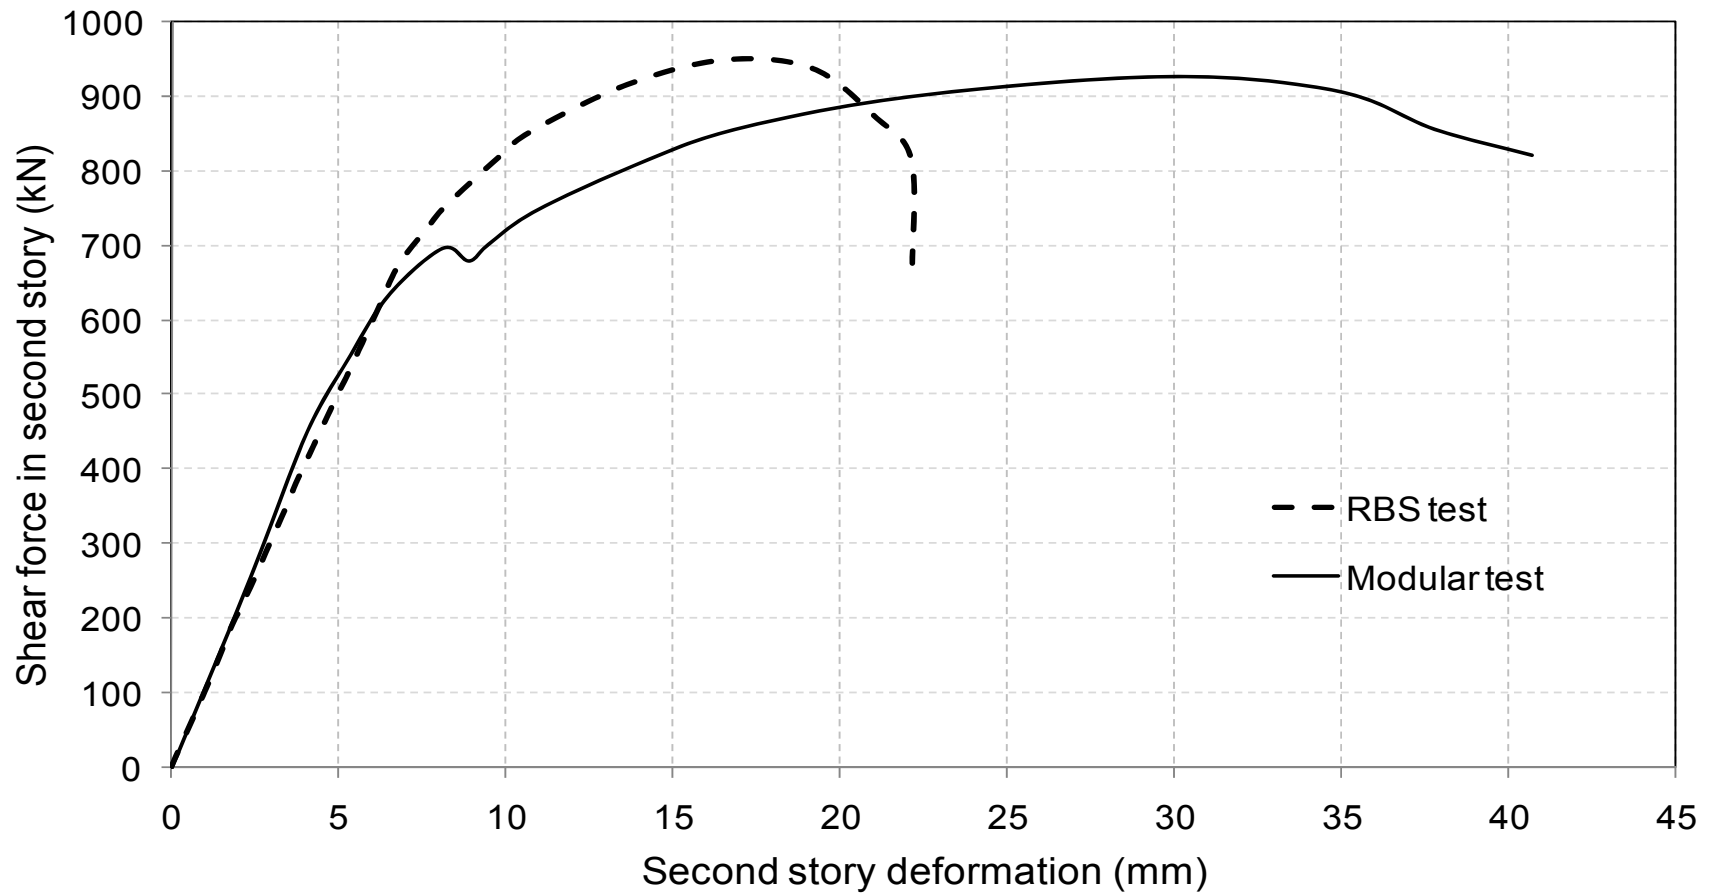
Figure 7.5: Envelope of the hysteretic loops of the second story of the modular and RBS tests

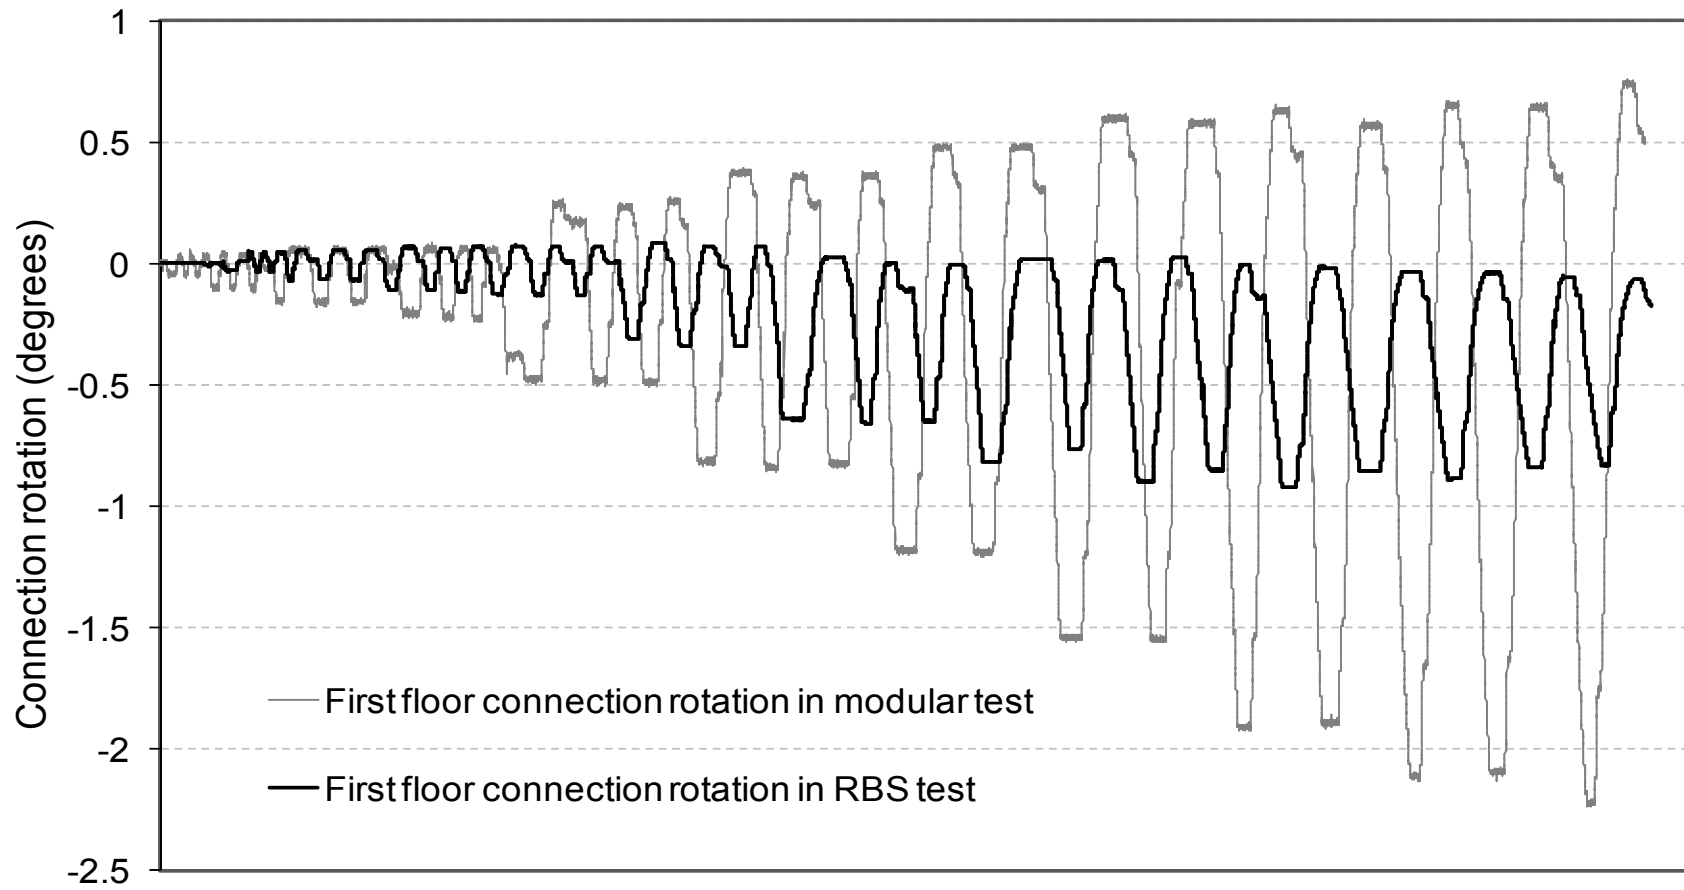
Figure 7.6: Rotation of the frame connection in the first floor during the modular and RBS tests

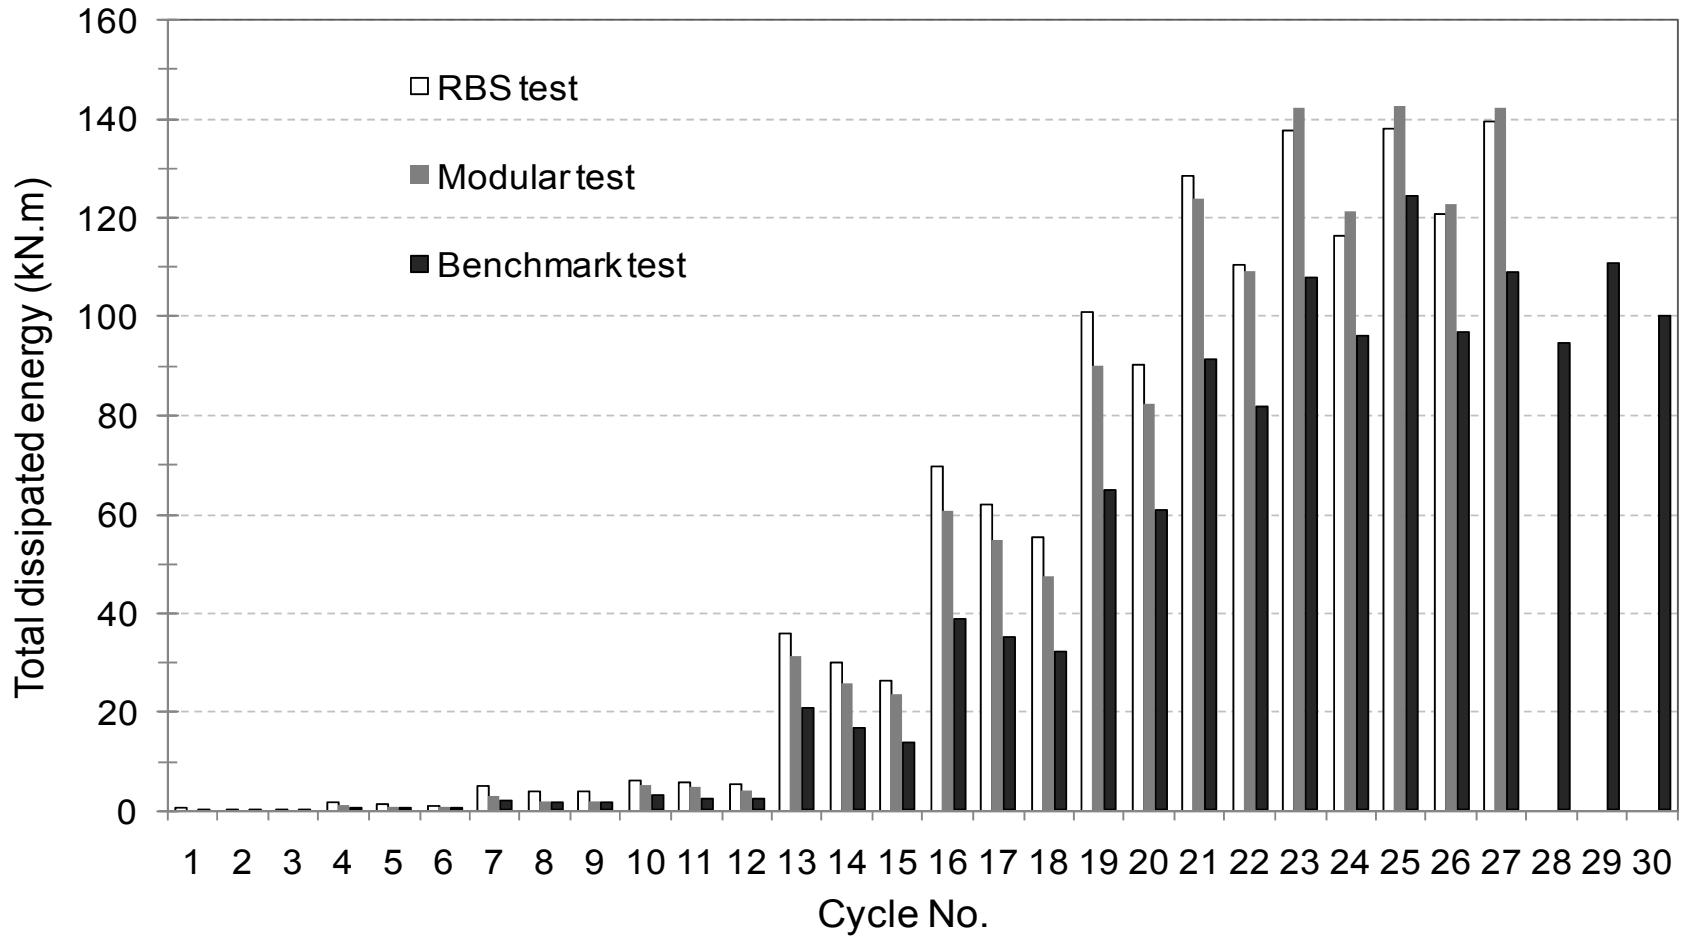
Figure 7.7: Total amount of the dissipated energy in each cycle during the benchmark, modular and RBS tests

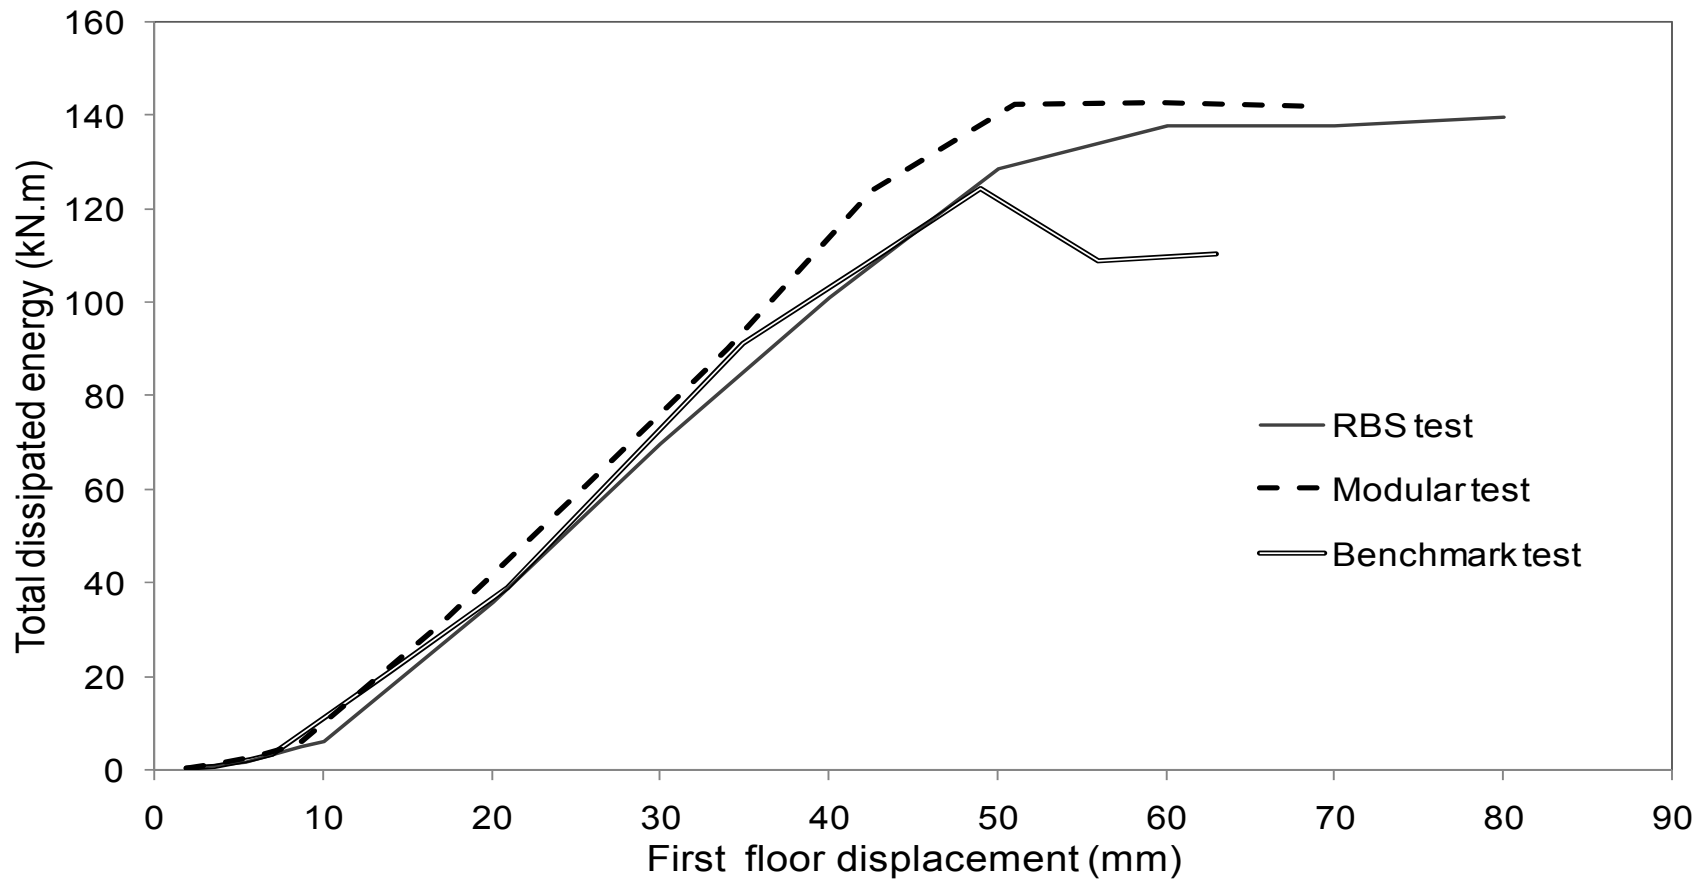
Figure 7.8: Total dissipated energy versus first floor displacement in the benchmark, modular and RBS tests
