DUCTILE STEEL PLATE SHEAR WALLS WITH PEC COLUMNS

Doctor of Philosophy

Structural Engineering

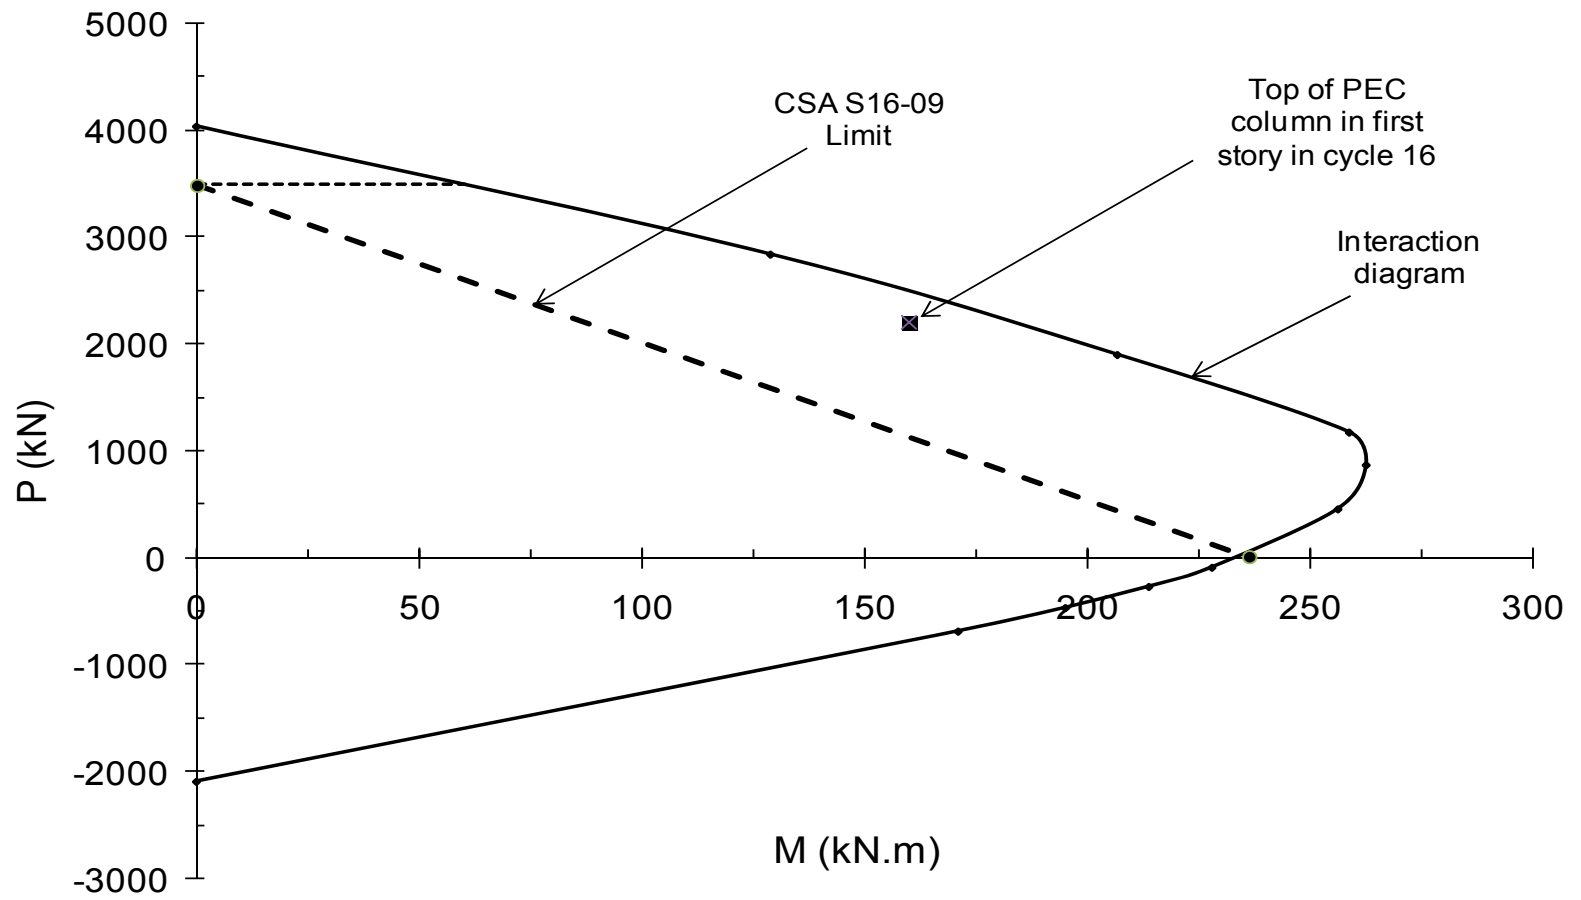
Figure 7.9: P-M interaction diagram for strong-axis bending of PEC column at top of the first story

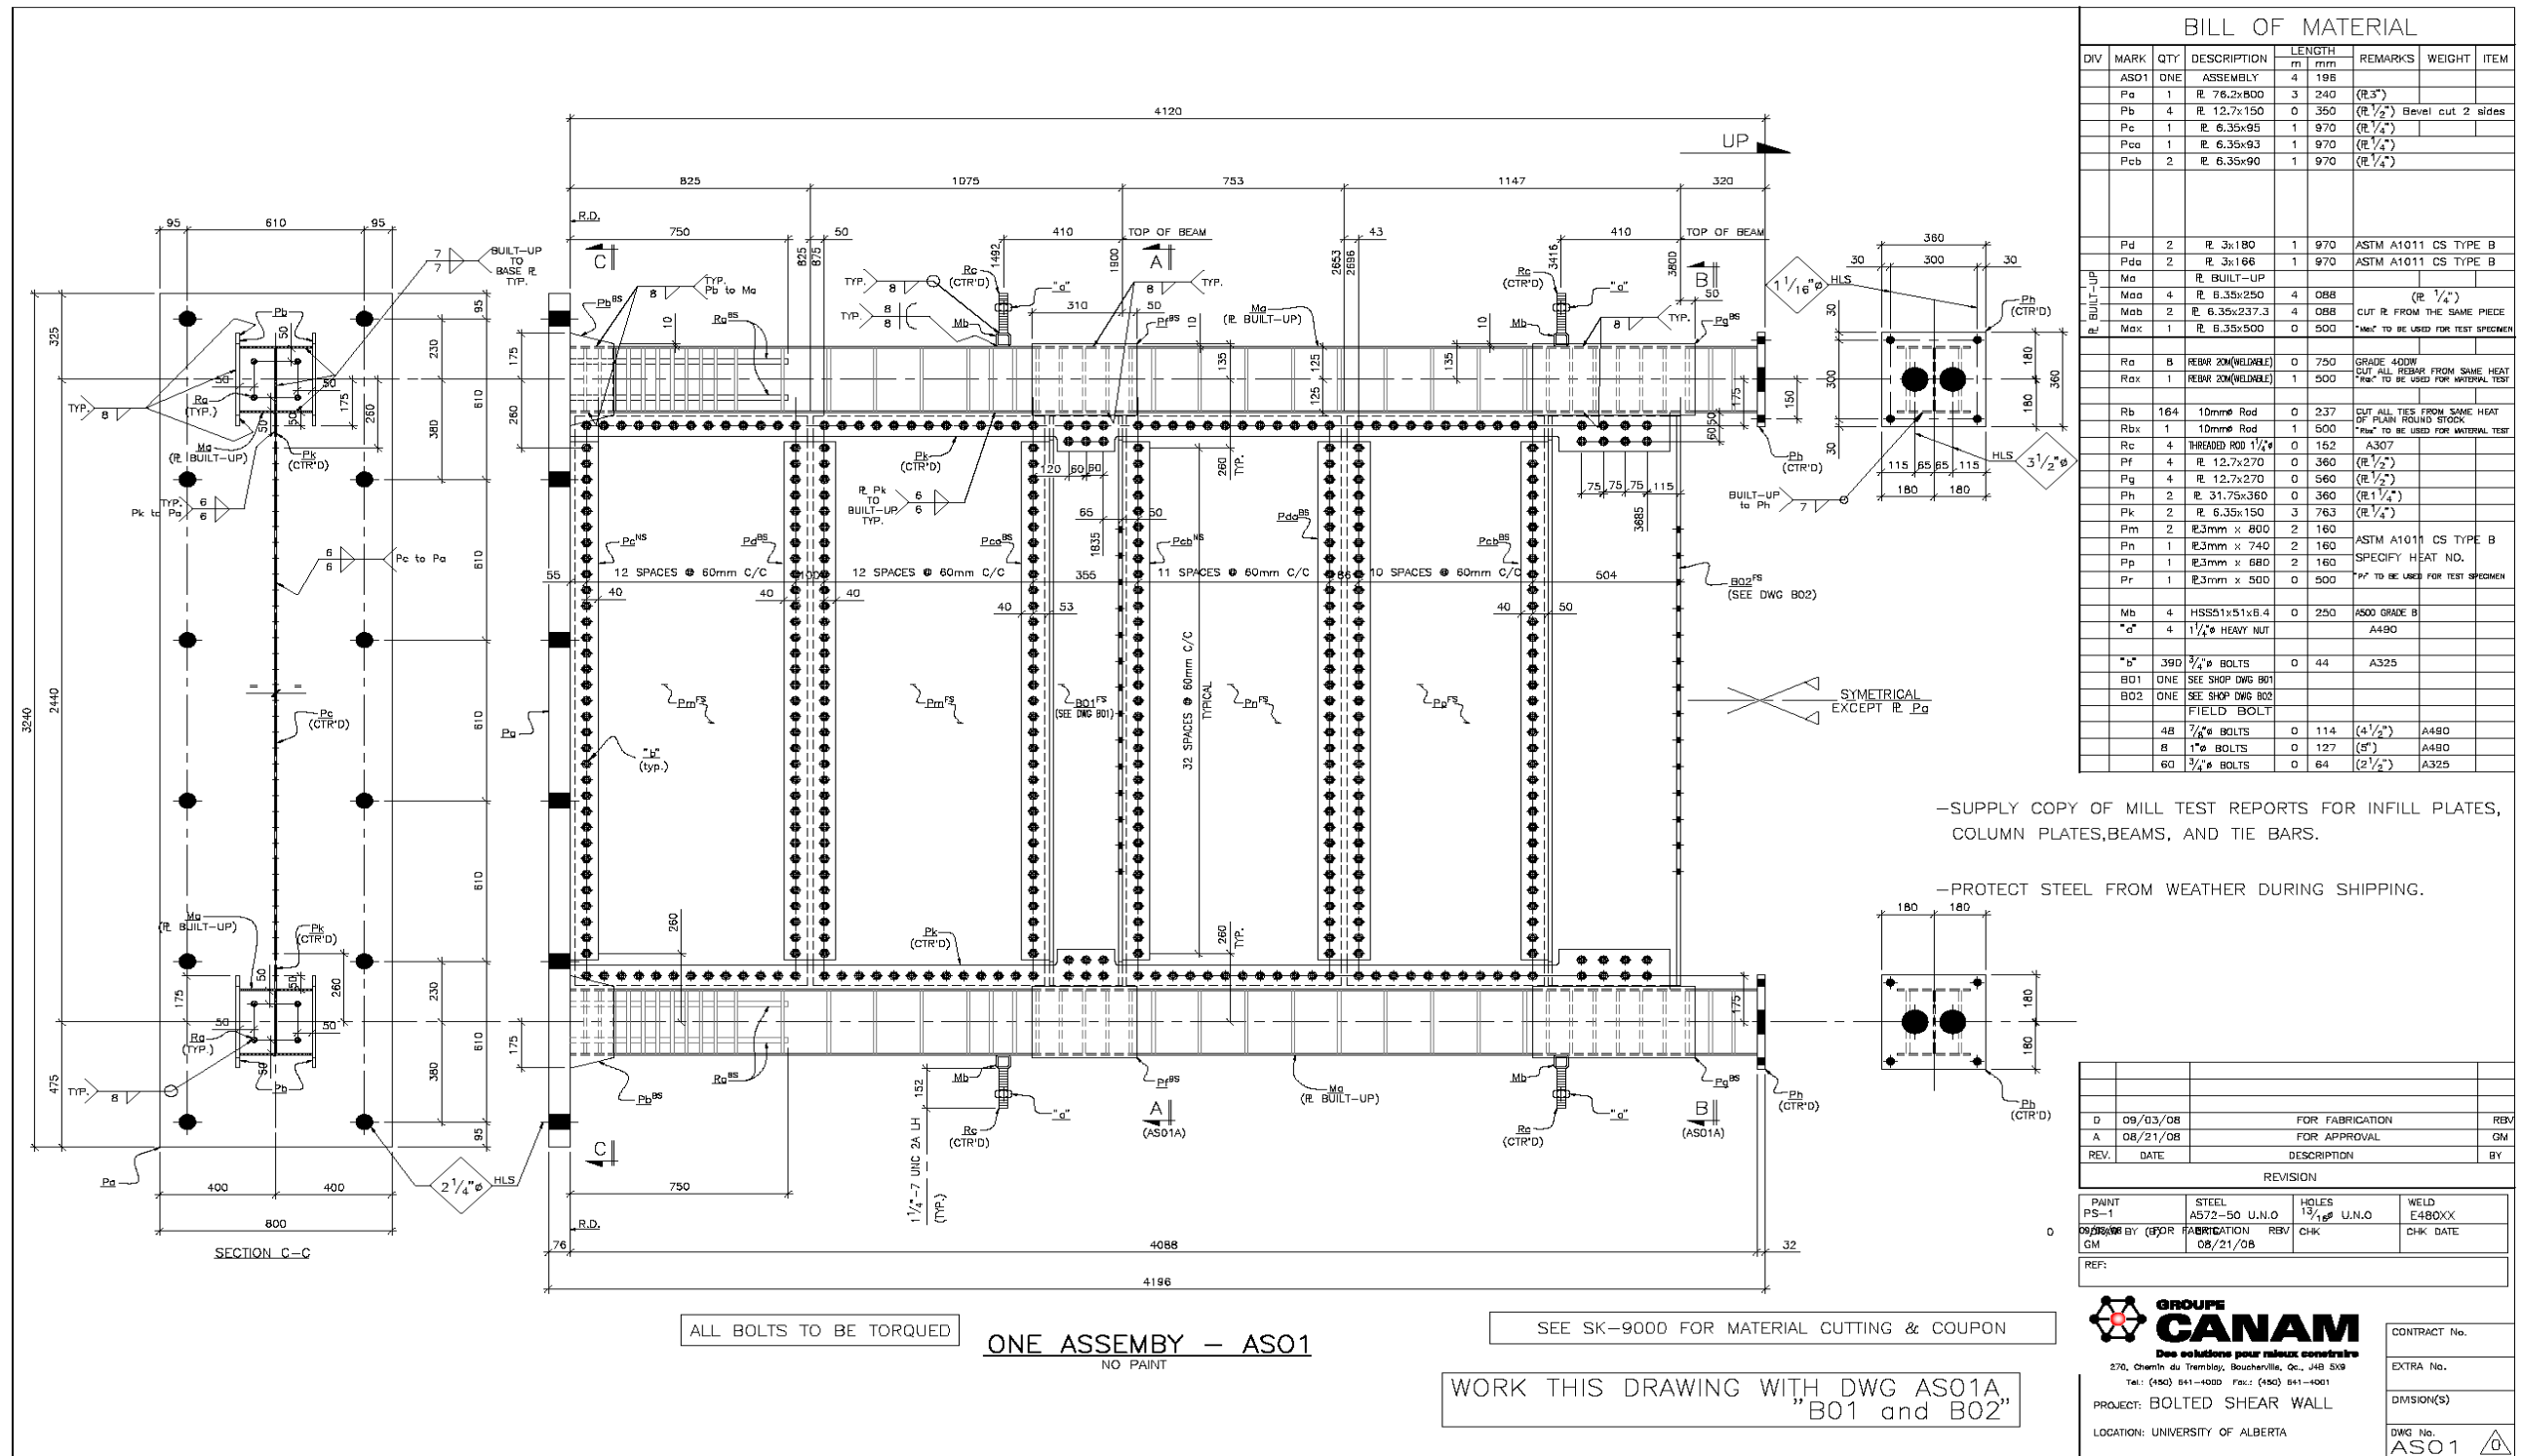
Figure A.1: Details of the assembled modular test specimen

Further details of the modular test specimen can be found in the shop drawings provided in Appendix A.

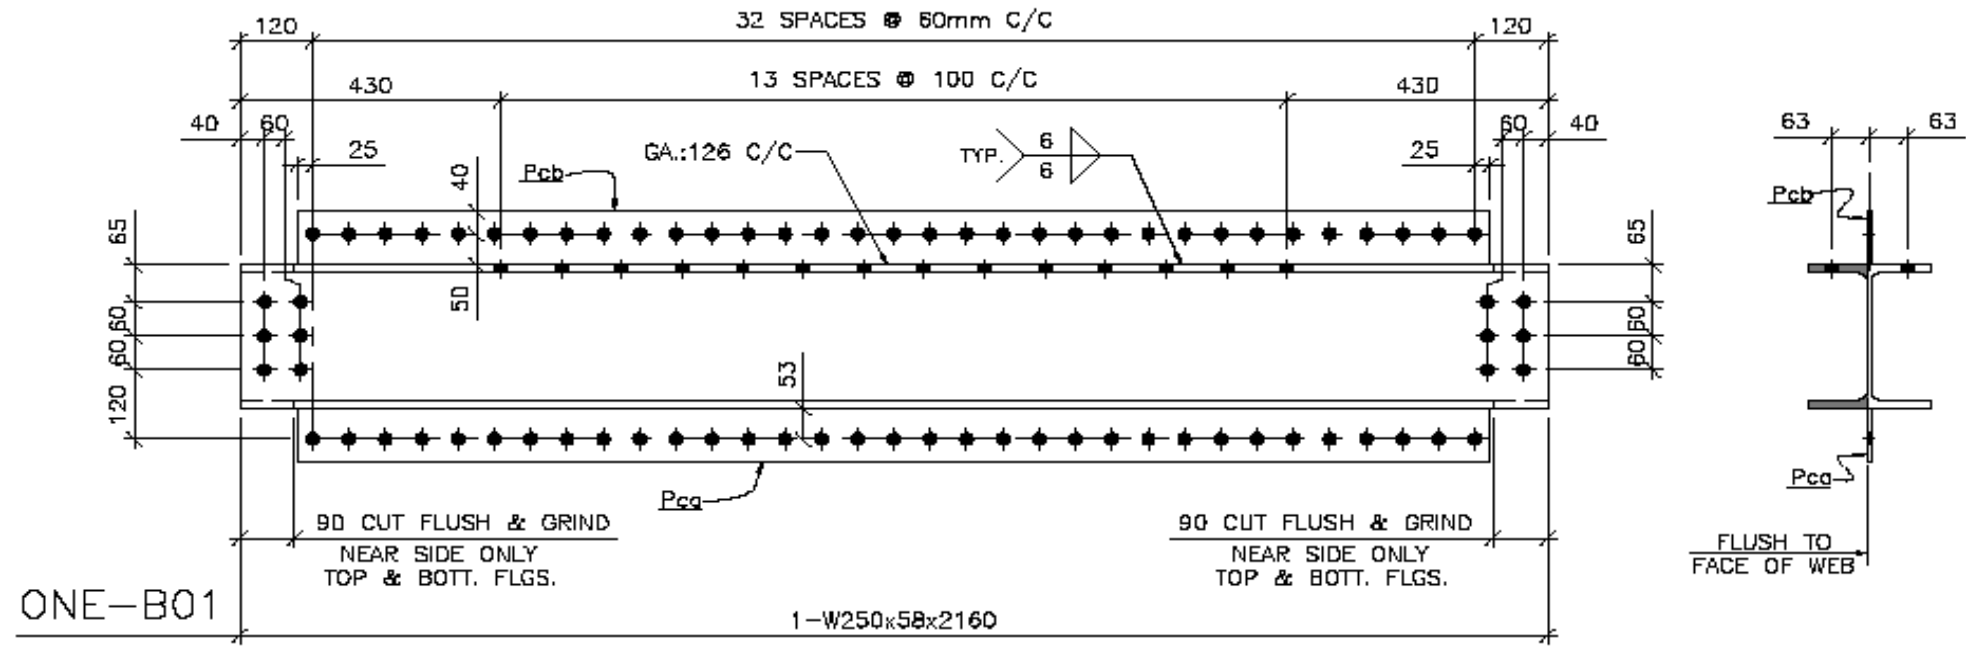
Figure A.3: Details of the first-floor beam in the modular test specimen

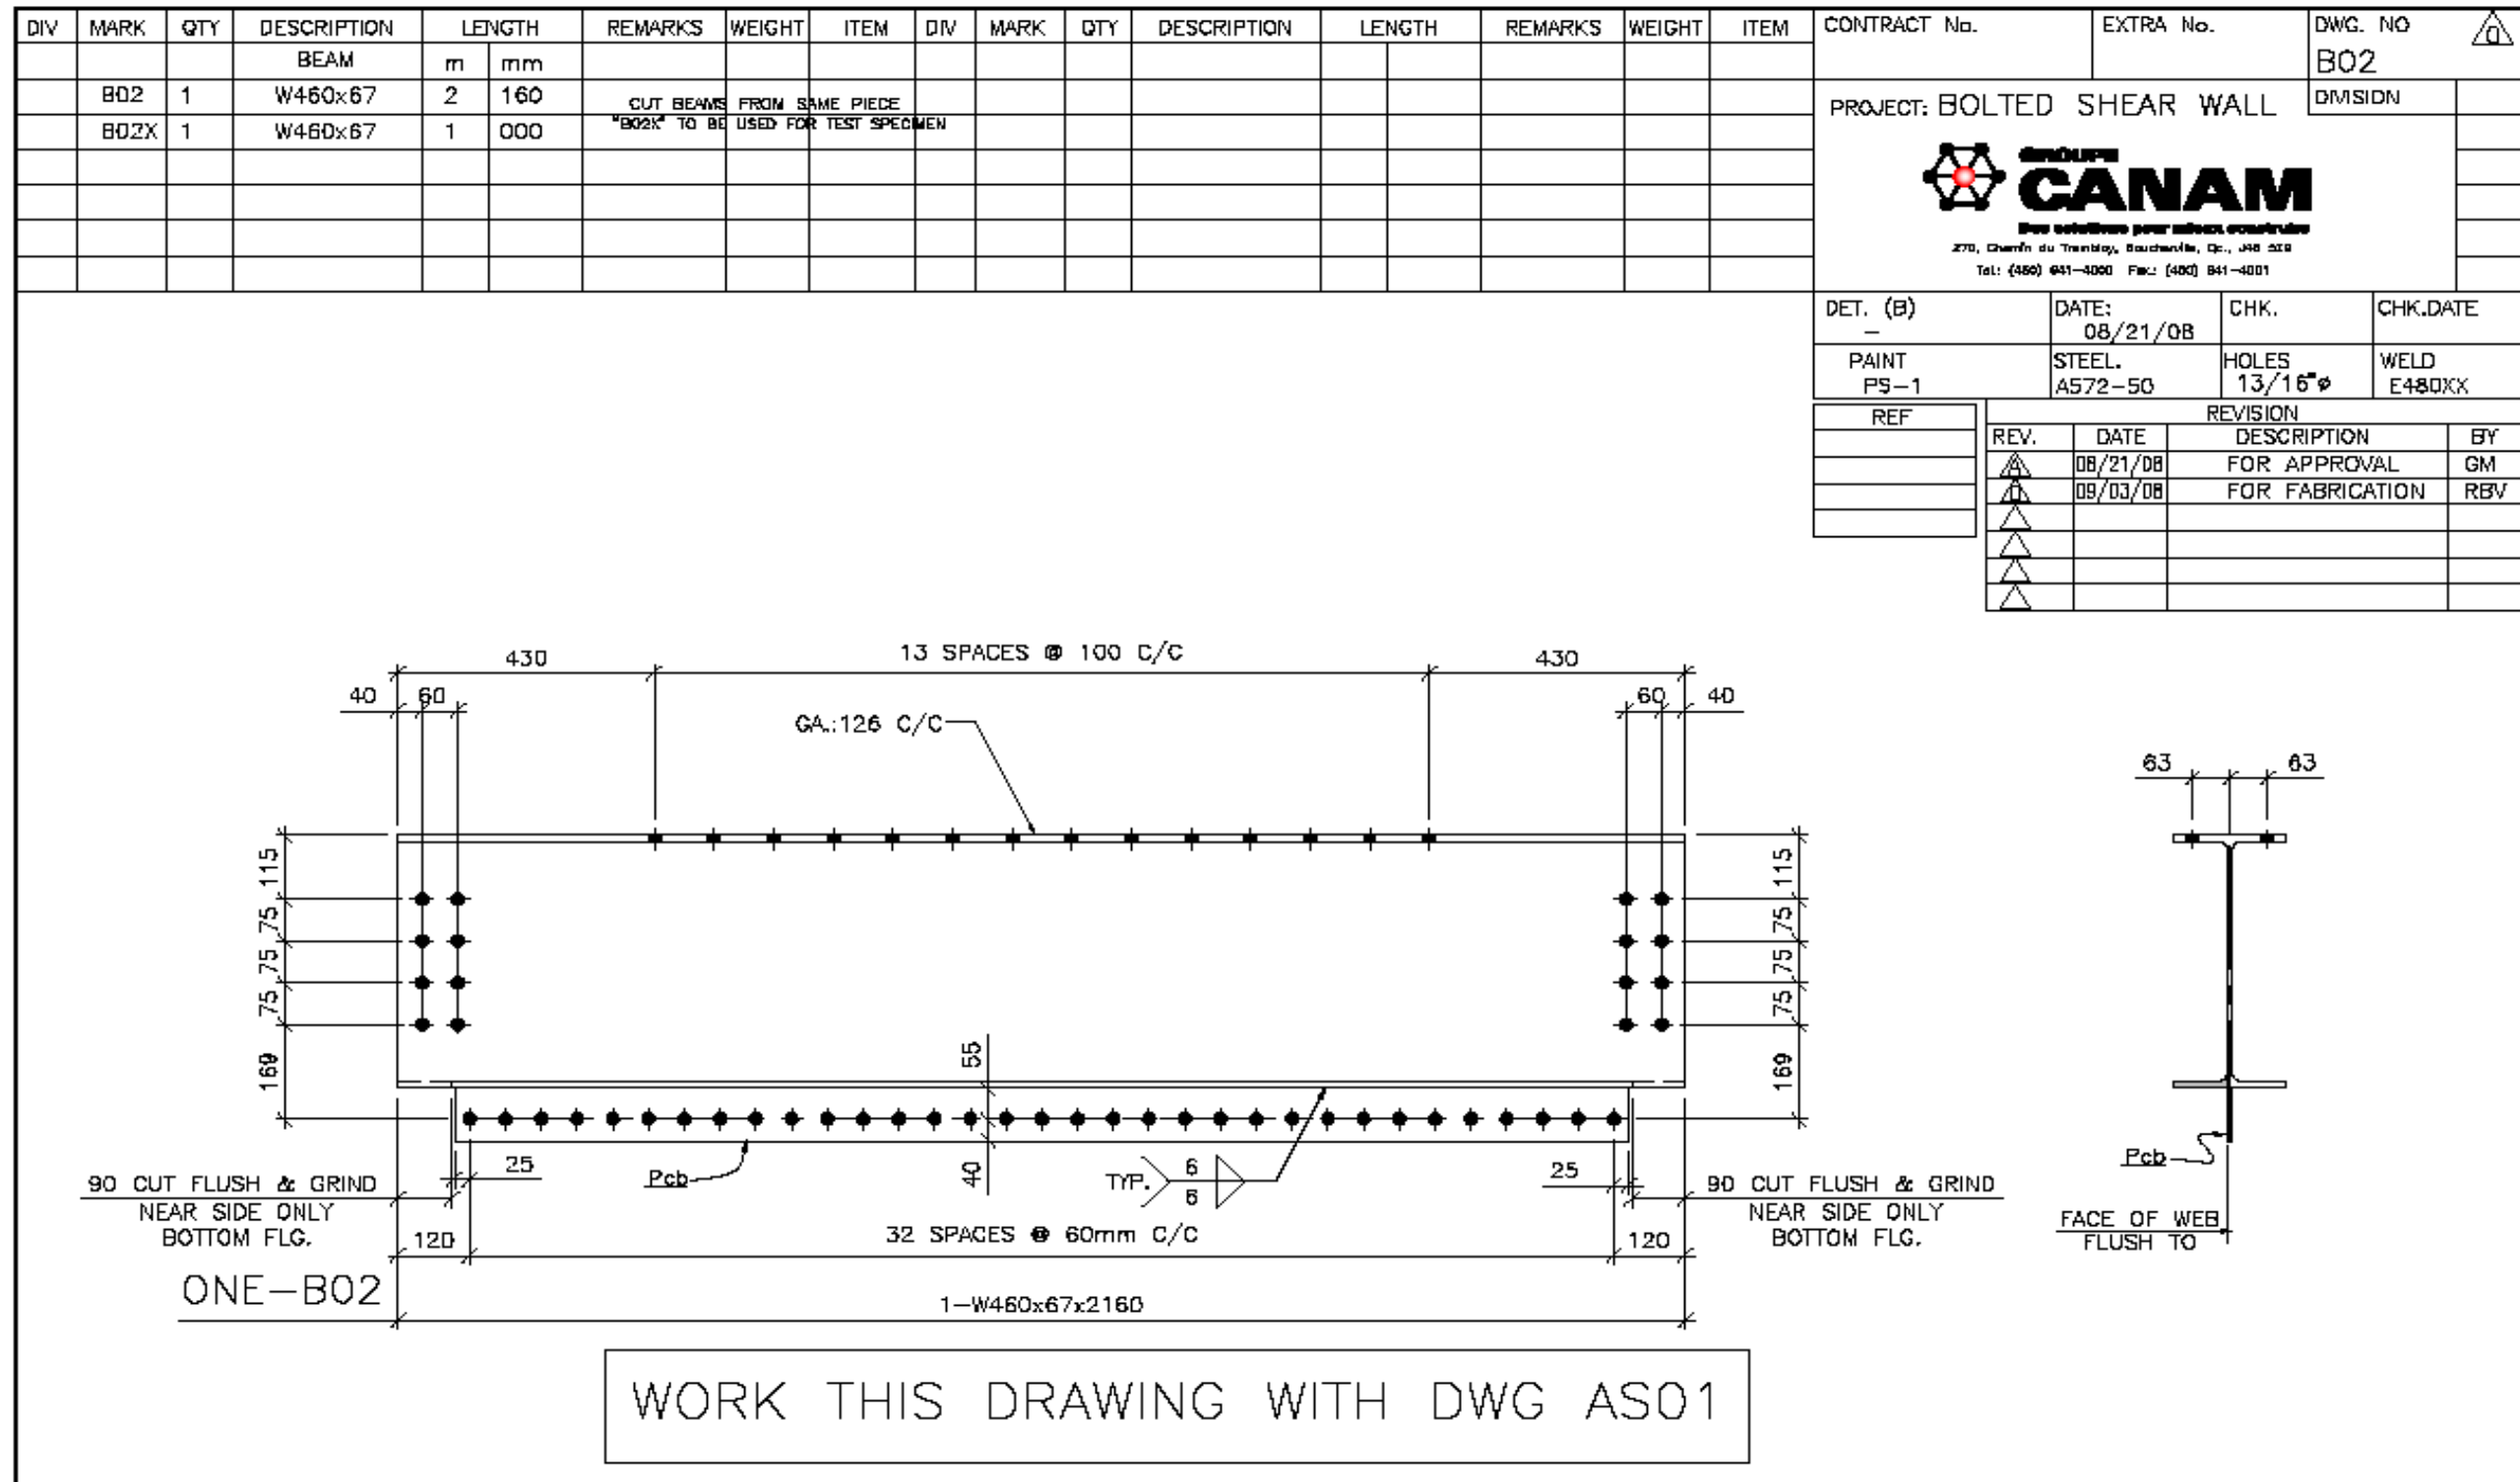
Figure A.4: Details of the second-floor beam in the modular test specimen

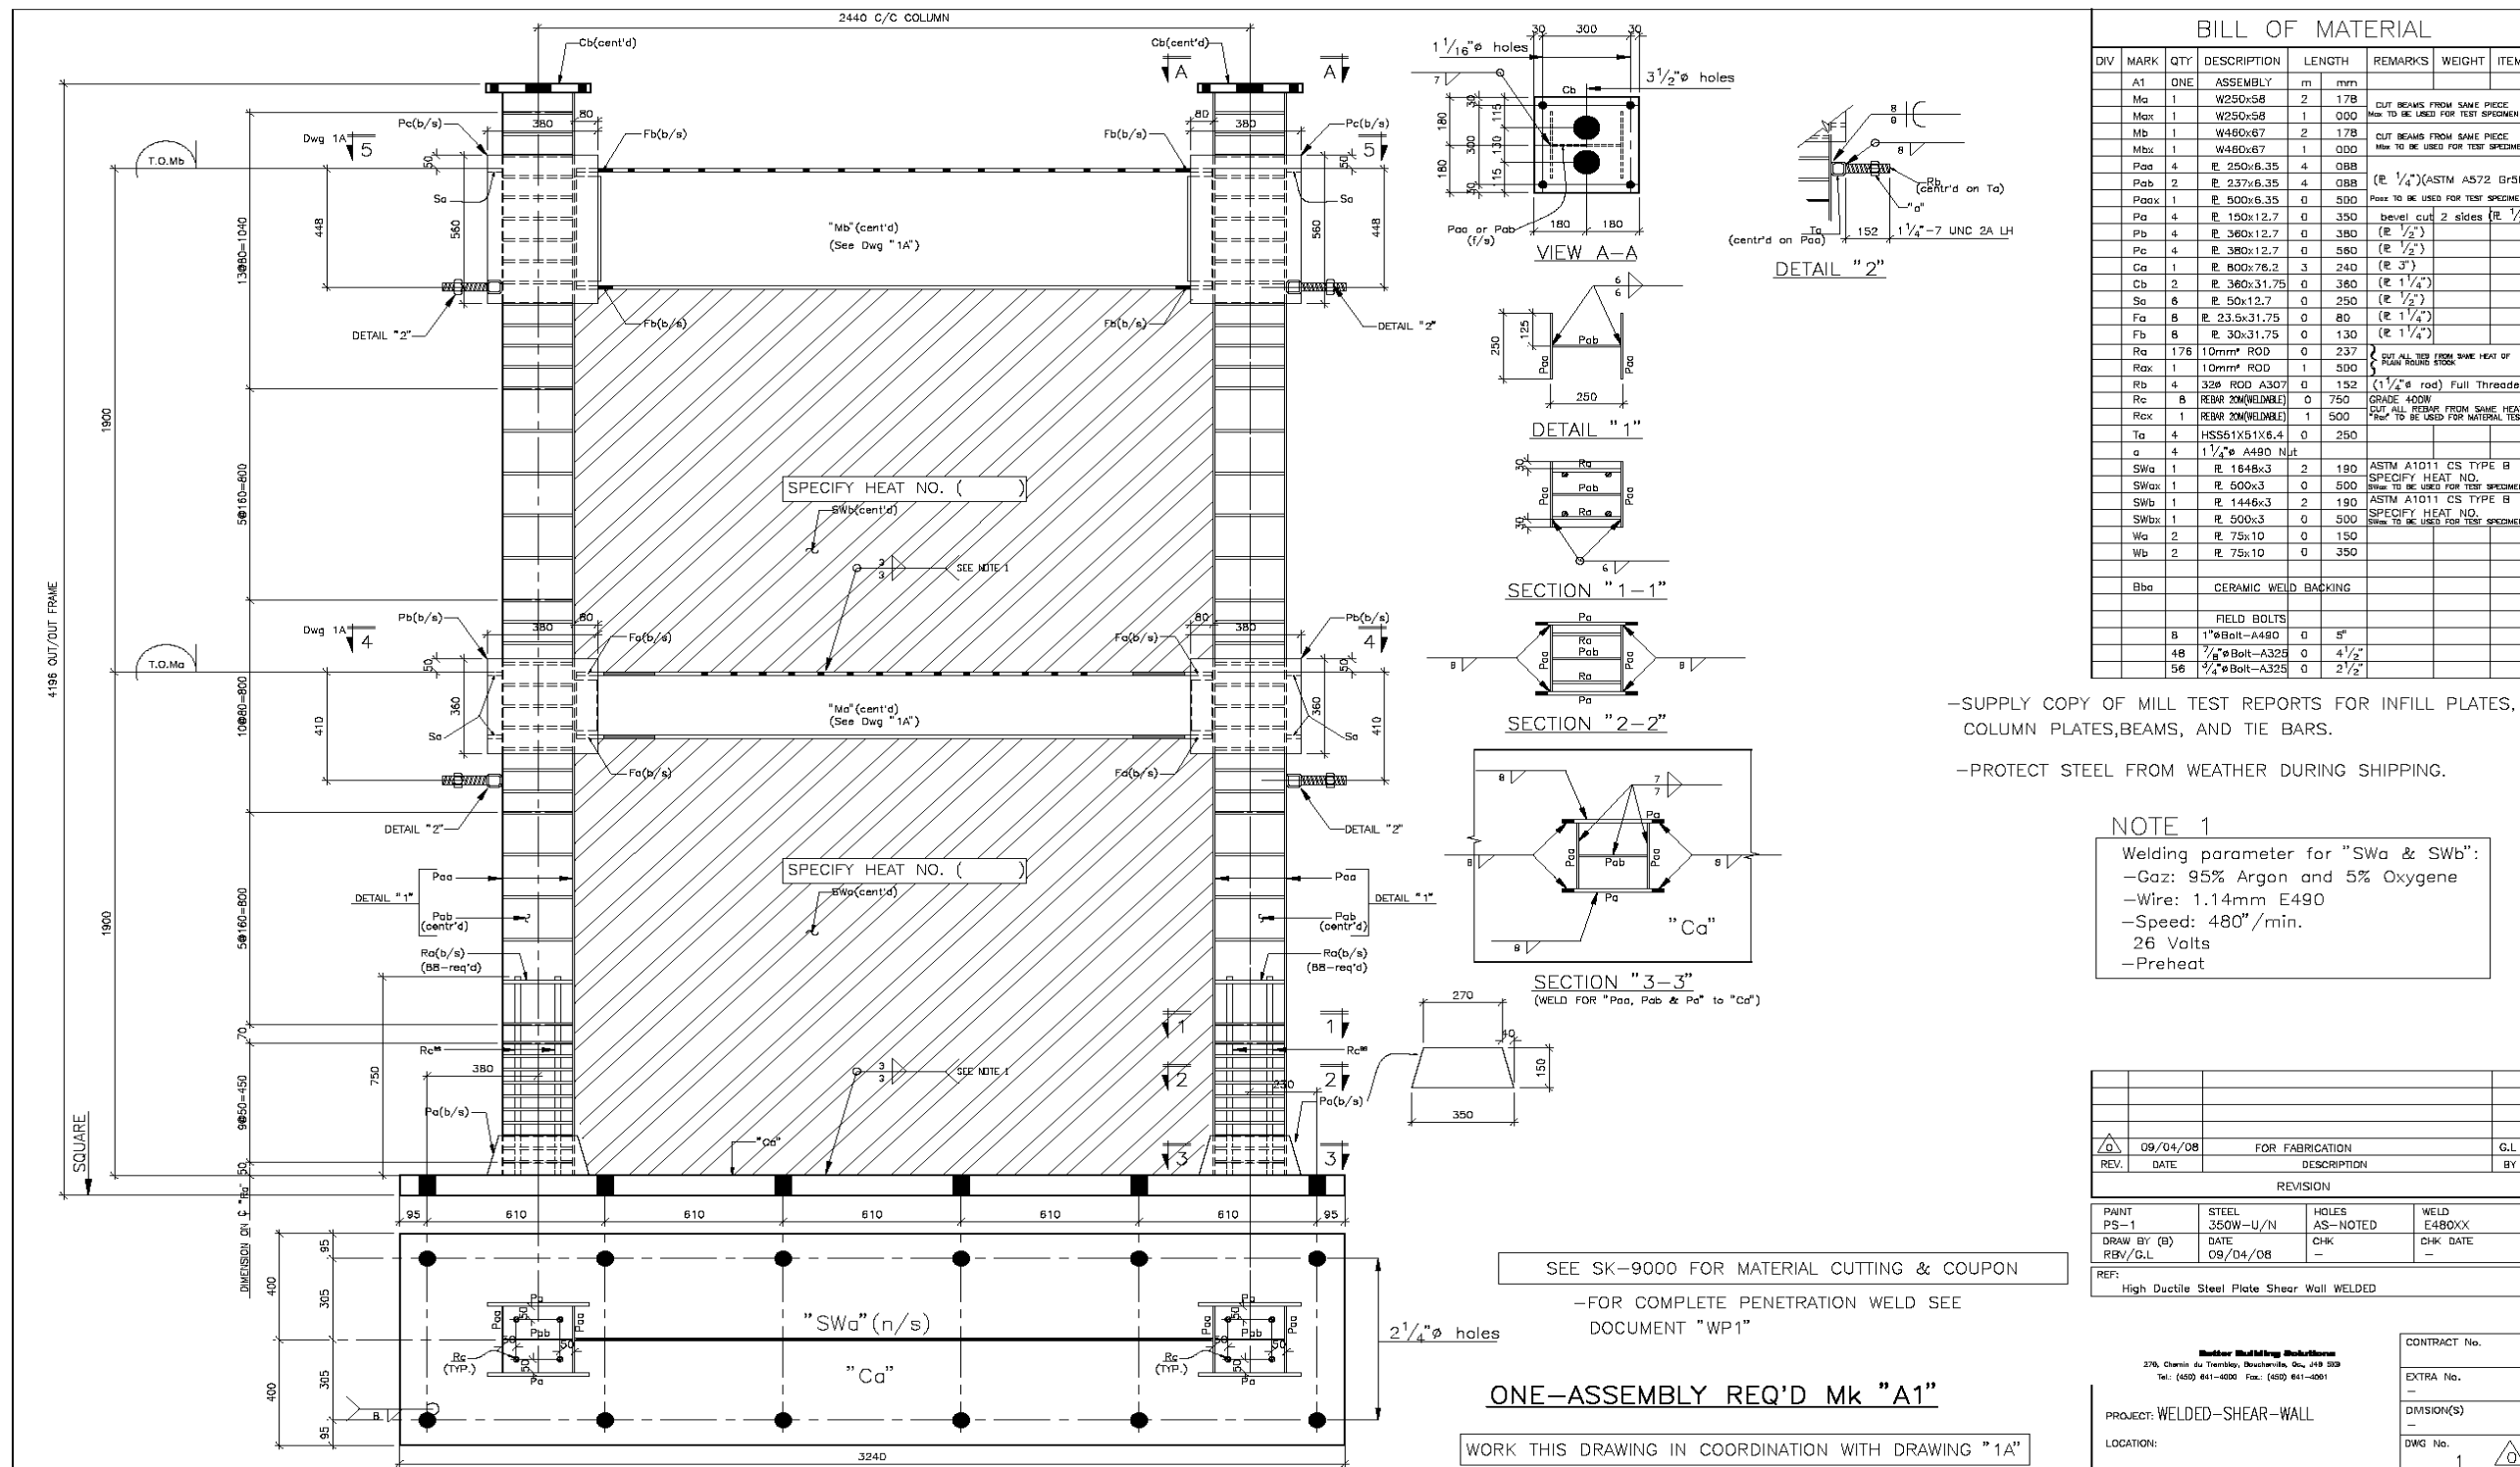
Figure A.6: Elevation view and details of the RBS test specimen

Further details of the RBS test specimen can be found in the shop drawings provided in Appendix A.
