UAV-based Post-disaster Damage Assessment of Buildings Using Image Processing

A thesis submitted in partial fulfillment of the requirements for the degree of

Master of Science

Structural Engineering

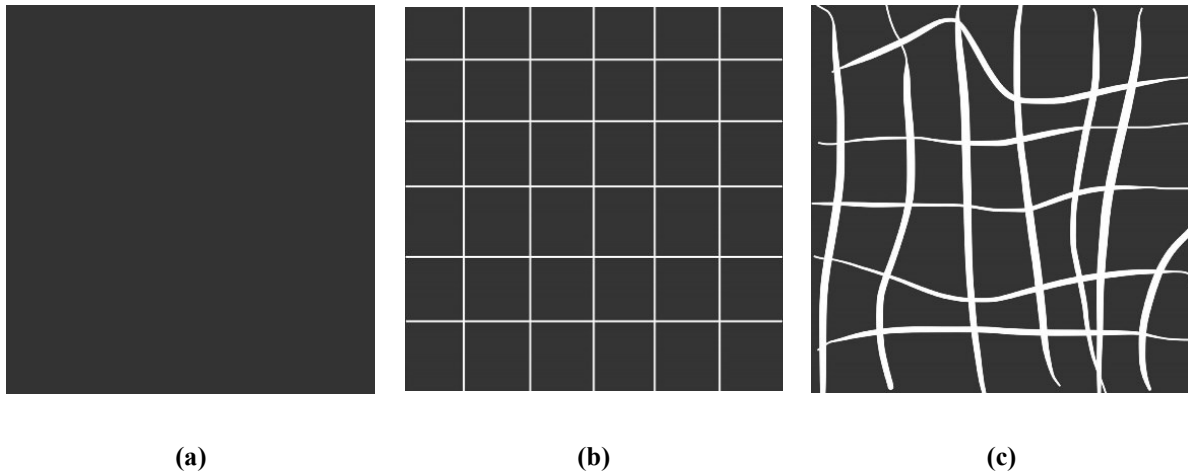
Fig. 3-3: Sample images for investigating the GLCM texture parameters of dissimilarity and homogeneity

To demonstrate the functionality of the indices on images, an example is provided in Fig. 3-3. In this figure, Fig. 3-3 (a) depicts a solid-colored image with a consistent gray level throughout. In Fig. 3-3 (b), the same solid-colored image incorporates narrow straight lines with a white color, while Fig. 3-3 (c) features thicker and irregular white-colored lines. From left to right, the dissimilarity index (I_d) is computed as 0, 0.96, and 1.35, respectively, demonstrating an ascending trend as the lines are introduced and the shapes become more irregular. Conversely, the homogeneity index (I_h) is calculated as 10, 9.32, and 8.55 for Fig. 3-3 (a), (b), and (c), respectively, indicating a declining pattern.

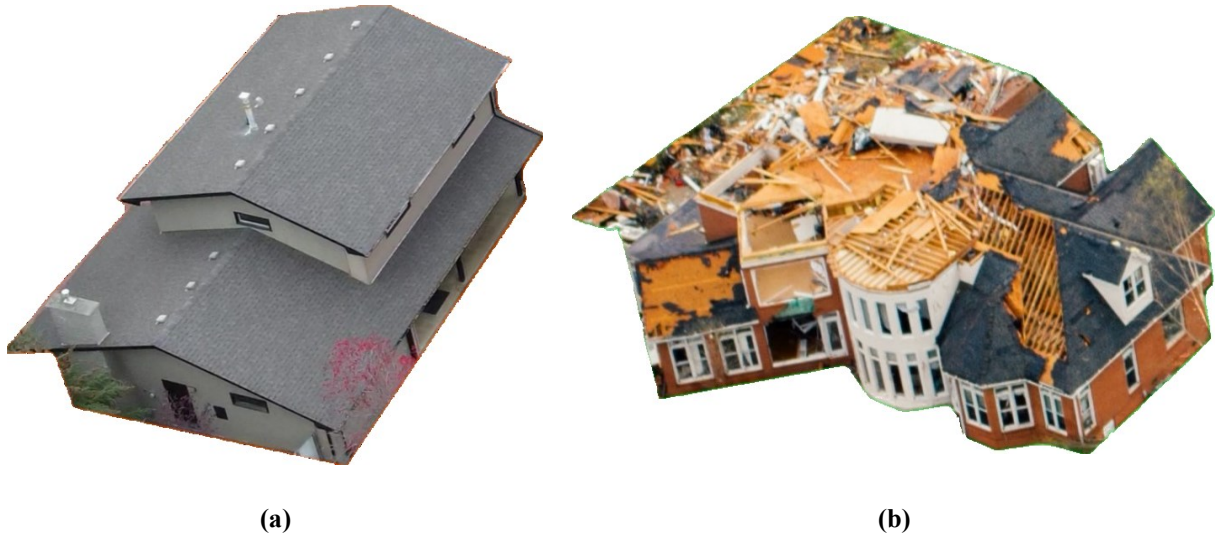
Fig. 3-4: Sample image of (a) an undamaged building captured using drone in an Edmonton neighborhood and (b) a damaged building captured by drone after a hurricane in Tennessee, USA [73]

Since increased abrupt fluctuations are anticipated in the gray level of pixels within the image of damaged buildings, an increase in the level of dissimilarity and a corresponding decrease in the level of homogeneity are expected. To illustrate this, an example of an undamaged building (Fig. 3-4 (a)) and an example of a damaged building (Fig. 3-4 (b)) are presented and their resulted feature

values have been compared. The calculated dissimilarity values are 1.52 and 3.82 for the undamaged and damaged scenarios, respectively. Additionally, the homogeneity values are determined as 1.88 and 1.04 for the respective cases. As expected, the undamaged building incorporates a higher homogeneity and a lower dissimilarity value.

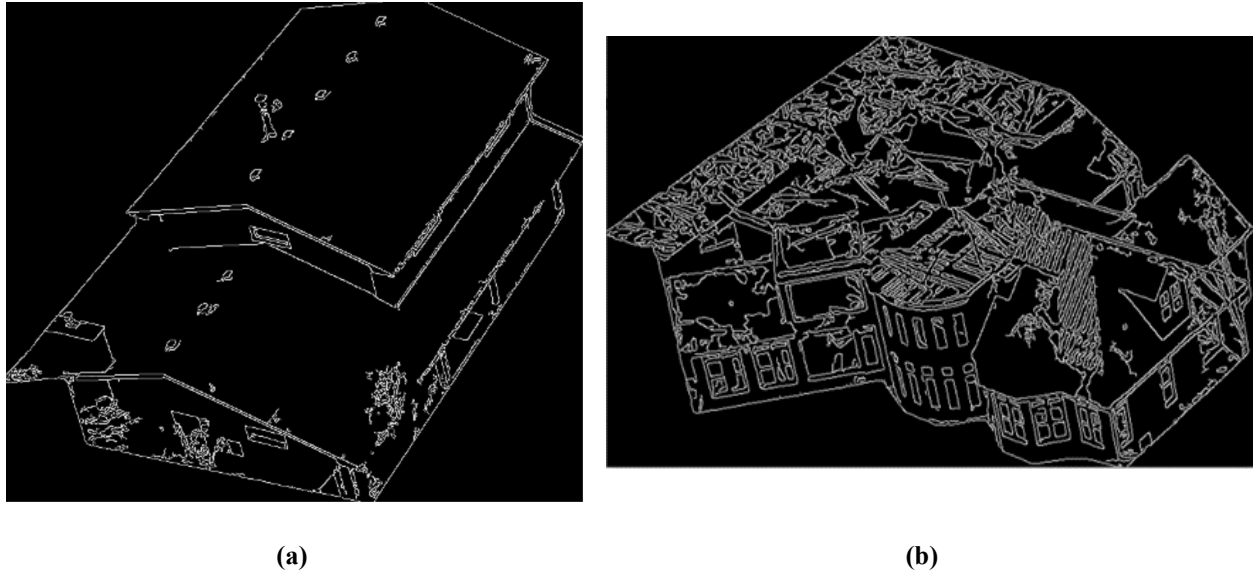
Fig. 3-5: Edge-detected images of (a) the undamaged case and (b) the damaged case shown in Fig. 3-4

Fig. 3-5 provides an illustration of the results obtained using the Canny edge method for the identical samples of undamaged and damaged buildings previously shown in Fig. 3-4, utilizing the default values for the gradient kernel size and gradient calculation.

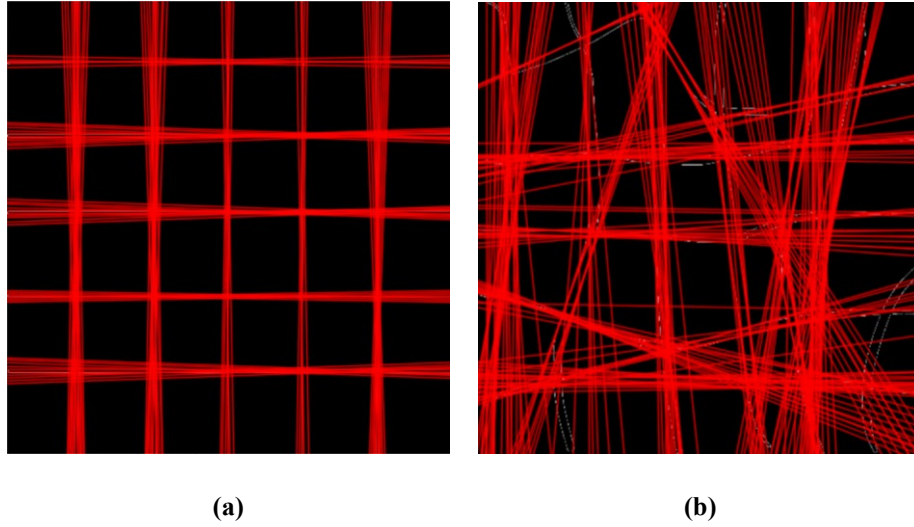
Fig. 3-7: Hough Line transform of sample images presented in (a) Fig. 3-3 (b) and (b) Fig. 3-3 (c)

The second edge-based index introduced in this study revolves around the orientation of edge lines and their distribution. To perform this analysis, the initial step involves the identification of lines within the edge-detected image. For achieving this, the Hough Line transform [86] is employed. This method which is applicable on the Canny edge detected image, relies on a vote-counting mechanism to detect lines and operates within a parameter space defined by slope (m) and intercept (c), with each data point represented by a unique (m, c) pair. Each (m, c) pair is in fact a representor of a distinguished line in the system. For every edge pixel (x, y) within the Canny edge-detected image, the general equation relating slope and intercept, namely $y = mx + c$, is established, and a vote is registered for each (m, c) pair that satisfies the equation. Subsequently, the (m, c) pairs with the highest local vote counts are selected, with each pair corresponding to a distinct line characterized by a specific slope and intercept. As a result, the approximate lines forming the edge-detected image can be identified. The results of the Hough Line transform for the images featured in Fig. 3-3 (b) and Fig. 3-3 (c) are depicted in Fig. 3-7 (a) and Fig. 3-7 (b), respectively.

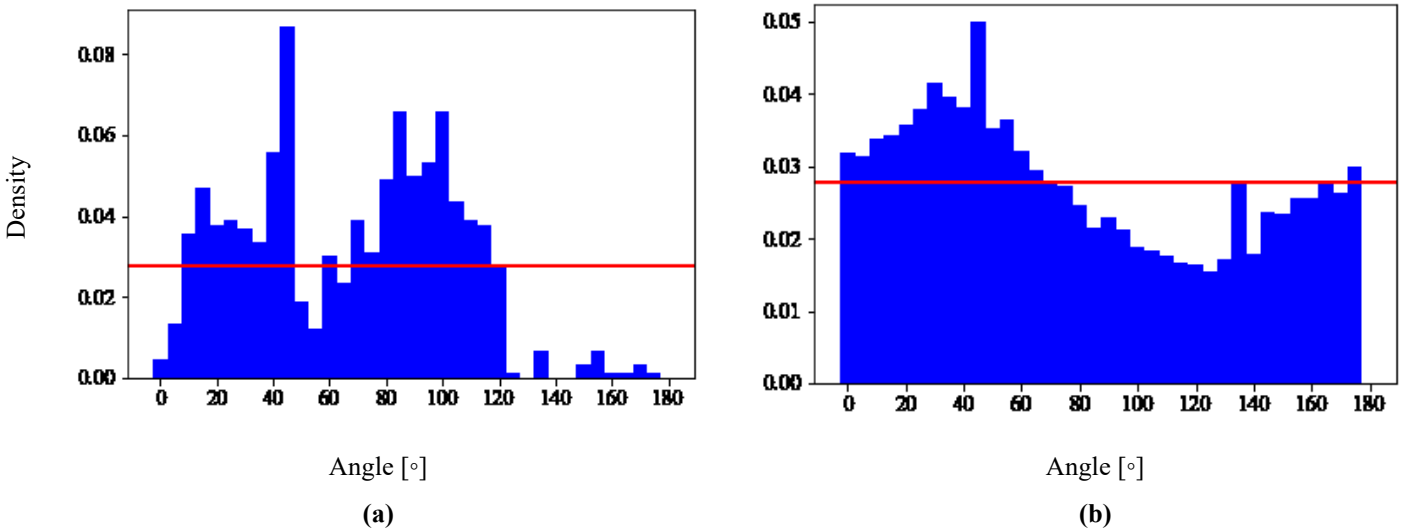
Fig. 3-8: The angle density histogram of (a) the undamaged and (b) the damaged case shown in Fig. 3-4

cases, as presented in Fig. 3-4. The undamaged and damaged case presented in Fig. 3-4 (a) and (b), are illustrated in Fig. 3-8 (a) and (b), respectively. Additionally, a red line representing the uniform distribution is overlaid on the histograms for reference. A histogram where the bars are closer to the uniform line indicates the existence of orientations in all different angles, depicting a chaotic and probably damaged image. As demonstrated in Fig. 3-8, the undamaged case sees a larger concentration of lines in specific angle ranges around 20, 40, 80 and 100 degrees, and there is quite an absence within 120 to 180 degree angles, while the damaged case conversely does not have a specific concentration and lines are present in many different angles.

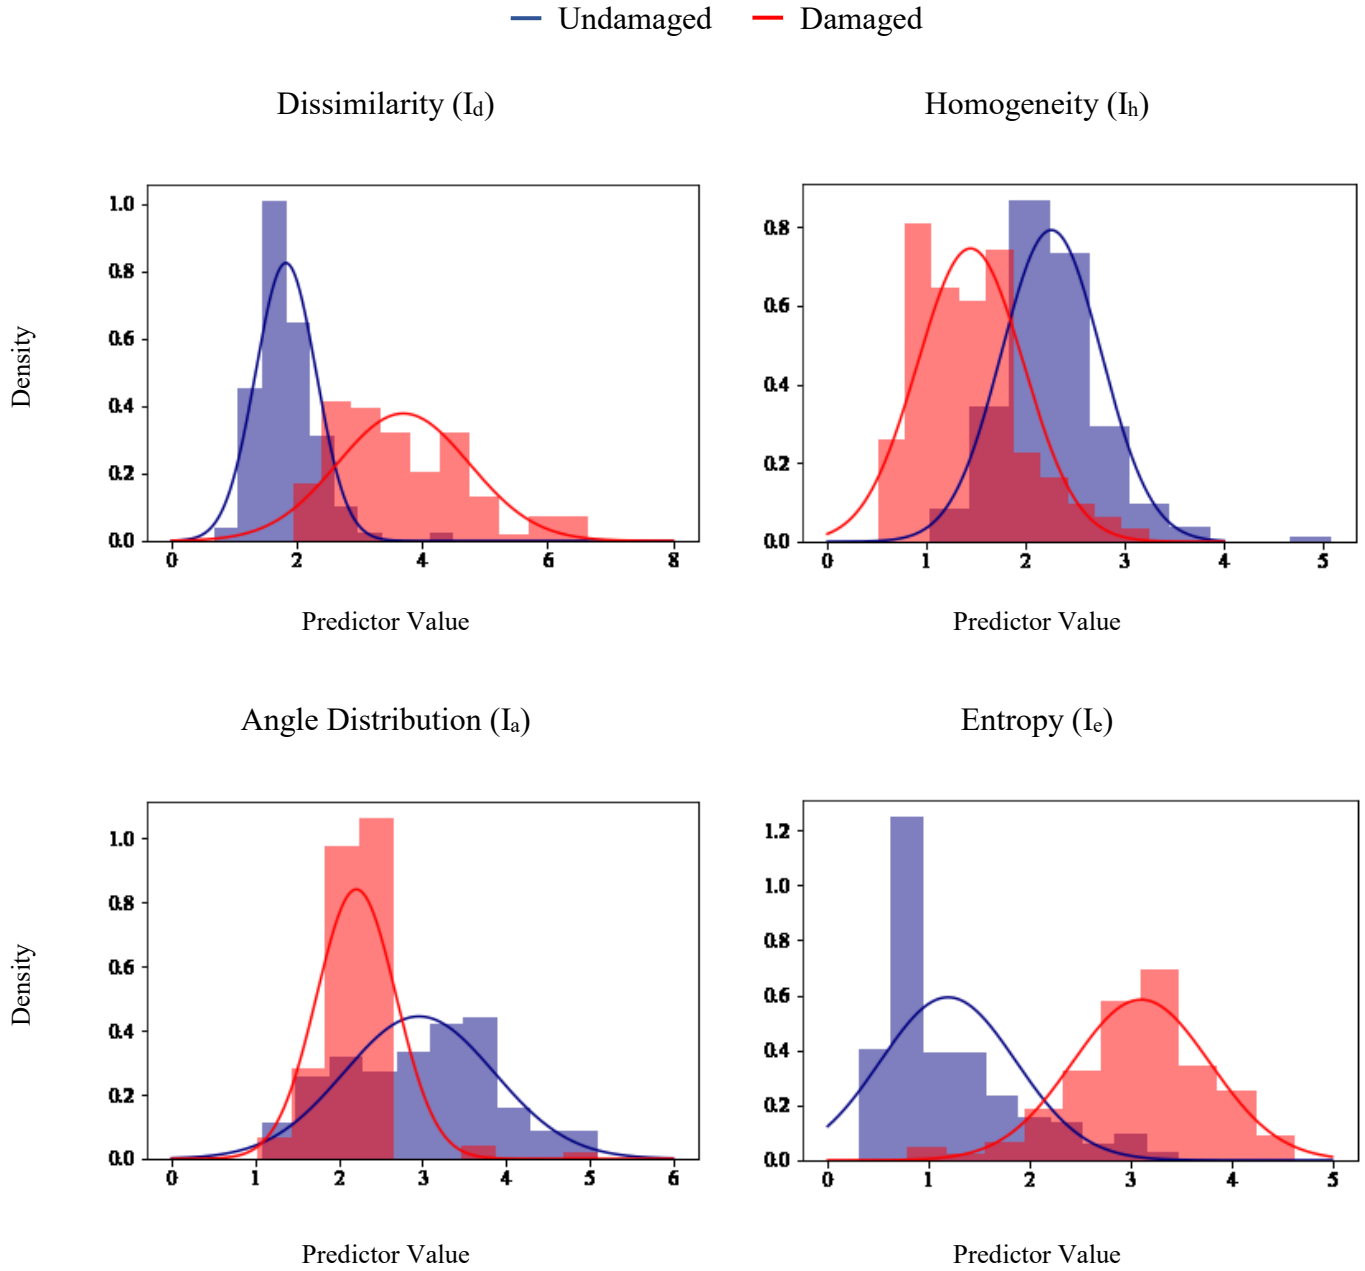
Fig. 3-9: Estimation of likelihood distributions for predicting parameters of I_d , I_h , I_a and I_e

From the graphs presented in Fig. 3-9, it could be seen that the normal distribution is a compliant fitting likelihood distribution function for each case. Since the likelihood distributions

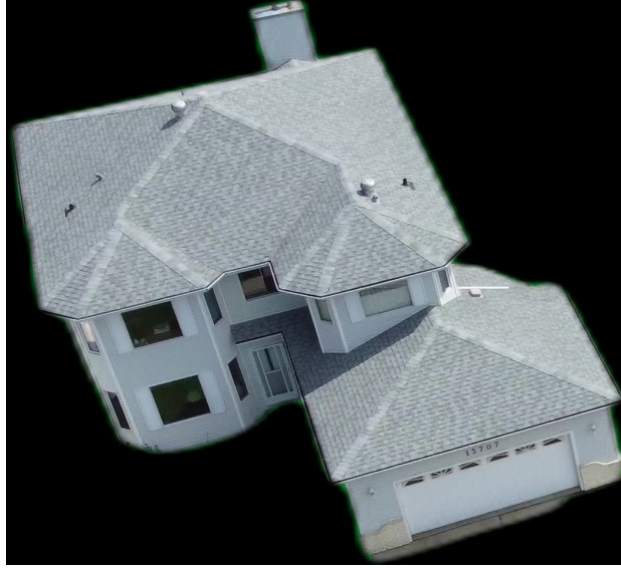
Fig. 3-10: A sample undamaged building captured by drone in Edmonton area

The feature indices of Fig. 3-10 are calculated accordingly as:

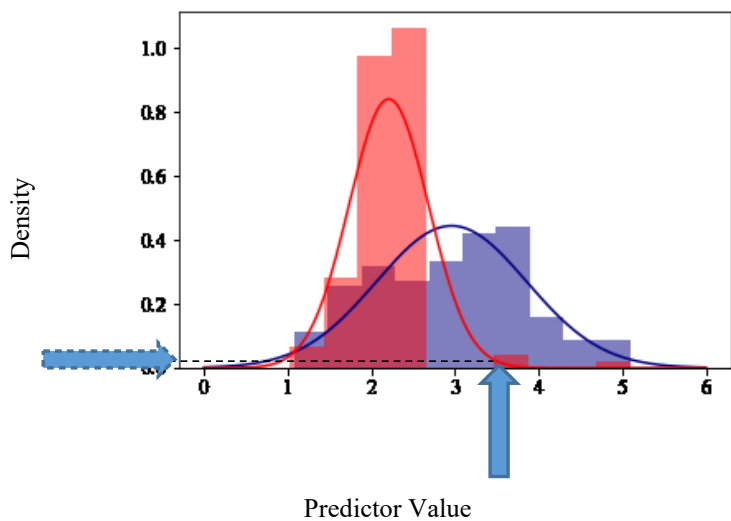
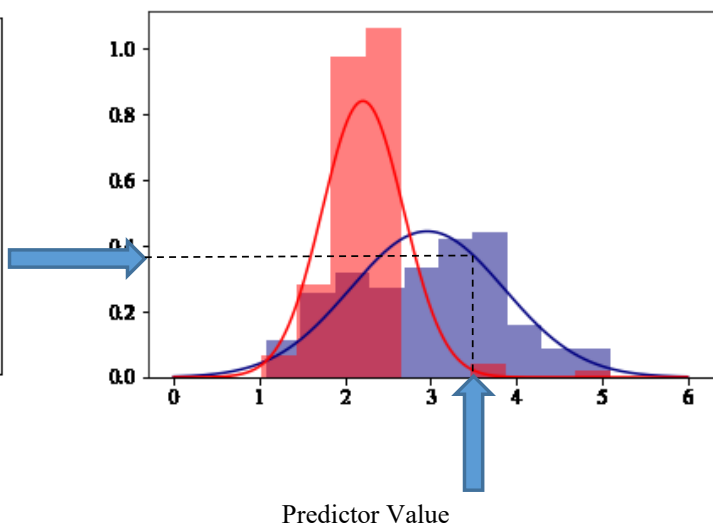
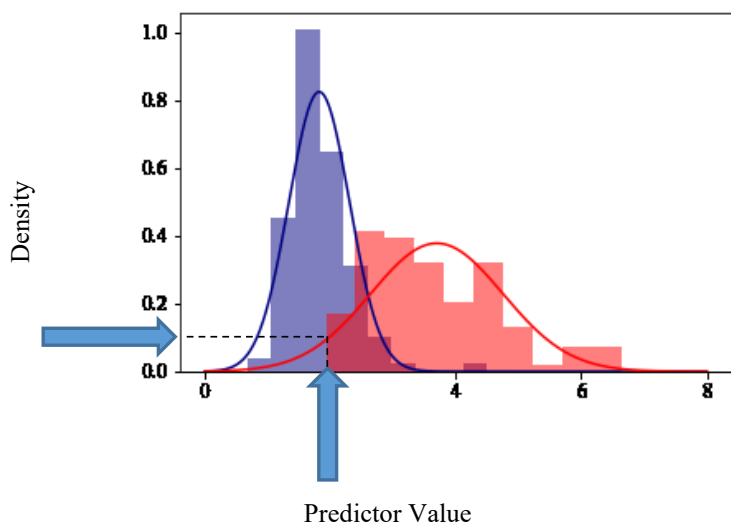
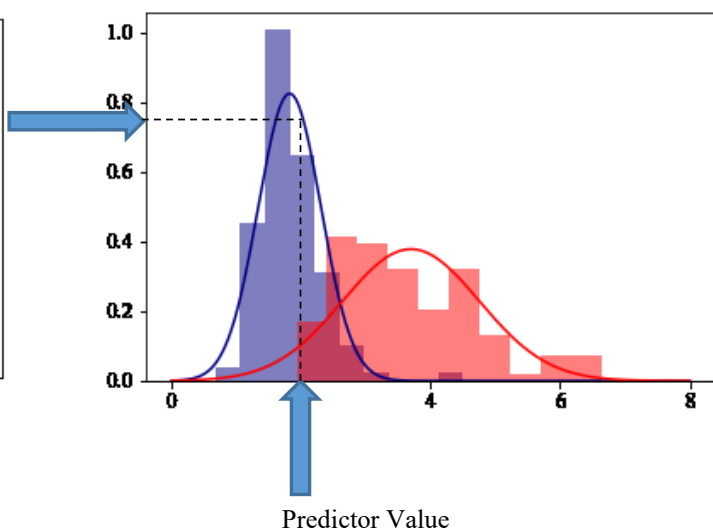
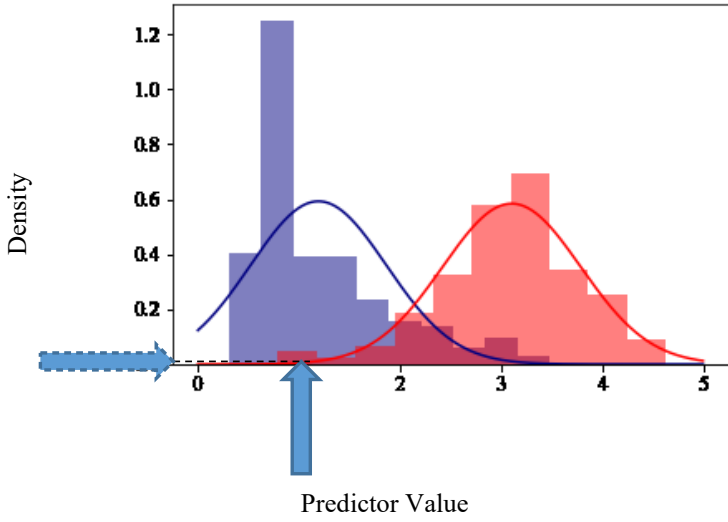
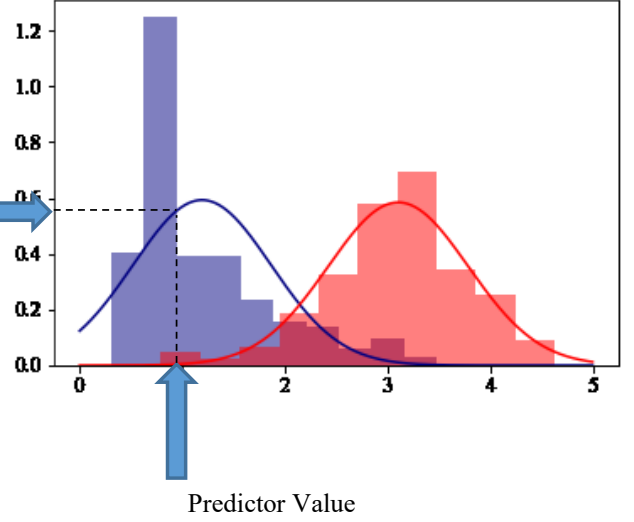
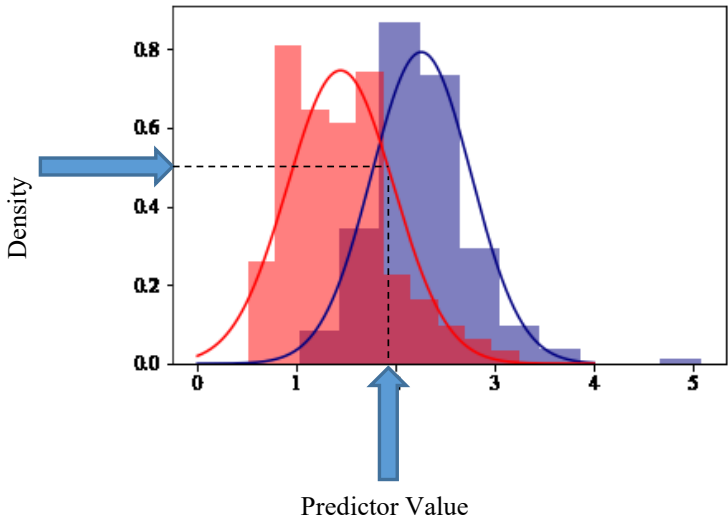
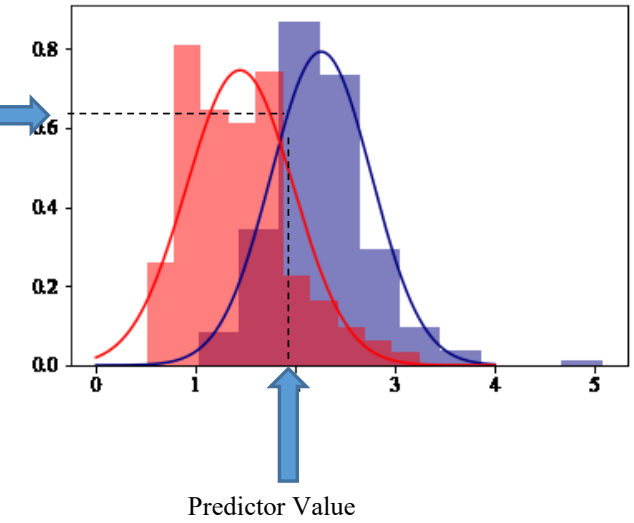
Fig. 3-11: Finding the probability density value for the parameters of (a) angle distribution, (b) texture dissimilarity, (c) edge entropy and (d) texture homogeneity calculated for the image in Fig. 3-9

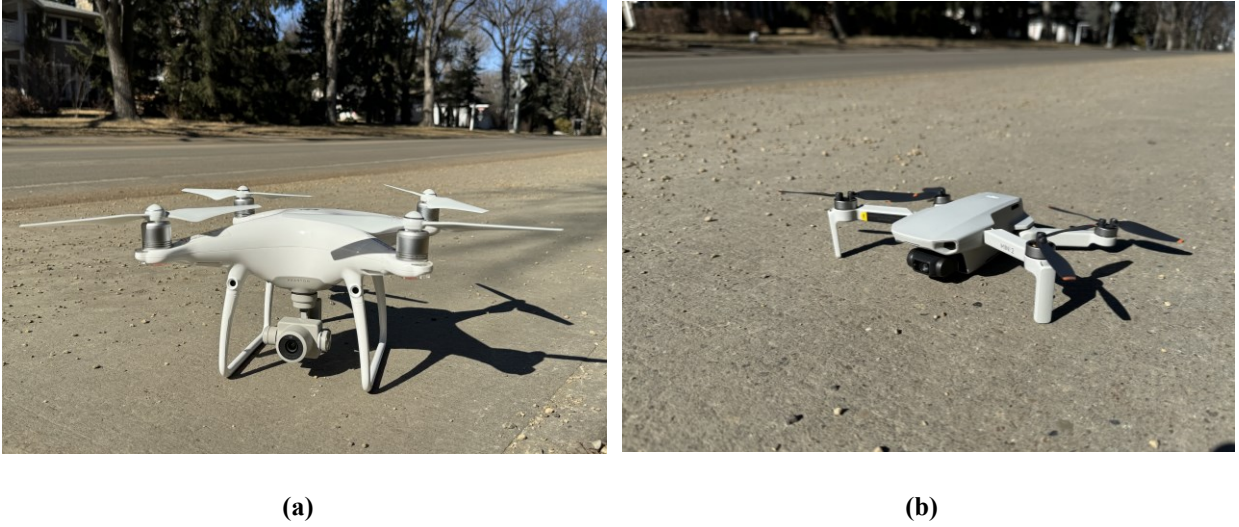
Fig. 4-1: The image of the drones utilized for data collection: (a) DJI Phantom 4 and (b) DJI Mini 2

The elevation of drone during the data collection has been approximately 30 meters from ground. The camera had an approximate pitch angle of about 40 degrees, whereas the yaw and roll angles have been zero. An illustration of the three axes and their corresponding rotation angles is presented in Fig. 4-2. This angle position theoretically means that the camera has a forward vision, but instead of looking directly straight, it is tilted 40 degrees towards down (ground). The combination of flying elevation and camera angle should be selected wisely, as it should enable an inclusive and multi-sided view of the buildings. In other words, a sufficient proportion of each of the buildings' roof and facades should be visible in the images.

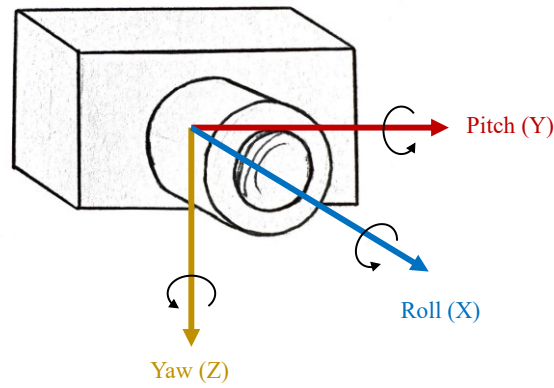
Fig. 4-2: The demonstration of Yaw, Pitch and Roll axes in the camera

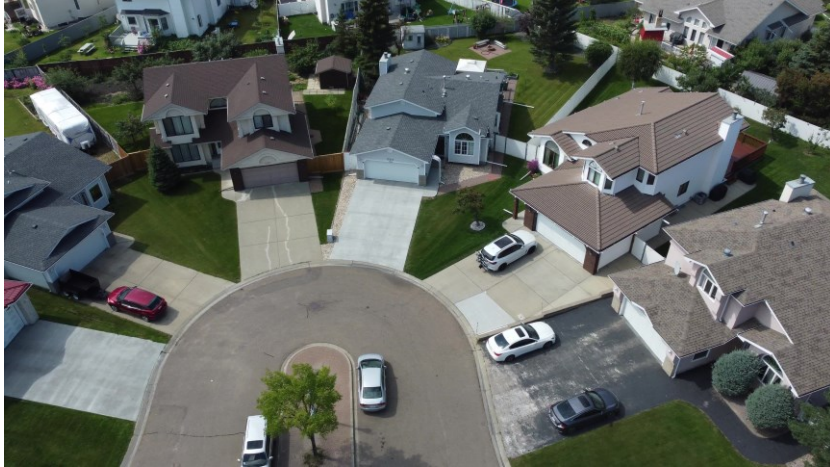
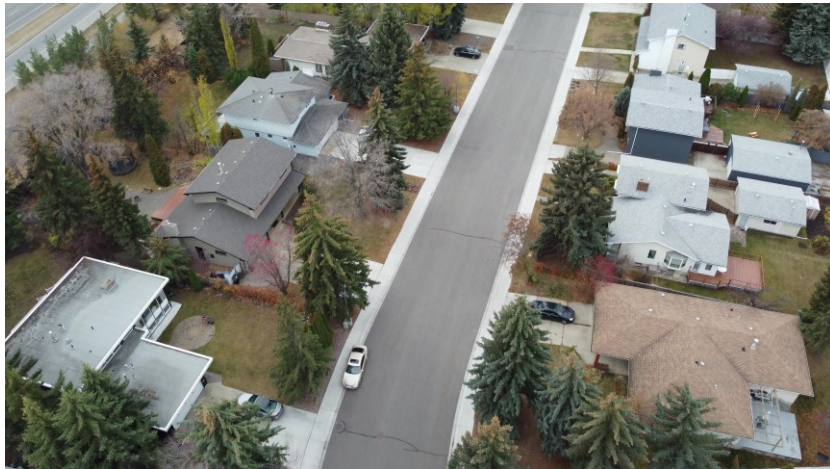
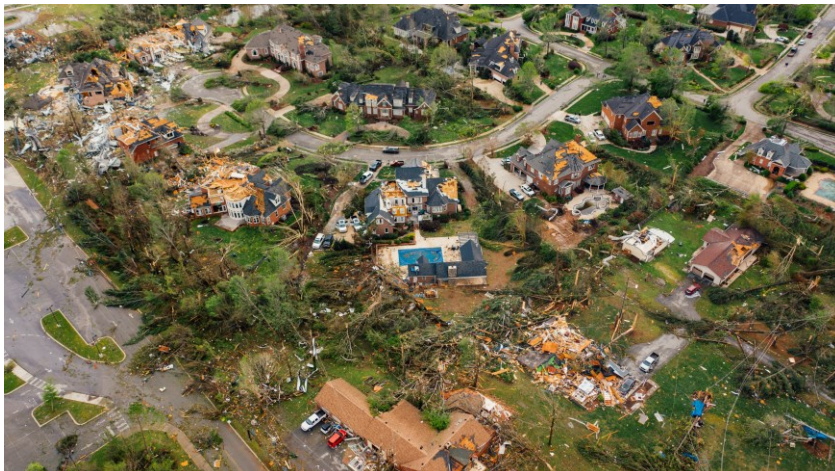
Fig. 4-3: Sample drone images utilized for preparing the database
(a): An image captured in the neighborhood of Castle Downs in northwest Edmonton
(b): An image captured in neighborhoods south of University of Alberta Farm
(c): An image showing post-storm damages in Chattanooga, Tennessee, US in April 2020 [73]

Sample drone images captured in two various neighborhoods of the city can be found in Fig. 4-3 (a) and (b). The location of this neighborhoods is shown in Fig. 4-4. The damaged database however is sourced completely through internet, mostly comprising of buildings damaged by hurricanes and, with a lesser extent, earthquakes. A sample drone image from a region hit by hurricane (storm) which is utilized in the database of this study has been presented in Fig. 4-3 (c).

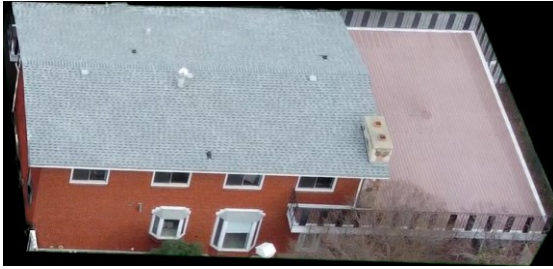
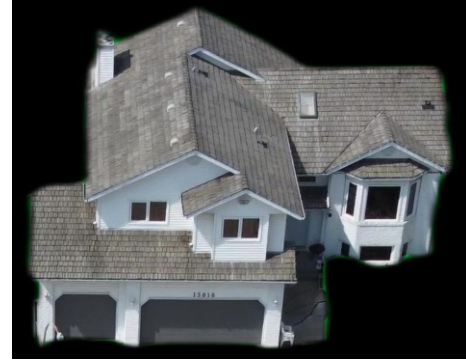
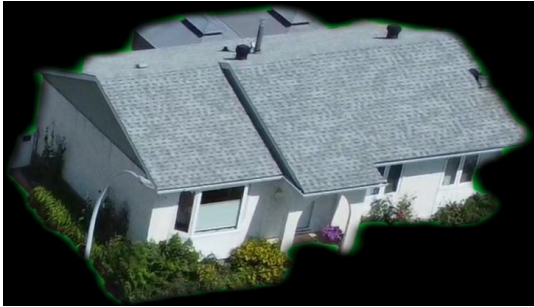
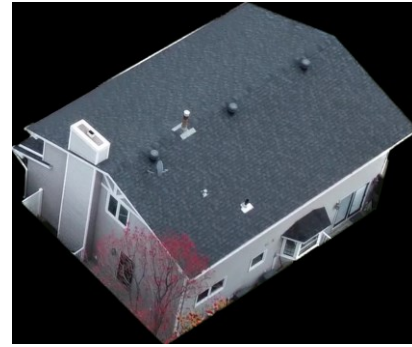
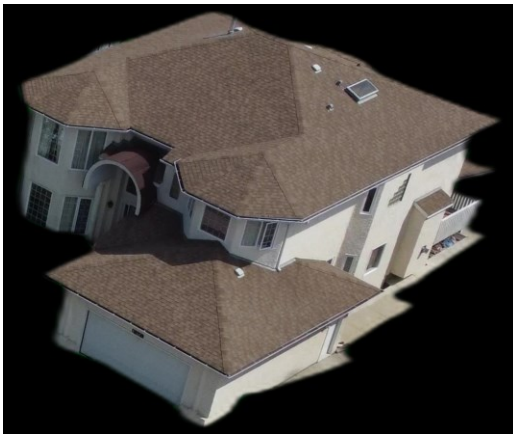
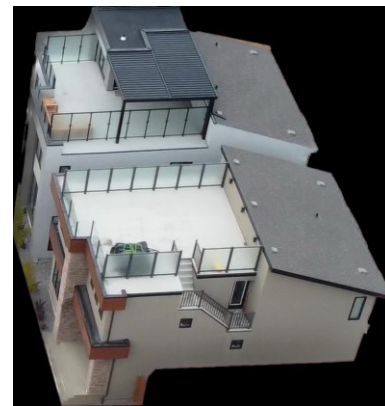
$$P(D|I) = \%98.5$$

$$P(D|I) = \%65.0$$

$$P(D|I) = \%66.6$$

$$P(D|I) = \%0.6$$

$$P(D|I) = \%0.1$$

The method as a result functions successfully in the absence of unseen data. Before running the model with unseen sets of database to test the accuracy, a number of cases are presented to further identify the underlying reason in achieving wrong results. Fig. 4-5 (a), (b) and (c) present three misclassified undamaged cases while Fig. 4-5 (d), (e) and (f) present three correctly-classified undamaged cases for comparison. All the images are captured by drone in the Edmonton area.

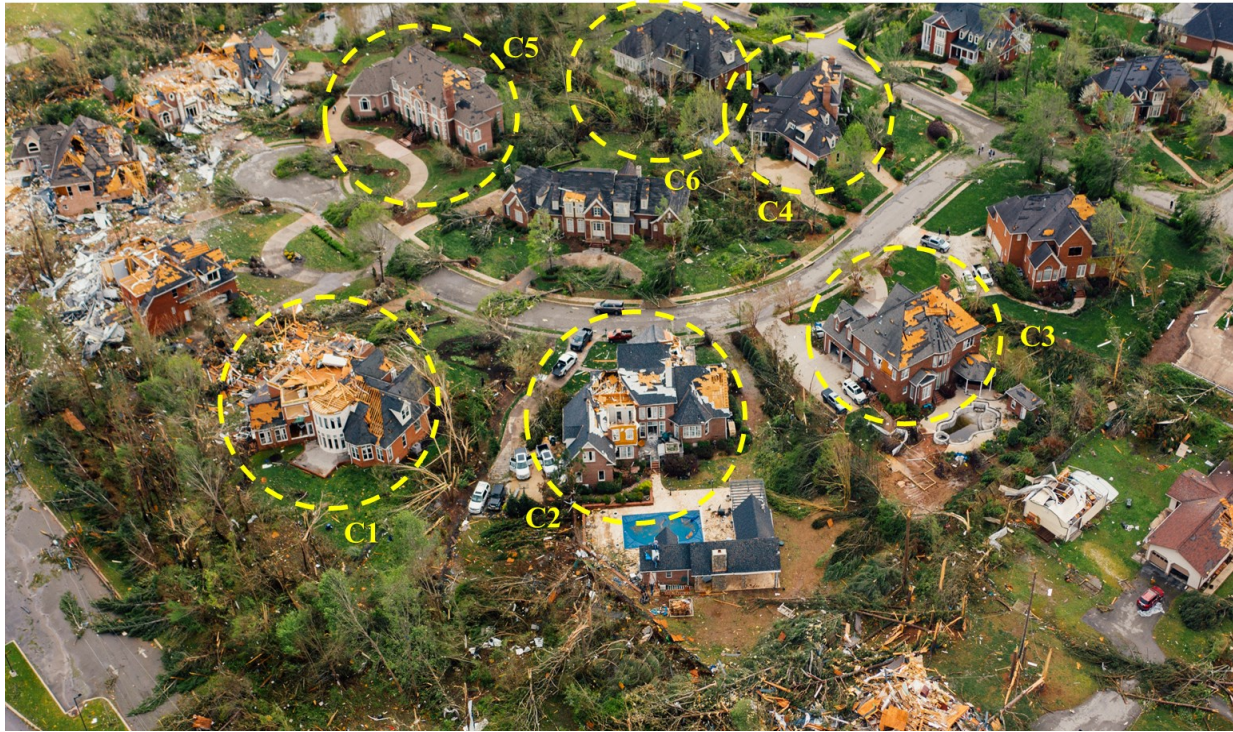
Fig. 4-6: The image presented in Fig. 4-3 (c) showing post-storm damages in Chattanooga, Tennessee, US and the 6 buildings selected for analysis

The damage analysis results of the selected cases is presented in Table 4-2, while the detailed index values on the corresponding probability density graphs have been presented in Fig. 4-7. In this figure, the probability of belonging to each category according to each index value ($P(I_x | D)$ and $P(I_x | U)$) can be approximated.
