Kinematics and Controlling Mechanics of the Slow Moving Ripley Landslide

Matthew B. Schafer

A thesis submitted in partial fulfillment of the requirements for the degree of

Geotechnical Engineering

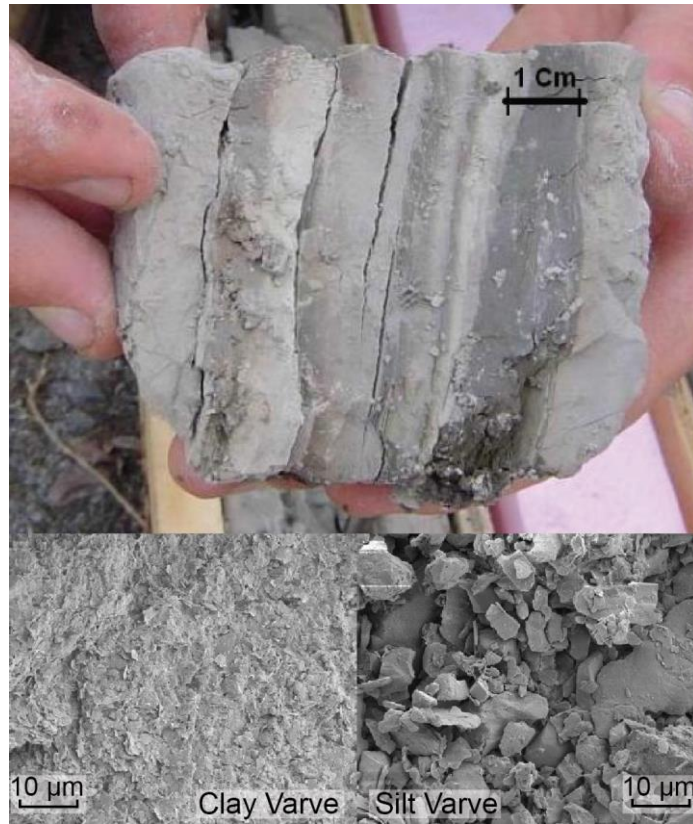
Figure 2-1 Sample of glaciolacustrine clay from borehole drilled near Ashcroft, British Columbia
(core photo courtesy of Dr. C.D. Martin; after Eshraghian et al. 2007)

The rhythmic nature of these clays can be seen visually in Figure 2-1. Figure 2-1 also shows the difference between the varves on a microscopic scale. Figure 2-2 shows a map of western Canada indicating the areas previously covered by glacial lakes. These areas include both advance and retreat phase lakes (Cruden 2016).

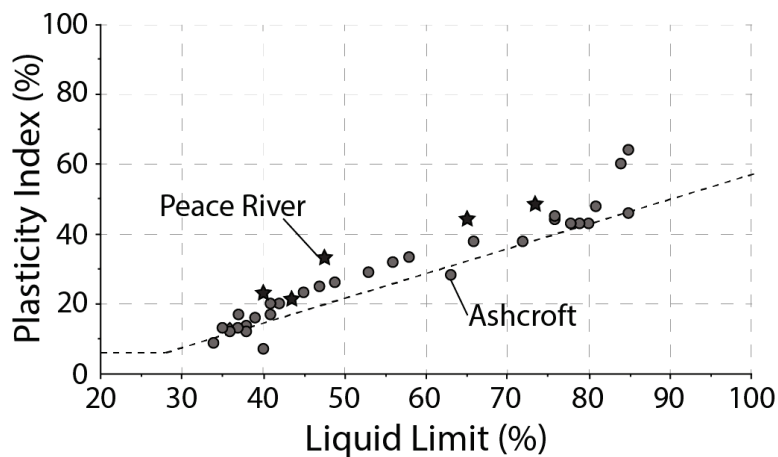
Figure 2-3 Index properties of glaciolacustrine silts and clays from the Ashcroft and Peace River regions (after Miller and Cruden 2002, Bishop et al. 2008)

The varying clay content in each varve is evident from the plasticity testing of these sediments. Figure 2-3 presents the index properties of various samples of glaciolacustrine from the Peace River and Ashcroft regions (Figure 2-2). The wide range of liquid limits observed in these sediments is due to the wide range of clay contents found in each varve.

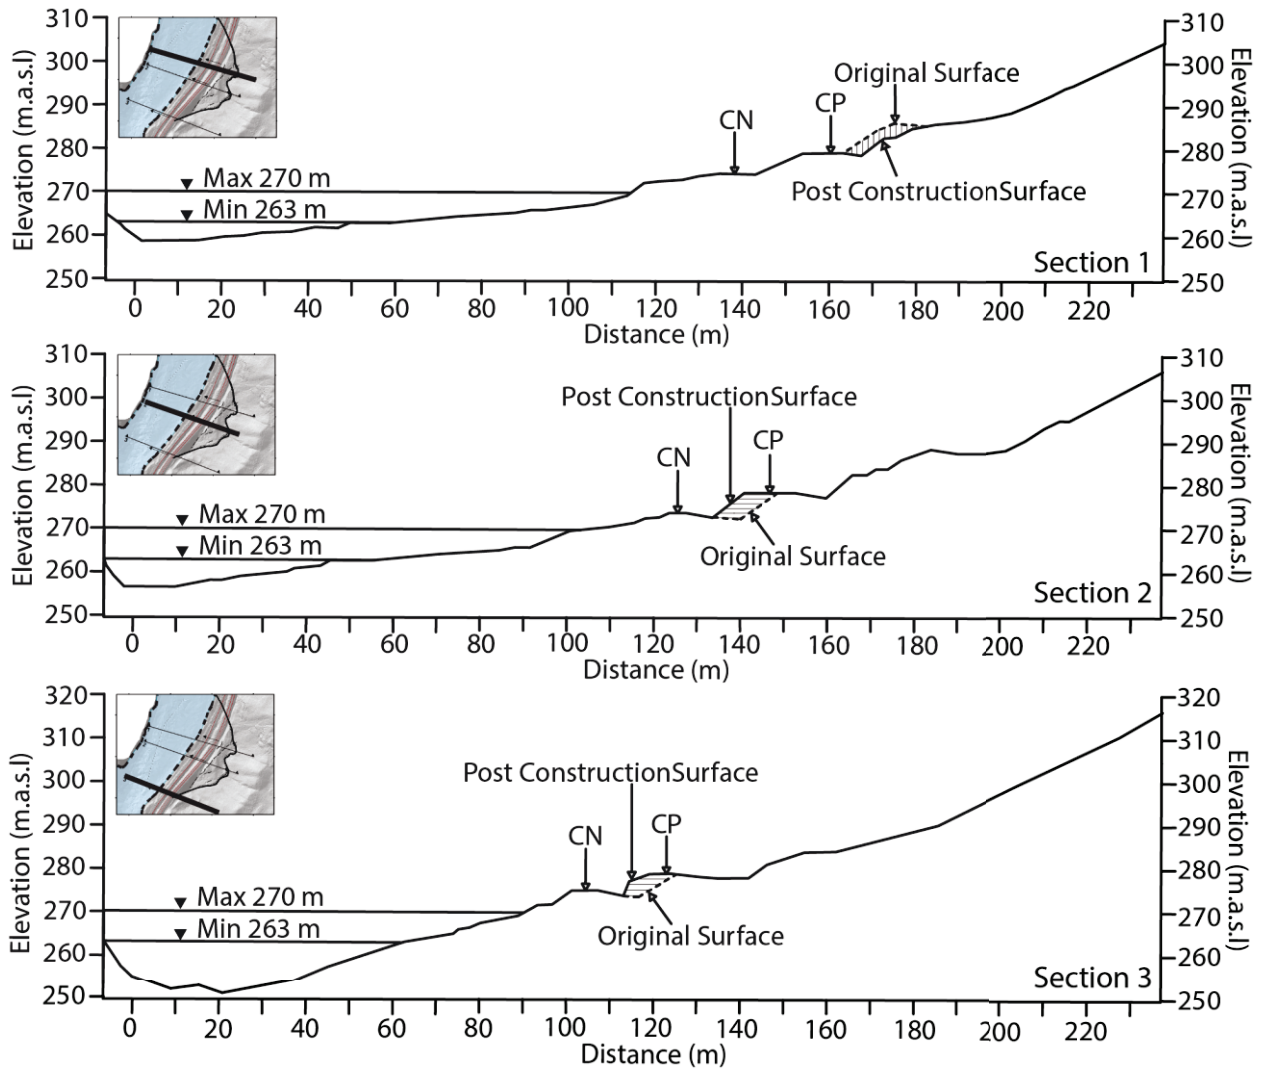
Figure 2-5 Comparison of slope geometry along three sections at the Ripley Landslide before and after the construction of the CP siding in 2005 (after Hendry et al. 2015)

CP constructed a siding across the landslide in 2005. The construction included cutting into the slope and the building of a retaining wall (Bunce and Chadwick 2012). Figure 2-5 shows the topography of the slope before and after construction. This figure was produced using an airborne light detection and ranging (LiDAR) scan which was taken before construction and a ground based LiDAR scan, which was taken 7 years after construction. The scans have different resolution so the areas of cut and fill are not precise but give an indication of the relatively small changes in slope geometry which were involved in the construction process.

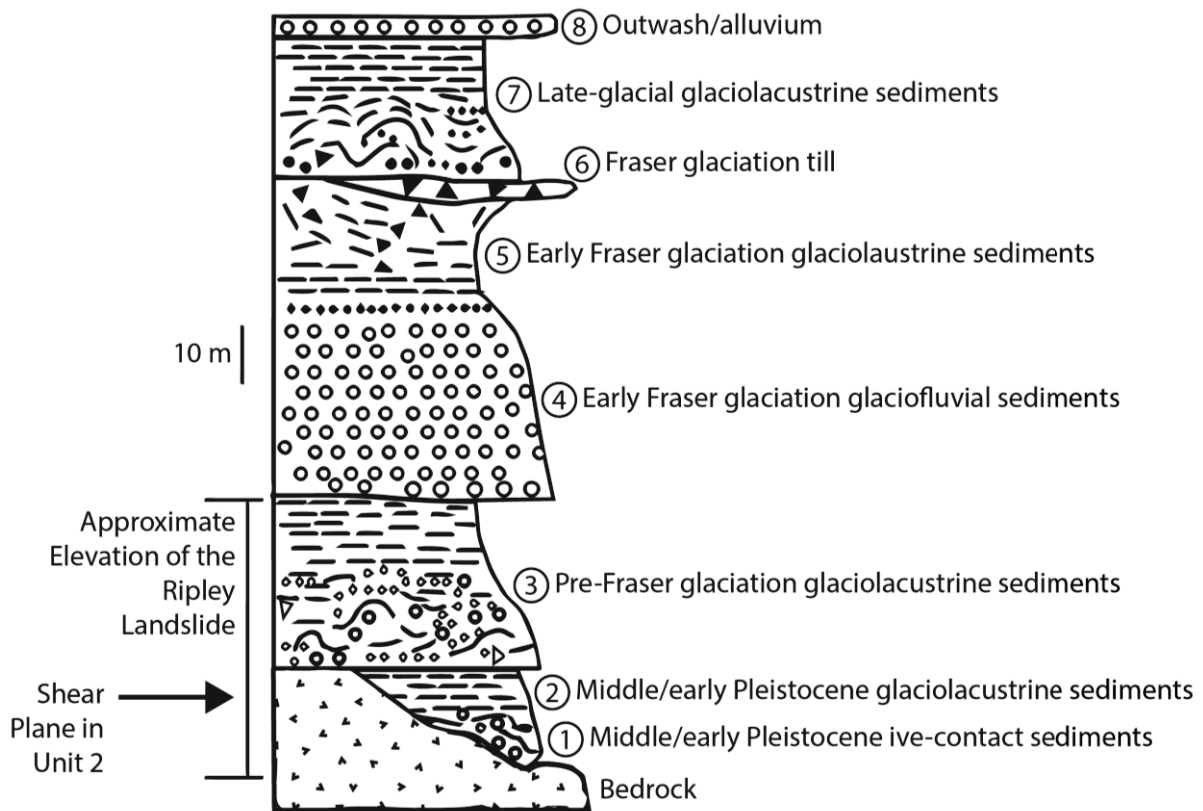
Figure 3-1 Regional stratigraphy considered while interpreting the borehole logs of the Ripley Landslide (after Clague and Evans 2003)

The results of the site investigation programs at the Ripley Landslide are interpreted within the framework of a regional geological model. The Thompson River Valley consists of layers of Quaternary sediment deposited during three glaciations (Clague and Evans 2003). Figure 3-1 presents the regional stratigraphy used to develop a geological model for the Ripley Landslide. This stratigraphical sequence is only expected to be complete in areas of deep fills or when drilling on the terrace above the landslide. The approximate elevation of the Ripley Landslide is indicated on the figure as well as the approximate elevation of the rupture surface. Many areas within the Thompson Valley have been subject to a large amounts of erosion during glaciation and the subsequent downcutting of the Thompson River. This has resulted in many unconformities in the stratigraphic sequence so certain units can be found at a range of elevations in different locations in the region. This has been observed during the investigation of other landslides in the region (Eshraghian et al. 2007).

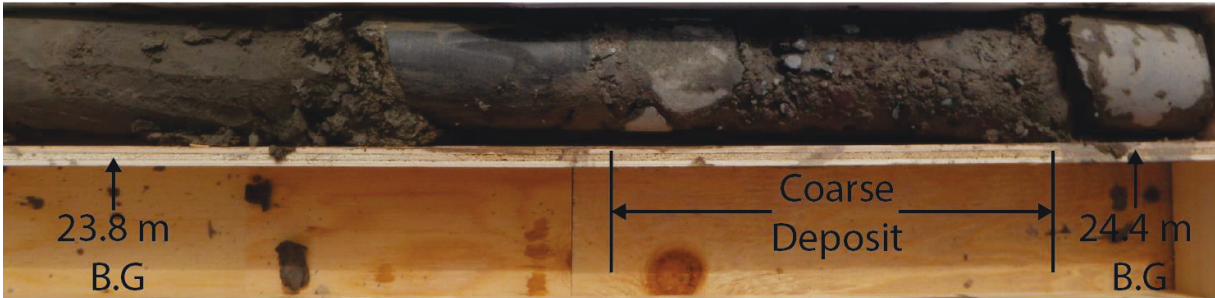
Figure 3-2 Coarse deposit within glaciolacustrine deposits at the Ripley Landslide

The primary concern of the investigations at the Ripley Landslide has been the second oldest of the glaciolacustrine deposits observed directly above the bedrock. Huntley et al. (2014) divided this layer into two smaller layers. The lower deposit was hypothesized to result from colluvium which was deposited into a pro glacial lake. The division between this lower “glaciolacustrine colluvium” and the overlying glaciolacustrine clay is marked by a coarse deposit of cobbles and sand which indicates a sharp change in the depositional environment. This coarse deposit was identified in both the 2013 and 2015 drilling investigations. The transition observed in the 2013 investigation can be seen in Figure 3-2.

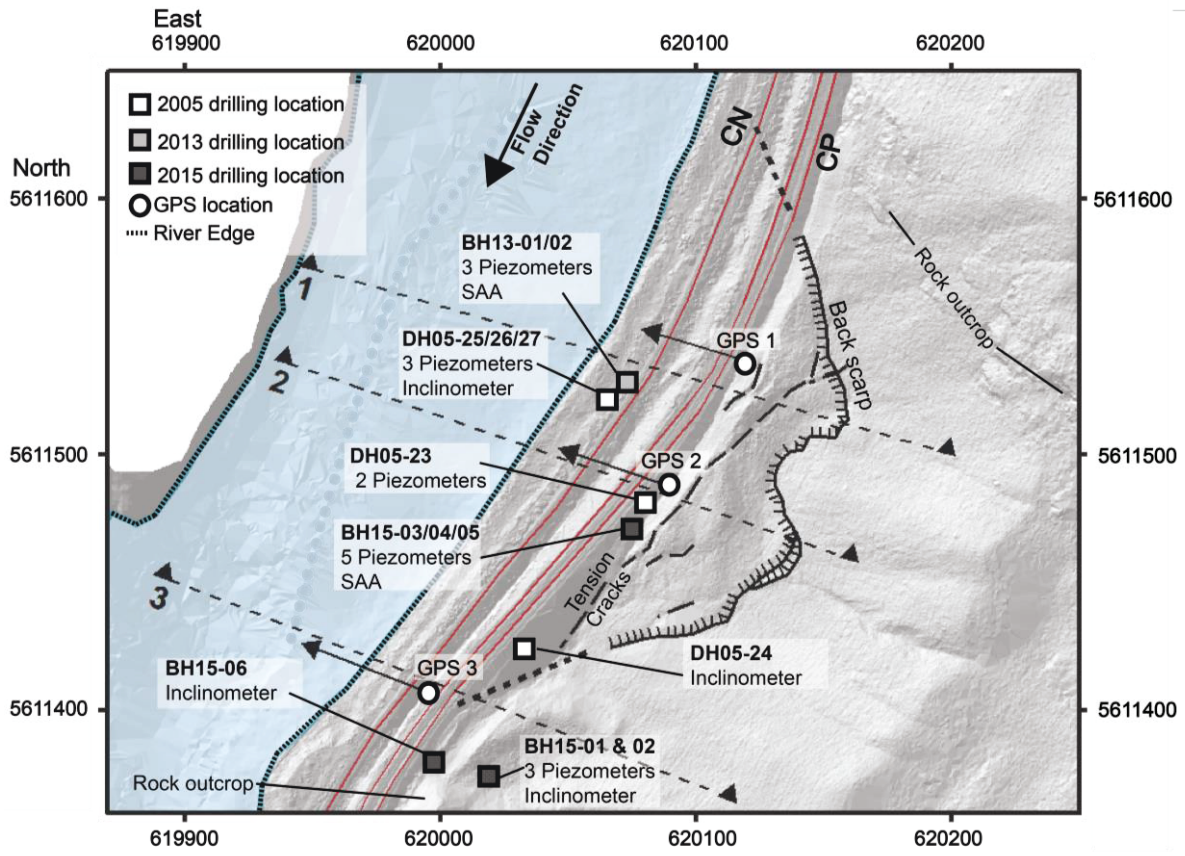
Figure 3-3 Location of boreholes drilled during the site investigation of the Ripley Landslide
(after Macciotta et al. 2014)

Another drilling and instrumentation program was performed in April 2013. The boreholes for this investigation (BH13-01 and BH13-02) were drilled near the same location as DH05-27 (Figure 3-3) in order to replace sheared inclinometer casings and upgrade the monitoring system. The displacement data from the 2005 investigation allowed the instrumentation to be concentrated around the previously identified shear zone. The instruments installed provide higher temporal resolution using a remote data acquisition system. An additional goal of this investigation was to retrieve high quality samples for material characterization.

Figure 3-3 summarizes the layout of the boreholes drilled during the site investigations. Figure 3-4 shows the surface elevation model of the landslide and the location of geophysical survey lines.

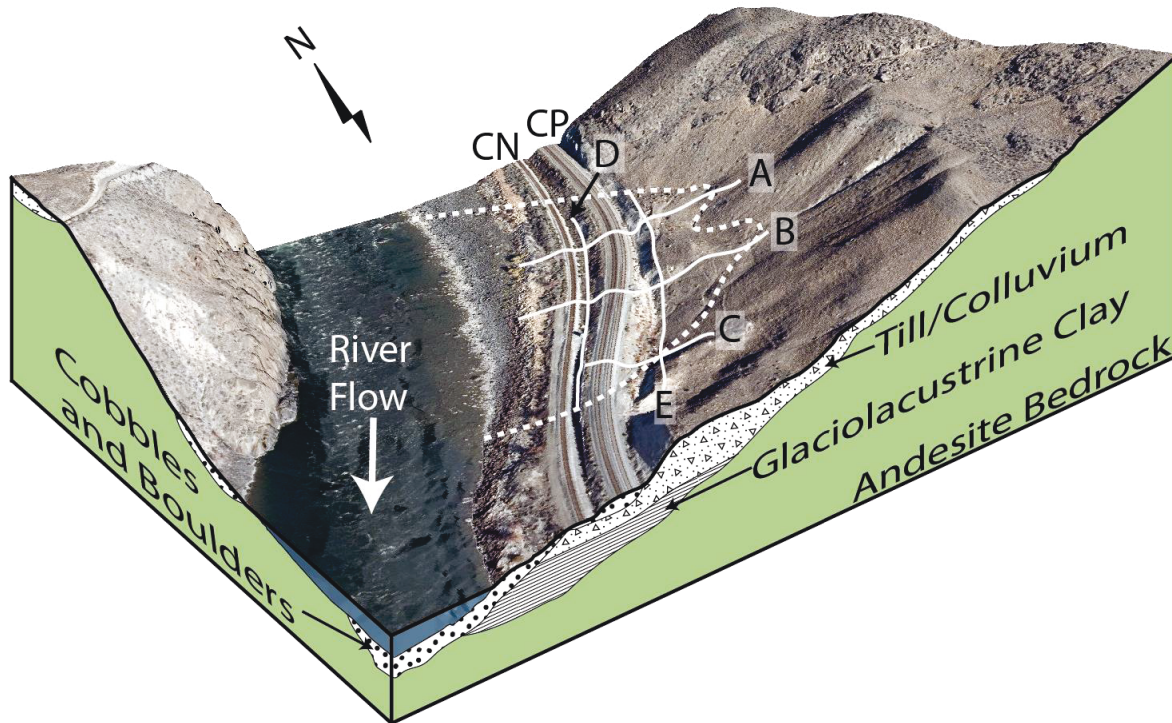
Figure 3-4 Surface elevation model of the Ripley Landslide with locations of geophysics survey lines (after Huntley et al. 2014).

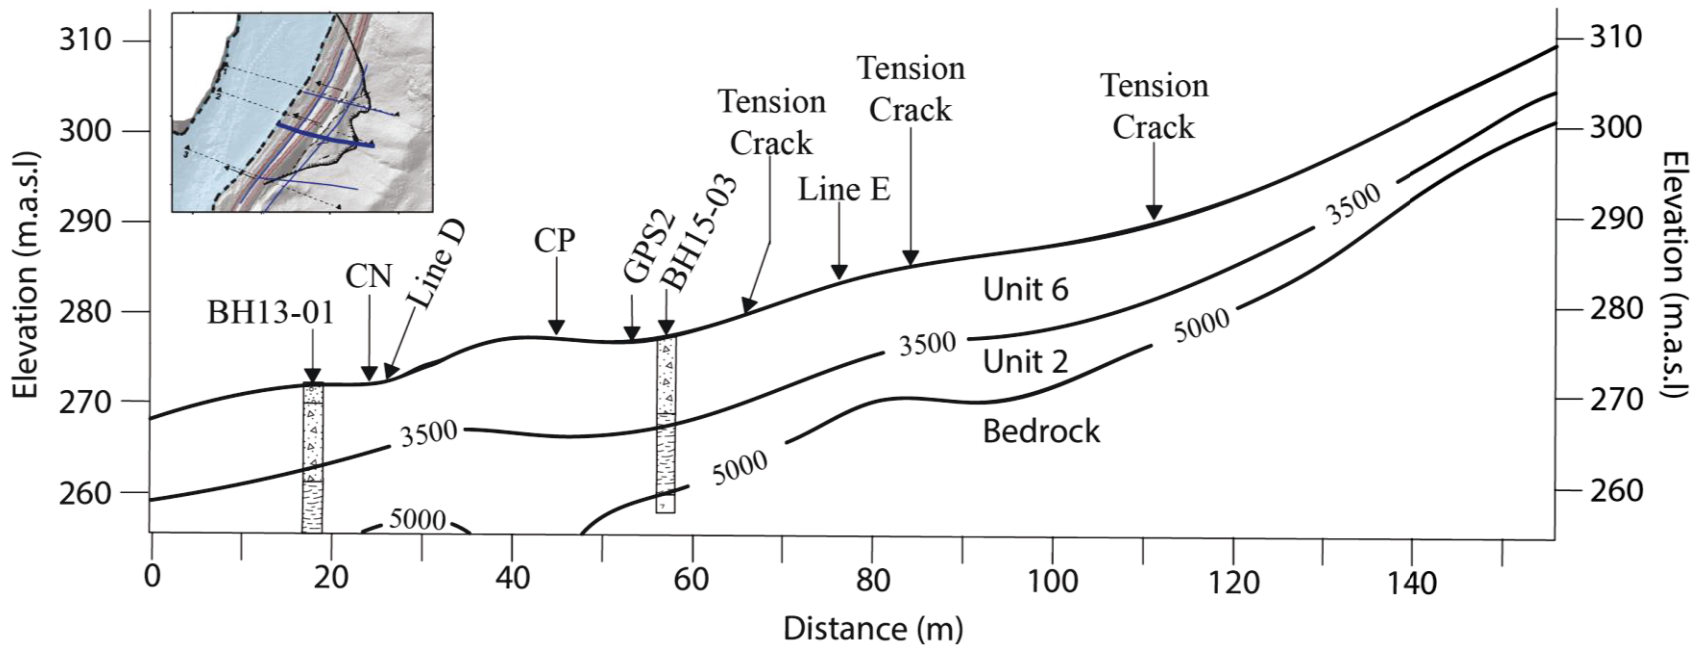
Figure 3-5 P-wave velocity contours interpreted from seismic refraction survey results along Line B of the Ripley Landslide
(after Huntley et al. 2014, contours are in m/s)

Figure 3-5 show a sample of the results of the seismic refraction surveys. The plotted contours are compression wave (P-wave) velocities. Higher P-wave velocities correspond to denser materials such as rock. Boreholes drilled near these geophysics surveys (Figure 3-3) were used to ground proof the seismic refraction results. The top of Unit 2 corresponded to P-wave velocities of approximately 3500 m/s. The top of bedrock corresponded to P-wave velocities of approximately 5000 m/s.

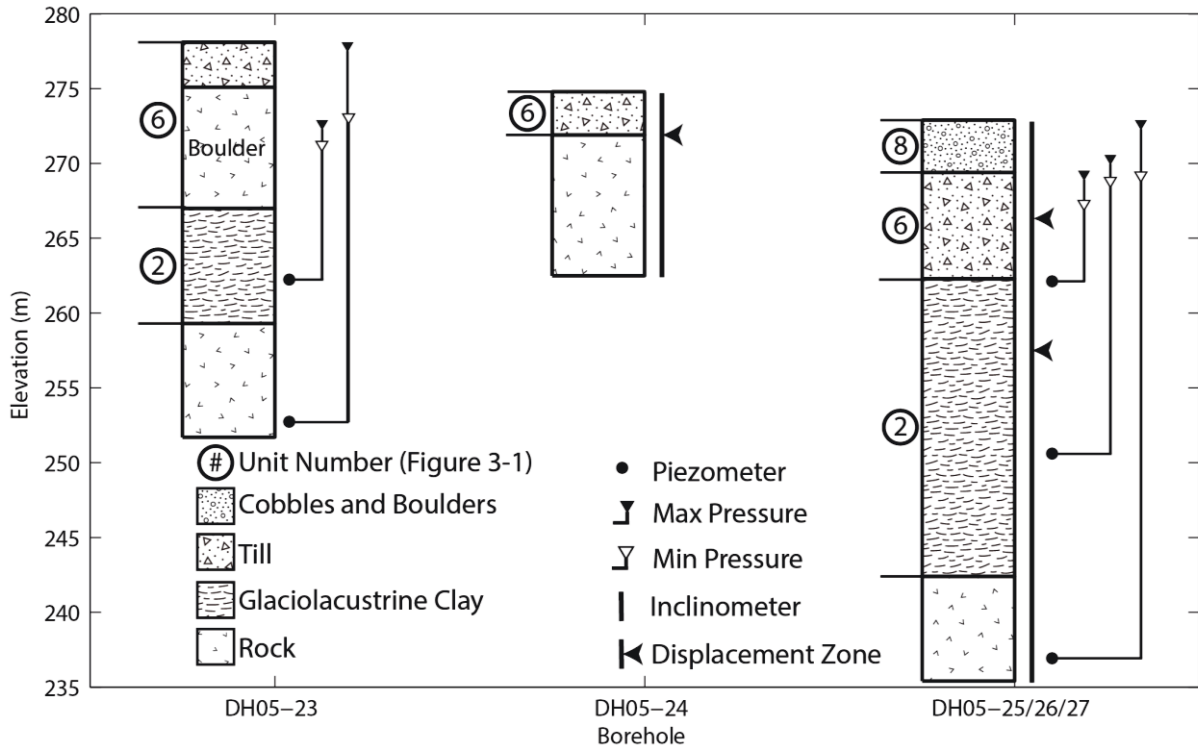
Figure 3-6 Stratigraphy and instrumentation layout of the 2005 investigations of the Ripley
Landslide

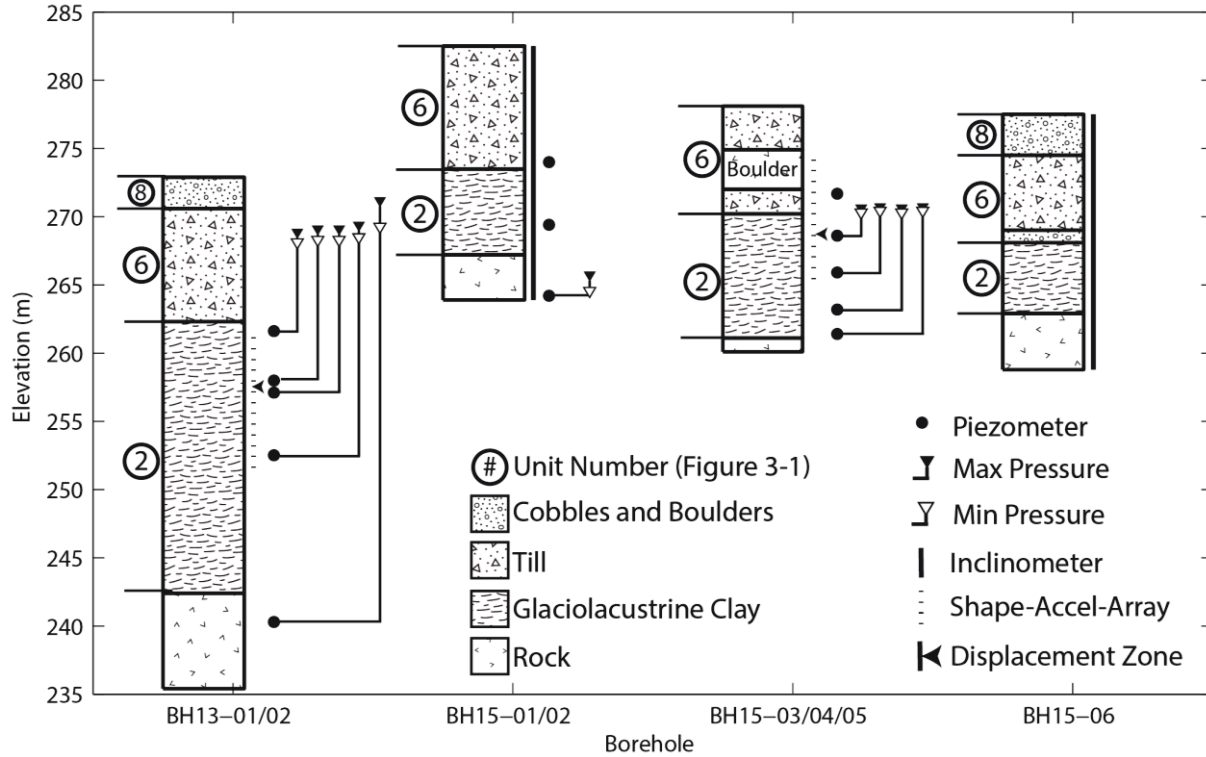
Figure 3-7 Stratigraphy and instrumentation layout of the 2013 and 2015 investigations of the Ripley Landslide

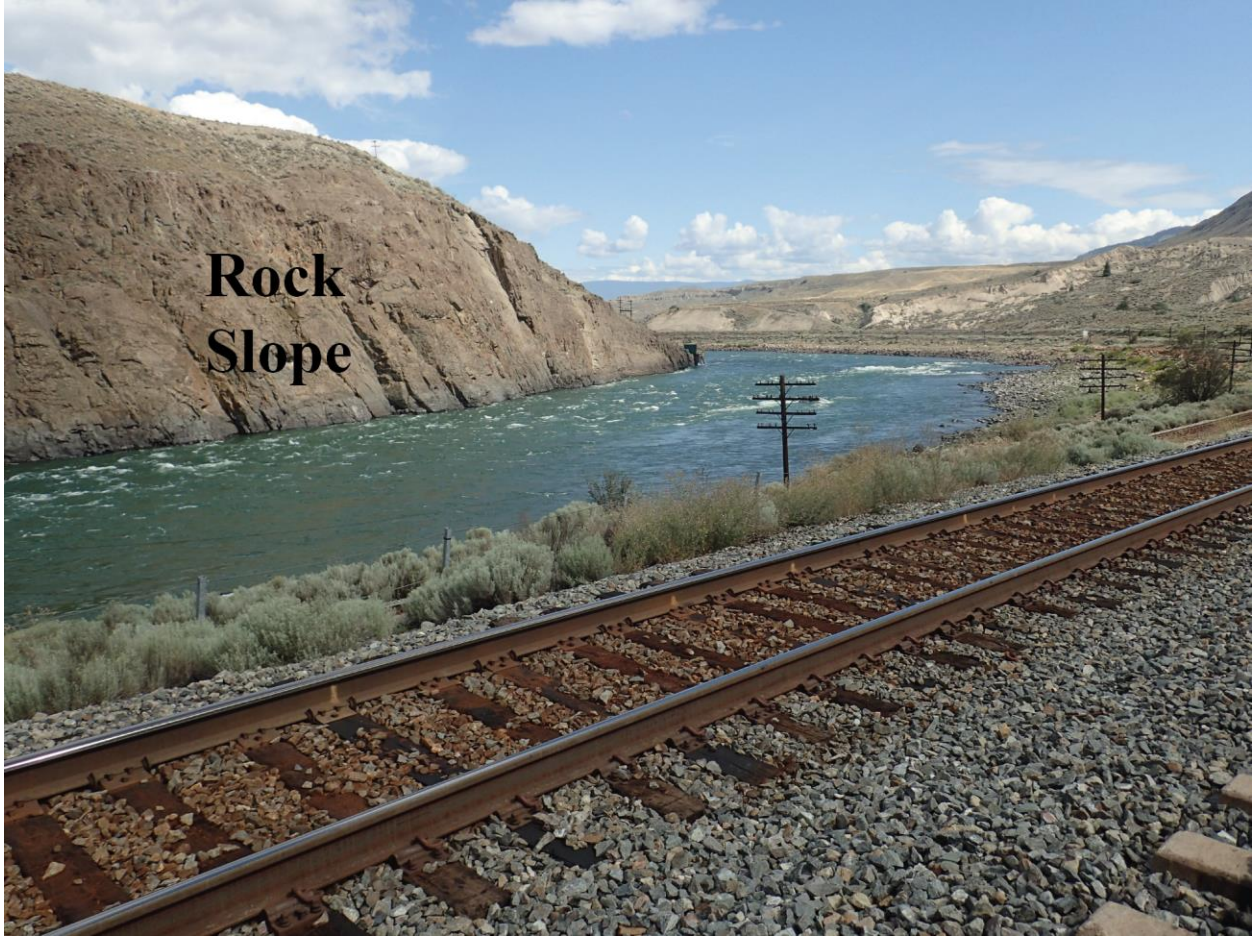
Figure 3-8 Rock slope along the West side of the Thompson River across from the Ripley
Landslide

There are several bedrock outcrops in the vicinity of the Ripley Landslide at the locations shown on Figure 3-3. Bedrock is typically greenish coloured volcanic rock which has been identified as andesite (Huntley and Bobrowsky 2014). The bedrock valley slope on the opposite side of the river from the Ripley Landslide appears to be constraining the location of the Thompson River (Figure 3-8). In addition there is a large rock exposure at the South margin of the landslide that appears to be a bedrock outcrop (Figure 3-9).

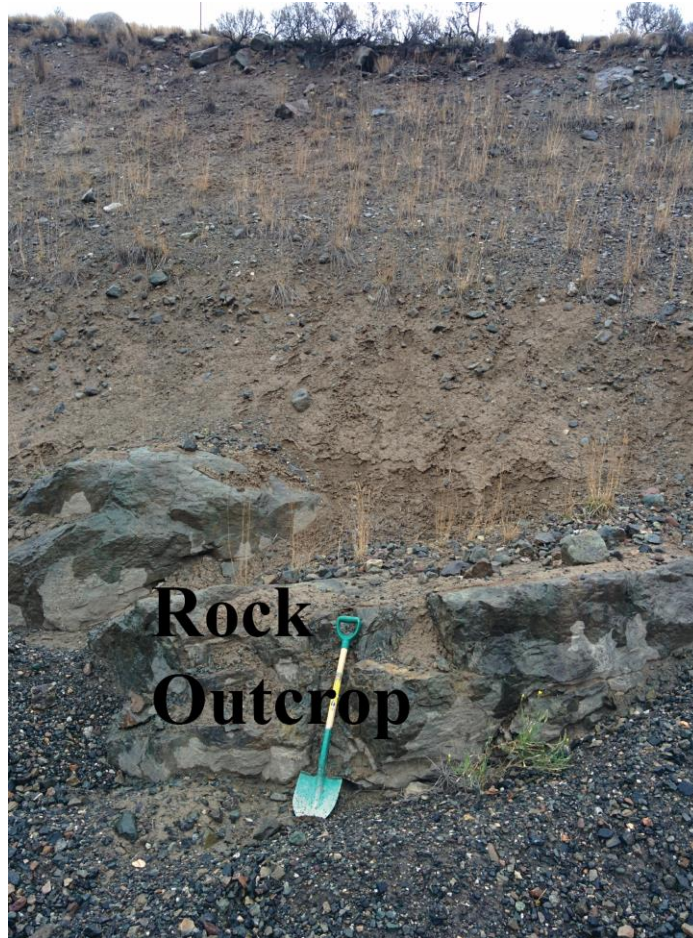
Figure 3-9 Andesite rock outcrop on southern boundary of the Ripley Landslide overlain by glacial till (Figure 3-3)

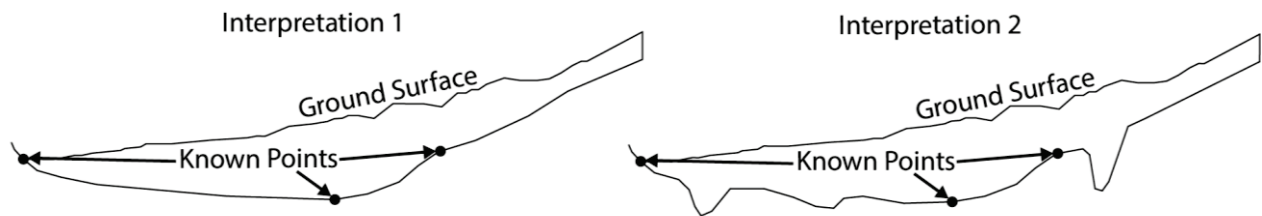
Figure 3-10 Two possible interpretations of bedrock profile based on a set number of known points and seismic P-wave survey results

rock slope on the adjacent bank are the only known points of bedrock elevation which can be used for developing a given section. The bedrock profile between these boreholes are interpolated based on seismic P-wave survey results (Figure 3-5). These surveys can be affected by geometric shielding effects (Perry 2016) which could result in irregularities in the bedrock profile, such as buried channels, being missed when developing sections (Figure 3-10).

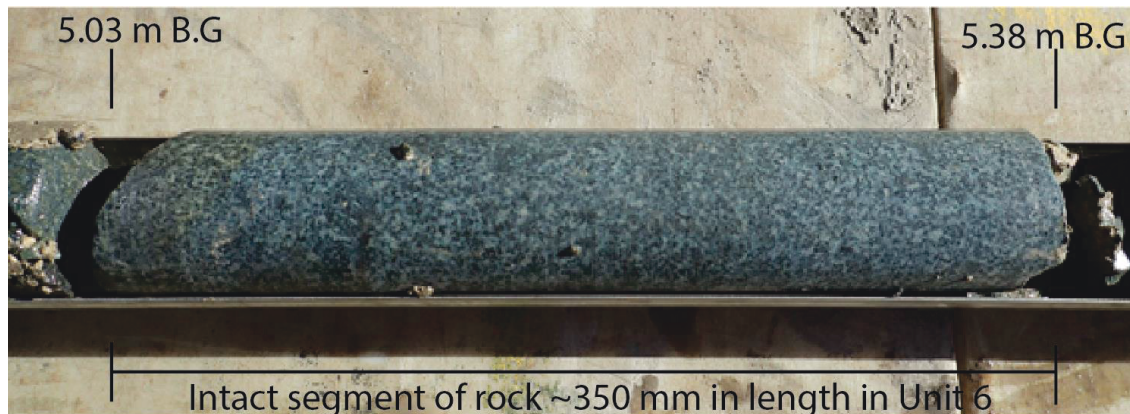
Figure 3-11 Andesite rock fragment obtained during the 2015 site investigation in BH15-03

The same large section of rock was encountered during the drilling of BH15-03. This hole was drilled approximately 7 m South of DH05-24. The rock section found in BH15-03 was smaller than that encountered in 2005 (~4.3 m). The largest fragment from the rock section encountered in BH15-03 can be seen in Figure 3-11. BH15-04 was drilled approximately 4 m further South from BH15-03. At this location the rock section encountered was even smaller based on the drill

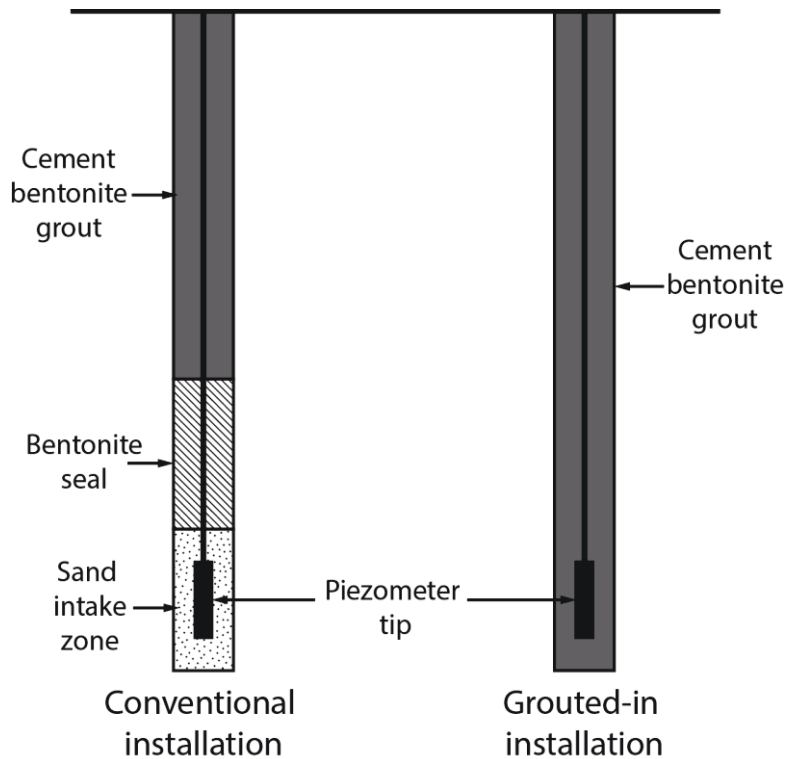
Figure 3-12 Comparison of the conventional and grouted-in installation methods of piezometers
(after McKenna 1995)

The conventional installation method of piezometers involves placing a piezometer tip in a high-permeability sand intake zone. The borehole is then sealed with a low-permeability bentonite seal above the sand intake zone. The remainder of the hole is filled with cement bentonite grout. The grouted-in installation method involves installing the piezometer tip and filling the entire borehole with cement-bentonite grout. The grouted-in method was originally proposed by Vaughan in 1969 but was not used in industry at that time (McKenna 1995). A comparison of these installation methods is shown in Figure 3-12.

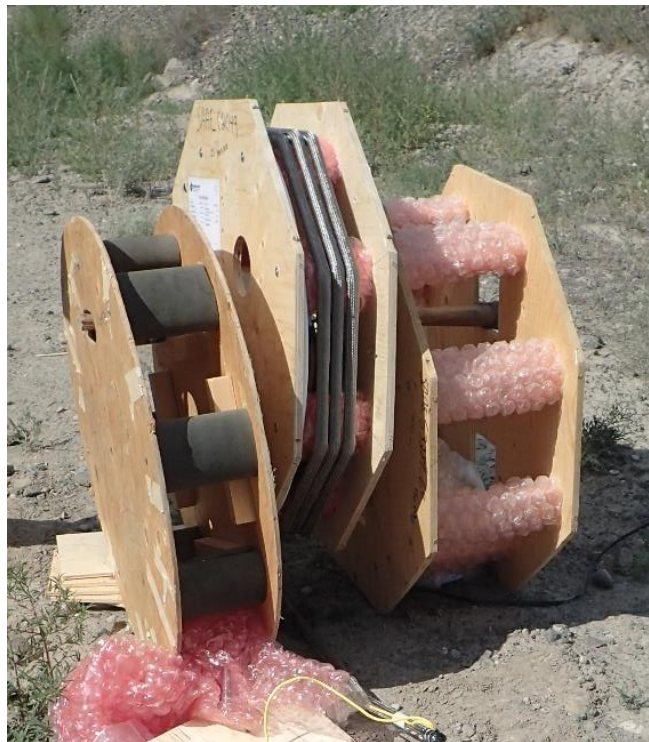
Figure 3-13 ShapeAccelArray on spool before installation has begun.

An SAA consists of a series of rigid segments which each contain a gravity sensor (Measurand 2013). These sensors determine the tilt of each segment which allows for the calculation of the position of each joint relative to the base of the SAA. Figure 3-13 shows the SAA before installation. The rigid links can clearly be seen wrapped around a spool for easy transportation and handling. Figure 3-14 shows the installation of an SAA into one of the boreholes drilled during the 2015 investigation.

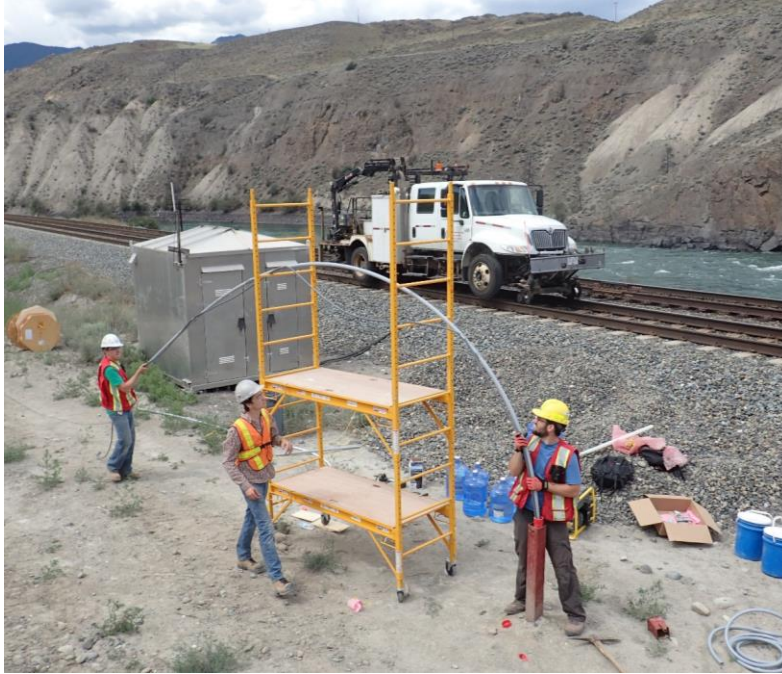
Figure 3-14 Installation of ShapeAccelArray into BH15-04 in July 2015

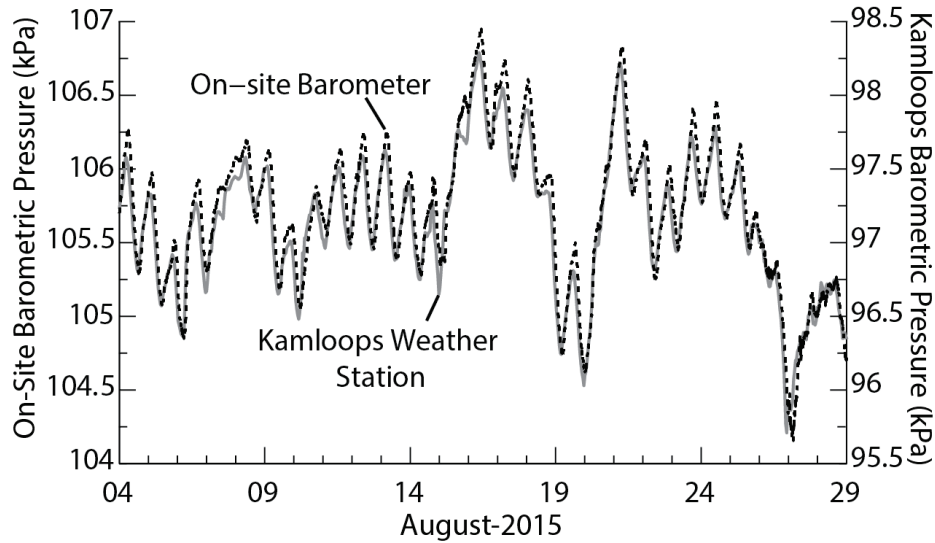
Figure 4-1 Comparison of the variation of atmospheric pressure measured by an on-site barometer and a distant weather station

Figure 4-1 shows that the variations of both data sets are in excellent agreement and the weather station data is representative of the site conditions.

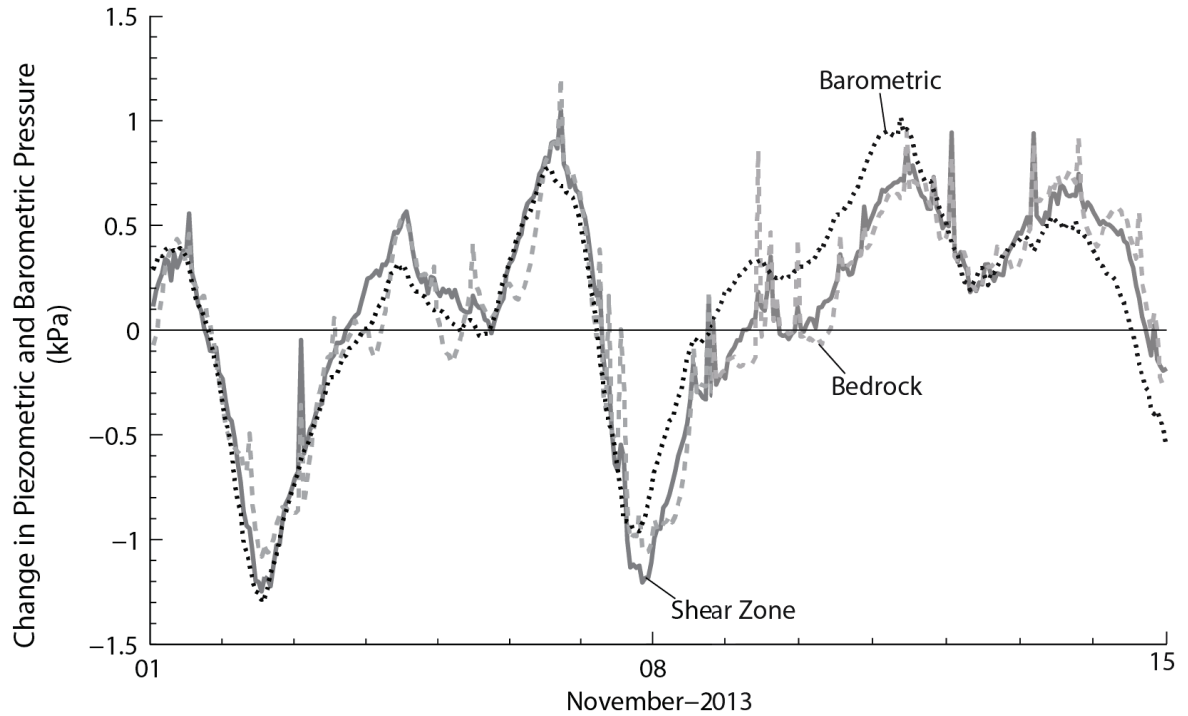
Figure 4-2 High Frequency Variation of Pore Pressure in the bedrock at a depth of 32.6 m and the shear zone at a depth of 15.6 m, and the Barometric Data provided by Environment Canada

The raw pore pressure and barometric pressure data (Environment Canada 2015) were filtered using a 10-day moving average which removed the high frequency variation of each data set. The difference between the raw data and the filtered data was then compared to determine if the high frequency variation of pore pressure correlated strongly to the high frequency variation of barometric pressure. Figure 4-2 shows the difference between the raw and filtered data for the barometric data and the pore pressures measured by piezometers installed in the bedrock and at the rupture surface.

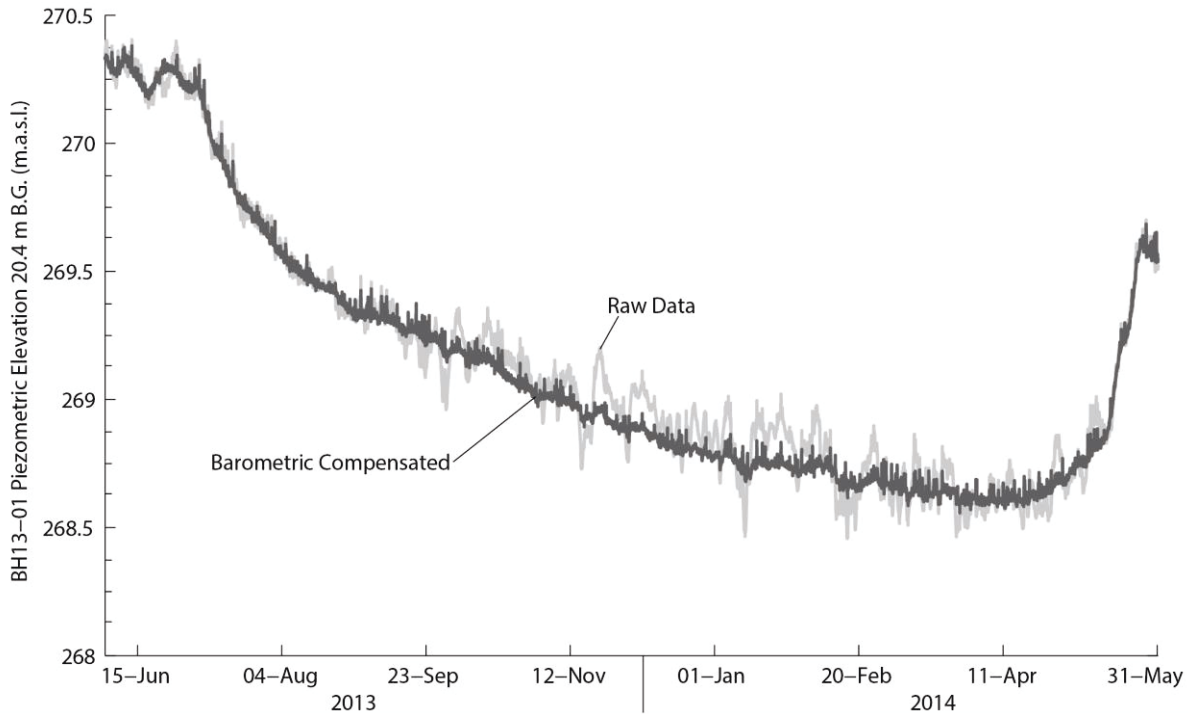
Figure 4-3 Comparison of raw and barometric compensated pore pressure for a VW-piezometer at 20.4 m depth in BH13-01

Figure 4-3 shows raw data from one of the piezometers installed at a depth of 20.4 m in BH13-01. This depth corresponds to the approximate midpoint of Unit 2. This figure also shows the pore pressure trend produced by applying the barometric compensation.

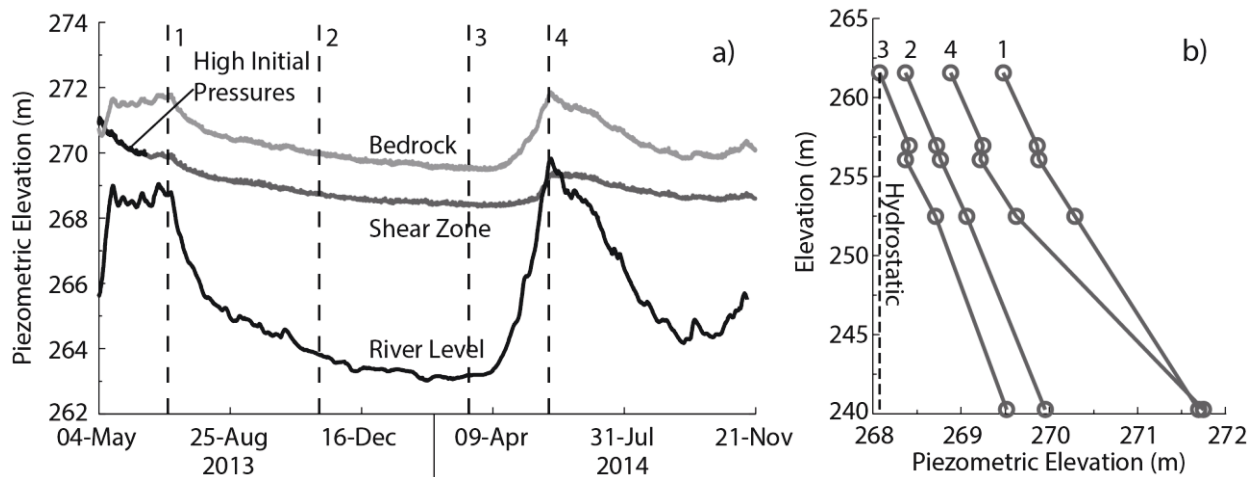
Figure 4-4 Barometric compensated fully grouted piezometer readings at the Ripley Landslide in the first 18 months of monitoring over time (a) and with depth(b)

There were high initial pressures observed in the piezometers installed in the clay at the Ripley Landslide. These readings do not follow the seasonal patterns of pore pressure and are likely not representative of the layer in which they are installed. This can be seen in the highlighted region of the shear zone readings in Figure 4-4a.

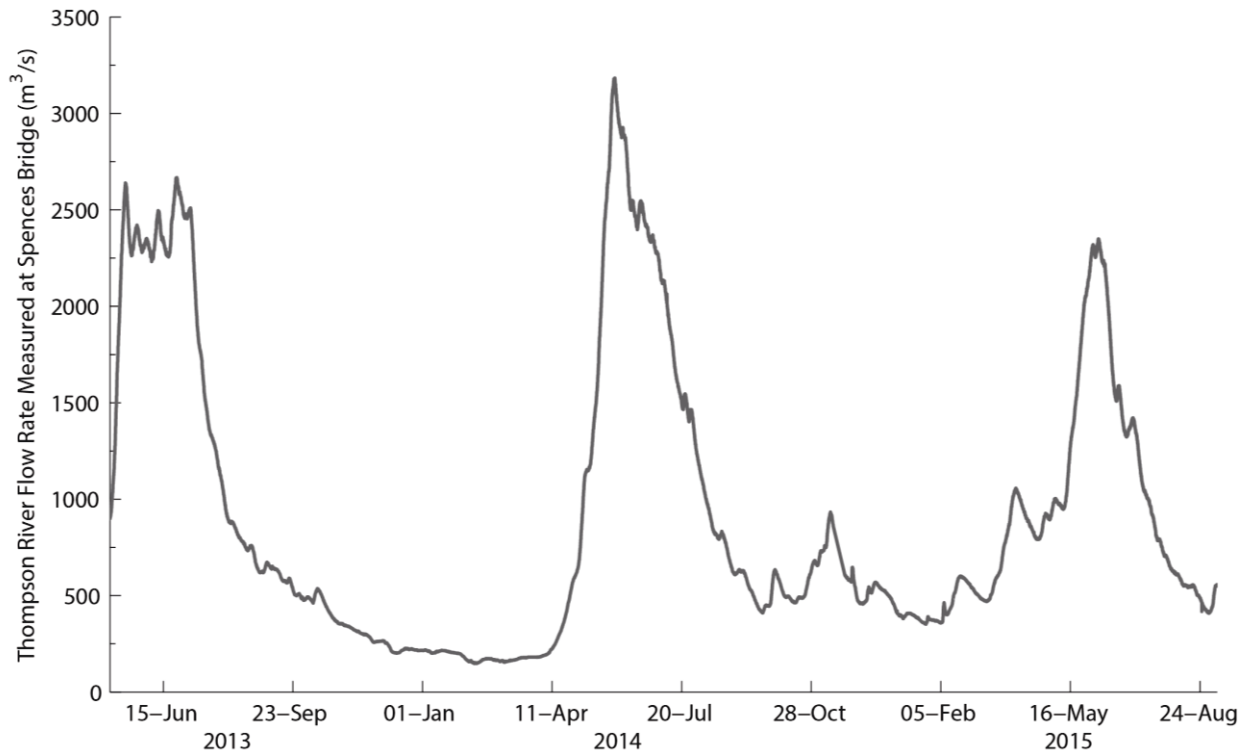
Figure 4-5 Seasonal flow rate variation of the Thompson River as measured at Spences Bridge

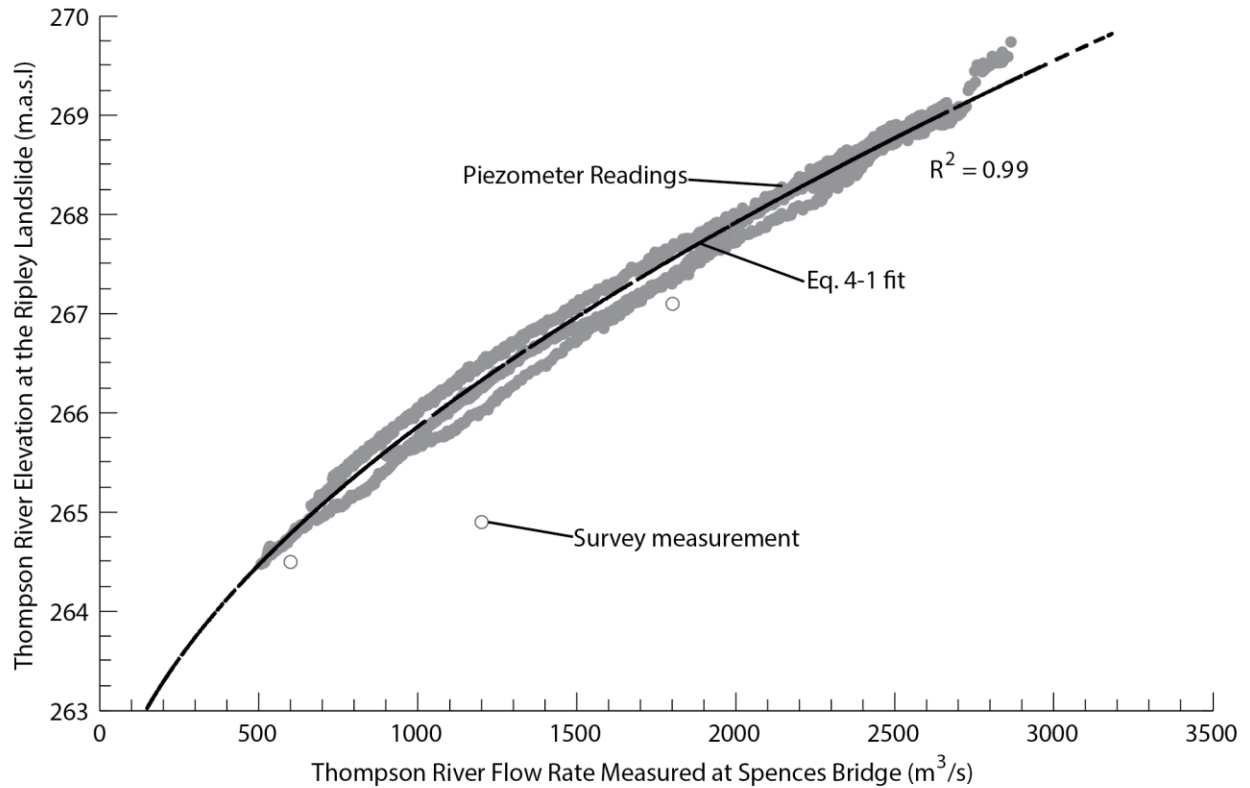
Figure 4-6 Correlation between the Thompson River elevation at the Ripley Landslide and the flow rate measured at Spences Bridge

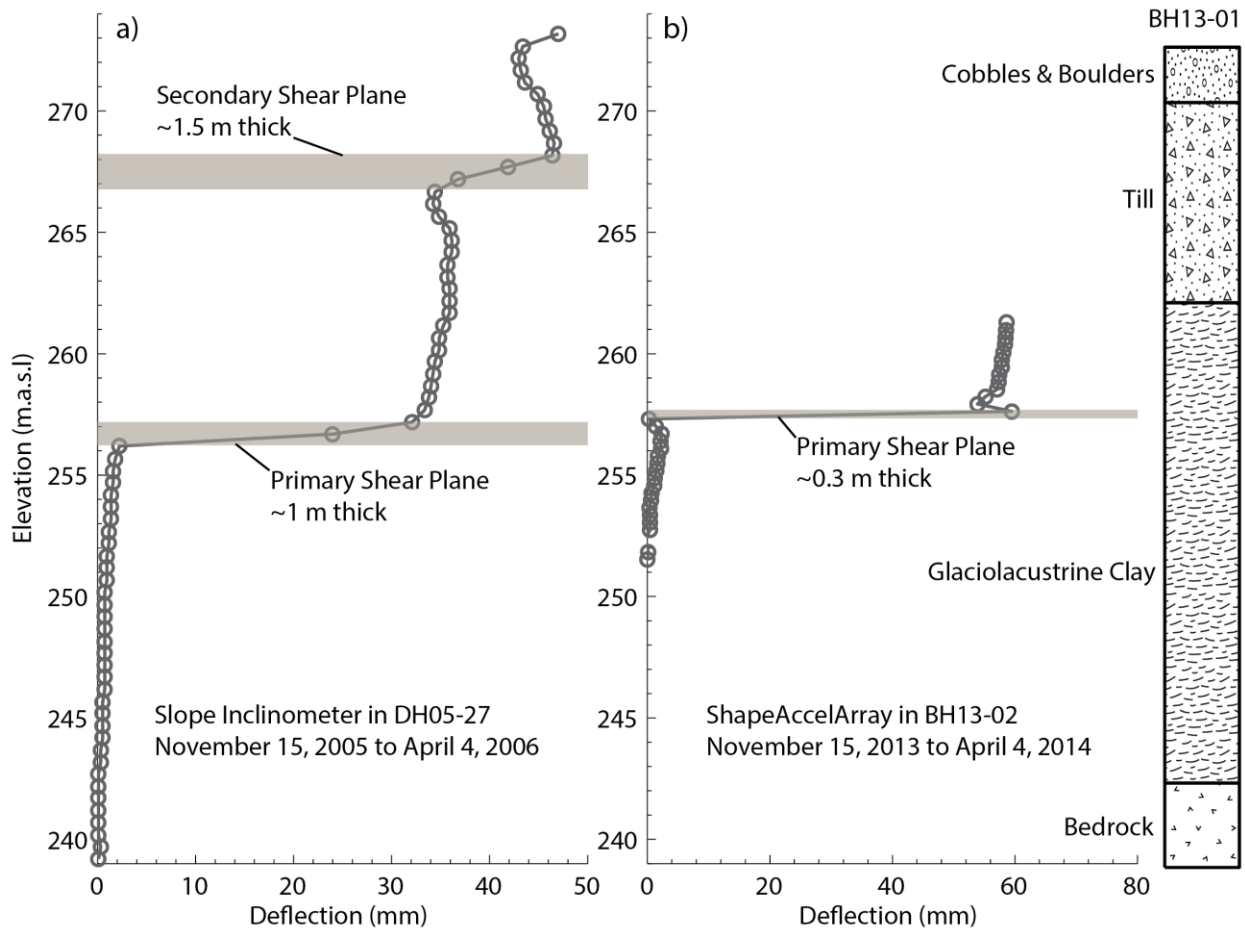
Figure 4-7 Deflection recorded at the Ripley Landslide by a slope inclinometer in DH05-27 (a) and a ShapeAccelArray in BH13-02 (b) for the same time period in different years
