Kinematics and Controlling Mechanics of the Slow Moving Ripley Landslide

Matthew B. Schafer

A thesis submitted in partial fulfillment of the requirements for the degree of

Geotechnical Engineering

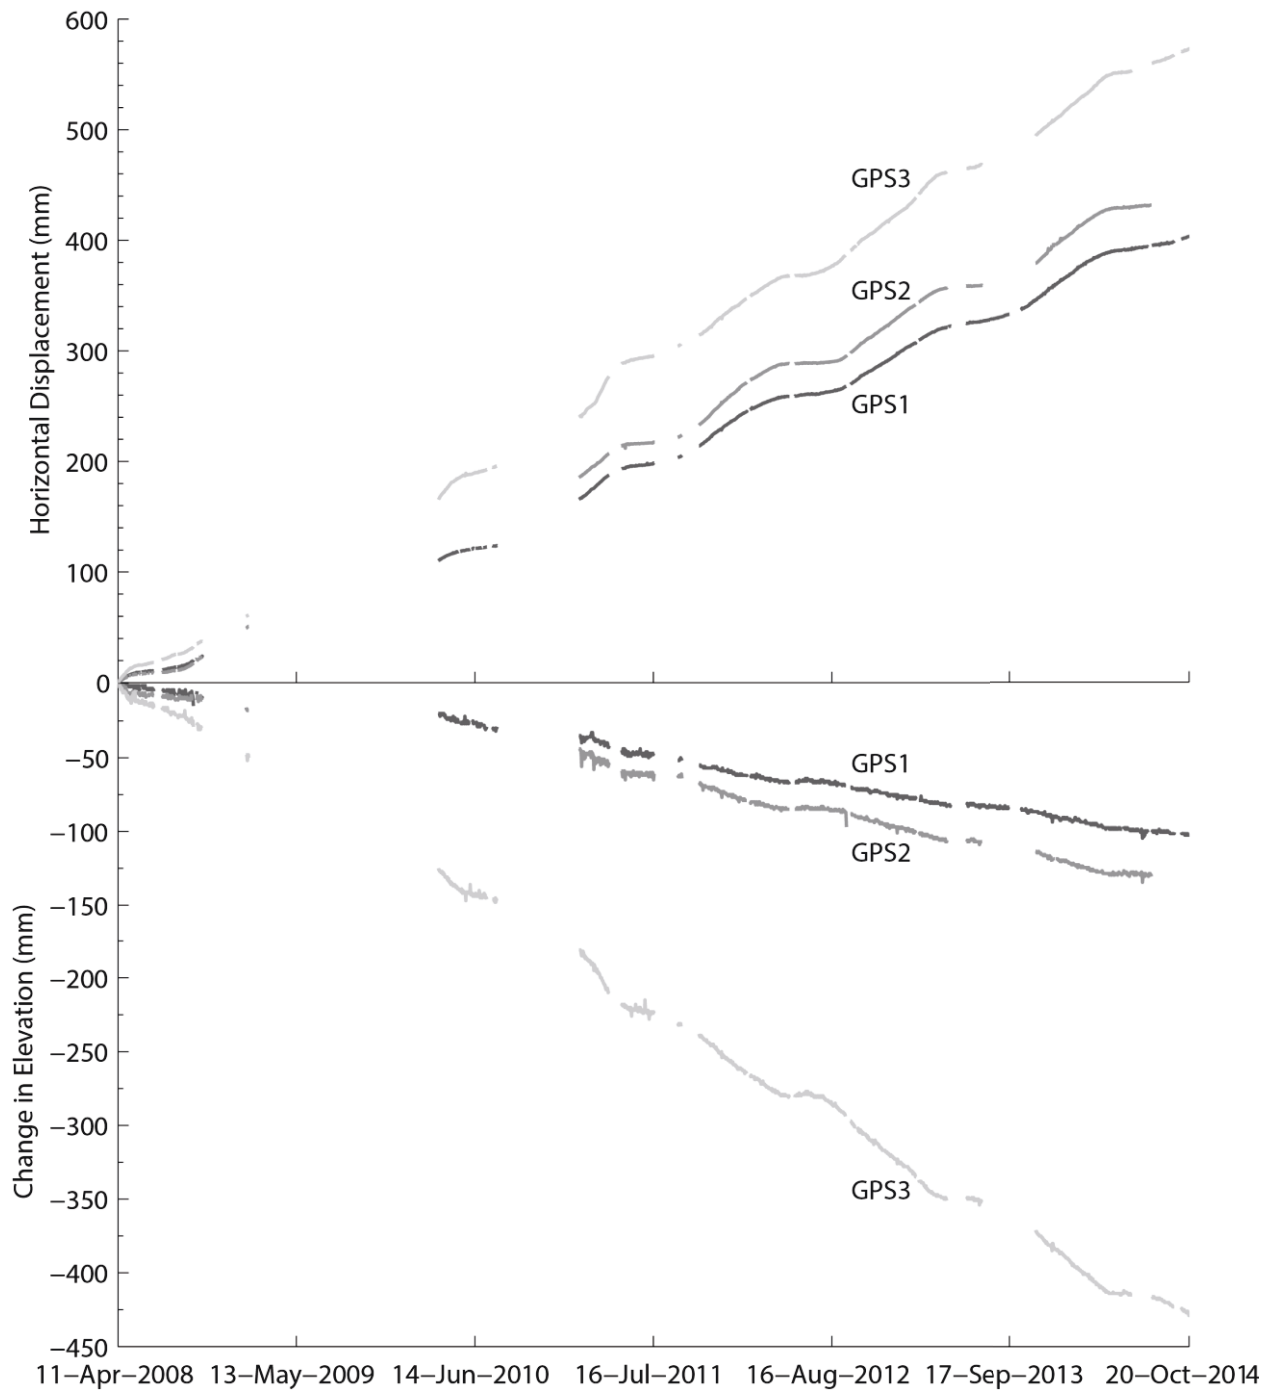
Figure 4-8 GPS surface displacements recorded on the Ripley Landslide

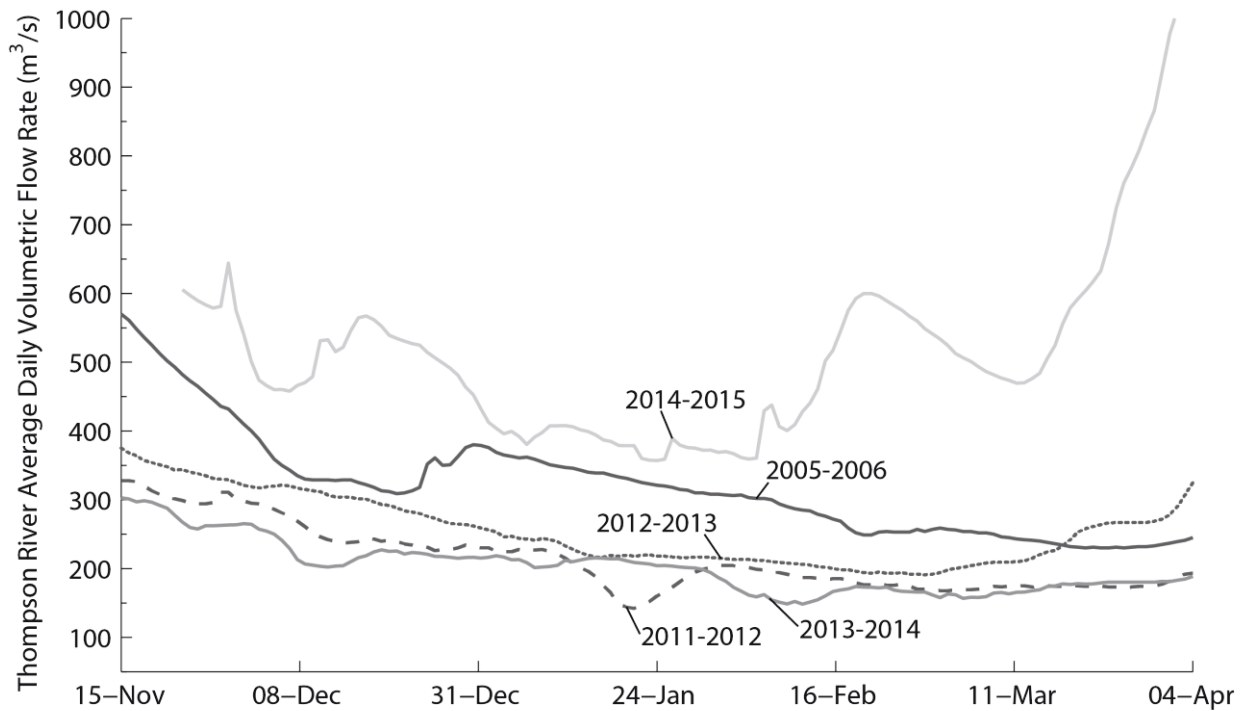
Figure 4-9 River flow in the Thompson River measured at Spences Bridge for the period of November 15 to April 4 for the various periods of slope monitoring compared in Table 4-1.

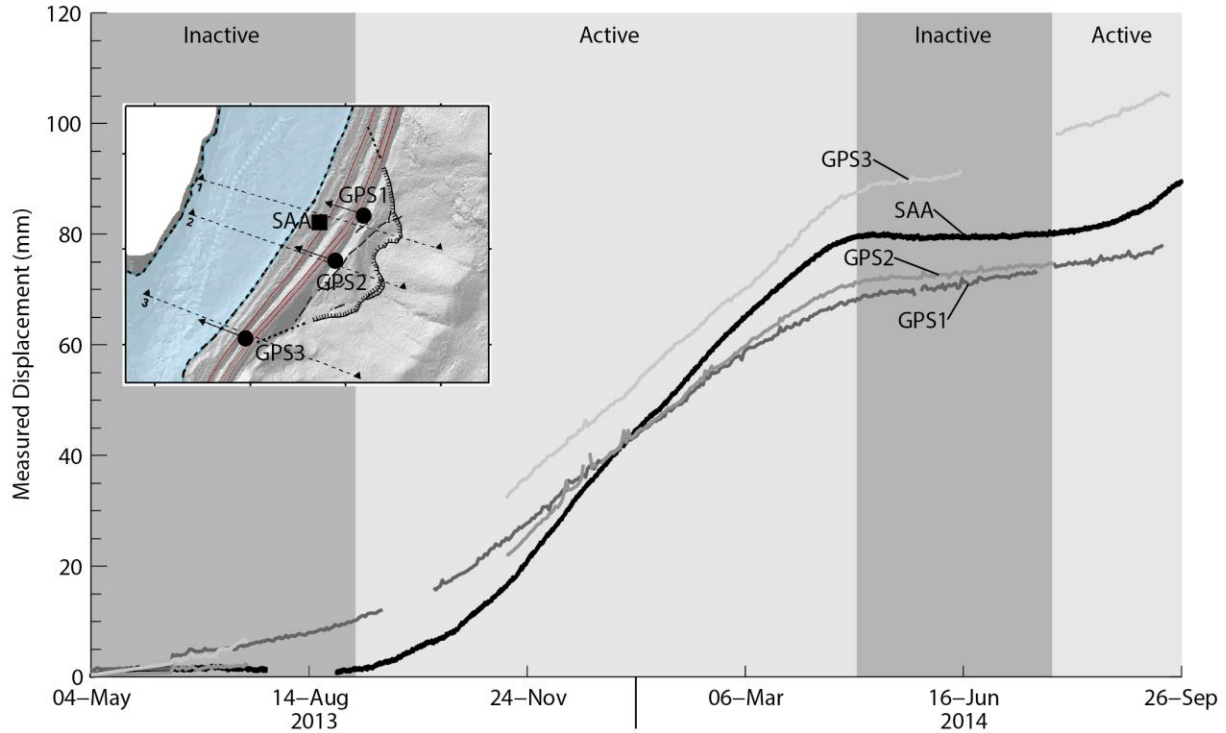
Figure 4-10 Comparison of displacement measurements of the SAA installed in BH13-01 and the GPS displacement units placed across the Ripley Landslide

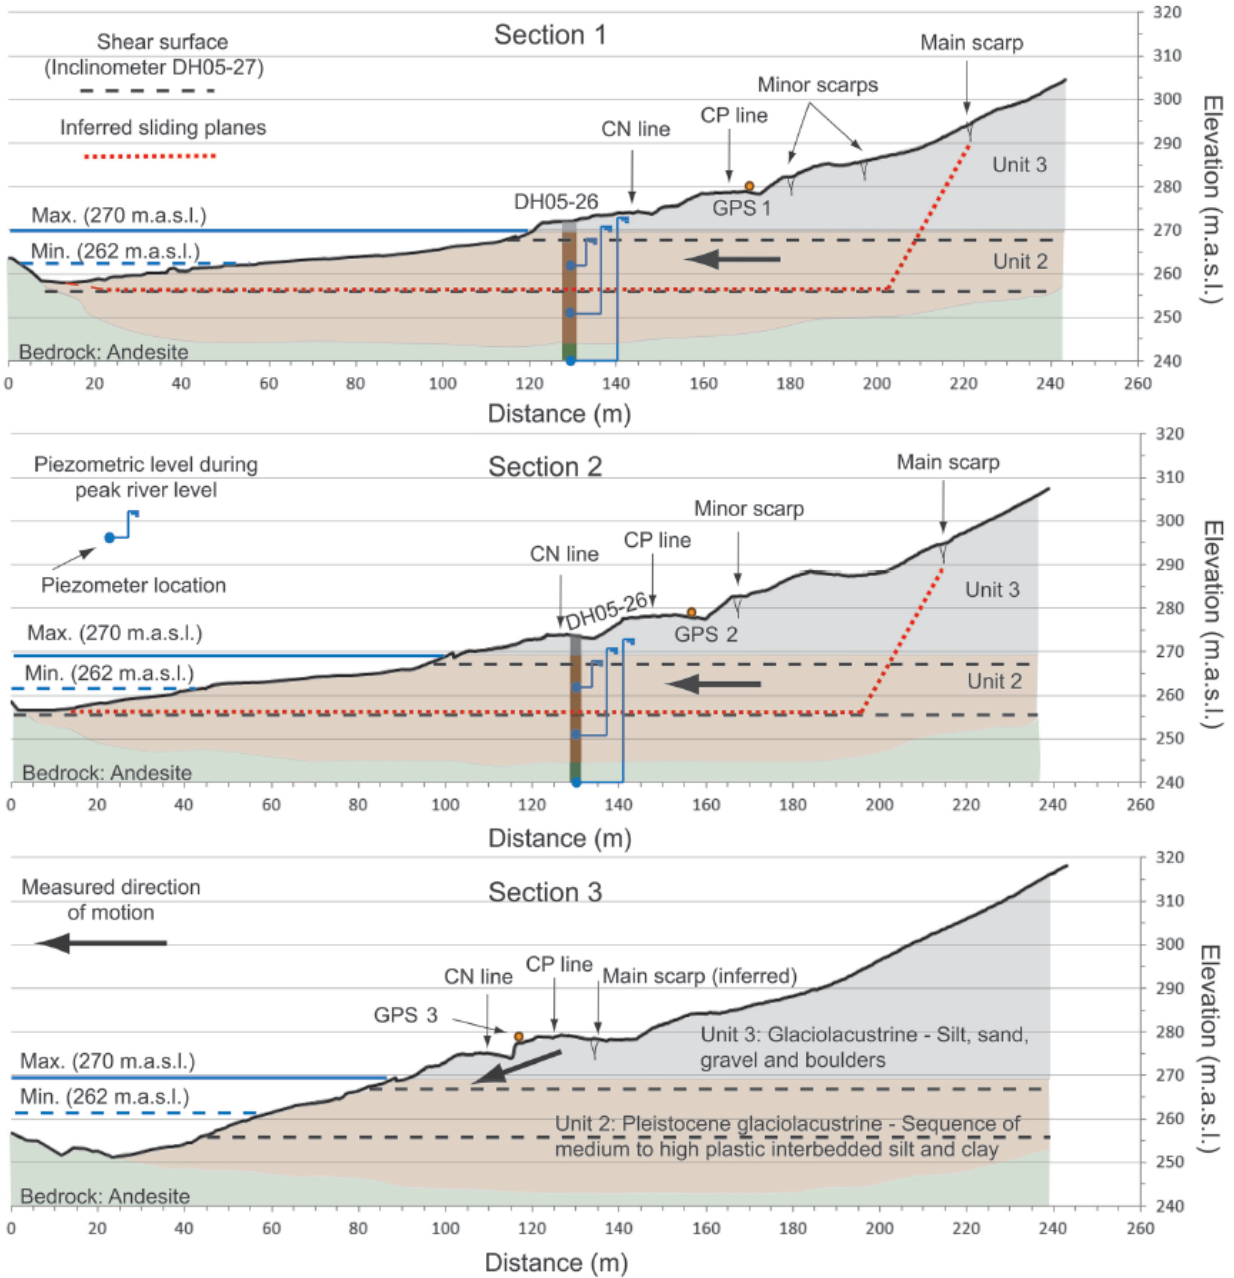
Figure 5-1 Cross sections of the Ripley Landslide by Hendry et al. (2015) showing rupture surfaces, estimated stratigraphy, measured piezometric elevations (see Figure 3-3 for locations)

The Hendry et al. 2015 cross sections are shown in Figure 5-1 for reference.

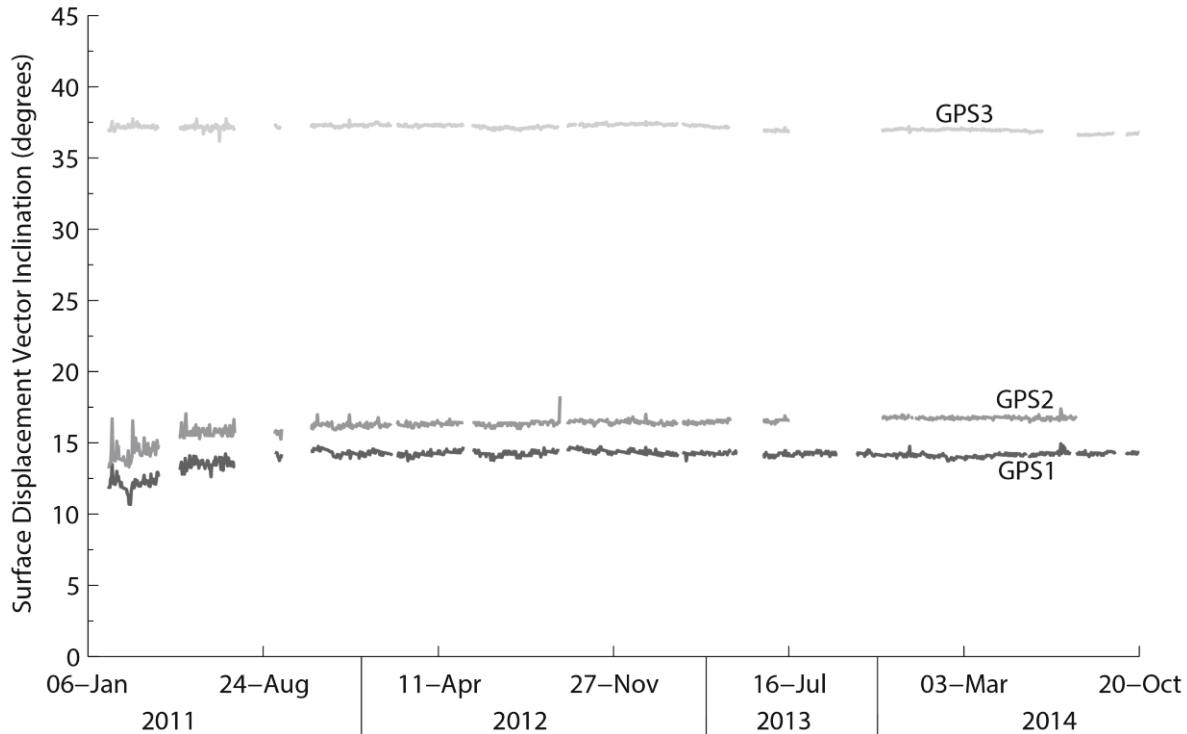
Figure 5-2 Surface displacement vector inclinations observed by three GPS monitoring units installed on the Ripley Landslide (see Figure 3-3 on p.28 for unit locations)

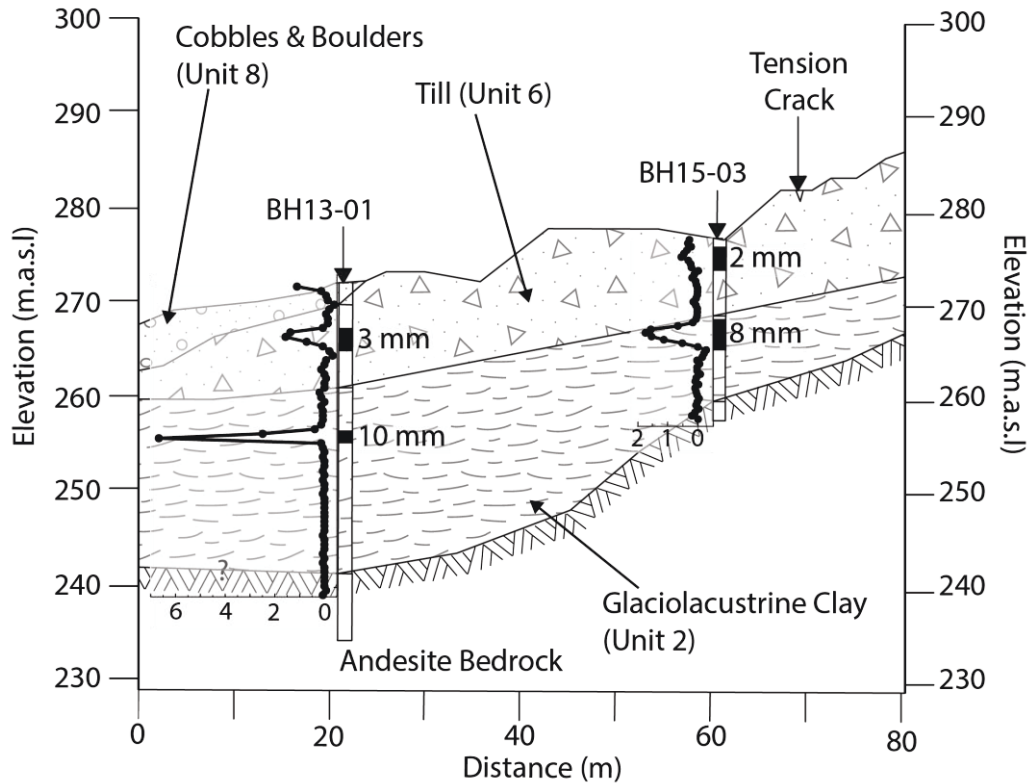
Figure 5-3 Incremental displacements (in mm) along Section 2 (Figure 3-3) between March 3, 2015 and July 13, 2015; Shear zones indicated in black with the cumulative displacement indicated beside them

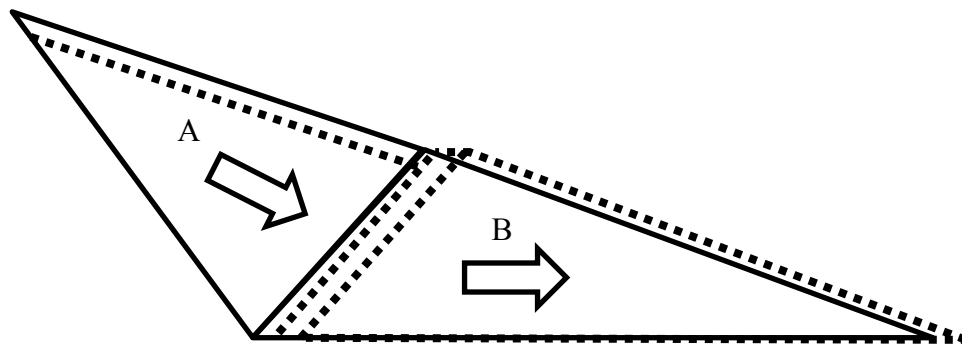
Figure 5-4 Simplified visualization of a compound landslide (after Norrish and Wyllie 1996)

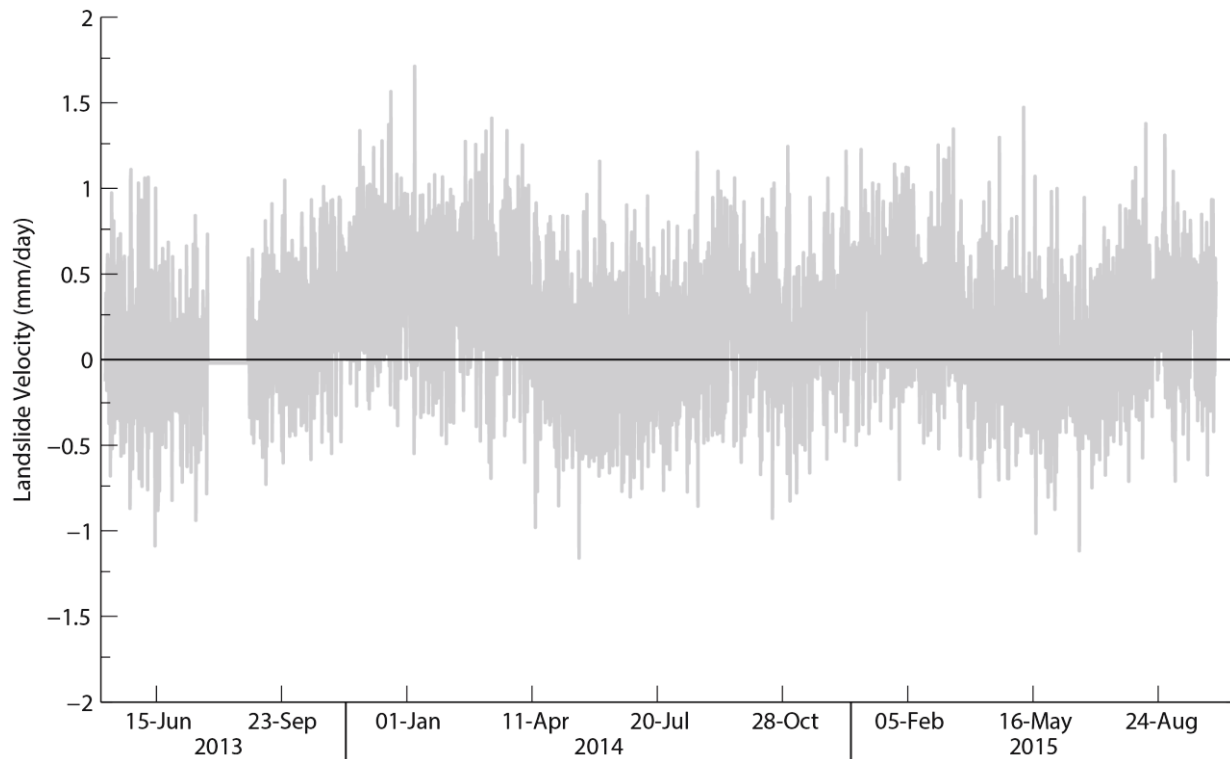
Figure 6-2 Instantaneous velocity calculated from 6-hour SAA readings from BH13-02 using Equation 6-1

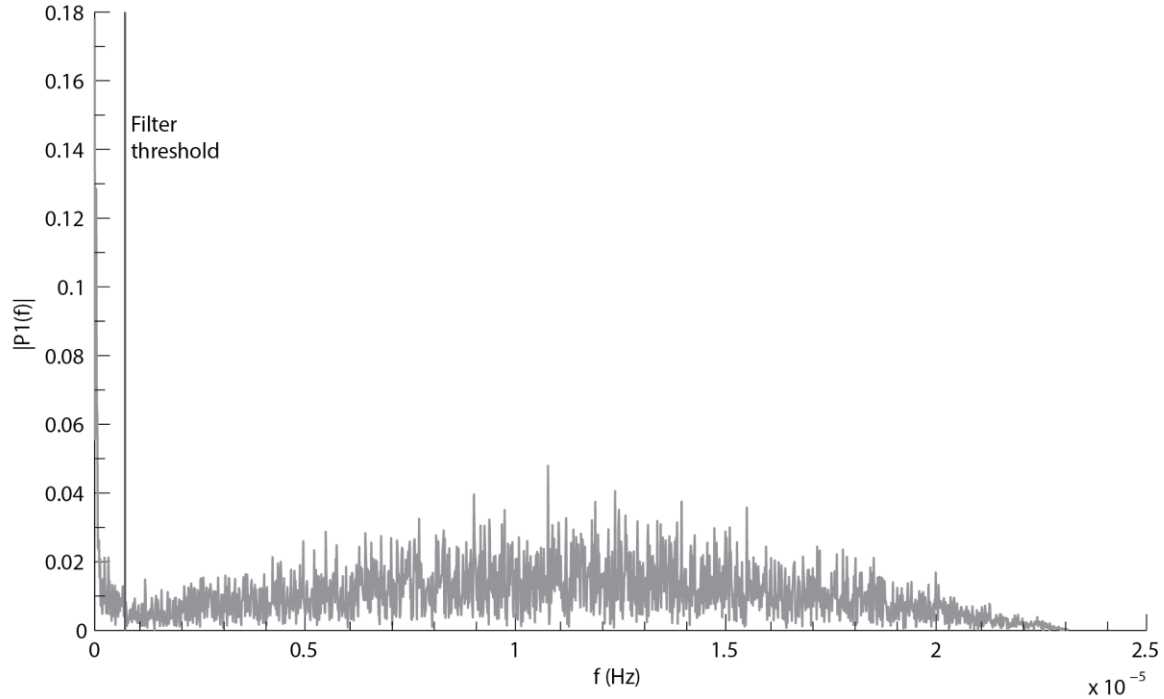
Figure 6-3 Fast fourier transform of instantaneous landslide velocity calculated from 6-hour SAA readings from BH13-02 using Equation 6-1

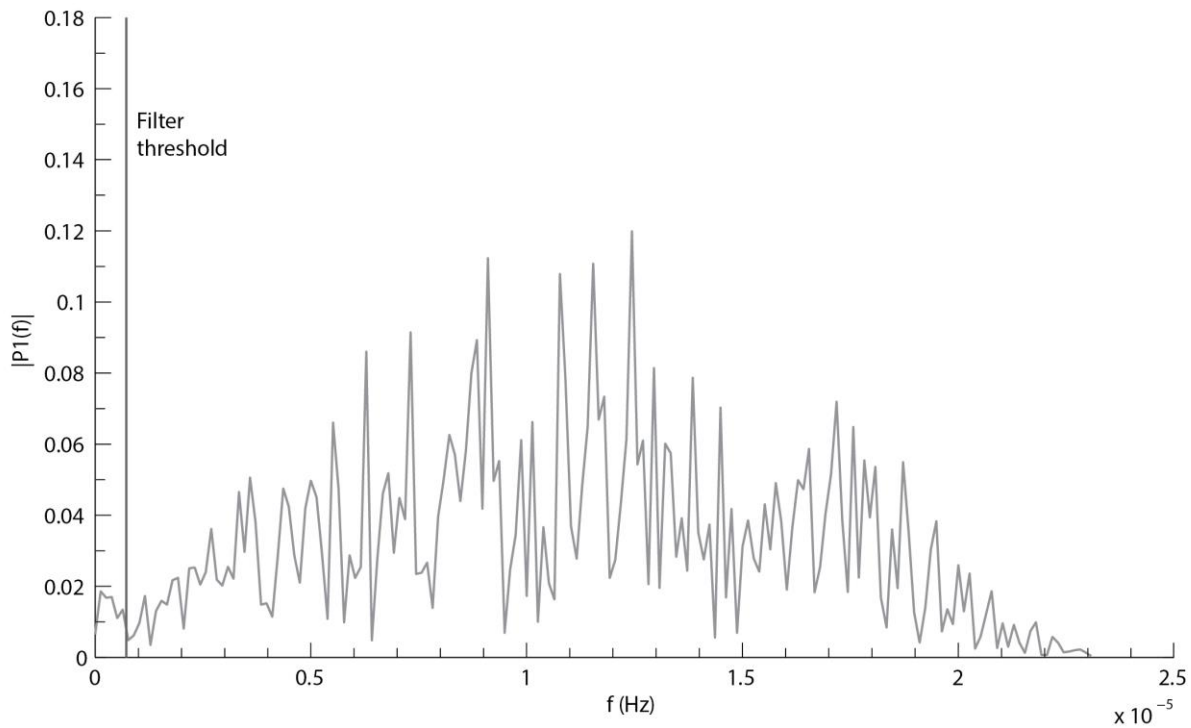
Figure 6-4 Fast fourier transform of landslide velocity during period of landslide inactivity in 2014 (Figure 6-1)

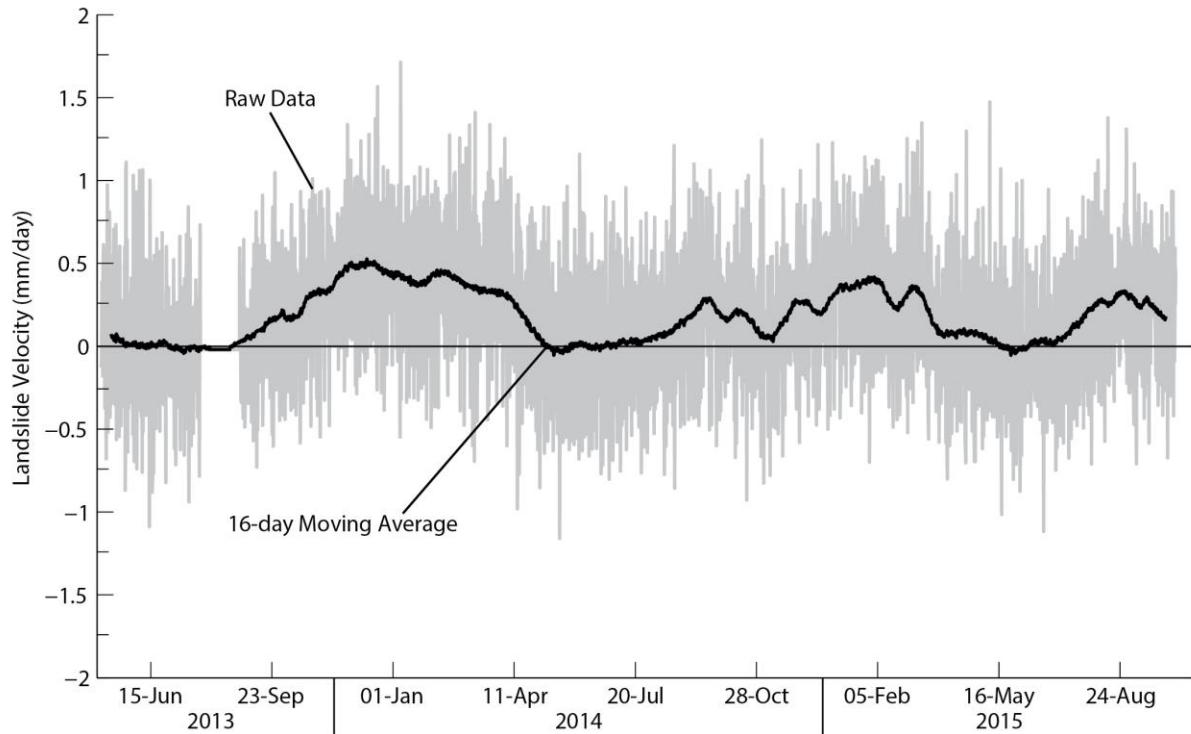
Figure 6-5 Instantaneous landslide velocity calculated from the 16-day moving average of 6-hour SAA readings from BH13-02

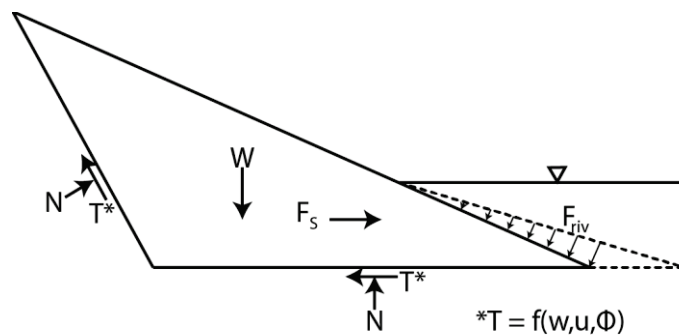
Figure 6-6 Forces acting on the landslide mass that produce a net instability (F_s)

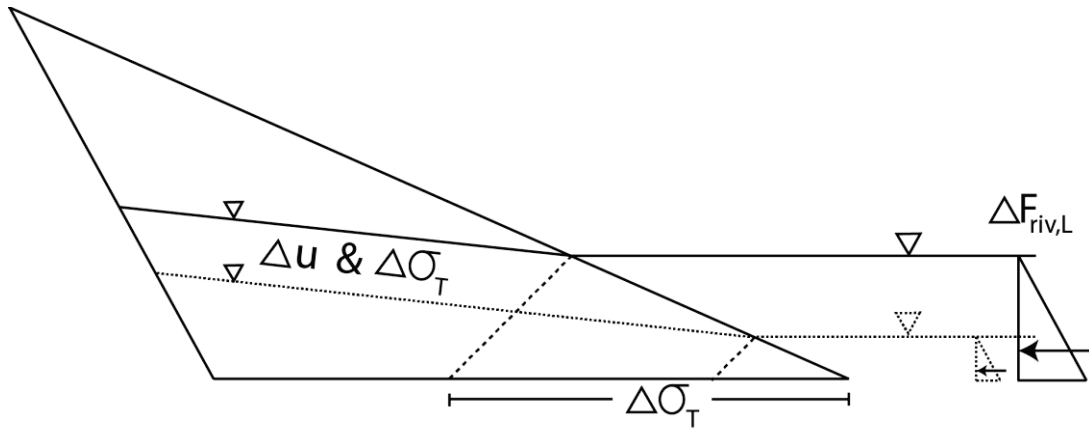
Figure 6-7 Changes to landslide mass caused by variation in the river elevation adjacent to the landslide

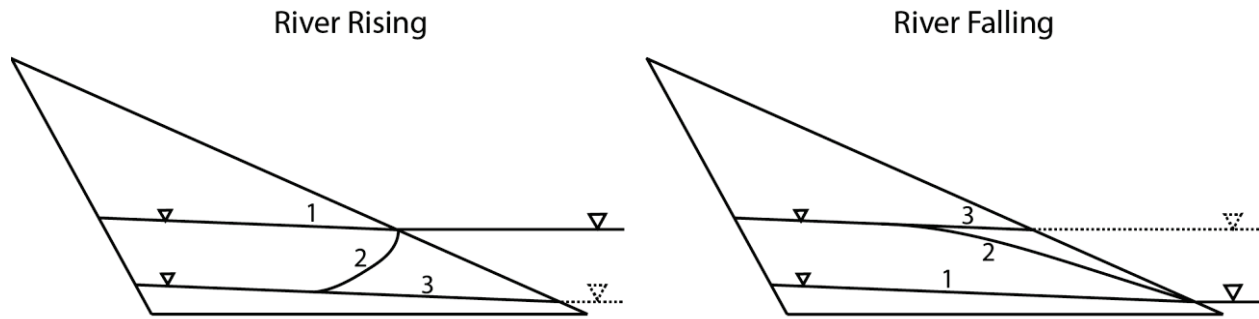
Figure 6-8 Phreatic surface resulting from an increase and decrease in river level for a landslide mass with (1) high permeability, (2) moderate permeability, and (3) very low permeability.

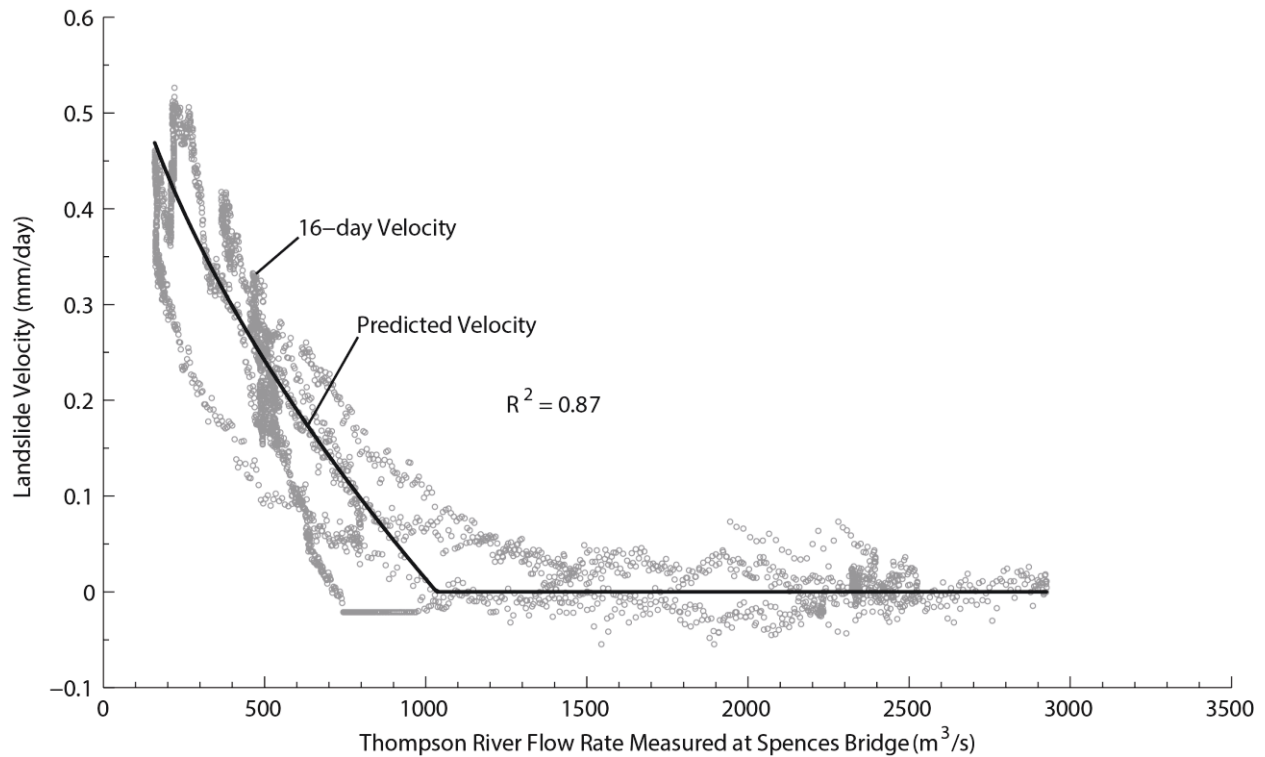
Figure 6-9 Trend of 16-day velocity with volumetric flow of the Thompson River as measure at Spences Bridge

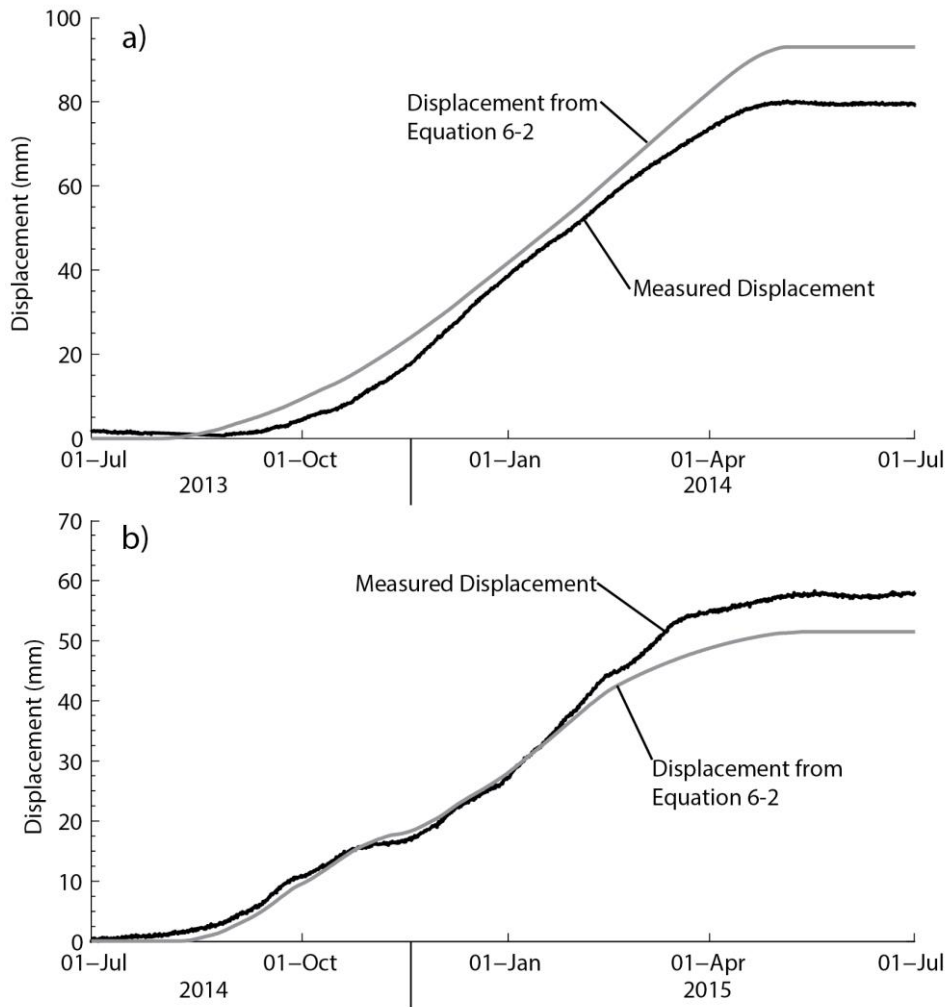
Figure 6-10 Displacements predicted based on river flow variation and the velocity trends presented in Figure 6-9 for the periods of July 1, 2013 to July 1, 2014 (a) and July 1, 2014 to July 1, 2015 (b)

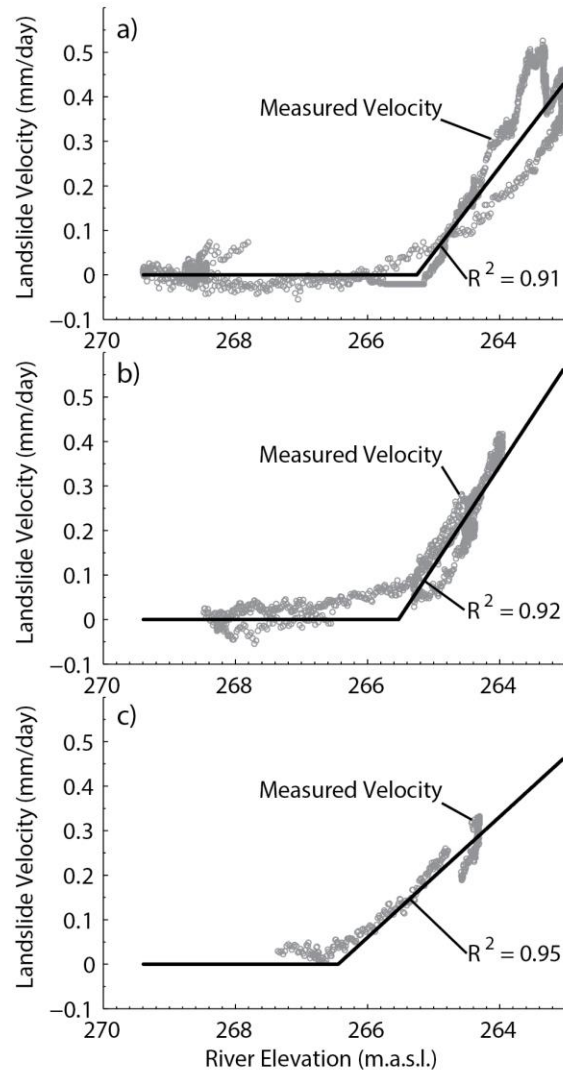
Figure 6-12 Landslide velocities for the movement seasons starting in 2013(a), 2014(b), and 2015(c) at the Ripley Landslide as a function of river elevation

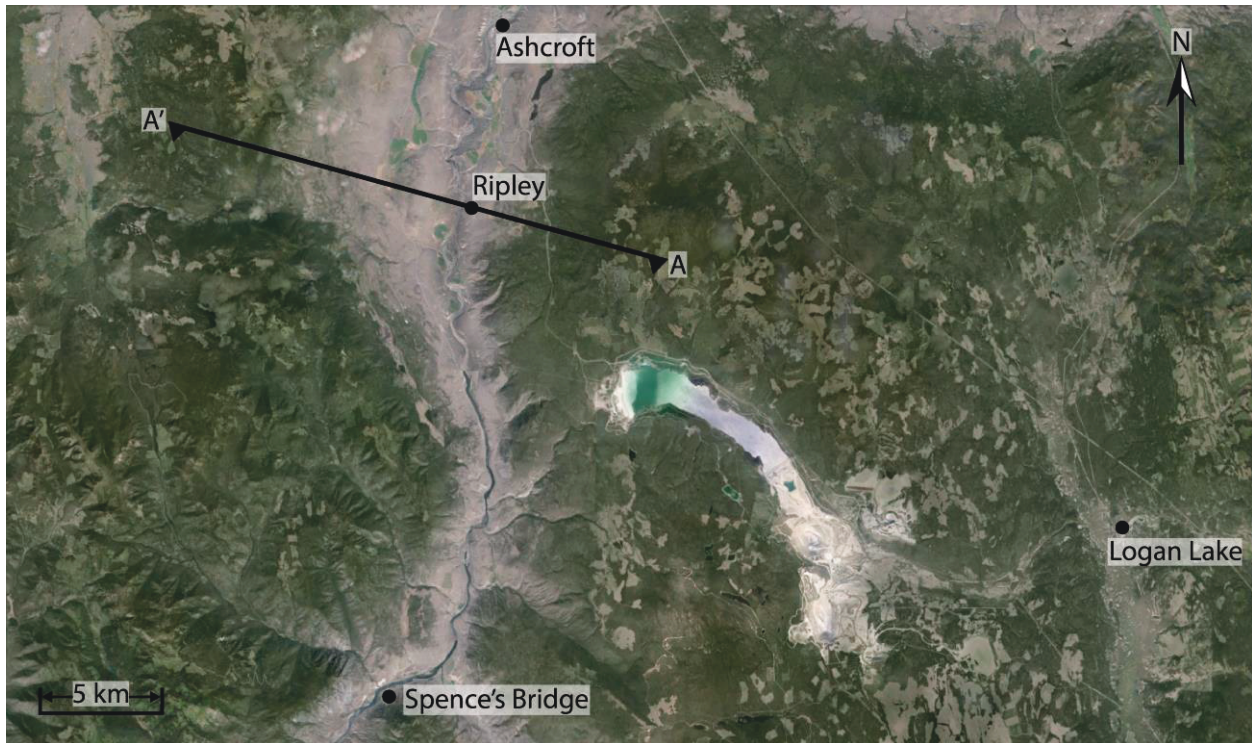
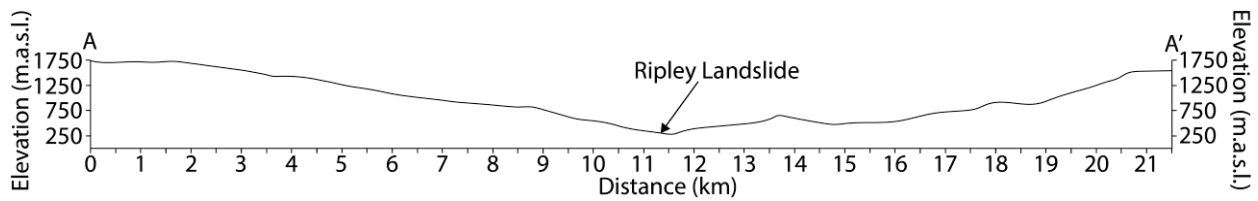
Figure 6-13 Regional map of the Thompson River valley and cross section A-A' centred at the Ripley Landslide (image and profile from Google Earth 2015)

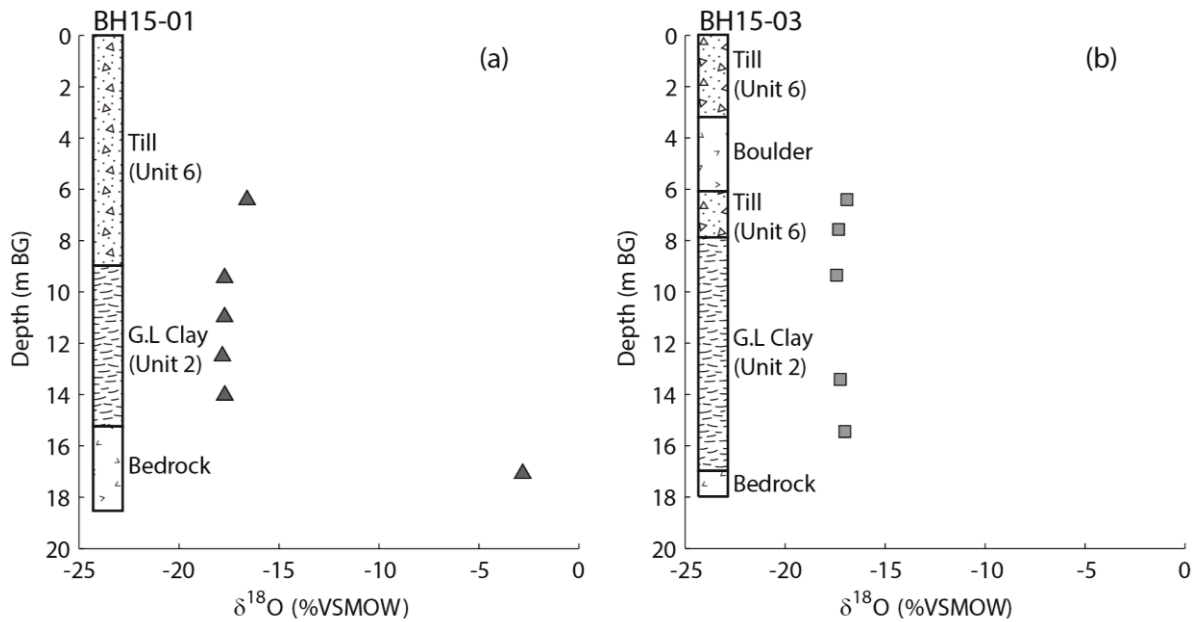
Figure 6-14 Isotope testing results with depth from BH15-01 (a) and BH15-03 (b) taken during the 2015 investigation of the Ripley Landslide (testing performed by Erin Schmeling)

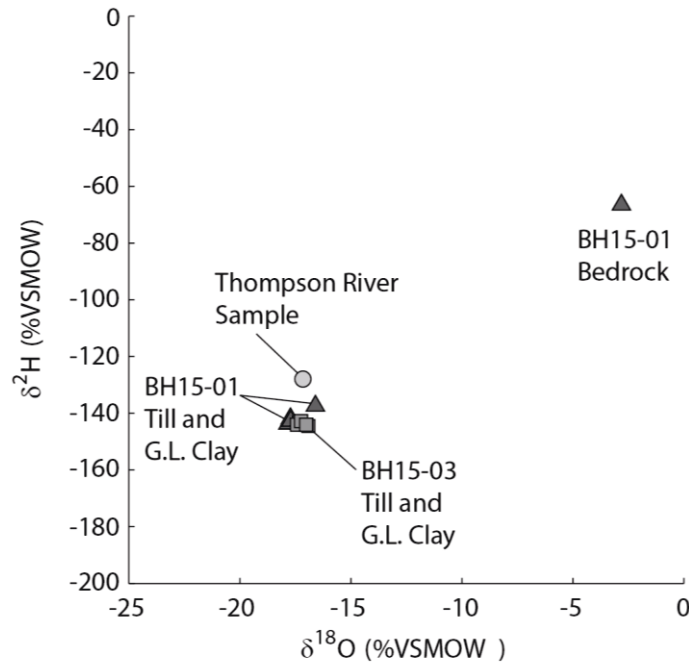
Figure 6-15 Co-isotope plot of testing results from the Ripley Landslide
(testing performed by Erin Schmeling)

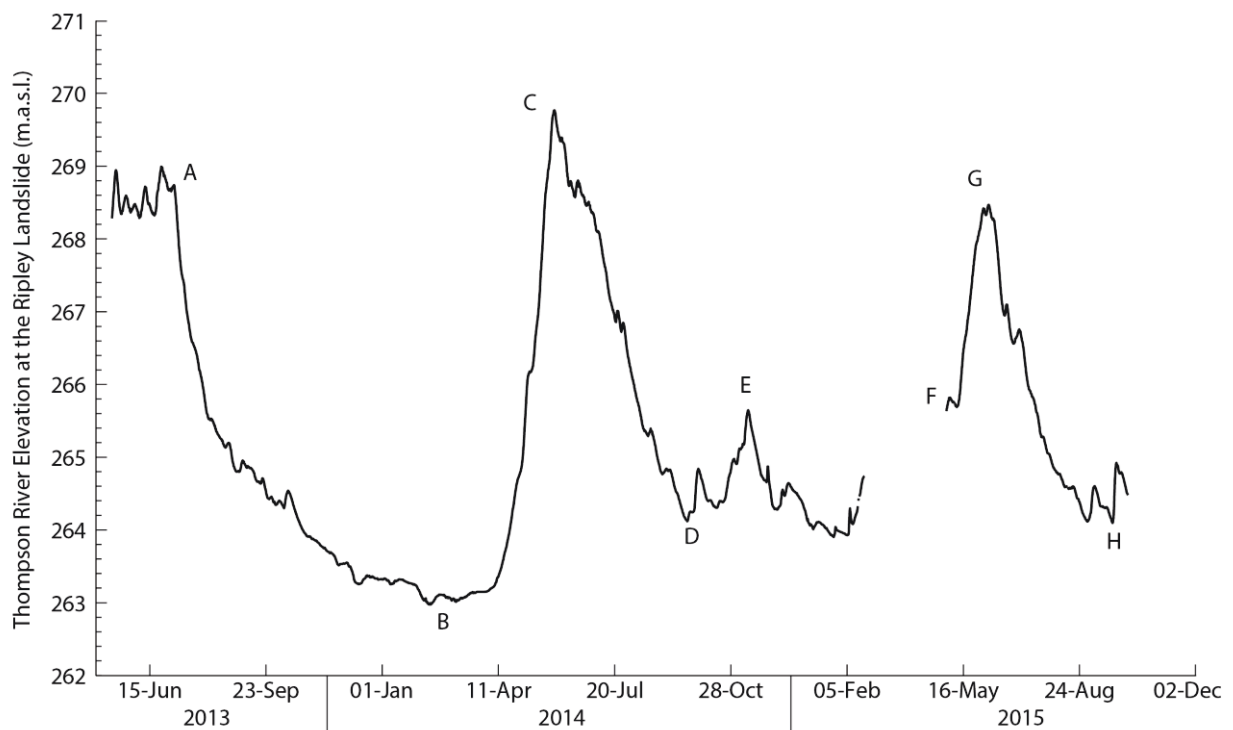
Figure 6-16 Seasonal variation of Thompson River elevation at the Ripley Landslide

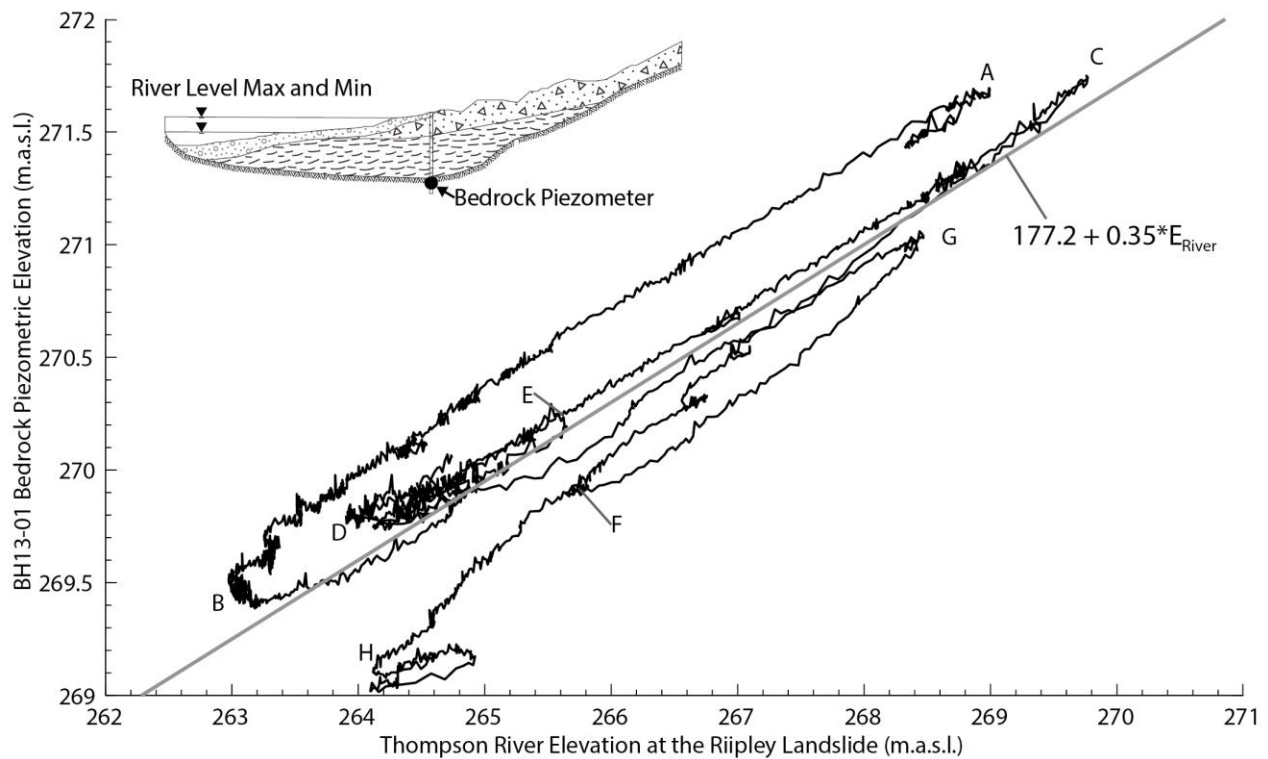
Figure 6-17 Variation of bedrock pressure as a function of river elevation

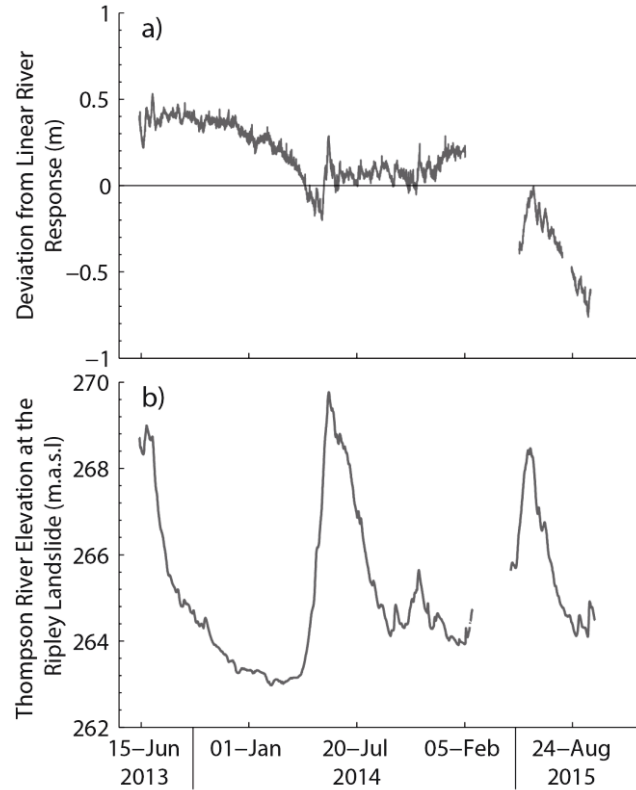
Figure 6-18 Deviation of bedrock pressures from linear river response over time as defined by Equation 6-3 (a) and Thompson River elevation adjacent to the Ripley Landslide with time (b)

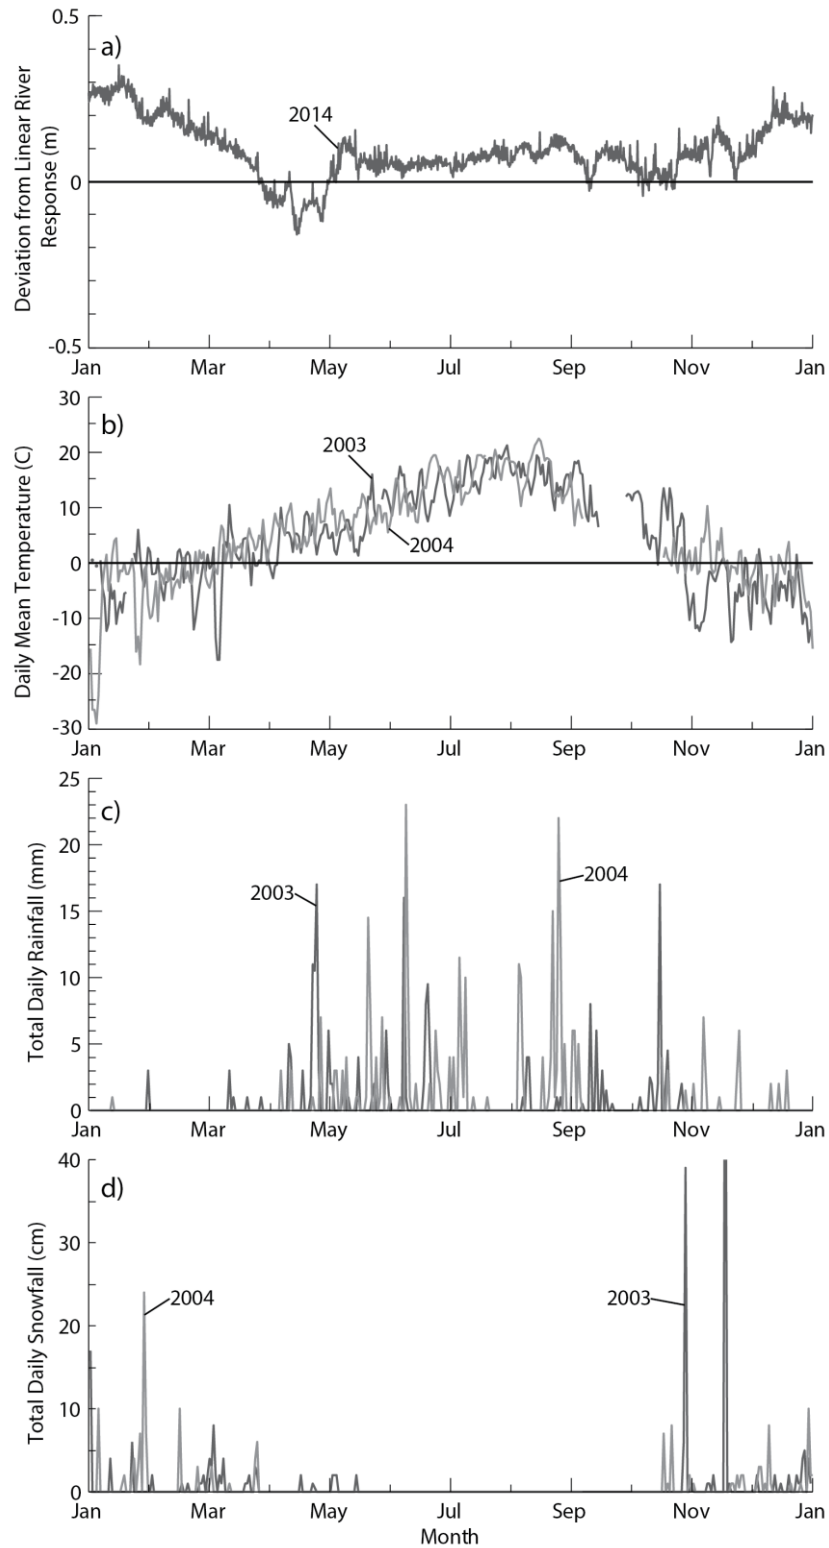
Figure 6-19 Non-linear pore pressures at the Ripley Landslide over time (a) and seasonal trends in temperature (b), rainfall (c), and snowfall (d) at Logan Lake
