NAME OF AUTHOR Allan M.R. MacRae
TITLE OF THESIS Case History of an Open Pit Coal Mine
 Slope Failure at Luscar, Alberta

CASE HISTORY OF AN
OPEN PIT COAL MINE
SLOPE FAILURE
AT LUSCAR, ALBERTA

This report describes the case history of a major open pit mine slope failure which occurred at Cardinal River Coals Ltd. pit 51-B-2 on November 10, 1979.

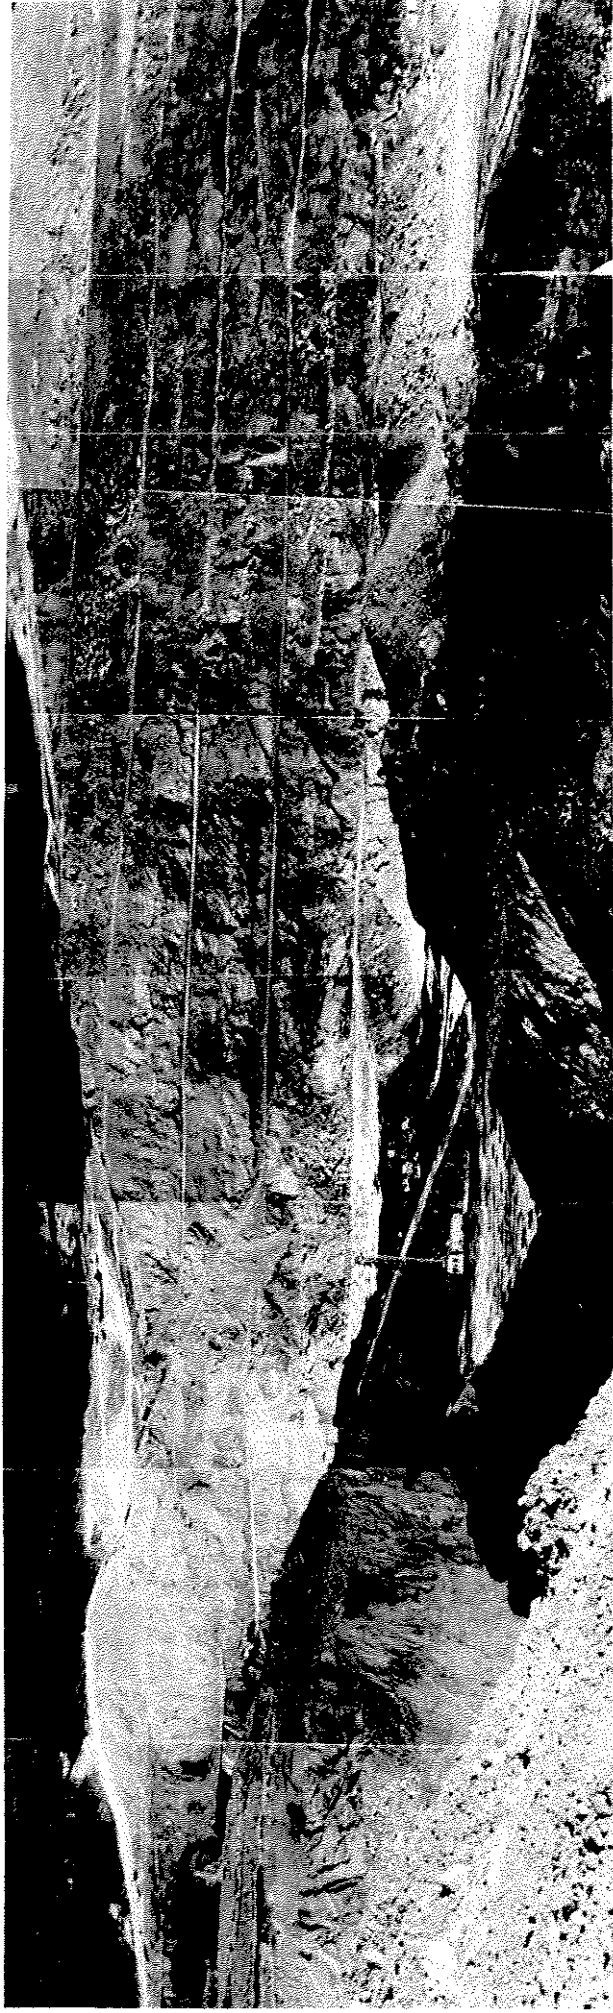
NORTH WALL

PLATE 1 - Pit 51-B-2 North and East Walls - Looking Northeast
Early Nov. 1979 - Before Failure

EAST WALL

Pit 51-B-2 is depicted in Figure A.4 and Plate 1.

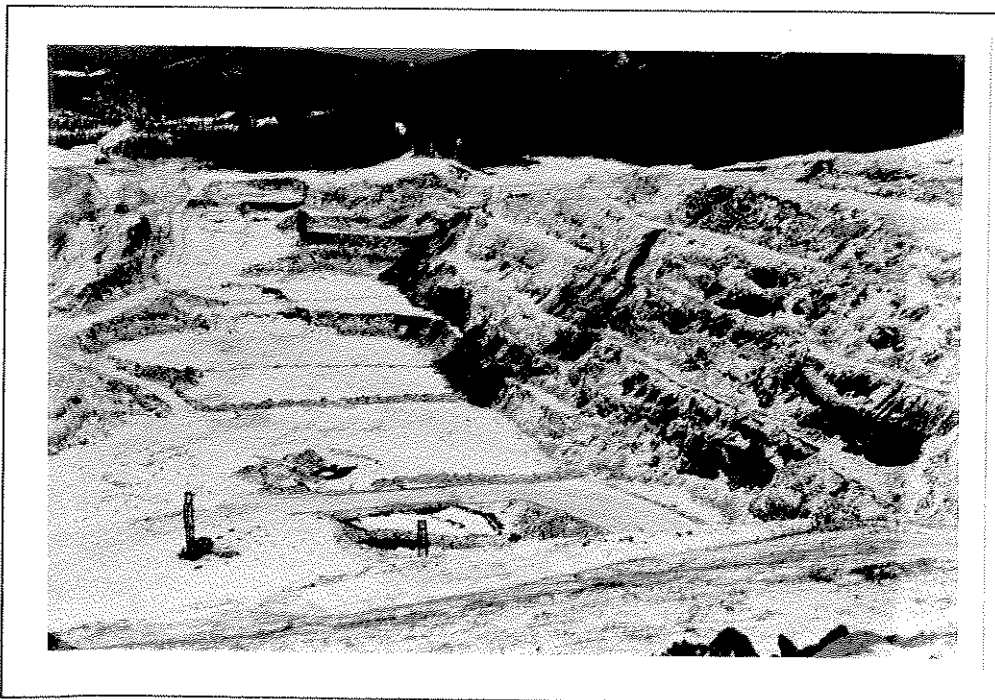
PLATE 3

North Wall Slope Failure - Looking Northwest
Approx. Nov. 12, 1979 - After Failure
NOTE: Observe Windrows on Pit Floor to Prevent
Access Below Failure, Plate 3

The November 10, 1979 slope failure occurred in the North Wall of Pit 51-B-2, as depicted in Figure A.4 and Plates 2 to 7.

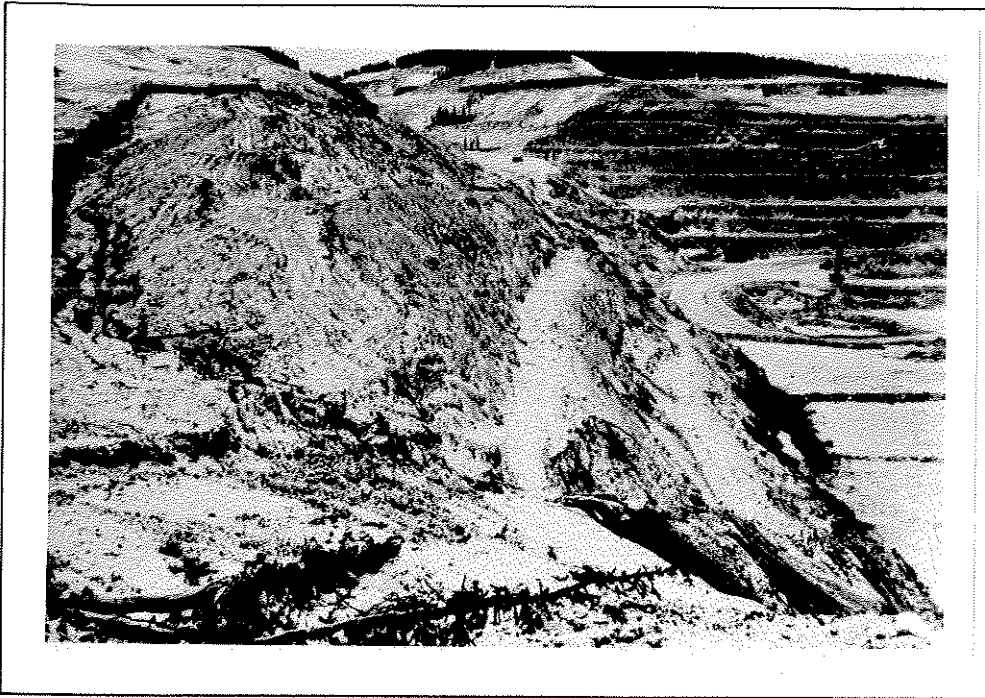
PLATE 4

North Wall Slope Failure - Looking East
Approx. Nov. 12, 1979 - After Failure

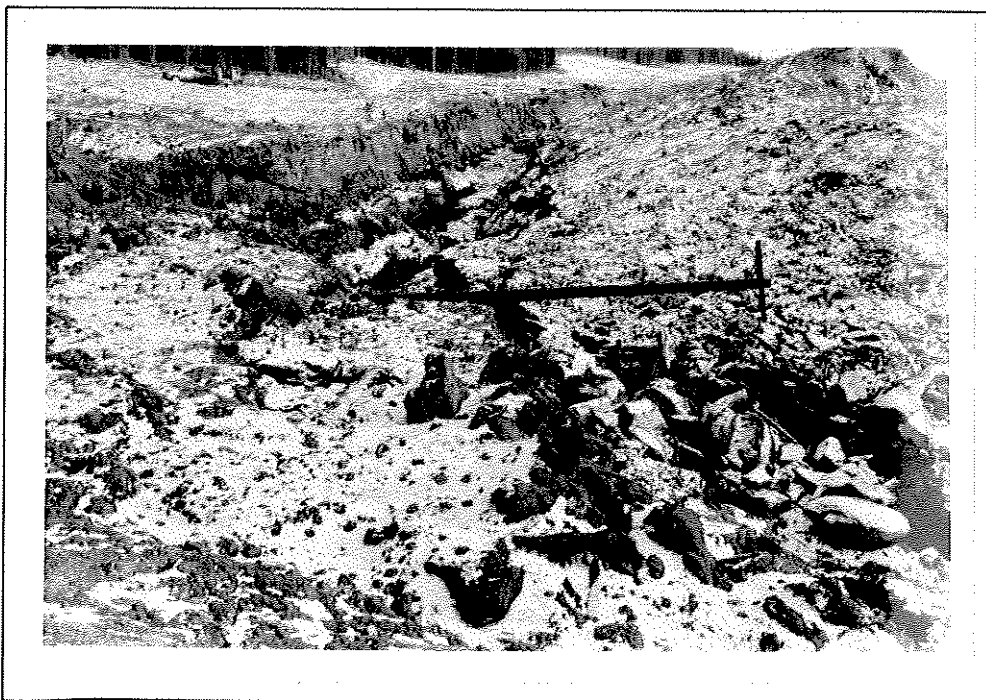
PLATE 5

North Wall Slope Failure - Close-Up of West
Limit Looking East
Approx. Nov. 12, 1979 - After Failure
NOTE: For Scale, Observe the Power Pole,
Foreground of Plates 4 & 5

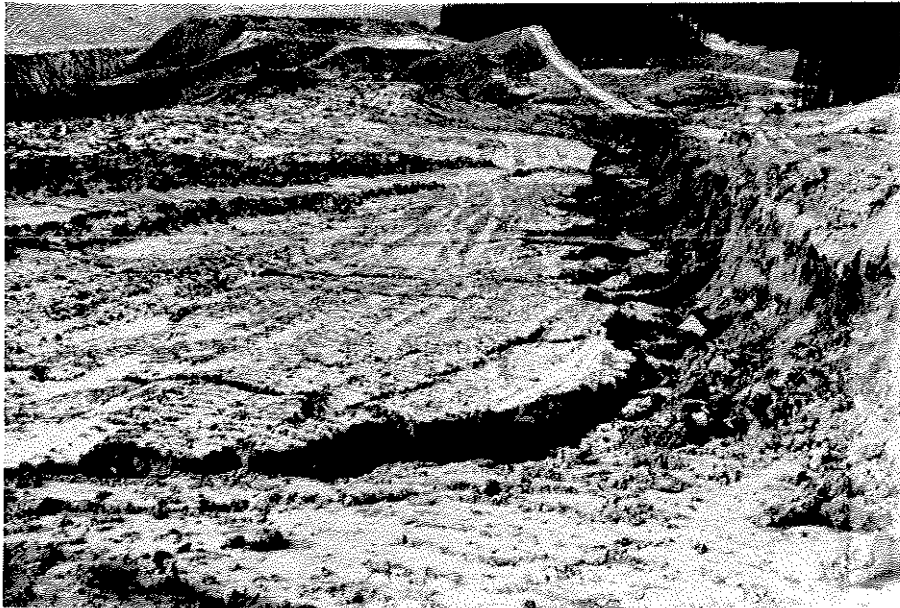
PLATE 6

**North Wall Slope Failure – Looking West
Approx. Nov. 12, 1979 – After Failure**
