NAME OF AUTHOR..... Kenneth George Taylor
TITLE OF THESIS..... Environmental Alteration and Natural
..... Revegetation at Discovery Mine,
..... Northwest Territories, Canada.
UNIVERSITY..... The University of Alberta
DEGREE FOR WHICH THESIS WAS PRESENTED..... M. Sc.
YEAR THIS DEGREE GRANTED..... 1976

ENVIRONMENTAL ALTERATION AND NATURAL REVEGETATION

AT DISCOVERY MINE, NORTHWEST TERRITORIES,

KENNETH GEORGE TAYLOR

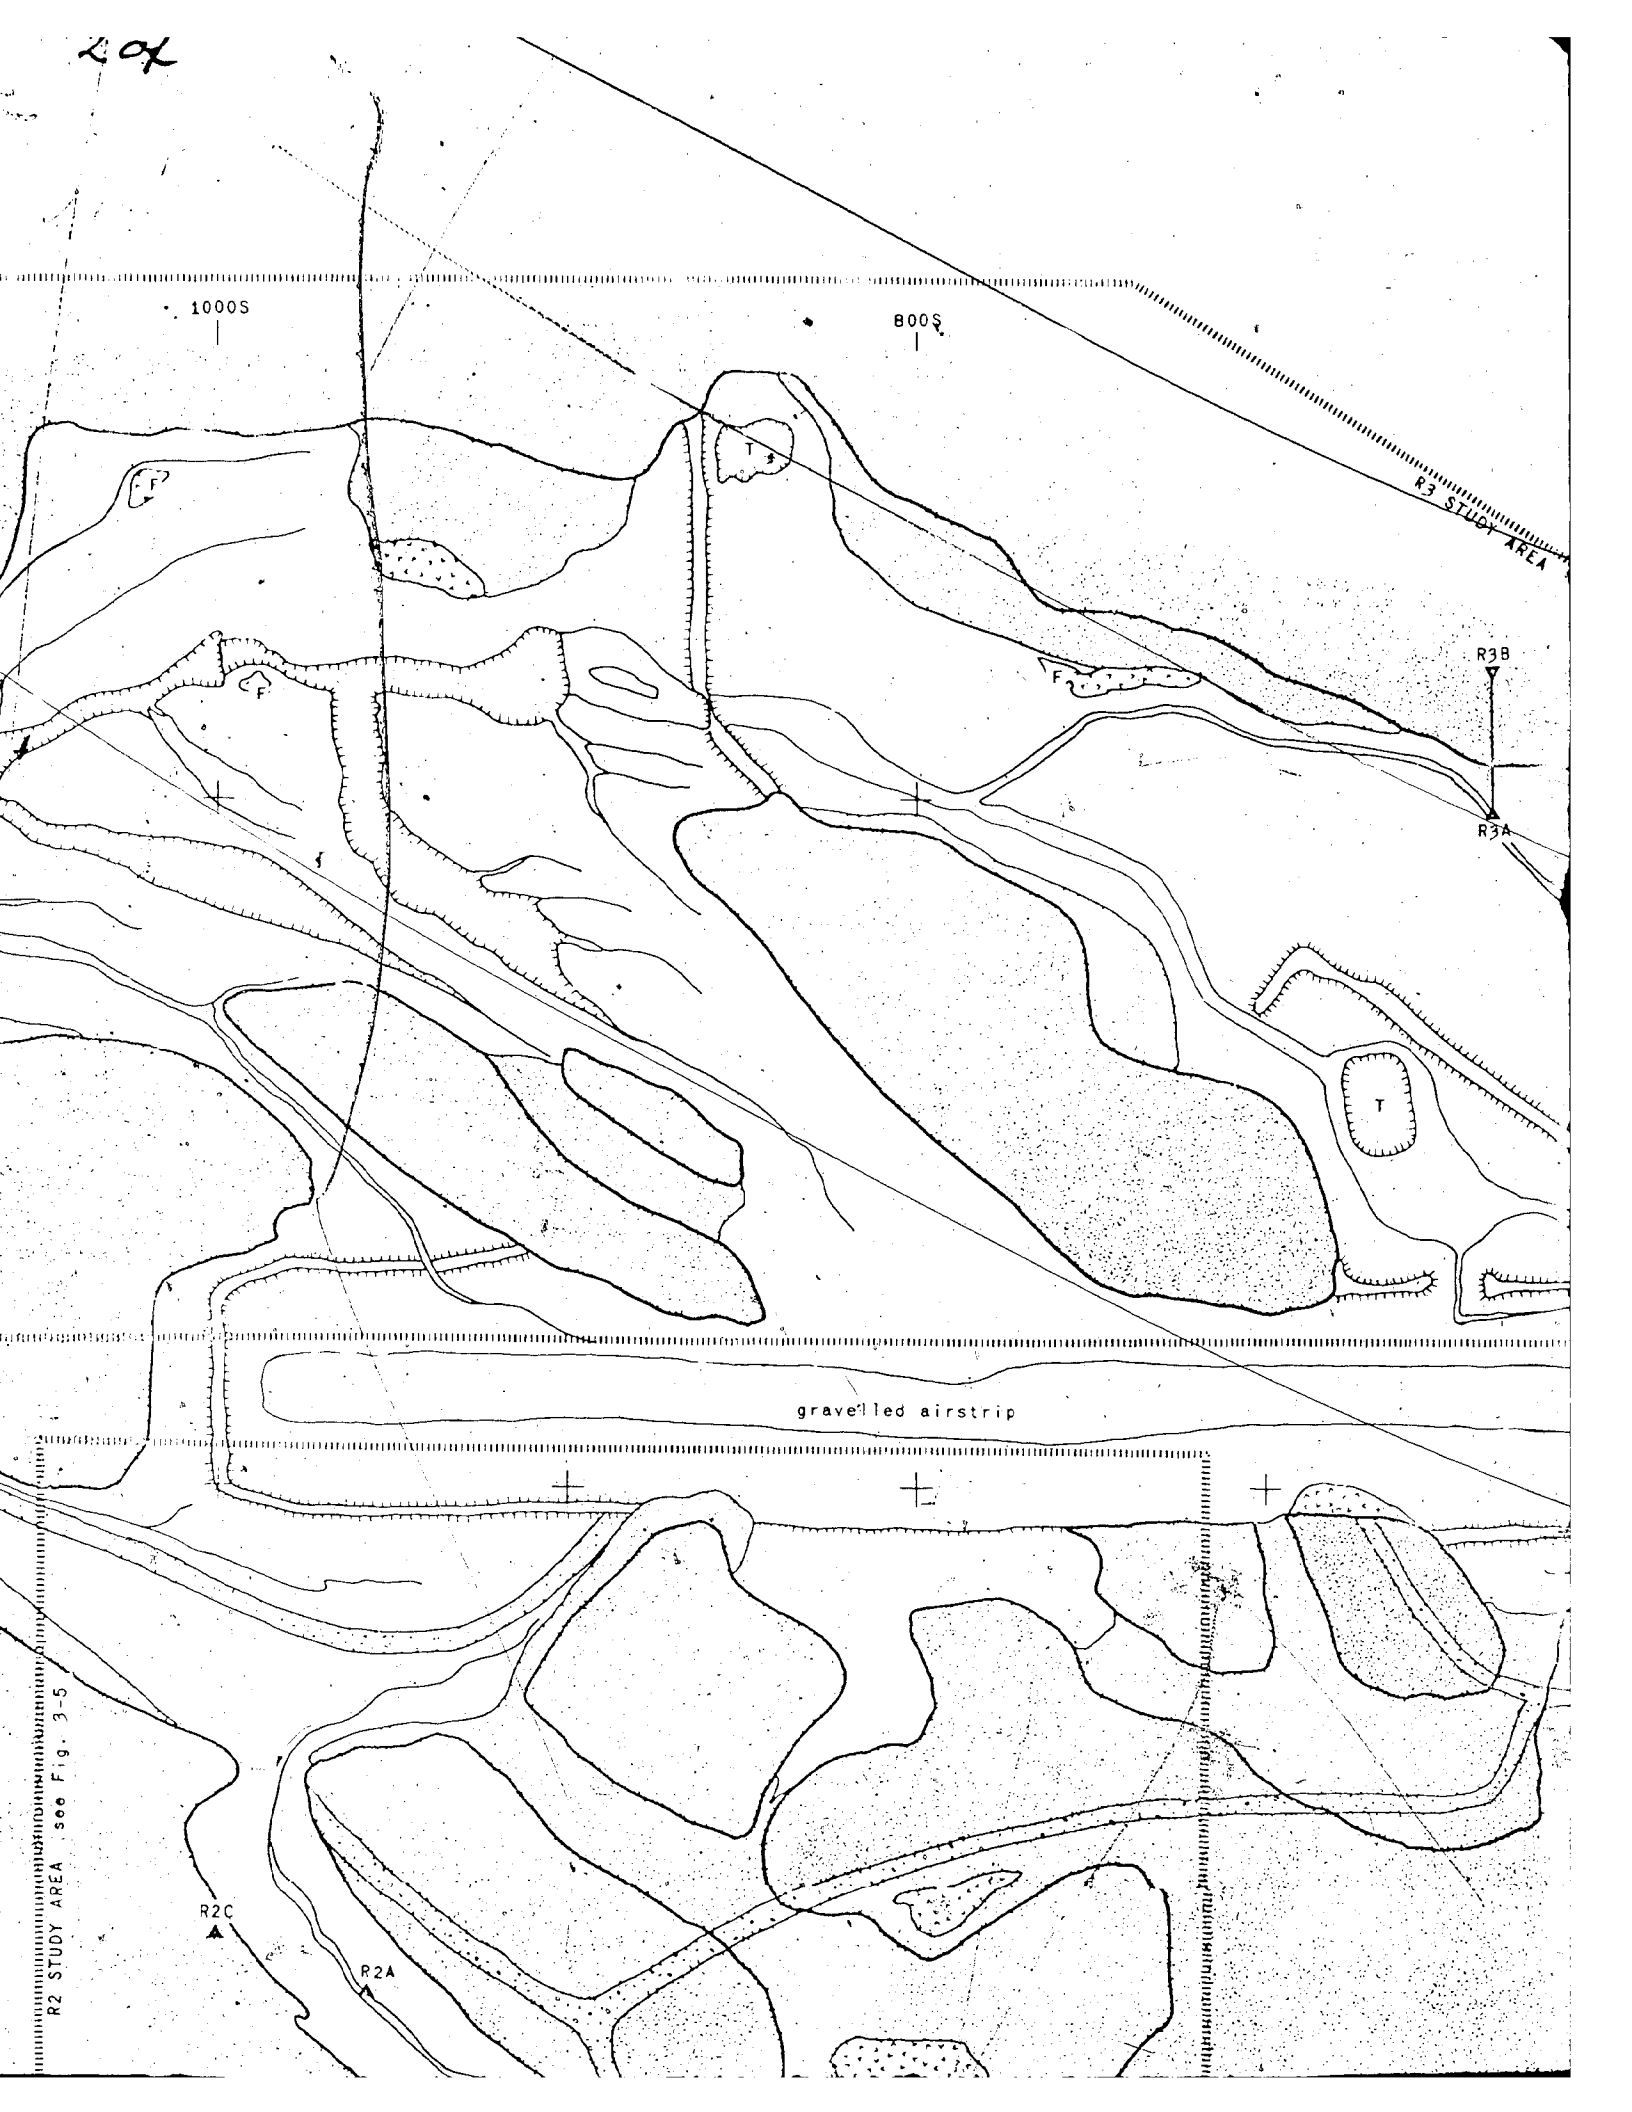
R3 STUDY AREA
(see Fig. 3-6)

R2 STUDY AREA see Fig. 3-5

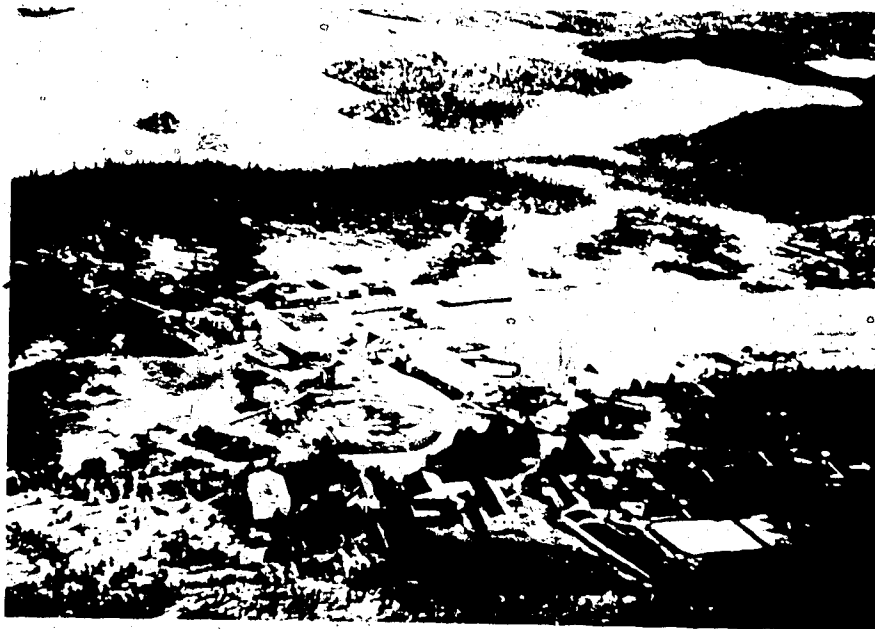
Plate 1-2. View of Discovery from the northwest. The mine shaft and mill facilities are located in the centre of the photo. Housing for staff is situated in the left background and the right foreground. 21 July 1971 - 12h30.

During the eighteen years in which the mine operated, a sizeable community was established (Plate 1-2). The isolation and self-containment of this industrial community made it unique in the north (Discovery Women's Institute 1968). At its maximum development the community was made up of more than 50 buildings. Included were bunk-houses capable of accommodating a total of over 100 men, plus thirty single family residences. A school, post office, commissary, dispensary, laundry, and a recreation complex including a theatre, library, curling rink and outdoor hockey rink completed the facilities.

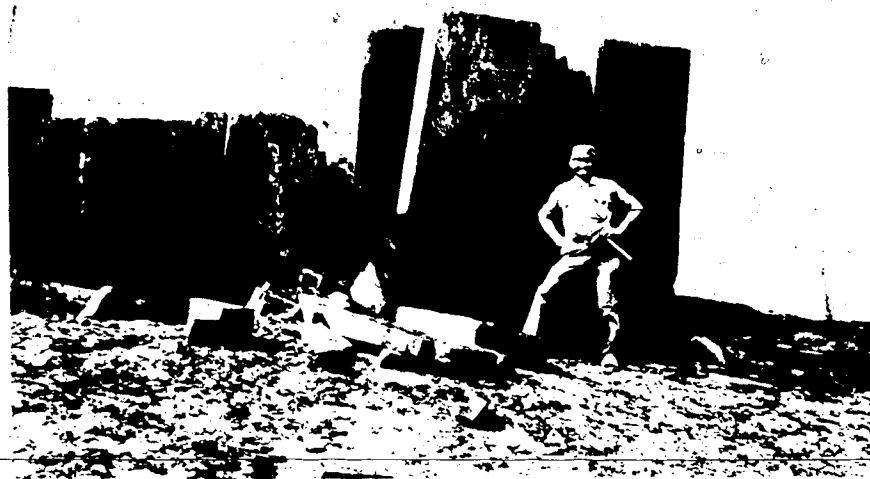
Plate 2-2. Frost-thrust slabs of bedrock, common in the vicinity of Discovery Nine, provide impressive evidence of frost action. The slabs are located at 500S-200E on the study grid. 15 July 1971 - 14h00.

An unusual feature of the area is the presence of huge frost-thrust blocks of bedrock, some of which are shown in Plate 2-2. These blocks may reach dimensions of 10 to 20 m, depending on the jointing planes of the bedrock. Many of the crevices left by the thrust blocks make excellent natural wells and indicate the presence, in some locations, of a subsurface drainage system.

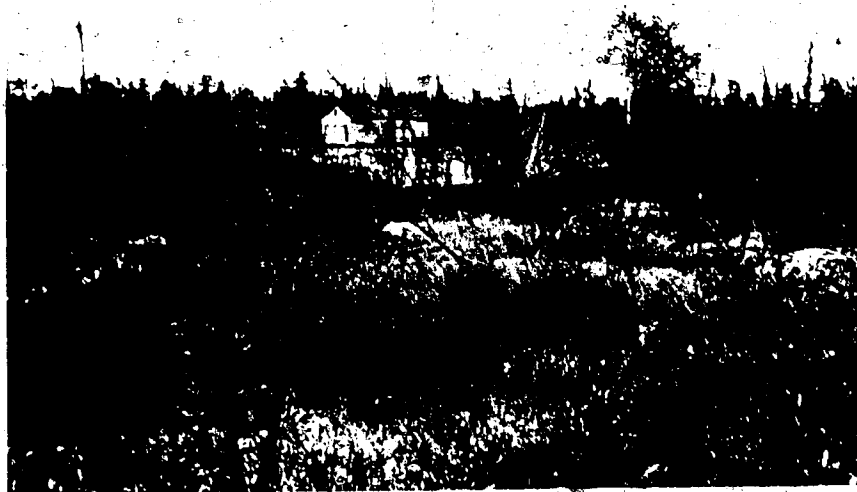
Plate 5-3. View north from 470S-190E showing a small thermokarst depression in which *Equisetum arvense*, *B. sylvaticum*, and *Eriophorum angustifolium* are now growing. The floor of the depression, which consists of tailings, now lies 1 m below the level of the 'Lichen hummock' bog topography which originally existed and still occurs on adjacent land. 15 July 1971 - 14h00.

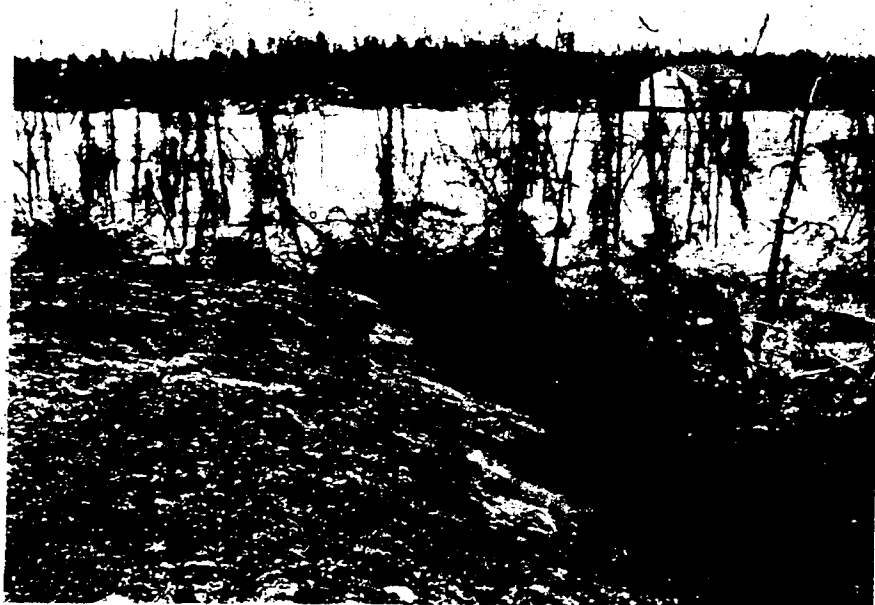
Plate 4-2. A hedge-like growth, dominated by *Betula papyrifera* and *Alnus crispa*, occurs along the tailings/bedrock interface at 475S-130E. 15 July 1971 - 14h15.

Plate 4-1 illustrates the barrenness of much of the study area. Plant growth occurs only along the margins of the tailings deposits. Plate 4-2 illustrates one such situation. In this instance plant growth is taking place along a tailings-bedrock interface which forms the western boundary of a depression centered near 470S-142E. On the left of the photo, the highest level of tailings or effluent is marked by the absence of lichens. Along the interface a number of species grow in a hedge-like manner. *Betula papyrifera*, *Alnus crispa*, and *Salix bebbiana* are the dominant species, but *Betula glandulosa*, *Salix arbusculoides*, and *S. glauca* are also present. The herb layer of the depression in the nearby tailings consists of *Equisetum arvense* and *E. sylvaticum*. In the lowest and dampest section *Eriophorum angustifolium* dominates, although *Equisetum arvense* is also present.

from the slope above. Of course such runoff need not stop at the bedrock-tailings interface, but may also reach depressions located near the edge of the tailings deposits. The section of the tailings discussed above is bordered on three sides by inward-sloping bedrock. The depression mentioned supports several plant species, whereas more centrally located depressions host little or no vegetation. The availability of runoff-borne nutrients may explain this difference in plant growth.

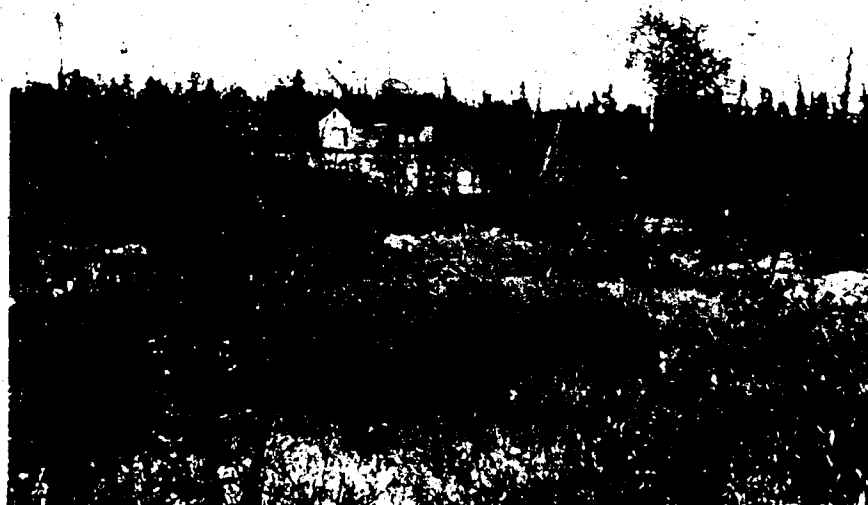
Plate 4-3. Revegetation in the vicinity of 470S-190E takes the form of small patches of *Salix arbusculoides*, *S. bebbiana* and *S. glauca* with a herb layer of *Equisetum arvense*, *E. sylvaticum*, *Eriophorum angustifolium*, and *Carex aquatilis*. 15 July 1971 - 14h00.

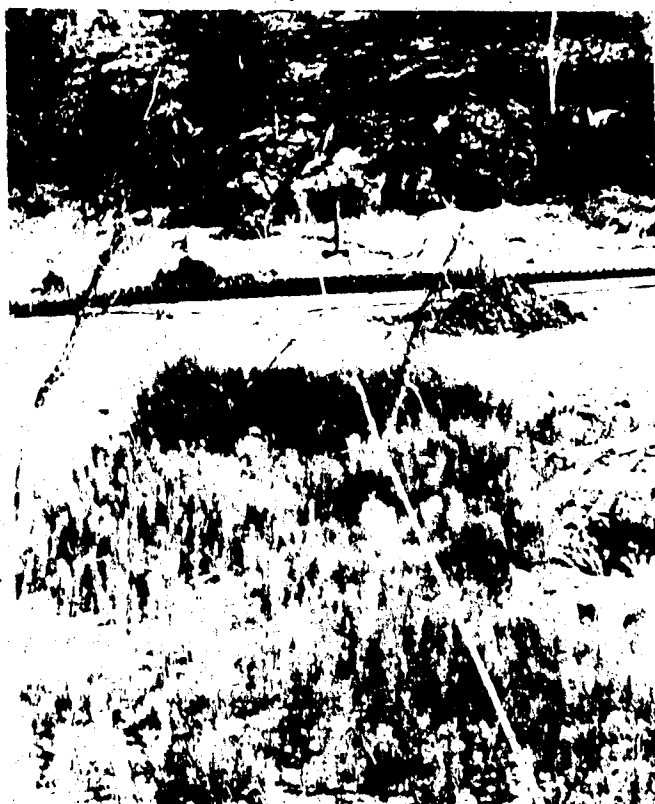
Plate 4-6. The southern end of transect R4AB as viewed from 0+10 m on the transect. Note the tailings disposal pipeline, a wire-bound wooden stave pipe in use until mine closure. Vigorous colonization of *Equisetum arvense* is evident in the foreground. 10 July 1971 - 11h00.
