**APPLICATION OF CFRP LAMINATES IN THE RETROFIT  
OF MASONRY DEEP BEAMS**

Zhangcheng Hao

**MASTER OF SCIENCE**

**Structural Engineering**

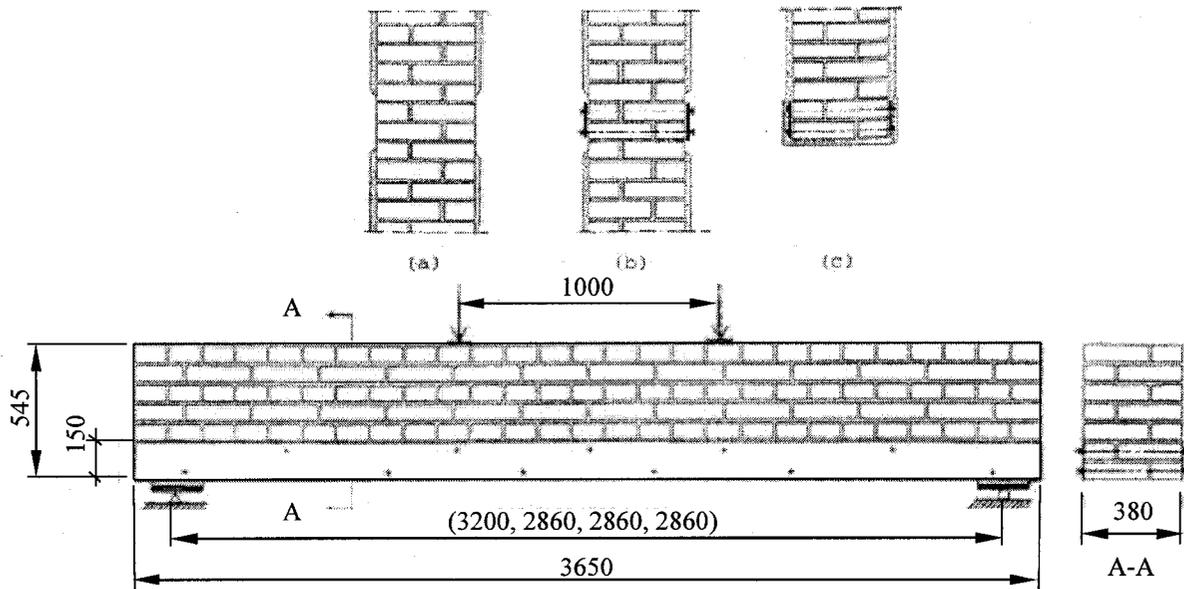
**Figure 2-1 Sketch of the Testing Arrangement in the Laboratory Experiments (After Magnusson, 1984)**

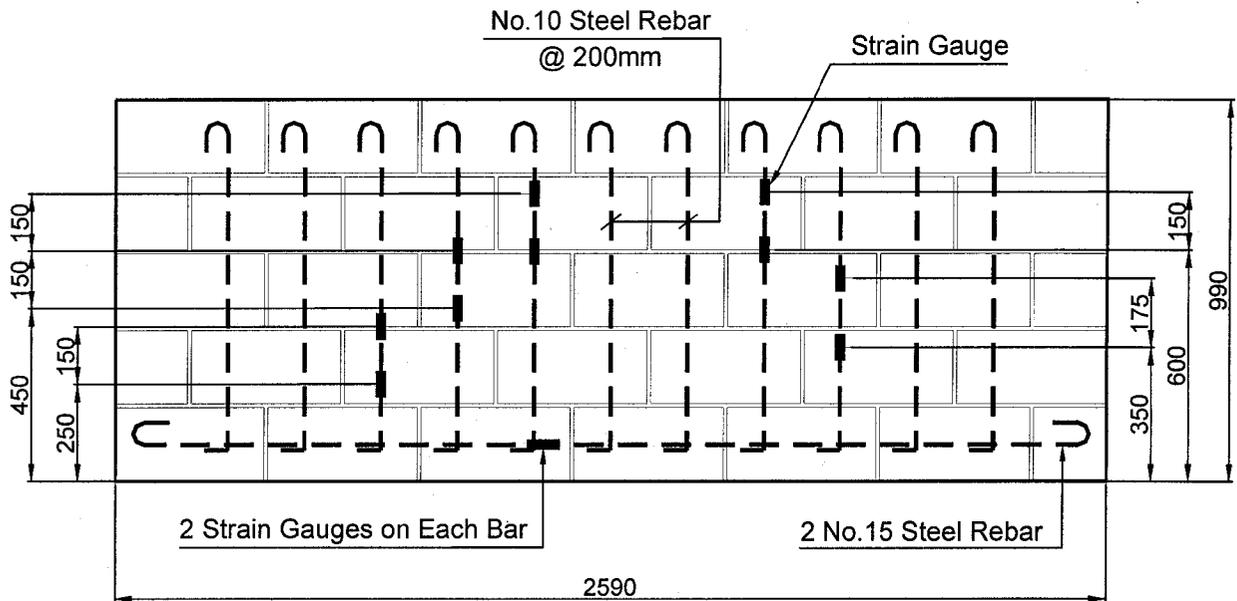
**Figure 3-5 Detail of Beam 3**

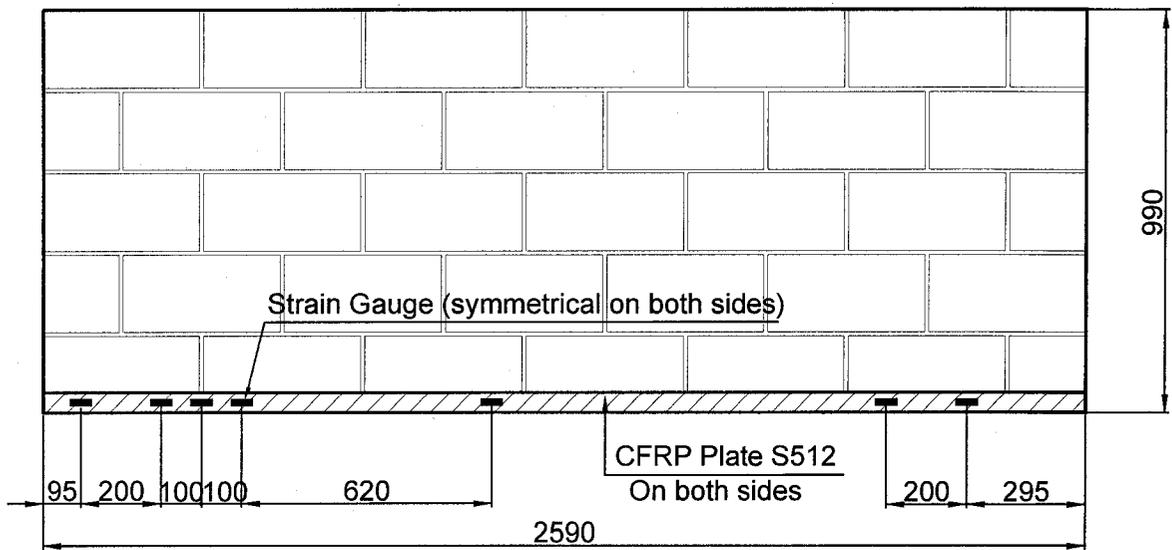
**Figure 3-7 Detail of Beams 5 and 6**

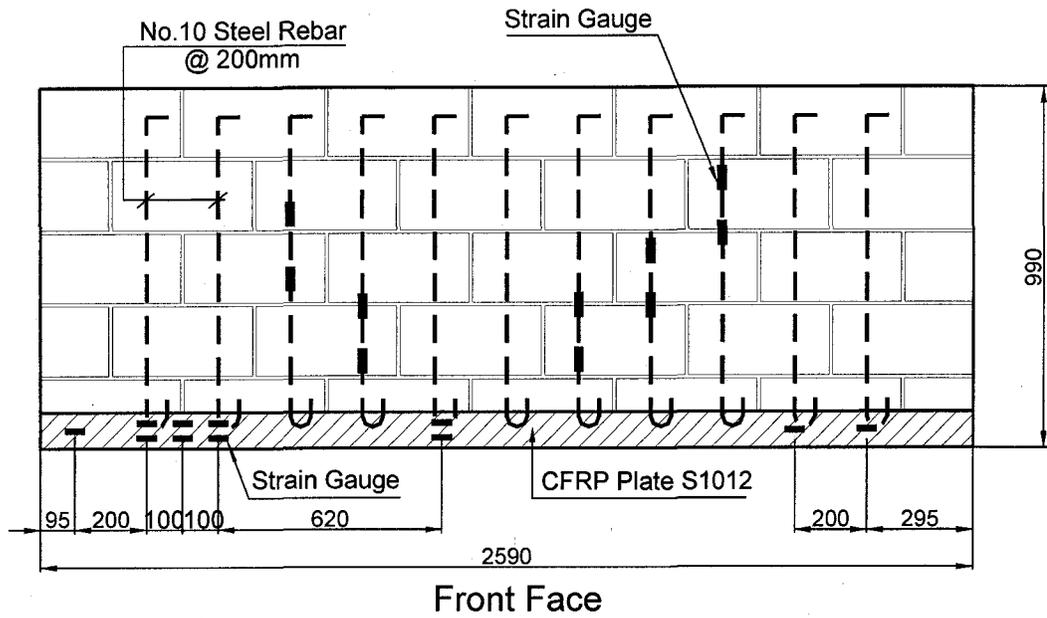
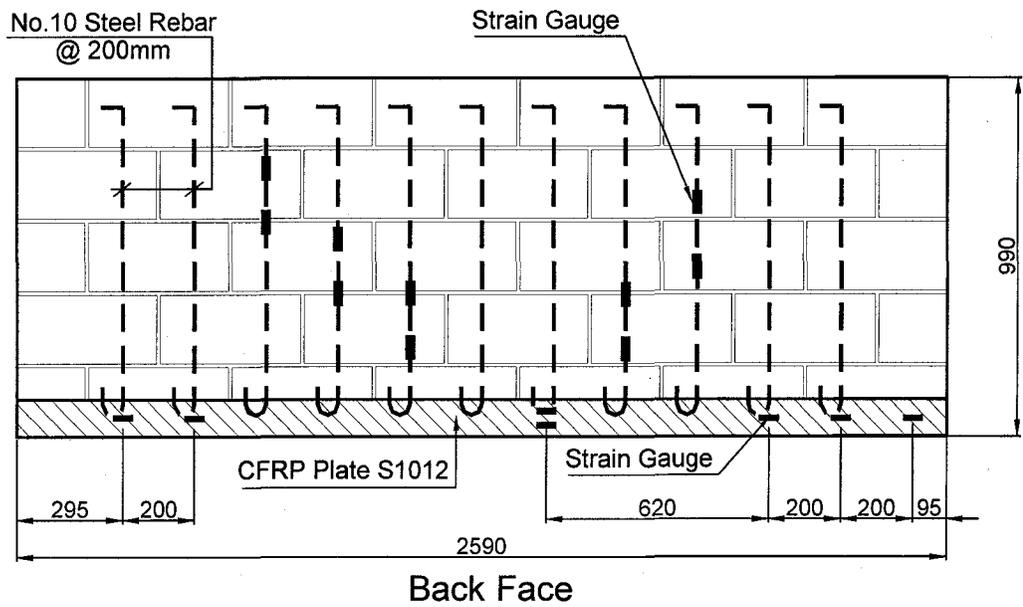
(The layout of strain gauges on the steel reinforcement was same as that in specimen 3)

**Figure 3-8 Detail of Beam 7**

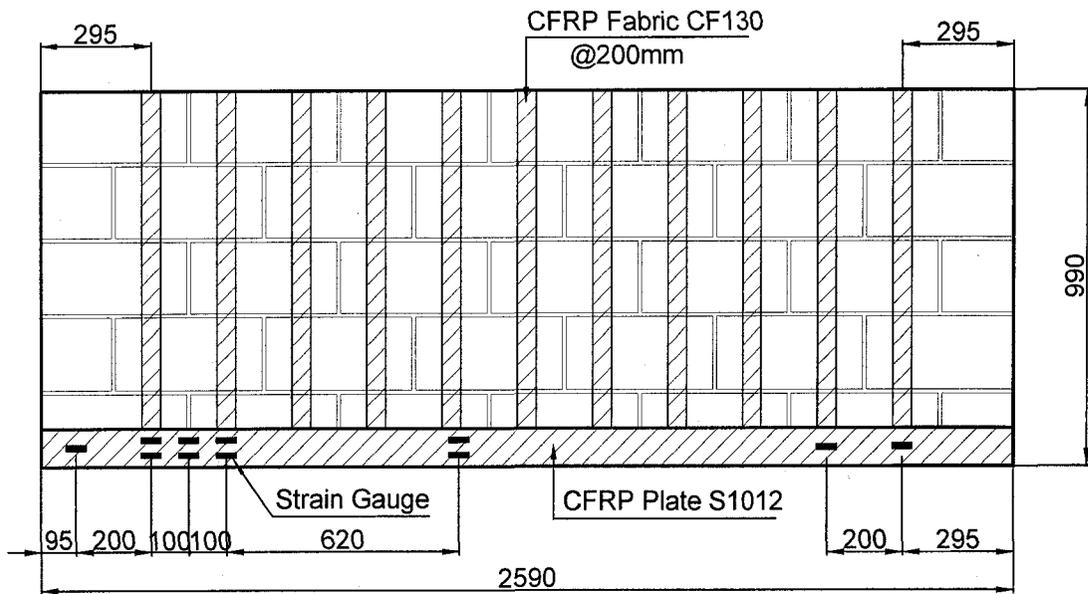
Figure 3-9 Detail of Beam 8

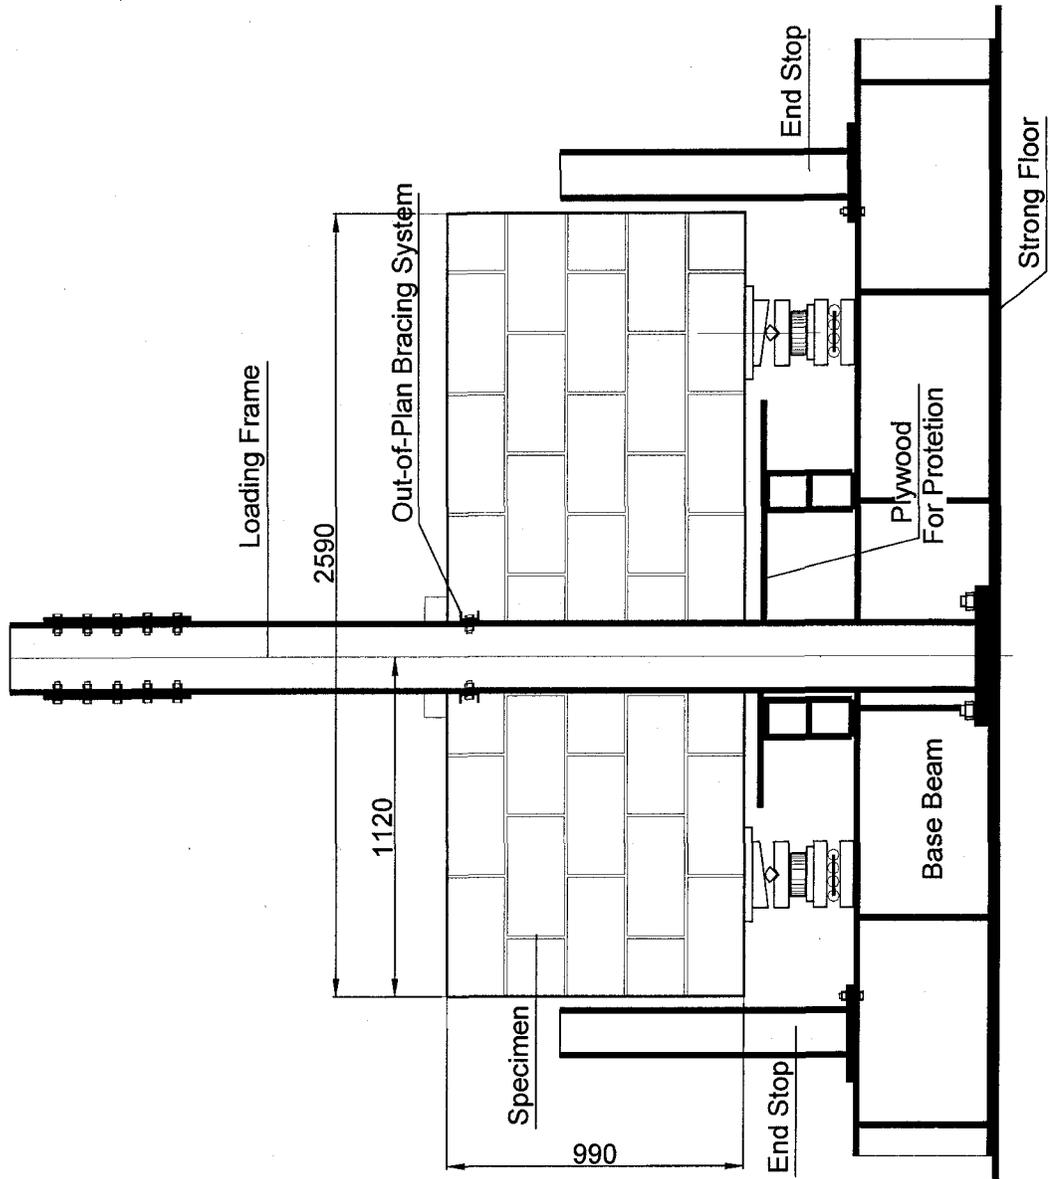
**Figure 3-10 Test Set-up**

Since masonry structures without steel reinforcement possess little ductility under heavy loading, most of the failure modes were expected to be brittle and catastrophic. In order to avoid any harm to operators and any damage to the instrumentation, some temporary protection arrangements were employed. Two stubbed steel columns were fixed at both ends of the specimen at the top of the strong base beam, and a 30 mm space between the stubbed column and each end of the specimen was left to allow the ends of the specimen to move outwards without confinement during the test. In addition, a piece of plywood was placed underneath the specimen and a 60 mm gap between the plywood and the bottom of the specimen was left to allow for flexural deformation of the specimen. These details are shown in Figure 3-10.

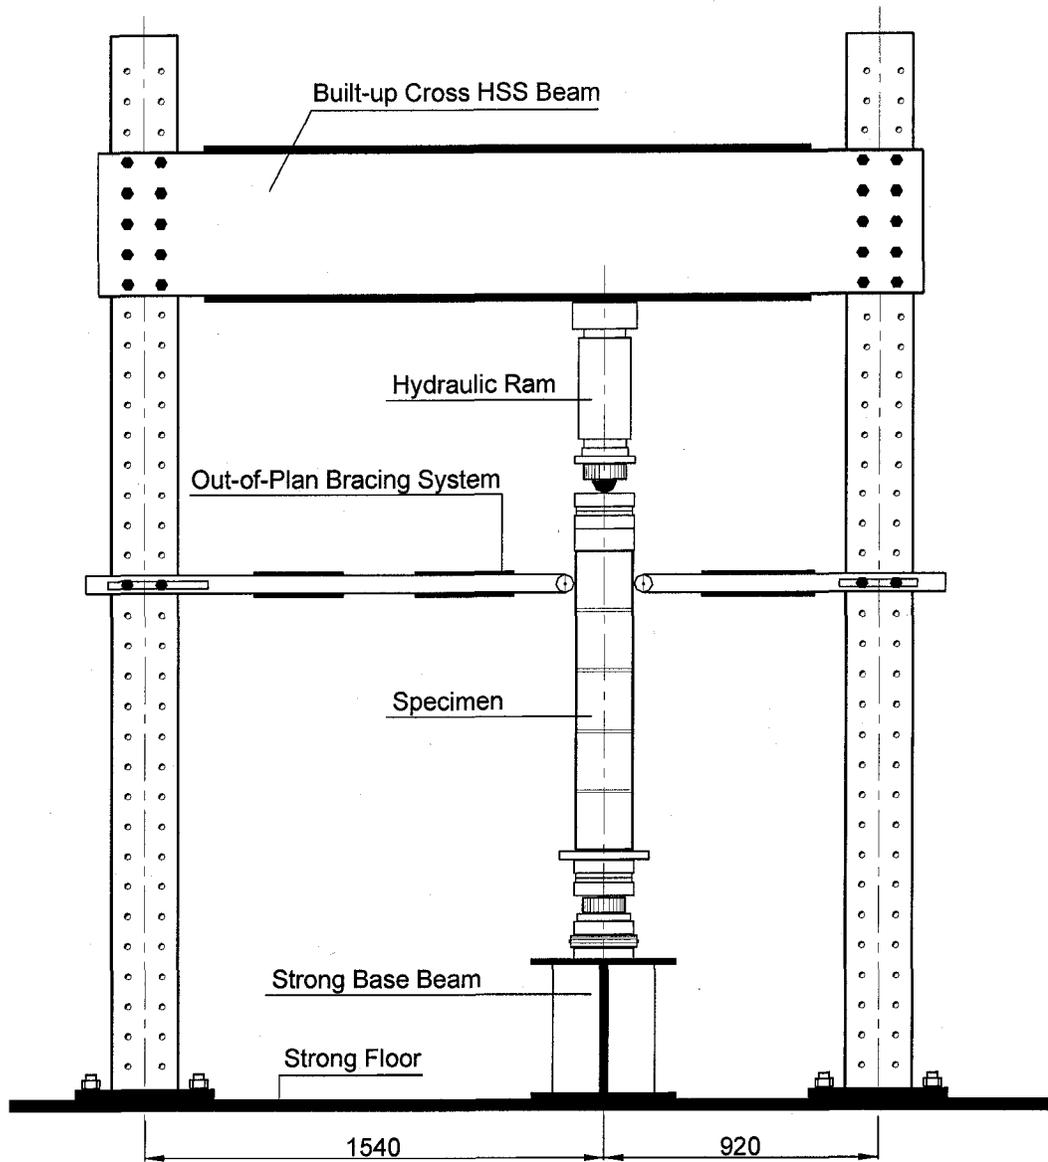
**Figure 3-11 Side View of Test Set-up**

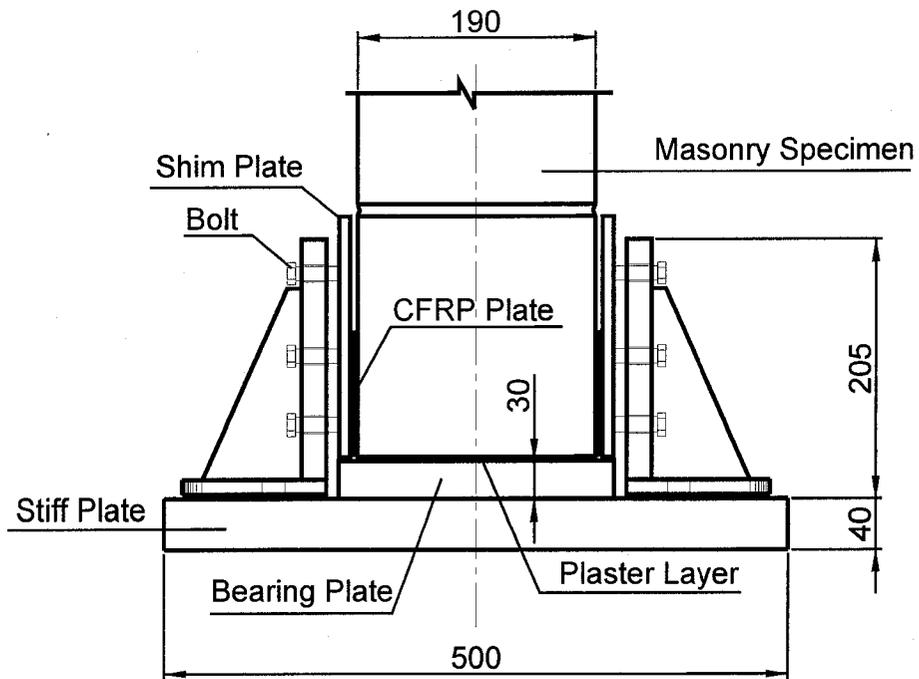
**Figure 3-12 Anchorage System for CFRP**

Premature failure often happens due to debonding between CFRP laminates and the surface of the rehabilitated structure. Therefore, in this study, an anchorage system was introduced to avoid premature debonding at the support regions, as shown in Figure 3-12. A base steel plate with two vertical steel plates formed a “U-Shape” scheme. Five holes were threaded on each vertical plate to place the bolts, which were then used to squeeze a half-inch thick steel plate that could push the CFRP plate against the masonry wall. This was intended to avoid or other delay the debonding. Again, a layer of plaster was applied between the steel and CFRP plates to obtain a uniform contact surface. Image 3-10 shows the actual anchorage system used during the test.

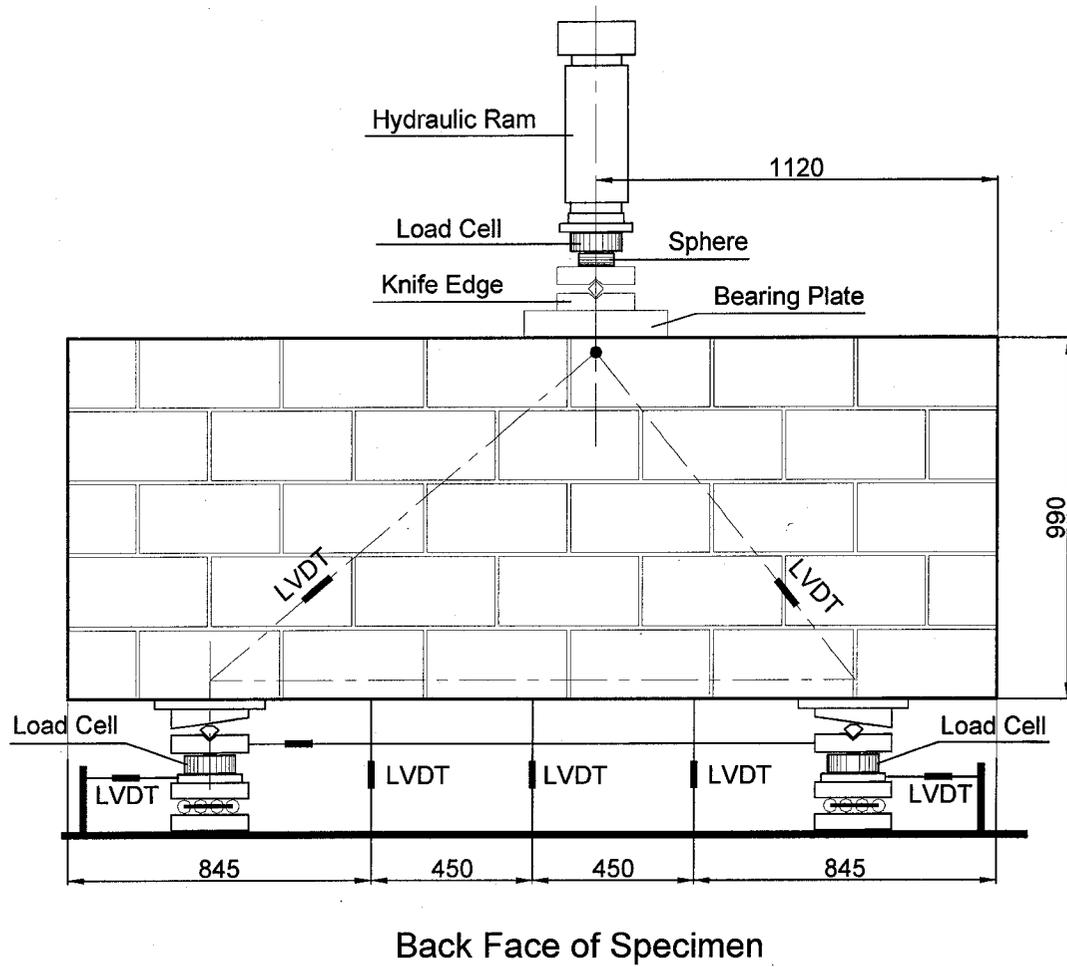
**Figure 3-13 The Layout of LVDTs and Load Cells**

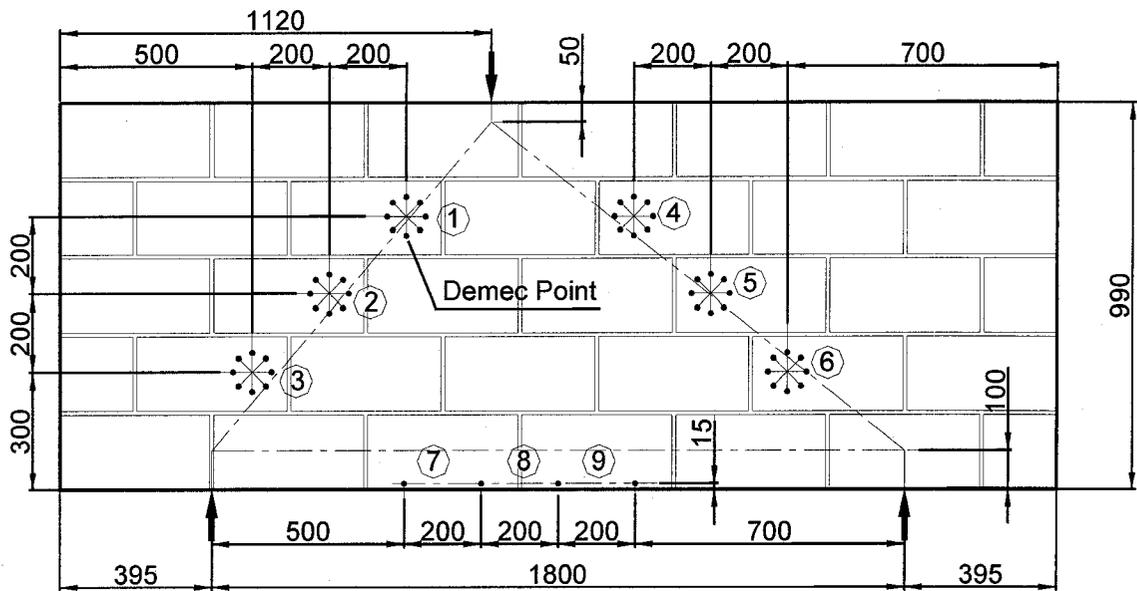
**Figure 3-14 The Layout of Demec Gauge Points**

Strain gauges are not ideal for measuring the strain on the surface of masonry specimen since masonry is a kind of brittle material and it is hard to predict the propagation of masonry cracks. Moreover, the coarse surface of masonry structures is not suitable for mounting strain gauges. Thus, a series of Demec gauges was used to monitor the strain distribution of the masonry specimens. Two types of Demec gauges were used: 50mm Demec gauge and 200 mm Demec gauge. The 50 mm Demec gauge points were arranged in a shape of a rosette along the diagonal struts to obtain the principal strain. The 200 mm Demec gauge points were installed onto the face shells of the bottom layer of the specimen at mid-span, and some of them were mounted onto the surface of CFRP plates and fabric strips. As one division represents a strain of  $2.5 \times 10^{-5}$  and  $0.81 \times 10^{-5}$  for 50 mm gauge length and 200 mm gauge length, respectively, it was possible to evaluate the strain during a test. Figure 3-14 shows the arrangement of Demec points in detail, where the Demec gauge locations were marked from 1 to 9.

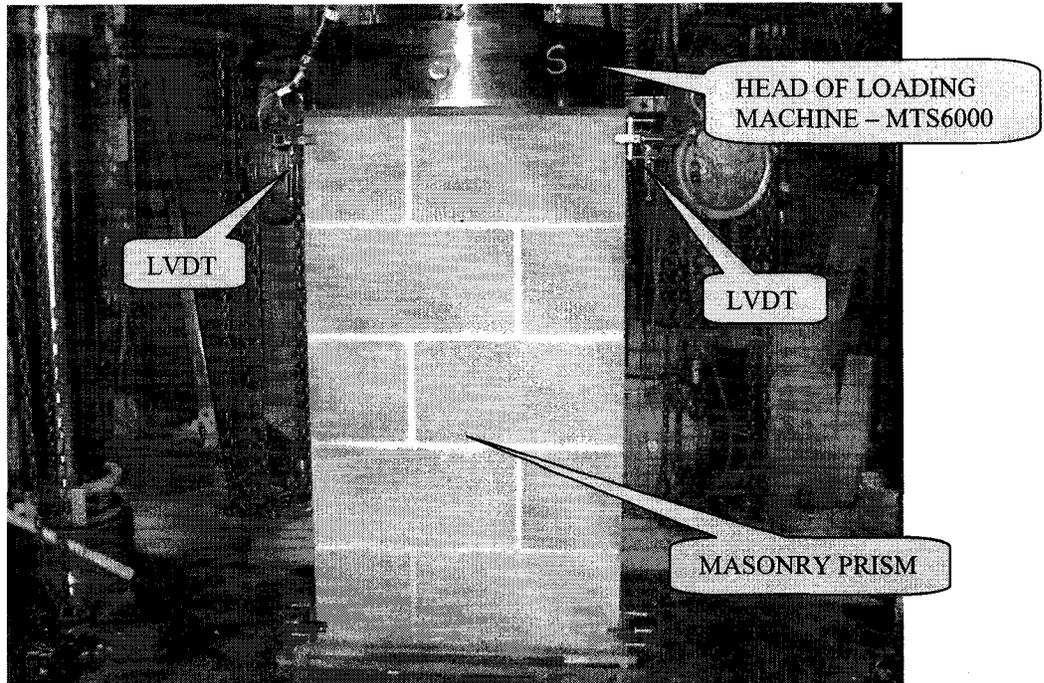
**Image 3-3 Test set-up for Grouted Masonry Prism**

The reason for this was the wedging action of the grouted cores. Image 3-3 and Image 3-4 show the test set-up and the typical failure mode of grouted masonry prisms, respectively.

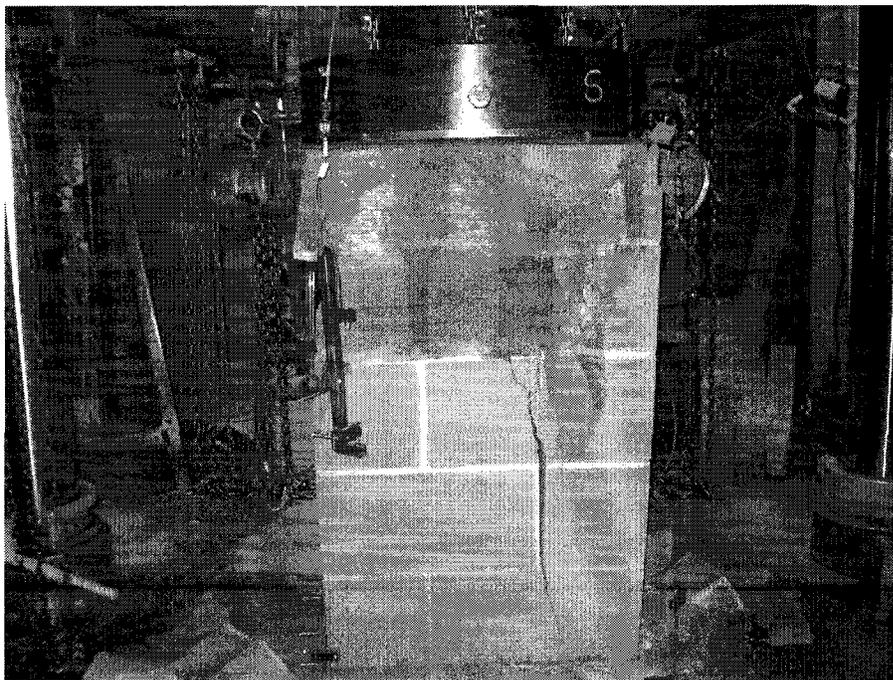
**Image 3-4 Typical Failure Mode of Grouted Masonry Prisms**

The age of the masonry prisms at the time of testing was 85 days, which is longer than 28 days recommended by ASTM C1314. The typical failure mode of masonry prisms was as follows: the face-shells of masonry blocks in the top two courses spalled away from the grouted cores and vertical cracks were formed at webs and face-shells of the prisms.

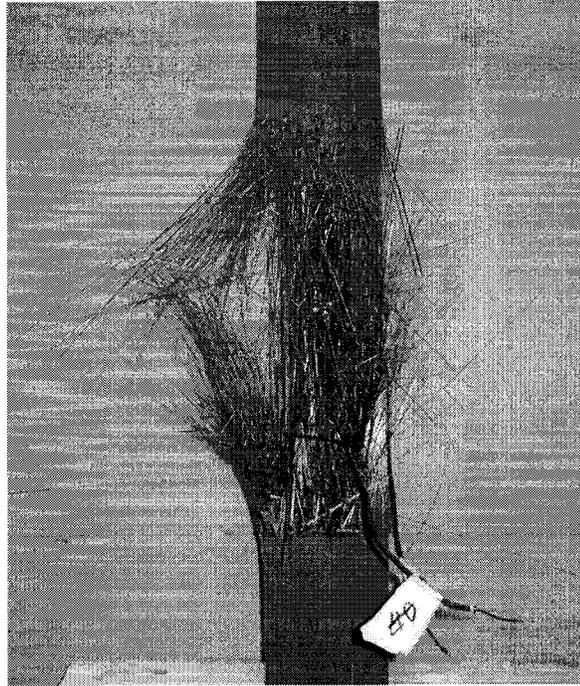
**Image 3-5 Typical Failure Mode of CFRP Plate Coupon**

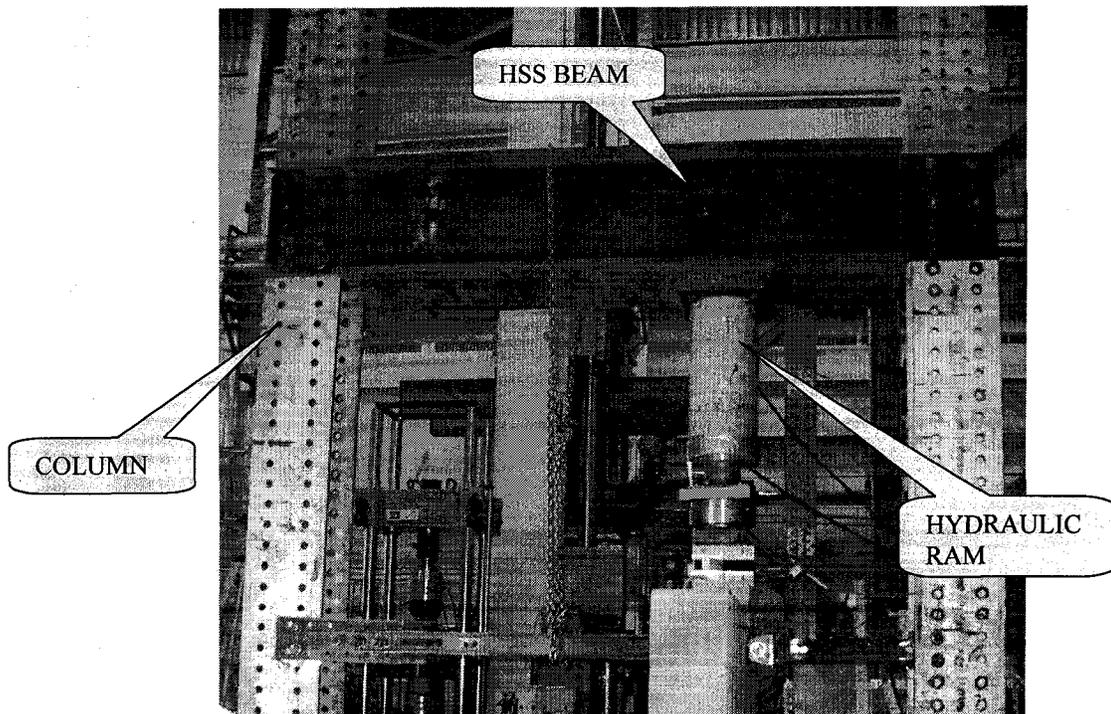
**Image 3-6 Loading Frame**

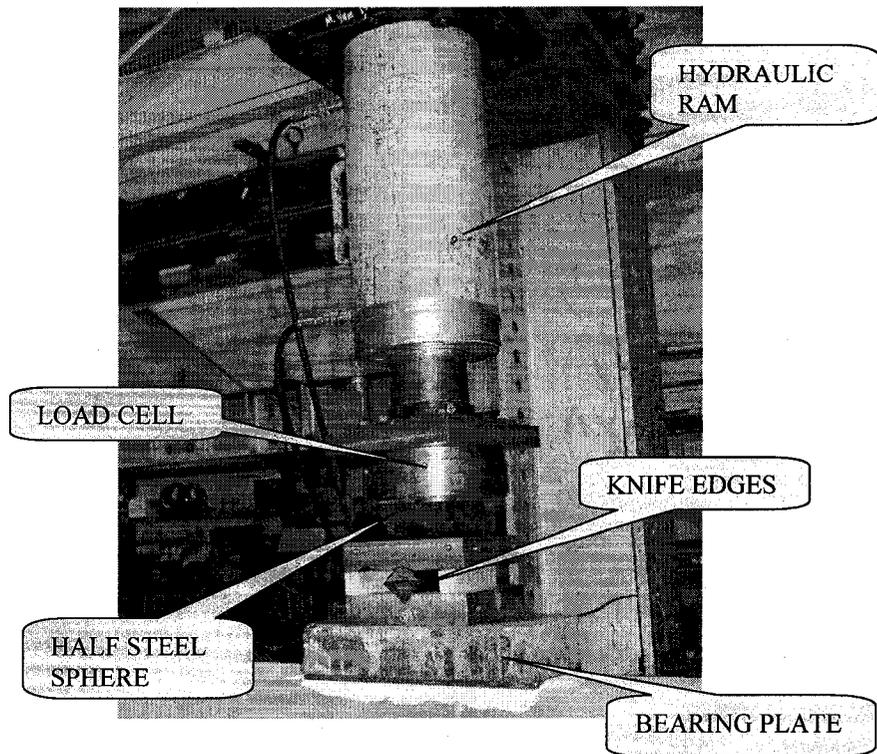
**Image 3-7 Top Loading System**

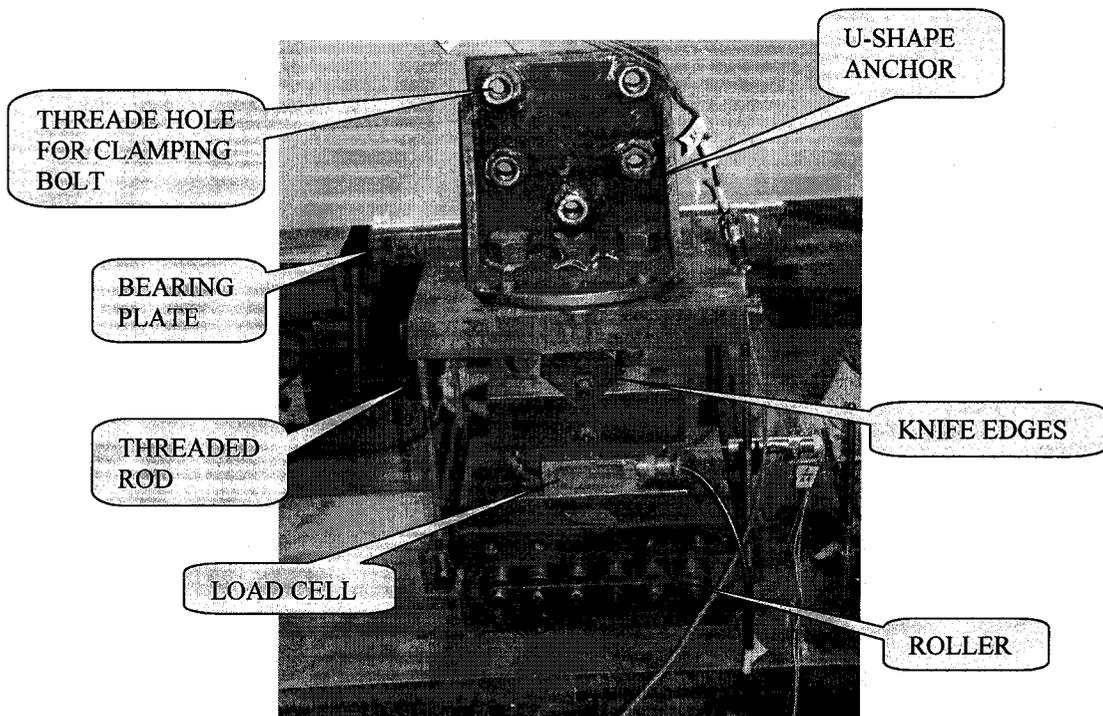
**Image 3-8 Bottom Reaction Assembled System**

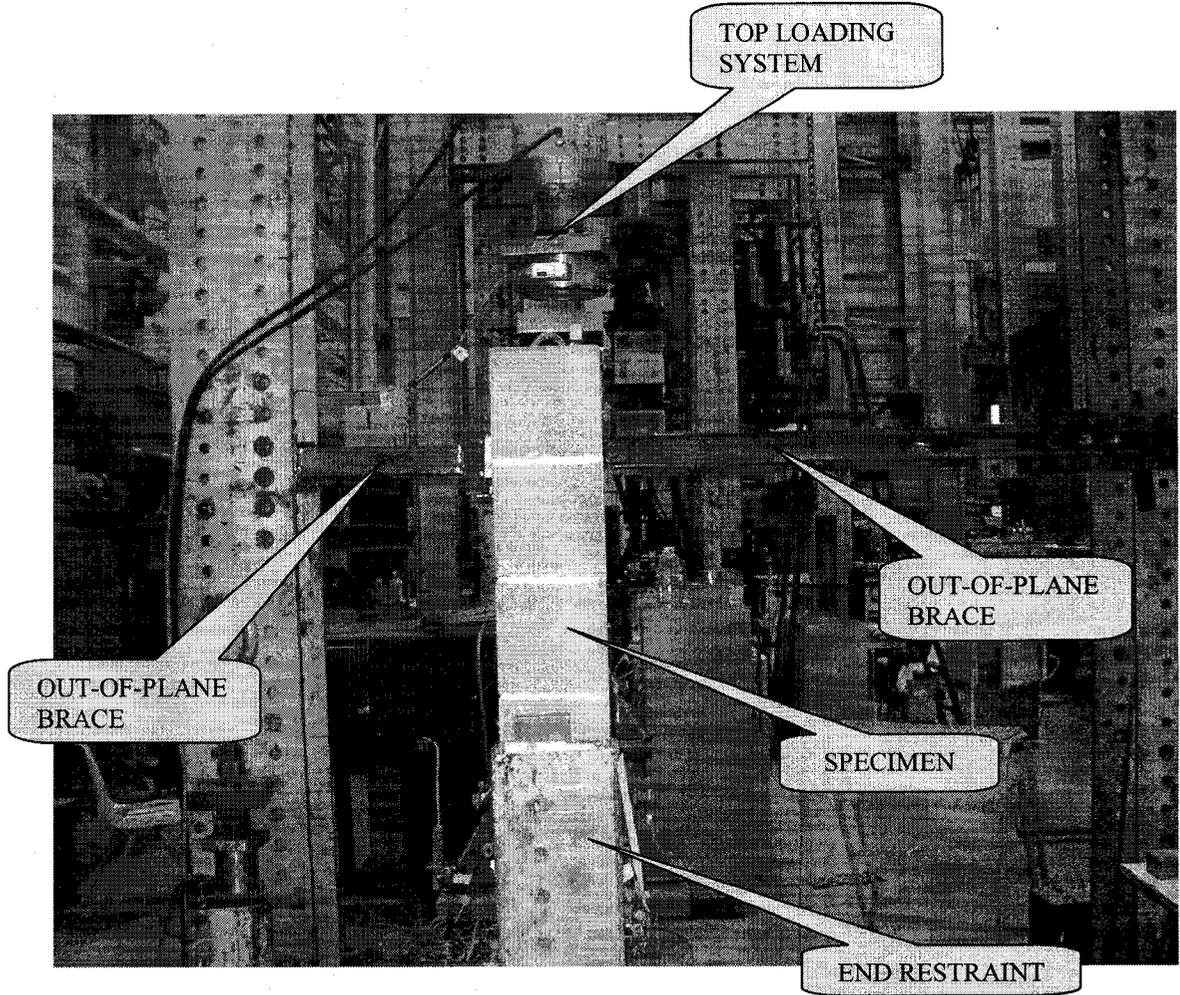
**Image 3-9 Out-of-Plane Bracing System**

Out-of-plane bracing system was designed to prevent any lateral movement of the specimen caused by an eccentricity of the vertical load. Two horizontal lateral bracing frames were set up perpendicularly to the specimen plane under the location of the top

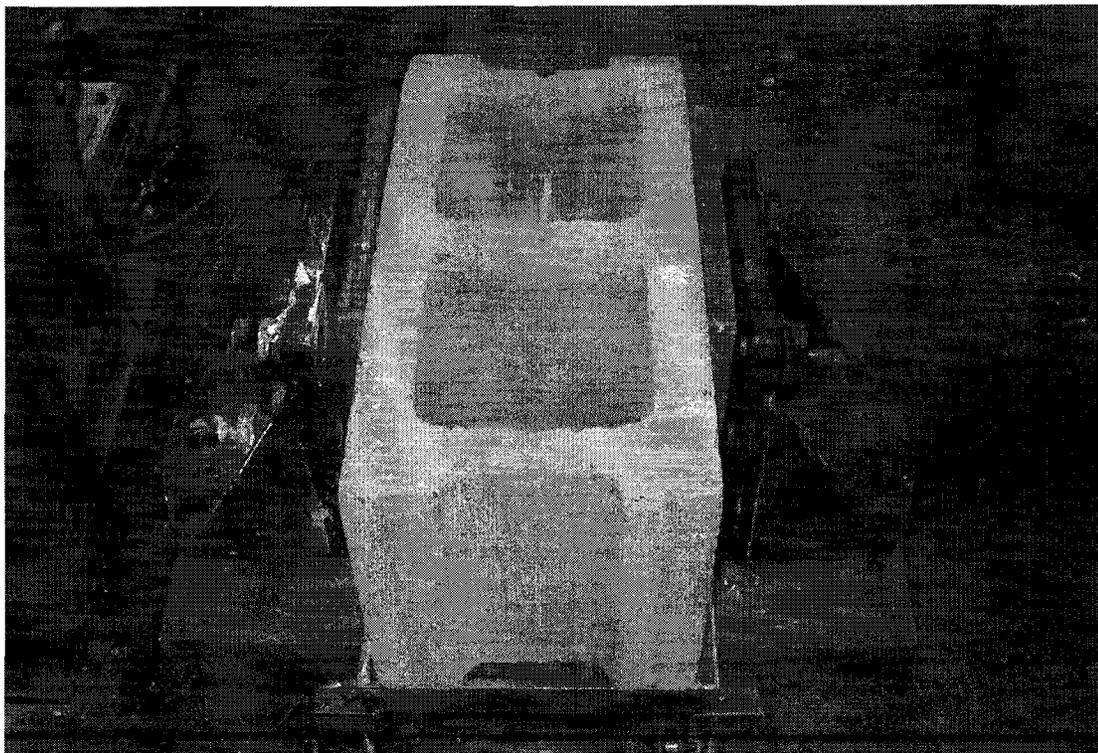
**c) Top View of Anchorage System**

**Image 3-10 Anchorage System for CFRP Plates at Supports**

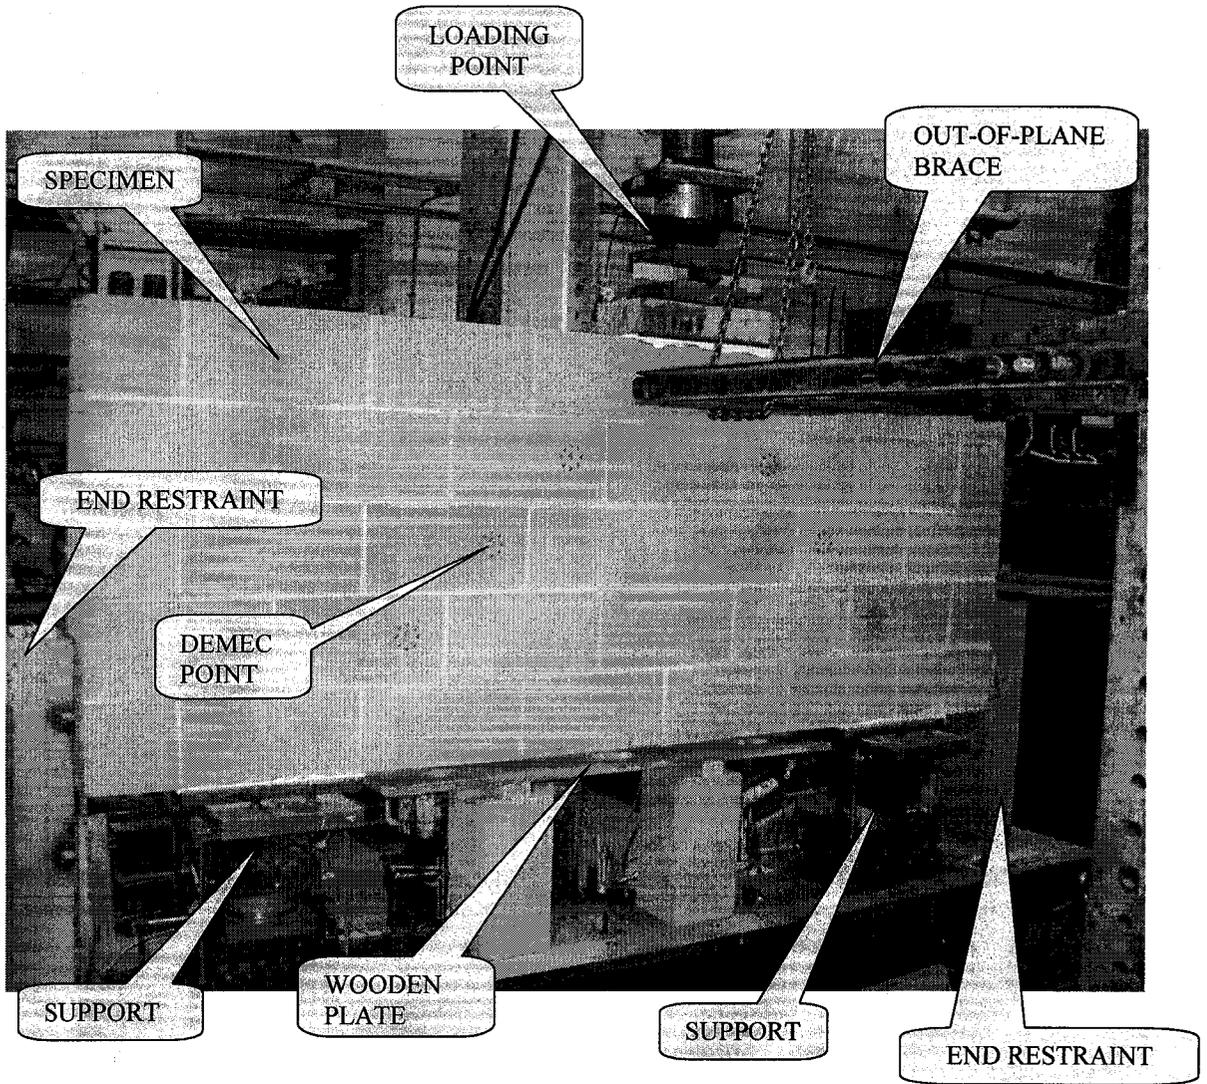
**Image 3-11 Test Set-up**

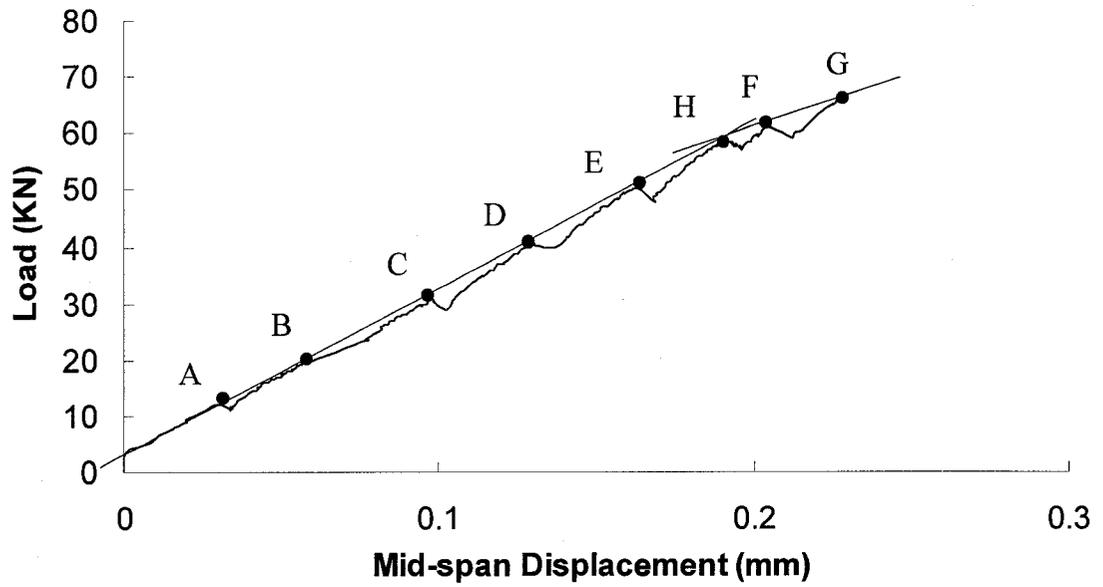
Figure 4-1 Load-Displacement of Beam 1

The Load-Displacement curve consists of two phases. The first phase starts from the beginning to Point H, at which the first visual crack appeared along the vertical mortar joint at the mid-span and the corresponding load was 59 kN. Point H to Point G belongs to the second phase. As can be seen, the slope of the line HFG was reduced since the stiffness of the beam was degraded due to the cracks. Furthermore, the deflection increased quickly under a small increment of the load after the crack formed. Shortly thereafter, the beam failed suddenly at a maximum load of 67 kN at Point G as seen in

Figure 4-1. According to the Load-Displacement curve, this beam was basically elastic before it failed and the specimen showed very little ductility, given that the maximum displacement was only 0.2 mm at mid-span. The crack patterns and the corresponding load were marked on the beam, and are presented in Image 4-1.

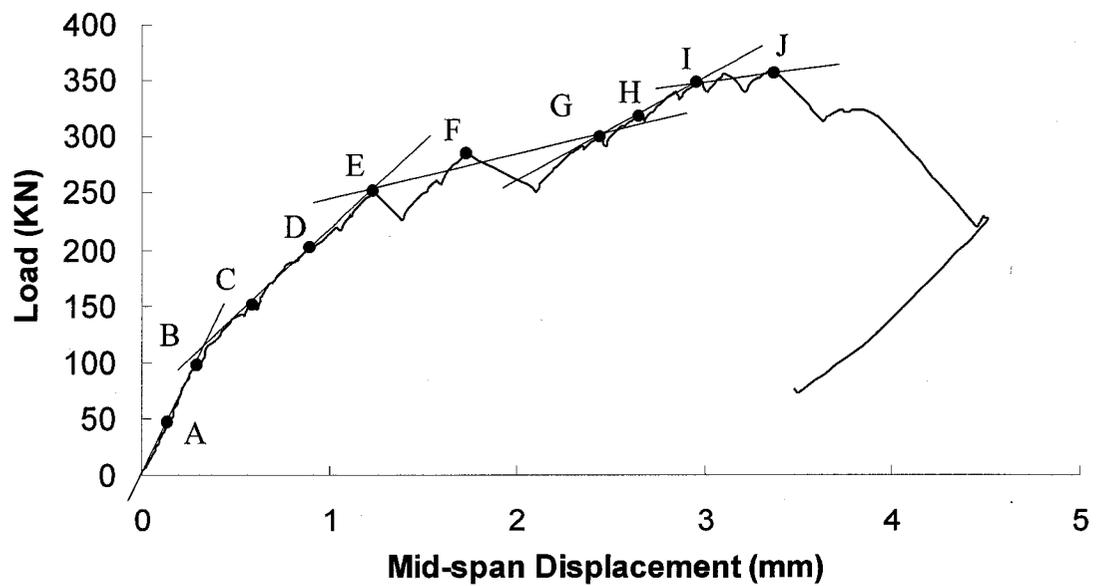
Figure 4-2 Load-Displacement of Beam 2

As a regular deep beam, Beam 2 was reinforced with two No.15 steel rebars longitudinally at the bottom of the beam, as shown in Figure 3-4. Figure 4-2 illustrates the behaviour of the load versus mid-span displacement of Beam 2, and the response includes five distinguishing load stages. Demec gauge reading was taken at intervals of 50 kN until Point E. After Point E, the readings were taken according to the crack propagation since the stiffness of the specimen degraded quickly even under small increments of the load.

The first load stage terminated at Point B, and the corresponding load and displacement were 107 kN and 0.3 mm, respectively. Even though there were several tiny cracks observed along the vertical mortar joints at mid-span, the beam was basically elastic within this stage.

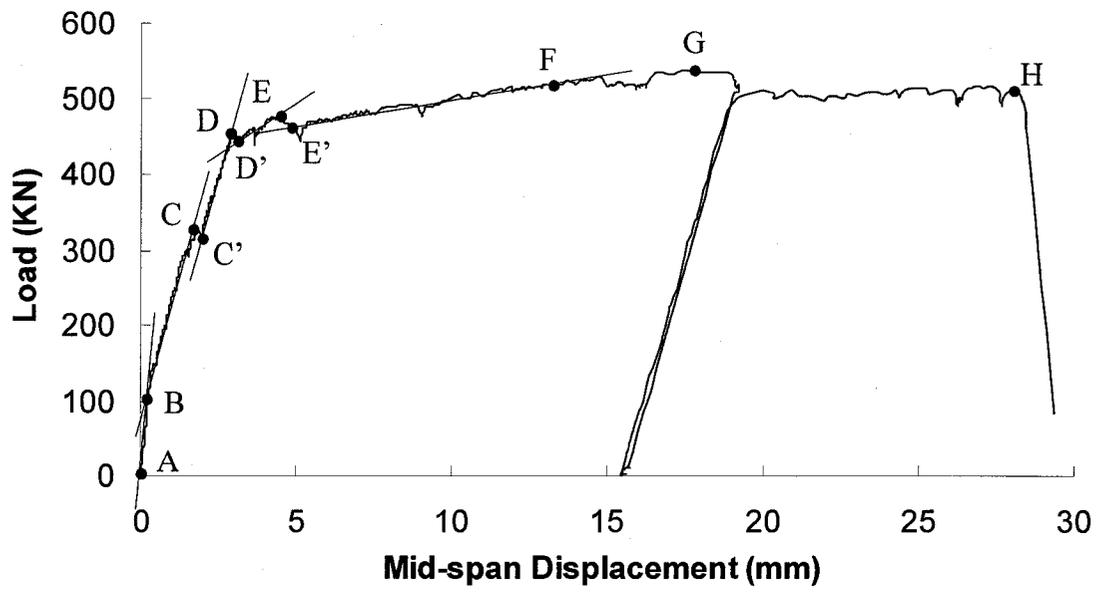
**Figure 4-3 Load-Displacement of Beam 3**

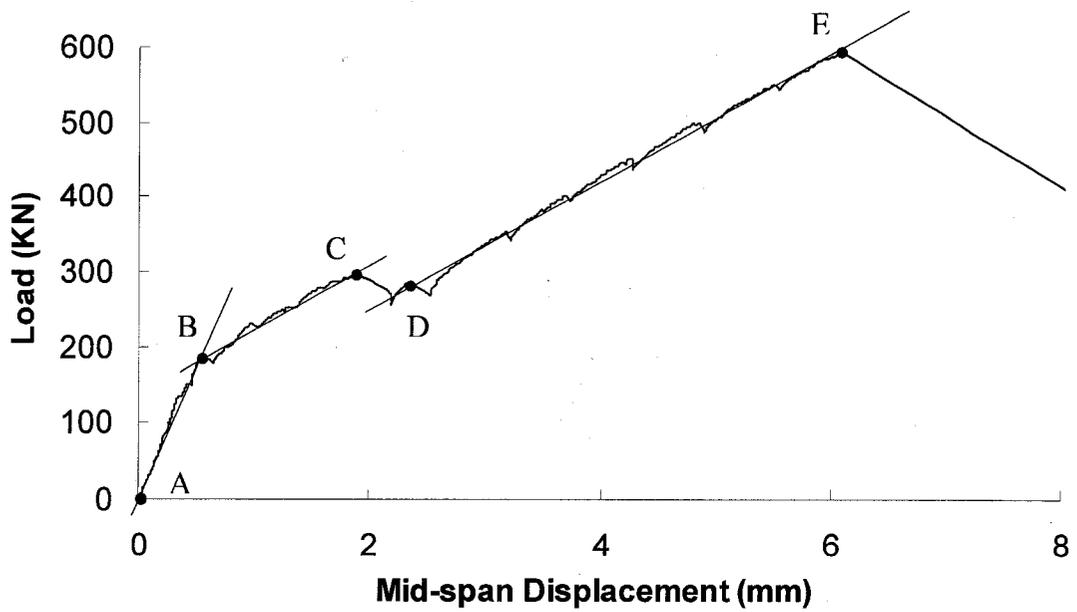
**Figure 4-4 Load-Displacement of Beam 4**

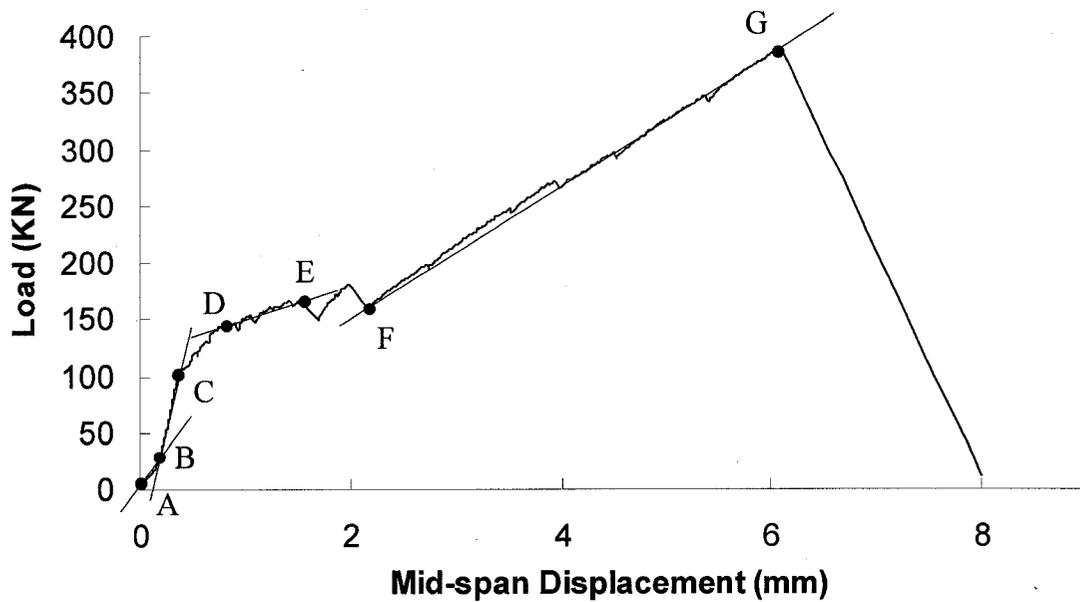
Figure 4-5 Load-Displacement of Beam 5

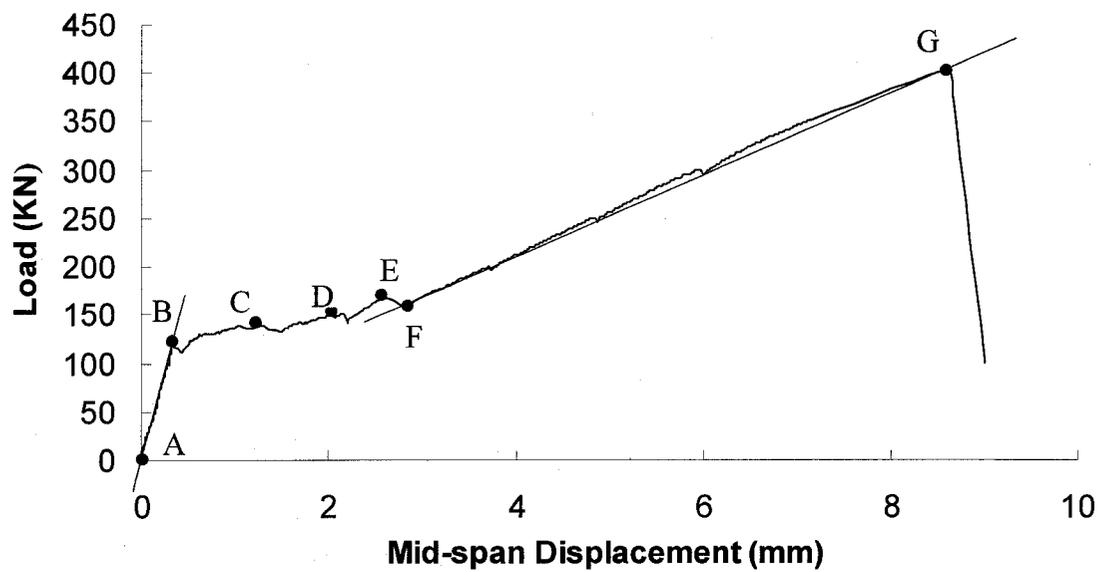
Figure 4-6 Load-Displacement of Beam 6

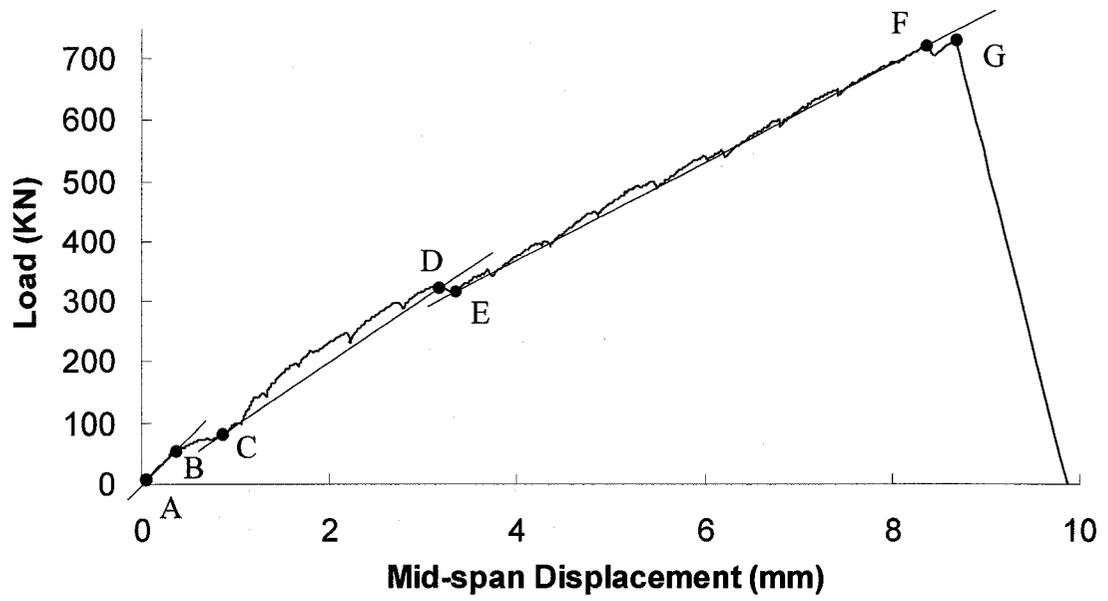
Figure 4-7 Load-Displacement of Beam 7

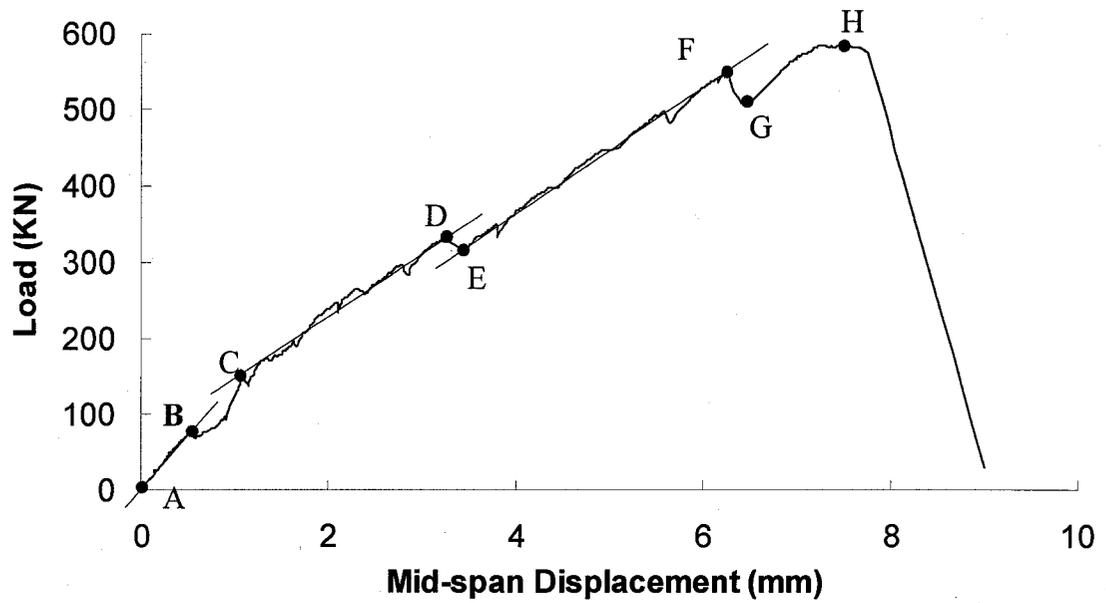
Figure 4-8 Load-Displacement of Beam 8
