**APPLICATION OF CFRP LAMINATES IN THE RETROFIT  
OF MASONRY DEEP BEAMS**

Zhangcheng Hao

**MASTER OF SCIENCE**

**Structural Engineering**

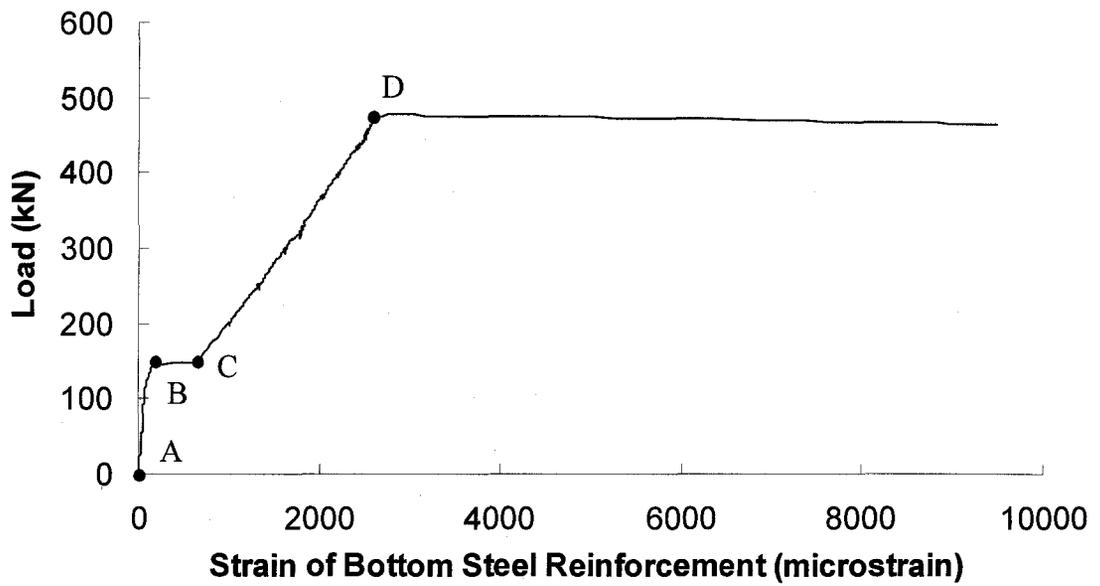
**Figure 4-10 Load-Strain on Bottom Steel Reinforcement of Beam 3**

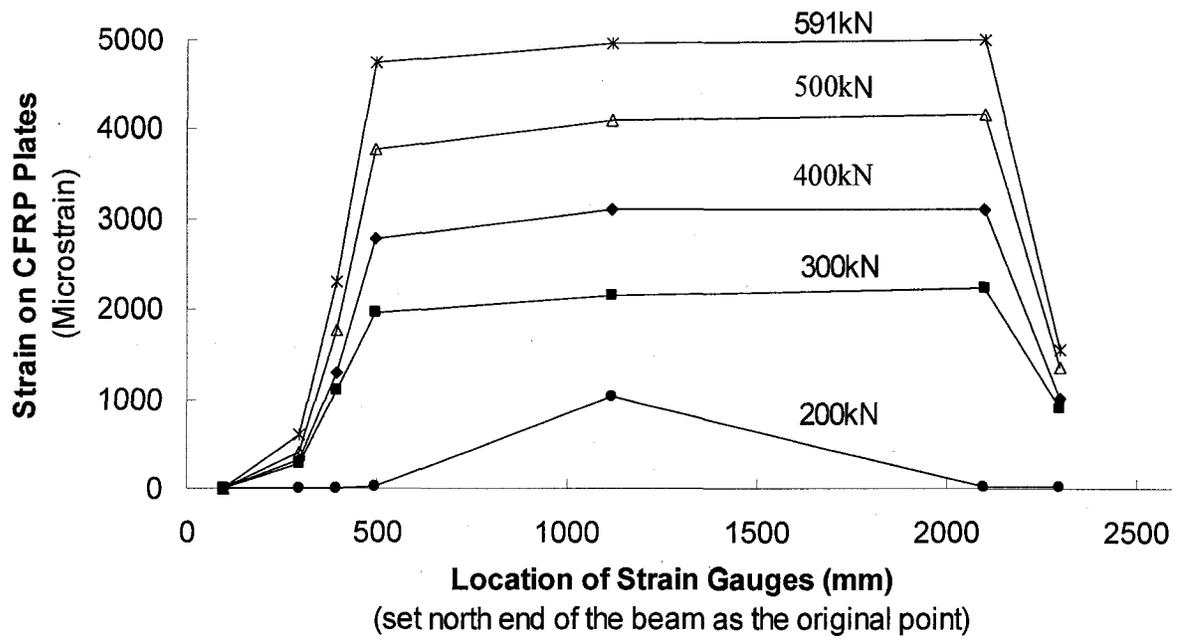
Figure 4-11 Load- Strain on CFRP Plates of Beam 4

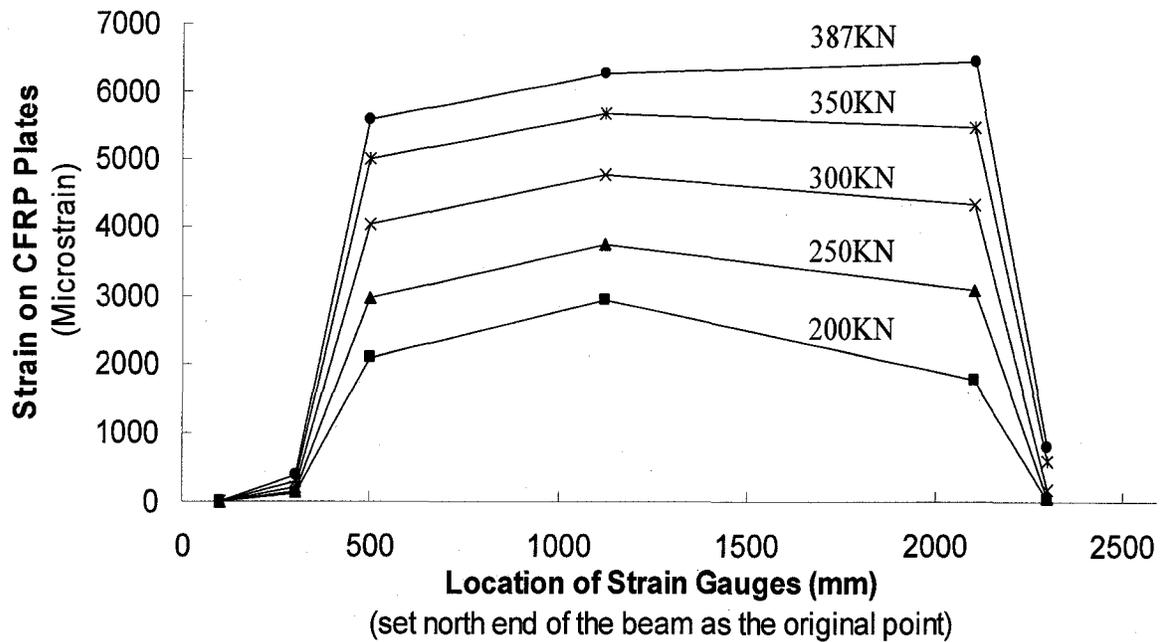
Figure 4-12 Load-Strain on CFRP Plates of Beam 5

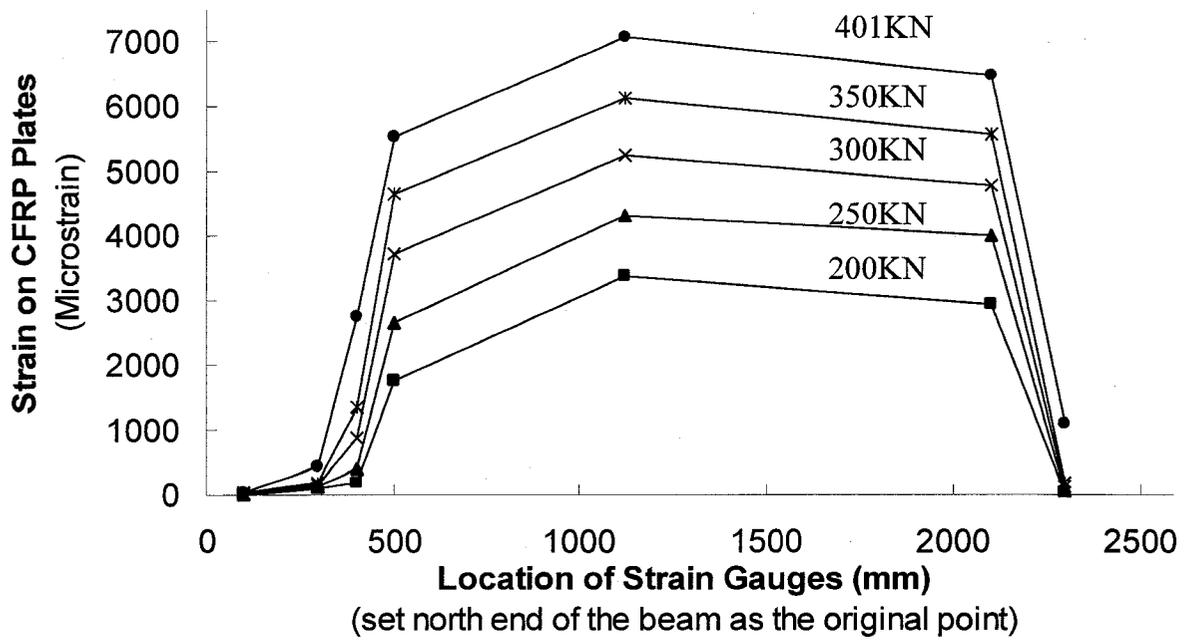
Figure 4-13 Load-Strain on CFRP Plates of Beam 6

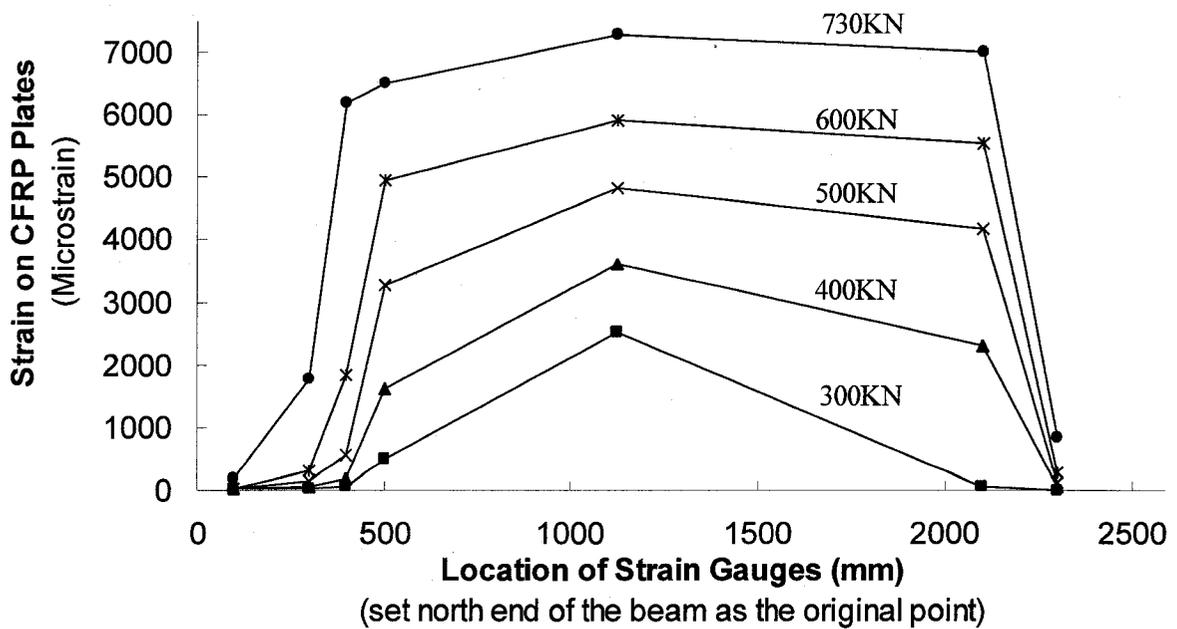
Figure 4-14 Load-Strain on CFRP Plates of Beam 7

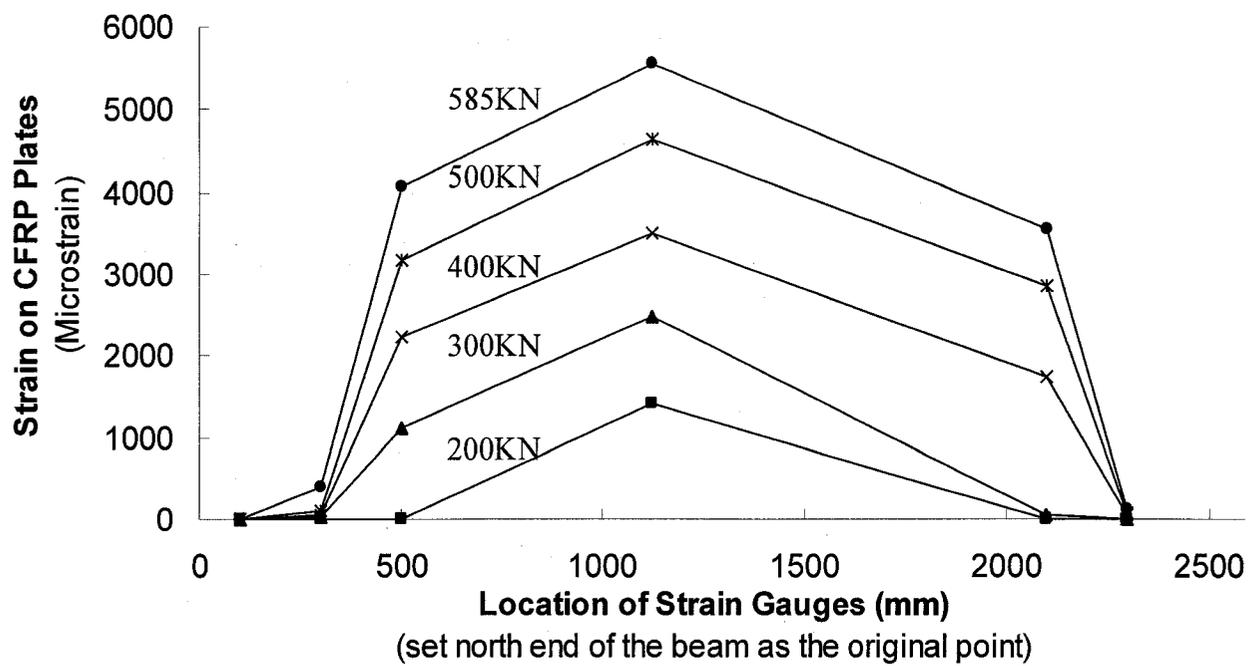
**Figure 4-15 Load-Strain on CFRP Plates of Beam 8**

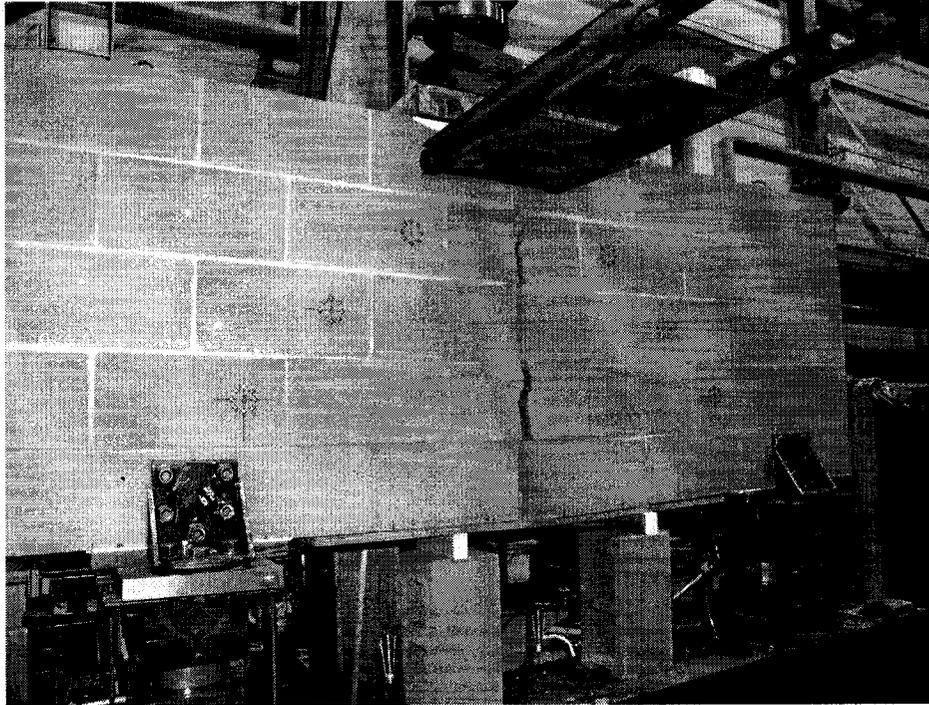
**Image 4-1 Crack Pattern of Beam 1**

Figure 4-1. According to the Load-Displacement curve, this beam was basically elastic before it failed and the specimen showed very little ductility, given that the maximum displacement was only 0.2 mm at mid-span. The crack patterns and the corresponding load were marked on the beam, and are presented in Image 4-1.

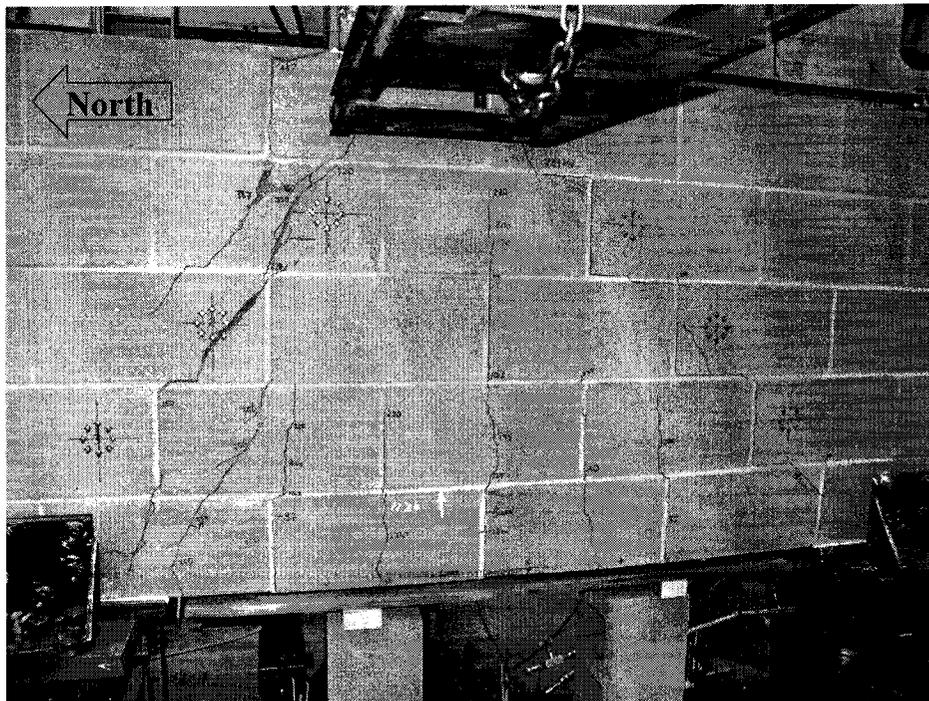
**Image 4-2 Crack Pattern of Beam 2**

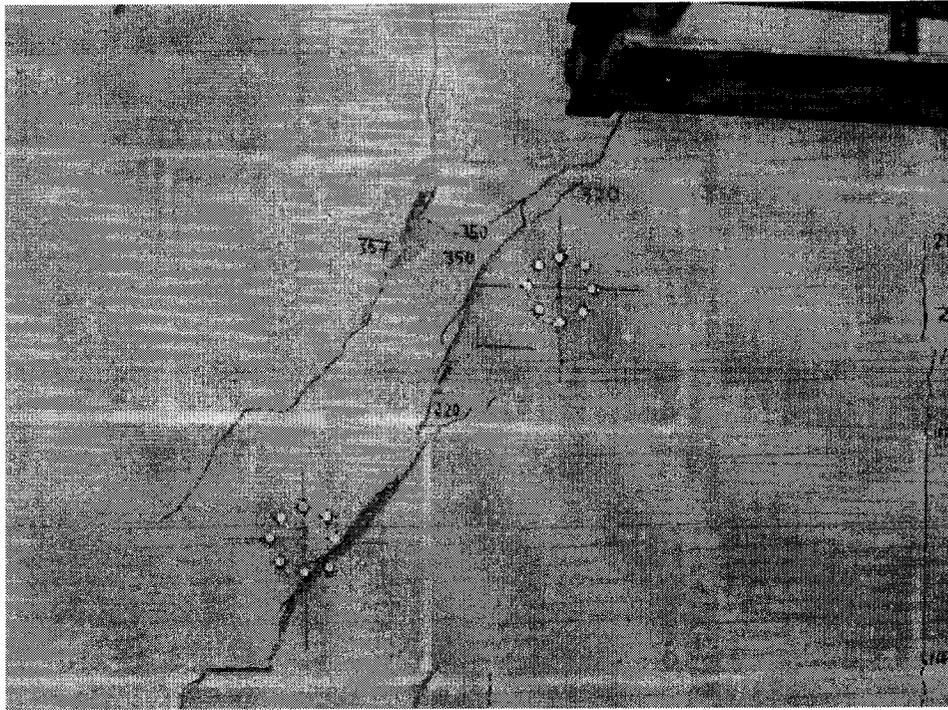
**Image 4-3 Spalling Area of Beam 2**

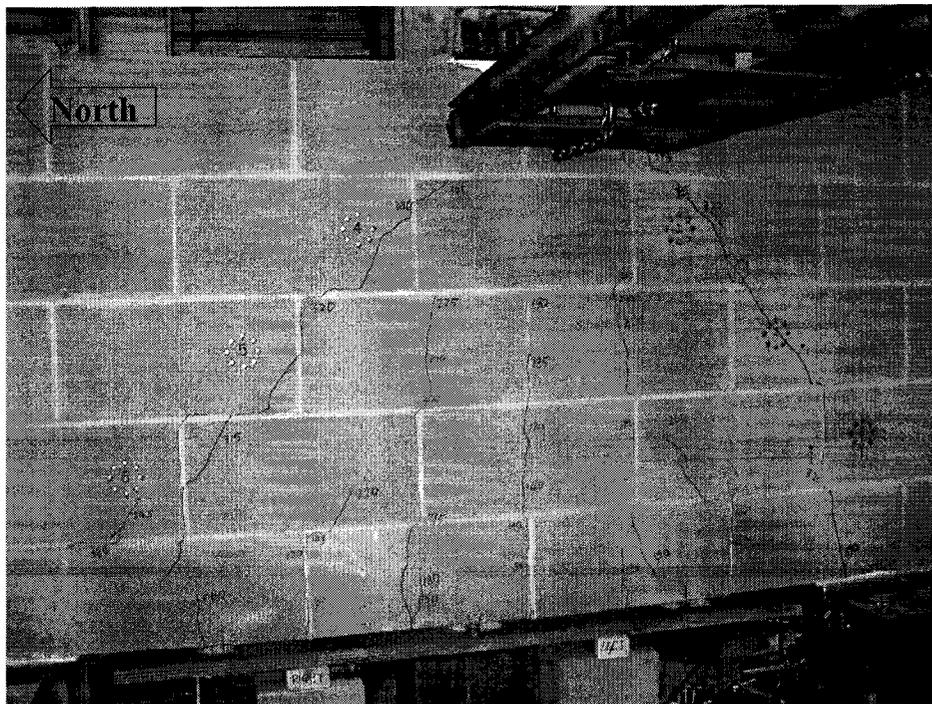
**Image 4-4 Crack Pattern of Beam 3 at the Load of 400 kN**

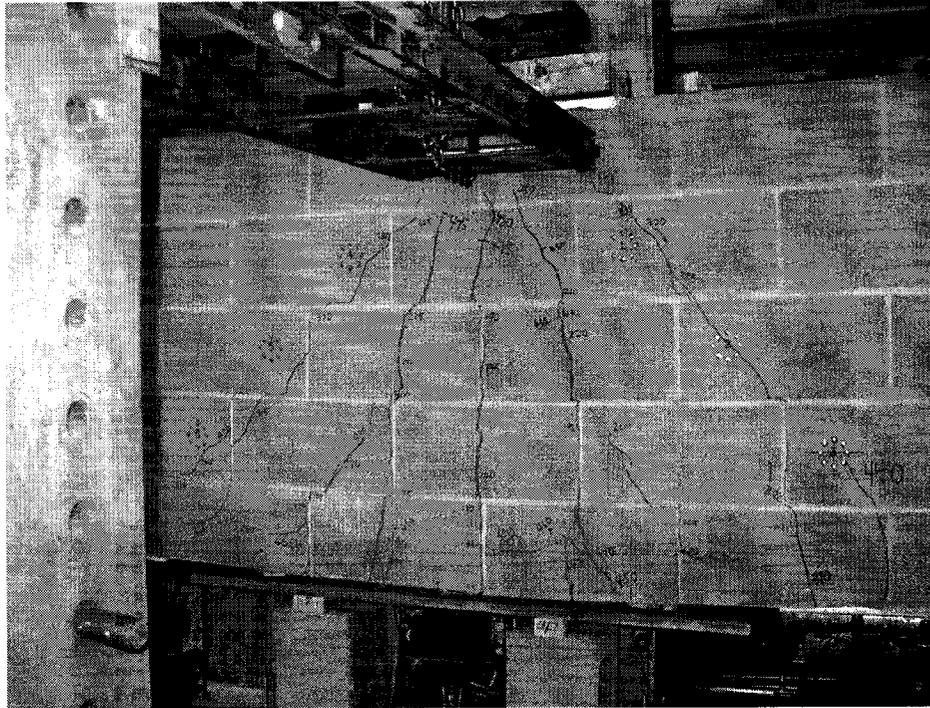
**Image 4-5 Crack Pattern of Beam 3 at the load of 480 kN**

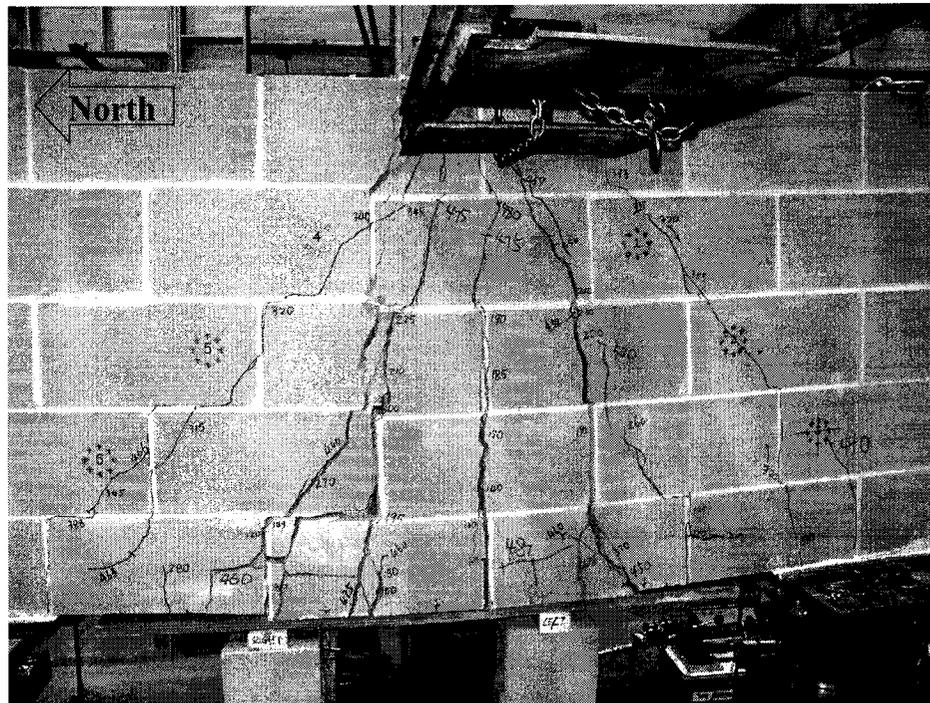
**Image 4-6 Crack Pattern of Beam 3 at Failure**

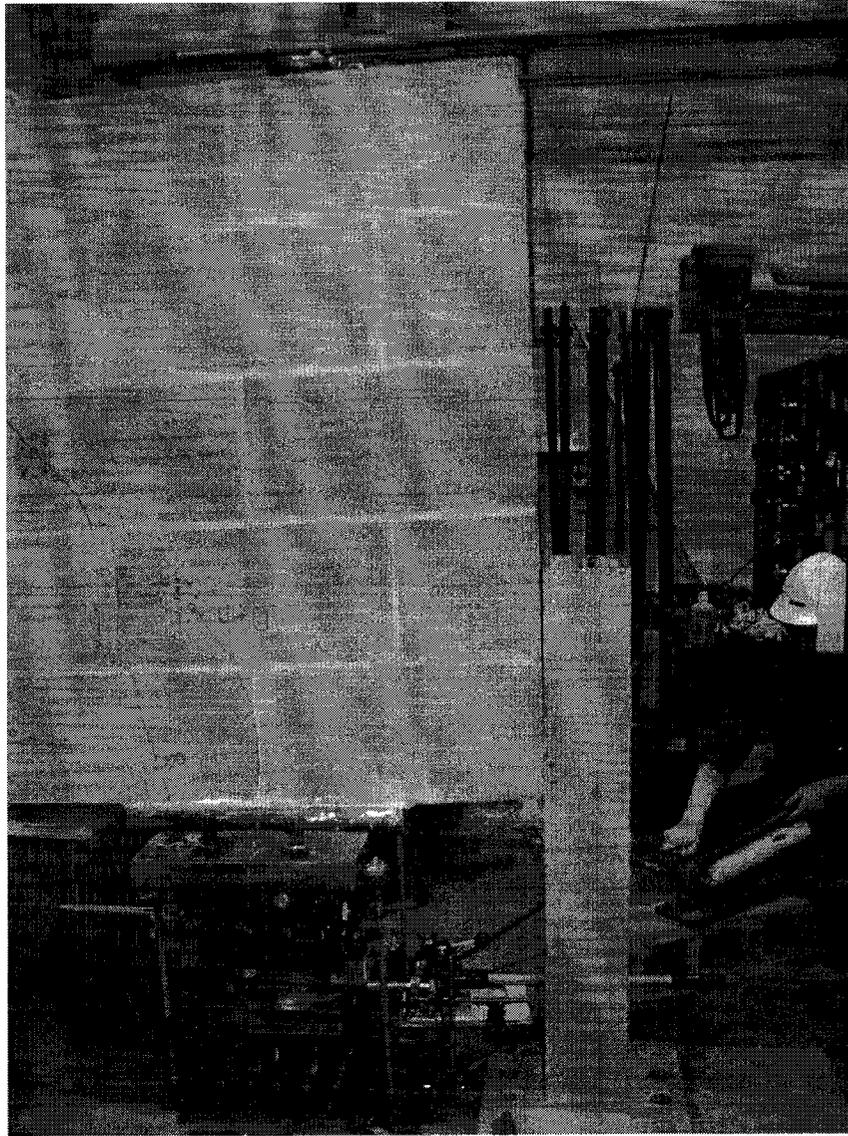
**Image 4-7 Contact Between the End of Beam 3 And South End Restraint**

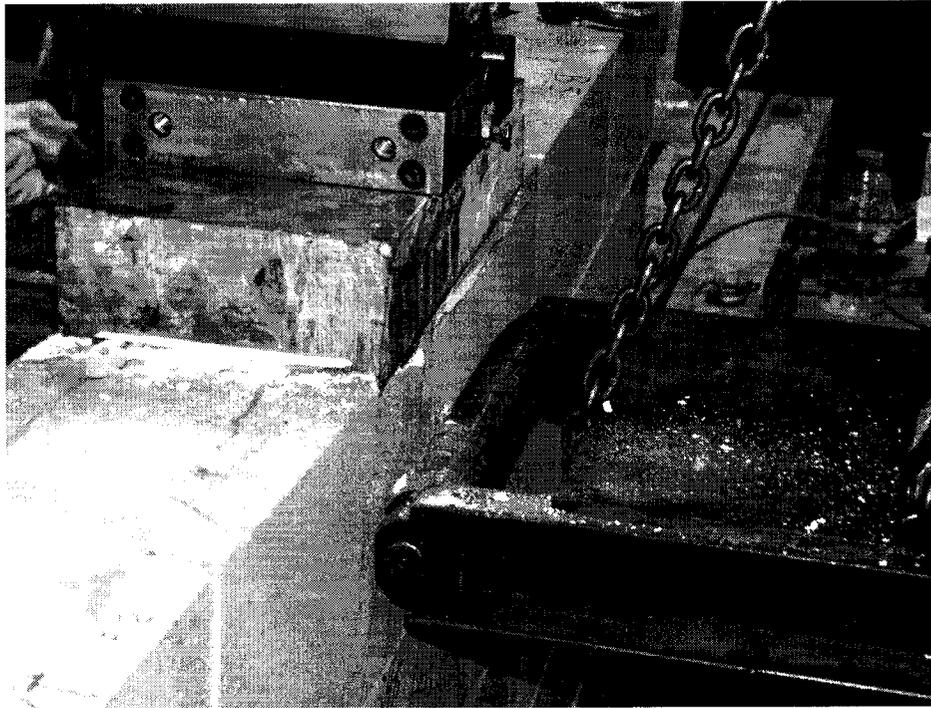
**Image 4-8 Crushing at the Top Load Point for Beam 3**

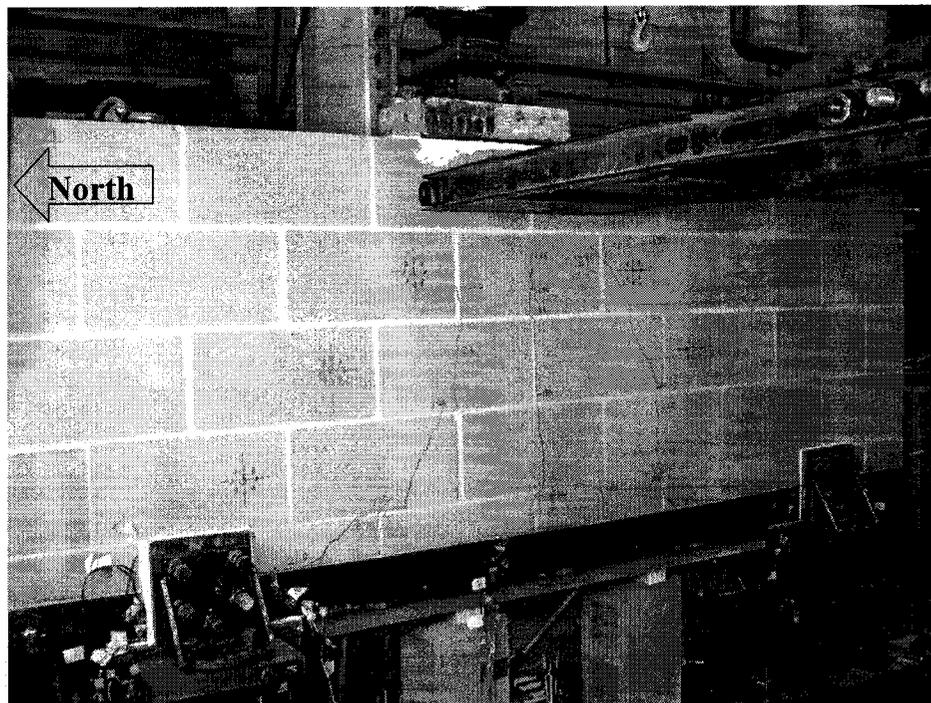
**Image 4-9 Crack Pattern of Beam 4 at the Load of 300 kN**

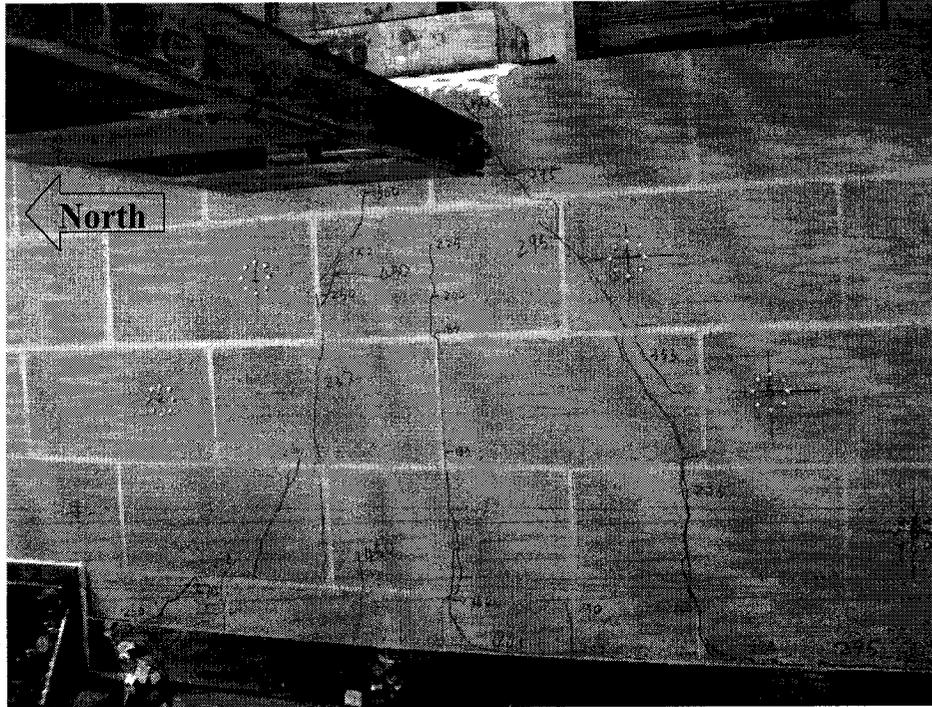
**Image 4-10 Crack Pattern of Beam 4 at the Load of 500 kN**

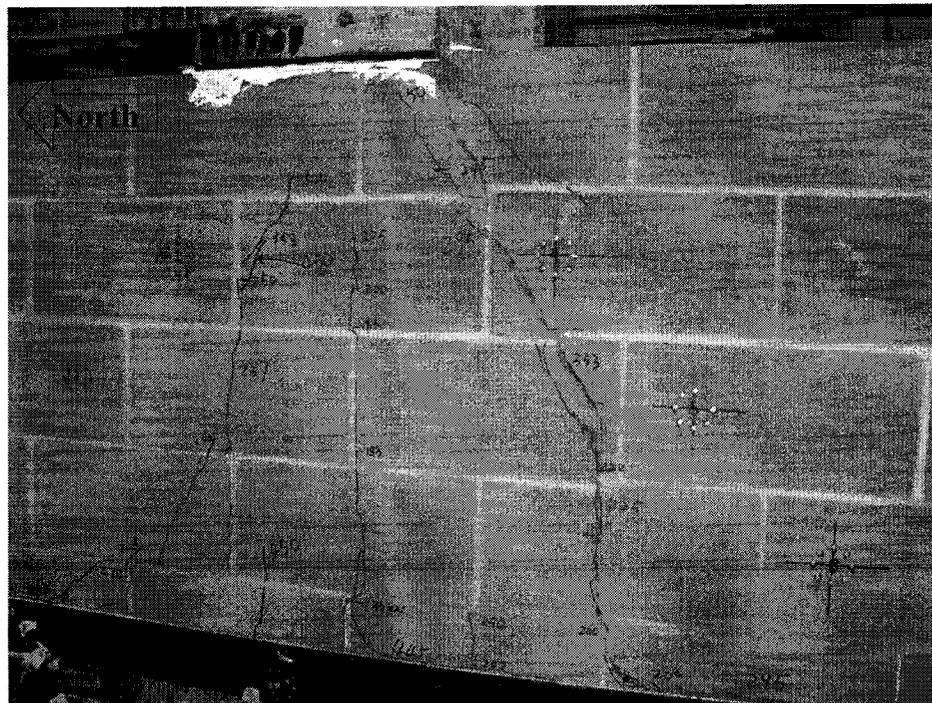
**Image 4-11 Crack Pattern of Beam 4 at Failure**

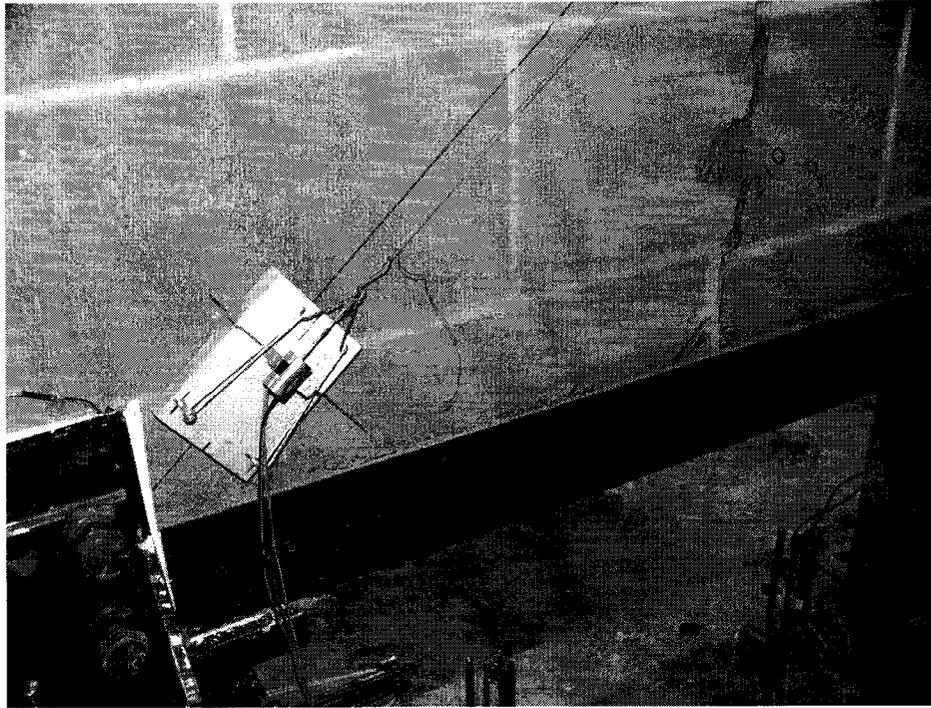
**Image 4-12 Debonding Between CFRP Plate and Masonry Surface of Beam 4**

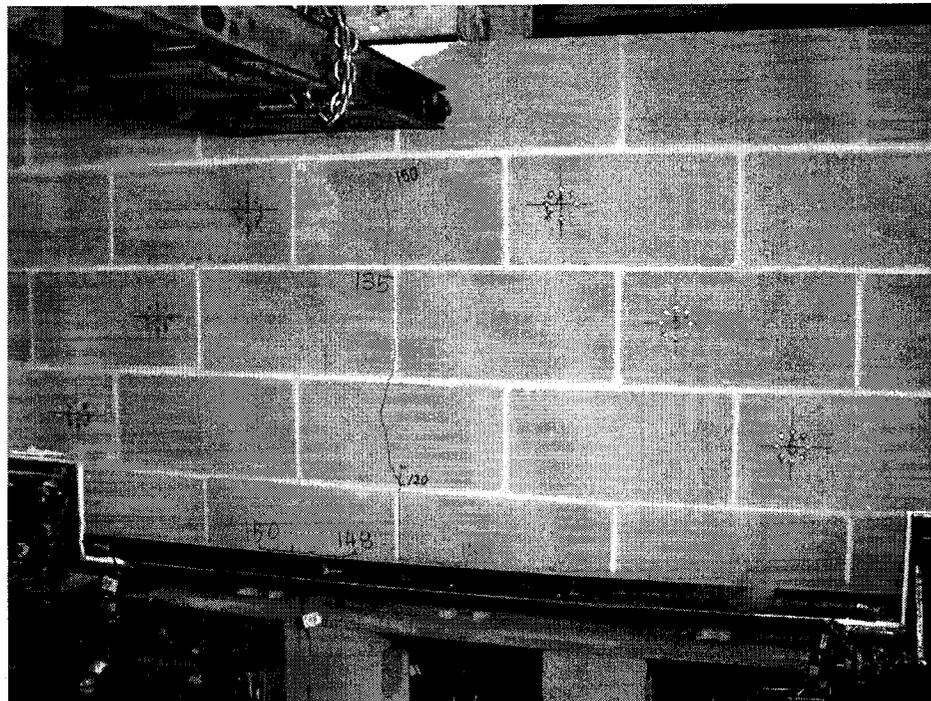
**Image 4-13 Crack Pattern of Beam 5 at the Load of 150 kN**

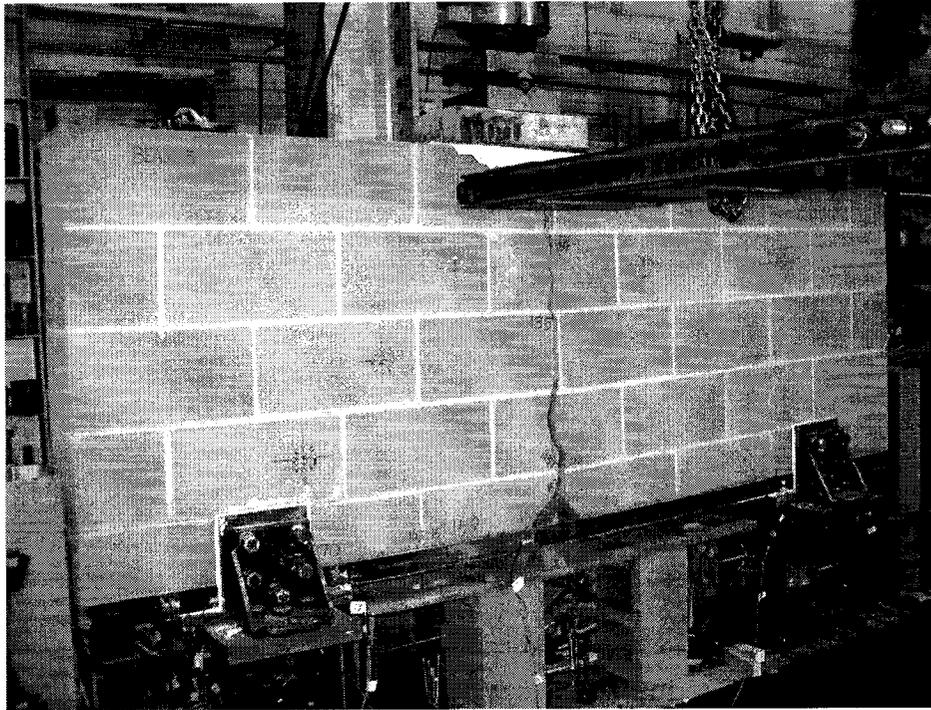
**Image 4-14 Crack Pattern of Beam 5 at Failure**

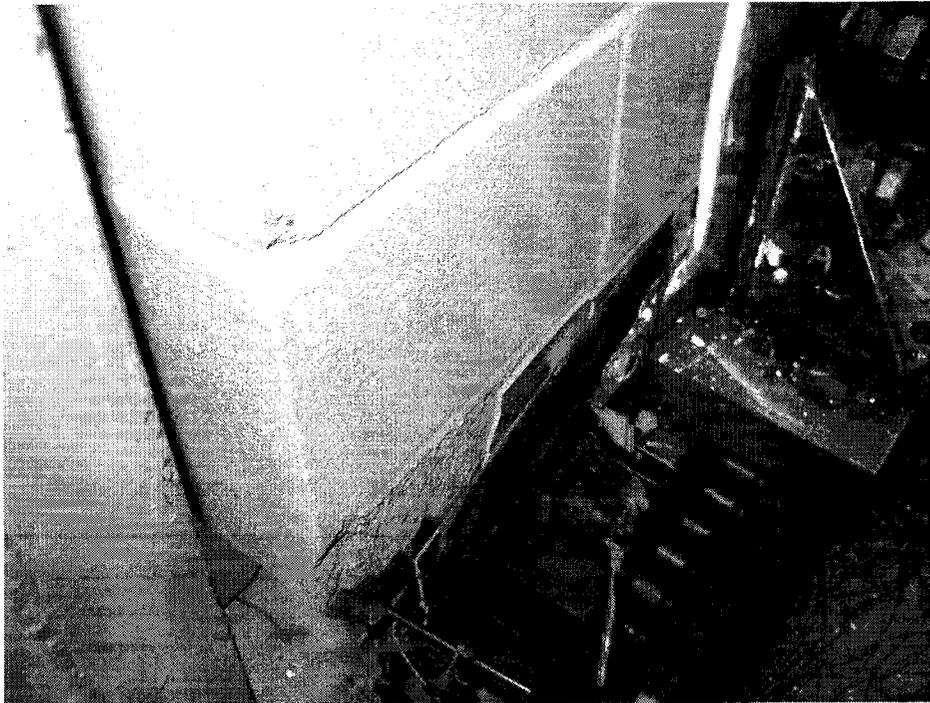
**Image 4-15 Peeling off at the End of Beam 5**

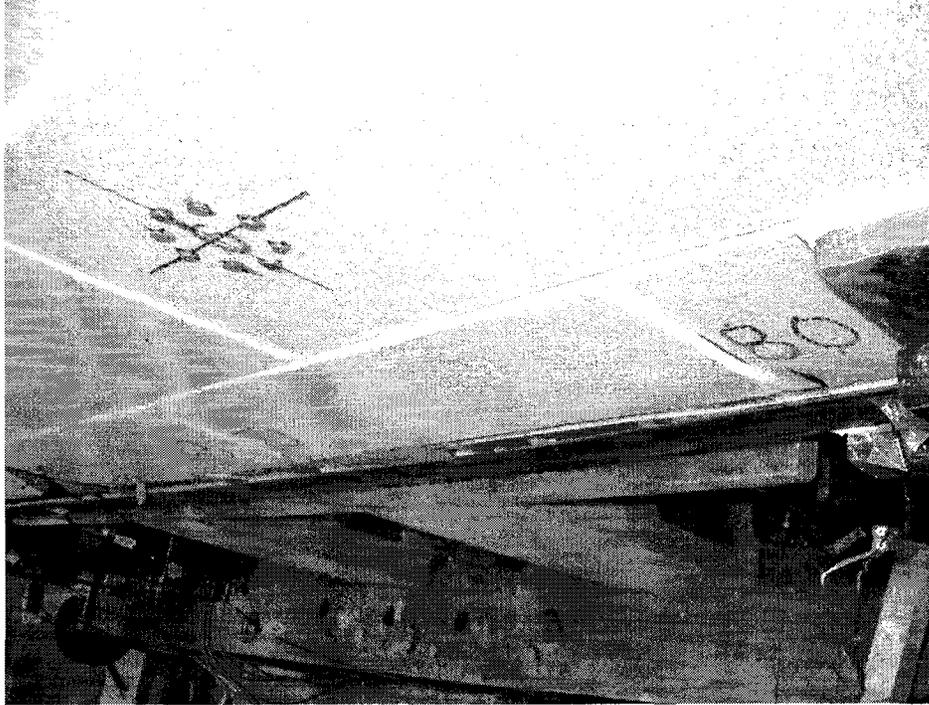
**Image 4-16 Debonding at the Mid-span of Beam 5**

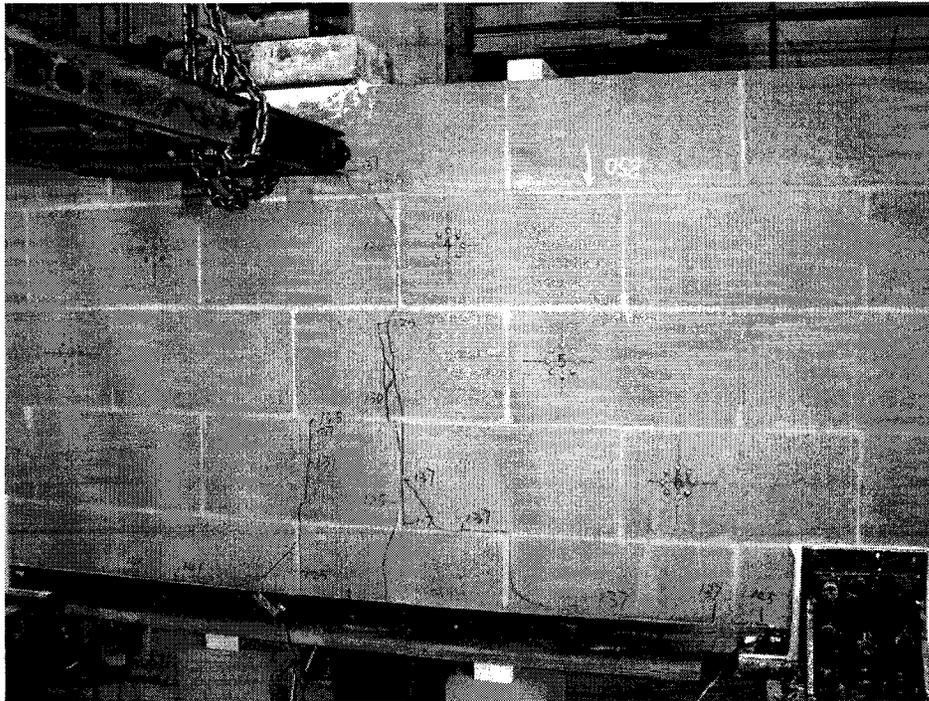
**Image 4-17 Crack Pattern of Beam 6 at the Load of 150 kN**

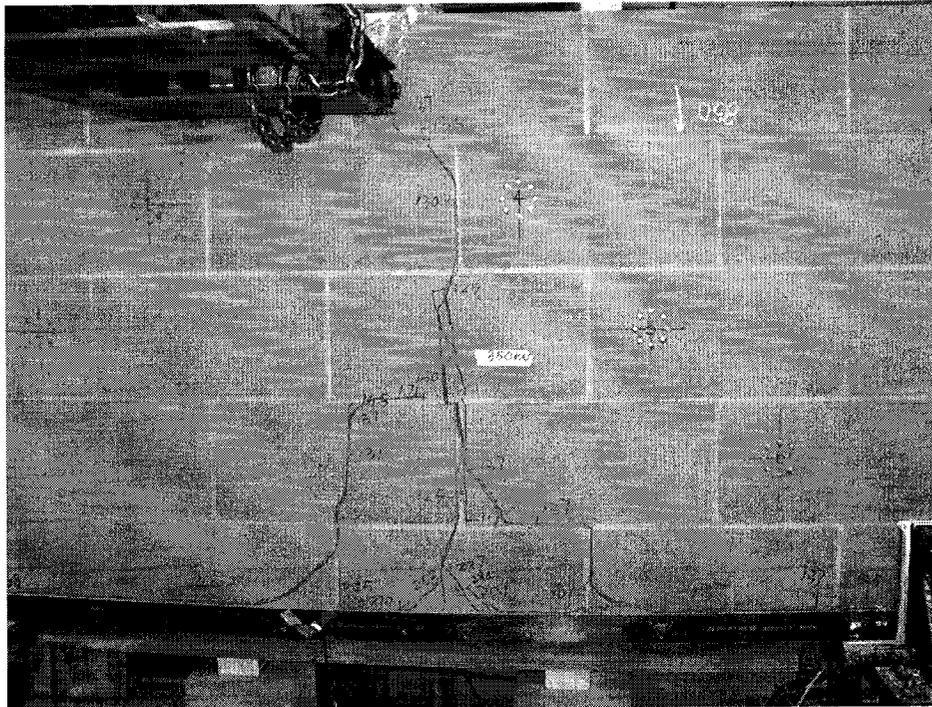
**Image 4-18 Crack Pattern of Beam 6 at the Load of 350 kN**

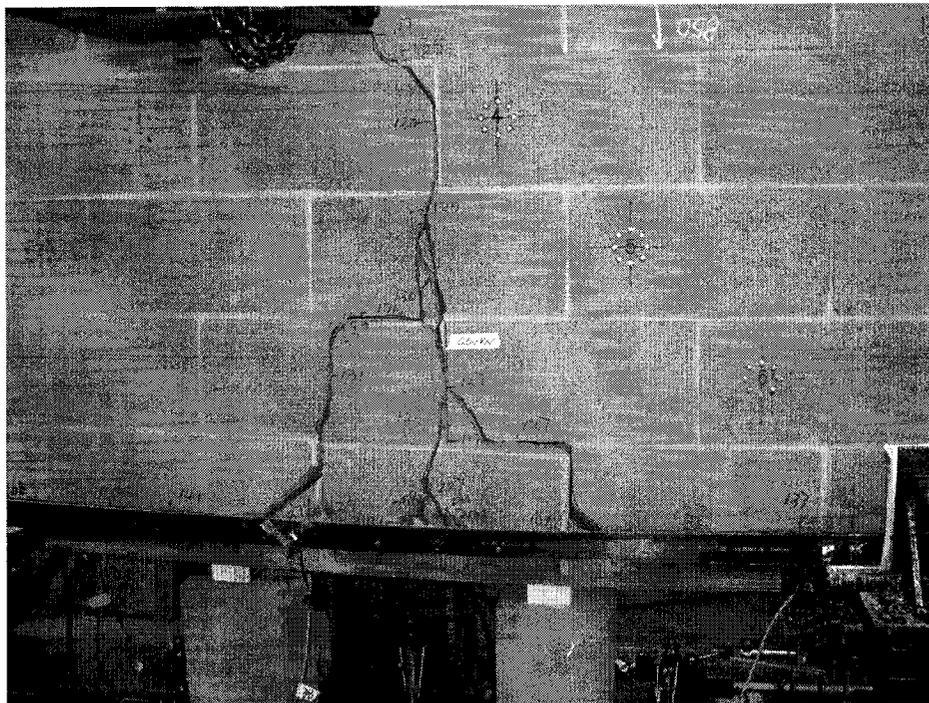
**Image 4-19 Crack Pattern of Beam 6 at Failure**

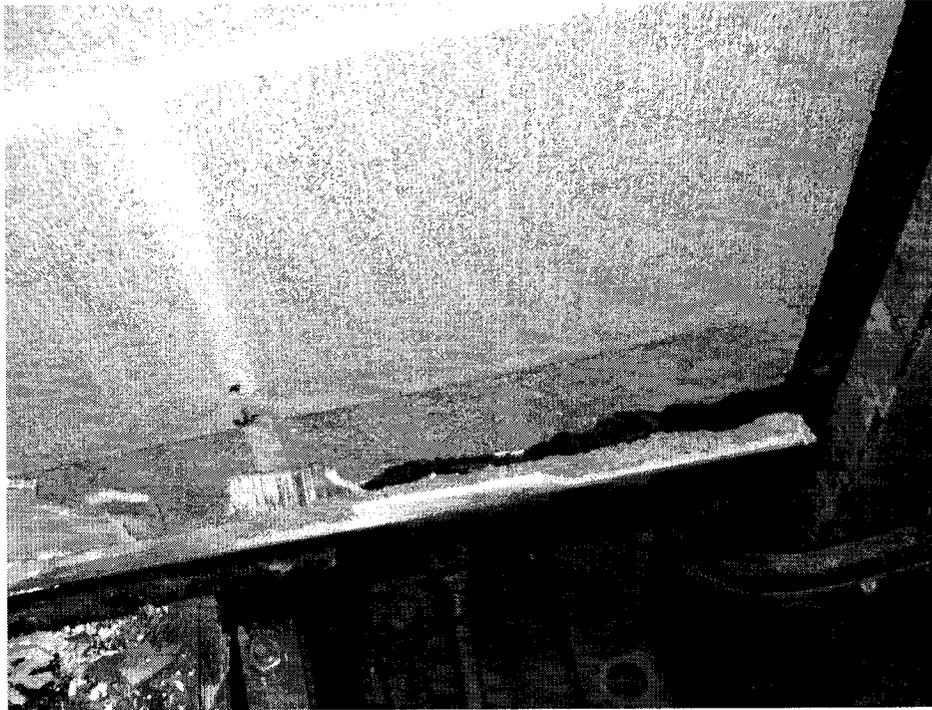
**Image 4-20 Peeling off at the End of Beam 6**

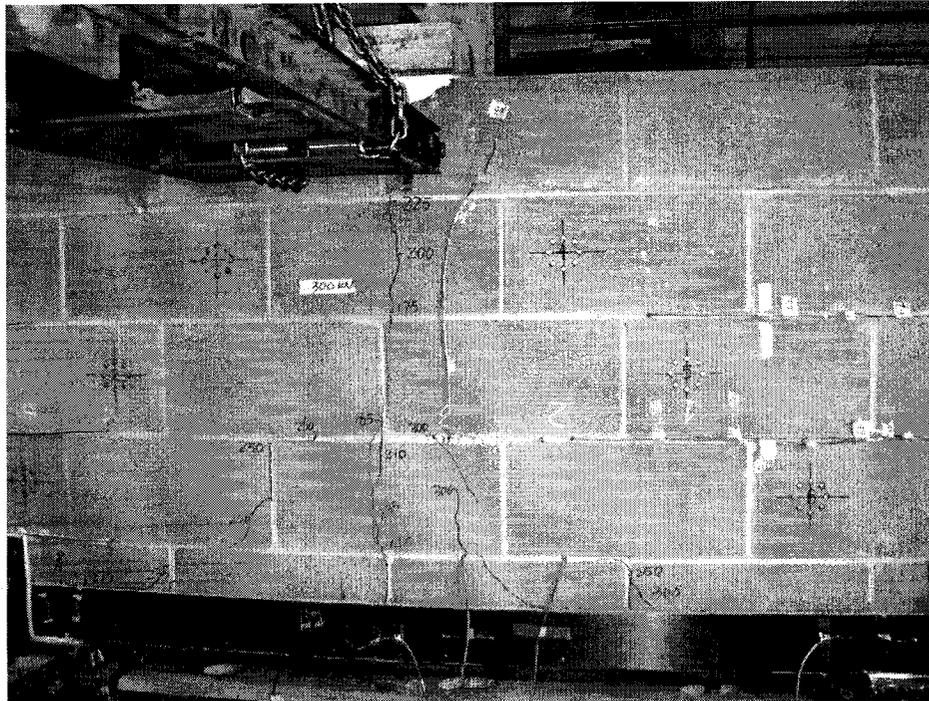
**Image 4-21 Crack Pattern of Beam 7 at the load of 300 kN**

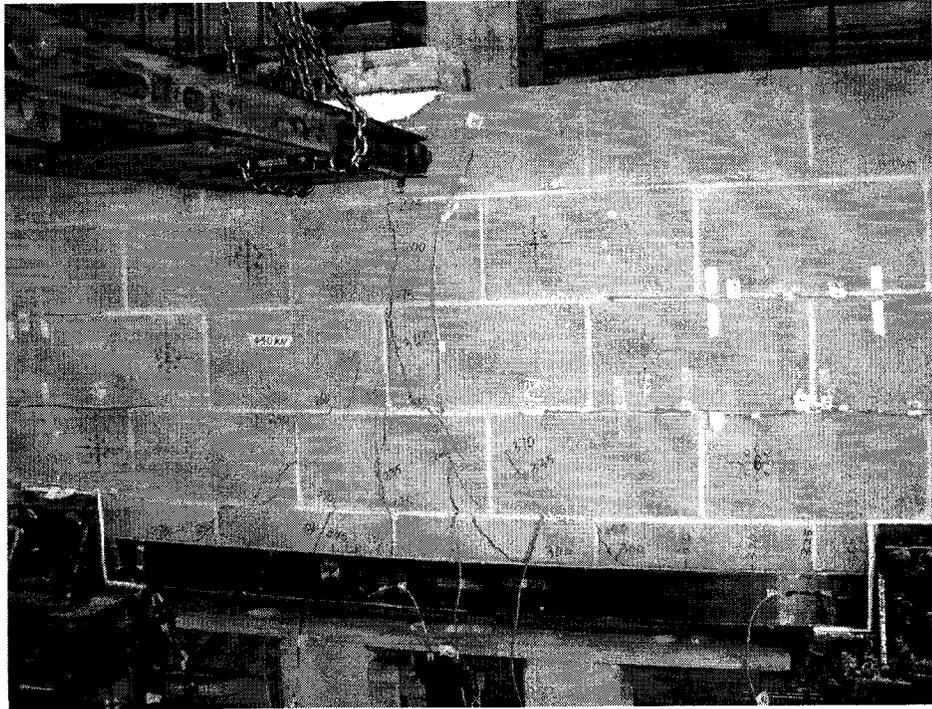
**Image 4-22 Crack Pattern of Beam 7 at the Load of 450 kN**

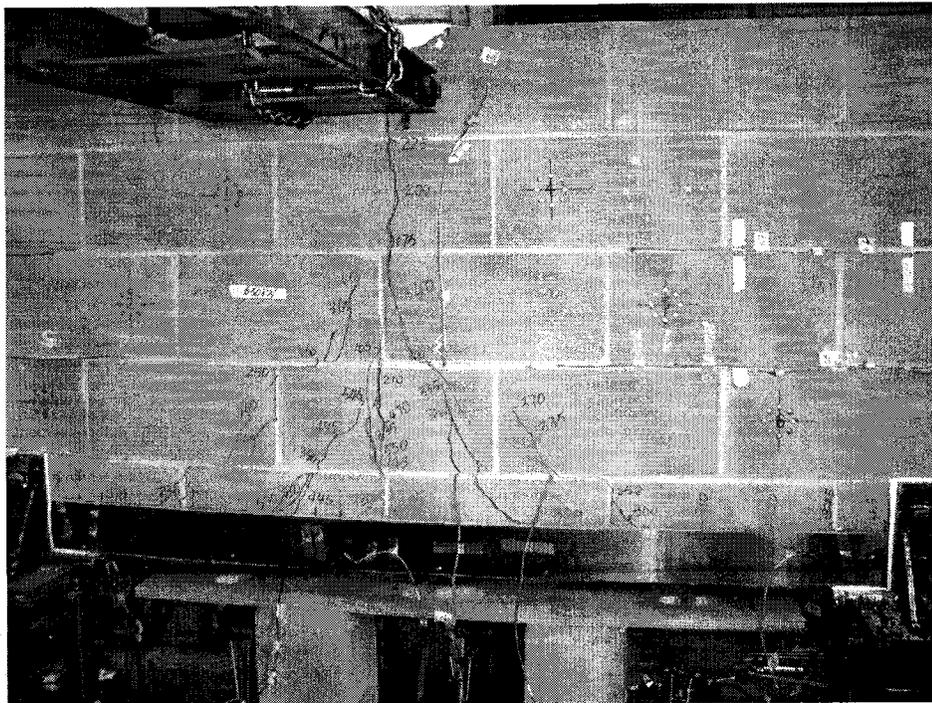
**Image 4-23 Crack Pattern of Beam 7 at the Load of 650 kN**

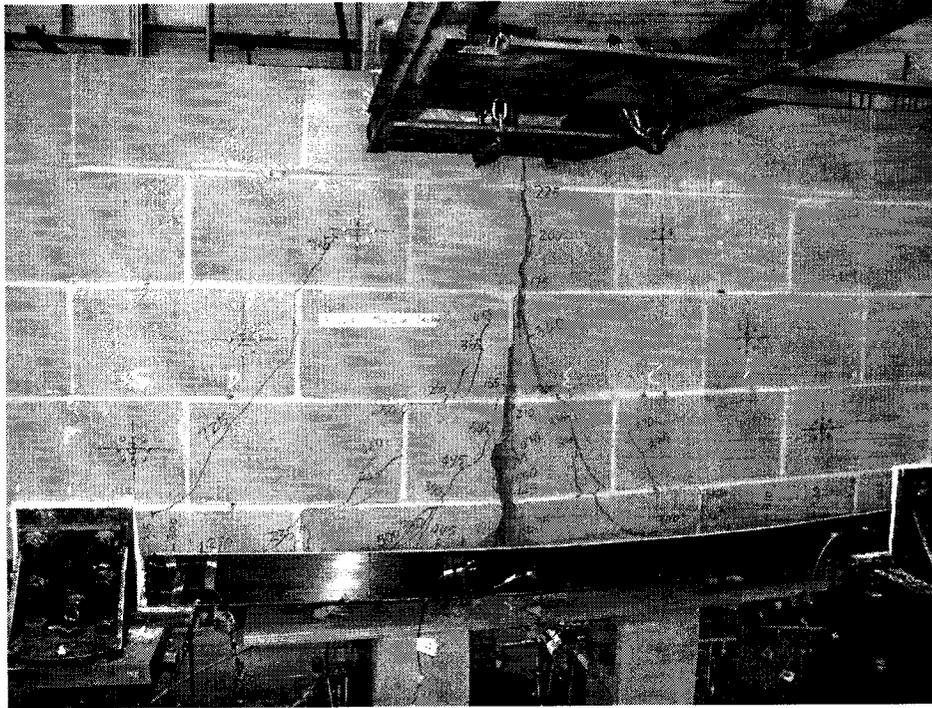
**Image 4-24 Crack Pattern of Beam 7 at Failure**

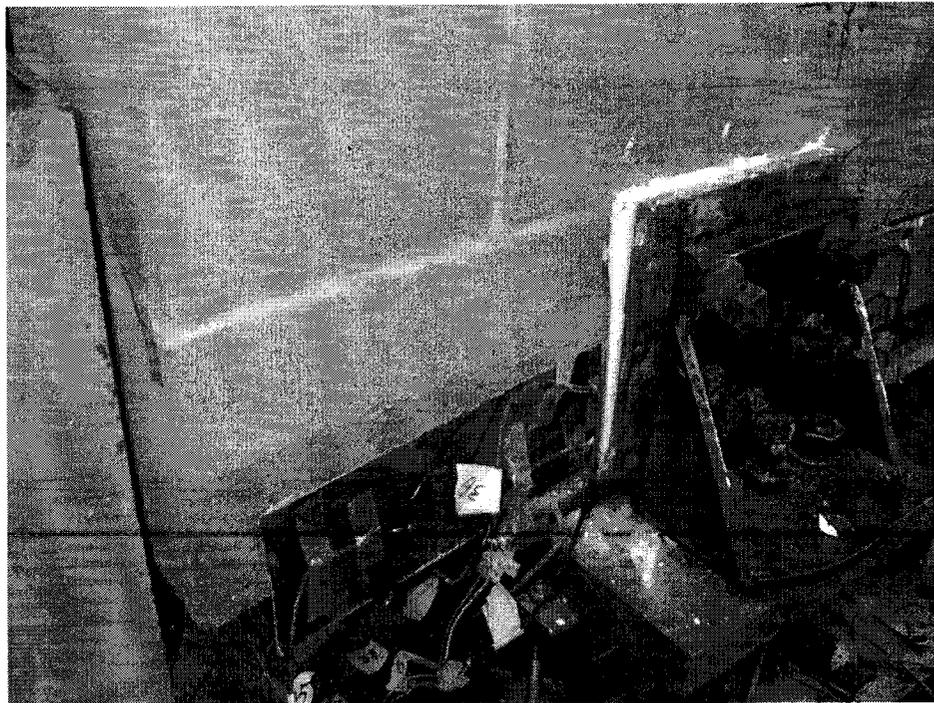
**Image 4-25 Peeling off at the End of Beam 7**

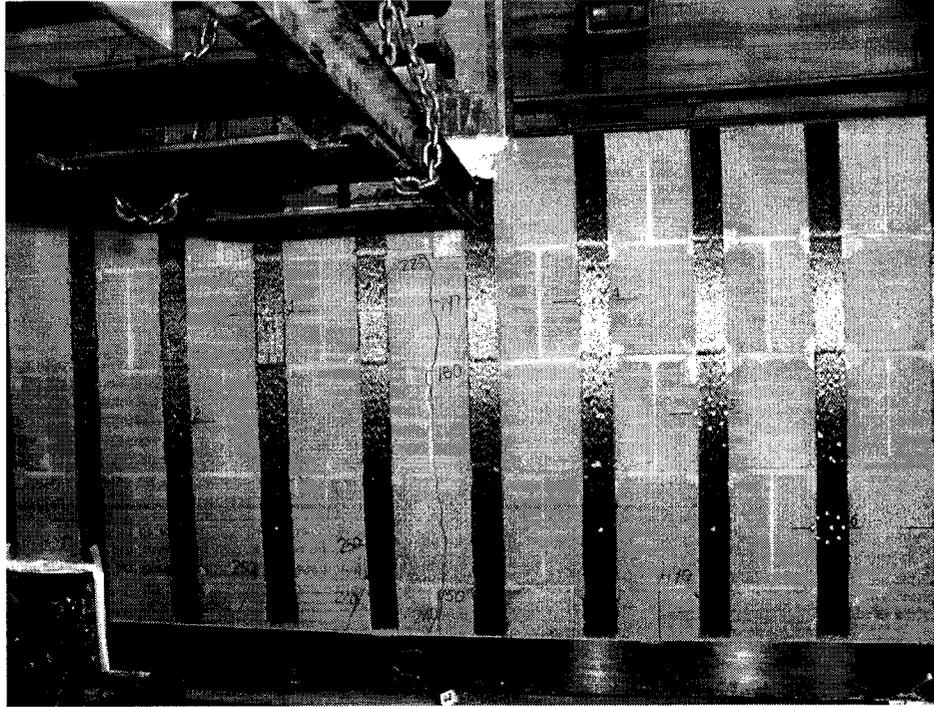
**Image 4-26 Crack Pattern of Beam 8 at the Load of 250 kN**

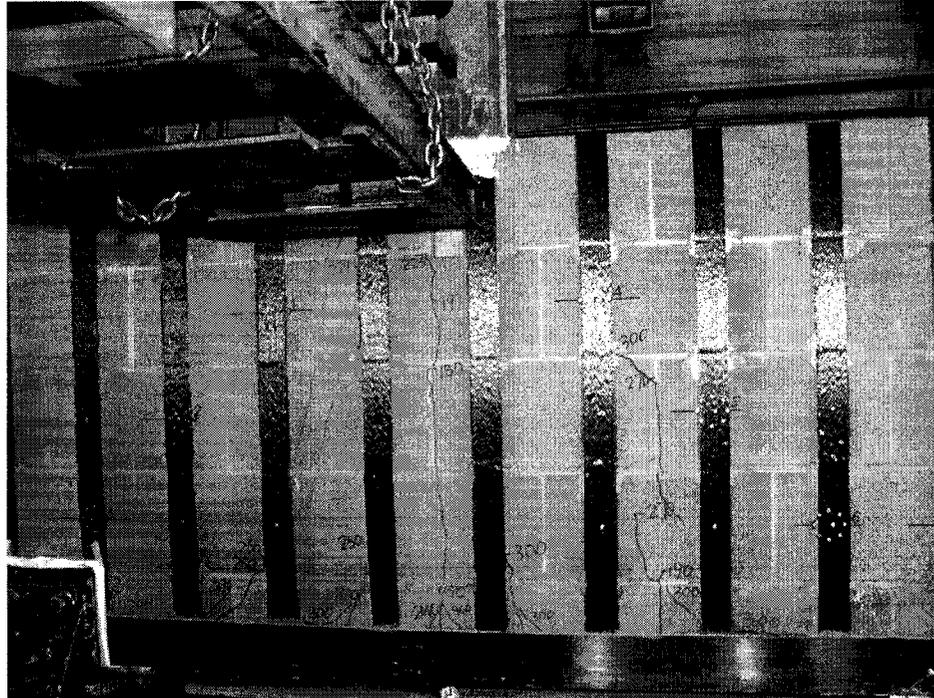
**Image 4-27 Crack Pattern of Beam 8 at the Load of 300 kN**
