**APPLICATION OF CFRP LAMINATES IN THE RETROFIT  
OF MASONRY DEEP BEAMS**

Zhangcheng Hao

**MASTER OF SCIENCE**

**Structural Engineering**

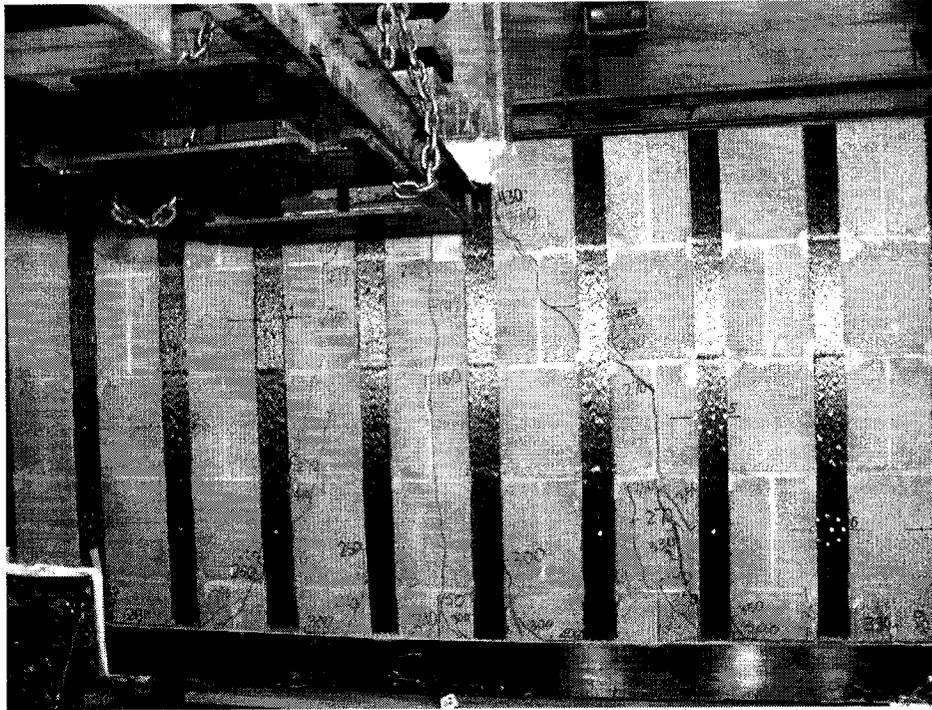
**Image 4-28 Crack Pattern of Beam 8 at the Load of 450 kN**

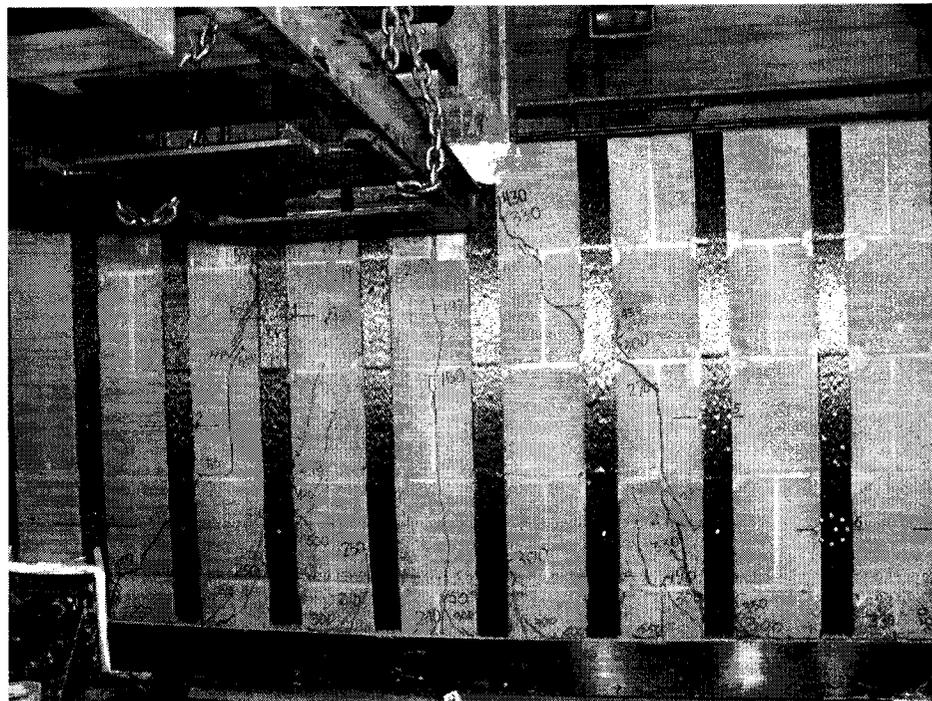
**Image 4-29 Crack Pattern of Beam 8 at the Load of 550 kN**

A primary diagonal shear crack, which is along the line joining the load point and the left support, appeared suddenly at the load of 550 kN, as illustrated in Image 4-29. During this load period, all the widths of inclined cracks increased, and the mid-span flexure crack started extending upward again. After the load reached 585 kN, one more diagonal crack in the right compression strut formed, which developed into the load zone. At the same time, a vertical CFRP sheet, which was crossed by this diagonal crack, debonded

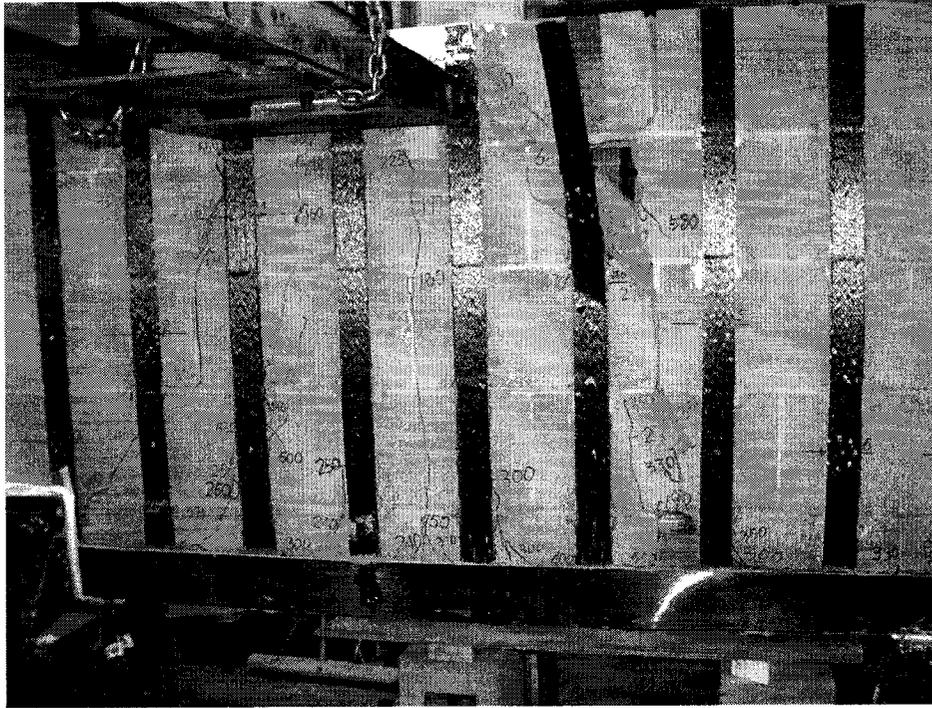
**Image 4-30 Crack Pattern of Beam 8 at Failure**

suddenly and caused the failure of the beam, as presented in Image 4-30. The failure was abrupt and may be classified as a shear-compression failure. The crack pattern indicates that the significant amount of the load was transferred to both supports by the compression thrusts between the load and the reactions.

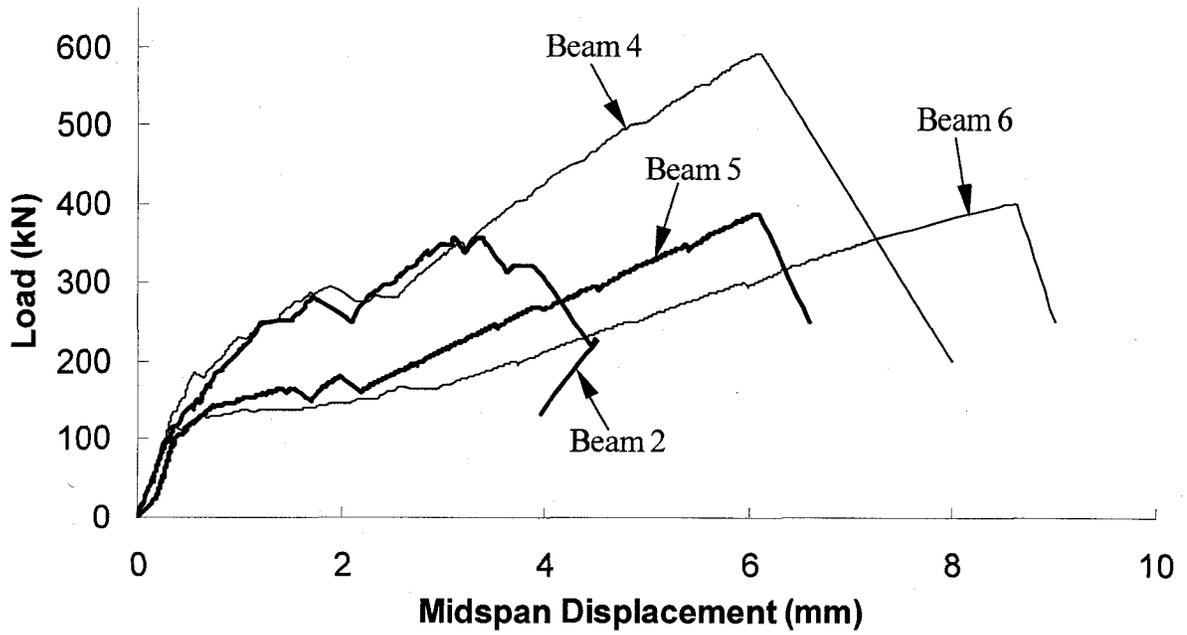
Figure 5-1 Load-Midspan Displacement Curves for Beam 2, 4, 5 and 6

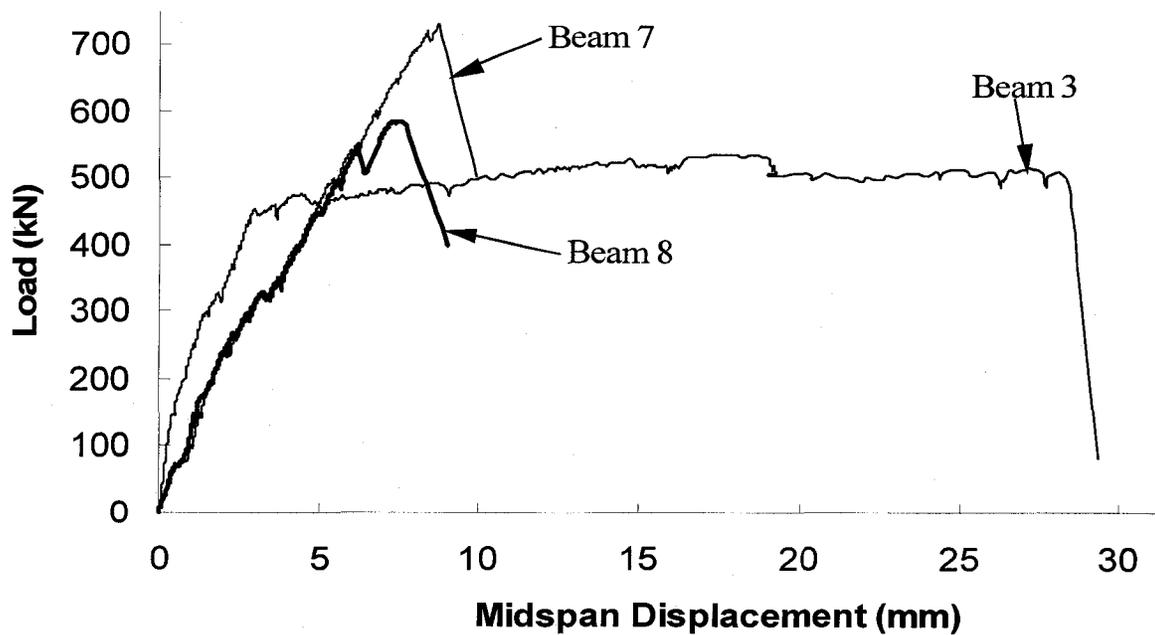
Figure 5-2 Load-Midspan Displacement For Beam 3, 7 and 8

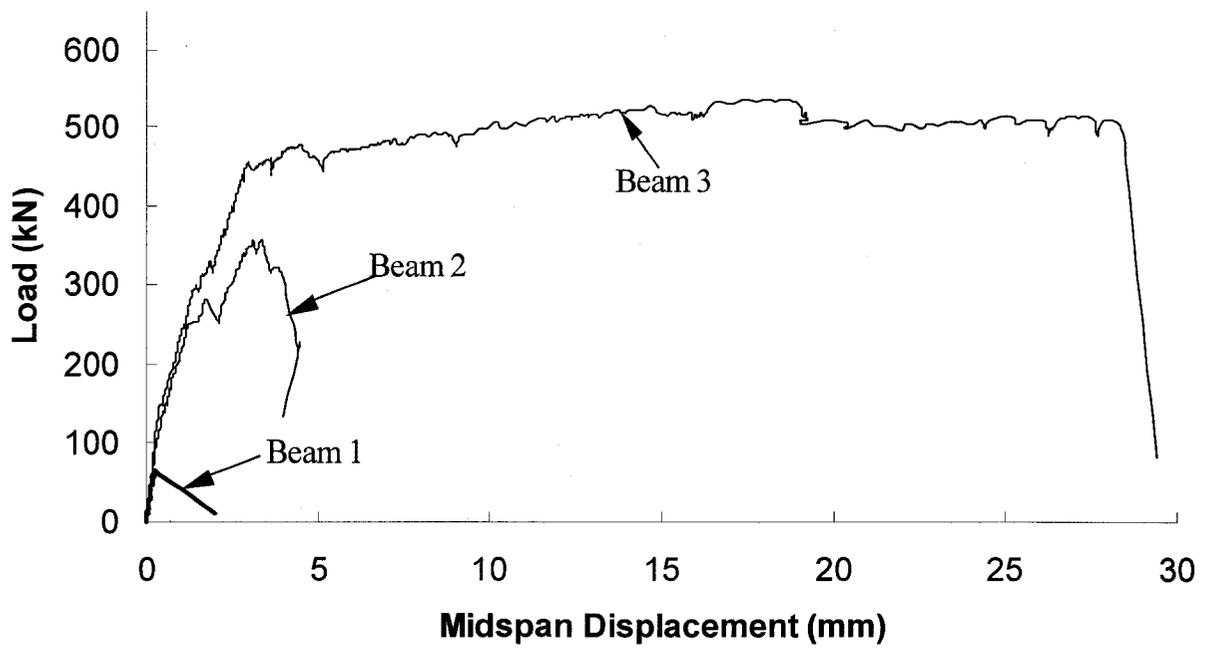
**Figure 5-3 Load-Midspan Displacement for Beam 1, 2 and 3**

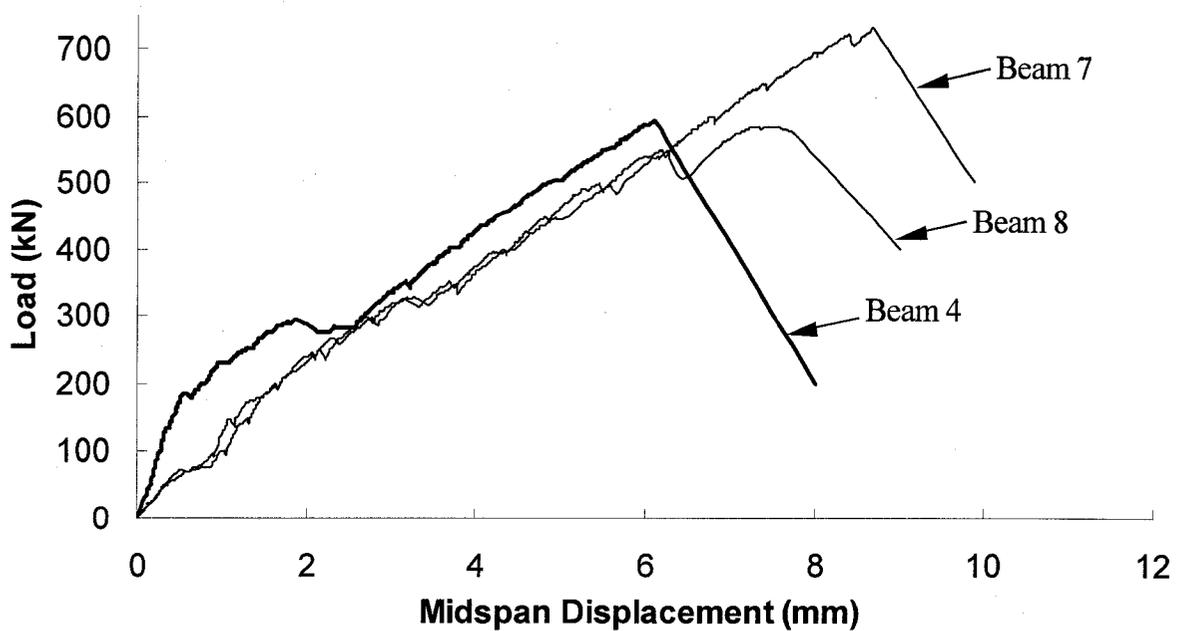
**Figure 5-4 Load-Midspan Displacement for Beam 4, 7 and 8**

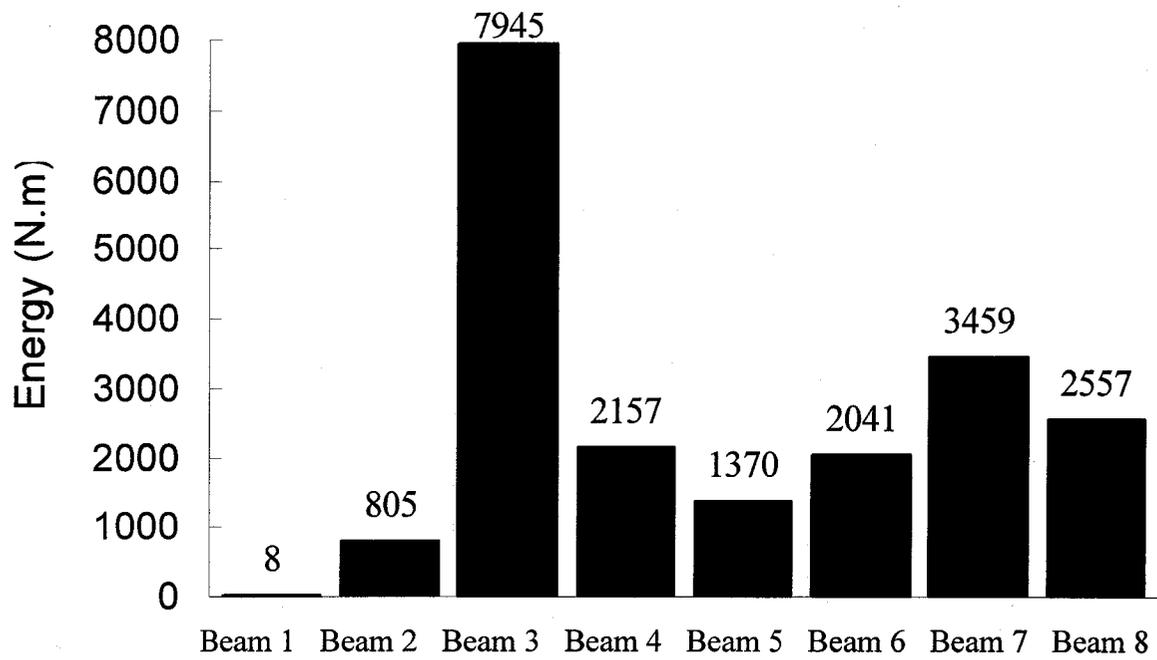
**Figure 5-5 Toughness of Specimens up to Peak Load**
