Performance of EPB-TBM in Mixed Face Conditions:

City of Edmonton South LRT Extension – University Station to Health Sciences Station

A thesis submitted to the Faculty of Graduate Studies and Research in partial fulfilment

Geotechnical Engineering

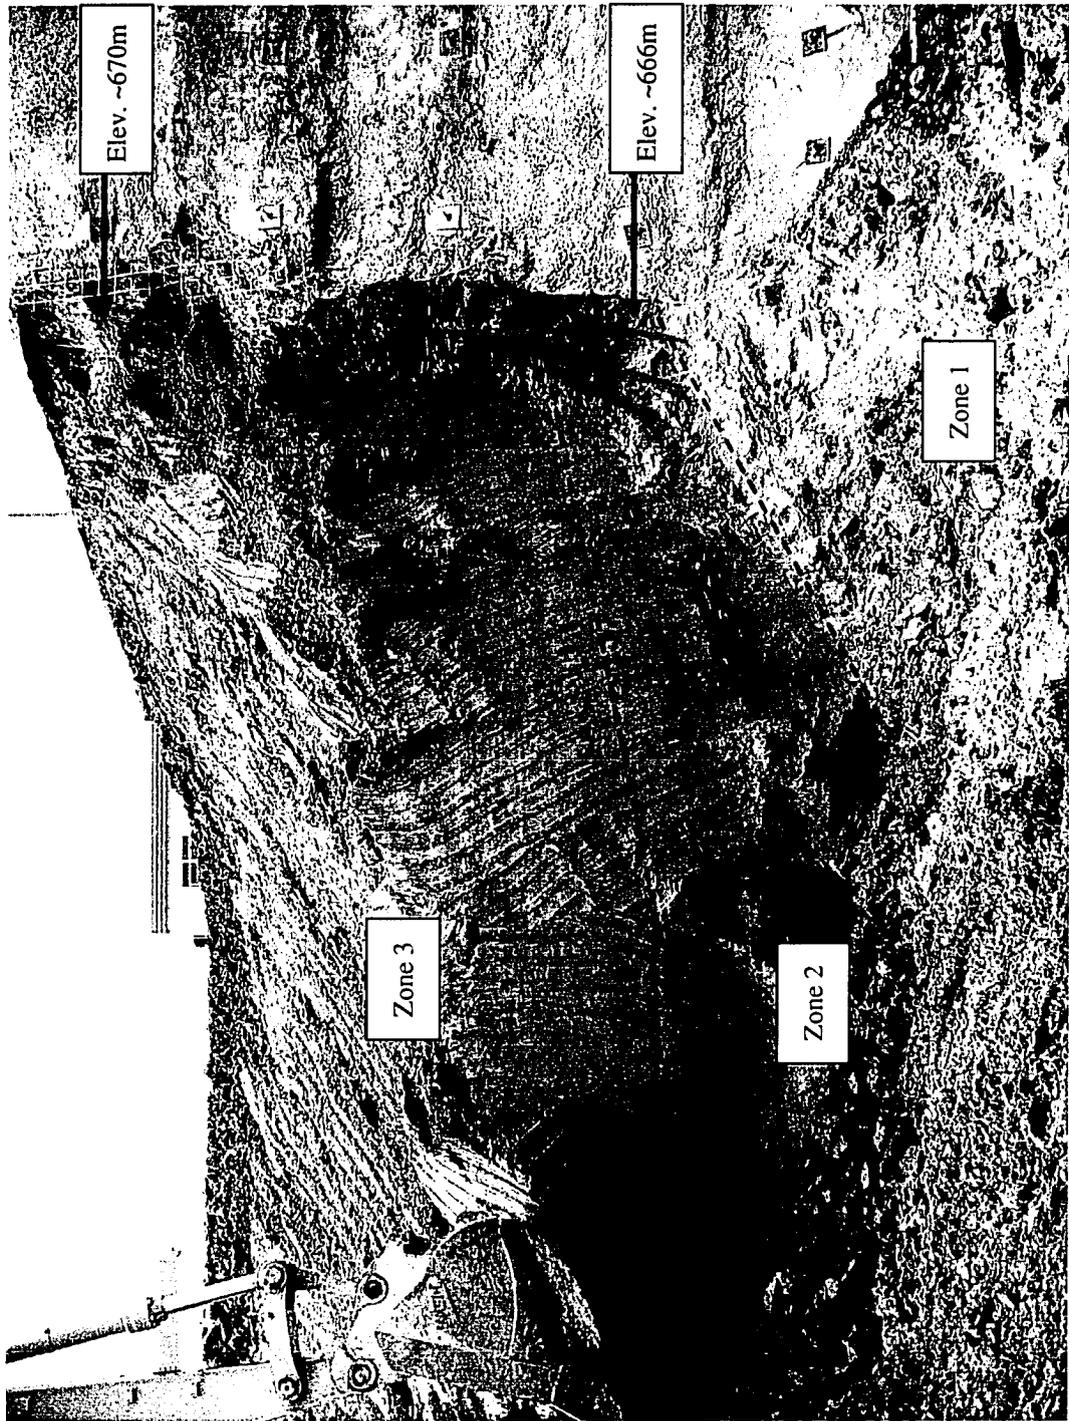
Figure 3-4 Transition zone between Outwash Sands and Silts and Lake Edmonton Clay.

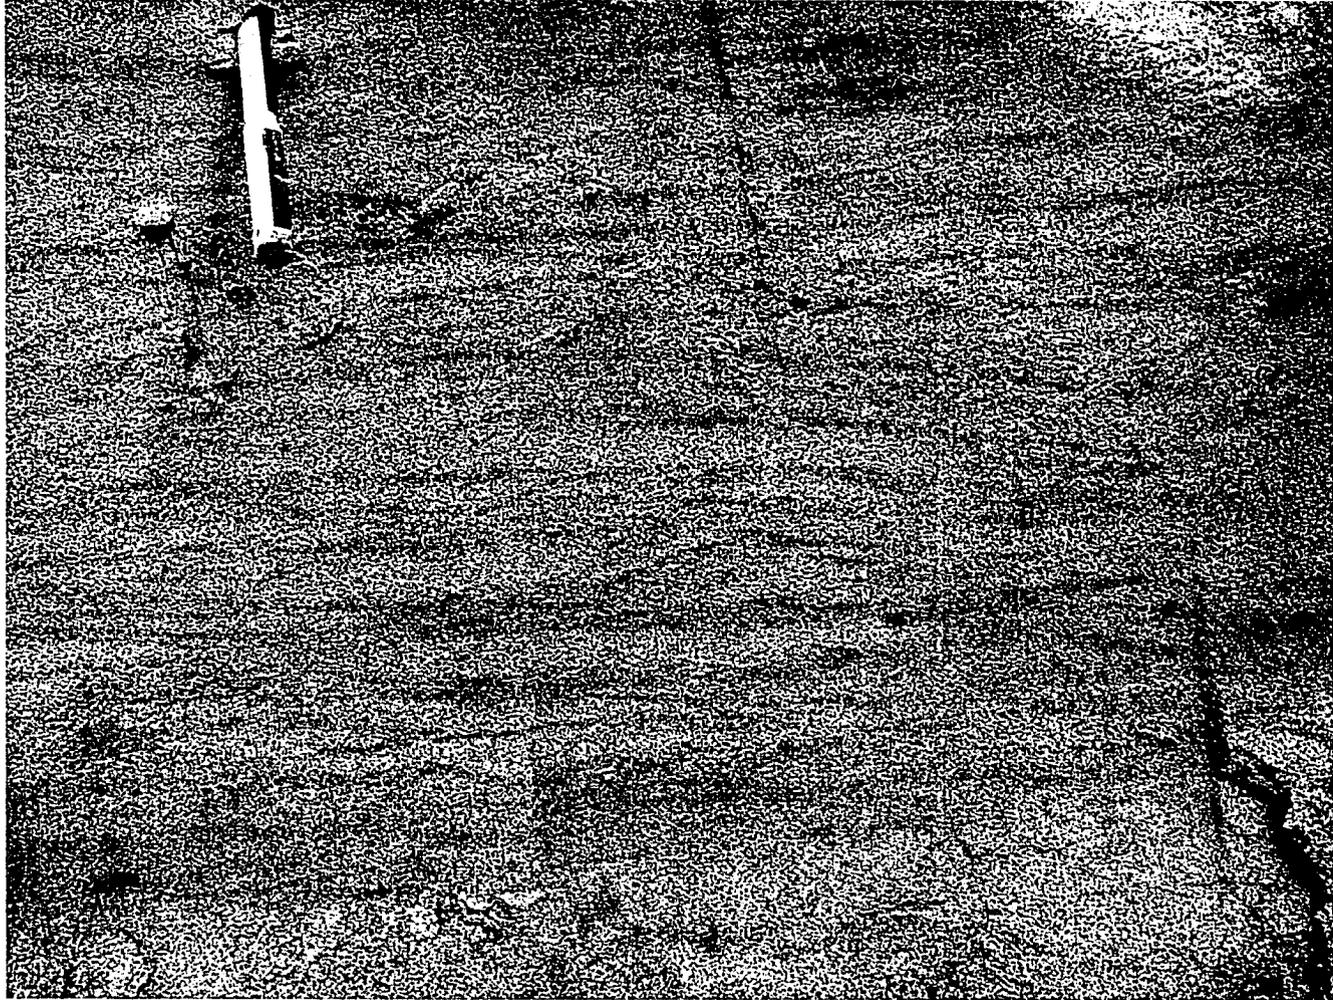
Figure 3-10 Enlargement of sand with silt inter-bedding visible in Figure 3-7 (elevation ~660.5, ~1.3m west of East Wall).

Figure 3-7 is located at the same elevation as Figure 3-6, along the East Wall of the excavation facing south. In contrast to Figure 3-6, Figure 3-7 presents a face with large quantities of silt present. At elevations below ~660.8m the appearance of the East face was of silt filaments within sand. Figure 3-10 (p 45) provides a more detailed view of the scale of this formation. Above an elevation ~660.8m, the material quickly transitions to sandy silt which then transitions several more times between sandy silt and sand with trace silt content and coal flakes. Another significant feature of the East Wall was the ripple formations present containing coal flakes. Throughout the excavation, the occurrence of coal flakes within the Outwash Sands and Silts was not particularly unusual. Although it was observed that the coal flakes appeared to largely be confined to areas of cleaner sand. Figure 3-11 (p 46) provides a more detailed view of this formation of coal flakes within the paleoripples.

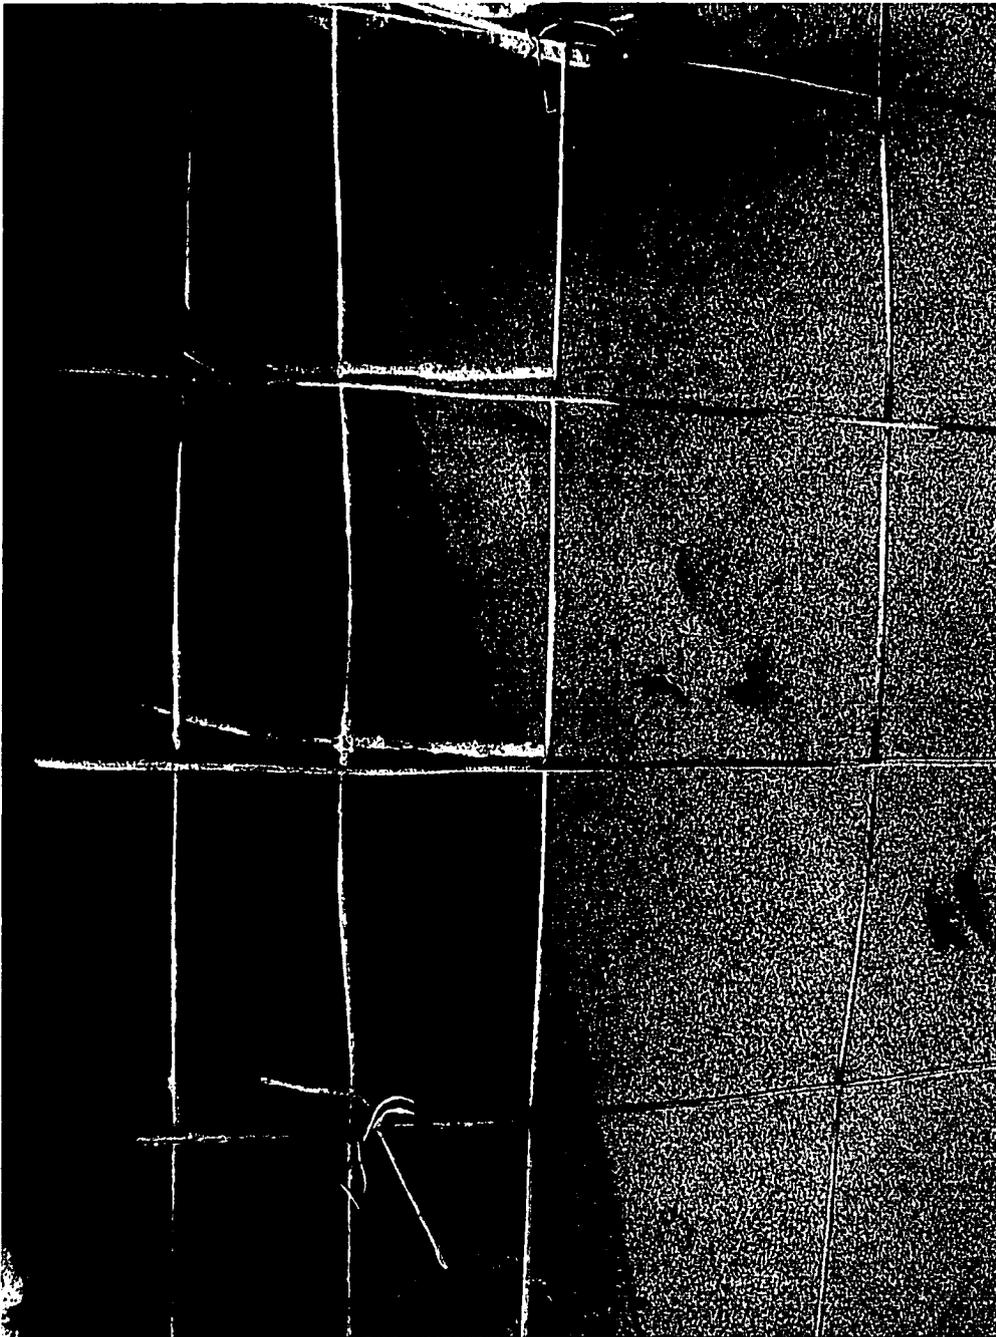
Figure 3-14 Transition from clean sand to sand with silt stringers (elev. 666m).

The exposed area was 3m vertical, and approximately 1.3m in width. The area exposed was located towards the West Wall of the portal, and some 6m behind the soil face that was shown in Figure 3-6 (p 41). The lines of red spray paint visible in the figure mark off 1m intervals. Visible in the exposed face, a number of clear soil transitions can be observed. Figure 3-13 (p 48) is a closer view of the exposed face at an elevation of 665.5m. In this photo, the rapid transition from relatively silty material to clean sand with large amounts of coal occurs over a very short vertical distance. Another example of this rapid transition can be found in Figure 3-14 (p 49) which shows the transition from relatively clean sand to sand with extensive silt stringers.

These siltier regions of the Outwash Sands and Silts can be grouped into two forms. The first form is that of interbedded sands and silts. Examples of these can be observed on a small scale in Figure 3-14 (p 49), and on a larger scale in Figure 3-7 (p 42). The second form is that of a massive body of silt located within the material. Examples of this form can be seen in Figures 3-12 (p 47) and 3-13 (p 48).

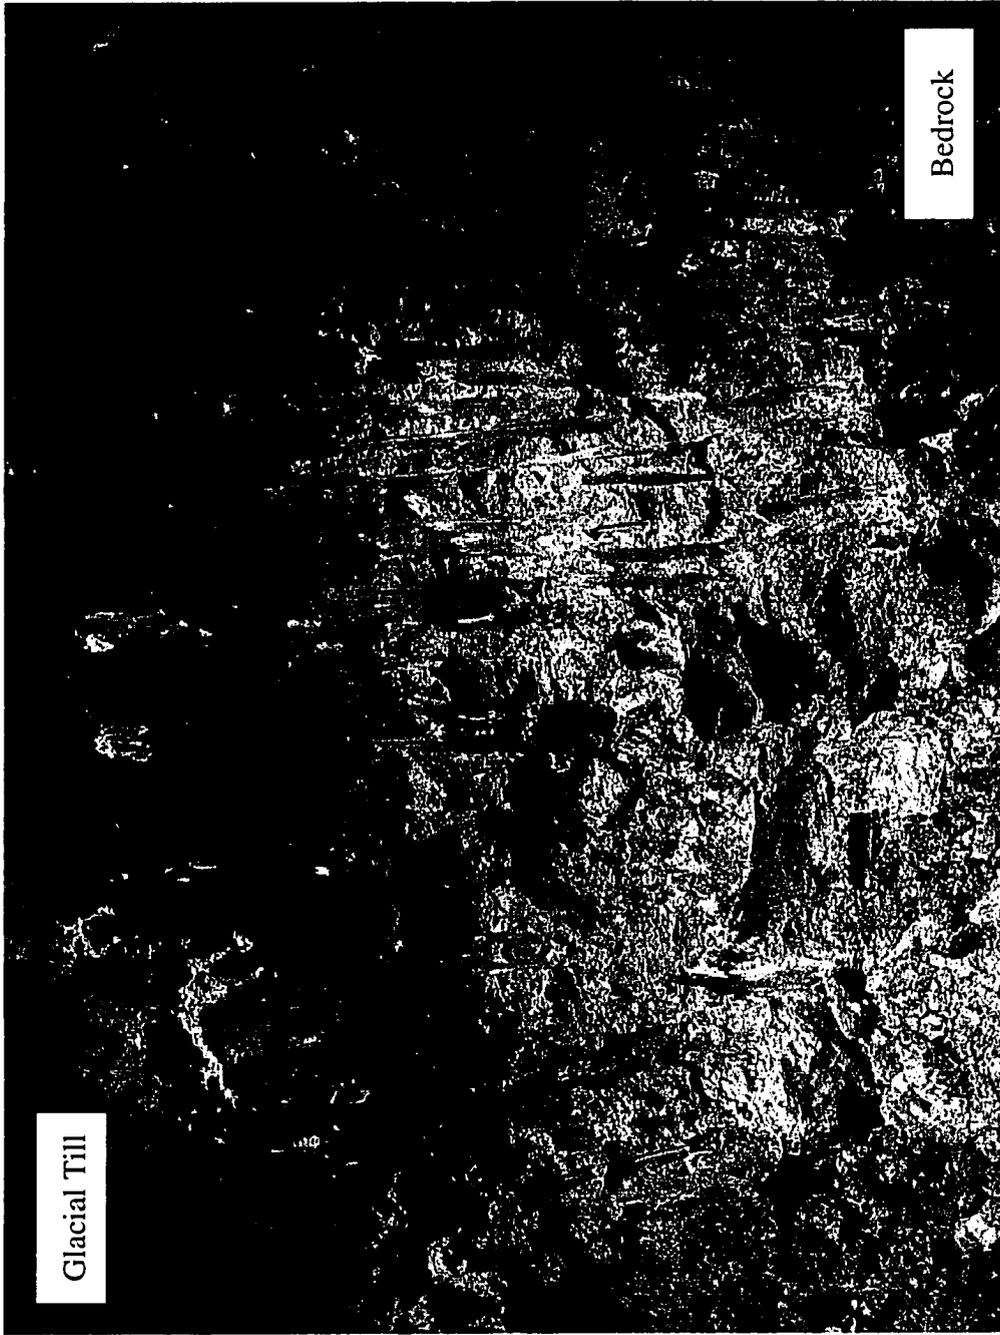
Figure 3-31 Transition from Bedrock to overlying Glacial Till (elev. ~653m).

During the glaciation prior to the deposition of the Glacial Till, the surface of the bedrock underwent extensive excavation and reworking. As a result, the zone of clay shale encountered in tunnelling is heavily slickensided as a result of the stresses placed on the bedrock by the movement of the glaciers. Figure 3-30 (p 67), taken during the construction of the removal shaft, shows the relatively clear transition between the light grey bedrock and the overlying glacial till. Figure 3-31 (p 68) taken at the same time as Figure 3-30 also illustrates the transition between bedrock and glacial till.

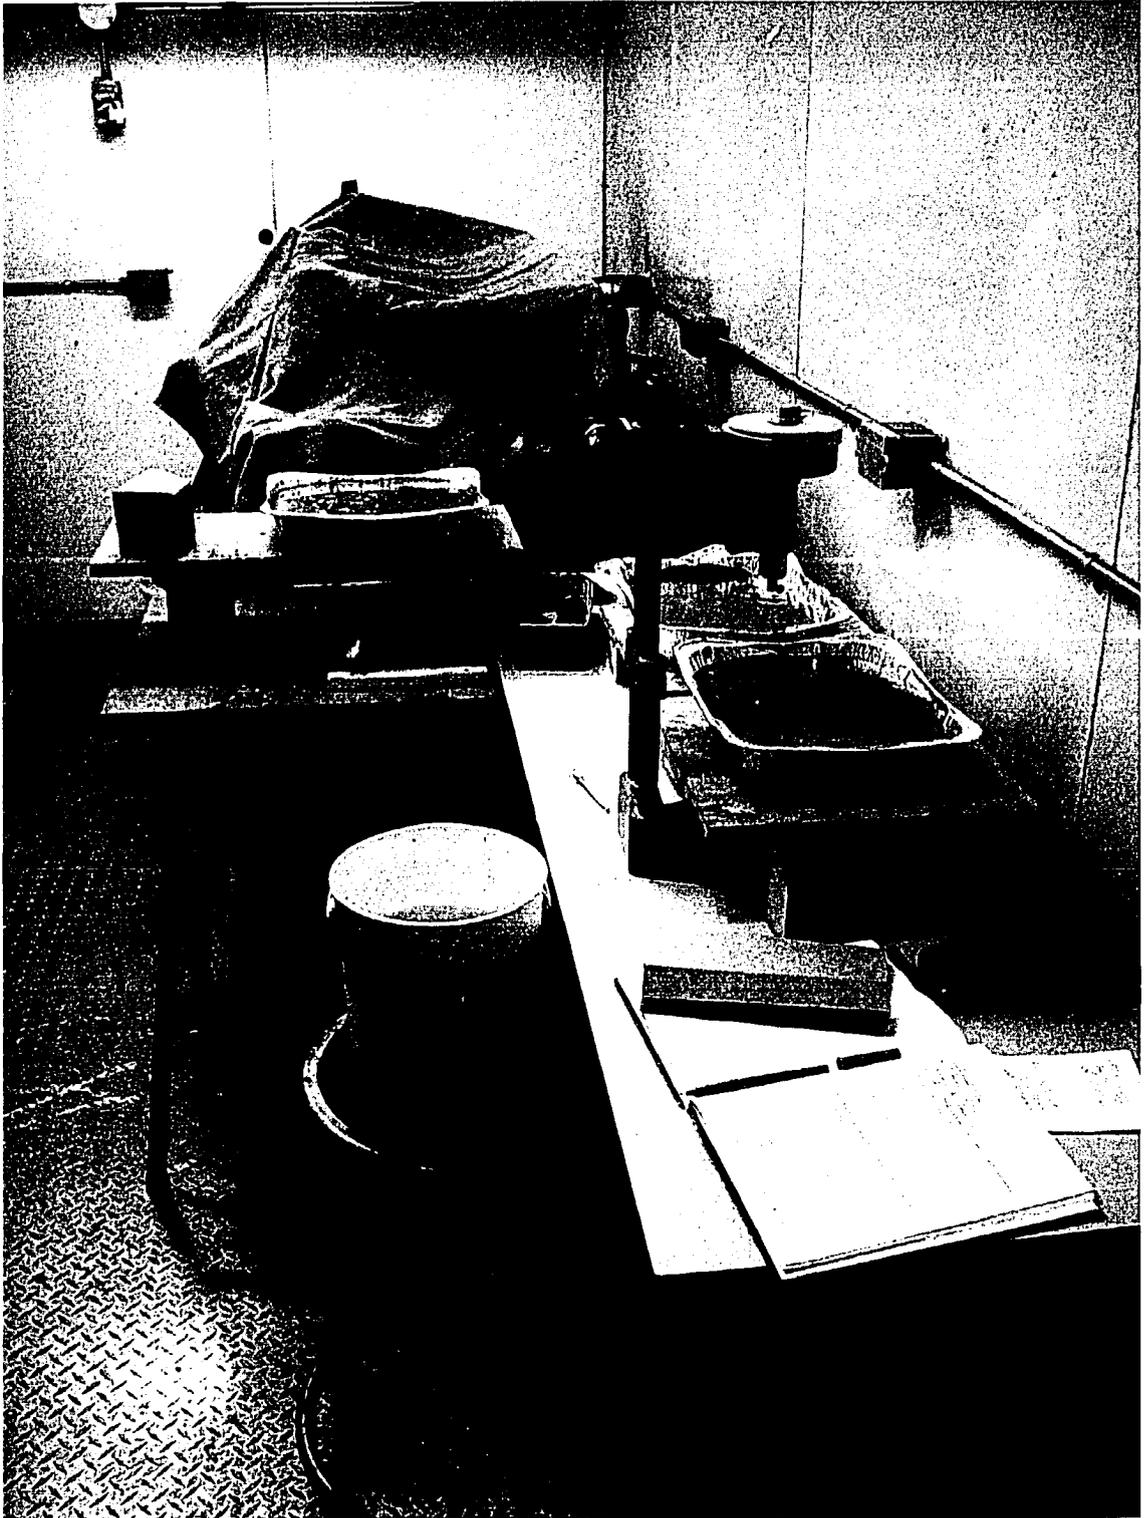
Figure 4-49 Set-up for testing of grout.

A series of vane shear tests were conducted on collected grout samples to develop a strength profile with time. The test was conducted using grout mixture '3' as identified on Table 4-1 (p 141). Samples were collected on the morning of January 19, 2004, and tested. The sample collected was taken to a cold room, poured into multiple trays, and allowed to set. The temperature of the cold room was maintained near 7C to approximate the in-situ ground conditions. Figure 4-49 (p 143) shows the set up for experiment, and Figure 4-50 (p 144) a tray of grout.
