Structural Engineering Report No. 205

Shear Strengthening of Concrete Girders Using Carbon Fibre Reinforced Plastic

by
E.H. Drimoussis
and
J.J.R. Cheng

October, 1994

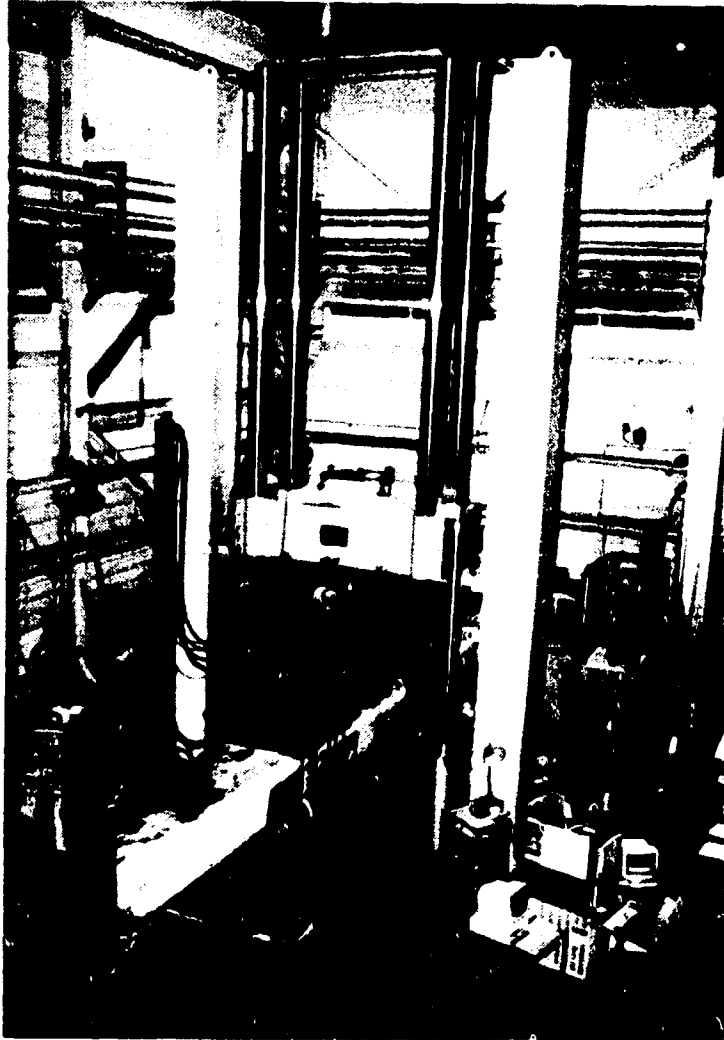
Figure 3.20 Overview of test set-up

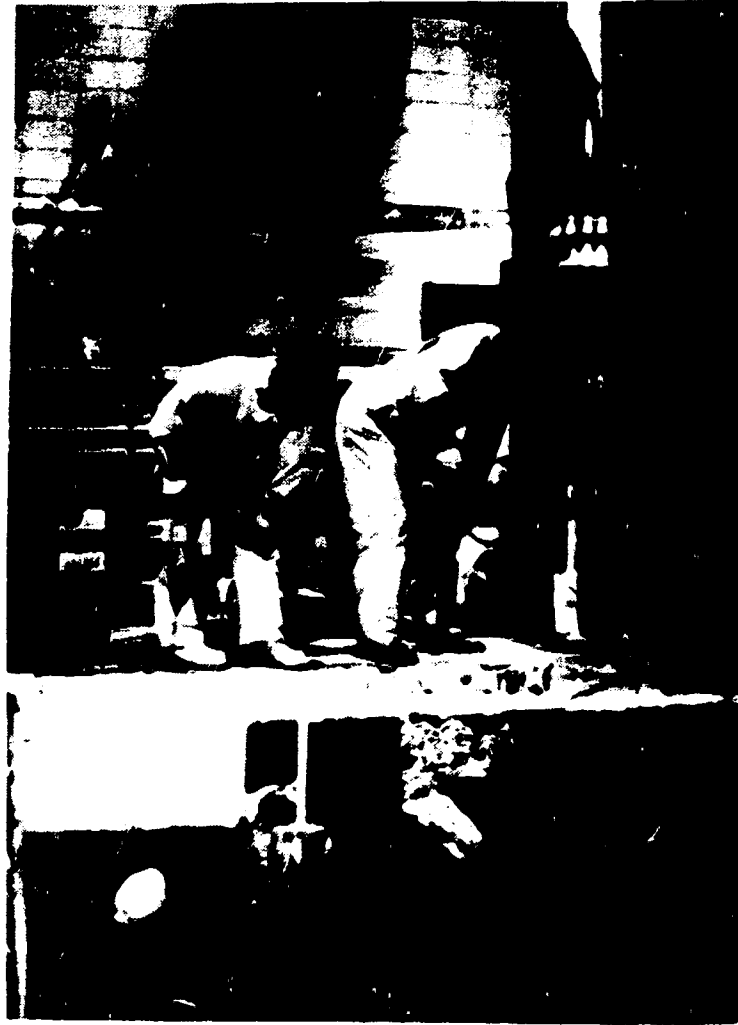
Figure 3.26 Installation of external repair stirrups

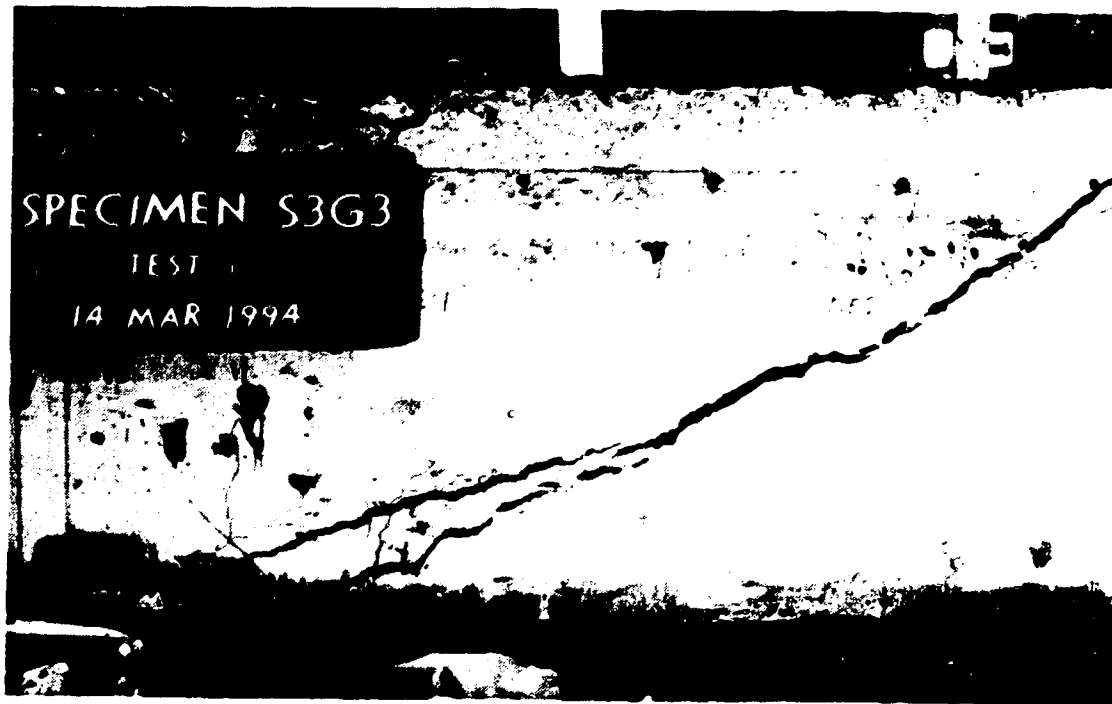
Figure 4.28 Girder 3, Test 2 - North West leg - Interior face of web

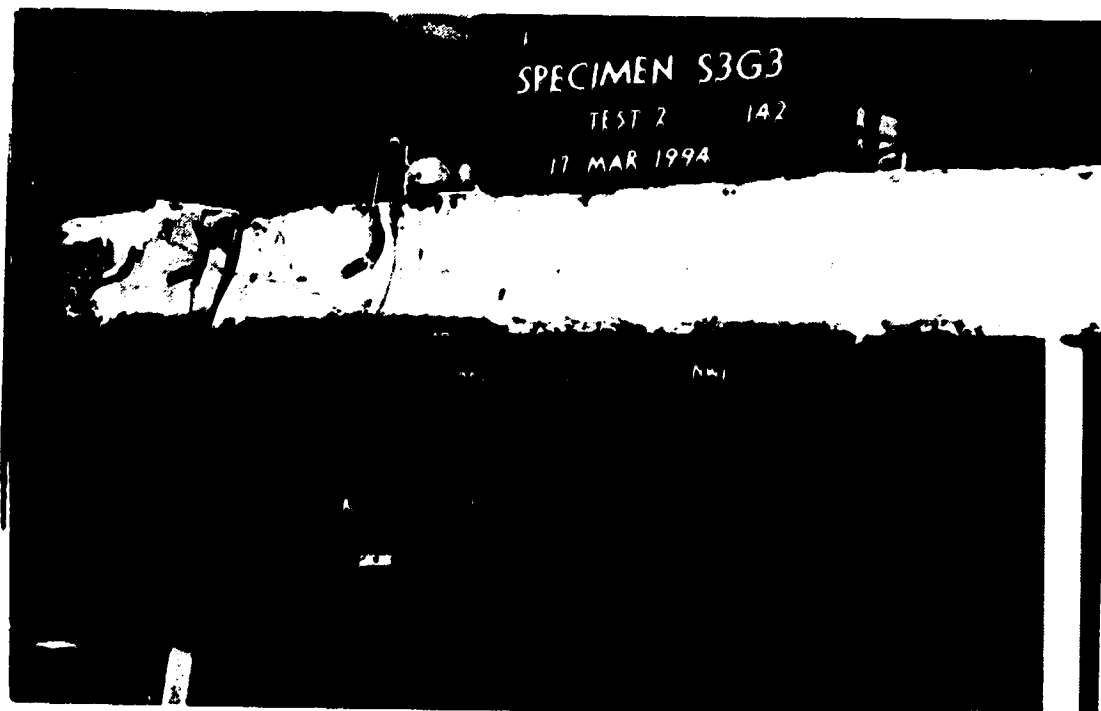
**Figure 4.31 Girder 3, Test 2 - South West leg - Exterior face of web -
Load step #142**
