Hazard Analysis of Reactivated Earth Slides in the Thompson River Valley,
Ashcroft, British Columbia

Doctor of Philosophy
in
Geotechnical Engineering

Department of Civil and Environmental Engineering

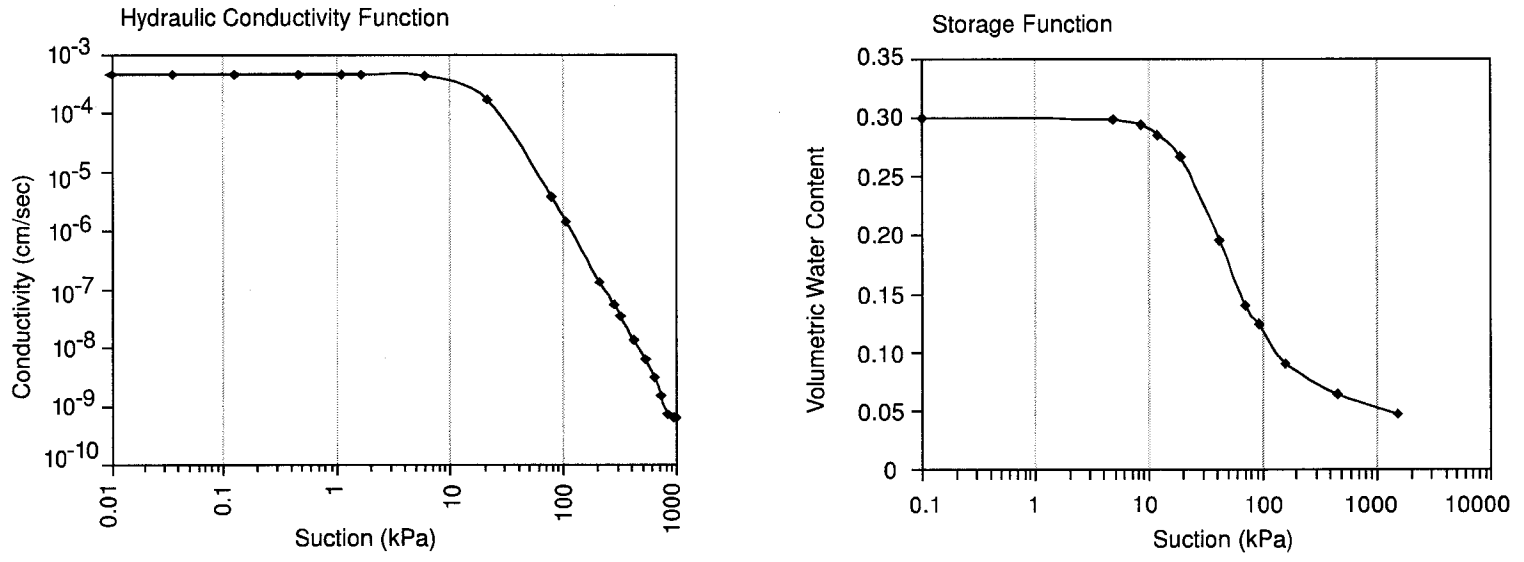
Figure 4.8. Hydraulic conductivity function and storage function for glacial till in Slide CN50.9.

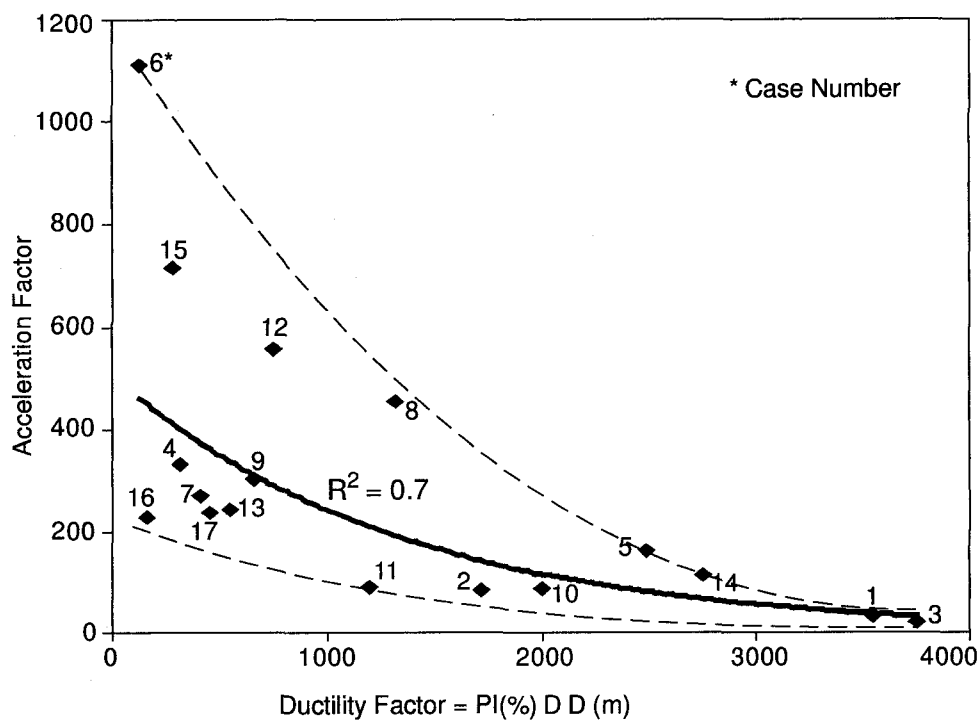
Figure 5.9. Acceleration Factor (A.F.) versus Ductility Factor.

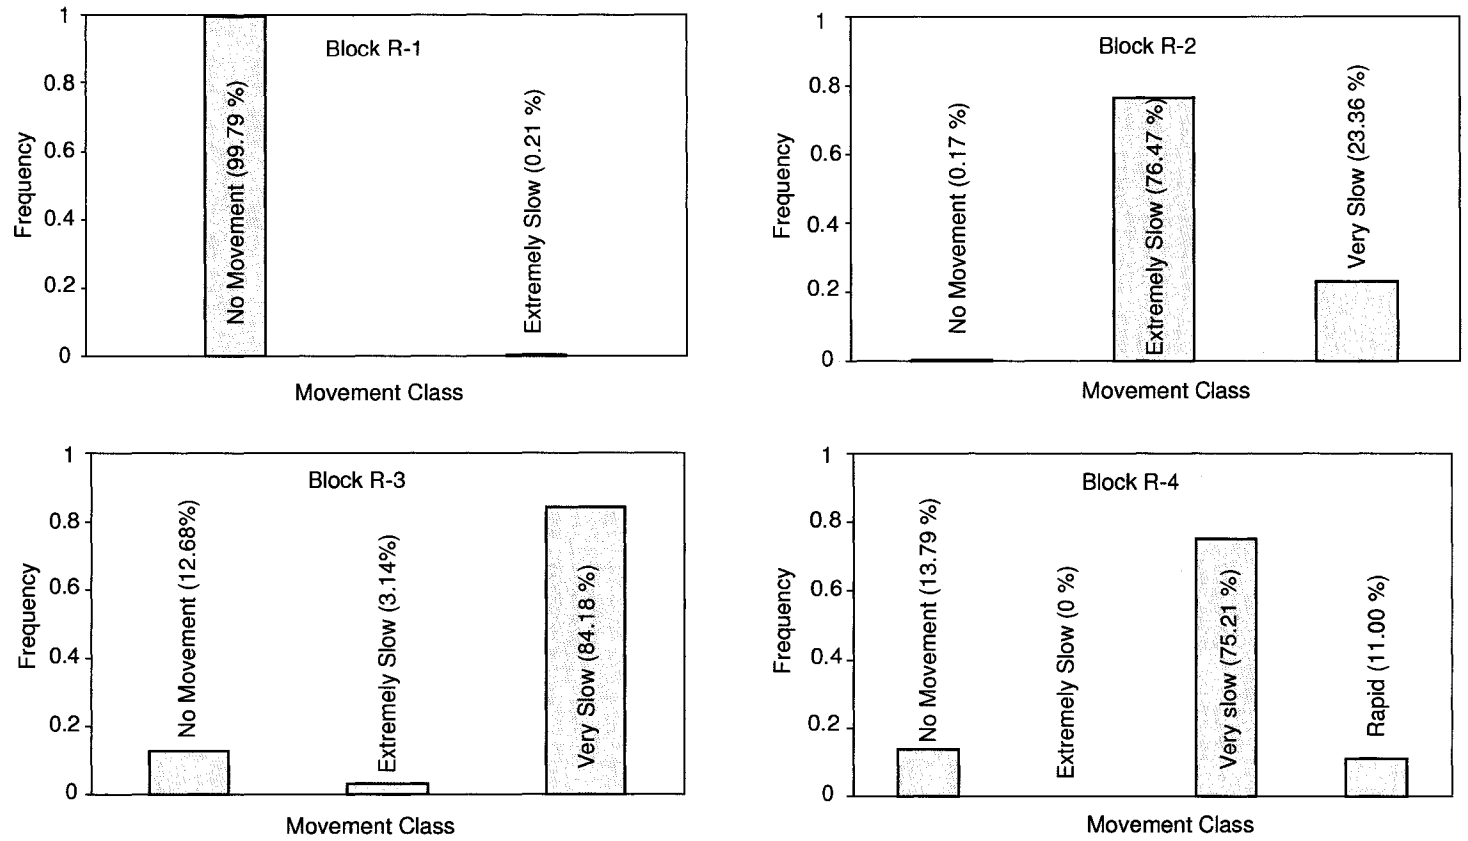
Figure 6.22. Frequency of different movement rate classes for reactivation blocks defined within Slide CN50.9. The duration of calculation is the design life time of the railway (100 years).
