**Stream Modifications to Enhance Fish Habitat in
Arctic Headwater Systems**

Gregory James Courtice

A thesis submitted to the Faculty of Graduate Studies and Research
in partial fulfillment of the requirements for the degree of

Water Resources Engineering

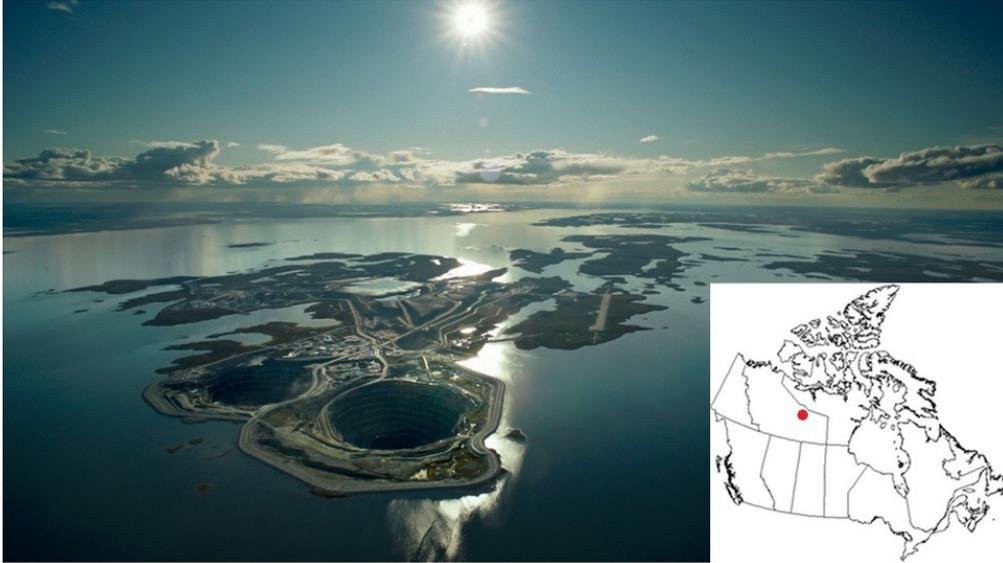
Figure 2.1: DDMI mine site is located 320 km northeast of Yellowknife, NWT in the Barrenlands region. The two open pits located in the image foreground were constructed over the Lac de Gras lake bed through the installation of dyke systems to allow for de-watering. The mine footprint caused extensive fish habitat loss, triggering habitat compensation projects to help offset environmental impacts. Photo courtesy Diavik Diamond Mines, Inc.

DDMI is located approximately 320 km northeast of Yellowknife, NWT in the Barrenlands region of Canada (Figure 2.1). The mine is approximately 100km north of the tree-line and falls within the Southern Arctic Ecozone (Environment Canada 1991). The Barrenlands feature relatively low topographical relief (<50 m) and 21% of the area is covered with interconnecting chains of lakes and streams (Jones et al. 2003a). The region receives approximately 200-300mm of precipitation annually (ca. half as snow) and the mean annual temperature is -12°C (Environment Canada 1991). The permafrost layer is continuous. Spring freshet in streams begins around

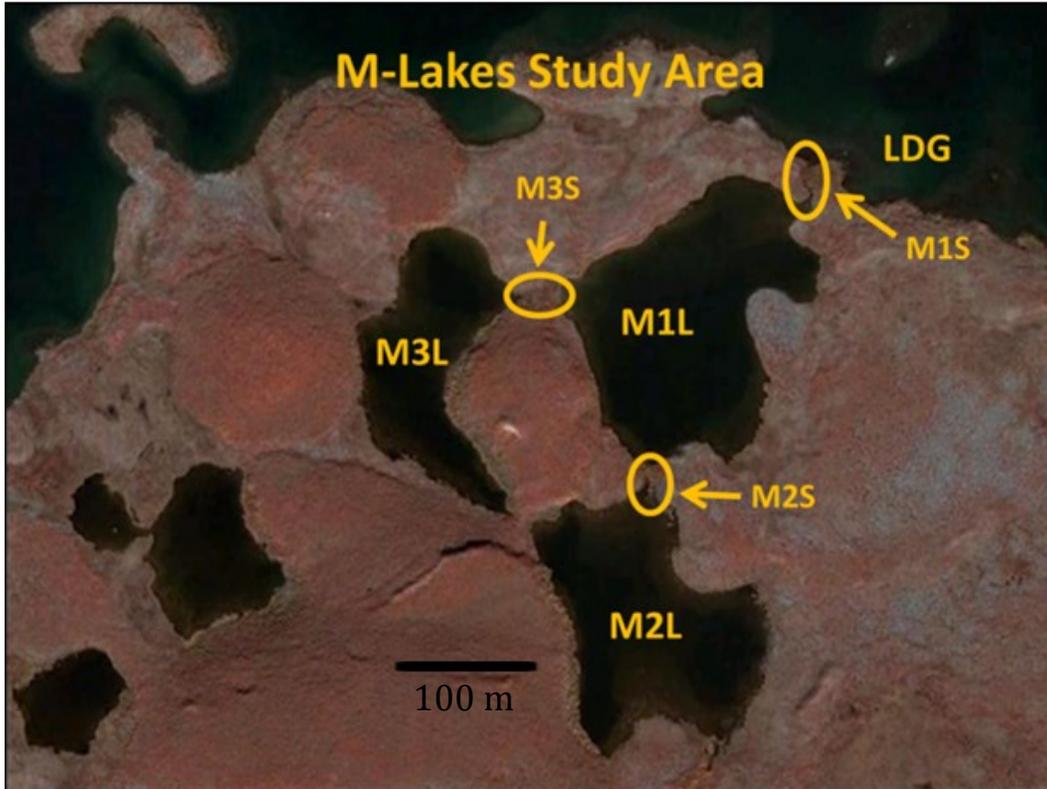
Figure 2.2: The M-Lakes system consists of two headwater lakes (M2L and M3L) that flow into a third lake (M1L) via two separate ephemeral streams (M2S and M3S); water then flows into Lac de Gras (LDG) via a third stream (M1S). Image adapted from Google Earth™.

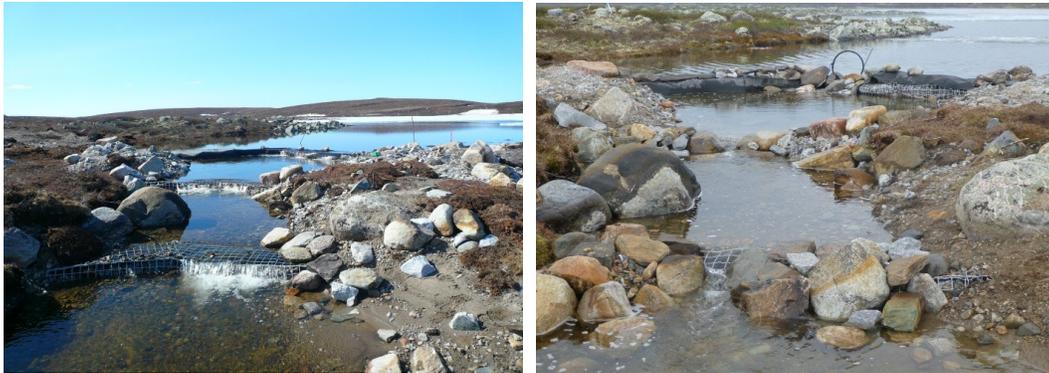
Figure 2.3: Comparison photos of the original gabion structures (left) and retrofitted boulder structures intending to enhance lake-stream connectivity suitable for fish migration. The original gabion structures were found to be ineffective through a preliminary ecohydraulic evaluation during 2012 freshet and were retrofitted fall 2012. The structures shown include the three most upstream structures (weirs 1, 2, 3) of M1S, with M1L shown in the background; photos taken 2 June 2012 and 15 June 2013, respectively. The hoop-like structure in 2013 is a PIT-tag antenna to monitor fish movement. Weirs 1, 2, and 3 are shown.

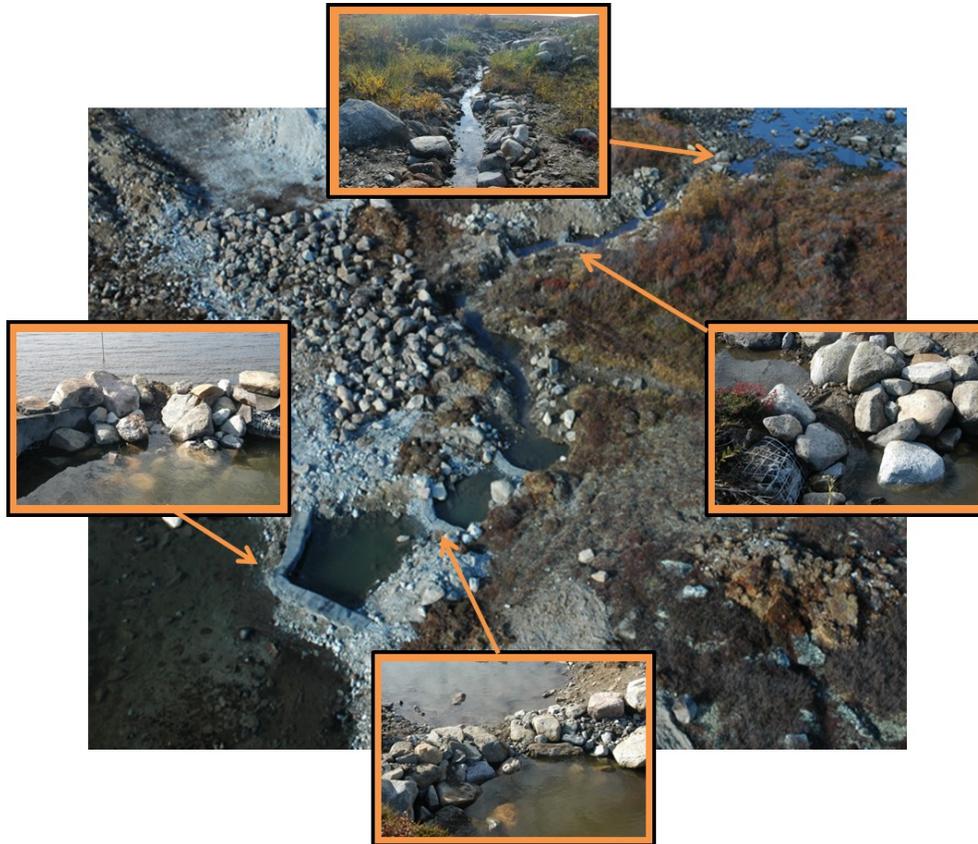
Figure 2.4: Aerial photo of M1S with original gabion structures. Overlaid images depict the location and details of various retrofitted structures including weir one (left), weir two (bottom), weir five (right), and the channelized M1S-LDG connection (top). Aerial photo courtesy of Praetorian Construction Management.

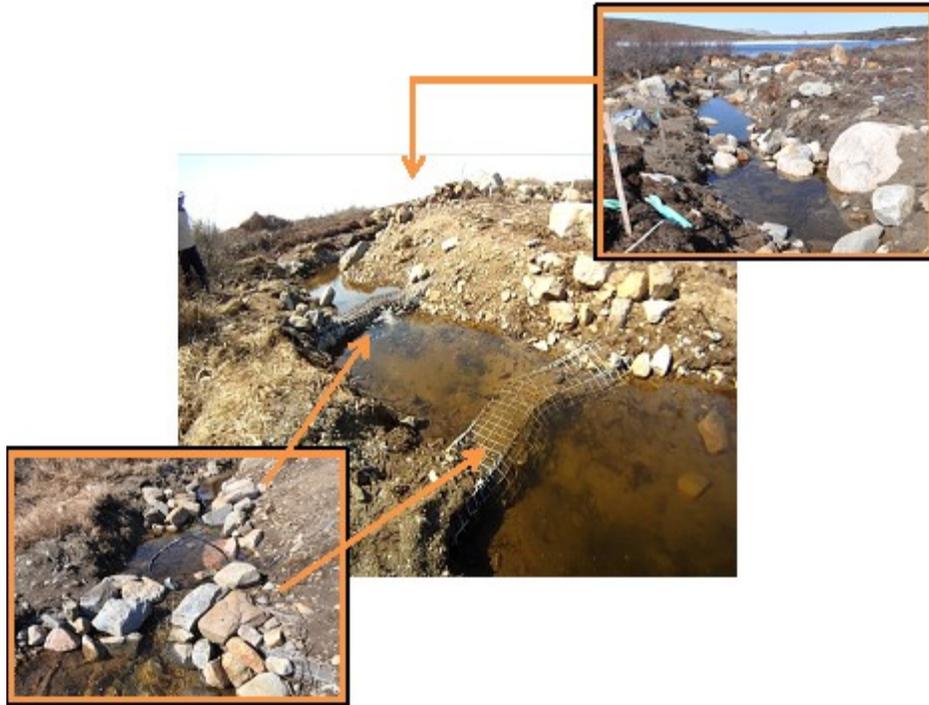
Figure 2.5: Image of M3S with original gabion structures at weirs four (left) and five (right); image is facing upstream towards M3L. Overlaid images depict the location and details of various retrofitted structures including weirs four and five (bottom left overlay) and weir two with additional minor boulder structures (top right overlay). Top right overlay image is located behind the bank in the main image and is not visible.

On 12 June 2012, weir two of M3S critically failed and no longer retained water. Consequently, new sediment was observed immediately downstream of the gabion. This indicated that failure likely resulted initially from a large pressure differential above and below the weir. An investigation of the structure during autumn 2012

determined that an adjacent boulder was forced against the gabion, likely caused by winter frost heave, and pierced through the bituminous liner.

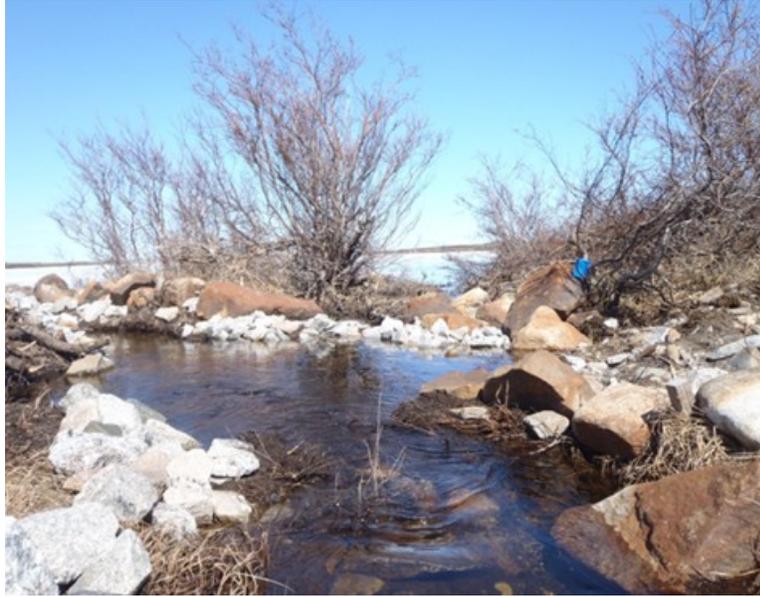
Figure 2.6: M2S choke-and-pool structure, facing downstream towards M1L. Preliminary evaluations indicated project goals were successful for this structure. A retrofit was not necessary unlike M1S and M3S. Fish were documented using M2S in 2012 and 2013.

M-Lakes compensation objectives were to improve connections between lakes, creating conditions favourable for fish passage, by modifying channels, reducing channel slopes, and installing hydraulic structures. A gabion berm was installed between M1L and LDG, increasing the former's water storage capacity to lengthen durations of flow in M1S during high return period events. Six gabion weirs, numbered one (upstream) to six (downstream), were installed in both M1S and M3S to create step-pool structures (Figures 2.3-2.5). The design drop height for these structures coincided with a suggested jump height of 20 cm for Arctic Grayling, *Thymallus arcticus*, reputed to be a species of limited jumping ability (Dillon 2004). Data regarding the downstream water level elevation in M3S was uncertain; M3S weirs five and six were installed to ensure drop heights throughout the stream were no greater than 20 cm. In M2S, one pool was constructed immediately downstream of a single choke-point (Figure 2.6).

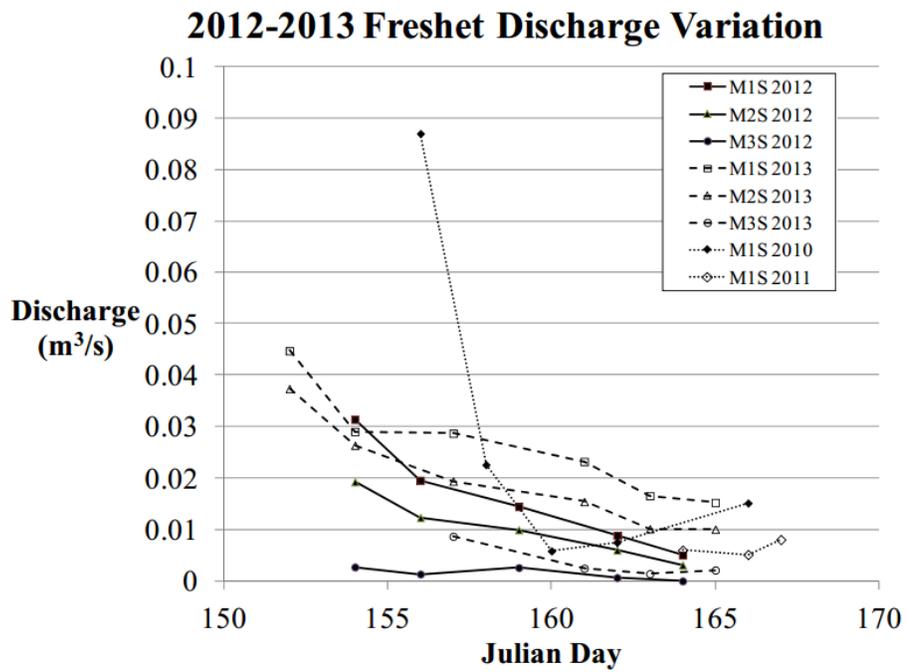
Figure 2.7: Post-construction (2012-2013) freshet direct discharge measurements from the three M-Lakes outlet streams; also shown are 2010-2011 baseline discharge measurements from M1S. Measurement dates were dependent upon logistics of travelling to site.

The lower gross slope of M2S allowed for a less intrusive construction than gabion weirs. The increase in M1L storage further reduced the gross slope to $< 1\%$, creating more desirable flow conditions during freshet. The gross slope, and hence discharge, of M2S became negligible by 12 June 2012 due to increased water retention in M1L (Figure 2.7). Nevertheless, M2S continued to connect the two lakes until late July, when evaporation caused lake levels to decline below the shallowest point in M2S. This point in M2S was approximately 10cm deep at the time discharge functionally ceased. Performance in 2013 was similar, although discharge continued through the entire freshet study period (Figure 2.7), likely due to differences in snowpack and timing of freshet.

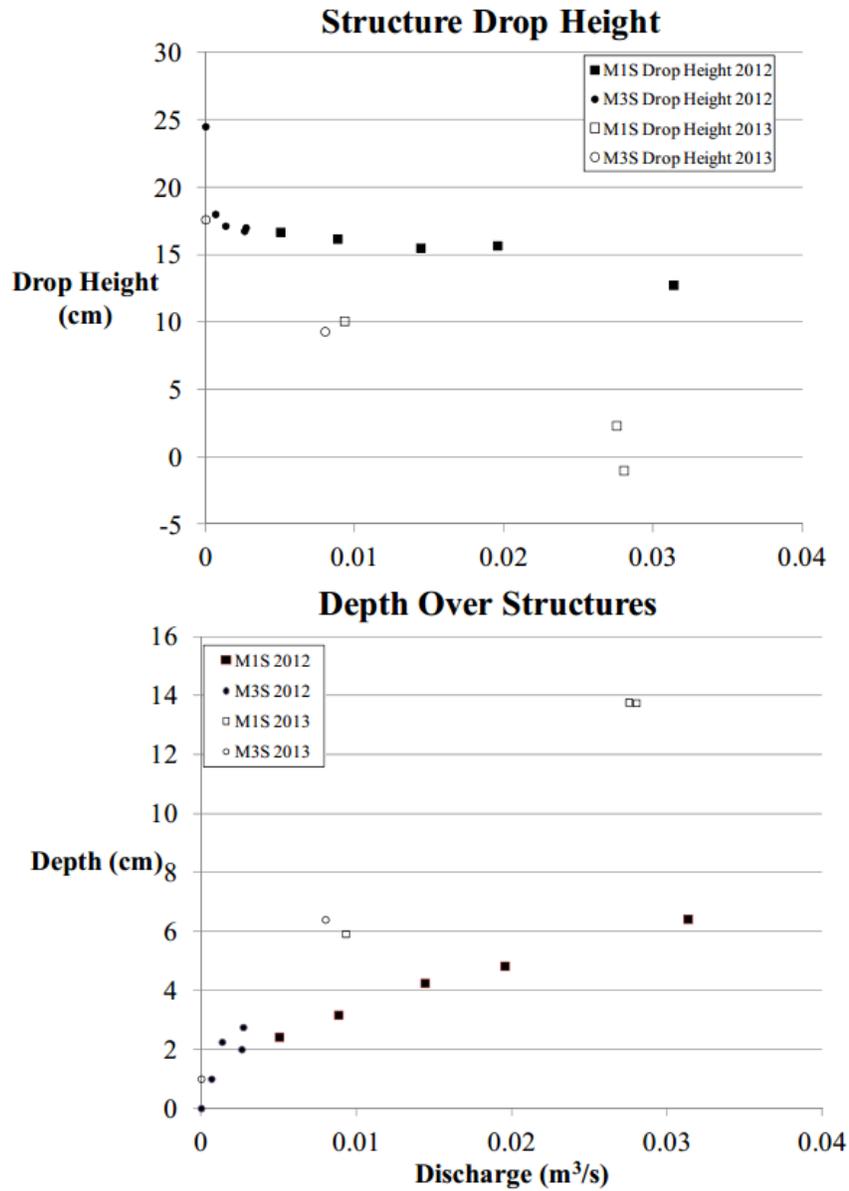
Figure 2.8: Mean drop height and mean depth over structures for M1S and M3S during freshet, before and after gabion retrofitting (2012 and 2013, respectively). Negative drop height indicates submergence relative to adjacent downstream water level.

In 2013, following retrofitting, M1S and M3S maintained lower drop heights than in 2012 (Figure 2.8), although the final structure in M1S (weir six) ended the freshet period at 20cm. Retrofitted structures in M1S also controlled water depths over the weirs more effectively than the original weirs (Figure 2.8). Weir six again became problematic during late freshet, with negligible water depth due to lack of subsequent downstream structures. Water depths in the retrofitted M3S were found to be only slightly greater than in 2012 and again declined to negligible levels within the study period (Figure 2.8).

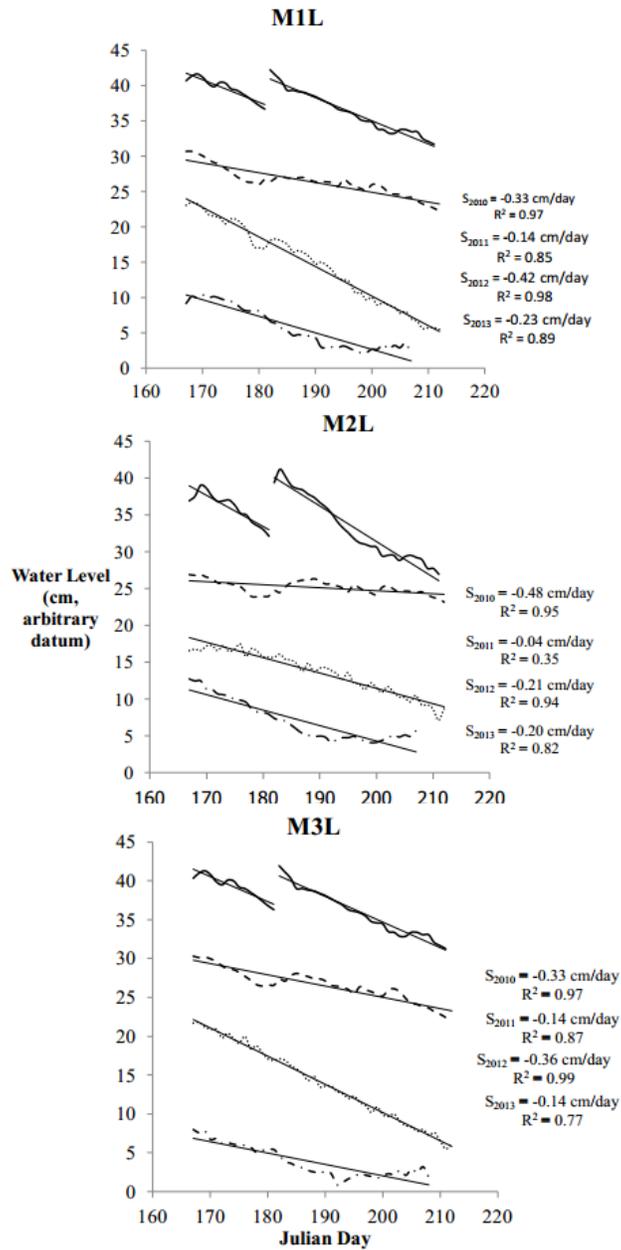
Figure 2.9: Comparison of daily averaged M-Lakes water storage trends. Water level datum is arbitrary for each lake and year. A significant rainfall event in 2010 required independent storage trends to be calculated before and after to reduce skew. These trends were then given a weighted averaged to obtain a single 2010 trend for each lake.

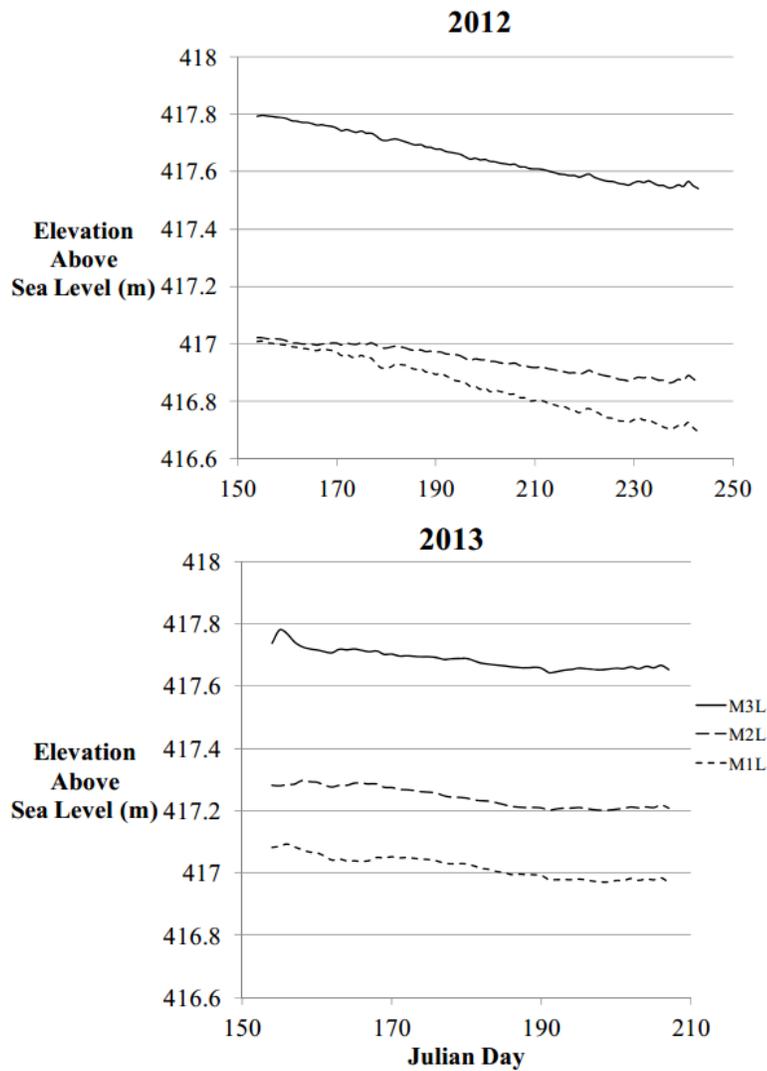
Figure 2.10: M-lakes elevations above sea level for 2012 and 2013. We attribute the less uniform 2012 lake elevations to the introduction of structures into the system, causing changes in available lake storage.

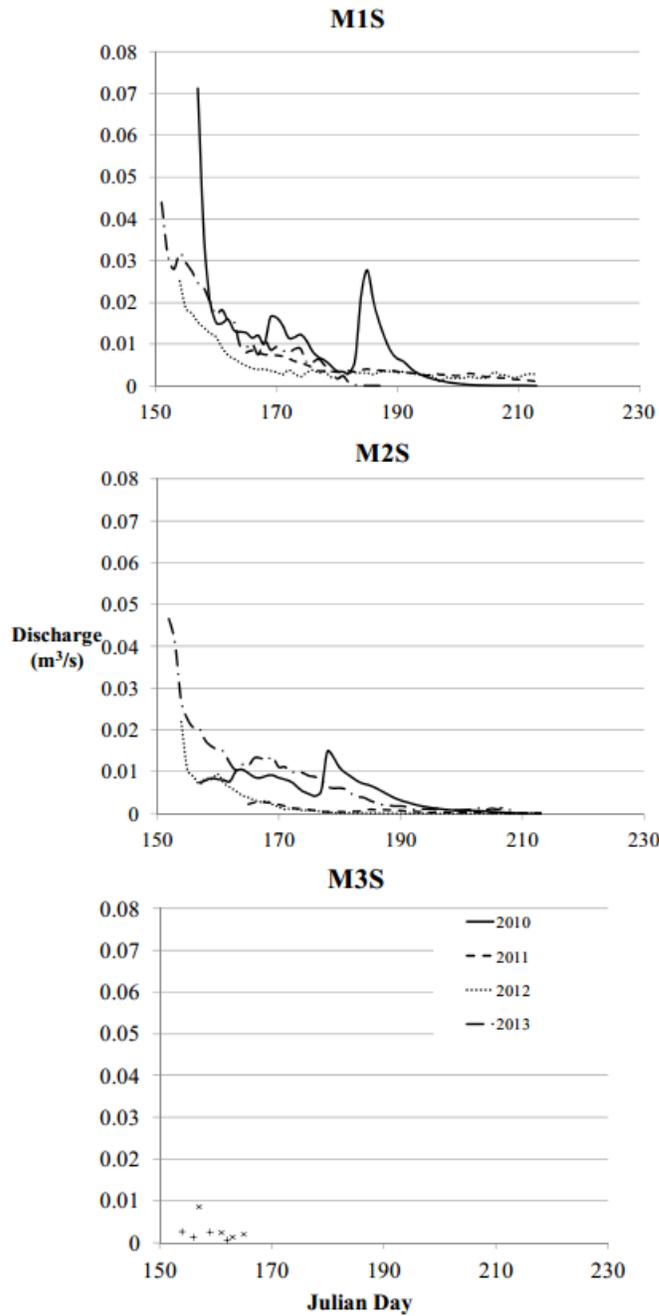
Figure 2.11: Comparison of discharges of M-lakes outlet streams, 2010-2013. Direct discharge measurements are presented where depth-discharge correlations were poor (M3S); pre-construction M3S discharges were omitted as flows were negligible.

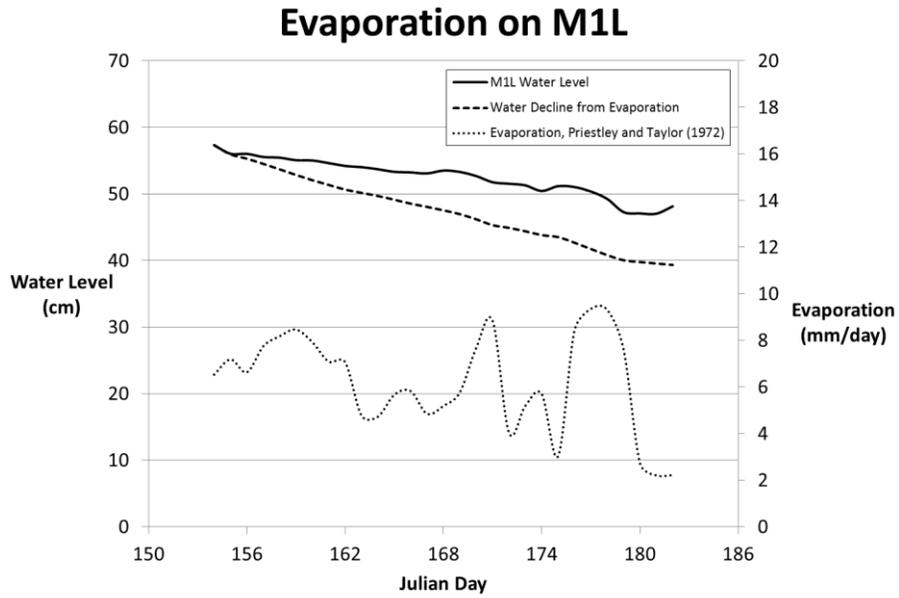
Figure 2.12: Contribution of evaporation to M1L storage during 2012 study period. Water level decline due to evaporation was calculated by the Priestley and Taylor (1972) method. An overestimation of M1L water declines indicate additional, unaccounted for infiltration and/or surface runoff.

overestimation in M1L storage decline due to evaporation during June 2012 indicated the presence of additional, unaccounted infiltration and/or surface runoff. M1L and M3L water levels both showed baseline trends of -0.33 cm/day and -0.14 cm/day for 2010 and 2011, respectively. After construction, trends between the two lakes were less comparable. M1L declined faster than M3L in 2012, at rates of -0.42 cm/day and -0.36 cm/day, respectively, suggesting improved hydraulic connectivity from M1L to LDG. Given the storage trends of M3L over the same period, the change in M1L appeared due to a larger fraction of available water storage leaving M1L in outlet discharge than in baseline years. In 2013, while the decline in M2L was similar to 2012, the M1L and M3L declines slowed to rates of -0.18 cm/day and -0.23 cm/day, respectively, following the retrofit process. This suggests M1L and M3L retrofitted outlets restricted discharge more effectively, prolonging duration of flows. Retrofitted M1S and M3S provided improved connectivity due to the re-sloped gabions that created an unimpeded hydraulic connection rather than a sudden drop. Greater variability in M2L trends through baseline years suggests more sensitivity to hydrological variation. The small and inconsistent elevation difference between M1L and M2L in 2012 was attributed to the increase storage retention in M1L, causing imbalances in the system. After this initial stabilization period, the larger and more consistent elevation difference in 2013 was attributed to an undisturbed hydraulic connection, allowing for the M1L water level to impact M2L.

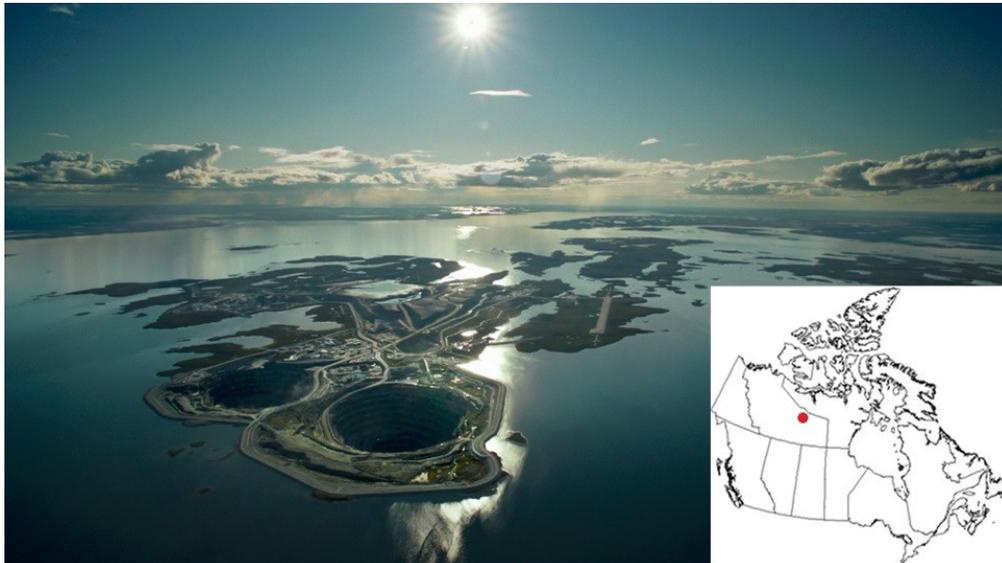
Figure 3.1: DDMI mine site is located 320 km northeast of Yellowknife, NWT in the Barrenlands region. The two open pits located in the image foreground were constructed over the Lac de Gras lake bed through the installation of dyke systems to allow for de-watering. The mine footprint caused extensive fish habitat loss, triggering habitat compensation projects to help offset environmental impacts. Photo courtesy Diavik Diamond Mines, Inc.

In 2012, Diavik Diamond Mines, Inc. (DDMI) initiated the West Island habitat compensation project to help offset aquatic impacts due to mining activities. DDMI is located 320 km northeast of Yellowknife, NWT, in the Barrenlands region of Canada. The Barrenlands consists of interconnecting lake-stream systems with relatively low topographical relief (<50m). Lakes range in size from small headwater lakes (<5 ha) to much larger lakes (ca. 57 000 ha) such as Lac de Gras. The climate is characterized by long, cold winters, quick and extreme spring flooding, and cool arid summers (Gibson et al. 1994). The water balance is governed primarily by spring snowmelt and summer evaporation. The West Island study site is located approximately 5 km west of DDMI within the Lac de Gras watershed (Figures 3.1 and 3.2).

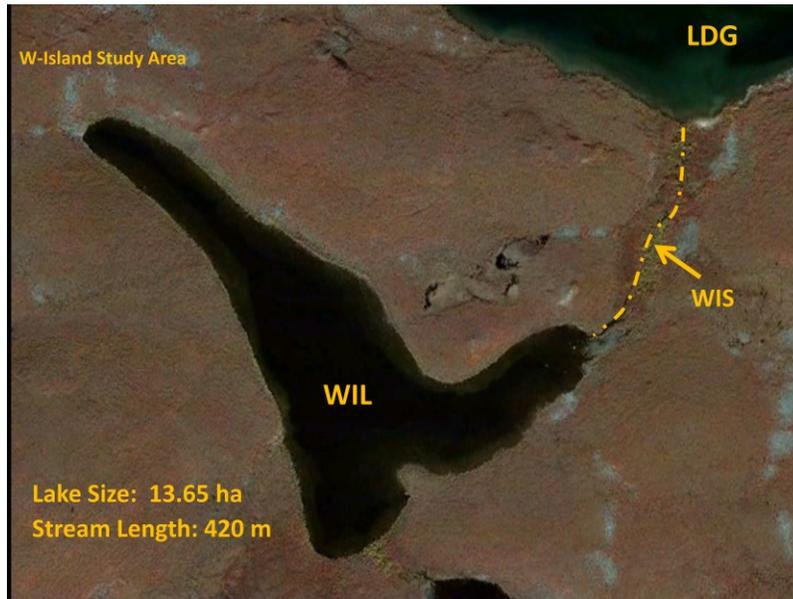
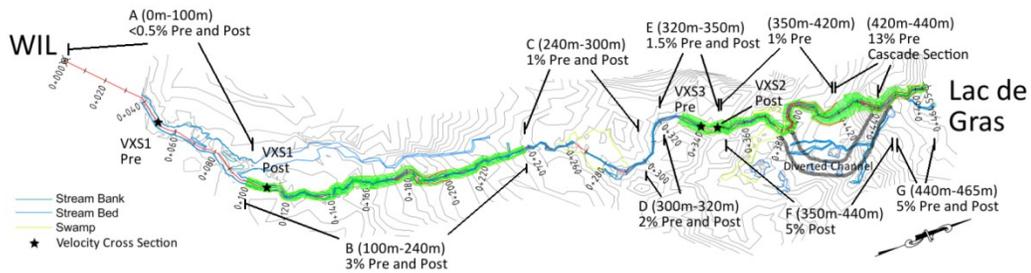
Figure 3.2: West Island study area (top) and stream alignment indicating unique reaches A through G. Diverted channel in reach F is identified from station 0+380m to 0+440m where a meander was created to the east of the original channel to bypass the cascade section. Locations of velocity measurement cross sections are also shown. Aerial image adapted from Google Earth™. Survey data and topographical drawing courtesy DDMI and Praetorian Construction Management.

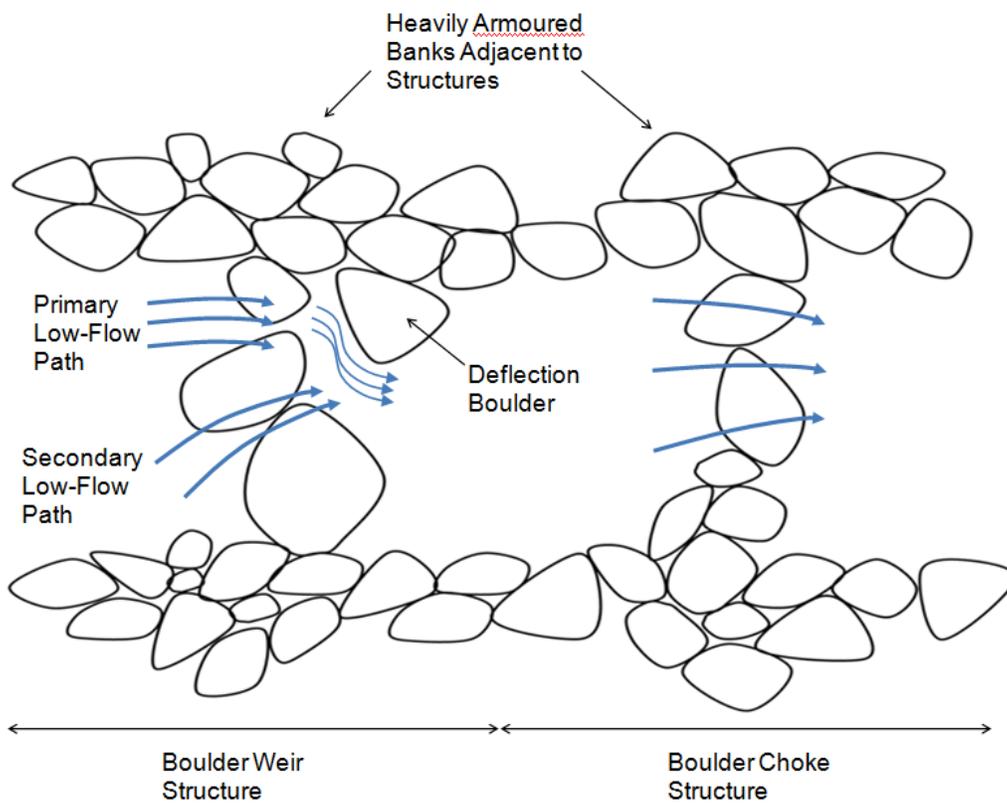
Figure 3.3: Plan view of boulder weir and choke structures installed in reaches B and F. As-built structures varied from single weir structures for lower gradient sections while higher gradient sections incorporated weirs with deflection boulders and in some cases choke structures when deemed necessary to reduce drop heights. Not to scale.

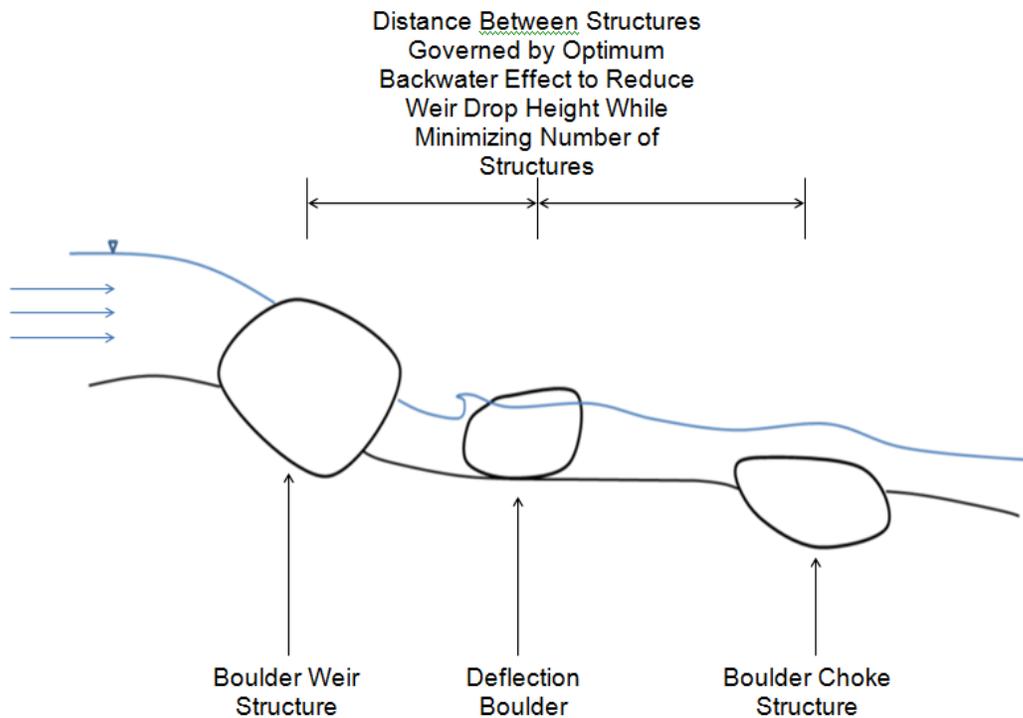
Figure 3.4: Profile view of boulder structures. If deemed necessary, we reduced the boulder weir drop height by placing a deflection boulder downstream and also a choke structure in higher gradient sections. The distance between each structure was governed by creating an appropriate backwater effect to reduce the upstream drop height while minimizing the number of structures required. Not to scale.

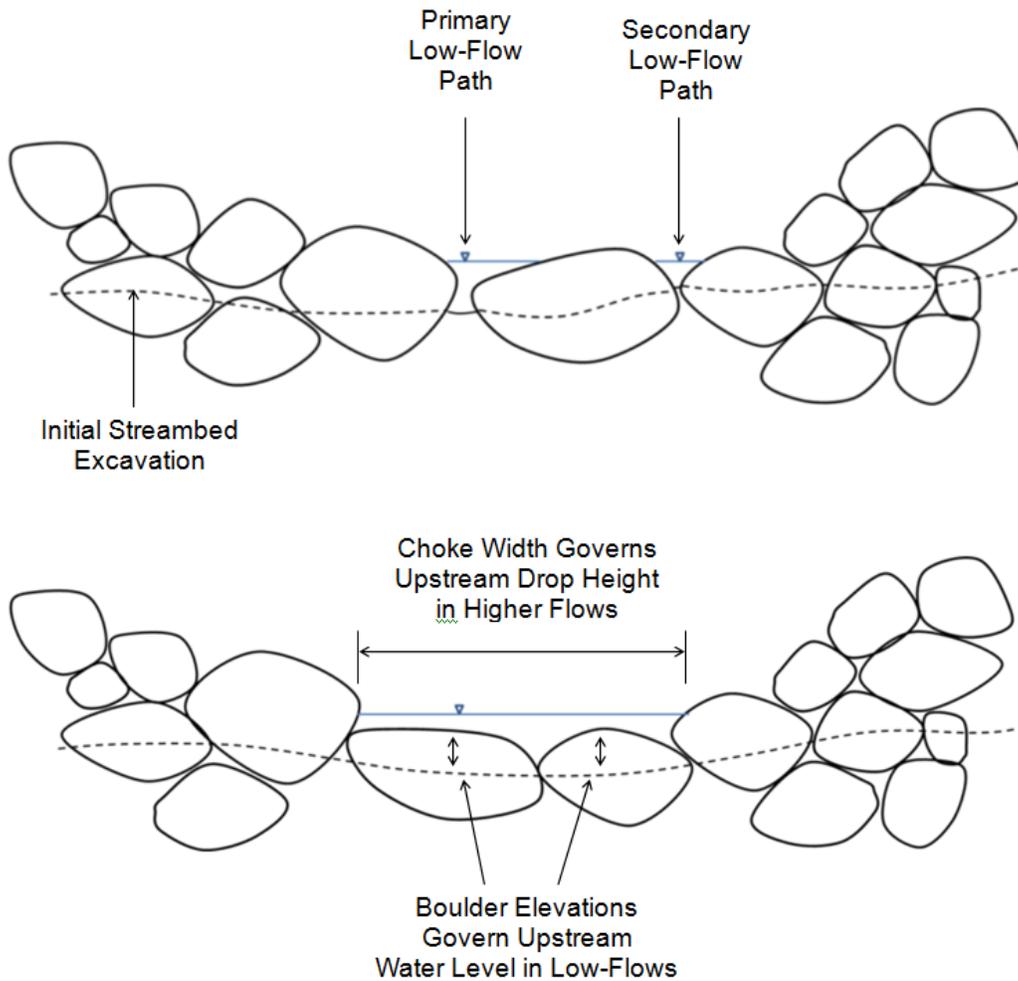
Figure 3.5: Cross-sectional view of boulder weir (top) and choke structures. Boulders were imbedded into the initial streambed excavation to obtain appropriate structure elevations. The boulder weir structure consists of one primary low-flow path and a secondary low-flow path. When higher flows are present, the larger scale structure controls the flow. The boulder choke structure consists of a narrowing of the channel. In low flows, the centre boulder elevation governs upstream water level whereas the width of the choke shall govern in higher flows. Not to scale.

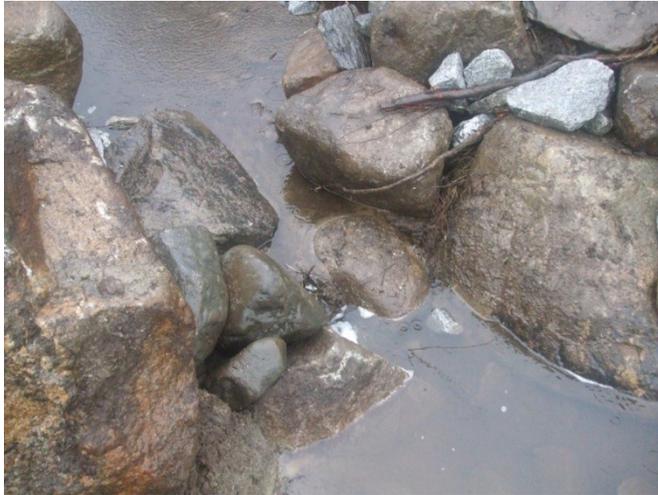
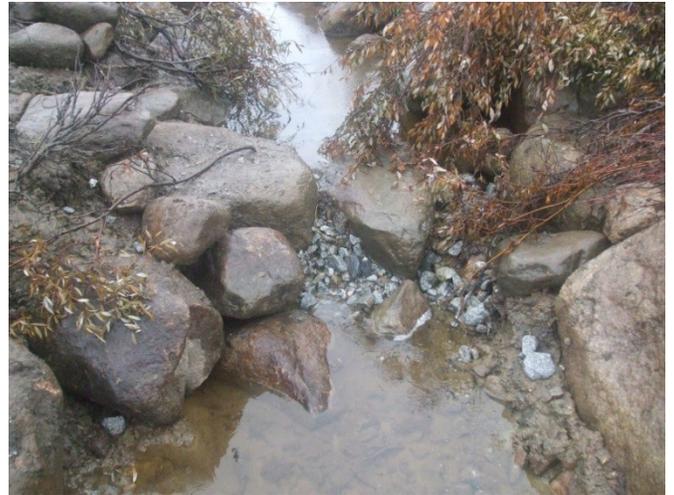
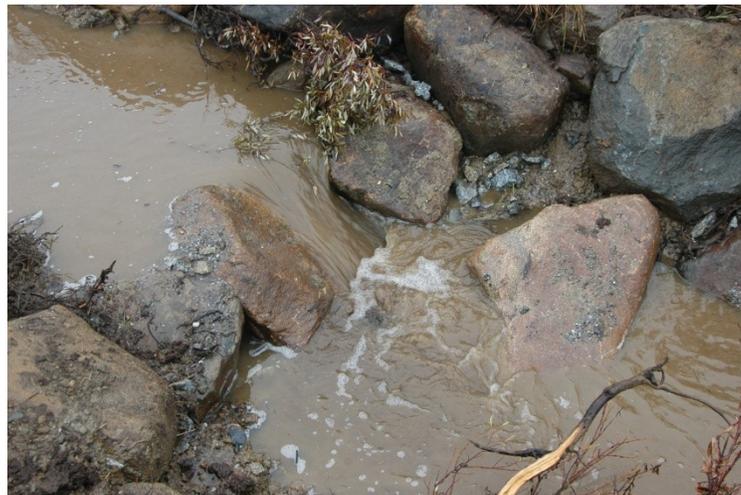
Figure 3.6: Various as-built structures during construction in fall 2012. Boulder choke (top left) shown after construction with no flow; boulder weir (top right) with a very rough primary low-flow path to increase flow depth during very low flows is shown after construction with now flow; and boulder weir (bottom) with deflection boulder during optimization phase of construction with approximately 5 lps discharge. This level of discharge exhibits low flow characteristics as flows are concentrated in the primary low-flow path; the deflection boulder is noticeably increasing water levels immediately downstream of the boulder weir, reducing the drop height.

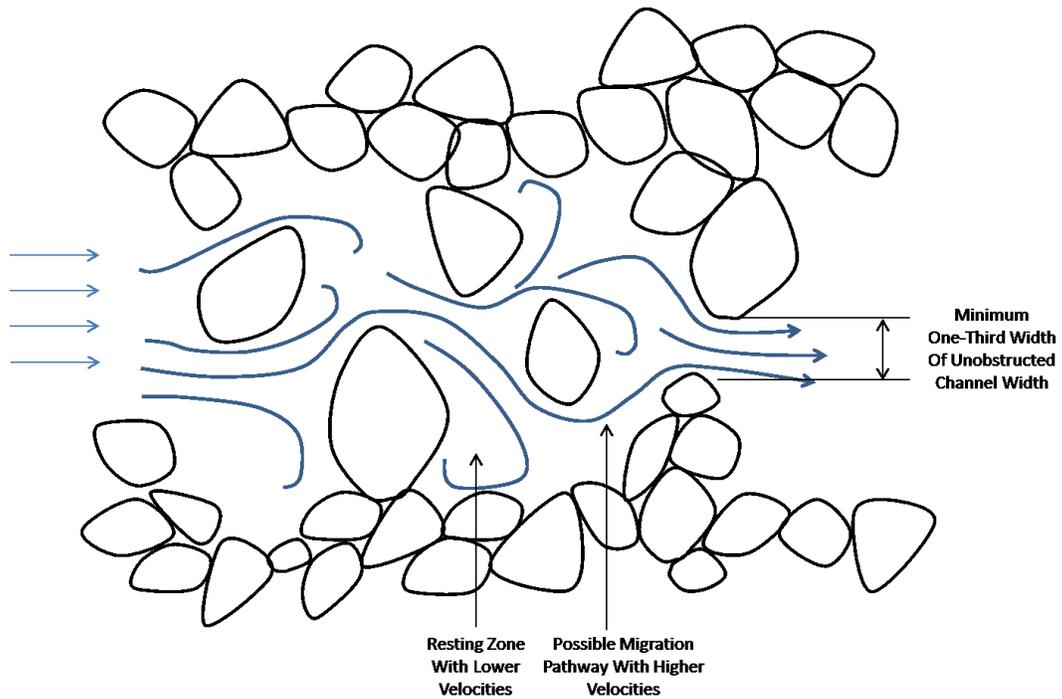
Figure 3.7: Plan view of rock ramp boulder configuration. Various flow path characteristics are depicted indicating resting zones and a possible migration pathway. This configuration is intended to maintain an unimpeded flow path by ensuring one-third of the unimpeded channel width is open at any given cross section. Not to scale.

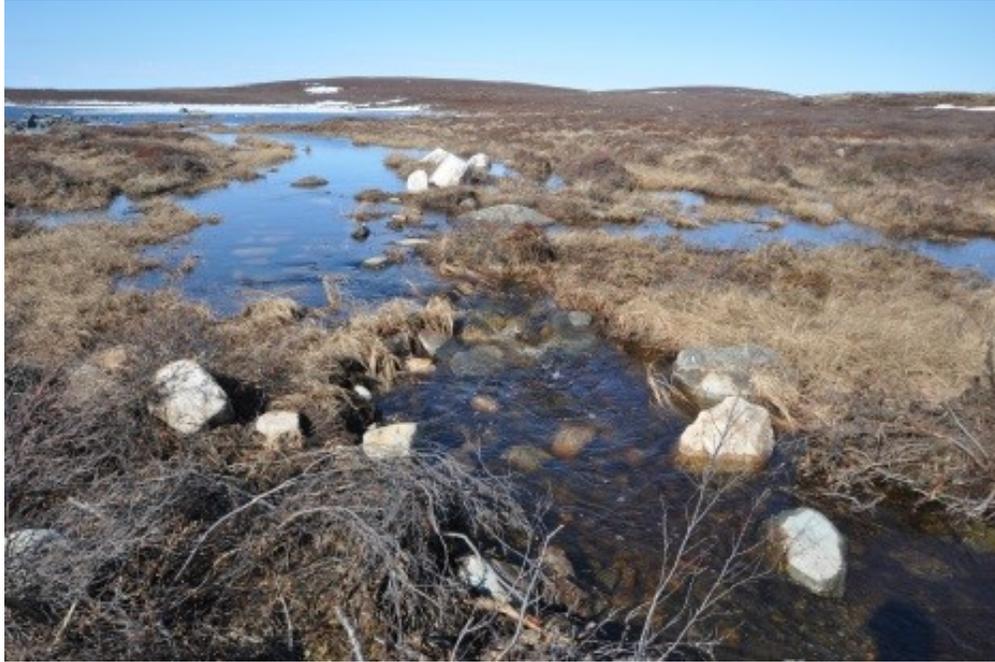
Figure 3.8: WIS Region A - Inlet - The upstream extent of construction is shown. A natural choke-point is located in the centre of the photograph. Upstream of the choke are several sub-channels which were blocked off with larger boulders to allow more flow into the main channel. This provides minimal hydraulic control during peak freshet as the reach functions as an active flood plain.

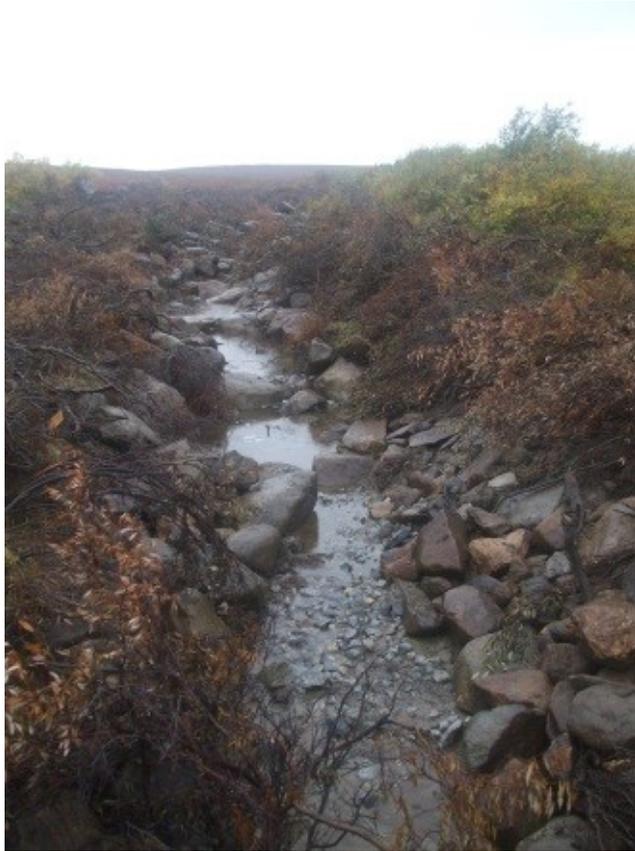
Figure 3.9: WIS Region B - Pool and Weir One - Looking upstream, the channel consists of boulders configured into weir and choke structures. The bed is lined with gravel and cobbles with willow vegetation on the banks to improve cover for fish habitat.

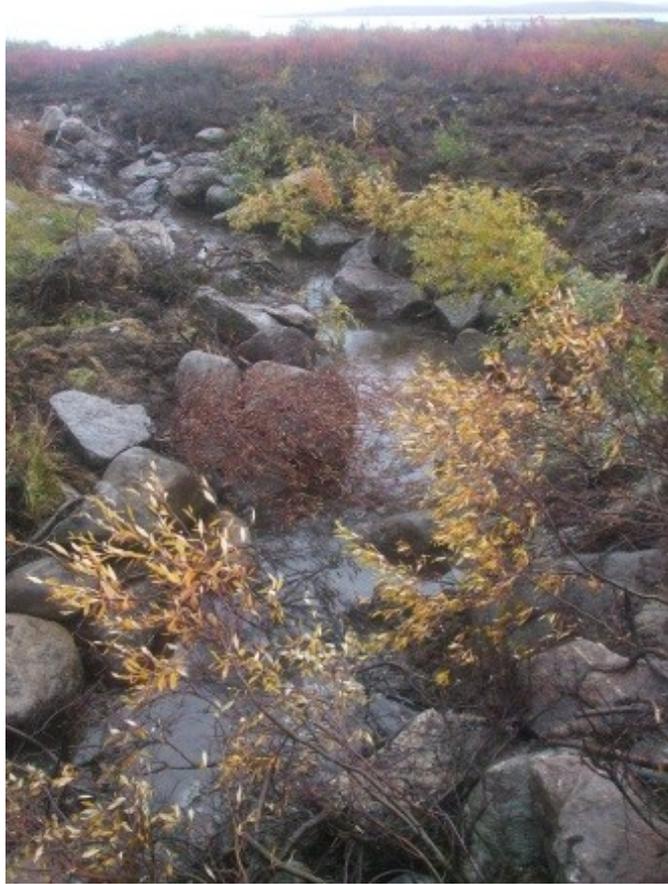
Figure 3.10: WIS Region C - Riffle One - Looking upstream, this section consists of a silt bed with a few larger boulders and willow vegetation on the banks to improve cover for fish habitat. During the first freshet period, additional silt was deposited in this reach due to the freshly excavated channel causing increased sediment transport.

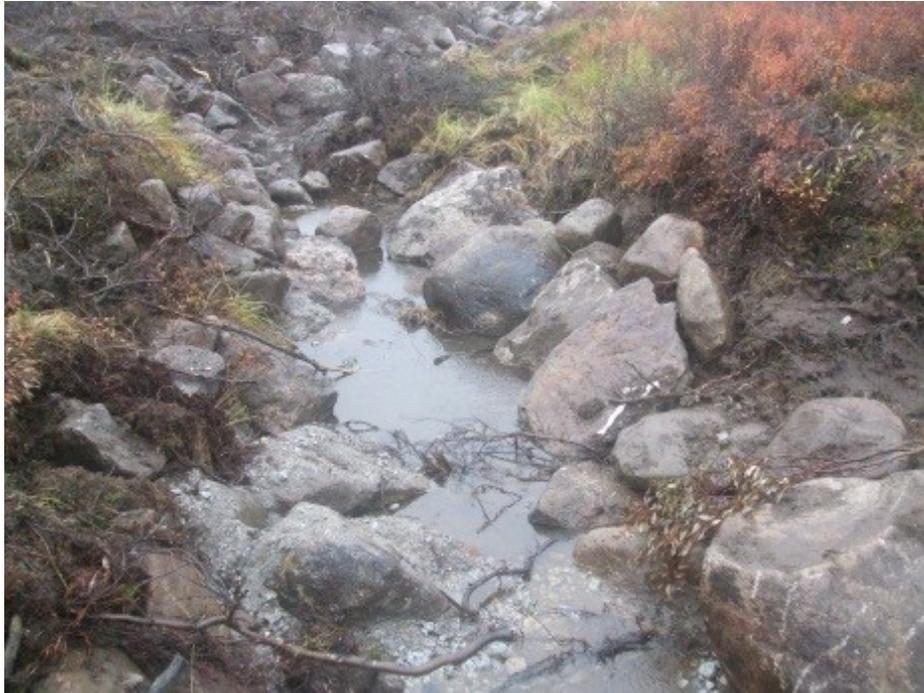
Figure 3.11: WIS Region D - Rock Ramp - Looking upstream, this section consists of a series of staggered boulders of various sizes with several choke structures in the foreground. Boulders optimize fish habitat suitability by creating additional flow variability, breaking up faster riffle flows with slower resting zones.

D- Rocky Ramp (Figure 3.11): Prior to construction, the unconfined flows found in reaches B and C began to concentrate in this reach. The constructed channel is 1 m

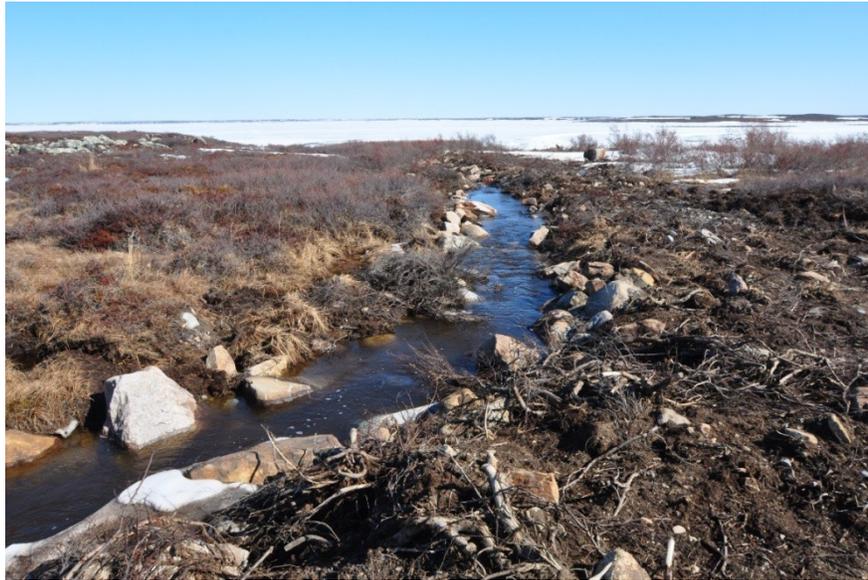
Figure 3.12: WIS Region E - Riffle Two - Looking downstream, this region is similar to Region C, consisting of a silt bed with a few large boulders. Substantial silt deposition occurred in this reach, altering the bed characteristics from the as-built channel. Photograph was taken several days after silt deposition declined. Channel characteristics changed over the first freshet period from variable and rocky to a more uniform and silted bed.

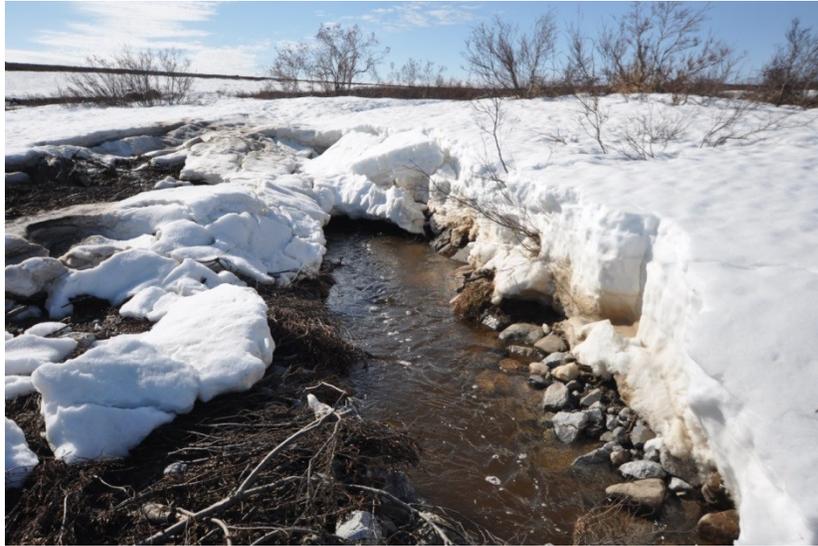
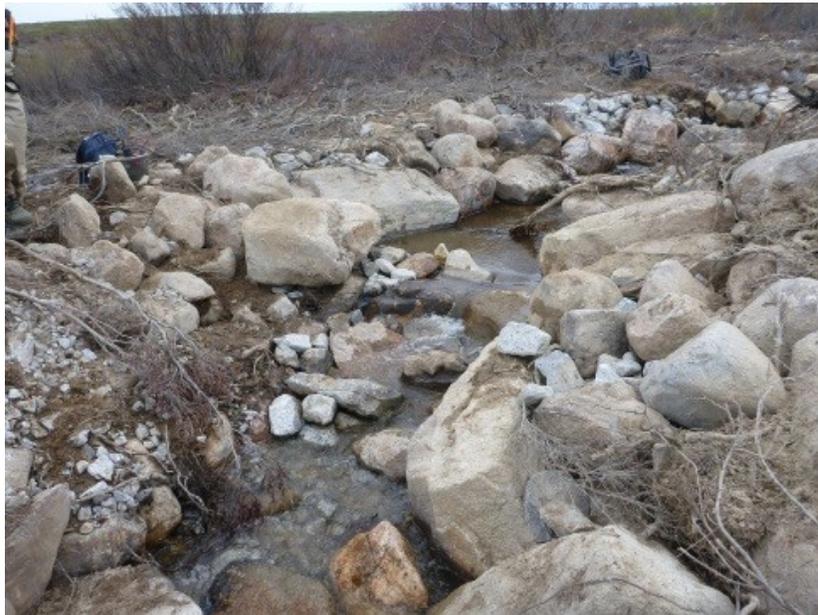
Figure 3.13: WIS Region F - Pool and Weir Two - Looking upstream, this region is similar to Region B, consisting of boulders arranged in weir and choke structures. This is the steepest section and was diverted around the original cascade which impeded fish migration. The top photo was taken 1 June 2013 at the beginning of the study period while there was still a considerable snow pack present; stream flows created a subnivean channel underneath the snow pack, causing minimal hydraulic impact. The bottom photo was taken on 22 June 2013 at the end of freshet.
