**Stream Modifications to Enhance Fish Habitat in
Arctic Headwater Systems**

Gregory James Courtice

A thesis submitted to the Faculty of Graduate Studies and Research
in partial fulfillment of the requirements for the degree of

Water Resources Engineering

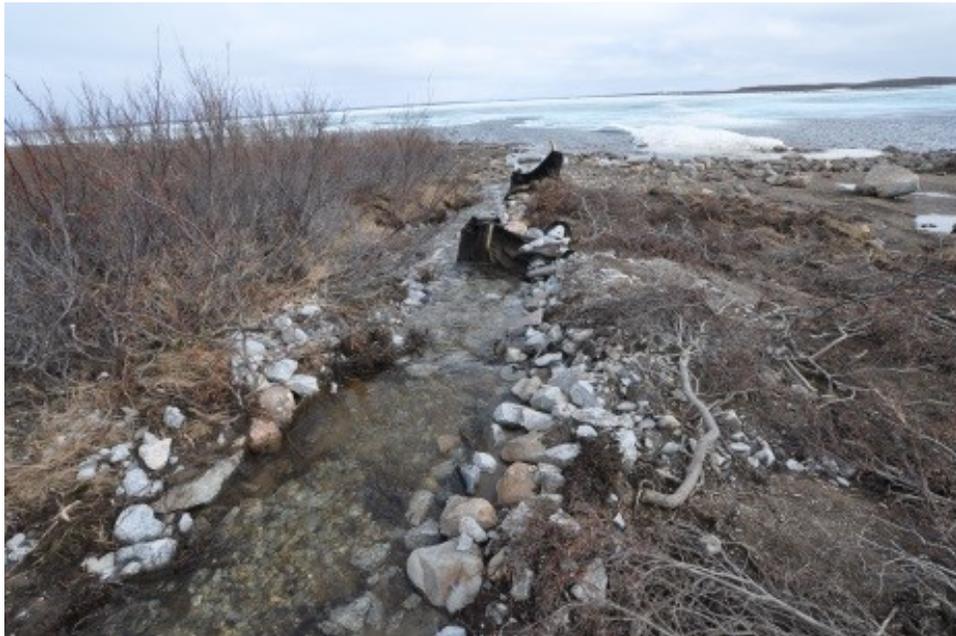
Figure 3.14: WIS Region G - Outlet - Looking downstream, Lac de Gras is shown in the background. This section was not modified from the natural channel as it was deemed suitable habitat and passable by fish. Silt fences are installed in the channel to reduce silt discharges into Lac de Gras from the disturbed sediment on the upper reaches of the newly excavated channel.

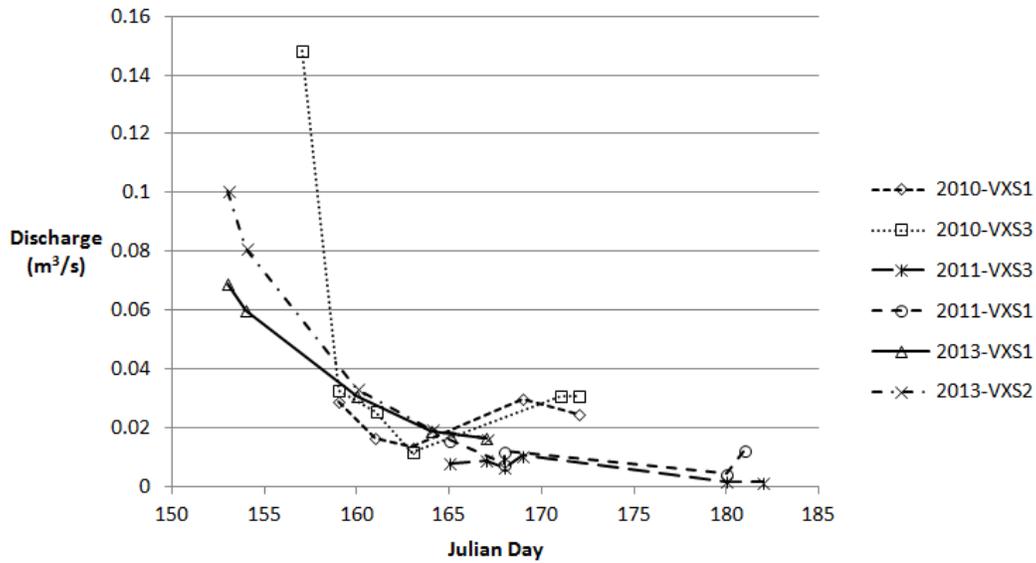
Freshet Direct Discharge Measurements

Figure 3.15: Direct discharge measurement for WIS upstream (VXS1) and downstream (VXS3-pre construction and VXS2-post construction) velocity cross sections during freshet. Accessing streams during peak discharges were difficult logistically therefore we only documented near-peak discharge in 2010 at VXS1 and 2013 at both VXS1 and VXS2.

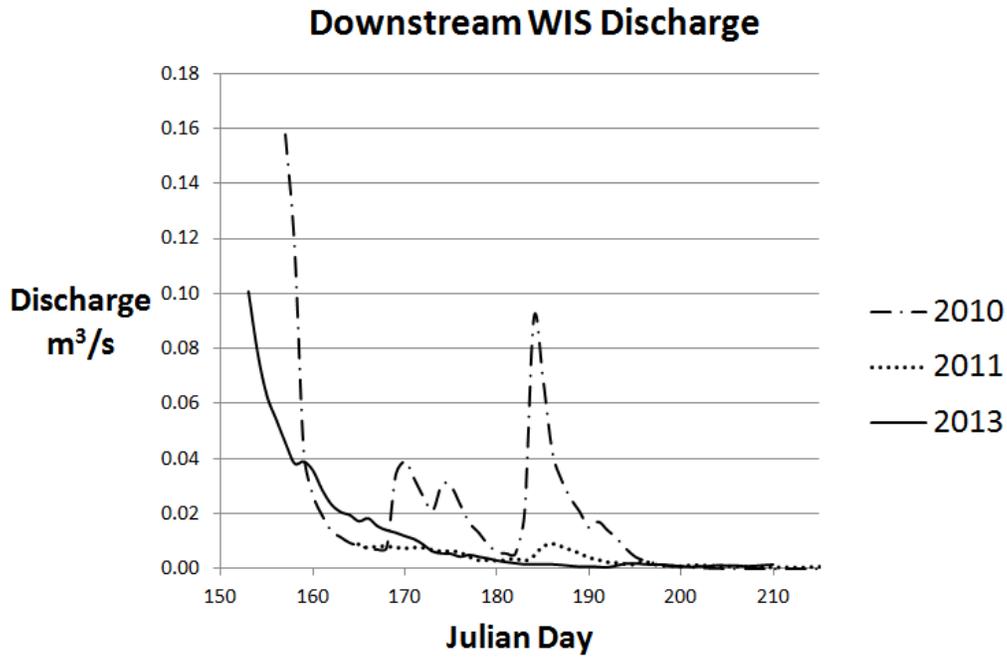
Figure 3.16: Daily-averaged continuous discharge data for 2010, 2011, and 2013. Discharge decline in 2010 was more rapid than 2013. Measurements in 2011 began near the end of freshet therefore it is not apparent how freshet 2011 compared with the other two study periods. Post freshet discharge decline in 2011 is comparable with 2013.

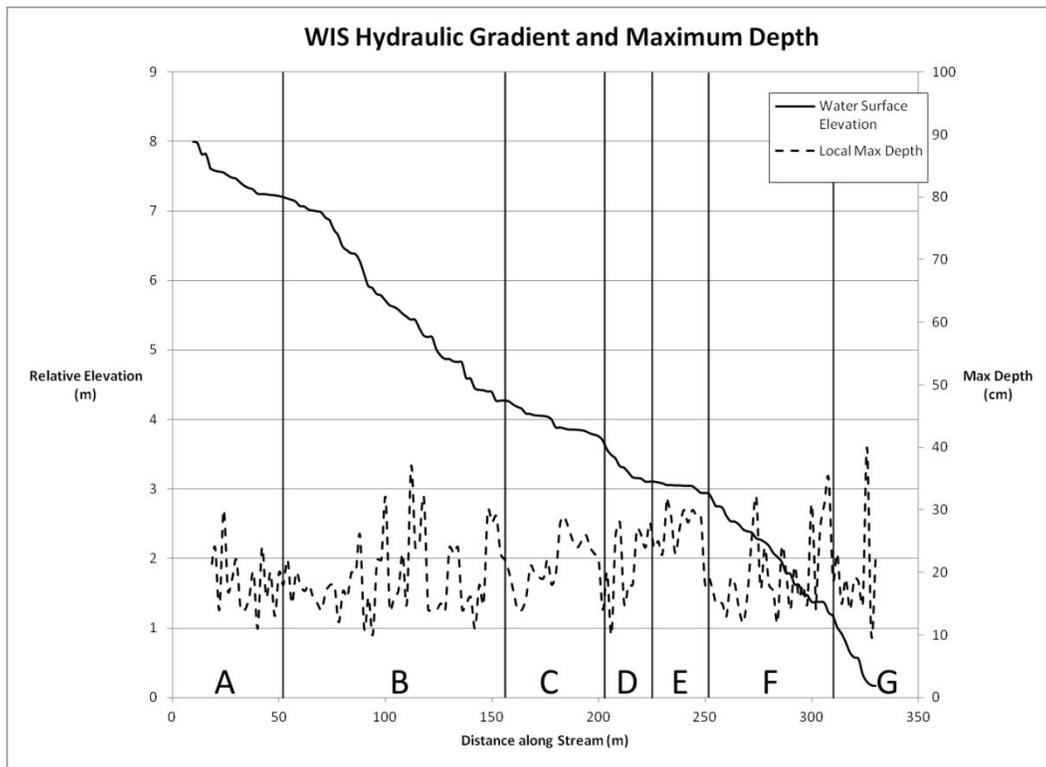
Figure 3.17: Water surface elevation and local maximum depth, separated by stream reach. Measurements were taken on 8 June 2013 at a discharge of 30 lps. Stream gradient ranges from <1% to 5%. Variability in local maximum depth is greatest in reaches B and F which consist of the pool and weir structures to overcome the steepest slopes. Reaches A and G have the lowest maximum depths and do not consist of any boulder structures.

The NLF structures were found to effectively control discharges in WIS on 8 June 2014 at 30 lps. A relationship between local maximum depth and hydraulic gradient was not apparent. This lack of relationship indicates the boulder structures controlled stream flows at all gradients found within the modified stream reaches (i.e. 1-5%). However as no other set of depth data was available from the post construction study period, we must determine structure responses and effectiveness through an assessment of the visible hydraulic responses during the optimization phase of construction (i.e. when discharges were manipulated) in conjunction with the preliminary hydraulic analysis.
