**ACOUSTIC EMISSION MONITORING OF DELAYED HYDRIDE CRACKING IN
ZIRCONIUM 2.5% NIOBIUM**

MASTER OF SCIENCE

METALLURGICAL ENGINEERING

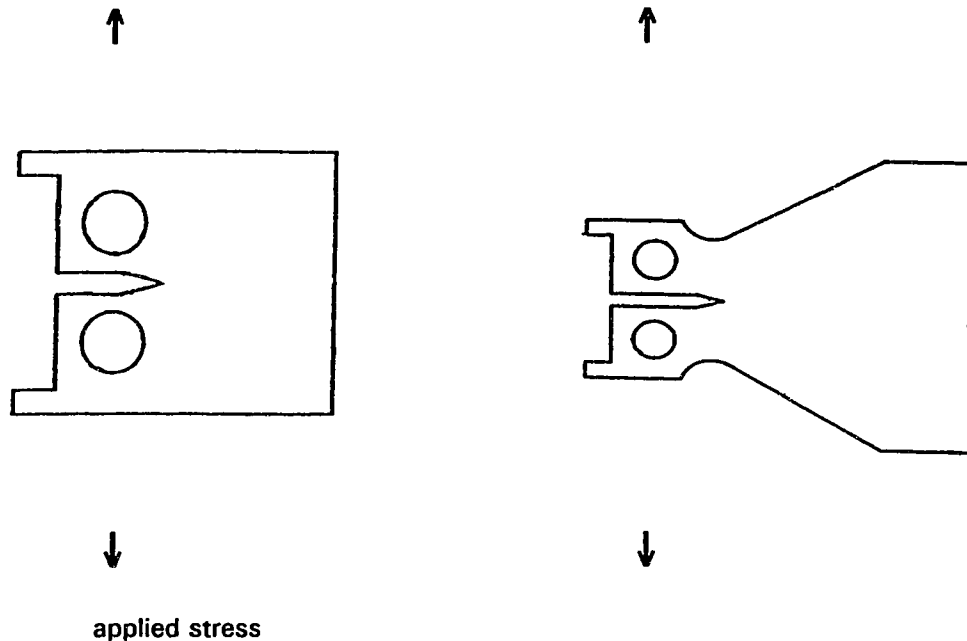
Figure 2.5: Compact Toughness/Double Cantilever Beam Samples.

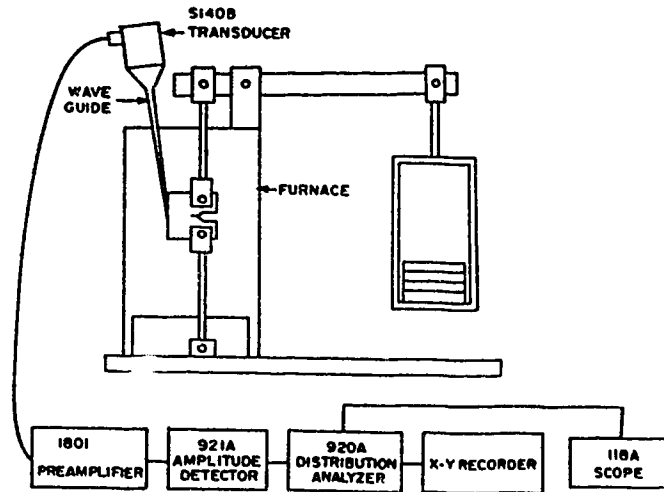
Figure 2.6: Wave guide used with AE Transducer [Amouzouvi and Clegg, 1988].

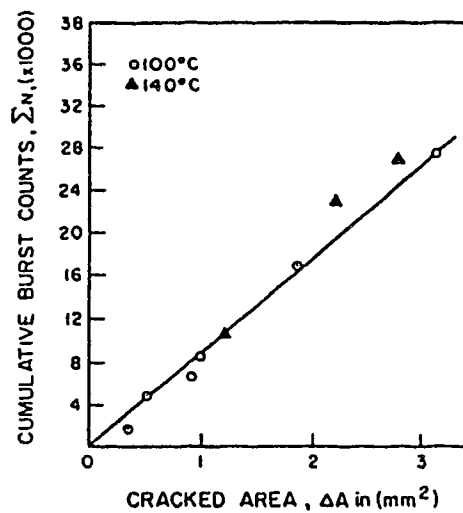
Figure 2.8: Cumulative burst counts vs. cracked area [Arora and Tangri, 1979].

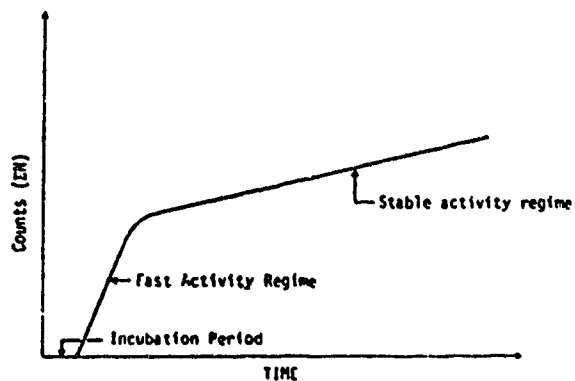
Figure 2.9: Cumulative burst counts vs. time [Arora and Tangri, 1981].

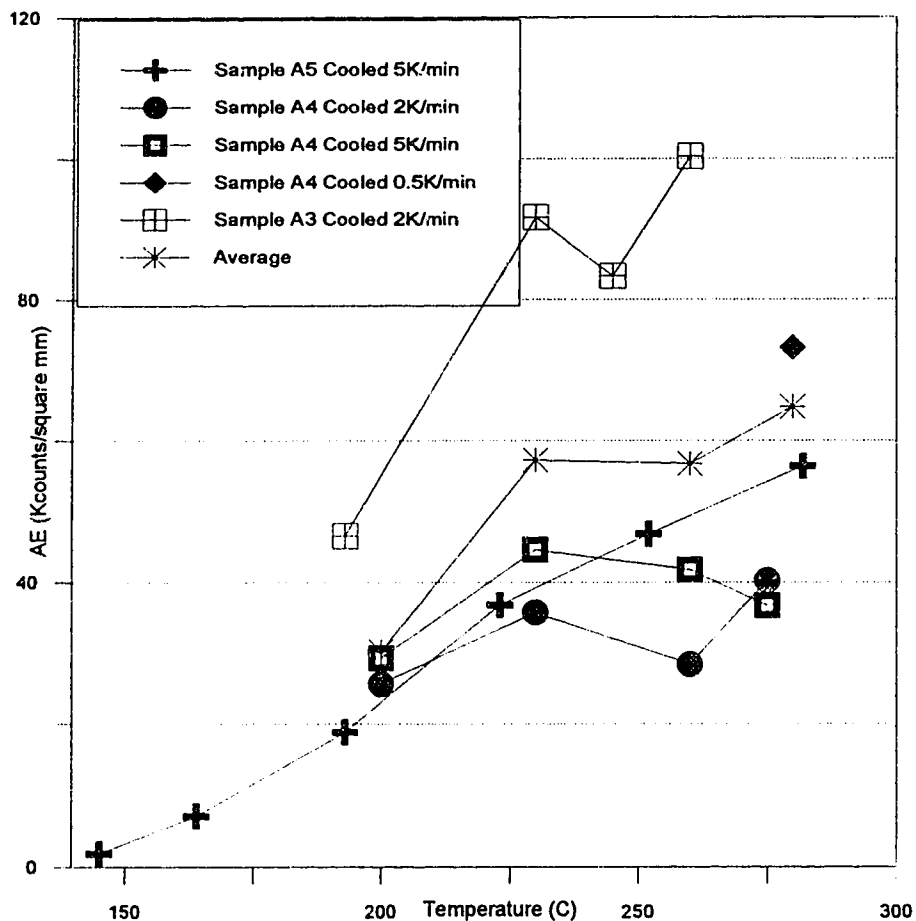
Figure 2.10: Kilocounts per mm^2 versus temperature [Eadie, Li, Shek and Sagat, 1993].

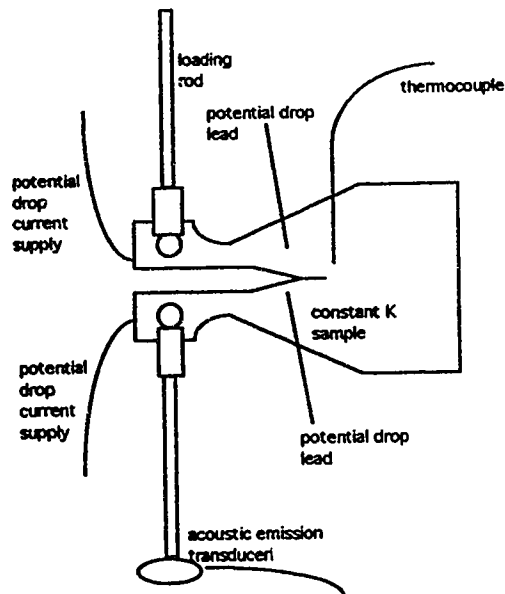
Figure 3.7: Constant "K" Sample with Attachments

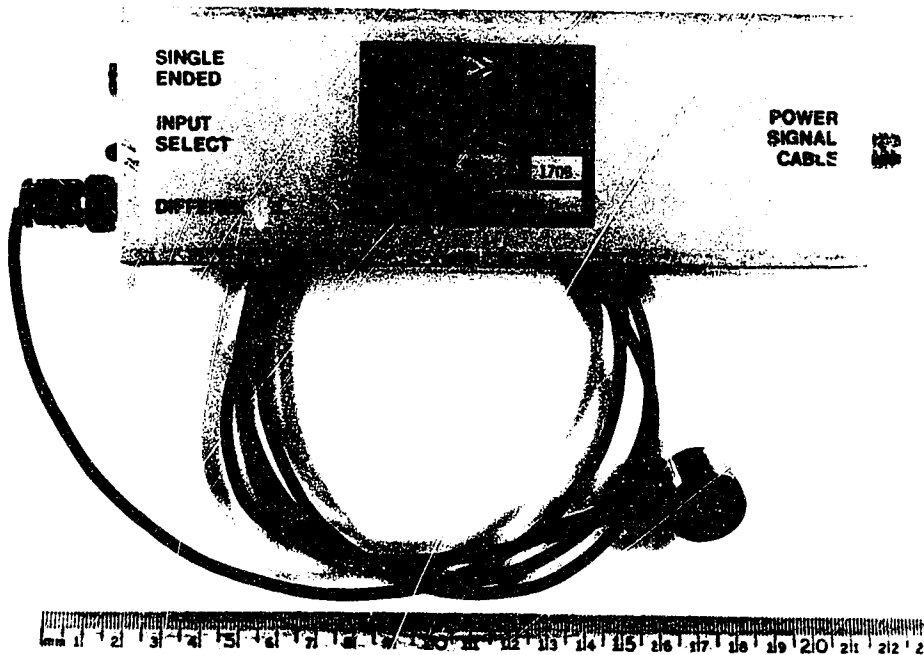
Figure 3.8: AE preamplifier and transducer.

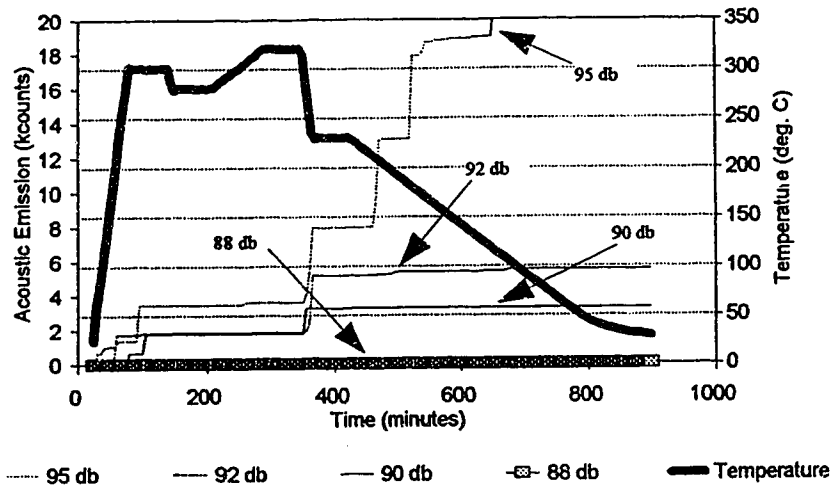
Figure 3.11: AE and temperature vs time for different gain settings - 1.5 kg load using dummy steel sample.

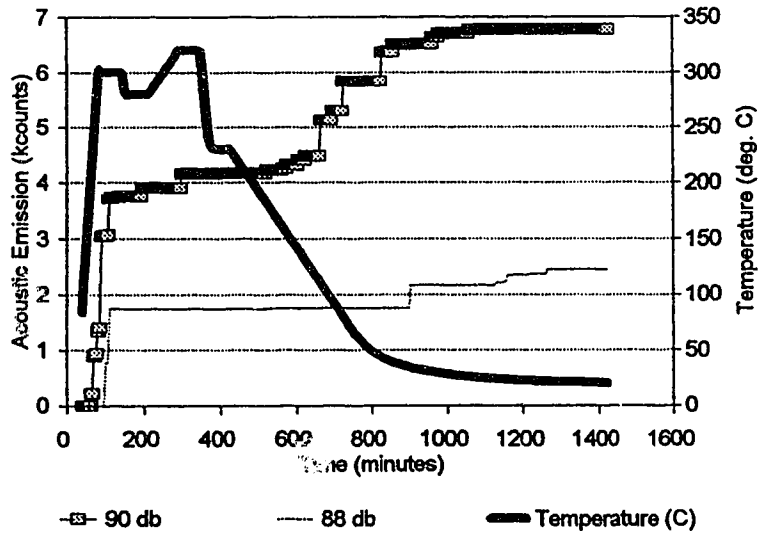
Figure 3.12: AE and temperature vs time for different gain settings - 15.08 kg load using dummy steel sample.

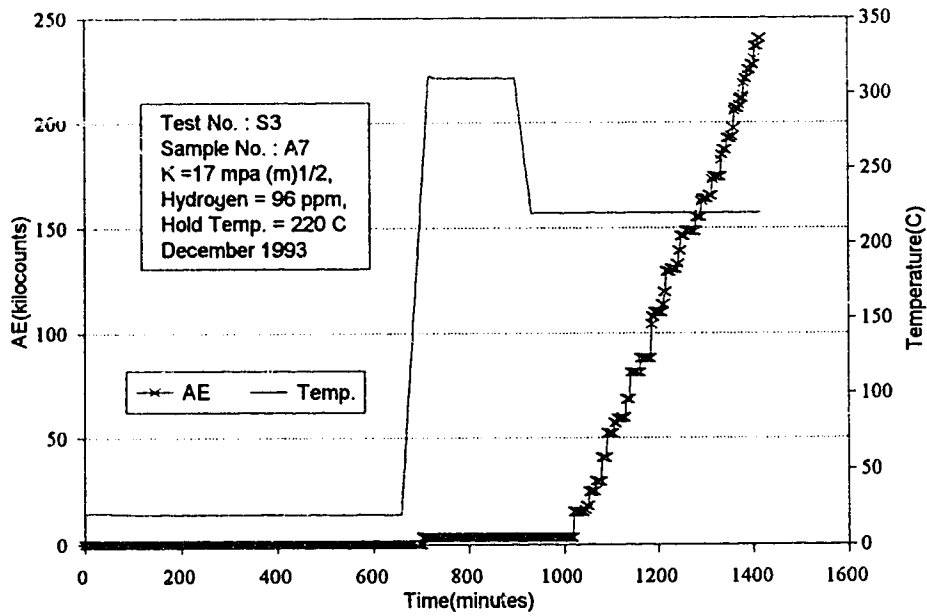
Figure 4.2: DHC Testing indicating >80% of AE Activity during Isothermal Holding.

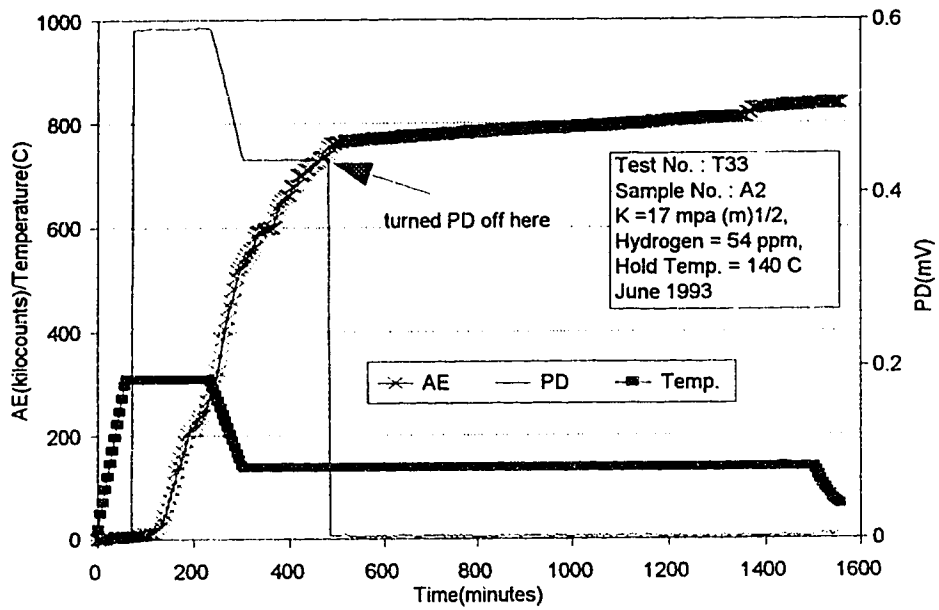
Figure 4.4: AE results before and after removal of potential drop equipment.

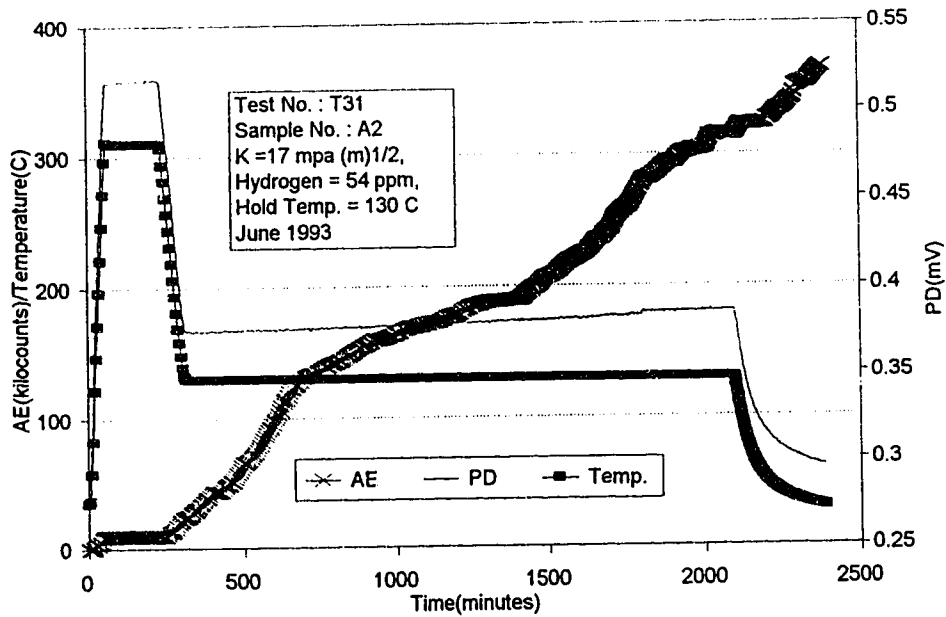
Figure 4.5: Possible anomalous AE results - due to interference with potential drop equipment.

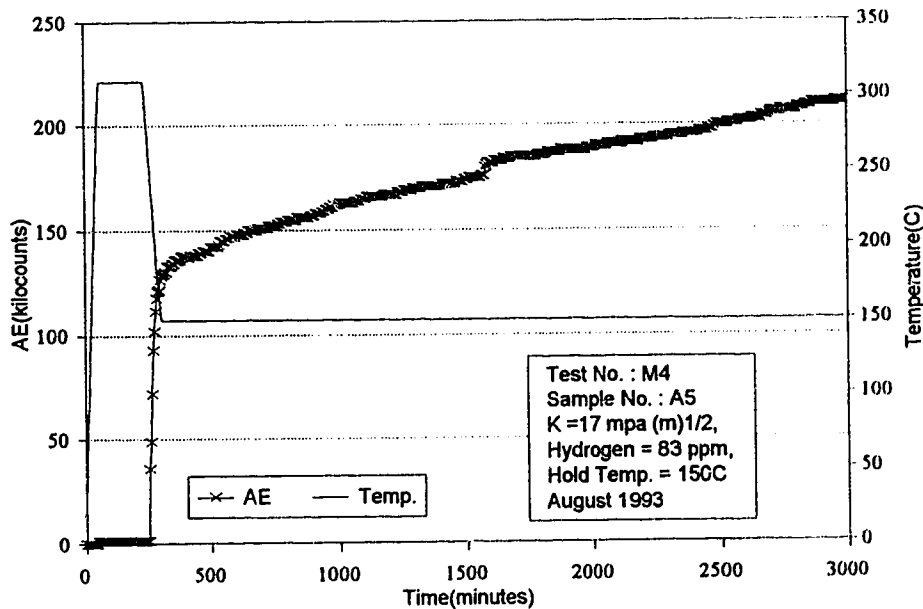
Figure 4.6: Typical set of AE results for the temperature at which the sample was tested.

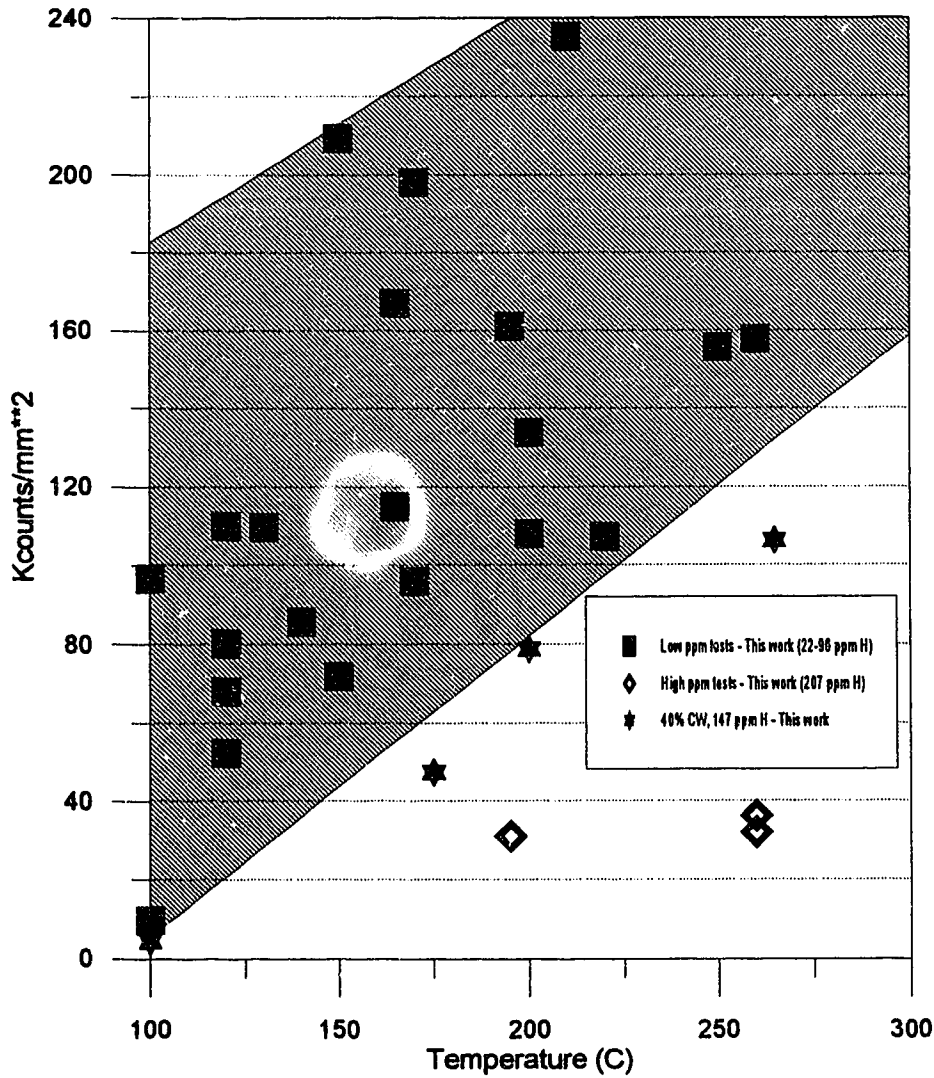
Figure 4.23: Summary of as-manufactured and cold worked material testing - kilocounts per mm² versus temperature from this work.

A summary of all the tests which were done in this study is found on Figure 4.23. In this figure a separation was made between the as-manufactured samples - low hydrogen (less than 100 ppm) and high hydrogen (approximately 160 to 207 ppm hydrogen) and the 40% cold worked material (with 147 ppm hydrogen).

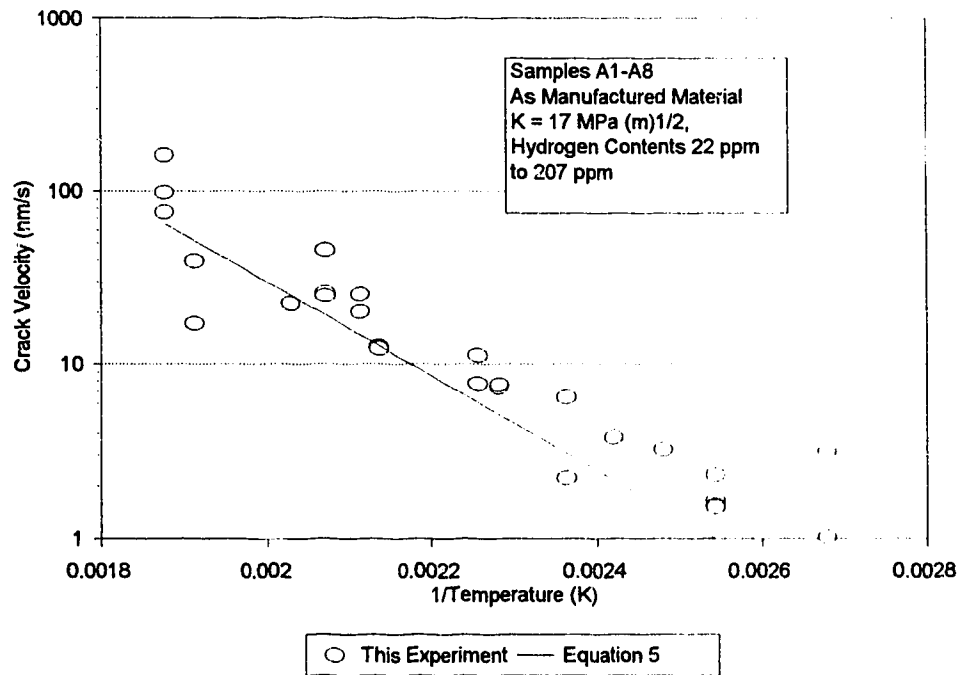
Figure 4.24: Summary of experimental crack velocities as compared to theoretical values [Eadie, Li and Shek, 1993] - as-manufactured material.

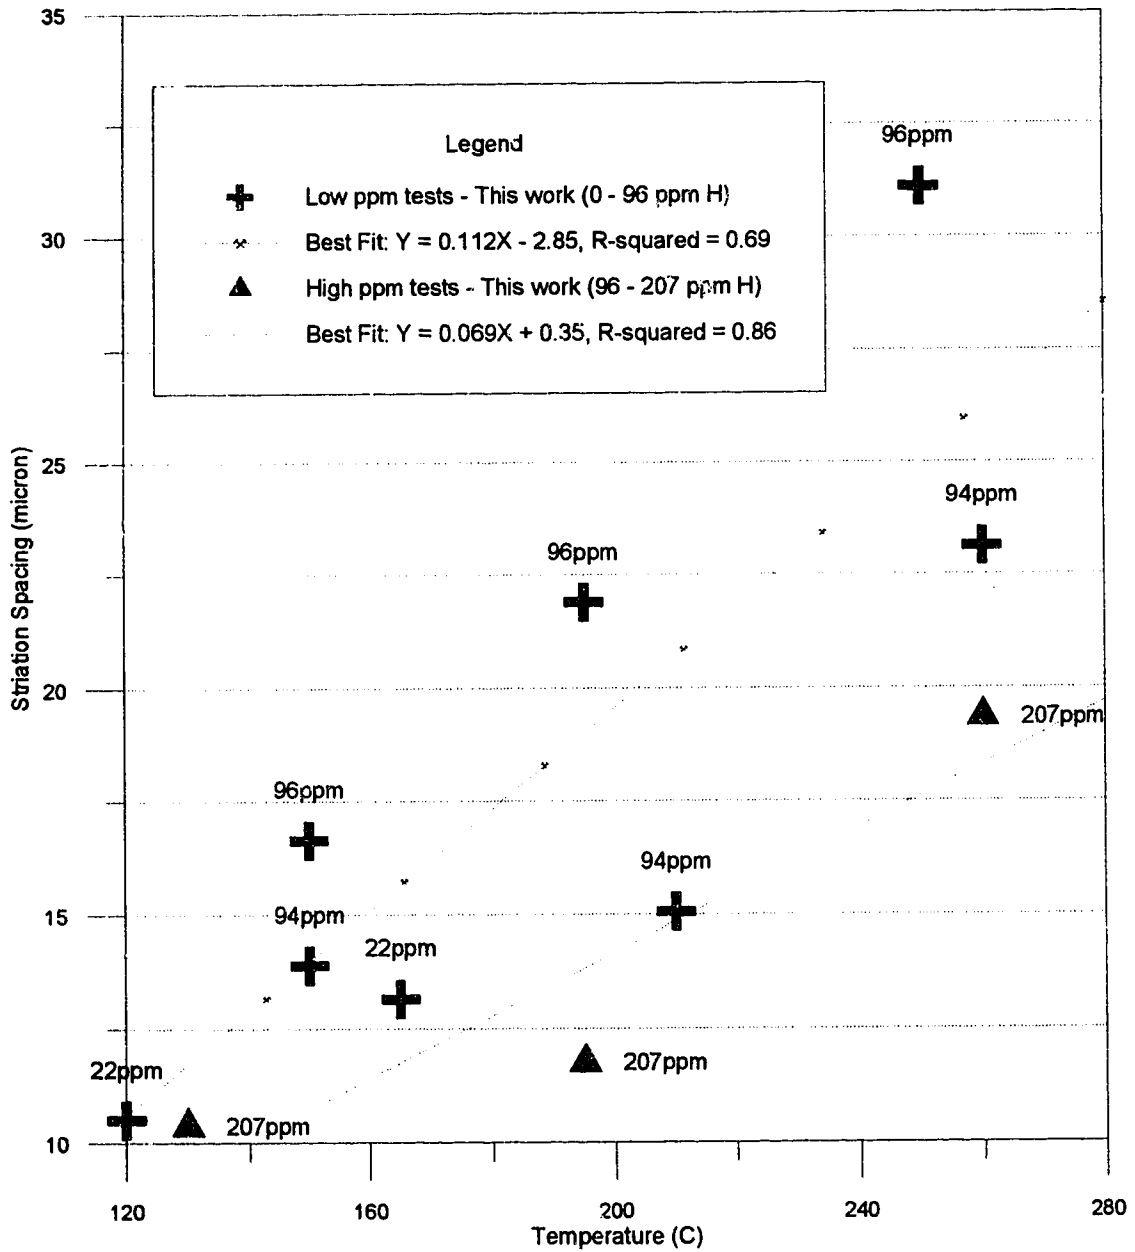
Figure 4.32: Striation spacing vs temperature. There is a trend toward a decrease in spacing with increasing hydrogen content. All tests were done at a constant K of $17 \text{ MPa}(\text{m})^{1/2}$.

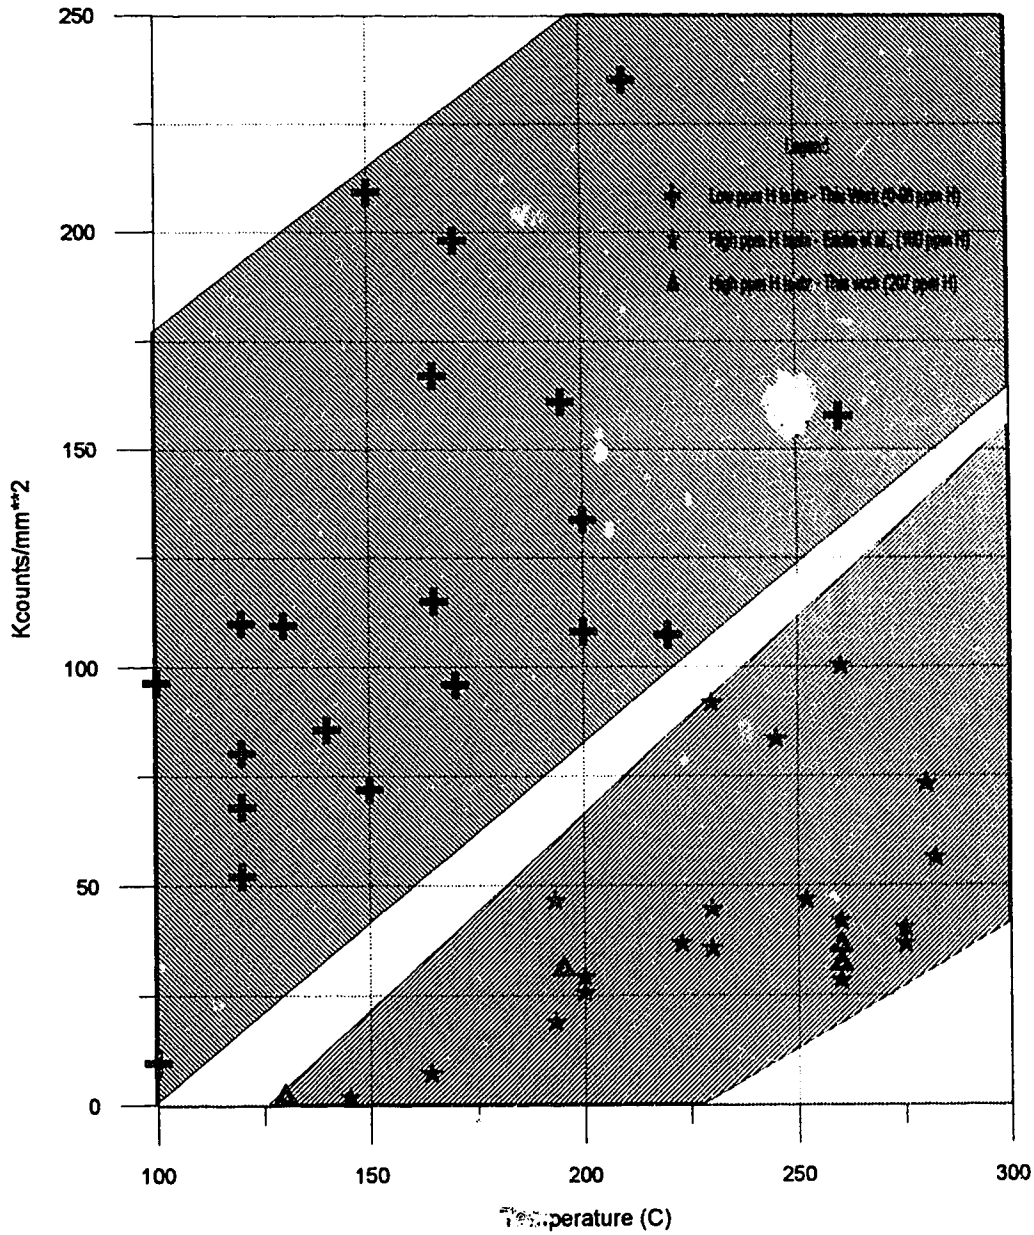
Figure 5.1: Summary of as-manufactured material testing - kilocounts per mm² versus temperature, (this work compared to Eadie, Li and Shek, 1993).

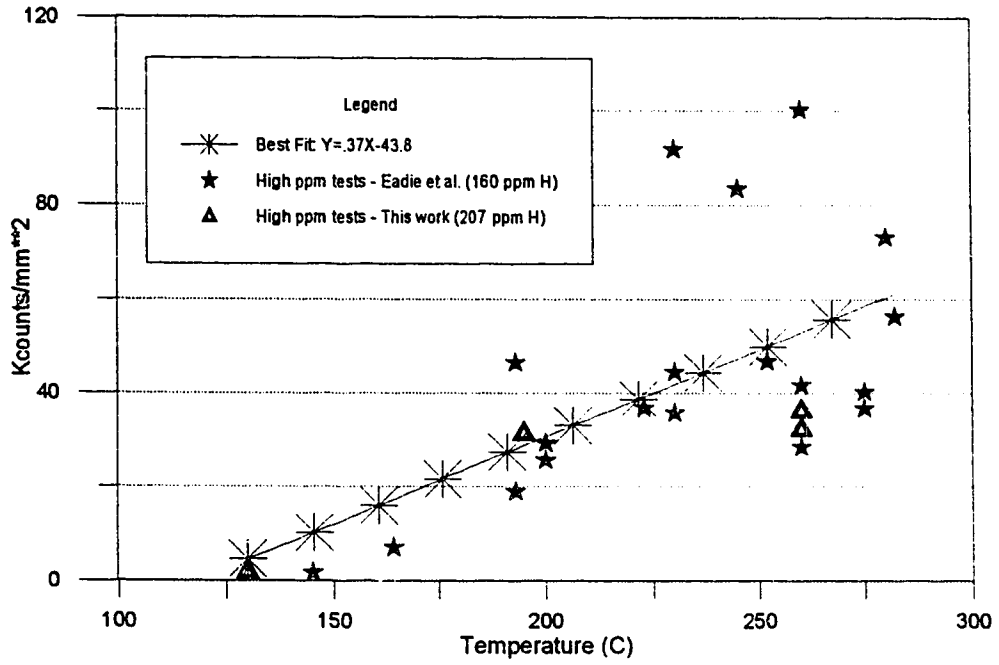
Figure 5.2: High hydrogen sample (207 ppm H), (this work, compared to the work of Eadie, Li and Shek, 1993).

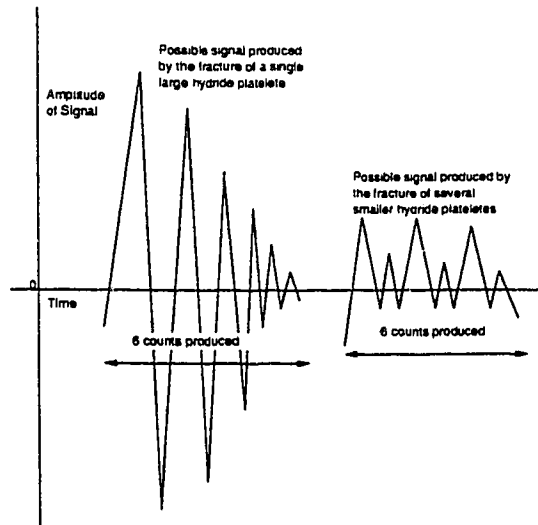
Figure 5.3: Comparison of amplitude of AE signals.

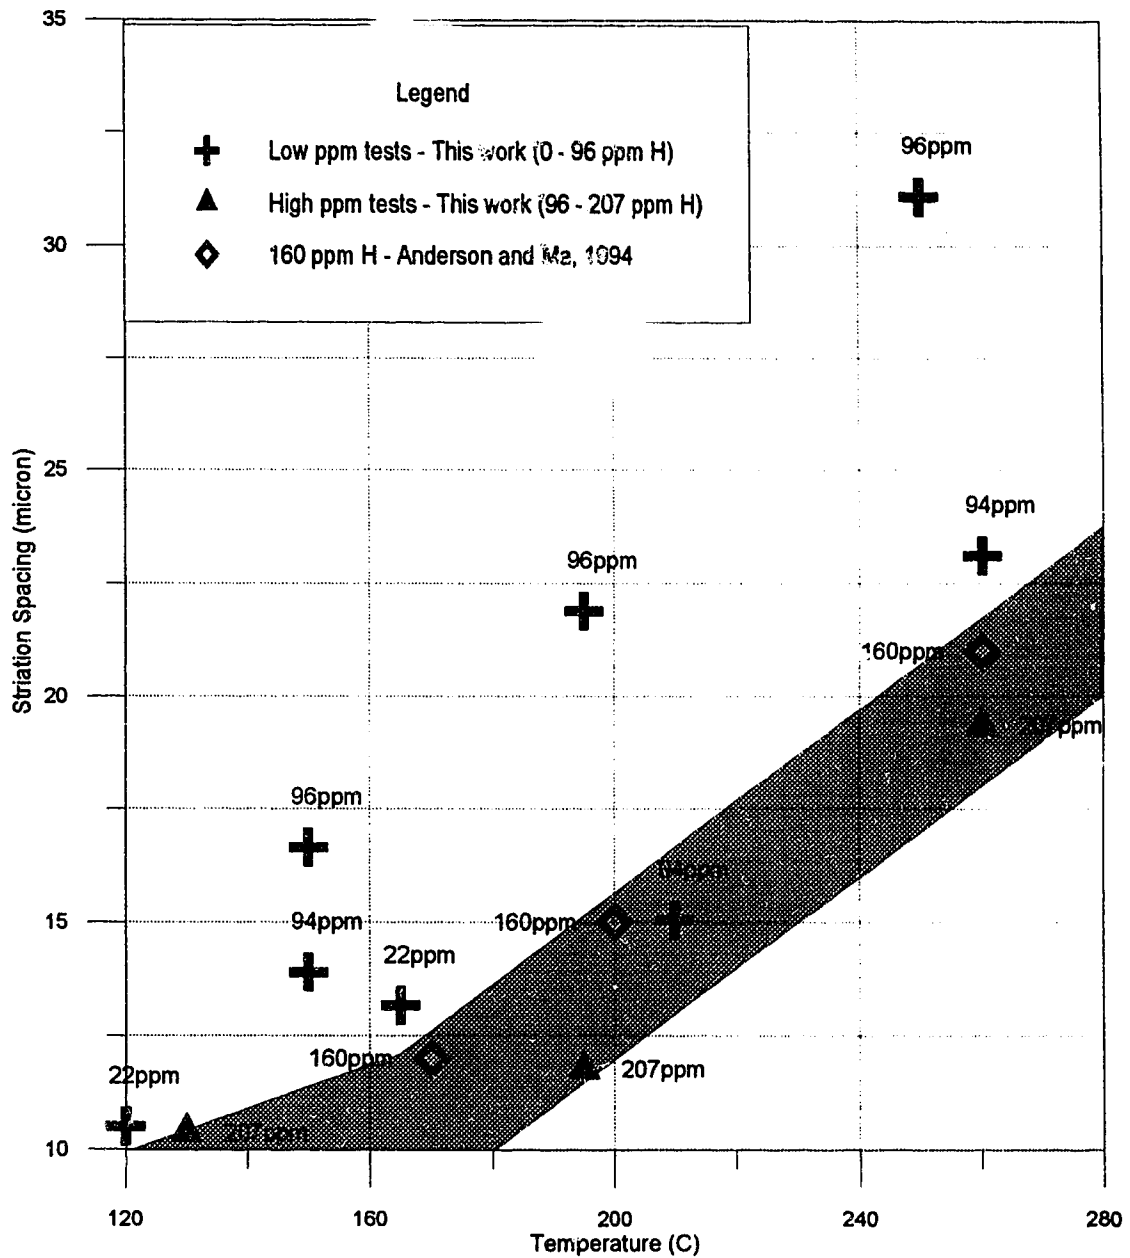
Figure 5.4: Striation spacing versus temperature - decrease in spacing with increasing hydrogen content. All tests were done at a constant K of 17 MPa(m)^{1/2}. Included are results from work of Anderson and Ma, 1994.

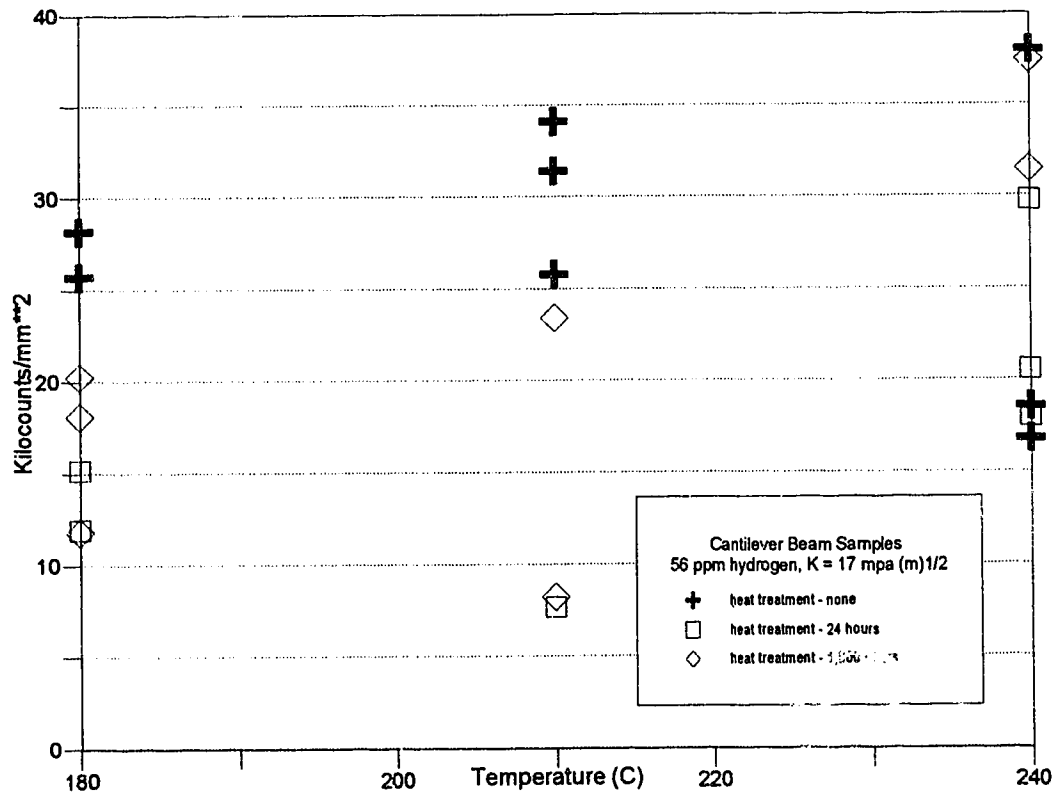
Figure 5.5: Kilocounts per mm^2 versus temperature [Eadie, Jovanovic, Ma and Shek, 1994].

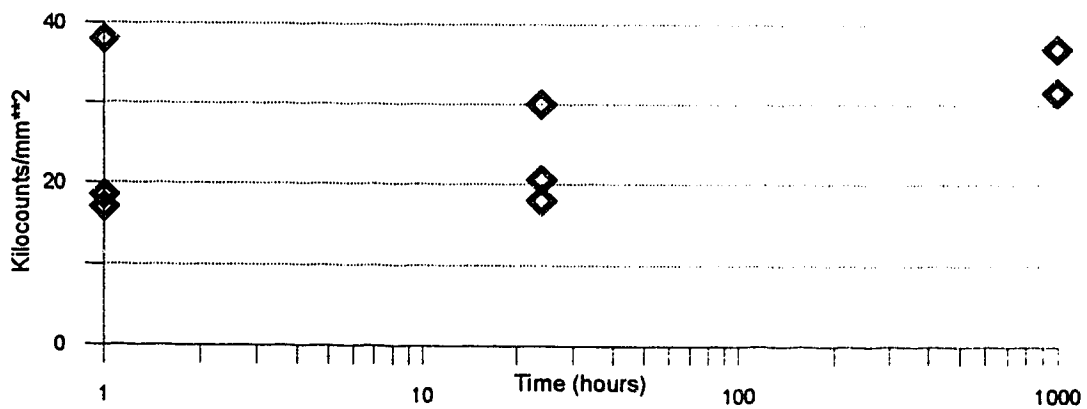
Figure 5.8: Hours of heat treatment versus kilocounts per mm² - test temperature 240° C [Eadie, Jovanovic, Ma and Shek, 1994].

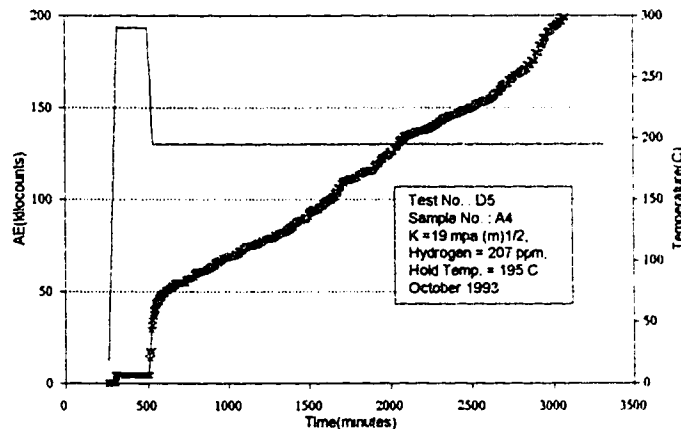
Figure 5.9: AE versus time for isothermal testing done at 195°C on as manufactured material showing high rate of AE just prior to the beginning of the isothermal hold. Examination of the corresponding fracture surface yielded few secondary cracks.

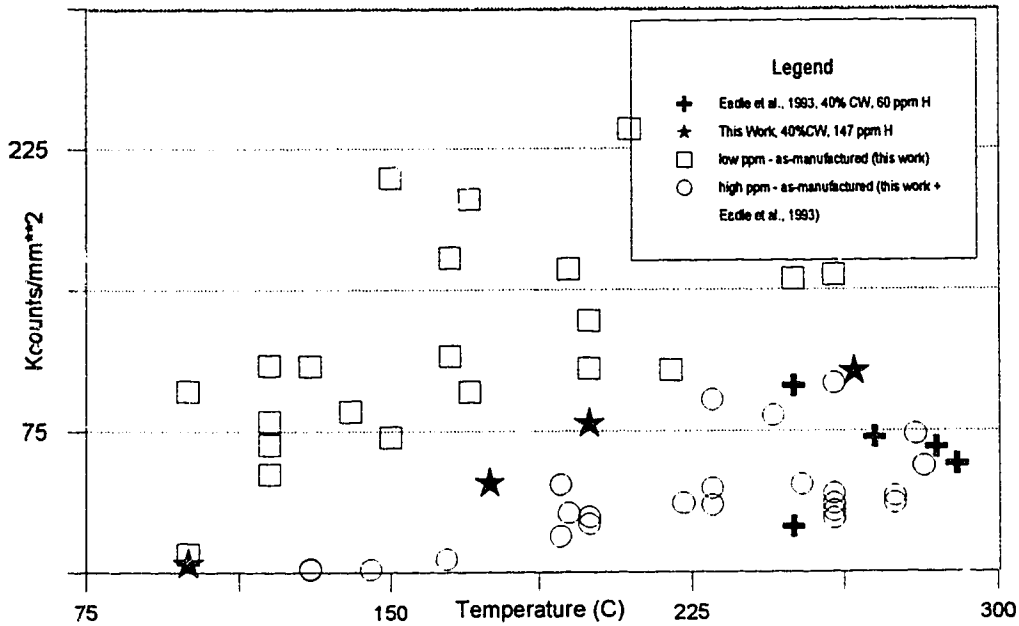
Figure 5.10: Kilocounts per mm² for both the as-manufactured data and cold worked data, (this work compared to work of Eadie, Li, and Shek, 1993).

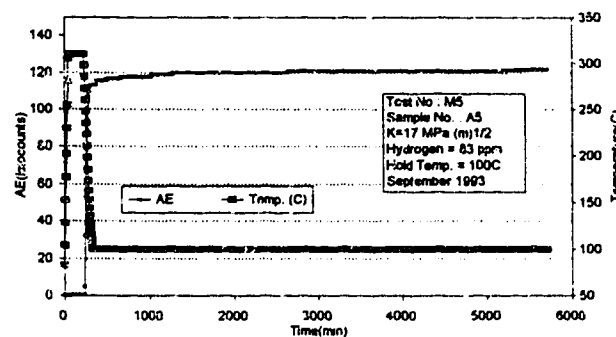
Figure 5.12: AE versus time for isothermal testing done at 100°C on as-manufactured material. AE appears to drop off entirely during the period of testing.
