**University of Alberta**

**FAILURE CRITERIA FOR TEARING OF TELESCOPING WRINKLES**

**Arman Uddin Ahmed**

**Structural Engineering**

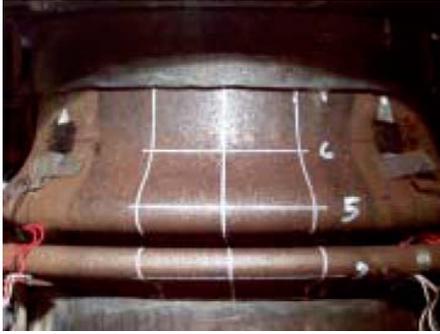
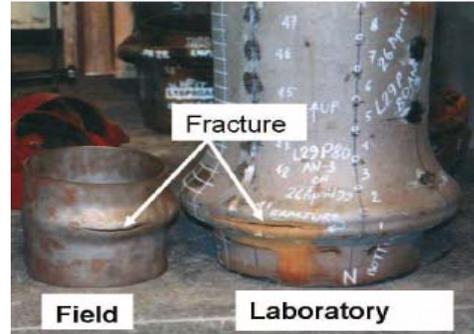
Figure 1.1 (a) Accordion type failure under monotonic loading (Das et al. 2002); and (b) fractures under cyclic deformation (Das et al. 2007c).

Previous research observations have also indicated that occurrence of fractures in pipe wrinkle is rare for monotonically controlled deformation processes in the laboratory and the norm for the deformation configuration of these wrinkles is essentially axisymmetric (Das et al. 2002). Under the continued presence of these deformation processes, there will be stacking up of wrinkles developing an “accordion” configuration, as shown in Figure 1.1a, and conceptually, there will be no danger of fracture at the wrinkle location (Das 2003). A cyclic deformation/loading producing plastic strain reversals in wrinkle location is necessary to generate fracture in the wrinkled pipe, as can be seen from Figure 1.1b (Das et al. 2007a).

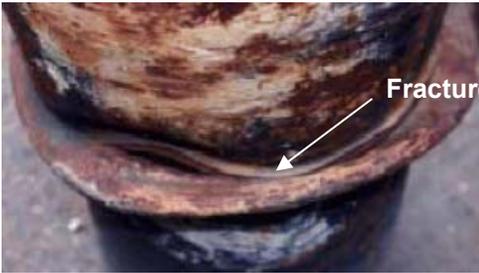
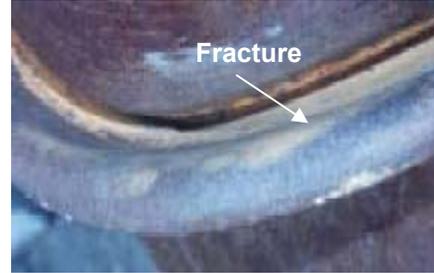
Figure 1.2 Pipe segment showing tearing fracture at wrinkle location obtained from (a) WestCoast Energy, and (b) Experimental work performed at University of Alberta (Das et al. 2002)

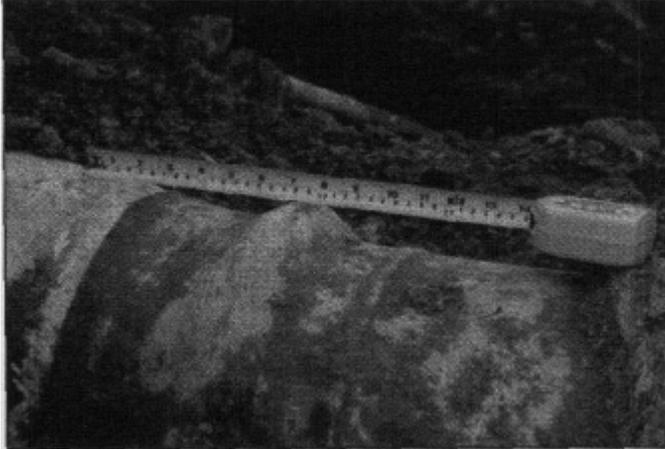
Figure 2.3 Exposed wrinkle of Norman wells pipeline at Slope 92 (Wilkie et al. 2001)

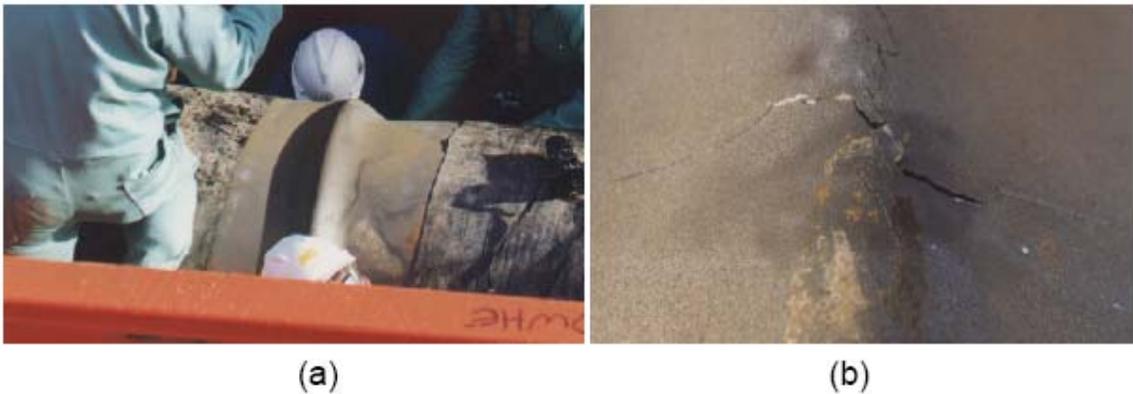
Figure 2.4 (a) Wrinkle (buckle) in a 40 inch diameter steel pipe with (b) close-up view of wrinkled pipe showing through-the-wall cracks (NTSB 1999)

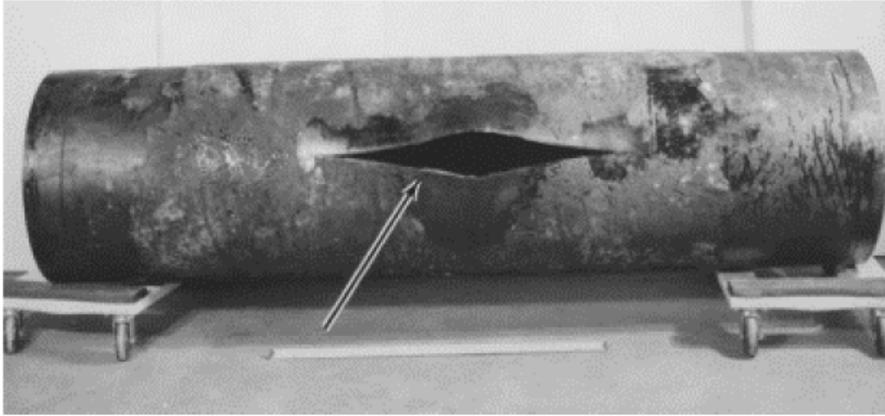
Figure 2.5 Rupture of an energy pipe due to presence of dent along with operating pressure fluctuations (NTSB 2001)

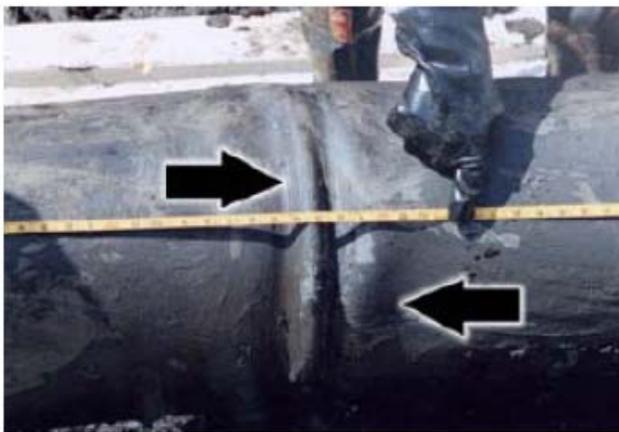
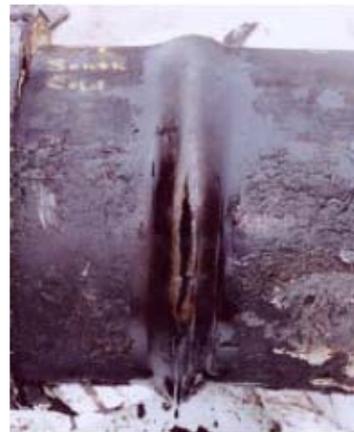
Figure 2.6 (a) Wrinkle or buckle location in the failed pipe, (b) Presence of significant crack at the wrinkle crest (NTSB 2002)

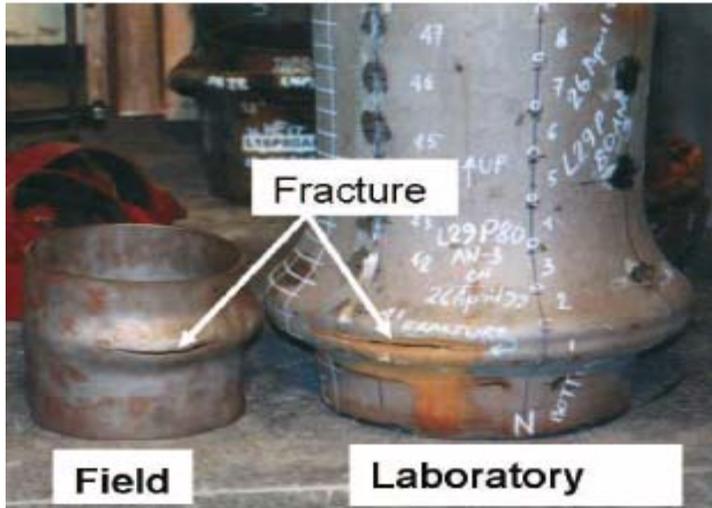
Figure 2.7 Fracture of wrinkled pipe under cyclic axial loading (Das et al. 2007a)

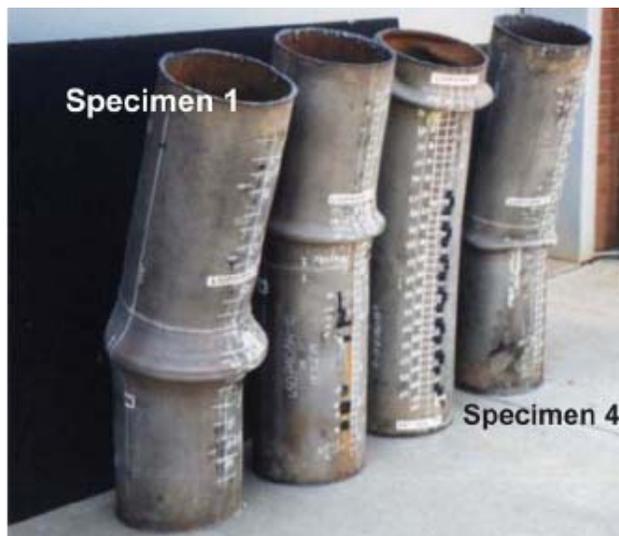
Figure 2.8 Non-axisymmetric wrinkles under bending deformation (Das et al. 2008)

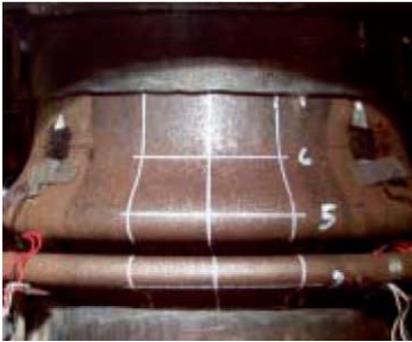
Figure 2.10 Accordion type of failure under monotonic loading (Das et al. 2002)

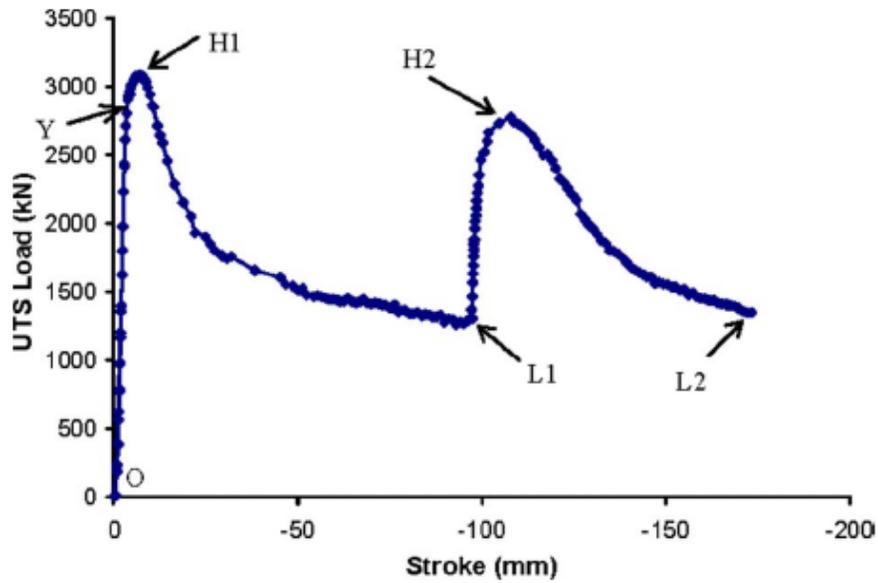
Figure 2.11 Load-displacement response of an NPS12 pipe under monotonic deformation (Das 2003; Zhang and Das 2008a)

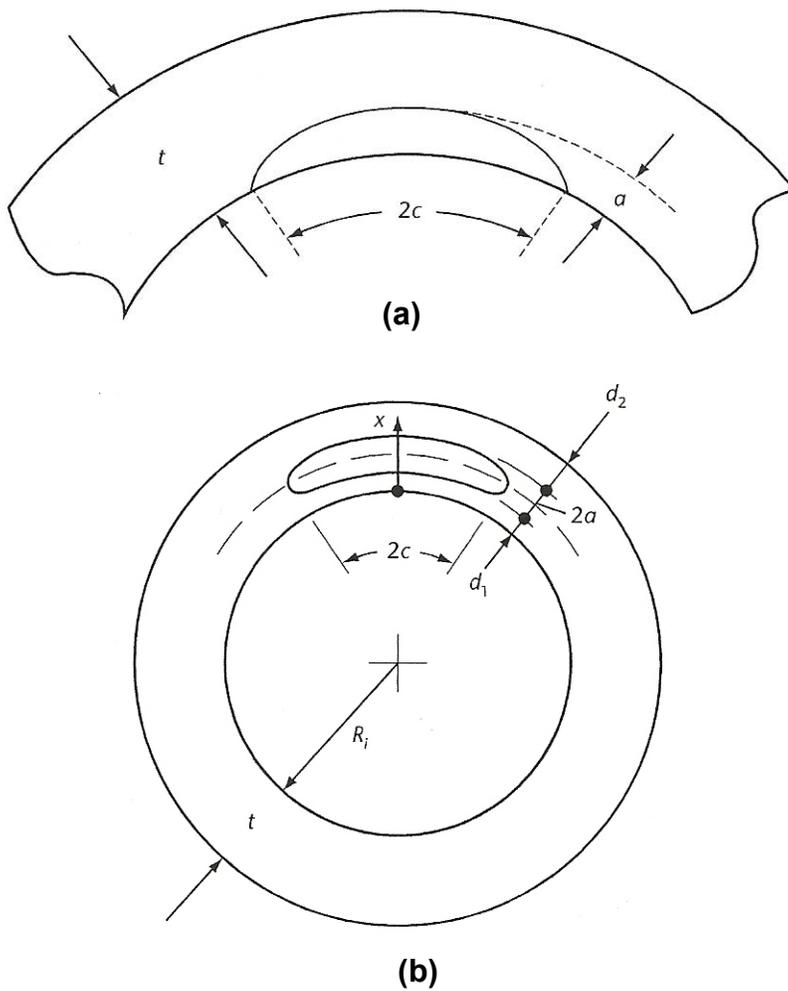
Figure 2.13 Schematic of (a) surface-breaking, and (b) buried defects in the pipe wall (Canadian Standards Association (CSA) 2007)

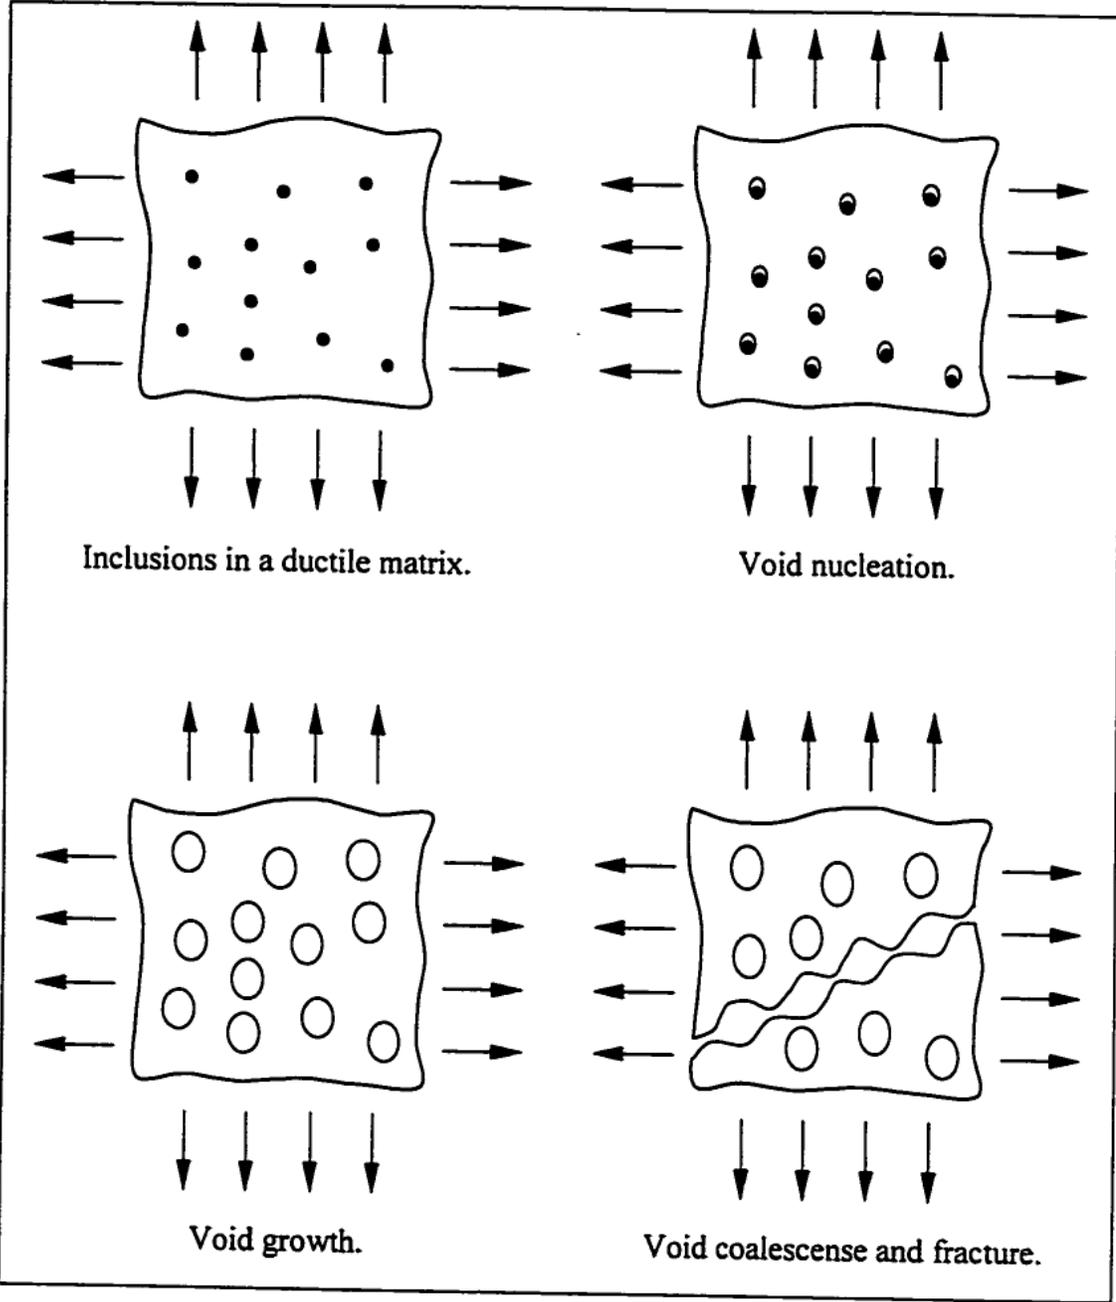
Figure 2.14 Mechanism of ductile fracture in metal (Khoo 2000)

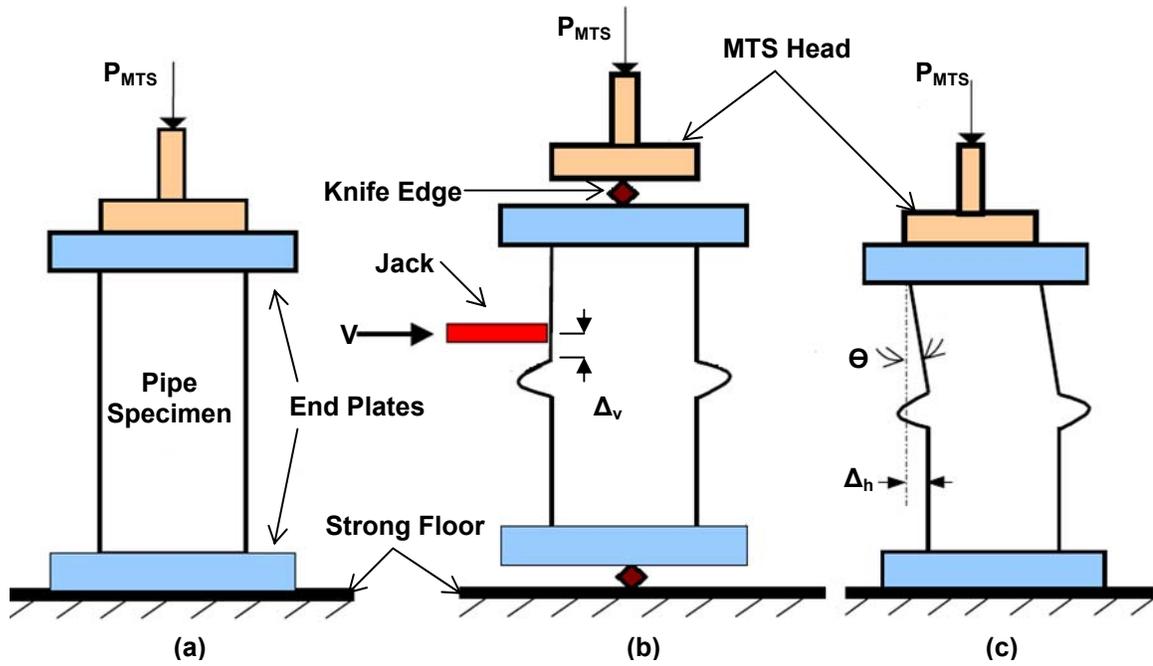
Figure 3.3 Schematic view of the test set with sequence of applied axial and transverse load (Das et al. 2002)

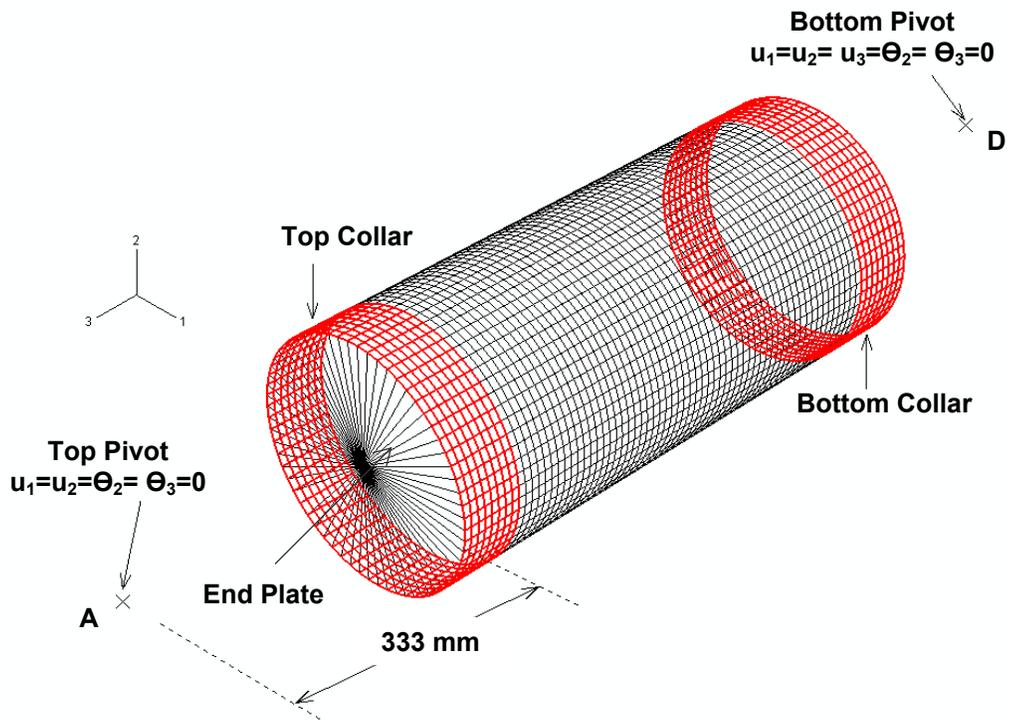
Figure 3.10 Typical geometry and initial boundary condition for the full-pipe model

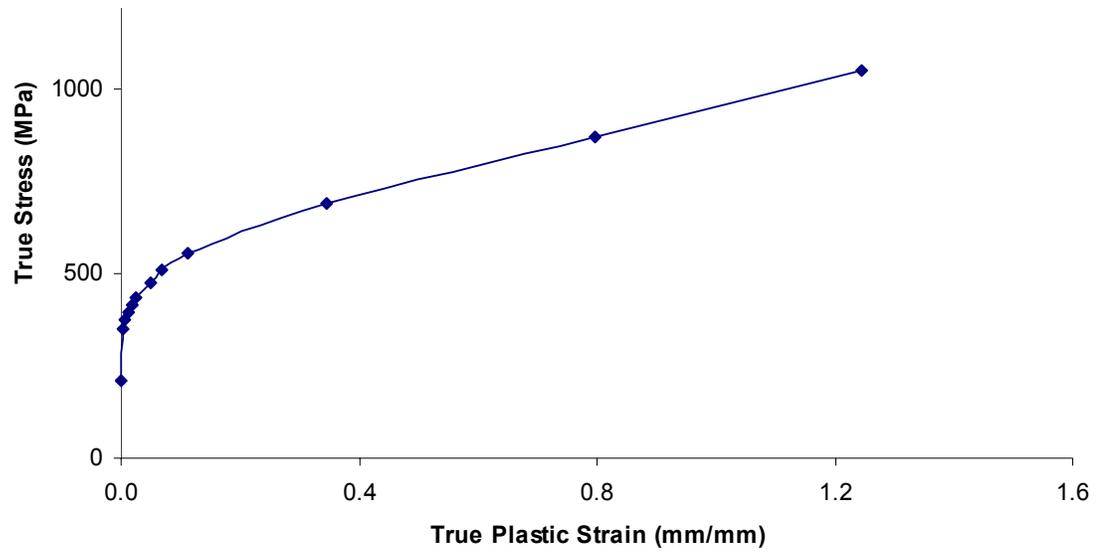
Figure 3.11 True stress versus true plastic strain behaviour until failure

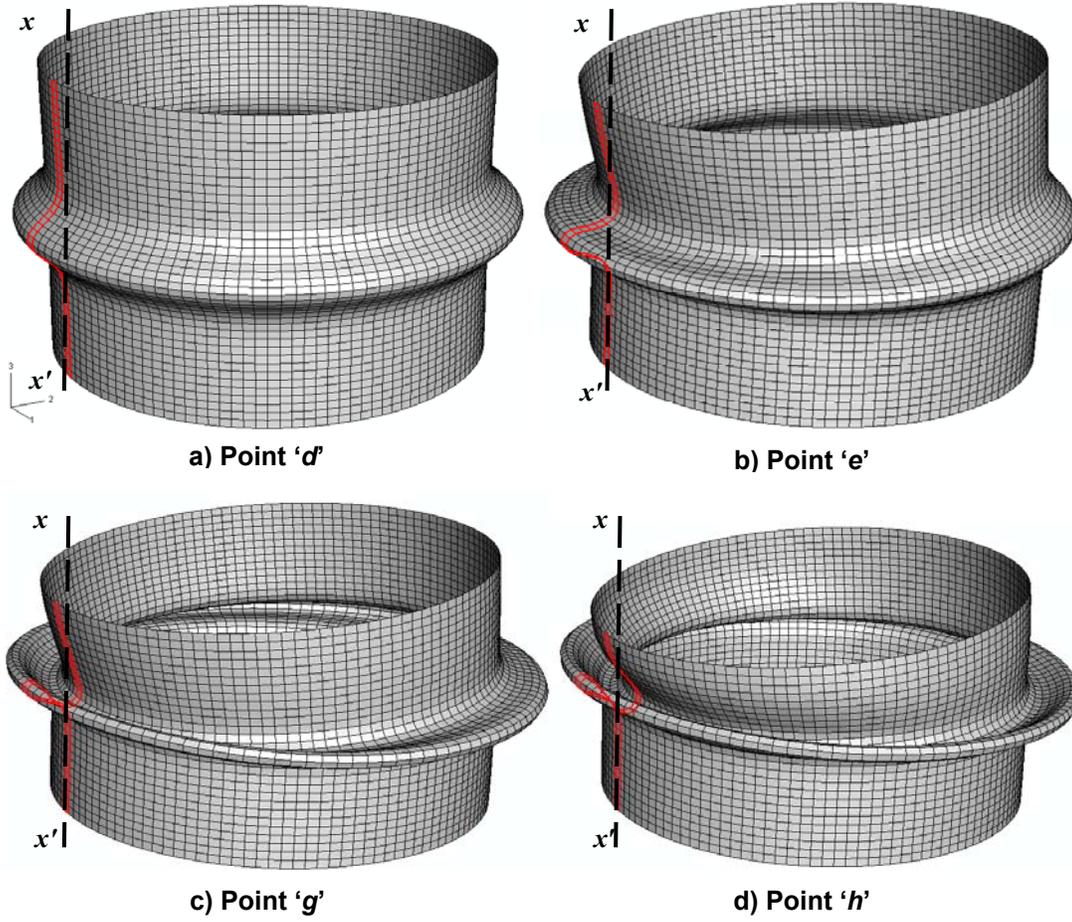
Figure 3.20 Predicted progression of deformed configuration for the pipe specimen

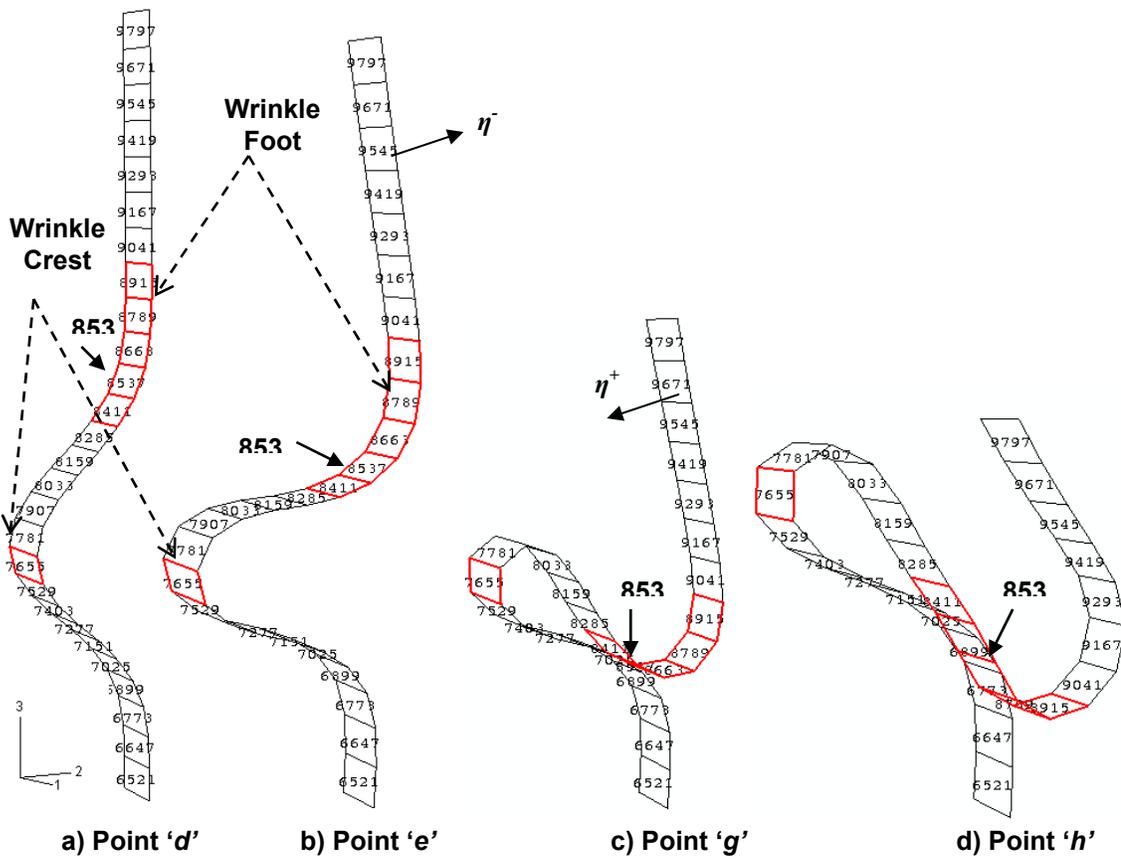
Figure 3.21 Predicted wrinkle formation process on the compression side of the pipe

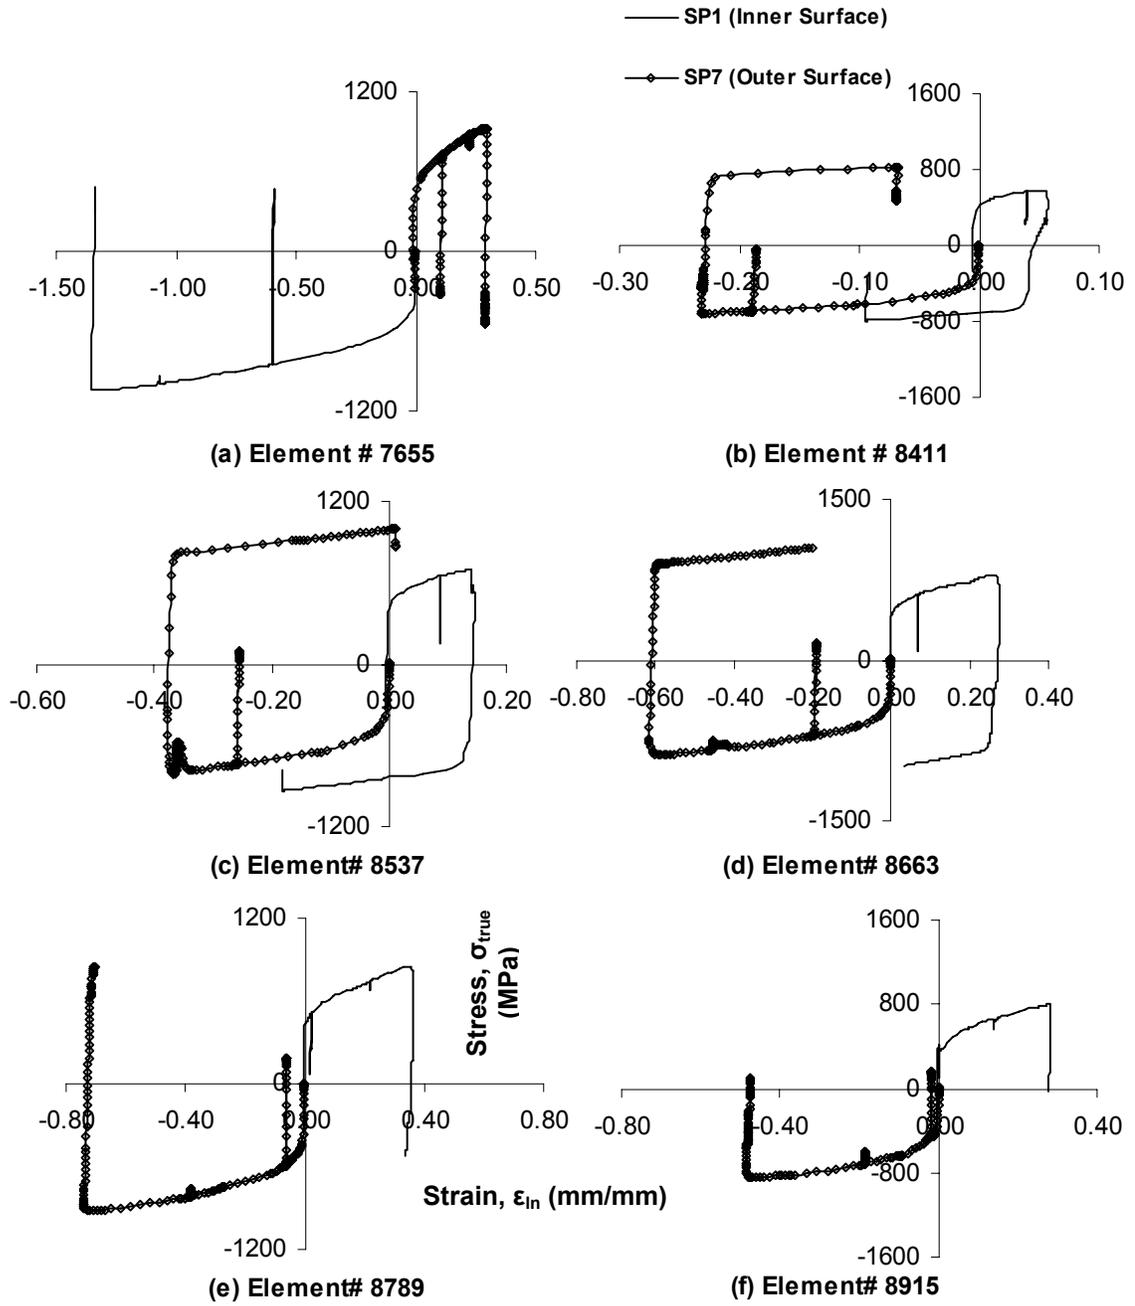
Figure 3.22 Longitudinal Stress-Strain relationship at some selected elements

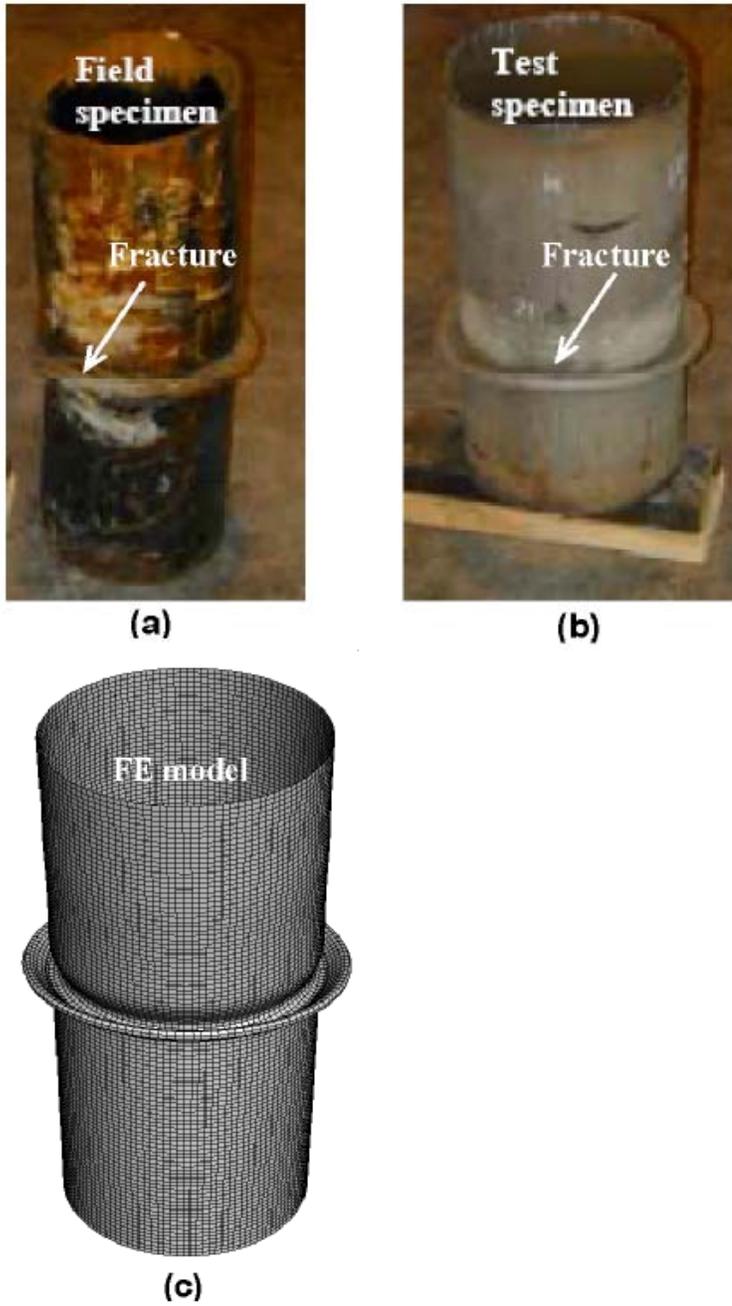
Figure 4.3 Final deformed shapes of the specimens obtained from (a) the WestCoast Energy Inc. (Das et al. 2002) , (b) the test (Das et al. 2002), and (c) the numerical work (Ahmed et al. 2010)

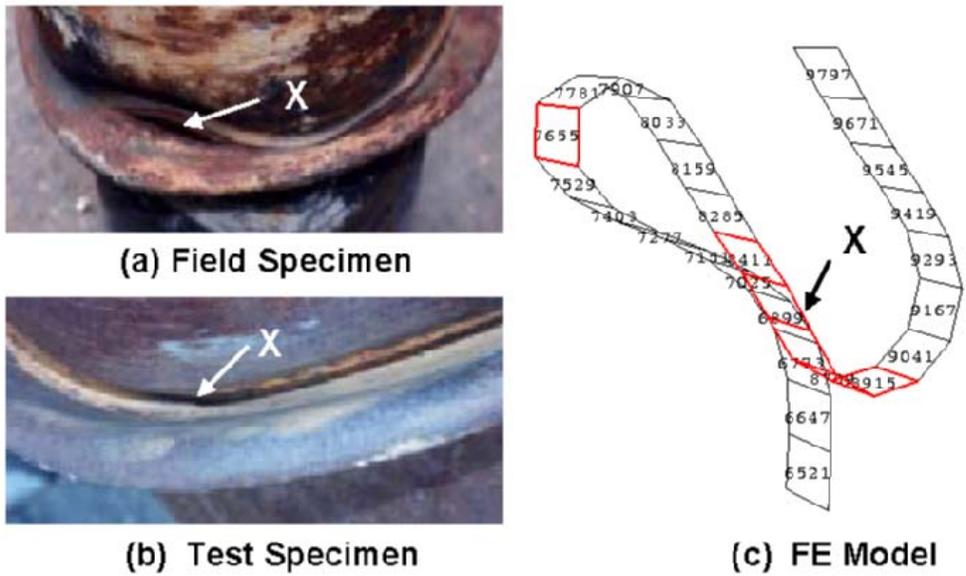
Figure 4.21 Fracture in the wrinkle fold of (a) the field (Das et al. 2002), and (b) the test specimen (Das et al. 2002); and location of strain reversal in FE model (Ahmed et al. 2010).

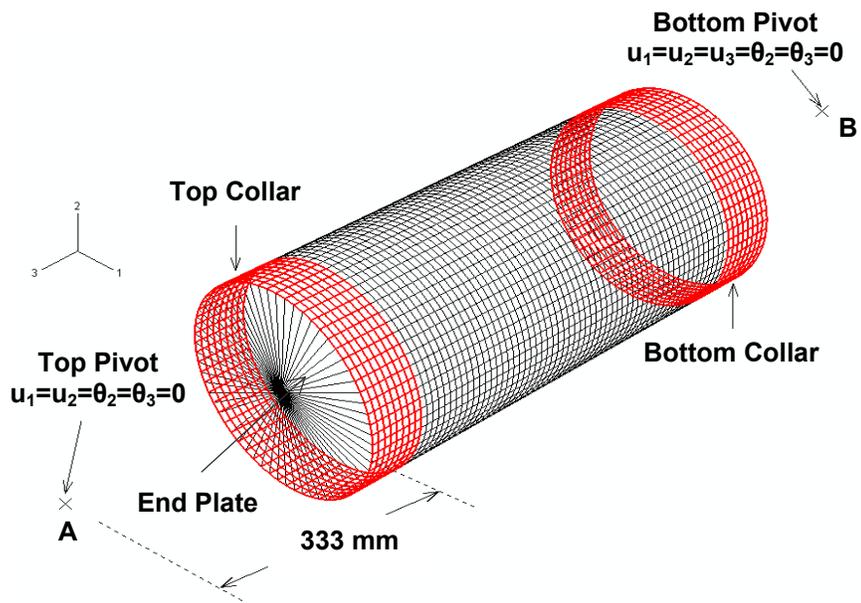
Figure 4.22 Typical geometry and initial boundary condition for full-pipe model

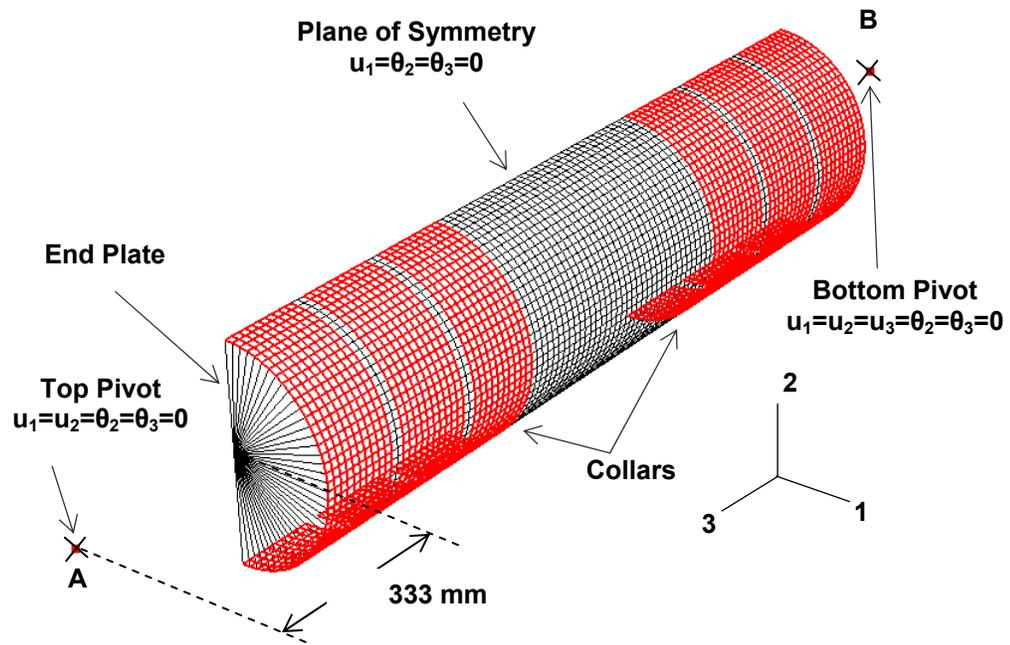
Figure 4.23 Typical geometry and initial boundary condition for half pipe model

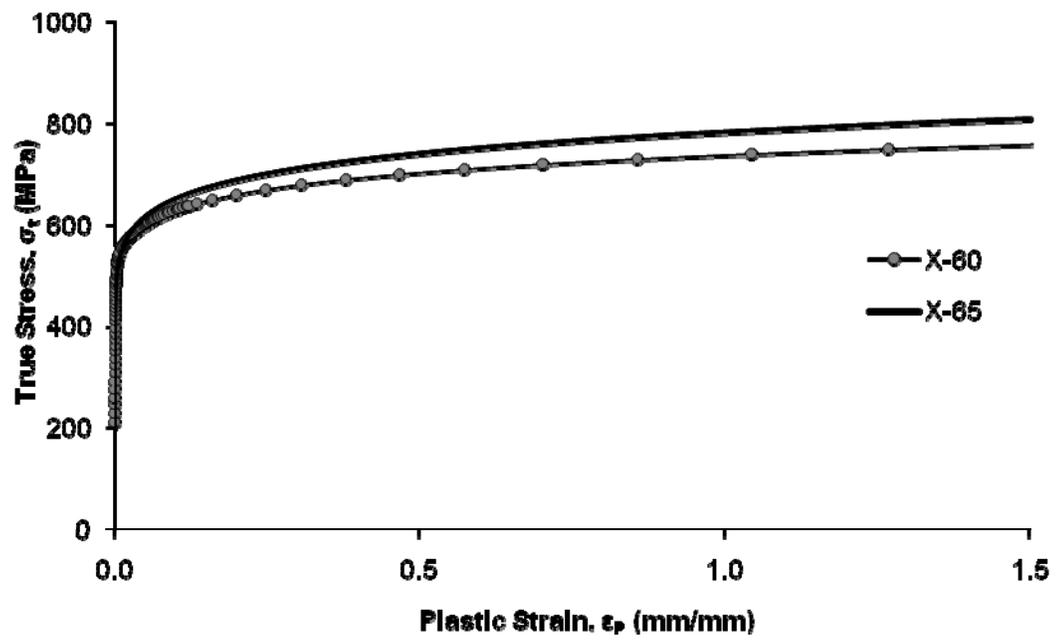
Figure 4.26 True stress-true plastic strain behaviour of X-60 and X-65 grade steel (up to failure)

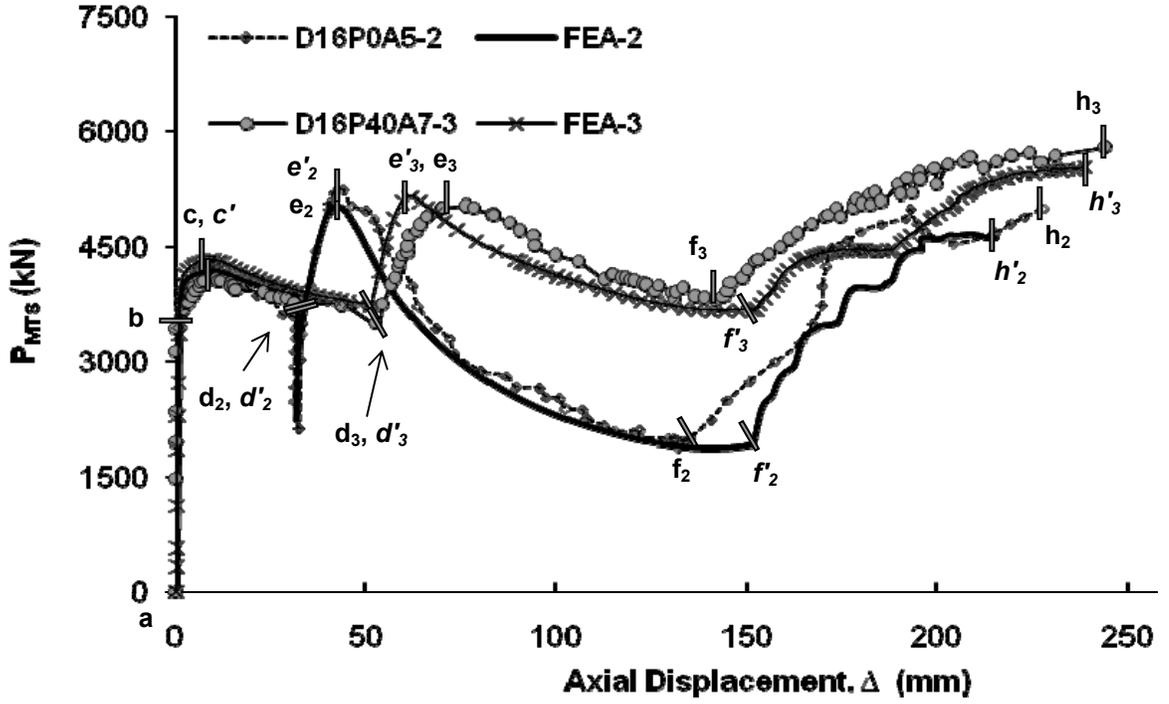
Figure 4.27 MTS load—displacement relationship obtained from FE analyses and test results of NPS16 pipes

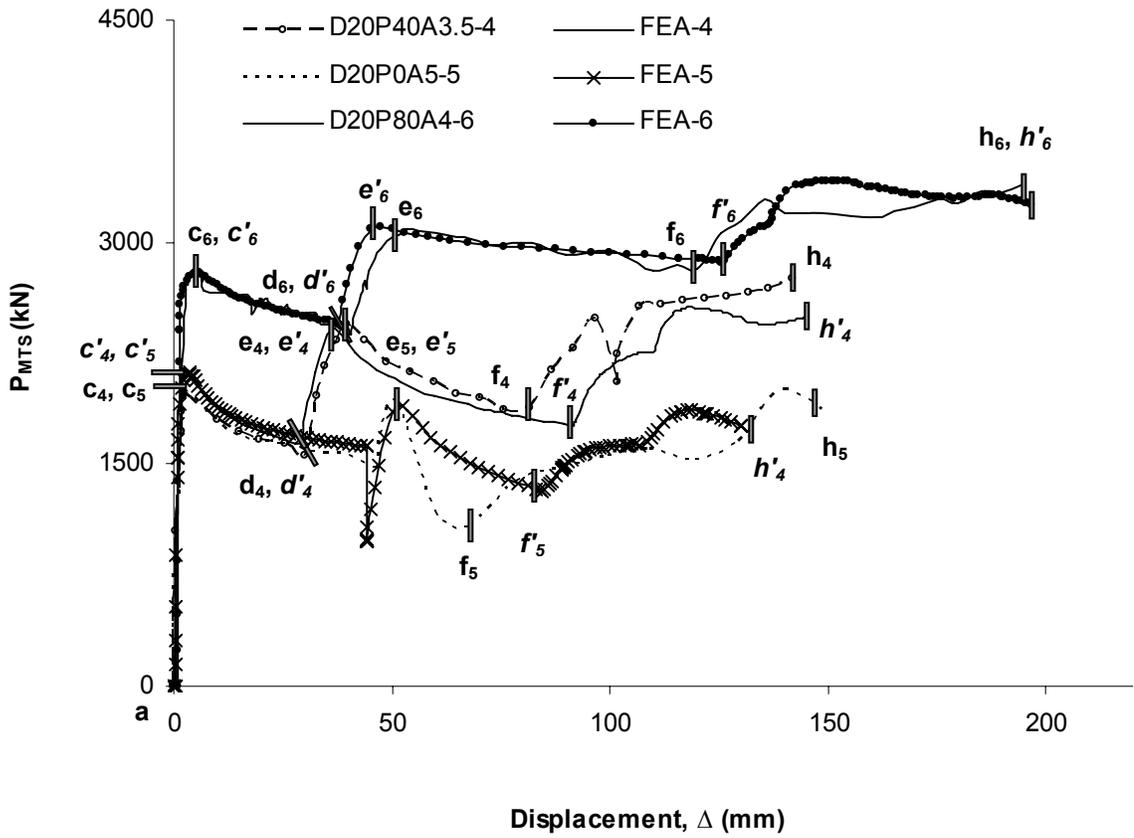
Figure 4.28 MTS load—displacement relationship obtained from FE analyses and test results of NPS20 pipes

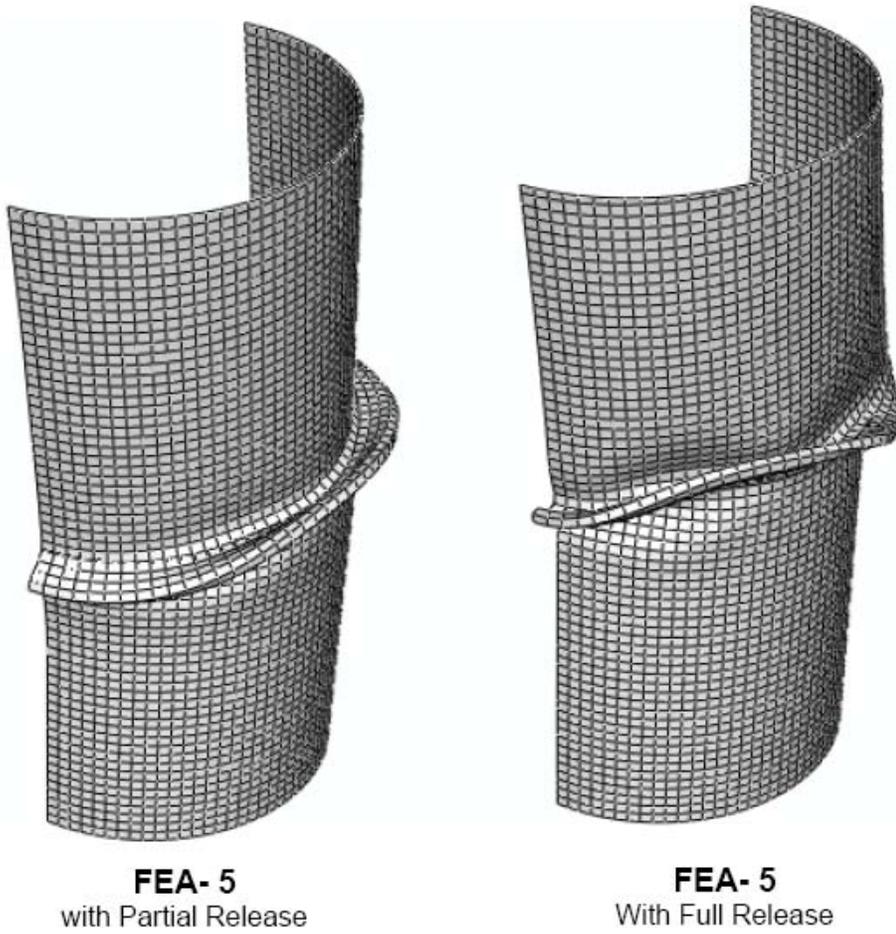
Figure 4.37 Comparison of final deformed shapes from FE analyses of specimen 5 with two different internal pressure conditions

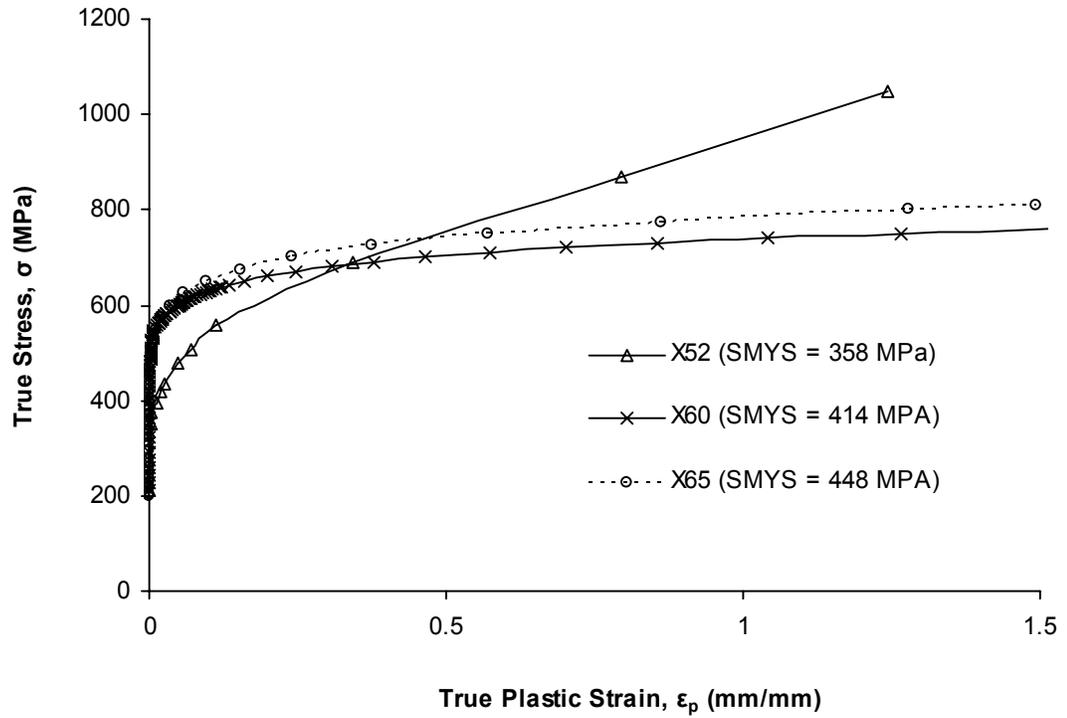
Figure 5.1 True stress-true plastic strain relationship (up to failure) all the pipe materials used in this research program

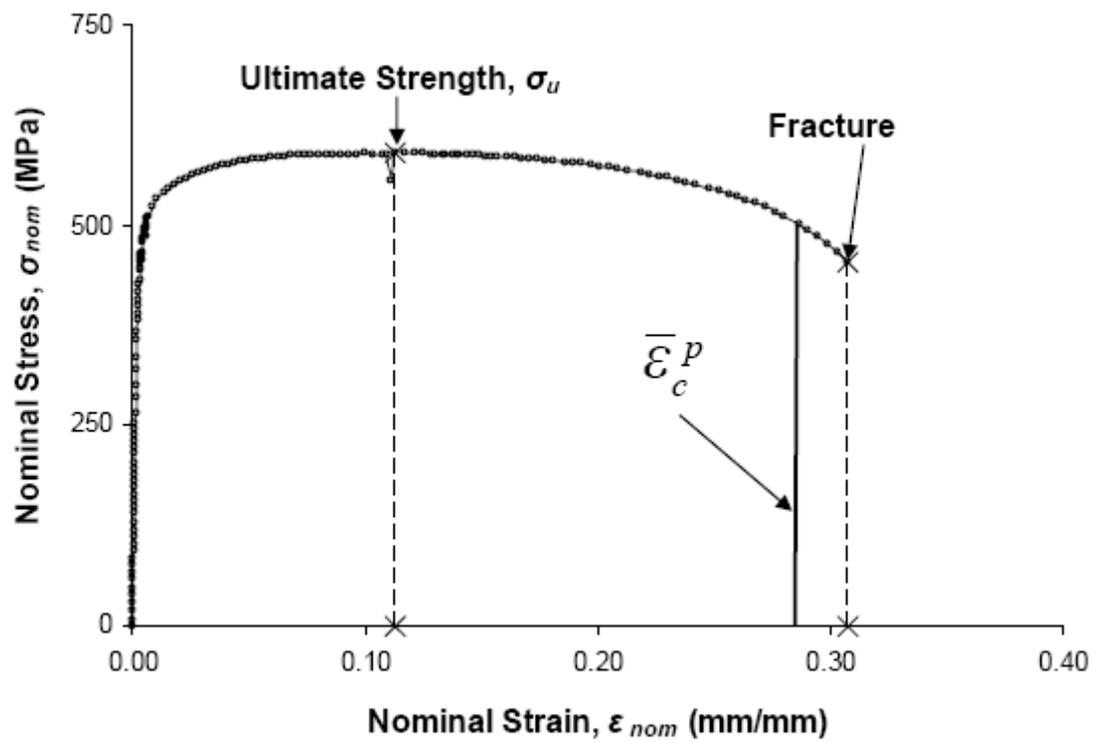
Figure 5.2 Typical engineering (nominal) stress-strain plot obtained from tension coupon test showing a schematic location of critical strain ( $\bar{\epsilon}_c^p$ )

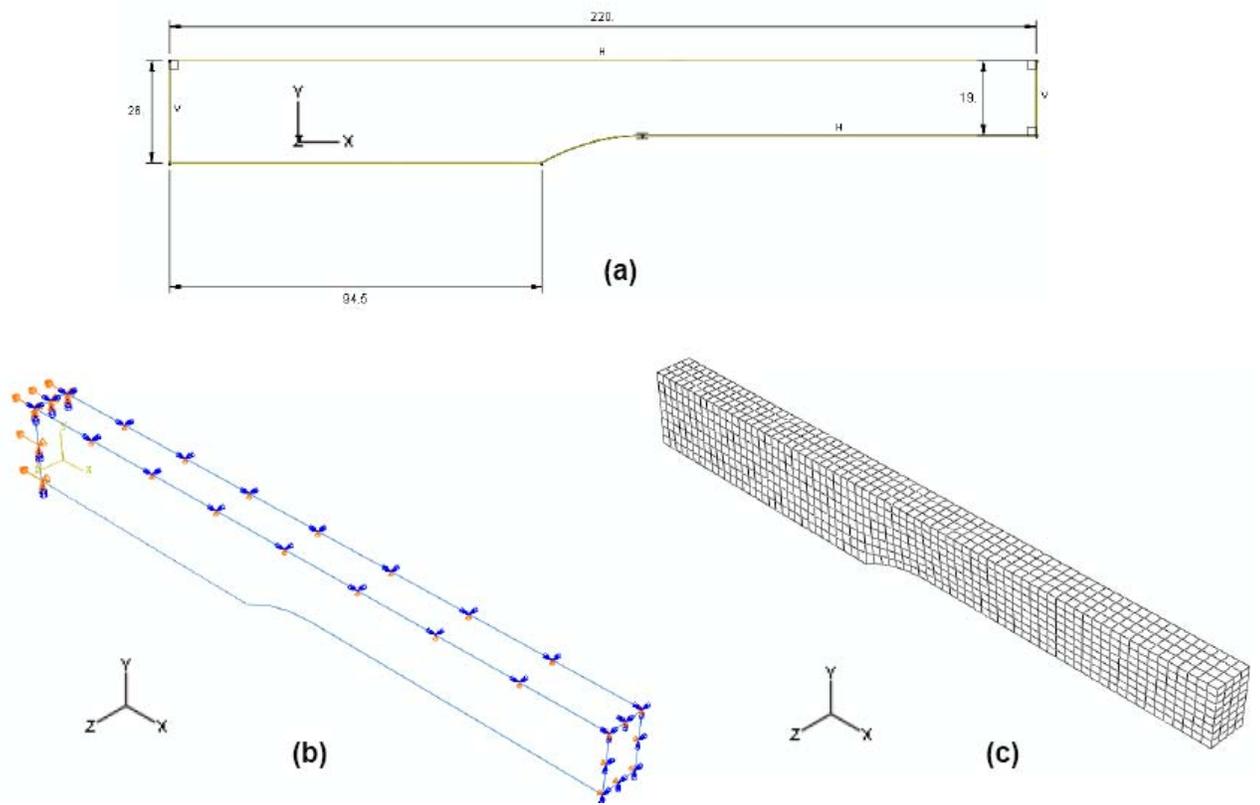
Figure 5.4 FE model of the steel tension bar: (a) a plane view with dimensions in mm; (b) loading and boundary conditions on a  $\frac{1}{4}$  FE model; (c) the FE mesh

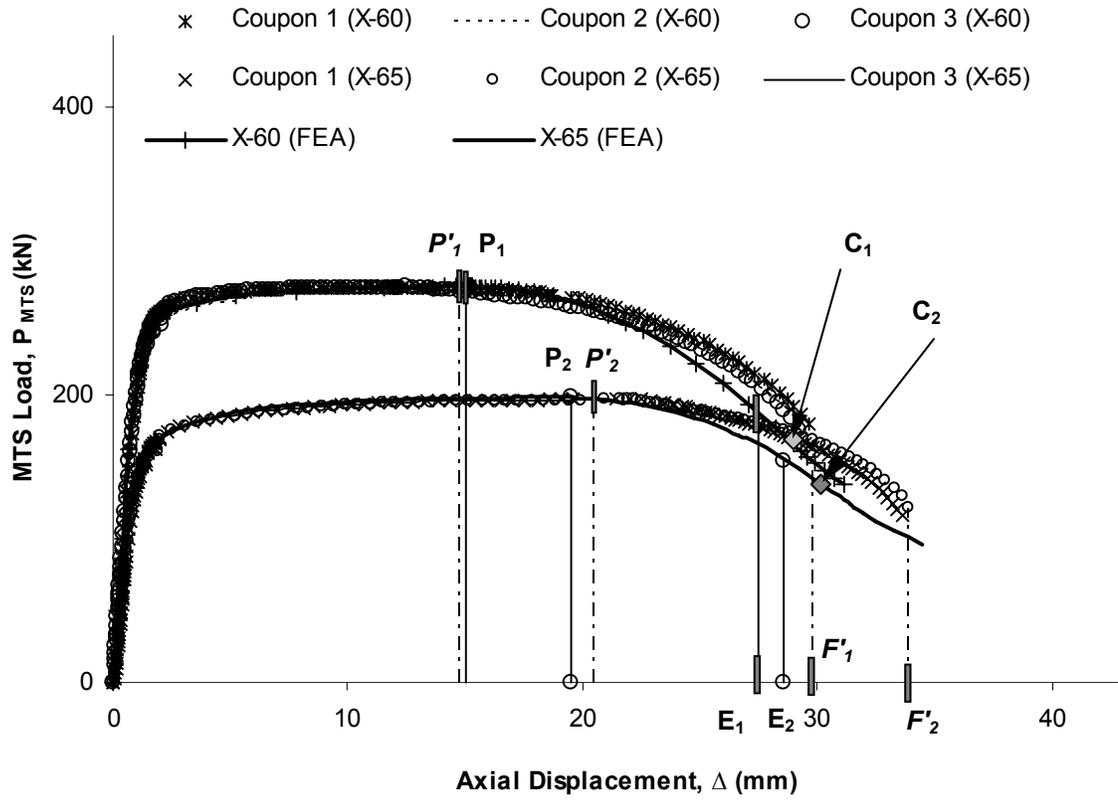
Figure 5.5 Experimentally measured and numerically computed load-displacement ( $P$ - $\Delta$ ) responses of X60 and X65 grade steel coupons

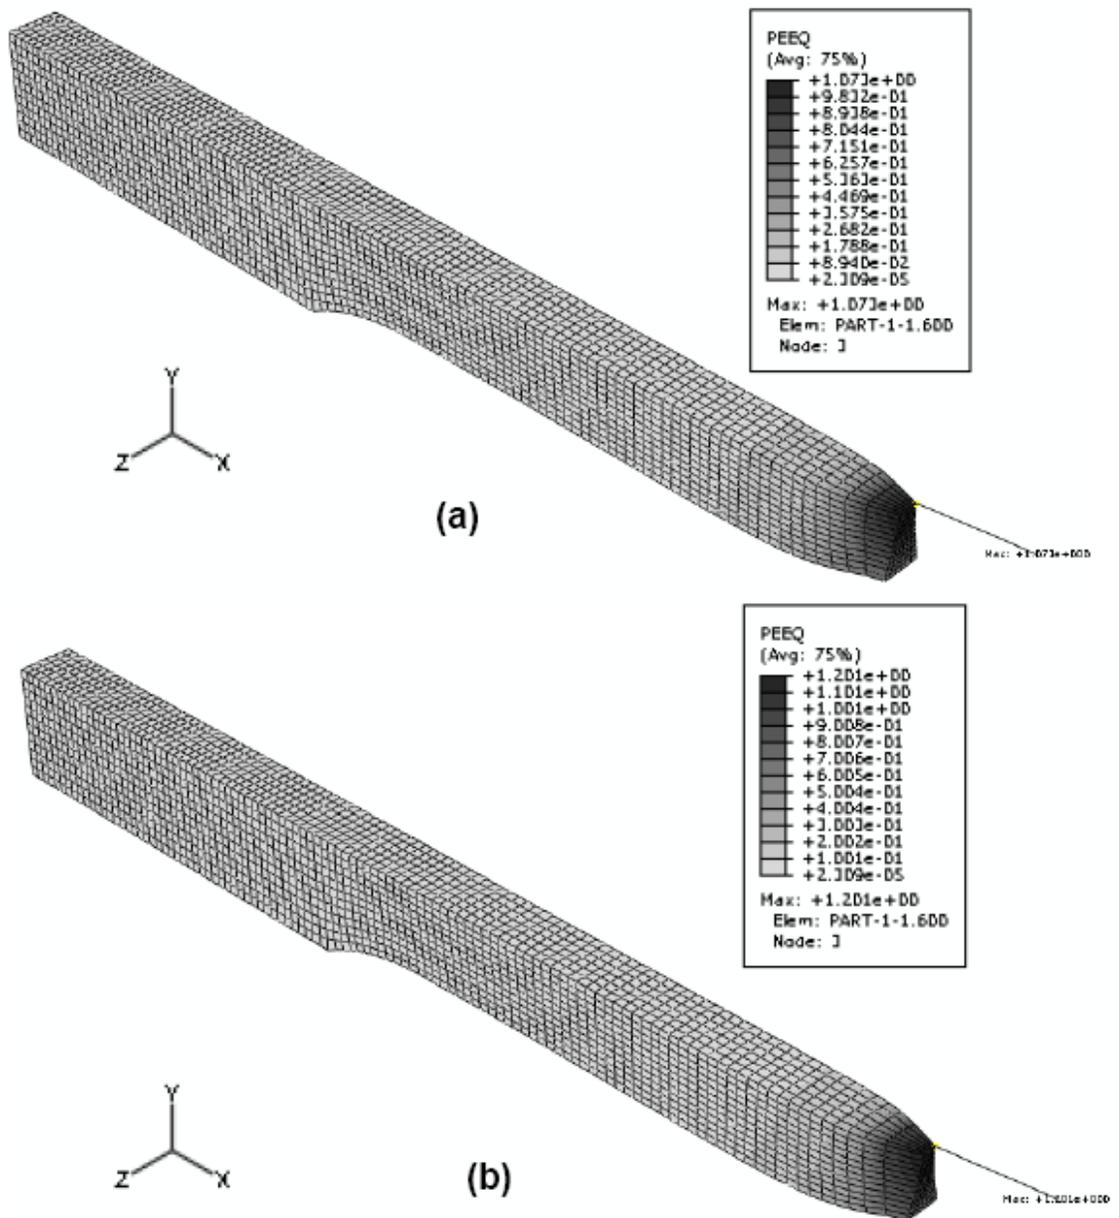
Figure 5.8 The distribution of the equivalent plastic strain (PEEQ or  $\epsilon^p$ ) at (a) point E<sub>1</sub>; and (b) point C<sub>1</sub> on P- $\Delta$  response of X60 coupon
