**University of Alberta**

**FAILURE CRITERIA FOR TEARING OF TELESCOPING WRINKLES**

**Arman Uddin Ahmed**

**Structural Engineering**

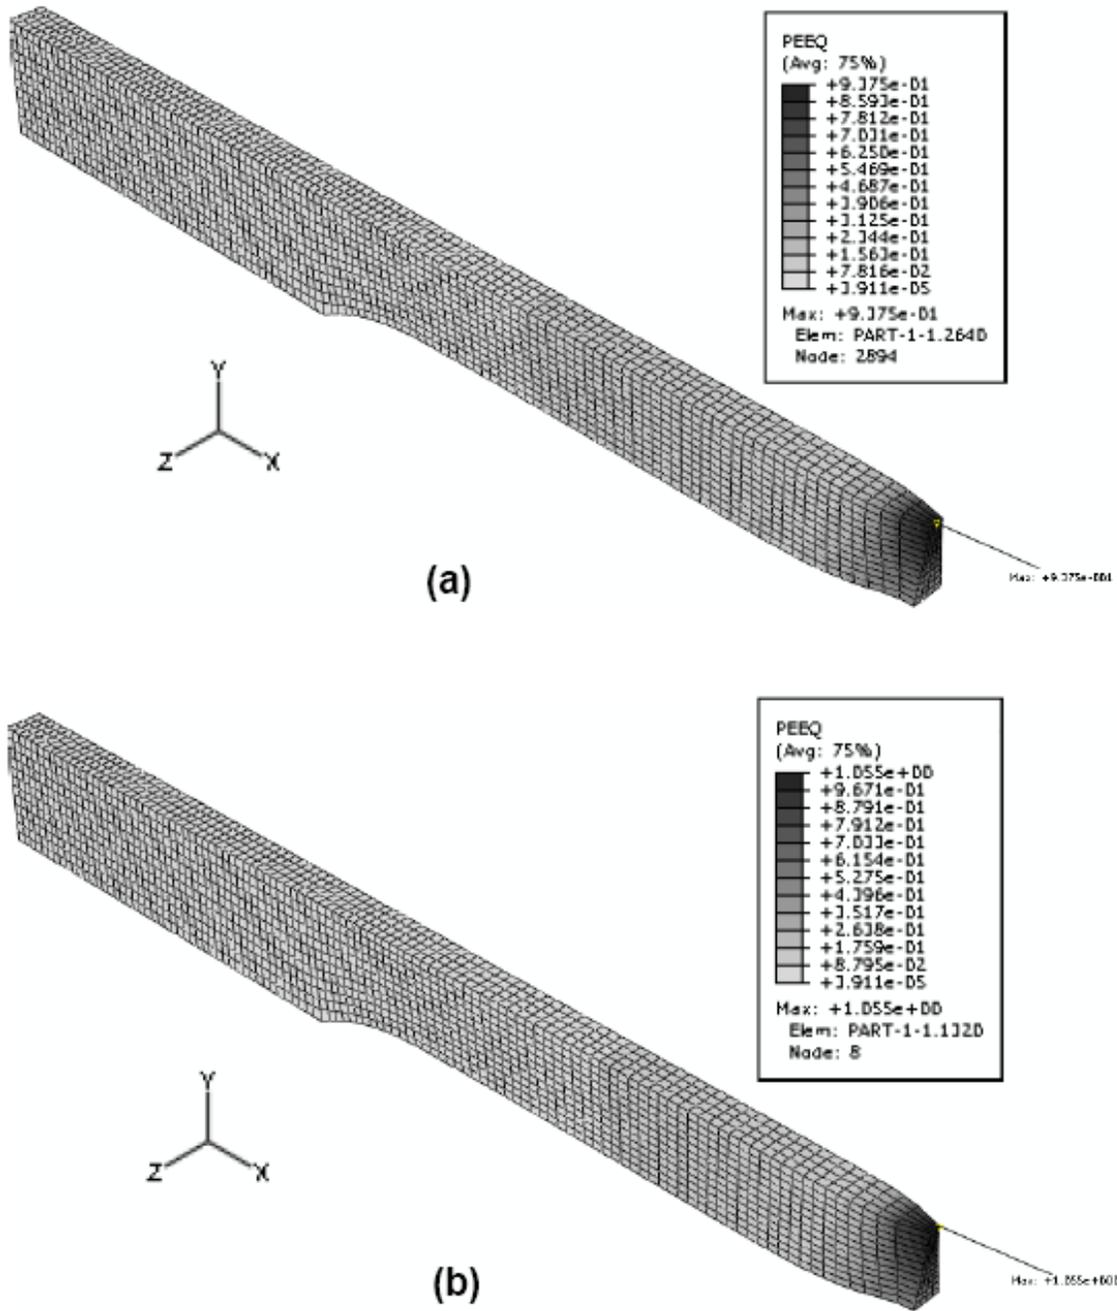
Figure 5.9 The distribution of the equivalent plastic strain (PEEQ or  $\epsilon^p$ ) at (a) point E<sub>2</sub>; and (b) point C<sub>2</sub> on P- $\Delta$  response of X65 coupon

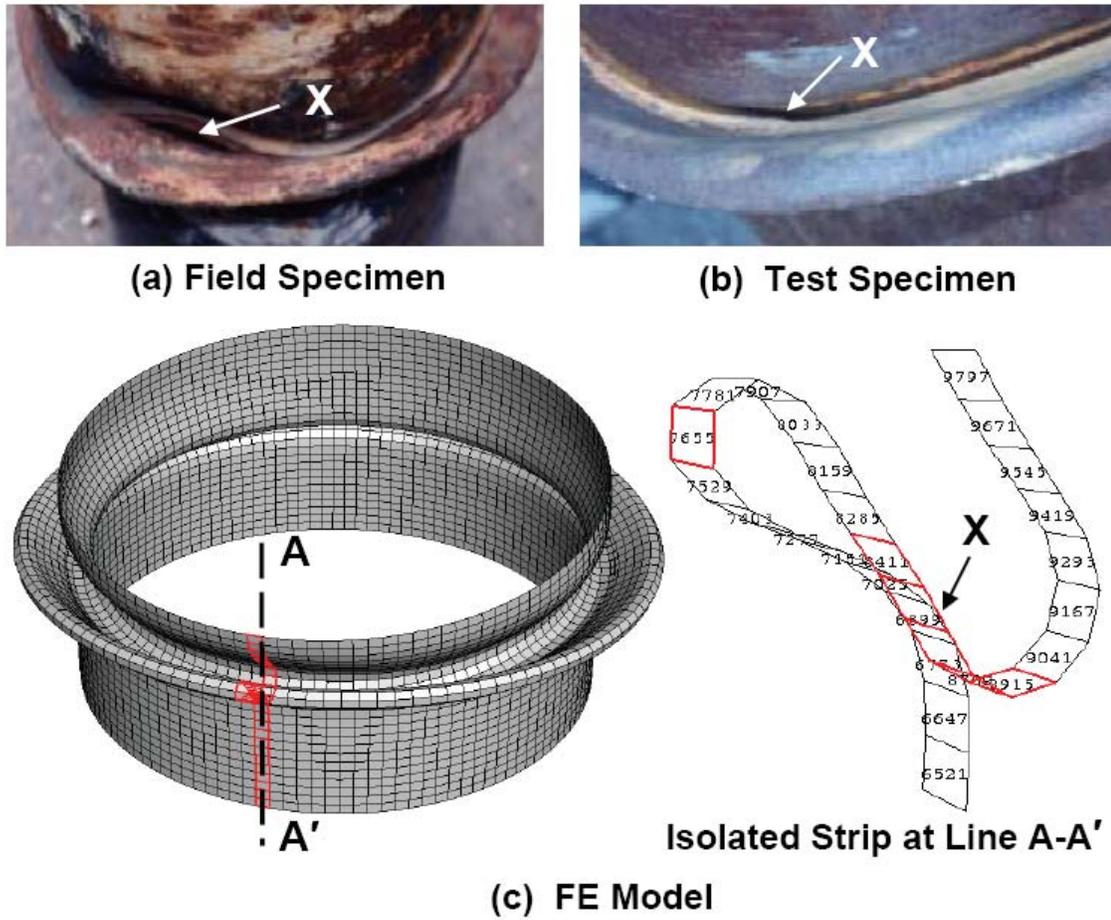
Figure 5.12 Fracture in the wrinkle fold of (a) the field (Das et al. 2002), and (b) the test specimen D12P0A3.4-1 (Das et al. 2002); and location of strain reversal in the FE (full-pipe) model (Ahmed et al. 2010)

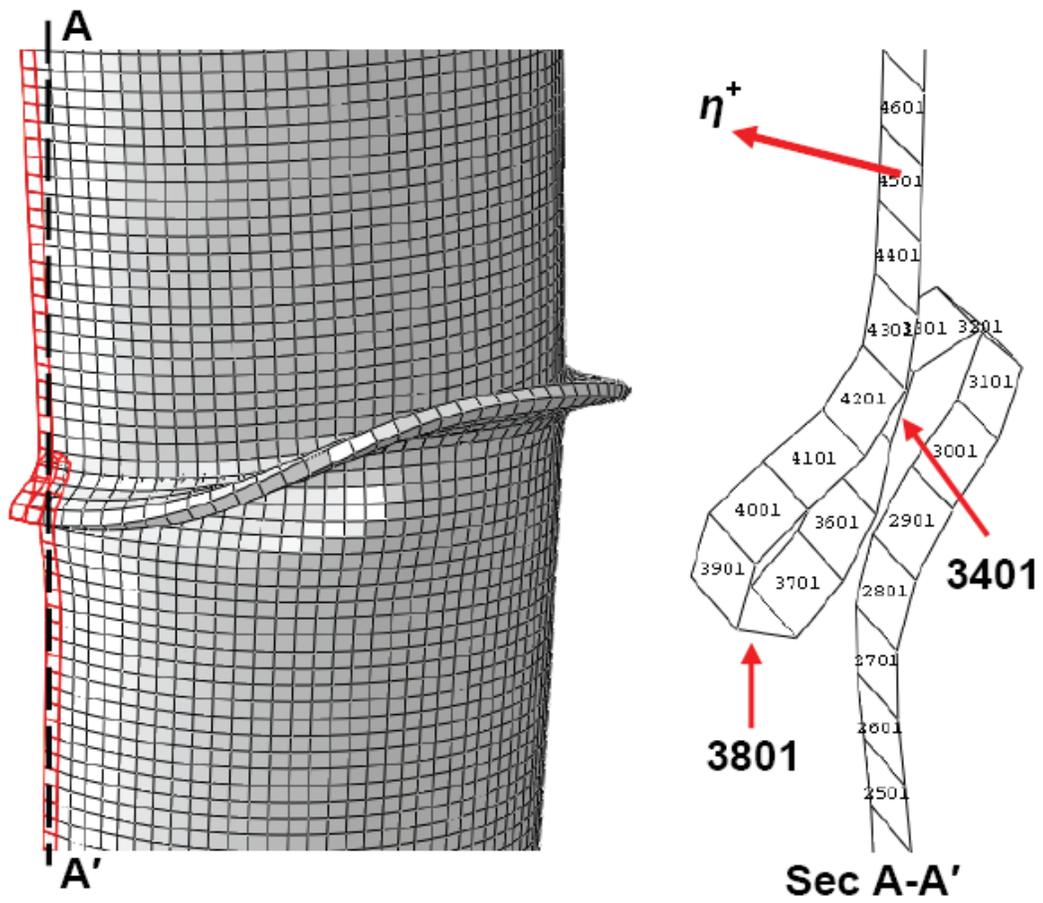
Figure 5.23 Close-up view of wrinkled pipe along with a wrinkle-strip for specimen 4

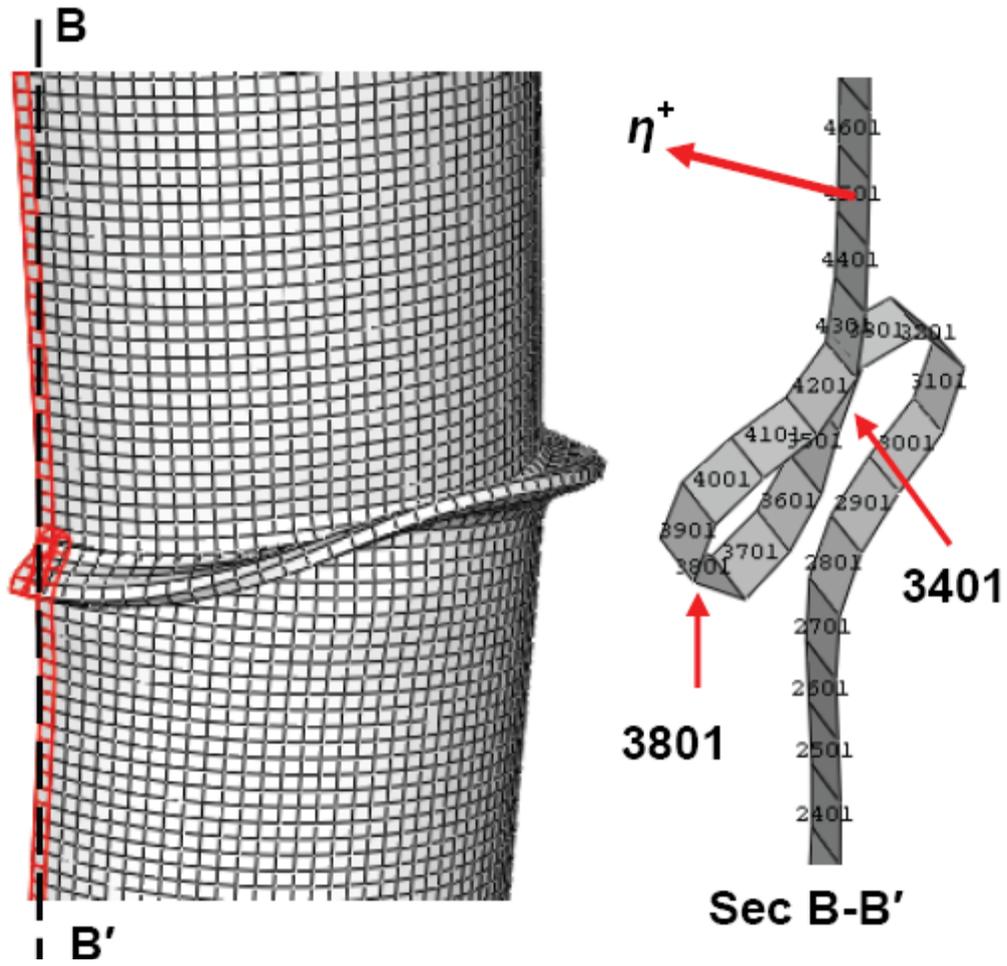
Figure 5.27 Close-up view of wrinkled pipe along with a wrinkle-strip for specimen 5

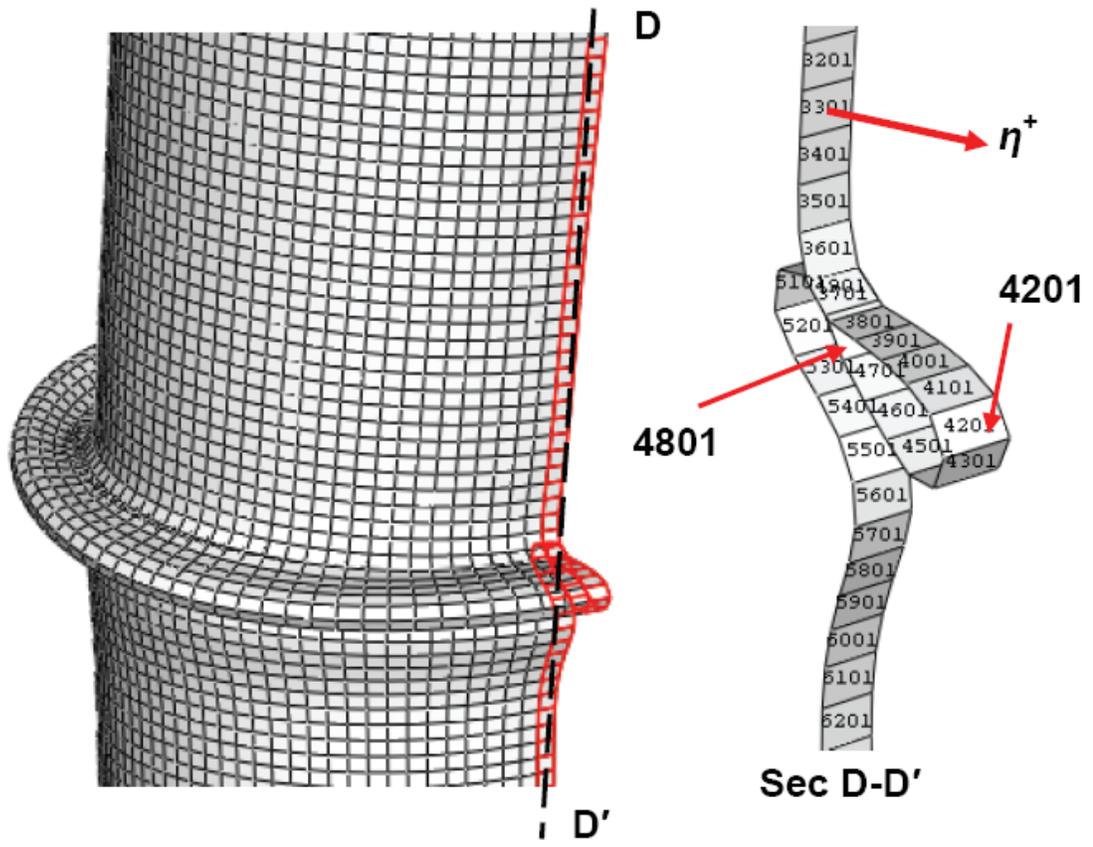
Figure 5.31 Close-up view of wrinkled pipe along with a wrinkle-strip for specimen 6

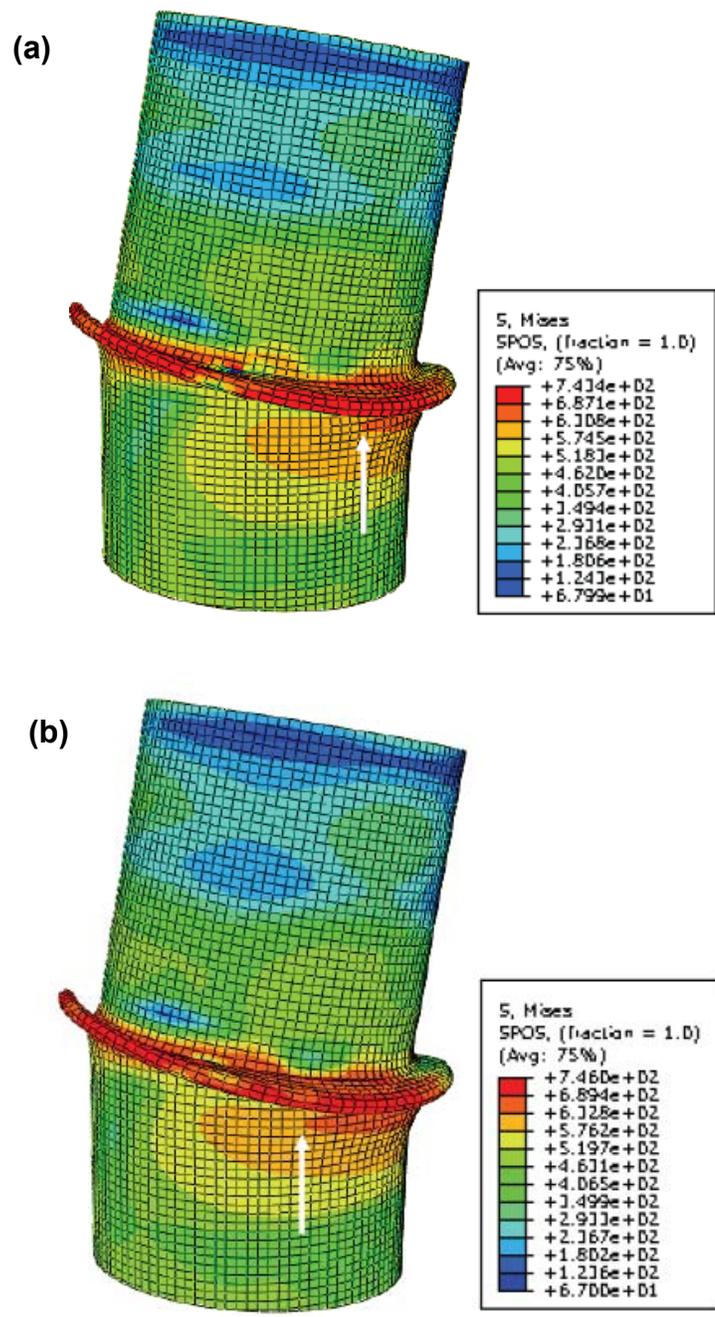
Figure 5.35 Progression of von Mises stress after few increments for specimen 6

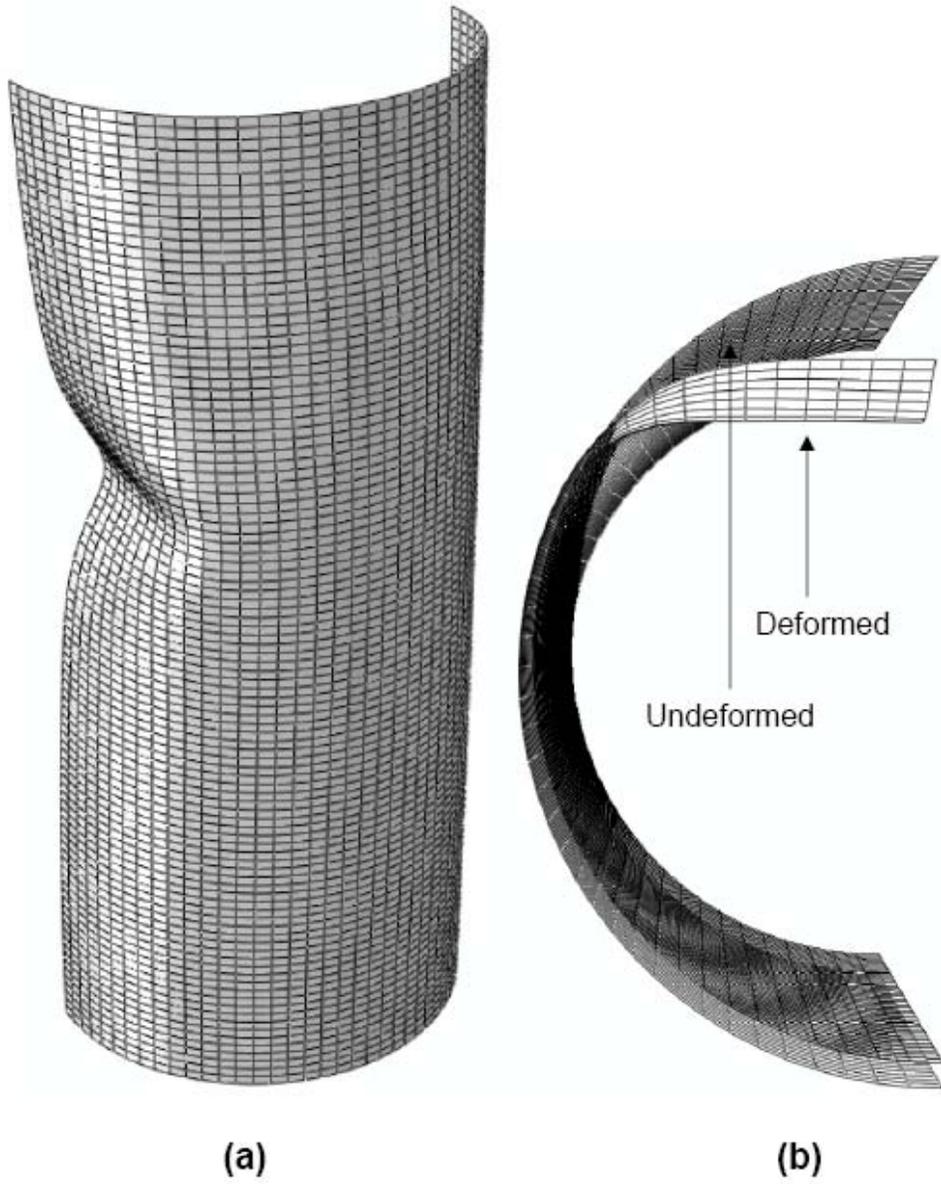
Figure 6.3 Deformed shape after applying shear load

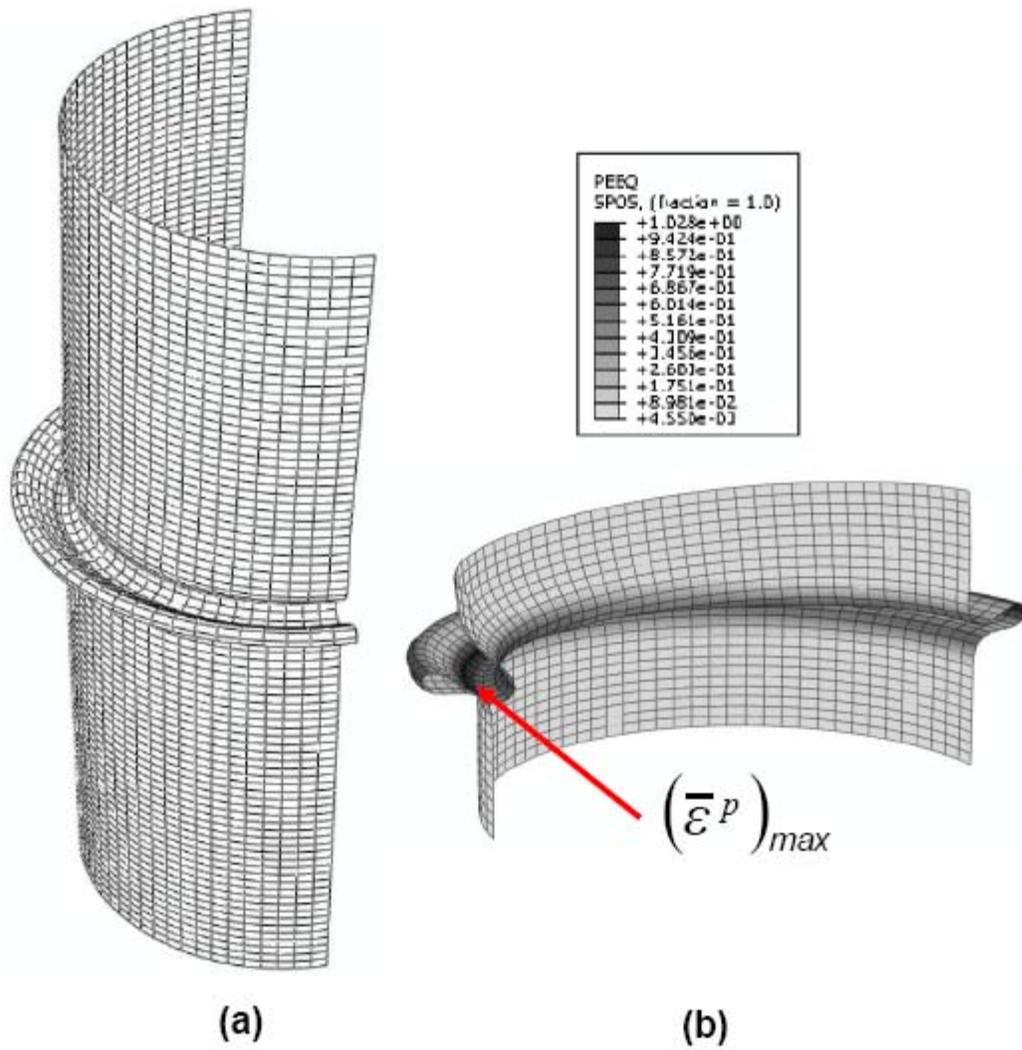
Figure 6.4 (a) Final deformed shape and (b) equivalent plastic strain contour of specimen 1 under end moments

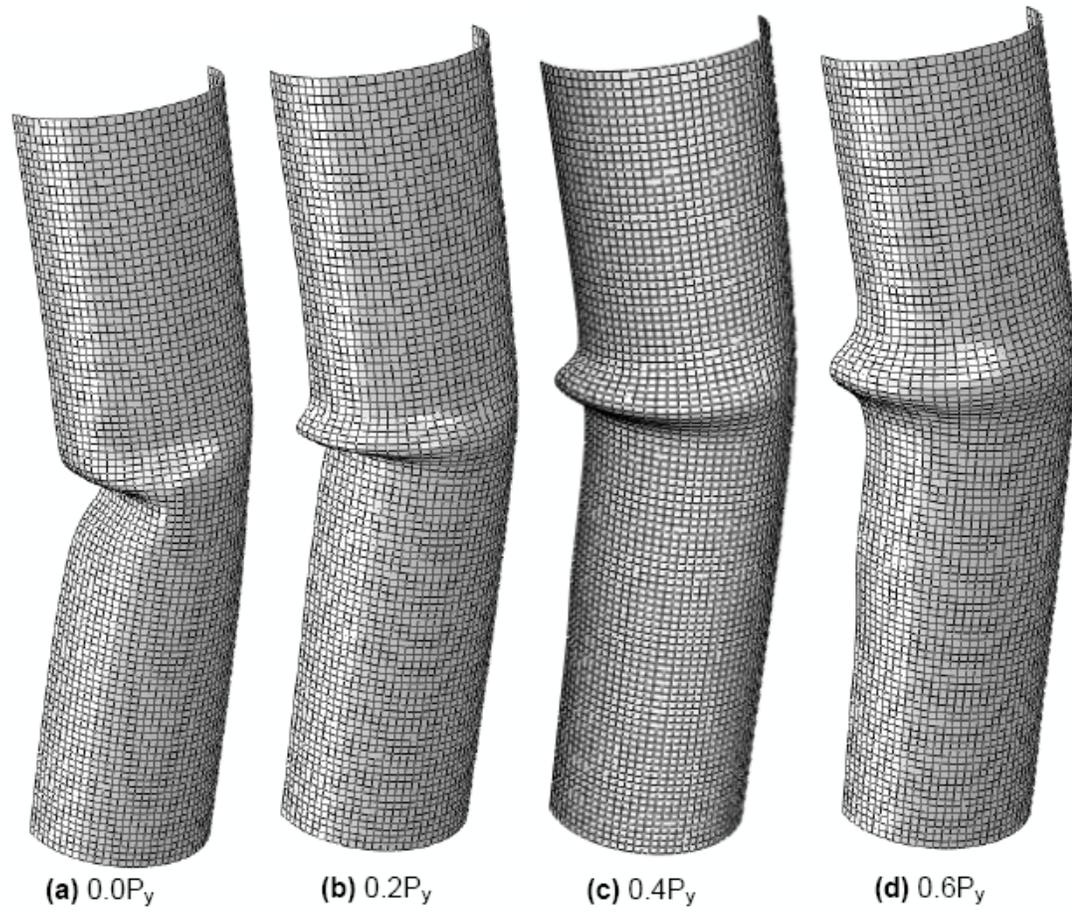
Figure 6.18 Effect of internal pressure on initial deformed shape

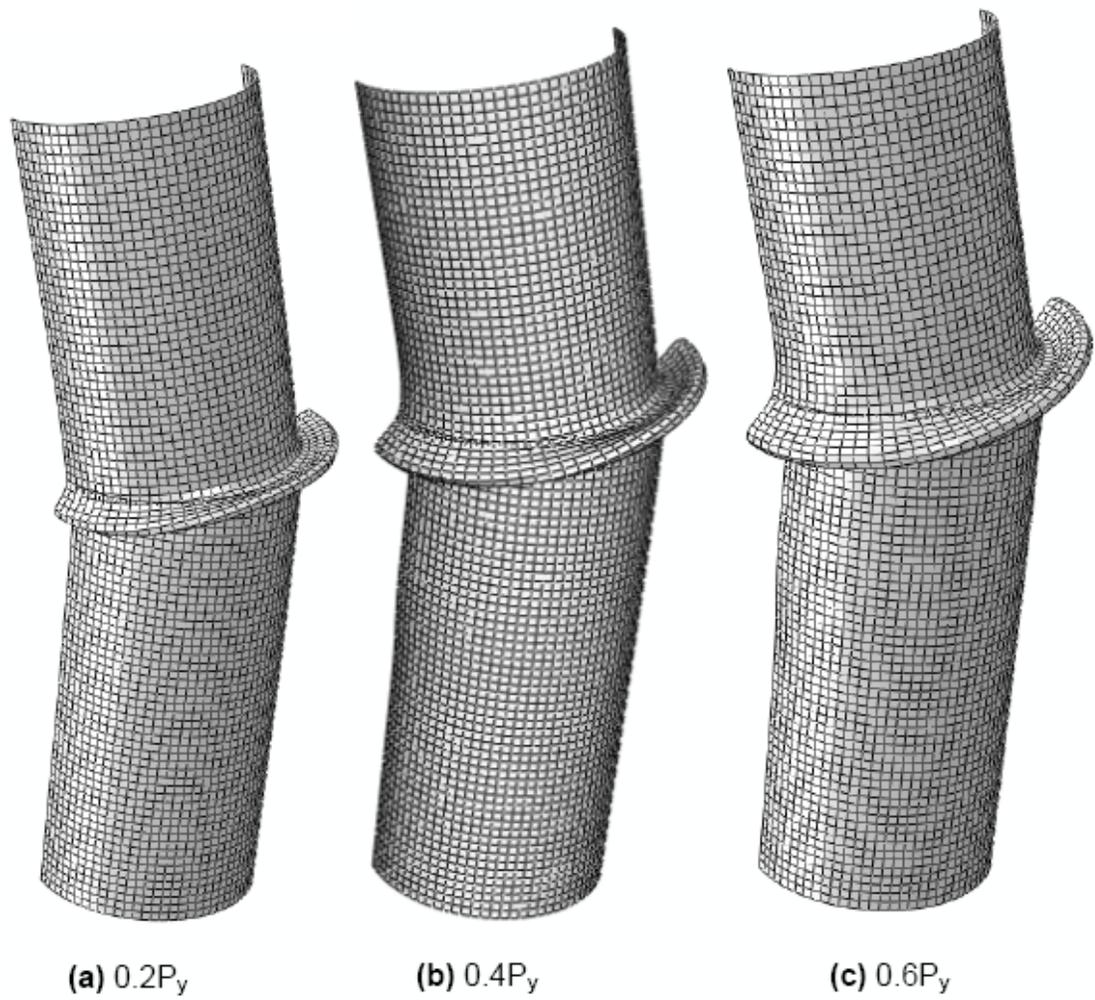
Figure 6.19 Effect of internal pressure on final deformed shape

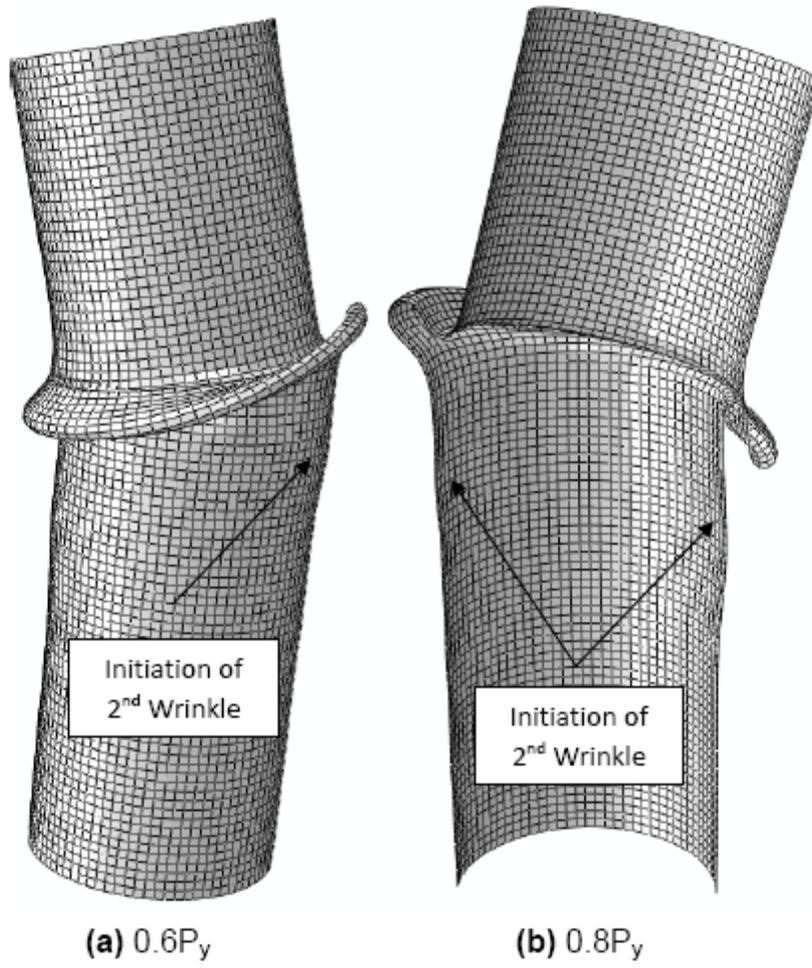
Figure 6.20 Initiation of second wrinkle under higher internal pressure condition

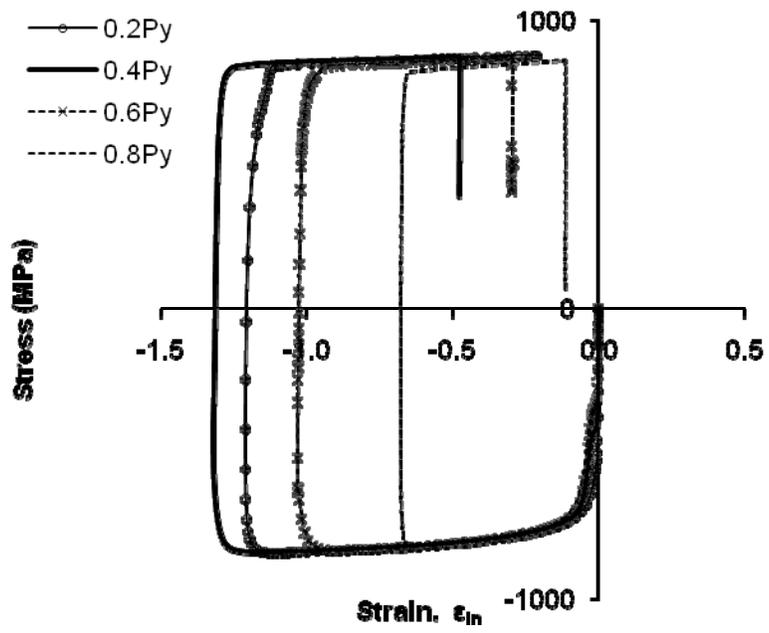
Figure 6.21 Effect of internal pressure condition on stress-strain relationship (i.e. Strain-Reversal)

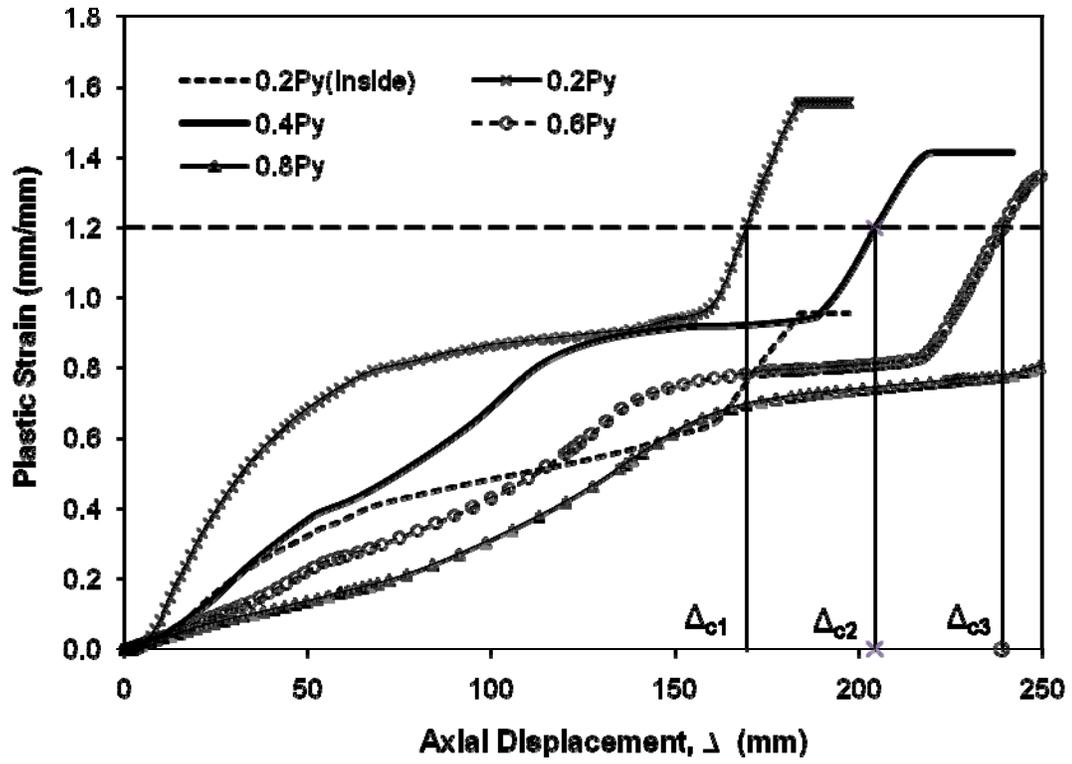
Figure 6.22 Plastic strain growth development under increasing curvature

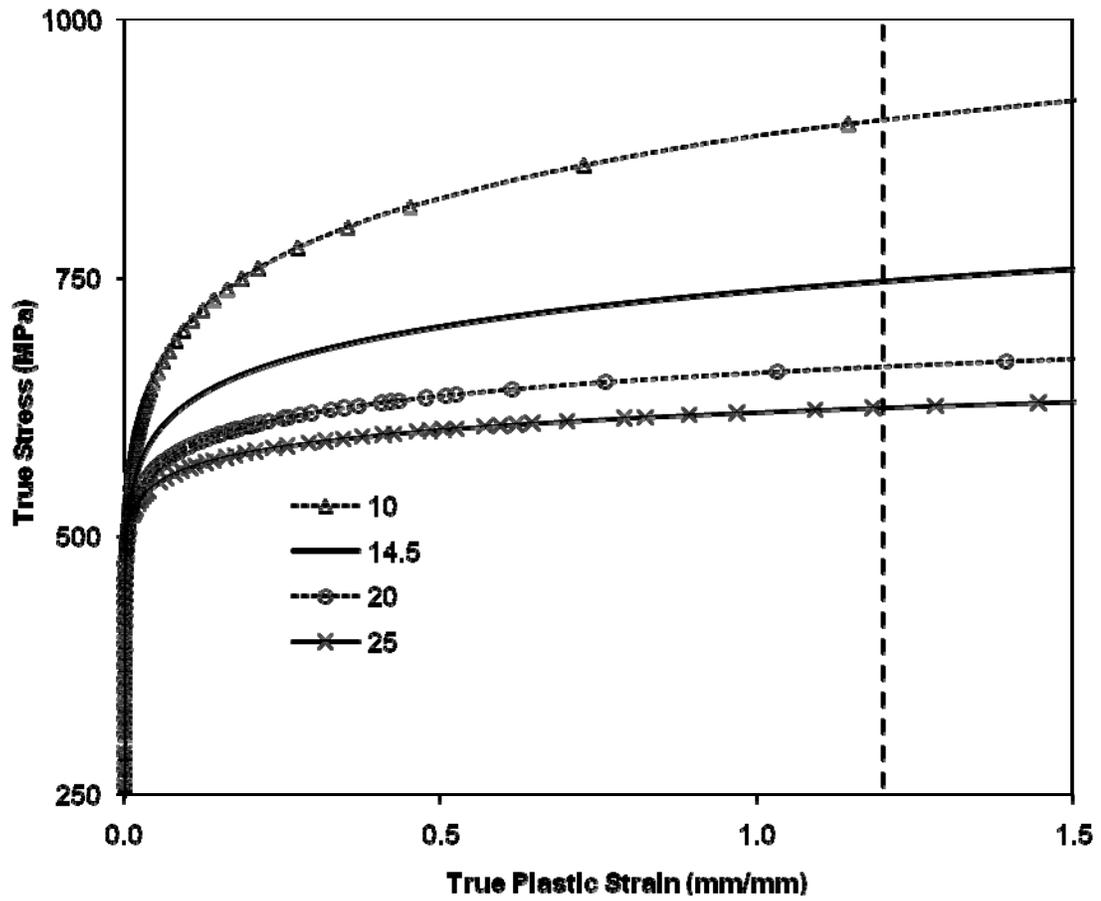
Figure 6.23 True stress-true plastic strain relations with different strain-hardening exponents (i.e. 'n' in Equation 4.13)
