### **TECHNICAL MEMORANDUM**

# **Appendix A – Historic Channels**

BLACKMUD/WHITEMUD CREEK WATERSHED MANAGEMENT STUDY

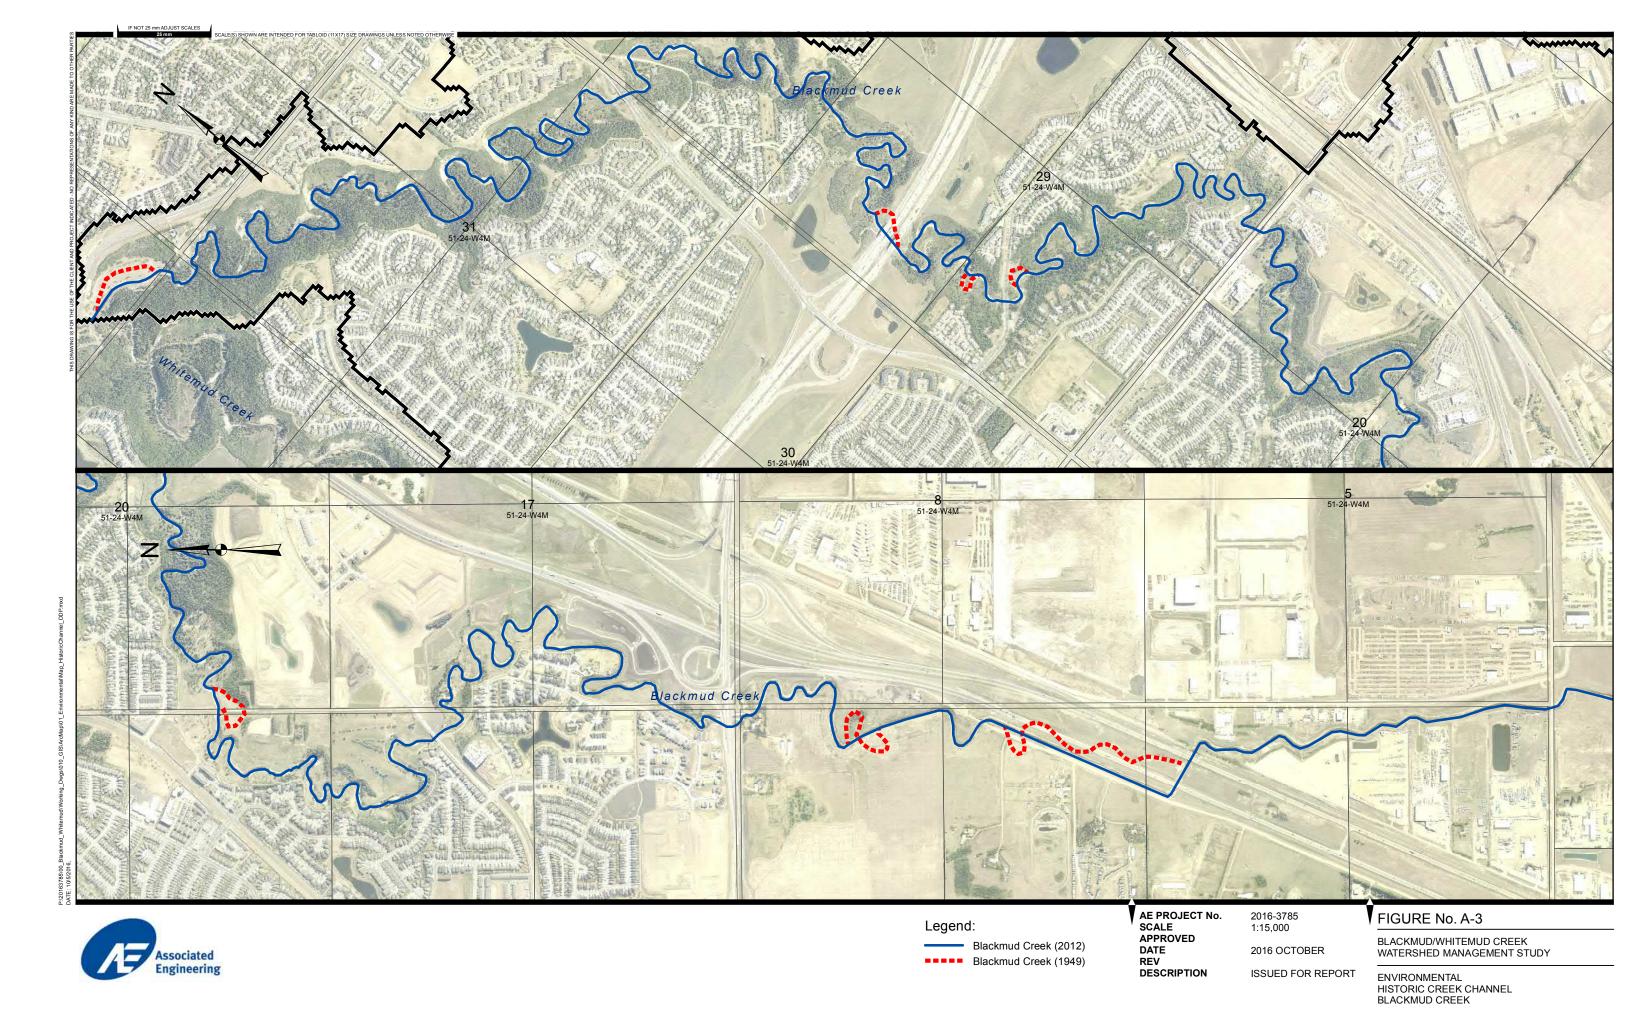
FIGURE No. A-4

Blackmud Creek (2012) Blackmud Creek (1949) AE PROJECT No. SCALE APPROVED DATE REV DESCRIPTION

ENVIRONMENTAL HISTORIC CREEK CHANNEL BLACKMUD CREEK
