A Geotechnical Asset Management Framework for the Department of Roads in Bhutan

A thesis submitted in partial fulfillment of the requirements for the degree of

Geotechnical Engineering

Department of Civil and Environmental Engineering
University of Alberta

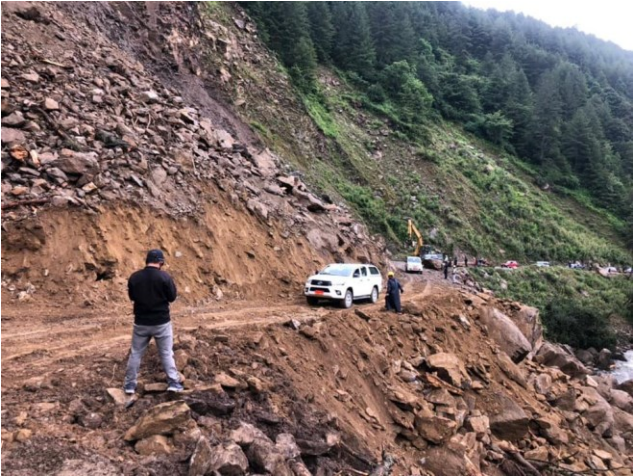
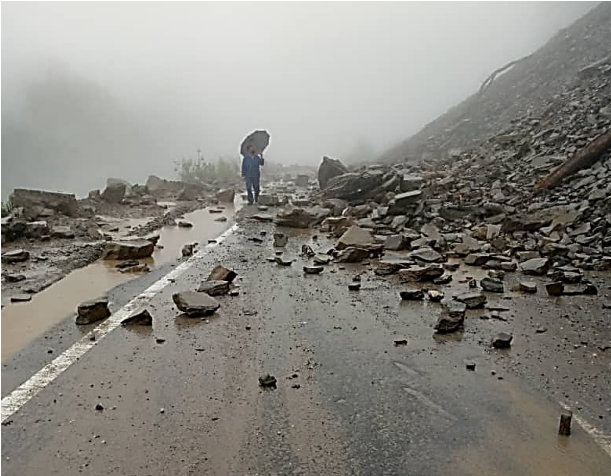
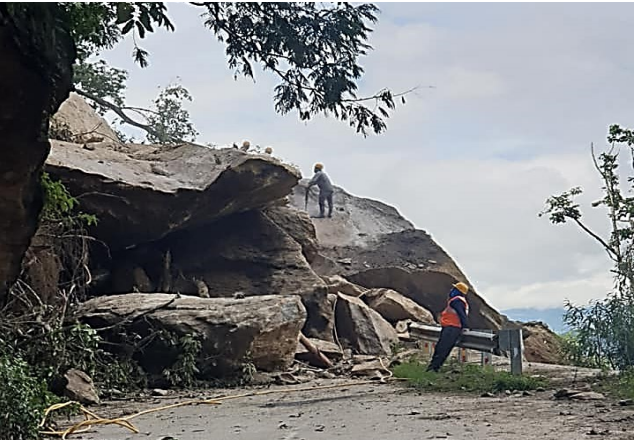
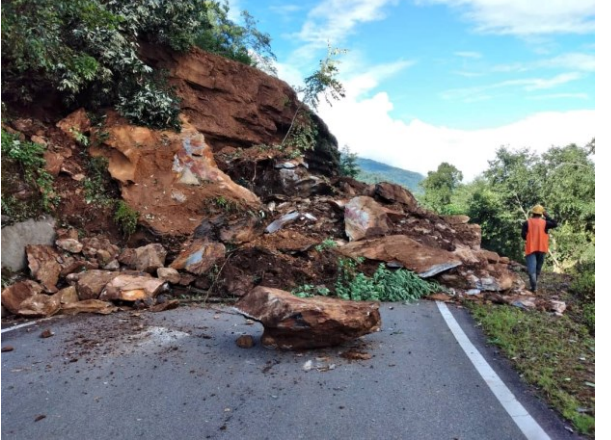
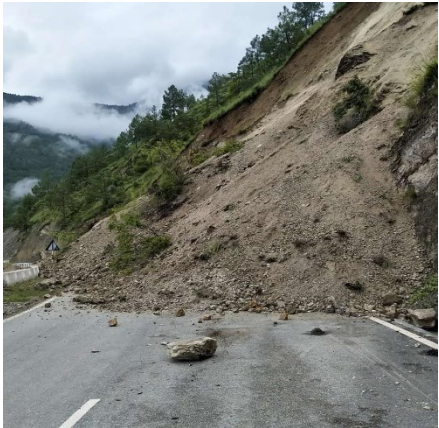
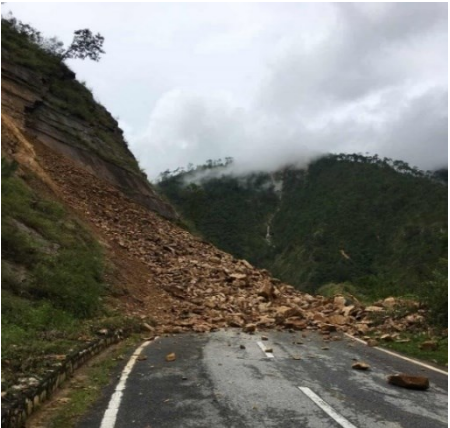
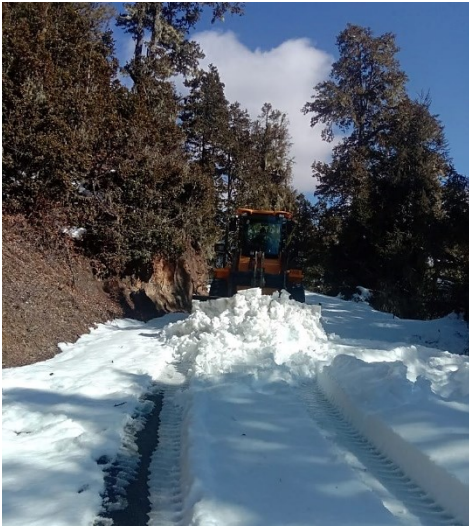
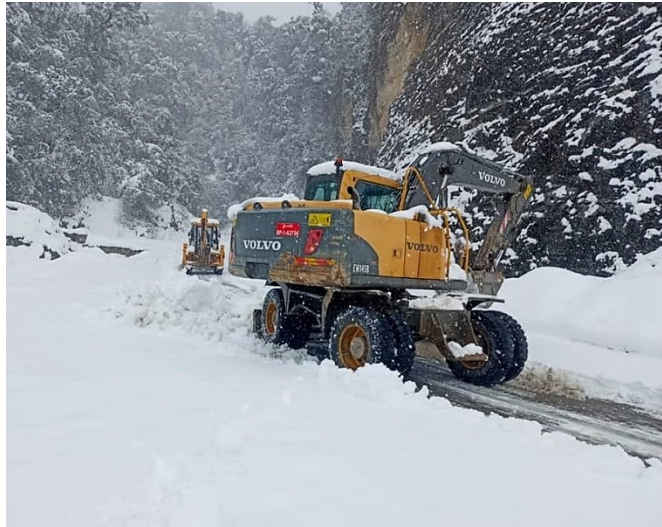
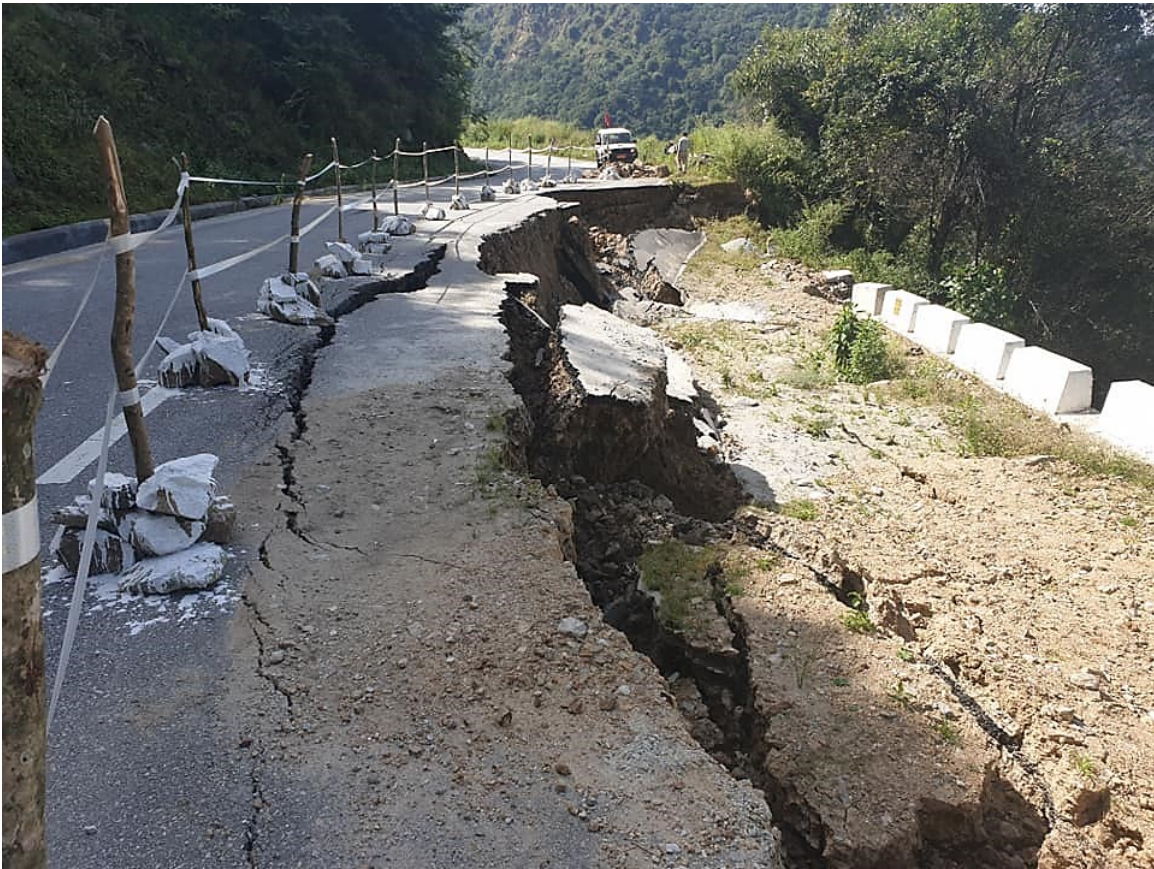
Figure 6: Examples of Roadblocks in Bhutan due to Various Geo-hazards (Courtesy of DoR)

Roadblocks due to Landslide

Roadblocks due to Rockfall

Roadblocks due to debris flow

Roadblocks due to snowfall

Roadblock due to subsidence/landslide

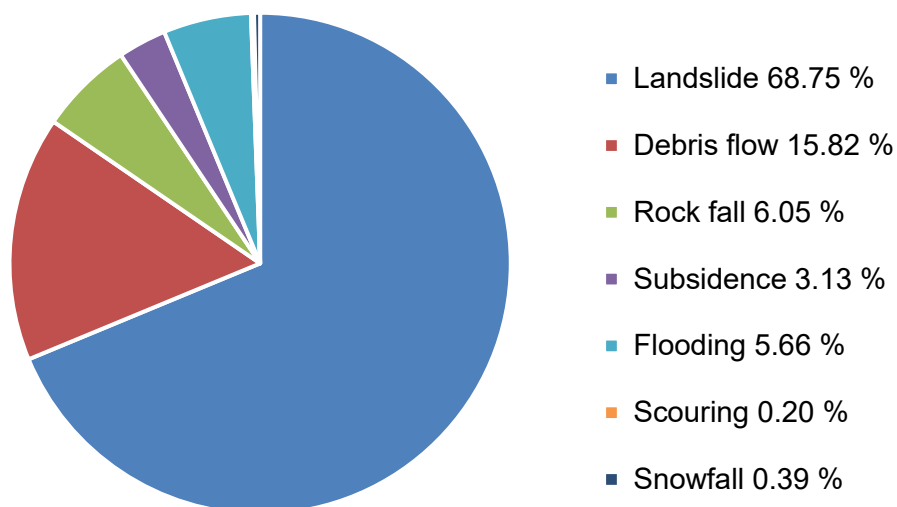
Figure 7: One-time Roadblock Occurrences in 2020 (Maintenance Division, DoR)

Regional Offices	Types of Geo-hazards						
	Landslides	Debris Flow	Rockfall	Subsidence	Flooding	Scouring	Snowfall
Lingmethang	26	0	2	2	1	0	2
Lobeysa	12	5	7	1	1	0	0
Phuentsholing	10	14	3	3	3	1	0
Samdrup Jongkhar	42	1	0	5	0	0	0
Sarpang	125	55	1	4	14	0	0
Thimphu	21	0	0	0	0	0	0
Tingtibi	17	3	8	0	1	0	0
Trashigang	20	1	4	0	2	0	0
Trongsa	79	2	6	1	7	0	0
Total	352	81	31	16	29	1	2

Sarpang and Samdrup Jongkhar ROs have the highest number of roadblocks caused by landslides. This contributes to the fact that landslides are the most common cause of roadblocks in Bhutan as illustrated in Tables 1 & 2 and Figures 7 & 8. It can also be deduced that rainfall and sub-tropical climate of the Southern Foothills are the major triggering factors of landslides in those regions.

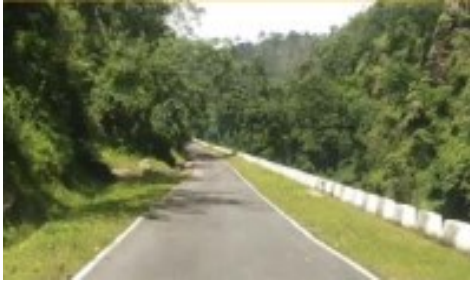
A	Perfectly smooth road pavement without any undulations

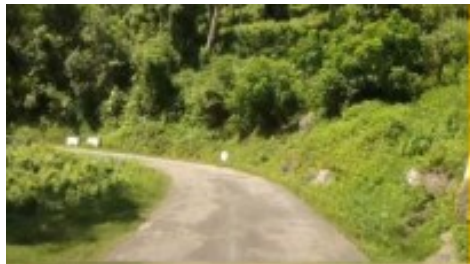
B	Good condition with small cracks, thin raveling, and small undulations

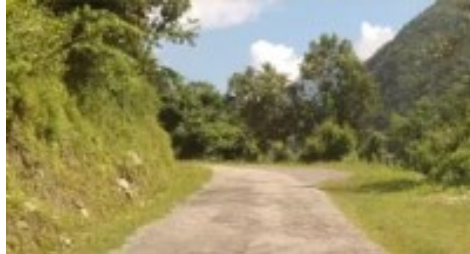
C	Significant cracks visible (Alligator cracks, longitudinal cracks, transverse cracks, etc.)

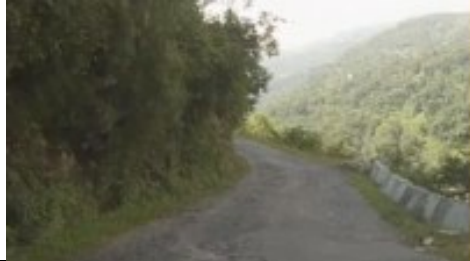
D	Small potholes, rutting and significantly undulating road surfaces.

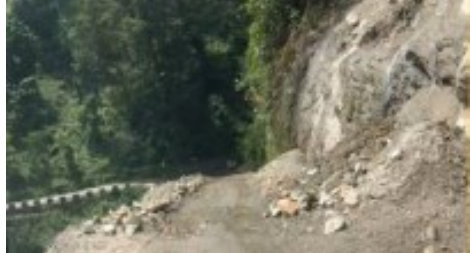
E	Major potholes, large cracks, and tremendous undulations; Unpaved roads.

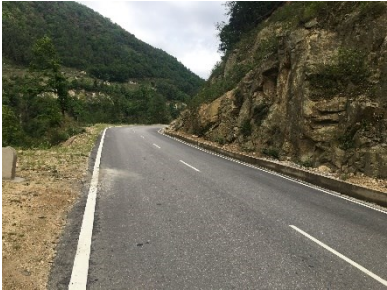
Table 9: An illustration of determination of risk due to physical deterioration for a stretch of pavement asset

<p>Equal to 100 – Asset Condition; Asset Condition in this case is 'A' as the pavement is newly built, with smooth surface, and it corresponds to numerical value '90', which is the mid-value of the range 80-100, hence the likelihood of failure is 100 – 90 = 10A.</p>	<p>It is the criticality of the pavement; *Criticality in terms of i) Functionality – 30+13.5+6 ii) Environment – 0 iii) Technical-Economical - 14+17.5+3.5 Total = 84.5 Consequence 5 *Details in Table 8</p>	<p>Risk level is 10A x 5 = 50 A. It falls in the range of 40-60A of the risk rating scale.</p>

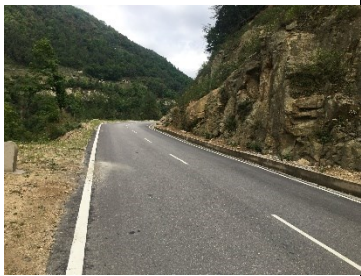
Table 12: An illustration of determination of risk due to natural hazard for a stretch of pavement

0.75	80	90A	<p>It is the criticality of the pavement; *Criticality in terms of i) Functionality – 30+13.5+6 ii) Environment – 0 iii) Technical-Economical - 14+17.5+3.5 Total = 84.5 Consequence 5 *Details in Table 8</p>	$RL = [0.75 \times (100 - (0.85 \times 80) + (0.15 \times 90)) \times 5]$ $RL = 69.4$ <p style="text-align: center;">A</p>

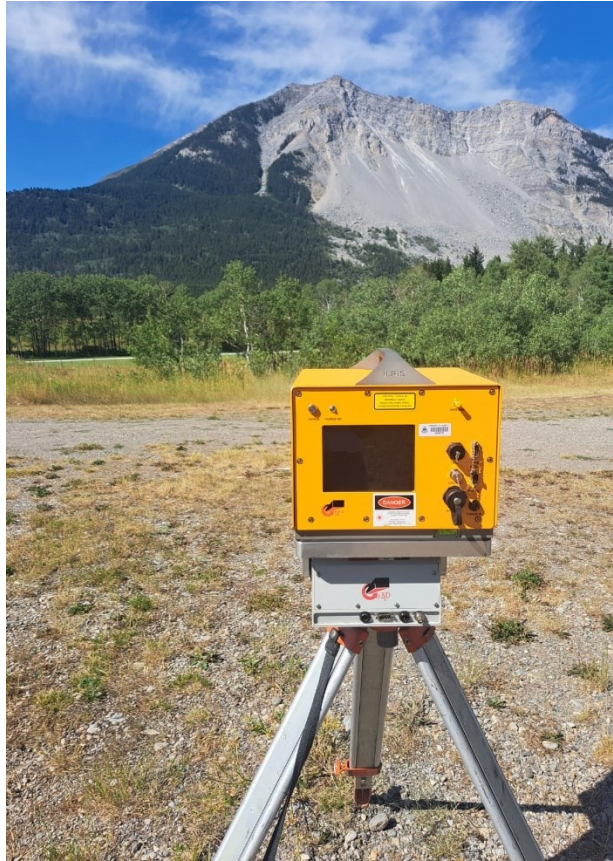
Figure 19: Use of TLS LiDAR at Frank Slide in Southern Alberta

Where c is the speed of light and t is the time required for light to travel from a light source to the object being scanned and back (Macciotta CIV E 683 notes 2021). Depending on the position of the sensor, two ways laser scanning developed are Airborne Laser Scanning (ALS) and Terrestrial Land Scanning (TLS), both of which send out laser pulses that get back-scattered by objects such as ground surface, vegetation, etc. and record the returning signal. The direction of Line of Sight (LOS) and the attitude of the device enables to determine the position Δx , Δy and Δz of a reflective surface with respect to the device. An ALS sensor position is defined by a GPS and the point cloud coordinates are estimated as $x + \Delta x$, $y + \Delta y$ and $z + \Delta z$, whereas on the other hand, the position and orientation of TLS are determined in the field (Jaboyedoff et. Al 2012). Figure 19 shows a TLS LiDAR used for Frank Slide in Southern Alberta.

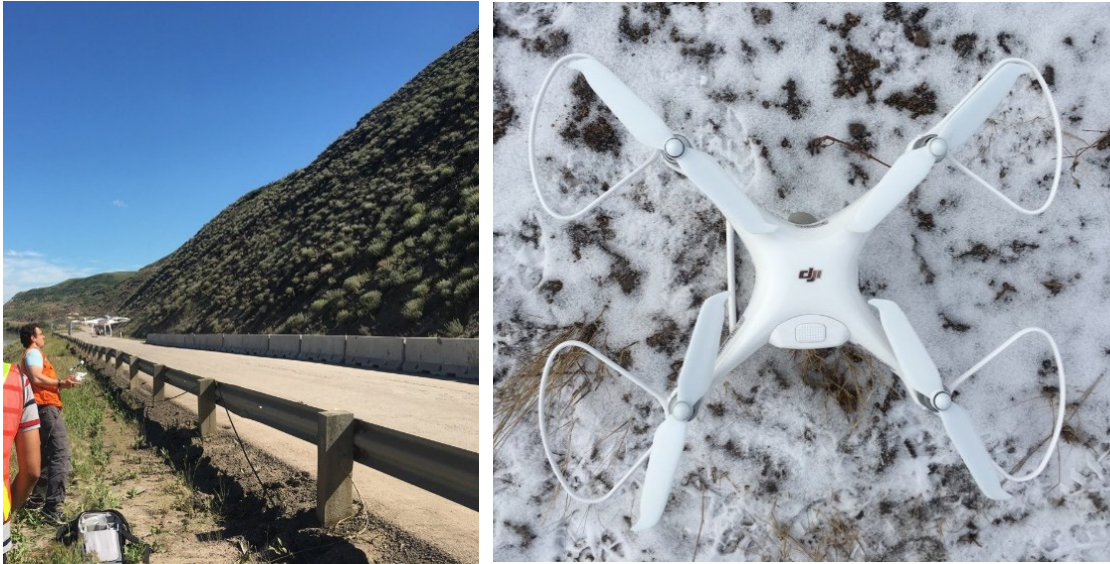
One of the biggest advantages of using UAV is its applicability in inaccessible and high-risk areas which would otherwise be impossible to reach and where manned systems cannot be flown. Data acquisition using UAVs is even possible in cloudy and drizzly weather conditions, provided the distance to the object permits flying below the clouds unlike in the case of manned aircrafts, which require larger flight altitude above ground in such weather conditions. It is highly commendable for its real-time ability and the capacity for fast data acquisition, transmission of images, videos, and orientation data in real time to the ground control stations. Implementing navigation and stabilization units in the UAV allows accurate flights resulting in sufficient image coverage and overlap (Eisenbeiß 2009).

Figure 20: UAV/Drone DJI Phantom 4 with 12 MP camera and 3-axis stabilizer used for CO18 site.

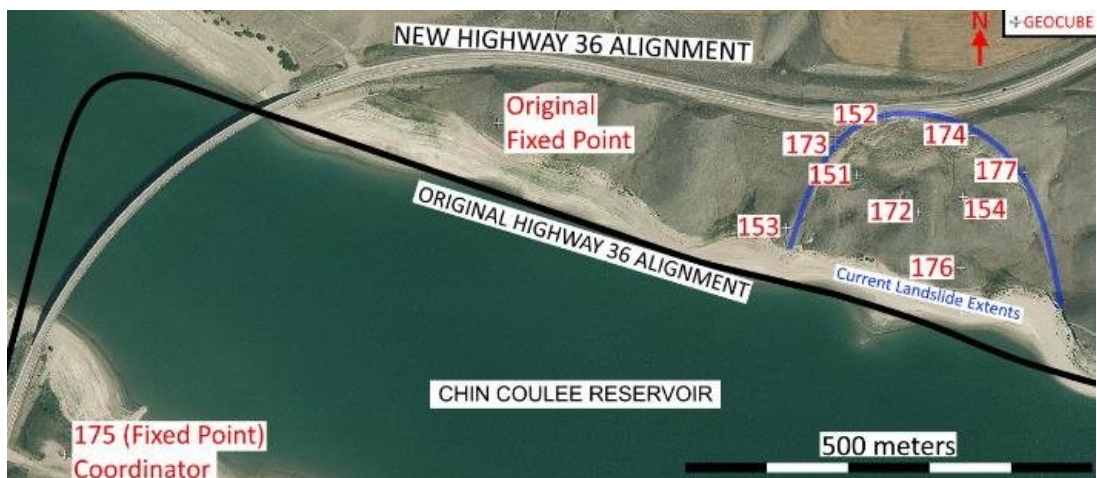
Figure 36: GPS Unit Location on Chin Coulee (Deane E. et al. 2019)

A differential GPS system comprising 10 Geocubes™ was installed at the Chin Coulee landslide in July 2018 as shown in Figure 36, with the aim to obtain continuous movement data for targeted regions in the landslide (Deane E. et al 2019). The movement data acquisition included the following major steps:

The Geocubes™ were installed using hand augered deck screw piles, the embedment depth of which was limited to 0.8 – 0.9 m due to the presence of gravel; each unit was equipped with a 10-Watt solar panel and two 12-Volt, 100 Ah batteries which provided continuous power to the system as shown in Figure 37. Some of the GPS units had to be raised almost 1 m above the ground to achieve communication; the installation height, however, increased the amount of error.

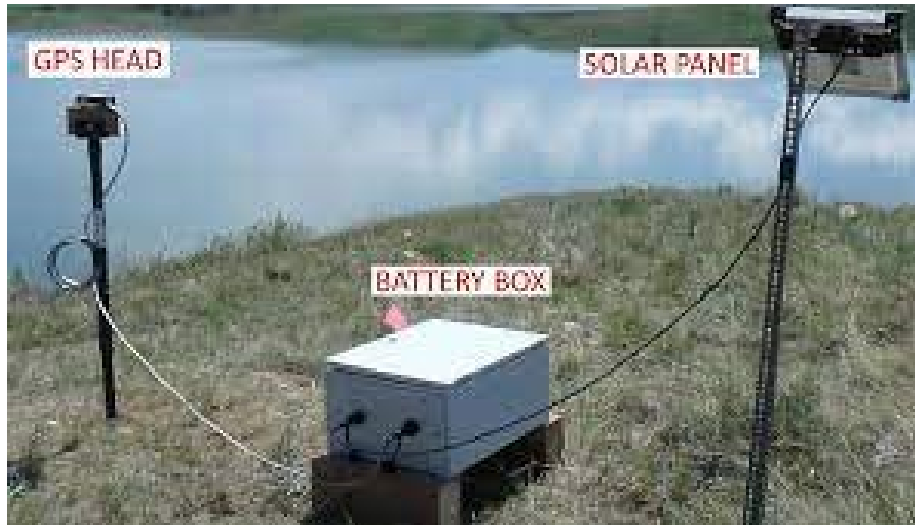
Figure 37:GPS and Battery Box Setup on Chin Coulee (Deane E. et al. 2019)

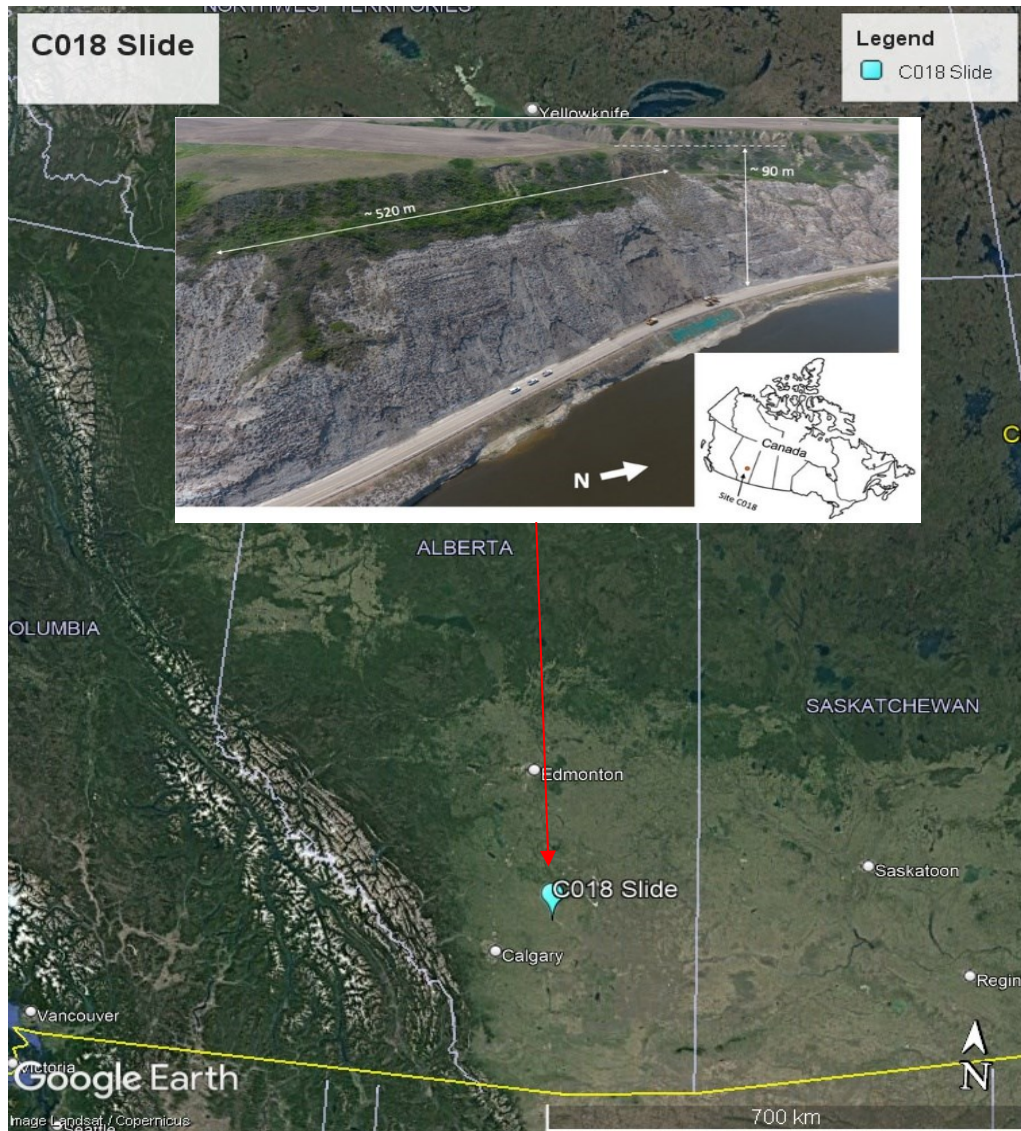
Figure 41: Location and aerial view of CO18 landslide (Adapted from Macciotta R. and Hendry M. 2021)

C018 landslide is in southeastern Alberta (region known as Badlands) adjacent to Highway 837 approximately 10 km northwest of the town Drumheller (Figure 41).

The slide is about 520 m long and 90 m high (Macciotta R. and Hendry M. 2021). The geology of the site causes Highway 837 to be vulnerable to different instability processes especially during precipitation events (Rodriguez et al. 2020). For instance, a large rockfall and debris flow event on May 23, 2018, following a 15-mm rainfall event which occurred 6 days prior to the event, blocked the highway. AT, then had to partially close one lane of the road by installing concrete barriers known as Jersey barriers of almost 90 m along the highway as shown in Figure 43.

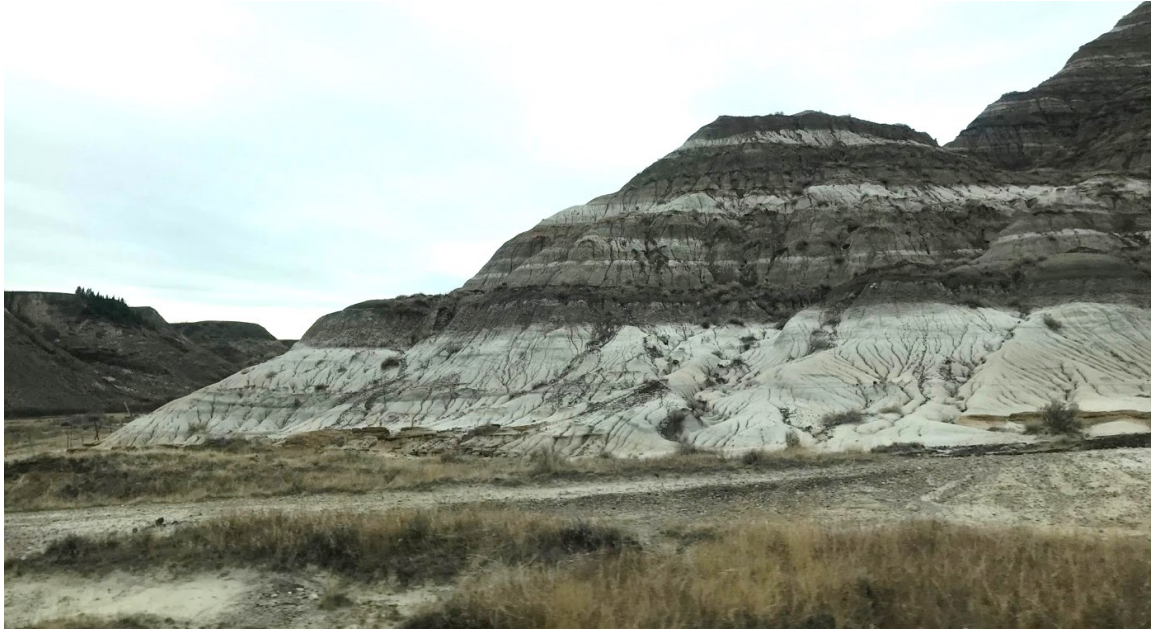
Figure 42: View of the sedimentary geology at C018 slide consisting of interbedded sandstone, siltstone, and mudstone.

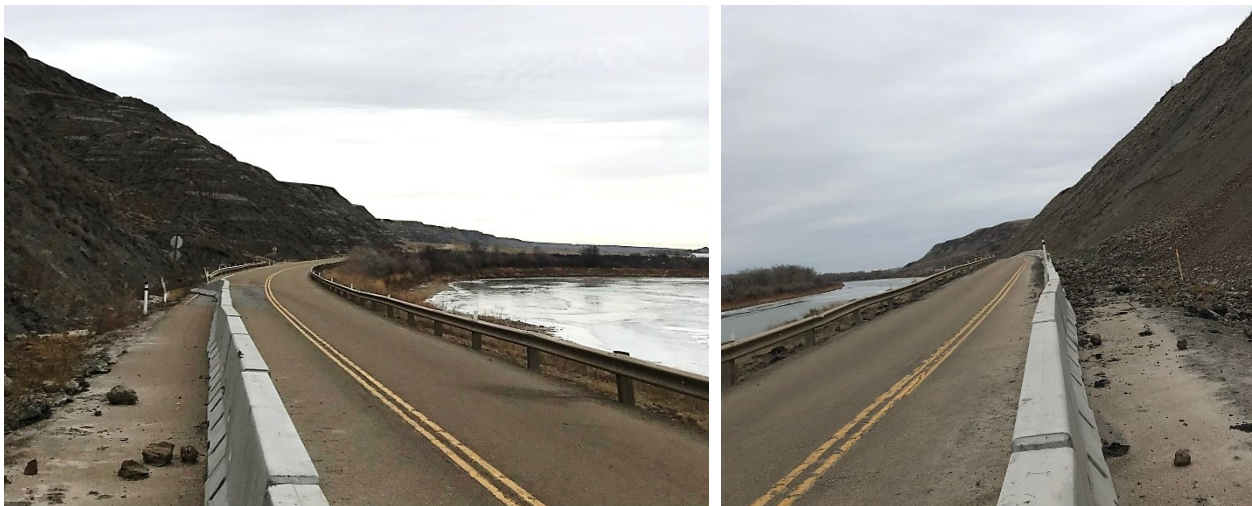
Figure 43: Jersey barriers partially closing one lane of Highway 837 at C018 site.

Continuous movement of debris has been observed at the site, in fact the highway has been partially closed to traffic following a large rockfall and debris flow event of May 23, 2018. Given the history and based on visual inspection of the site, a preliminary risk rating of '80 -100' is assigned. Since this range of rating corresponds to 'Very Poor'

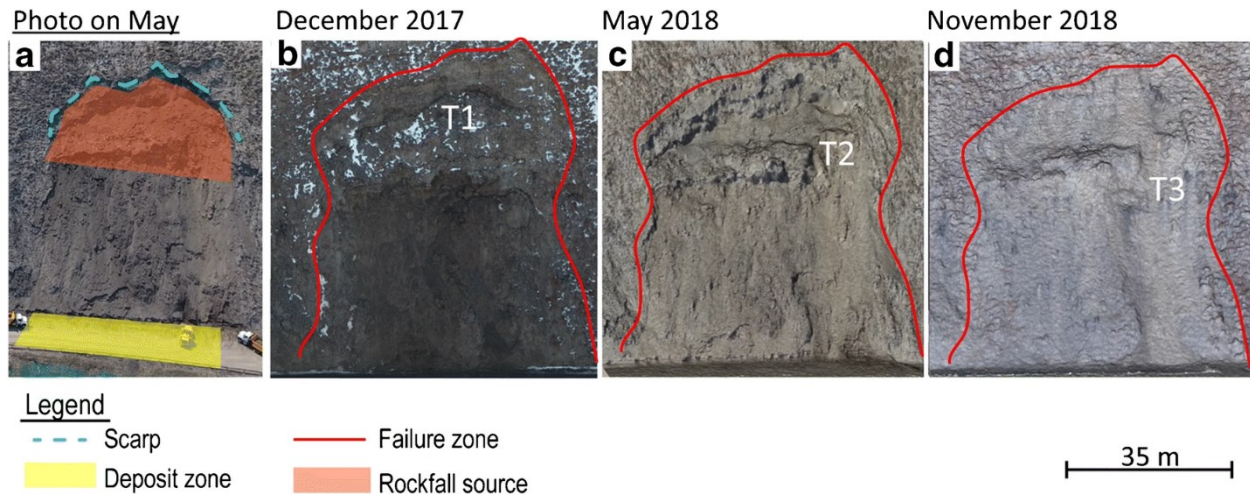
Figure 44: Point clouds for the most active zone a) UAV photo taken after May event b) point cloud from first UAV survey c) from second UAV survey d) from third UAV survey (Rodriguez et al. 2020 licensed under [CC BY 4.0](https://creativecommons.org/licenses/by/4.0/))

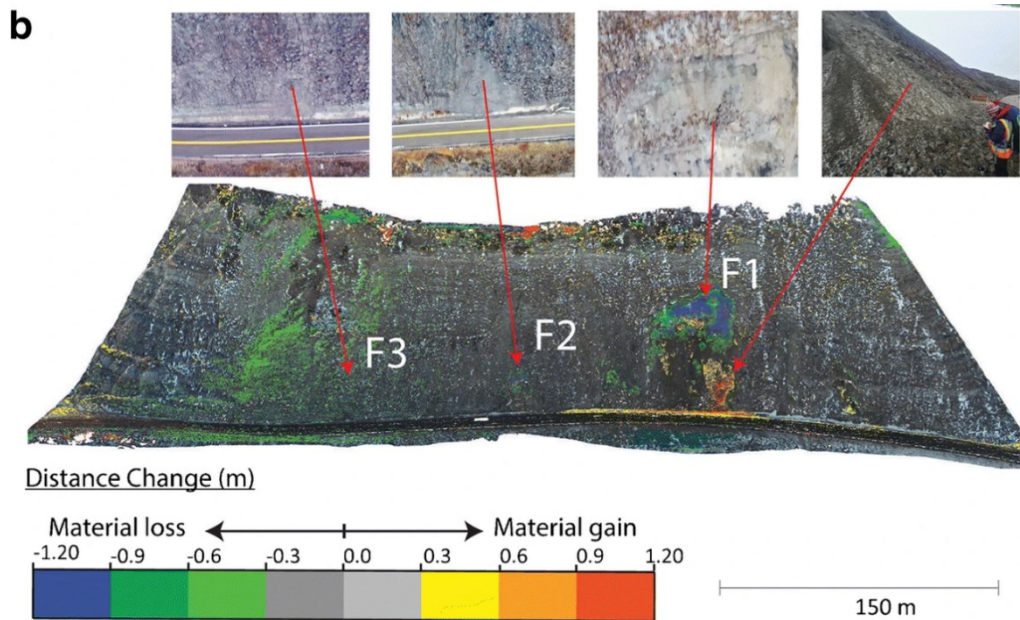
Figure 46: Change detection based on the second and the third surveys (Rodriguez et al. 2020 licensed under [CC BY 4.0](https://creativecommons.org/licenses/by/4.0/))
