# **Landslides in Weakly-Cemented Lake Sediments, Morkill River, British Columbia**

Slopes in weakly cemented lake sediments in the Morkill River Valley in the Canadian Rocky Mountains stand at up to 65 degrees. Instability is due to the softening of the soils by frost action and the leaching of calcite cement. Field density profiles demonstrated depths of weathering and relative carbonate contents. Laboratory tests of carbonate content indicated a positive correlation between calcium carbonate and density in the lake sediments. The relationship was strongest in sands, in which leaching and dissolution were the dominant components of softening. In clays, frost action was the dominant component of softening. Freeze/thaw tests showed over a 50% decrease in strength after one cycle of freeze and thaw in the silts and clays.

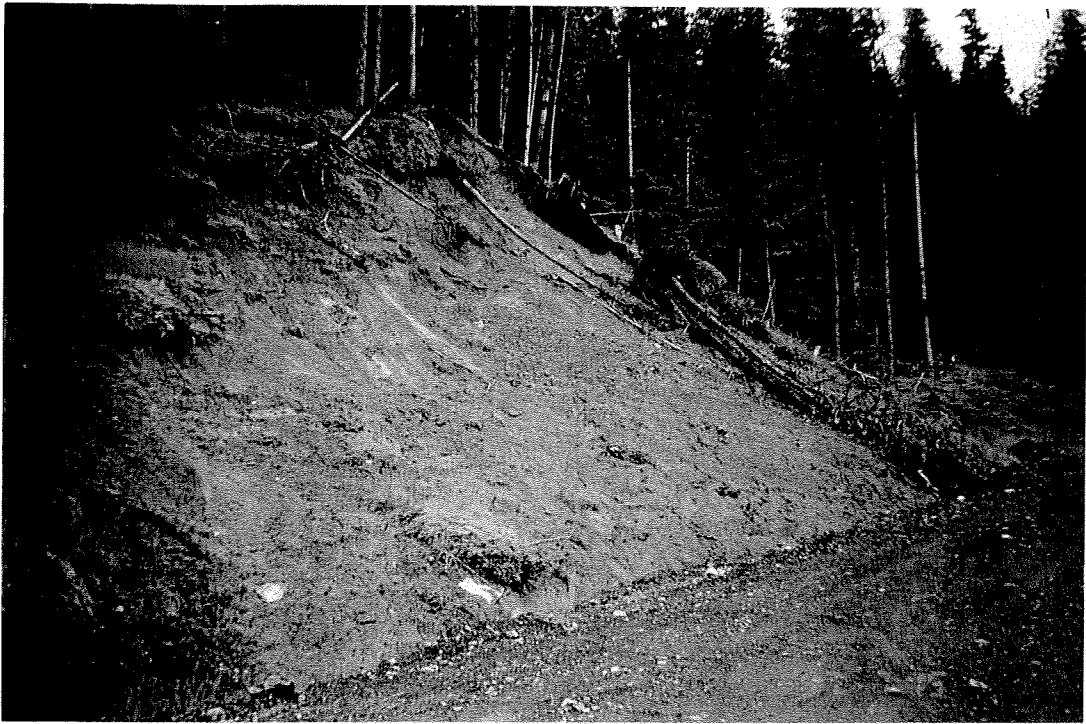
**Figure 4 Earth slide in silty soils on the Hellroaring Road at 2.8 km (Figure 2)**

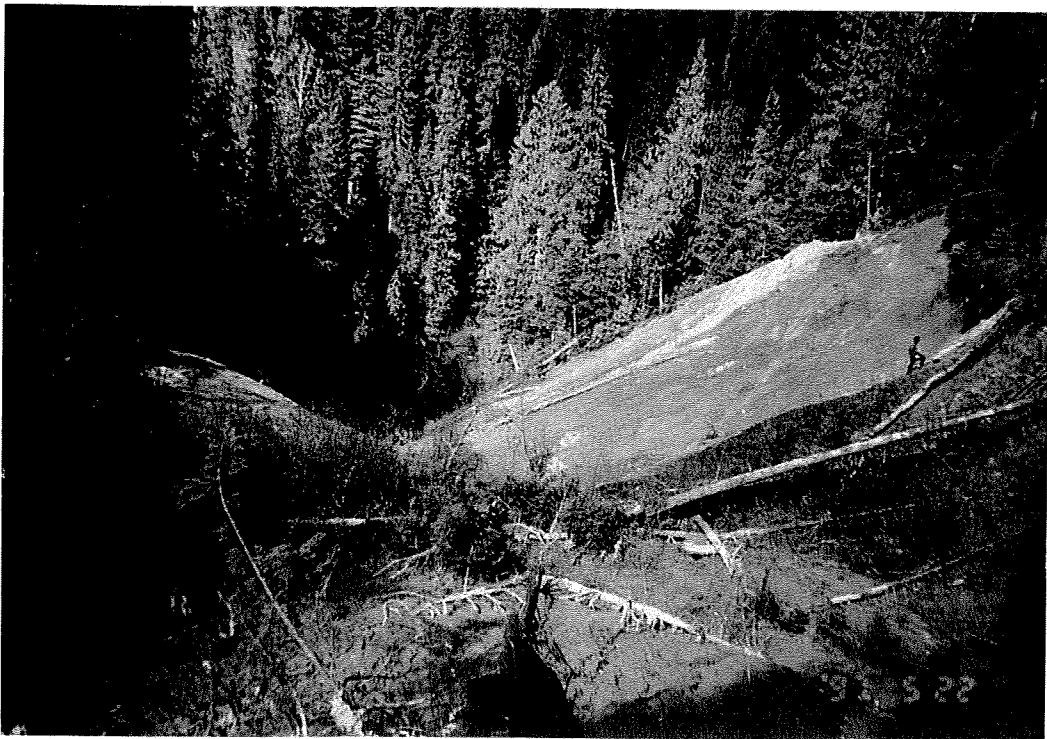
**Figure 5 Earth slide incorporated into large gully (65235:06, Figure 2)**

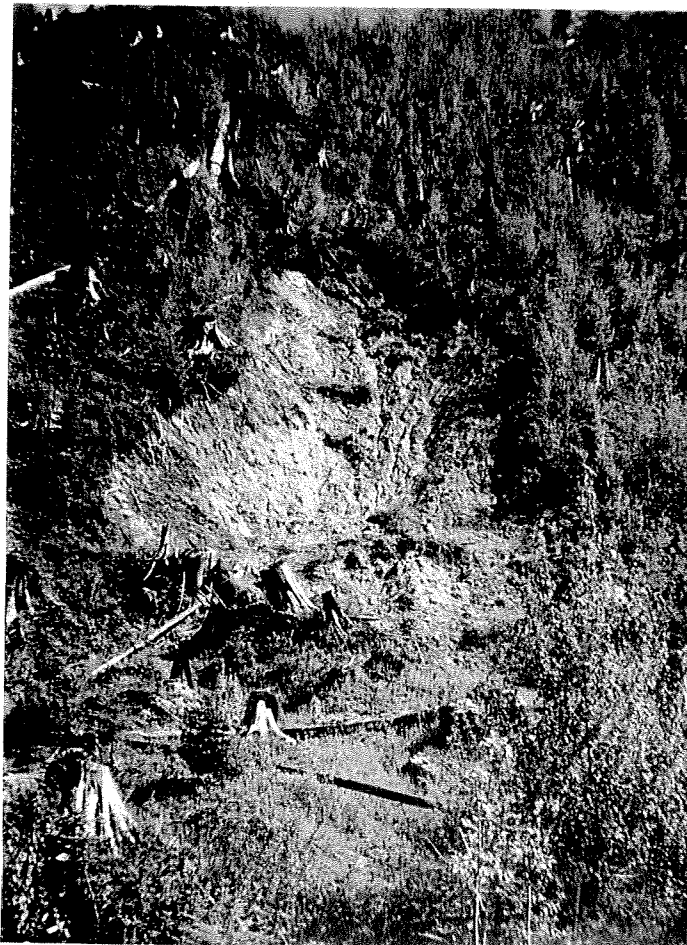
Figure 8 (Left) Slide 66044:03 (Figure 2)  
Composite earth slide-earth flow in harvested cut block

Evidence of successive flow events was noted in the Morkill River valley. The landslide in Figure 8 appears to have initiated as an earth slide followed by earth flows in subsequent years. The flow deposit shown in Figure 9 has a lateral extent of 40 metres from the toe of the slope with an average thickness of 0.3 m. Evidence of soil on small trees in the area (Figure 10) indicated that when the soil flowed, it reached levels up to 0.3 metres above the present levels without destroying the vegetation. This indicates a moderate to slow flow rate.

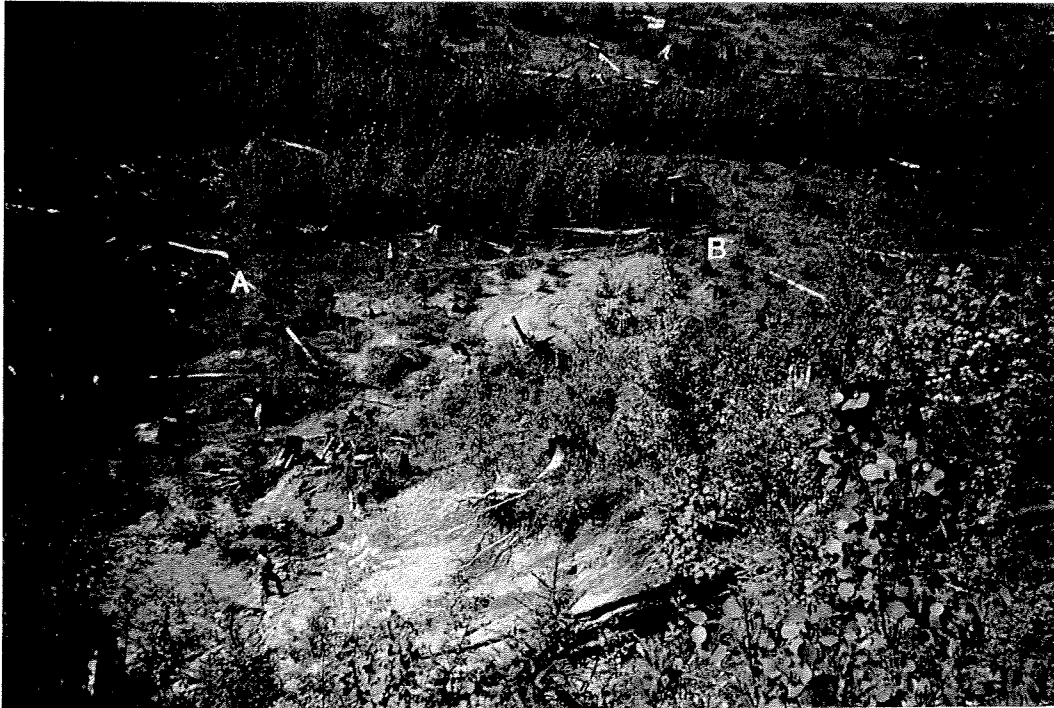
**Figure 9** Slide 66044:03 (Figure 2) View from head of rupture surface showing path of initial accumulated mass (A) and subsequent earth flow (B). Person in lower left corner for scale.

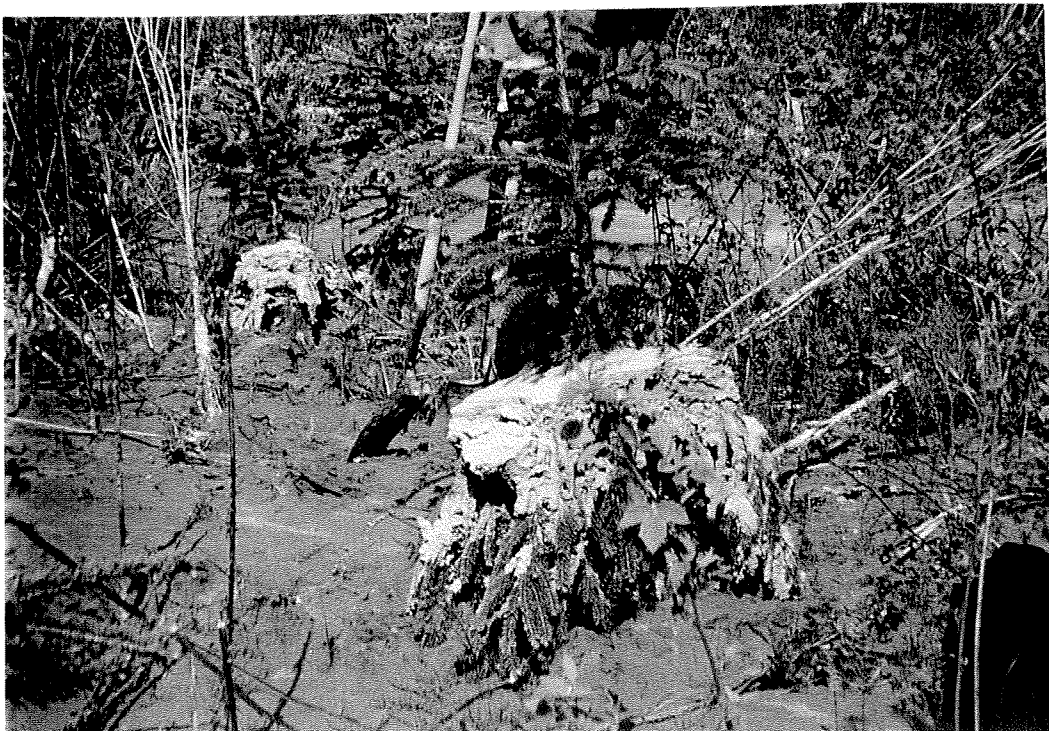
**Figure 10** Slide 66044:03 (Figure 2) Soil on young spruce trees is indicative of recent earth flow activity

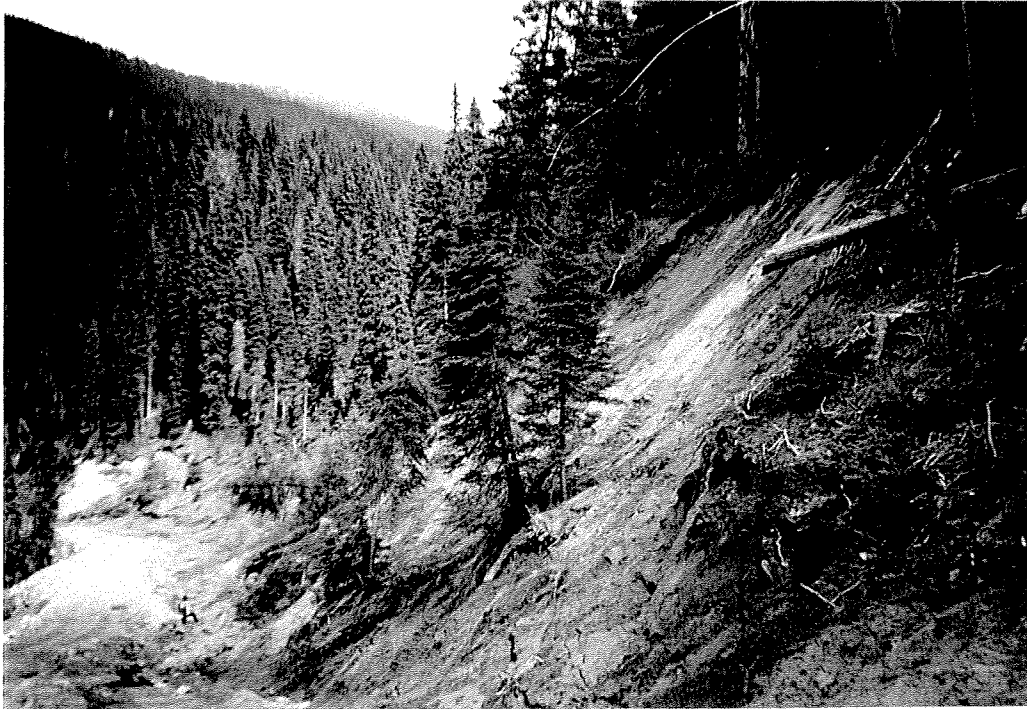
**Figure 13** Morkill 45.7 km (Figure 2): Earth slide in sandy soils adjacent to road

in the landslides ranging from 37° to 70°. The rupture surface at 70°, in a landslide (Figure 13) that had occurred in late spring 1997, had not then been exposed to frost or chemical weathering.

The most likely contributor to instability in the sandy soils is the dissolution and leaching of calcite. The higher permeability sand facilitates water flow and allows it to wash calcite out of the soil matrix more readily. Figures 13 and 14 show typical earth slides in the sandy soil of Lake C. The rupture surfaces in landslides in these sediments typically ranged in depth from 1.0 to 1.5 metres. The landslide in Figure 13 was assisted by the removal of toe material during road construction and subsequent excavation during seasonal ditch cleaning.

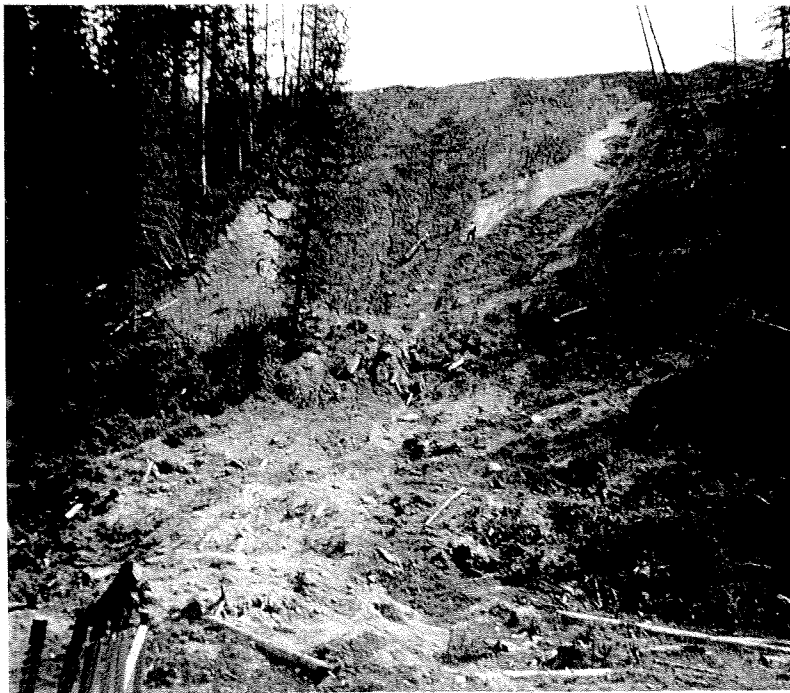
**Figure 14** Morkill 31.5 km (Figure 2): Earth slide in sandy soil below an abandoned cutting permit access road

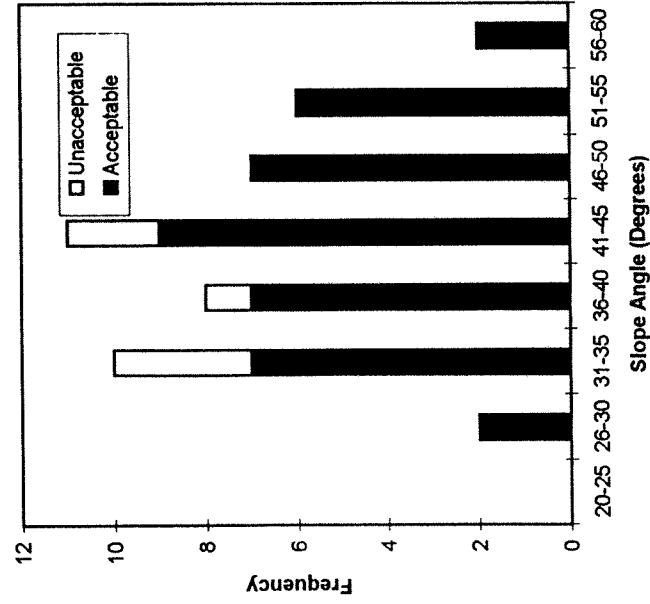
Figure 15 Slope angle frequencies in silty soils

We also visited 102 road cut exposures in the sandy and silty sediments of Morkill River valley. Histograms showing the distribution of slope angles in these sediments are shown in Figures 15 and 16. We have divided each bar in the histogram into 2 sections: slopes that were performing acceptably, showing minimal erosion or instability, and slopes that were not performing acceptably. It is apparent that cuts with slope angles greater than 30 ° in the silty and sandy lake sediments have a higher
