**Characterization of a landslide-prone glaciolacustrine clay from the Thompson  
River Valley near Ashcroft, British Columbia**

Geotechnical Engineering

University of Alberta

© Gael Le Meil, 2017

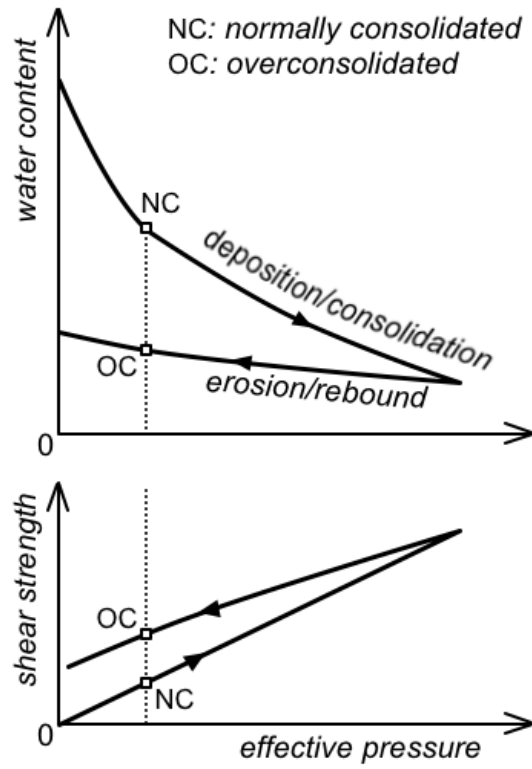
Figure 2.2. Overconsolidation of clay

The increase of effective stress associated with consolidation causes soil particles to pack in a denser state (Terzaghi and Peck 1967). The process can be quantified in terms of a void ratio and water content decrease. In the overconsolidation process, removal of pressure causes rebound of the clay. The magnitude of void ratio change during rebound is less than during consolidation (Figure 2.2). The packing of soil particles is not fully reversed and therefore the soil is denser in the overconsolidated state than in the normally consolidated state, though both states experience the same effective pressure (Skempton 1964). As the pore space is reduced and the particle packing is denser in overconsolidated clay, the hydraulic conductivity and the compressibility are lower (Mitchell 1976).

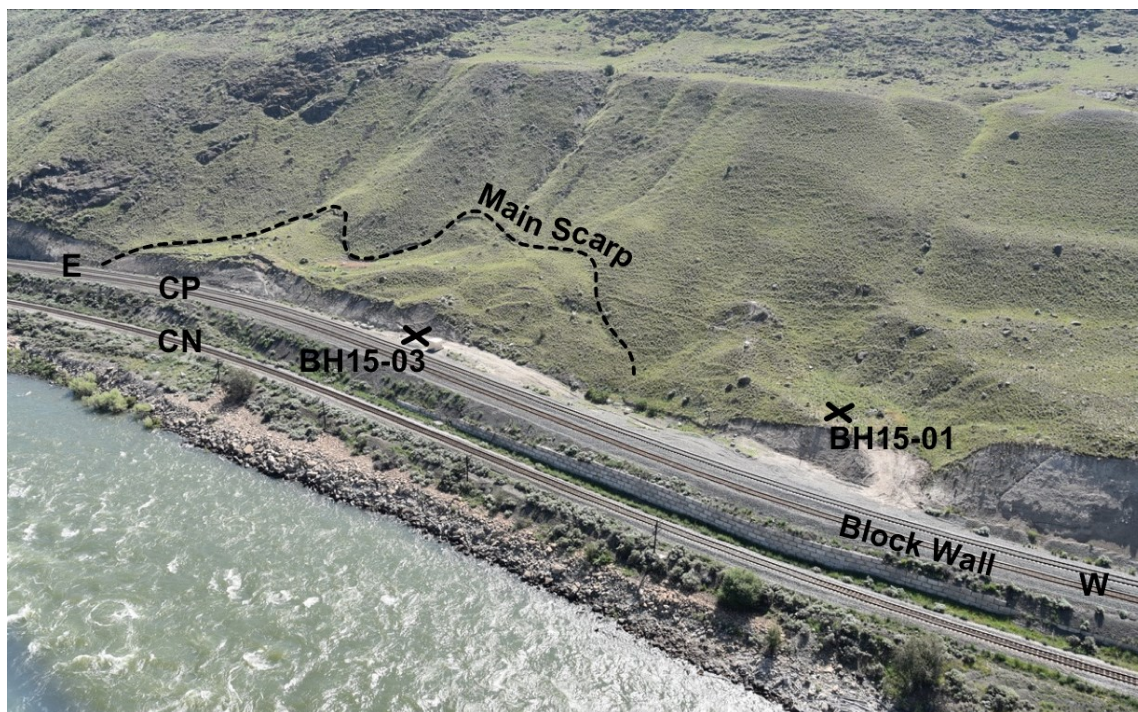
Figure 3.3. 2016 aerial photograph of the Ripley slide (courtesy of CN)

operations were needed to realign the tracks. Tension cracks had developed, making the back scarp of the landslide largely apparent. Optical survey monitoring in 2007 revealed that the landslide velocity was 25 to 180 mm/year (Bunce and Chadwick 2012).

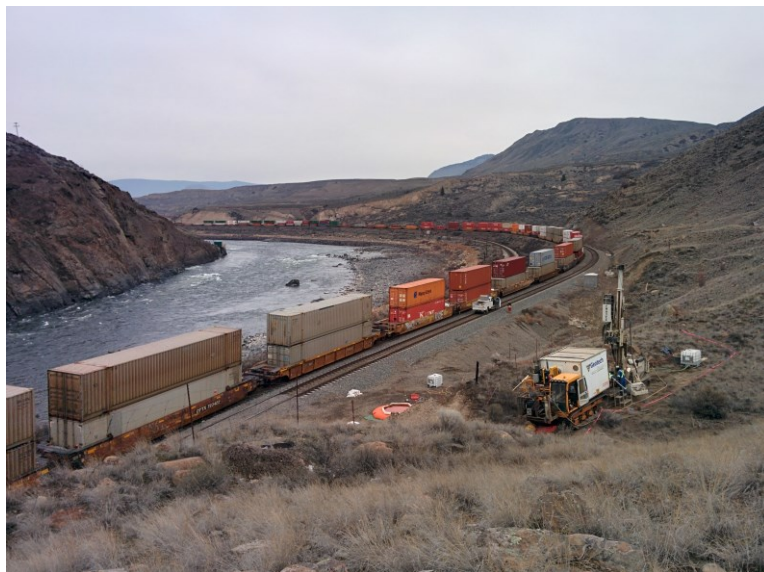
Figure 4.2. BH15-01 drilling location, looking north

As part of this thesis and the thesis by Schafer (2016), a campaign of drilling and instrumentation was conducted in February 2015. Five boreholes were drilled at different locations of the site (Figure 4.1, Figure 4.2) through the valley fill material and until bedrock was reached, thus complementing the 2013 campaign.

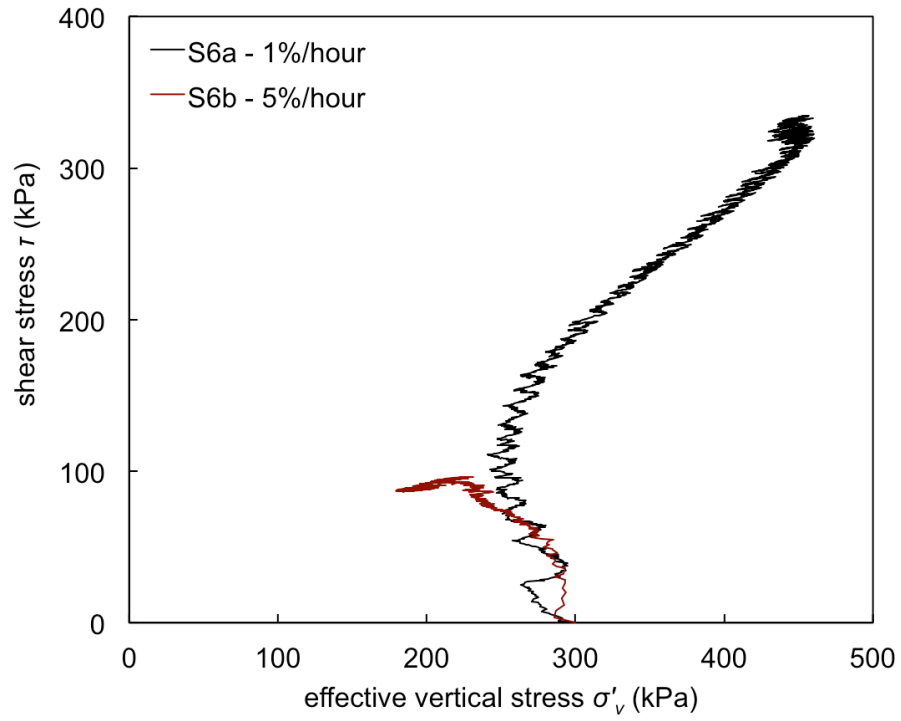
Figure 4.19. Effective stress paths for DSS tests S6a (1%/hour) and S6b (5%/hour)

When large non-uniformities cause the soil to fail by default in the boundary zone, the response is by no means that of uniform simple shear and the observed behaviour is not that of heavily overconsolidated glaciolacustrine clay. Le Meil et al. (2016) discuss these technical matters in more depth (see Appendix J).

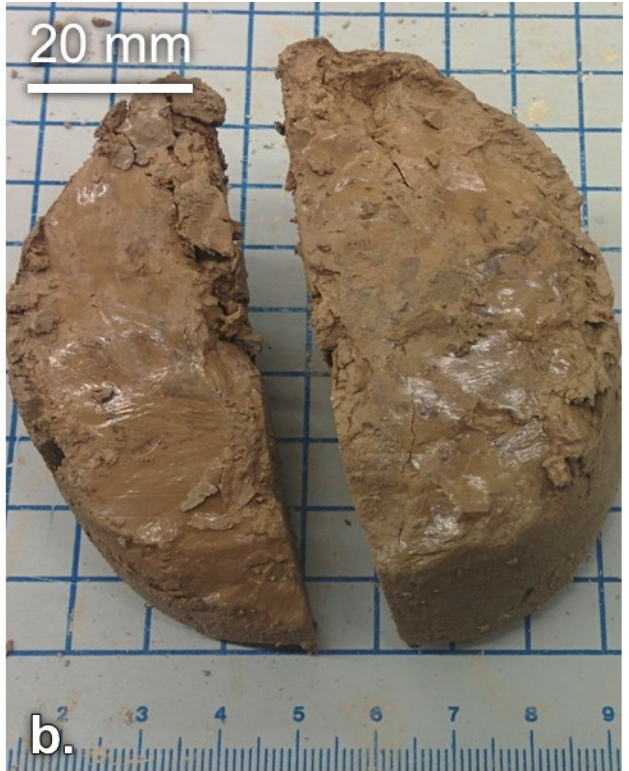
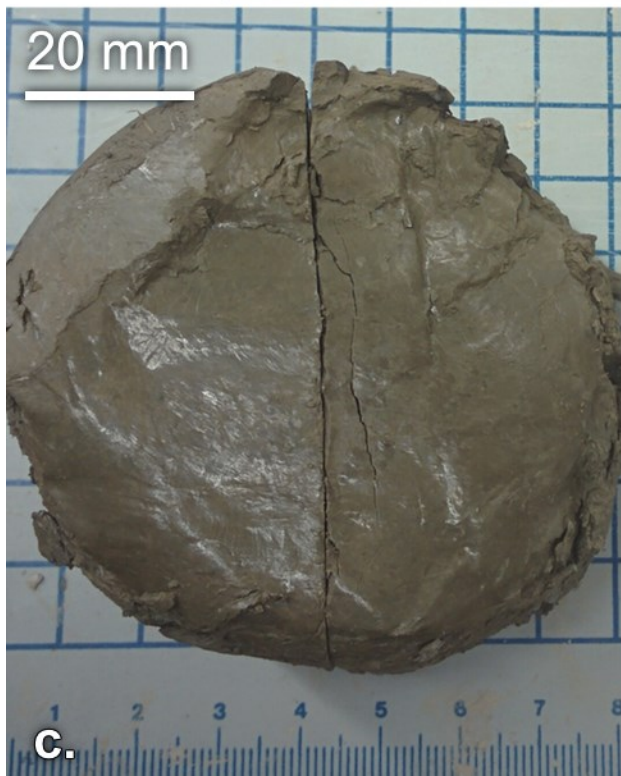
Figure B.2 Slickensides: (a) BH15-03 depth 9.5 m; (b) BH15-01 depth 10.1 m; (c) BH15-01 depth 12.0 m; (d) BH15-01 depth 7.7 m

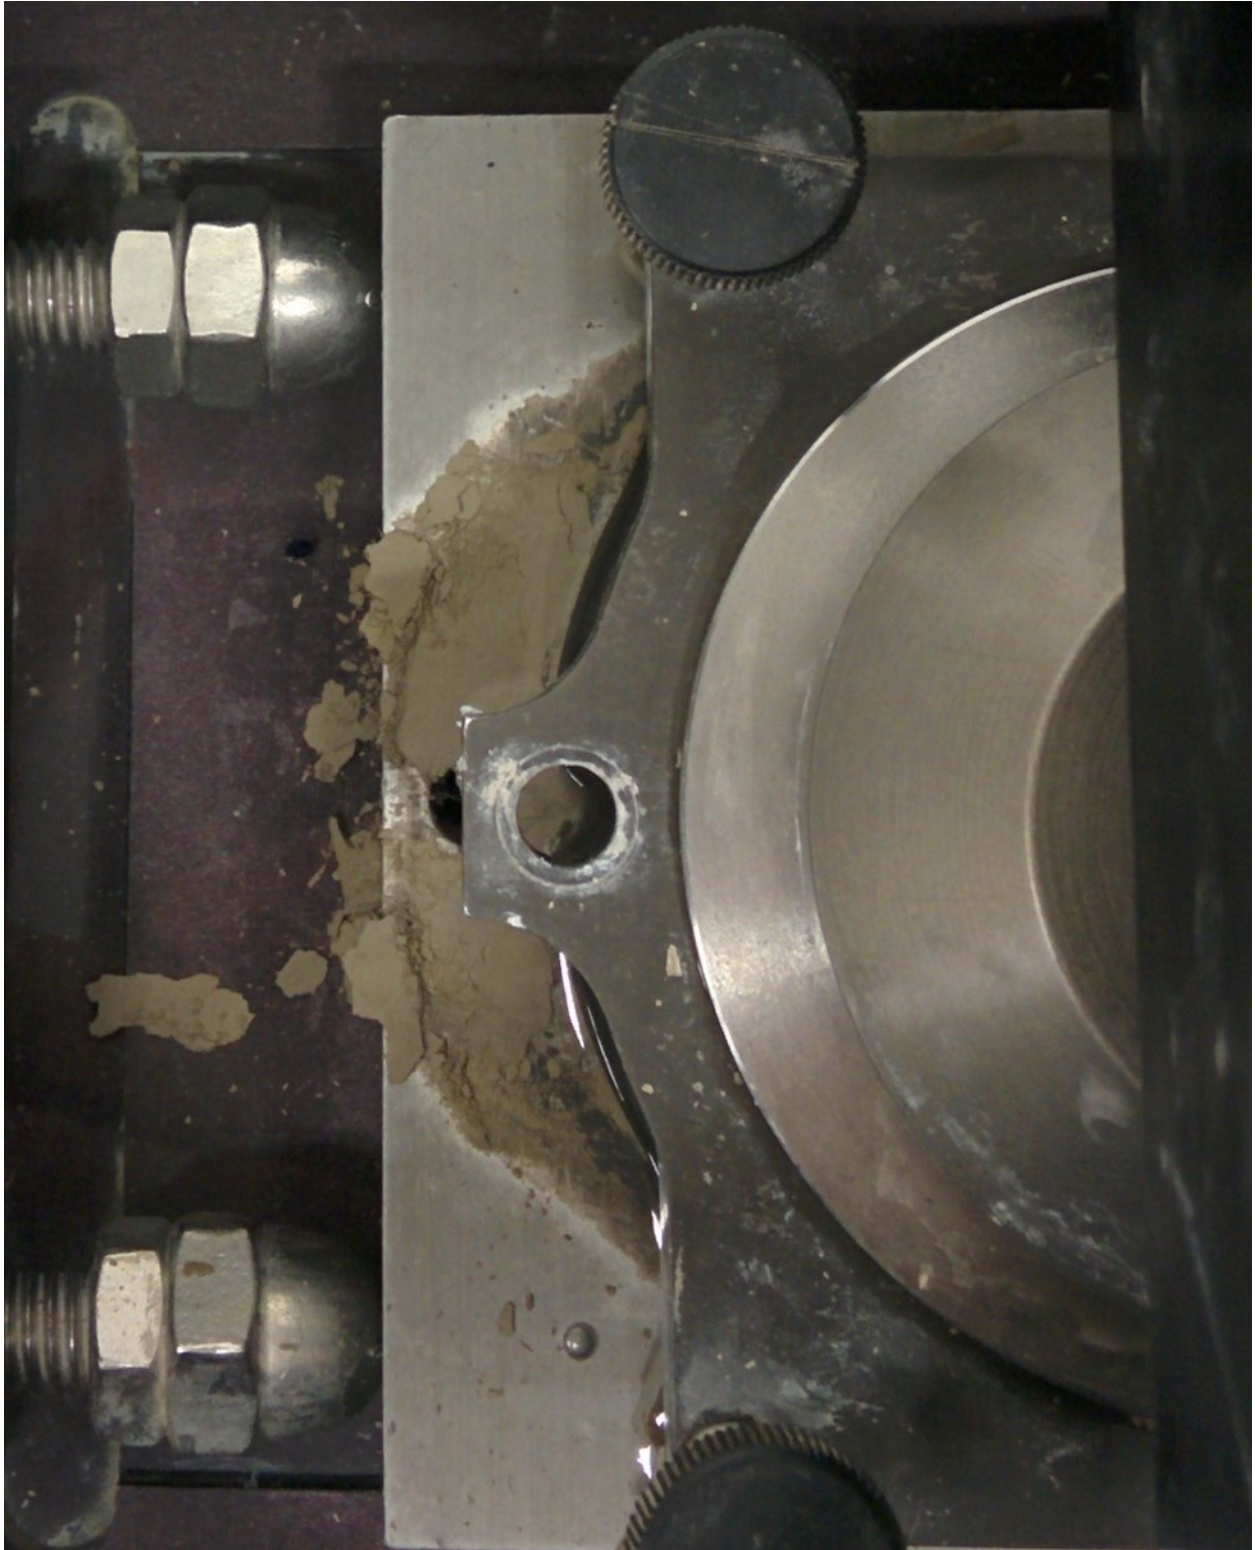
*Figure F.1. Soil extrusion at gap between shear box halves in Test S42\_2*
